Low Head Pipeline Replacement Project, Dolgarrog,

Archaeological Survey and Recording Report

Project No. G2158

Report No. 1114

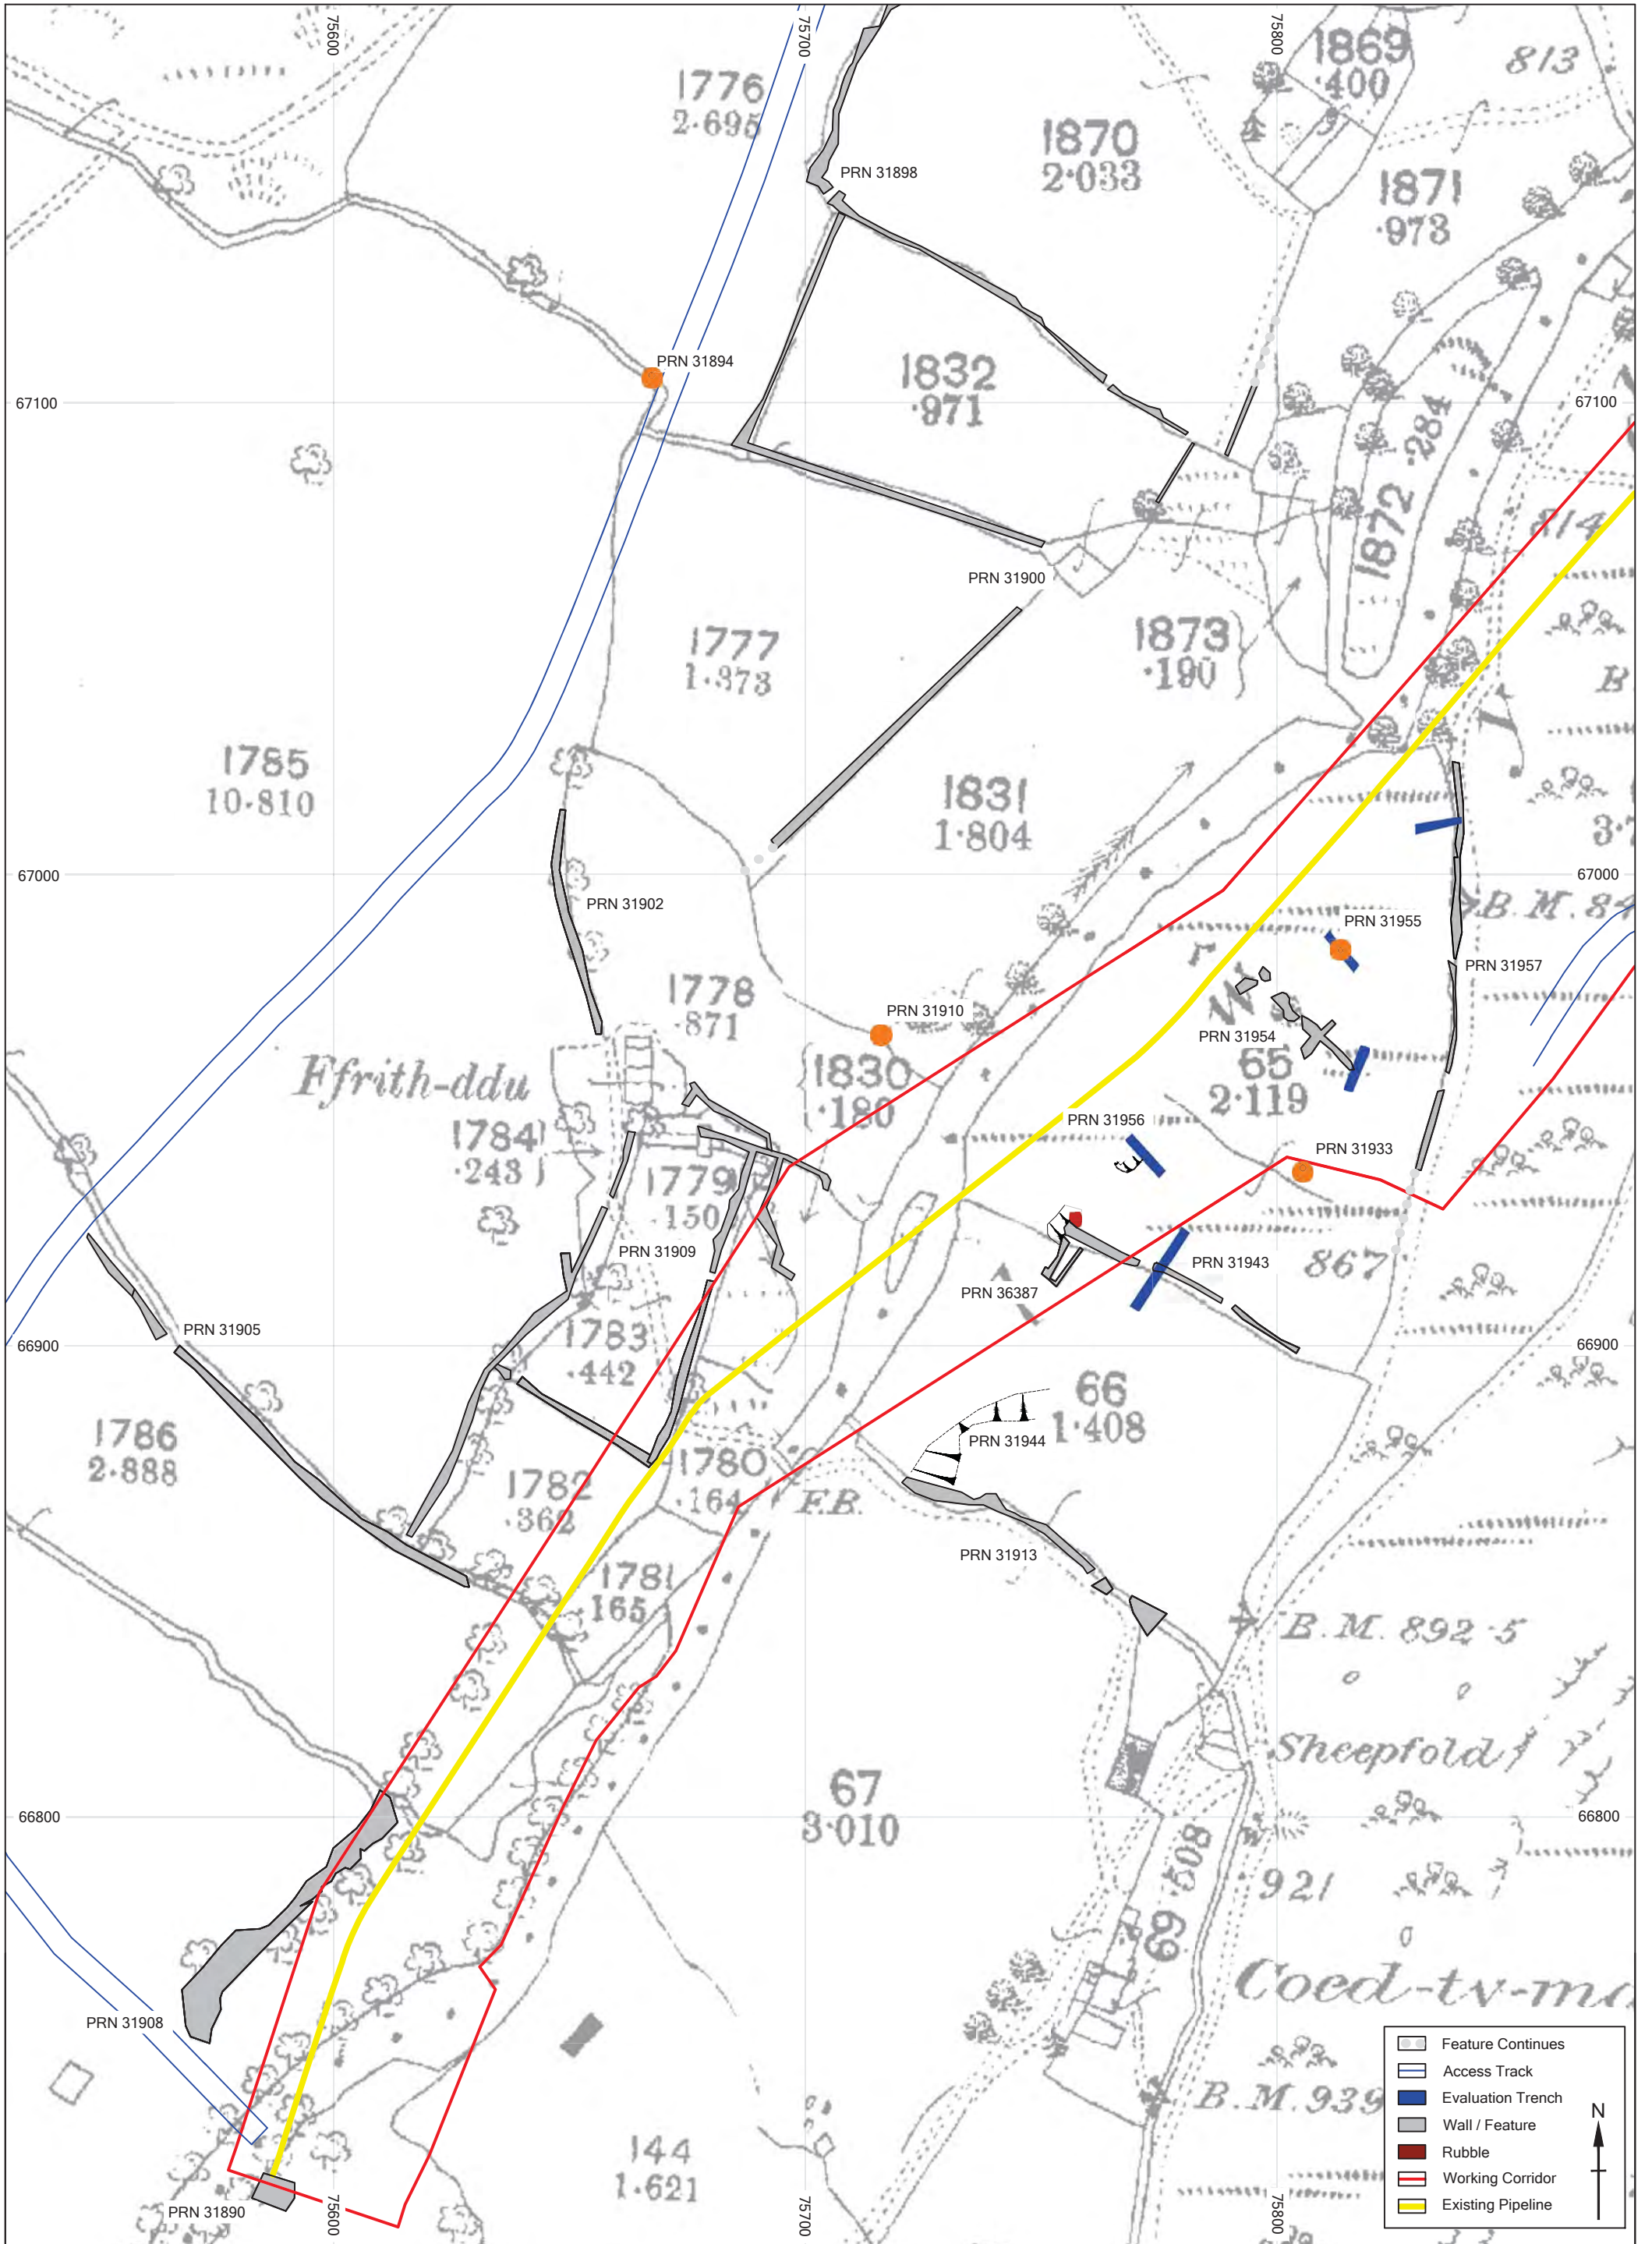
Fig. 2: Topographic Survey: Western Part. Overlain on the OS 1st Edition 25 Inch Map (1889)

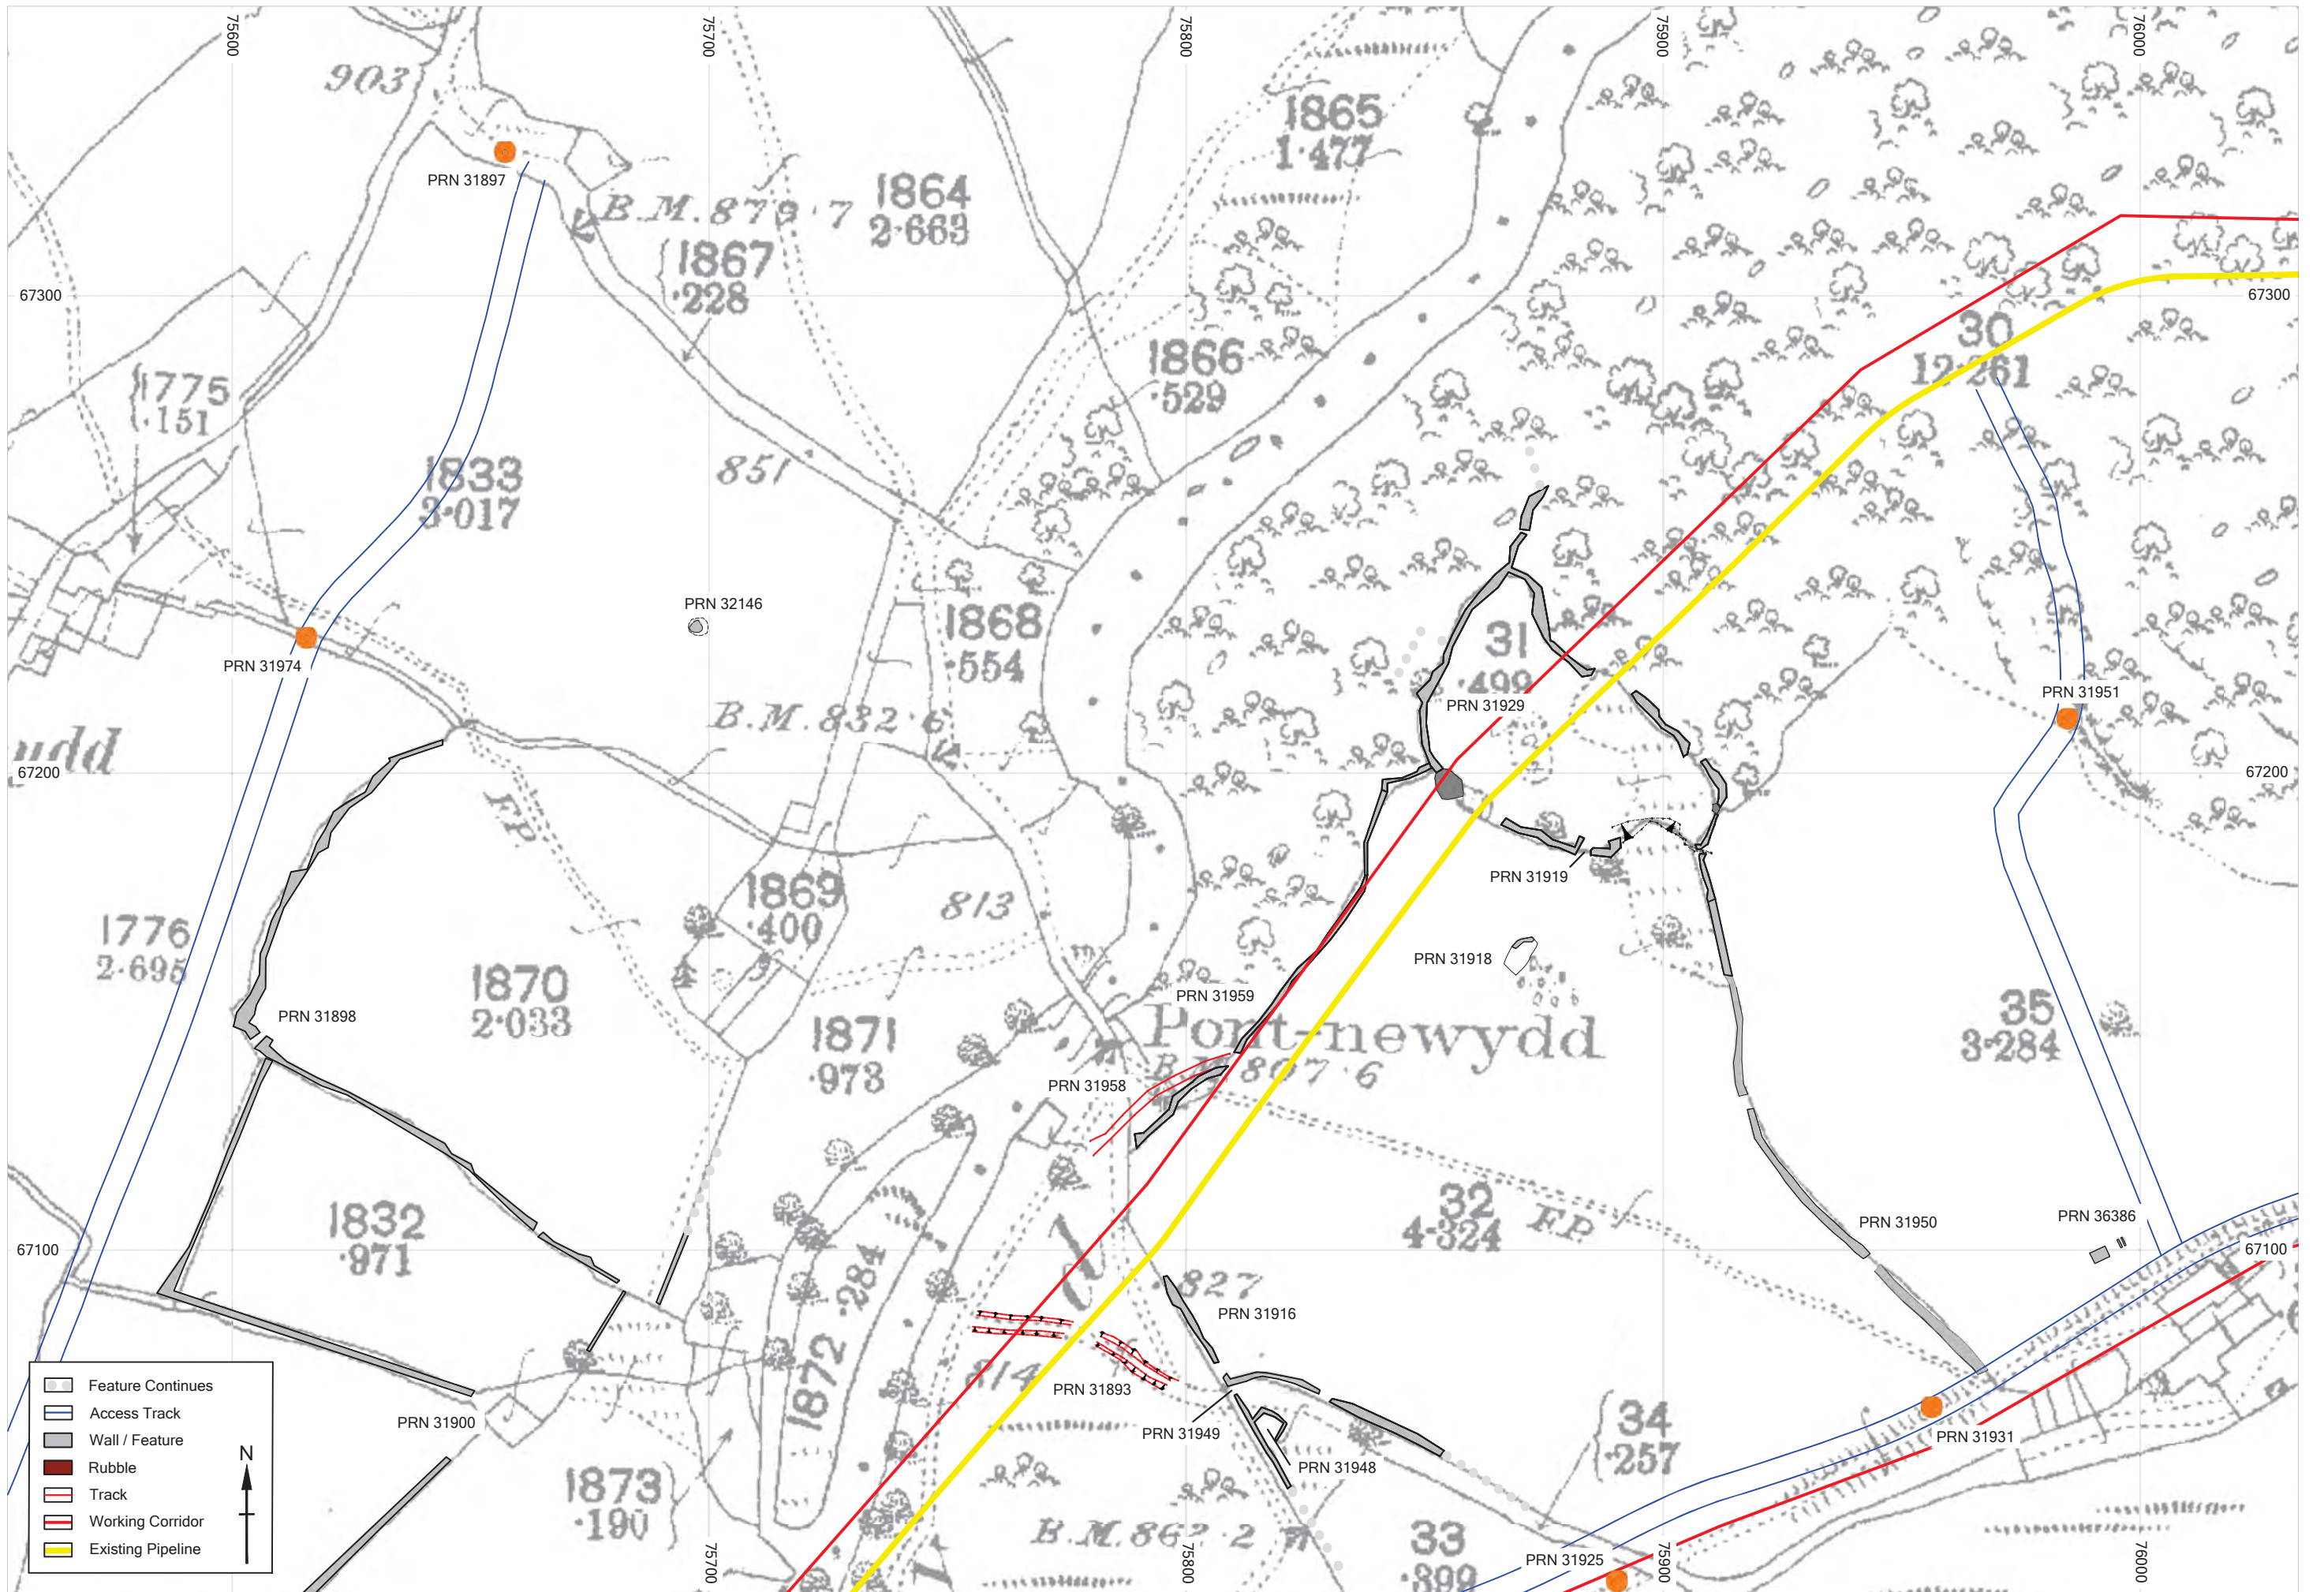
Fig. 3: Topographic Survey: Central Part. Overlain on the OS 1st Edition 25 Inch Map (1889)

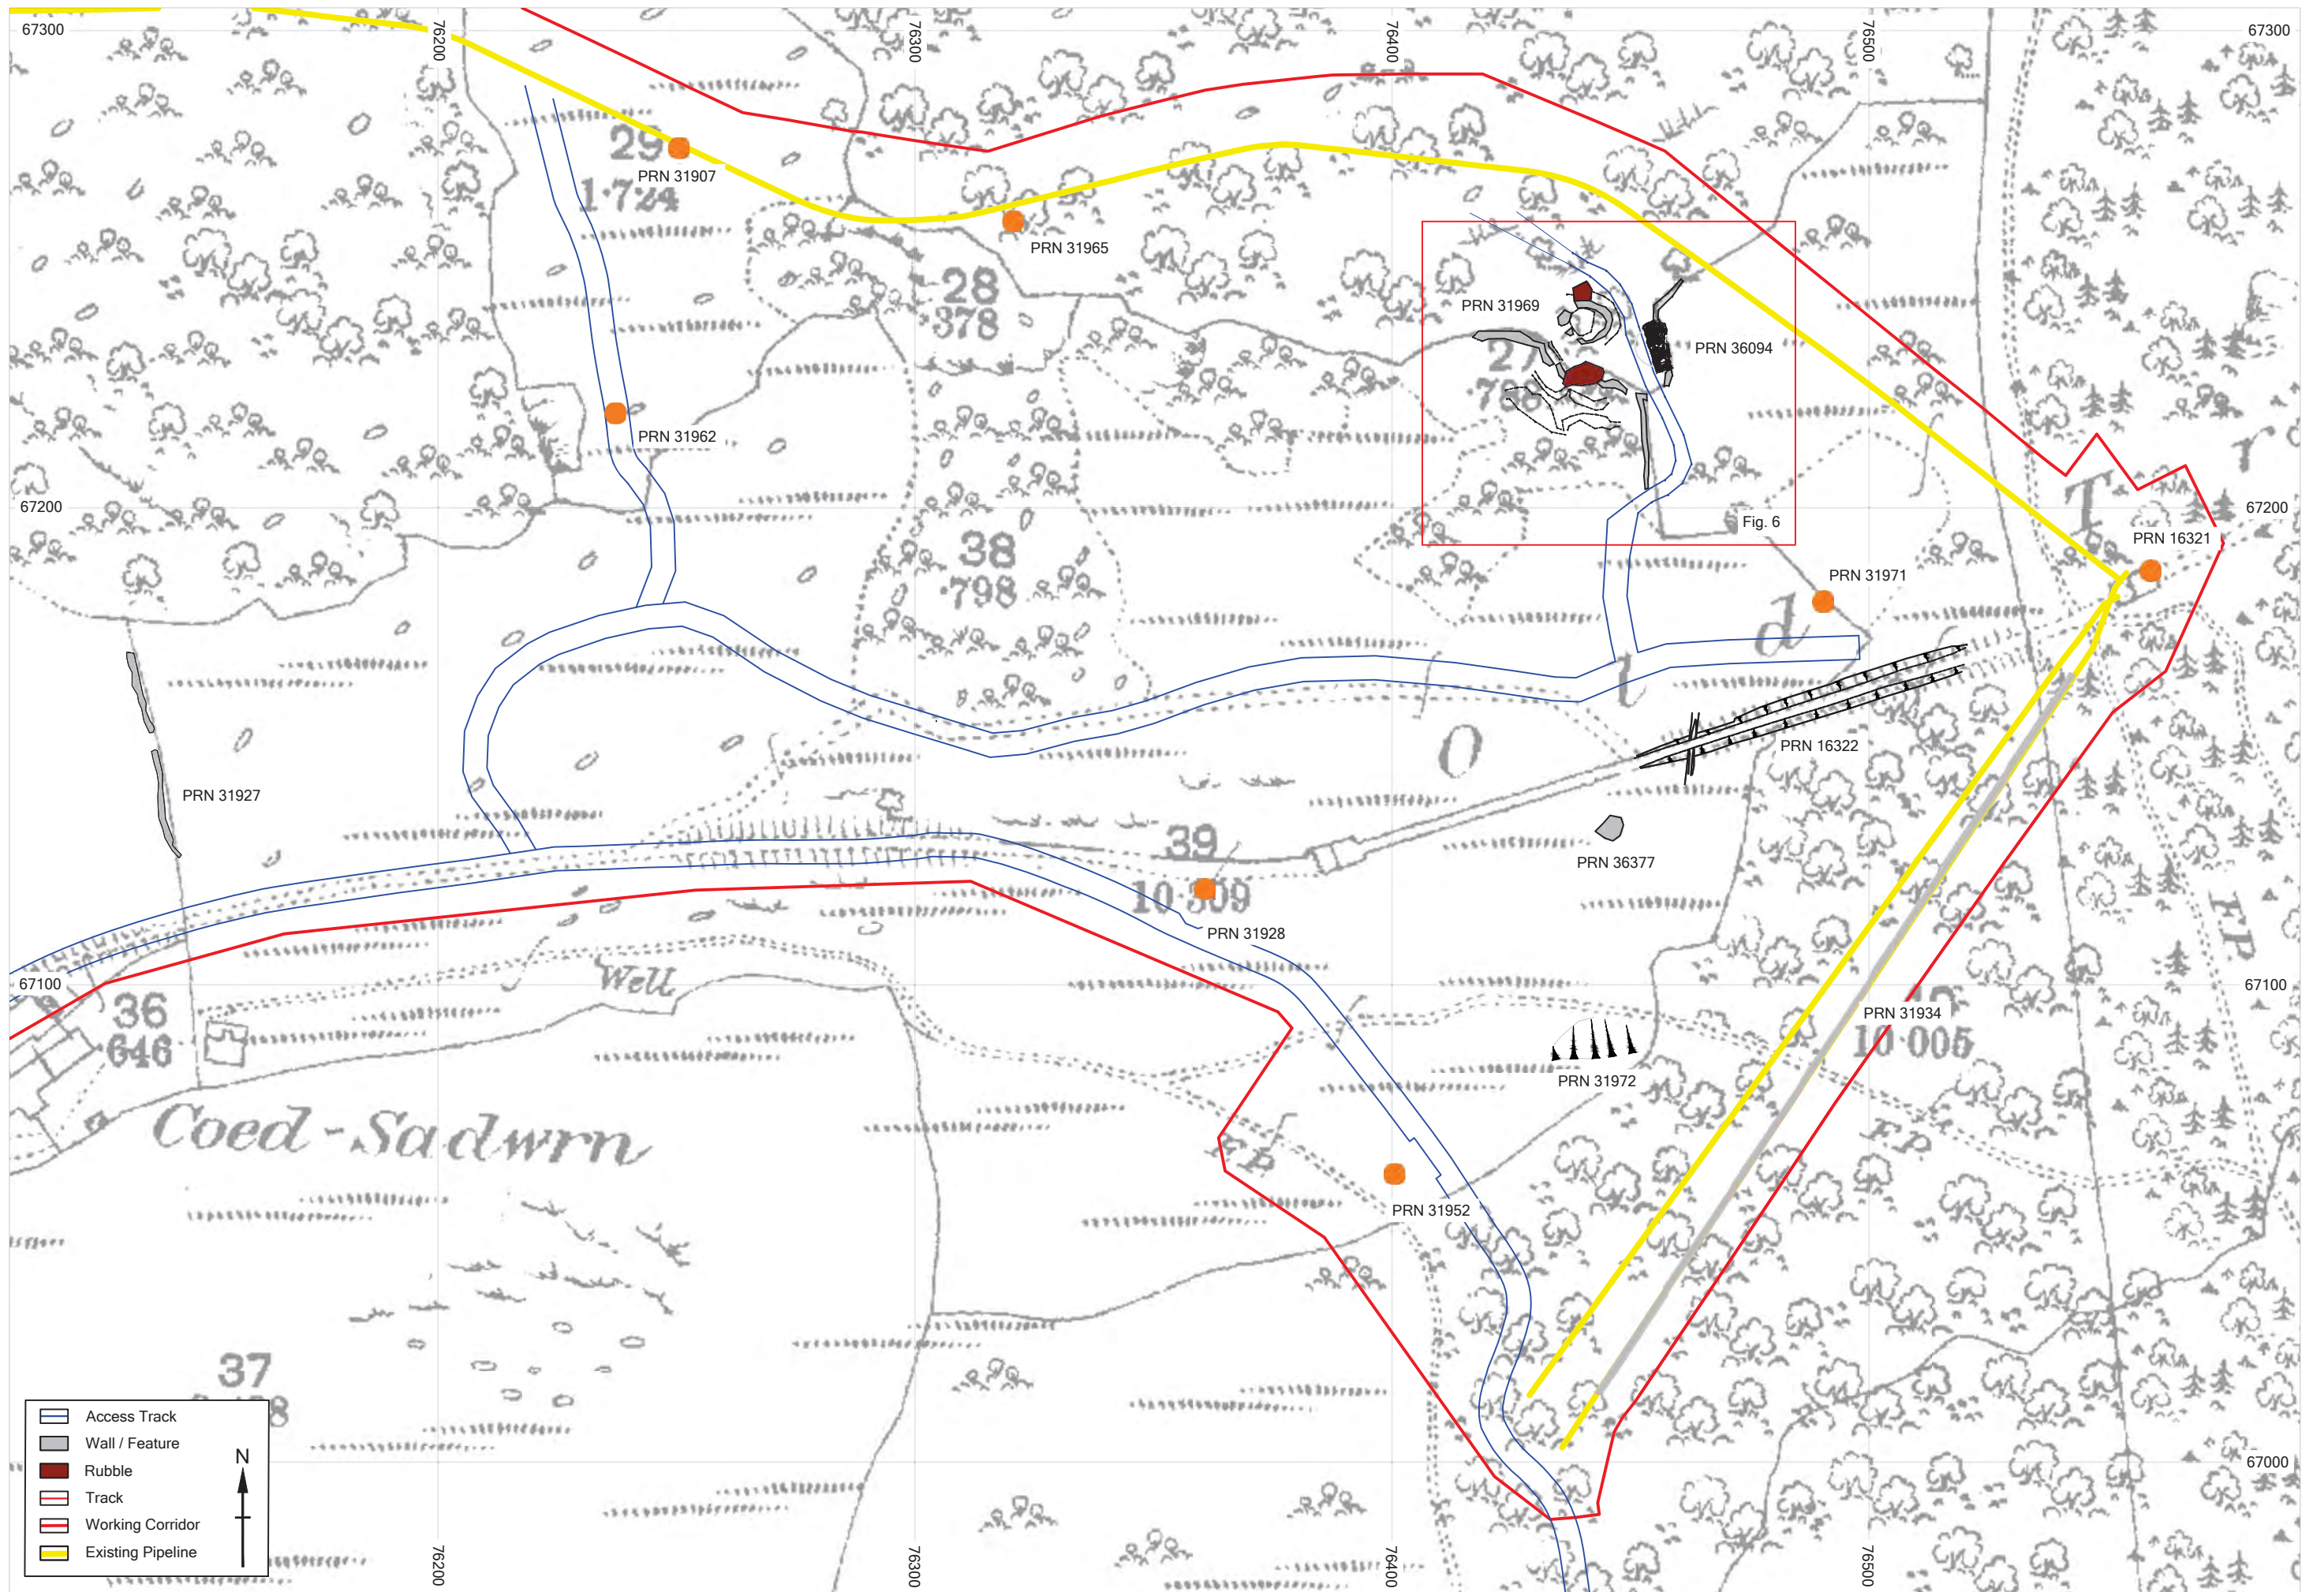
Fig. 4: Topographic Survey: Eastern Part. Overlain on the OS 1st Edition 25 Inch Map (1889)

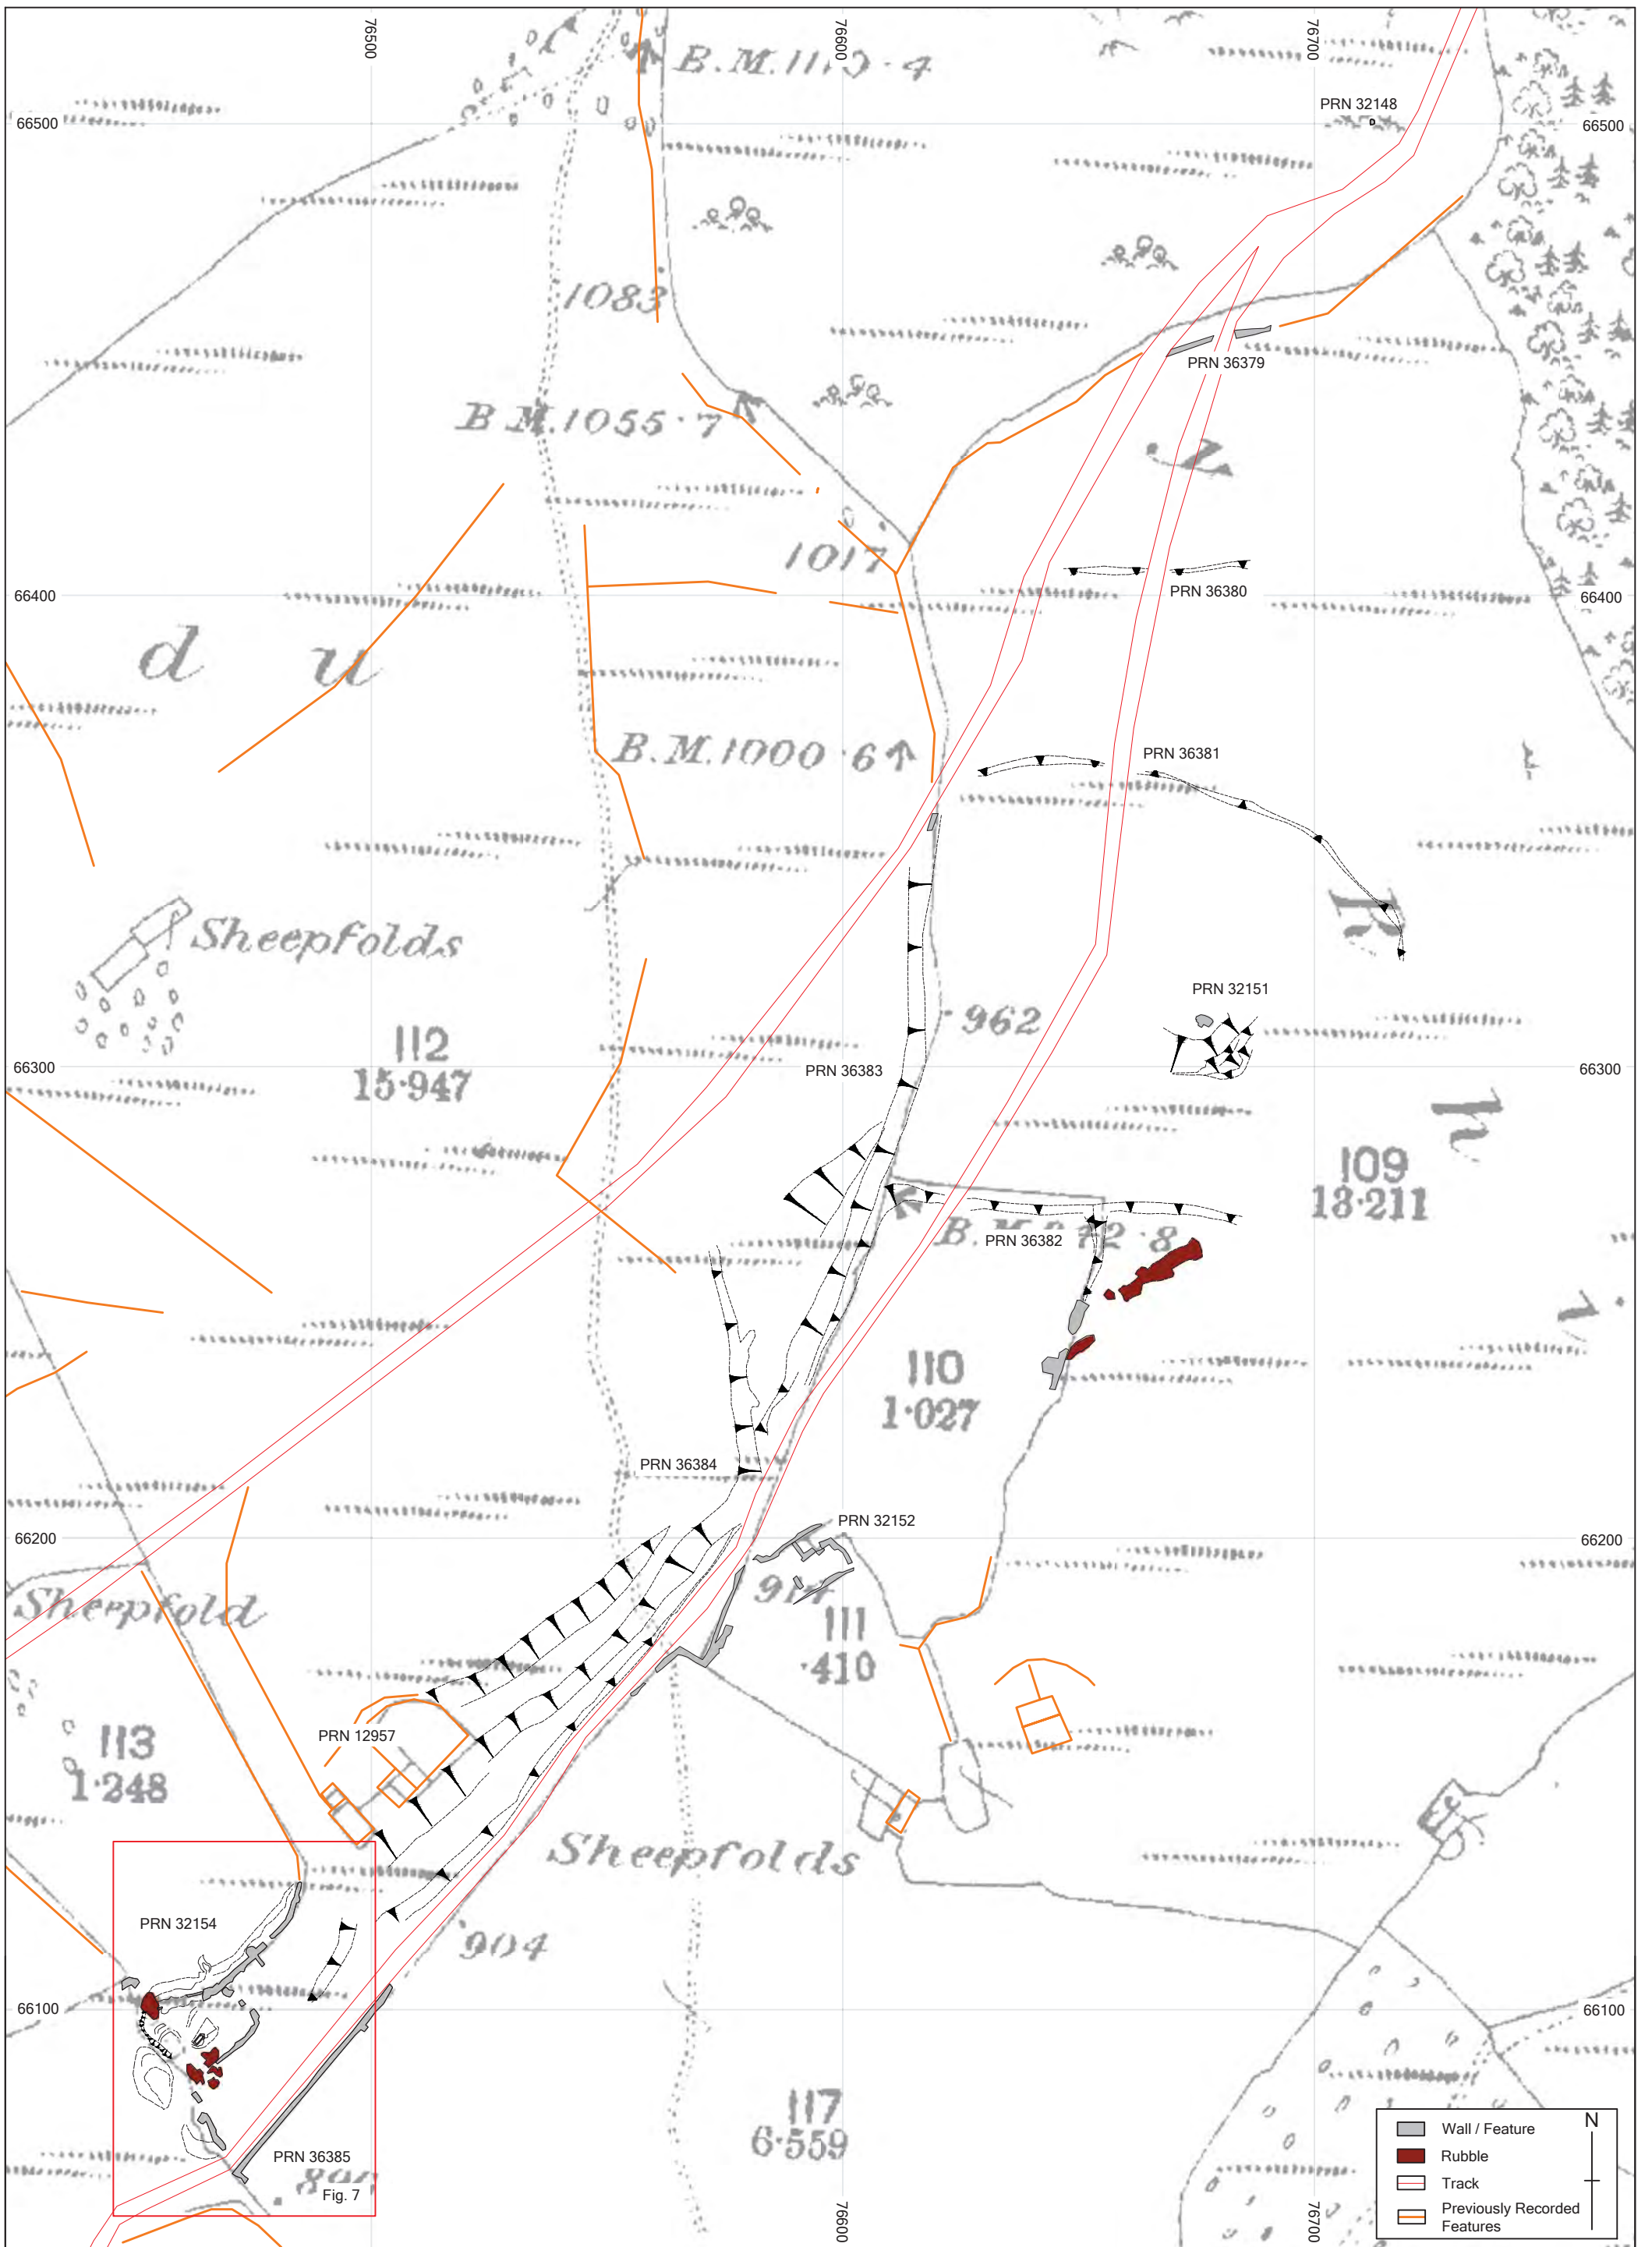
Fig. 5: Topographic Survey: Ardda Township Area. Overlain on the OS 1st Edition 25 Inch Map (1889)

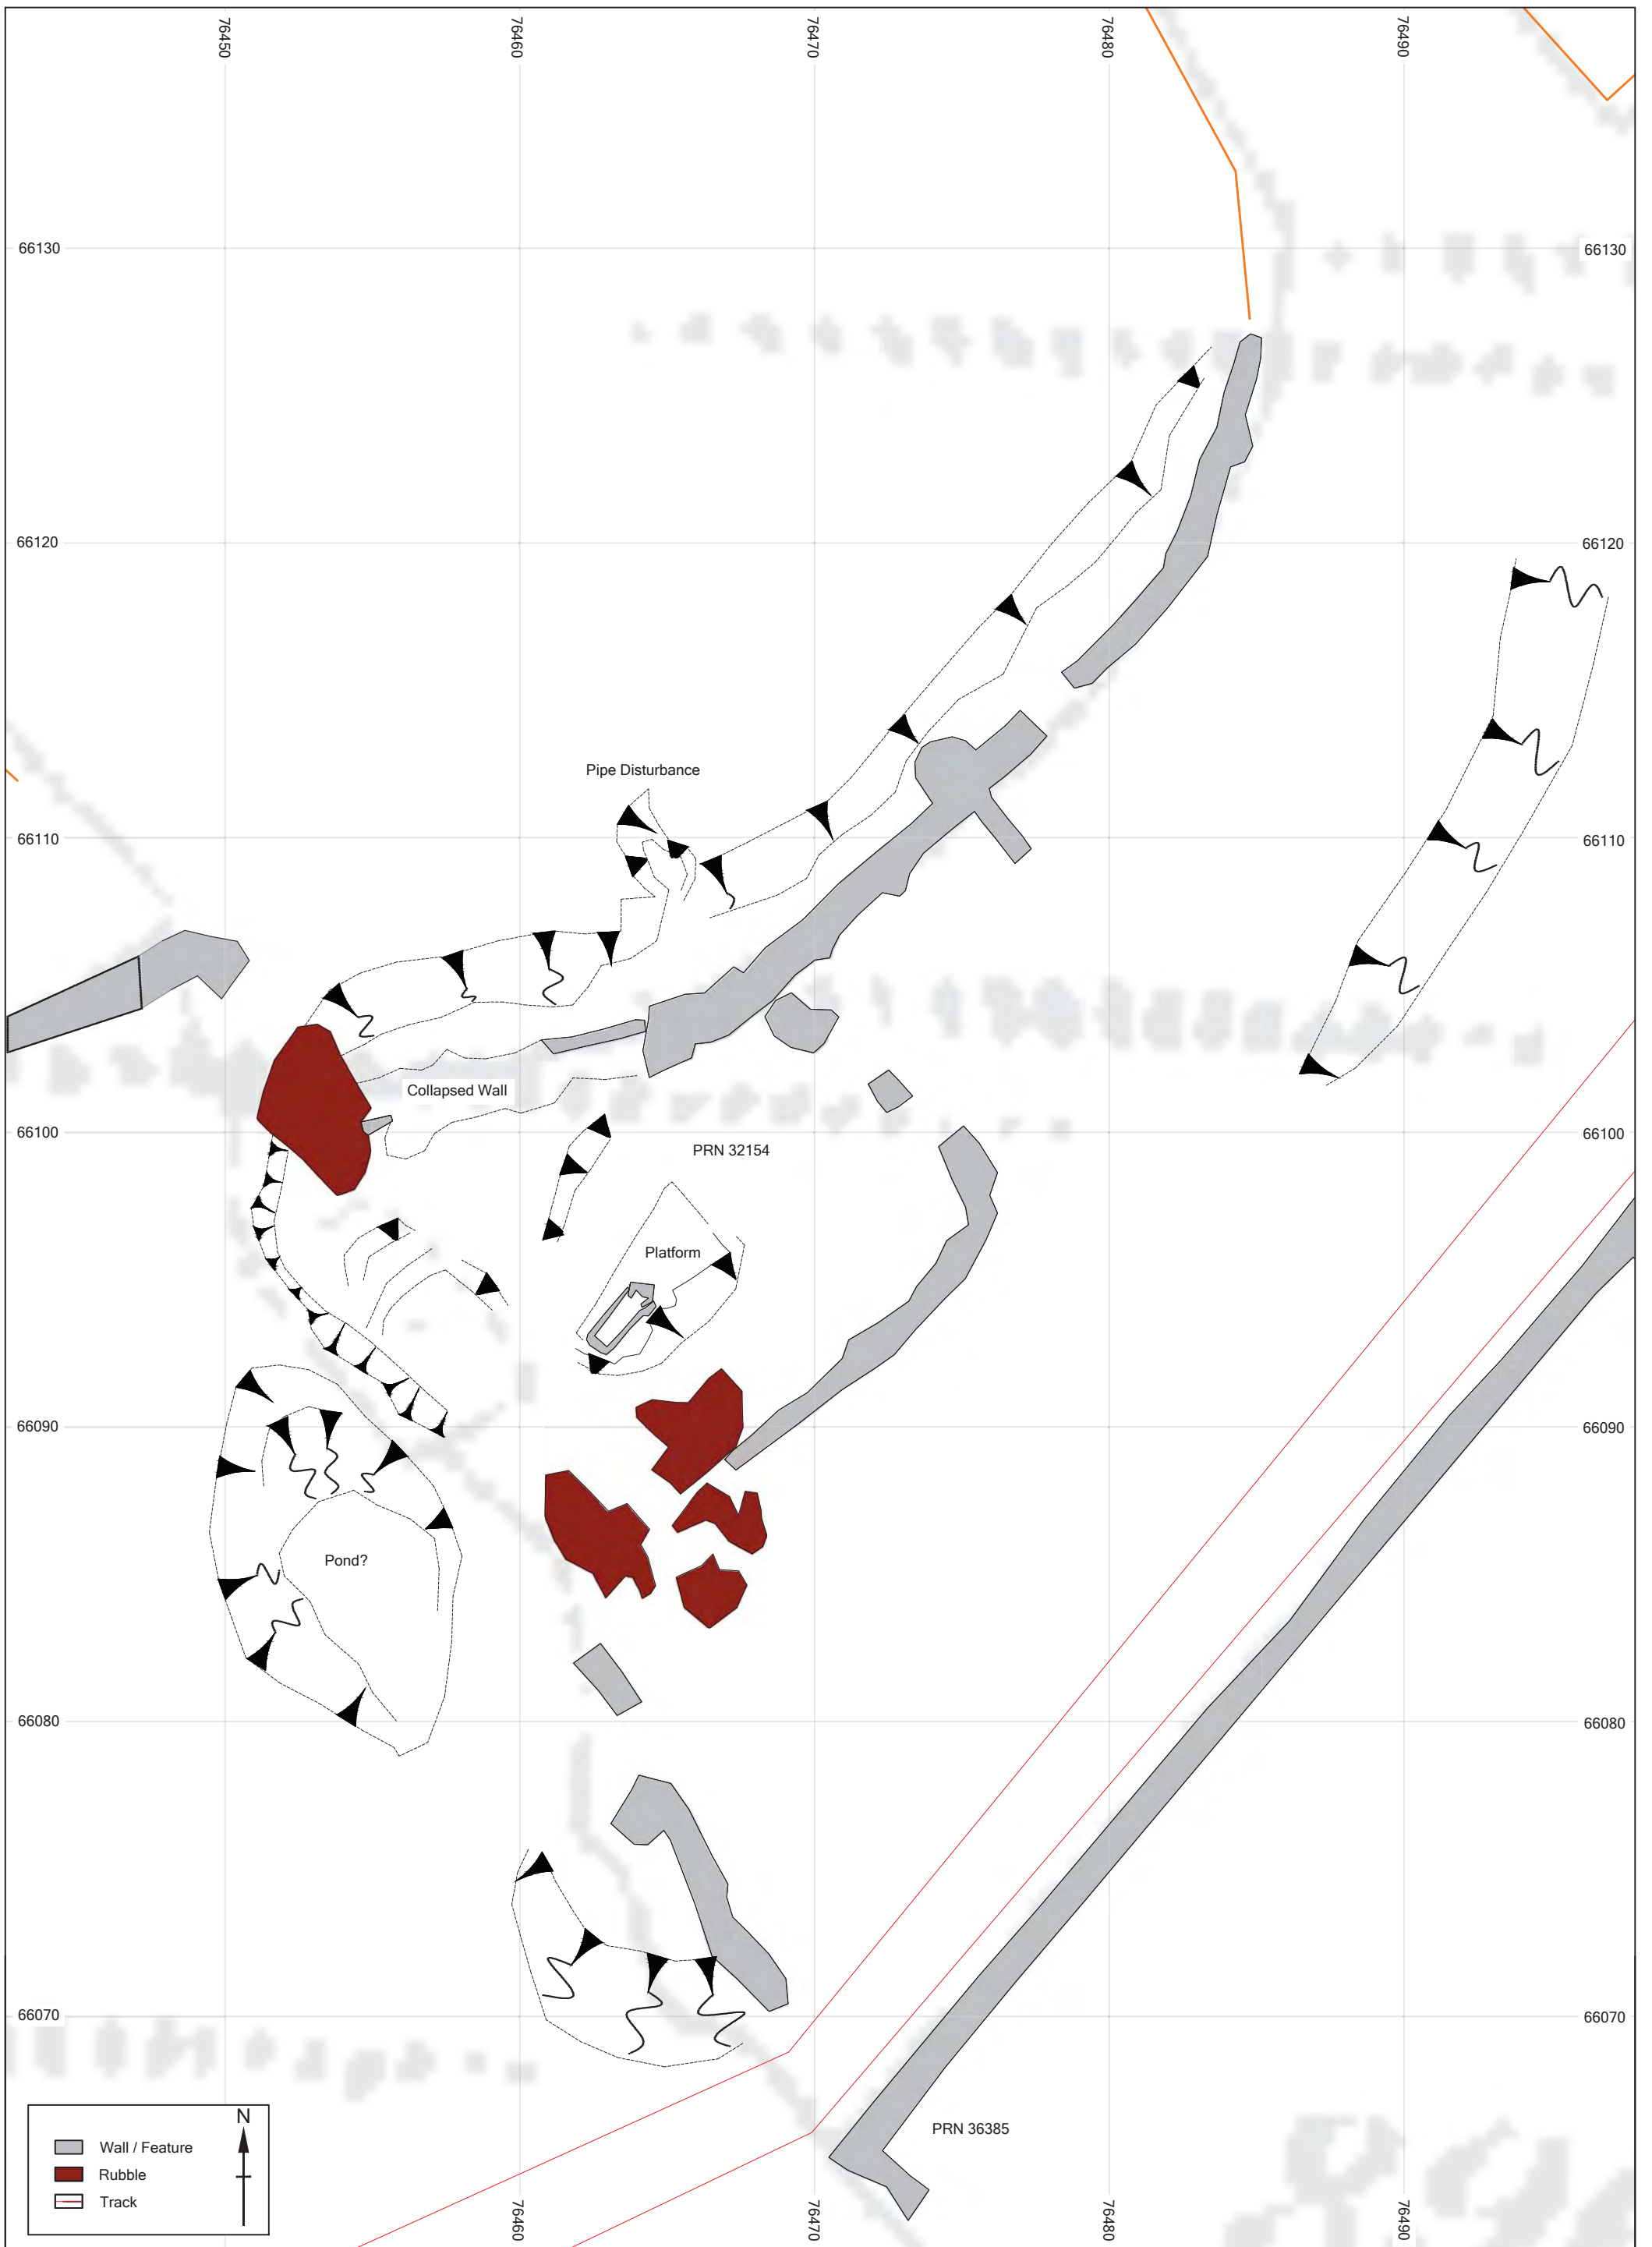
Fig. 7: PRN 32154: Ardda Township. Overlain on the OS 1st Edition 25 Inch Map (1889)

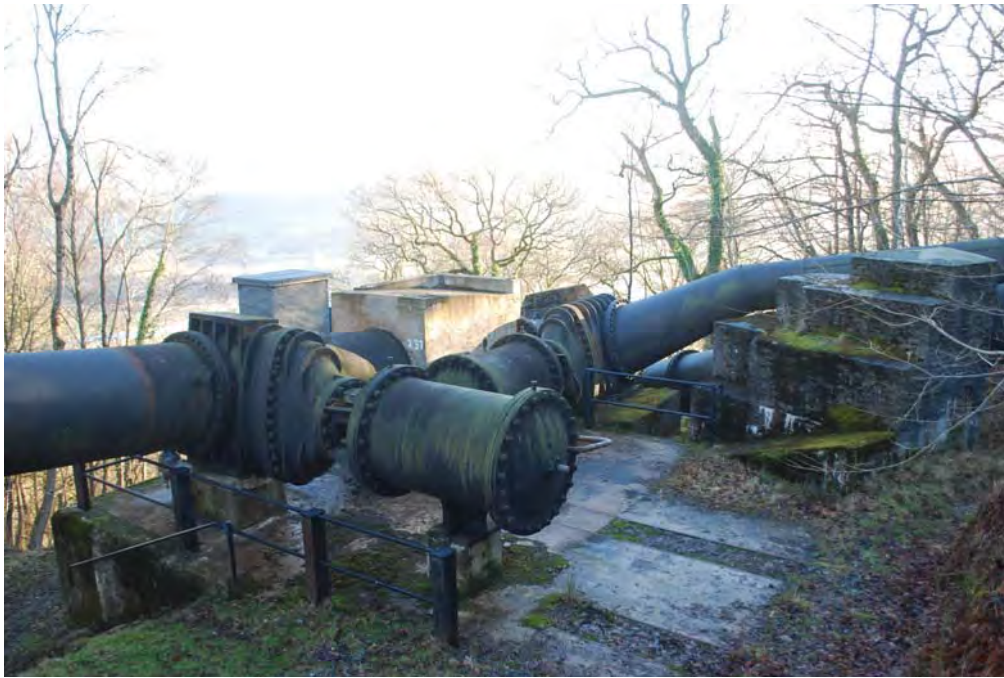
Plate 01: PRN 16321 - Marble Arch Pipe Junction, View From SW

The junction of pipes and valve house known as Marble Arch, after an iron gantry footbridge over the incline. The original Marble Arch had to be demolished as it was unsafe, with this arch being built at some point after 1925.

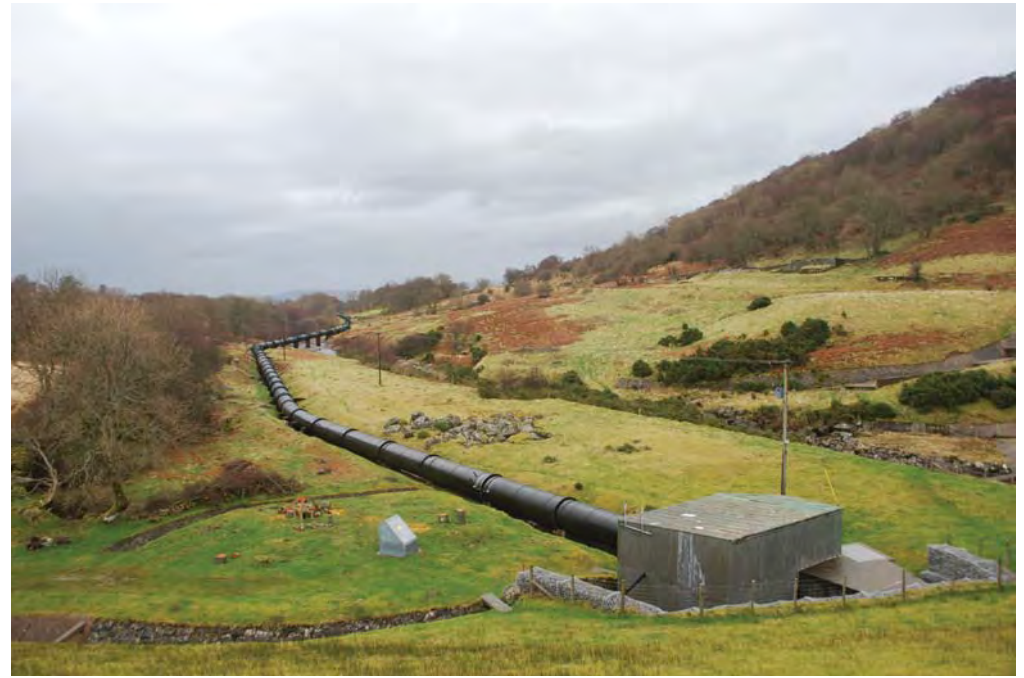
Plate 03: PRN 31890 and 31907 - Llyn Coedty Valve House and Pipe, View From SW

- **PRN 31907 (NGR SH75526674 to SH76566718): Pipe** - A riveted and welded 6 foot pipe running from Coedy Reservoir to its junction with other pipes at Marble Arch, and thence down to the power station at the aluminium works (plate 1). It was built on concrete piers and a plinth, and completed 1924, but there were problems with it and it failed under test and caused flooding in the village (GAT Report 928: 32). The pipe was damaged in the flood of November 1925 and rebuilt by March 1927 (*ibid*).

A riveted and welded six foot pipe running from Coedty Reservoir to its junction with other pipes at Marble Arch, and thence down to the power station at the aluminium works. It was built on concrete piers and a plinth, and was completed in 1924. However, there were problems with the pipe and it failed under test and caused flooding in a village. The pipe was damaged in the flood of November 1925 and rebuilt by March 1927. There are numerous points along the pipe where water is leaking from it.

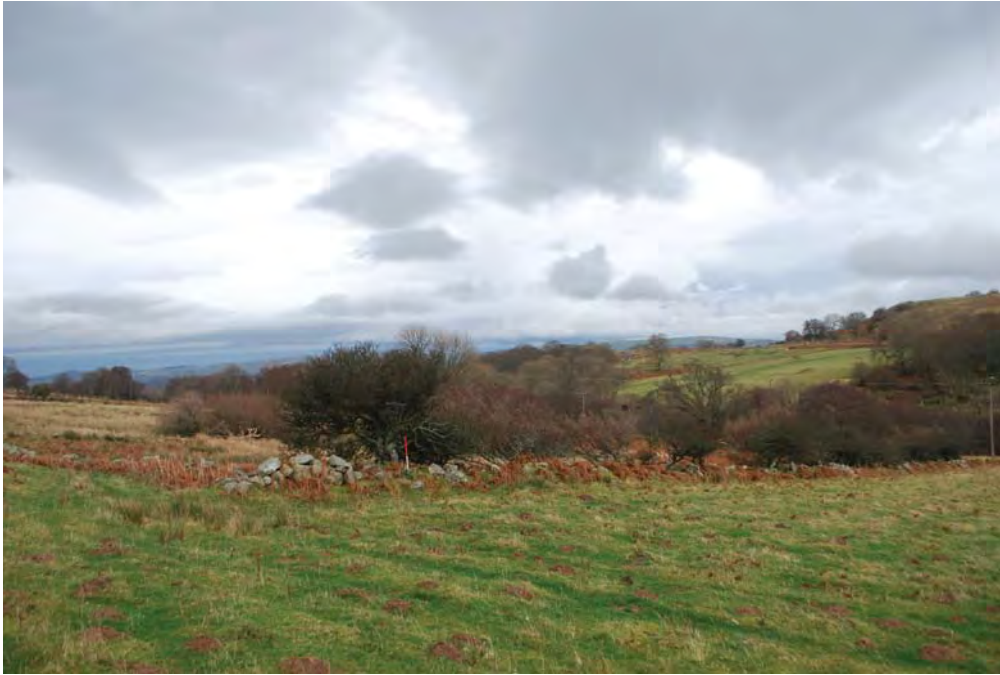
Plate 08: PRN 31900 - Field Boundary, View From SW

- **PRN 31900 (NGR SH75696709): Drystone wall** – 19th Century well-built drystone wall, surviving up to six courses high, of loose rounded boulders. The wall is up to 1m high in places. Its character appears to be of 19th century date, and built on a regular straight alignment. It probably forms a later sub division of some of the wandering wall systems. Large plant access requires removal of wall. Detailed recording prior to this event followed by an archaeological watching brief during breaching.

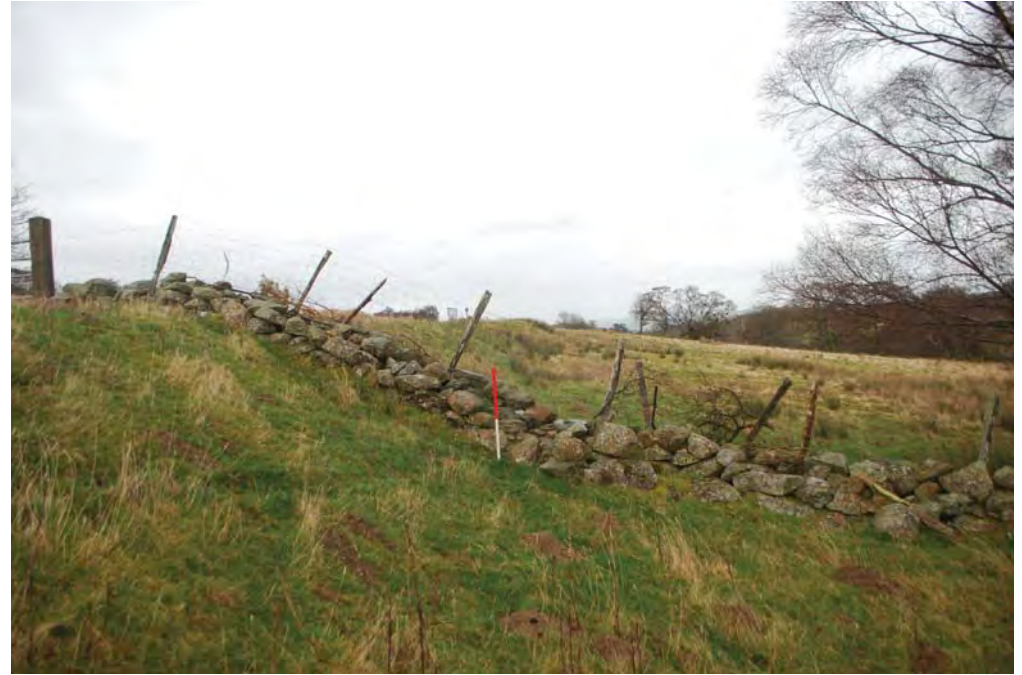
Plate 10: PRN 31905 - Field Boundary, View From SW

- **PRN 31905 (NGR SH75576690C): Drystone wall** - Late medieval/early post medieval wall Probably rebuilt and straightened at NW end but probably part of the older field system. A well-built drystone wall of loose rounded boulders. The wall is up to 1m high in places. Its character appears to be of 19th century date, but its south-eastern end was far from straight as shown on the 1889 map. It is probable that the wall has been rebuilt and straightened but was originally part of the wandering wall system around Ffrith-Ddu. The south-eastern end of this wall may have to be removed. . Detailed recording prior to this event followed by an archaeological watching brief during breaching.

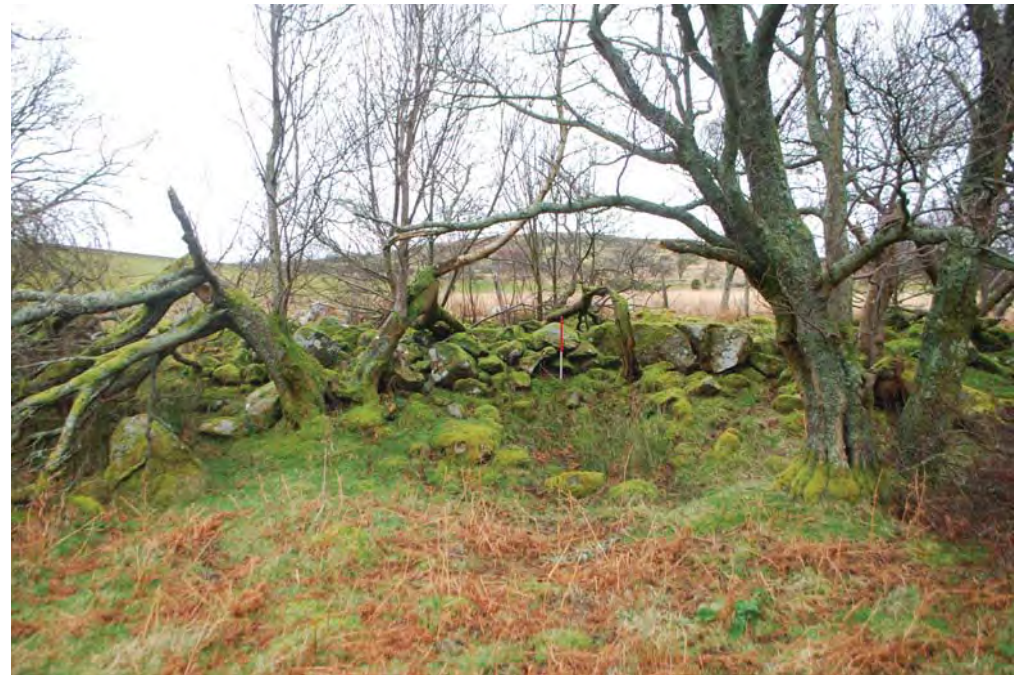
Plate 11: PRN 31908 - Field Boundary, View From SE

- **PRN 31908 (NGR SH75606678 C): Drystone wall** - Late medieval/early post medieval well-built drystone wall of loose rounded boulders, although now very collapsed. The wall is up to 0.5m high in places. Trees grow along its length. Detailed on the 1889 map as a line of trees, so the wall must have been out of use by then. Detailed recording prior to groundworks followed by an archaeological watching brief during breaching.
