Low Head Pipeline Replacement Project, Dolgarrog,

Archaeological Survey and Recording Report

Project No. G2158

Report No. 1114

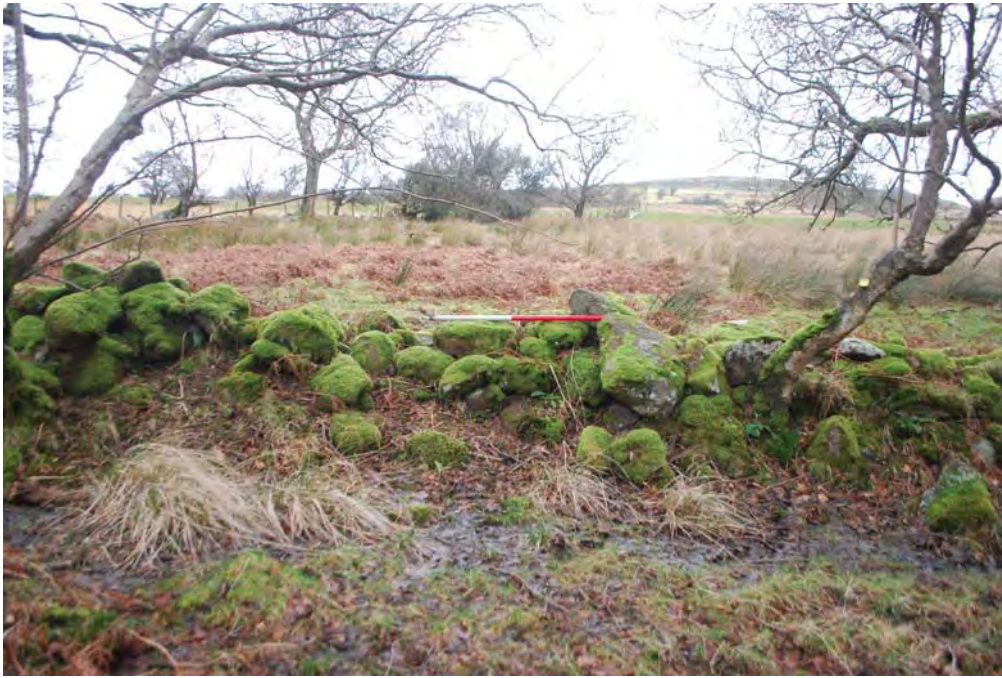
Plate 12: PRN 31909 - Field Boundary, View From SE

- **PRN 31909 (NGR SH75646690): Drystone walls south of Ffrith Ddu House** - Late medieval/early post medieval well-built drystone wall of loose rounded boulders. The wall is up to 1m high in places. Associated with other less well preserved walls forming small rectangular fields. These walls wander slightly and are probably of pre-19th century date. Detailed recording including survey. Watching brief including recording of section.

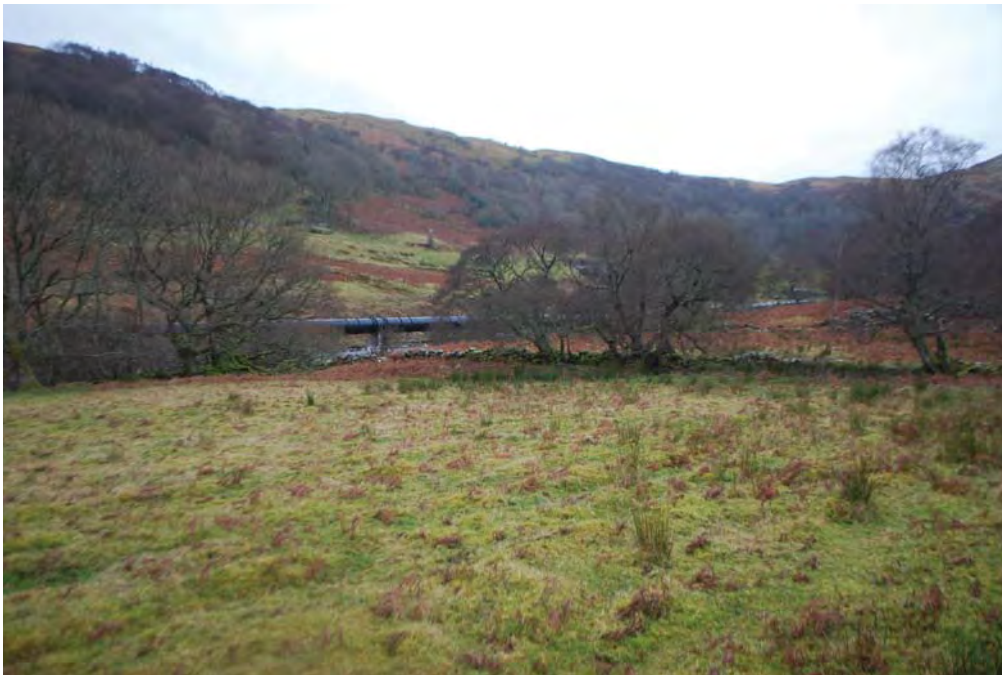
Plate 13: PRN 31910 - Field Boundary, View from N

- **PRN 31910 (NGR SH75726697): Drystone wall with possible inscribed stone** - Late medieval/early post medieval much collapsed drystone wall, probably associated with Ffrith Ddu farmhouse. It included a rough boulder, about 1.3m high and 0.4m wide, inscribed with a possible Latin Cross orientated slightly north-north-west to south-south-east. The stone is broken along its western side. The SE end of this wall may have to be removed. Detailed recording, watching brief

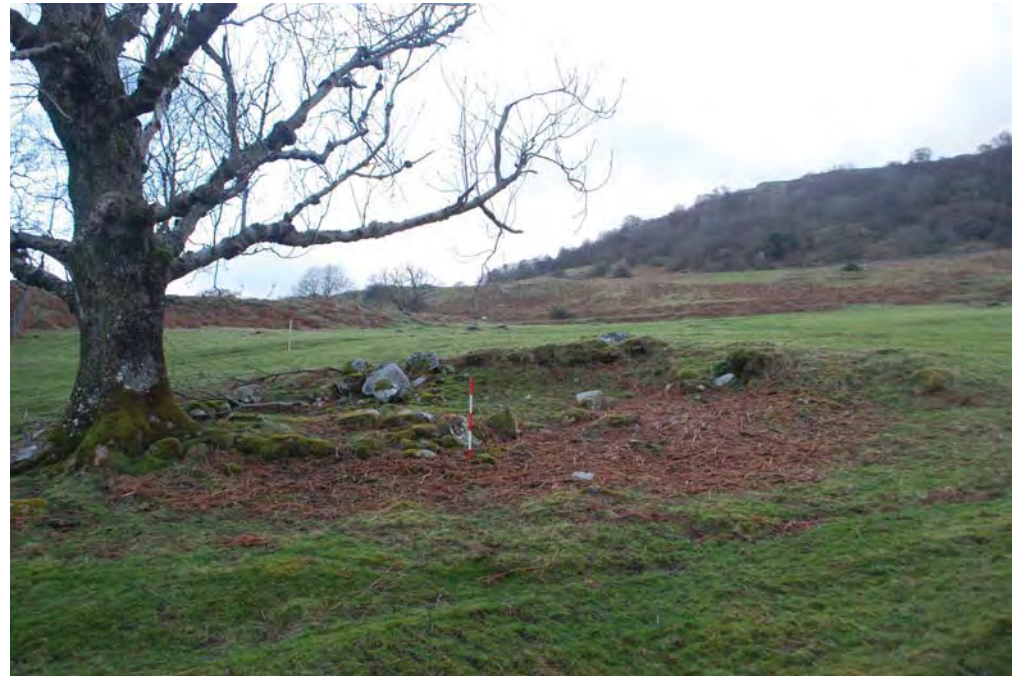
Plate 16: PRN 31918 - Remains of Long Hut, View From NW

- **PRN 31918 (NGR SH75976716):** Stone structure/long hut - late medieval/early post medieval. Small rectangular stone built structure orientated north-east south-west, measuring c8.5m x 4.7m externally (plate 7). It is built of rough coursed angular shale slabs, and smaller stones forming walls about 0.7m wide. The SE wall is best preserved as it is terraced into the slope and it stands c.1m high, the SW wall is also fairly well preserved but the other two walls survive only at foundation level. The NW wall has a line of facing stones surviving at foundation level. The interior is full of rubble. The building runs along the slope rather than perpendicular to it and has no other characteristics of medieval long huts. Its preservation also suggests an early post medieval rather than a medieval date. It was probably the house associated with a small farmstead including the adjacent enclosure. *The fencing should be very clear as the whole field is to be used for access.*

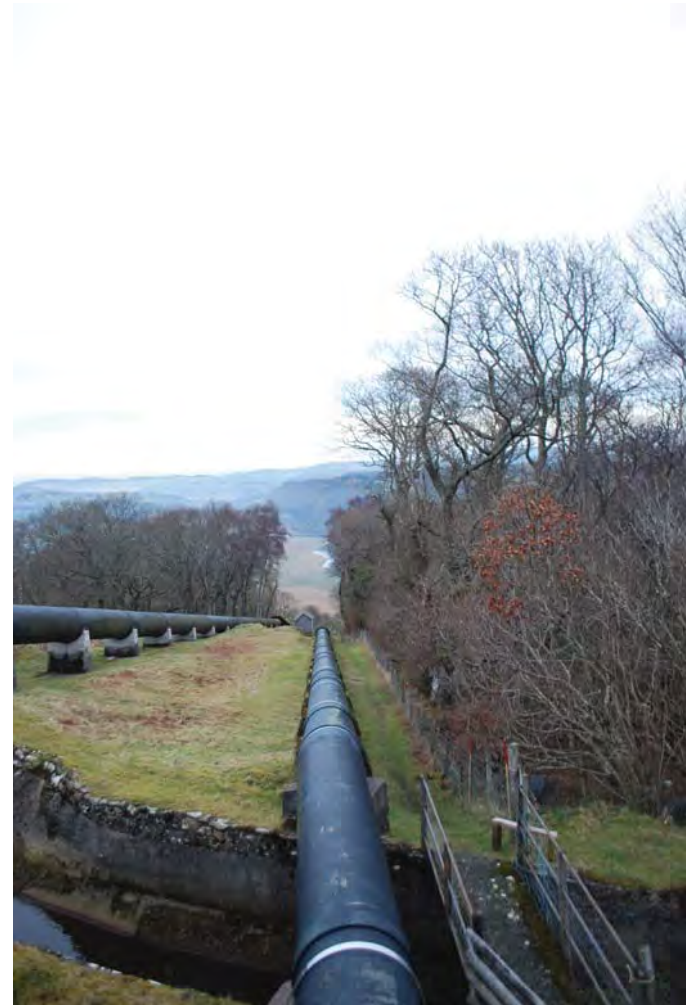
Plate 24: PRN 31934 - Incline and Water Pipe, View From SW

- **PRN 31934 (NGR SH76476704): incline and water pipe** - Part of water catchment system for hydro-power station built for the aluminium works between 1907 and 1911, an incline taking water in a pipe from the upper leat to the power station. The incline is shown on 1913 map, although it does not indicate the pipe. The pipe was made redundant when the pipeline from Llyn Cowlyd was constructed in 1936 and 1937 (*ibid.*: 40), but is still used as part of the surge protection for the Coedty system. This pipe is to be entirely removed and replaced, and will possibly be mounded over and partially buried. The impacted area indicated on ES Chapter 6 Figure 6.3 (reproduced in Appendix IV), will be surveyed; a detailed record will also be completed.

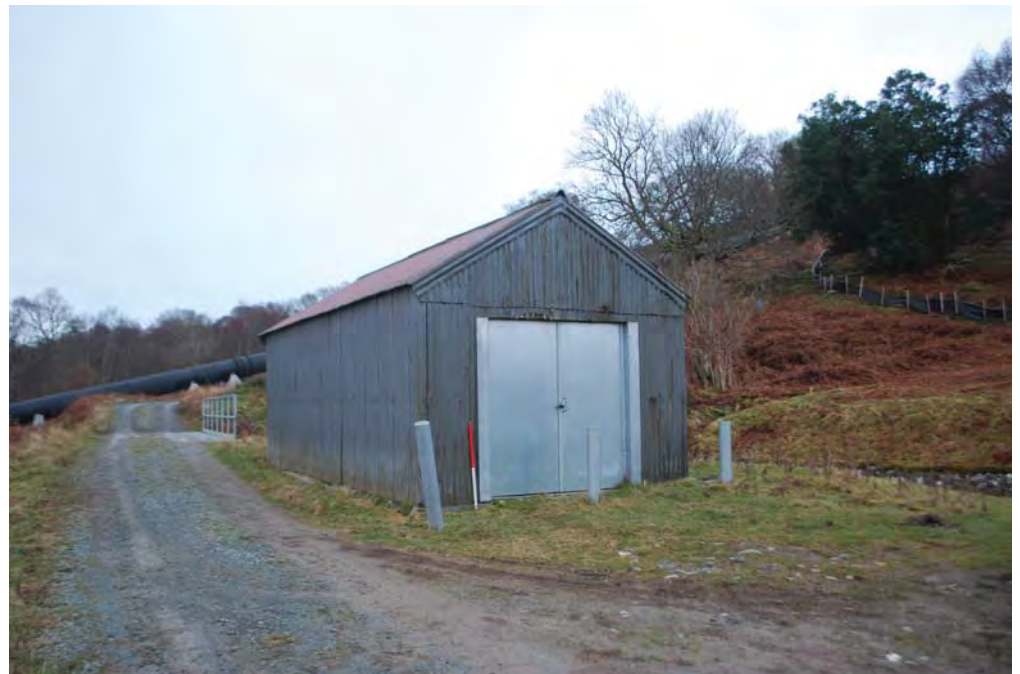
Plate 31: PRN 31952 - Former Locomotive Shed, View From NNW

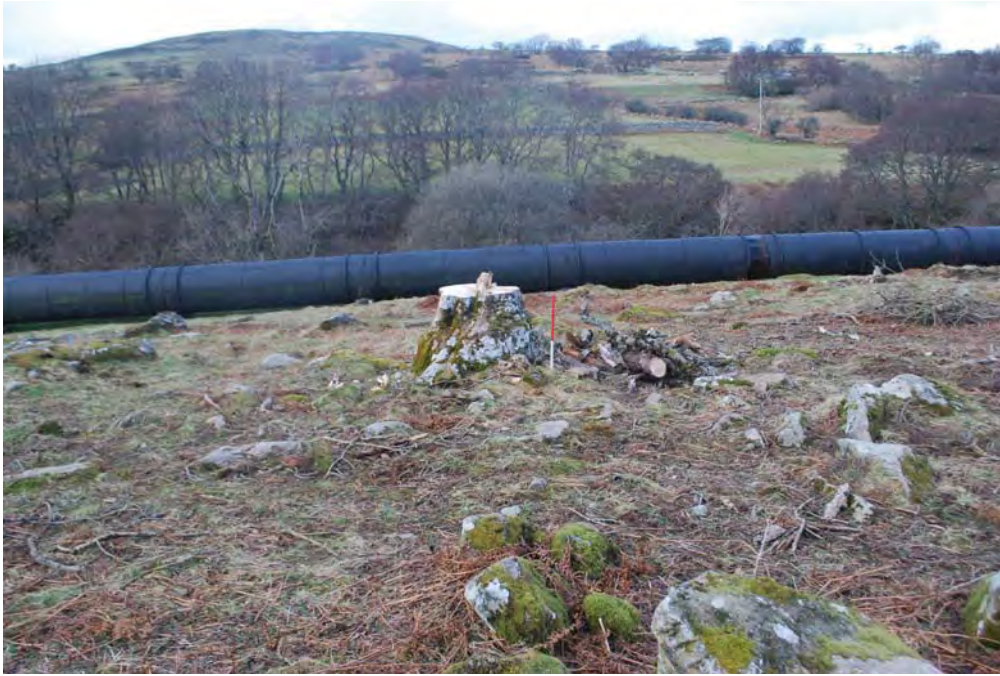
Plate 32: PRN 31954 - Field Boundary, View From SE

- **PRN 31954 (NGR SH75826696): Possible ancient wall** – A rough line of stones running c. NW-SE uphill, including one stone set on edge (plate 3). The alignment continues for about 22m with a large natural boulder forming part of it. Some of the stones in the line look possibly laid and others look natural. The field is very stony and this could be a chance alignment but it is quite coherent and may be a much denuded field wall. If it is the latter its condition suggests that it might be older than the other boundaries in this area and could be prehistoric. This field may have suffered severely from erosion as it is shown on the 1788 map as being under arable, which currently seems unlikely with the quantity of stones. However if it was of much better quality in the past its use as a prehistoric field seems more likely. A targeted trench measuring 10m by 2m will be located across the receptor; the results may lead to further mitigation that will be discussed in a future project design.

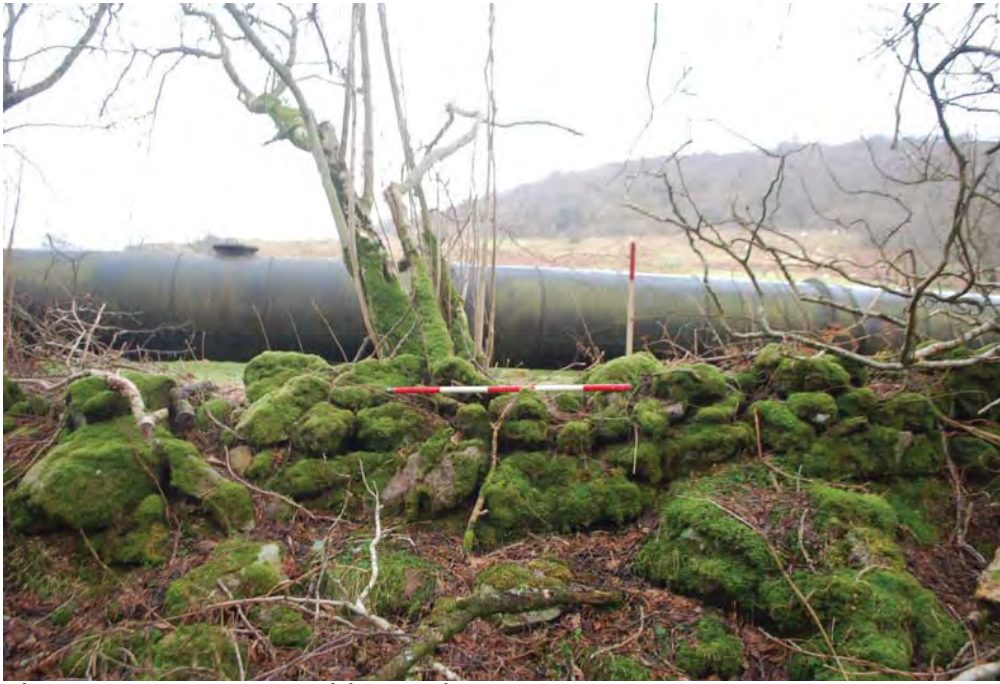
Plate 36: PRN 31959 - Field Boundary, View From NW

- **PRN 31959 (SH75926716 C): Field wall/revetment** - Late medieval/early post medieval field boundary wall running along top of natural escarpment. Revetment of rounded boulders c1m high facing NW. The ground to SE is level with the top of the wall. A line of hazel and ash grows along the wall indicating a former hedge. Many of the hazel are old coppices and some trunks are bent showing where they were once laid. Wall is fairly close to the existing pipeline so care must be taken that the wall is not damaged when the pipe is dismantled.

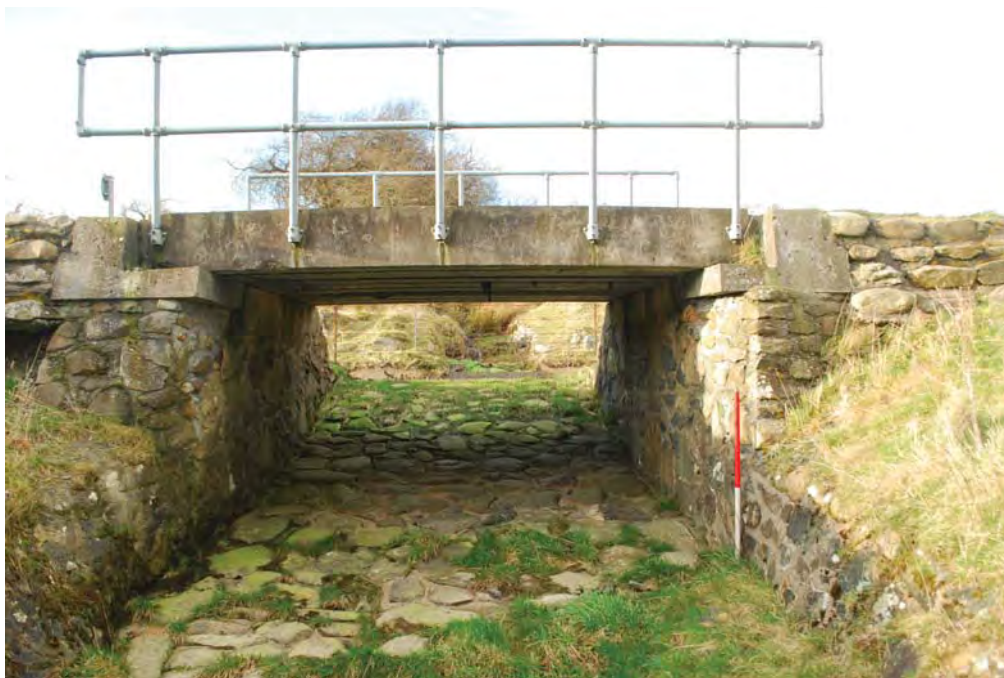
Plate 44: PRN 31974 - Channel for Stream Passing Under Leat, View From SE

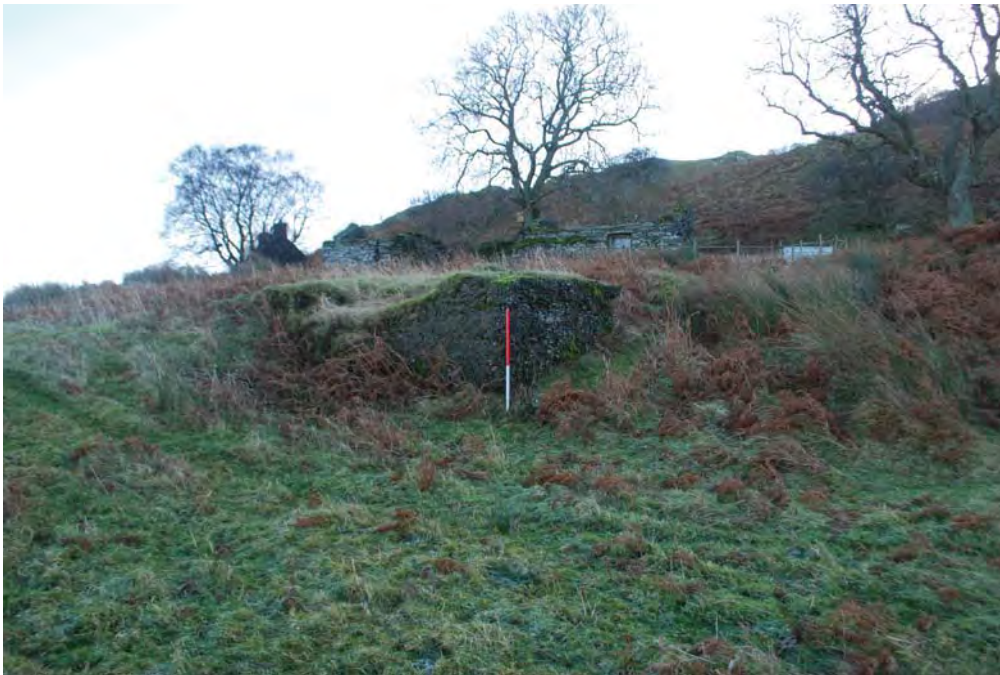
Plate 60: PRN 36386 - Concrete Platform, View From NW
