Low Head Pipeline Replacement Project, Dolgarrog,

Report on Archaeological Works

Project No. G2158

Report No. 1145

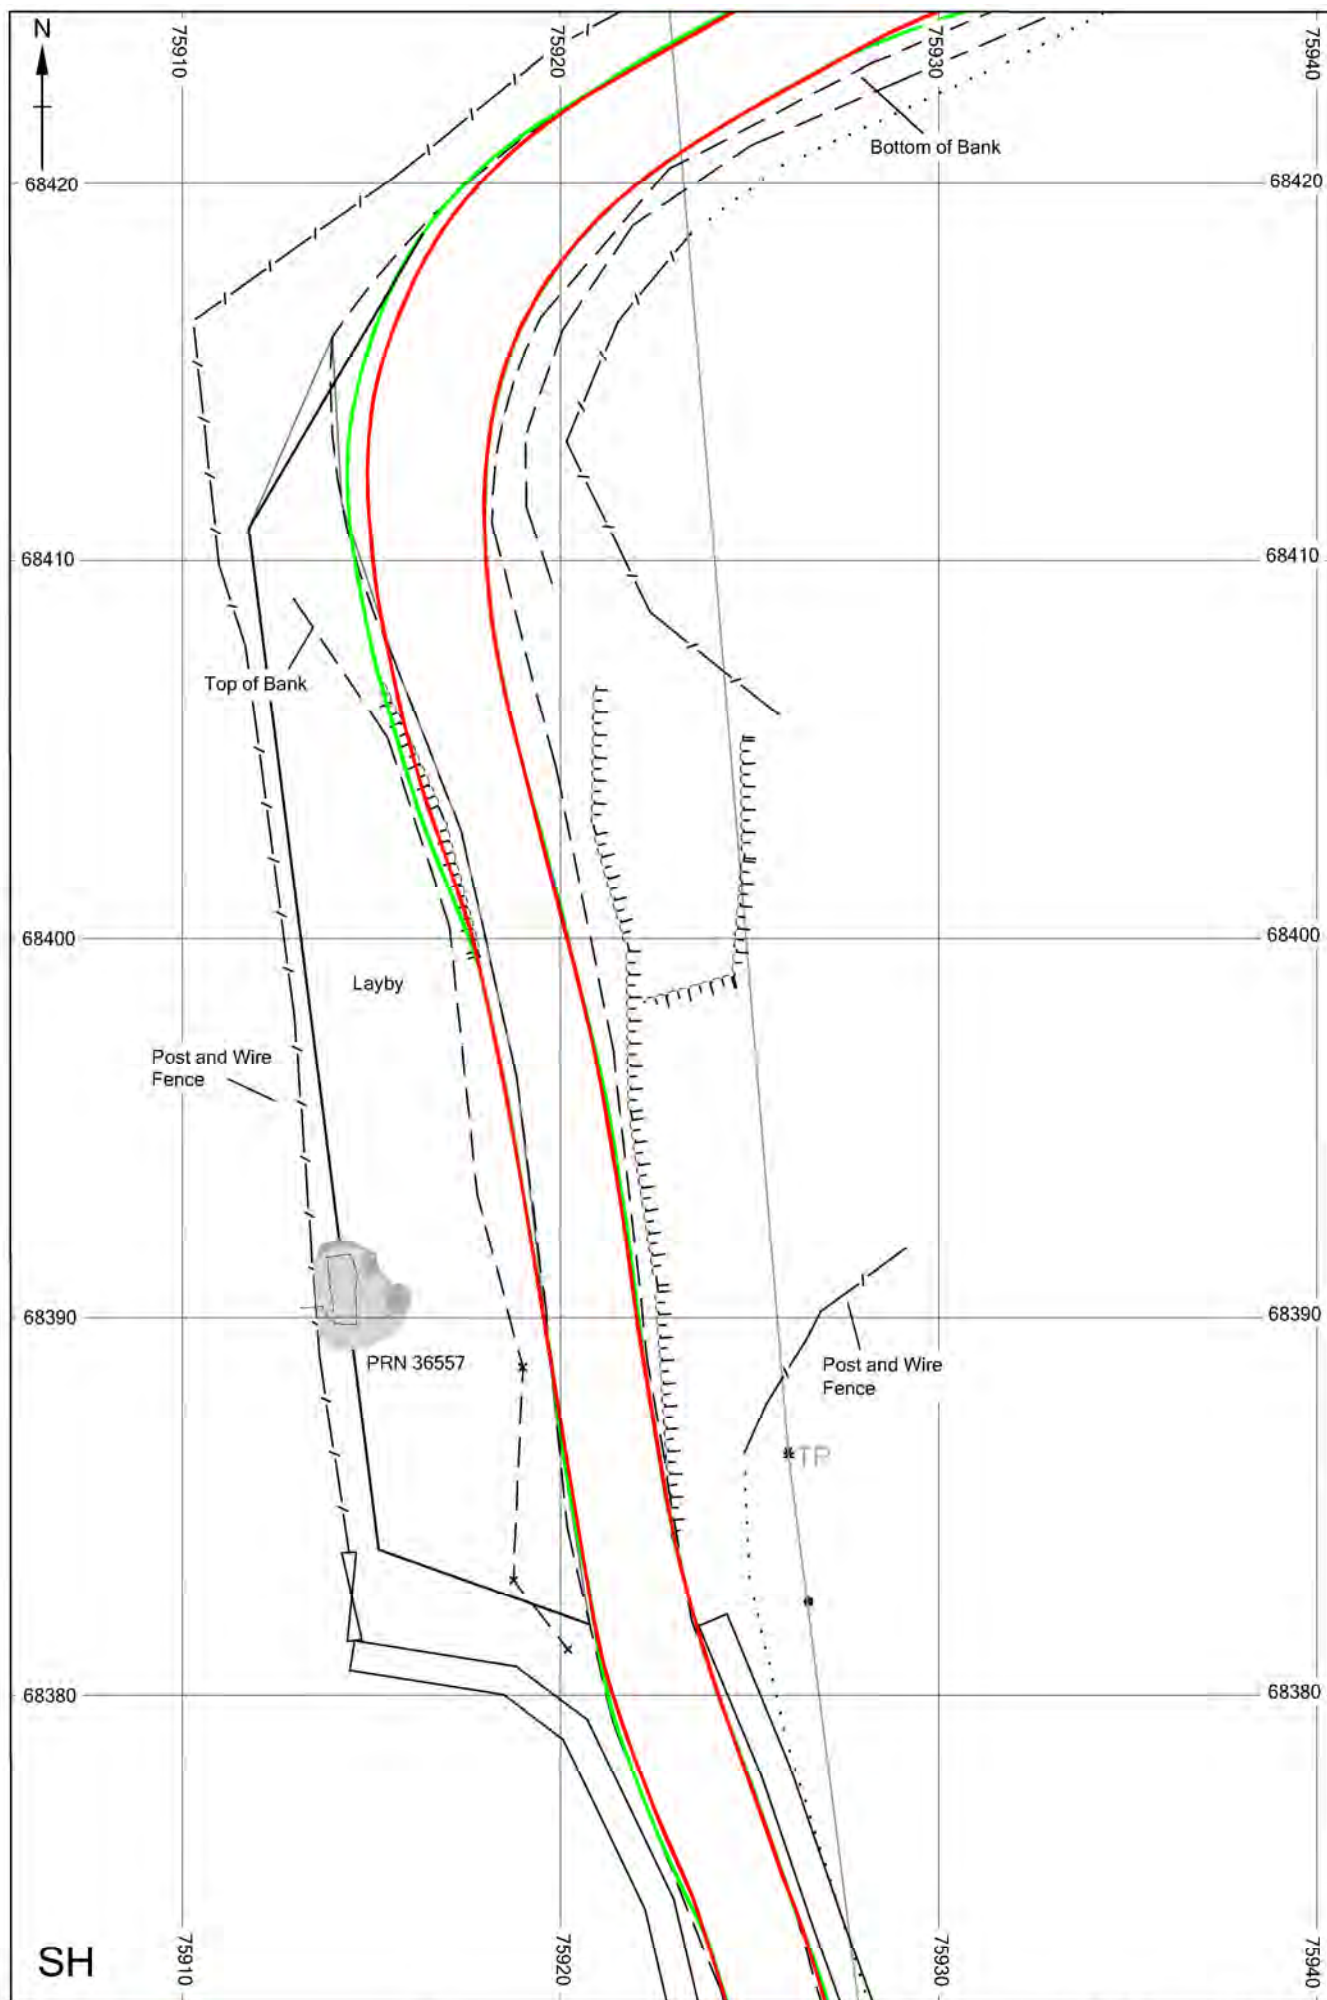
Fig. 11: Location of Rock Cannon PRN 36557

Rock cannon PRN 36557 was located on the side of the northern access road within a proposed layby (Figures 2 and 11). Vegetation and turf was cleared by hand from the rock cannon and the surrounding area within the layby area, so as to reveal its extent. It measures 1.8 x 1.55m as exposed and consists of 12 visible holes joined by channels. The rock cannon is drilled into a flat area of bedrock measuring c.2.8 x 1.8m within the layby area. The flat area continues to the west, outside this area on the other side of a fence and within a field, but only one hole was visible on this side as it was not cleared of vegetation and turf (Figure 12; Plate 10).

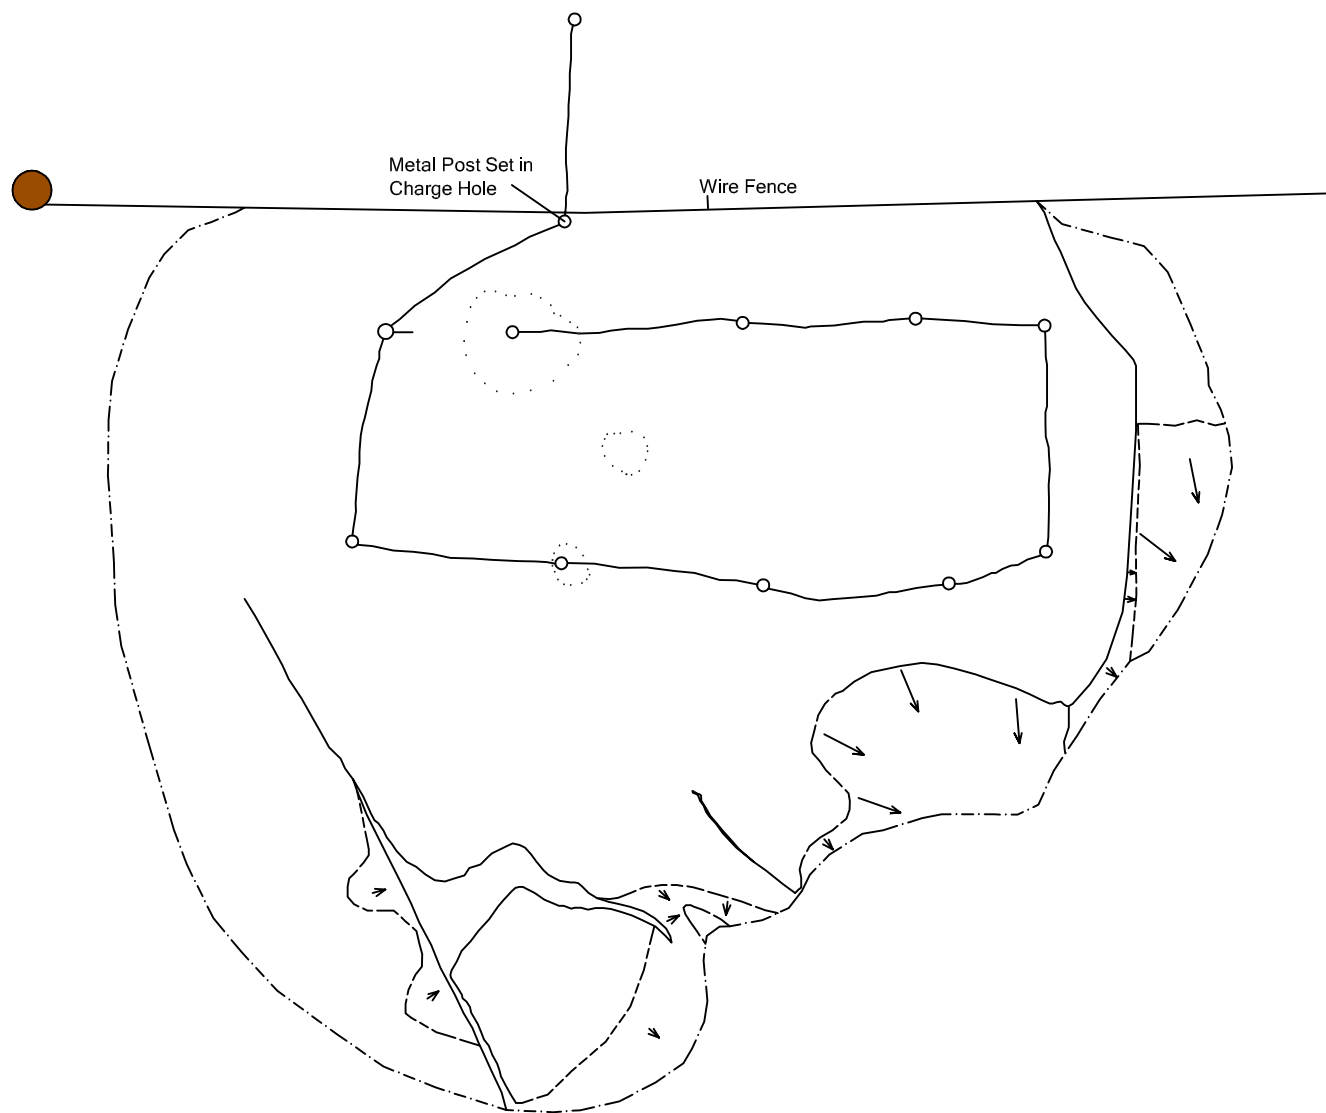
Fig. 12: Plan of Rock Cannon PRN 36557

- Edge of Cleared Area
- Edge of Flat Surface
- Fence Post
- Charge Hole
- Spalling

The holes are circular and vary slightly in size but seem to have been drilled with a 1¼" drill (32mm). All the holes were partly infilled but the deepest measurable one was 14mm deep. The holes are joined by a channel up to 20mm wide, which has a broad V-shaped profile and is a maximum of 5mm deep. The hole on the west side of the fence was joined to the other holes but had no other channel running from it. Some of the holes had slight spalling around them showing that the cannon had been fired. Other cracks on the rock surface are natural fissures. One hole has been used to hold an iron fence post. This fence post and another to the south appear to be supports for some machinery that have been reused as fence posts.

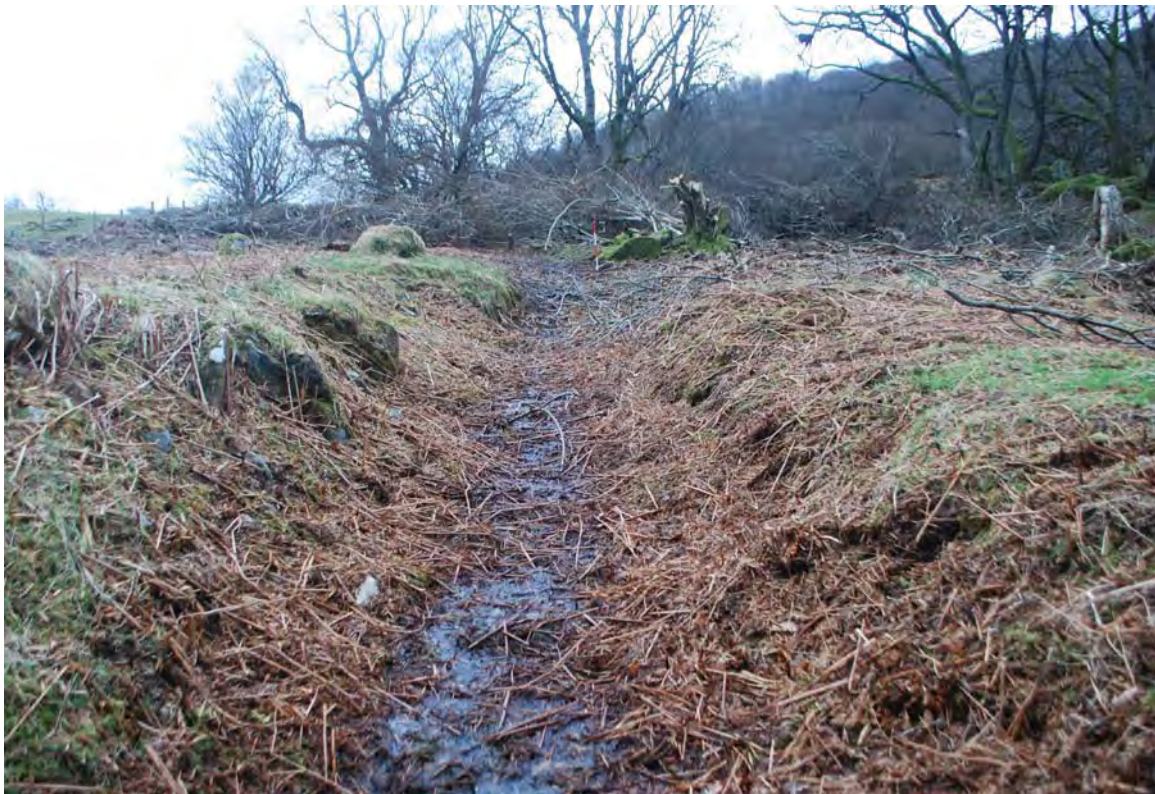
Plate 12: Trackway PRN 31893. View from the Southeast

Only one trackway (PRN 31893) not related to the industrialisation of the area was recorded during the archaeological works (Figure 4). This was a 3m wide track aligned WNW-ESE running from the modern road, underneath the pipeline, and towards Coed Sadwrn farm (Plate 12), which was shown on the 1889 1st Edition OS map. At its WNW end the track is fairly shallow, however after running underneath the pipe it deepens to approximately 1m and then proceeds to gradually get shallower as it runs uphill until it virtually disappears before entranceway PRN 31949. The trackway runs between natural outcrops of bedrock, most likely using them as a natural edge as there is no evidence that it has been cut into to form the trackway. No evidence of any road surface survives in the area disturbed by the works, suggesting that this may have been a hollow-way rather than a proper trackway.

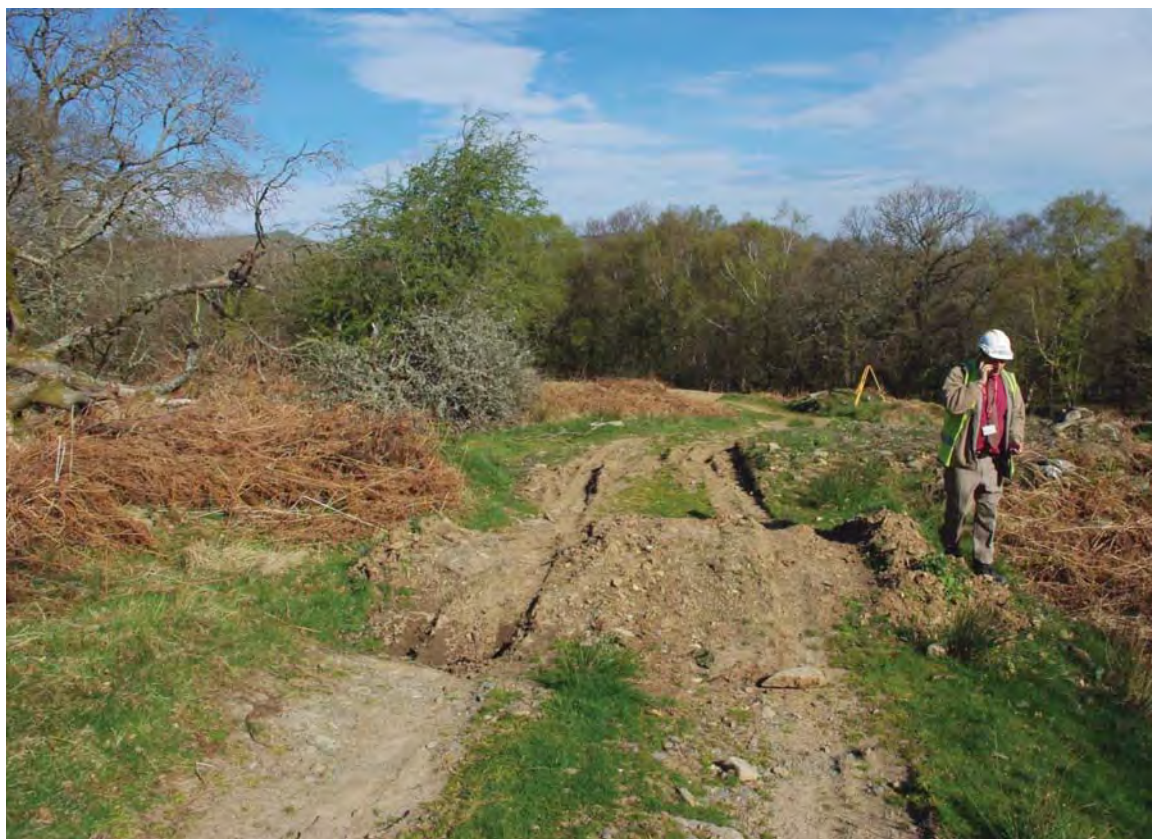
The site was visited on 16/04/2014 to establish how successful the diverting and blocking of the track had been. This revealed certain issues. The bund to the north of the site had not been created because there had been a sharp drop at that side preventing access. However landscaping had removed that drop and access up the track was possible. When the site was visited a pick-up truck was parked on the site. It was also clear from tyre tracks that vehicles had occasionally driven over the bund to the south-east of the site (plate 13). It was agreed with RWE Npower that boulders would be placed at each side of the site on the track to more reliably prevent access. It was noted that the new track that had been planned avoiding the site to the north-east had never been created and access to this area was via an existing track further east.

Plate 13: Former access track through possible roundhouse settlement PRN 31969, showing bund. View from the south-east
