Nant Cottage, Menai Bridge

Archaeological Mitigation - Photographic Survey and Building Record

Prosiect Rhif / Project No. G2446

Adroddiad Rhif / Report No.1279

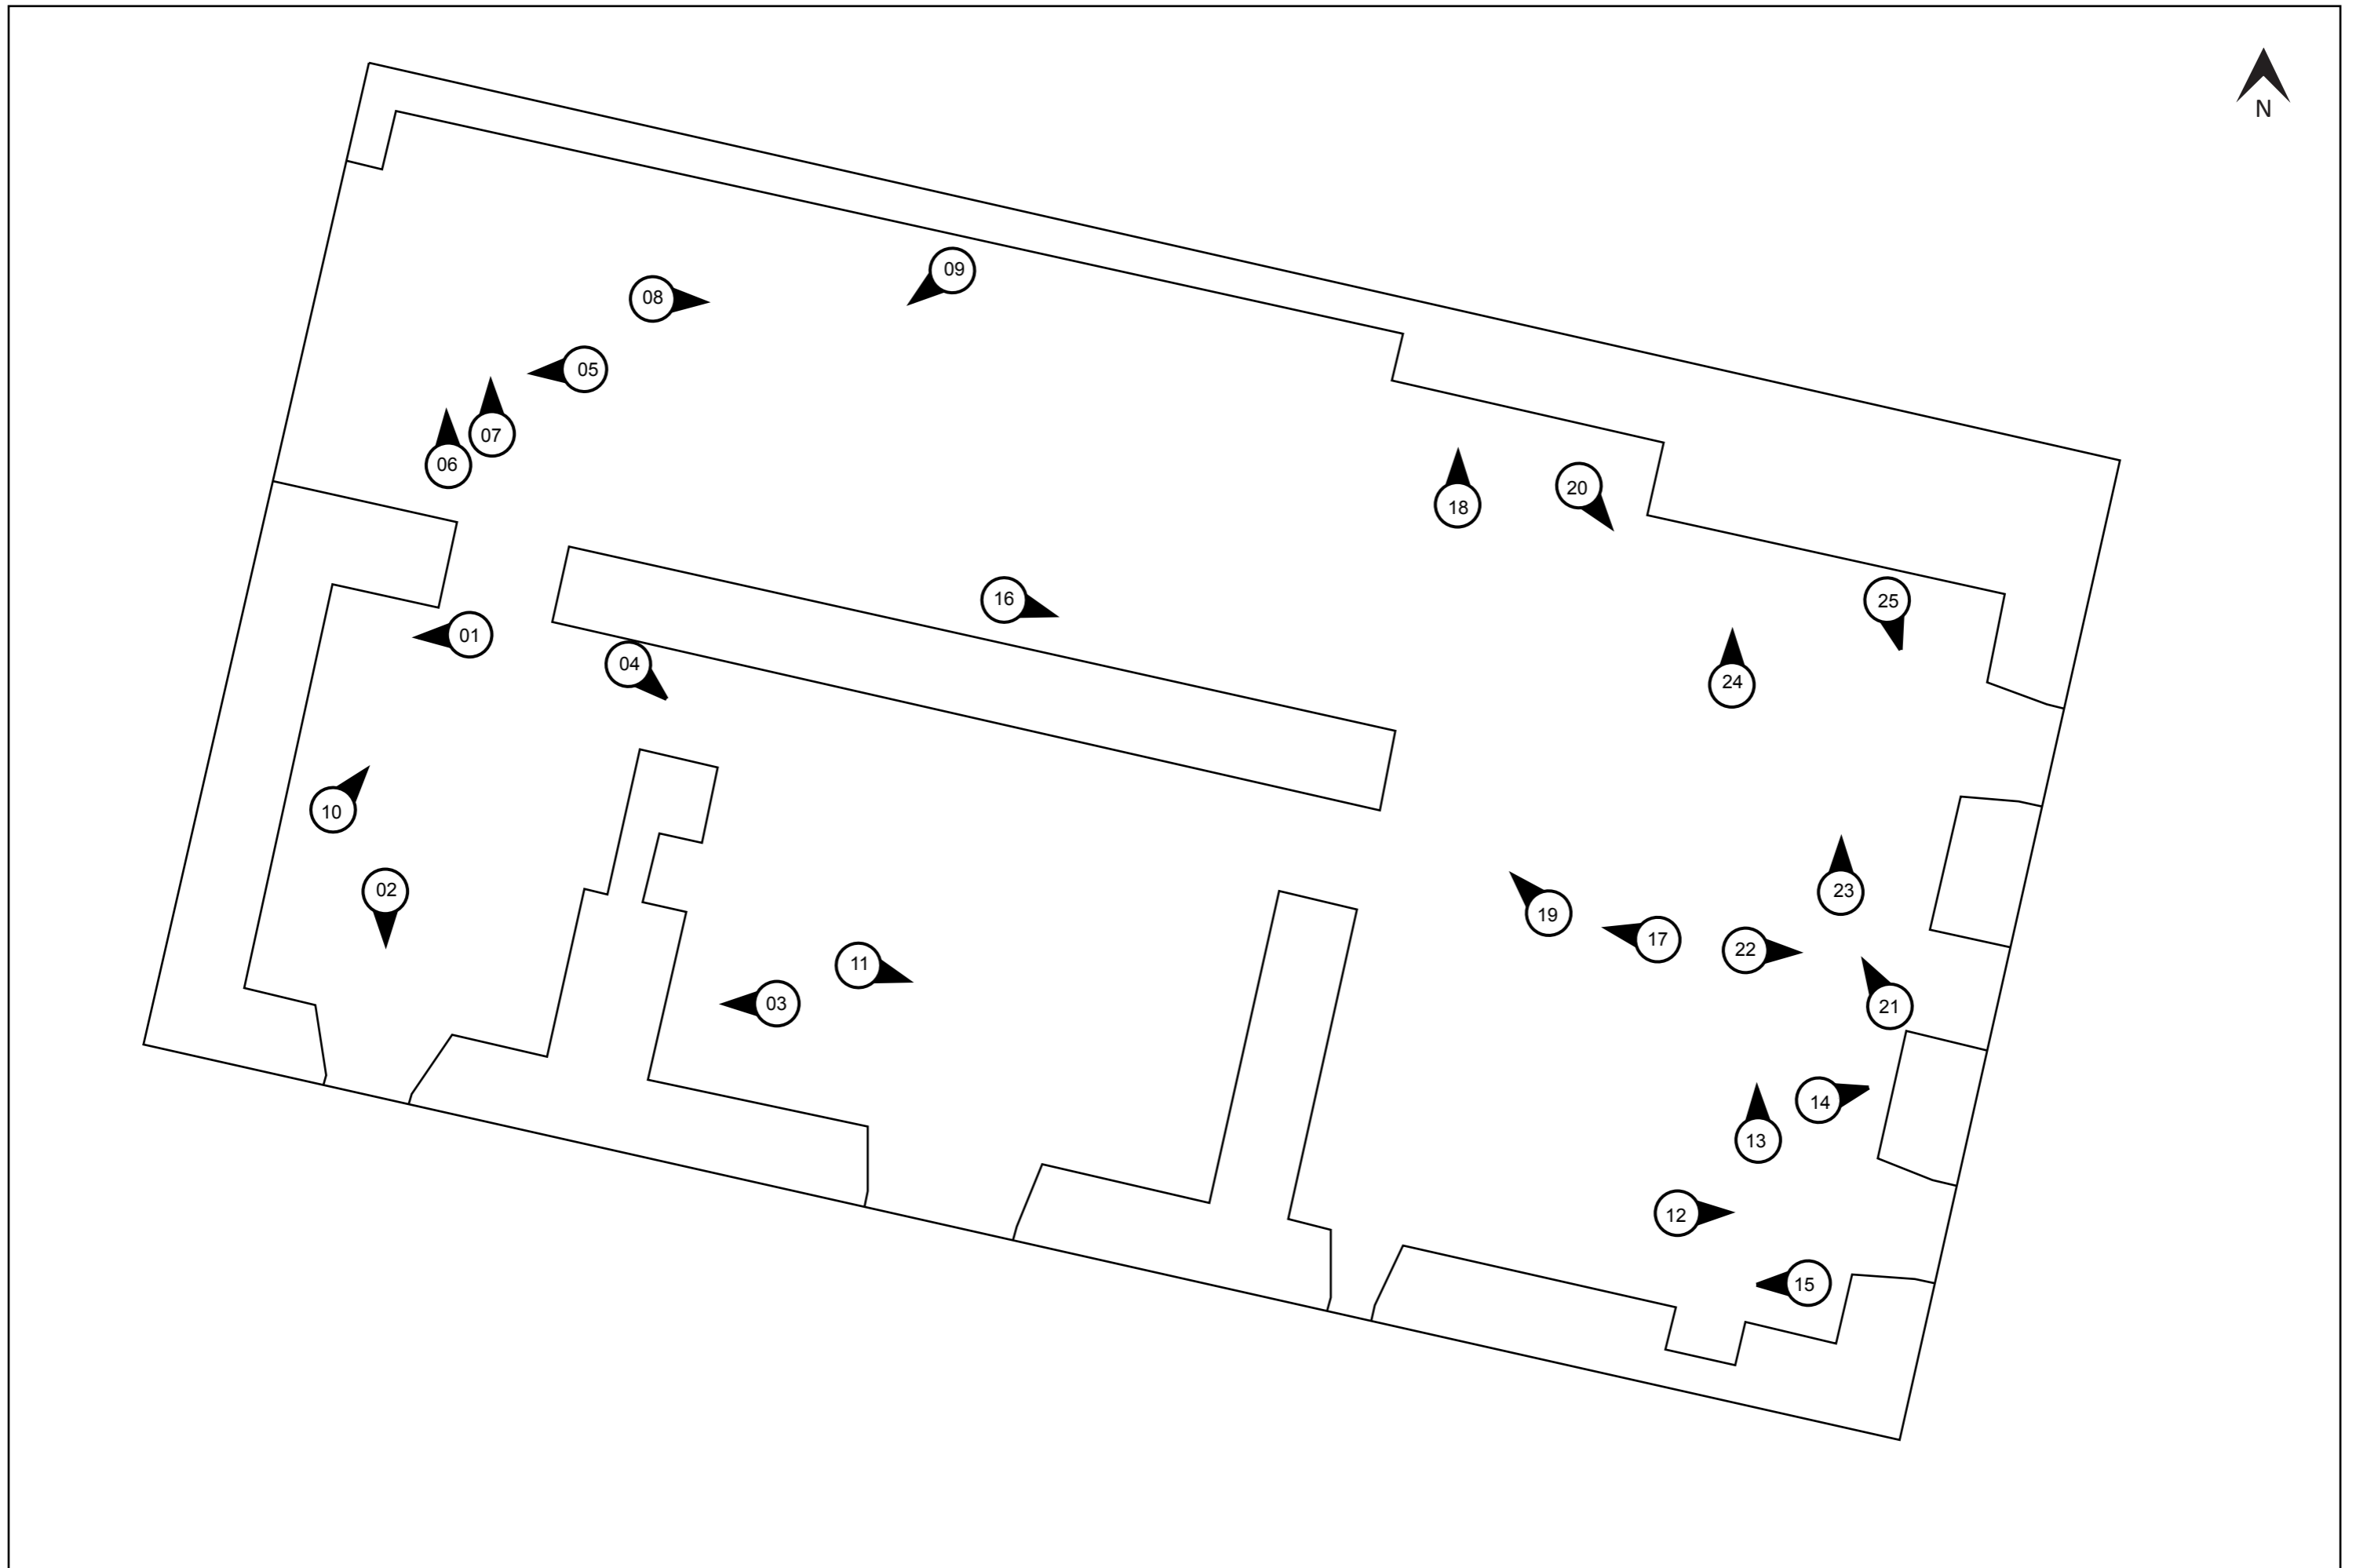
Figure 02: Ground Floor - location and orientation of photographic archive images G2446_001 to G2446_025. Note: building outline represented only. Scale: 1:50@A3

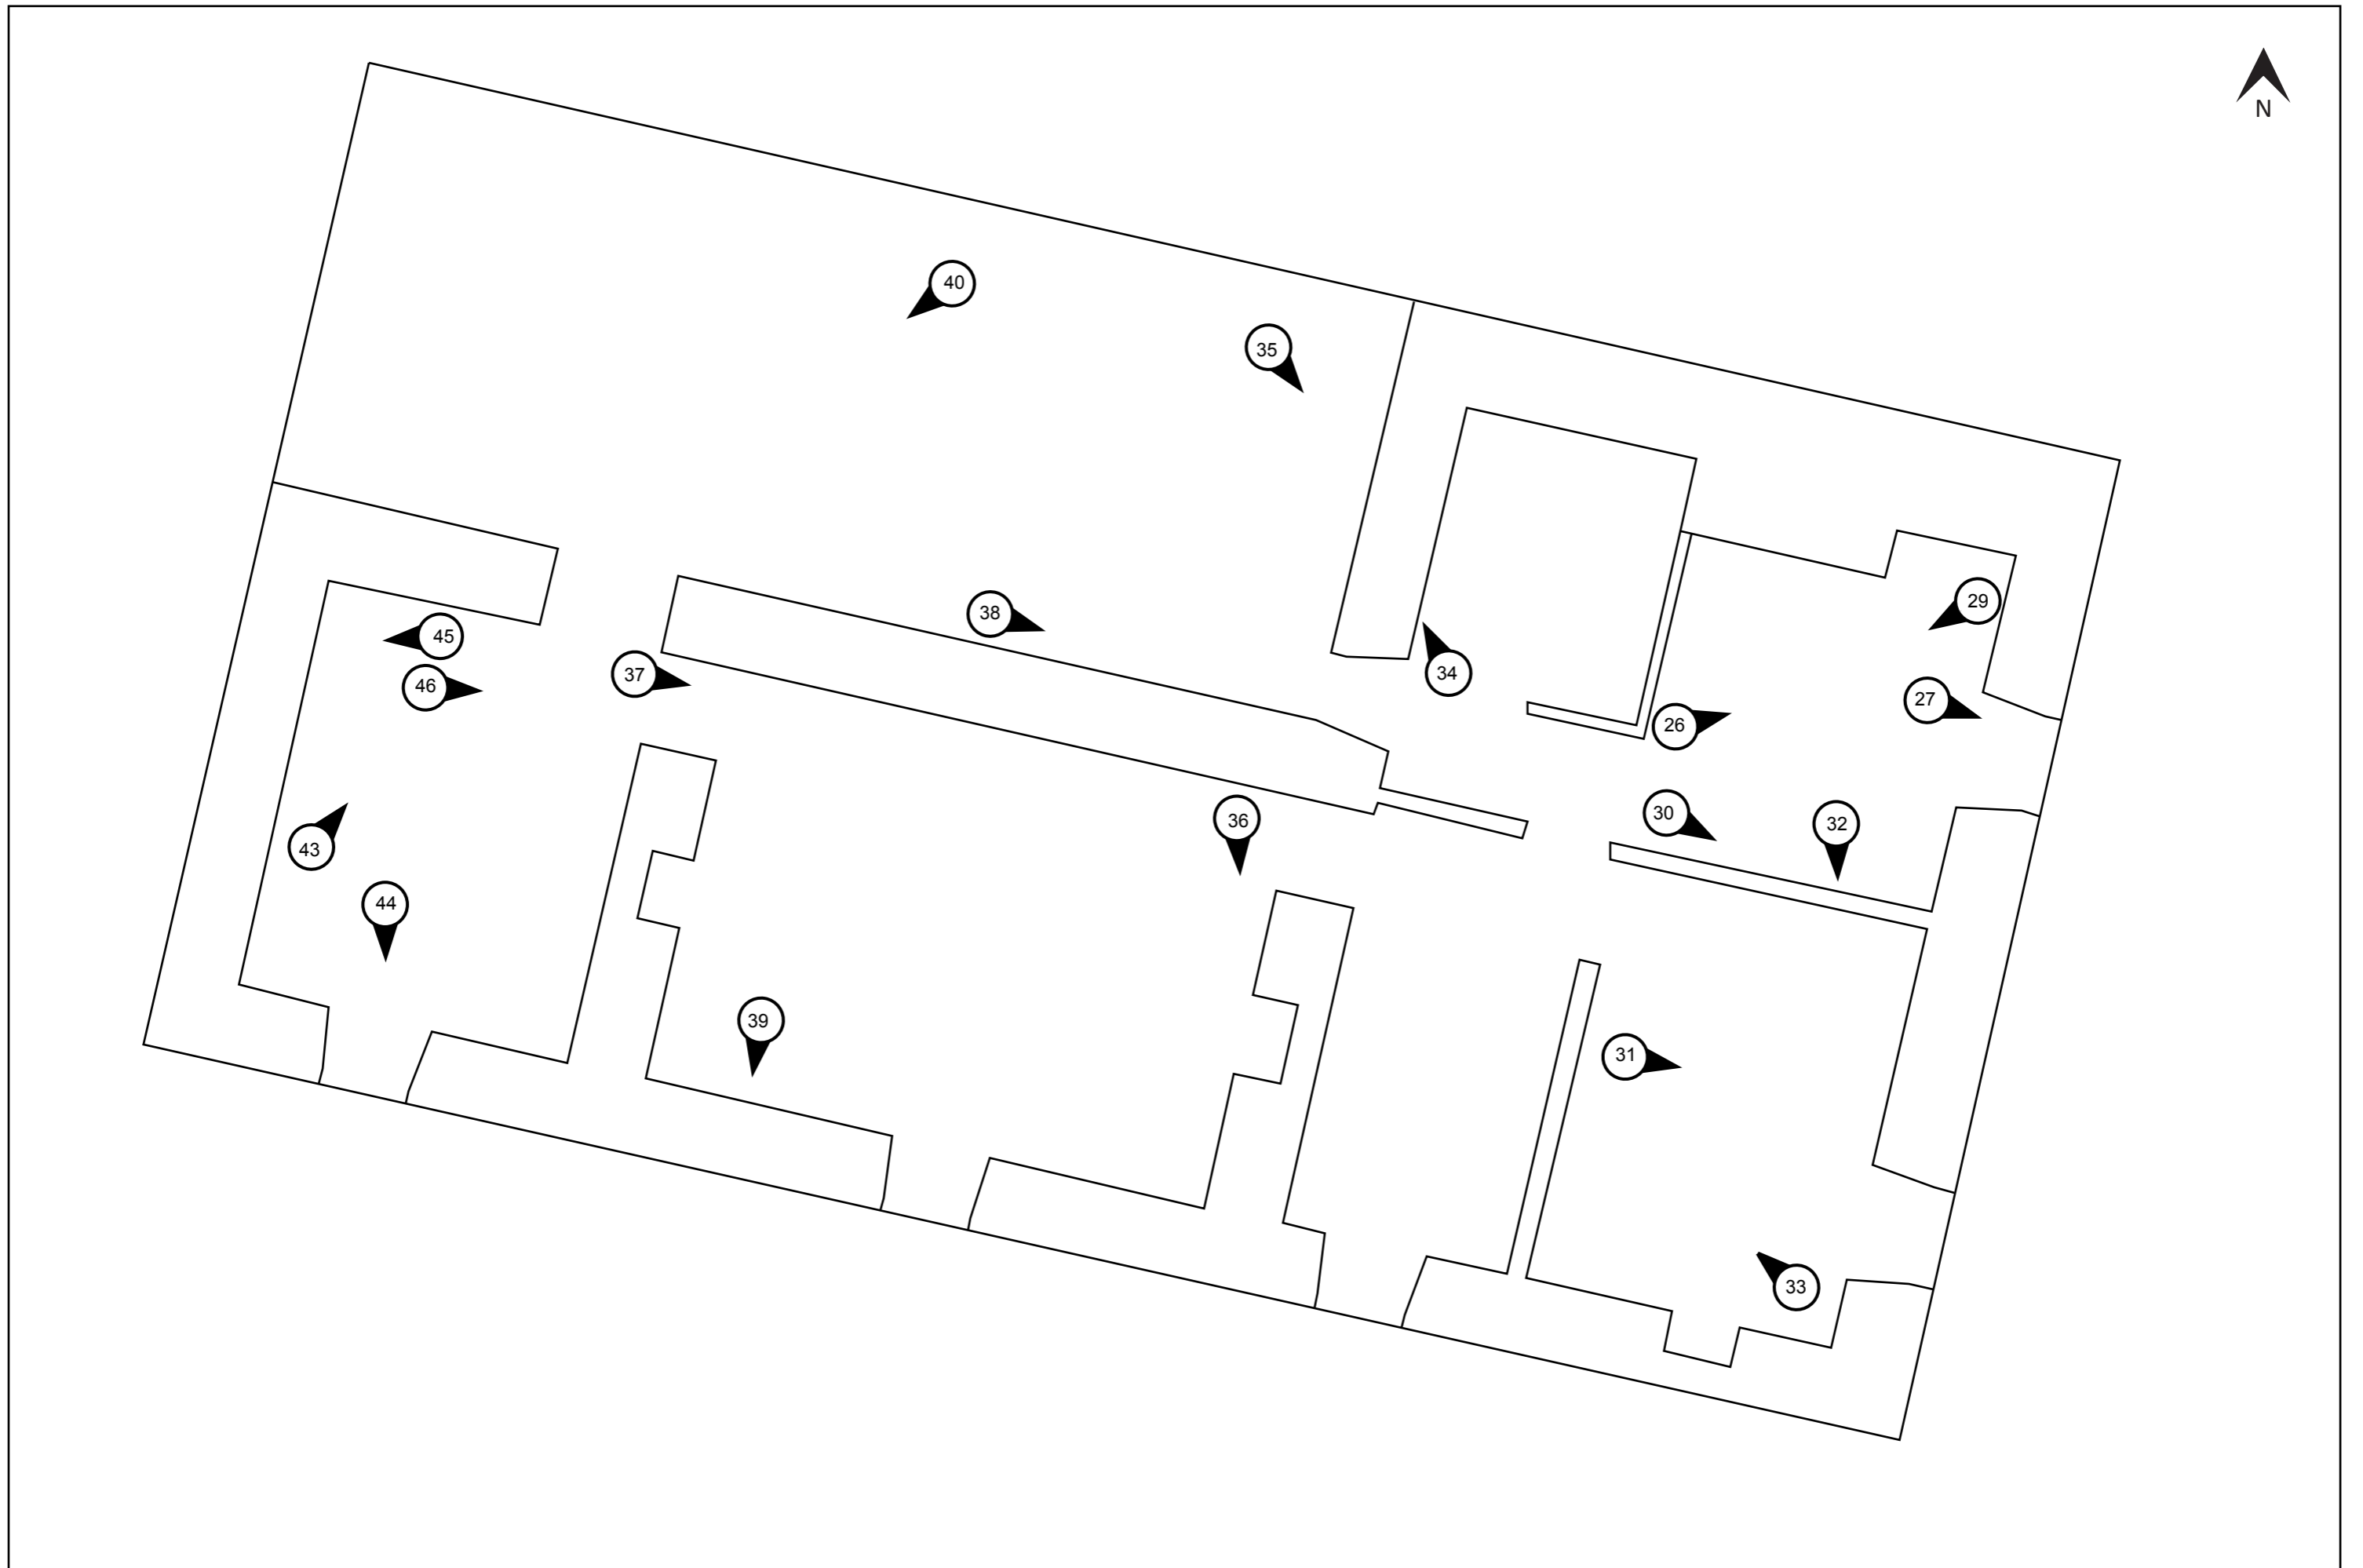
Figure 03: First Floor - location and orientation of photographic archive images G2446_026 to G2446_046. Note: building outline represented only. Scale: 1:50@A3

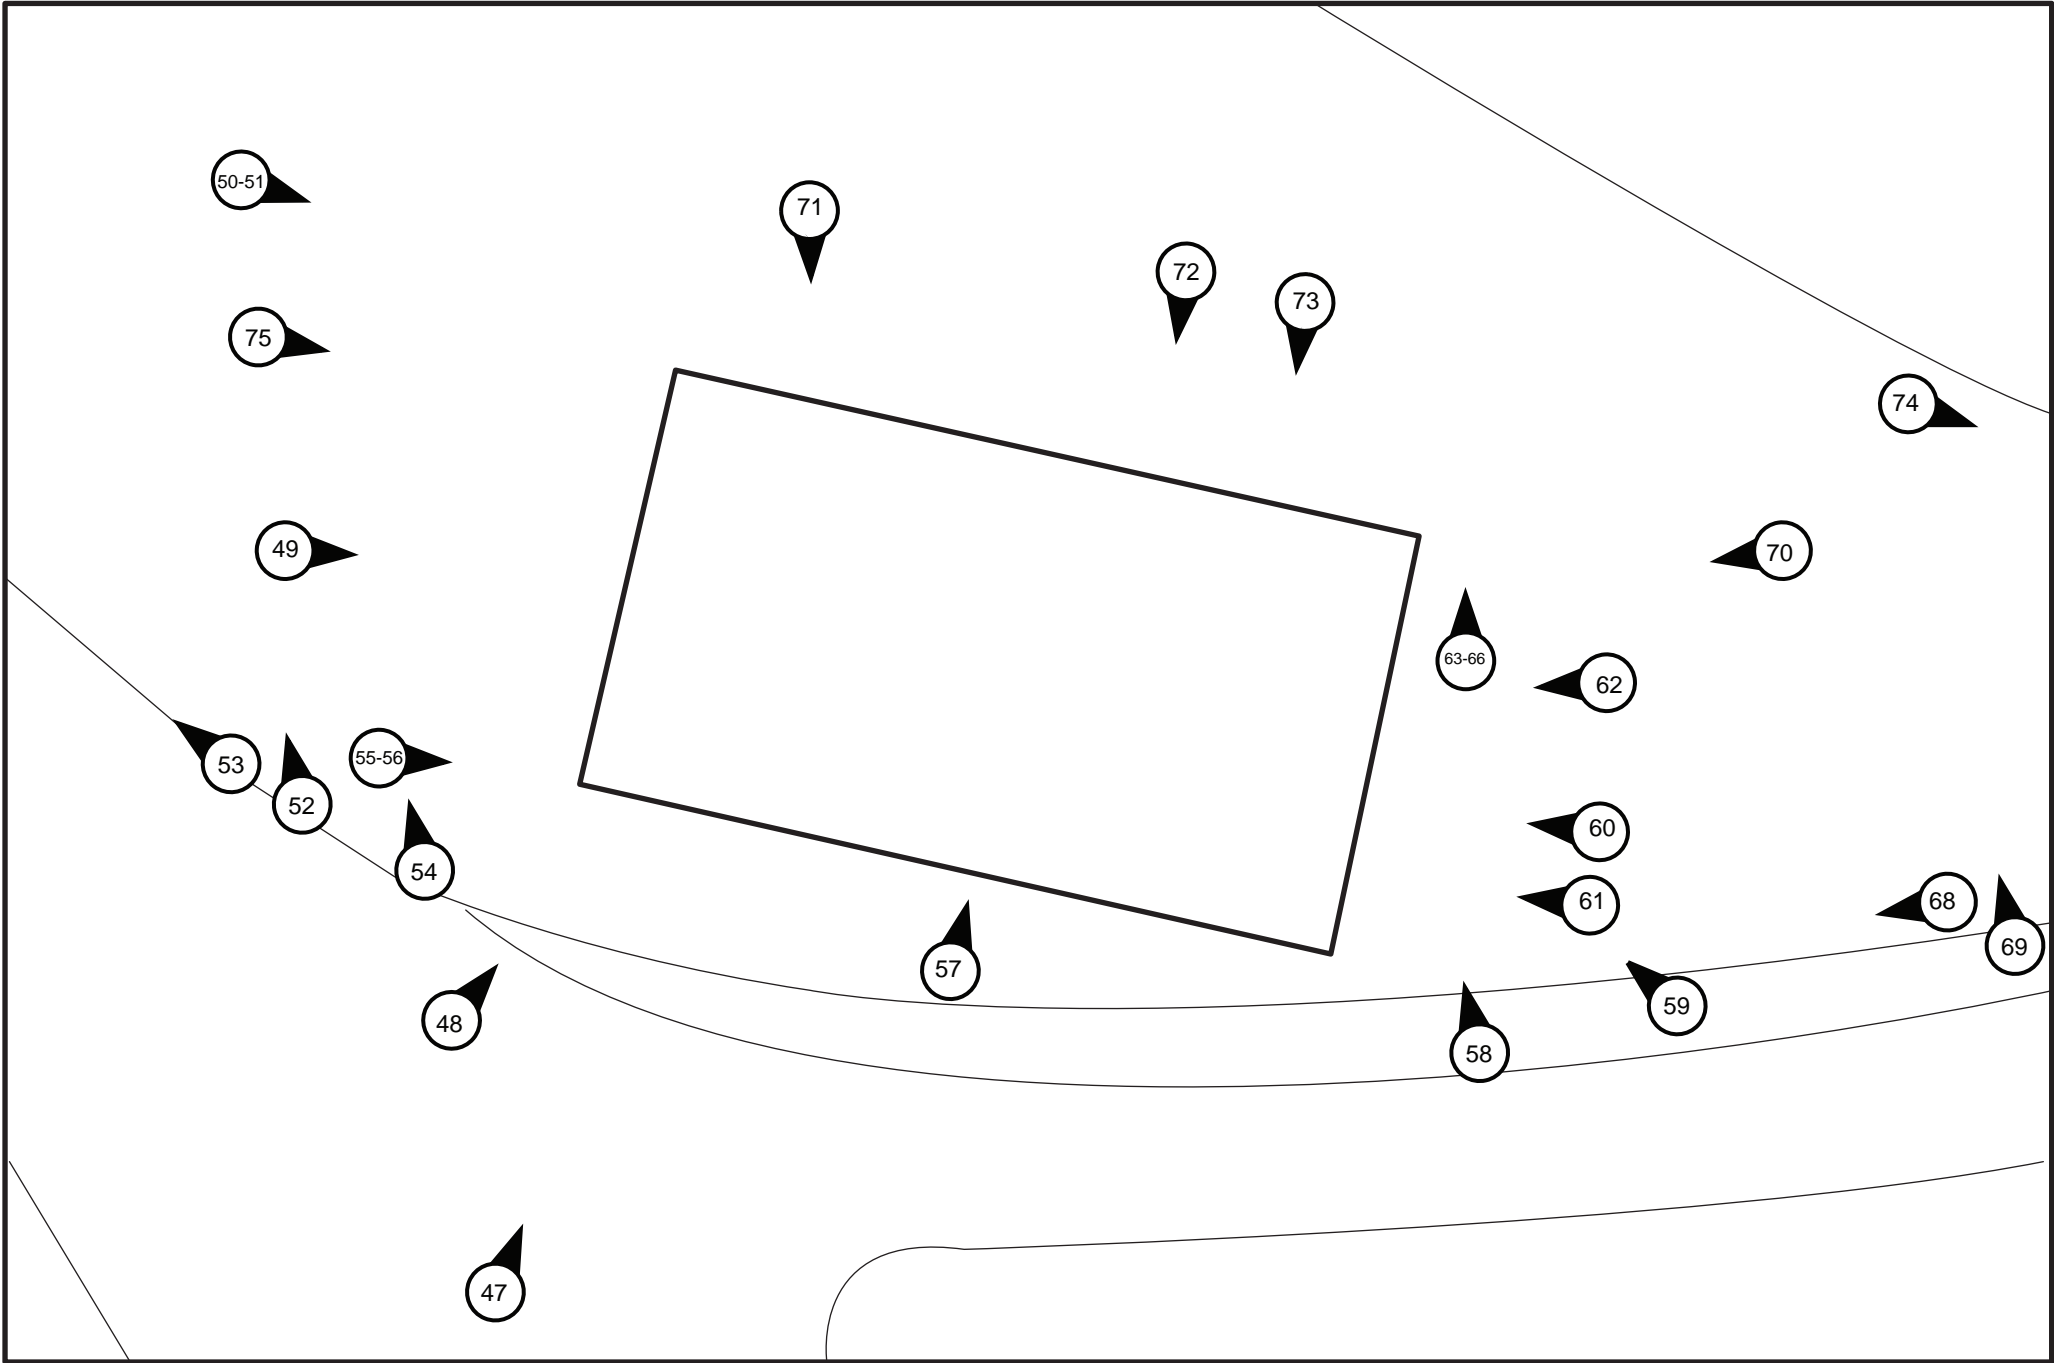
Figure 04: Exterior plan - location and orientation of photographic archive images G2446_047 to G2476_025. Scale: 1:100@A4

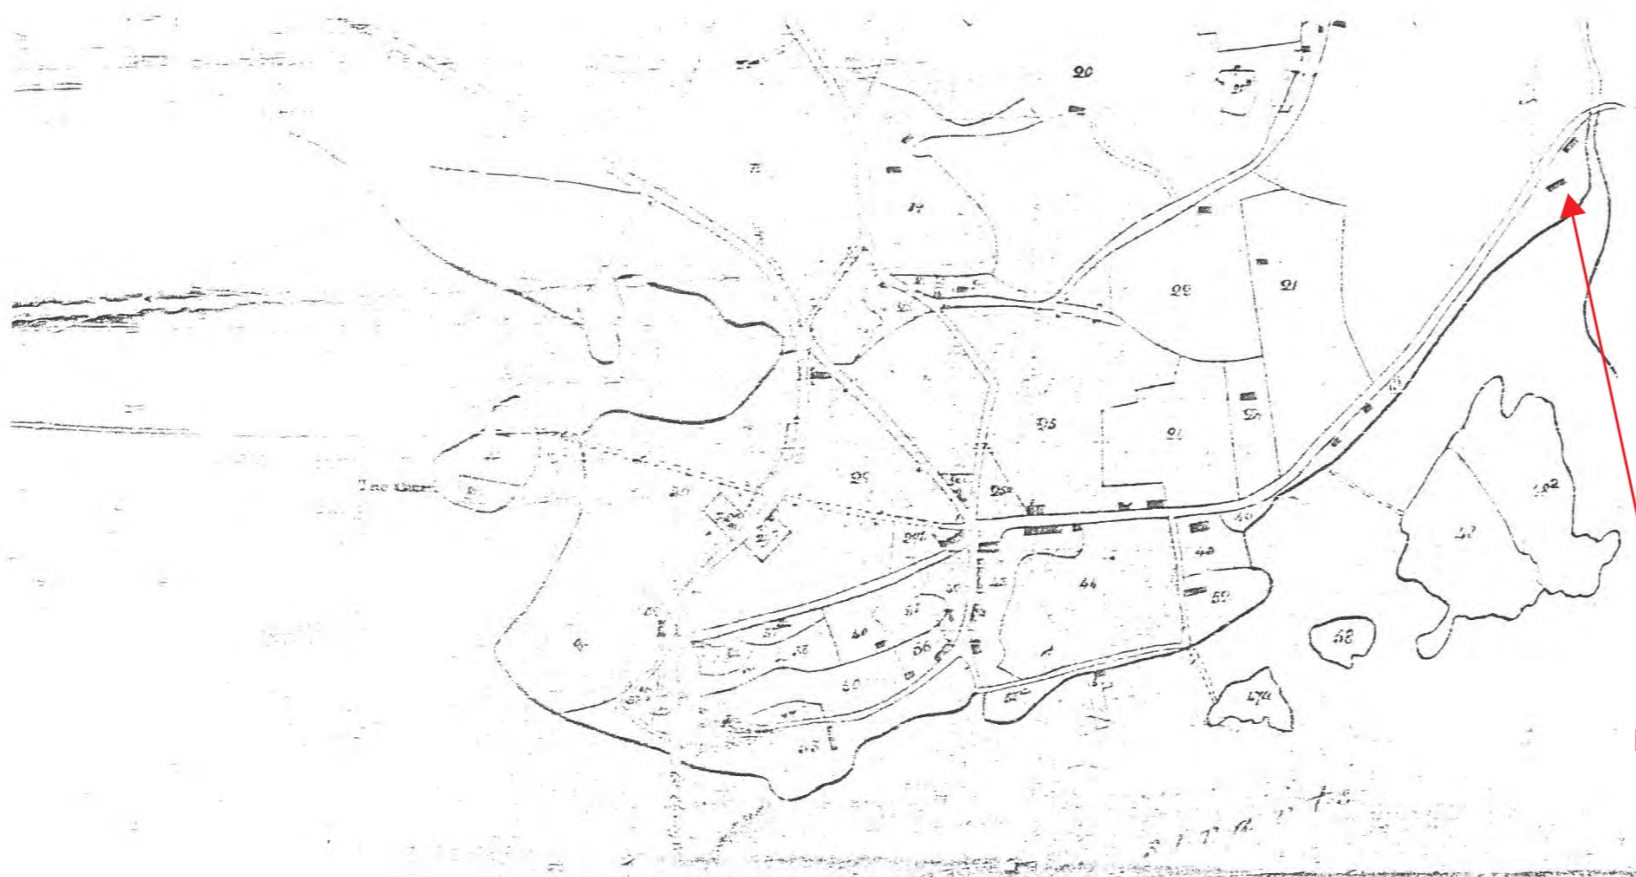
Figure 05: Partial reproduction of the 1840 Llandysilio Parish Tithe Map, detailing Nant Cottage. Not to Scale. Source: Anglesey Archives.

contain detailed rentals or any estate mapping, so it has not been possible to trace the development of the role of Nant Cottage as part of the Cadnant Estate through this method. Nant Cottage is shown on the tithe map and apportionment of 1840 for the parish of Llandysilio (Figure 05). However, it is shown within a large parcel of land of the Plas Cadnant estate, with the property sub-divisions not defined, so the information to be derived from it is limited. The property had a prime position on the Beaumaris Road leading north-east out of Beaumaris, and formed a focal point for Plas Cadnant and its estate. It is shown on the 25 inch 1st edition Ordnance Survey map of 1889 fulfilling this function (Figure 06).

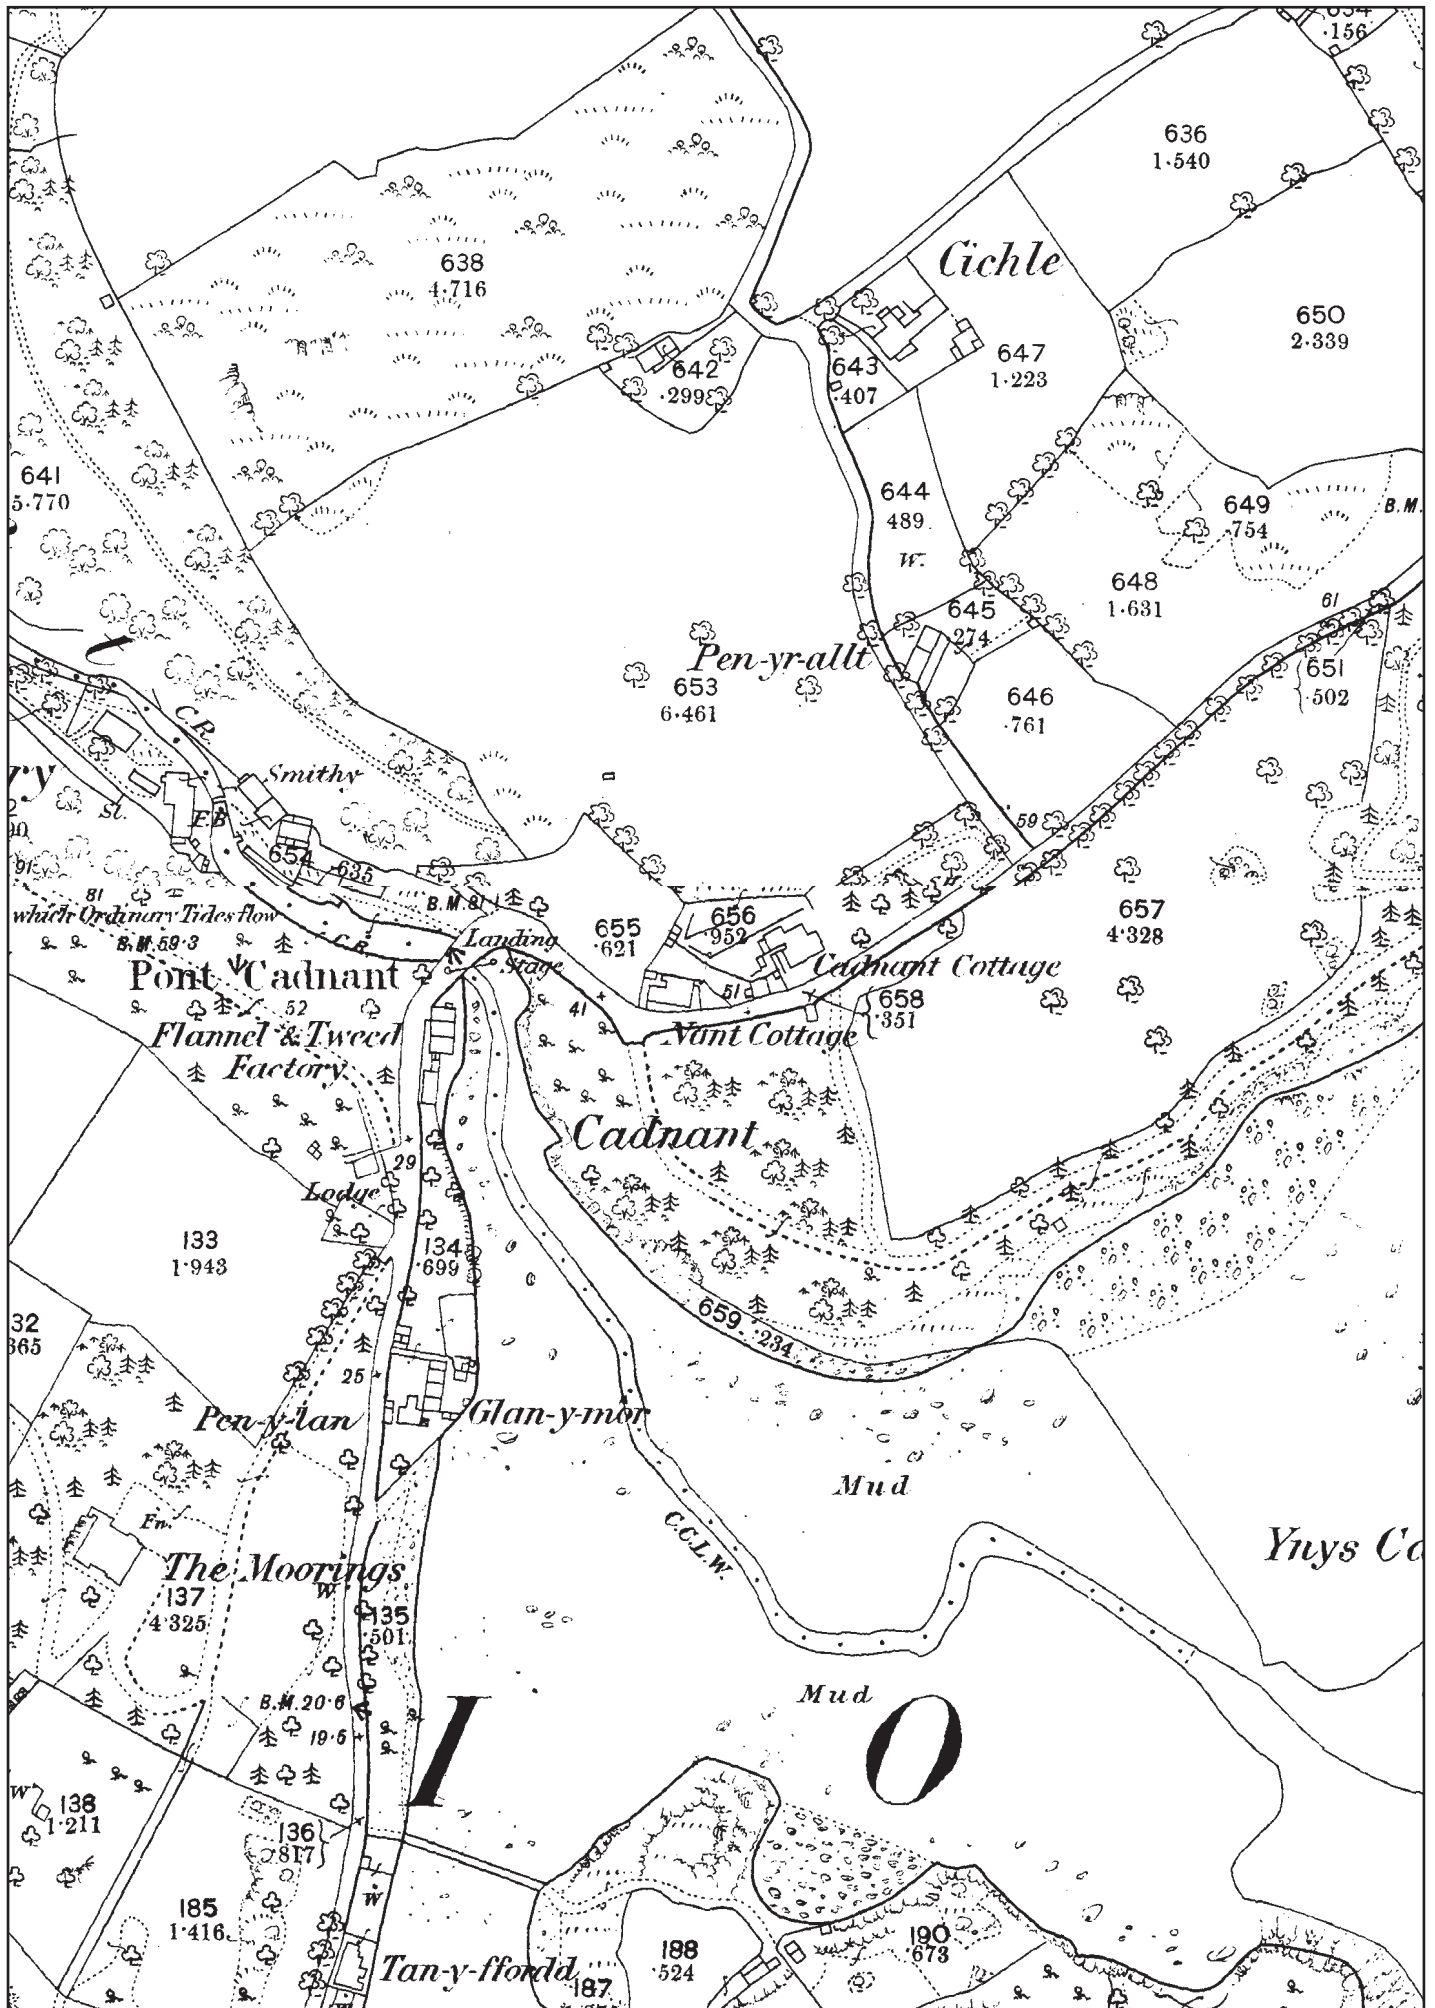
Figure 06 Reproduction of the First Edition Ordnance Survey Map of 1889 Anglesey County Series 25 inch map sheet IX.7 and IX.11.

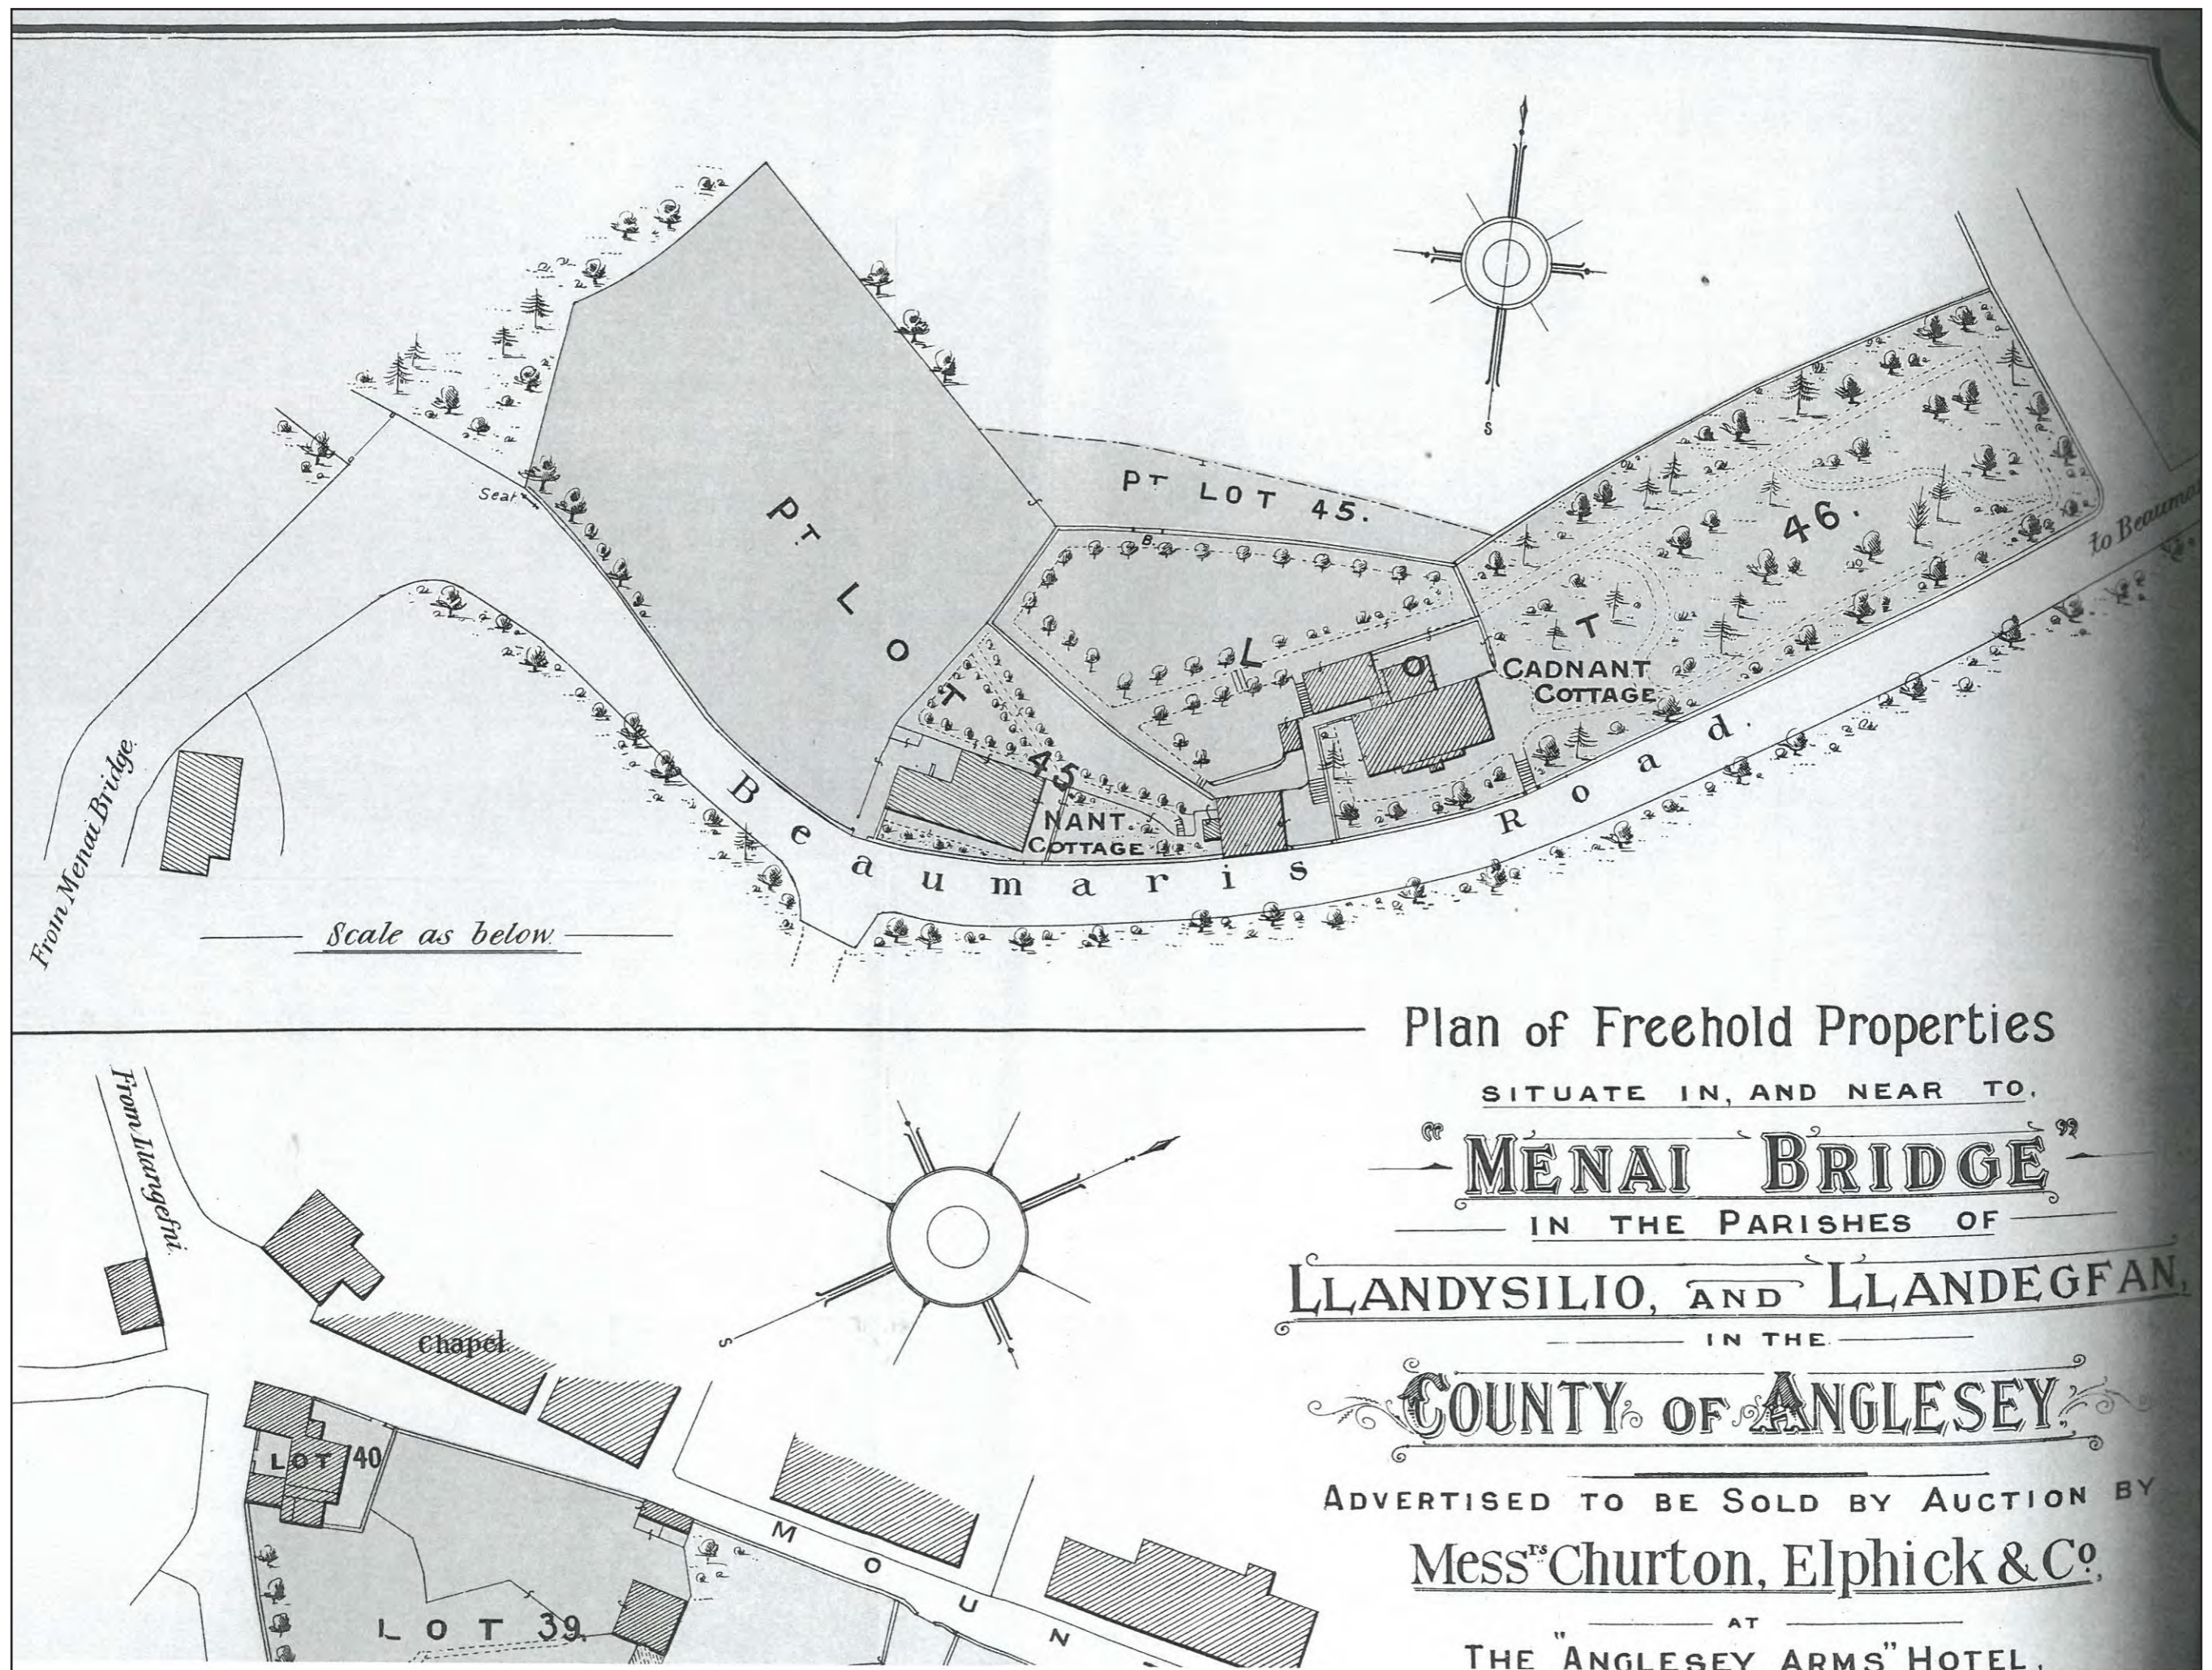
Figure 07: Reproduction of a sale map for "Freehold Properties forming part of the Plas Cadnant Estate" including Nant Cottage, published in 1900. The Nant Cottage freeholdings include all of Lot 45. Not to Scale. Source: Anglesey Archives (Ref. WF/37)

Nant Cottage remained part of the Cadnant Estate until it was sold off on August 28th 1900, as a separate entity from the rest of the estate (WF/37). It was a part of a sale of the 'Freehold Properties forming part of the Plas Cadnant Estate', and was sold by auction at the Anglesey Arms Hotel, Menai Bridge', with Nant Cottage forming Lot 45. It is shown in detail on the sale catalogue map (a reproduction of the 2nd edition 25 inch Ordnance Survey map) as consisting of the house and grounds to the north and east with small outbuildings, with a paddock of land to the west, from which a strip of a field to the north of Cadnant Cottage was accessible (Figure 07). This strip, consisting of a single southernmost portion in a larger field to the north, is very intriguing, as it may represent a surviving remnant of a medieval strip field, and represent the Nant entitlement within the larger field. This interpretation remains tentative at this stage however.

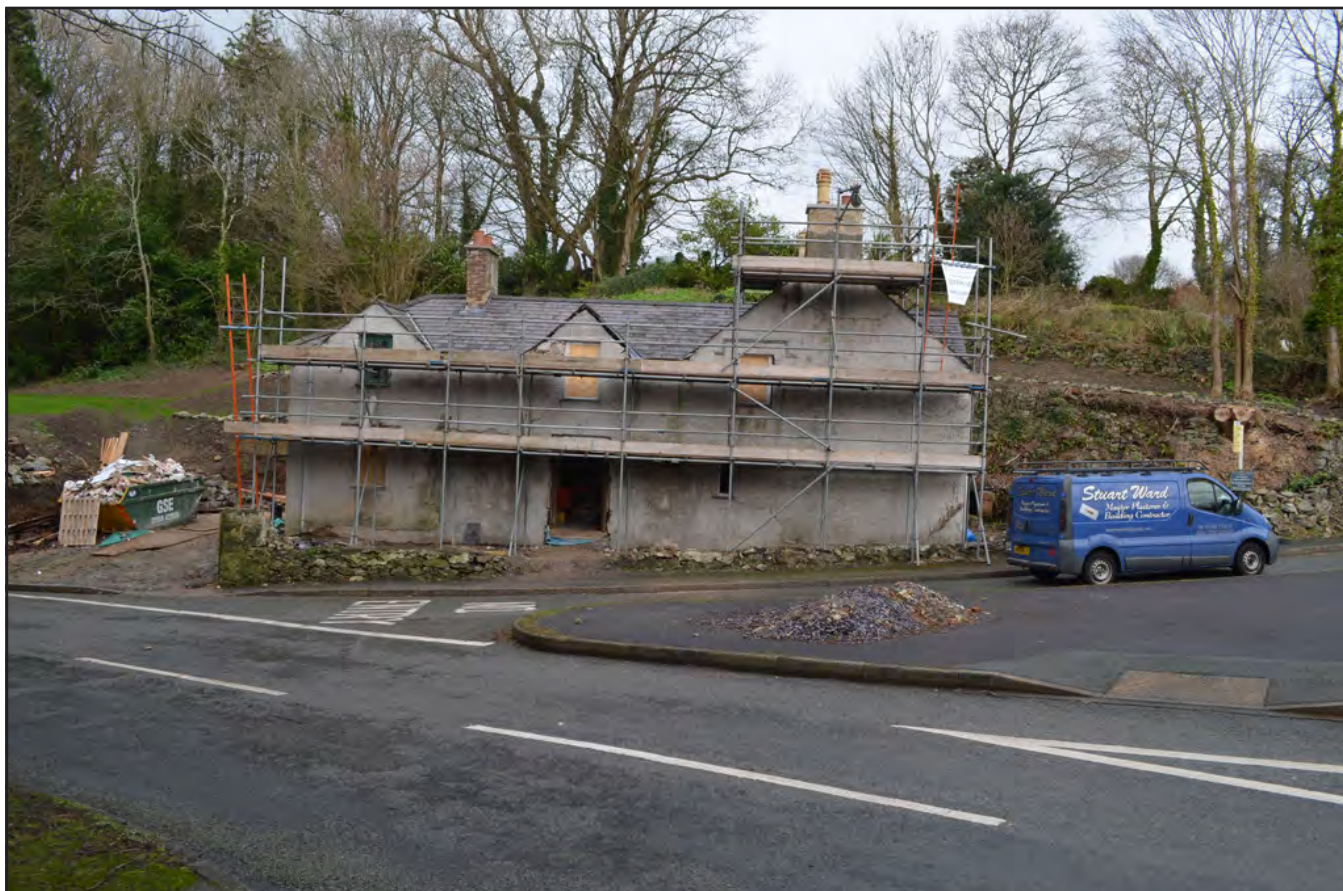
At the time of the photographic survey the southern elevation and sections of the roof of Nant Cottage were partially obscured by scaffolding (Plate 1). Prior to the survey vegetation, in particular a number of mature trees had been cleared from the rear and sides of the property. The exterior elevations of the original cottage are covered by a cement render which masks structural details and any changes or previous development of the cottage. In limited areas where the render is no longer present, such as around the door in the eastern elevation, there is an indication that at least sections of the cottage were constructed from a mixture of undressed locally sourced stone and red brick, bonded by a course white lime mortar (Plate 2). In addition, it is evident that concrete blocks and red bricks, bonded with cement, have been used below the first storey windows on the eastern elevation during the current phase of renovation works.

Plate 01: View from the southwest of southern elevation of Nant Cottage

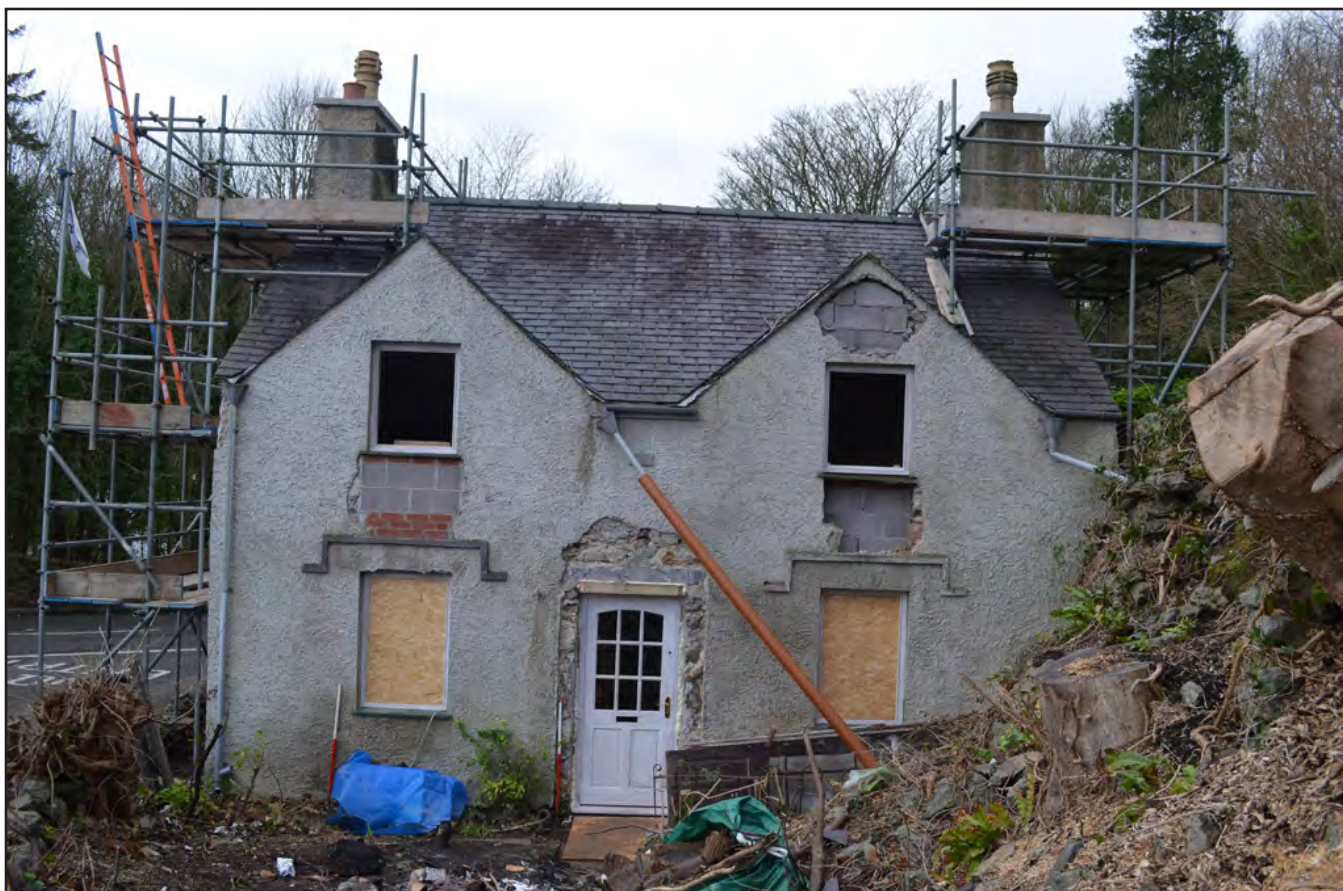
Plate 02: View from the east of eastern elevation (Scale: 1 x 1.0m)

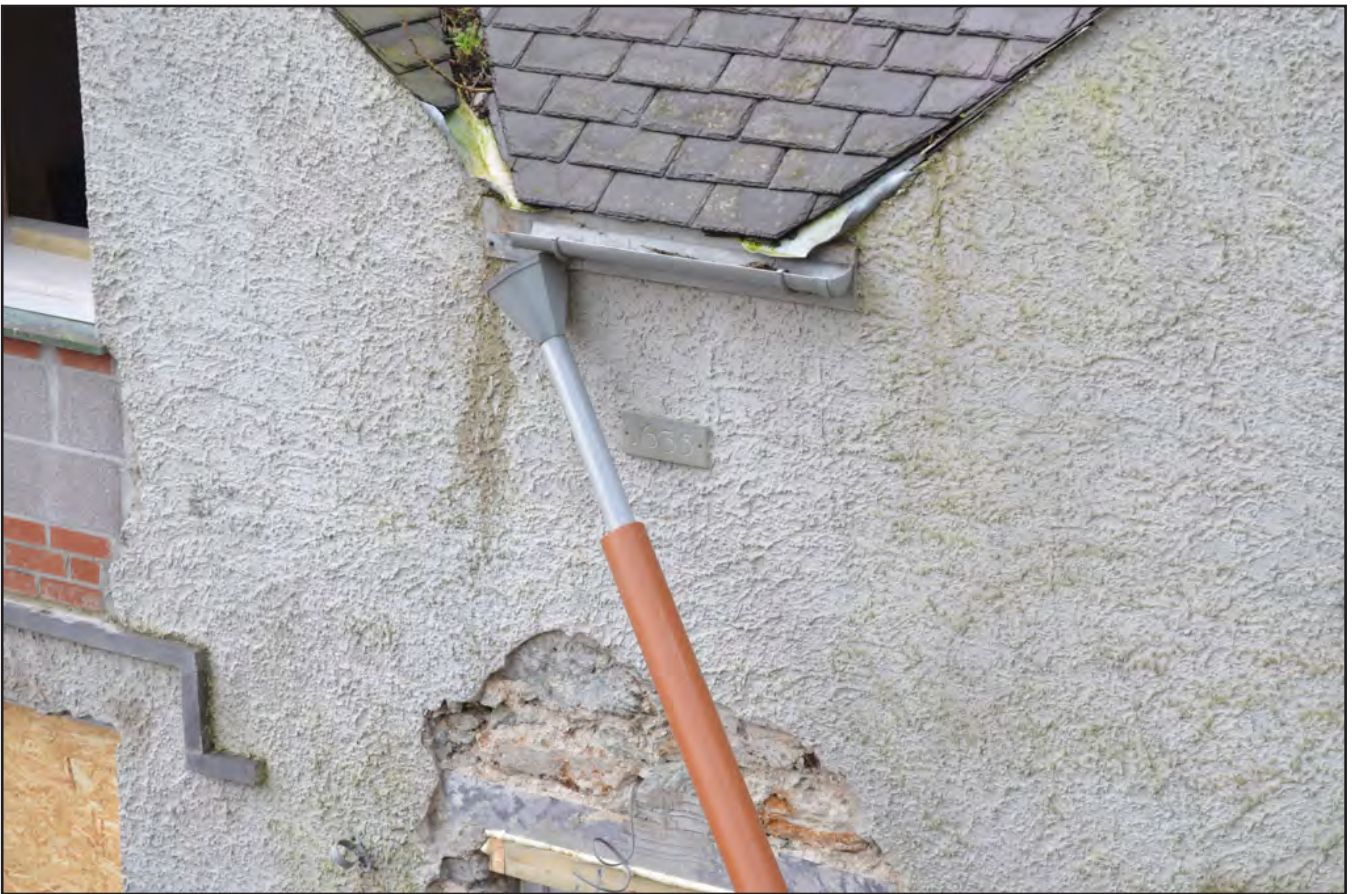
The surviving evidence of the building suggests that it is mainly of 18th or early 19th century date, but the house also incorporates elements of an earlier house, as indicated by a 1635 date stone above the eastern doorway.

- The '1635' dating stone is still in-situ above the front door on the eastern elevation (Plate 3);
- A covered, stone and mortar built well located immediately adjacent to the eastern elevation (Plate 4);
- Remnants of a cast iron fence set in a low stone and mortar wall that separates the cottage from the garden at the eastern side of the property (Plate 5);
- Dry stone retaining walls (Plate 6) which frame an east-west aligned garden path and stone steps at the eastern end of the property;
- Steep-pitched slate roofs of the eastern and southern wings of Nant Cottage (Plate 7).

Plate 03: Date stone on eastern elevation (reads 1635)
