Nant Cottage, Menai Bridge

Archaeological Mitigation - Photographic Survey and Building Record

Prosiect Rhif / Project No. G2446

Adroddiad Rhif / Report No.1279

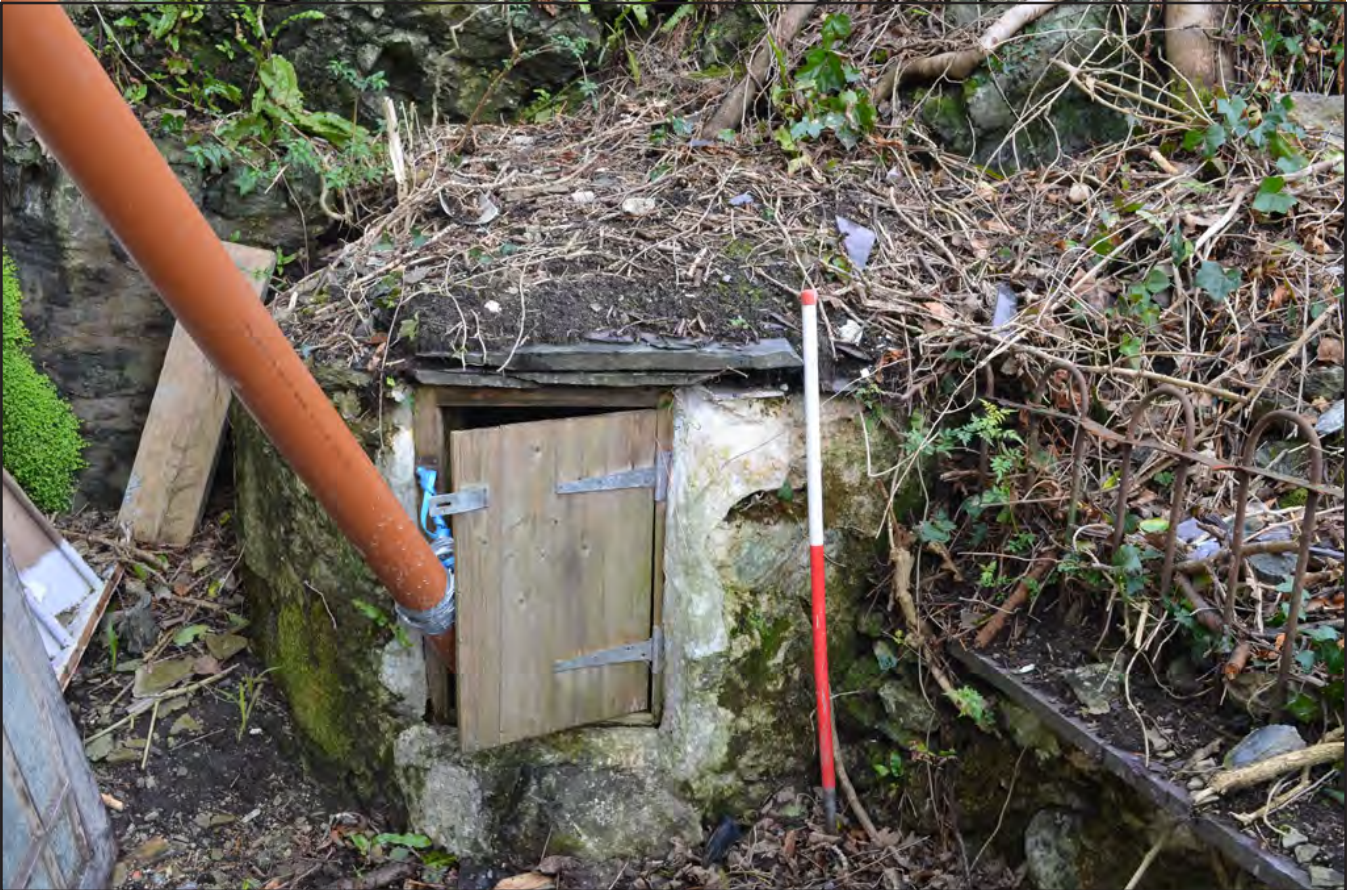
Plate 04: Possible enclosed well at north eastern edge of the cottage (Scale: 1 x 1.0m)

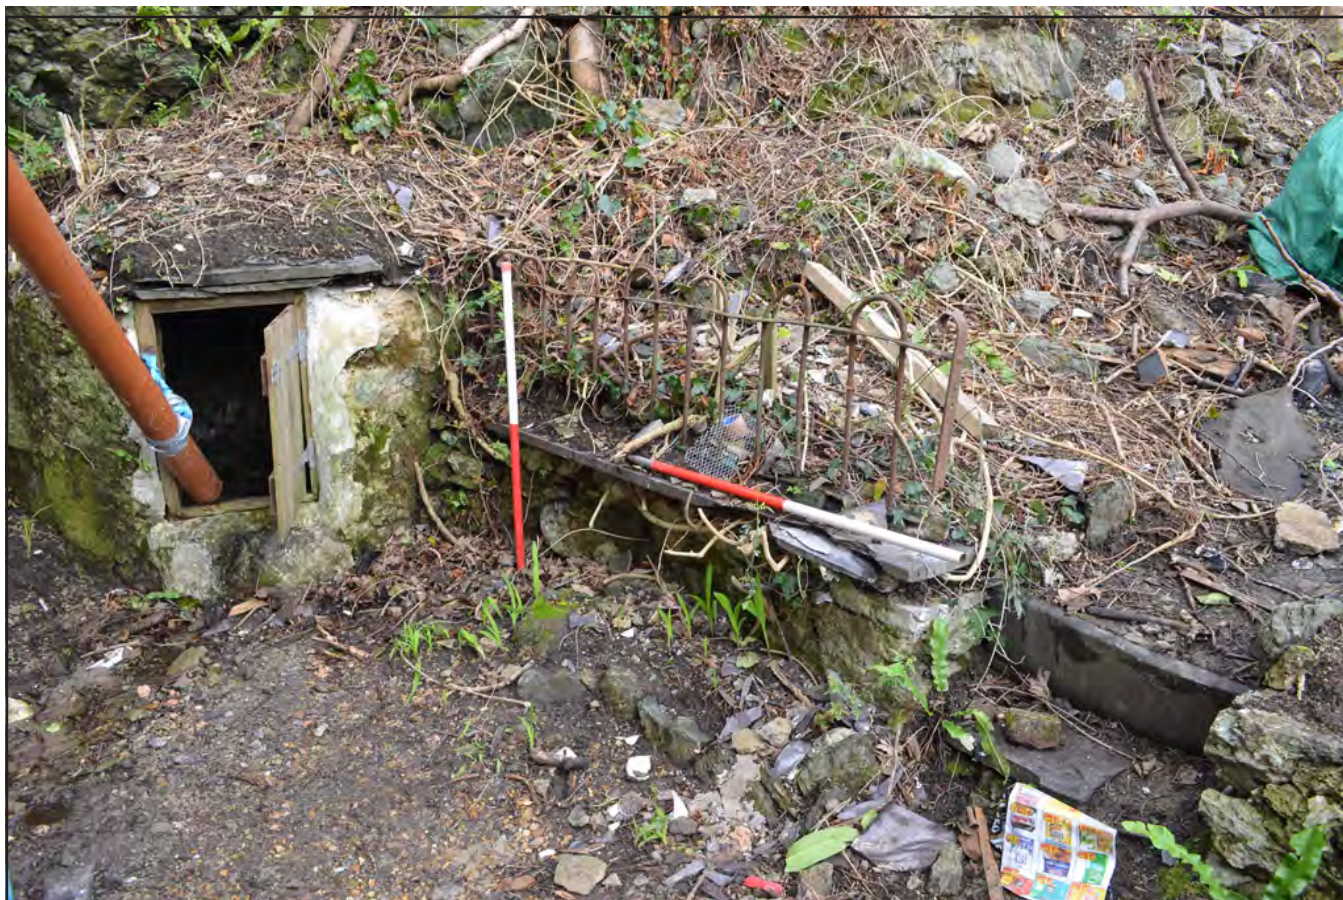
Plate 05: View from the southwest of possible enclosed well and remnants of cast iron railings and stone wall at eastern end of cottage (Scale 1 x 1.0m)

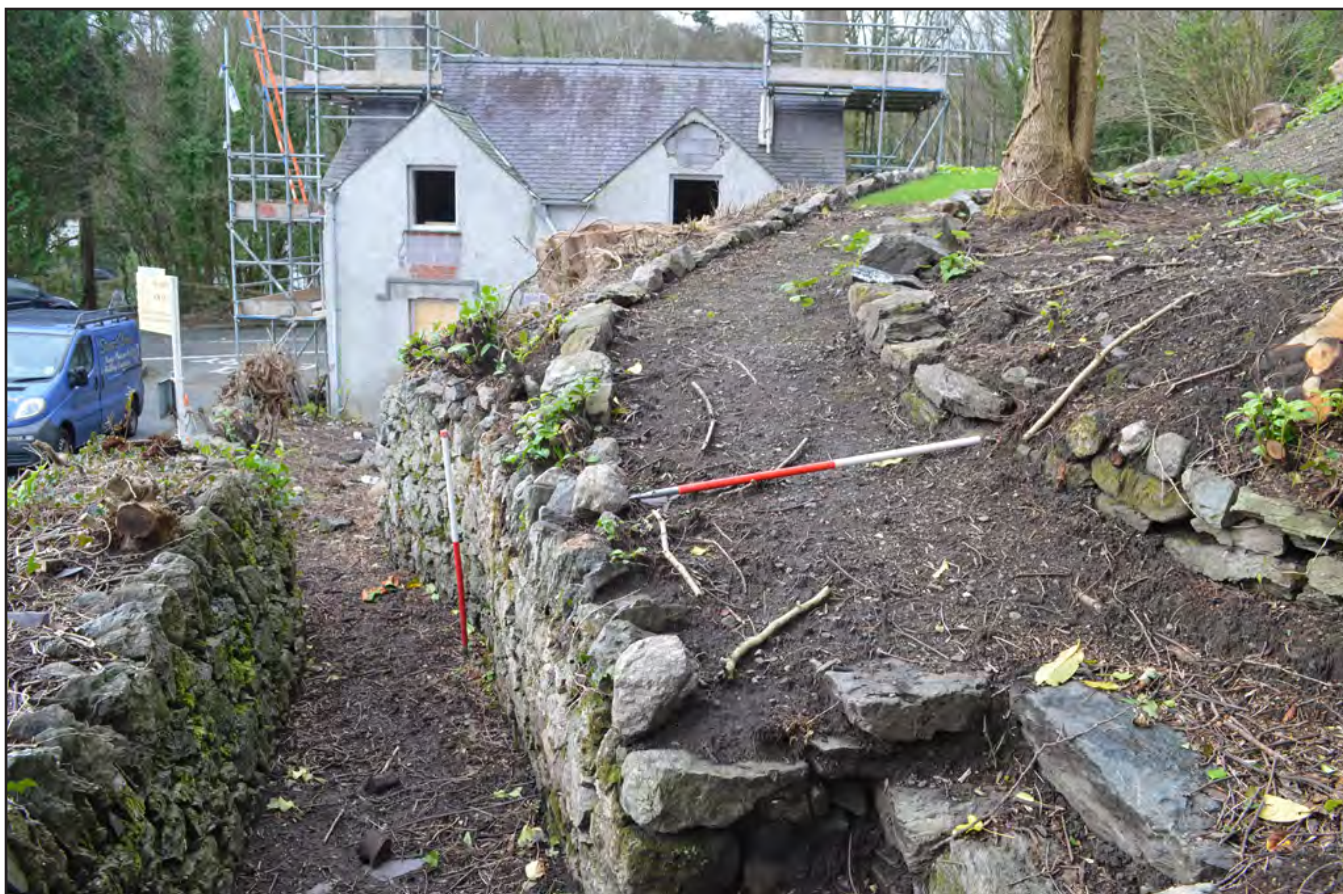
Plate 06: View from the east of garden path, with view of eastern elevation of cottage (Scale: 1x1 m).

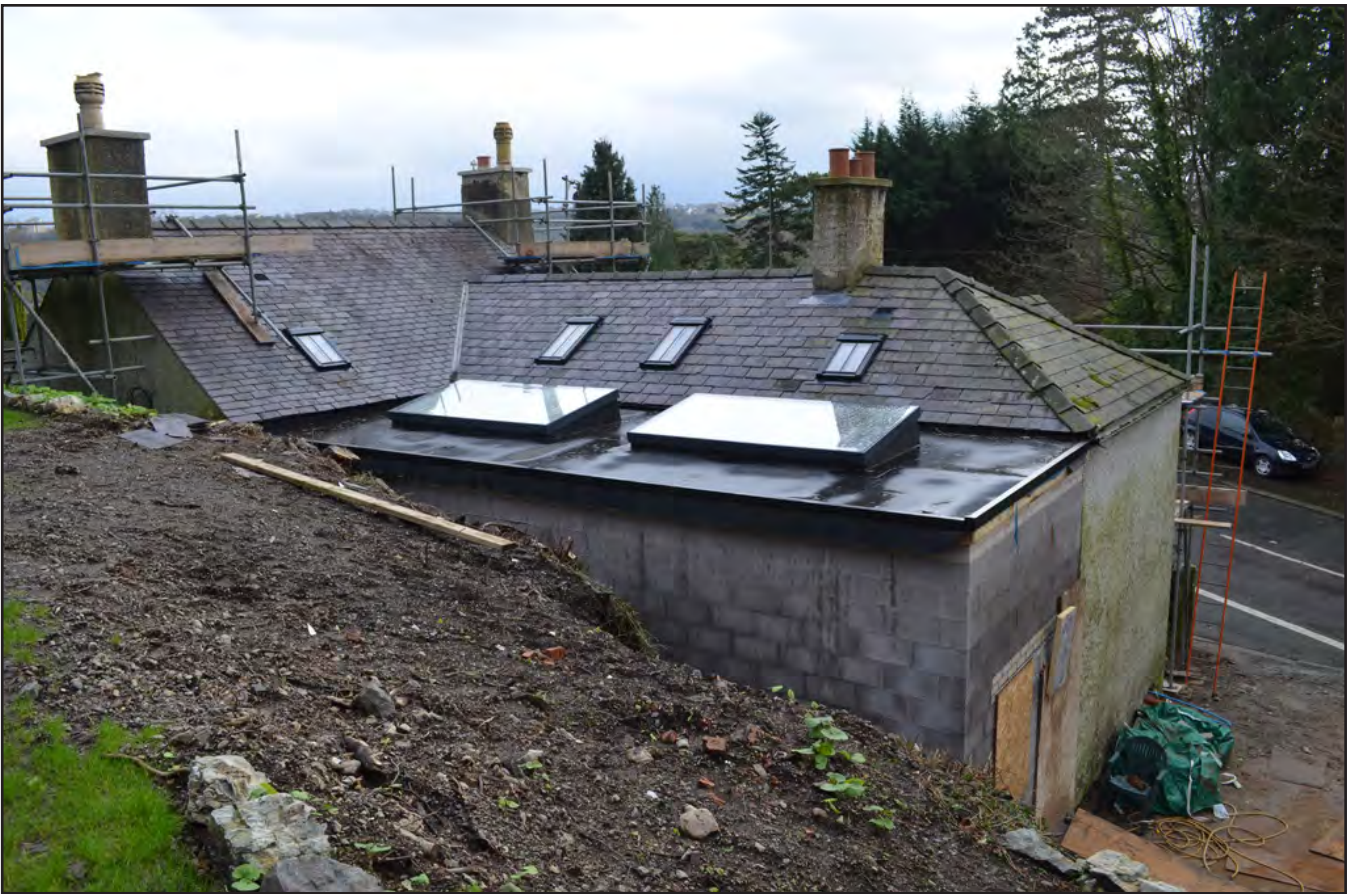
Plate 07: Northern elevation of the cottage with view of pitched roof.

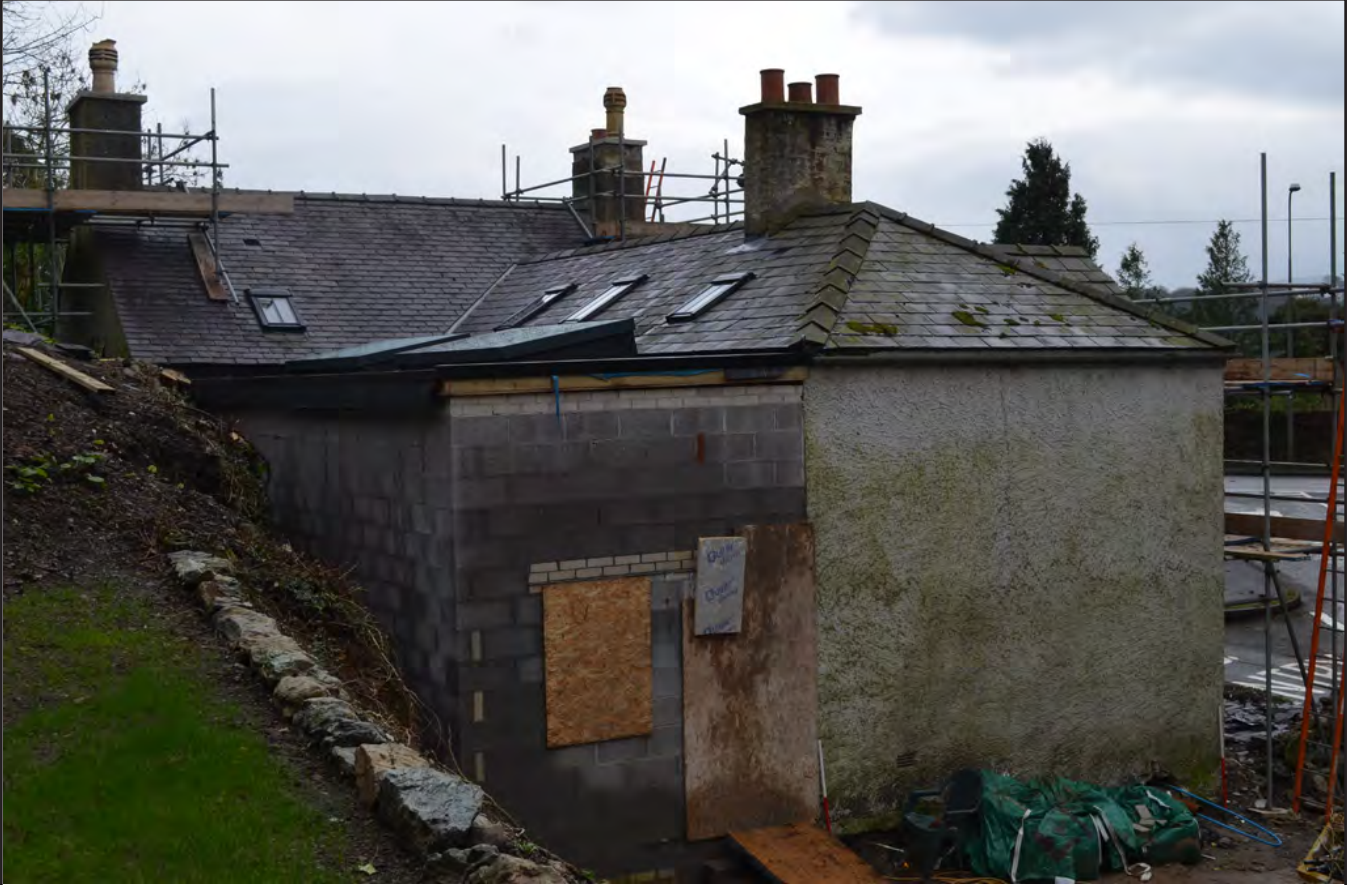
The renovation of the cottage also included a new extension at the rear, northern elevation of the property, which is in line with the western elevation. The extension is built of concrete blocks with a flat roof and large sky-lights (Plate 8).

Plate 08: Detail of western end of Nant Cottage.

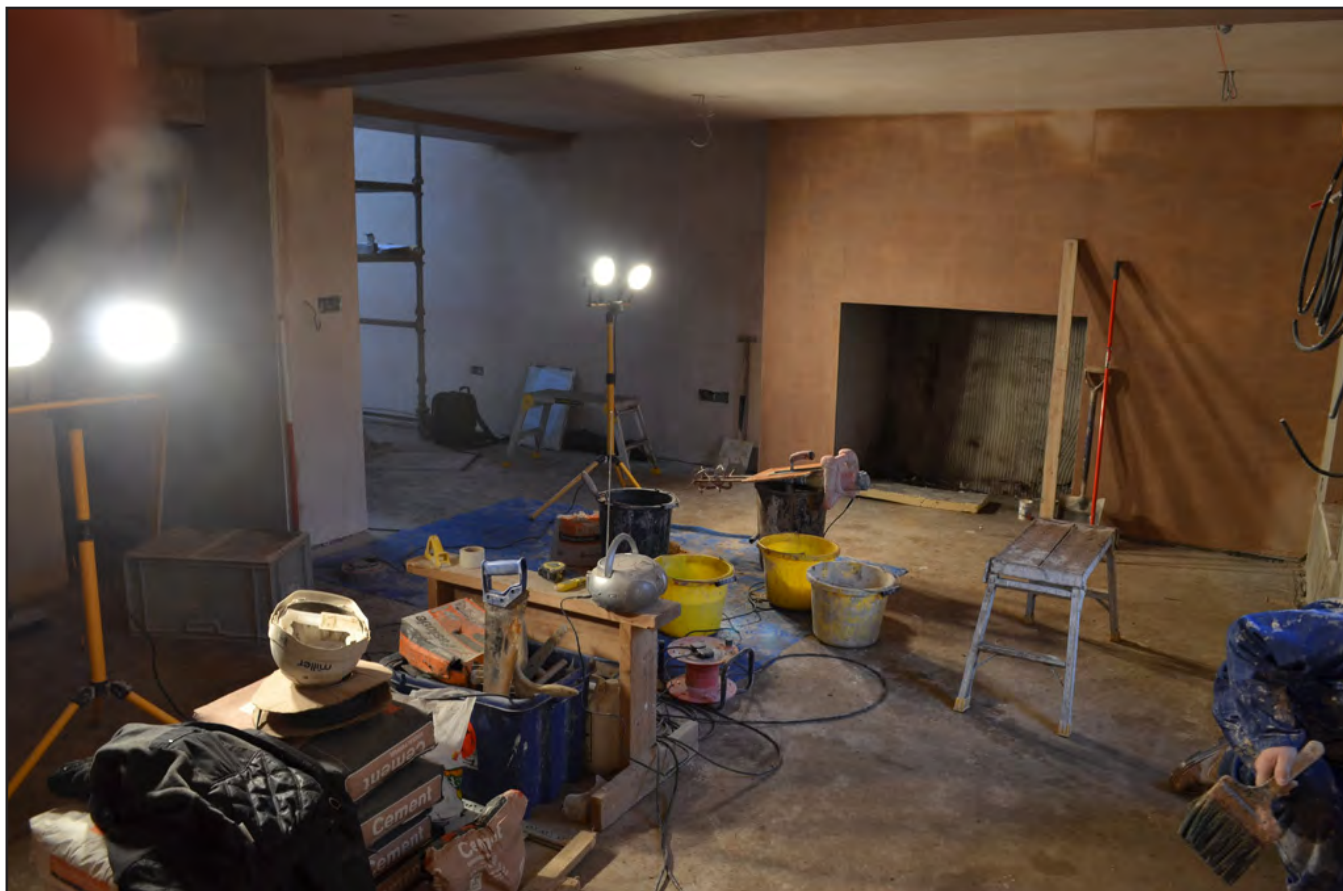
Plate 09: Internal view from southwest of central ground floor during conversion into lounge & dining room at eastern half of the cottage (Scale: 1 x 1.0m)

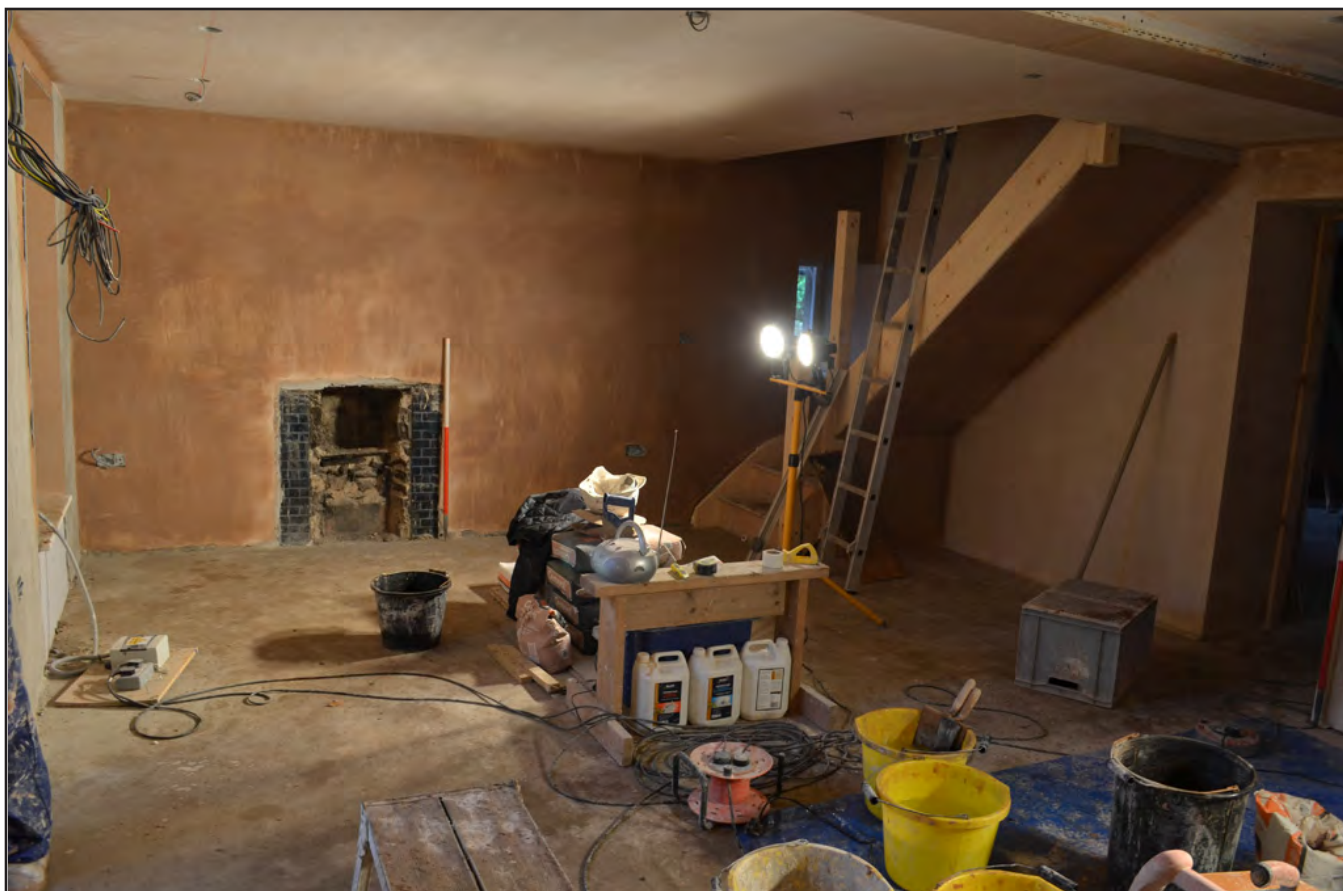
Plate 10: Internal view from southwest of central ground floor during conversion into front lounge at eastern half of the cottage (Scale: 1 x 1m)

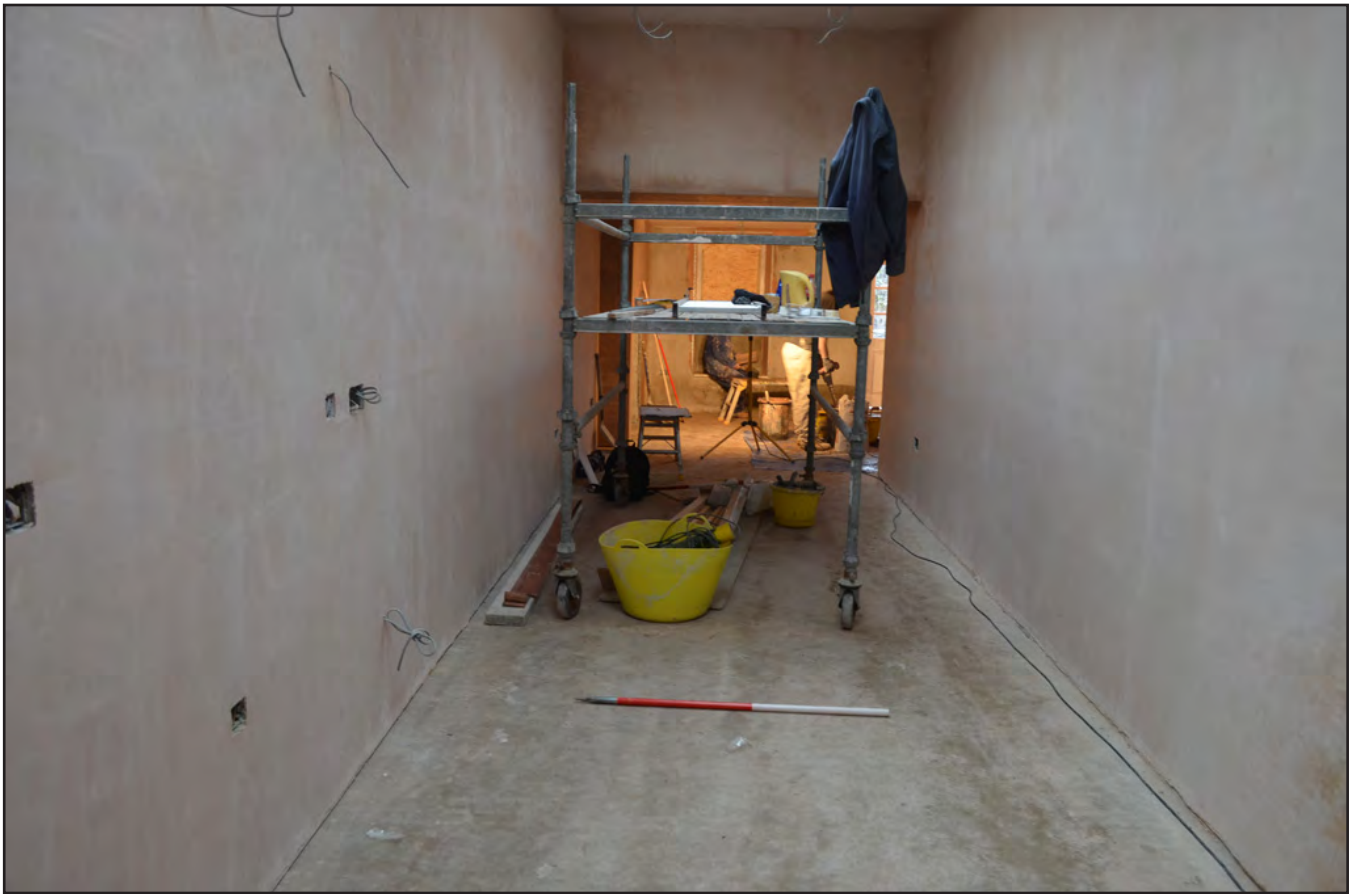
Plate 11: Interior view from the west of the new extension (Scale: 1 x 1m).

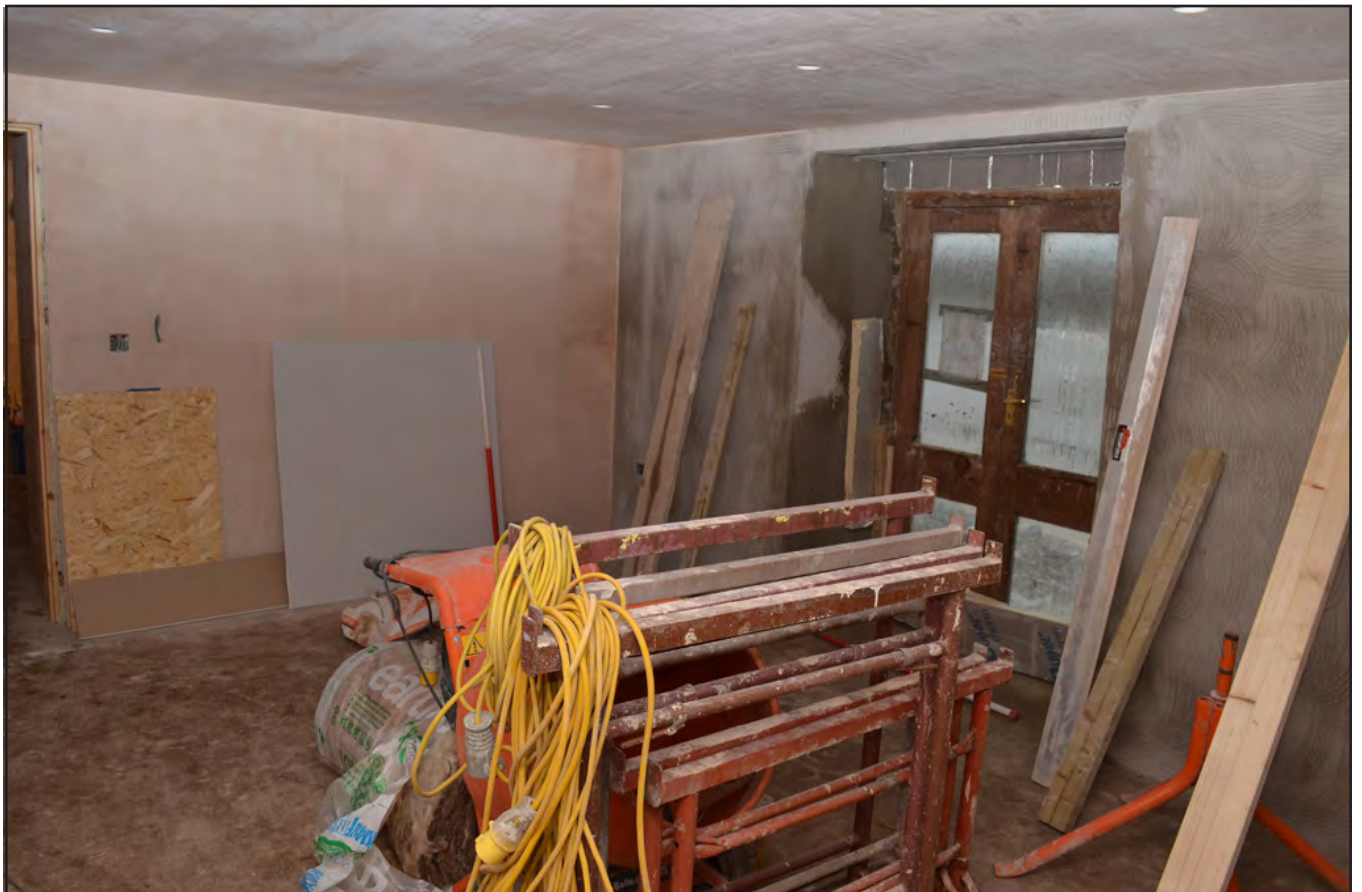
Plate 12: Internal view from the northwest of the ground floor centre showing new middle lounge during conversion (Scale: 1 x 1m).

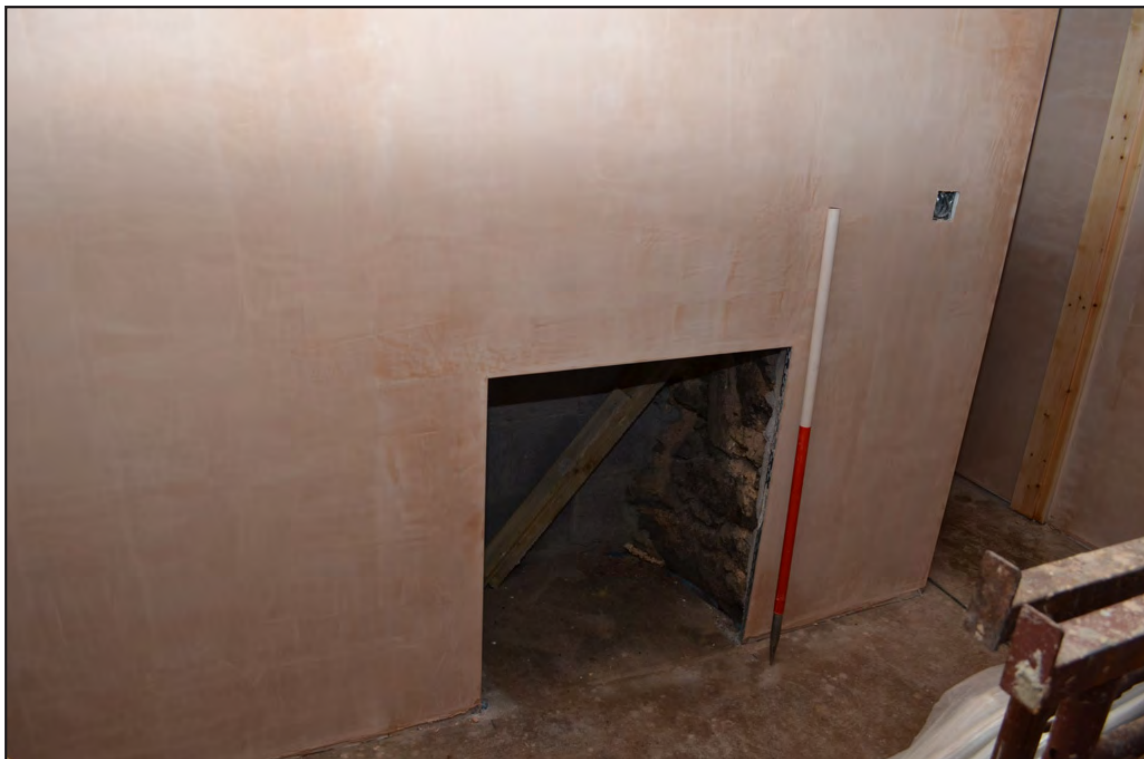
Plate 13: Internal view fireplace in wall between middle lounge and rear hallway (Scale 1 x 1m).

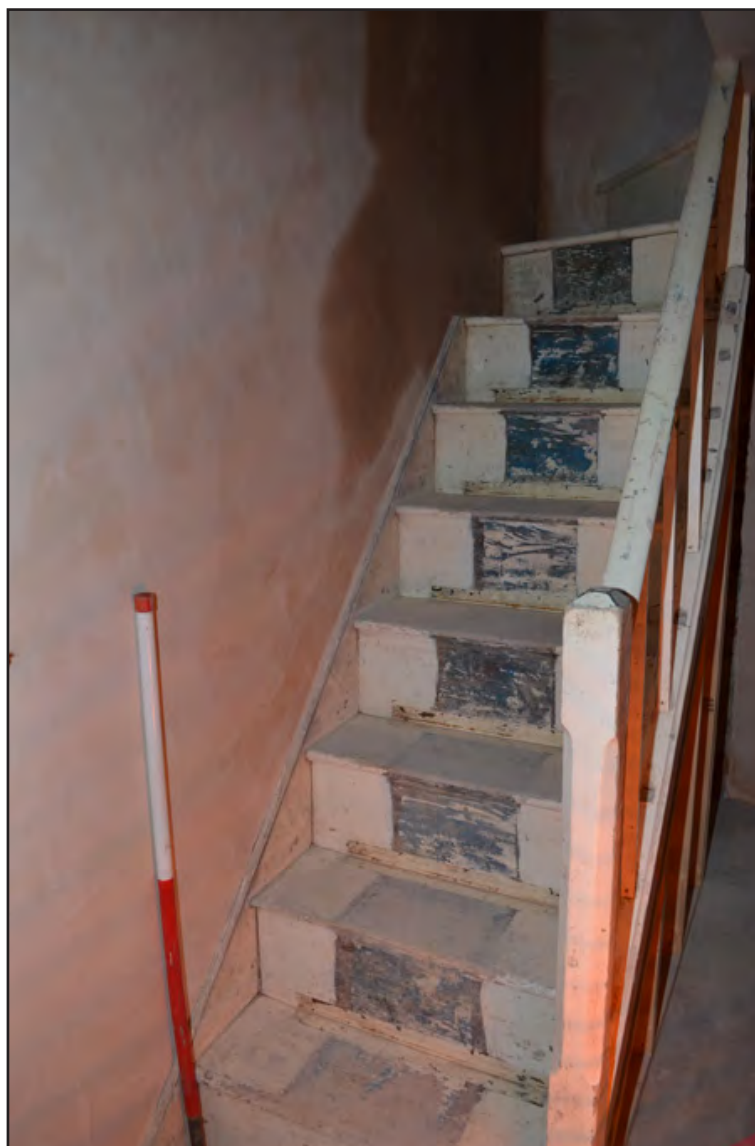
The interior of Nant Cottage had been stripped bare and all of the internal walls had been covered in fresh plaster by the time of the photographic survey. The ground floor consisted of four rooms. The eastern wing was cluttered with the building contractor's equipment, with a new stairwell leading to the first floor and the two fireplaces still evident, with the smaller of the two in the south elevation being the more intact (Plates 9 and 10). The new extension is currently a long, open space and appears to have enclosed a yard, as a manhole cover was still visible (Plate 11). The remaining two rooms of the ground floor were in the southern wing of the cottage. The larger of the two rooms, which is proposed to be a lounge, had a double door in the south elevation and fireplace at the west elevation of the room (Plates 12 and 13). The rear stairwell at the northern limit of the cottage appeared to have largely retained an existing set of stairs (Plate 14).

Plate 14: Internal view of stairwell in rear hallway. (Scale 1 x 1m).

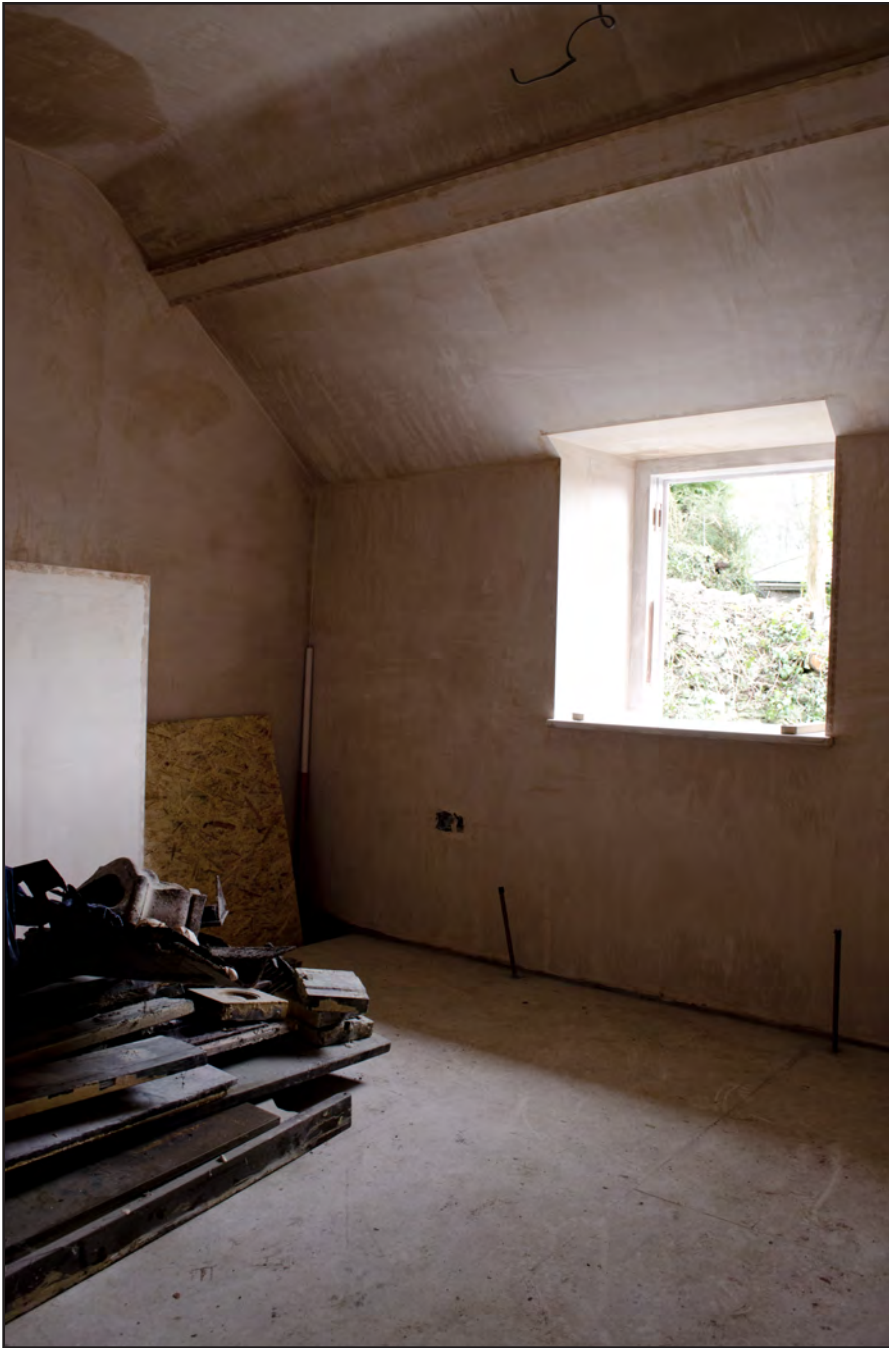
Plate 15: Internal view from southwest of first floor room (Scale 1 x 1m).

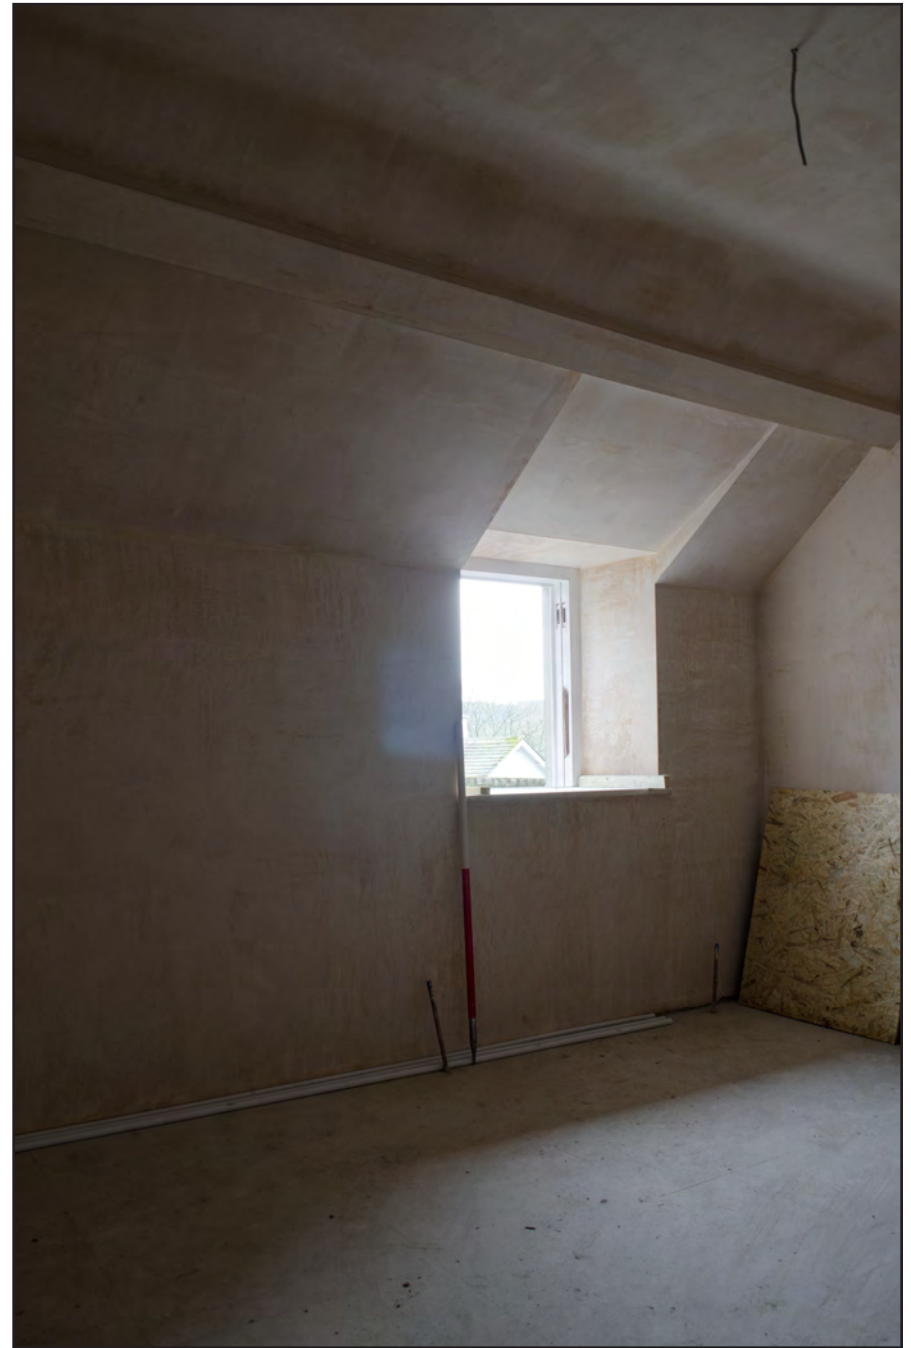
Plate 16: Internal view from northwest of first floor room (Scale 1 x 1m).

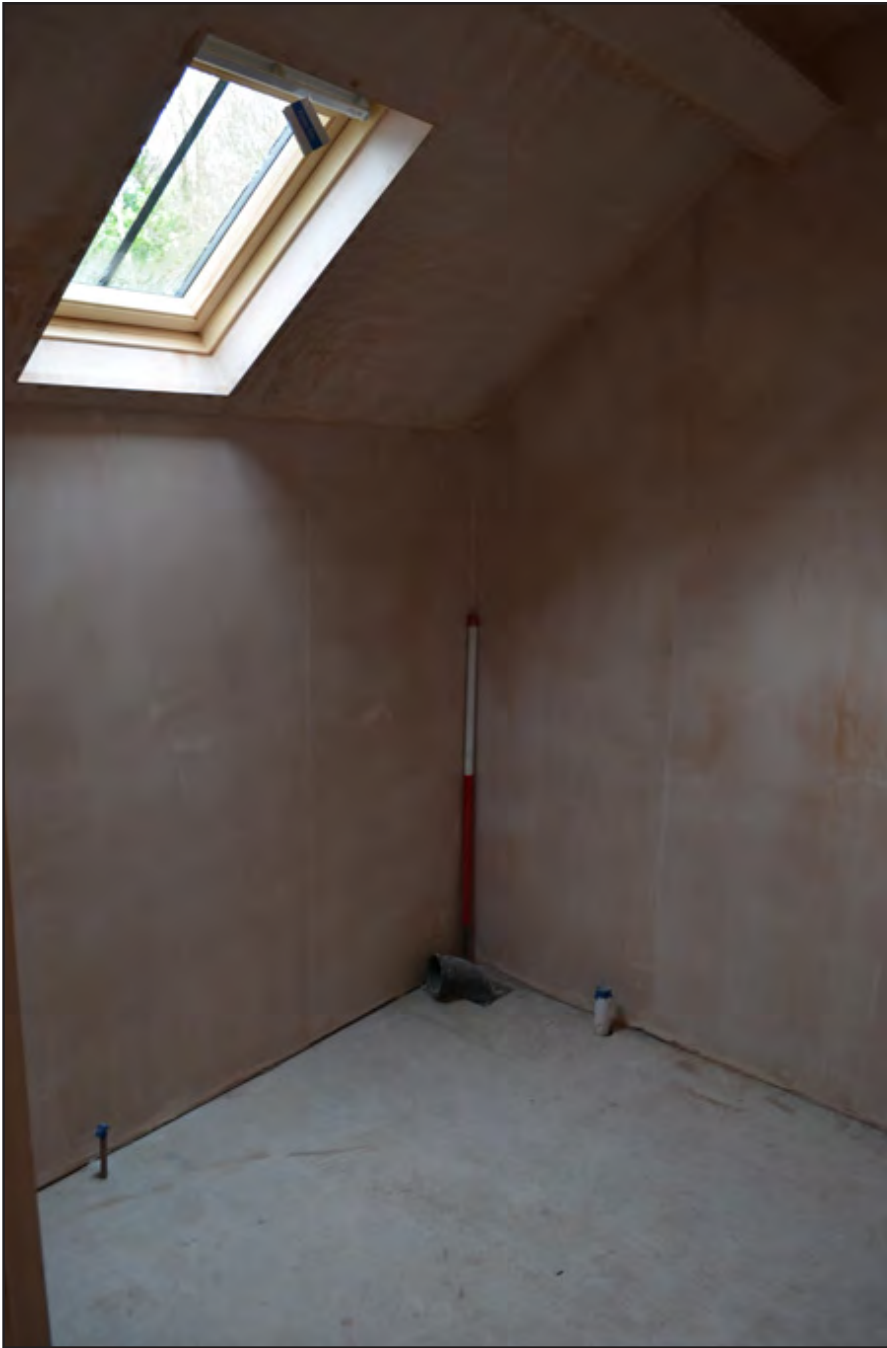
Plate 17: Internal view of bathroom adjacent to front bedroom (Scale 1 x 1m).

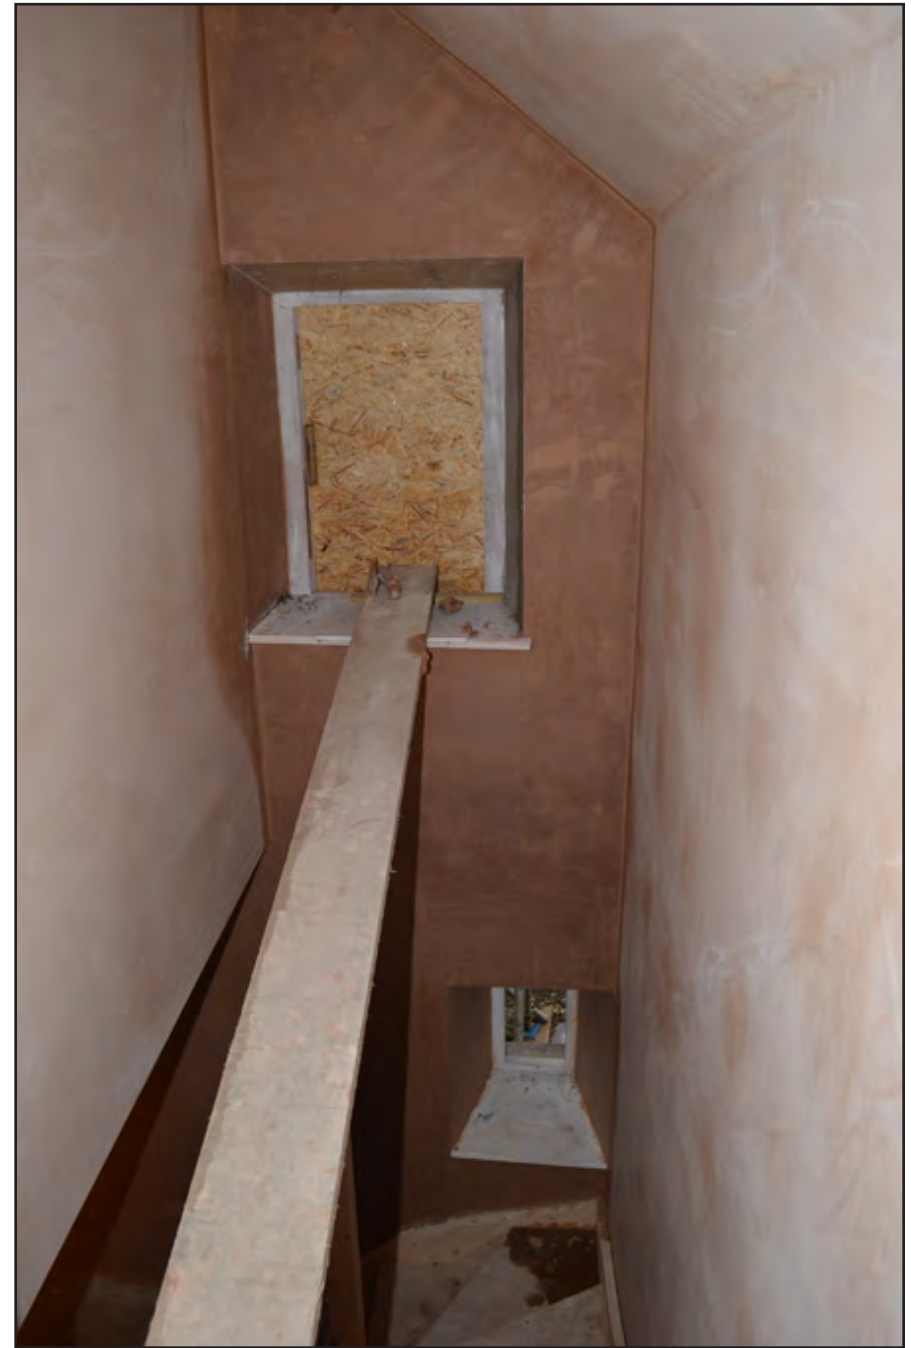
Plate 18: Internal view of windows along southern wall of cottage at the stairwell.

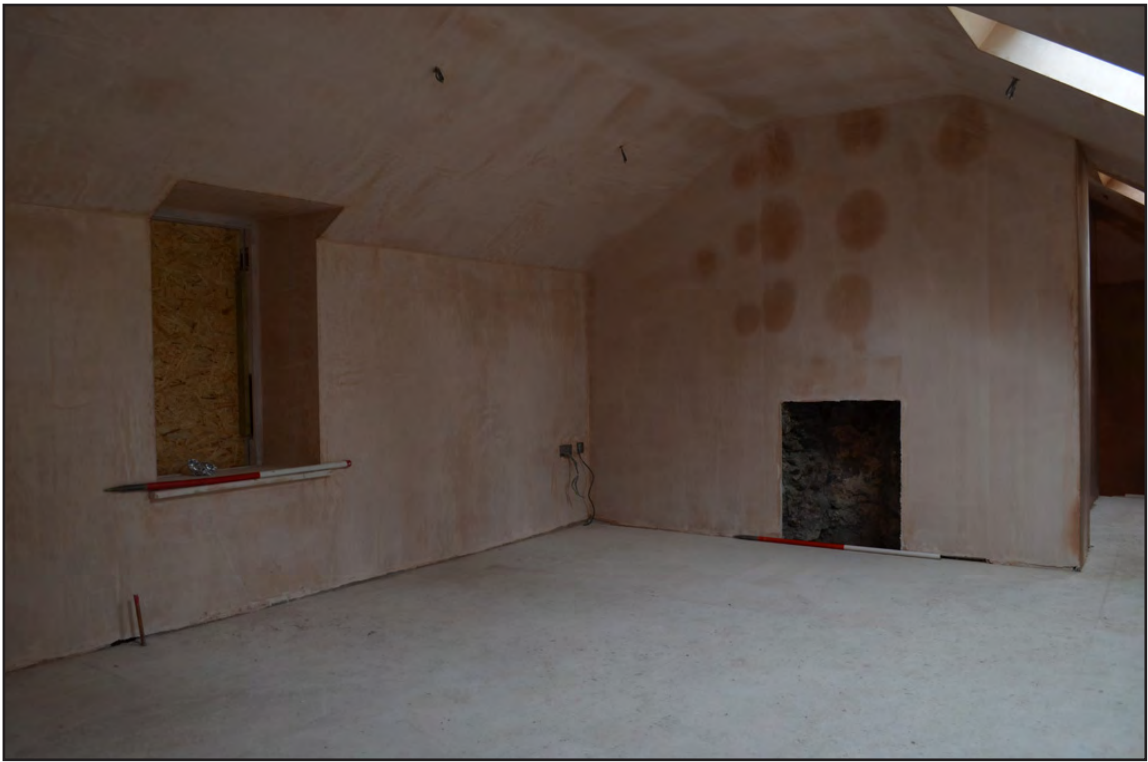
Plate 19: Internal view of first floor southern and western walls of main bedroom(Scale 2 x 1m).

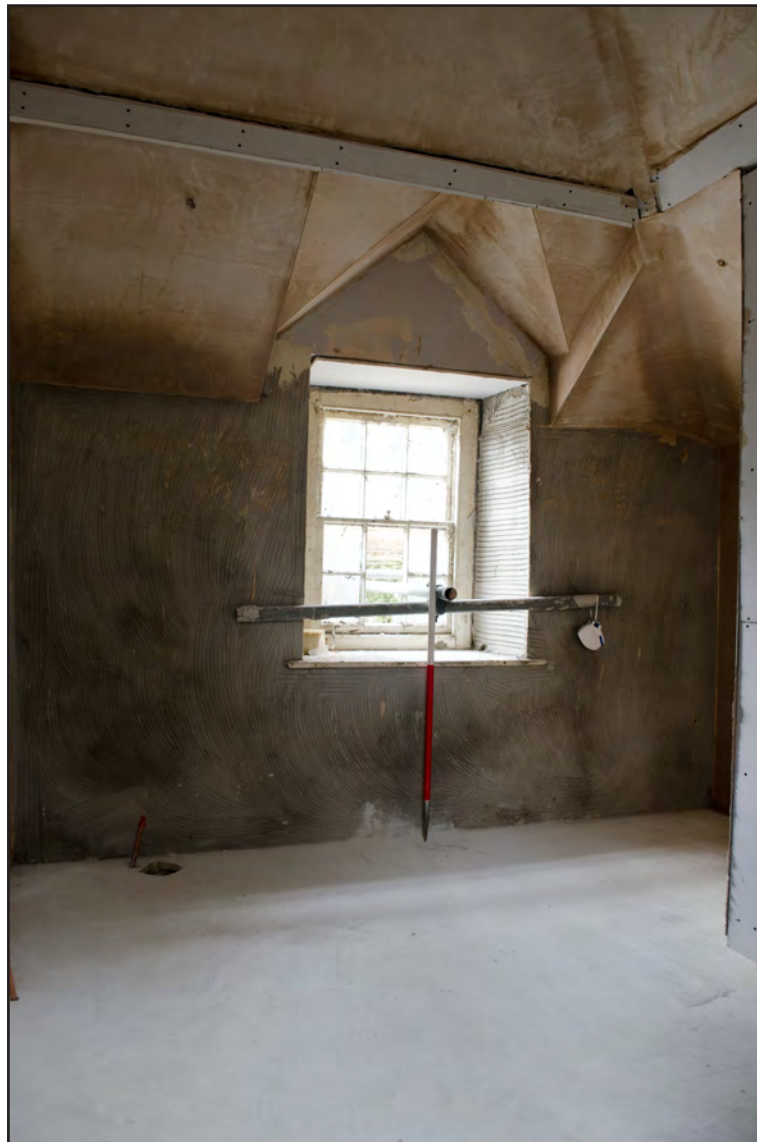
The first floor consisted of six rooms. The eastern wing had two similar sized rooms that are proposed bedrooms, each of which appear to have had the ceiling raised as part of the renovation (Plates 15 and 16) and a window in the east elevation. The proposed bathroom off the hallway is similar in design as the 'bedrooms' and had a skylight (Plate 17). The hallway was open plan, tall and narrow, with two windows in the south elevation (Plate 18). The largest room on the first floor had an existing window in the south elevation, an existing fireplace in the west elevation of the room and two new skylights (Plate 19). The proposed 'main bathroom' beyond had retained its sash window in the south elevation and like the other rooms had a high, pointed ceiling (Plate 20).

Plate 20: Internal view of first floor window in southern wall of main bathroom (Scale 1 x 1m).
