# Vanner Caravan Park, Llanelltyd: Archaeological Watching Brief

GAT Project No. 2105  
Report No. 836  
November 2009

Prepared for  
Rhys Llwyd Davies

By  
Matt Jones

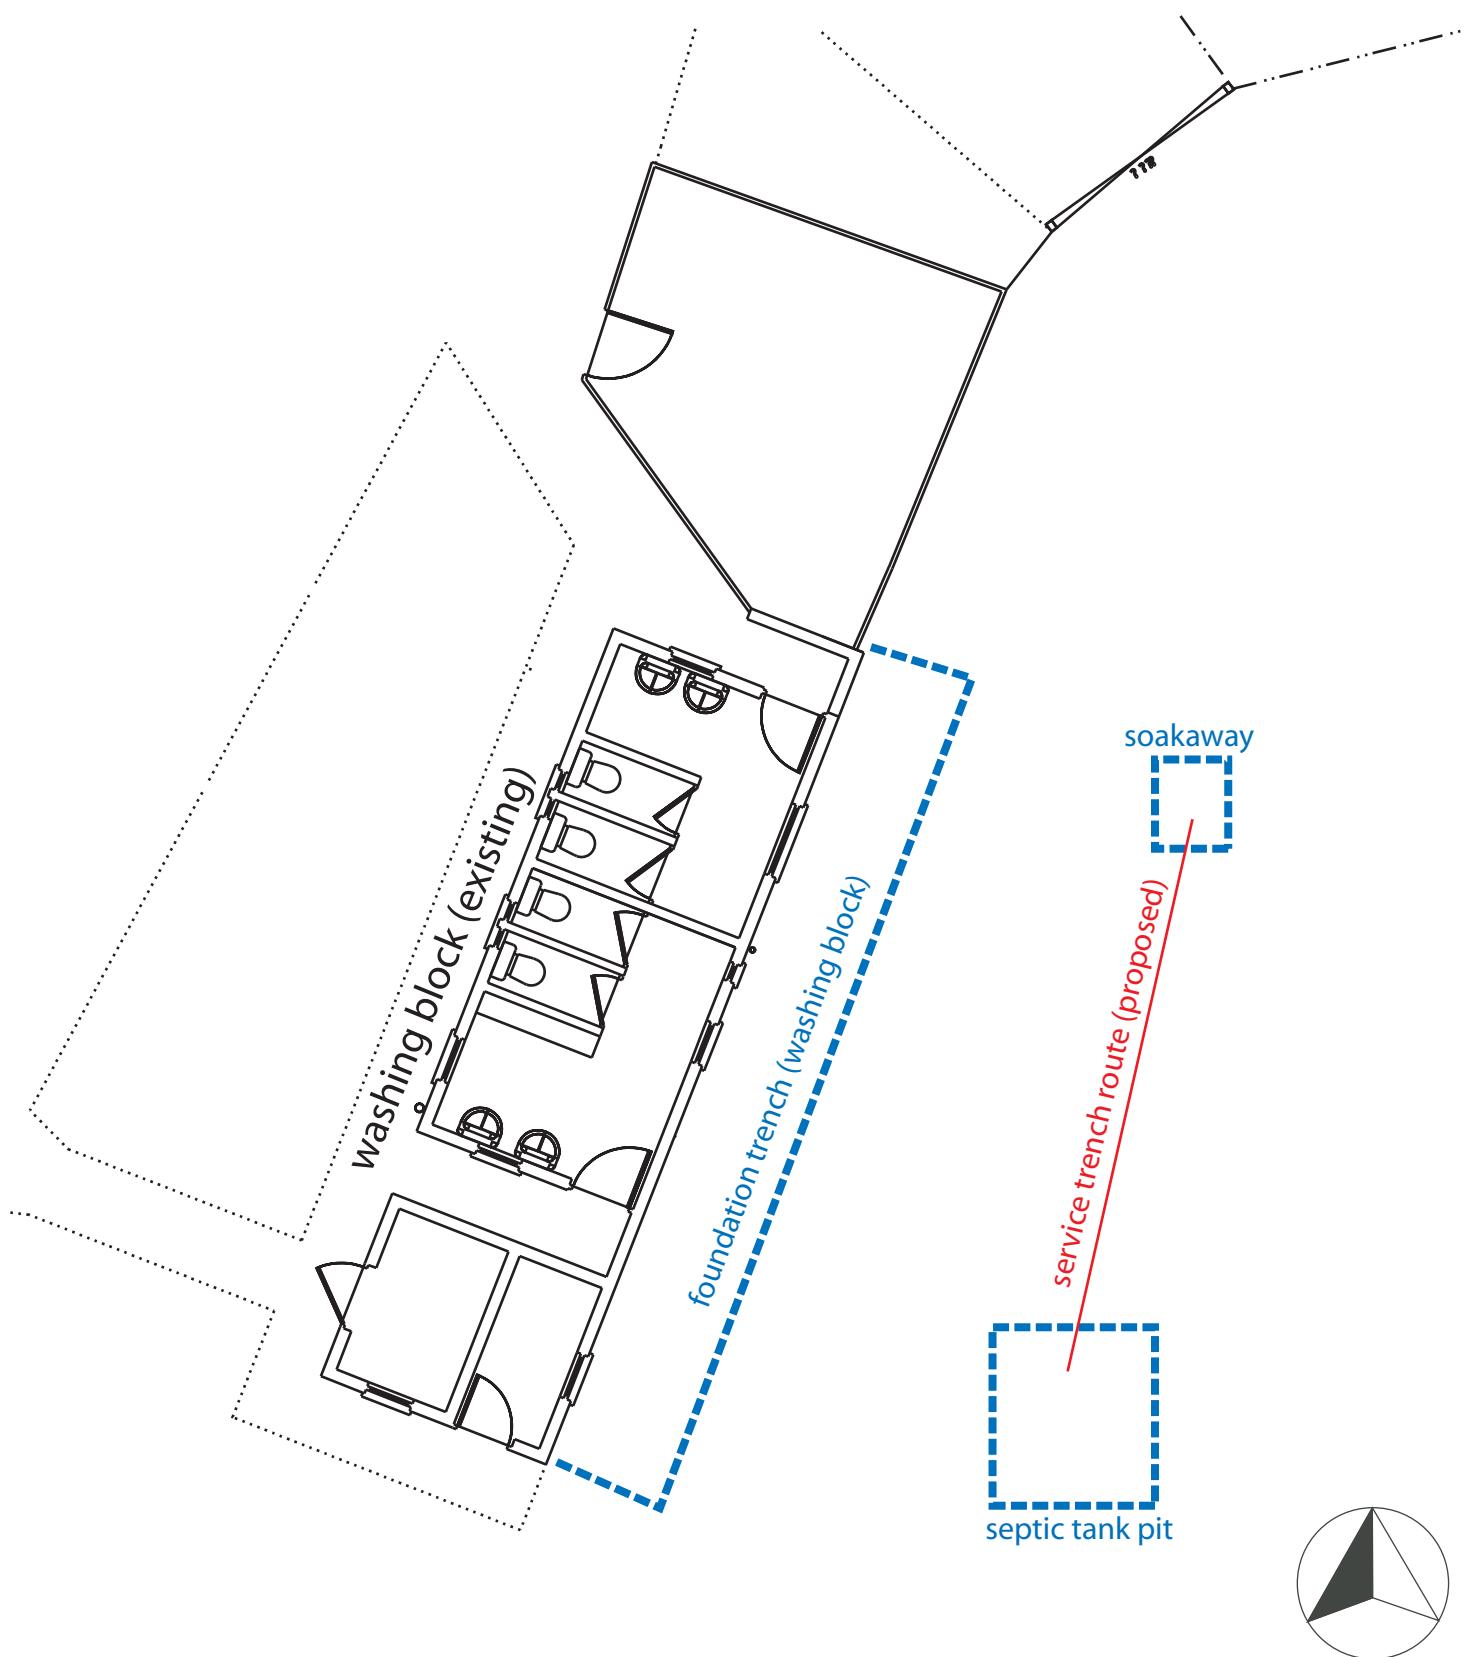
Figure 02: location of groundwork areas discussed in the text (highlighted **BLUE**). The existing washing block will be demolished as part of proposed works and will be replaced by a washing block on the revised footing dictated by the foundation trench. A proposed service trench (highlighted **RED**) was not excavated during the watching brief discussed in the report but is proposed for a later date. Based on the observations from the excavated areas, it is thought that the archaeological potential is low and a further watching brief is not required. (based on client drawing 124(F)L05; scale 1:100@A4)

**existing washing block  
(to be demolished)**

**footings trench**

**septic tank pit**

**soakaway pit**

The groundworks monitored by the watching brief included (cf. figure 02):

- washing block footings: 12.0m long by 2.0m wide (depth 0.10m – 0.25m);
- septic tank pit: 2.40m long by 3.80m wide (depth 2.30m – 2.50m);
- soakaway: 2.0m long by 1.45m wide (depth 1.30m).

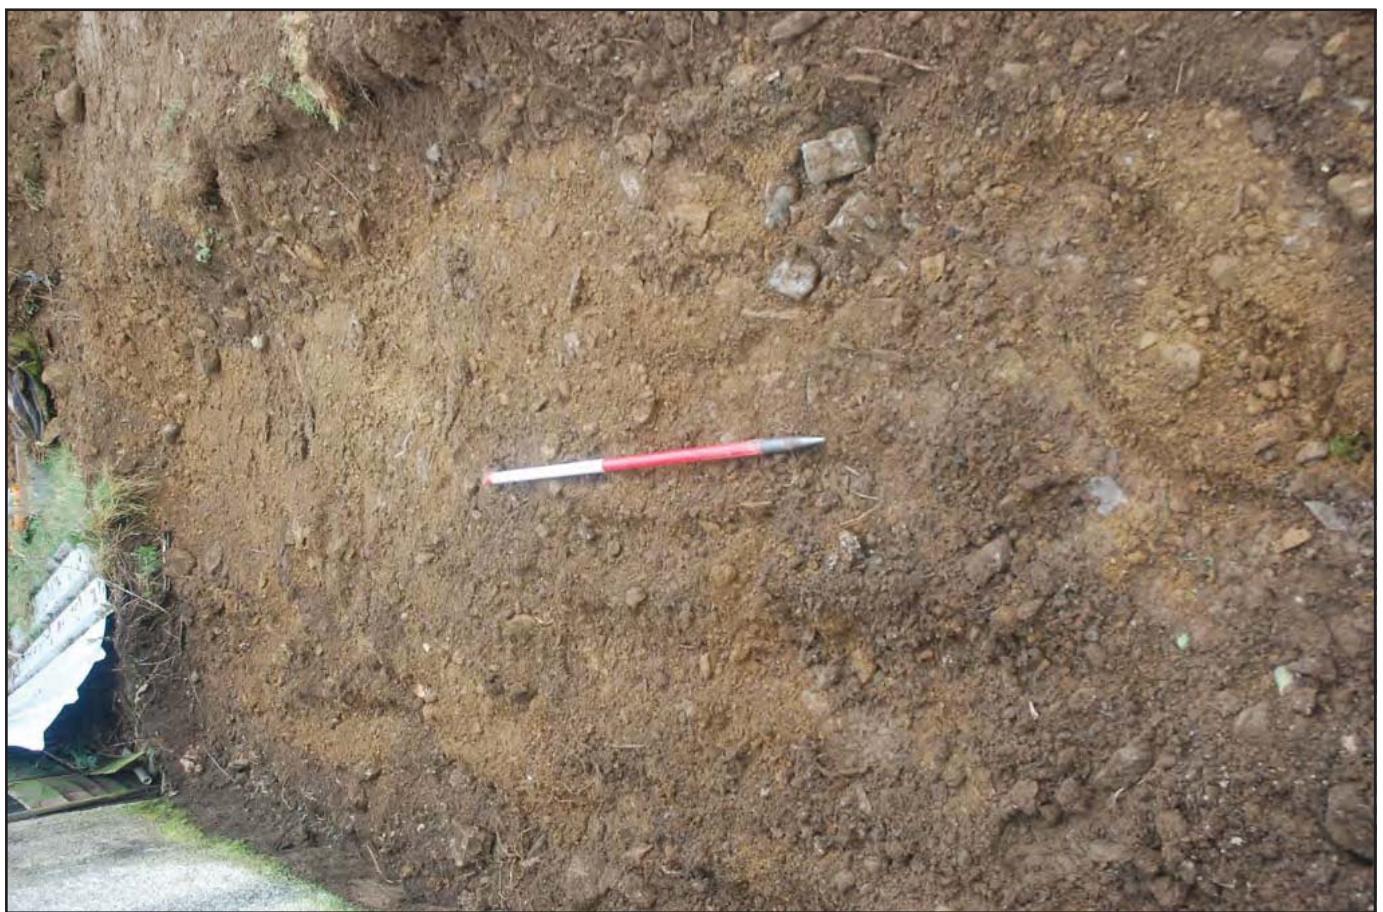
Plate 03: view north of washing block footings detailing limit of excavation.  
Note the modern disturbance associated with the construction of the existing  
block (ranging pole: 1.0m)

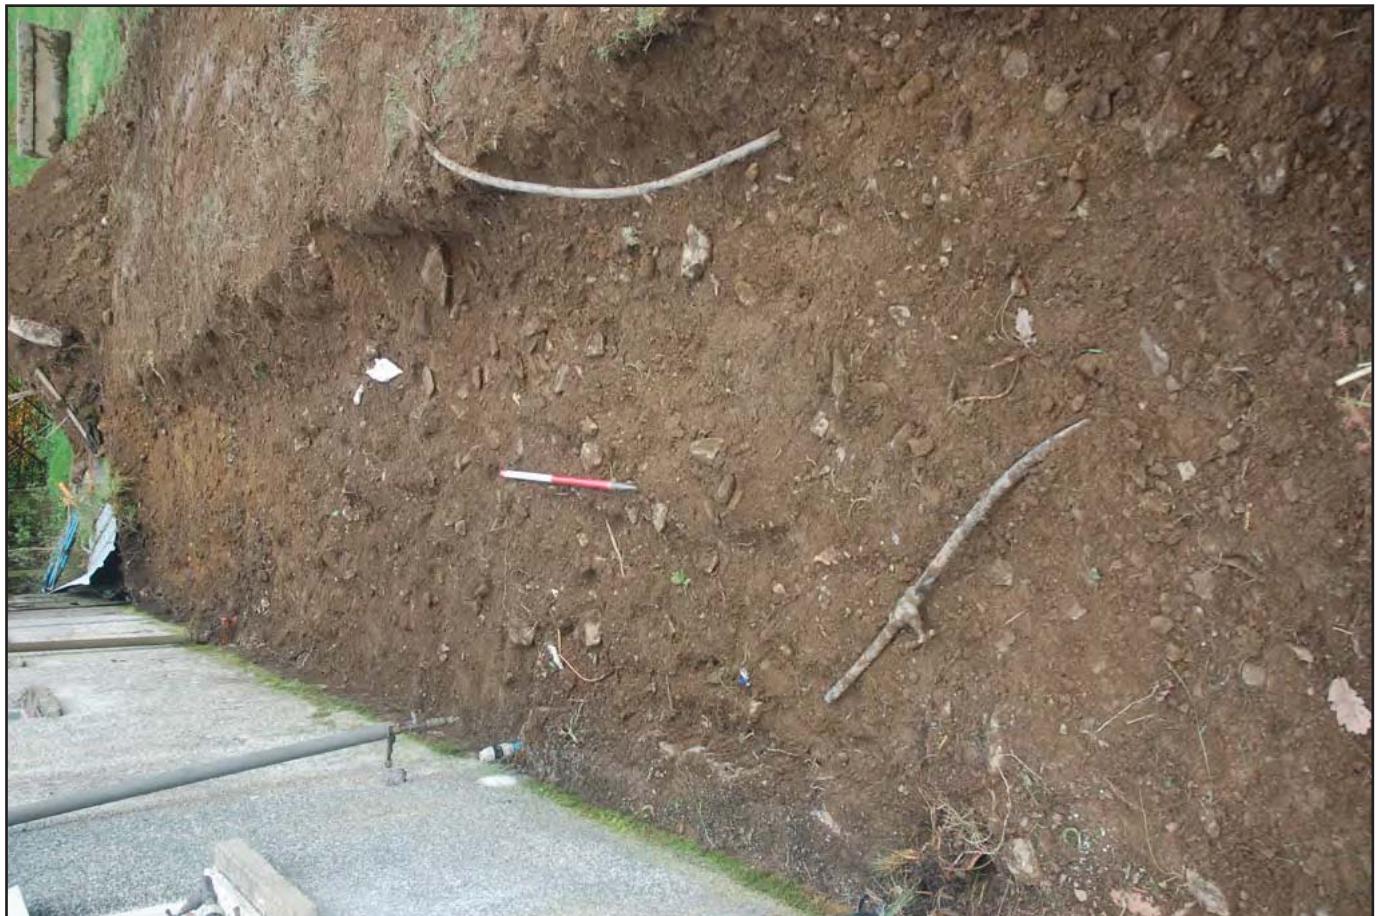
The northern end of this trench (length: c.4.0m) was heavily disturbed and appeared to be the backfill of an existing soakaway/drainage pipe that was part of the original washing block construction. This fill contained broken bricks of the same type used for the extant washing block.

Several 50mm black plastic pipes were also identified crossing the southern end of the footings excavation (plate 02).

Plate 02: view north of washing block footings during excavation.  
Note the modern disturbance associated with the construction of the existing  
block (ranging pole: 1.0m)

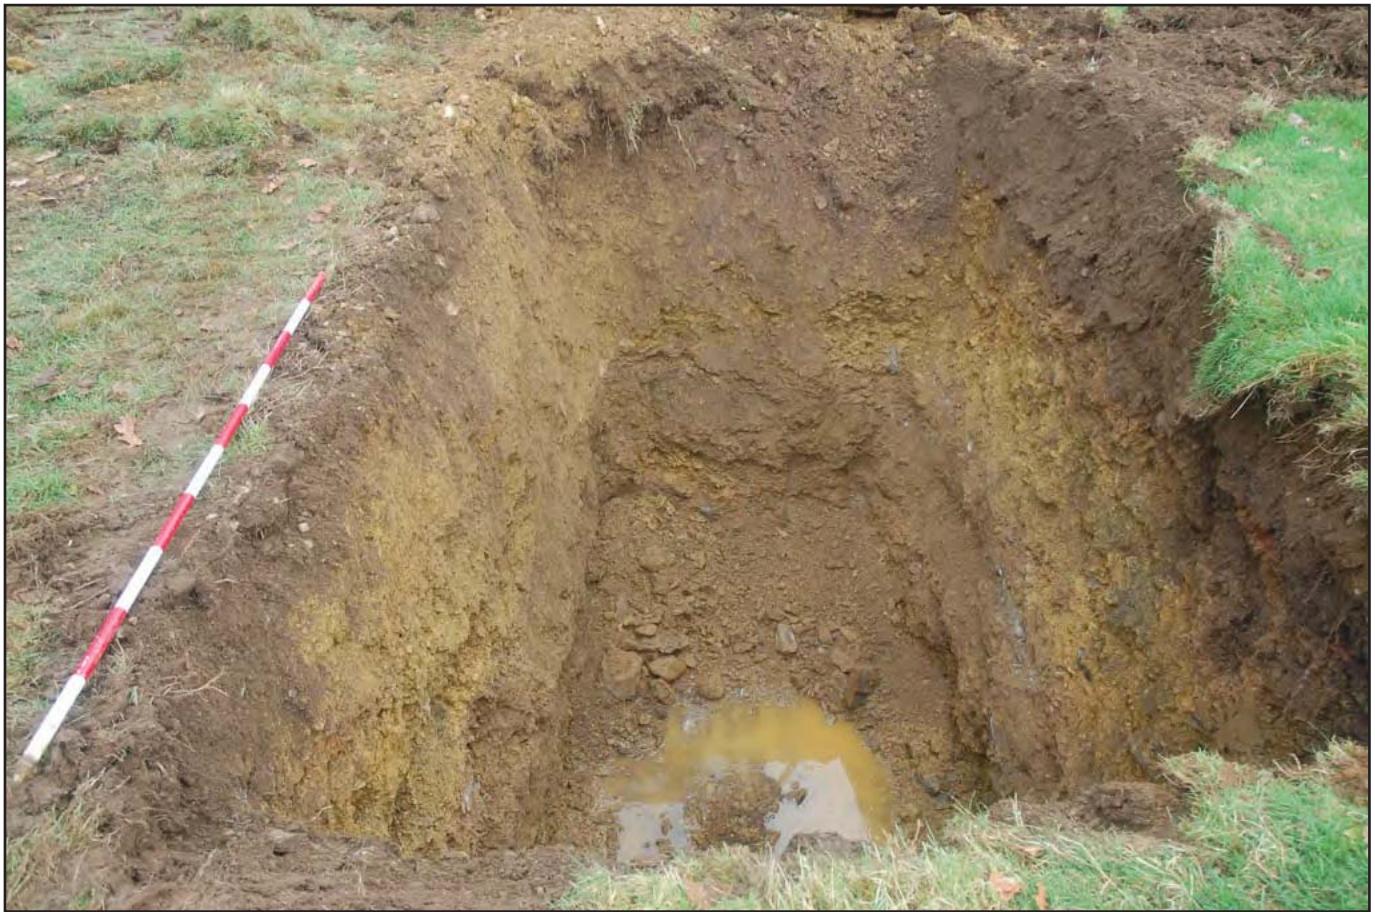
The stratigraphy within the septic tank pit comprised three visible sections: turf/topsoil (mid-brown clay-silt, between 0.25m and 0.53m thick); a yellow clay-gravel with frequent very small rounded stones and rare sub angular flat stones (between 0.92m and 1.31m thick); below this there was a mid brown gravel clay with frequent very small rounded stones and rare sub angular flat stones, (between 0.74m and 1.05m thick).

Plate 04: view north of the septic tank excavation detailing limit of excavation. The pit was excavated into a slope and comprised topsoil of varying thickness followed by two distinct glacial deposits (ranging pole: 2.0m)

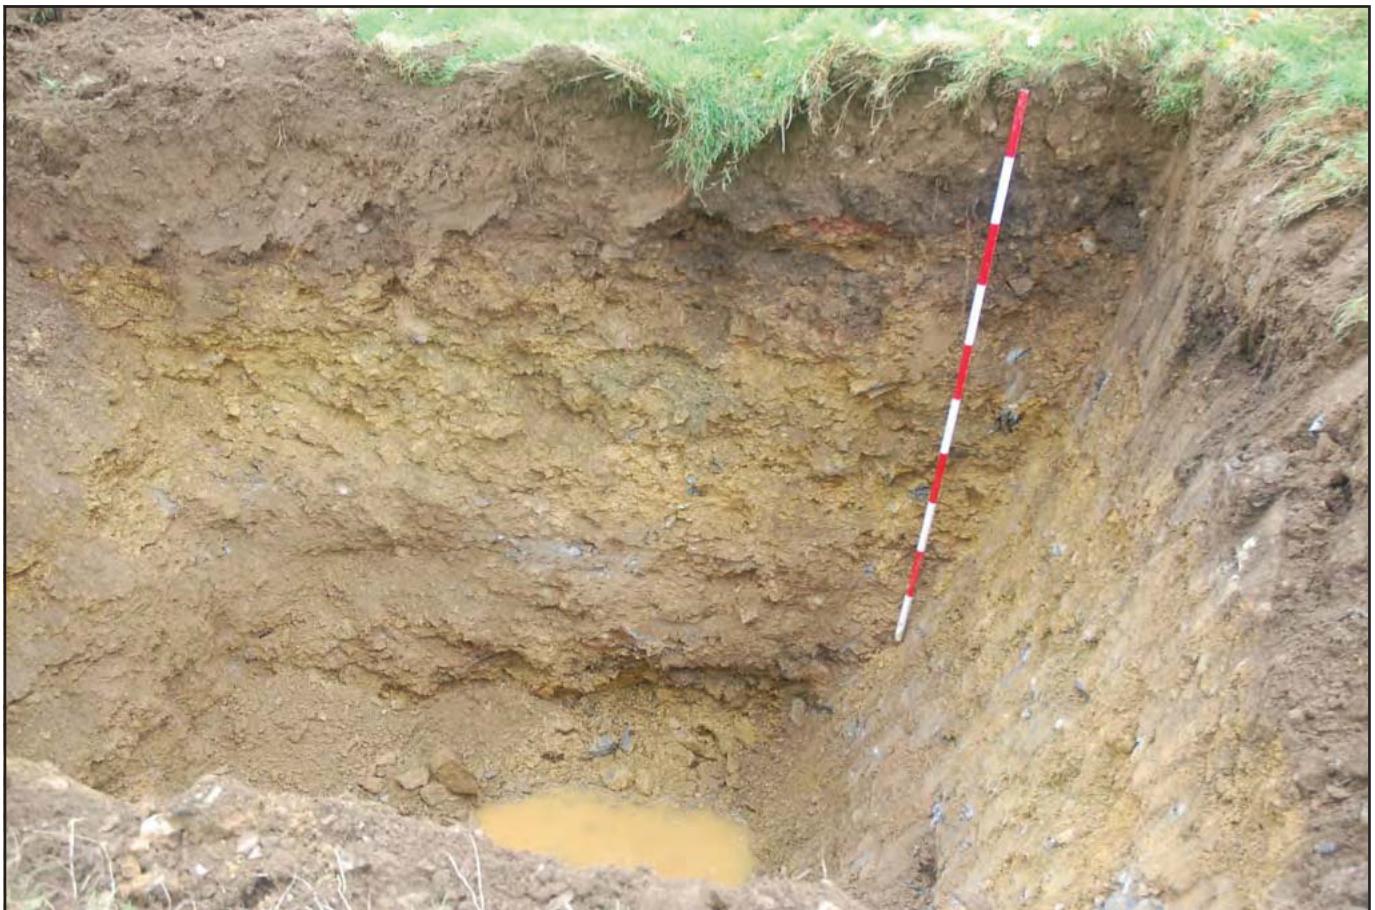
Plate 05: view west of the septic tank excavation detailing limit of excavation. The pit was excavated into a slope and comprised topsoil of varying thickness followed by two distinct glacial deposits (ranging pole: 2.0m)

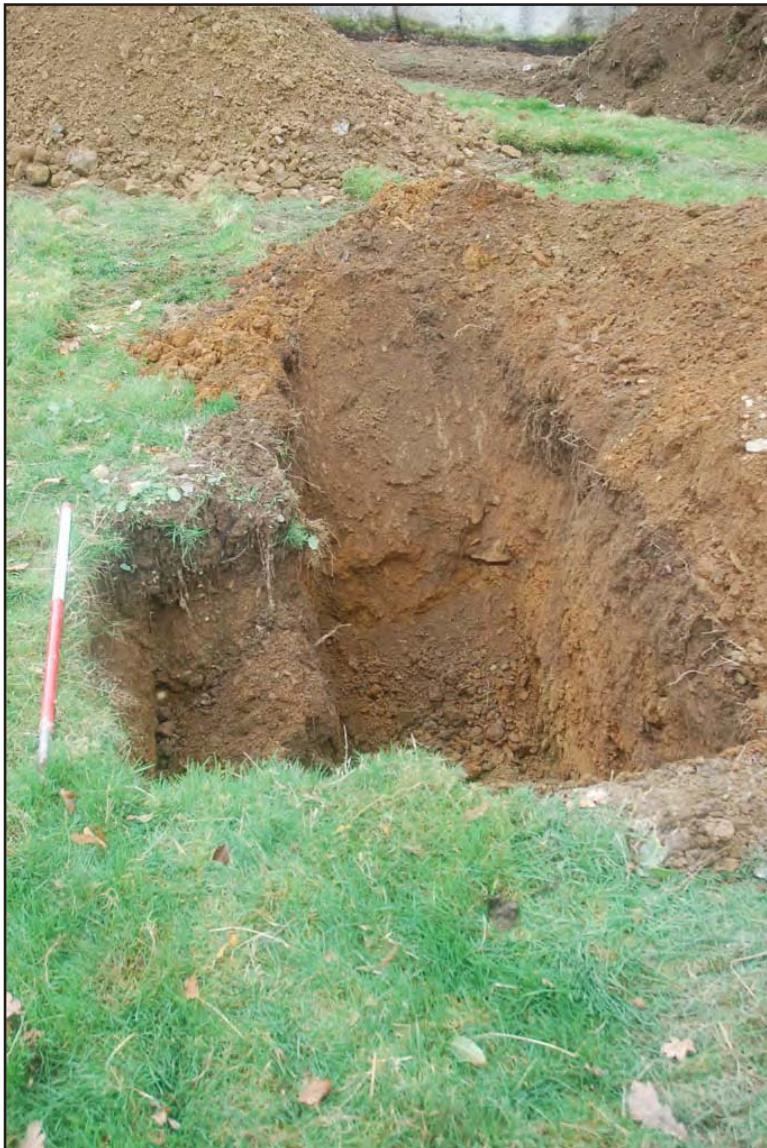
The stratigraphy within the soakaway comprised three visible sections: turf/topsoil (mid-brown clay-silt, 0.26m thick); an orange clay-silt with rare small flat irregular stones (0.48m thick); a mid-brown gravel-clay with frequent very small rounded stones and rare sub angular flat stones (1.05m thick).

Plate 06: working shot of soakaway detailing exposed sections and stratigraphy. The topsoil was extant to a depth of 0.26m followed by an orange clay-silt; followed by a mid-brown gravel-clay to limit of excavation (ranging pole: 1.0m)

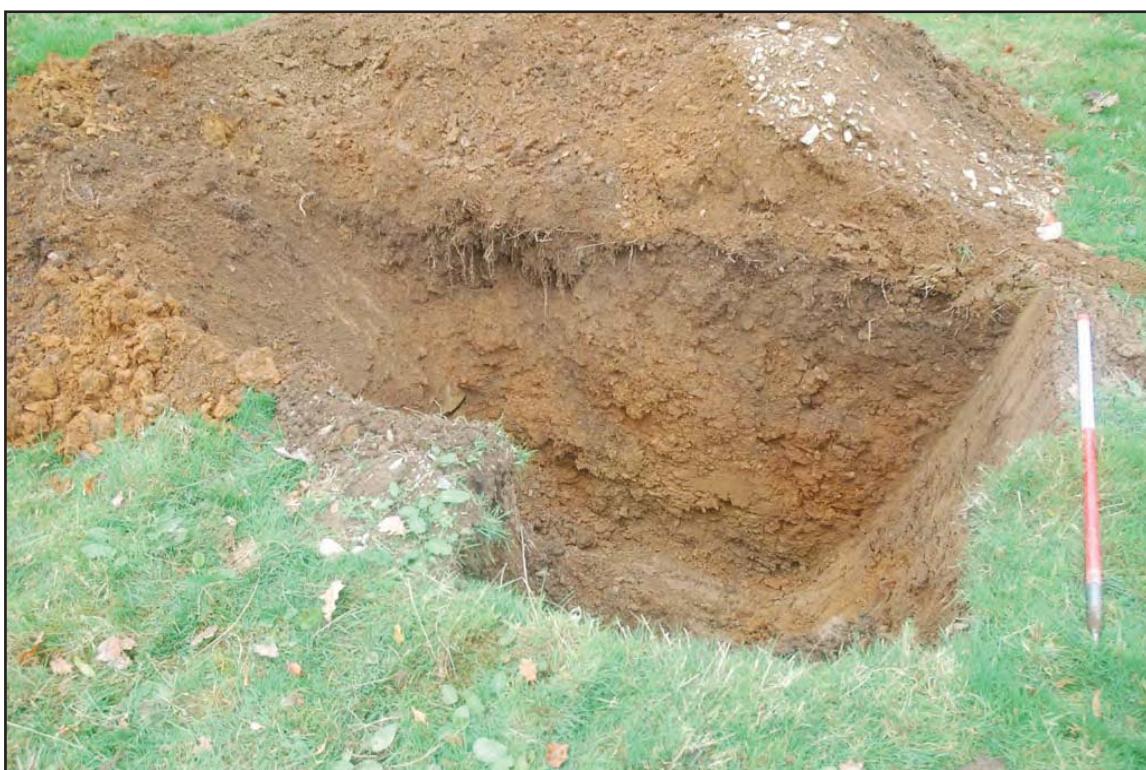
Plate 07: east-facing section of soakaway detailing limit of excavation and exposed sections/stratigraphy. The topsoil was extant to a depth of 0.26m followed by an orange clay-silt; followed by a mid-brown gravel-clay to limit of excavation (ranging pole: 1.0m)
