Beaumaris Pier: **ANGLESEY**

Archaeological Assessment and Photographic Survey

GAT Project No. 2122

Report No. 848

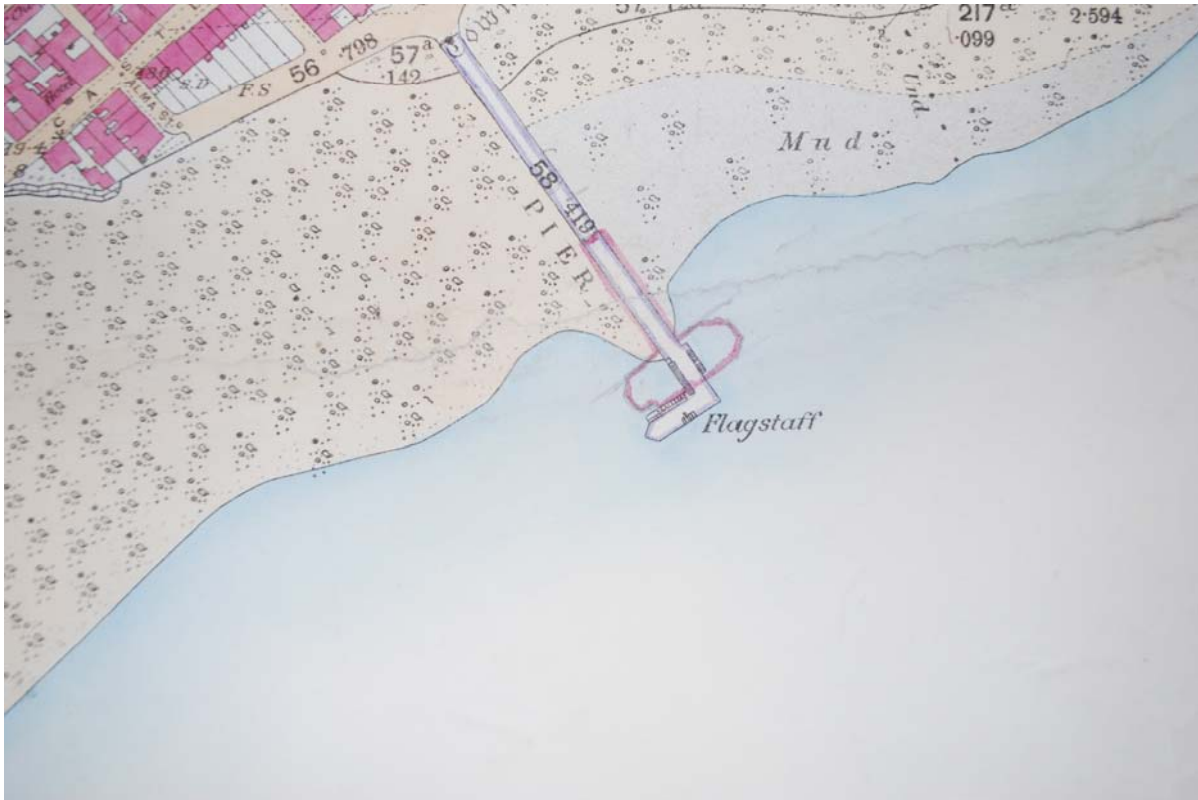
Fig. 7 Extract from 1st edition 25 inch Ordnance Survey map of 1889. Sheet Caernarvonshire VII.5, annotated with proposed alterations to pier head and creation of 'T' shaped pier head. Dated to approximately 1895.

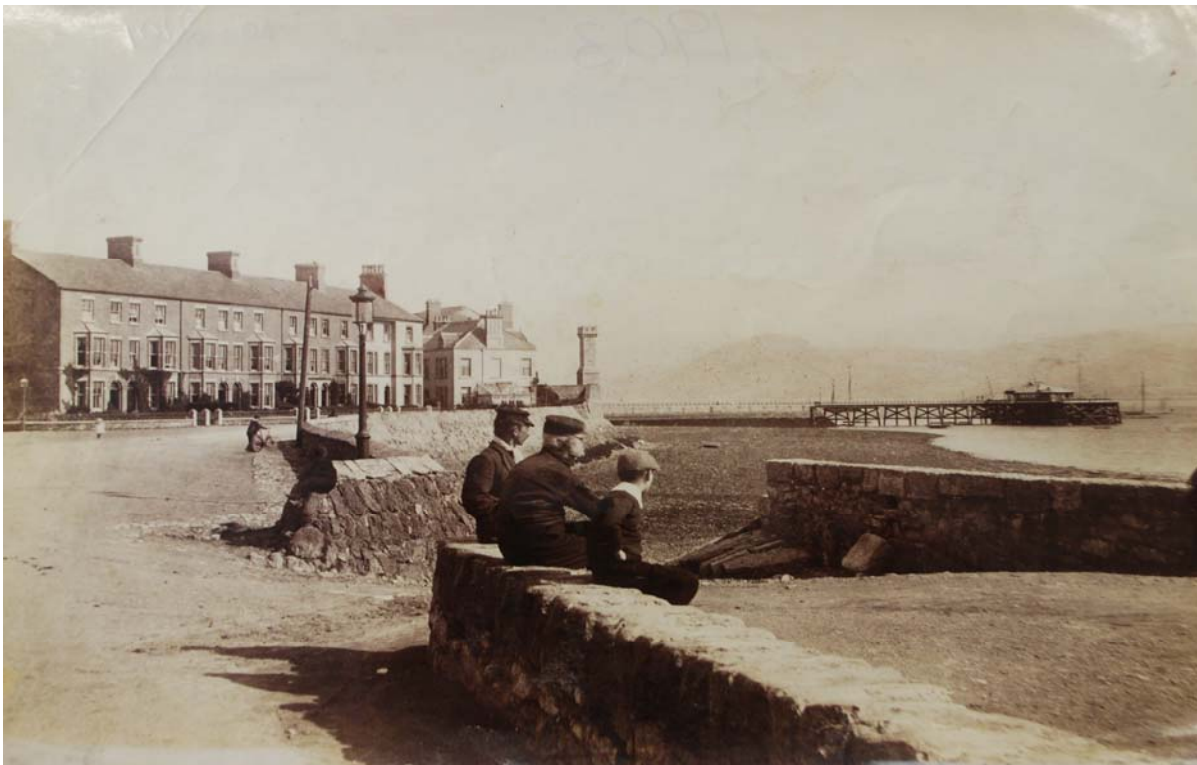
Fig. 9 View of Beumaris pier from the west, taken from Townsend, dated to 1903. It shows the 'T' shaped head and 1895 pavilion (Anglesey Archives WSC/134).

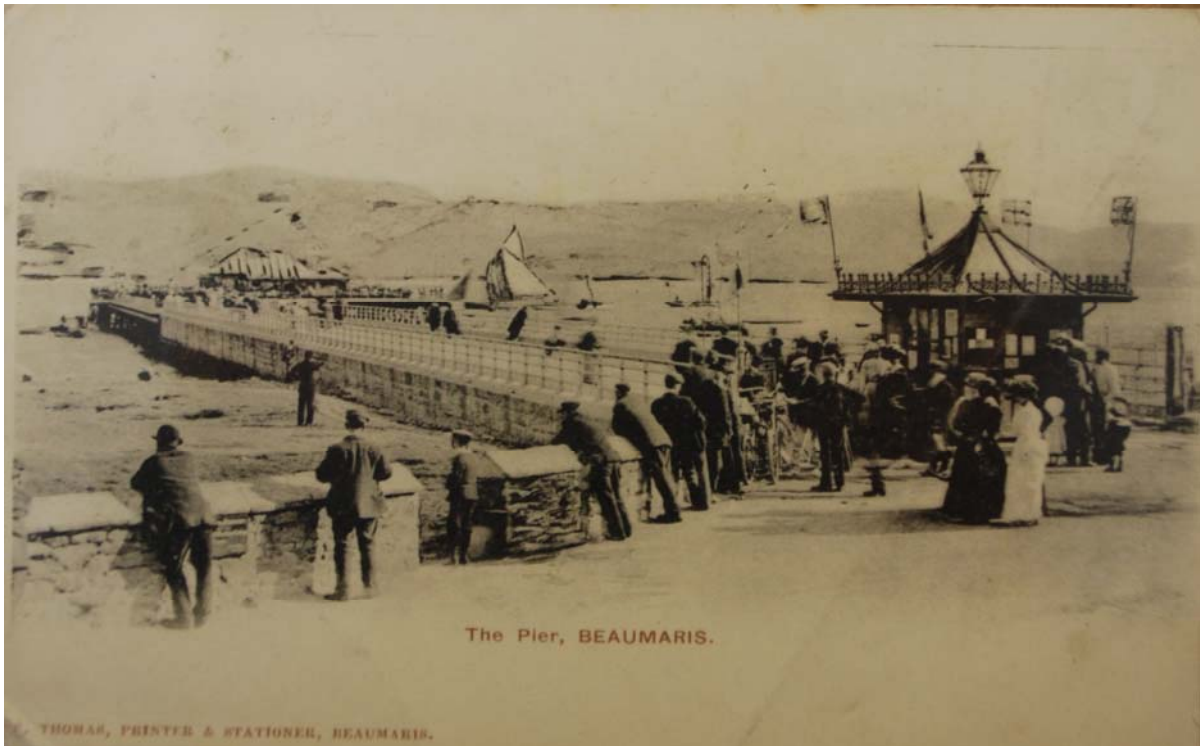
Fig. 10 The Pier, Beaumaris from a postcard postmarked 1905, showing the late 19th century kiosk (Anglesey Archives WSC/372)

Beaumaris Pier was built between 1840 and 1846, and has undergone substantial changes in 1865, 1895 and 1926, with other phases of refurbishment. The T shaped pier head was demolished in the 1950s. The stone causeway part of the pier is likely to be part of the original construction. The timber piles are of Green Heart wood, and are likely to date from the refurbishment of 1926. The timber decking is of post-war date, a partial renewal being carried out in 1964, although the 19th century decking is shown on photograph WSC/134, held at Anglesey Archives, Llangefni. Good evidence for the appearance of the pier at the turn of the century can be seen on photograph WSC/372, dated to 1905. The sea wall parapet is also shown.

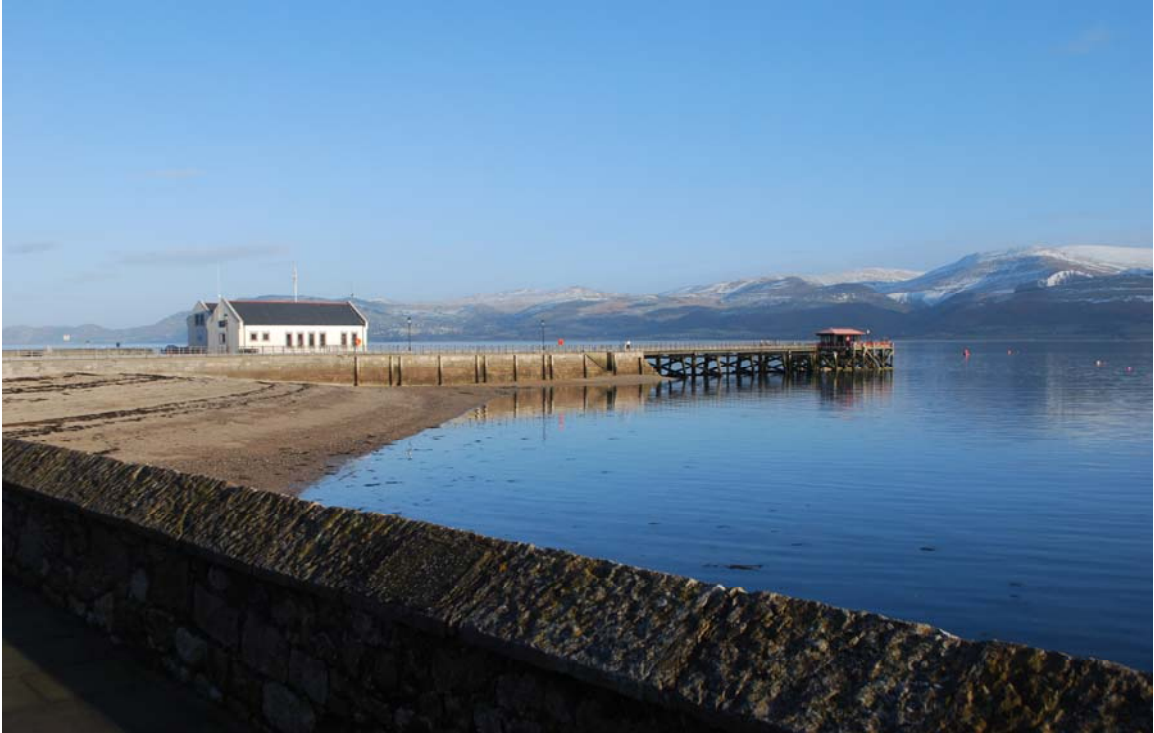
Plate 1 Beaumaris Pier from the west, showing stone and timber sections

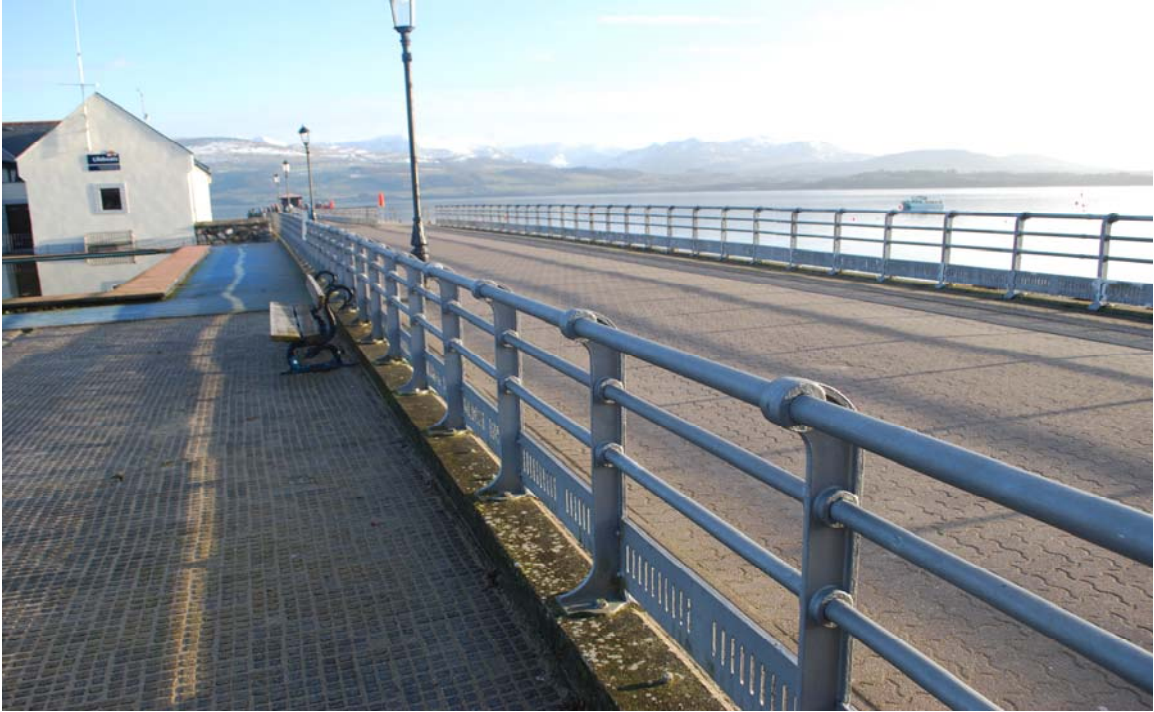
Plate 3 Pier railings from the north-west

The ironwork fencing on either side of the pier (Plate 3) is of similar character to that noted on the archive photographs of the pier, and may be of 19th century date. It appears to be re-used on the renewed section of timber pier, and should be retained wherever possible, or if this is not possible replaced with a barrier of similar design. The timber decking, although renewed, seems to be of a similar character to that it replaced, and this character should be retained in any future renewal.

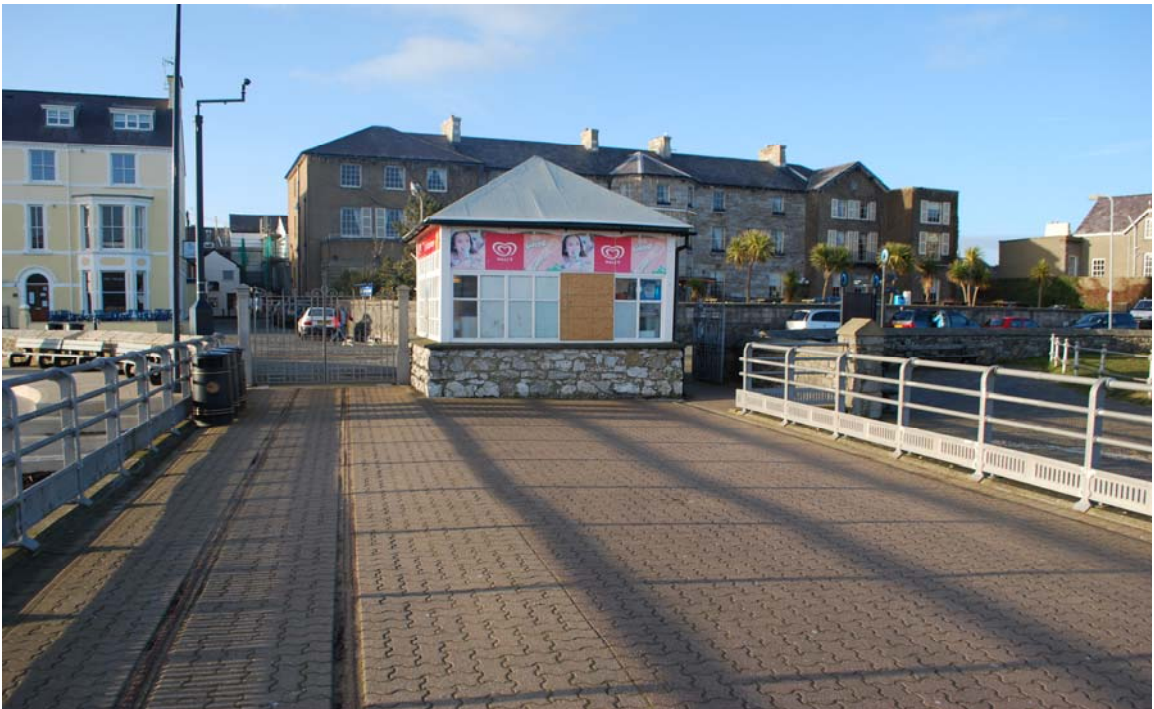
Plate 4 The kiosk and 19th century ironwork gates at the landward end of the pier, from the south

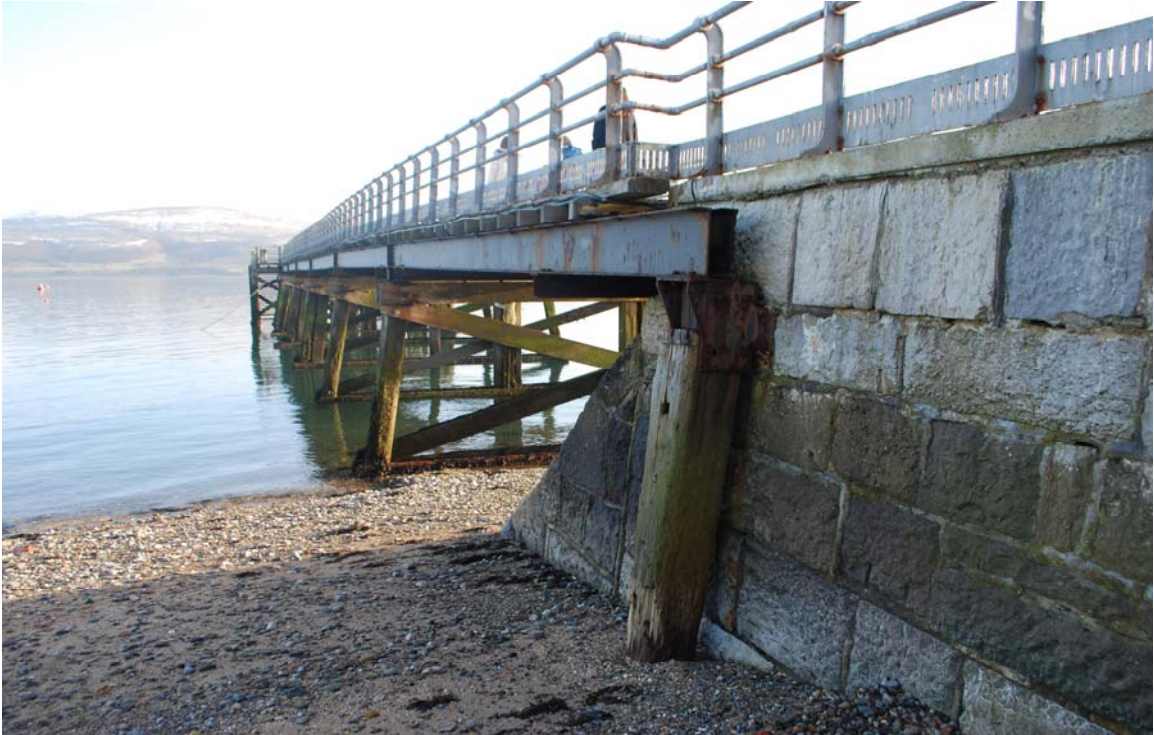
Plate 5 Detail showing the junction of the stone and wooden pier sections, from the north north east

The pier is in two parts; the landward part is a stone causeway, some 100m long and 8m wide, constructed with regular coursed limestone blocks (Plate 5). This stone portion appears to date from the original construction of the pier. The seaward 50m of the pier consists of a timber deck on steel girders supported on five trestles of green heart with timber piles. The pier head is of elaborate timber construction. These are of various dates, the decking appears to be post war, though the piles and steel girders date from 1926 (Anglesey Archives, WCD/288). Steps lead down on the east and west side of the wooden section of the pier to allow the loading of small boats, these appear to be of relatively recent date, certainly post-war and probably carried out in the 1960s.

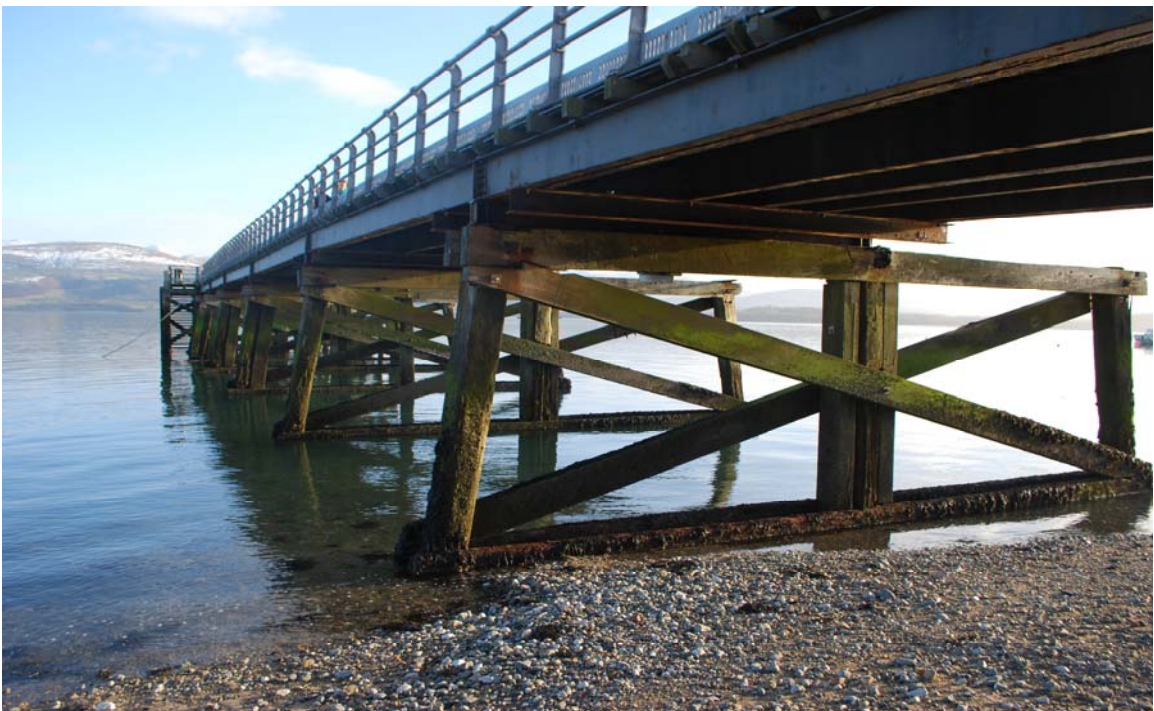
Plate 6 The iron girders supported on trestles of Green Heart wood on the timber section of the pier

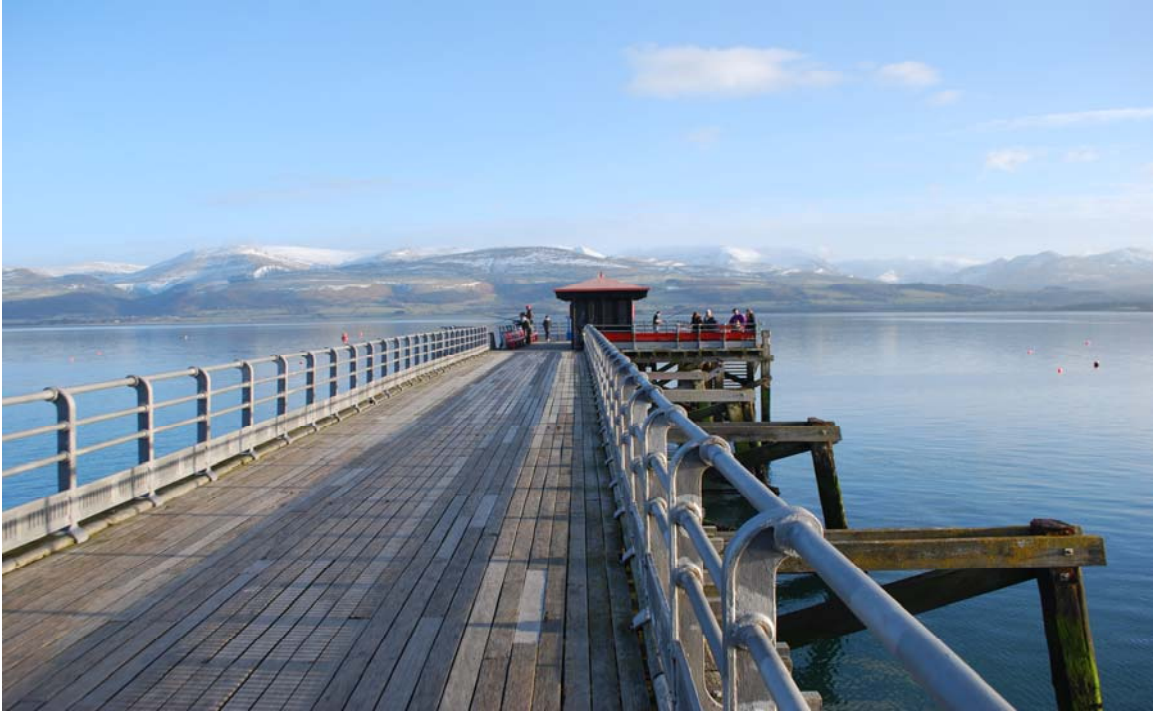
Plate 7 The timber decking with the shelter and landing stage at the southern end of the pier

The surface of the timber section of the pier is surmounted by timber decking, which appears to have lain up to, and is therefore later than the wood and glass shelter at the pier head. This was constructed after the demolition of the 'T' shaped jetty, and was a replacement built in 1986. It is of timber post and board construction with a hipped roof and barge boards, with shelter openings to the north and south (Plate 10). This replaced a much larger and elaborate building on the former landing stage (Figs. 10 and 11), which was presumably a booking office for the steamers as well as a waiting room.

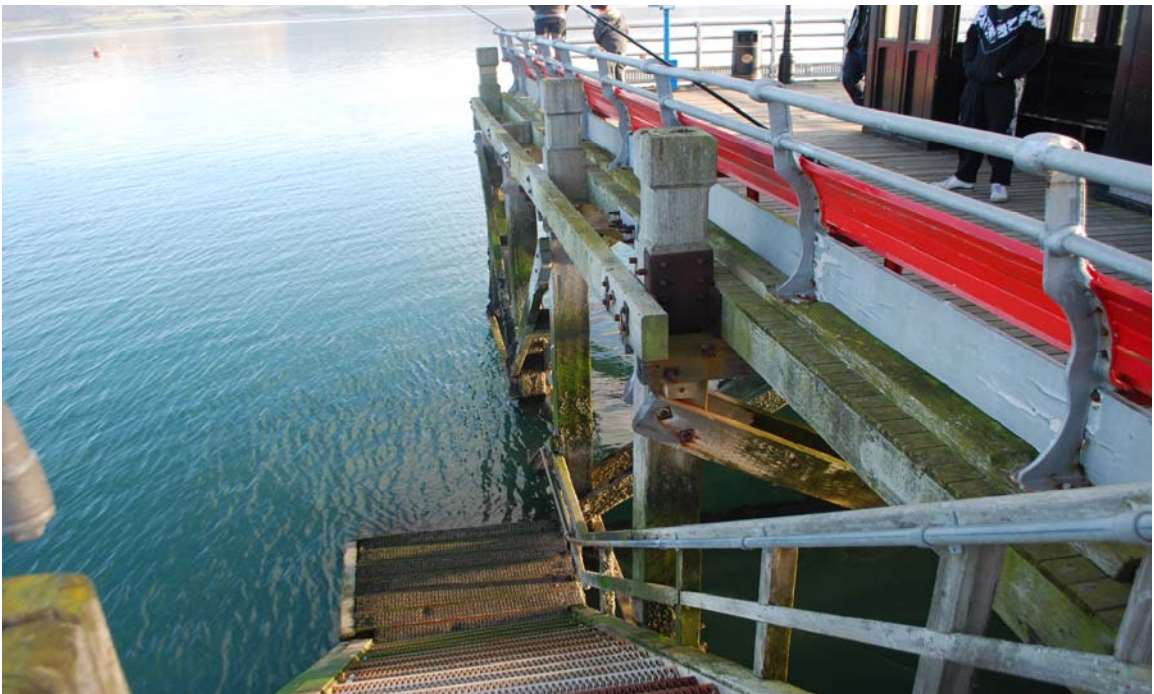
Plate 8 The landing stage, with modern steps

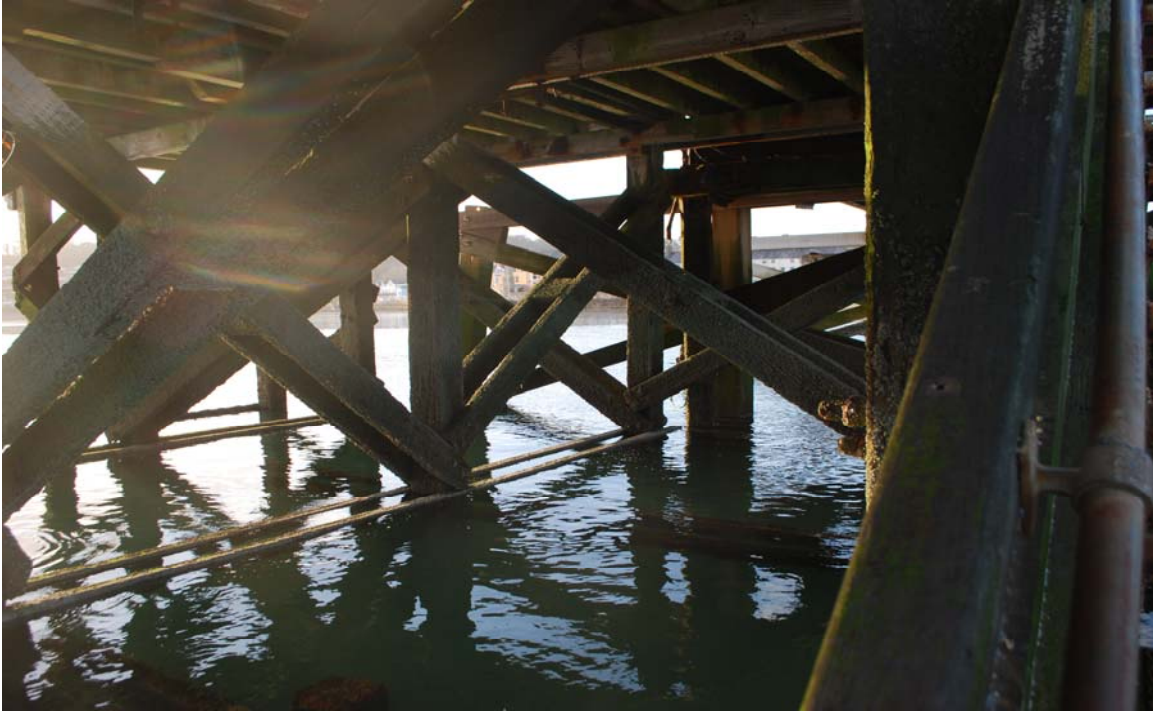
Plate 9 Detail showing the construction technique at the pier head

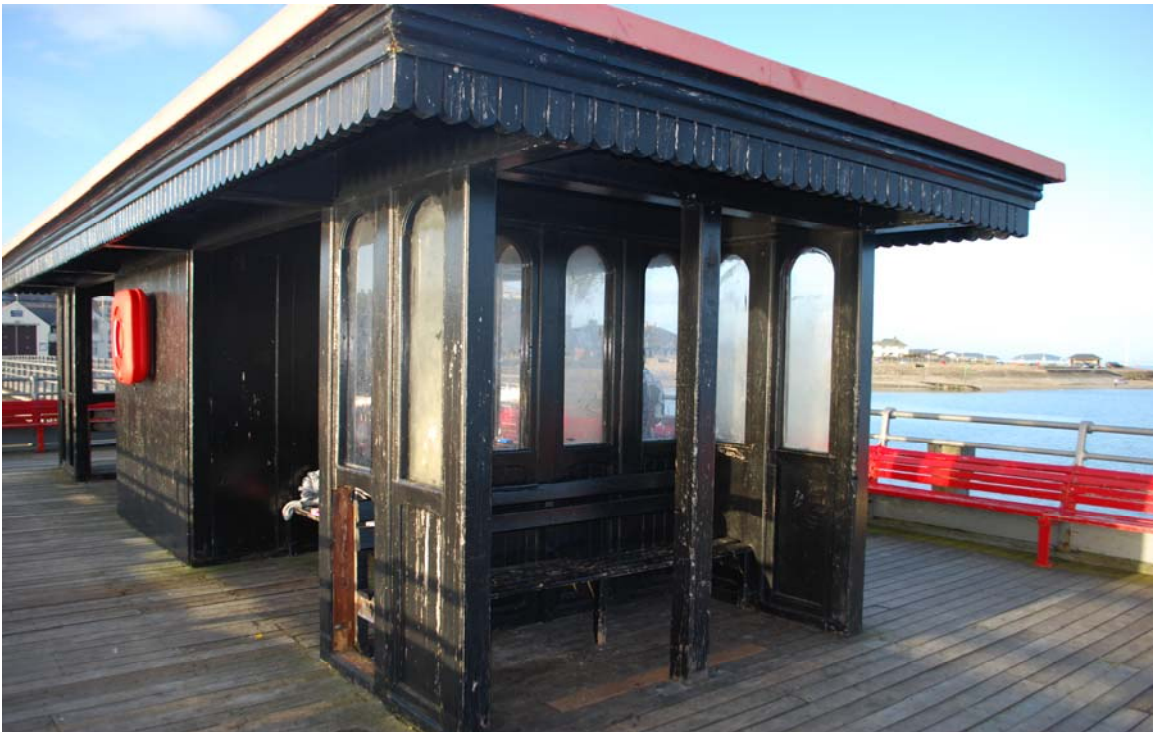
Plate 10 The shelter at the southern end of Beaumaris Pier, built in 1986
