Ysgol Jones Bach: Caernarfon, Gwynedd

Archaeological Building Record

GAT Project No. 2172

Report No. 921

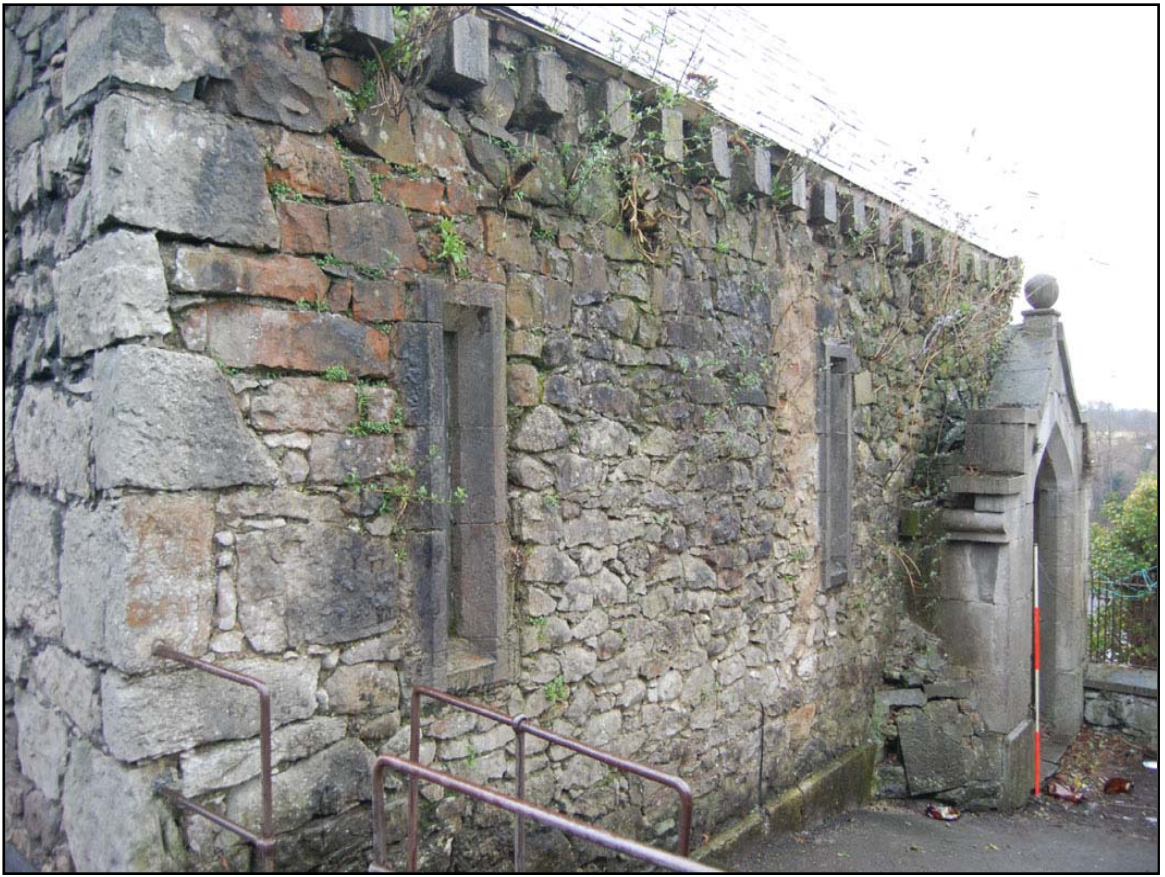
Plate 1. Ysgol Jones Bach north elevation (external).

The northern elevation (plate. 1) has two narrow and blocked embrasures, and a corbel table repeated on the southern elevation, beneath the remains of a wooden weatherboarding originally lined with lead. The entranceway (plate. 2) is at the west end of the north wall and is entered through a stone porch of ashlar masonry, with stepped gable on moulded kneelers and with apex ball finial. The porch has a Tudor

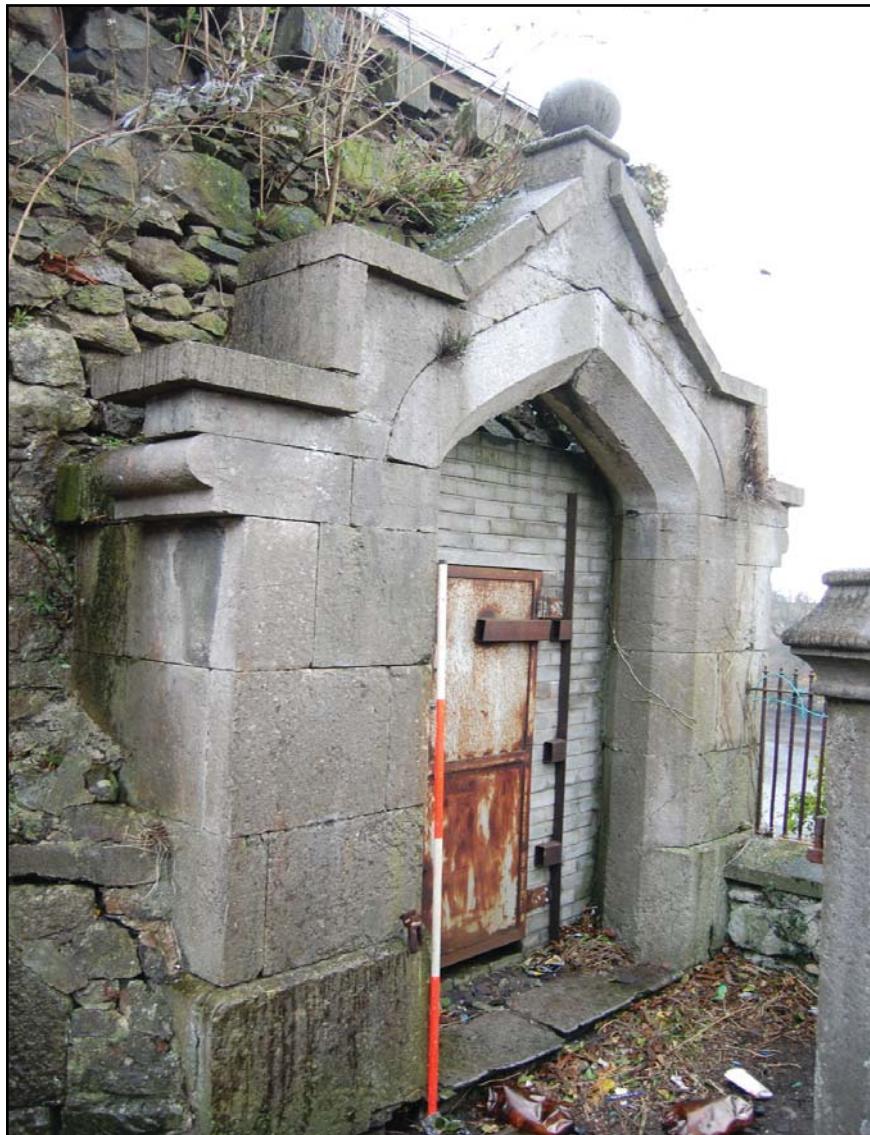
Plate 2. Ysgol Jones Bach porch, north elevation (external).

arch, and the roof is missing. The eastern gable (plate. 3) has a stepped three light mullioned and transomed window, with slate infill, and a former wooden notice board to the top of the centre light. A small slate plaque is located to the left of the window with the initials *F.P.* and the digits 23.

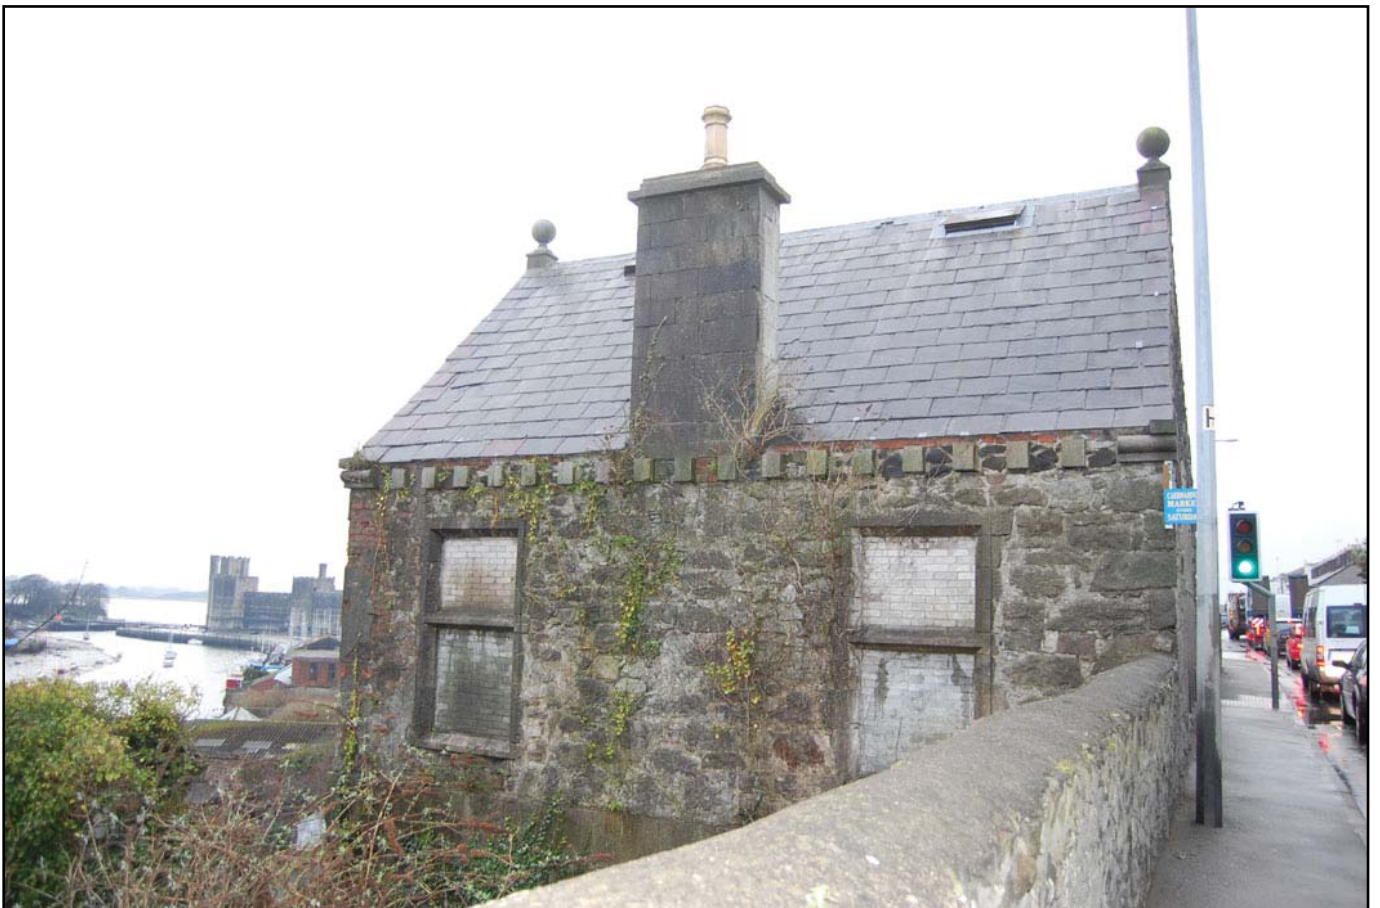
Plate 4. Ysgol Jones Bach south elevation (external)

The southern elevation (plate. 4) has two vertical windows to the right and left of the elevation, each divided horizontally by a single transom. The windows sit above a horizontal string course of ashlar blocks which continue across the west gable end. The windows are architecturally balanced by a single, tall ashlar stone chimney stack rising from the eaves. The western (plate. 5) gable has a three stepped mullioned and transomed window, blocked at lower levels with brick, and with lozenge and hexagonal pattern iron glazing bars retained above the transom. The basement has a blocked doorway with slate lintel, and a segmental-headed window, also blocked, to the right.

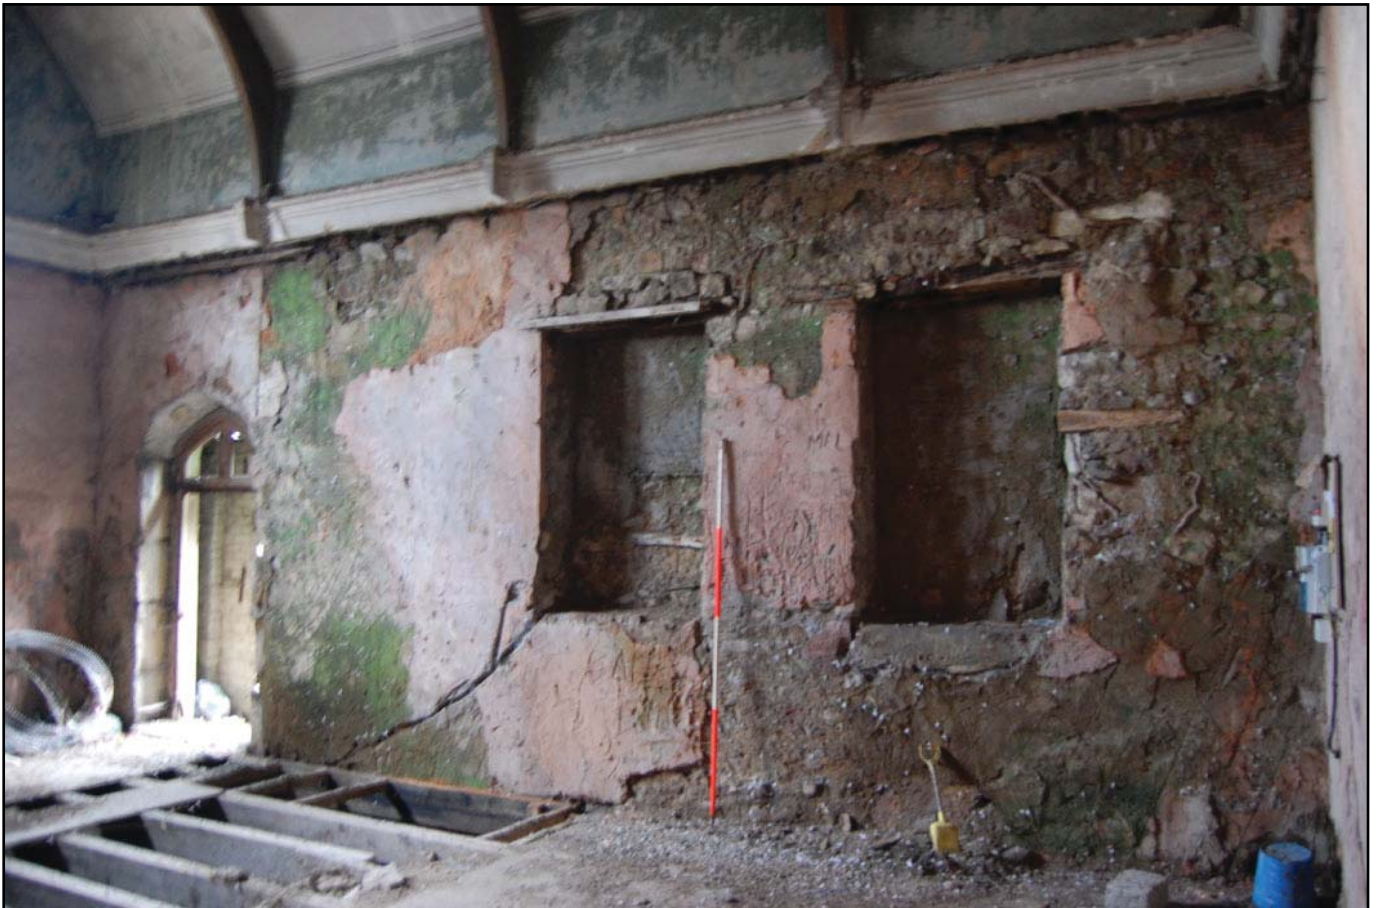
Plate 6. Ysgol Jones Bach north elevation (internal)

A white moulded plaster cornice (plate. 6) is located at the foot of the roof trusses. Below the cornice the walls retain elements of faded red paint, whereas above the cornice they were painted green. The cornice is interrupted by stone carved corbels (plate. 11) supporting the roof trusses, and terminates one-third of the way in on each side of the southern elevation to permit the inclusion of a stone-built fireplace and flue (plate. 12). This has sides of red-brick at ground-level and continues into the basement finishing in a second fireplace (plate. 13). Both fireplaces appear to be original, but have suffered collapse.

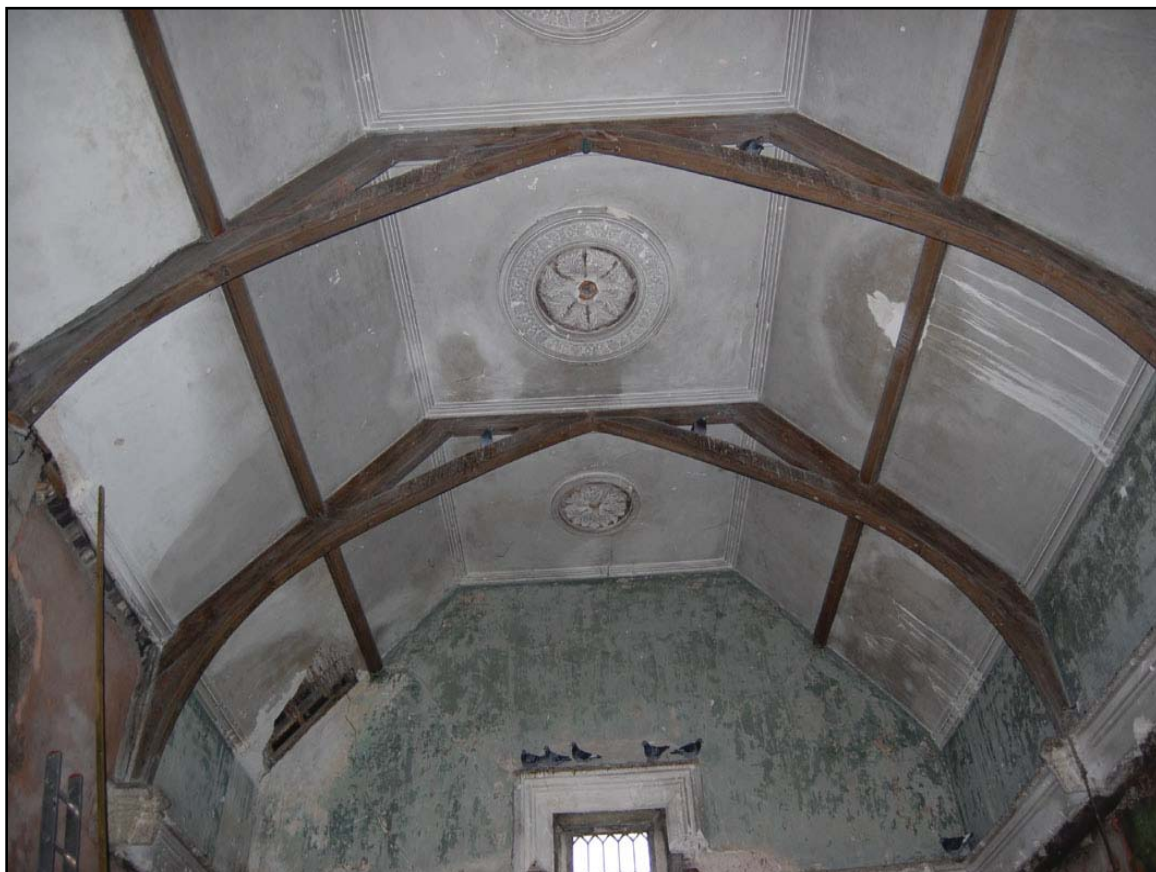
Plate 14 . Ysgol Jones Bach hammer-beam trusses, west elevation (internal).

The roof is divided into four bays by three hammerbeam trusses (plate. 14), only partially visible due to a false ceiling, which rest upon the corbel stones. The collar beam of each truss is visible and is linked by struts to the principal, with a single purlin visible on each side. Each roof bay is adorned with a plaster moulded, arabesque, formalised foliage roundel, the central two (plate. 15) adorned with moulded acanthus leaves with a border of smaller acanthus and thistle, interspersed with volutes. The outer two roundels (plate. 16) display a mixture of acanthus and more formalised acanthus leaves, surrounded by a plain moulded border.
