AFON GANOL TIDAL GATES, PENRHYN BAY ARCHAEOLOGICAL WATCHING BRIEF: GI PROGRAMME

Archaeological Watching Brief

GAT Project No. 2143

Report No. 882

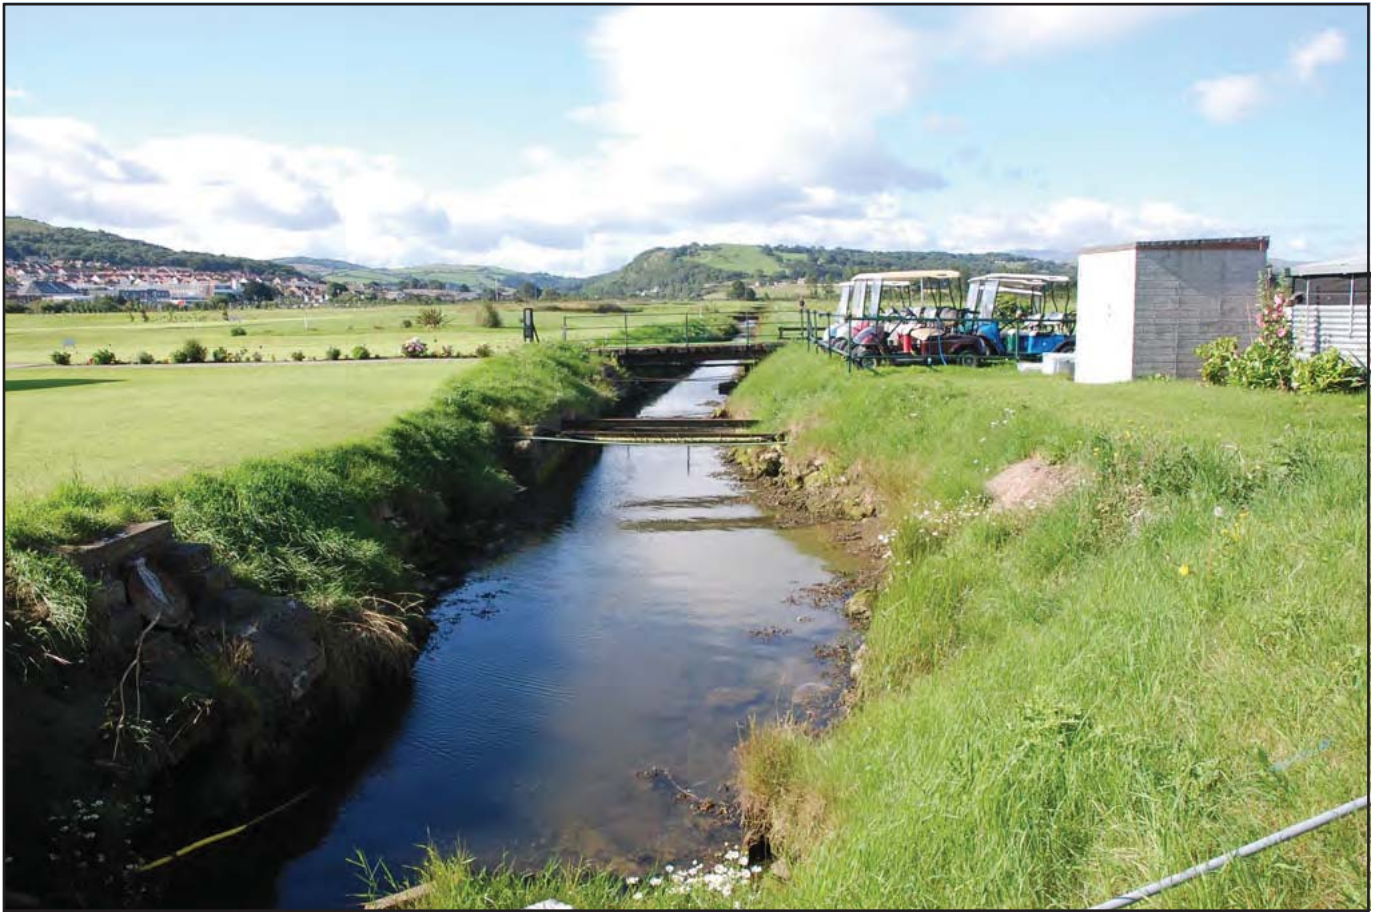
Plate 01 - View south of the canalised Afon Ganol that leads to the tidal gates. The Rhos-on-Sea golf club can be seen either side of the river

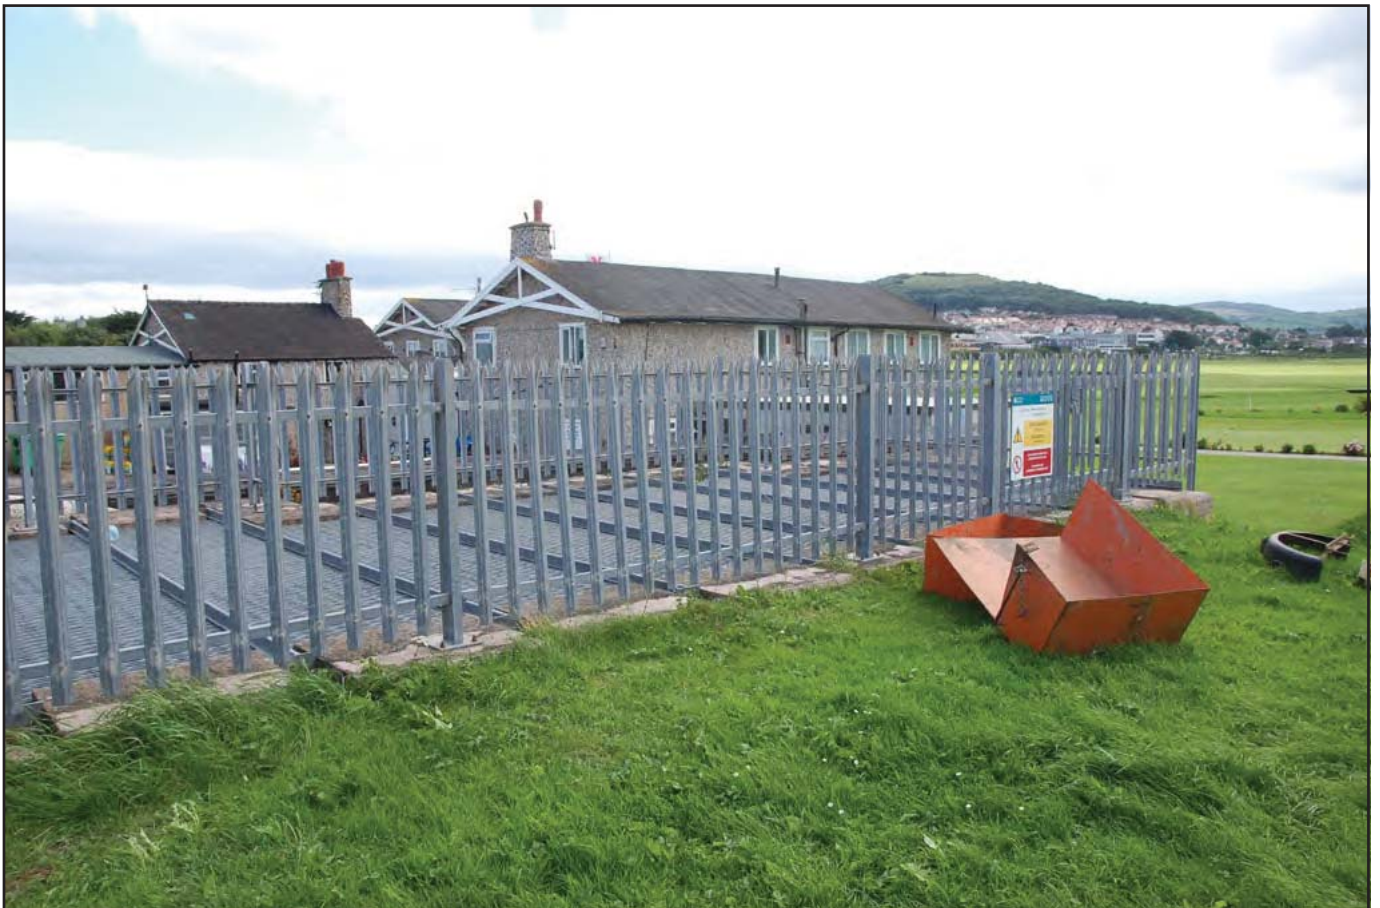
Boreholes 01 and 02 were located either side of the tidal gate structure, within the Rhos-on Sea golf club (figure 01). The tidal gate (NPRN **308,563**) includes an outfall chamber enclosed in concrete with a mesh decking (plate 02), secured from public access via a 1.2m galvanised palisade fence. The chamber is partitioned in two with timber gates and is linked to a precast concrete pipe that continues under Marine Drive Road and along a fishtail groyne into the sea (plate 04).

Plate 02 - View southeast of the current tidal gates/outfall chamber structure. The mesh decking is an early 1990s addition and masks the original structure

In addition to the boreholes, GAT was commissioned by the Environment Agency to inspect the tidal gates, if accessible. GAT was unable to access the gate at this time; it is recommended that the tidal gate/outfall chamber structure is investigated further during the main engineering works as part of the watching brief mitigation.

The tidal gates/outfall chamber were inaccessible at this time and no additional information was recovered that updated the CAP Ltd. report from 2001 (CAP Ltd. Report **206**). It is recommended that the tidal gate/outfall chamber structure is investigated further during the main engineering works as part of the watching brief mitigation. Discussion with *Black & Veatch Ltd* has confirmed that these works will include structural alterations to the existing gate structure and an associated excavation on the west site of the gate to accommodate the engineering programme. This excavation will include a batter several metres wide, excavated from the existing ground level.

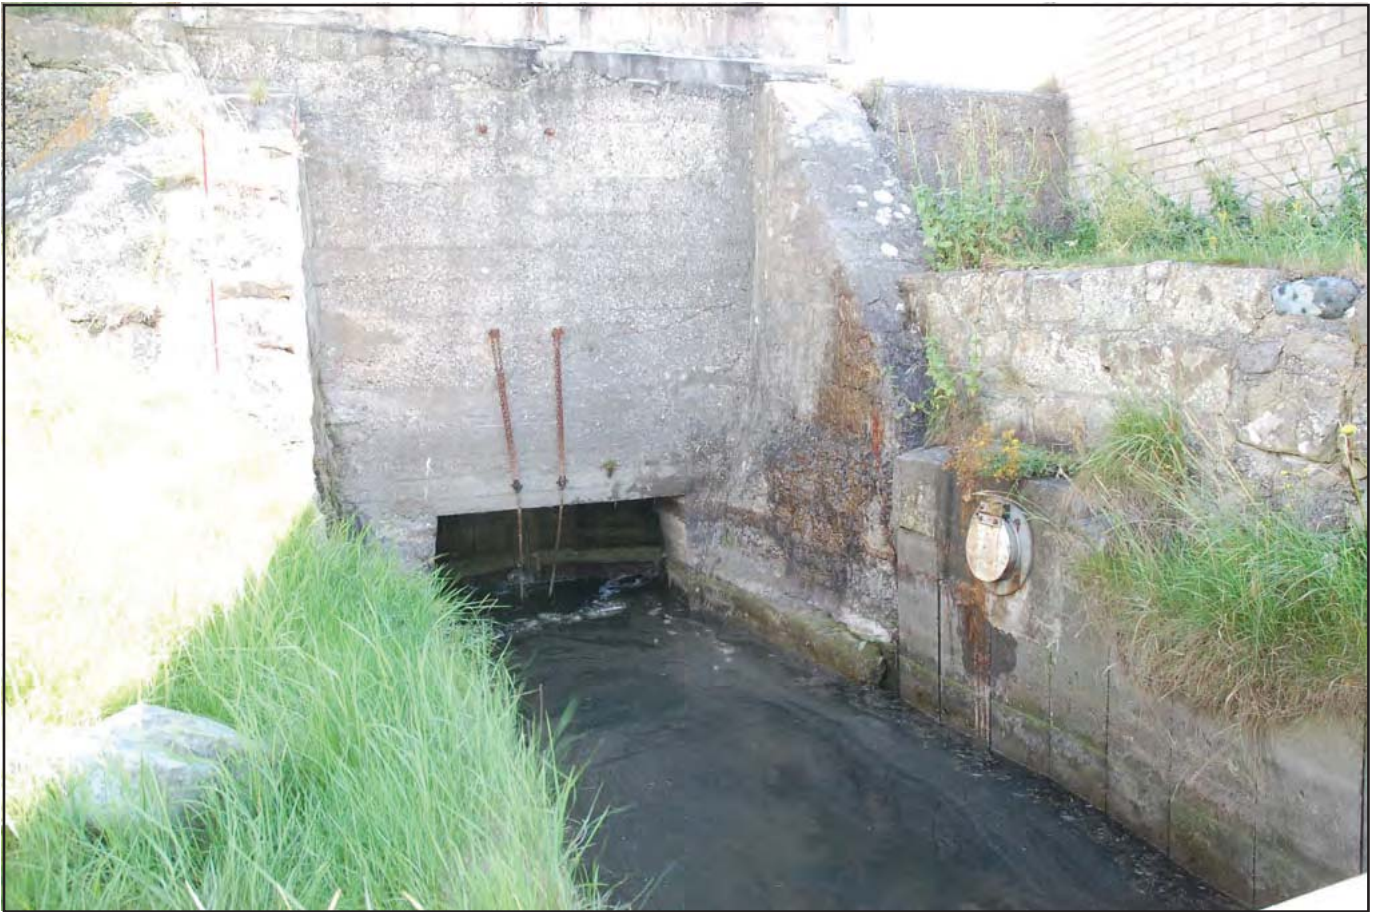
Plate 03 - View north of tidal gates/outfall chamber, detailing the timber mitre gates that the lead into the outfall chamber. The canalised Afon Ganol drains into this chamber. The outfall chamber is sub-divided into two smaller chambers by a partition wall (not visible). The second chamber is entered through a timber flap gate hung from a timber frame mounted on the downstream face of the partition wall.

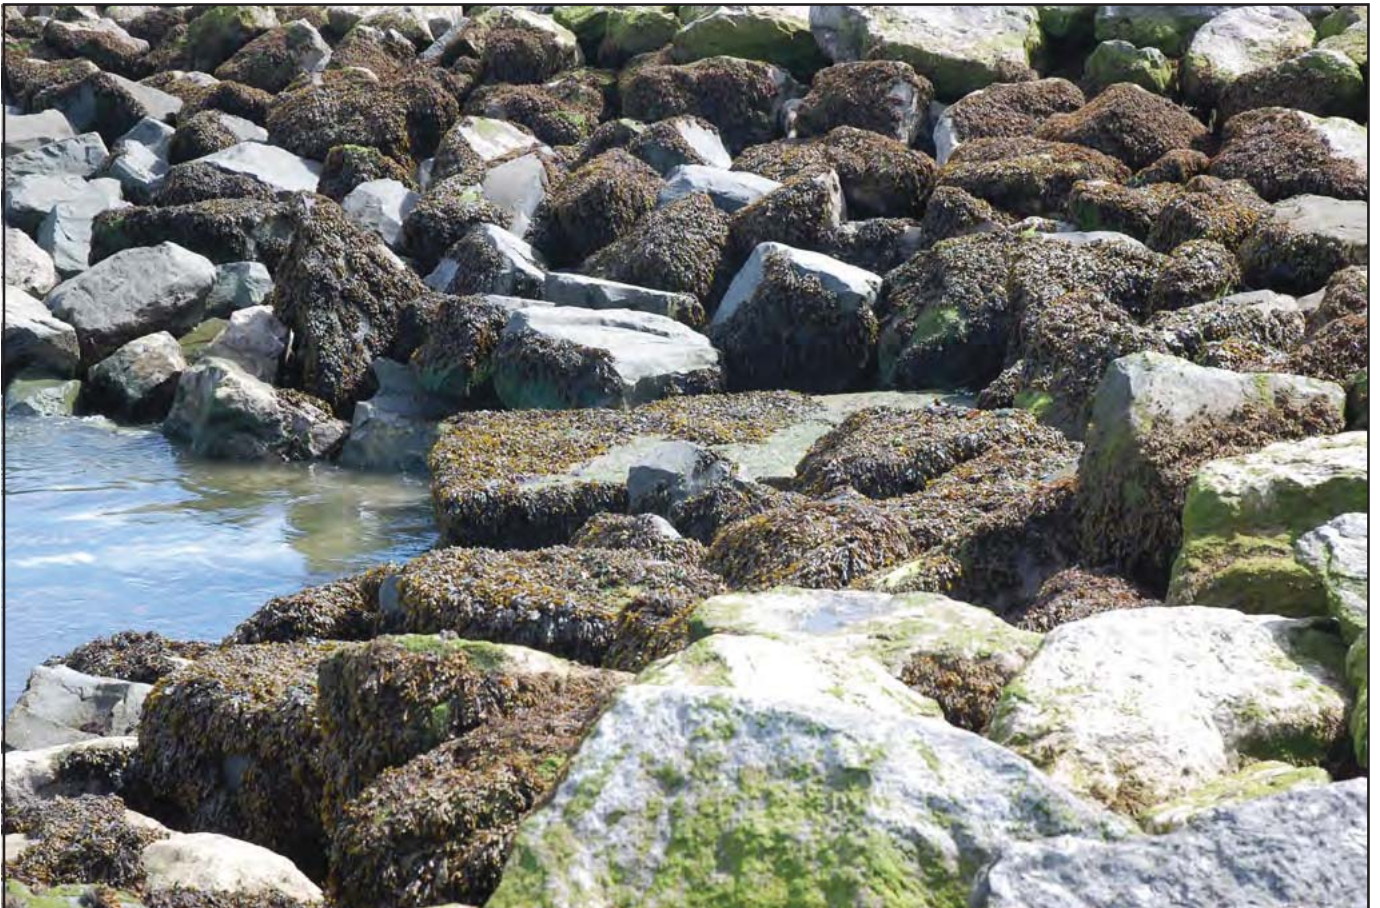
Plate 04 - View east of the outfall pipe that is linked to the tidal gates, as it enters the sea via the foreshore

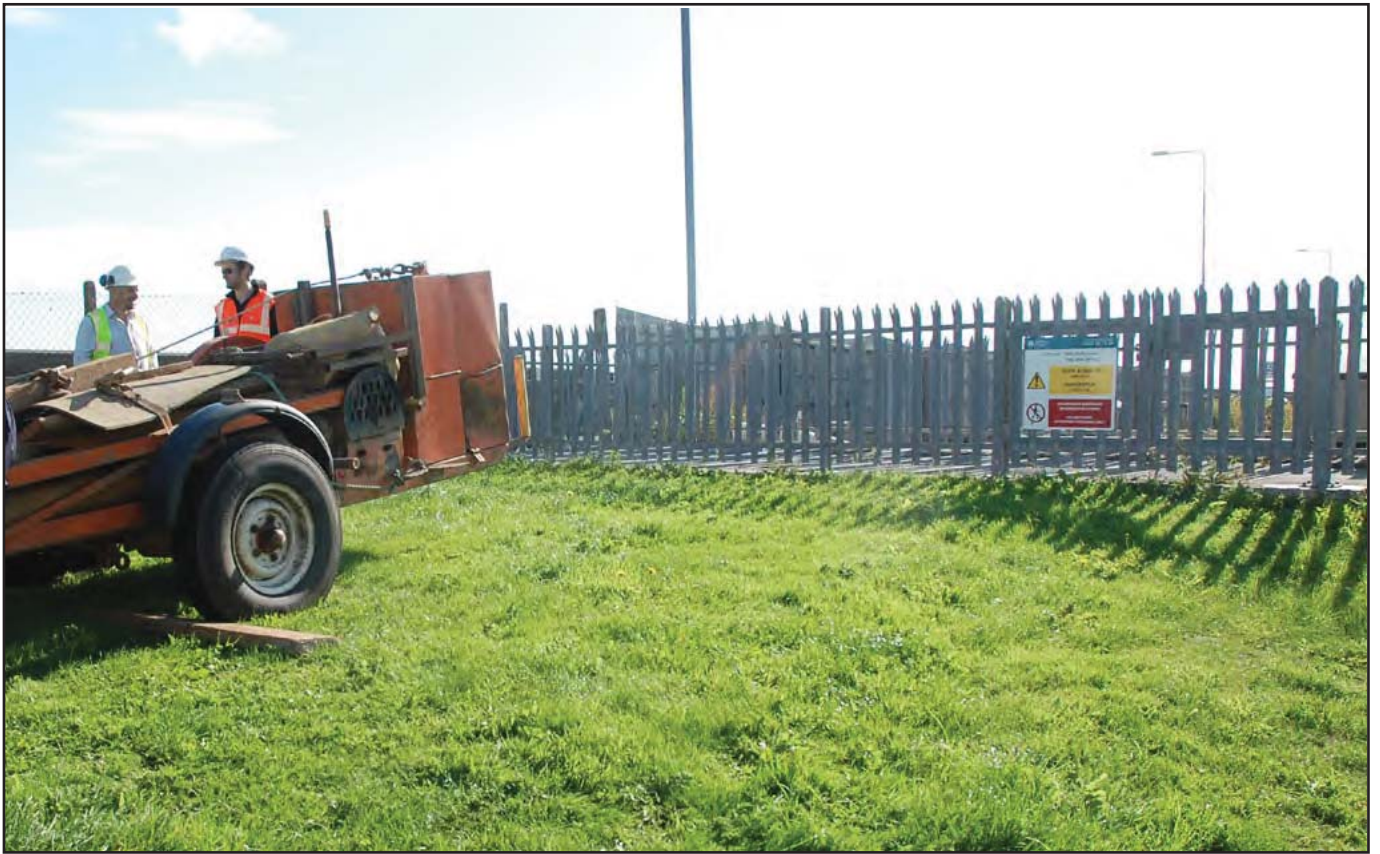
BH01 was located c.7.0m west of the outfall chamber (plate 05). The initial 5.0m within the borehole comprised imported material/sea wall defences. No organic material was identified

The borehole indicated the extent of landscaping/sea defence material extant at this location. Due to the confined nature of the borehole, the composition of the sea wall could not be determined. No archaeological activity or organic material were identified within the confines of the borehole.

Plate 05 - View south of the location of Borehole 01, which was located within a landscaped area within the golf club. The cable percussion rig can be seen on the left side of the image. The borehole contained imported seawall defence material.

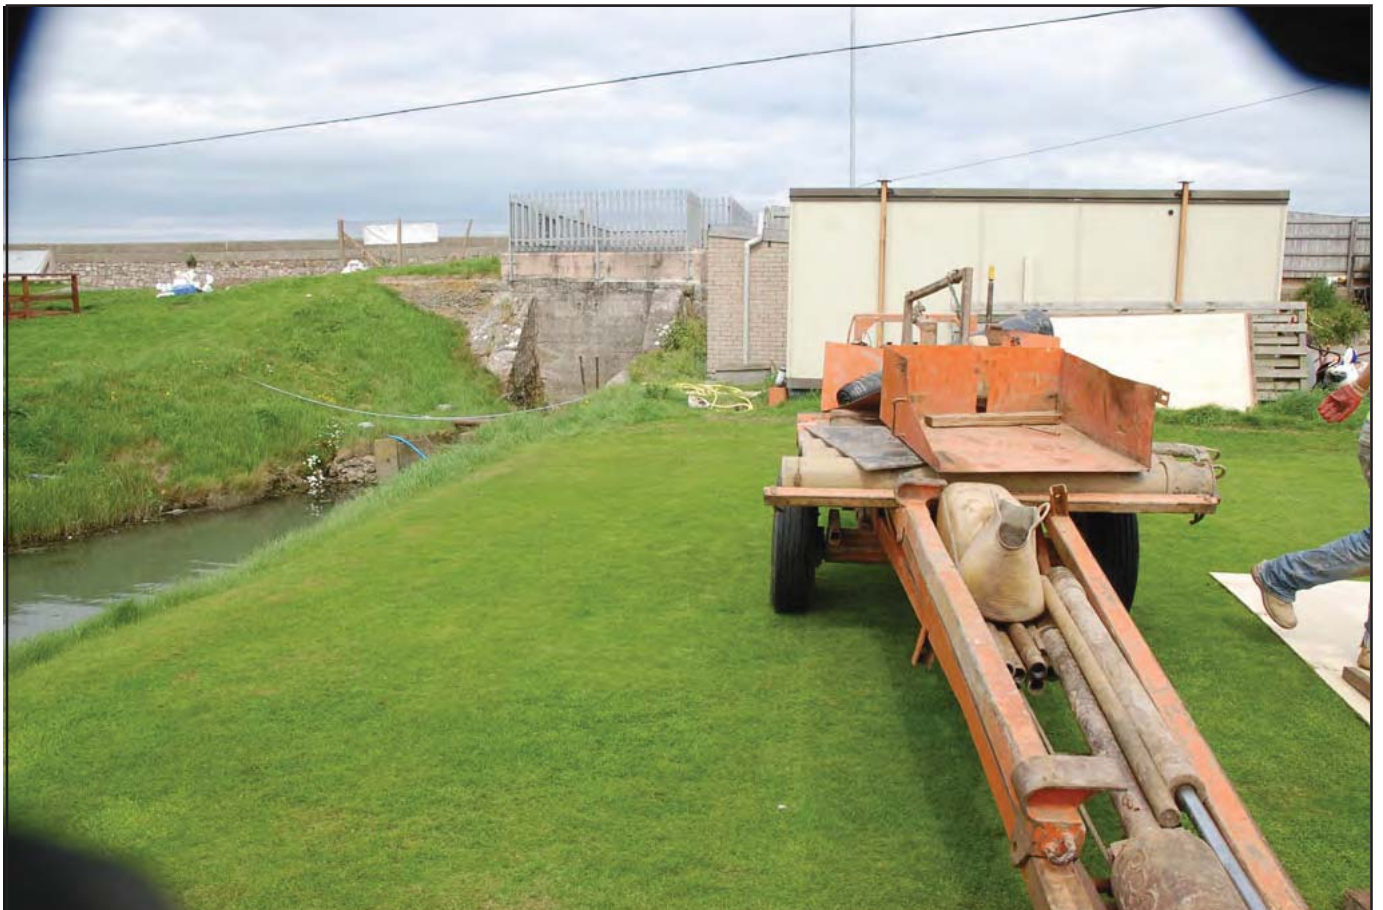
BH02 was located c.15.0m west of the Rhos-on-Sea golf club clubhouse within a lawned area (plates 06 and 07). The borehole was initially hand dug to a depth of 0.80m: the upper 0.25m was a dark grey-brown topsoil, followed by a 0.10m depth of gravel-rich hardcore (imported material), above a coarse orange-yellow sand that continued past the 0.80m depth to 1.50m below ground surface level (BGL). Between 1.50m and 3.50m was a yellow-grey sand-clay, followed by sand and gravel to 4.00m

Plate 06 - View north of Borehole 02 prior to excavation. The cable percussion rig can be seen in the foreground, the tidal gates in the background. Afon Ganol is on the left side of the image.

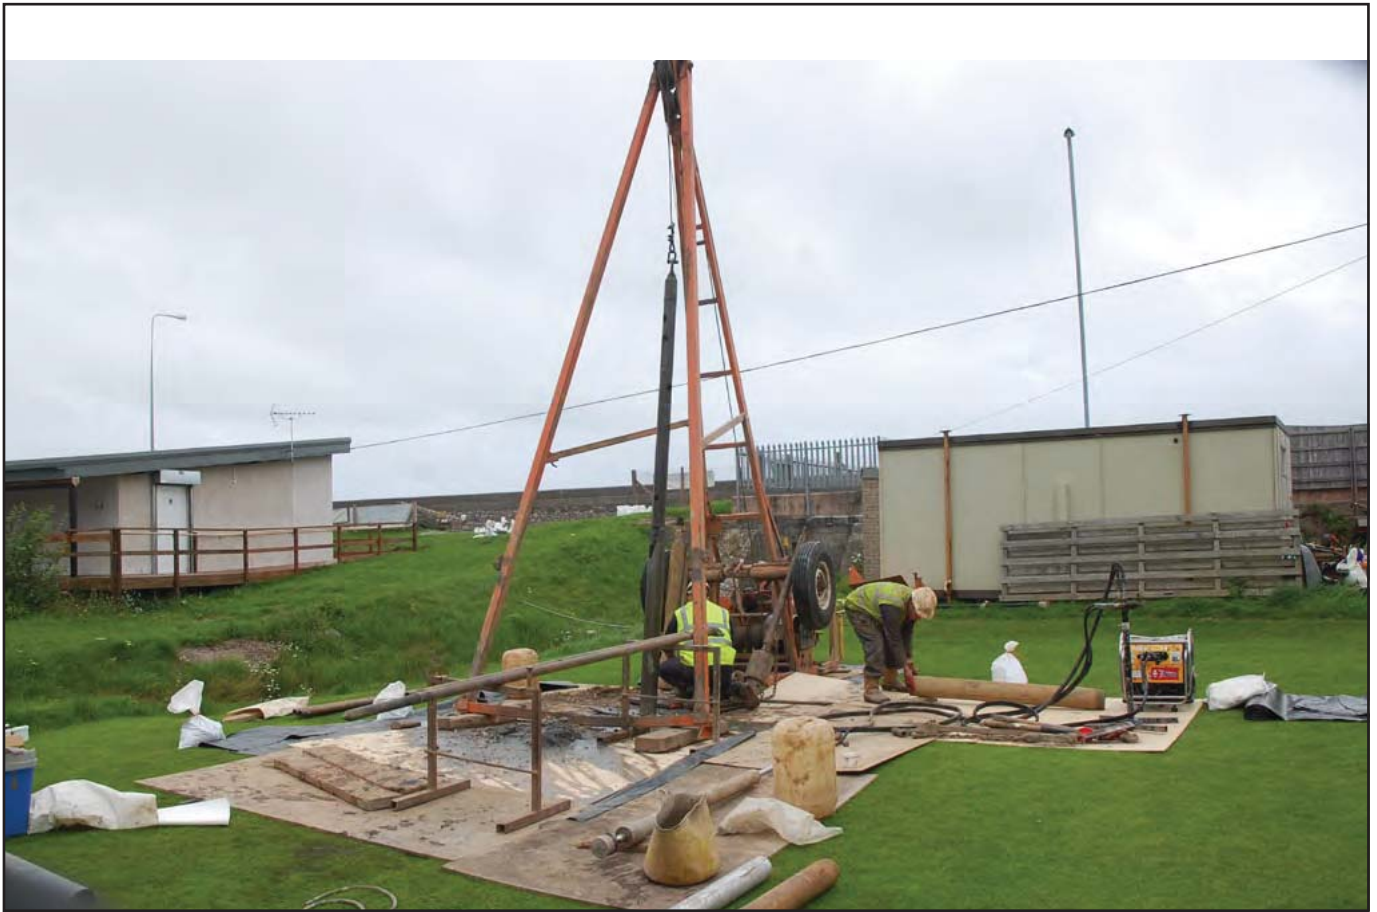
Plate 07 View northeast of Borehole 02, detailing the cable percussion rig in action. The initial 0.35m was topsoil and imported hardcore, followed by tidal and/or fluvial sand/silts

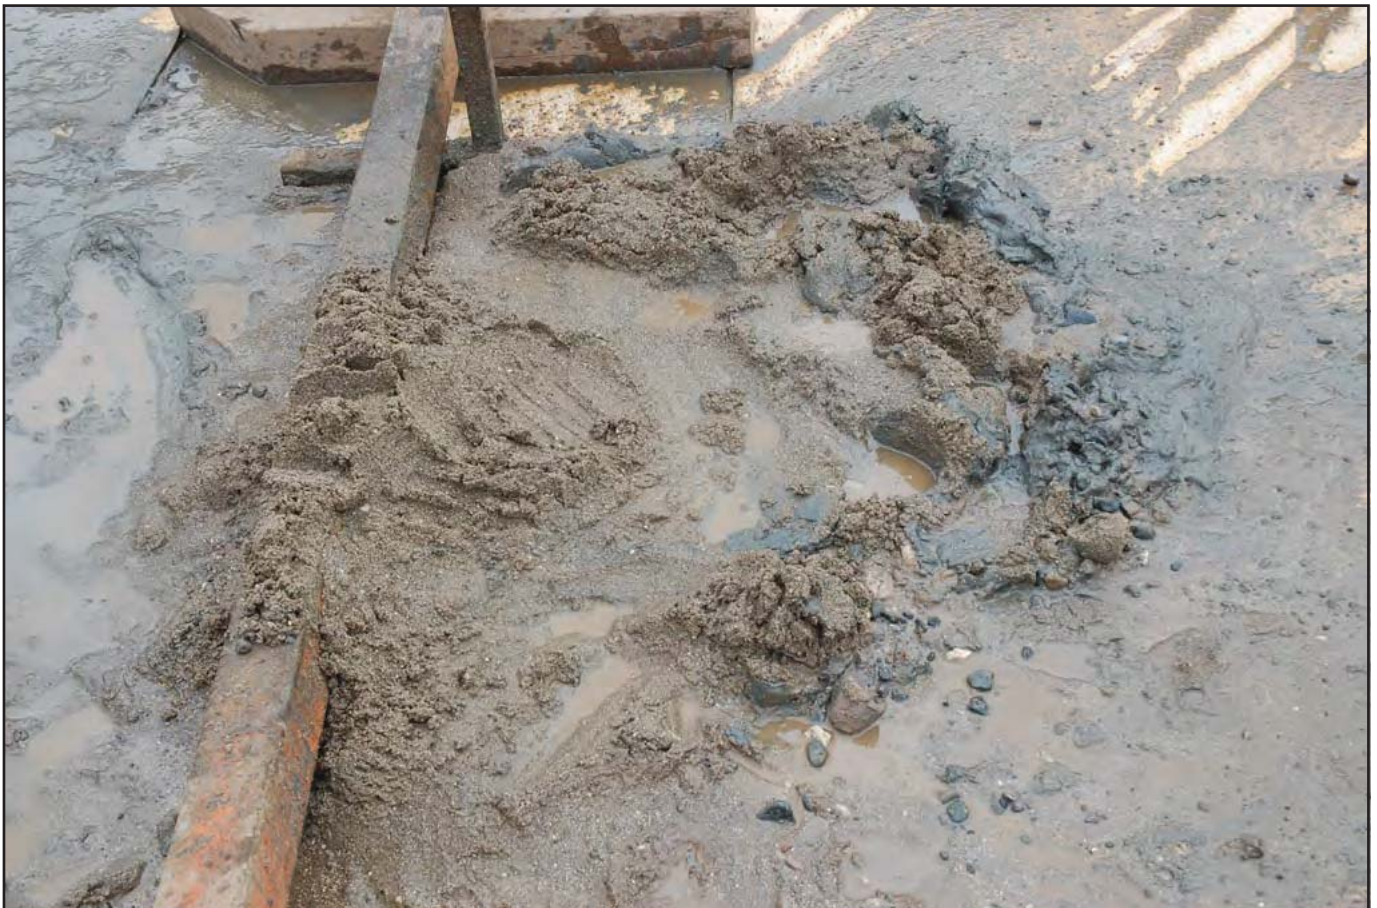
BGL. The remainder of the borehole contained medium to coarse grained sand from 4.00m to 8.00m BGL (plate 08). No peat deposits were identified within the borehole.

No archaeological activity or organic material were identified within the confines of the borehole. All identified deposits beneath the imported hardcore were tidal and/or fluvial in origin.

Plate 08 - Close-up view of material from borehole: detailing a deposit of sand recovered from 7.0m bellow ground level. All identified deposits beneath the imported hardcore were tidal and/or fluvial in origin associated with the river mouth.

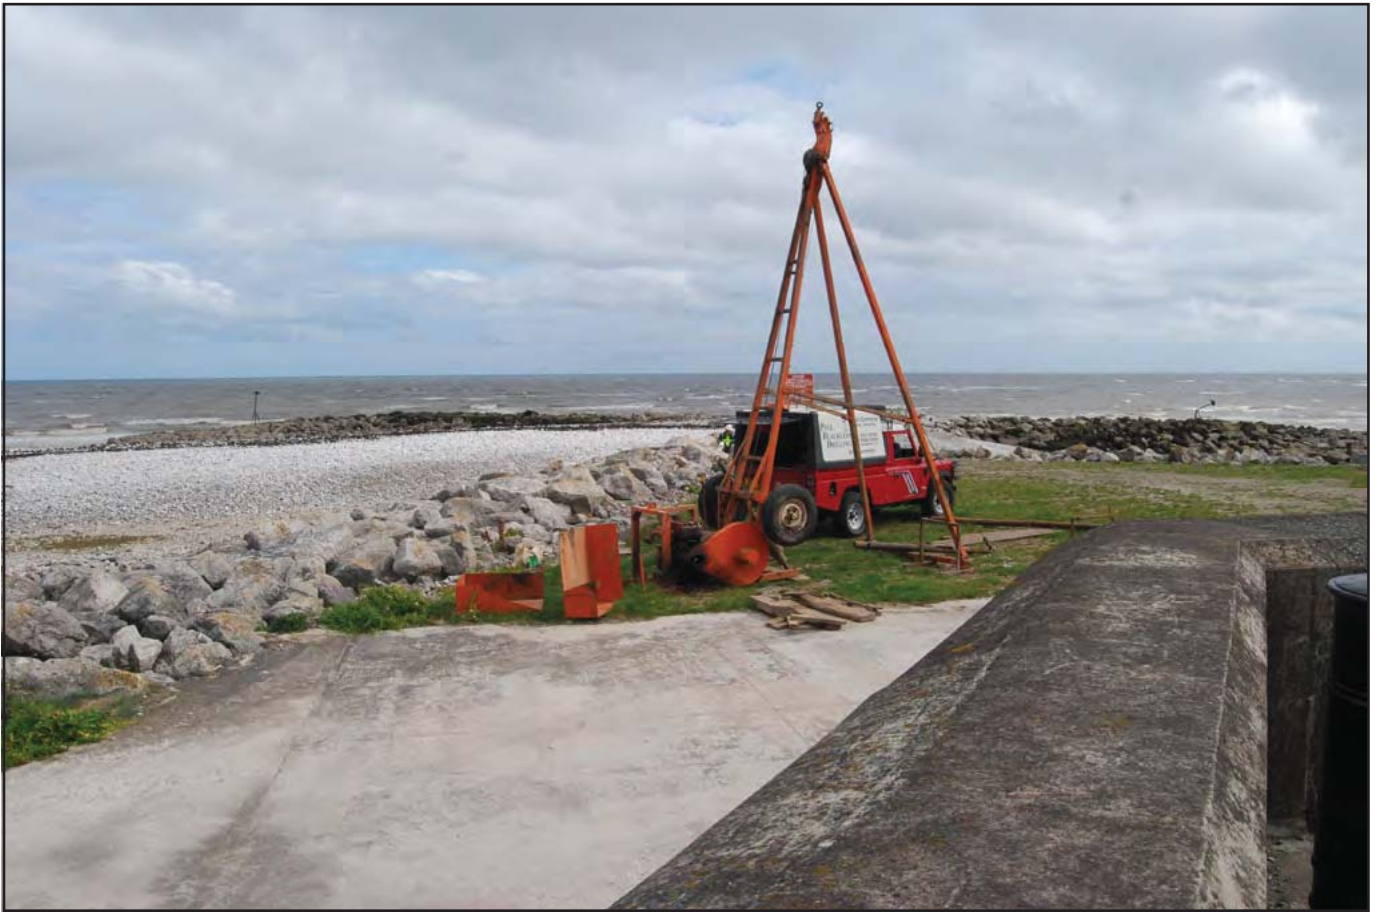
Borehole 03 was not completed due to the presence of rock armour that prohibited the use of the cable percussion rig.

Plate 09 - View northeast of Borehole 03 location with the cable percussion rig in situ. Borehole 03 was located on a fishtail groyne sea defence to the east of the tidal gates.

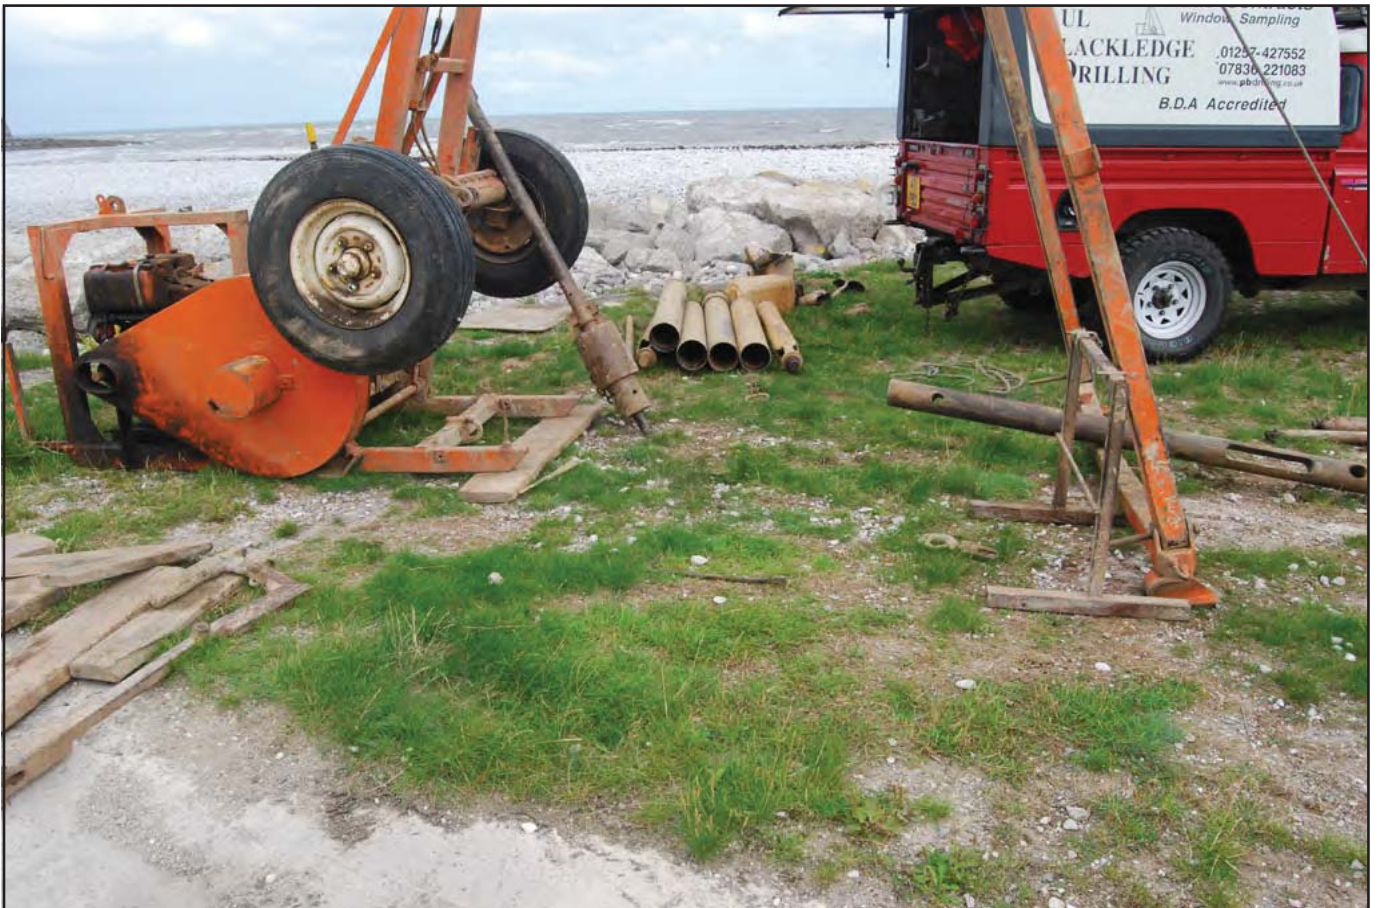
Plate 10 - Close-up detail of Borehole 03 prior to excavation, with the cable percussion rig in situ. The borehole was not completed due to the solidity of the rock armour that formed the groyne.
