MINFFORDD HOSPITAL, BANGOR GWYNEDD: ARCHAEOLOGICAL BUILDING RECORD

Archaeological Building Record: Level 2/3

GAT Project No. 2125

May 2010

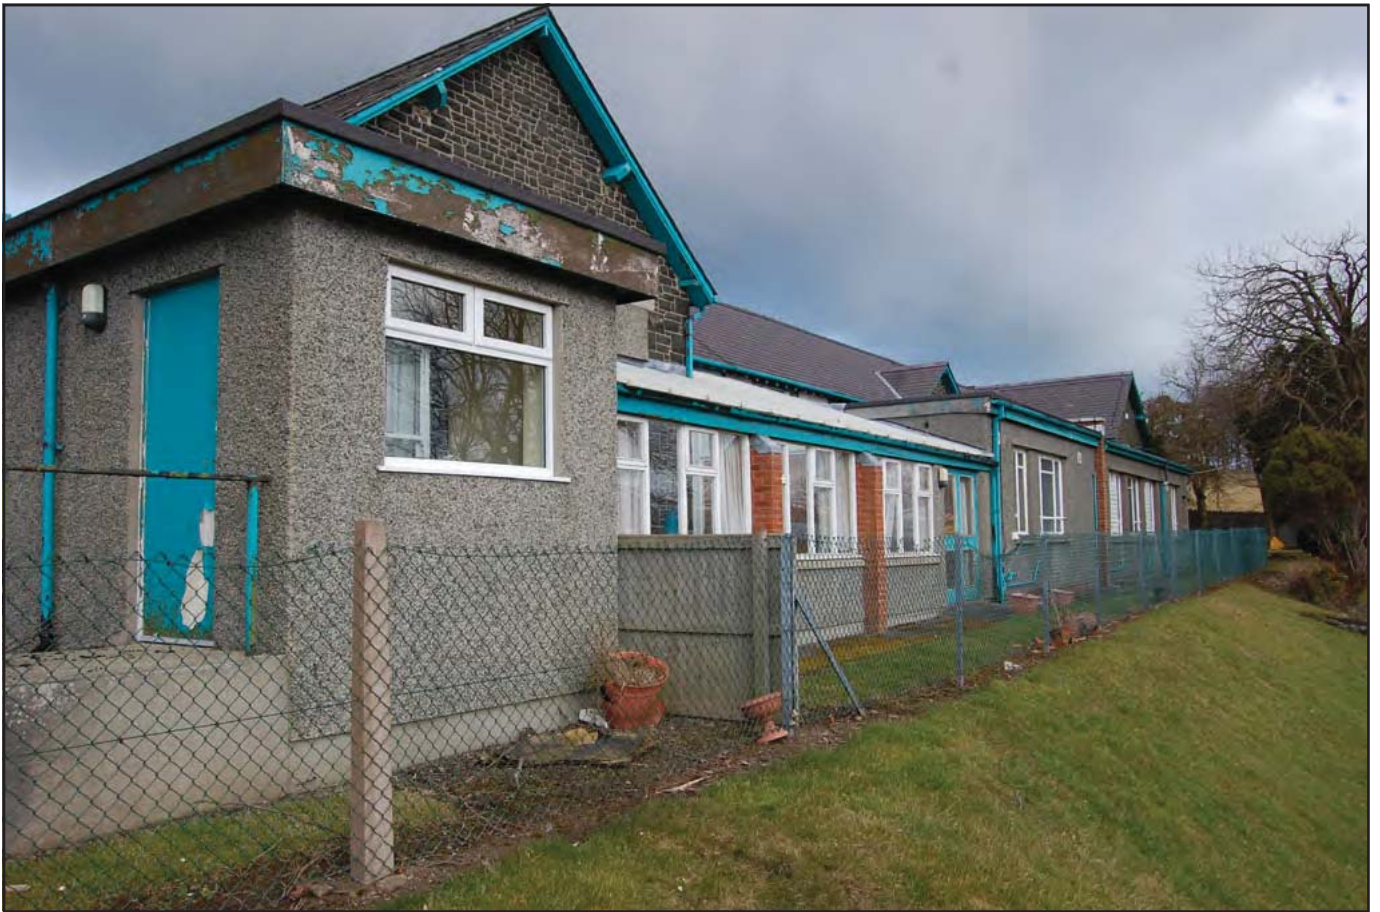
Plate 03: Long Stay Unit (External): Southeast facing elevation detailing late twentieth century veranda extension and flat roof extensions to the original structure. The Link Corridor is in the left foreground of image. The gable end of the male wing is also visible in the foreground, detailing original structural style.

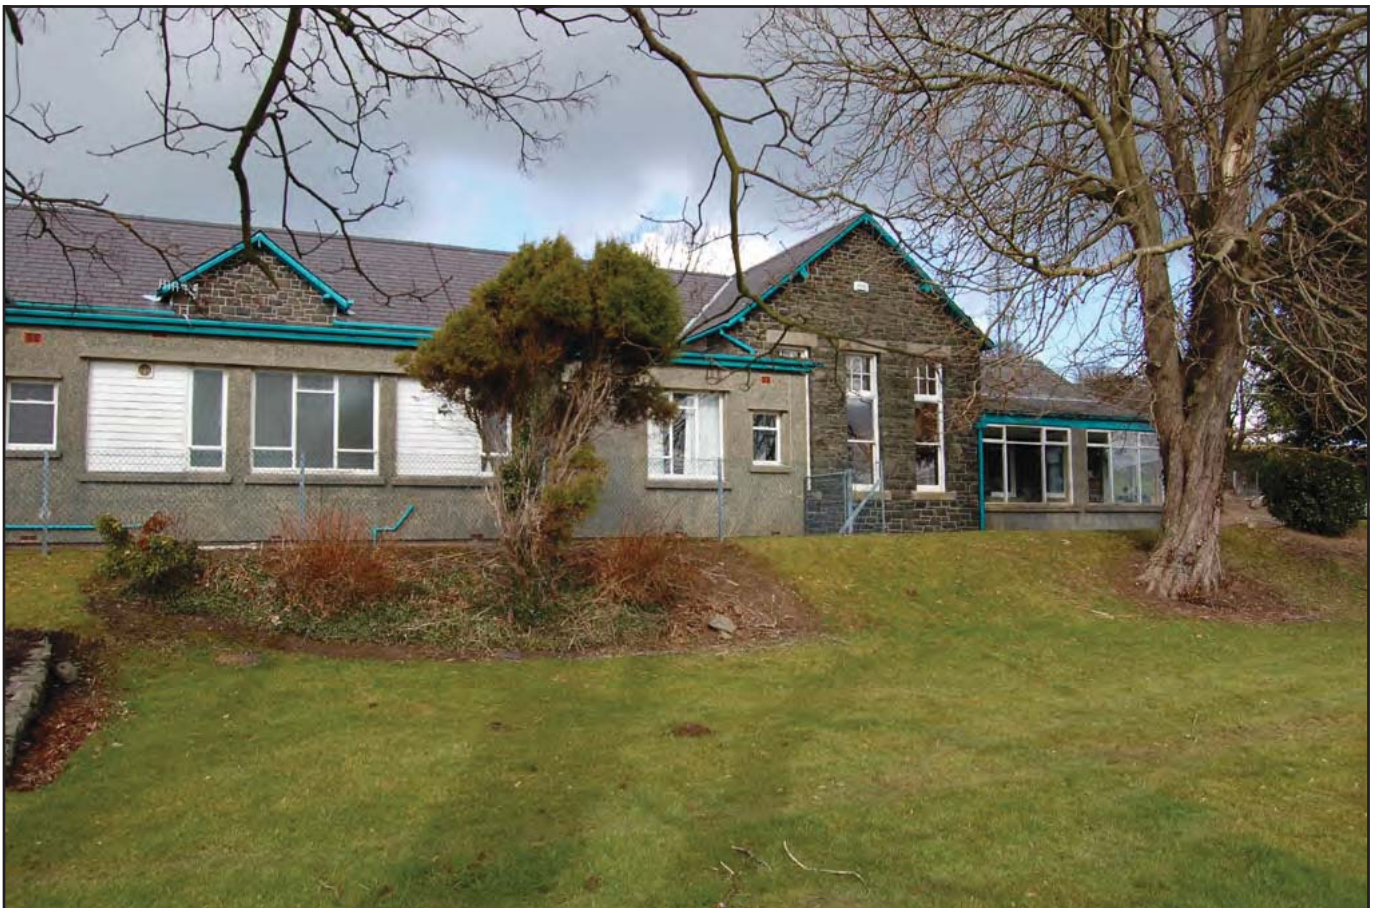
Plate 04: Long Stay Unit (External): Southeast facing elevation detailing late twentieth century flat roof extensions to the original structure. The Link Corridor is in the left foreground of image. The gable end of the female wing is also visible, detailing original structural style.

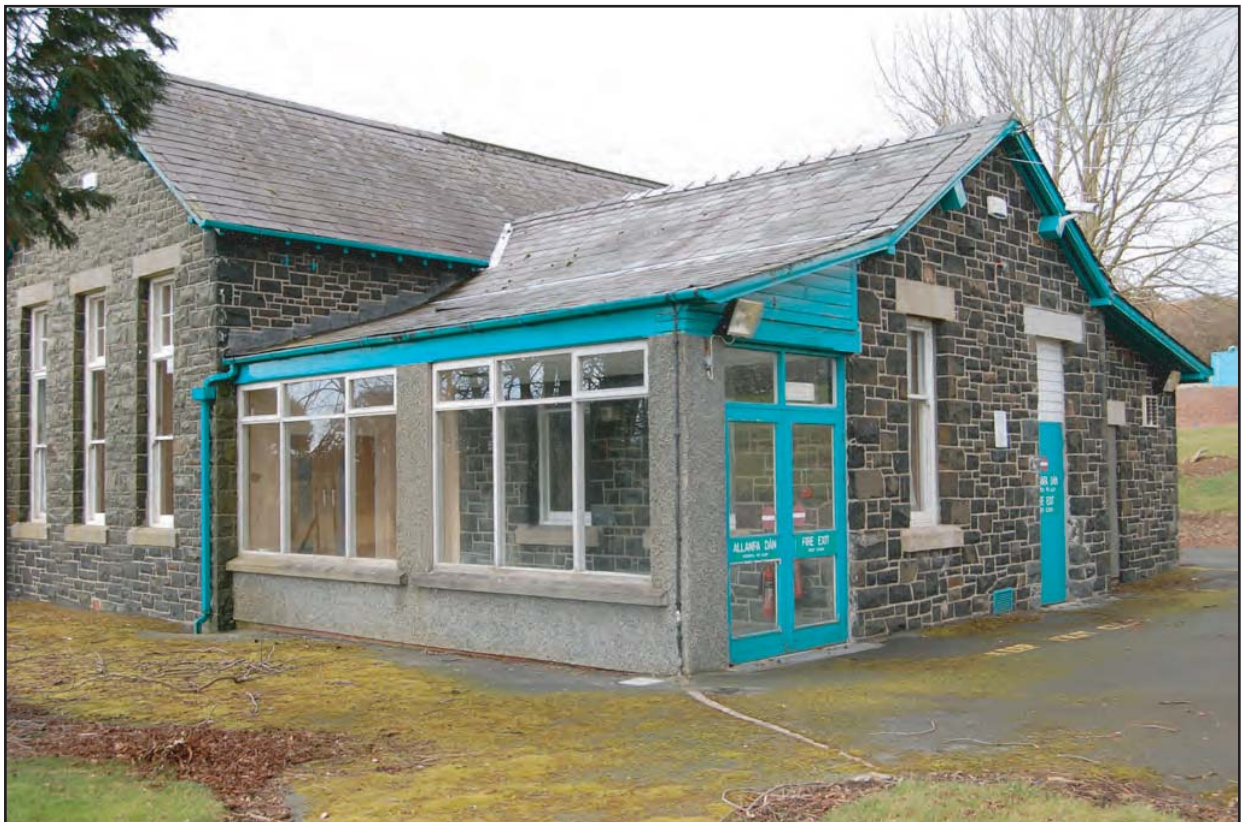
Plate 06: Long Stay Unit (External): Southeast and northeast facing elevations detailing original female wing (Room G11) and later extension (Room G12). The later extension was constructed between 1900 and 1914.

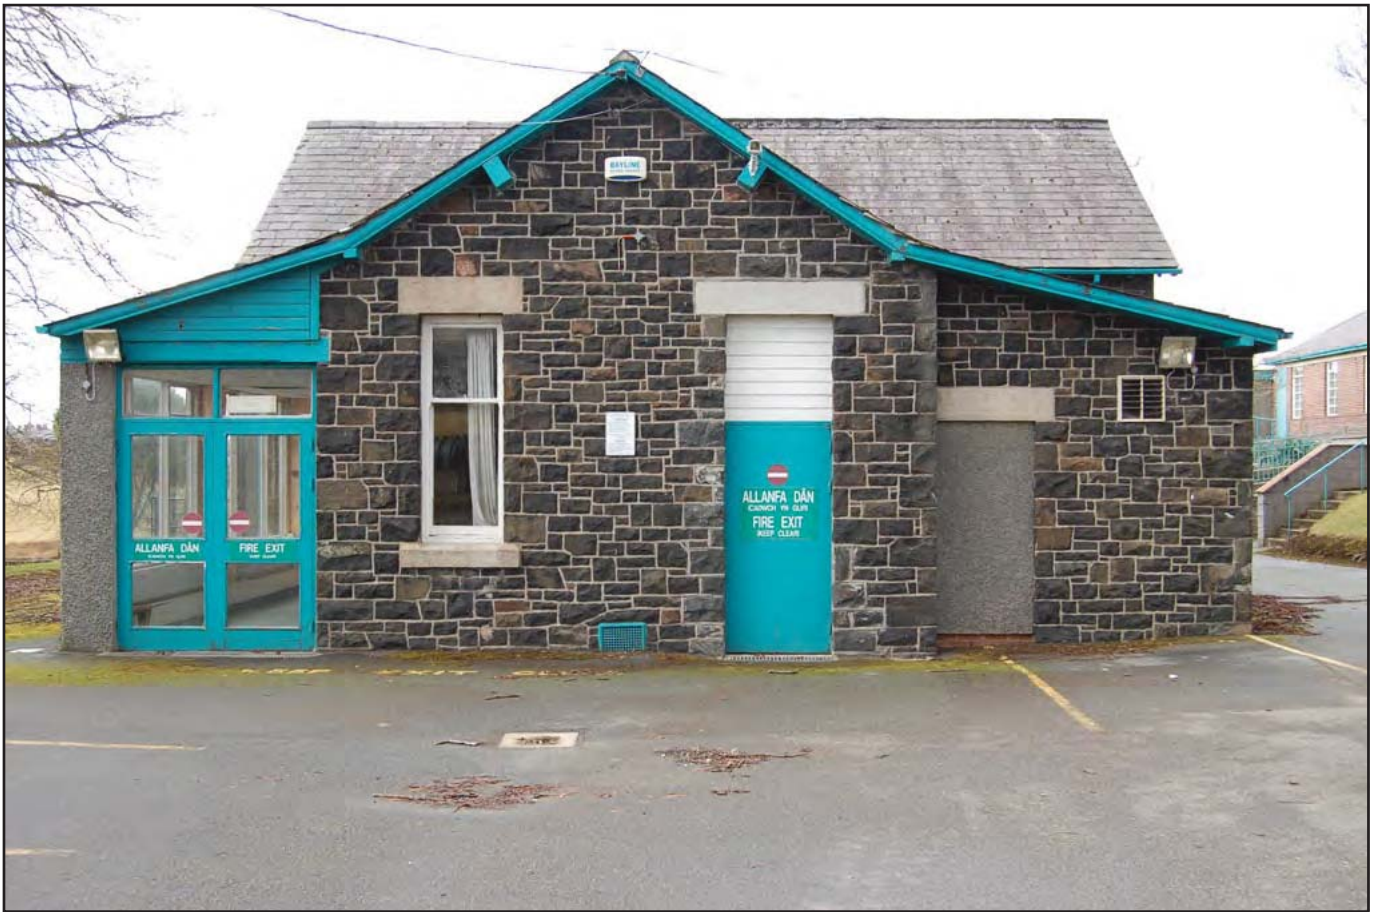
Plate 07: Long Stay Unit (External): Northeast facing elevation of early twentieth extension (Room G12), detailing the use of sub-rectangular stonework and quoin edging. The roof of the female wing (Room G11) is in the background.

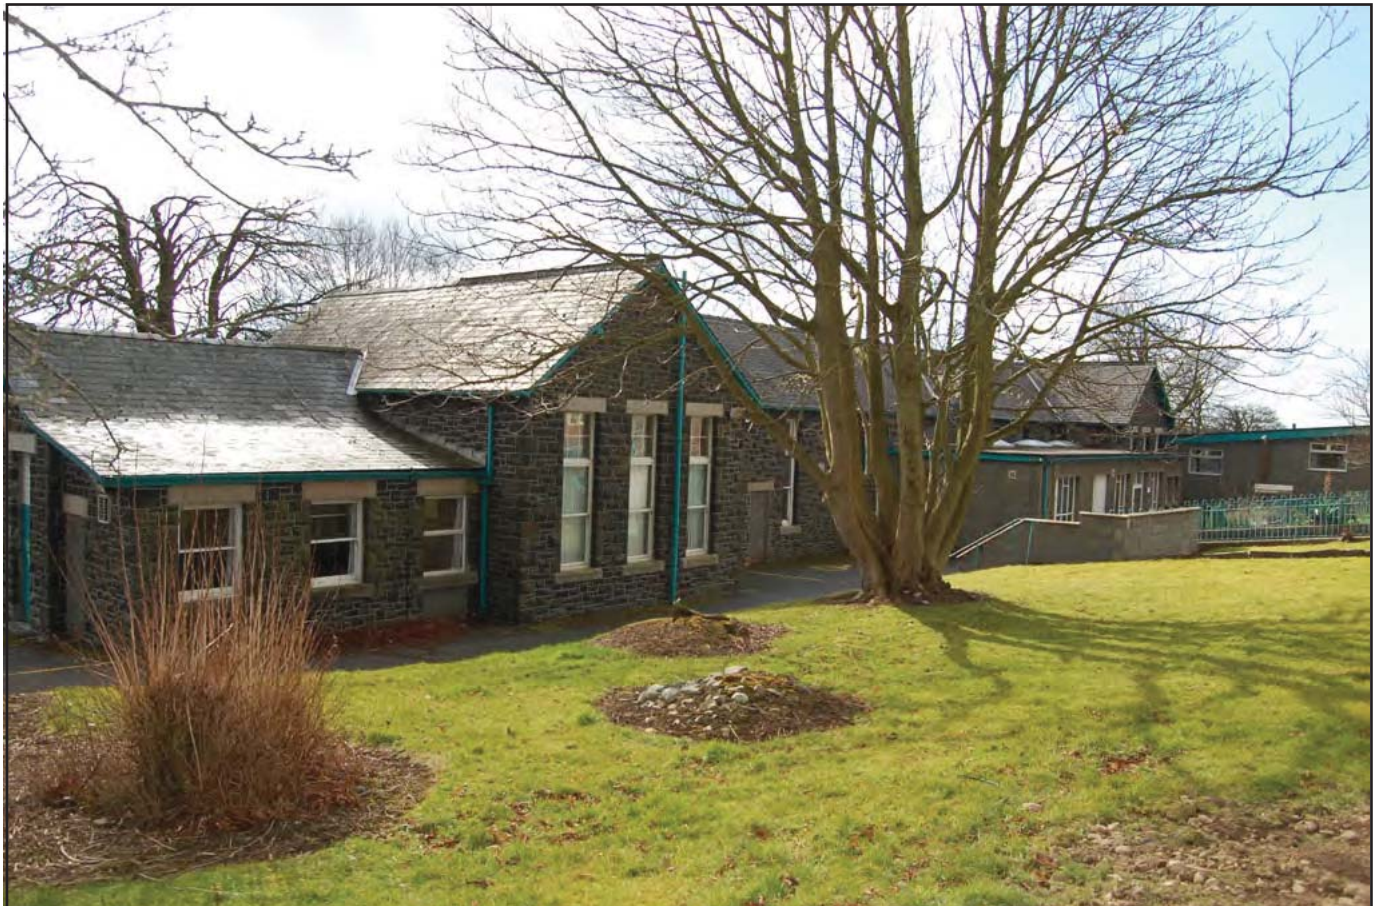
Plate 08: Long Stay Unit (External): Northwest facing elevation. The female wing (Room G11) and an extension (Room G12) are visible in the foreground. An flat roofed extension and the link corridor can be seen towards the right of the image.

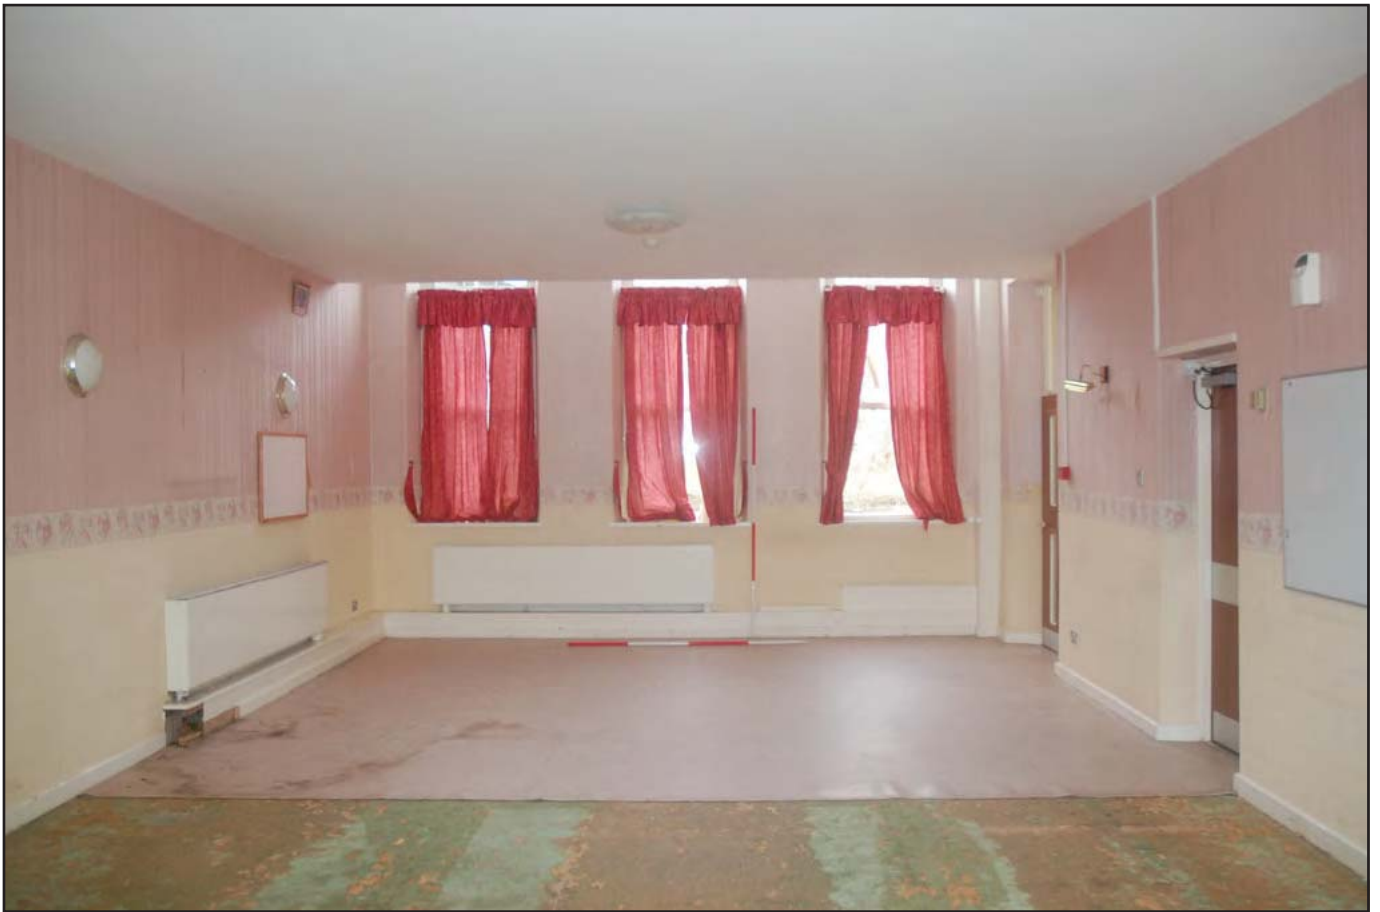
Plate 09: Long Stay Unit (Internal): Room G01 - view northwest detailing extant windows and entrance points as well as current decorative styles and features. All doors are fire doors. Bullnose skirting boards are visible.

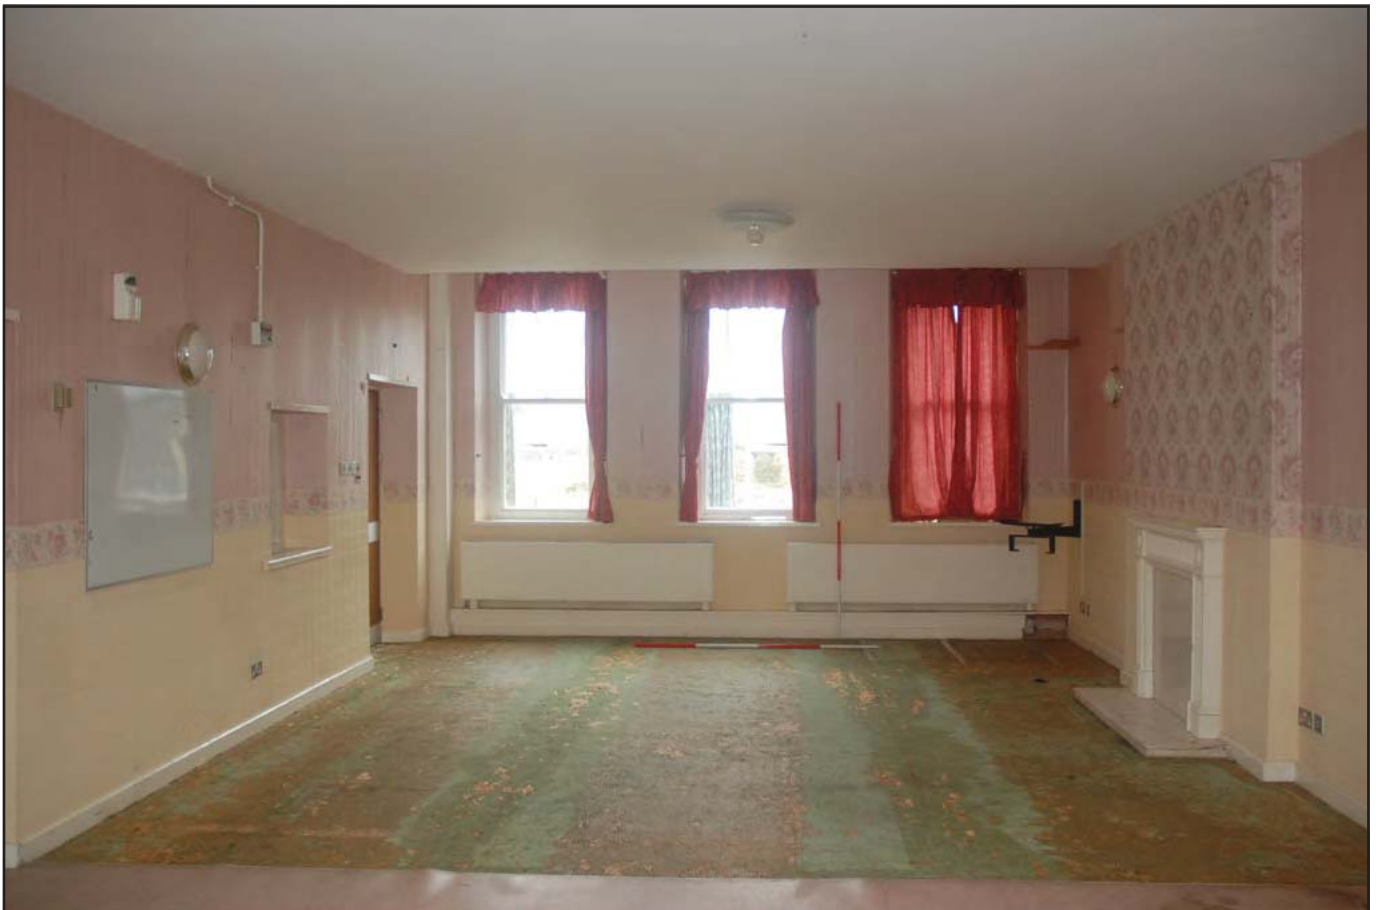
Plate 10: Long Stay Unit (Internal): Room G01 - view southeast detailing opposite view to Plate 09. Note disused fireplace to right of image.

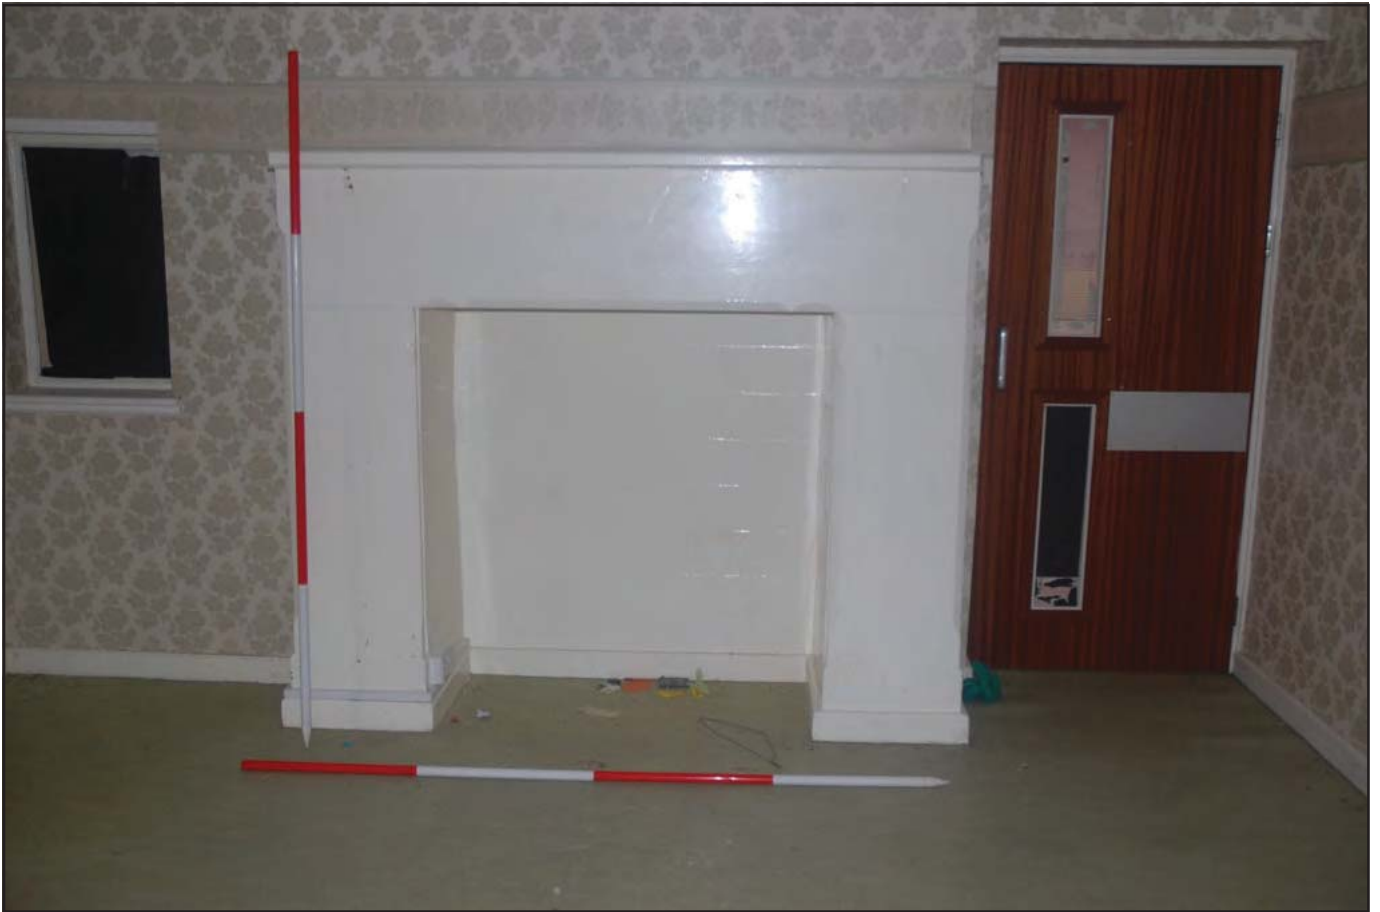
Plate 11: Long Stay Unit (Internal): Room G02 - view southwest detailing former ward kitchen fireplace current decorative styles and features. All doors are fire doors. Bullnose skirting boards are visible.

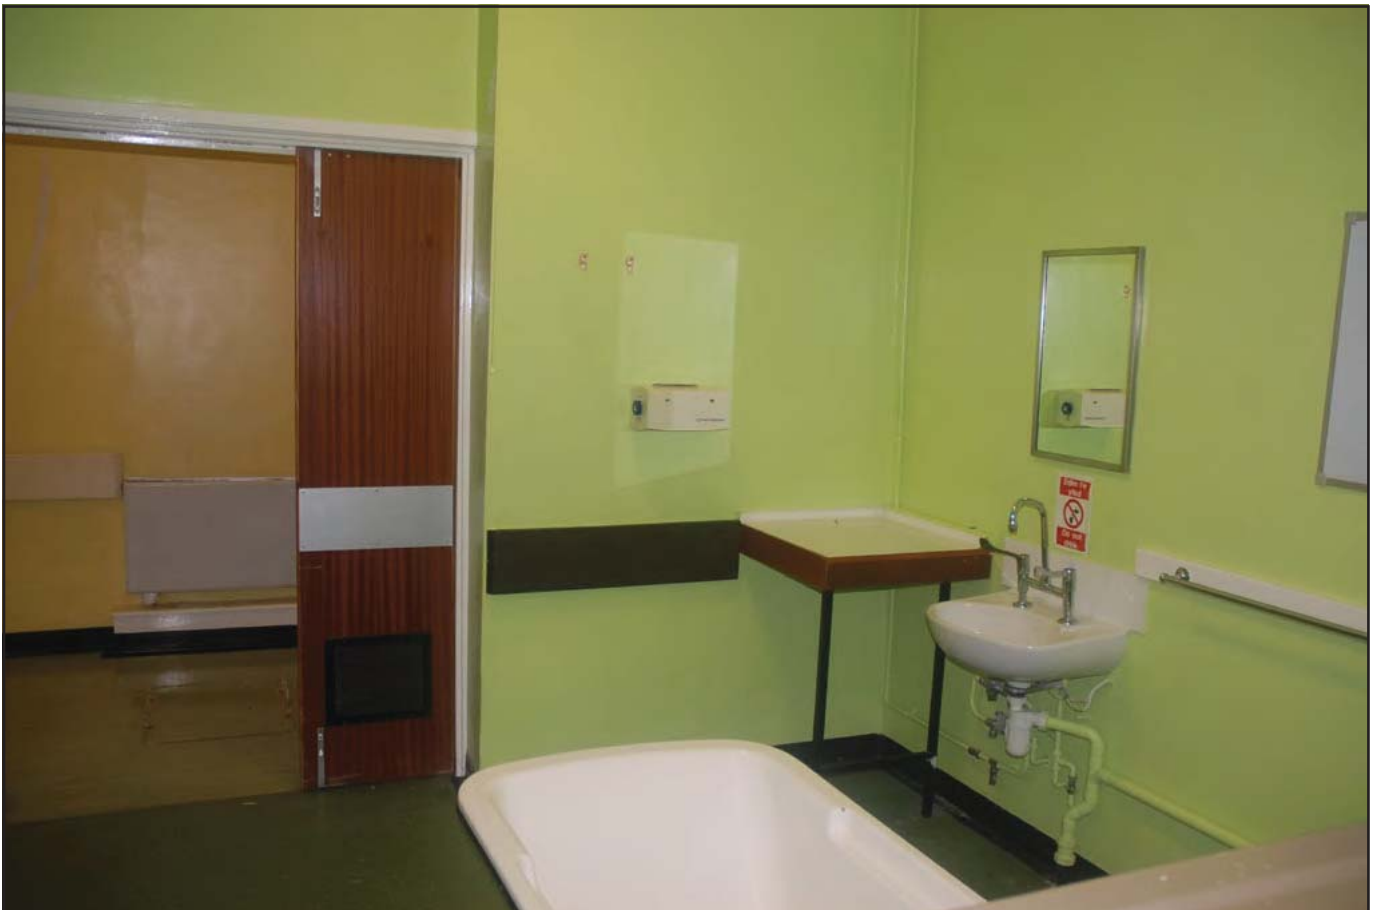
Plate 12: Long Stay Unit (Internal): Room G04 - view southwest detailing former female ward. This room was converted into a bathroom space for it's final use. Note large fire door entrance and bath in foreground.

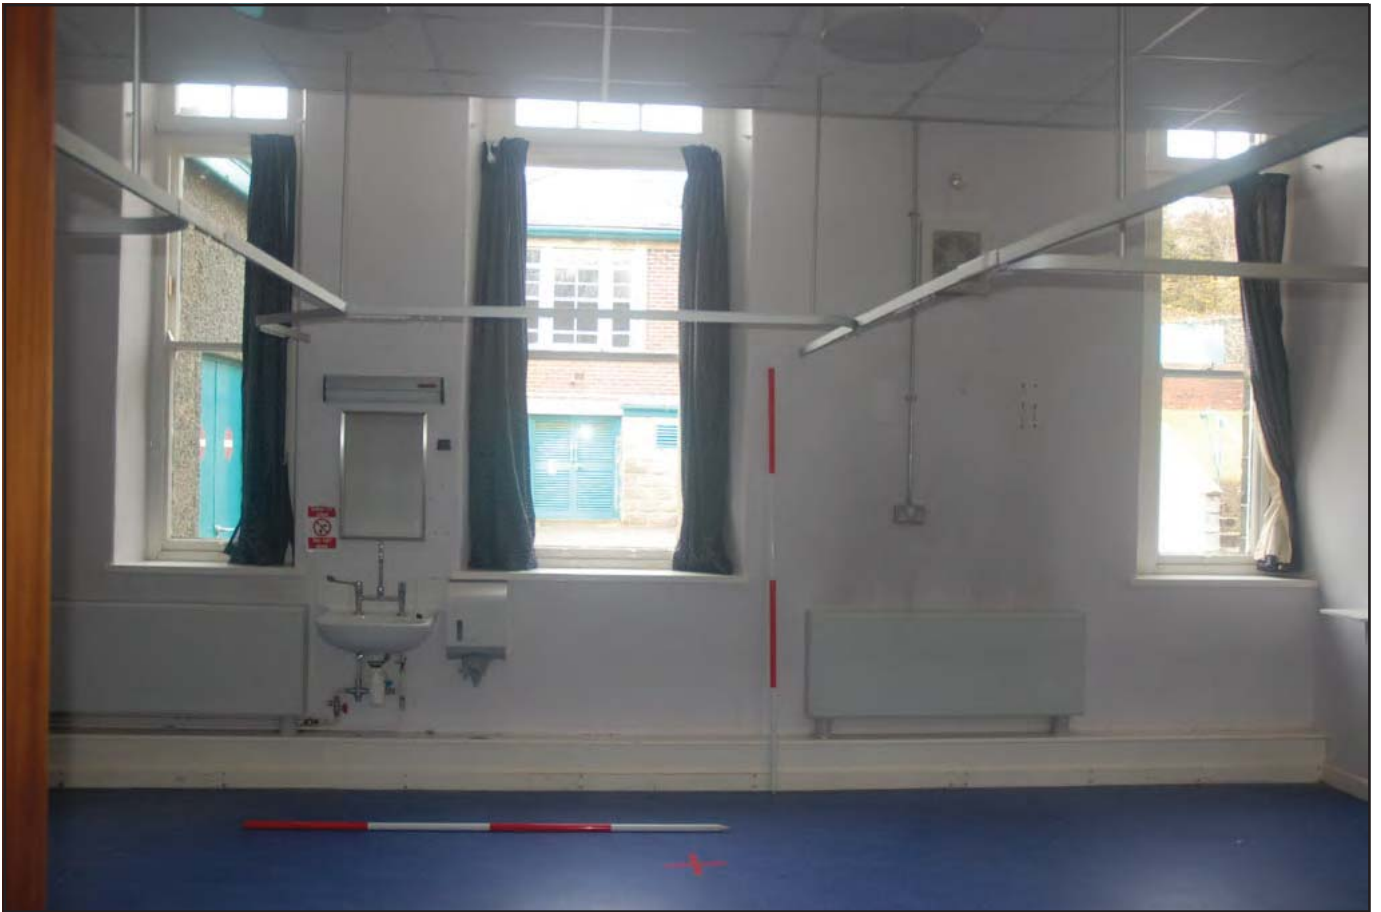
Plate 13: Long Stay Unit (Internal): Room G05 - view northwest detailing former male ward. All doors are fire doors. Bullnose skirting boards are visible. Note the Short Stay Unit visible through the windows as a brick-built structure (Scales: 2 x 2.0m)

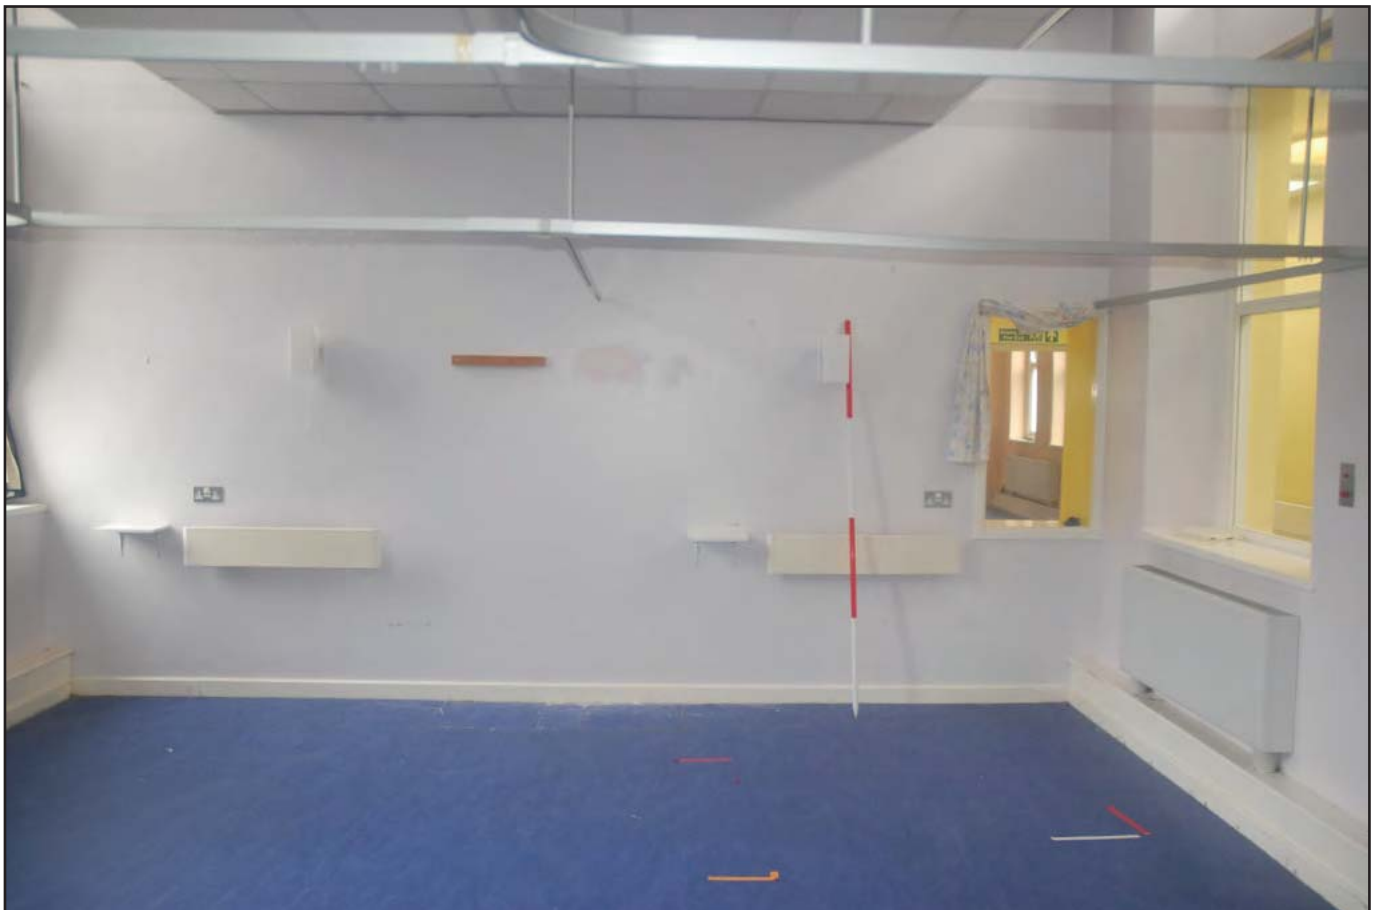
Plate 14: Long Stay Unit (Internal): Room G05 - view southeast detailing former male ward. All doors are fire doors. Bullnose skirting boards are visible. Note: internal corridor visible through openings (Scales: 2 x 2.0m)

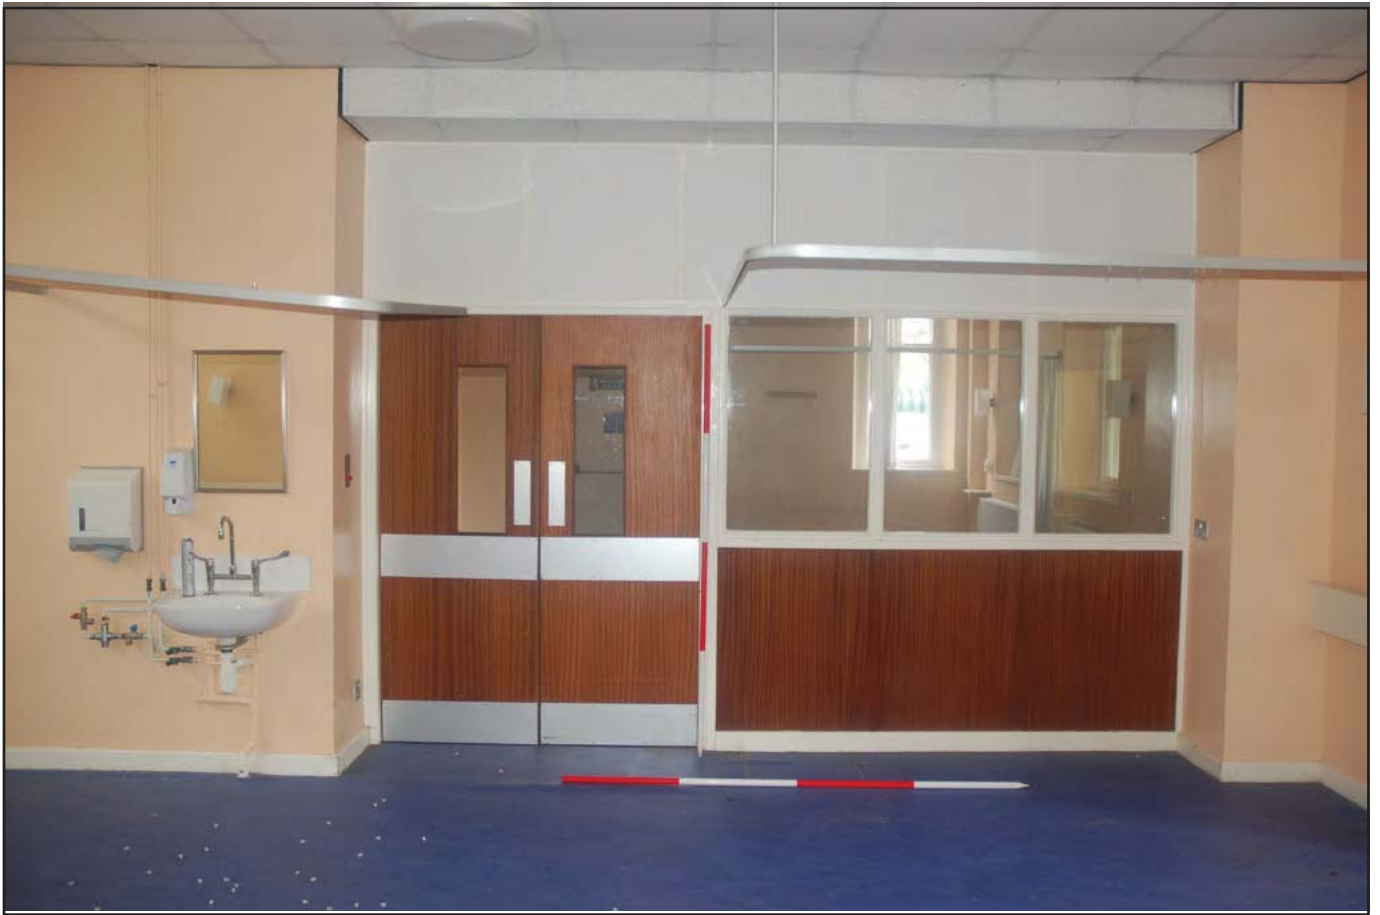
Plate 15: Long Stay Unit (Internal): Room G11 - view northeast of former female ward, detailing entrance via fire doors. Bullnose skirting boards are visible. Note Room G12 visible through the doors and screen (Scales: 2 x 2.0m)

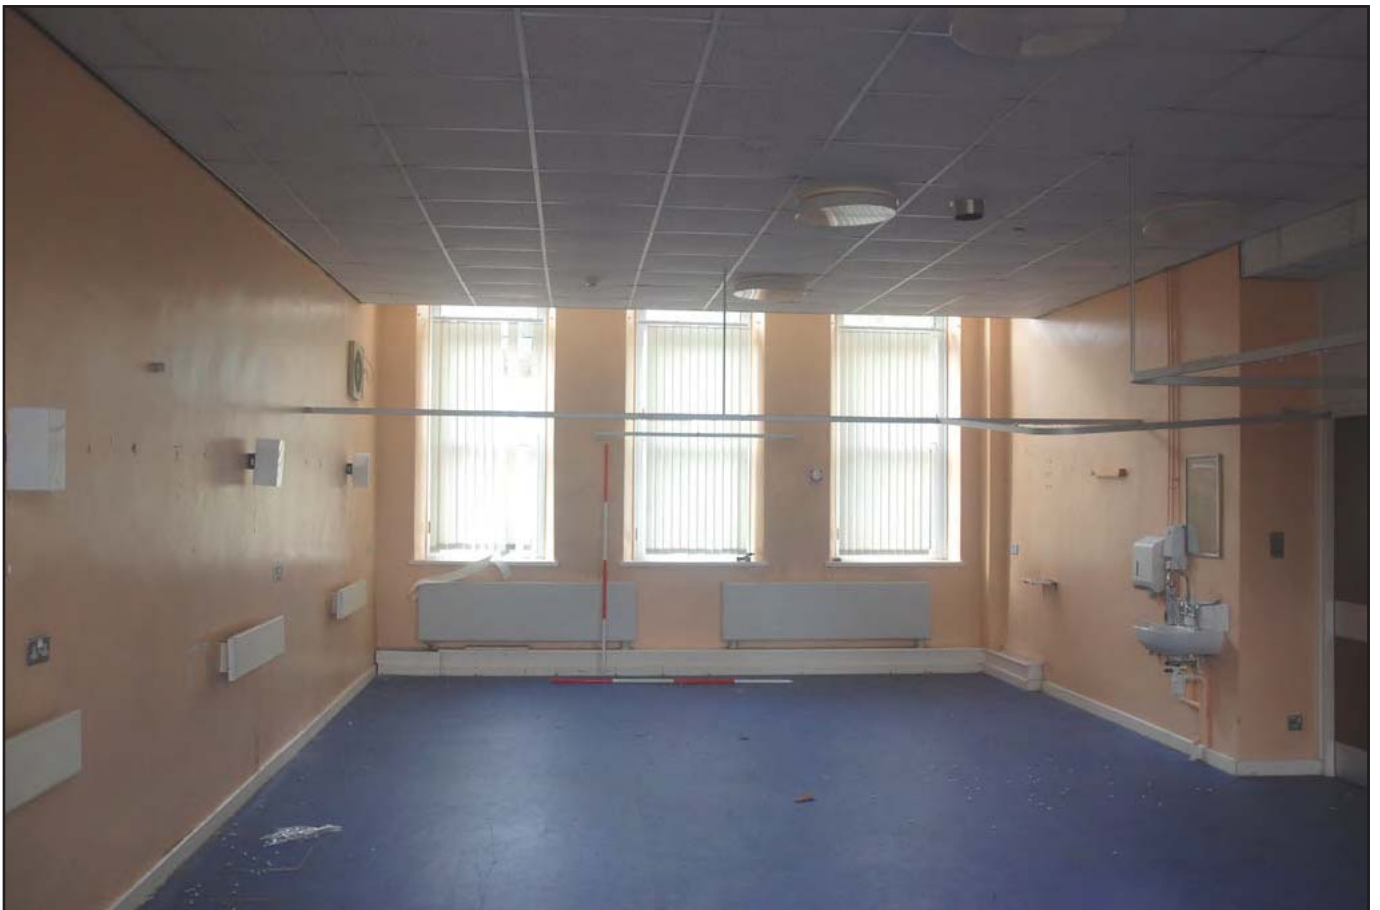
Plate 16: Long Stay Unit (Internal): Room G11 - view southeast of former female ward, detailing window fittings and bullnose skirtings. Original ceiling is disguised by a suspended ceiling (Scales: 2 x 2.0m)

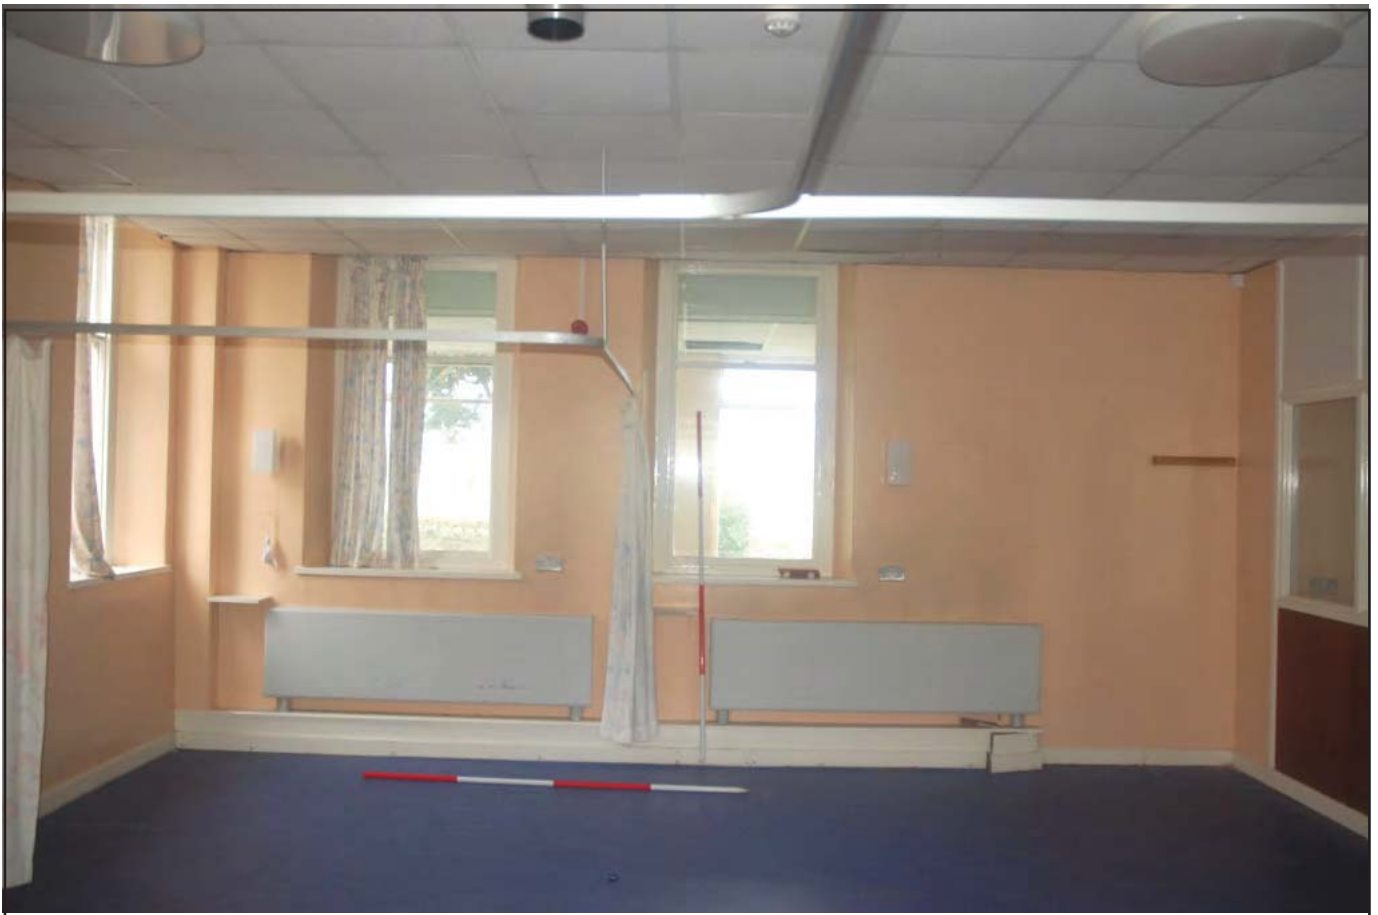
Plate 17: Long Stay Unit (Internal): Room G12 - view southeast of former female ward annexe. This room was created from the conversion and alteration of the former sewing, treatment and linen rooms into one room; therefore, most of the original internal structural elements have been altered and/or disguised. A suspended ceiling is in place and the screen separating Rooms G12 & G11 can be seen to the right of the image (Scales: 2 x 2.0m)

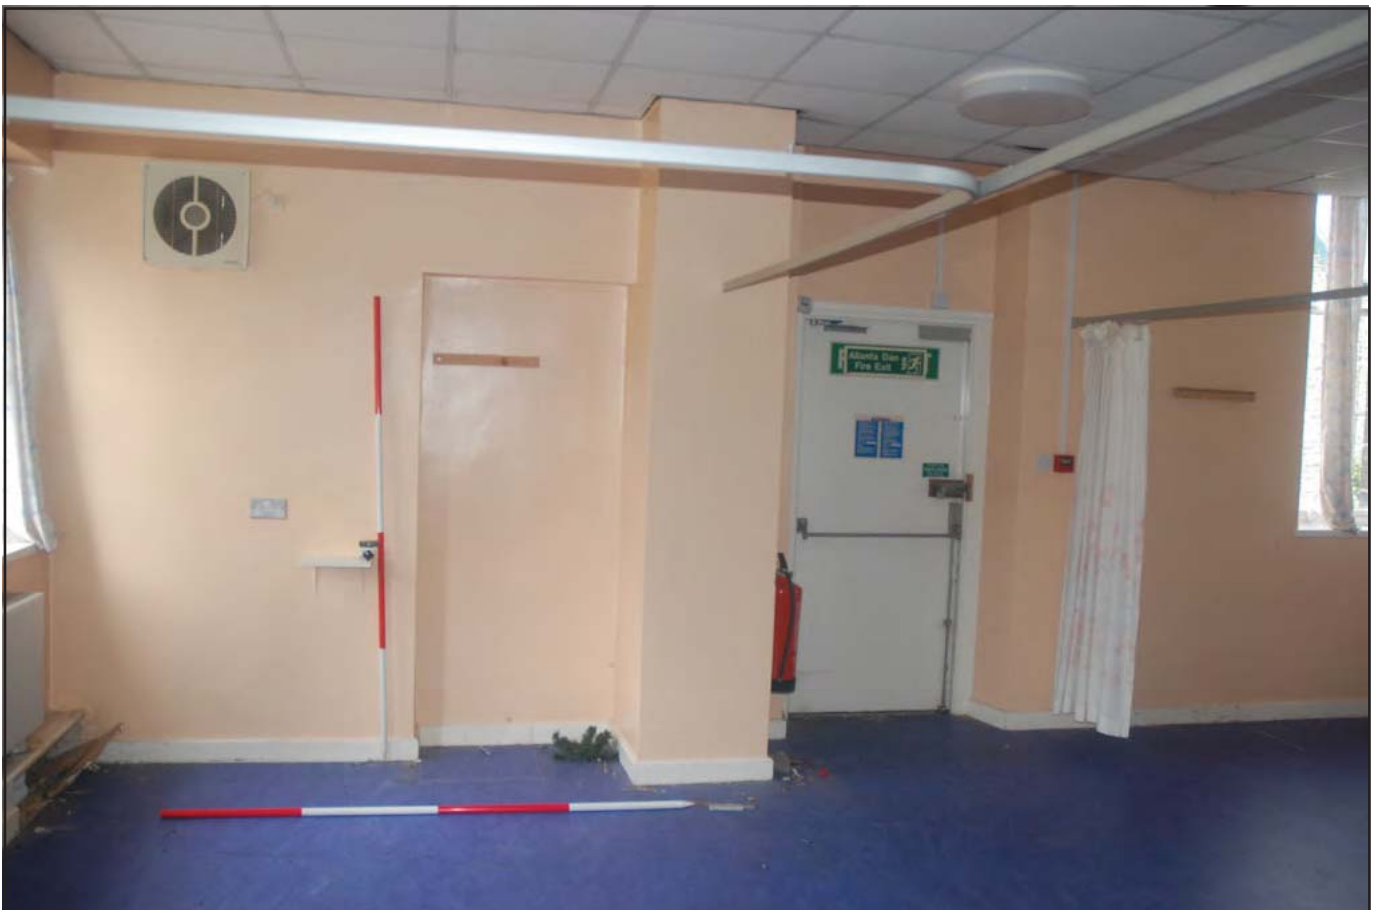
Plate 18: Long Stay Unit (Internal): Room G12 - view northeast of former female ward annexe. This room was created from the conversion and alteration of the former sewing, treatment and linen rooms into one room; therefore, most of the original internal structural elements have been altered and/or disguised. The partition wall separating the sewing and linen rooms can still be seen as a truncated stub; the entrance into the sewing room from outside can be seen as a blocked door. The alterations were completed after 1984 (Scales: 2 x 2.0m)

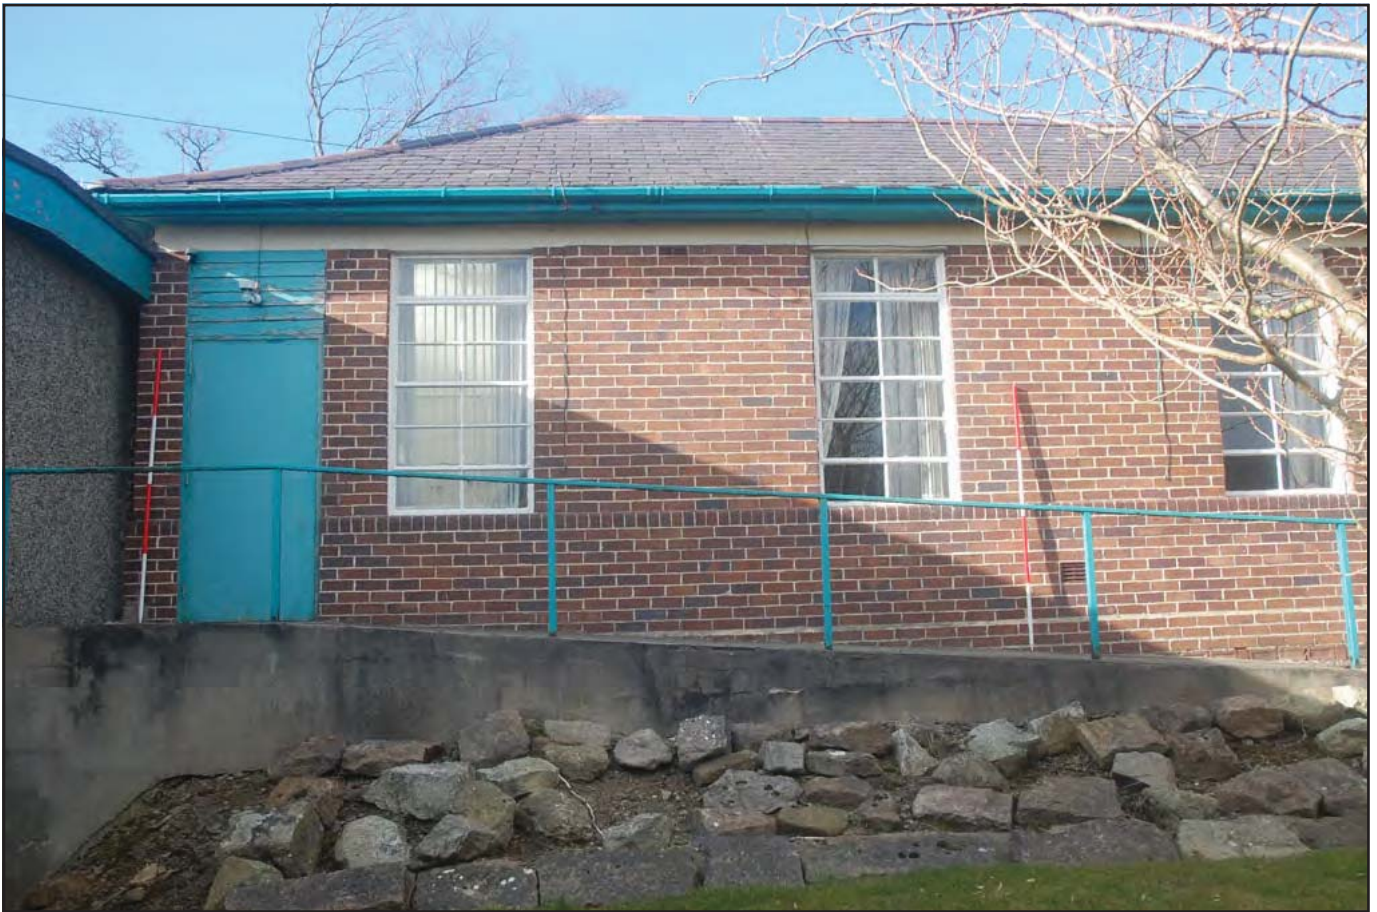
Plate 19: Short Stay Unit : Southeast facing elevation. Built from brick and not stone as the original buildings. Hip gable roof visible along with casement windows (Rooms G09, G10 & G13) and disabled access into G13. The courtyard separating the Long and Short Stay Units are visible in the foreground; the Link Corridor is visible to the left of the image (Scales: 2 x 2.0m)

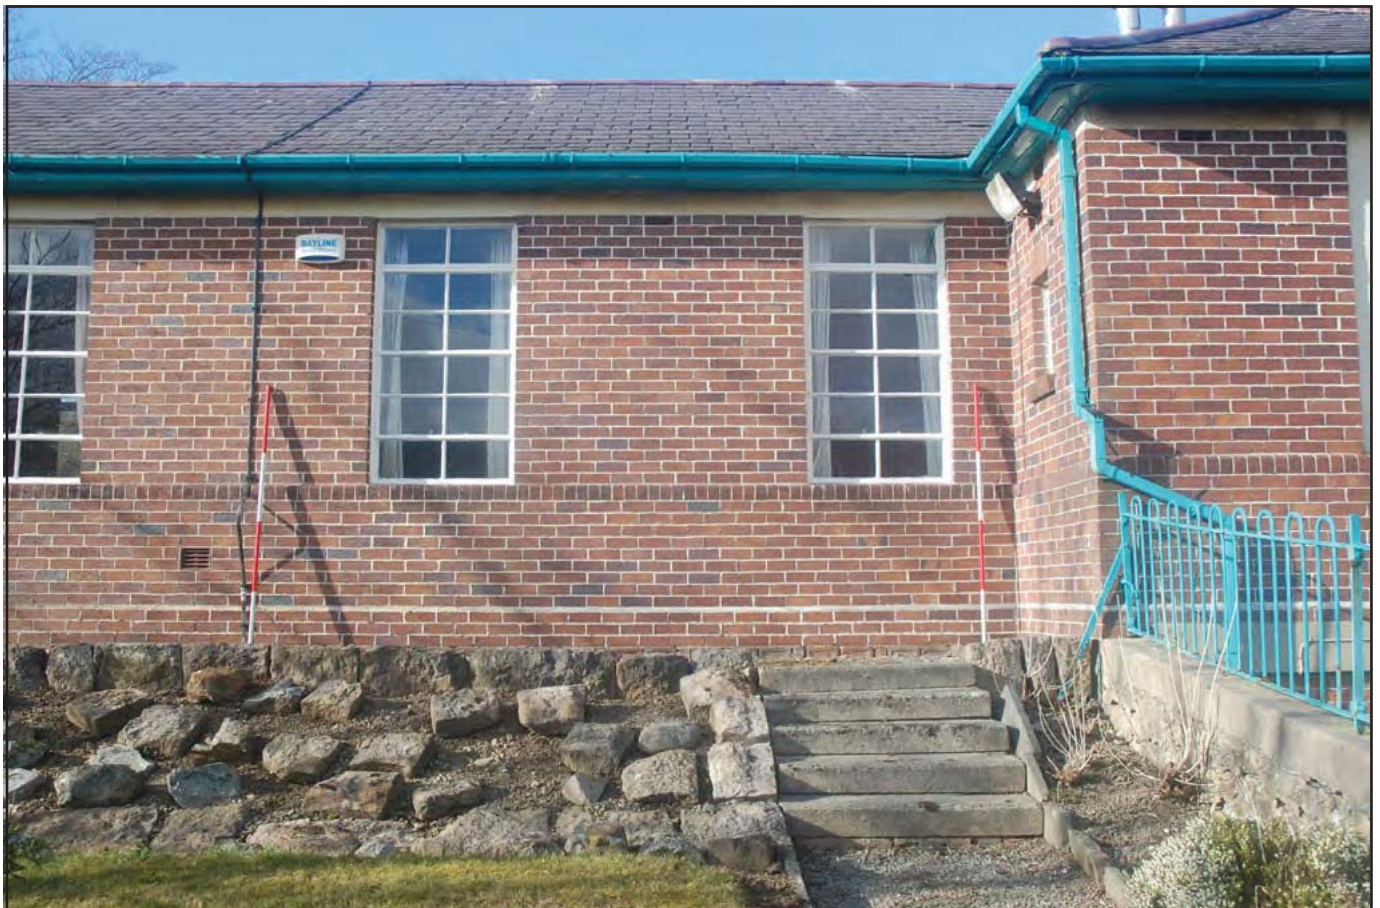
Plate 20: Short Stay Unit : Southeast facing elevation. Built from brick and not stone as the original buildings. Hip gable roof visible along with casement windows (Rooms G06 to G8). The courtyard separating the Long and Short Stay Units are visible in the foreground; the day room wing (Room G01) is visible to the right of the image (Scales: 2 x 2.0m)
