MINFFORDD HOSPITAL, BANGOR GWYNEDD: ARCHAEOLOGICAL BUILDING RECORD

Archaeological Building Record: Level 2/3

GAT Project No. 2125

May 2010

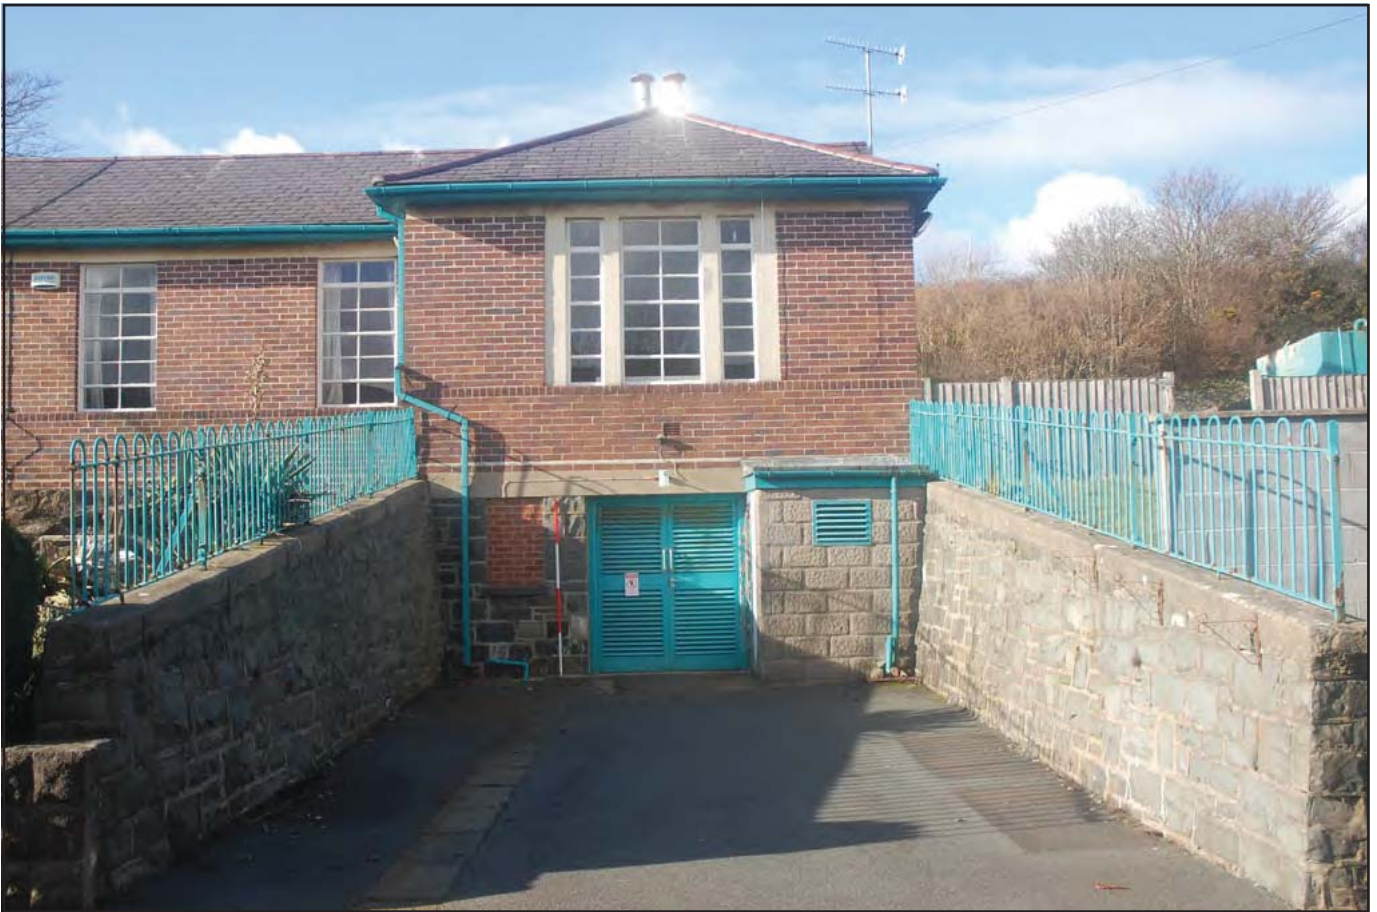
Plate 21: Short Stay Unit : Southeast facing elevation - Former Day Room (Room G01) and basement level boiler house; the latter includes a lean to annexe with a louvred window. The courtyard separating the Long and Short Stay Units is to the left of the image (Scale: 1x 2.0m)

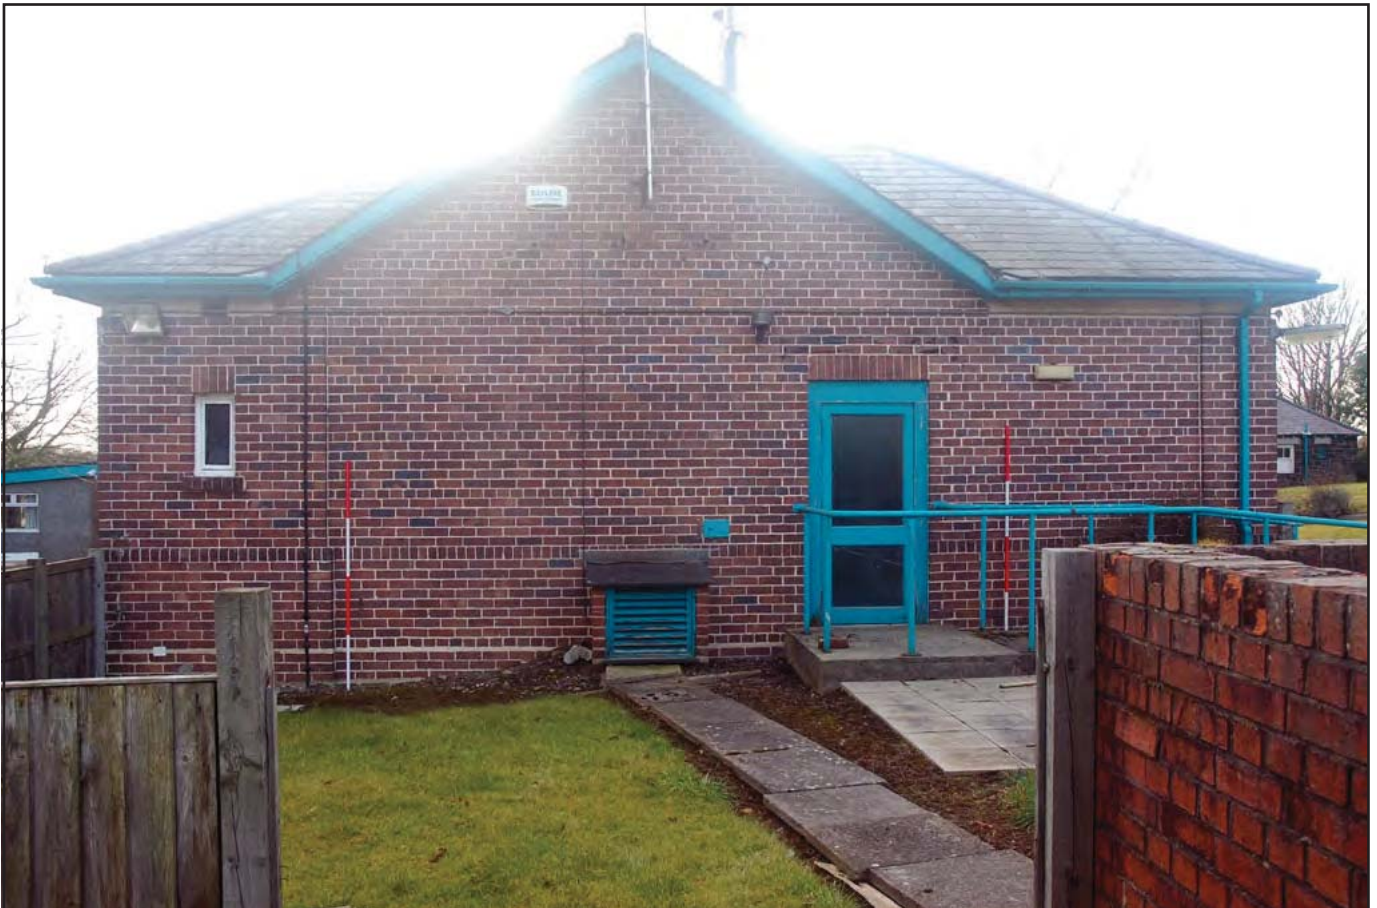
Plate 22: Short Stay Unit: Northeast facing elevation with gable end of the former Day Room (Room G01) visible. The door towards the right of image provides access to the central corridor of the building (Scales: 2 x 2.0m)

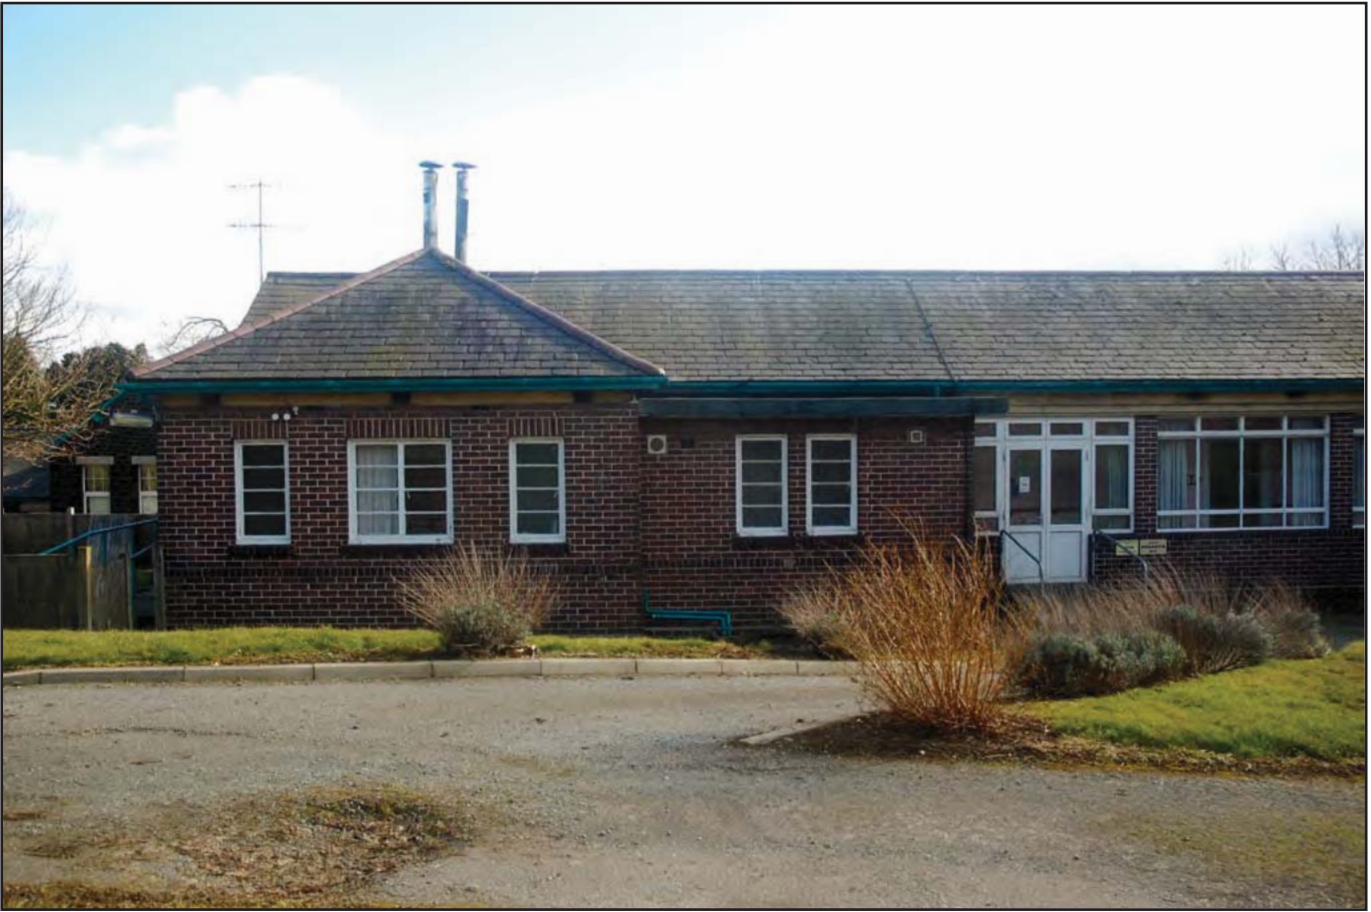
Plate 23: Short Stay Unit: Northwest facing elevation - Rooms G02 to G05 and main entrance; detailing English Garden Wall bond brick style and casement windows

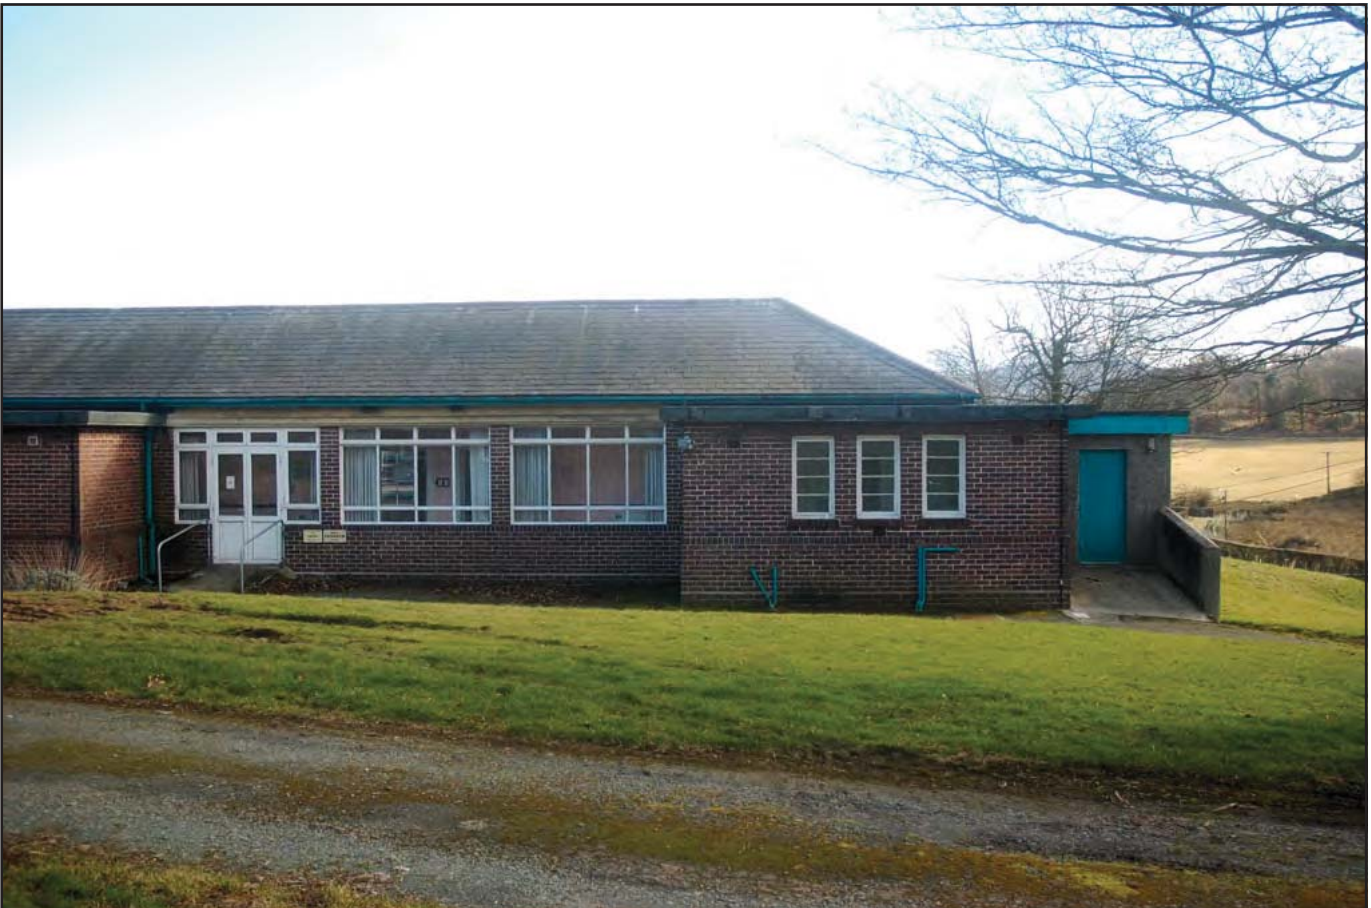
Plate 24: Short Stay Unit: Northwest facing elevation - main entrance and Room G11 (Kitchen); detailing English Garden Wall bond brick style and casement windows. Note the link corridor attached to the southwest facing elevation towards right of image

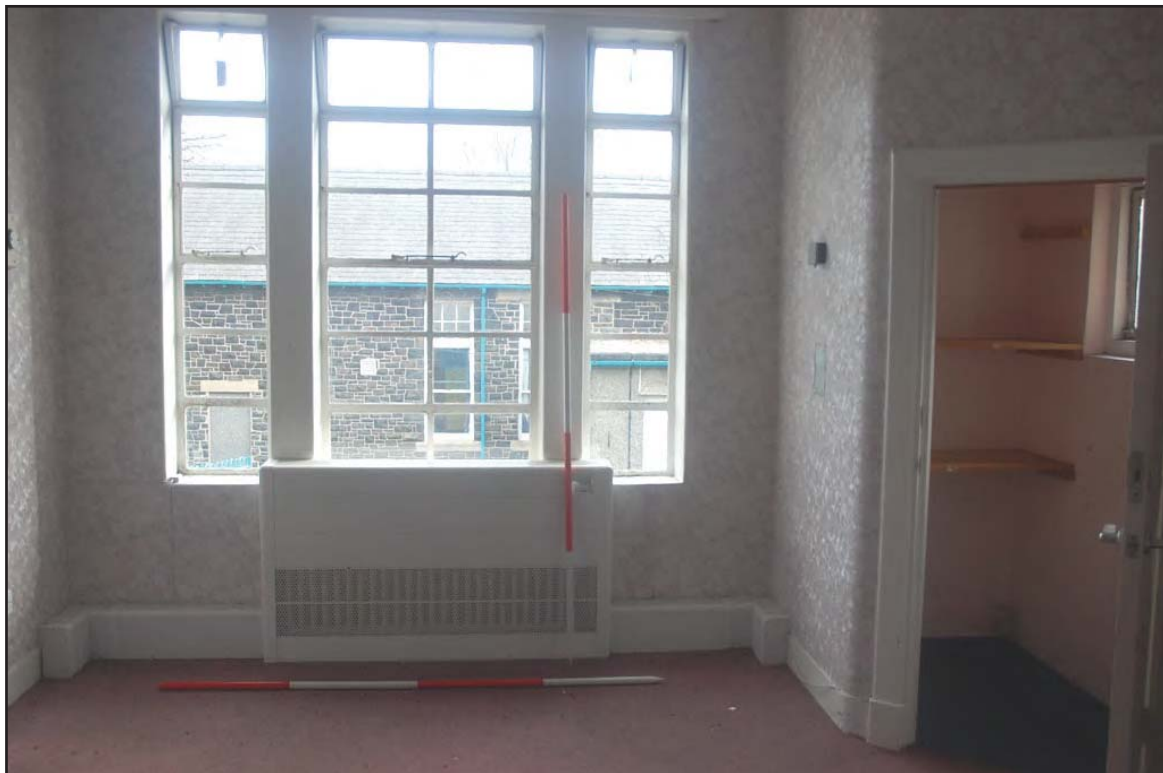
Plate 26: Short Stay Unit (Internal): view south of Room G01, detailing large casement window and internal structural and decorative features, including storage cubby (cf. Plate 25), door moulding and bullnose skirtings. Note the rear elevation of the Long Stay Unit visible through the window

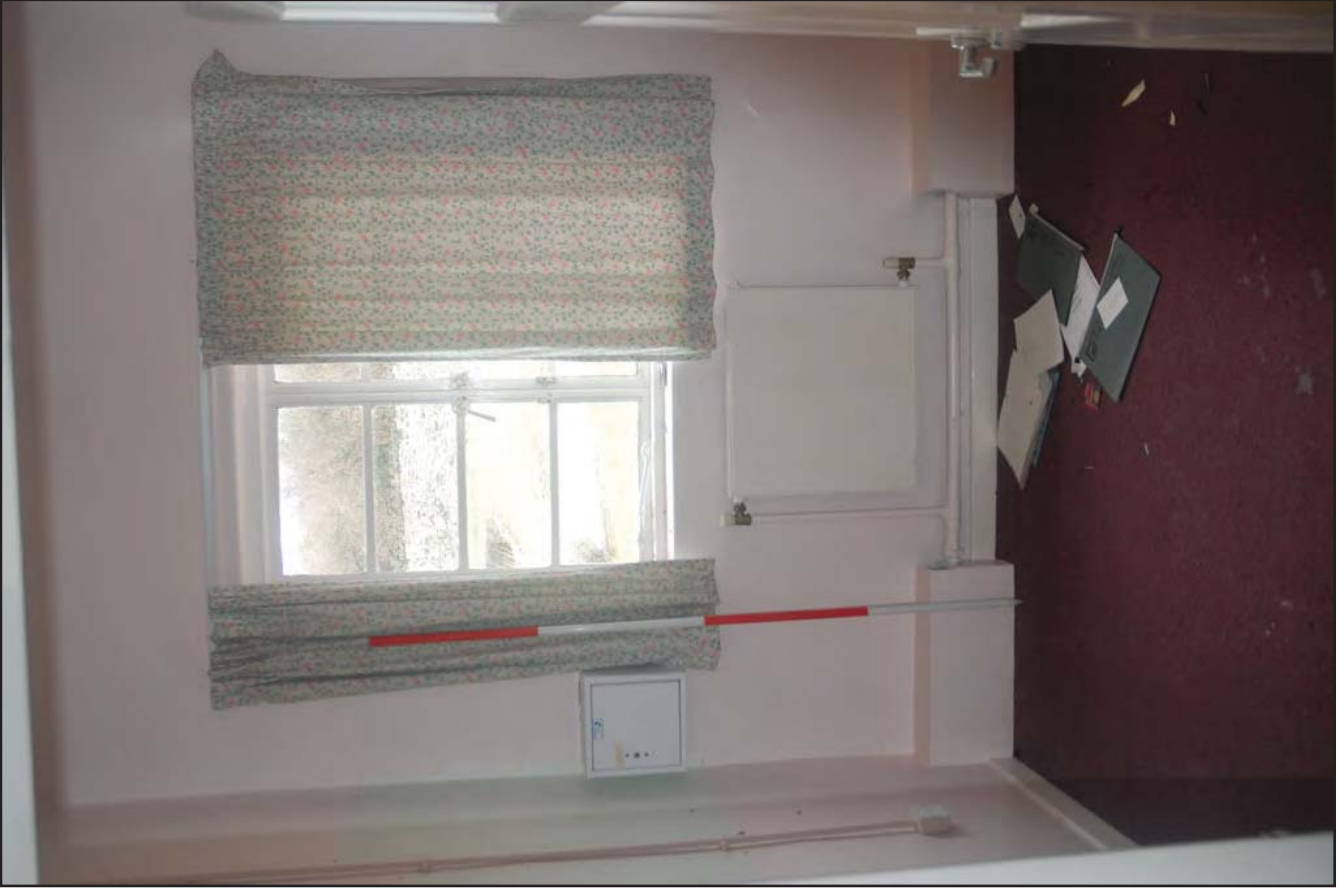
Plate 27: Short Stay Unit (Internal): view northwest of Room G03, detailing casement window and bullnose skirtings. Note moulded panel entrance door and not fire door as used in the Long Stay Unit (Scale: 1 x 2.0m)

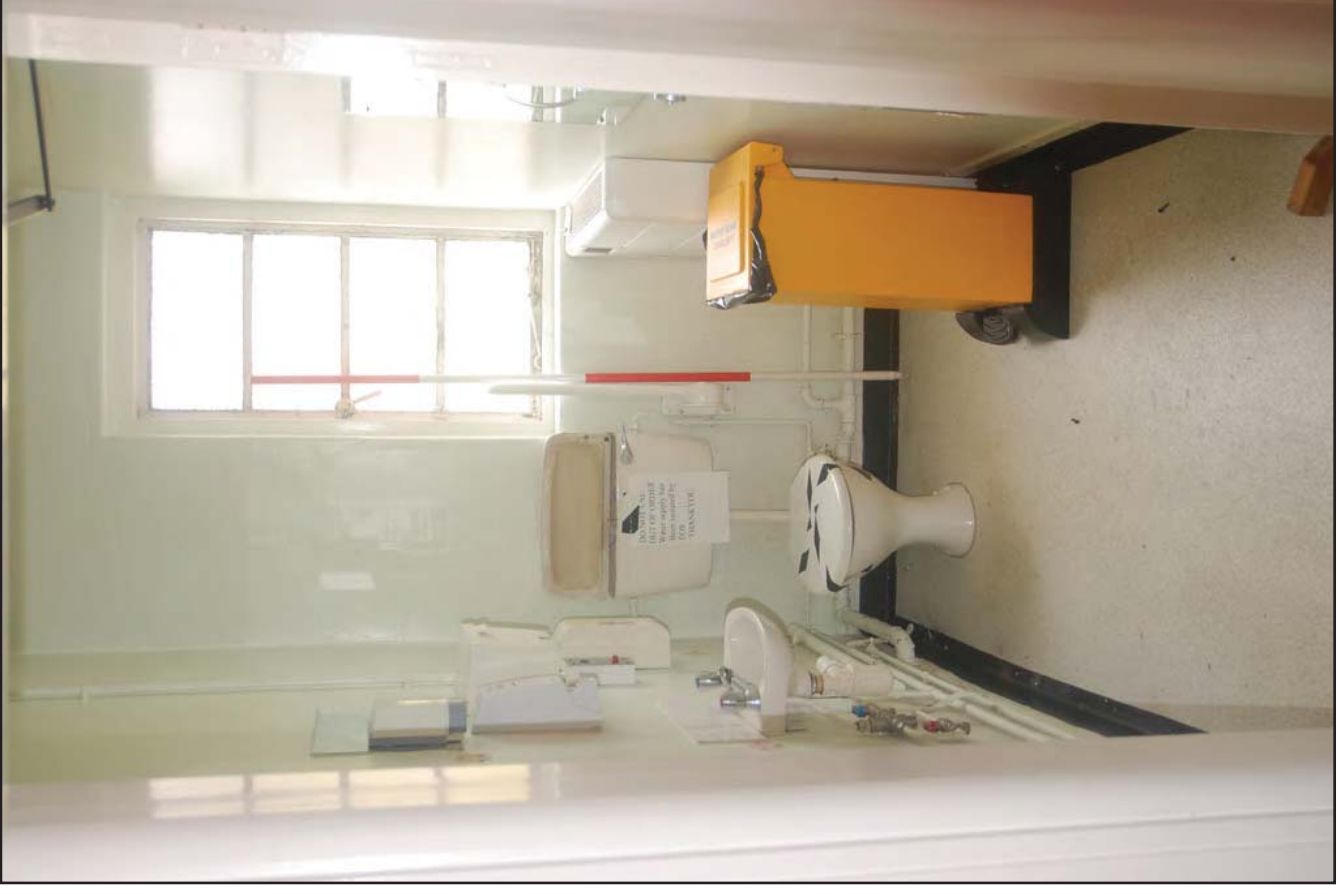
Plate 28: Short Stay Unit (Internal): view northwest of Room G04, detailing current usage as a staff WC. Casement window is visible (Scale: 1 x 2.0m).

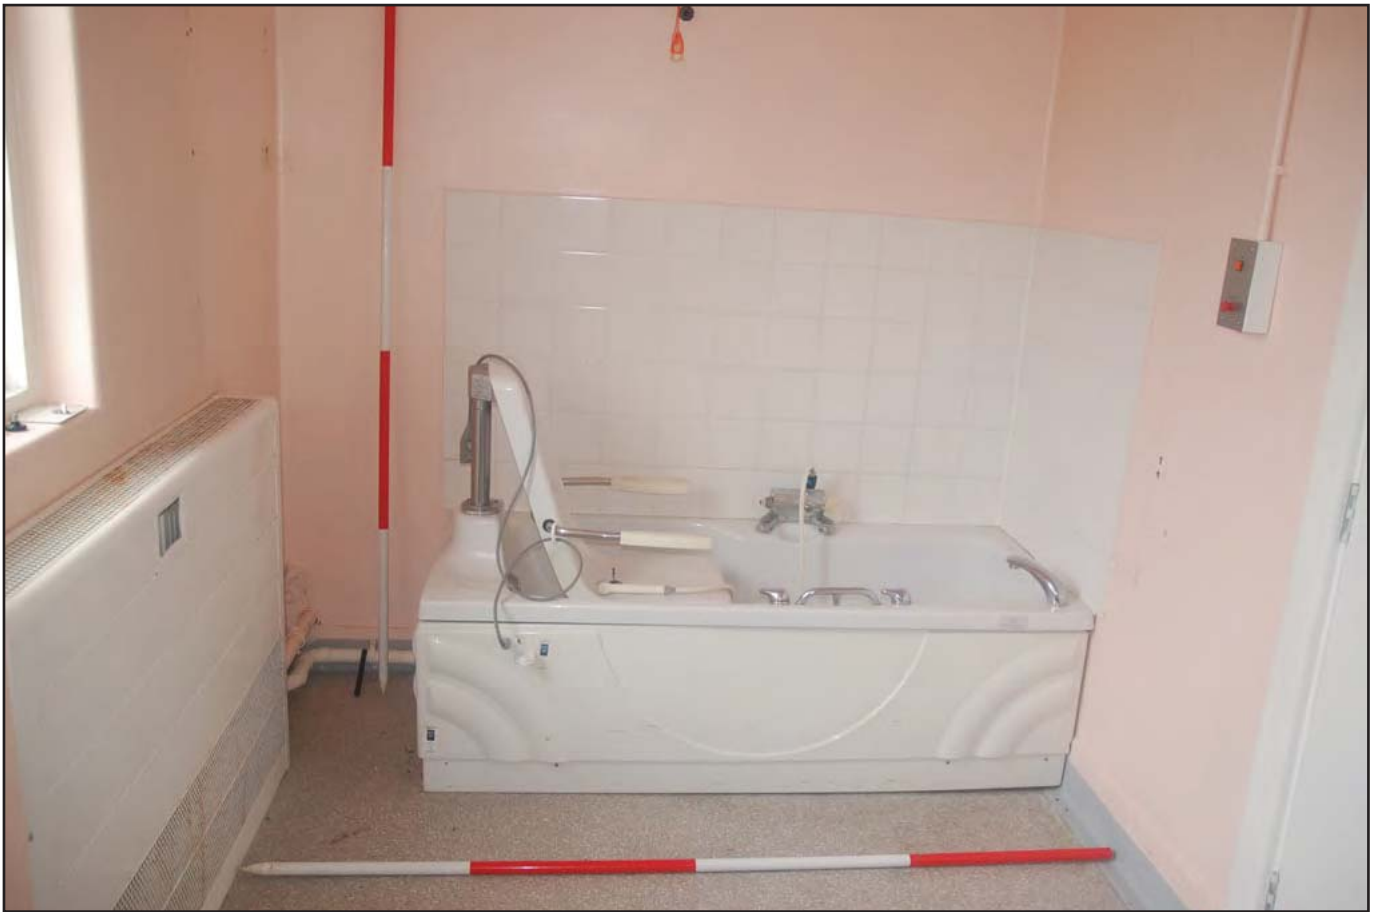
Plate 29: Short Stay Unit (Internal): View northeast of Room G05 detailing current use as a bathroom. Originally two rooms: sluice and bathroom, which were combined into a single room; original visible fittings limited to the casement window (left of image) (Scales: 2 x 2.0m)

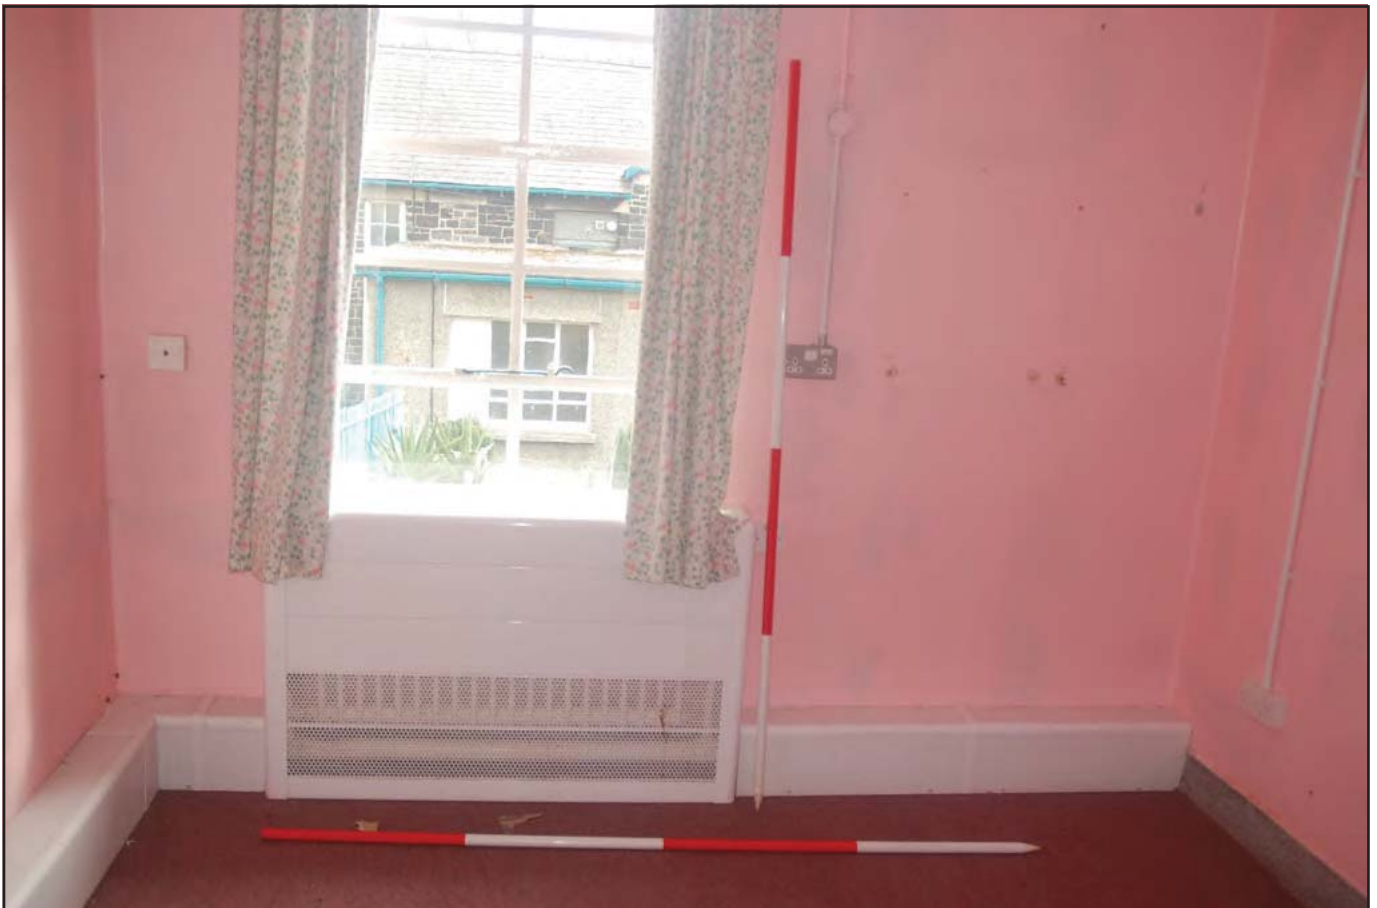
Plate 30: Short Stay Unit (Internal): View south of Room G06 detailing current use as a ward. Storage heater visible below original casement window, with boxed in plumbing (Scales: 2 x 2.0m)

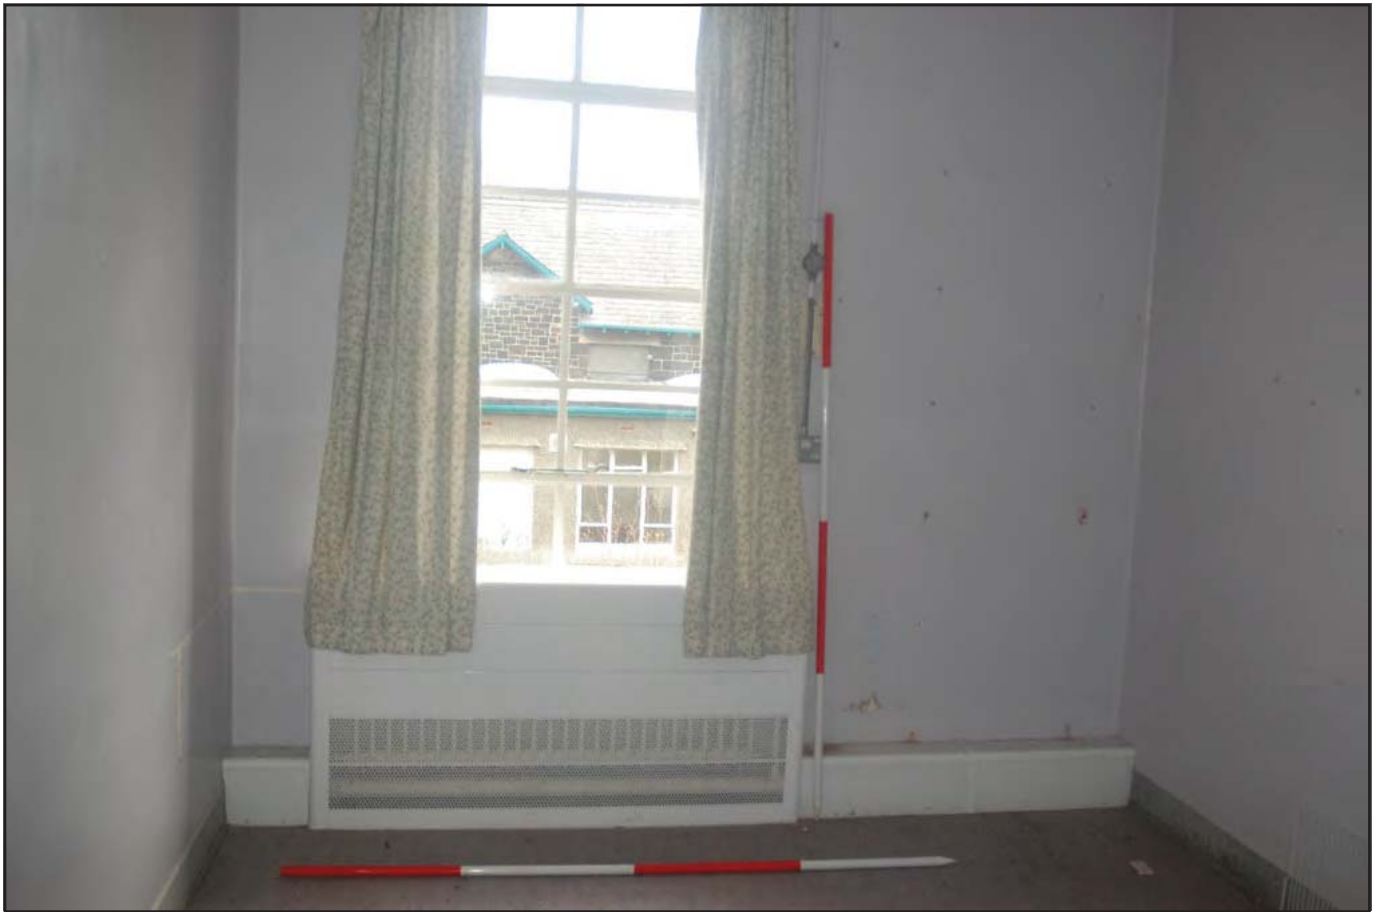
Plate 31: Short Stay Unit (Internal): View southeast of Room G07 detailing former use as a ward. Storage heater visible below original casement window, with boxed in plumbing (Scales: 2 x 2.0m)

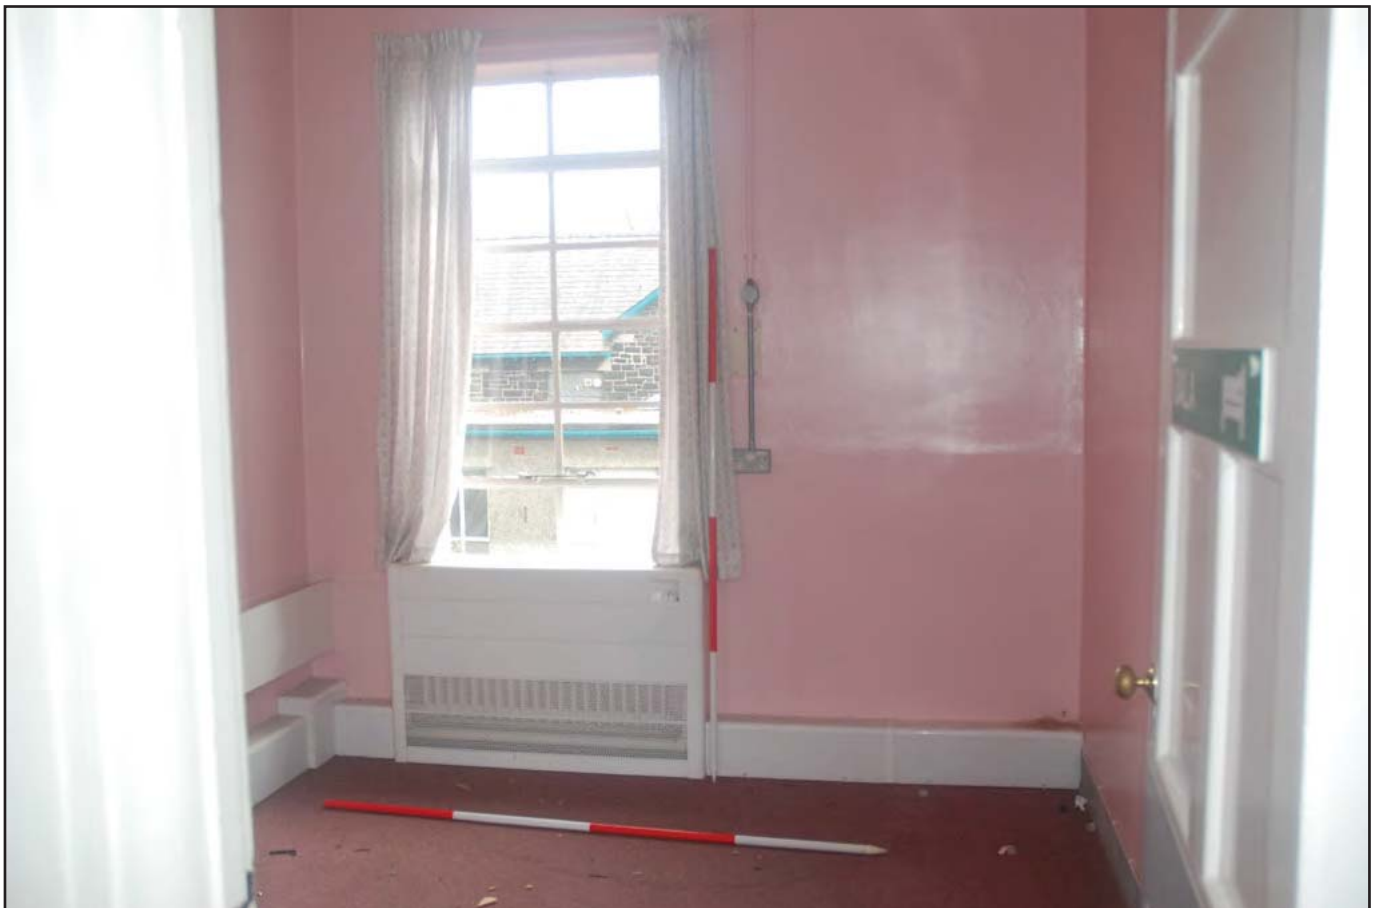
Plate 32: Short Stay Unit (Internal): View southeast of Room G08 detailing current use as a ward. Storage heater visible below original casement window, with boxed in plumbing. Panelled and moulded entrance door visible in image foreground. Rear of Long Stay Unit through window (Scales: 2 x 2.0m)

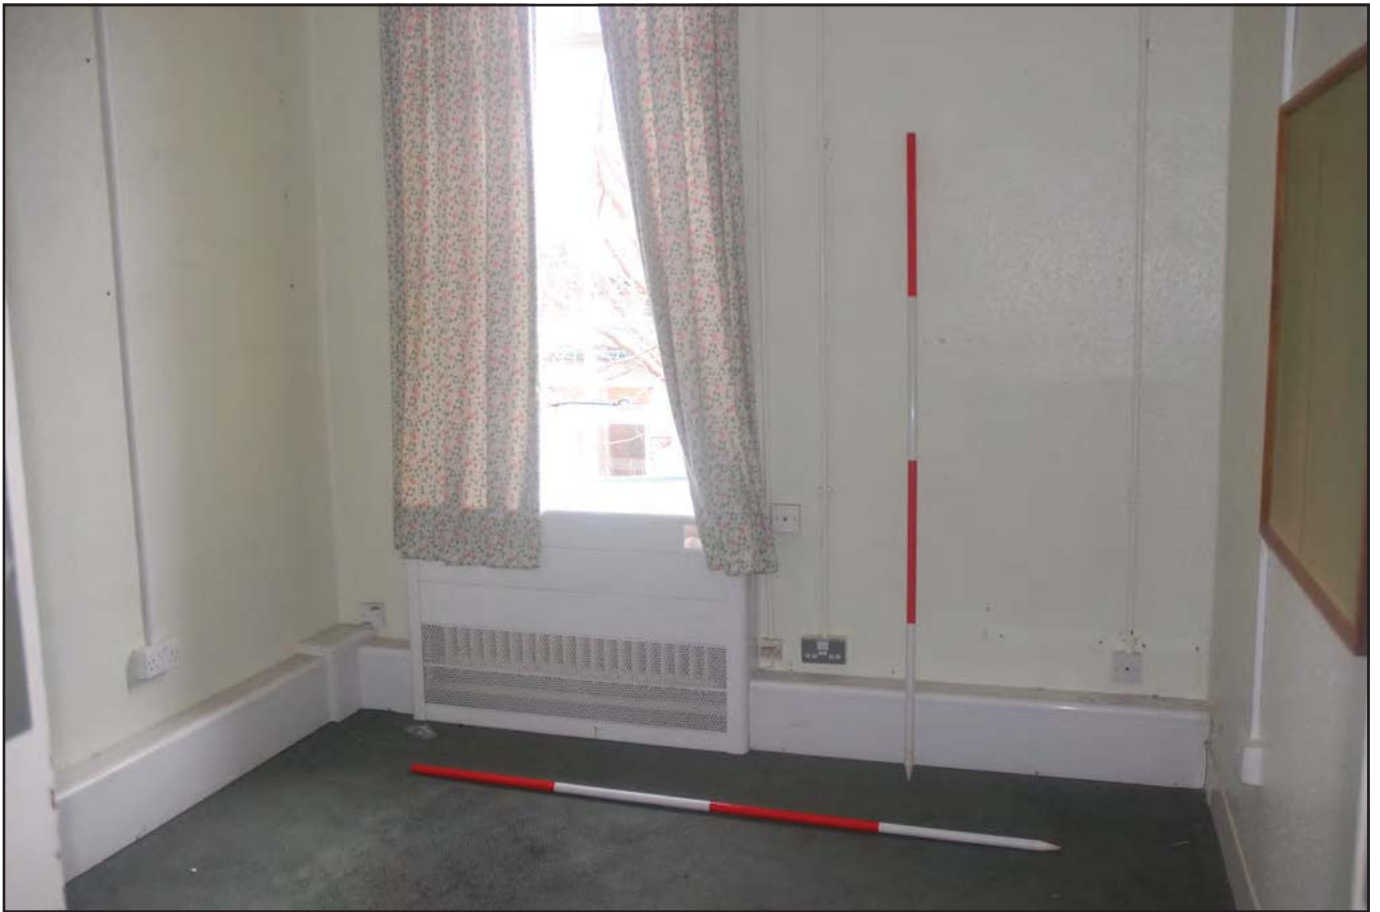
Plate 33: Short Stay Unit (Internal): View southeast of Room G09 detailing former use as a ward. Storage heater visible below original casement window, with boxed in plumbing (Scales: 2 x 2.0m)

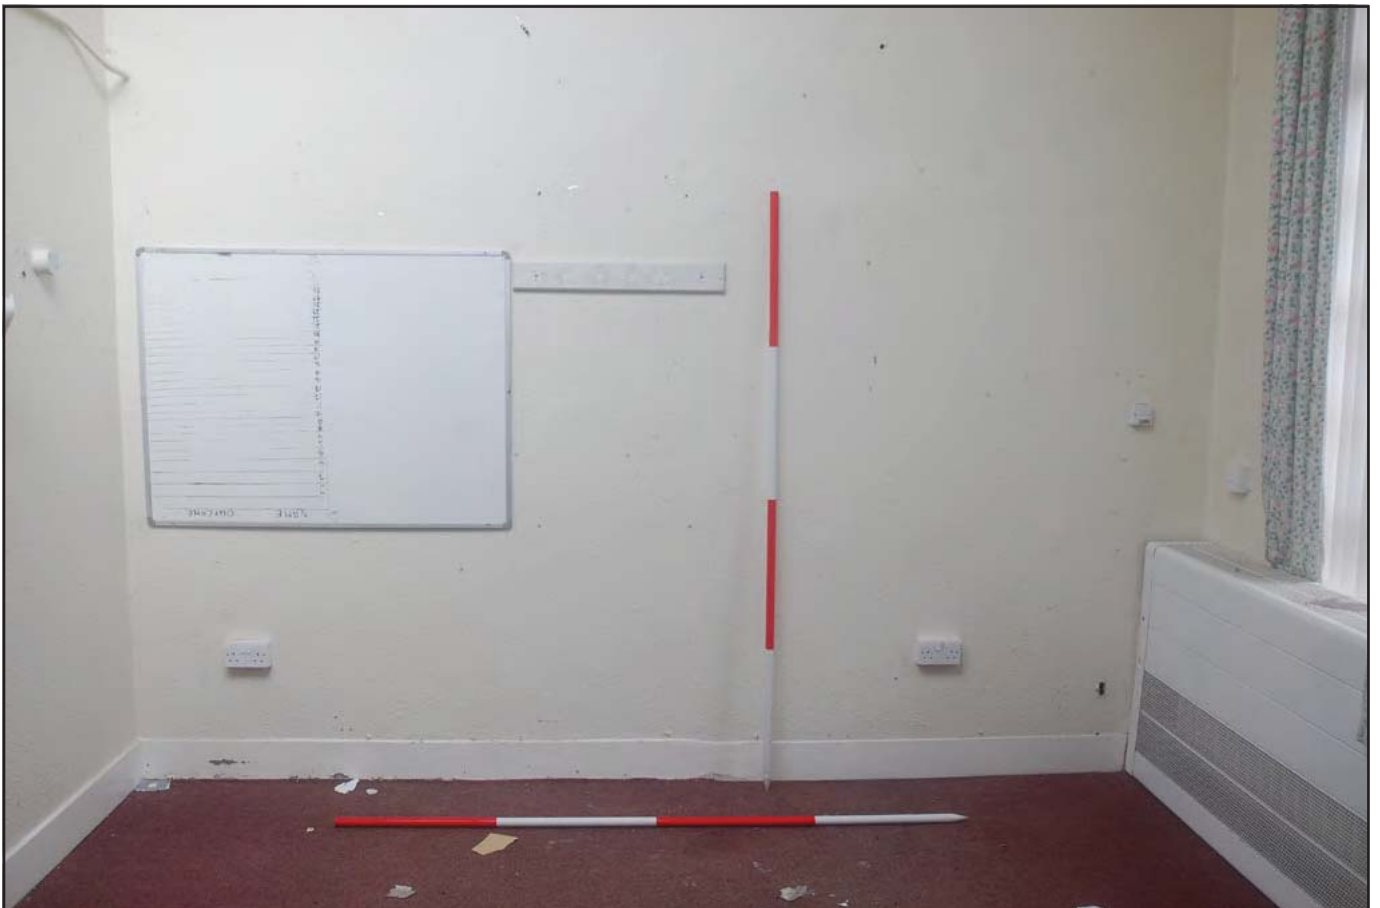
Plate 34: Short Stay Unit (Internal): View east of Room G10 detailing current use. Storage heater visible below original casement window, bullnose skirtings extant. (Scales: 2 x 2.0m)

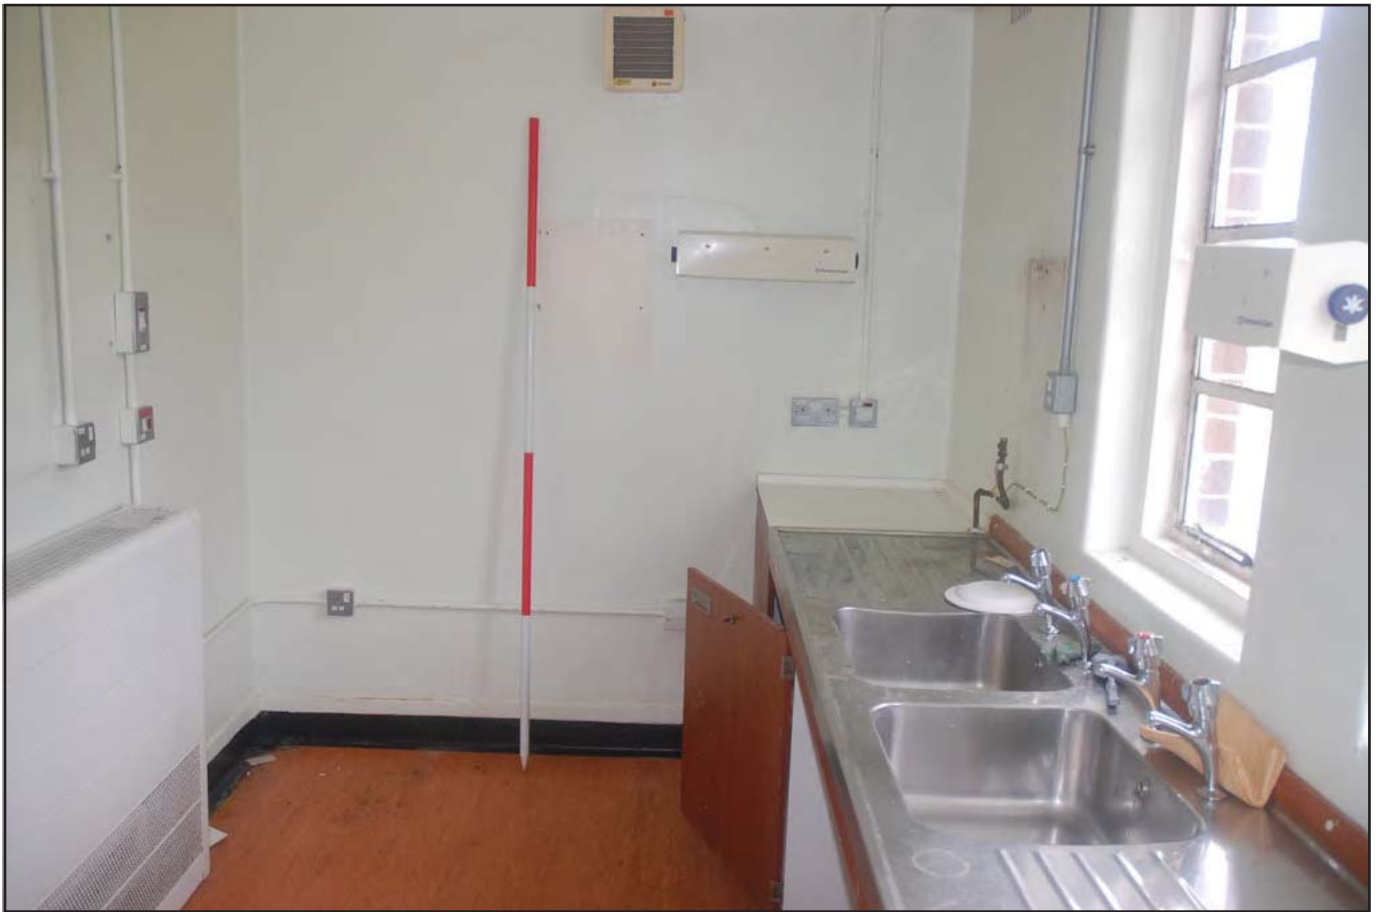
Plate 35: Short Stay Unit (Internal): View southeast of Room G11 detailing current use as kitchen. Originally two rectangular rooms, converted into a single larger rectangular room (Scale: 1 x 2.0m)

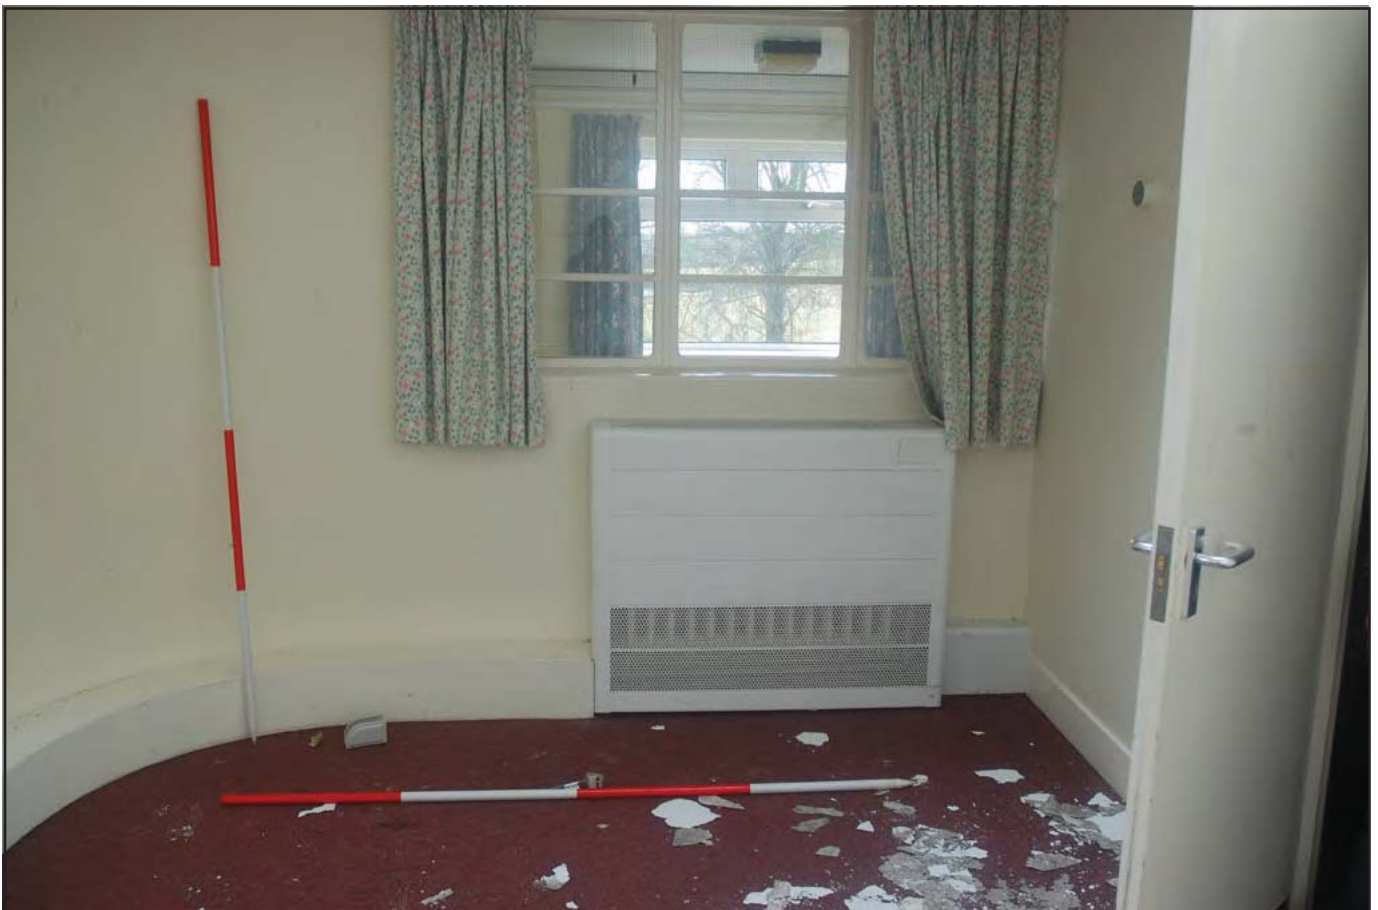
Plate 36: Short Stay Unit (Internal): View southwest of Room G12 detailing current use and original casement window fitting. Formerly a treatment room. Curved floor plan indicates former shape of the southwestern end of the building now disguised by the link corridor (visible through the casement window). Particleboard door in use rather than original panelled door seen elsewhere within the structure as room size was reduced and a new partition fitted. (Scales: 2 x 2.0m)

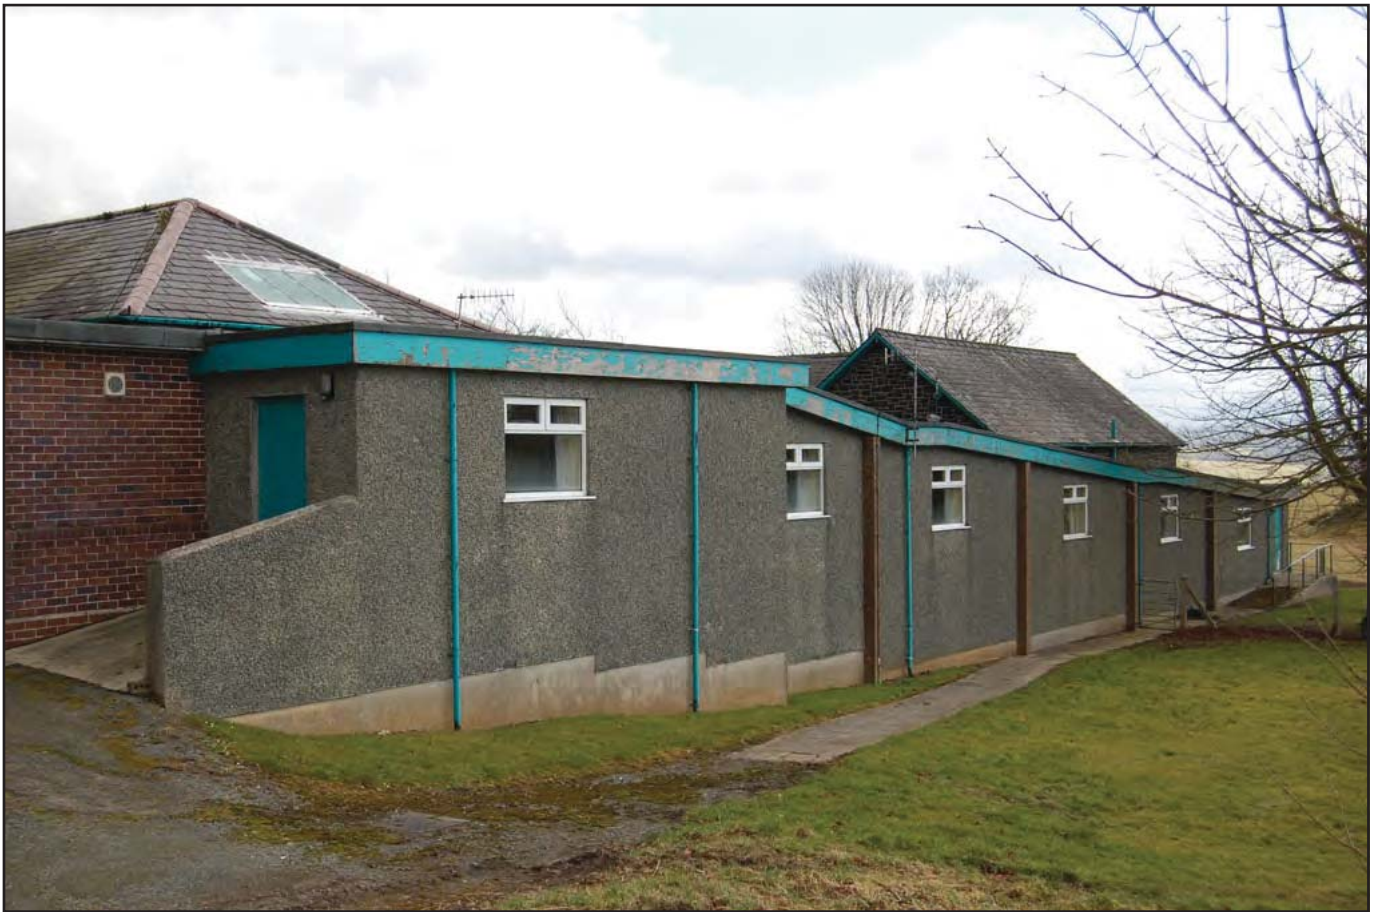
Plate 37: Link Corridor connecting Long and Short Stay Units: View south. Built 1991. Pebbledashed fronted with a box gutter and awning windows. Provides access to respective units; effectively masks the southwest facing elevations of both.

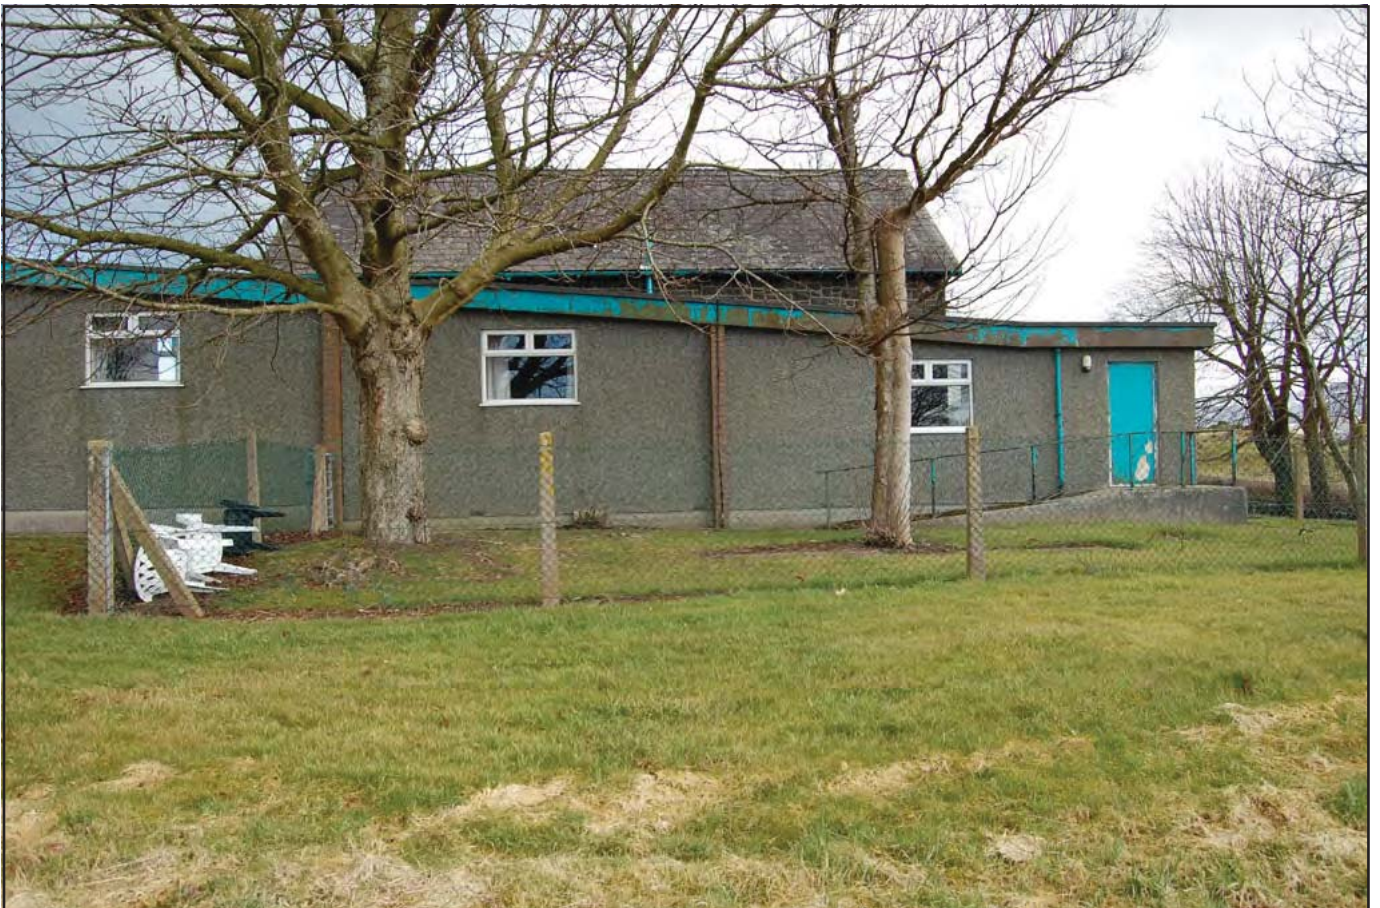
Plate 38: Link Corridor connecting Long and Short Stay Units: View east. Built 1991. Pebbledashed fronted with a box gutter and awning windows. Provides access to respective units; effectively masks the southwest facing elevations of both. Male ward wing of the Long Stay Unit is visible in the background as a slated pitched roof

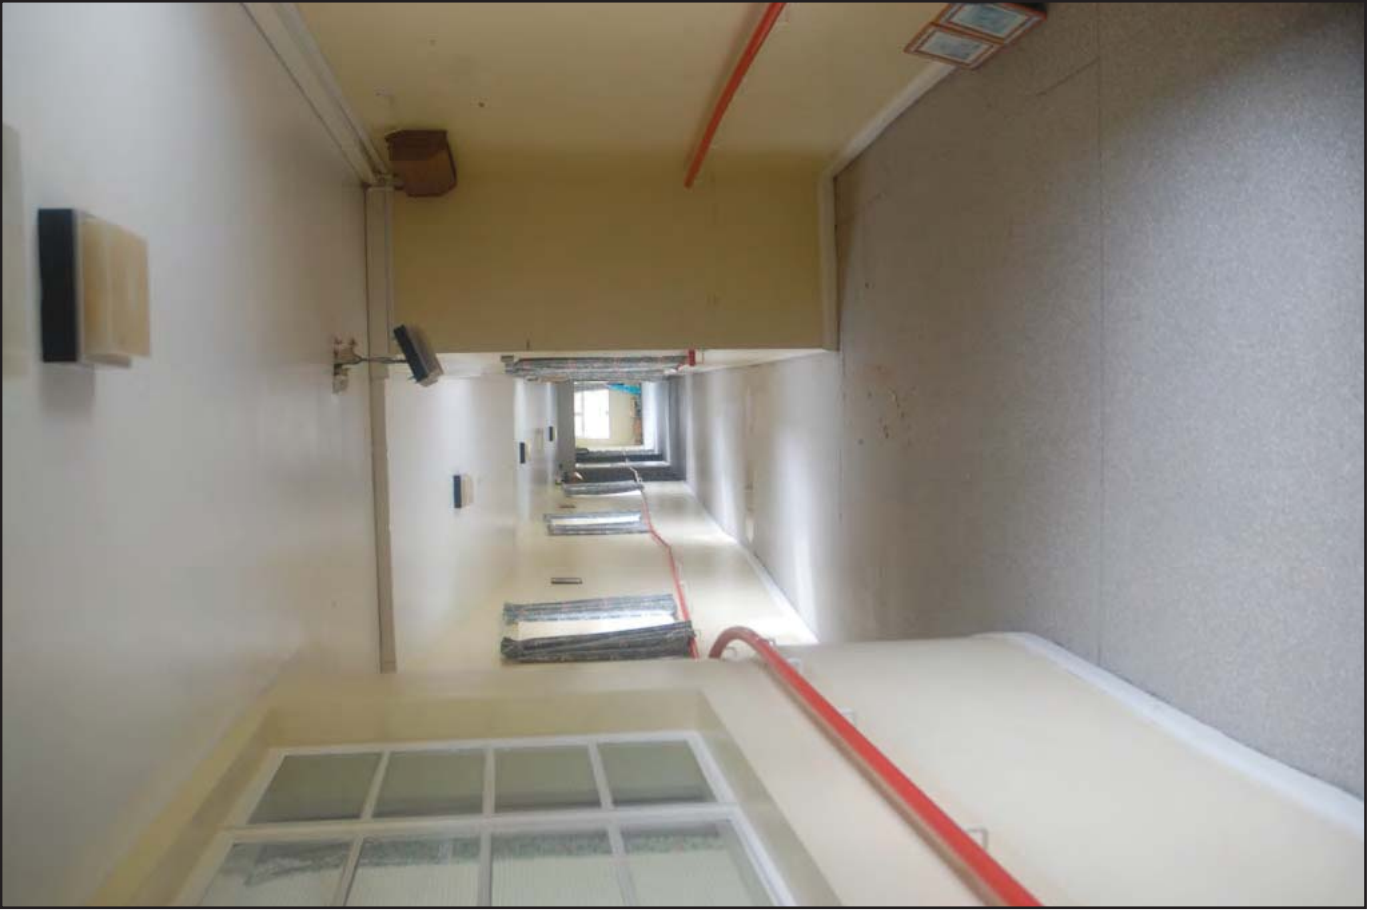
Plate 39: Link Corridor connecting Long and Short Stay Units (Internal): View southeast. Former exterior window of Room G12 visible in left foreground.
