MINFFORDD HOSPITAL, BANGOR GWYNEDD: ARCHAEOLOGICAL BUILDING RECORD

Archaeological Building Record: Level 2/3

GAT Project No. 2125

May 2010

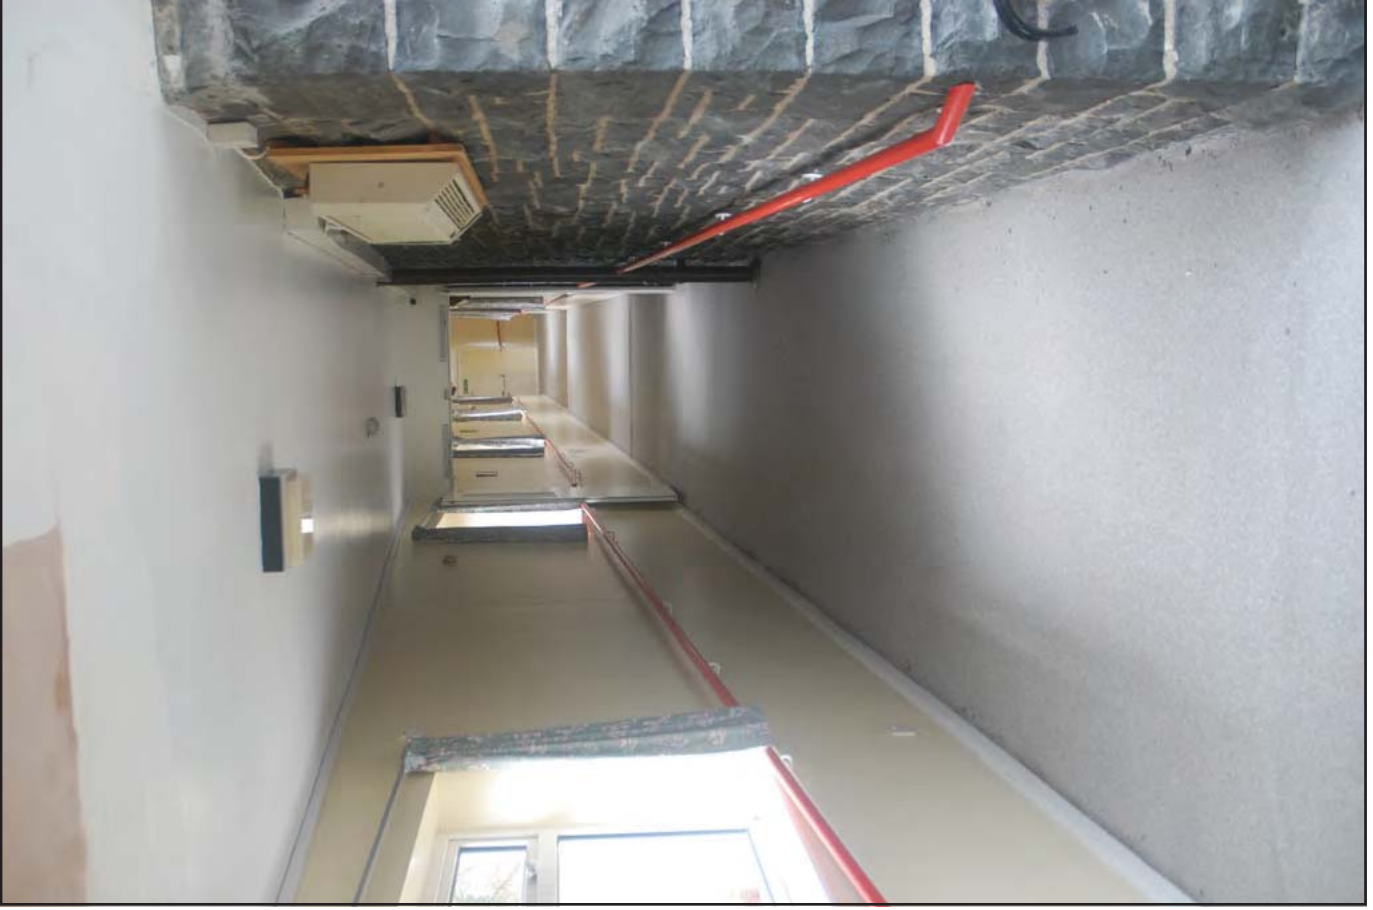
Plate 40: Link Corridor connecting Long and Short Stay Units (Internal): View northwest. Former building exterior visible in right foreground, now an internal wall.

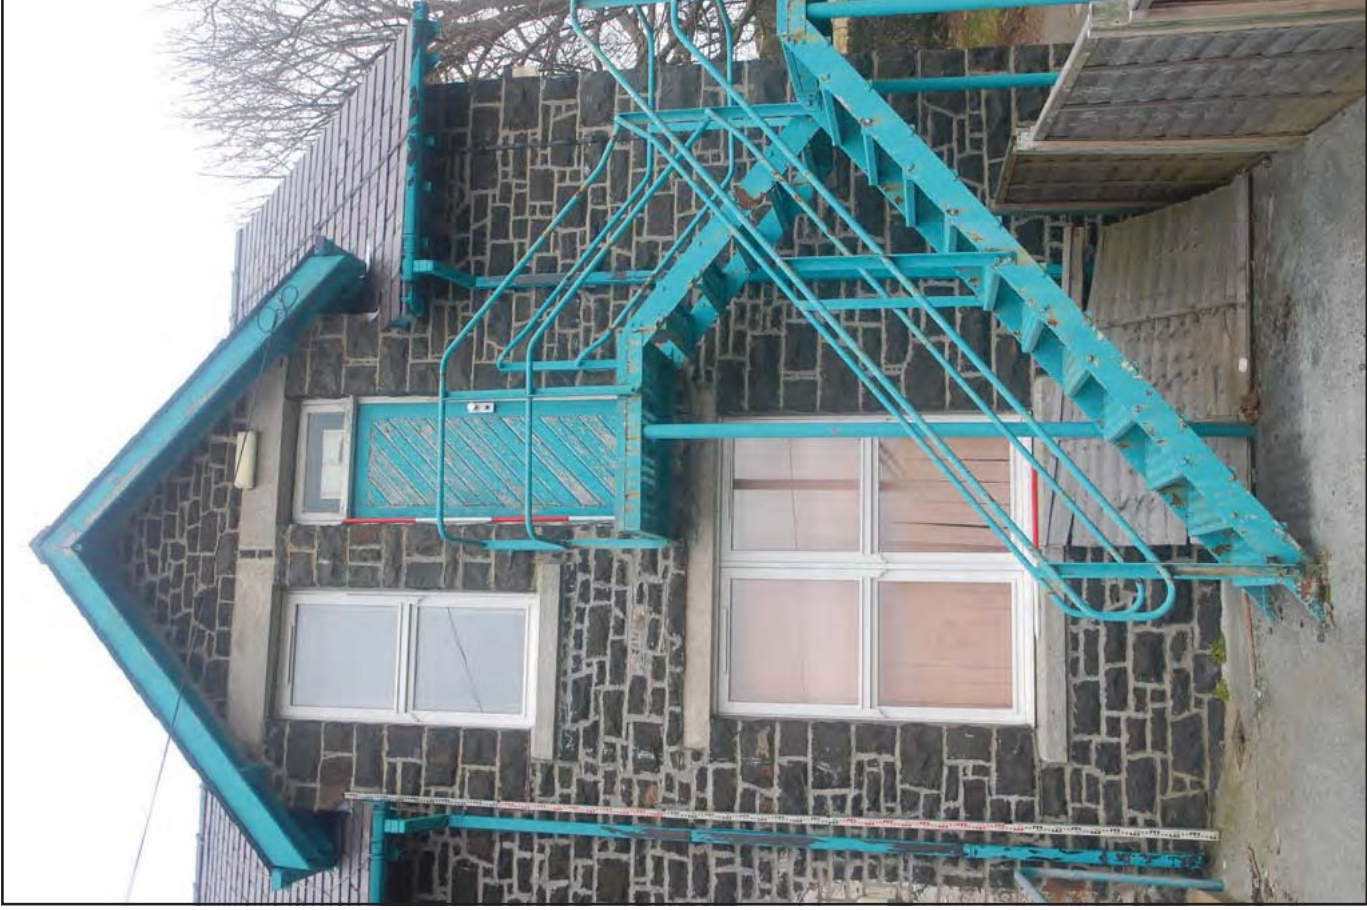
Plate 41: Administration Block: Southeast facing elevation. Ground floor Room G02 and first floor Room F04 are visible; Room F04 includes a fire exit, which is a converted window space. Stone voussoirs and sills in use. Original main entrance (cf. Plate 42) is to left of image (out of shot). Scales: 2 x 2.0m and 1 x 5.0m.

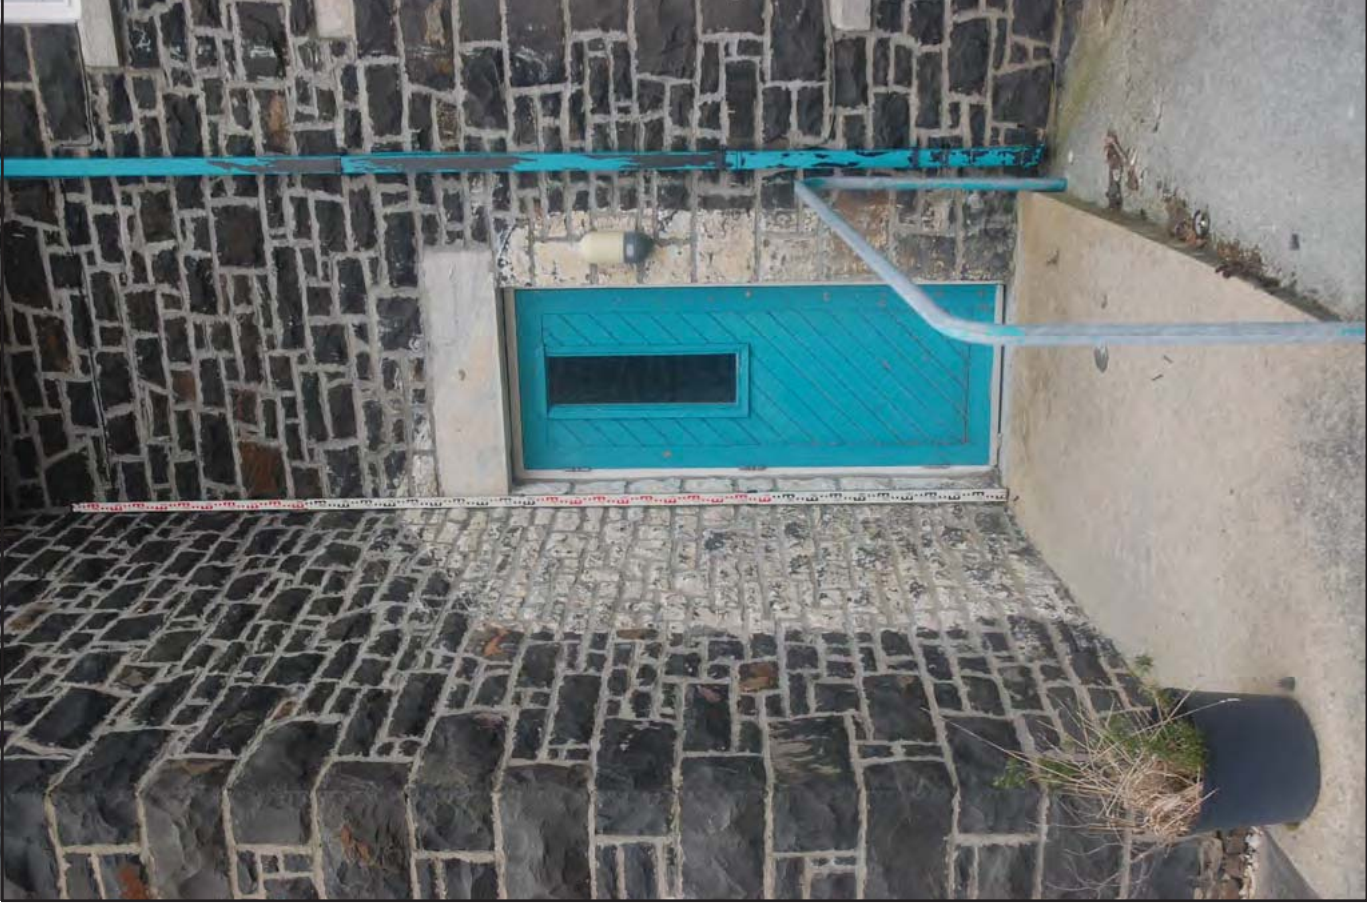
Plate 42: Administration Block: Southeast facing elevation. Ground floor former main entrance (now a fire exit) with a panelled door. Original porch has been removed, but outline is still visible. (Scale 1 x 5.0m).

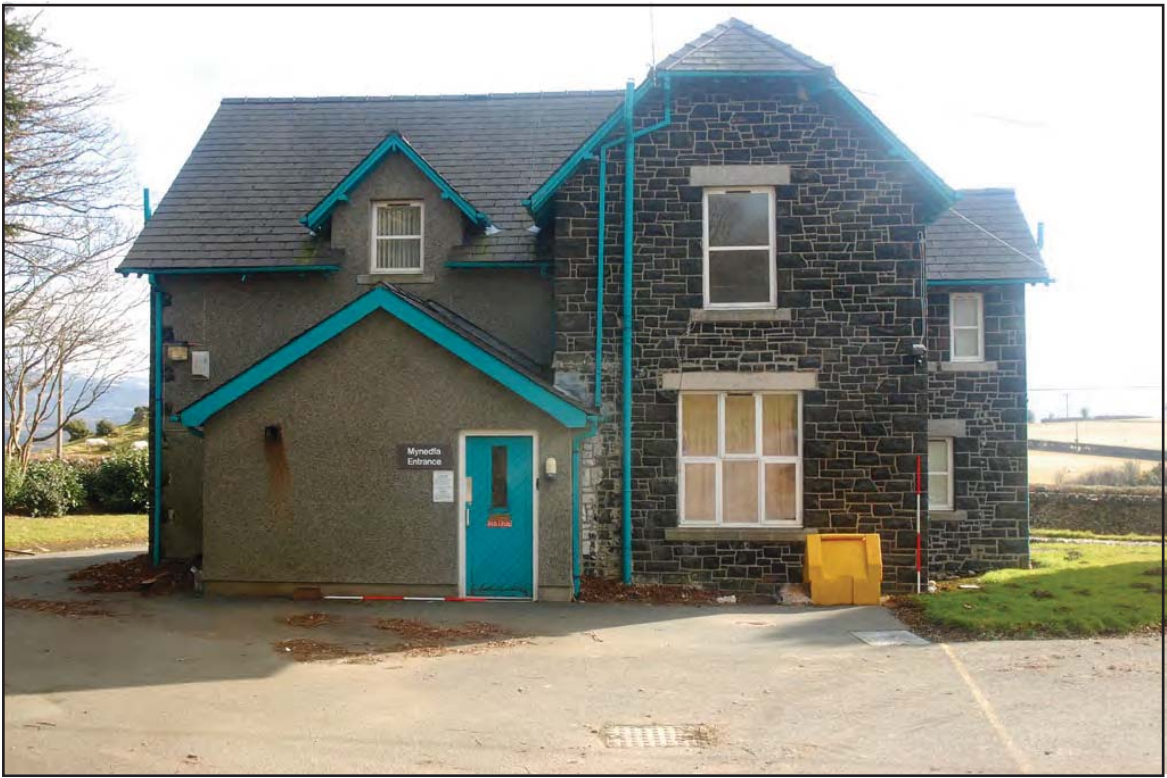
Plate 43: Administration Block: Northwest facing elevation detailing ground floor Room G04 and first floor Rooms F03 to F05. The rear of the property was altered c.1991, with the removal of a ground floor wing that included a kitchen, prep room and store. The kitchen was reduced in size to create the pebbledashed gabled main entrance/photocopy room visible in the image. Remnants of the alteration work can be seen where the main entrance is keyed into the original build. (Scales: 2 x 2.0m)

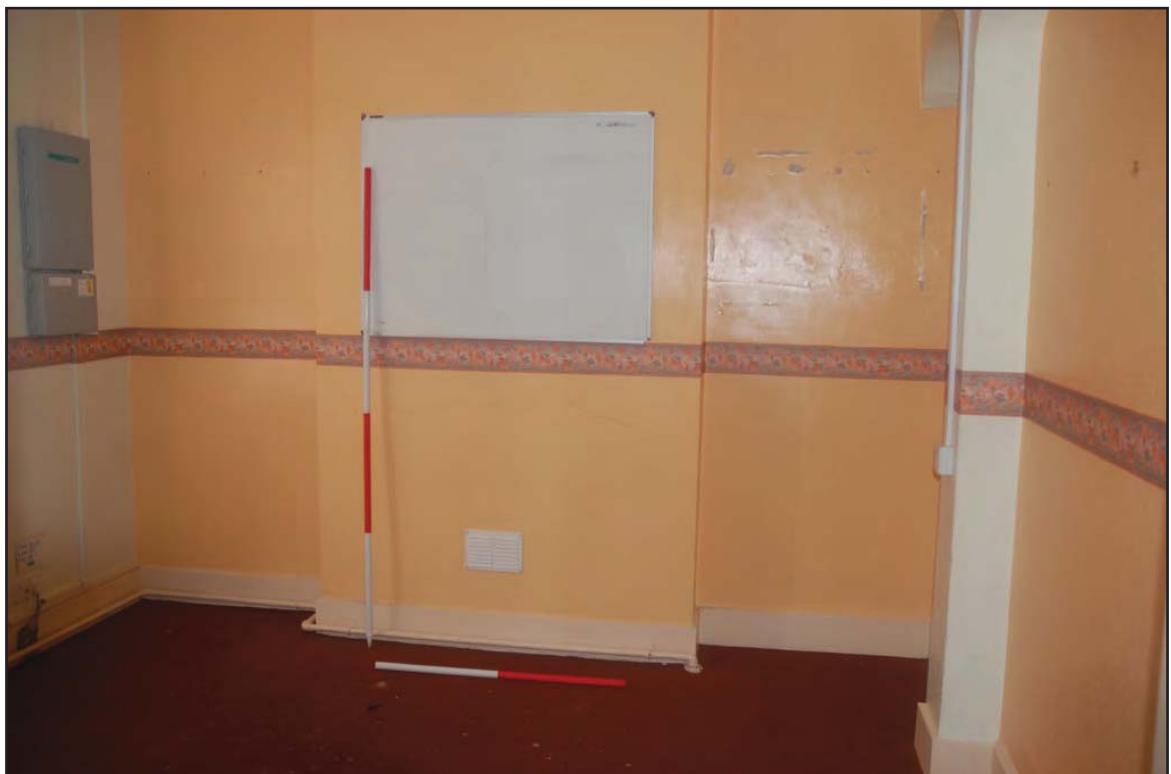
Plate 46: Administration Block (Internal): View southwest of former matron's office (Room G03) detailing redundant fireplace and current decor. Scales: 1 x 2.0m and 1 x 1.0m

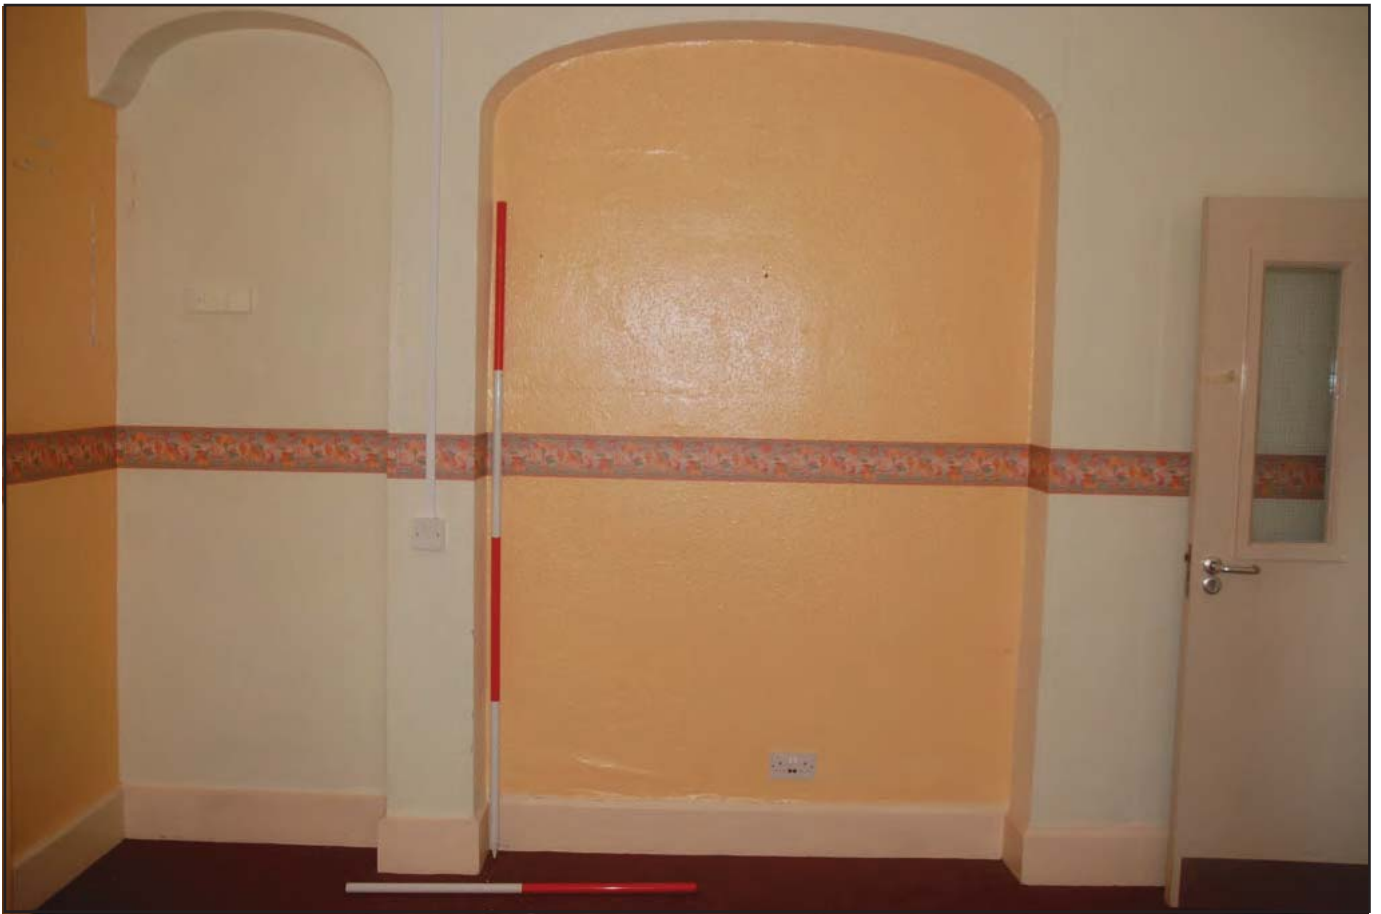
Plate 47: Administration Block (Internal): View northeast of former matron's office (Room G03) detailing redundant archways and modern fire door. Scales: 1 x 2.0m and 1 x 1.0m.

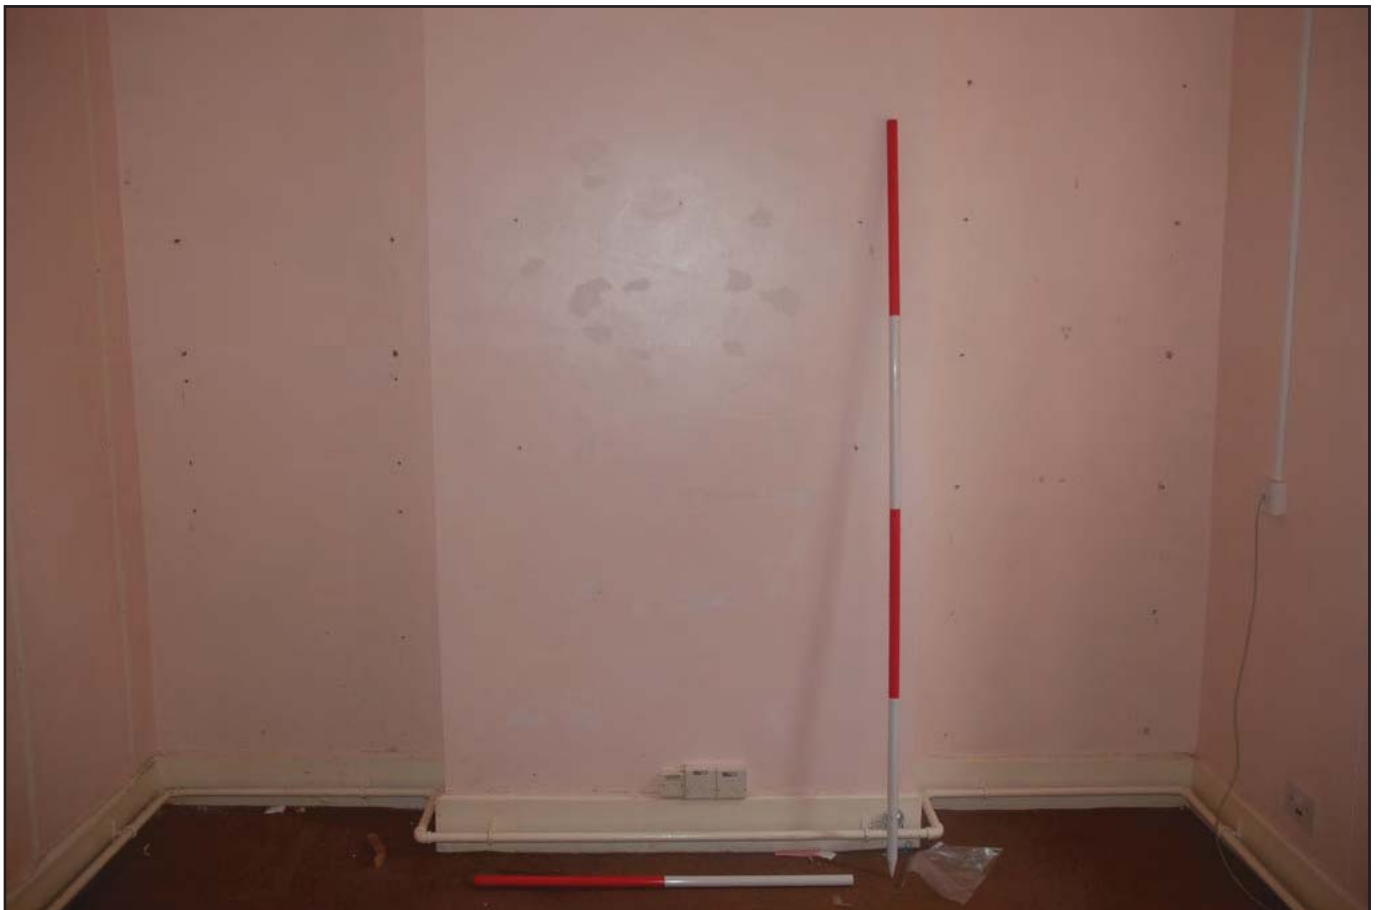
Plate 48: Administration Block (Internal): View northeast of former maid's sitting room (Room G04) detailing redundant fireplace. Scales: 1 x 2.0m and 1 x 1.0m.

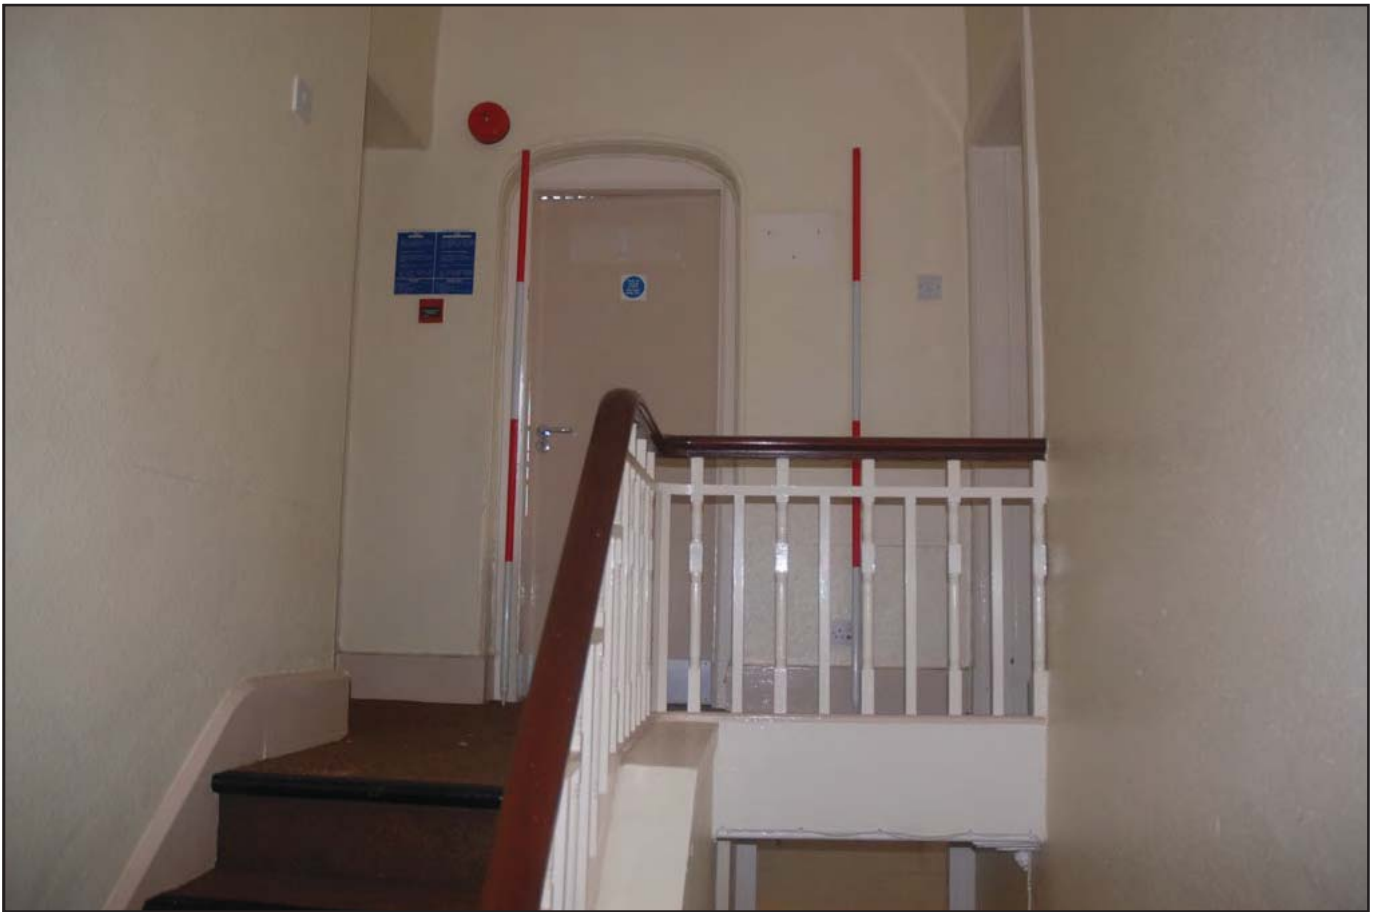
Plate 49: Administration Block (Internal): View northeast of first floor stairs leading to Rooms F02, F03 and F05. Room F03 is located at the centre of the image: the curved door arch is clearly visible. The staircase has a moulded rail with turned balusters; the tread and risers are carpeted.
(Scales: 2 x 2.0m).

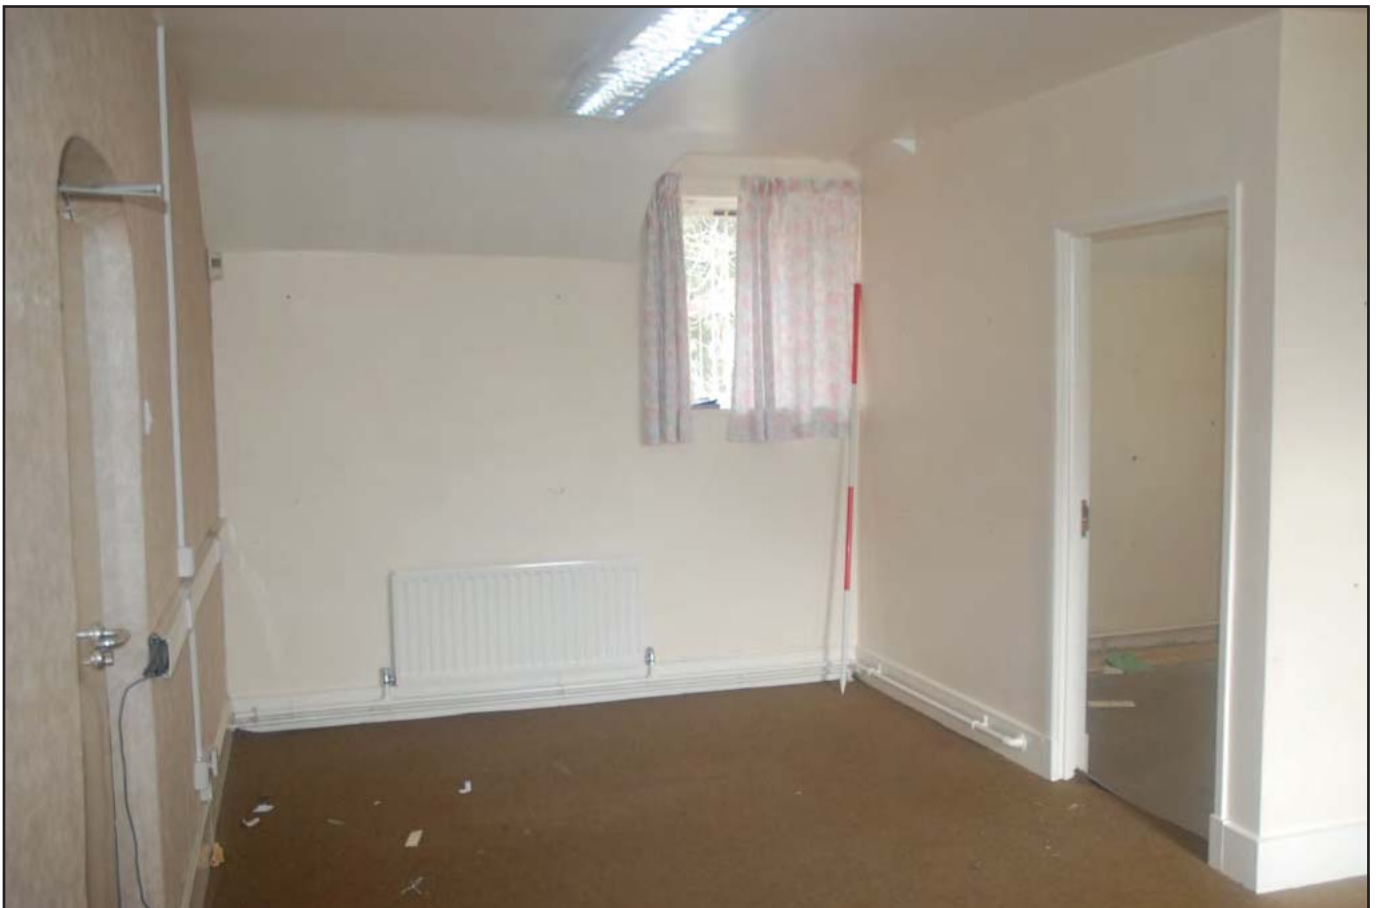
Plate 50: Administration Block (Internal): View northeast of former nurses changing room (Room F03) with the former sister's changing room (Room F04) as a boxed partition at right of image. Room F03 was converted from four rooms into two rooms (F03 and F04), with the removal of a sister's bedroom and a cook's bedroom. The original corridor entrance has been converted into the main entrance for F03 and is approached via a staircase and small landing (cf. Plate 48)
(Scales: 1 x 2.0m).

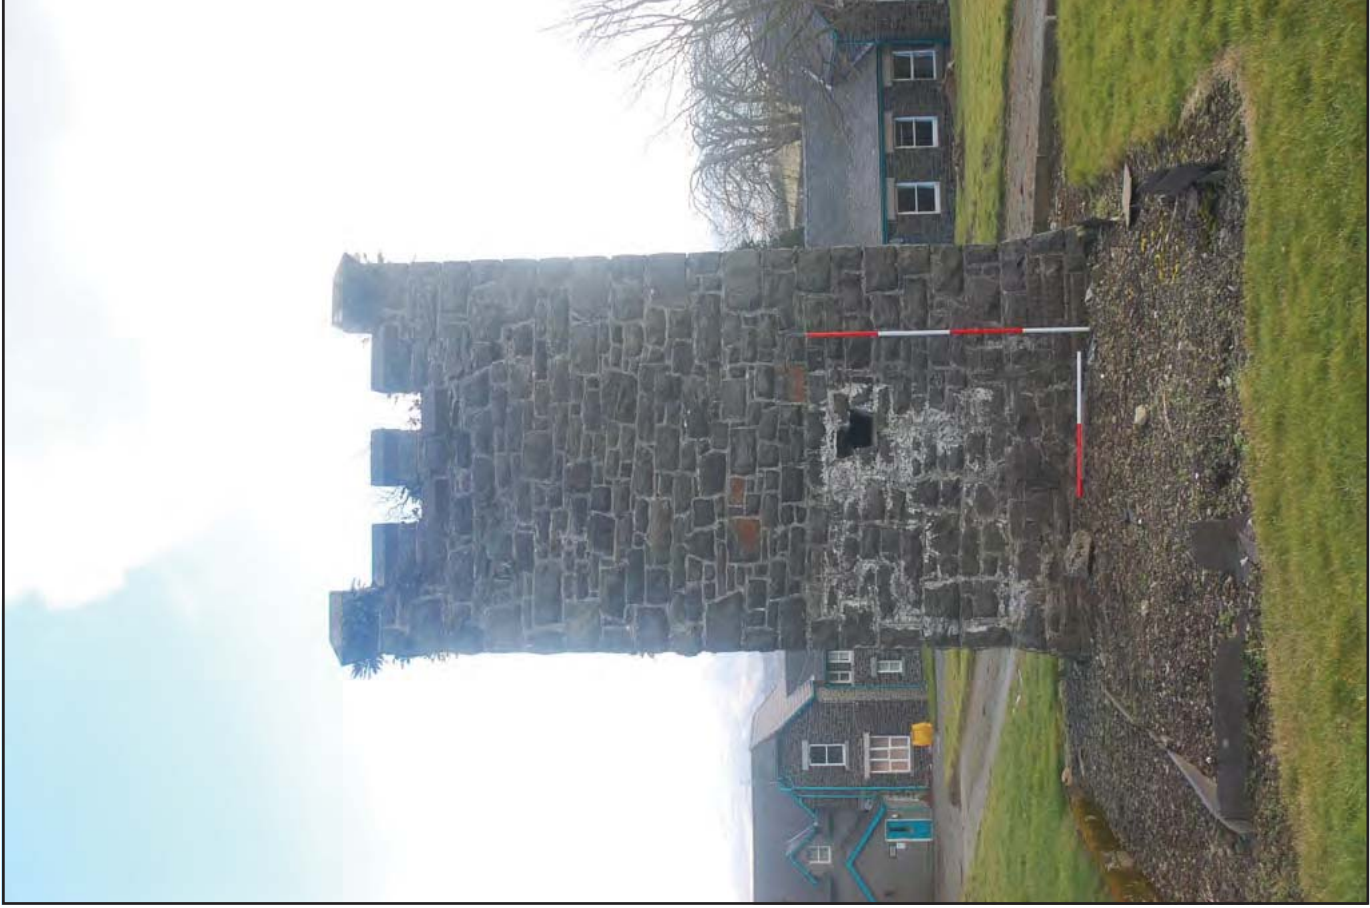
Plate 51: Water Tower - Northwest facing elevation detailing construction form, including crenellated capping and an internal buttress. Note the external slate defined area that appears to have functioned as a possible small garden area, note also the administration block in the left background and the Long Stay Unit in the right background (Scales: 2 x 2.0m).

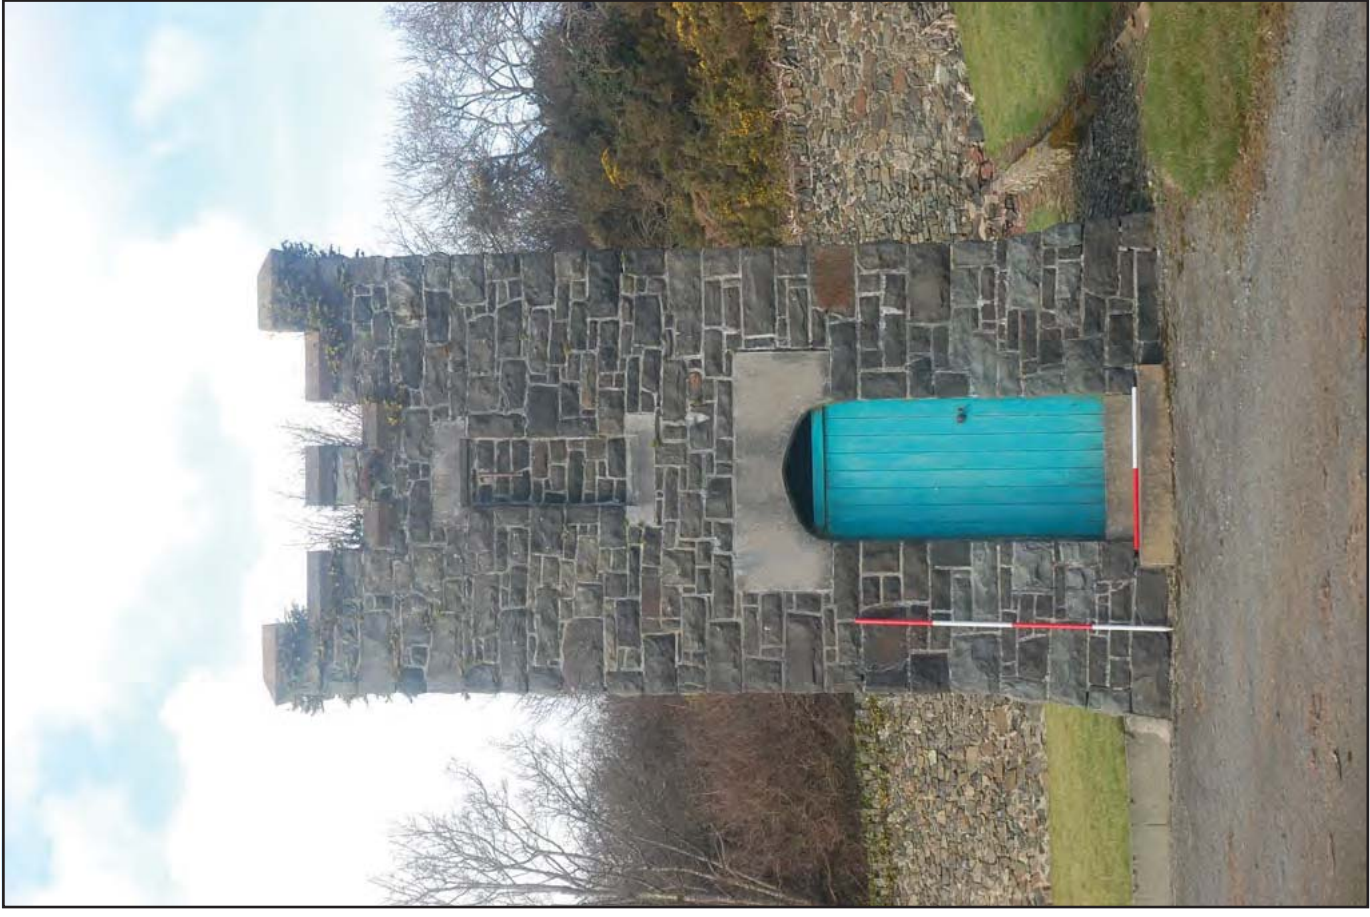
Plate 52: Water Tower - Southeast facing elevation detailing construction form, including crenellated capping, internal buttress and main entrance via pannelled door. Note the boundary wall at rear of image (Scales: 2 x 2.0m).

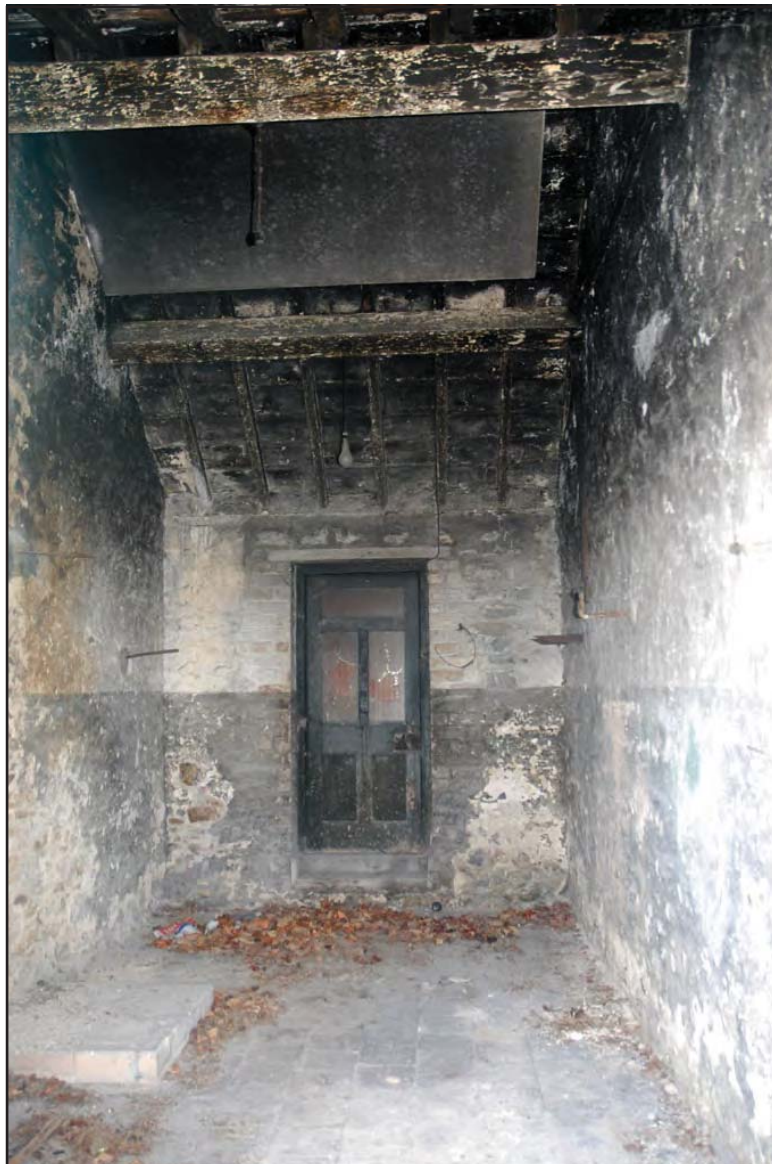
Plate 56: Garage (Internal): View northwest of main room interior detailing decor and usage: quarry tile floor, fireplace (?) plinth and roughcast walls. Rear door visible brick repair surround suggesting the door/entrance has been rebuilt or reused.

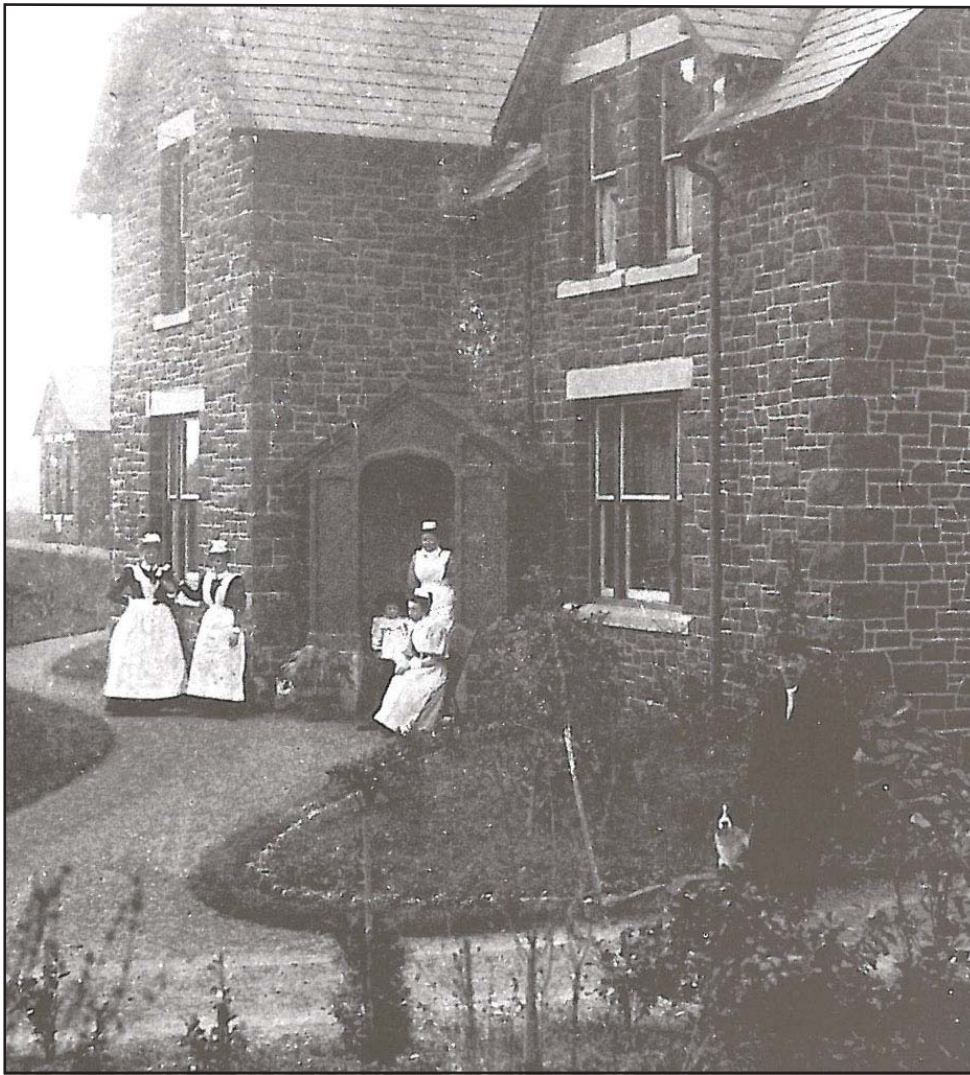
Plate 67: Administration Block - archive image from the nineteenth/early twentieth century detailing main entrance. The entrance porch has since been removed (cf. Plate 42); the front garden and path have been replaced with tarmacadam; the windows with modern sash replicas. A modern fire escape stairwell is now present linking the first floor parallel sash windows to the ground level; one of the two windows is now a fire escape door (Source: Roberts & Evans, 1995)
