Building 54 and 54a: Pen yr Orsedd Slate Quarry **Nantlle**

Level 2 photographic building record

GAT Project No. 2071

Report No. 835

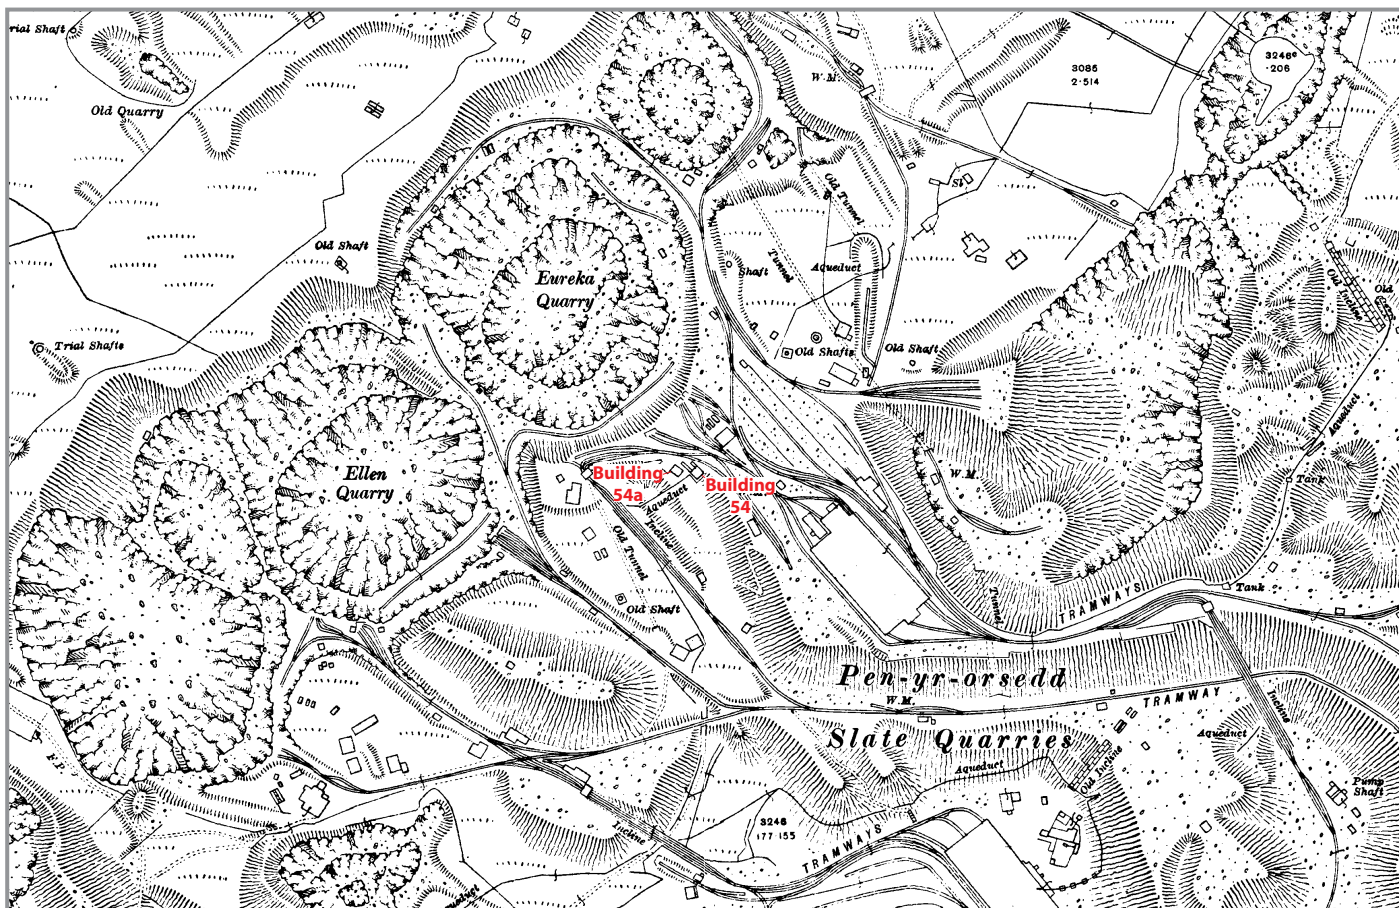
Figure 2: Third edition Ordnance Survey. Caernarfonshire county series 1915. XXI.5 (1:4,000)

Both building 54a and 54 are first seen on the ordnance survey map 1915 lying on the edge of the Eureka quarry and in the area of the Eureka mill and tramway which was constructed in 1889 (figure 2).

The south-east facing wall is all that remains of what is presumed to have been a steam winding house, possibly one which was superseded by building 54, though both buildings were constructed between 1900 and 1915 (figure 2). The remainder of the building was demolished to build the track which now runs past the wall. The surviving wall of bonded slate blocks with signs of render in places appears to consist of two gables, approximately 2m high to the eaves. A gap of approximately 1m separates the two walls in the upper sections, however they are joined at ground level by a 0.75m high wall containing a chute or hole. The function of the chute is unknown, however it disappears into the slate tip behind (plate 2). There are fragmentary remains of two return walls to the north-west and south-east (plate 3).

Both building 54 and 54a were constructed between 1900 and 1915 (fig 2). The function of building 54a is unclear, though a winding house is the most likely. Building 54 had three phases of use. It was originally constructed as a winding house associated with the Eureka quarry to the south-west. This quarry became the main focus of works in the late 19th century, and the Eureka mil was built in 1898. The two winding houses were built during expansion of the quarry pit after 1900. Though the relative dates are not known, building 54 became an office when it was no longer needed for a winding house, and more recently an explosives store.

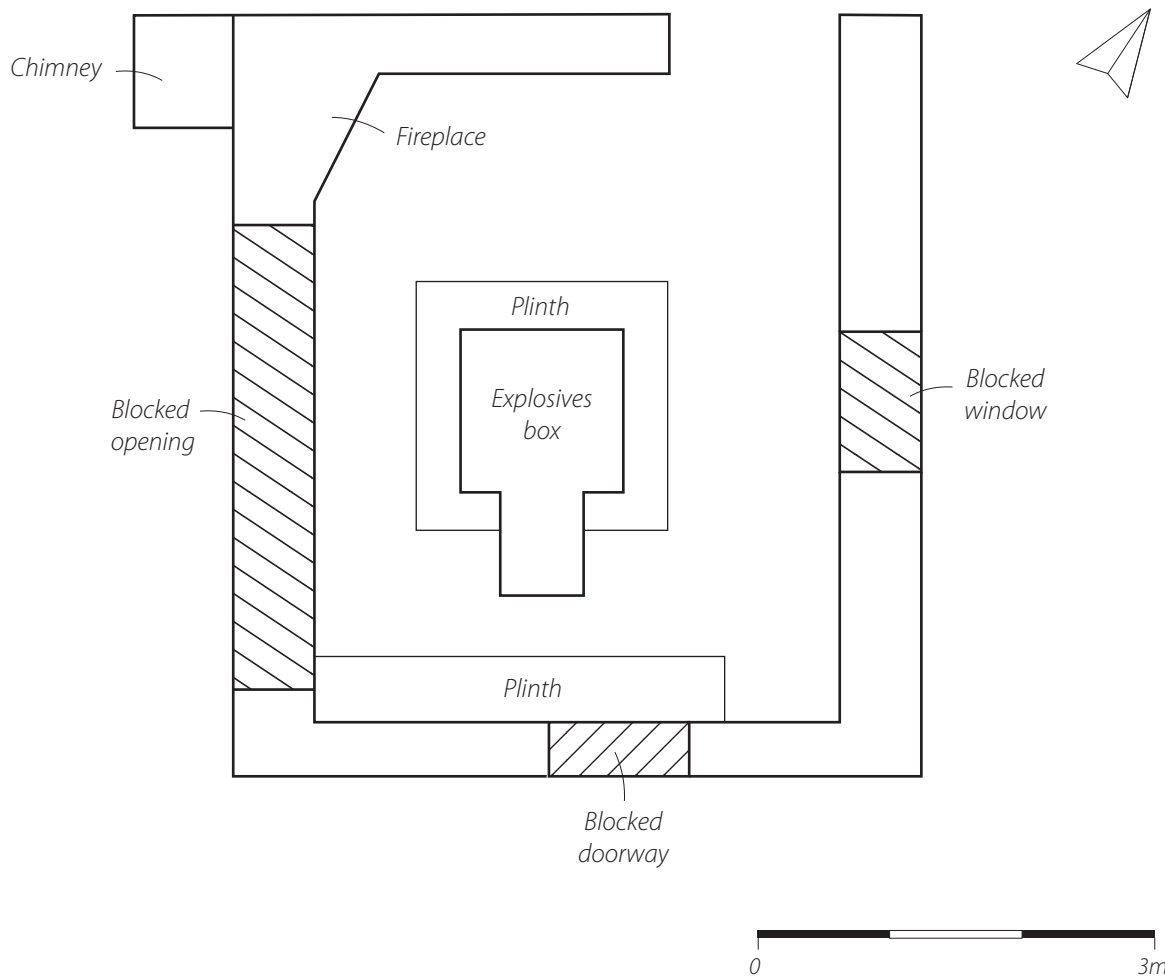
Figure 4: Building 54 ground plan

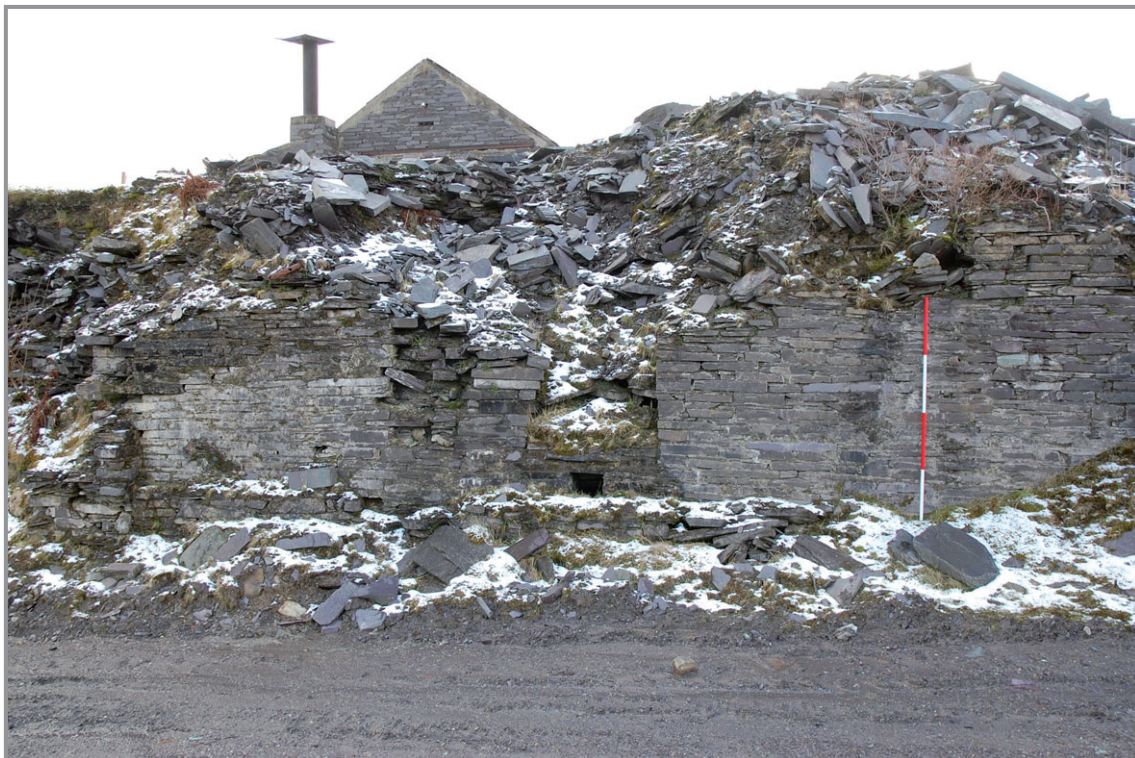
Plate 2: Building 54a. View taken from the south-west. Showing the south-east facing elevation two possible gables joined by a lower level wall containing a chute or hole, of unknown function.

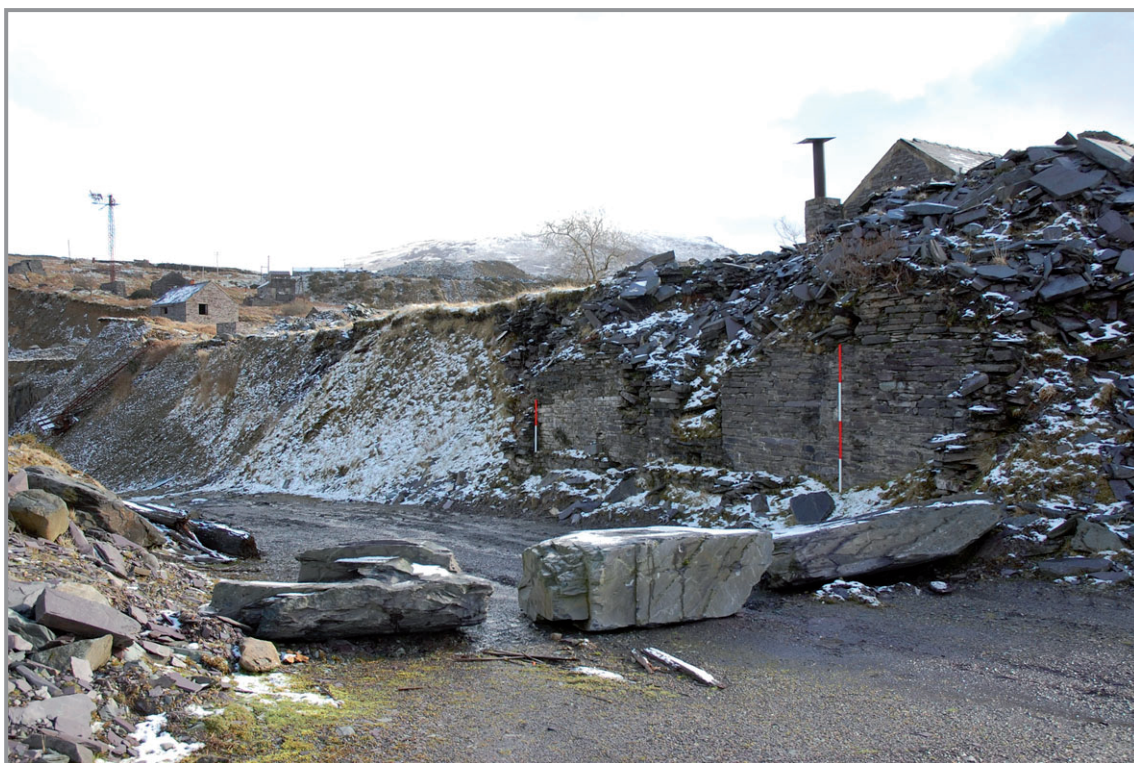
Plate 3: Building 54a. View taken from the south. Showing the return walls in the south-east facing elevation.

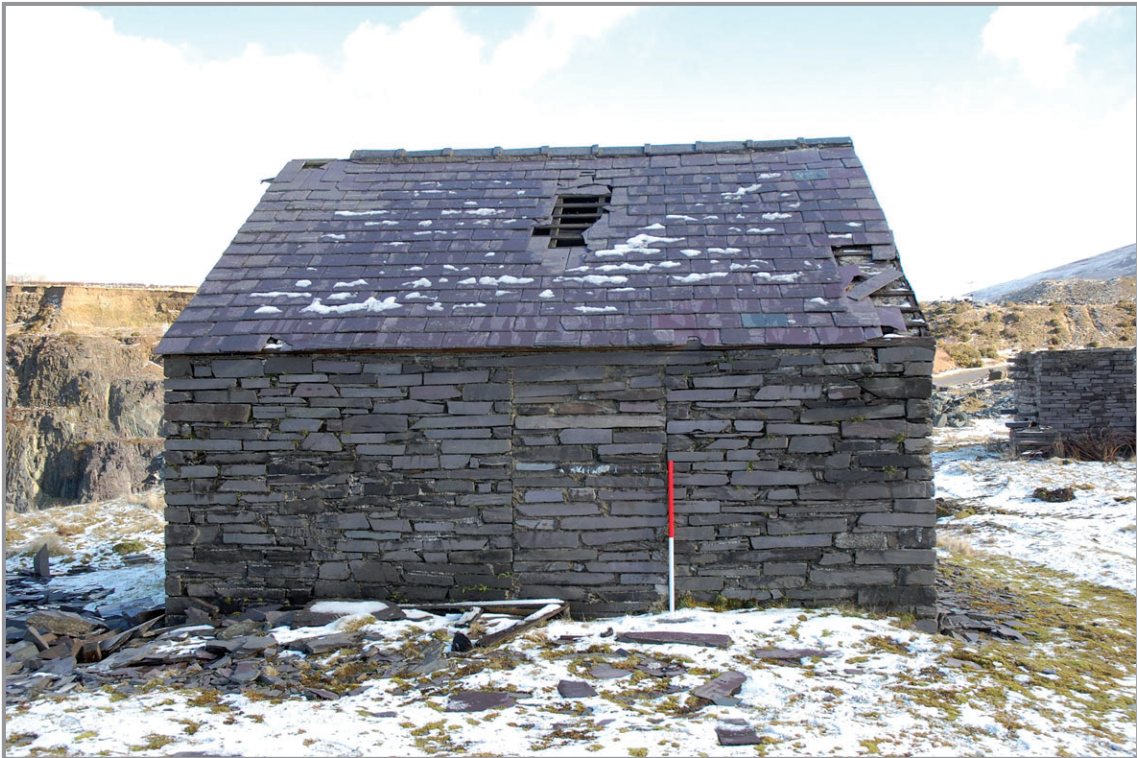
The south-east facing elevation (plate 4) contains a blocked doorway 1m wide and 1.5m high with a slate lintel. Internally the door was blocked using breeze blocks. The bonding in this blocked doorway is similar to that seen in the first phase of blocking in the south-west opening so therefore this event is likely to have occurred when the structure became an office.

Plate 4: *Building 54. View of the south-east facing elevation. Showing the blocked doorway.*

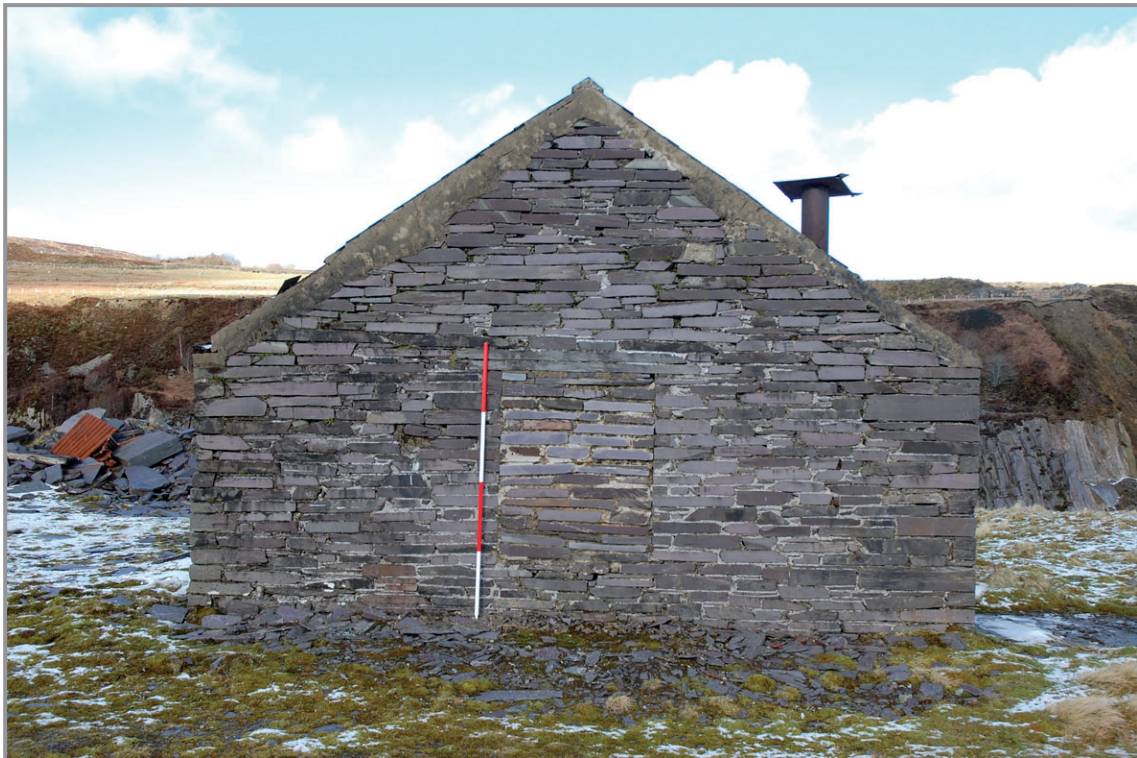
The north-east facing elevation (plate 5) contains a blocked window 1m wide and 1.25m high with a double slate lintel. Internally the window was blocked using breeze blocks. The external blocking is similar to the bonding seen in the second phase of the blocking of the south-west opening so this is likely to have occurred when the building was converted into an explosives store.

Plate 5: *Building 54. View of the north-east facing elevation. Showing the blocked window.*

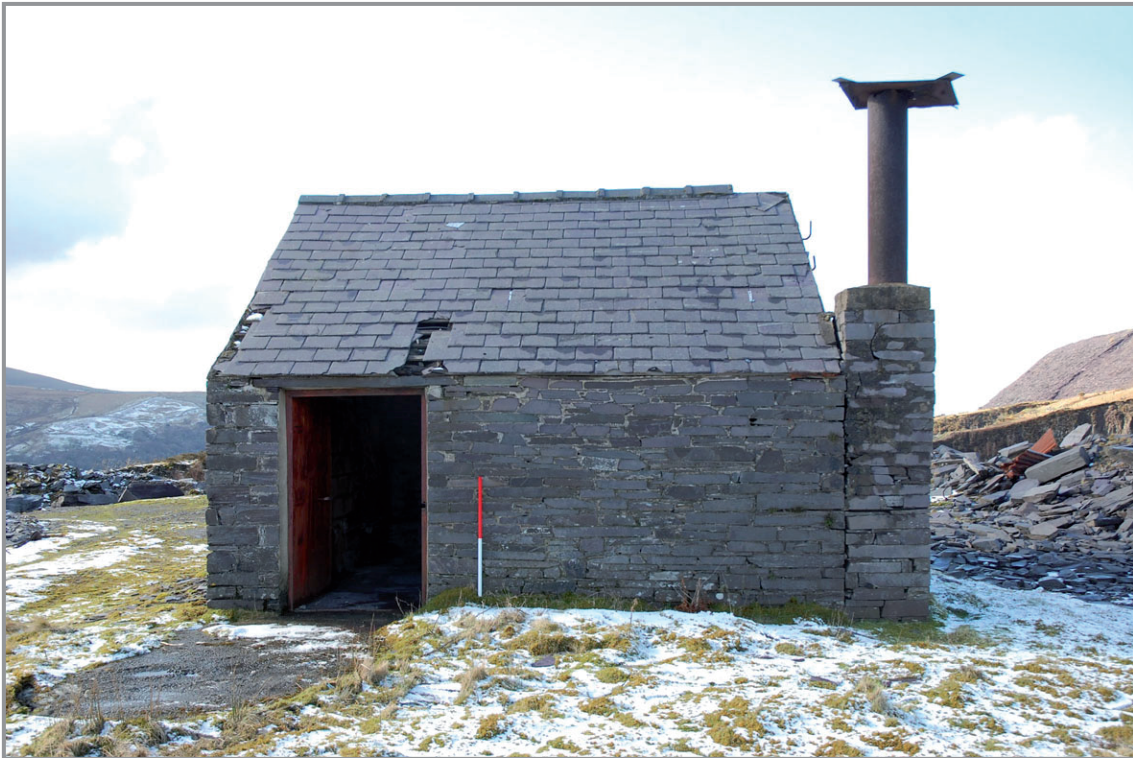
The north-west facing elevation (plate 6) contains the access doorway to the structure with a slate lintel. It contains a substantial metal door, inserted when the building was converted to an explosives store.

Plate 6: *Building 54. View of the north-west elevation. Showing the main entrance.*

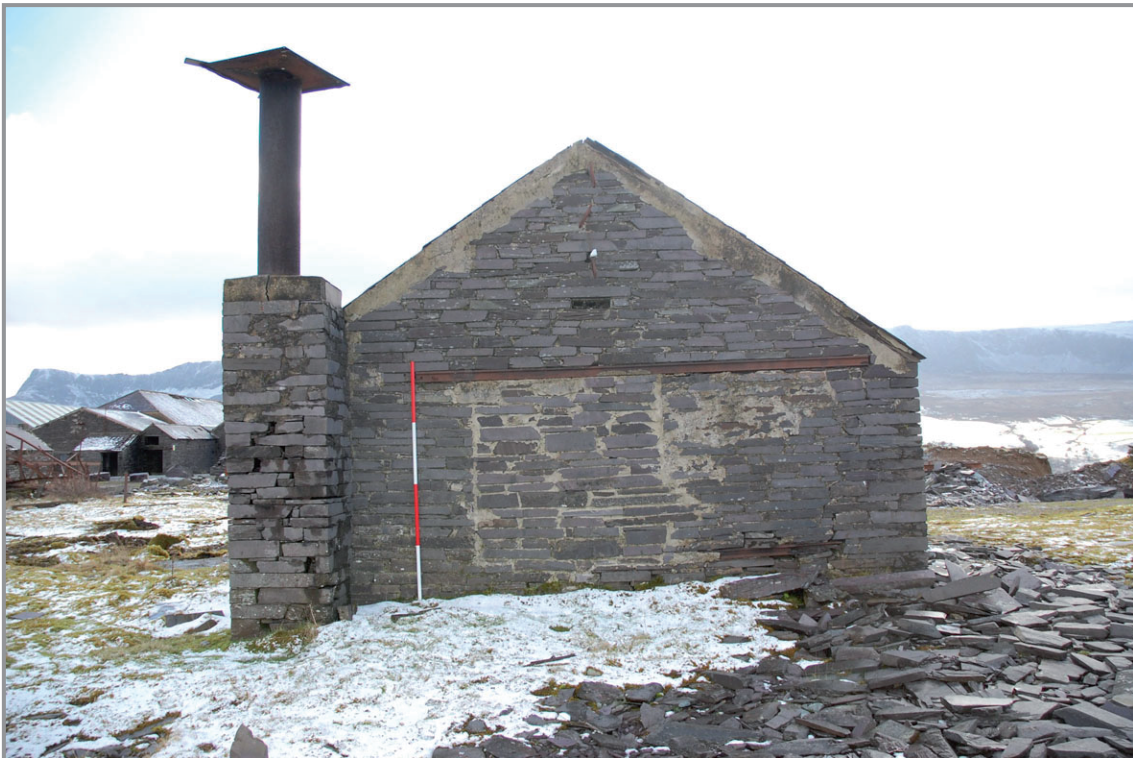
The south west facing elevation (plate 7) has a blocked opening 3.5m in length and 2.70m high with reinforced lintel and base, of reused narrow gauge rail. This elevation faces on to the Eureka quarry which suggests that this was the opening for the winding mechanism when this structure functioned as a winding house. The winding opening seems to have been blocked in two phases. The first phase was the blocking of the south-east of the opening to create a smaller window, possibly when the building was changed into an office. The opening was then totally blocked at a later date possibly when it was changed into an explosives store. There is a later external chimney attached to the north-west of this elevation which was probably constructed when the use was changed to an office. A single surviving ceramic terminal remains on this side.

Plate 7: *Building 54. View of the south-west elevation. Showing the two phases of the blocked opening and chimney, which was added at a later date. With the Eureka mill in the background*

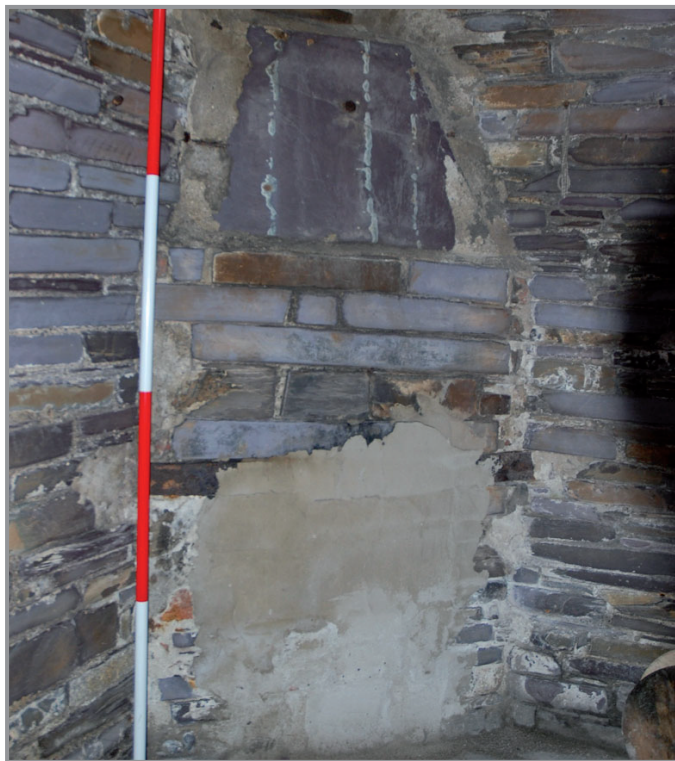
A blocked fireplace is seen in the west corner of the room. It is constructed of slate and slate blocks and was possibly created when the building became an office. The fireplace was probably blocked when the structure became an explosives store. A platform/plinth is seen running along the north-west facing elevation associated with the blocked door.

Plate 8: *Building 54. Internal view taken from the east. Showing the blocked fireplace.*

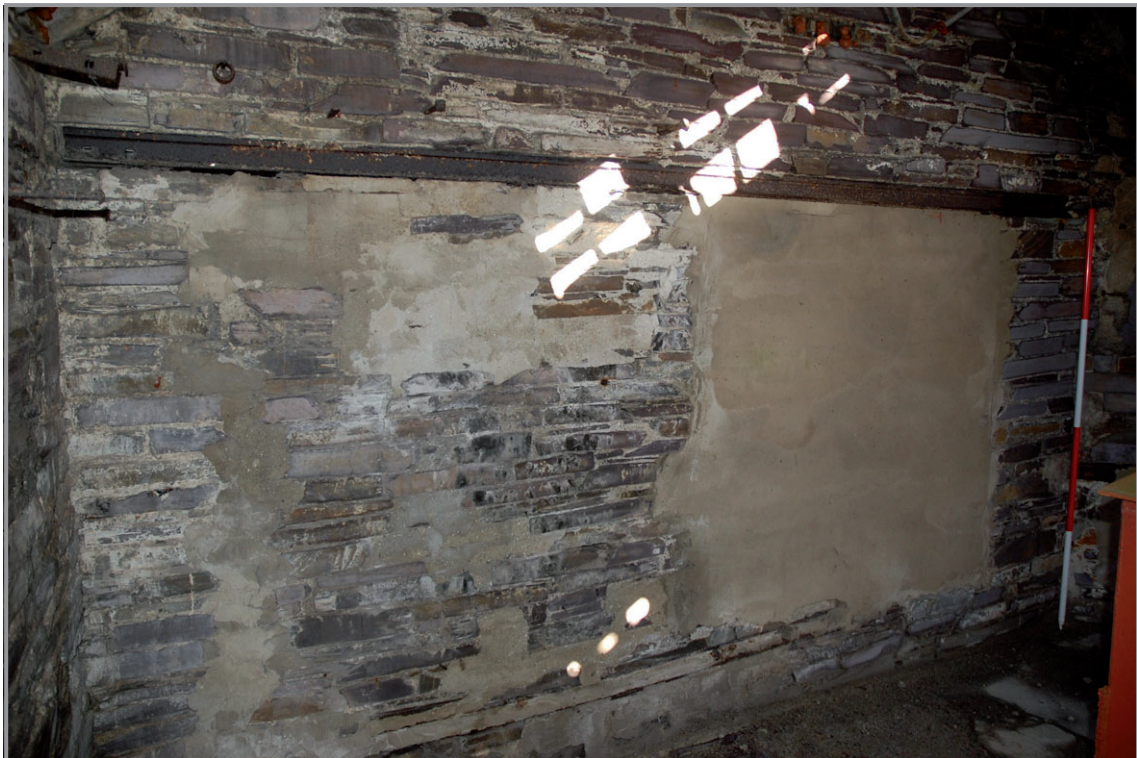
Plate 9: *Building 54. South-west elevation internal. Showing the two phases of blocking of the original winding house opening.*

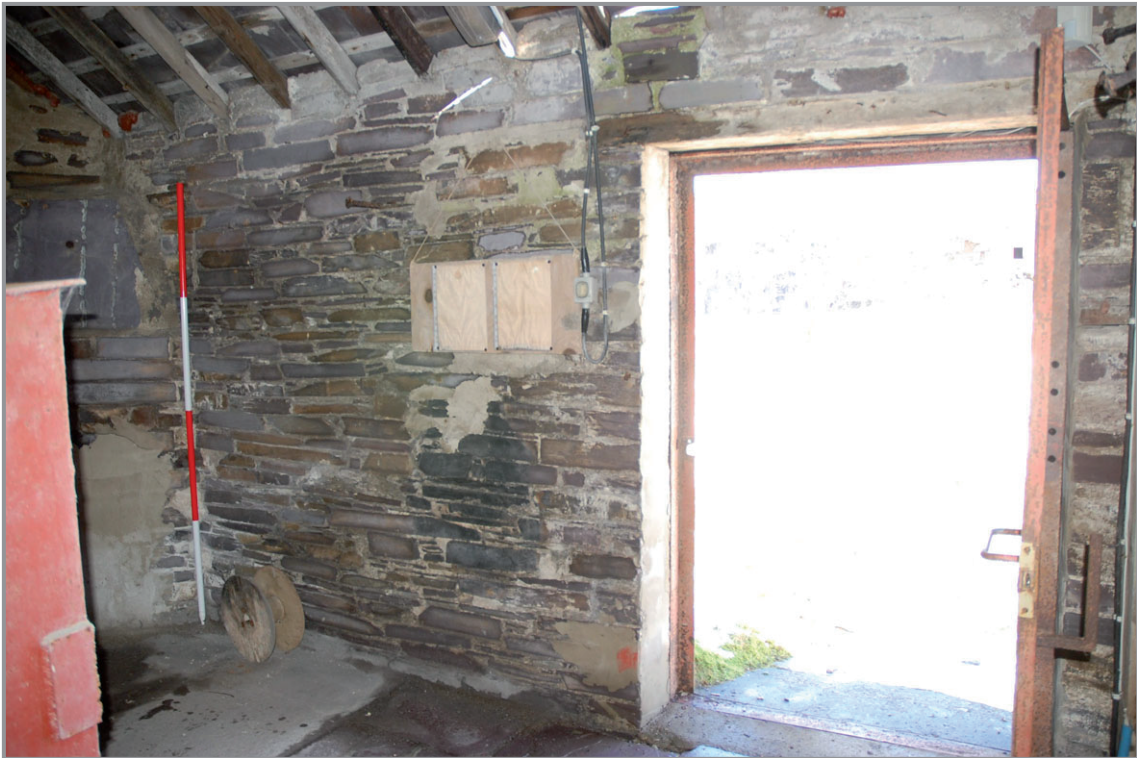
Plate 10: *Building 54. Internal view taken from the south-east. Showing the main entrance.*

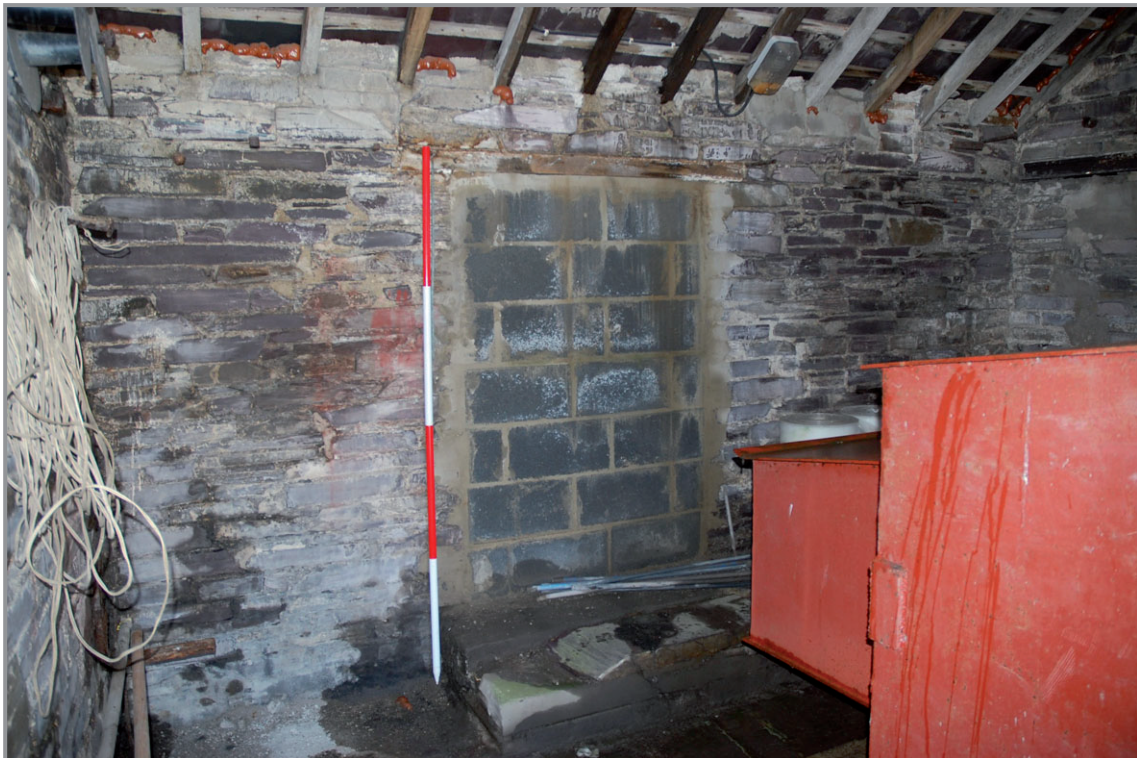
Plate 11: *Building 54. South-east elevation internal. Showing the blocked doorway in the north-west facing elevation.*

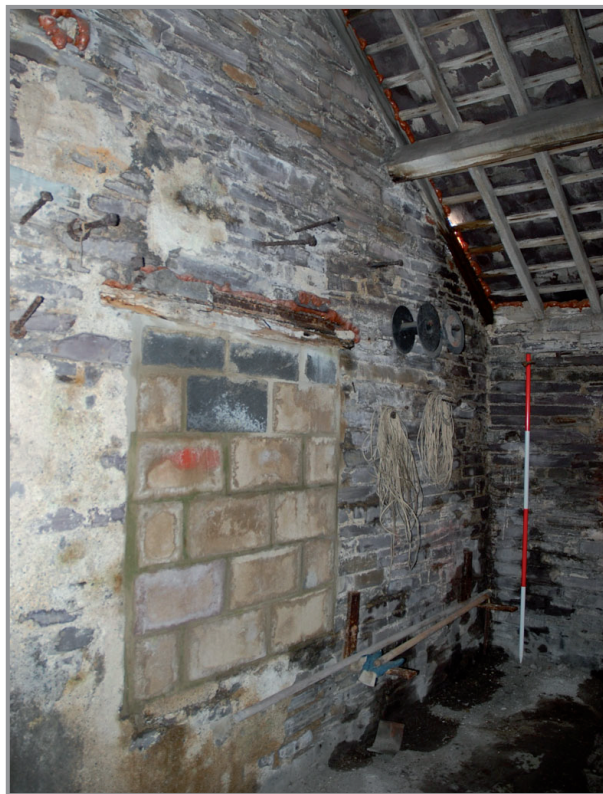
A red metal explosives store is located in the centre of the room (plate 12). 1.23m wide, 1.23m depth and 1.25m high, with a smaller box 0.78 wide, 0.63m depth and 0.5m high attached to its south-east side (plate 15). The explosives store stands on a concrete plinth 1.90m wide, 1.88m depth and 0.29m high. A plaque on the box reads Hornsby and Goodwin LTD, Engineers. Scunthorpe Lincolnshire (plate 14). A notice seen on the north-west facing elevation shows a license given in 1993 for the use of mixed explosives.

Plate 12: *Building 54. North-east elevation internal. Showing the blocked window.*

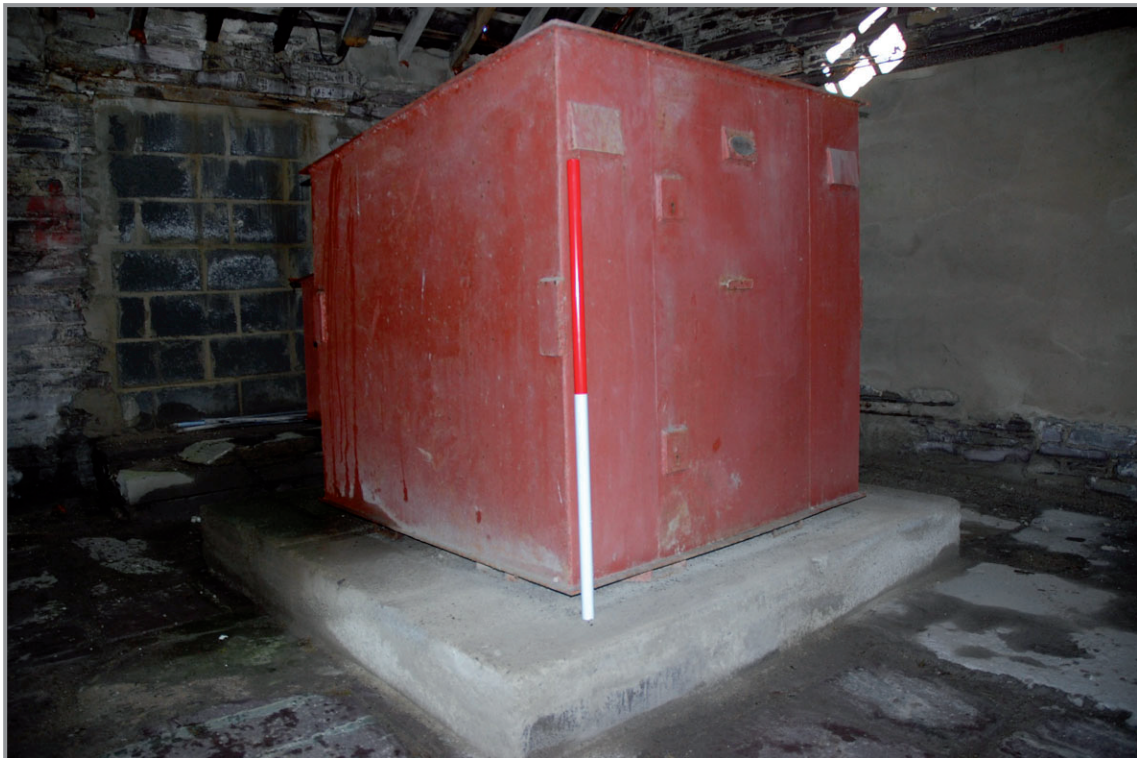
Plate 13: *Building 54. Internal view taken from the north. Showing the explosives store.*

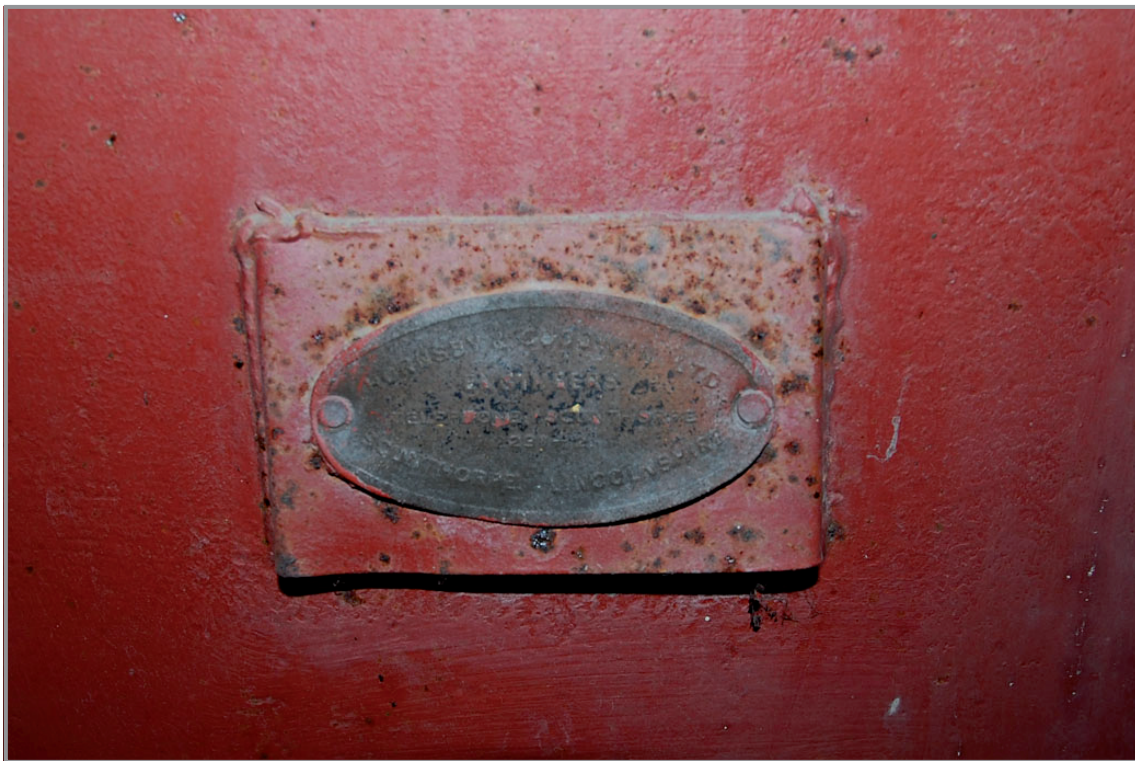
Plate 14: Building 54. Plaque on explosives store. 'Hornsby & Goodwin LTD, Engineers, Scunthorpe Lincolnshire.'

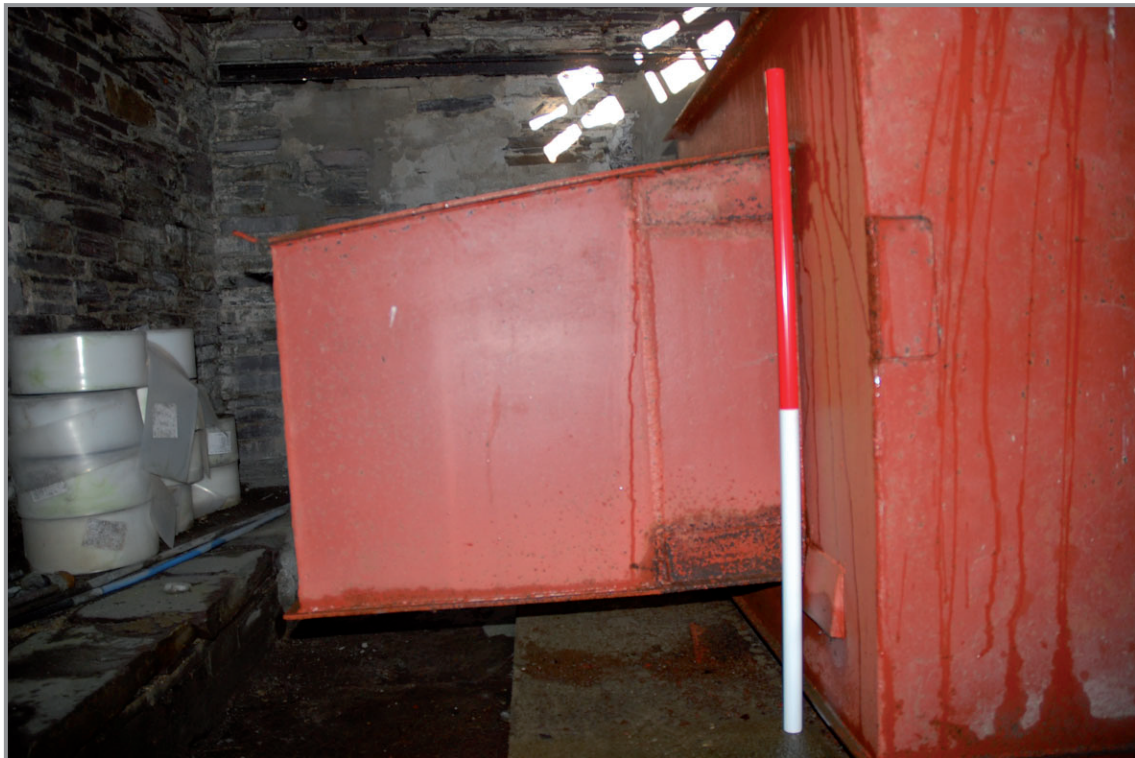
Plate 15: Building 54. View taken from the south-east. Showing the explosives store.

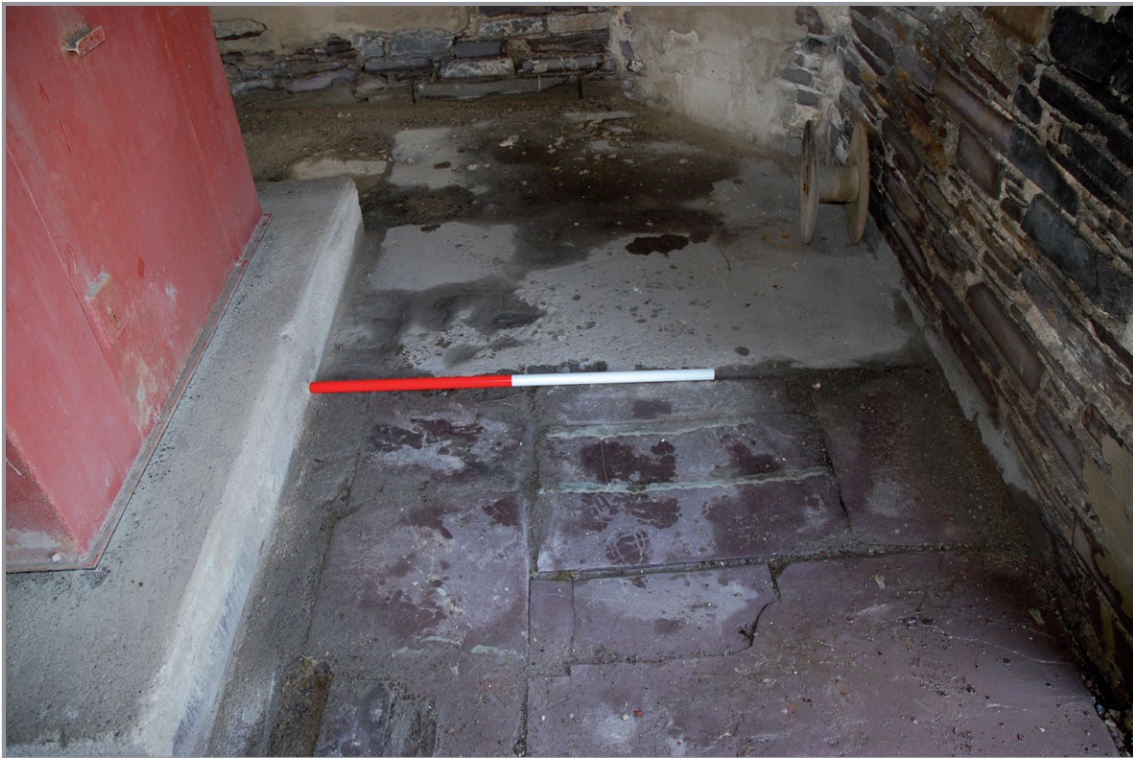
The interior of the building has a floor of slate slabs (plate 16). The single room is open to the roof, which has 13 timber rafters supported on 2 purlins (plate 17). This roof may be a replacement of the original.

Plate 16: Building 54. Internal view taken from the north-east. Showing the slate floor.

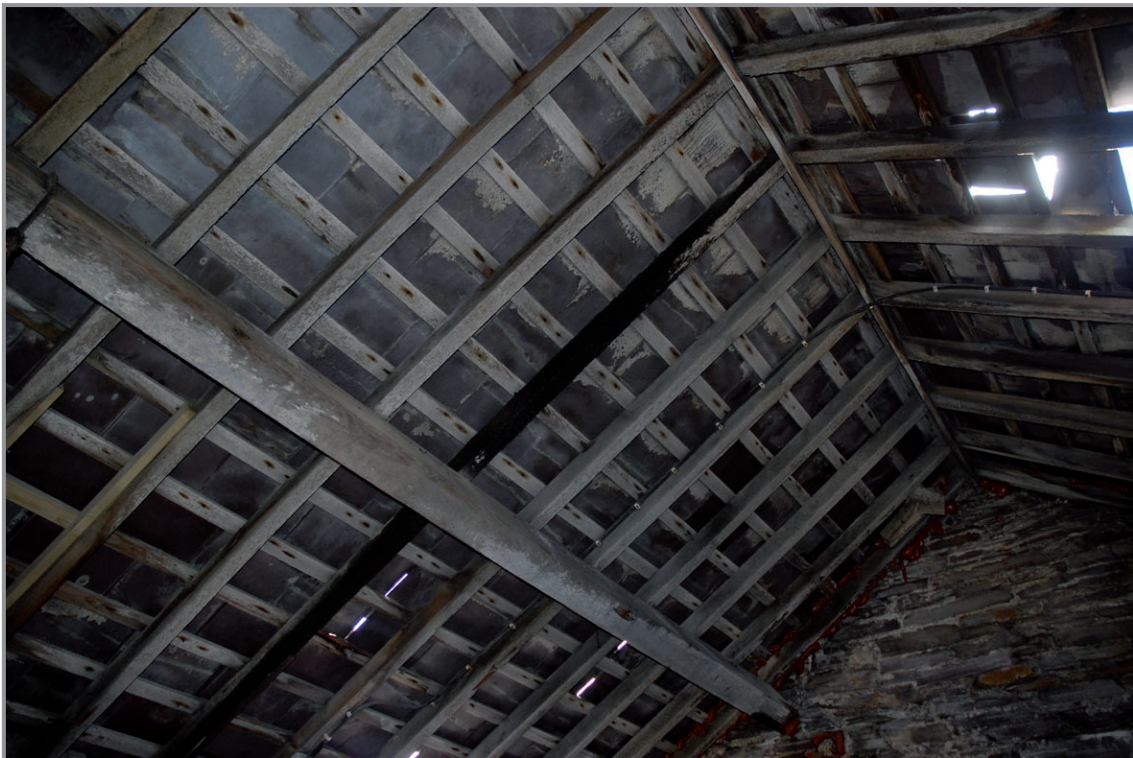
Plate 17: Building 54. Internal view taken from the south. Showing the replacement roof.
