CPAT Report No 1139

Strata Marcella Abbey, Welshpool, Powys

SURVEY AND RECORDING 2011-12

March 2012

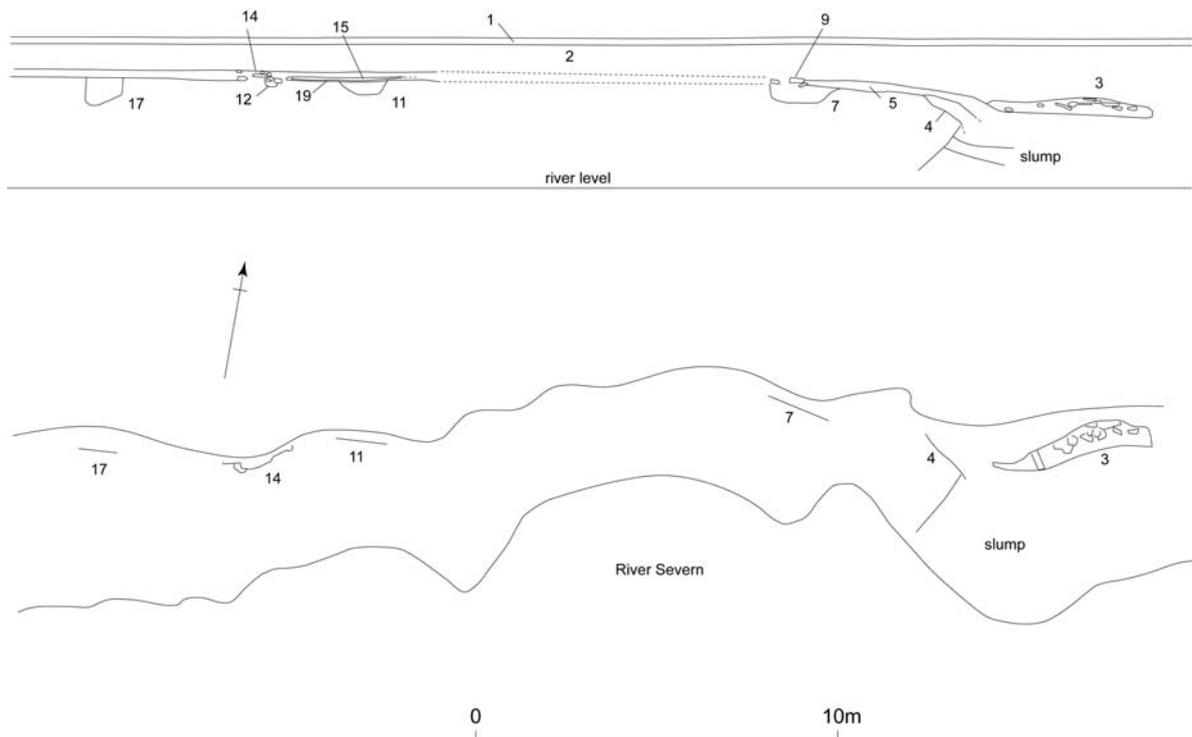
Fig. 5 Plan and section of features visible along the riverbank in October 2011.

- 3.2 The exposed section demonstrated that there had been considerable deposition since the medieval period, effectively sealing features beneath up to 1.7m of alluvium (2). The 28m-long section of riverbank contained four gullies (7, 11, 12 and 17), a ditch (4), and three sections of stonework which could represent the remains of walls (3, 9 and 14).
- 3.3 Although it was not possible to examine any of the features in detail owing to their location there was the impression that the gullies at least may have been aligned at an angle to the river bank, perhaps extending to the north-north-east, a slightly different alignment to that of the abbey.
- 3.4 It was evident that this section of the river bank is actively eroding and further archaeological features are likely to be revealed over time.

3.1 A range of features visible in the river bank between SJ 25123 10321 and SJ 25099 10321 were recorded in October 2011 (see Figs 3 and 4 for location). Where possible, the exposed river bank, which was up to 4.5m above the level of the river, was cleaned by hand to enable a written and photographic record to be produced, with the features being recorded in plan and section by means of total station surveying (Fig. 5).
