Pen-y-gaer Roman Vicus, Cwmdu, Powys: Draft Interim Report

ARCHAEOLOGICAL EXCAVATION

R Hankinson and N W Jones

August 2011

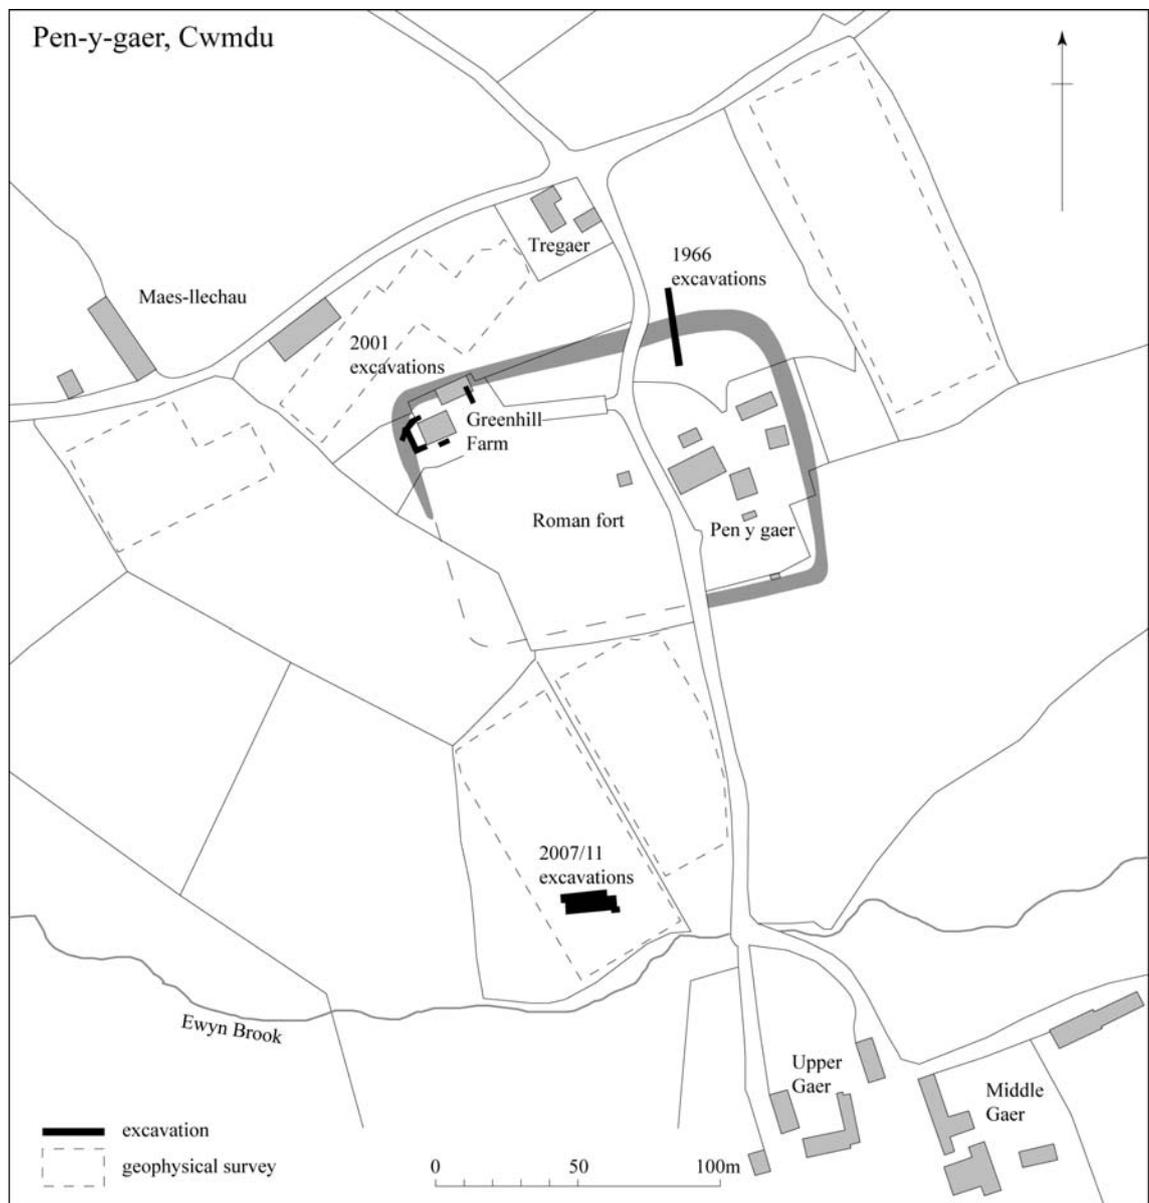
Fig.1: Location of the fort, together with the excavations and areas of geophysical survey

- 1.1 Pen-y-gaer Roman fort (Fig. 1; SO 168 219) stands on a small knoll about 2km to the east of a pass between Buckland Hill and the Cefn Moel ridge, now occupied by the village of Bwlch in what was Brecknock but is now southern Powys. It lies approximately half way along the Roman route linking the larger forts at Brecon and Abergavenny.

- 1.4 Renewed interest in the site came with the completion by CPAT in 2006 of a programme of geophysical survey in the area surrounding the fort (see Fig. 1), with funding from Cadw. This identified an area in the field to the south of the fort which appeared to be of some archaeological potential, and included a possible building (Fig. 2; SO 16849 21796).

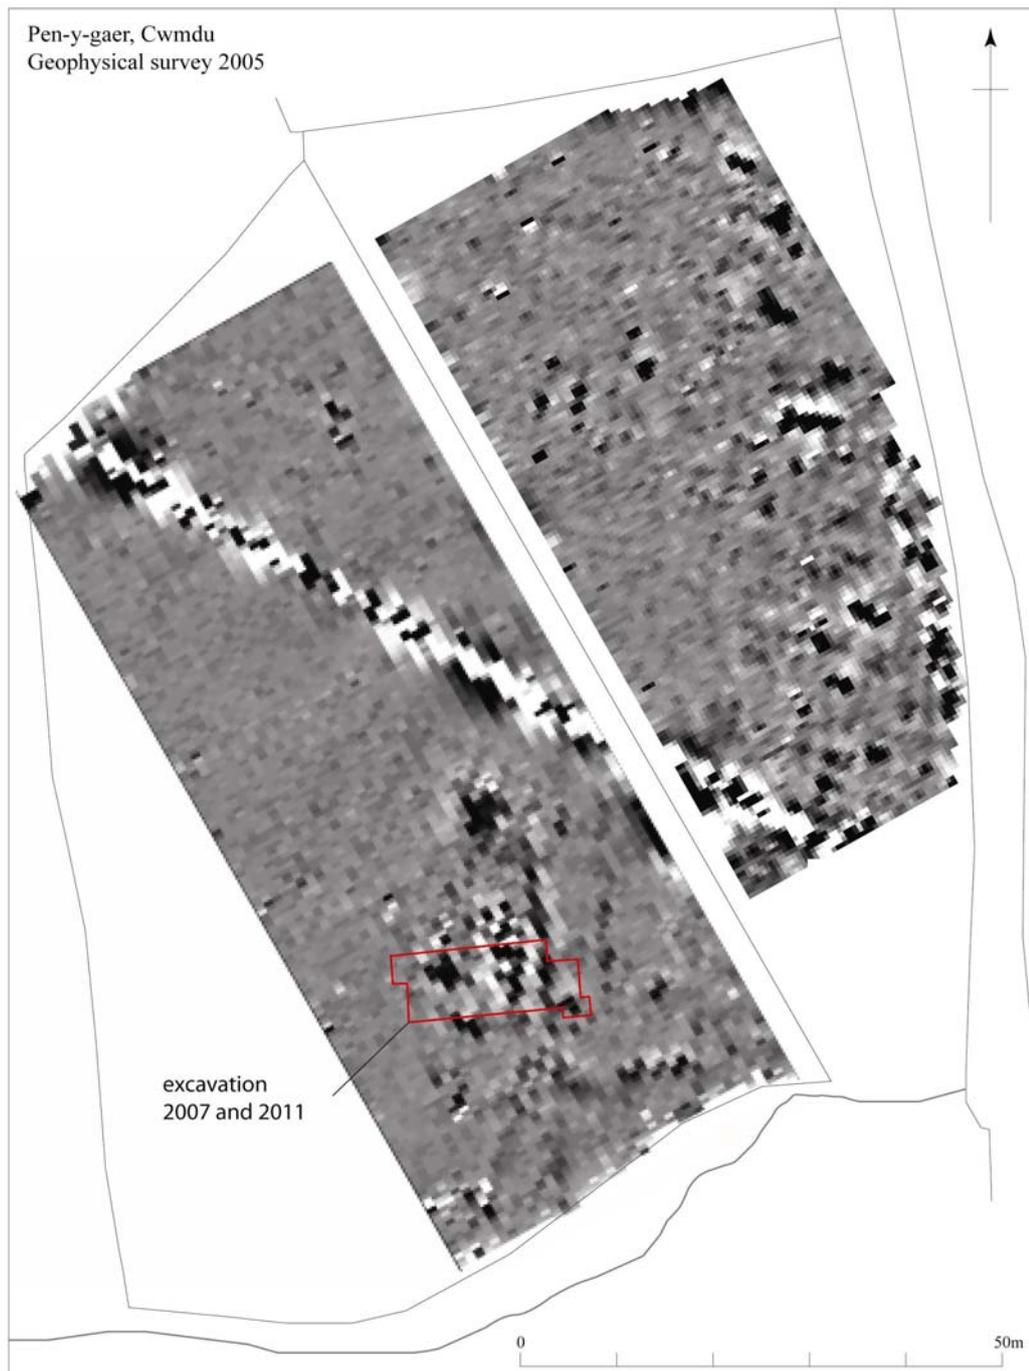
Fig. 2: Geophysics results from the field to the south of the fort

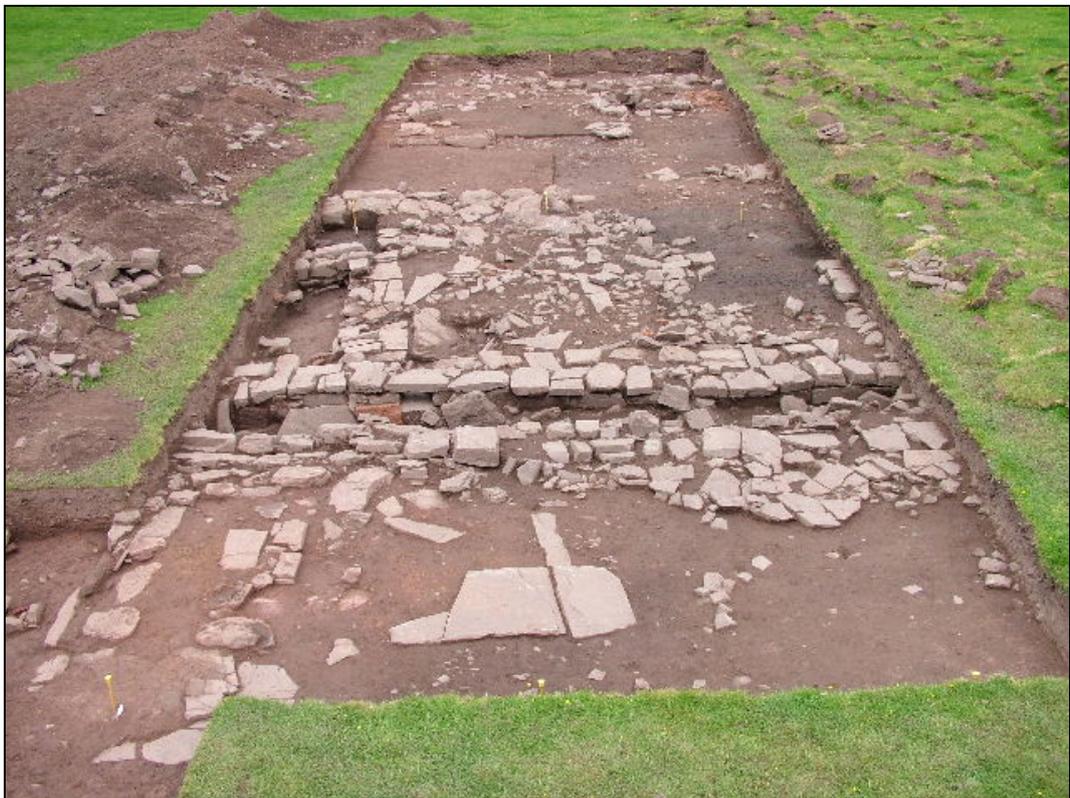
Fig. 3: The 2011 excavation viewed from the east. Photo CPAT 3295-0194

- 2.1 The 2011 excavation investigated an area measuring around 17.9m east/west by 5.0m north/south, with a small extension at its south-east corner (Figs 3-4). This had been carefully positioned to include part of the 2007 excavation along the northern side in order to allow the integration of the earlier results. The topsoil was carefully removed by machine, with all subsequent excavation and cleaning carried out by hand. The numbers in brackets in the following text refer to individual contexts recorded in the combined site archives for the two excavations.

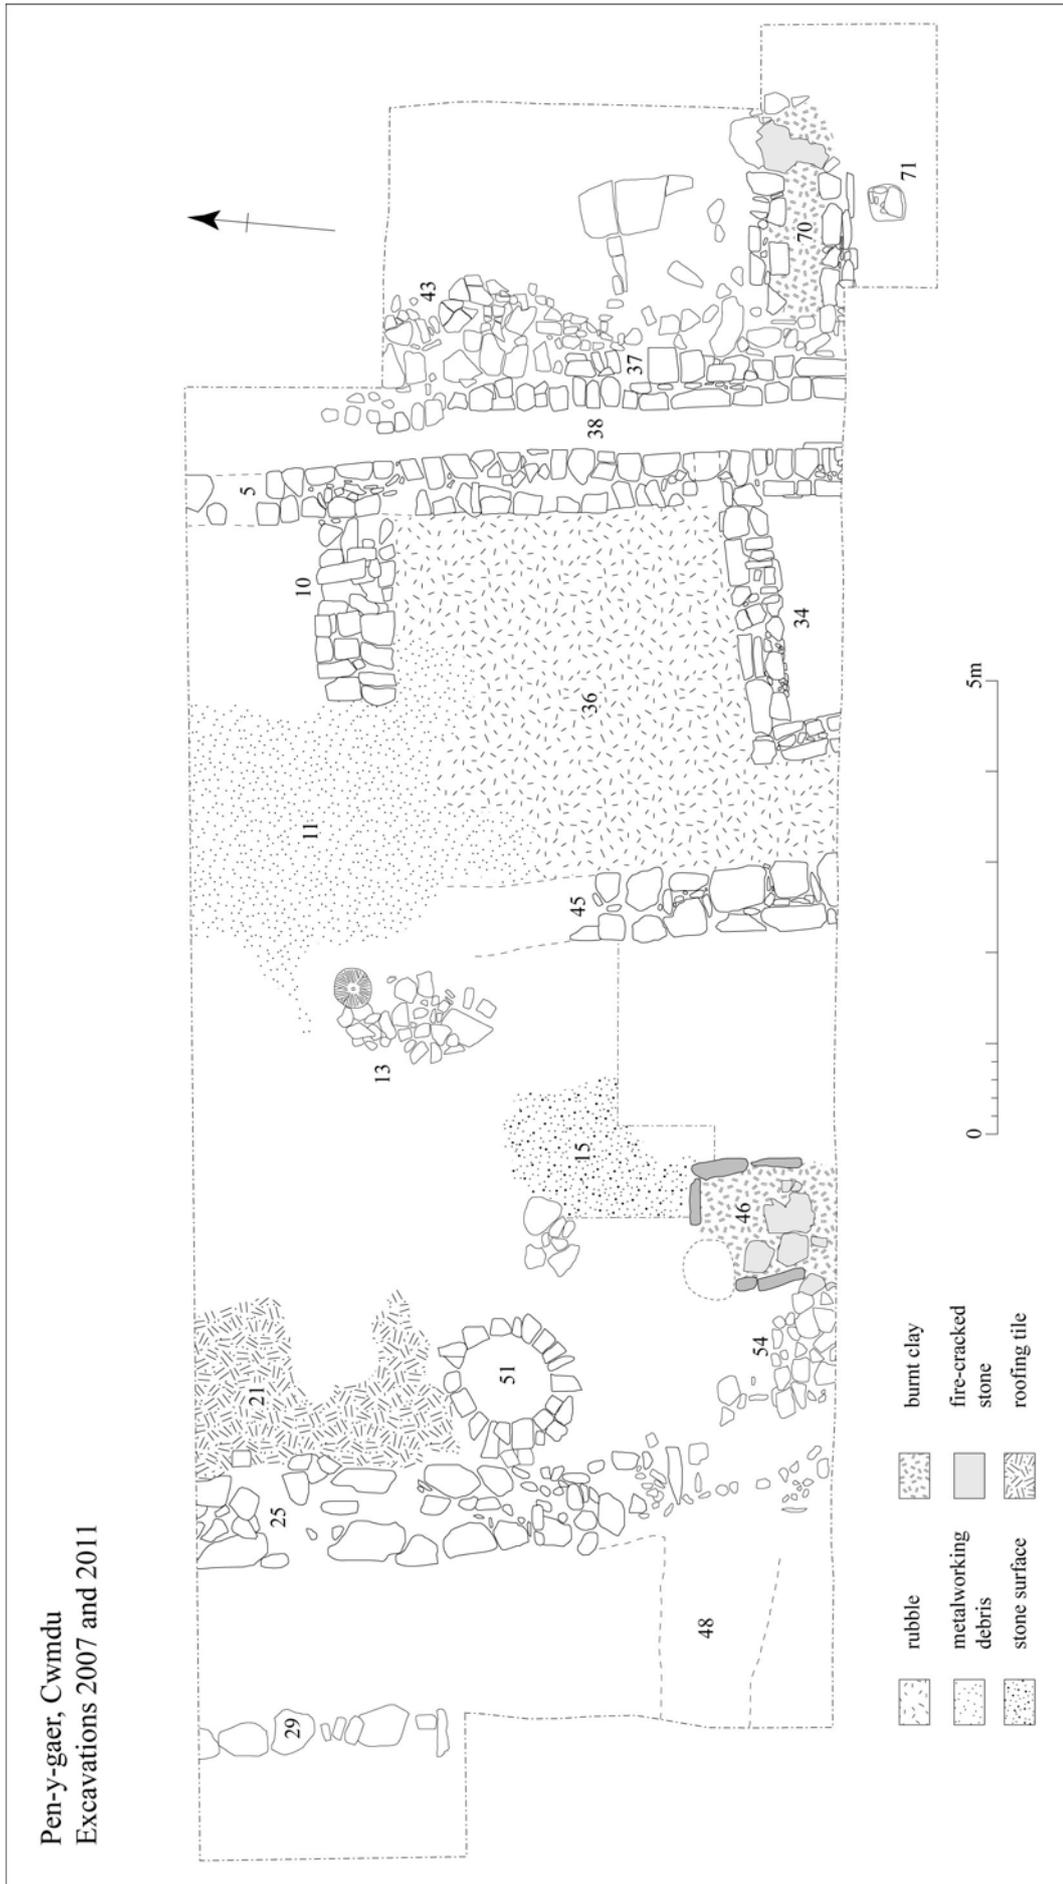
Fig. 4: Composite plan of the 2007 and 2011 excavations

- 2.2 The excavation revealed a sequence of buildings and other structures which are dealt with individually below. It seems likely that the earliest building (58) is represented by two parallel walls (25 and 45), respectively 1.1m and 0.8m in width, aligned roughly north/south and 5.8m apart, with both ends beyond the limits of excavation. The walls were of similar, un-mortared construction, utilising large boulders with small packing stones in between. Only the basal courses of stone survived and both walls were incomplete, having been partly robbed as well as having some stones displaced by the plough. The presence of a further structure to the west of the building is suggested by a possible robber trench (48), running out at right angles from (25) which may indicate the position of a wall, and the base of a relatively insubstantial wall (29) composed of a single alignment of stones.

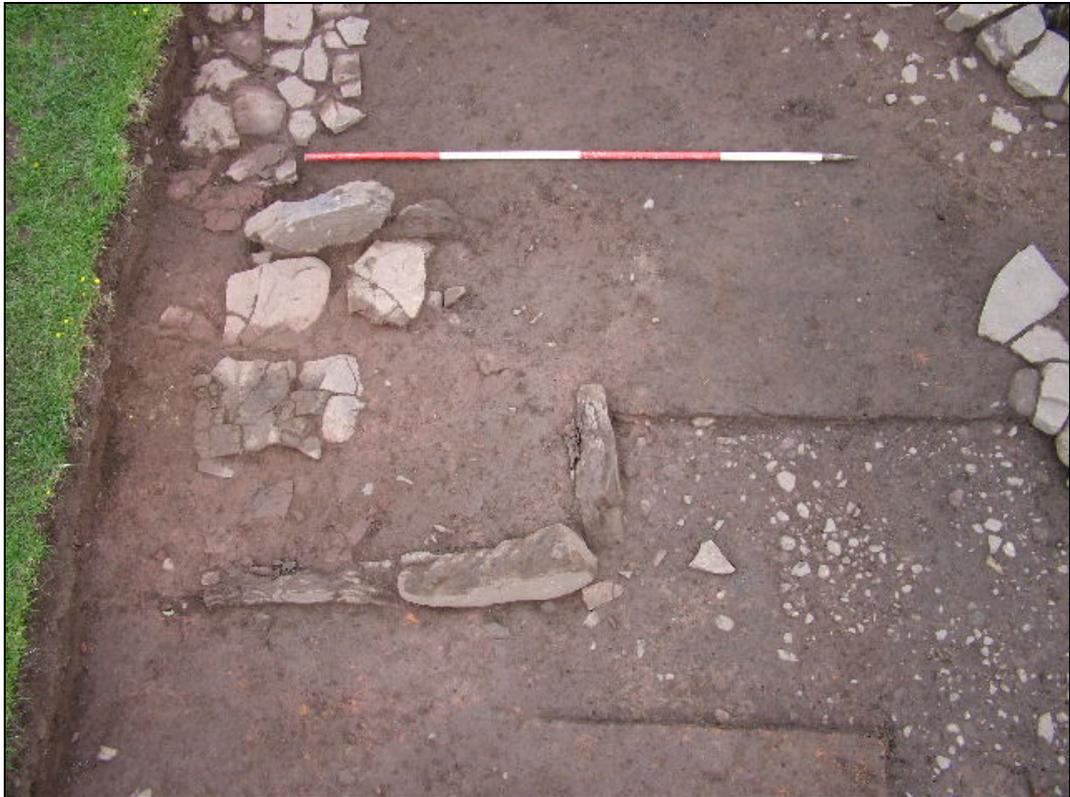
Fig. 5: The hearth (46) and adjoining paved area (54), also showing part of floor layer (15), viewed from the east. Photo CPAT 3295-0186

- 2.3 Within the building there was a worn pebble surface (15) and a hearth (46) which may be contemporary (Fig. 5). The hearth, which measured 1.45m across, was surrounded by edge-set stones and within these were the remnants of a flagstone surface which had been cracked by the heat. An area of possible stone paving to the west (54) was also partially heat-affected.

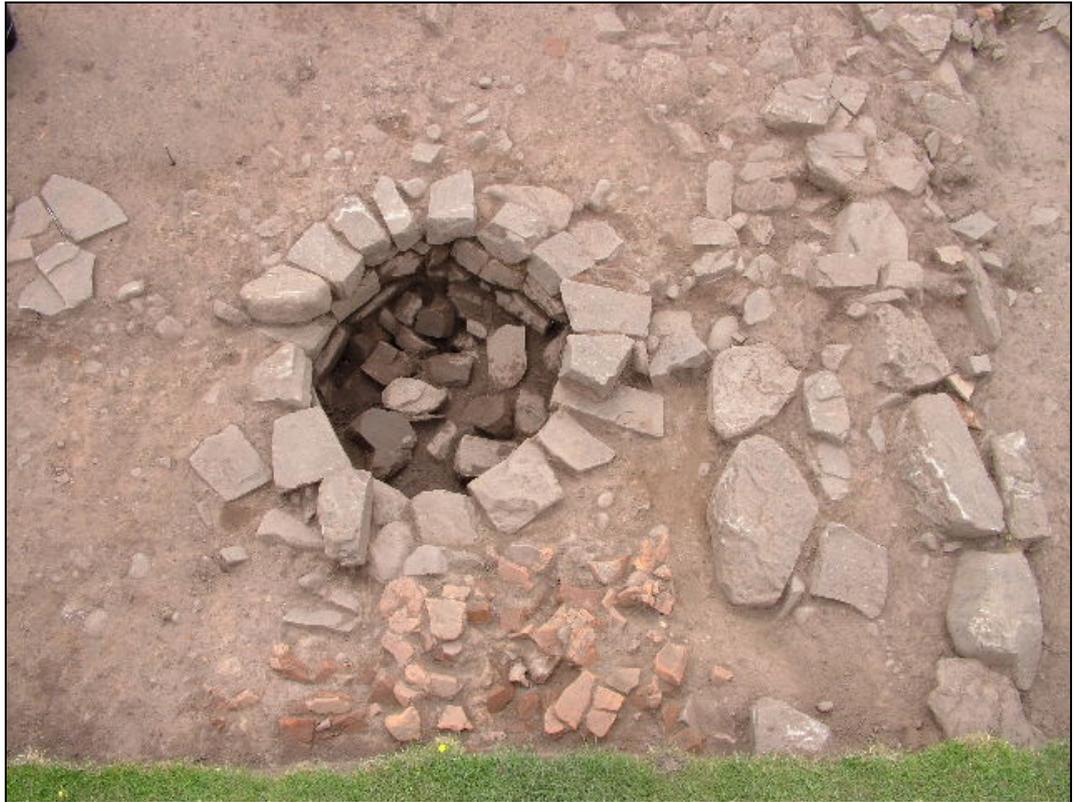
Fig. 6: The well (51) and area of roof tile (21) on the east side of wall (25), viewed from the north. Photo CPAT 3295-0138

- 2.4 Also within the building, although without any stratigraphic relationship to confirm an association, was a small, stone-lined well (Fig. 6). This was sub-circular in plan and measured up to 1.0m in diameter internally. Only the upper 0.5m of fill was removed, consisting of voided rubble, sufficient to confirm the nature of the feature. A spread of roof tiles (21) lay immediately to the north of the well perhaps associated with a lean-to structure, while an area of stone (13) to the east, from which part of a rotary quern was recovered in 2007, may indicate the position of a rubble-filled pit.

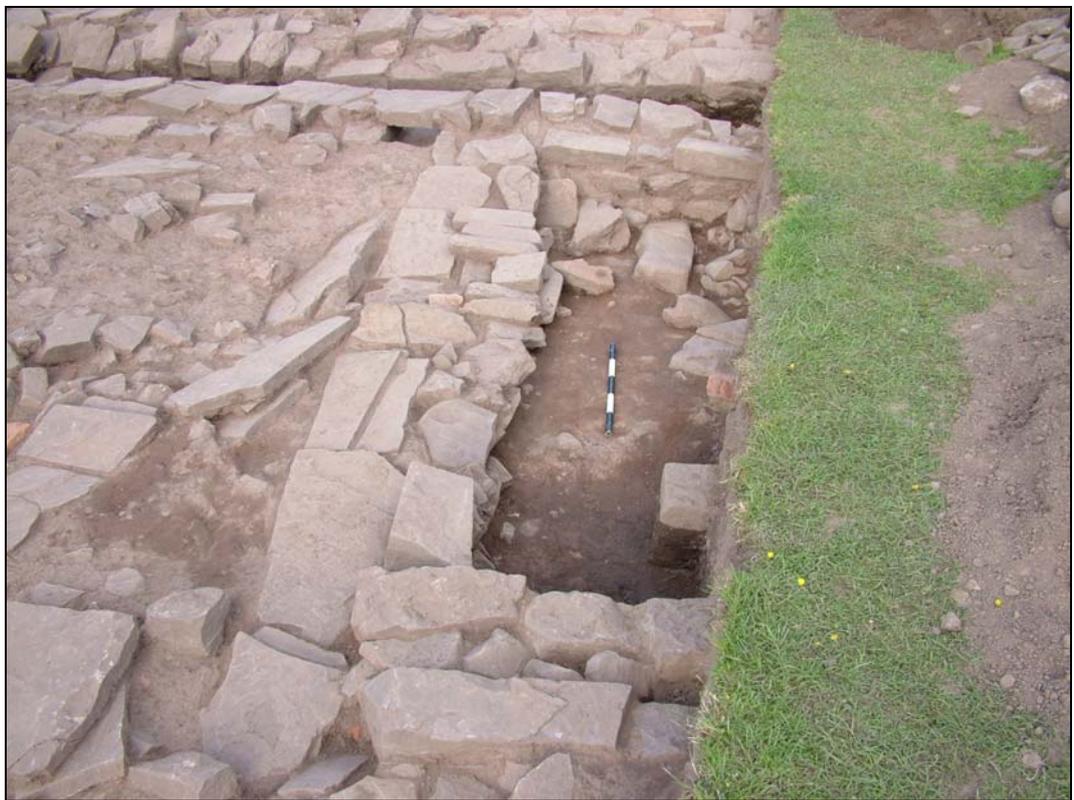
Fig. 7: The room in building (59) defined by wall (34), viewed from the west. Photo CPAT 3295-0121

- 2.5 A second building (59) was identified less than 0.5m to the east of the rubble-walled building (58), and respecting its position and alignment, such that the two may have been standing at the same time. This had been built of higher quality masonry, using sandstone slabs to construct walls that were faced on either side, and had rubble infill. Again the walls were unmortared.

- 2.6 The form of the building is uncertain as it extended beyond the excavated area to the north and south. The eastern side was formed by a wall (5) around 0.7m thick, three courses of which survived to a height of around 0.4m above the stepped foundation, which itself extended for at least a further 0.2m in depth. Tied in to this wall, on its western side, was a further wall (34) of similar construction which defined part of a room with an internal measurement of 2.5m east/west. Around 3.6m to the north were the remains of another wall (10). This was discontinuous and did not appear to be tied in to the eastern wall. Possibly it may be a later addition. It is possible that the building was in part open-fronted, with two enclosed rooms and an open-sided yard in between. Alternatively, the eastern wall may have been a boundary wall with a contemporary building (34) at the southern end and the other wall (10) forming part of a lean-to structure.

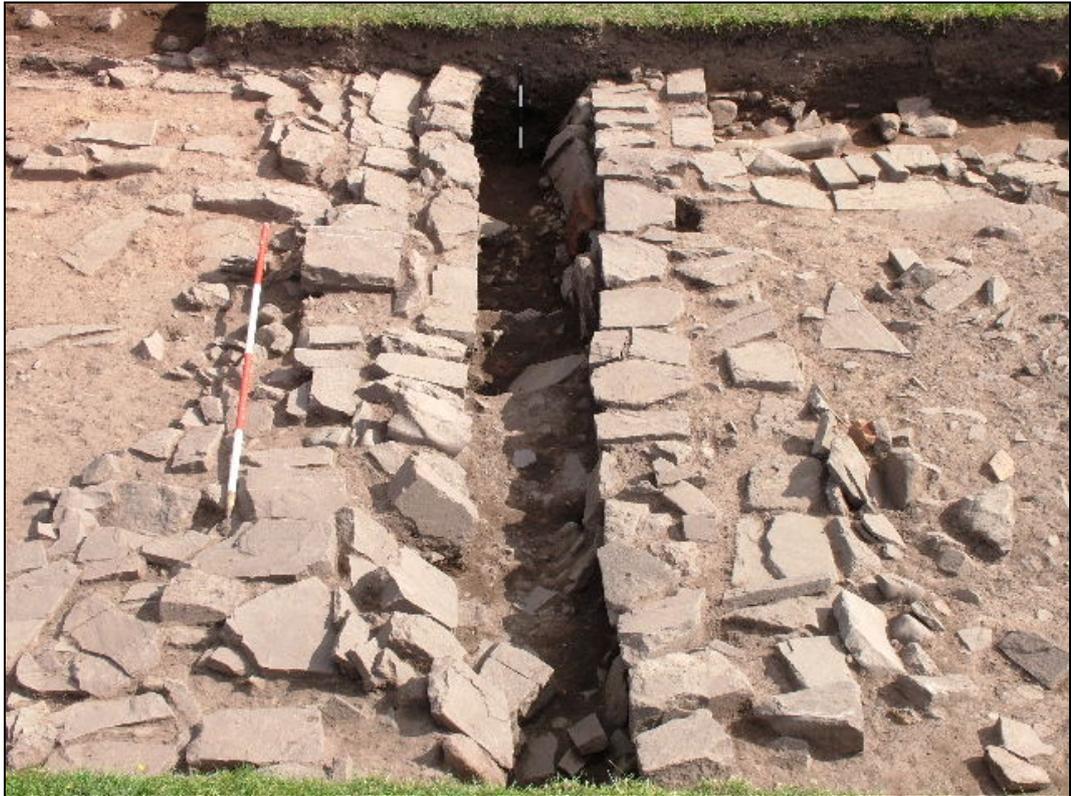
Fig. 8: The drain (38) viewed from the north with wall (5) to the west and wall (37) to the east, showing the area of collapse. Photo CPAT 3295-0102

- 2.9 A drain (38) lay immediately to the east of wall (5) and this appears to be the same as a feature revealed by the geophysical survey, extending for around 16m north of the excavation and a further 22m to the south, presumably ending at the stream. Only limited excavations were undertaken to investigate the drain, which indicated that it was at least 0.55m deep, with the lower fill including a significant quantity of smithing waste (68), similar to the deposit (11) identified on the western side of the wall. Interestingly, the external face of the wall had been reinforced throughout by the later addition of a line of edge-set stones (65), which included a single Roman tile. The wall also incorporated a culvert (56) which fed into the drain from the area to the north of wall (34).

- 2.11 Over time the drain had evidently fallen out of use. It became completely infilled, and then its eastern side was sealed beneath a masonry wall (37) which ran parallel to wall (10) and was of similar construction, perhaps representing part of a further building (60). Within the excavated area the northern part of this wall had clearly subsided into the drain, leading to its collapse (Fig. 9).

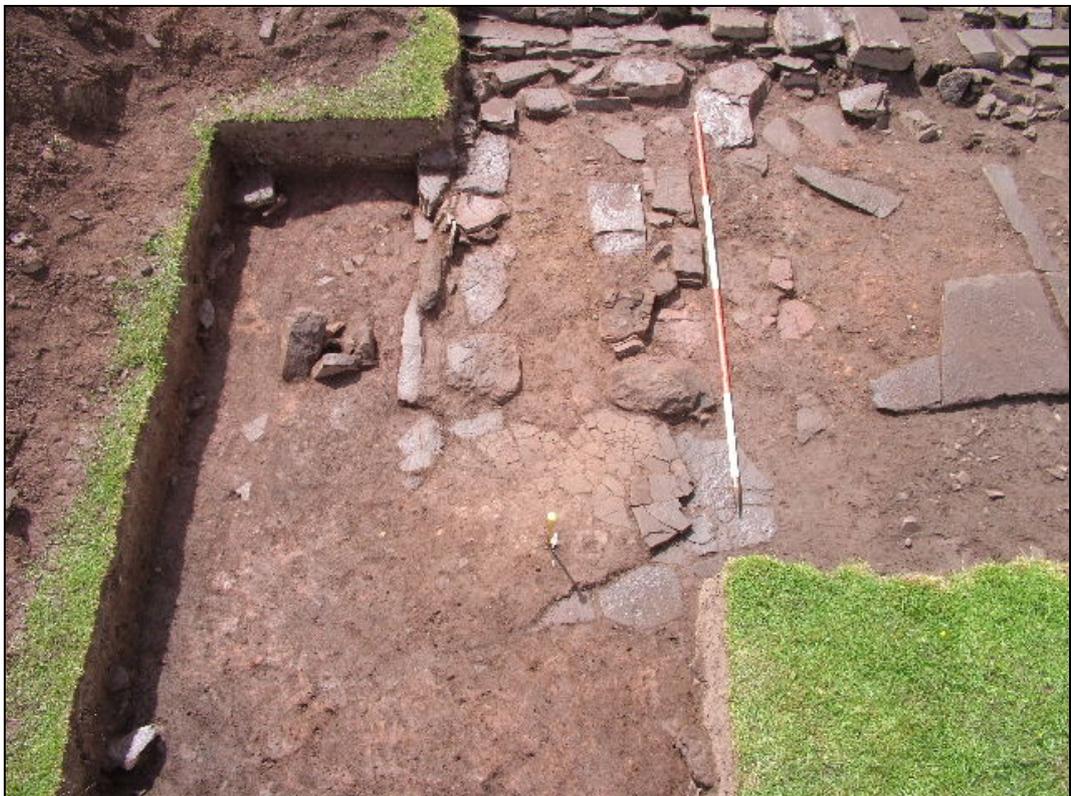
Fig. 9: The probable corn-drying kiln (70), viewed from the east. Photo CPAT 3295-0167

- 2.10 To the east of the drain, in the south-east corner of the excavation, were the remains of what appears to have been a small corn-drying kiln (70). The flue consisted of two parallel walls with a surviving length of 1.8m and set 0.4m apart, aligned east/west. At the eastern end there were the remains a floor formed by stone slabs, some of which were heavily fire-cracked, although at this stage it is uncertain whether this was the drying chamber or the stokehole. Only the very base of the structure survived, although a post-hole (71) immediately to the south may have been associated with some form of wooden superstructure. It may be significant that one of the upper fills (66) of the drain (38) contained burnt material which could have originated from the kiln. However, given the close proximity of the drain to the western end of the flue it is perhaps unlikely that the two features were in contemporary use; the kiln is likely to be the earlier feature.
