Lower Berse Farm, Wrexham in 1970

In 1970 the Royal Commission visited Lower Berse Farm near Wrexham to investigate the history of the building and provide advice to the owners, who wanted to modernise the upper floor. There was a medieval hall house hidden amid a rebuild of 1873. Drawings were made and photographs taken for deposition in the archive.

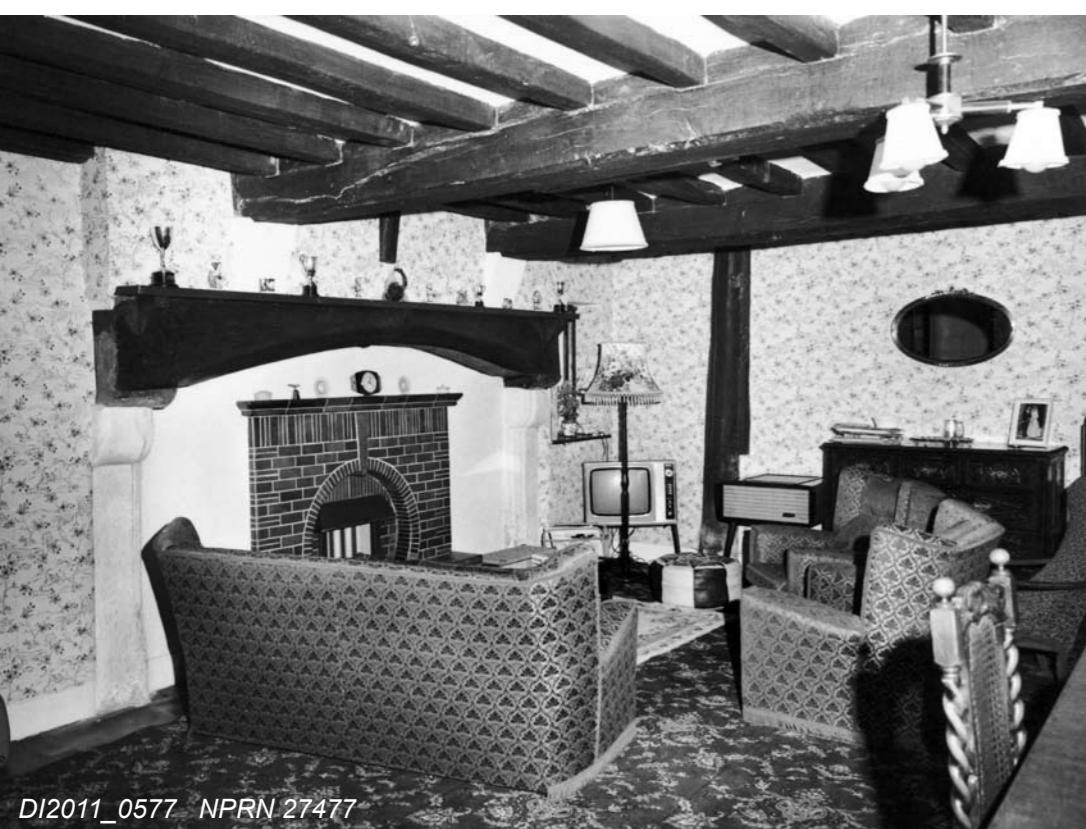
DI2011_0577 NPRN 27477

Left: The living room at Lower Berse Farm. Although the photograph was taken in 1970, the decoration reflects styles and patterns that were popular from the early 1900s onwards.

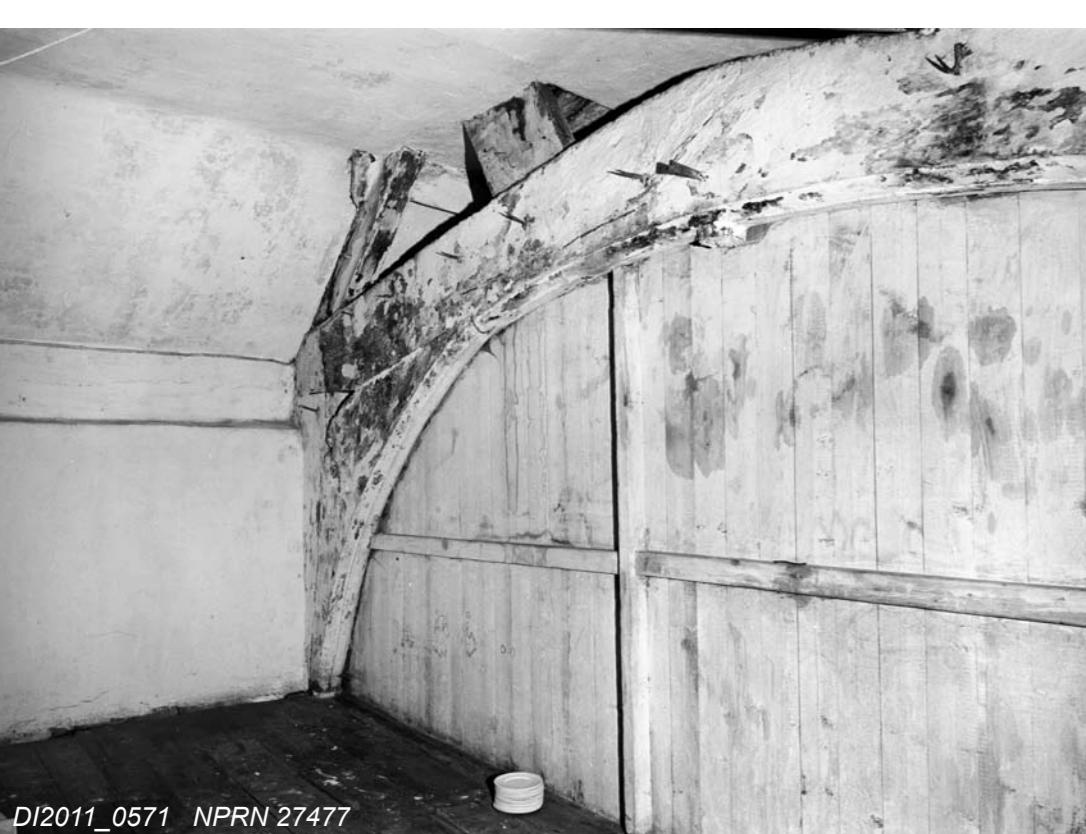
DI2011_0571 NPRN 27477

Left: When an upper floor was inserted into the building, the carved roof trusses were hidden from view. These can provide important information on the date of the building and the development of Welsh traditional architecture.

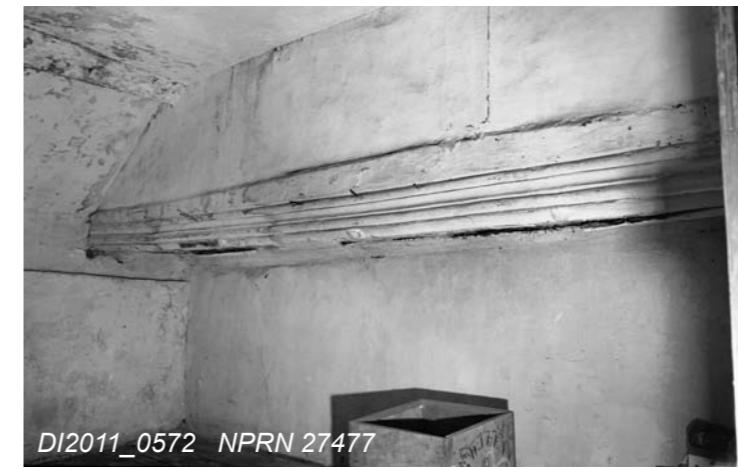
DI2011_0572 NPRN 27477

Left: The Dais Canopy at Lower Berse Farm, under which the owner of the property sat to eat and conduct business at his table is deftly carved, and is a clear status symbol.

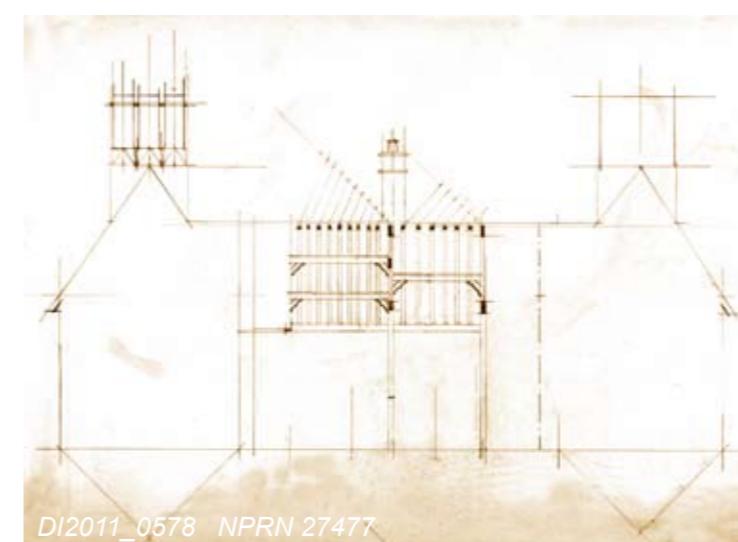
DI2011_0578 NPRN 27477

Left: This drawing was made to show the roof timbers in relation to the rest of the building structure.

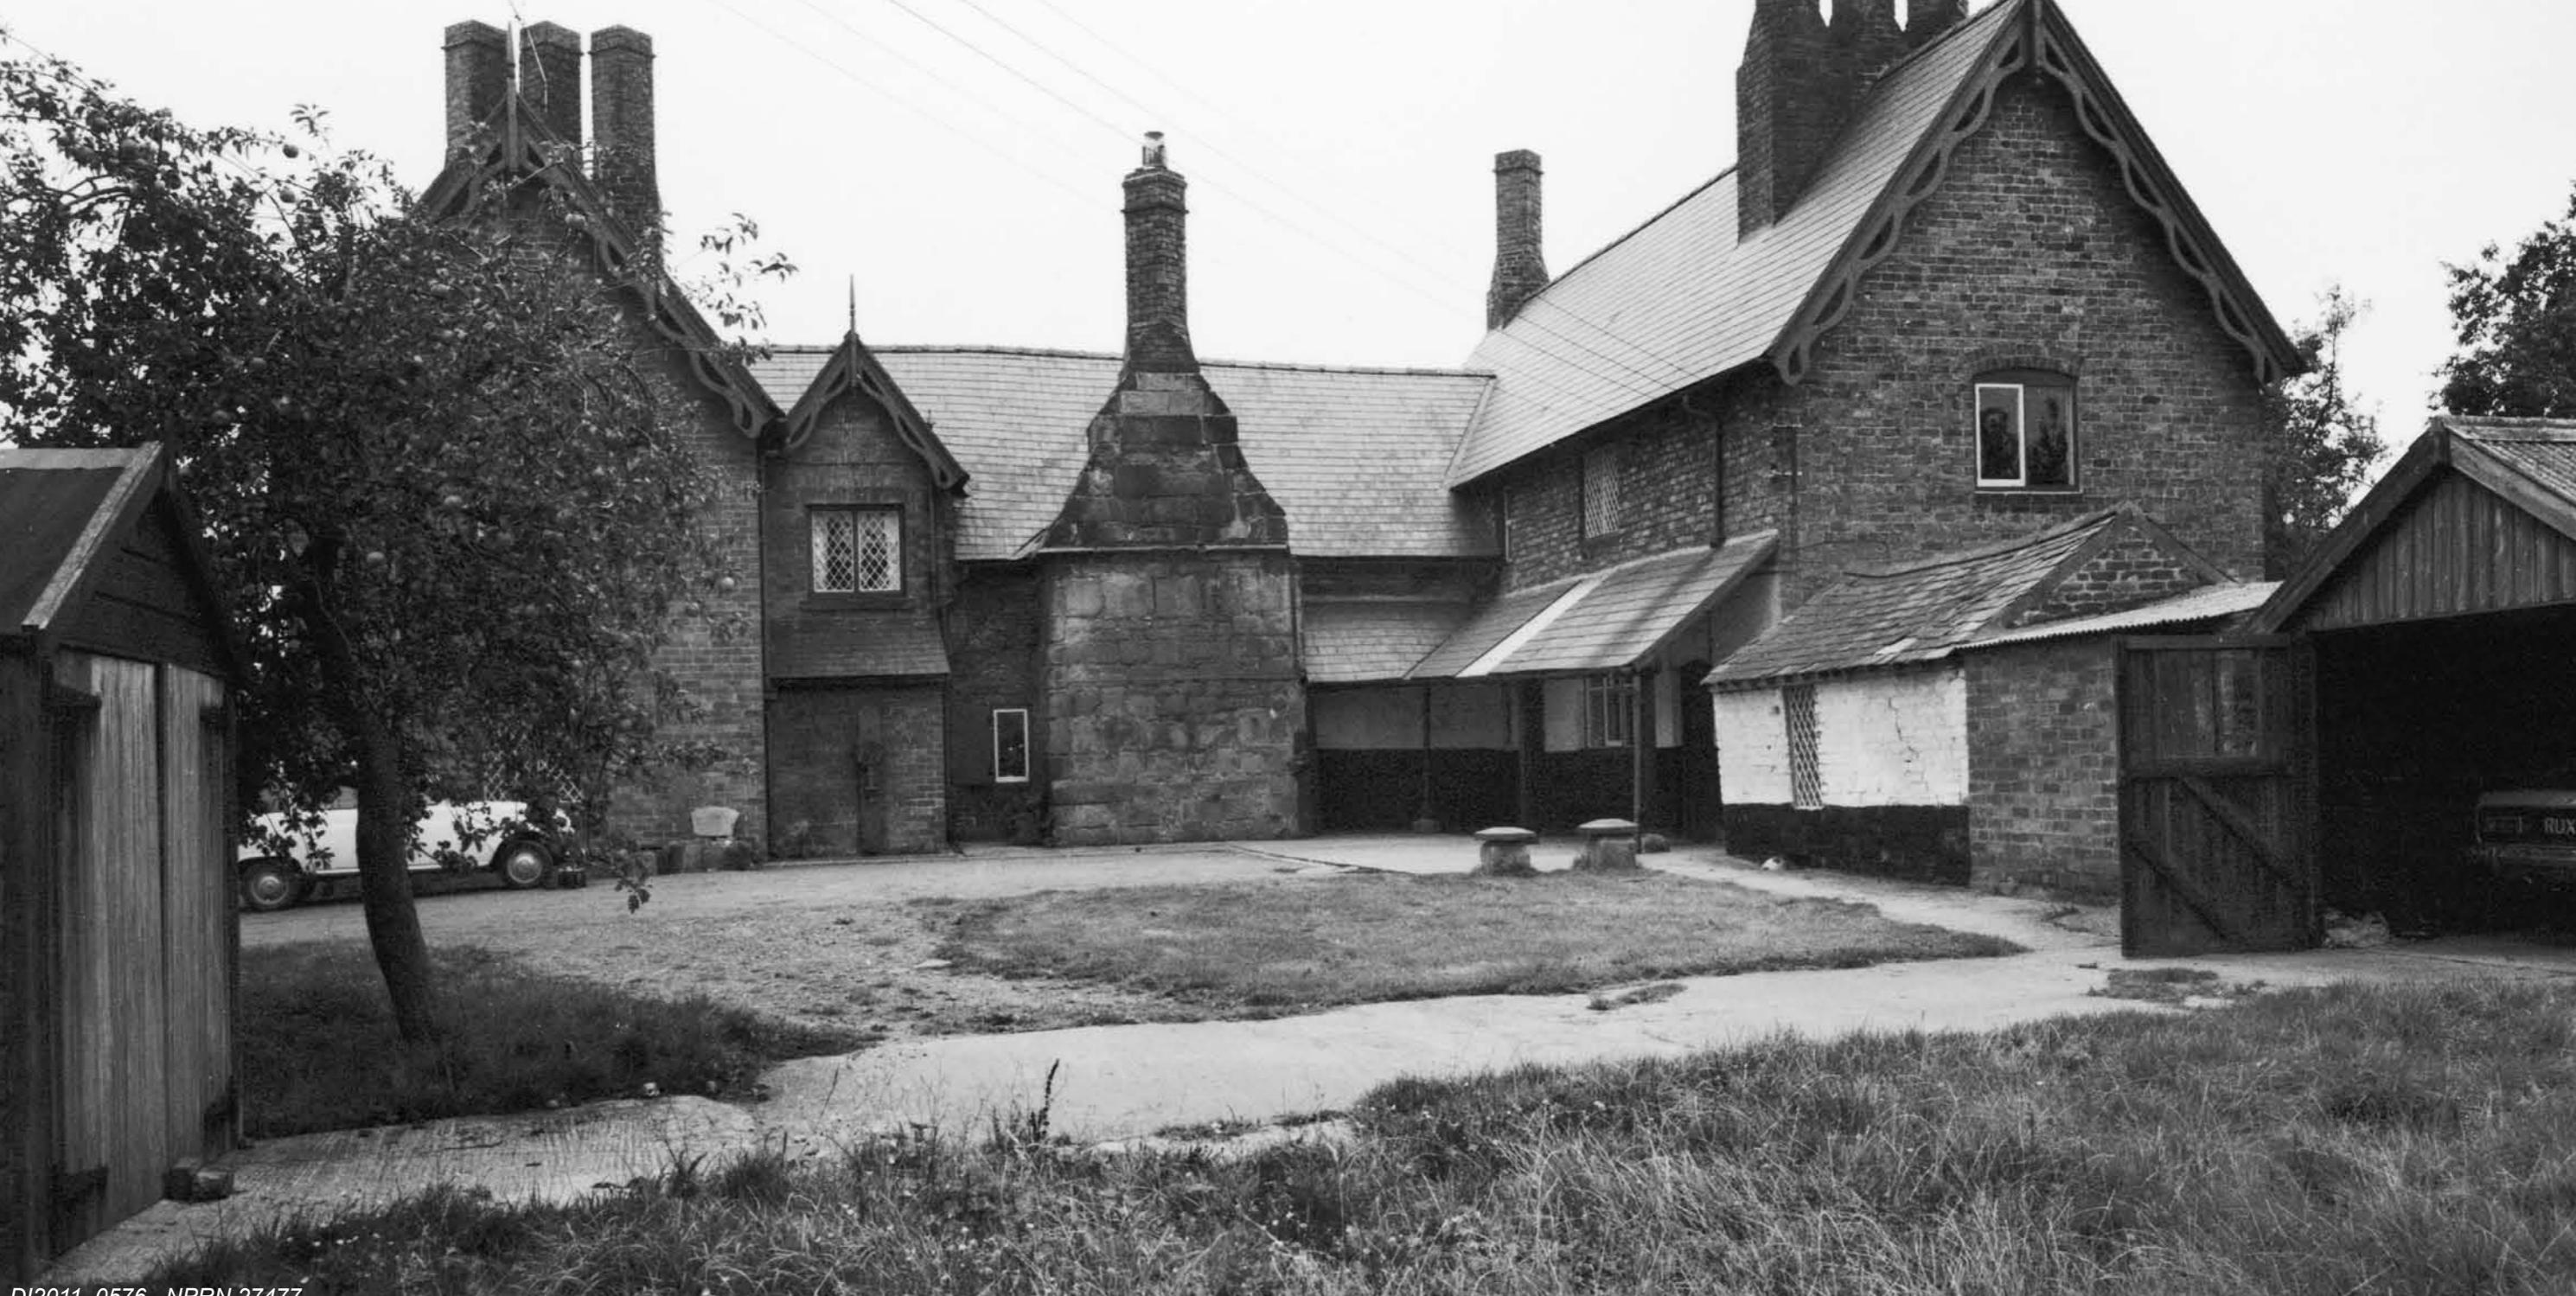
DI2011_0576 NPRN 27477

Below: Lower Berse Farm is just one of thousands of buildings which the Commission has surveyed. The public can access these records at the Royal Commission's office in Aberystwyth, increasingly, online through www.coflein.gov.uk
