NEW CAR PARK, ST TUDNO'S ROAD, GREAT ORME, LLANDUDNO, CONWY

**NEW CAR PARK, ST TUDNO'S ROAD, GREAT ORME
AN ARCHAEOLOGICAL WATCHING BRIEF**

GAT Project no. G2049

GAT Report No. 757

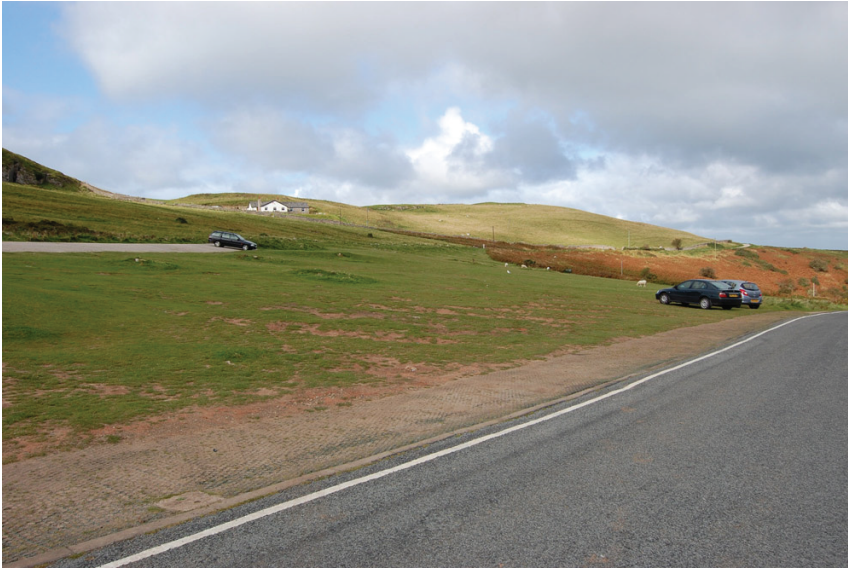
Plate 1: Site of new car park before start of works, from SE

The location of the proposed car park had previously been disturbed by construction of the road and had suffered most from erosion (plates 1 and 2), so the loss of well preserved archaeological remains would be minimal. To confirm this a geophysical survey (Hopewell 2007) was carried out. The possibility remained that slight buried features of archaeological significance might be present so a watching brief by an archaeologist was necessary during ground-works. This would enable any significant features to be identified and either recorded during the works or proposed for full excavation. The works were to include the construction of several parking spaces surrounded by an earth bund with a soak-away for drainage.

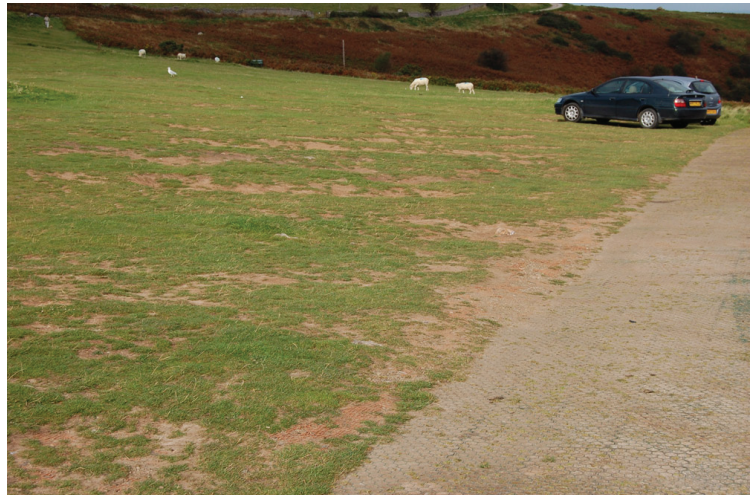
Plate 2: Erosion on site of new car park, from SE

The ridge and furrow extended into the area proposed for the car park but it had been disturbed by the construction of the road, previous attempts to create some hard standing along the road edge, and by vehicle erosion.

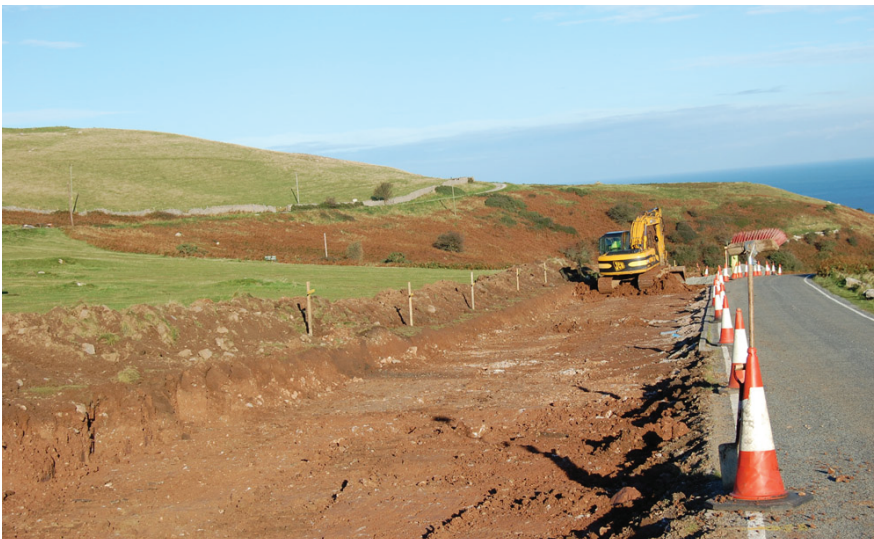
Plate 3: Trench dug for car park foundations, from SE

Although the excavation process was rapid the machine driver was very competent and produced a clean, flat surface. Within the ploughsoil and the silt layer below any features present would have been visible if their fills were sufficiently different to the general layer. The boulder layer was stony and a clean surface was impossible to achieve so small features would probably have been missed but large pits or ditches would have been visible. The area reduced for the car park was 106m in length and 7.2m wide. Its depth varied due to the hill slope but was up to 0.8m deep.

There was a 2m wide zone of hard standing adjacent to the road but the rest of the of the disturbance shown in the geophysical survey (anomaly 7) could not be attributed to any specific features on the ground. It is likely to have been largely the result of compaction. However there were some isolated dumps of modern material in this area including one adjacent to anomaly 3. The trench was not wide enough to investigate this anomaly, but it is possible that it is the result of a spread of modern material. Anomaly 2 was not identified within the trench.

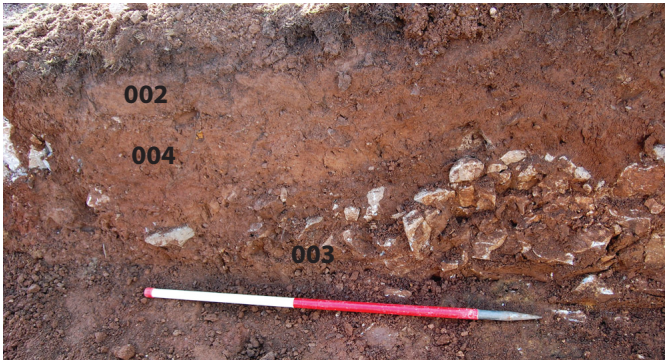
The boulder clay itself (003) was very variable (plates 4 and 5). In places it was very rocky with pieces of limestone raised up through the clay by frost action towards the end of the last glaciation. There were also lenses and pockets of yellow-brown gravelly clay and finer lenses of silt, some of which had been stained black by mineral precipitation.

Plates 4 and 5: Section showing variation in the natural boulder clay (003)

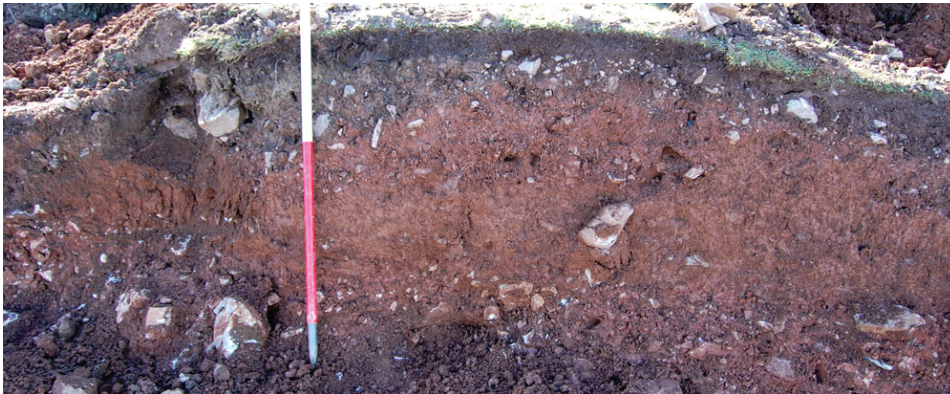
A roughly rectangular modern pit (cut 007) had been dug through the ridge and furrow towards the south-eastern end of the trench (Figure 2). This was partly filled by tarmac fragments and broken bottles. The clay from digging this pit had been dumped on its north-western edge to form a mound (context 005, plate 6), and it is possible that at least anomaly 6 on the geophysics survey is another of these mounds next to a modern pit as it has no obvious bedrock outcrop in the surface. The mound 005 preserved the ploughsoil to a greater depth than elsewhere but did not reveal any further information about the ridge and furrows (Figure 4).

Plate 6: Section showing ploughsoil (002) preserved under mound (005)

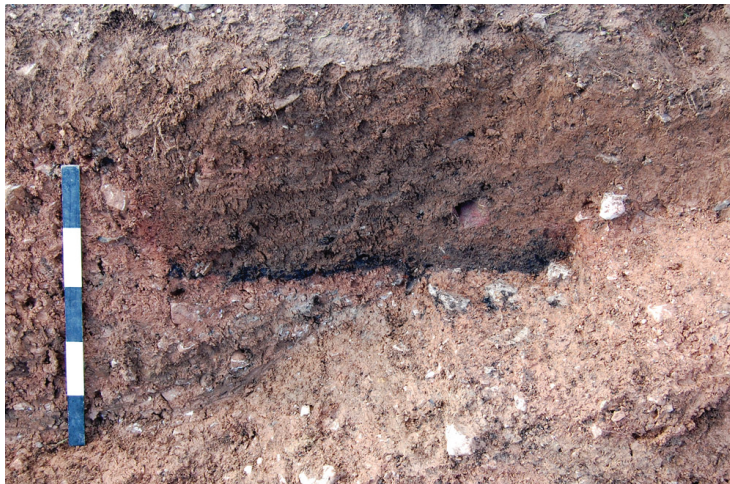
About 14.5m from the south-east end of the trench against the south-western baulk was found the only ancient feature (Figure 2). No other features were noted in this area. This feature was a small pit (cut 010) 0.7m across and half obscured under the baulk (Figures 5 and 6, and plate 7). It was not visible until the boulder clay had been reached so the machine took part of it away but enough survived for a quarter to be excavated by hand. In its base was a thin lens of charcoal (009) and this was collected. The main fill (008) was a mid brown clayey silt with some fragments of charcoal and a lens of red-brown clay towards the top. The charcoal lens suggests this may have been a fire pit or oven, and this was supported by faint traces of burning on the pit sides.

Plate 7: Section of pit 010 showing fills 008 and 009

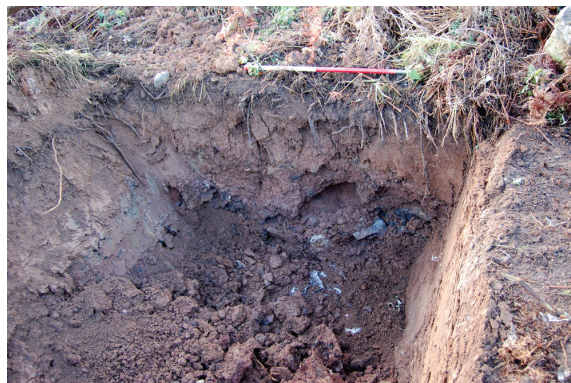
Plate 8: Soak-away from NE

The soak-away was dug on the north-east side of the road and measured 2.4m square. It was 1.7m deep and a trench 0.5m wide and 1m deep was dug on its western side. The topsoil and ploughsoil together were 0.2m deep from the ground surface. The B horizon below (004) was a further 0.2m deep, then the boulder clay continued to the base of the soak-away. Towards the bottom the boulder clay became very stony but no *in situ* bedrock was seen. No archaeological features were identified and although the ridge and furrow runs across this area the trench gave no new information on these. The hole was too deep and unstable to allow access so the trench sides were not cleaned to inspect whether furrows were clearly visible, but as the soak-away was located only 2m from the road edge preservation was unlikely to be good.
