Stable Block - North Elevation

Stable Block - South Elevation

Stable Block Section A

Stable Block & Store - West Elevation

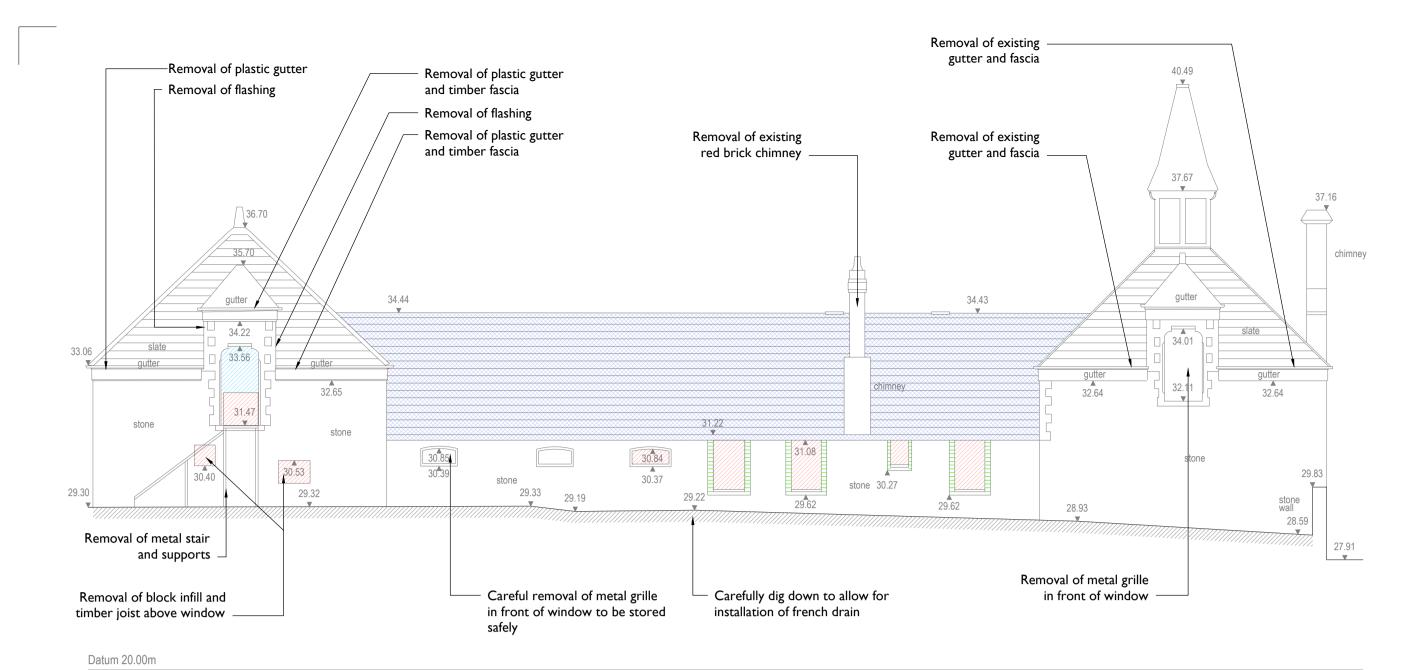
Removal of timber and No access - roof structure unknown metal fence and gate May need removal and modification Removal of SVP Remove all plant growth Remove plant growth Carefully remove slates and stack Remove fascia for inspection and re-use Removal of gutters and timber fascia area covered by 32.59 woodlap fence 31.48 stone wall 29.53 groove in wall 28.25 - Carefully remove render Remove block and Removal of metal to expose stone behind
