CPAT Report No. 1652

Ffrydd Vaughan, Dolfor Road, Newtown, Powys

Building Survey

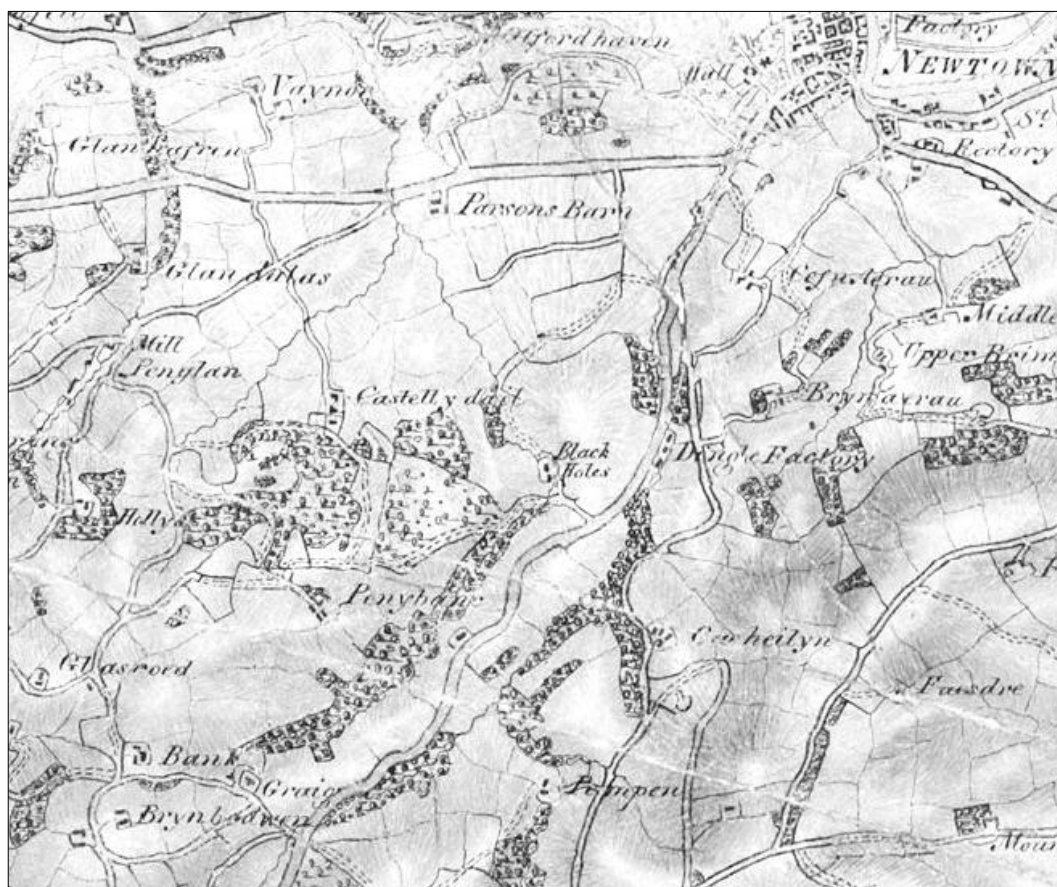
Fig. 2 Extract from the 1817 Ordnance Survey Surveyors' Drawing (no. 198)

- 2.1. The building is not recorded in the regional Historic Environment Record or the National Monument Record and the online catalogues for Powys Record Office and the National Library of Wales failed to reveal any likely useful sources.
- 2.2. The earliest cartographic evidence for the building is provided by the Ordnance Survey in the form of the Surveyors' Drawing of 1817 and the 1836 Old Series mapping (Figs 2 and 3). The former does not depict Ffrydd Vaughan while the latter does, although it is not named. It also shows the new turnpike road between Newtown and Llandrindod Wells, which was built following a Turnpike Act for Montgomeryshire in 1834, suggesting that the farmhouse dates from 1834-6.

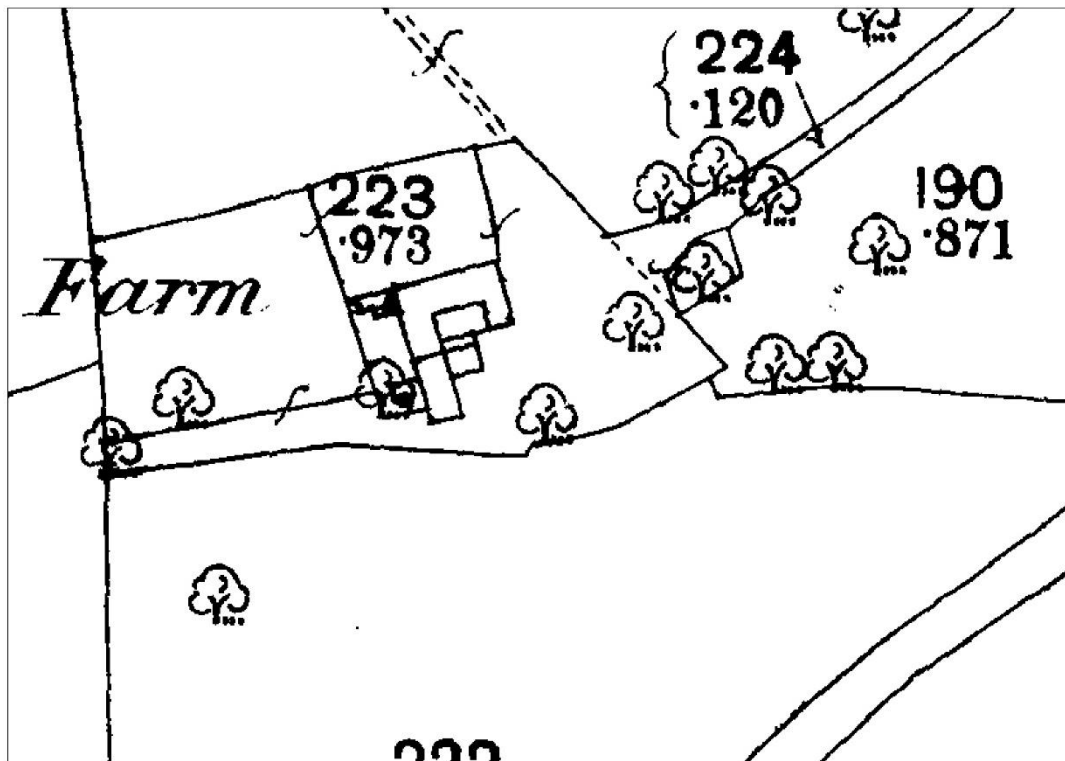
Fig. 5 Extract from the 1886 Ordnance Survey 1st edition 25" mapping

- 2.3. The Tithe Survey for Newtown of 1843 (Fig. 4) identifies the house as 'Ffrydd Vaughan', 'house, buildings, garden, stackyard and lane', in the ownership of Reverend George Arthur Evors and occupied by William Reese.
- 2.4. By the time of the Ordnance Survey large scale mapping of 1886 (Fig. 5) the house was known as Ffrydd Farm and comprised the farmhouse with an adjoining U-shaped range to the north. By 1902 (Fig. 6) two new buildings had been added to the western side of the house. The relationship between the surviving building and those recorded in 1902 is depicted in Fig. 7.

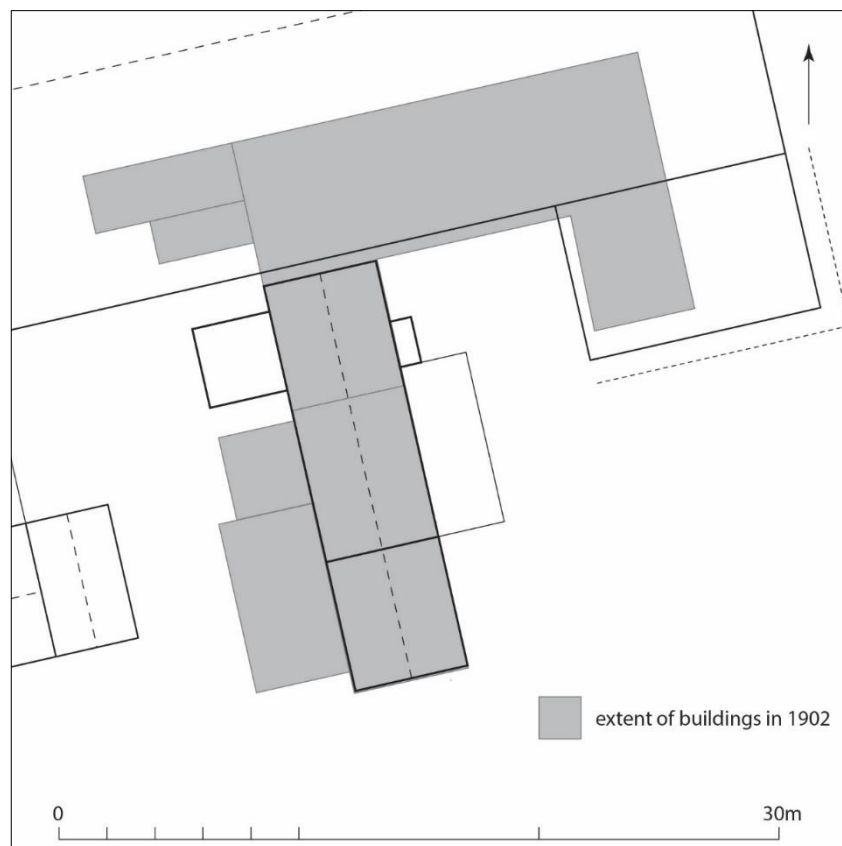
Fig. 7 Comparison between the existing buildings and those depicted by the Ordnance Survey in 1902

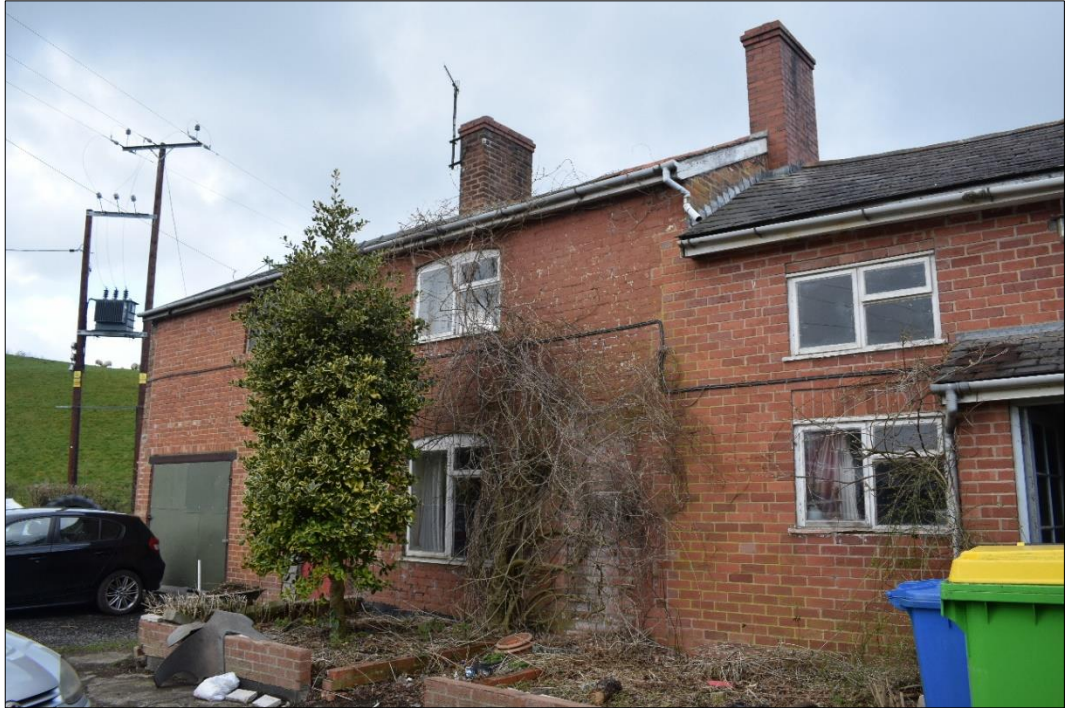
Fig. 8 The eastern elevation. Photo CPAT 4630-0002

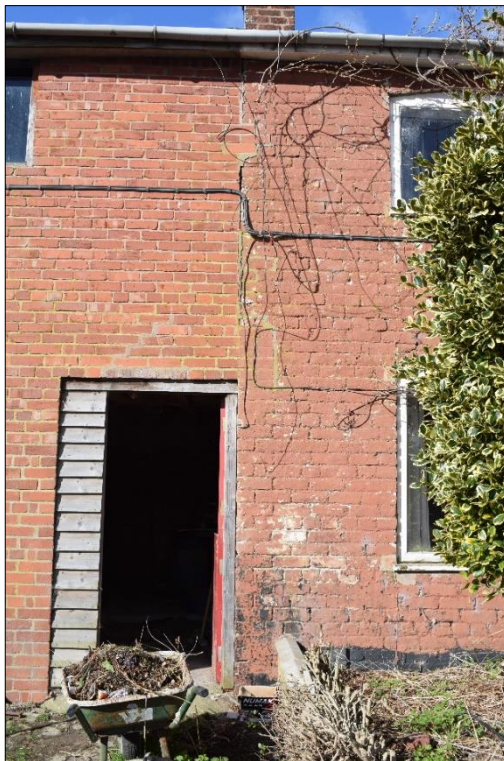
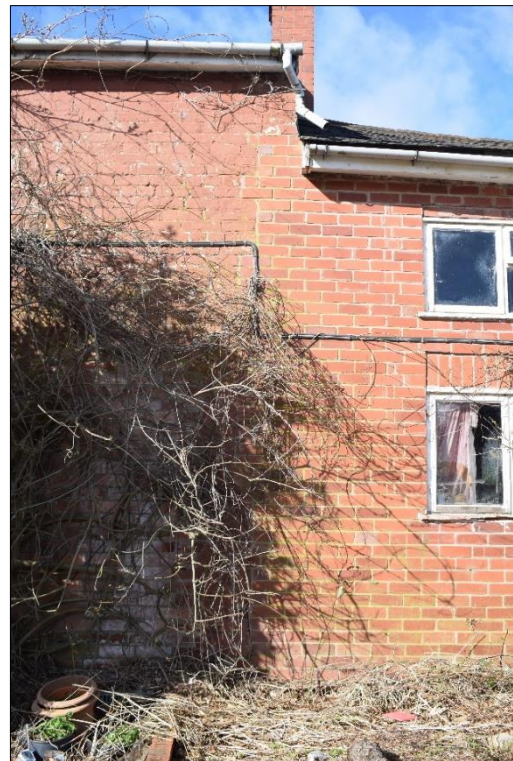
- 3.4. The northern end of the house appeared to be later, the west elevation having a joint in the stretcher courses, but with the headers acting as a tie, the style of the brickwork being the same (see Fig. 22). On the east elevation the northern end of the house had been rebuilt in modern brick, such that the phasing was not apparent. What is curious, however, is that the northern end had a lower roof line and although the brickwork suggested that this end is later, internally this was not apparent.

- 3.5. The southern end was certainly a later addition, having straight joints between this and the original house on both elevations, although again the brickwork was in the same style, but using more uniform bricks. At the time of the survey this was used as a garage and store with loft above, but was not accessible. It was likely to have been built as a stables and/or cart shed, with a hayloft above, accessed via external wooden stairs on the southern gable (Fig. 13).

Figs 9 and 10. The eastern elevation showing the joints between the original house and the store (left) and later rebuild (right). Photos 4630-0014 and 15

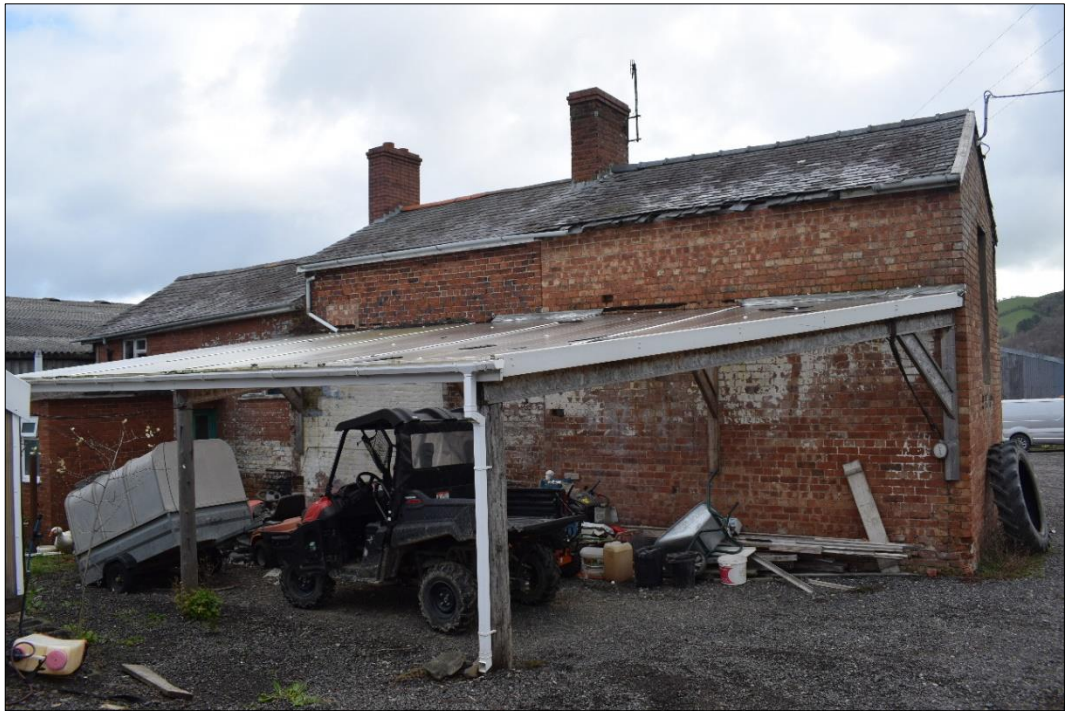
Fig. 11 The western elevation. Photo CPAT 4630-0006

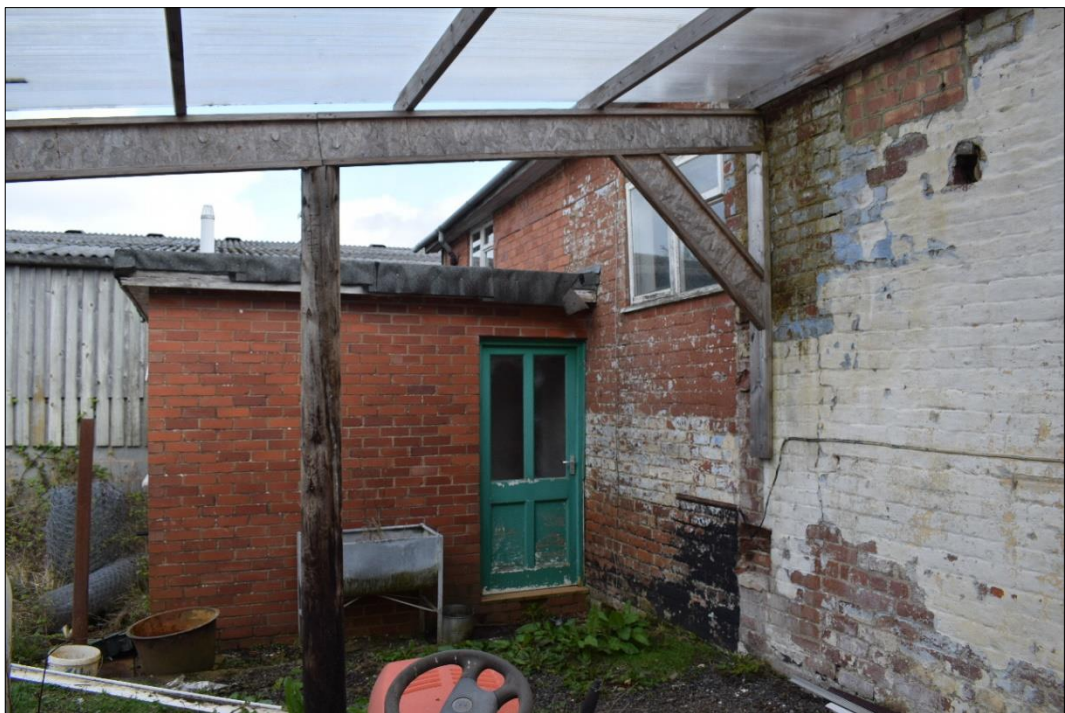
- 3.3. The house was built of red brick, forming two storeys with a slate roof and ceramic ridge tiles. The oldest surviving part was the central section, which had hand-made bricks 237-245mm (c. 9 ¹/₃ to 9 ²/₃ inches) long, 110-115mm (4 ¹/₃ to 4 ¹/₂ inches) wide and 75mm (3 inches) thick, laid using English garden wall bond, with one course of headers for every three courses of stretchers. The ground- and first-floor windows on the east elevation both had arched brick voussoirs, while the western elevation had only a small, blocked window (Fig. 12) which would have lit the landing at the top of the stairs.

Fig. 12 The western elevation, showing the extension and blocked first-floor window on the landing. Photo CPAT 4630-0011

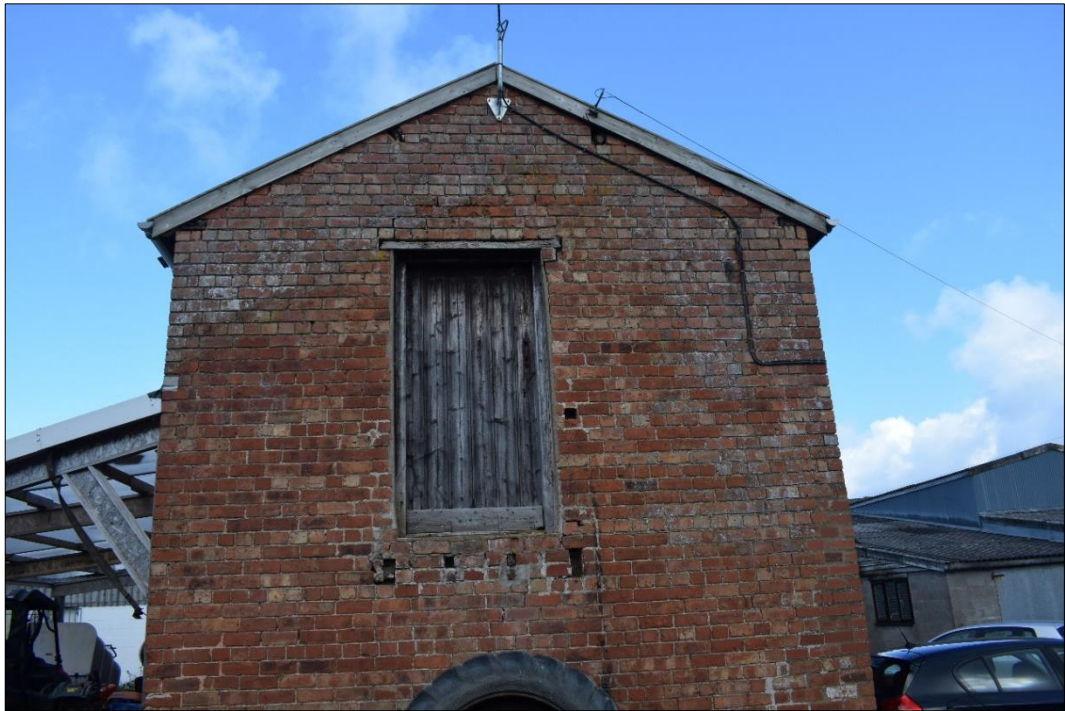
Fig. 13 The southern gable end showing the first-floor access and sockets for landing and handrail. Photo CPAT 4630-0013

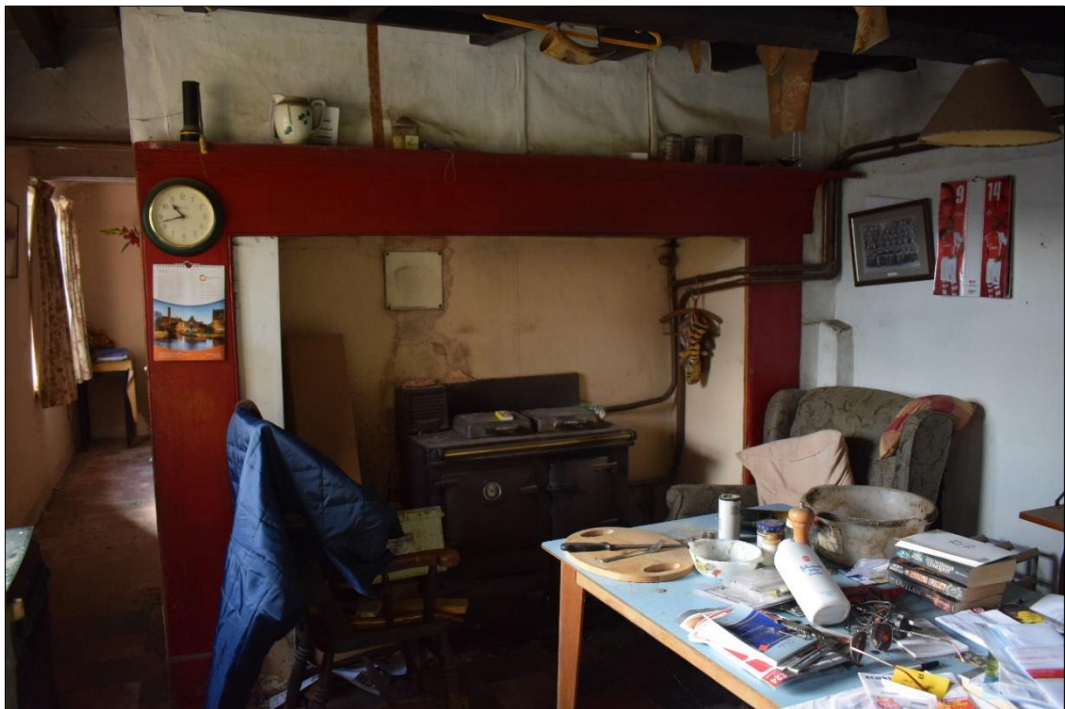
- 3.6. Internally the house was divided into three units on the ground floor. The main entrance, from the east, led into the kitchen (Fig. 14), which had a door into a living room (Fig. 15) to the south and another to the west leading to the stairs, a utility to the north, and a modern bathroom/WC extension. The kitchen and utility had quarry tiled floors in a red and black chequerboard pattern, while the living room had plain, red tiles.

Fig. 14 The kitchen. Photo CPAT 4630-0017

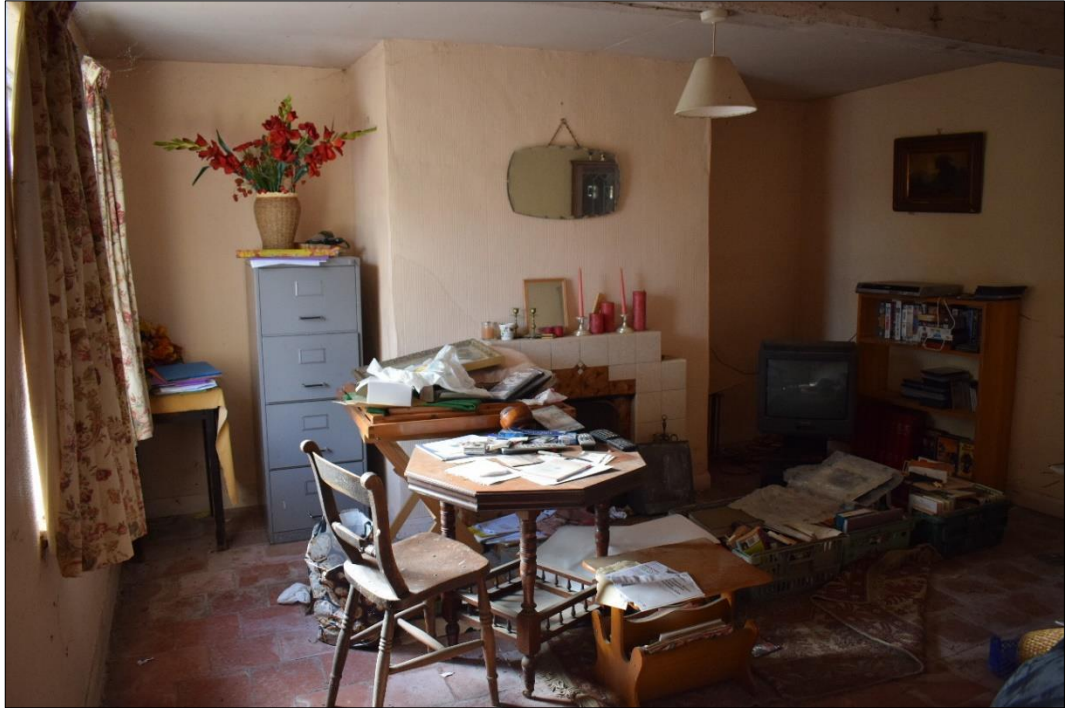
Fig. 15 The living room. Photo CPAT 4630-0019

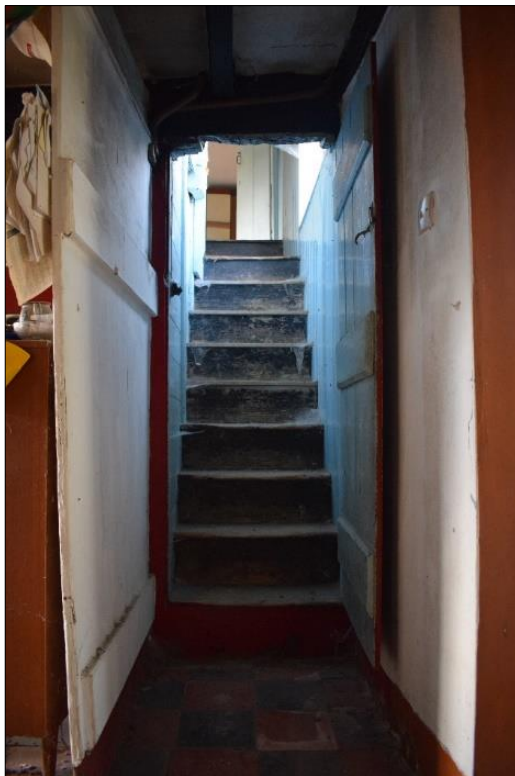
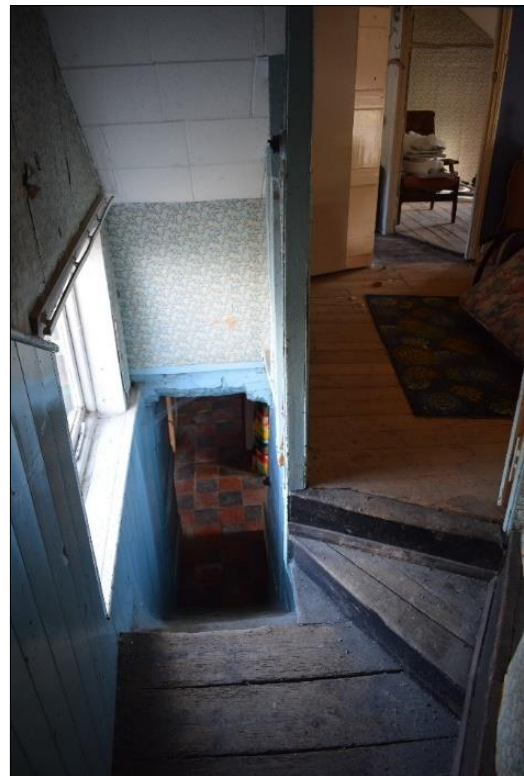
- 3.7. The stairs (Figs 16-17) led to a half landing, originally lit by a small window, later blocked and and at the time of the survey hidden behind panelling. There was a further step ahead to the main bedroom (Fig. 18) to the south, and two steps to the left to a landing bedroom (Fig. 19). This led through to a further bedroom, which was later divided into two by a timber partition (Fig. 20).

Figs 16 and 17 The stairs viewed from the ground floor (left) and landing (right).
Photo CPAT 4630-0022 and 25

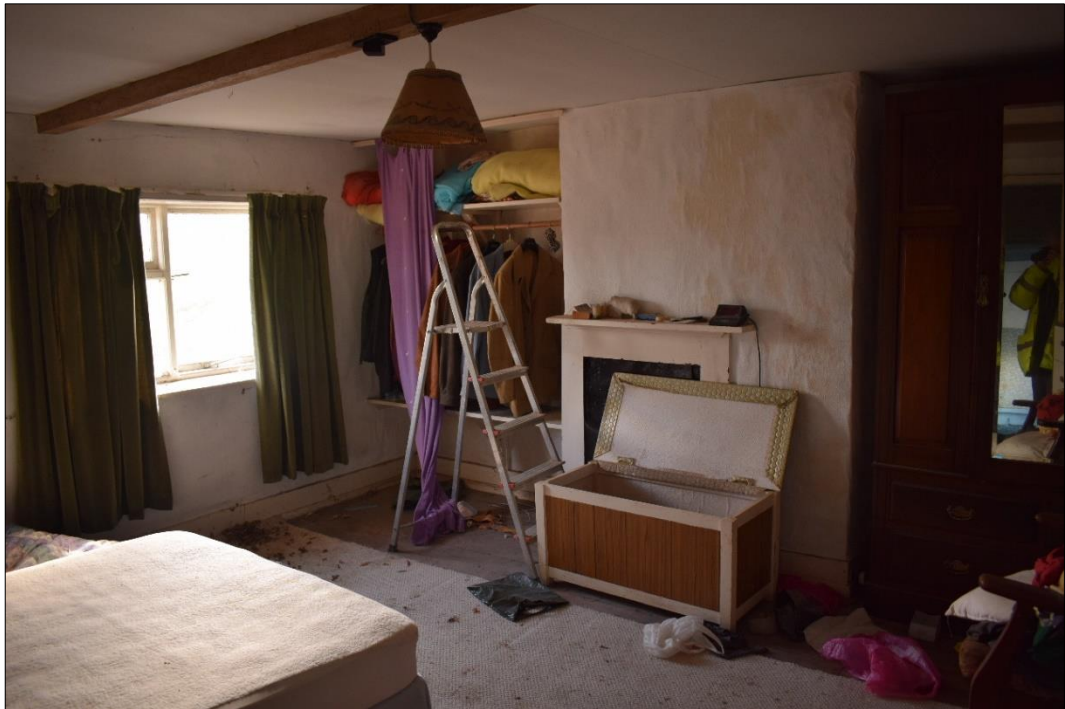
Fig. 18 The bedroom in the original house. Photo CPAT 4630-0026

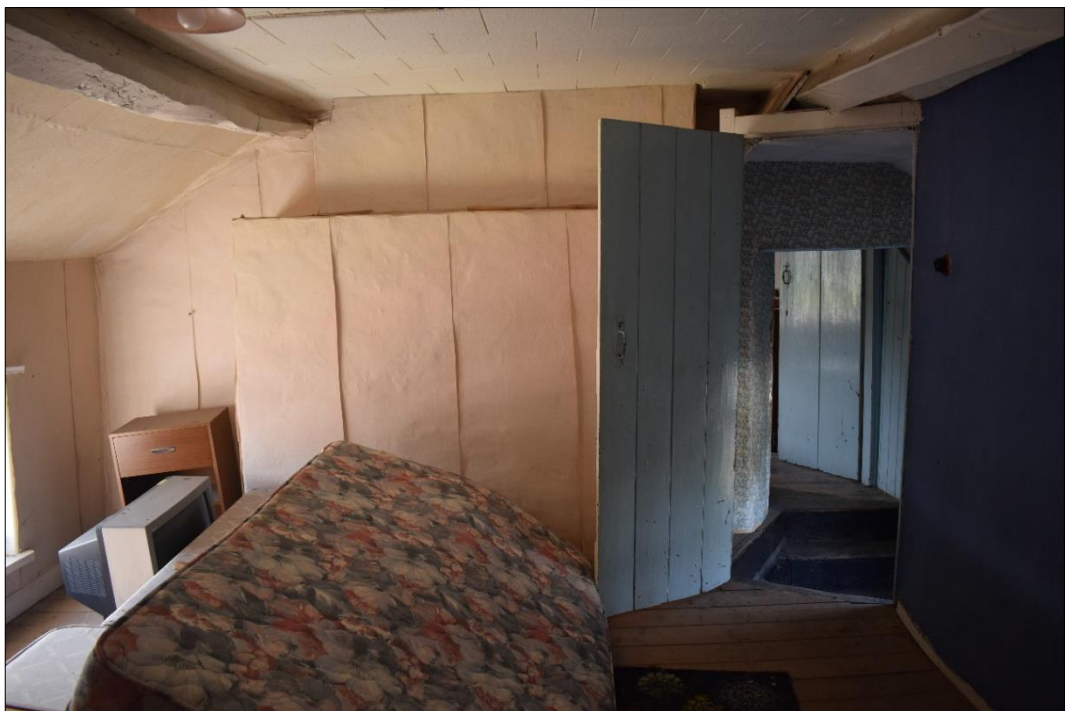
Fig. 19 The central, landing bedroom. Photo CPAT 4630-0029

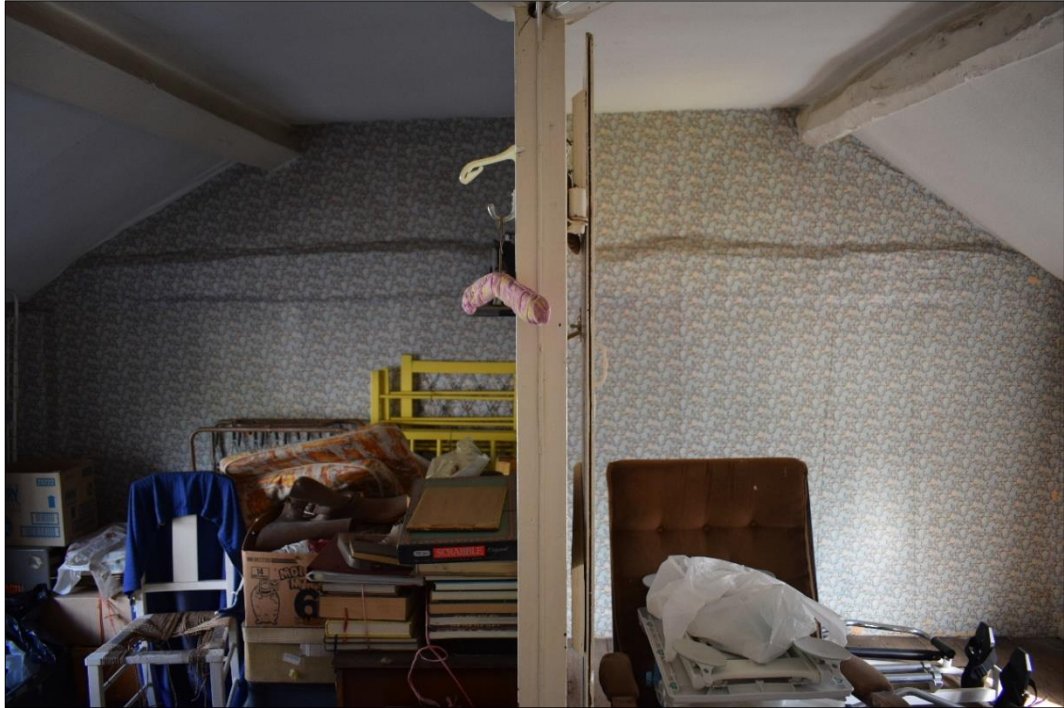
Fig. 20 The two northern bedrooms. Photo CPAT 4630-0030

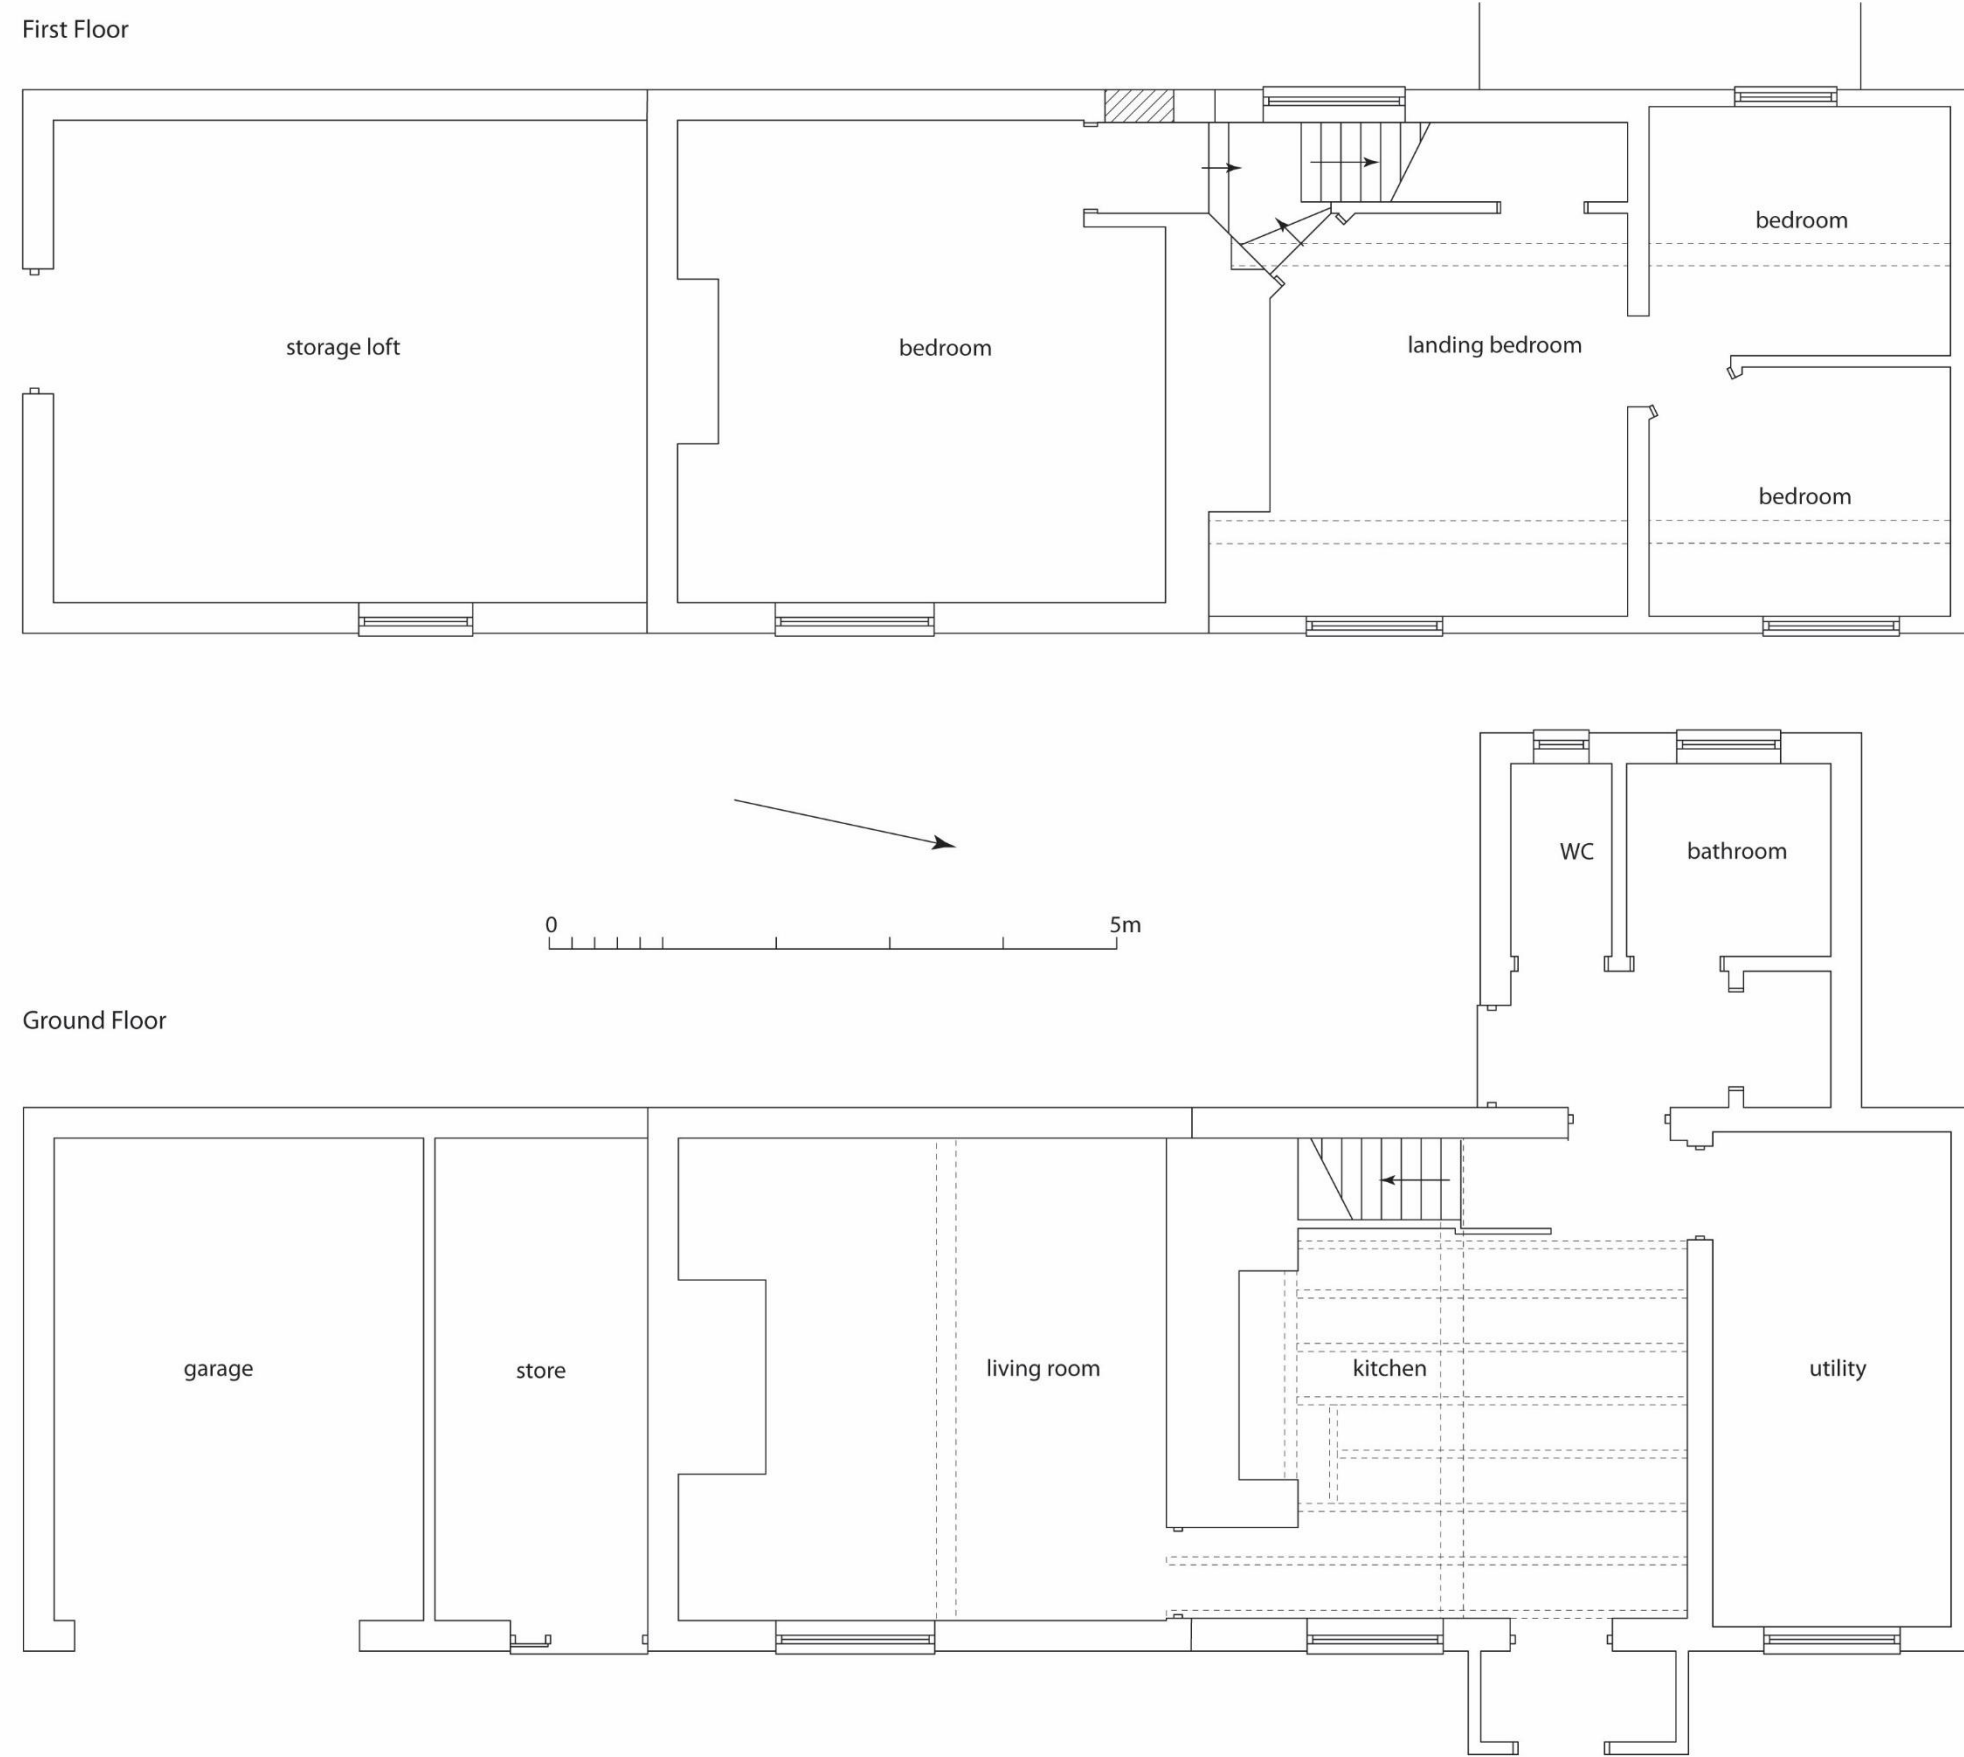
Fig. 21 Ground and first-floor plans

- 3.1. The survey was conducted on 2 April 2019 and took the form of a Level 3 building survey as defined by Historic England (2016) *Understanding Historic Buildings: a guide to good recording practice*. Floor plans and elevations are provided at the rear of the report (Figs 21-23), together with a plan locating the positions and direction of views of the photographs (Fig. 24).
