## **Gupton Farm, Freshwater West Pembrokeshire**

Building Recording  
& Watching Brief

Report No. 1595

Prepared For: The National Trust Wales

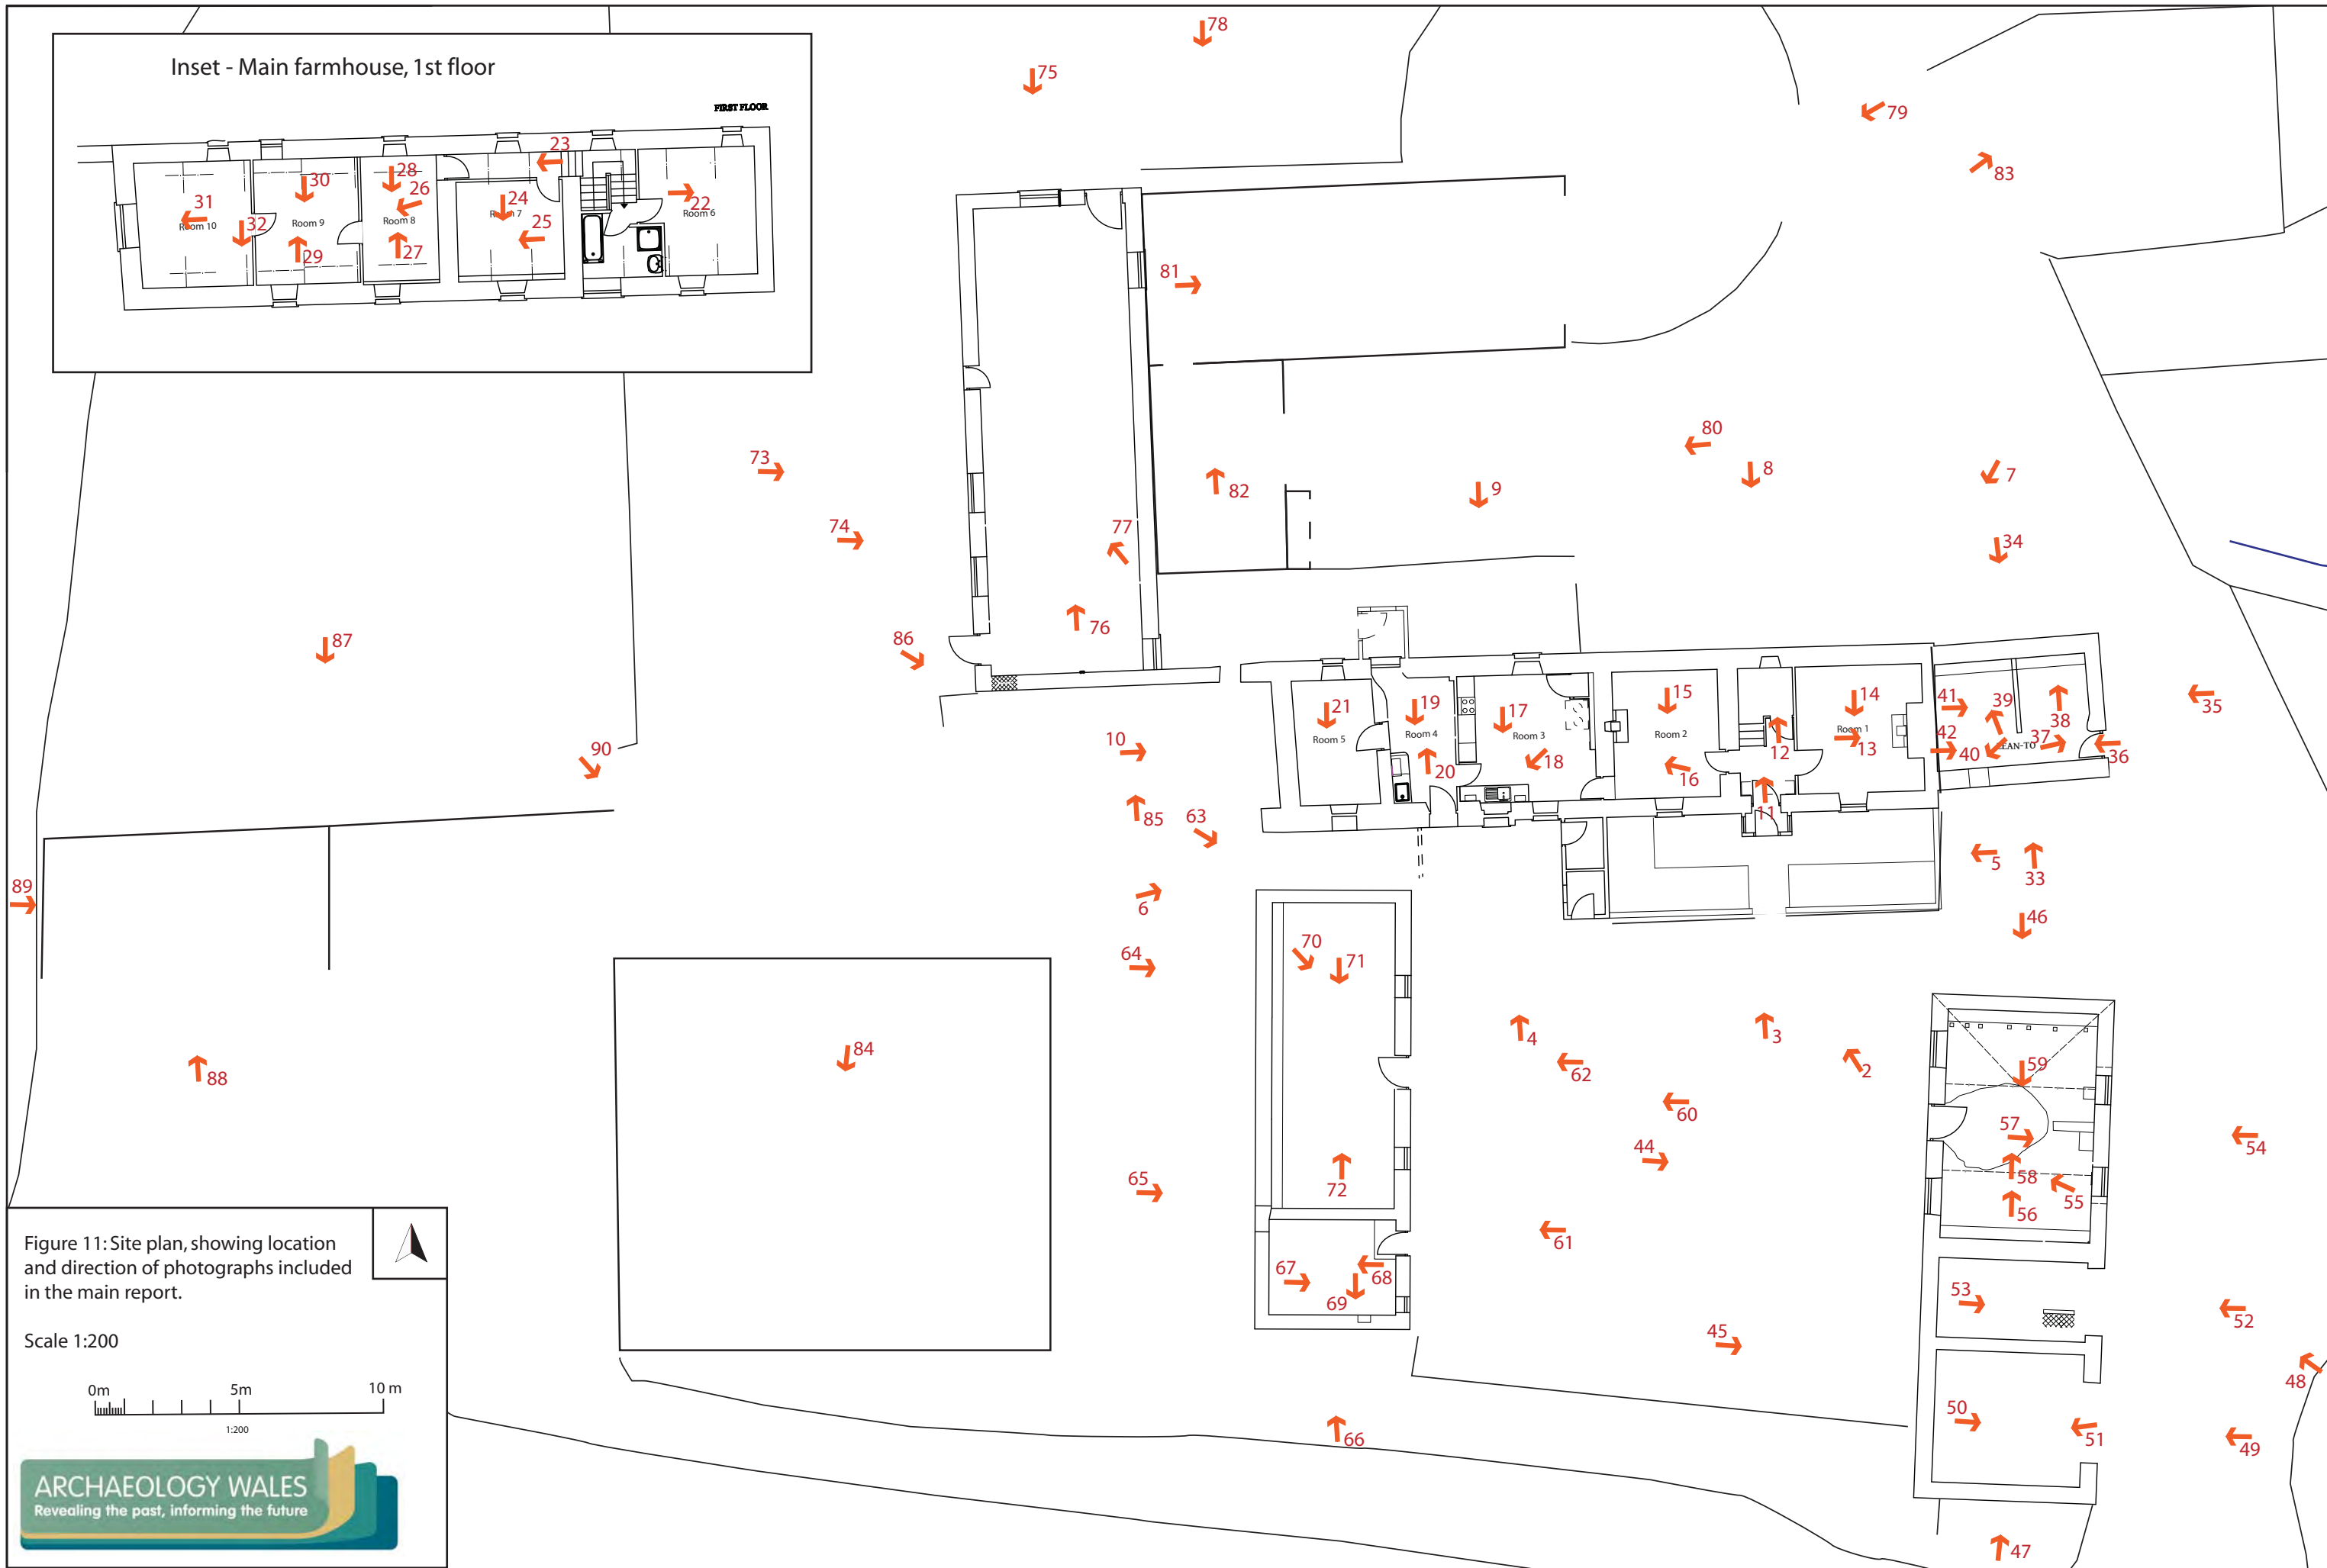
Figure 11: Site plan, showing location and direction of photographs included in the main report.

Inset - Main farmhouse, 1st floor

- 6.1.1 Figure 6 shows the existing ground floor plan of the main farmhouse building, Figure 7 shows the elevations. Figure 11 shows the location and direction from which the photographs were taken: the number after each red arrow corresponds to the plate on which the photograph appears.

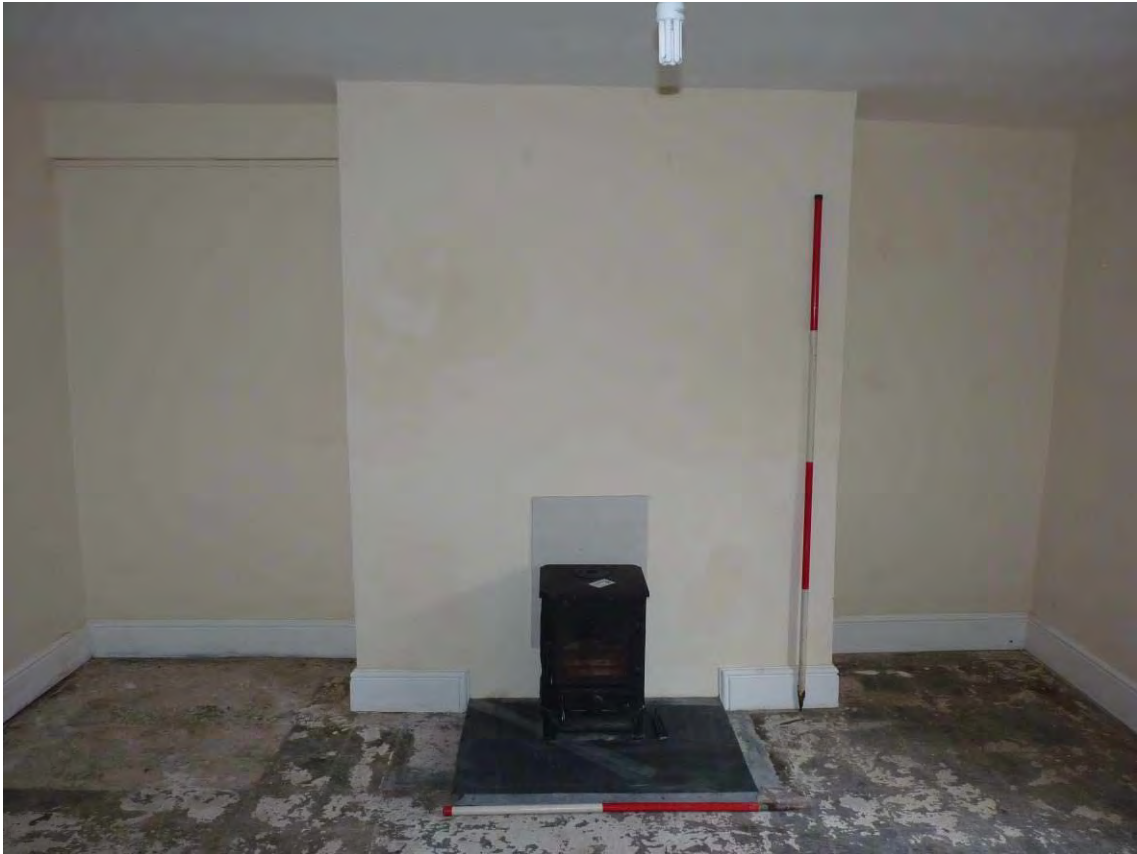
Photo 13: The Farmhouse interior, Room 1. Looking East. 1m & 2m scales

- 6.1.9 An inserted stud wall divides the entrance hall from Room 1 to the east, which is accessed via a doorway (1.78m x 0.84m) with a white-painted wooden door. This room is square (4.4m x 4.4m), with painted plastered walls and ceiling, modern white skirting and concrete tile flooring. There is a protruding chimney stack located centrally on the eastern wall, now blocked and fronted by a wood-burning stove on a slate plinth. Placed slightly off-centre in the southern wall there is a window (1.1m x 0.9m) within a recess 1.9m tall with no sill, which indicates this infills a former doorway.

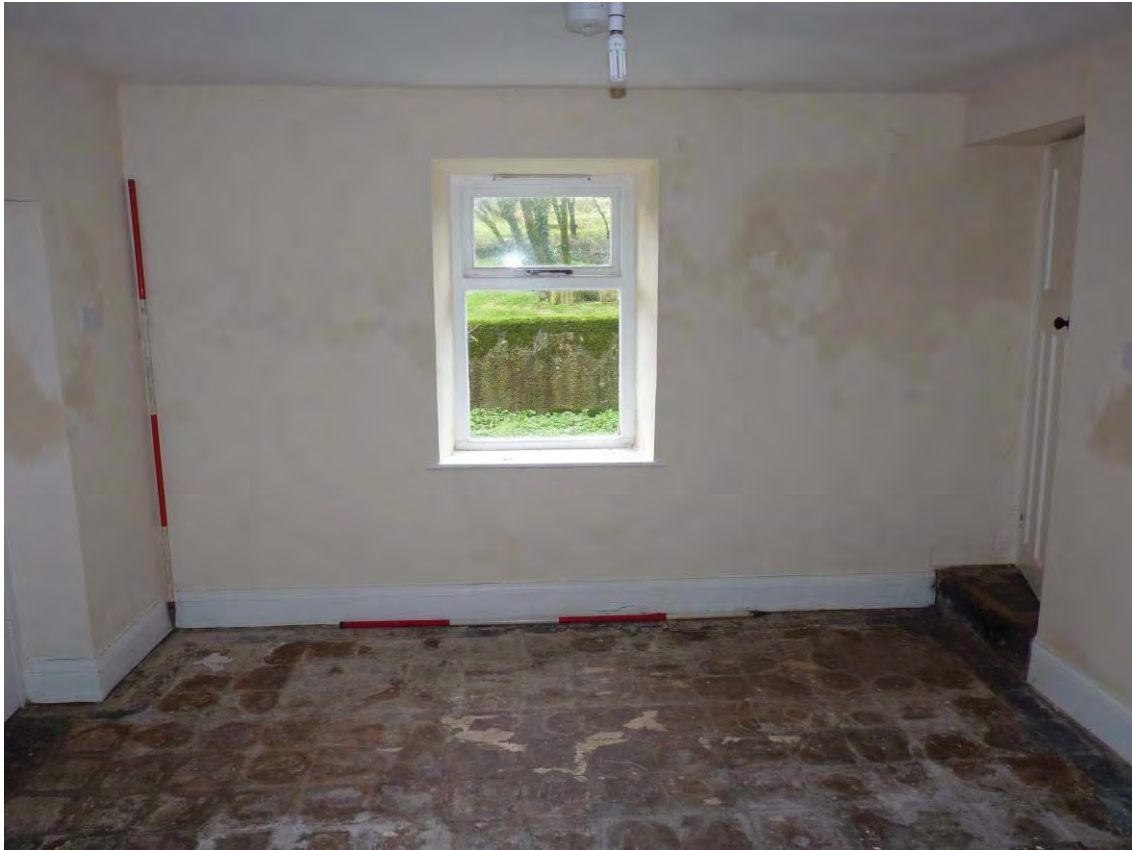
Photo 15: The Farmhouse interior, Room 2. Looking South. 2m scales.

- 6.1.10 To the west of the entrance hall a 0.7m wide wall divides it from Room 2, accessed via a doorway (1.86m x 0.87m) with a white-painted wooden door. The room is sub-square (4.4m x 3.6m), 2.44m high, with painted plastered walls and ceiling, modern white skirting and concrete tile flooring. A centrally-located fireplace lies flush to the western wall, now blocked and fronted by a wood-burning stove on a slate plinth. A single window (1.1m x 0.9m), with a wooden sill, is positioned centrally on the southern wall.

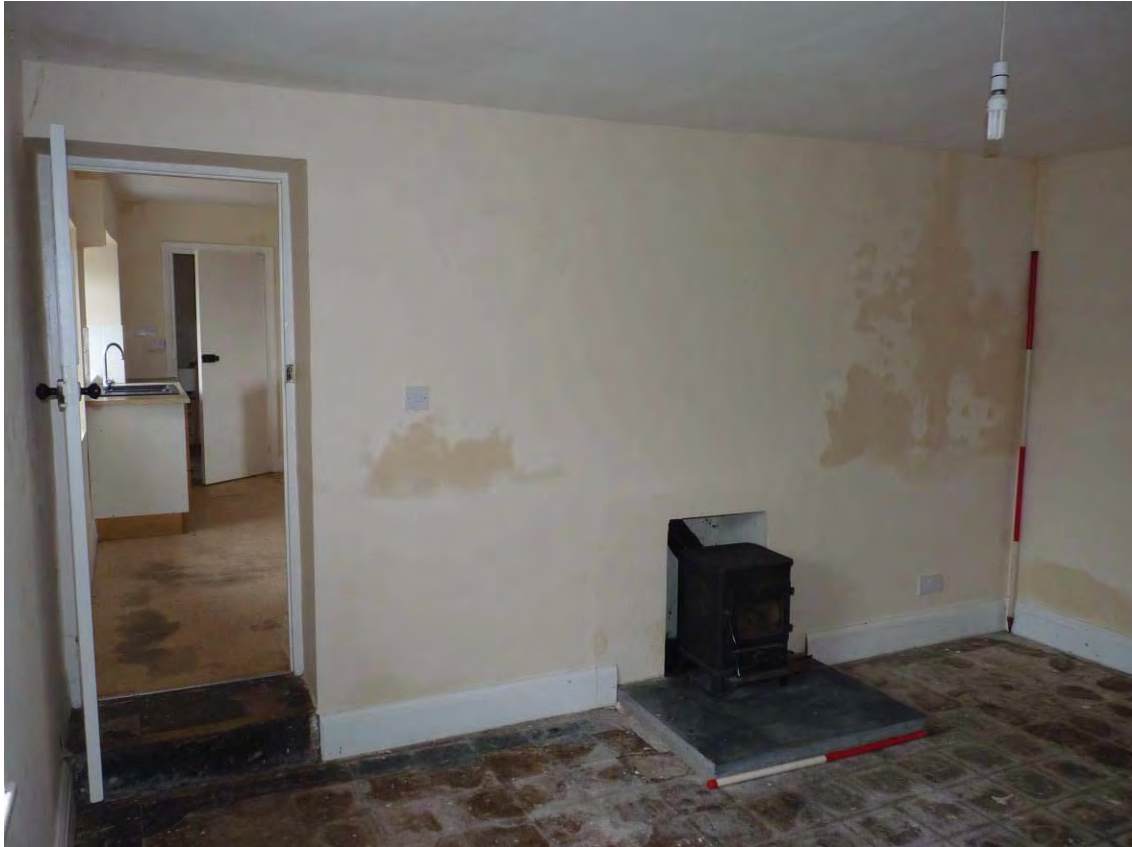
Photo 16: The Farmhouse interior, Room 2. Looking West-northwest. 1m & 2m scales.

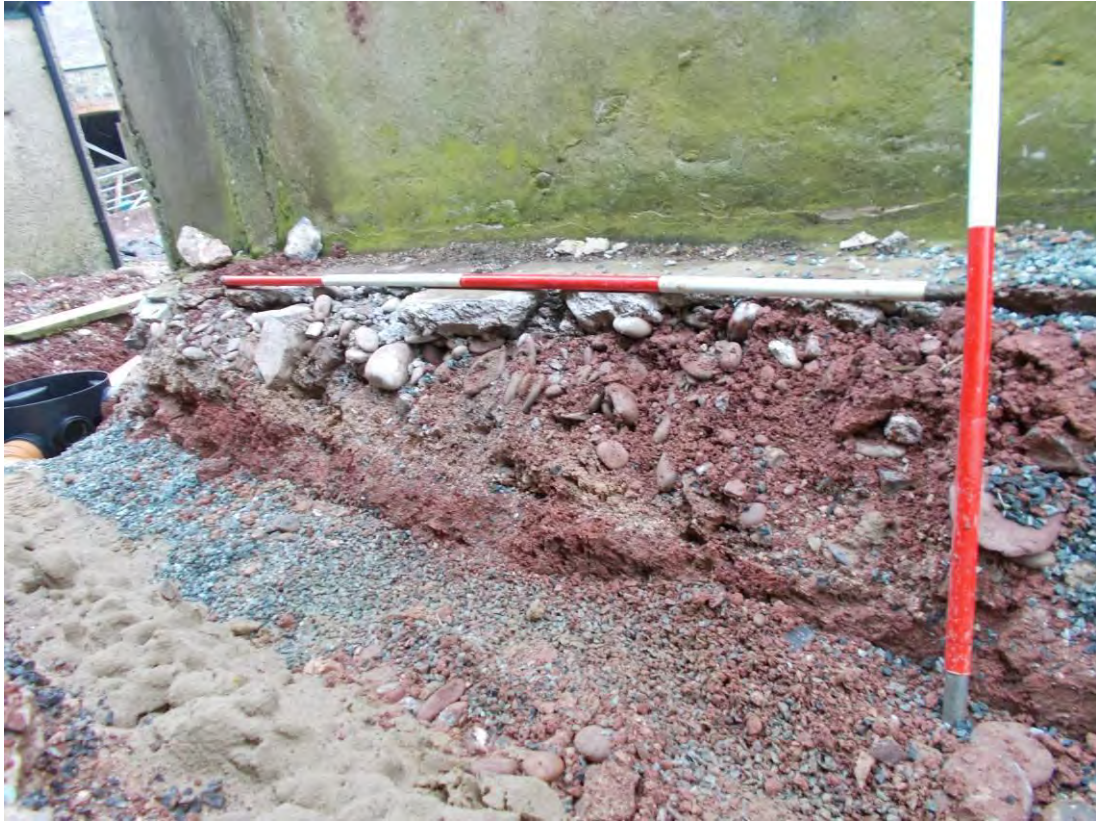
Photo 93: Service trench excavations - trench through passageway between Farmhouse and Cart Shed, north facing section. 1m & 2m scales.

- 7.2.2 The passageway between the farmhouse and Cart Shed had largely been infilled, but visible lying above the natural subsoil (101) was a 0.12m thick layer of light-brown sandy-mortar with abundant stone inclusions (103). This was topped by a 0.1m thick layer of loose rounded stone (104), itself topped by a 0.08m thick layer of concrete (105). Layers (103) and (104) appeared to represent sub-base deposits for the modern concrete surface.

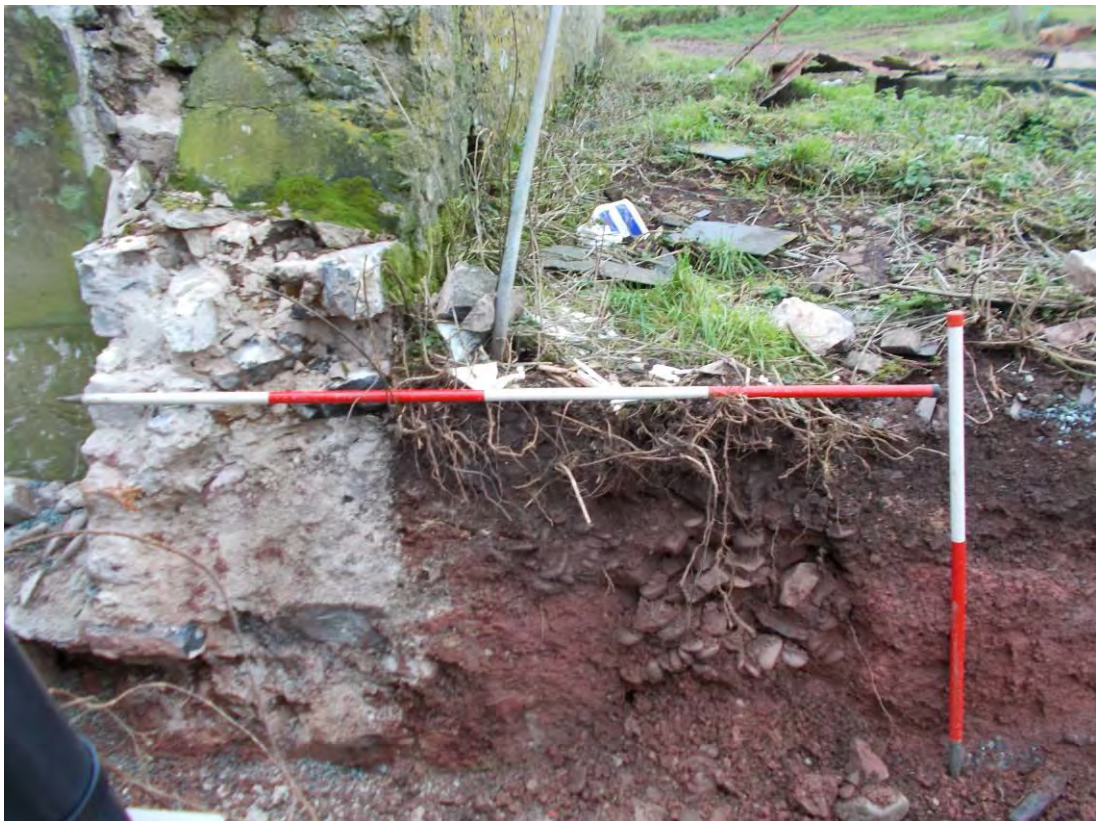
Photo 94: Service trench excavations - trench immediately to the west of the Cart Shed, showing wall [107] and drain [109]. North facing section. 1m & 2m scales.

- 7.3.2 To the west of the passage, subsoil deposit 101 increased in thickness, with bedrock no longer exposed within the service trenches (Section 1). Immediately to the west of wall 107 the subsoil was overlaid by a loose mid reddish-brown clayey-silt with abundant sub-rounded stone inclusions (109). This deposit was at most 0.2m thick. 0.5m to the west of wall 107 both subsoil 101 and layer 109 were cut by a straight-sided, flat bottomed feature [110], 0.55m wide and 0.6m deep. This was infilled with a single loose deposit of mixed large rounded and sub-rounded stone and broken slate, in a mid-reddish-brown clayey-silt (111). The very loose nature of this infilling material would suggest this acted as a drain. This was topped by 0.25m of topsoil (102).
