**ARCHAEOLOGICAL WATCHING BRIEF**

**WB/LPA/17**

**Great Triley, East**

**Planning Application No: 16/13919/FUL**

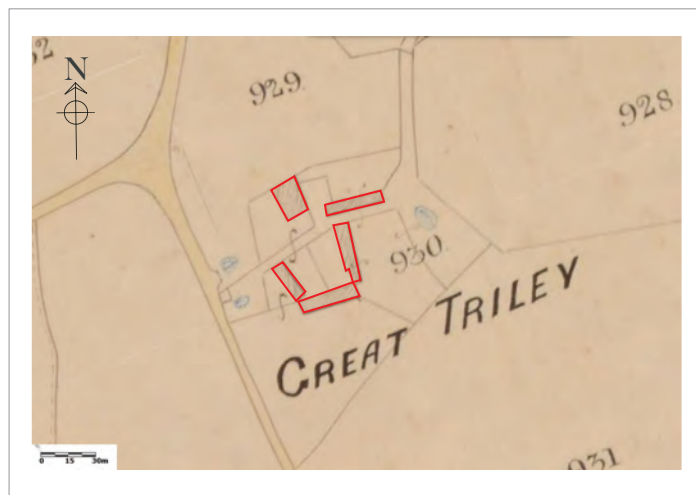
Fig 3A: Tithe map 1839

On the 1839 Tithe map of “Great Triley”, fig 3A, a building plan can be clearly seen, consisting of five buildings; highlighted in red, situated off an access road to the west, (Cw) D2203.

On the 1839 tithe map, no building is shown in the location of the current work; the present building now called Great Triley East had not been built; its location, formerly field 929 is listed in the apportionment as an orchard.

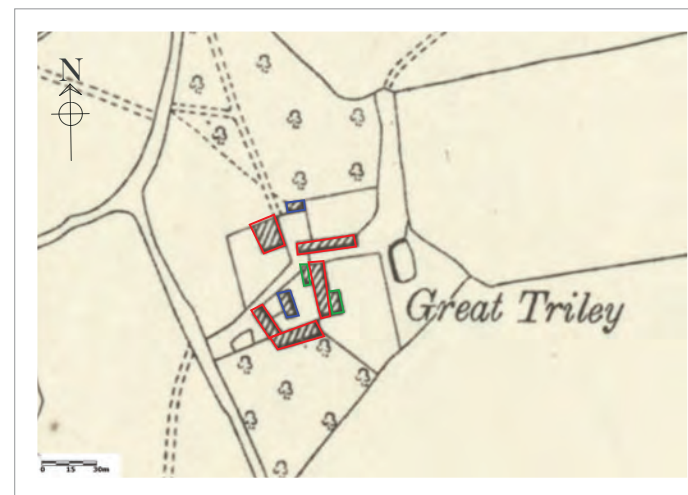
Fig 3B: Monmouthshire VI.NE. Revised 1899, Published 1902

The 1902 Monmouthshire Ordnance Survey map VI.NE, fig 3B, records the survival of the previously listed buildings, the addition of two isolated buildings, highlighted in blue and two extensions, highlighted in green.

The small blue outlined building at the top and right of a new path, is in the location of Great Triley East to which the proposed extension is to be built.

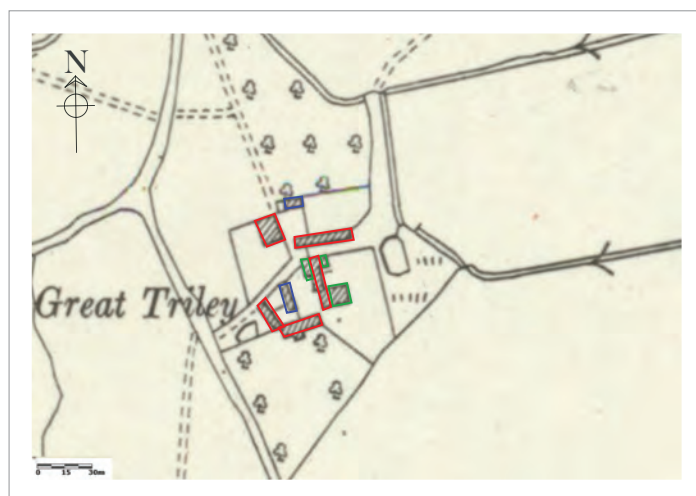
Fig 3C: Brecknockshire XLII. Revised 1916 to 1917, Published 1922

A further small extension is shown to this building on the 1922 Brecknockshire map, fig 3C, however not much else has changed.

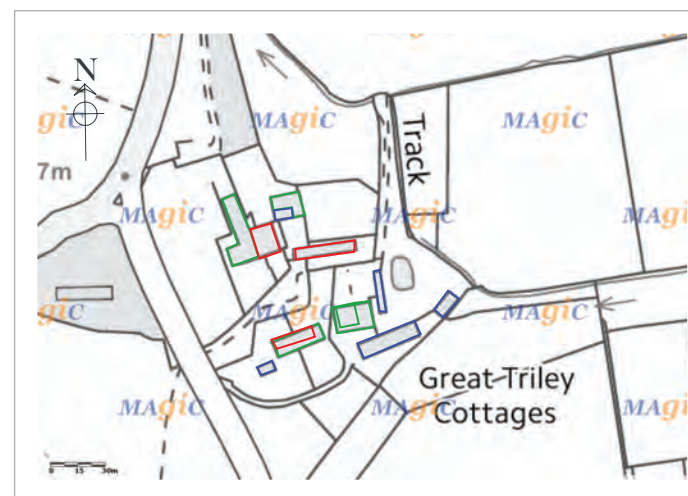
Fig 3D: Magic maps

The last map progression, fig 3D, shows the site as it currently stands, the proposed extension is to the north west corner of Great Triley East; see inset fig 01.

There have been major changes to the southern part of the complex, with the removal of three buildings and the erection of four new ones; however, this does not impact on the immediate site.

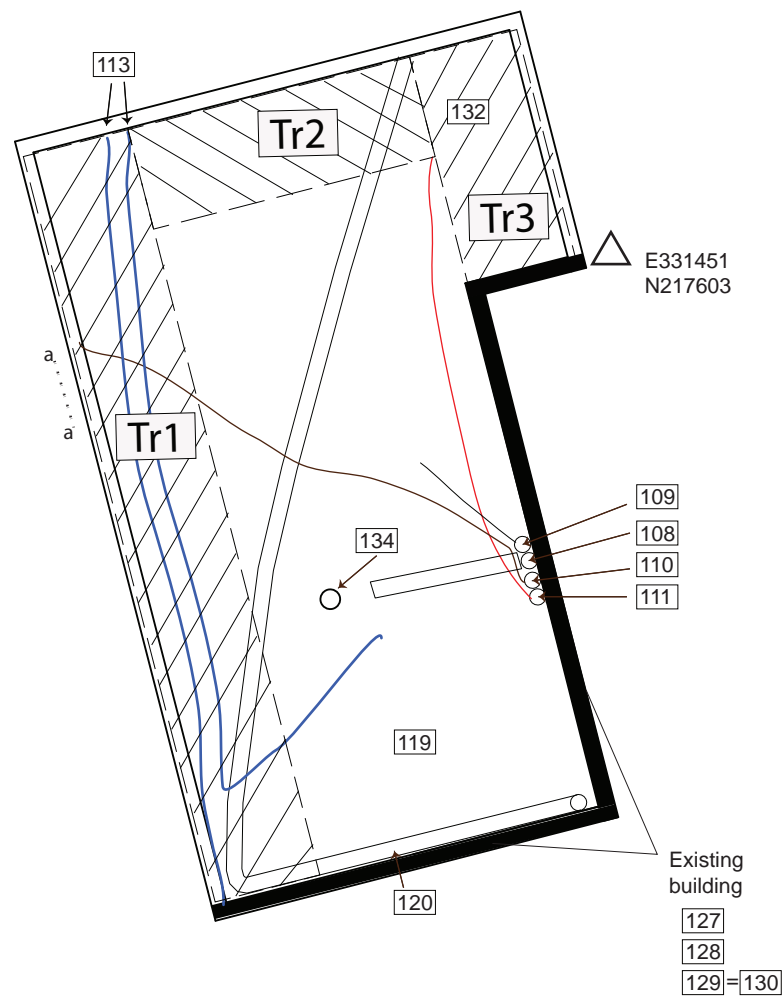
Fig 04: Site Plan View

The proposed work comprised excavation to 750mm of three foundation trenches for the three walls of the extension to the existing property, fig 04.

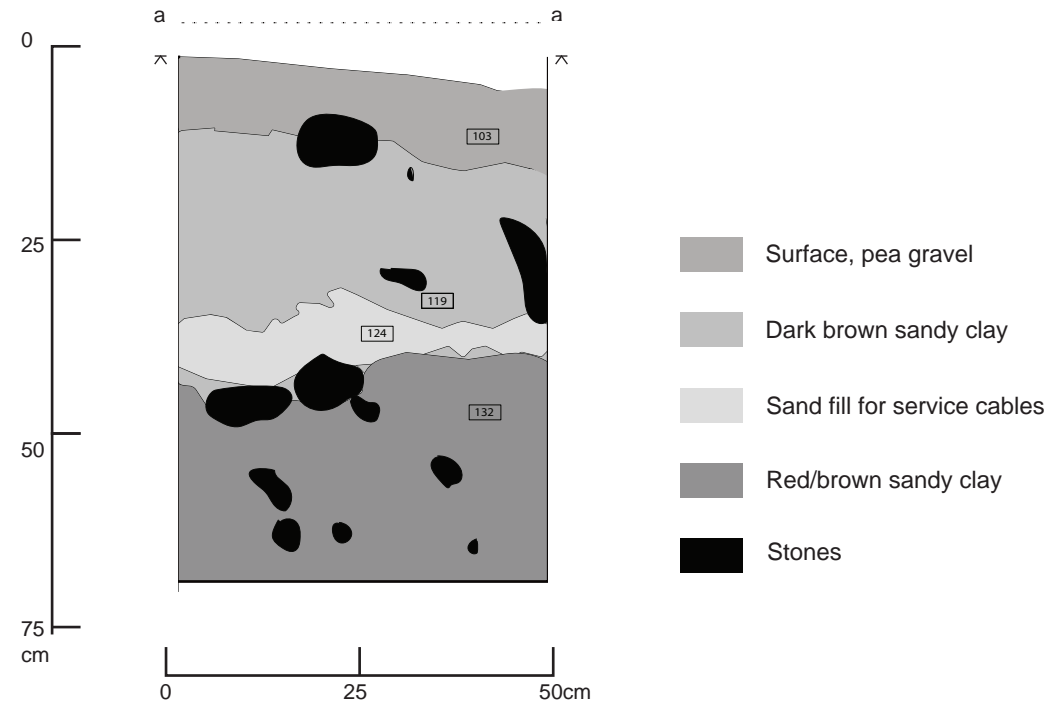
Fig 05 Section aa

*Fig 05 scale drawing is the general context sequence throughout the trenches.*

Beneath this relatively recent patio was a stratigraphic sequence of redistributed, dark brown sandy clay [119] above a natural deposit of undisturbed, red/brown sandy clay [132], PL02.

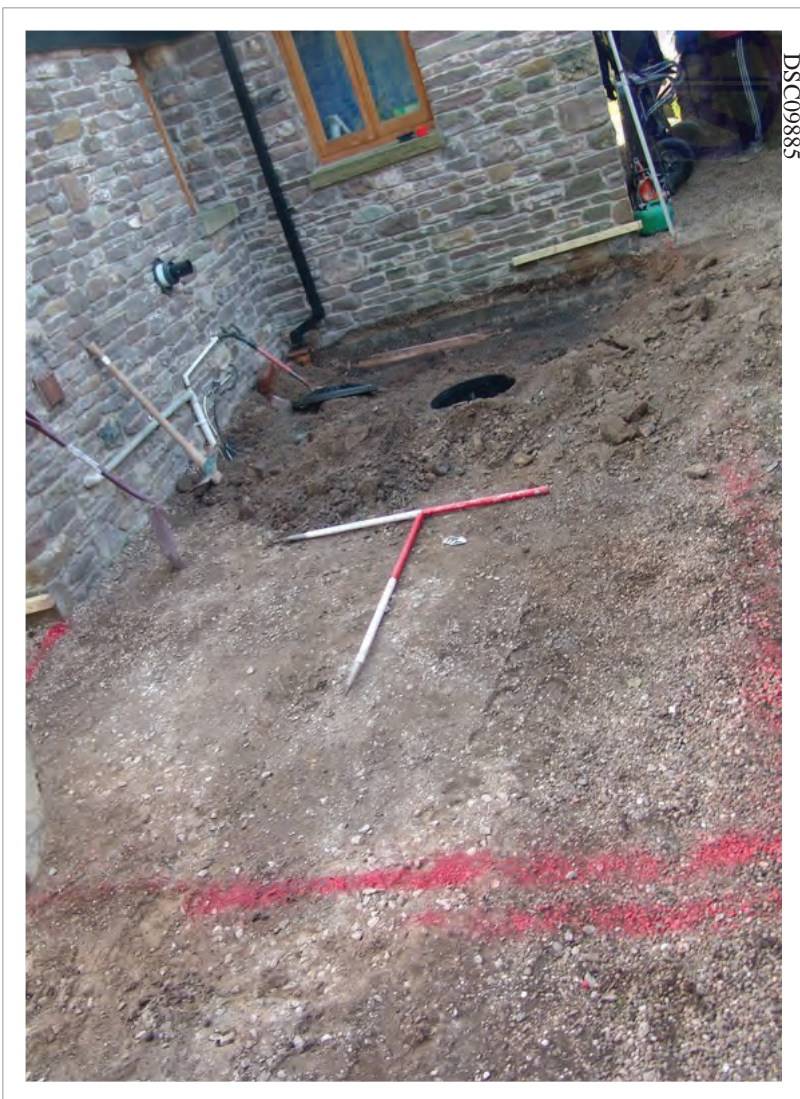
Plate 01: Plan of site pre-excavation

The works started with the removal of a patio [100] slab with sand base [101], pea gravel [103] and compacted dust chippings fill [104] within cut [102], PL01.

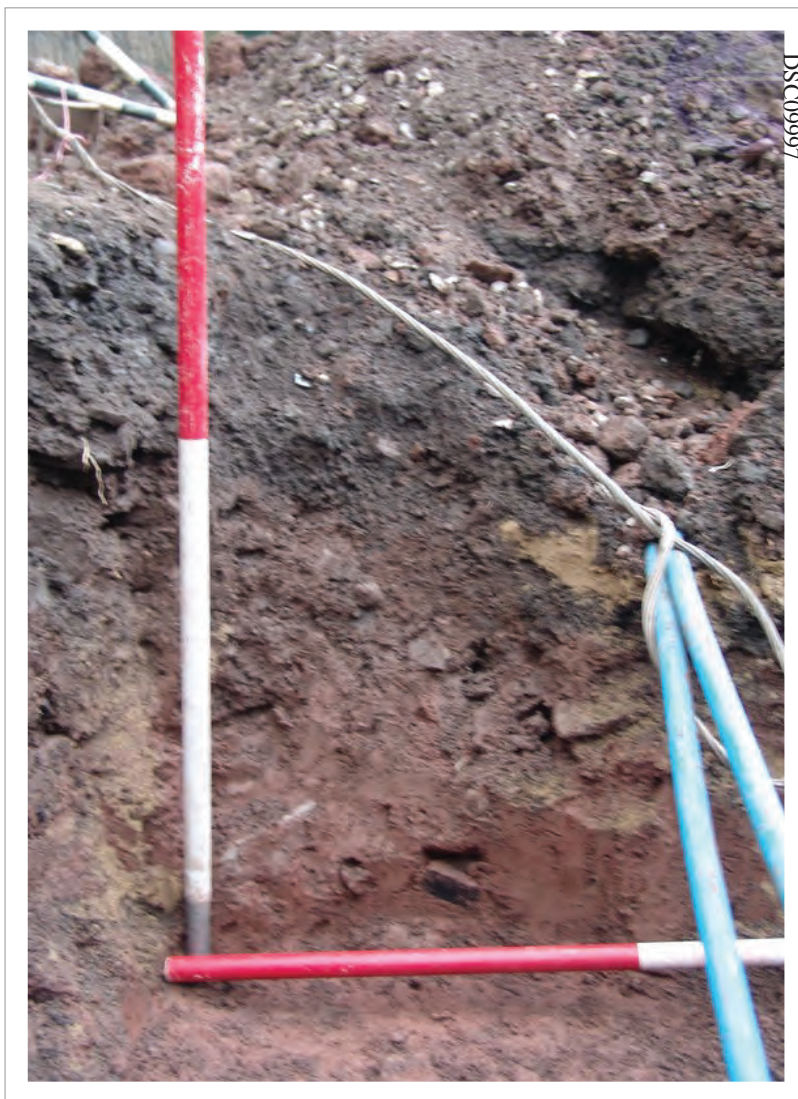
Plate 02: Trench 1, east facing terminus, trench 2, south facing section, [103], [104], [119], [132]. (sequence)

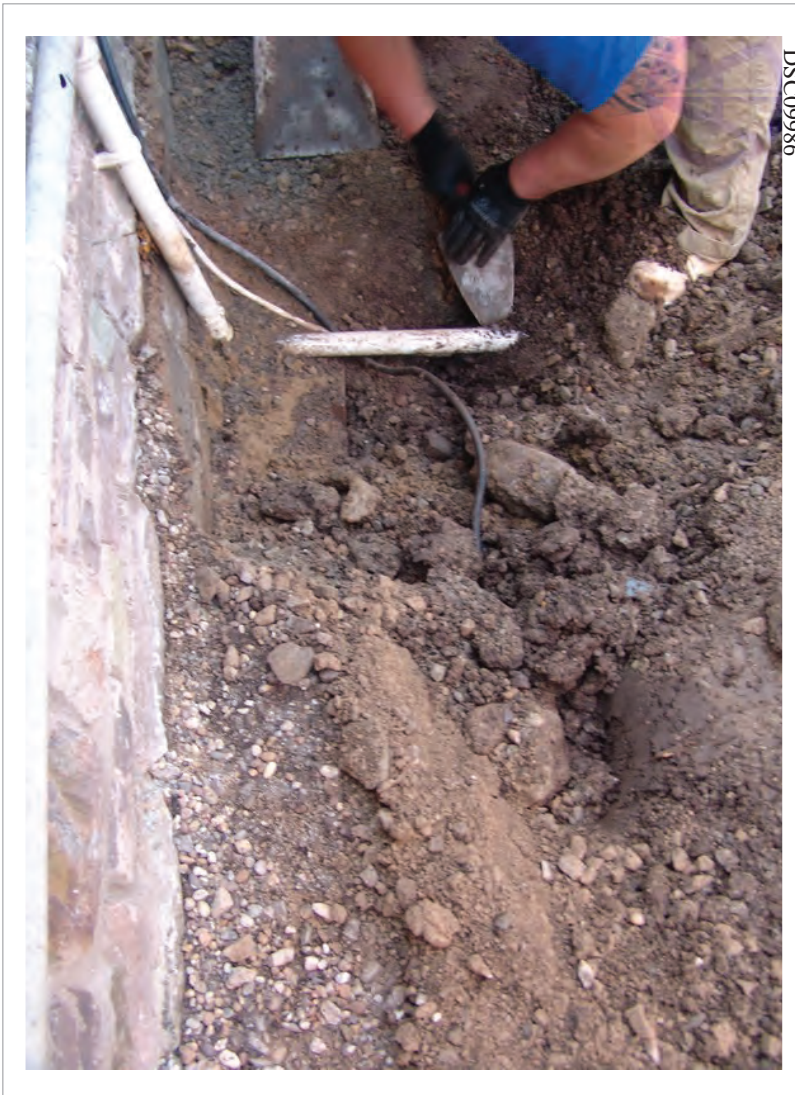
Plate 03: Service pipes

Within the dark brown sandy clay [119] where multiple service cables and pipes most of which appeared to be relatively recent.

Boiler overflow pipe [109] in cut [115] with fill [123]  
Kitchen waste pipe [108] in cut [114] with fill [123]  
Fuel oil pipe [110] in cut [116] with fill [122]

Electric cable [111] in cut [117] with fill [121]

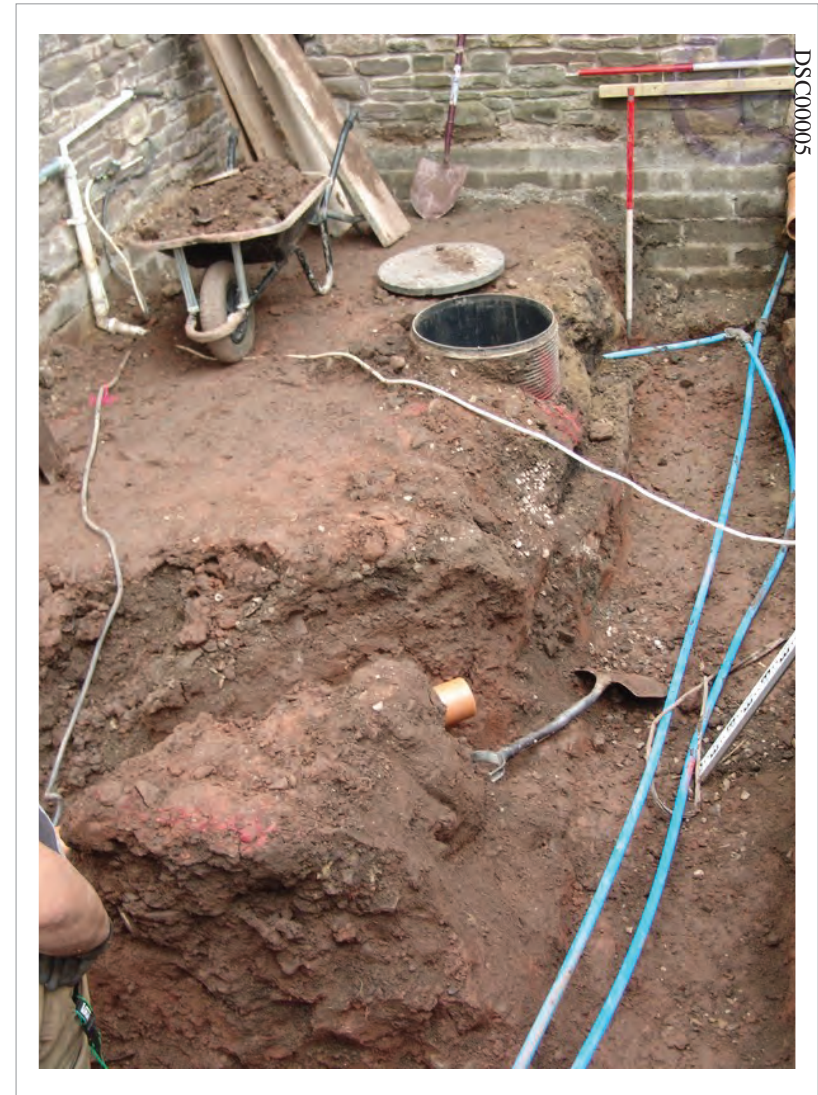
Two blue plastic water pipes [113], [125], within a sand fill [124]

Plate 04: Trench 1, Water pipes [113] south to north.

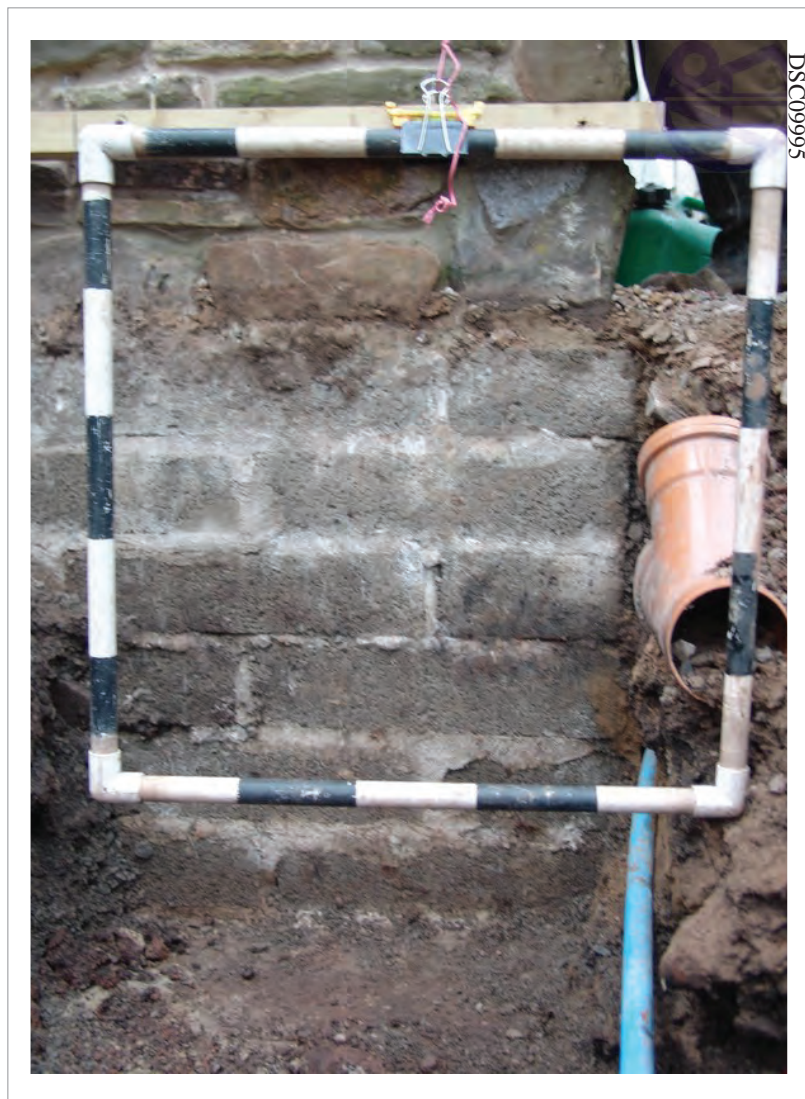
To the south of trench 1, PL05, and trench 3 PL06, the building stonework [126], [127] and foundations [128], [129], [130], [131] were exposed to a depth of 750mm in the layer of red/brown sandy clay [132].

Plate 05: Trench 1, north facing terminus. [127] wall of house, cut [126] over [129] foundation, cut [128], backfill [130]. (sequence)

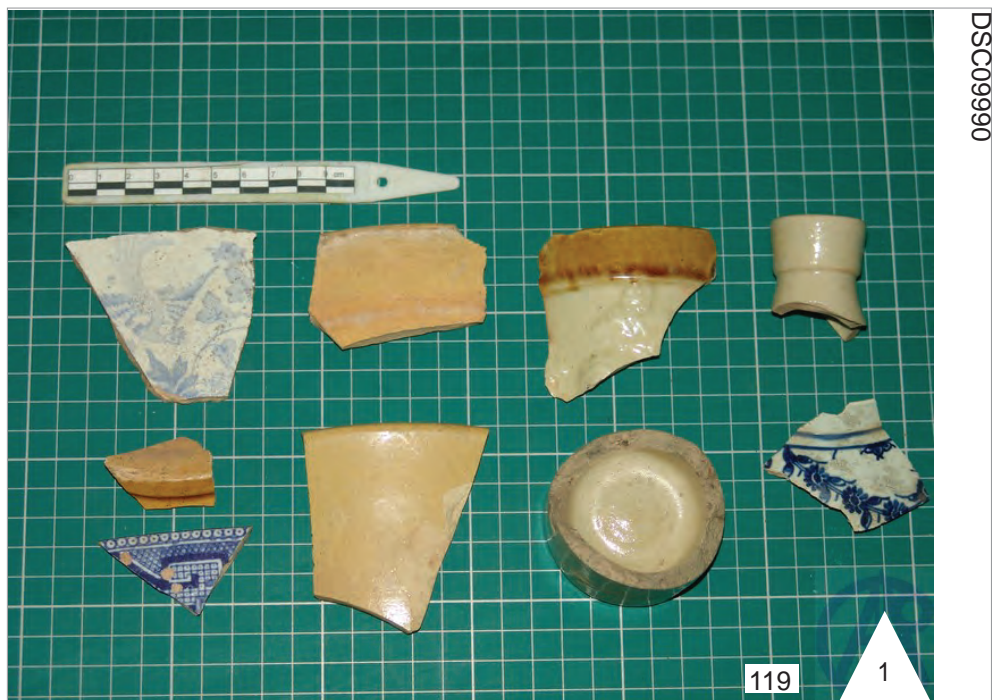
Find no	Area	Context	Description	Period	Date
1		119	1 sherd Staffordshire slipware 1 sherd stoneware flagon/jug rim with raised decoration 2 sherds stoneware bottle. 1 rim, 1 base 1 sherd Pearlware jar rim with blue floral decoration 1 sherd white china with blue decoration 1 sherd willow pattern rim 2 sherds Mochaware rims	18 <sup>th</sup> 18 <sup>th</sup> /19 <sup>th</sup>  19 <sup>th</sup>	19/04/17
Find no	Area	Context	Description	Period	Date
2		119	1 clay pipe stem 1 sherd stoneware base 1 bone fragment 1 jaw bone (animal) with approximately 3 intact teeth	18 <sup>th</sup> /19 <sup>th</sup>	19/04/17
Find no	Area	Context	Description	Period	Date
3		119	1 shard blue glass bottle neck 1 sherd glazed earthenware 1 small sherd Creamware handle 1 sherd white china base with interior blue decoration 1 sherd willow pattern 1 sherd hand painted porcelain plate base 2 sherds Mochaware 1 sherd white glazed stoneware 1 sherd white glass rim with decorated ridge. Possibly modern ashtray	18 <sup>th</sup> ? 18 <sup>th</sup> /19 <sup>th</sup> 19 <sup>th</sup>    19 <sup>th</sup> /20 <sup>th</sup> 20 <sup>th</sup> /21 <sup>st</sup>	19/04/17
