# LLYN CONWY WATER TREATMENT WORKS

## Archaeological Watching Brief

Project No. G2215

Report No. 1147

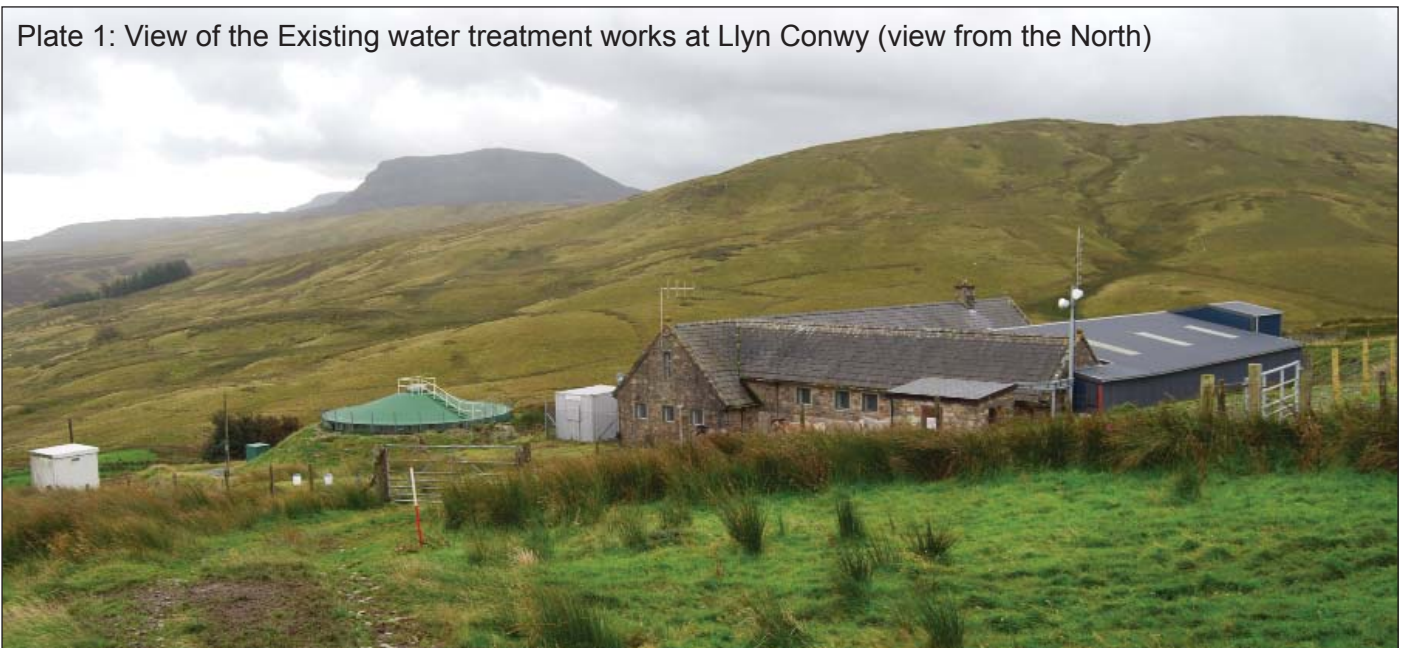
Plate 1: View of the Existing water treatment works at Llŷn Conwy (view from the North)

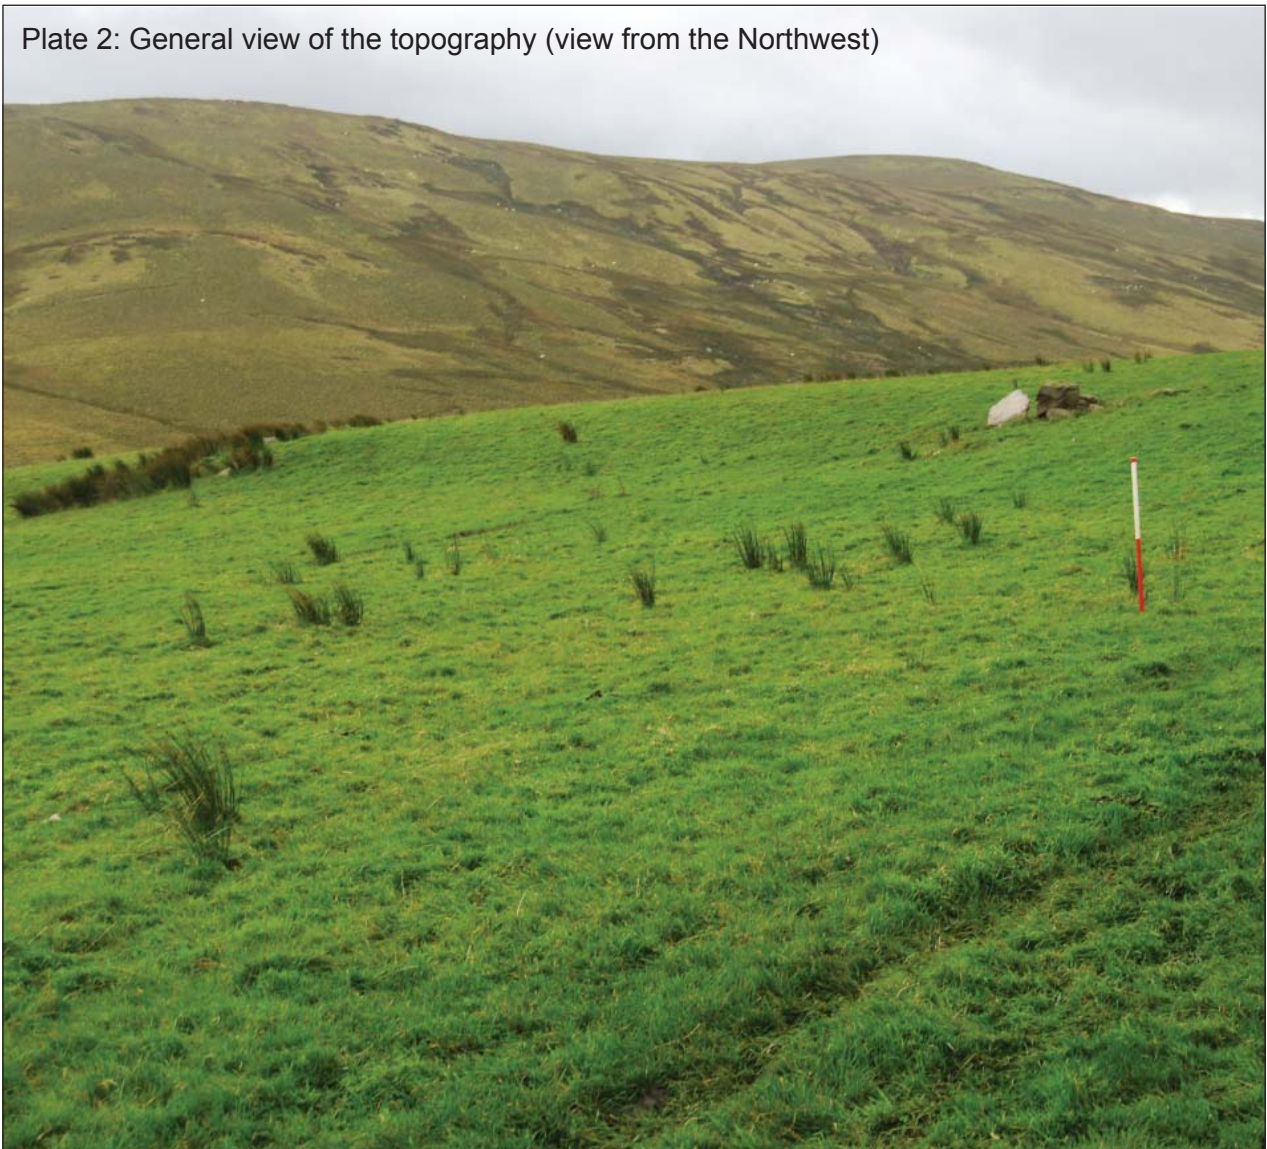
The GAT assessment report of the proposed WTW (Evans, R. 2011. GAT Report **977**) noted that the study area was located within an upland landscape on the north side of the upper reaches of the Afon Conwy. The extension zone/existing WTW were located on the border between enclosed pasture and upland grazing (see plate 2). The report stated that:

Plate 2: General view of the topography (view from the Northwest)

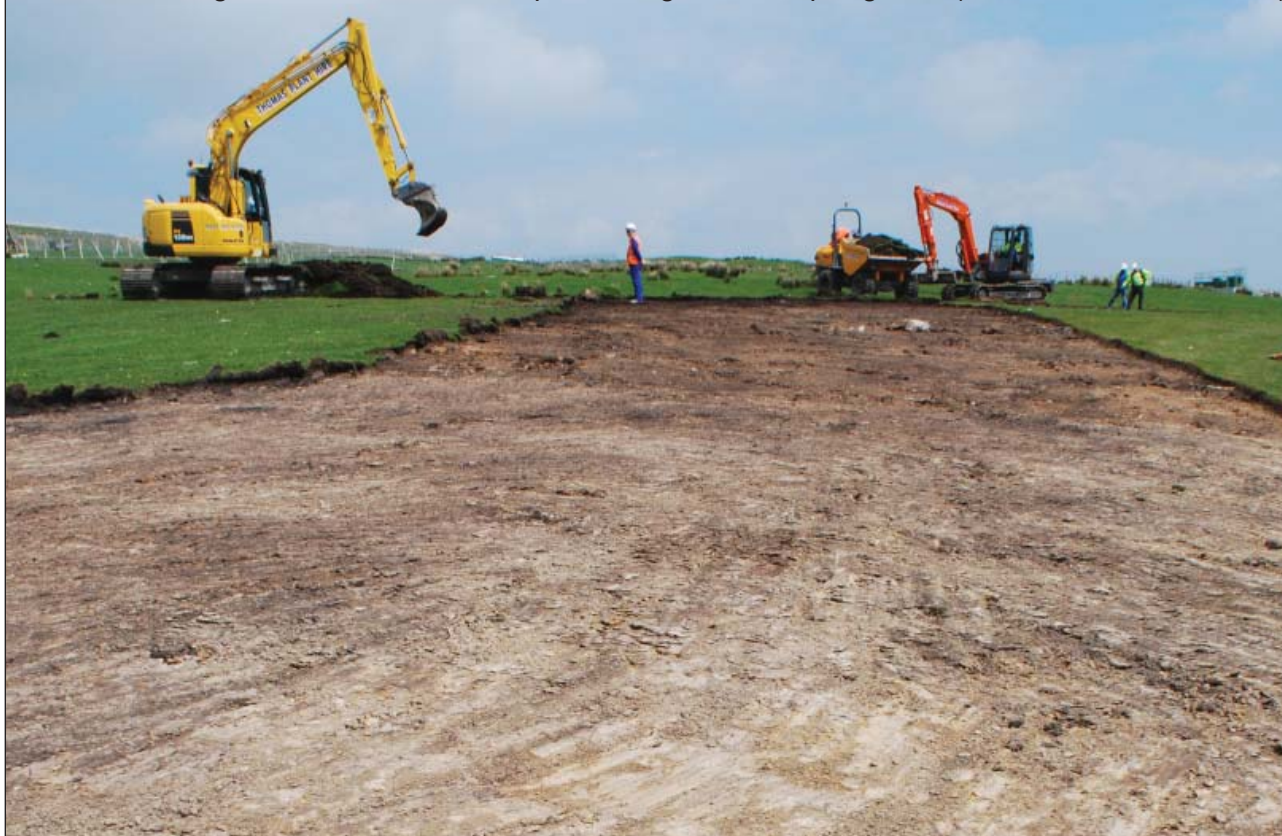
The watching brief was undertaken between the *5<sup>th</sup> of June and 29<sup>th</sup> of July 2013*. The weather and ground conditions ranged from clear and dry to wet and extremely muddy. The deposits were removed using a tracked excavator with a toothless ditching bucket (see plate 3).

Plate 3: Working shot of the earthworks processing and stockpiling area (view from the Southeast)

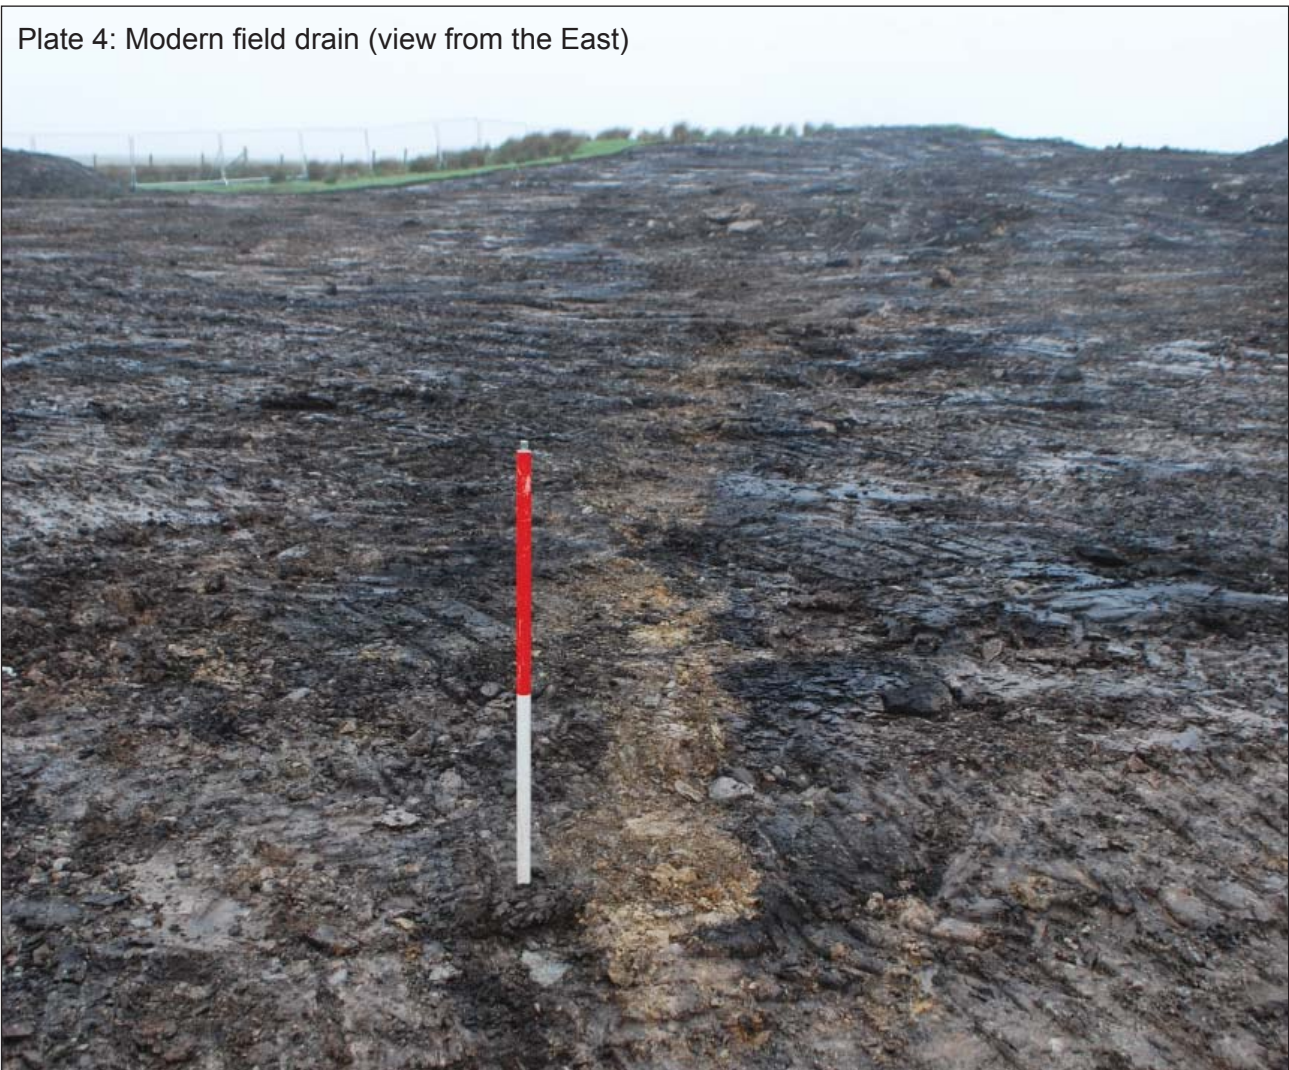
Occasional modern field drains were observed running northeast/southwest and east/west across the site as a whole (See plate 4). These features were filled with gravel and appeared to have been excavated using a mechanical excavator, based on the very regular nature of the cuts and near vertical sides.

Plate 4: Modern field drain (view from the East)

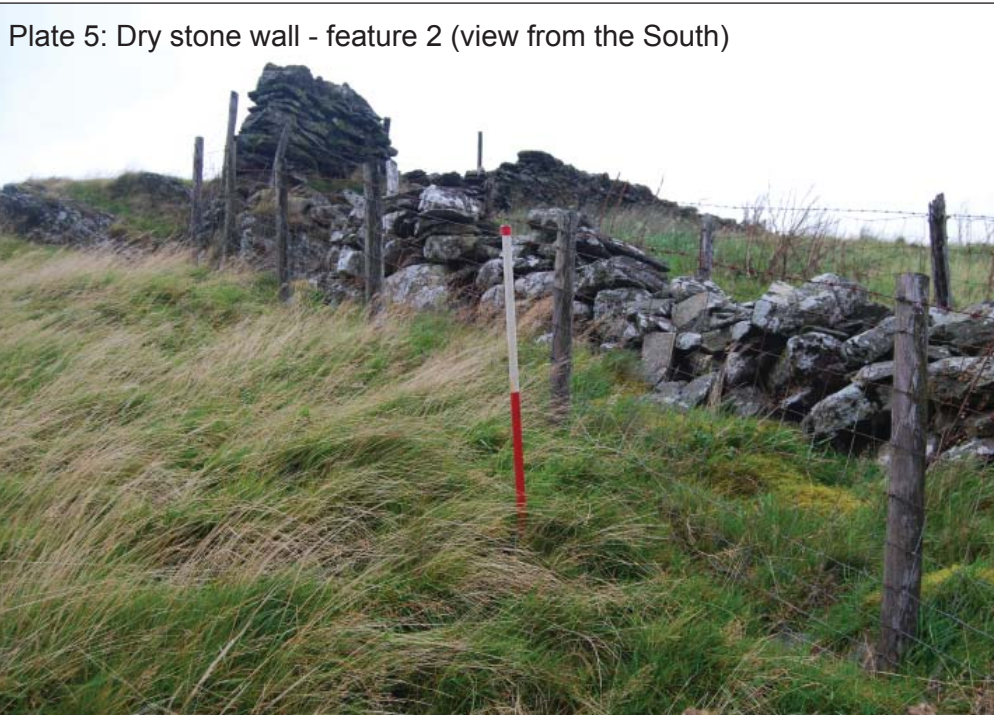
The post medieval dry stone wall (feature 2, plate 5) observed in the assessment survives in a slightly ruinous condition, standing to a maximum height of 1.3m, with a width of 0.5m. It consists of small to medium shale slabs up to 0.5m long and up to 0.2m thick and has remnants of stock proofing along the top. This wall has not been maintained in recent years but the boundary has been re-enforced with modern fencing. The section of this wall which falls within the development zone (some 120m in total) was demolished as part of the groundworks.

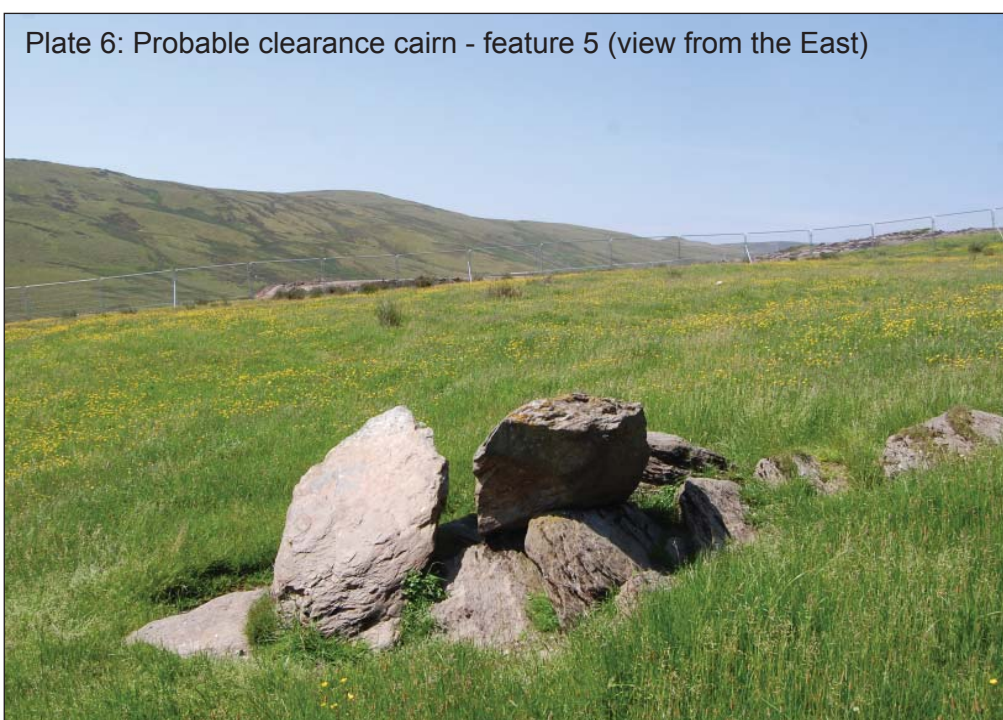
The two probable clearance cairns (features 5 & 6, plate 6) identified during the assessment were demonstrated to be fractured rock outcrops, cleared into slight cairns.

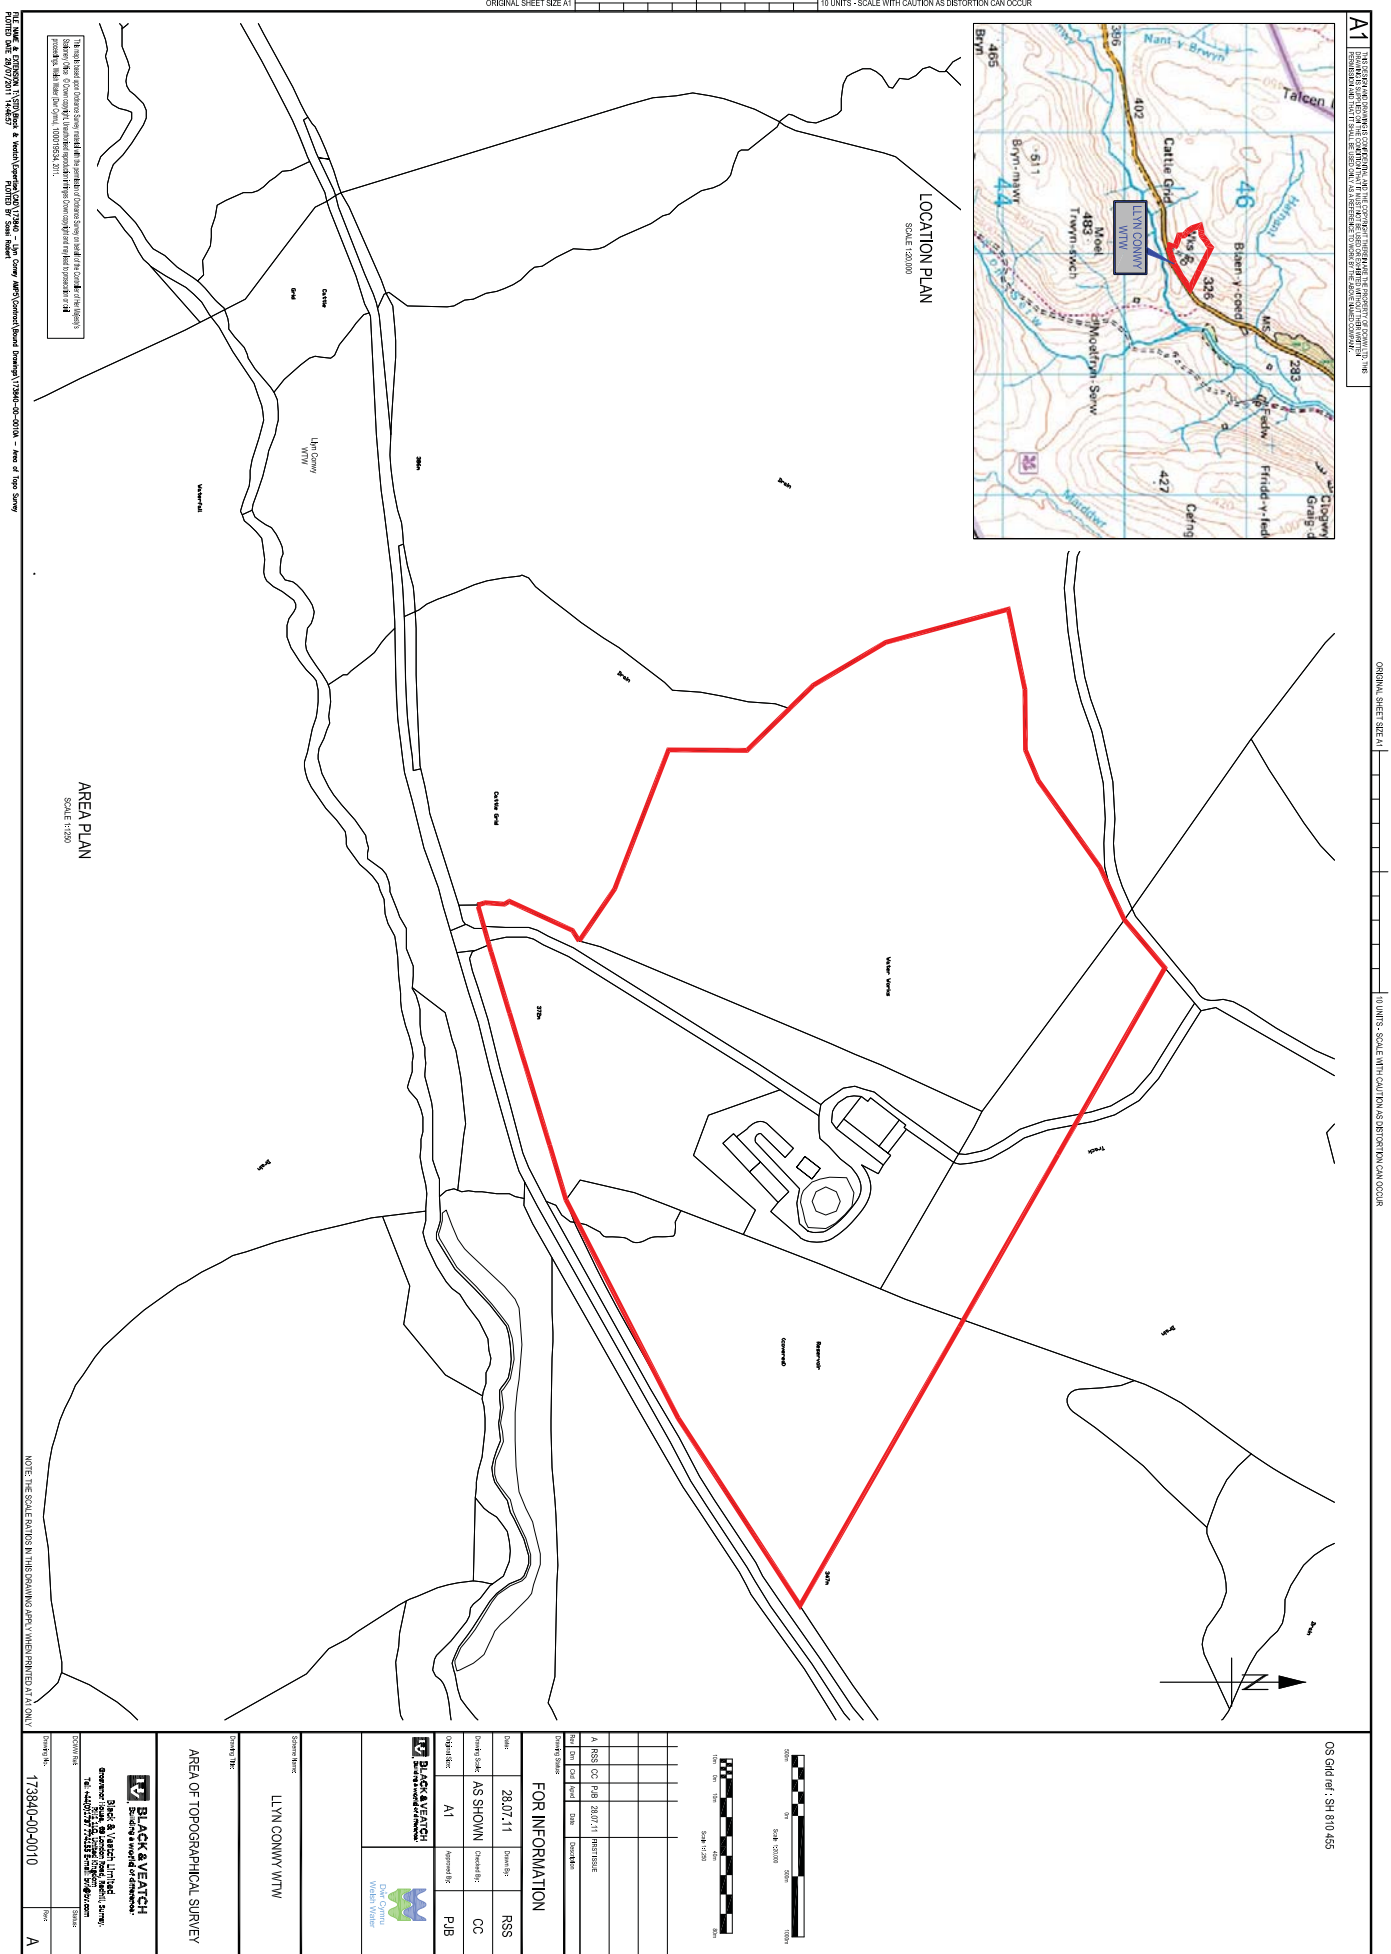
Figure 1 - Reproduction of Black & Veatch Drawing No. 173840-00-0010

The area immediately surrounding the existing water treatment works was shown to be disturbed to a depth of more than 0.5m. Significant deposits of made ground, associated with the construction of the original structure were identified to northeast of the main building and to the northwest of the tarmac access track. It is probable that such disturbance surrounds the entire original structure, though not all sides were investigated as part of this project (see figure 1).

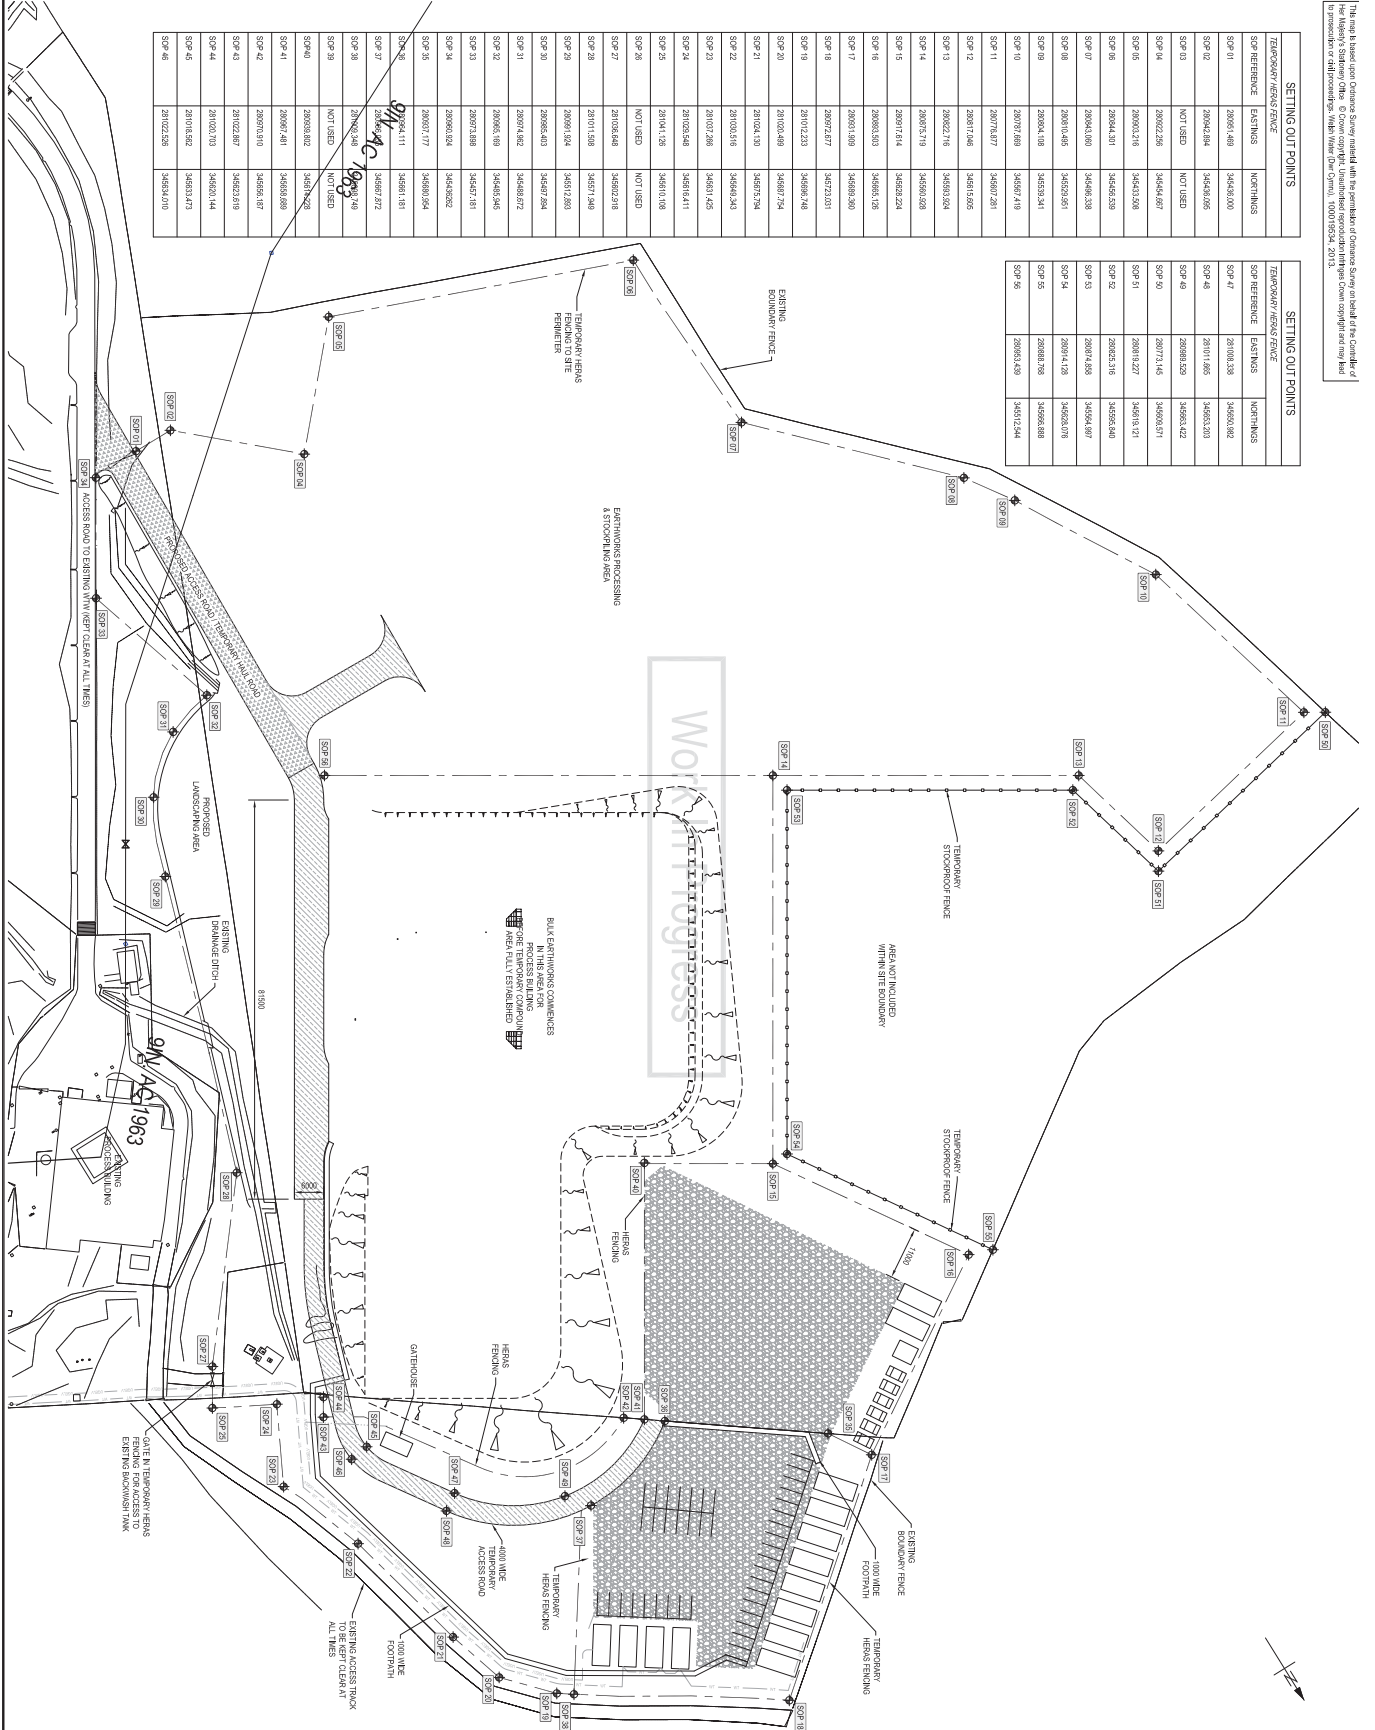
**Figure 2 - Reproduction of Black & Veatch Drawing No. 173840-00-002187**

The scheme consisted of the extension of the existing WTW into a large irregular shaped field to the north, see Black & Veatch Drawing No. **173840-00-002187 A** (reproduced as Figure 2). The extension groundworks encompassed an area of c.3.8ha and included:

- Bulk earthworks for the new process building;
- Construction of an access road (6.0m wide) linking the current WTW access road to the new process building;
- Construction of a temporary haul road (4.0m wide) linking the current WTW access road to the temporary site compound
- Construction of a temporary site compound at the eastern end of the extension zone;
- An earthworks processing and stockpiling area to the west of the new process building.

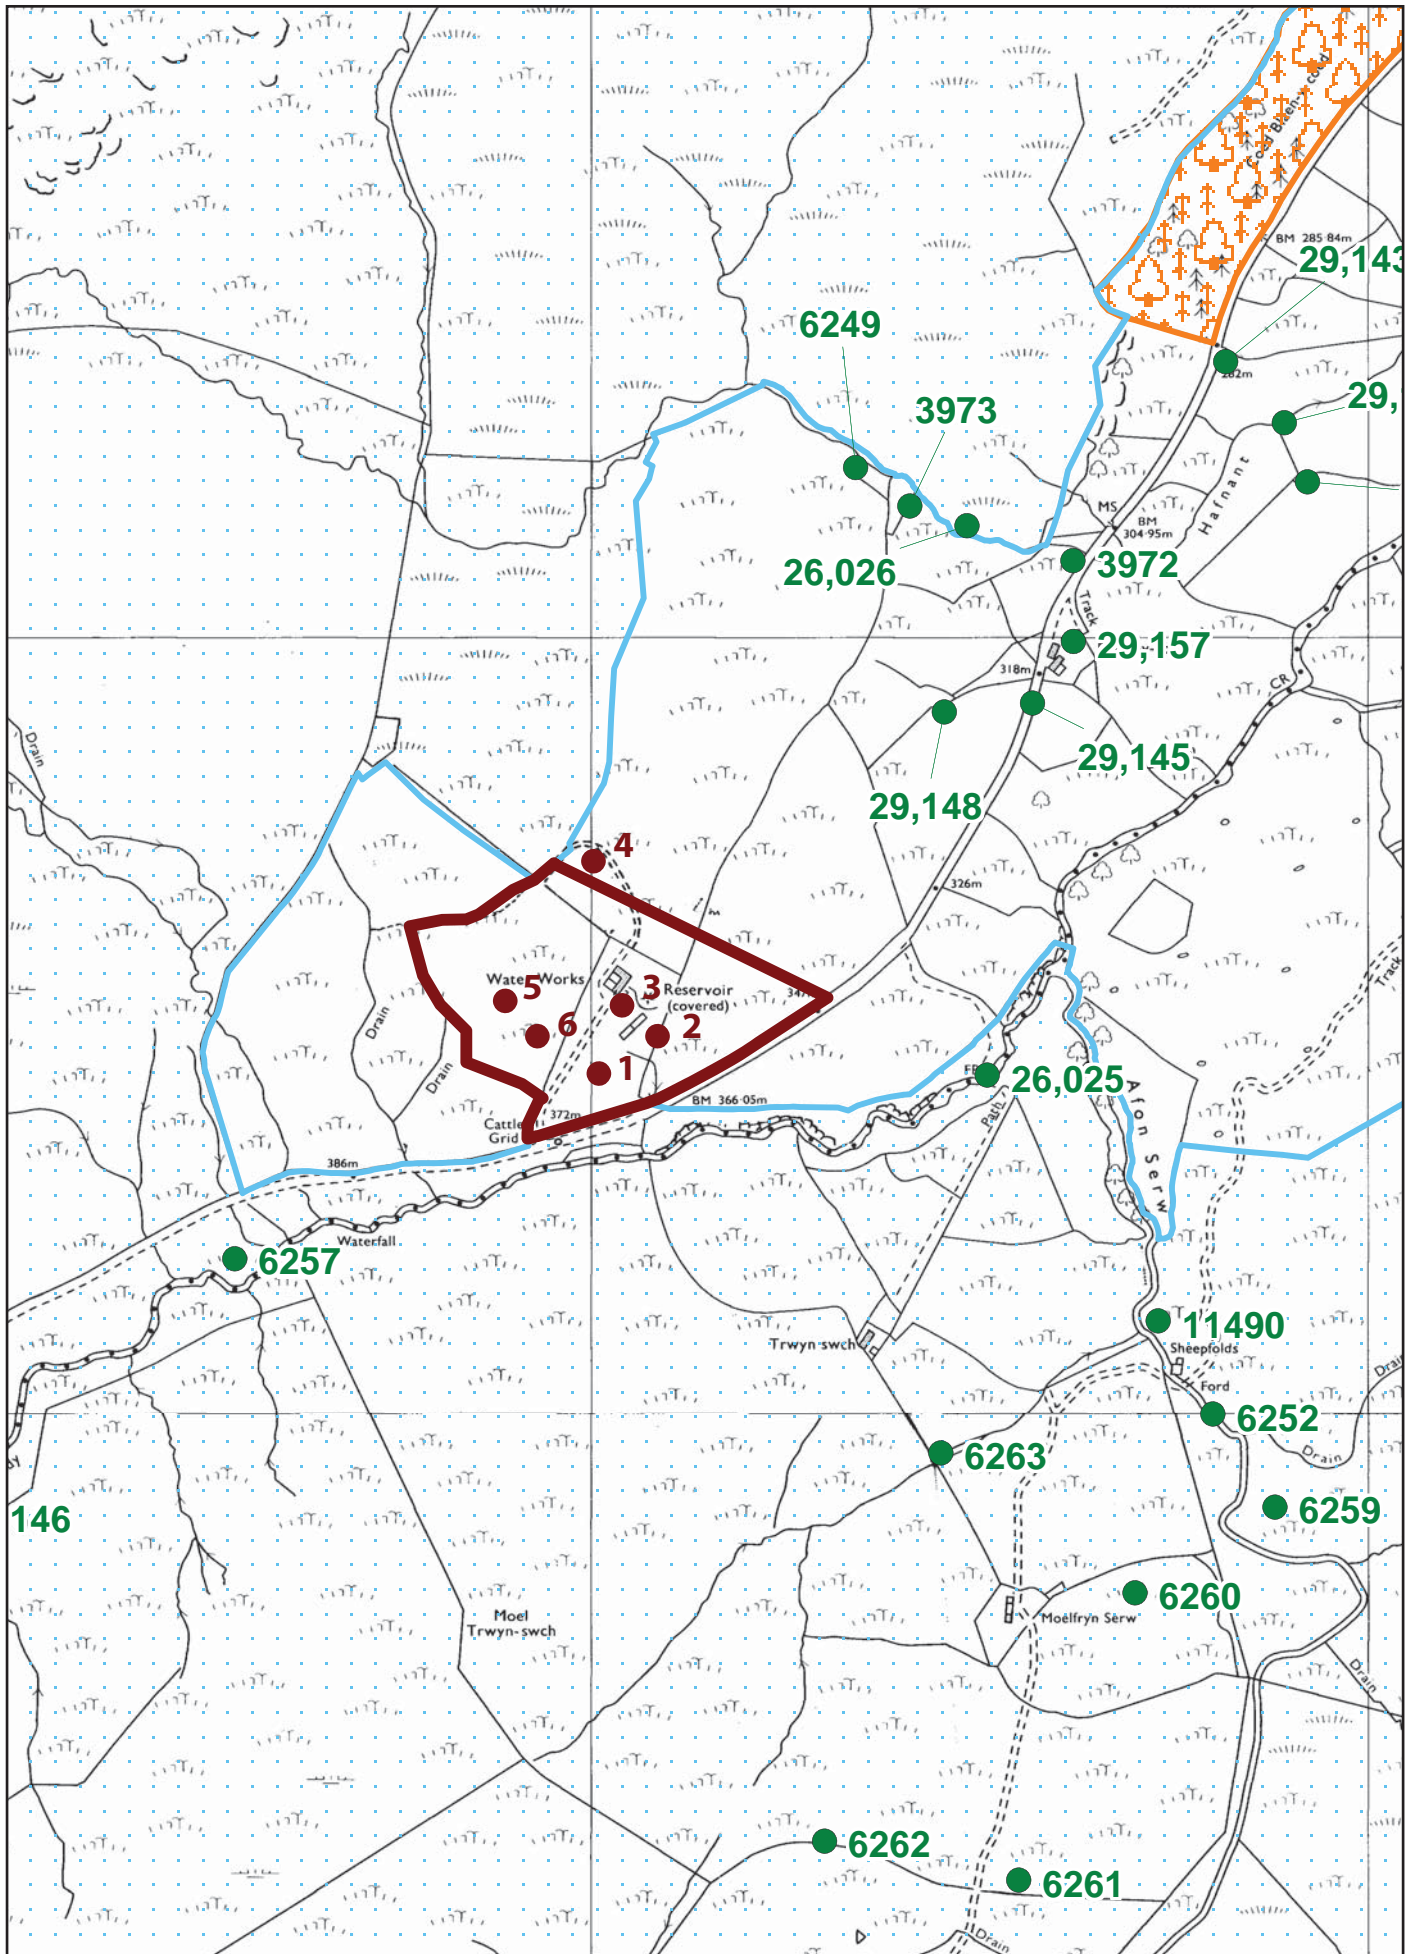
GAT Report 977 identified six features within or within proximity to the extension zone and the existing WTW, along with recommendations for further actions (see figure 3).

**Figure 3** - Reproduction of figure 1 from GAT Report 977 showing the location of the six features identified within or within proximity to the extension zone and the existing WTW.
