Archaeological Building Recording
at
**LLWYNA FARM BARN,
FARHILL, LLANISHEN, MONMOUTHSHIRE.**
for
Mr & Mrs Robbie

Report No. 1779/2007
NPRN No. 43282

Archaeological Building Recording
at
**LLWYNA FARM BARN,
FAR HILL, LLANISHEN, MONMOUTHSHIRE.**

SUMMARY

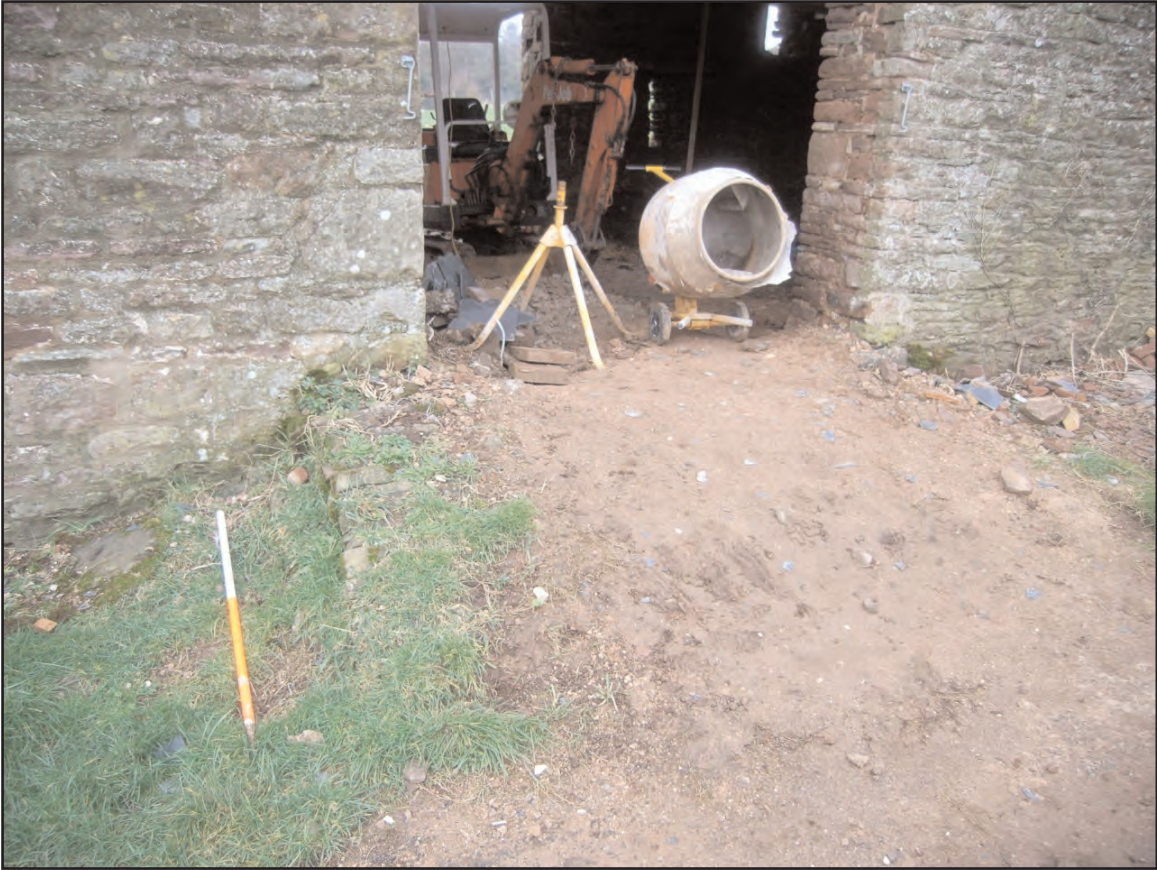
Plate 7 Remains of pitched-stone ramp to southern doorway, looking north

- 5.2 There are two opposing double doorways to the barn, both adjoining the farmhouse gable. The doorways differ in size, the south-eastern one being the smaller of the two measuring 2m in width by 2.3m in height, however the original lintel and masonry over the doorway had collapsed and is now rebuilt (**Plate 6**). The remains of a sloping, pitched-stone ramp survived outside this doorway (**Plate 7**).

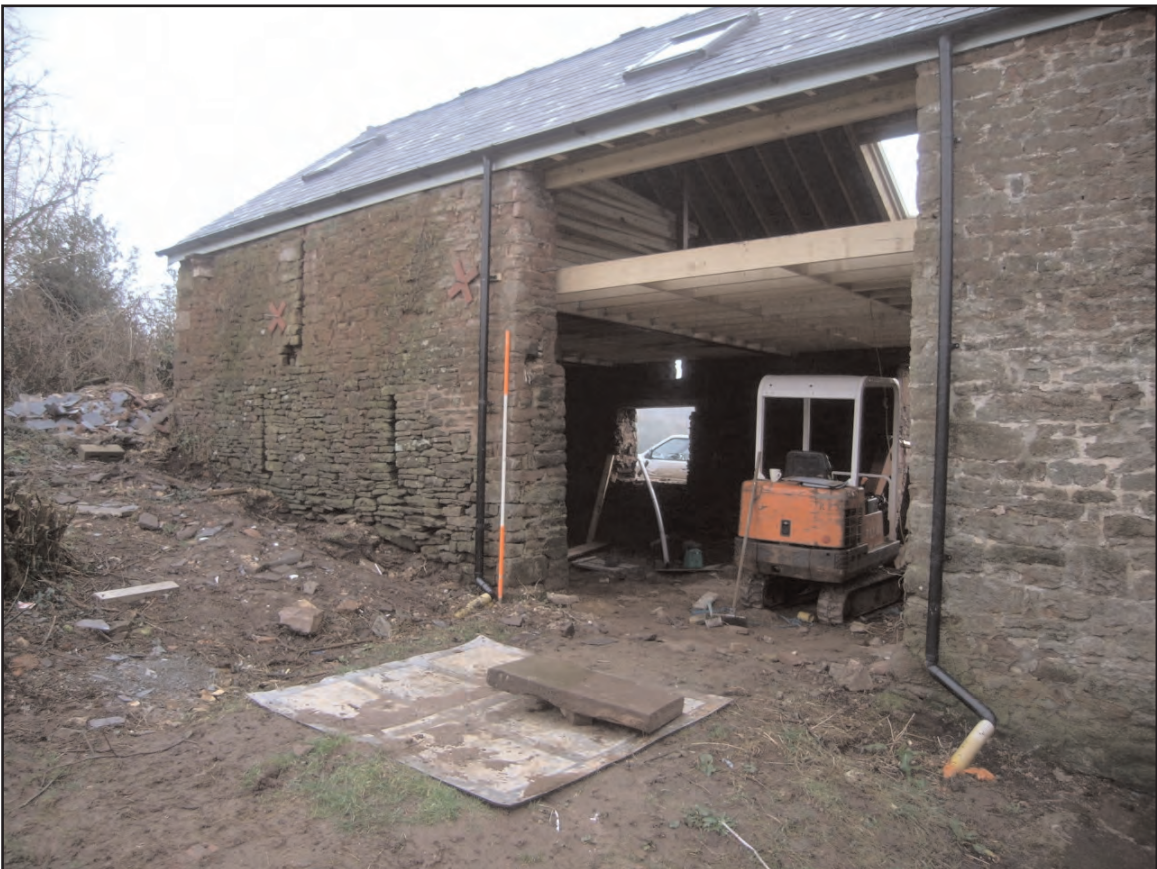
Plate 8 Northern doorway of barn, looking north-east

- 5.3 The north-western doorway measures 3m in width and up to 3.5m in height as it now extends to the eaves of the modern roof (**Plate 8**). The original height of this door would have been approximately 1.8m. The jambs of the doorway sat on stone pads that were still in place.

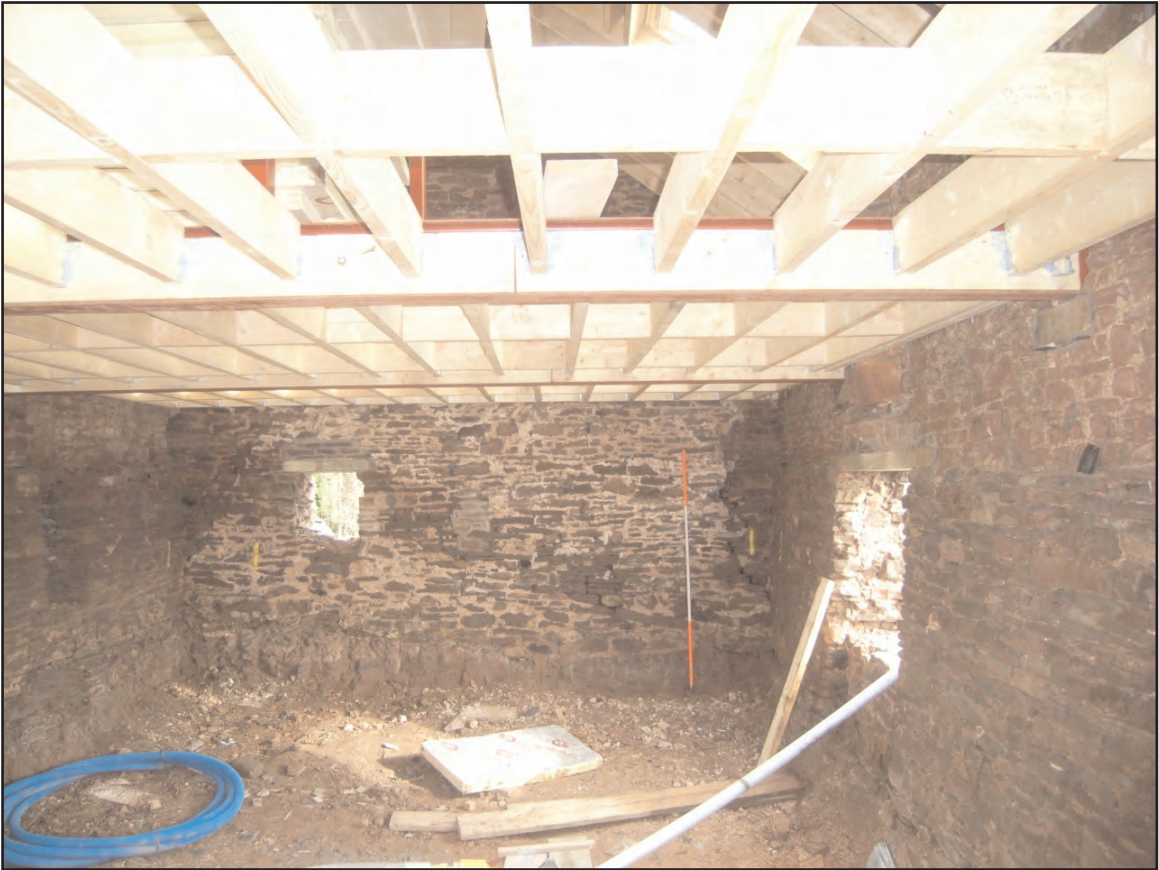
Plate 9 North gable interior showing footings resting on ridges of bedrock, looking north-east

- 5.4 The sandstone walls of the barn were founded directly onto the underlying bedrock. As the barn is built on the side of a hill the ground floor level has been cut into the bedrock to a maximum depth of 600mm, so the walls sit on ridges of exposed rock (**Plate 9**).

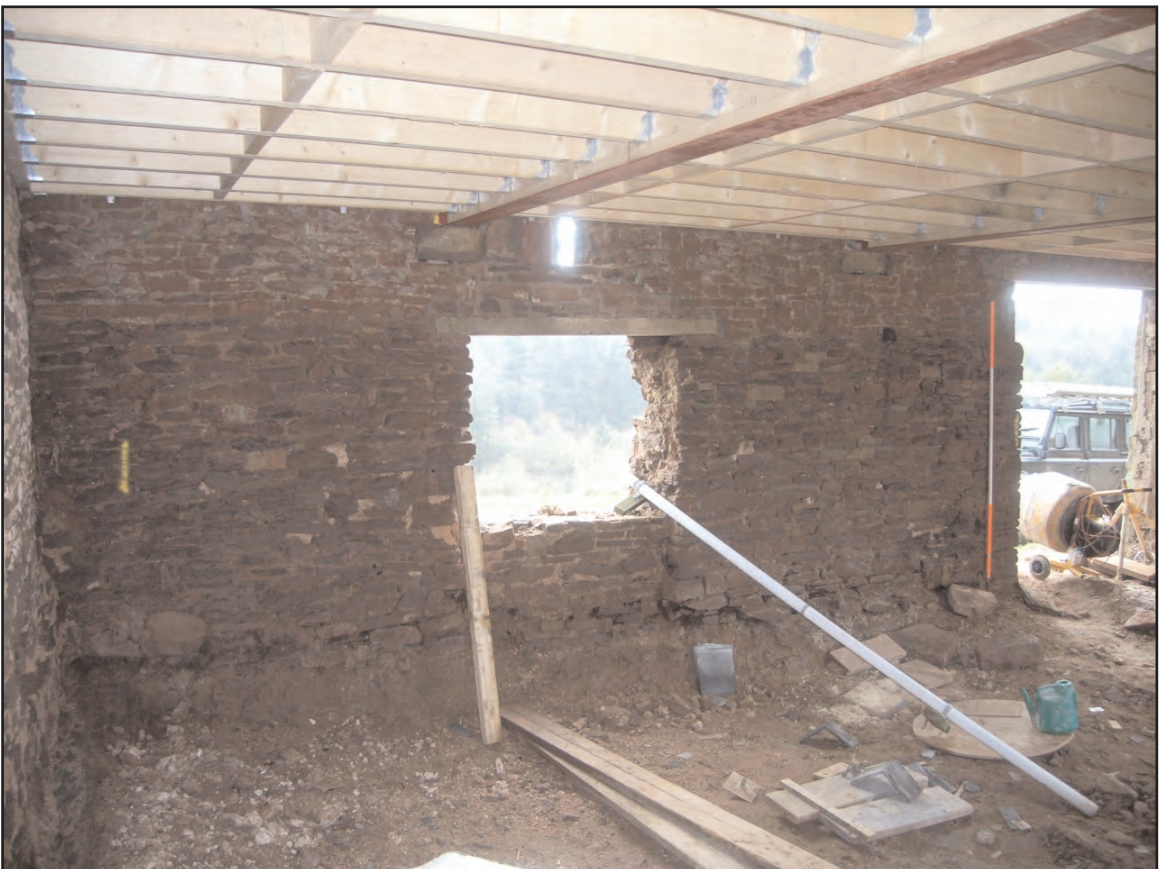
Plate 10 Interior of south-western wall showing partially blocked doorway, looking south

- 5.5 There are two principle historic phases of construction to the barn as originally this was a single-storey building. The walls of the earlier phase are up to 620mm thick and built of Pennant Sandstone. As Pennant is not local to this area it may be that the stone for the barn was salvaged from another building in the vicinity. There were two ventilation slits in the north-western wall, that differed slightly in size. The south-eastern wall had a wide single doorway, contemporary with the ventilation slits. The doorway had been partially blocked to sill level in antiquity to convert it to a window and recently repaired with a modern concrete lintel (**Plate 10**).

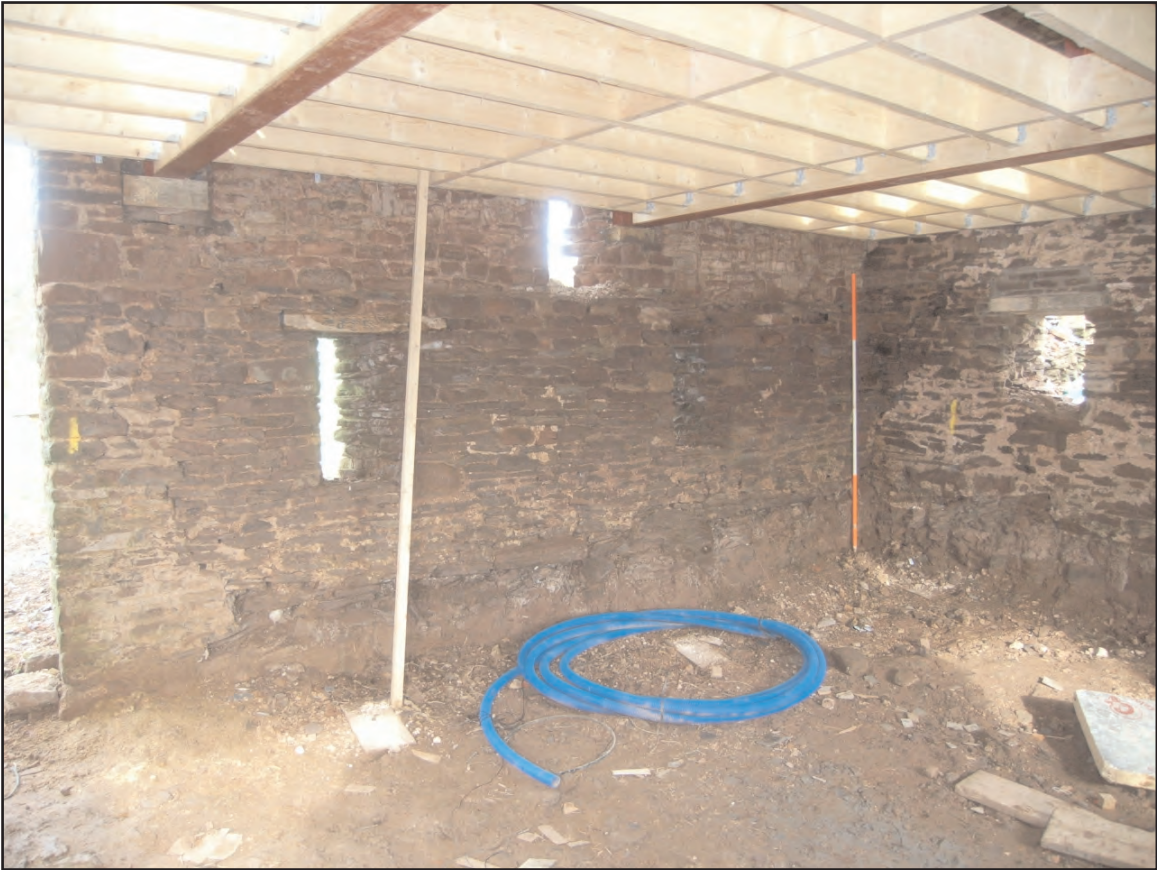
Plate 11 Interior of barn, showing window in gable wall and surviving timber lintel of ventilation slit, looking north

- 5.6 The northern gable wall of the barn had a small square window at ground floor level, measuring 530mm by 615mm that had been repaired with a modern concrete lintel. The only timber lintel to survive was above one of the ground floor ventilation slits (**Plate 11**). The original slope of the barn roof was visible as a scar in the masonry of the northern gable wall with a blocked opening measuring 1.16m by 1.15m at first floor level (**Plate 12**). The roofline scar was also visible in the southern gable wall (**Plate 13**).

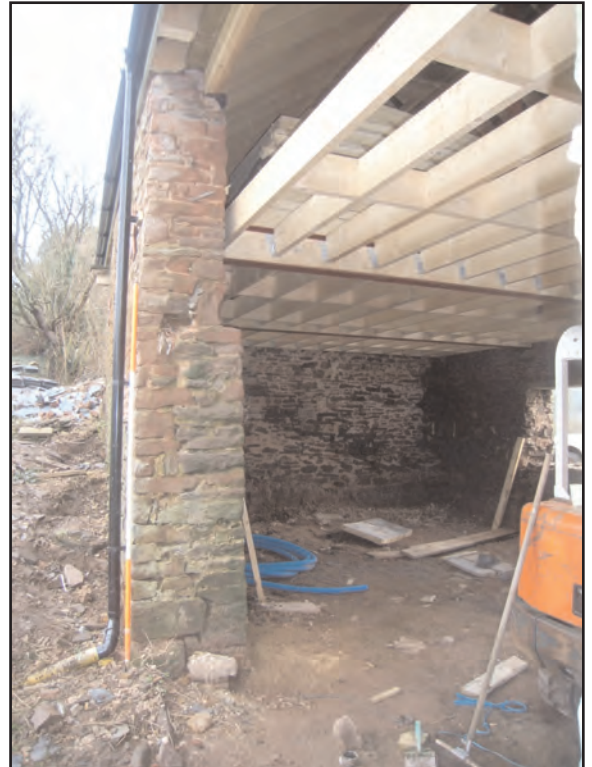
Plate 14 North-western wall showing differing thickness of upper & lower storeys, looking north-east

- 5.8 The side walls of this upper floor are slightly thinner than the ground floor, being only 500mm in width (**Plate 14**). The upper quoins at the northern end of the barn are blocks of Sandstone Conglomerate (**Plate 15**). There are two ventilation slits for the upper floor, one in each of the side walls; these slits are larger than those of the ground floor and extend to the present roof level.
