Little Wern-Y-Pentre, Clyro, Powys

Archaeological Watching Brief

Report No. 1441

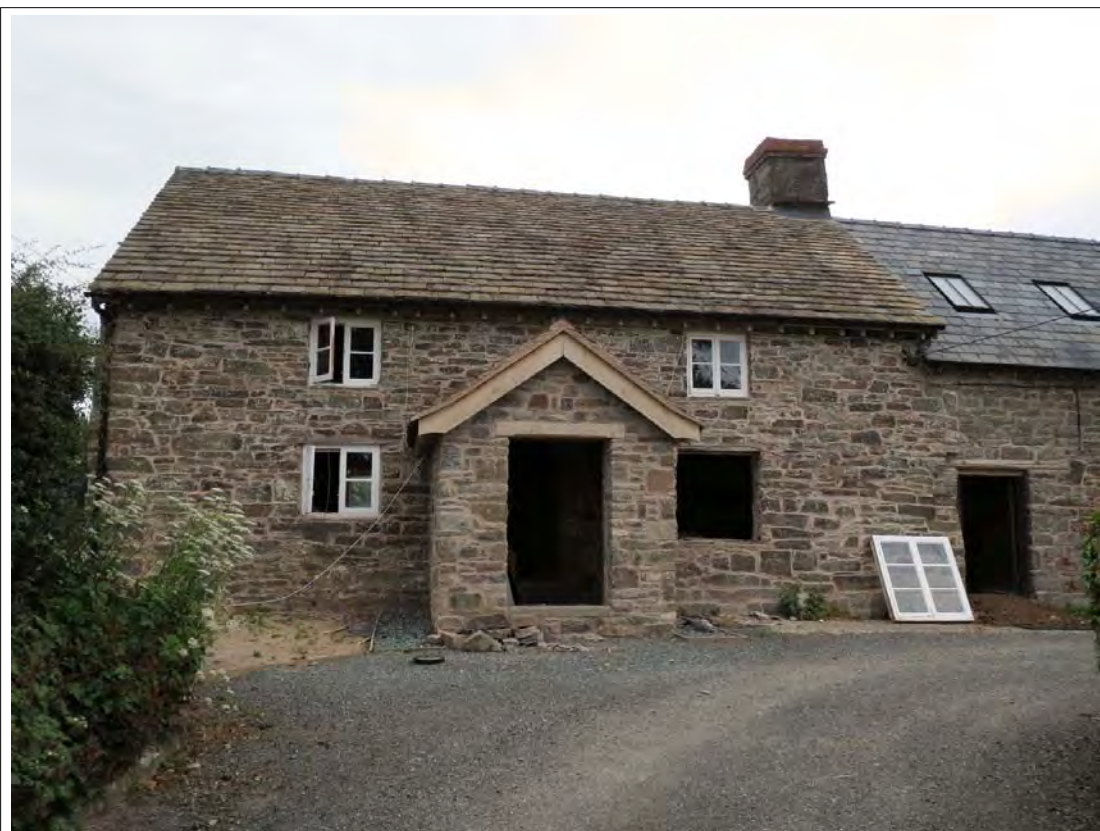
Plate 1. General view of Little Wern-y-Pentre. The 18th century (or earlier) stone-built farmhouse originated as a late 15th century timber-framed hall-house. Looking North.

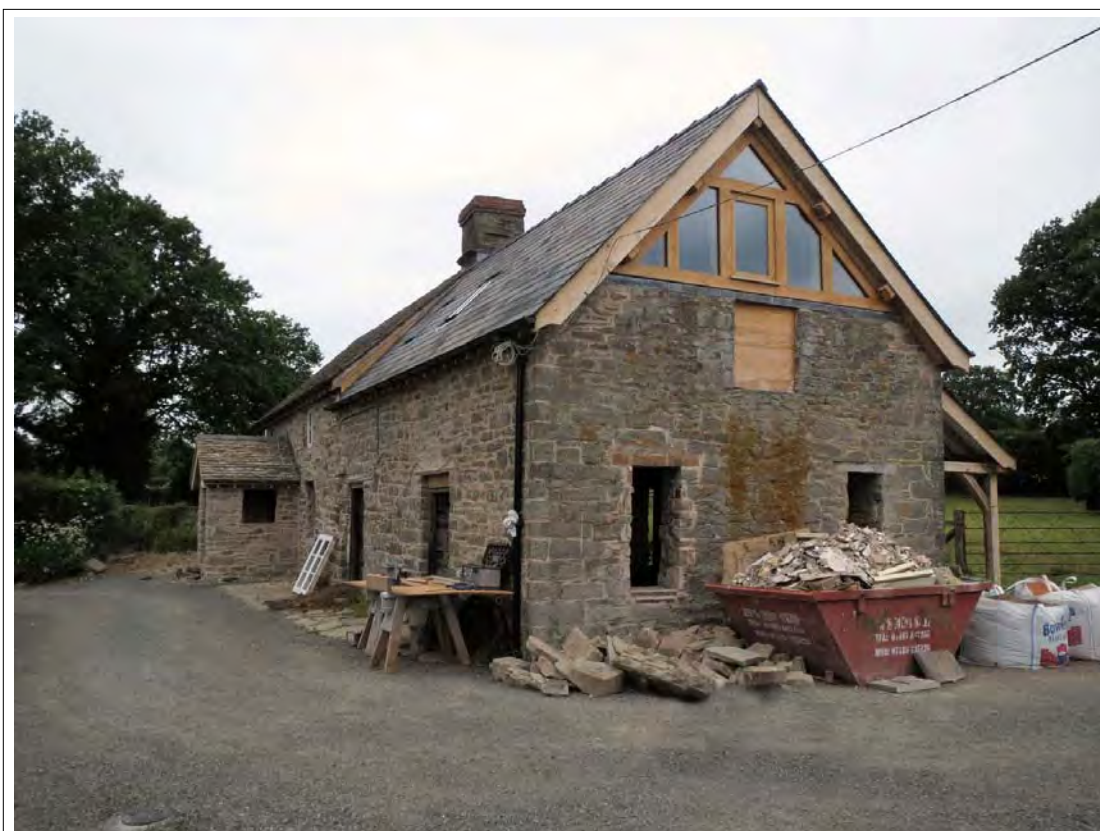
Plate 2. View of the 18th century (or earlier) stone barn to the east of the farmhouse. This replaced the 'outer-room' of the 15th century hall-house. Looking NW.

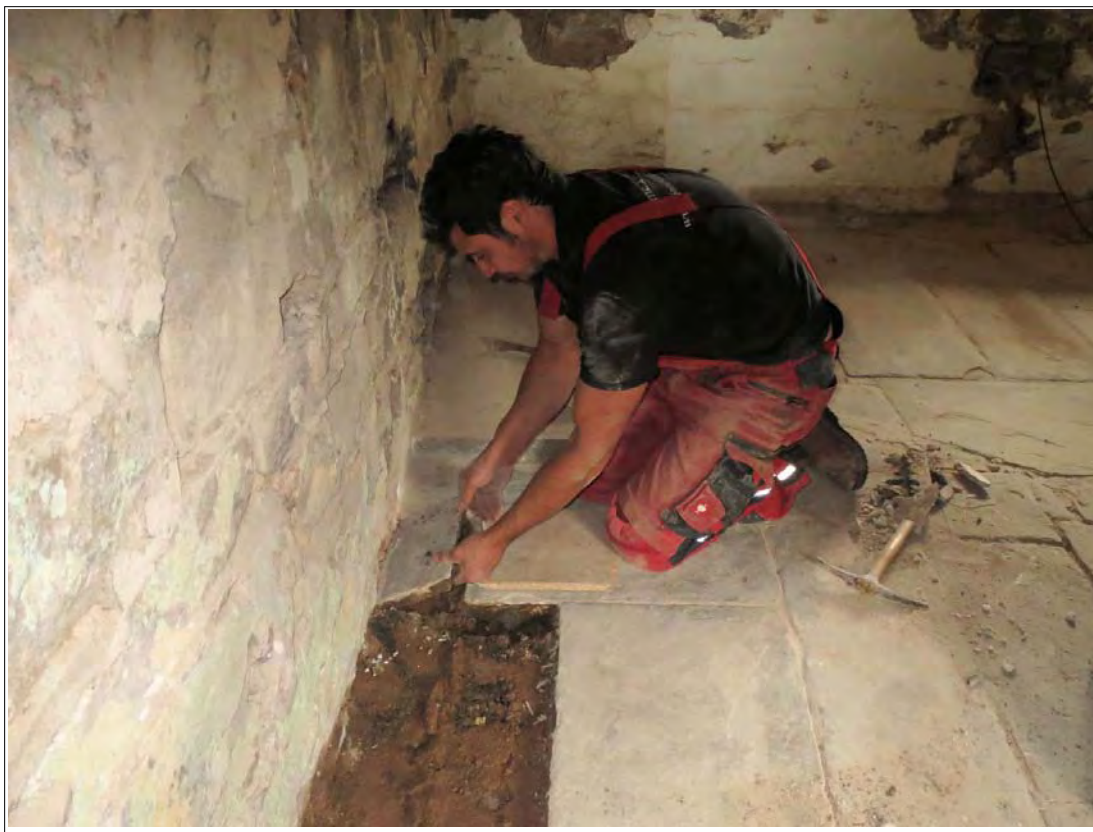
Plate 3. Working shot of the stone flags being lifted within the 'inner-room' (west wall) of the former hall-house. The flagstones (100) were bedded on lime mortar (101), above blinding material (102). Looking North.

- 4.1.2 The flagstones (100) within Area A were bedded on lime mortar (101), over a thin layer of redeposited subsoil (102). The latter deposit comprised a soft mid brown-orange and mid grey silt with inclusions of charcoal and clinker. This deposit was interpreted as a blinding layer. Disturbed natural (103) was encountered below the construction layers for the slab floor (Plates 4-6).

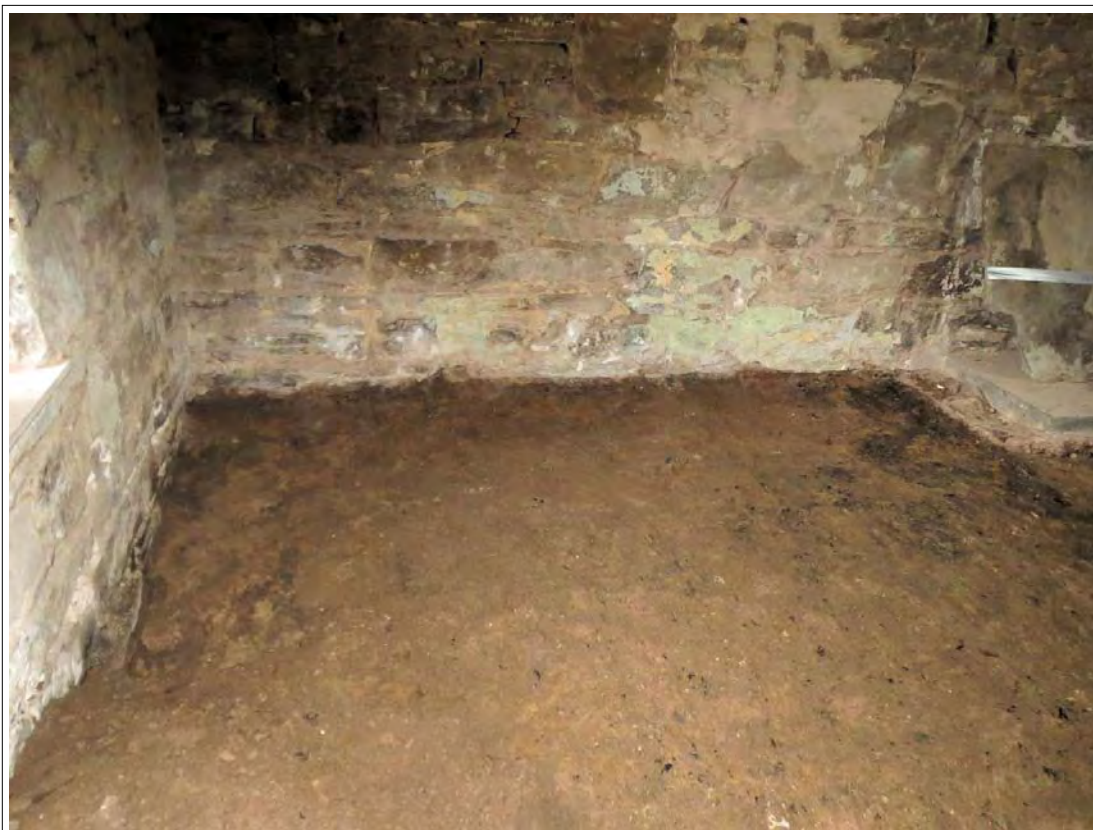
Plate 4. The south-west corner of the 'inner-room', showing a layer of disturbed natural (103) encountered below the blinding material (102). Looking West.

- 4.1.4 The floor deposits were hand excavated down to disturbed natural (103); the latter extended across the entire area of the former kitchen (the inner-room of the fifteenth century hall-house). The deposit comprised a stiff mottled light mid brown-orange and mid grey silt with inclusions of lime mortar and charcoal. The disturbed natural was encountered at approximately 97.80m Site Datum. This deposit was cleaned and sample excavated by hand. The layer was determined to be approximately 0.05m thick.

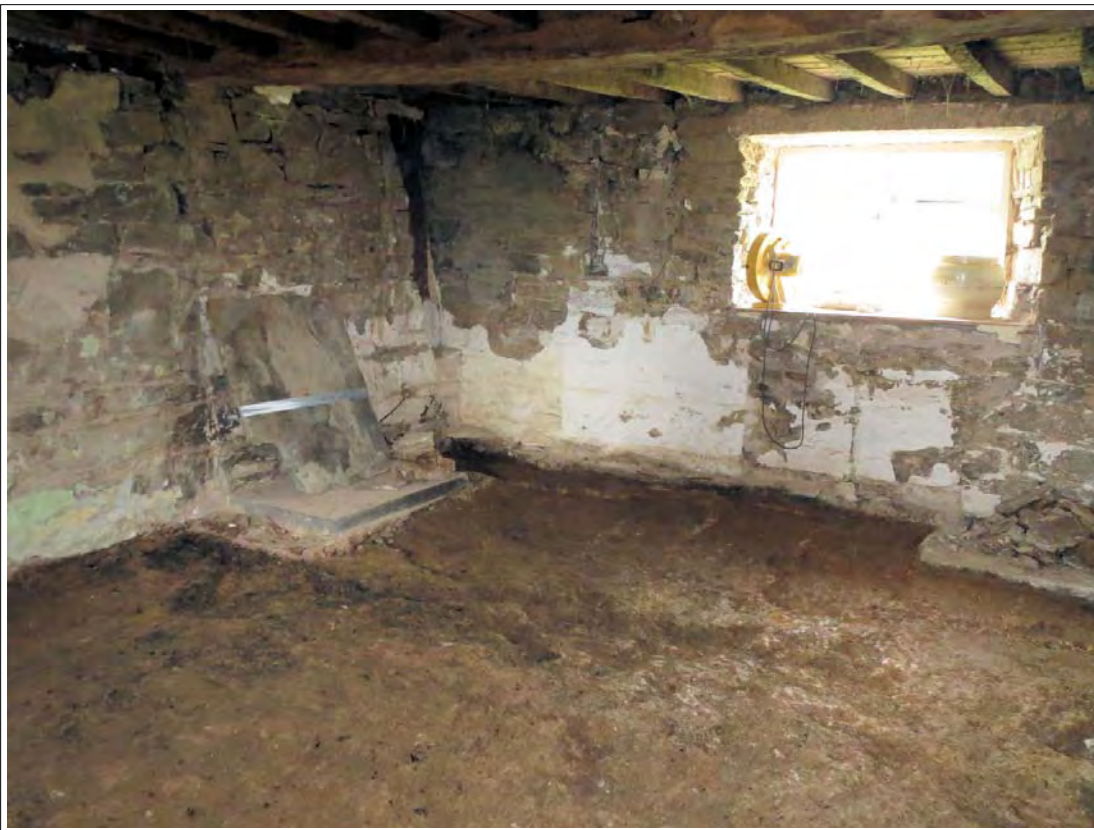
Plate 5. The layer of disturbed natural (103) within the north-west corner of the 'inner-room'. Looking North-West.

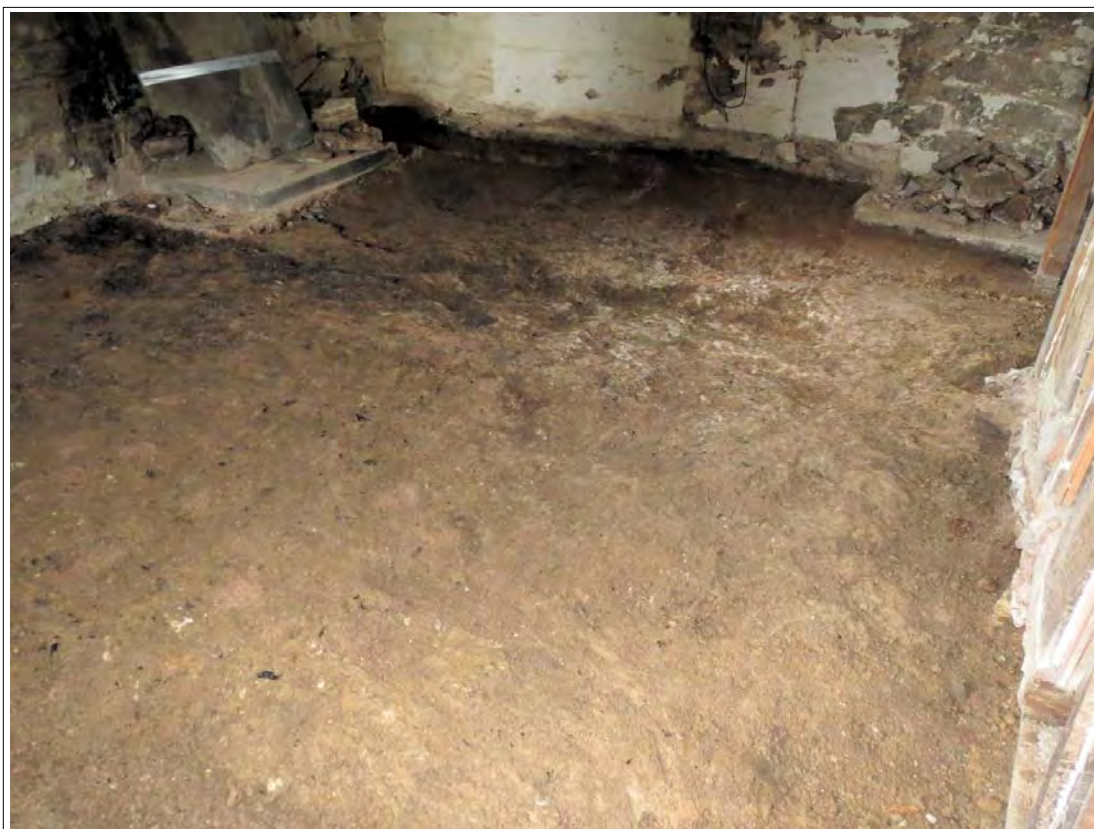
Plate 6. View along the northern wall of the 'inner-room', showing layer 103. Looking North-North-West.

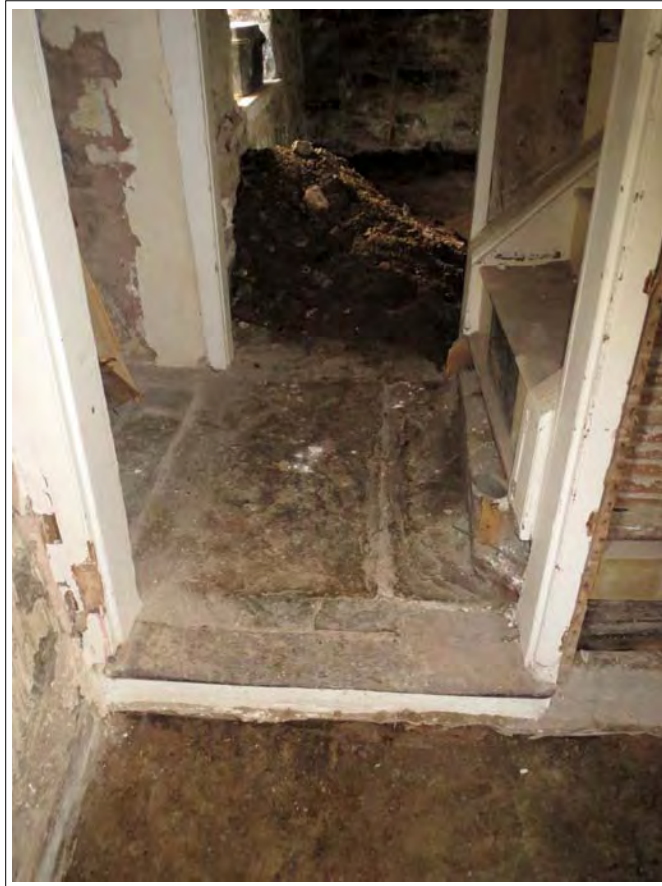
Plate 7. Looking across the (reinstated) 18th or 19th century entrance to the farmhouse (on the south elevation). Looking West.

- 4.2.2 It should be noted that the ground level within this part of the house is some 0.15m lower than Area A (Plate 7). This indicates that the floor has been partly reduced from the original level of the fifteenth century hall (and possibly the eighteenth century farmhouse).

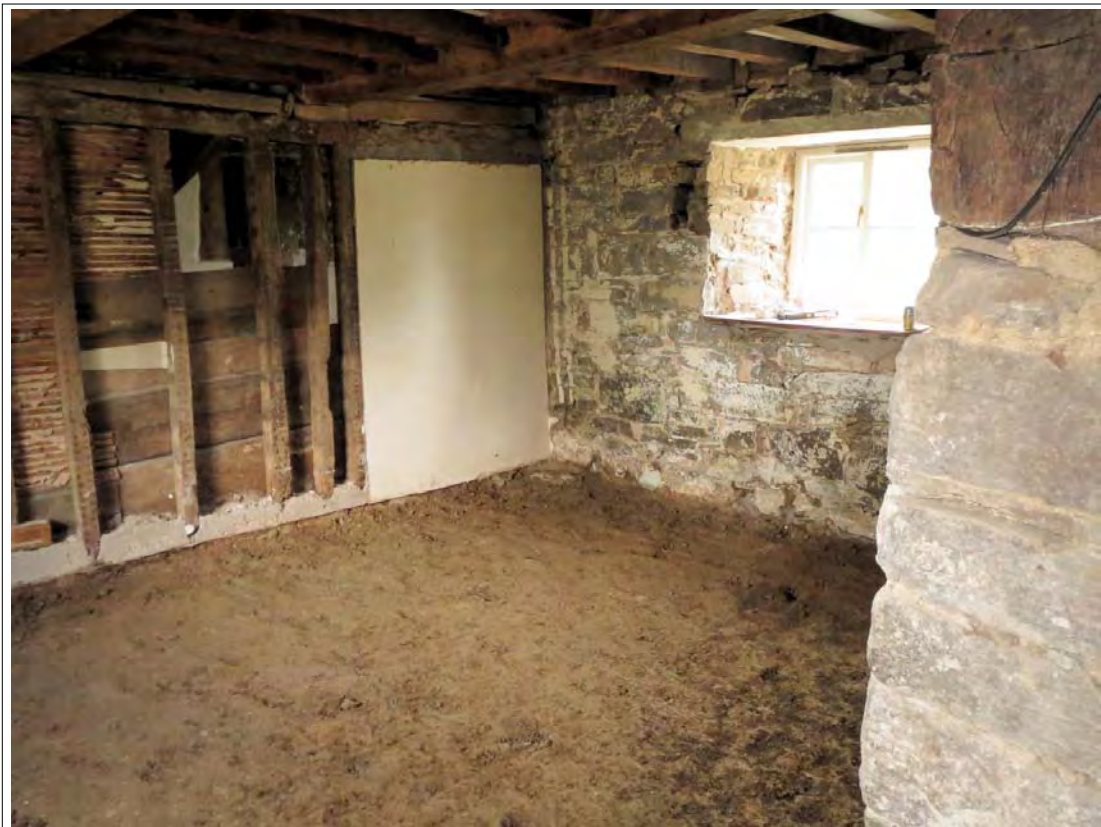
Plate 8. A deposit of disturbed natural (203) located across the (former) north-west corner of the 15th century hall. This was encountered below the slab floor (200), mortar bedding (201) and uncompact blinding material (202). The 17th century ceiling beams of the farmhouse as well as the (later) stud partition to the stairs are also shown on the photograph. Looking North-West.

- 4.2.5 The floor deposits were hand excavated down to disturbed natural (203); this layer extended across the entire area of the former living room, the central area of the fifteenth century hall (Plates 8-10). The deposit comprised a stiff mottled light mid brown-orange and mid grey silt with inclusions of lime mortar and charcoal, similar to layer (103). The disturbed natural was encountered at approximately 97.70m Site Datum. This deposit was cleaned and sample excavated by hand. The layer was determined to be approximately 0.05m thick.

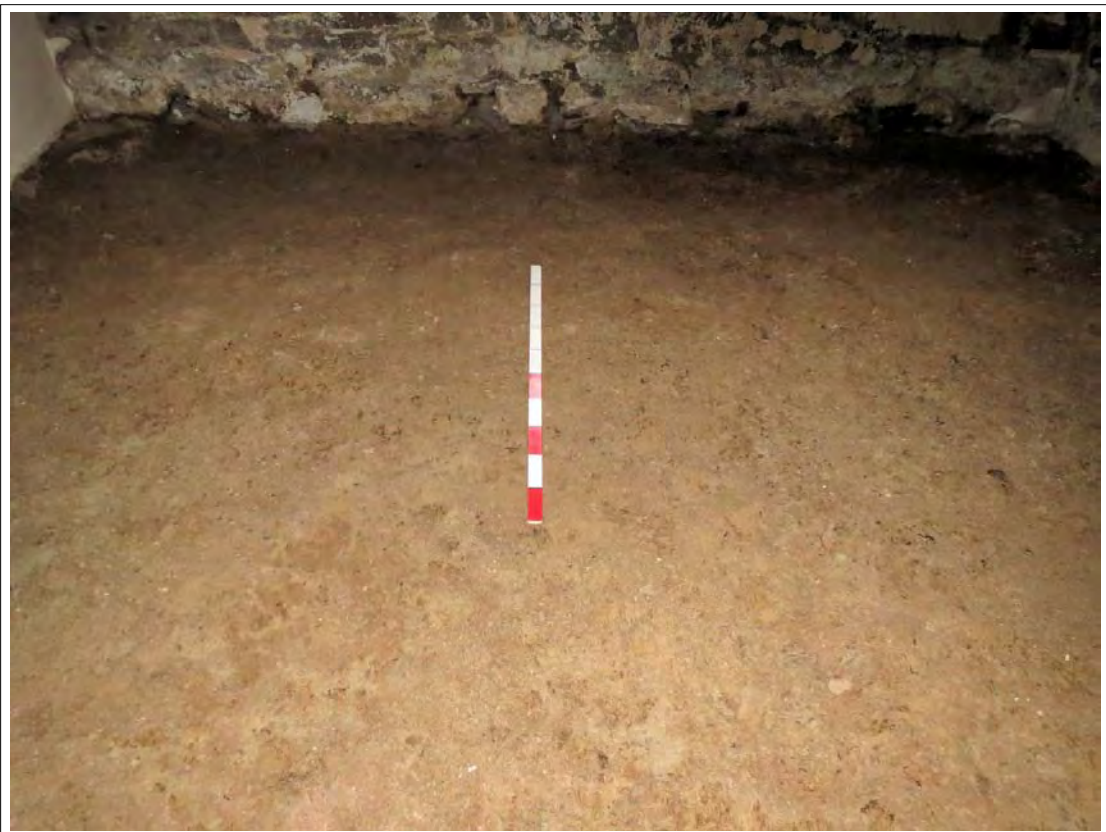
Plate 9. General view of layer (203) within the former hall. Looking North.

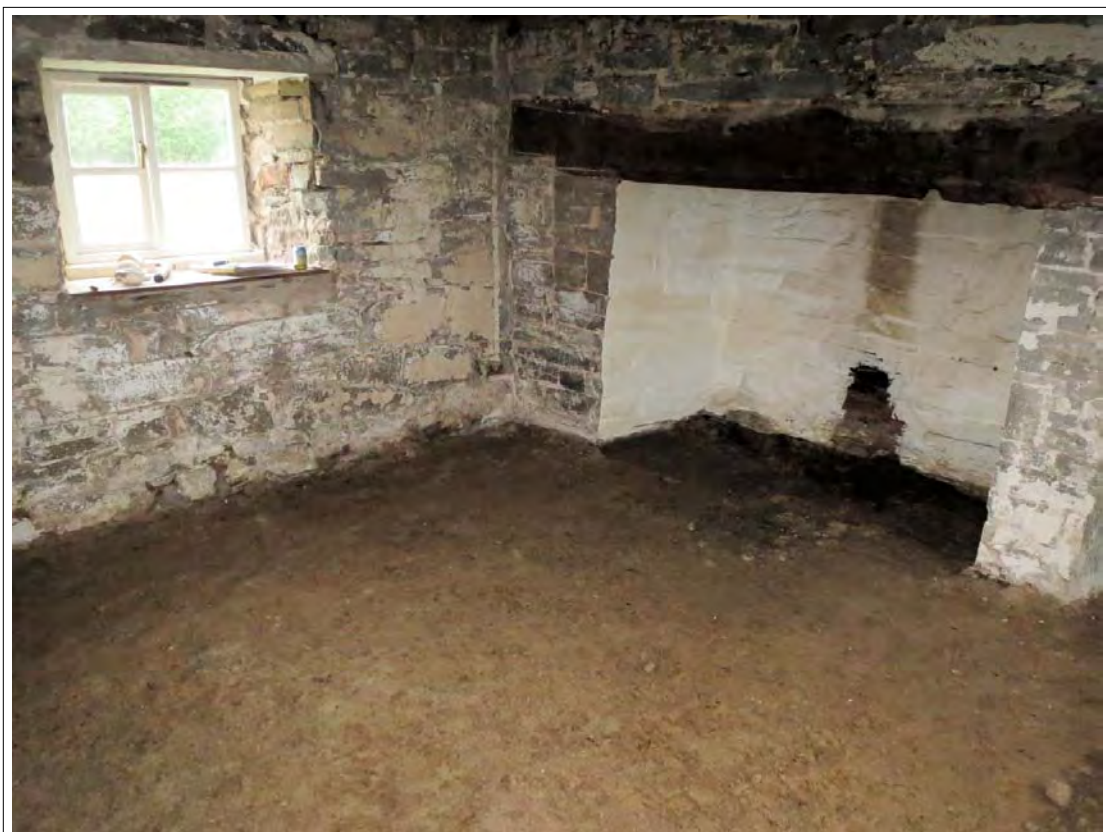
Plate 10. The layer of disturbed natural (203) recorded at the north-east corner of the 17th century farmhouse (located within the area of the 15th century hall). Looking North-East.

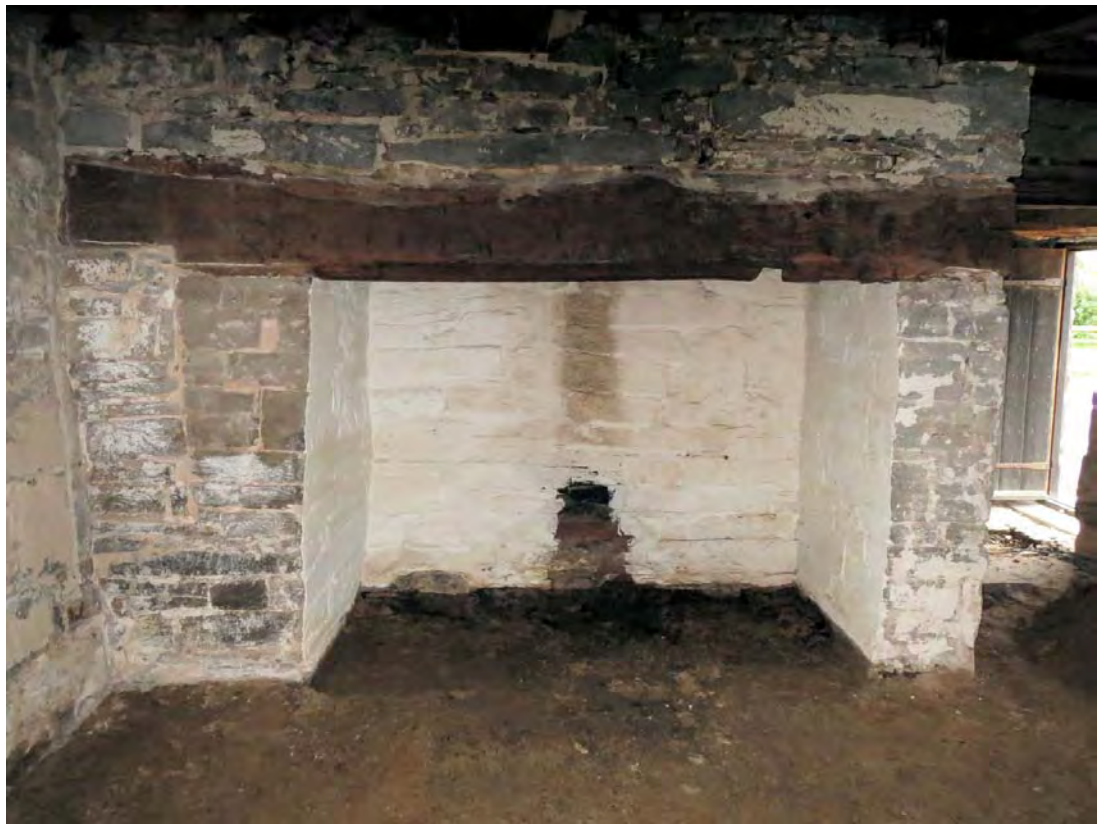
Plate 11. The 17th century fireplace located on the eastern side of the former hall. Looking East.

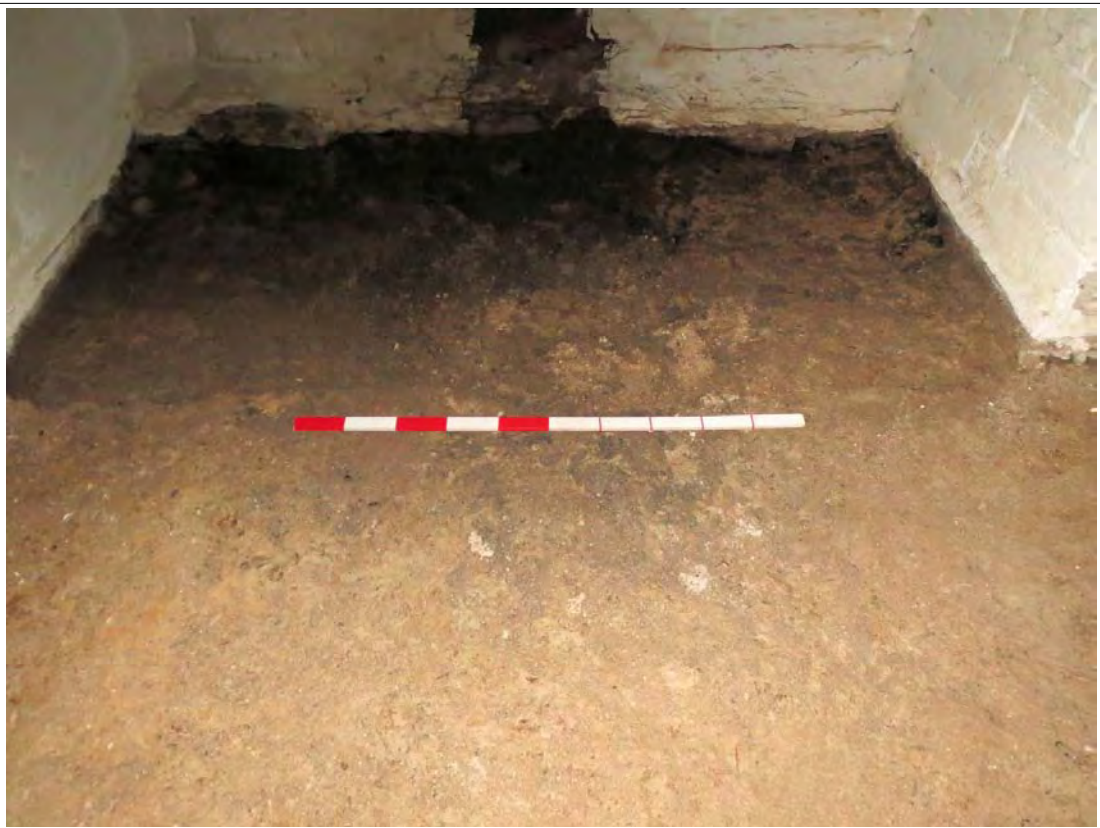
Plate 12. Pre-excavation shot of an irregular feature (205) [206] located directly to the west of the fireplace. Looking East.

- 4.2.6 At the level of the disturbed subsoil (203), an irregular feature (205) [206] was identified adjacent to the large central fireplace (Plates 11-14). This feature was interpreted as a shallow pit, with a small slot at the base. The latter probably marked the position of a stone slab that measured some 0.07m wide and 0.40m long. The fill comprised redeposited natural, with inclusions of lime mortar and charcoal. The central position of the pit (205) [206] indicates this could be associated with the central hearth of the original hall-house. The reduced floor level within this part of the farmhouse would suggest this feature has been truncated; this may explain why there was no evidence for *in situ* burning. It should also be noted that the feature is positioned centrally within the later fireplace, and may in fact be near contemporary, or post-date, the construction of the seventeenth century chimney.

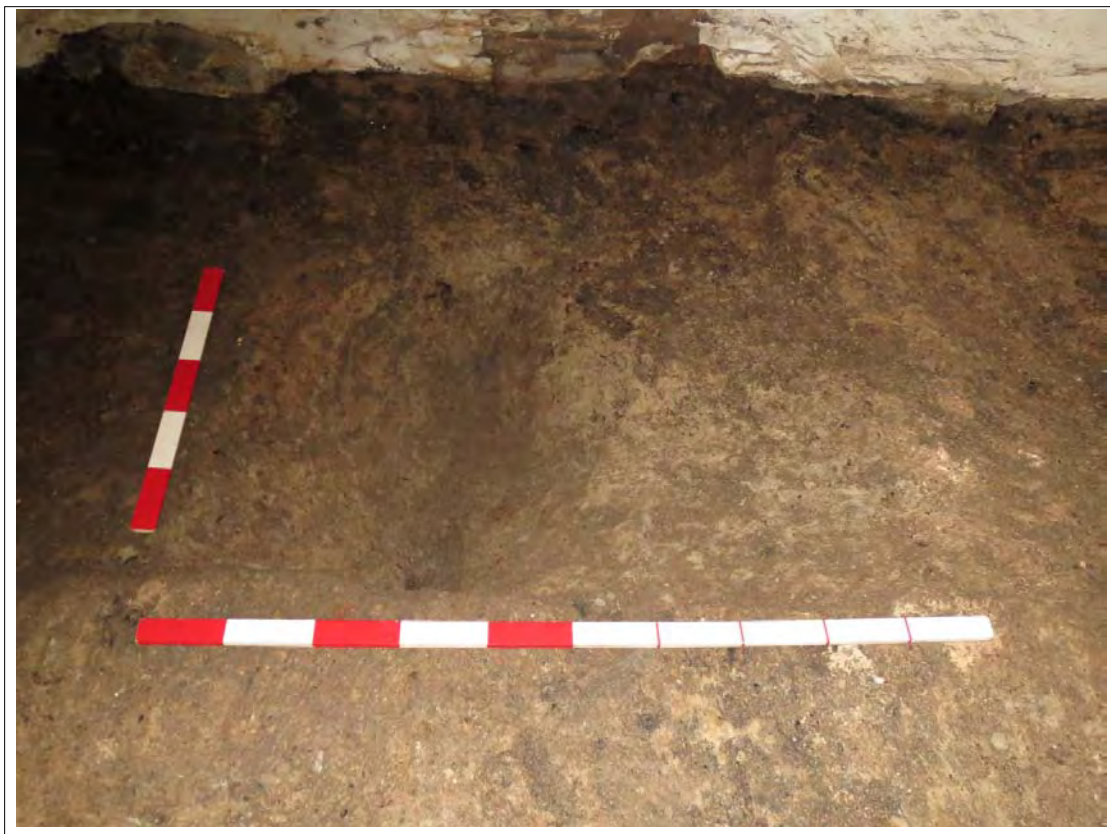
Plate 13. Post-excavation shot of feature (205) [206]. Looking East.

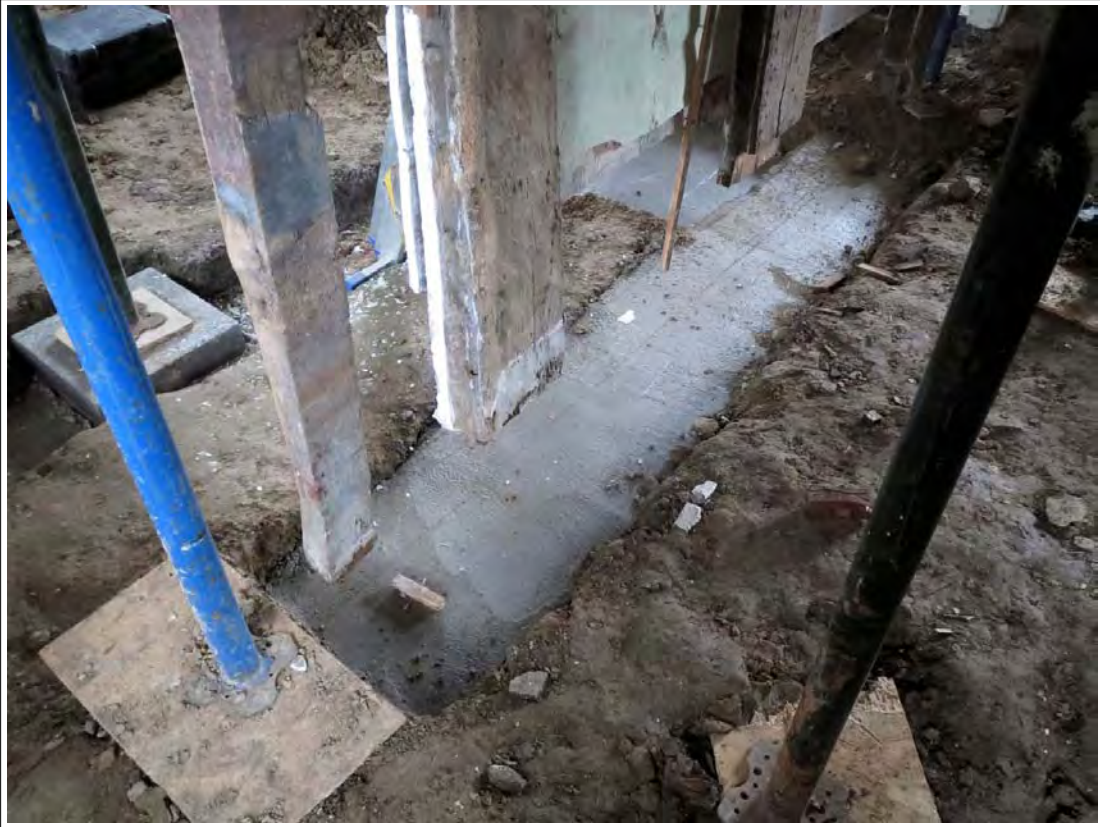
Plate 15. Foundations for the western timber partition supporting the staircase (as located within the 18th century farmhouse). A partition at this location formerly divided the 15th century hall and the 'inner-room'). Looking South-East.

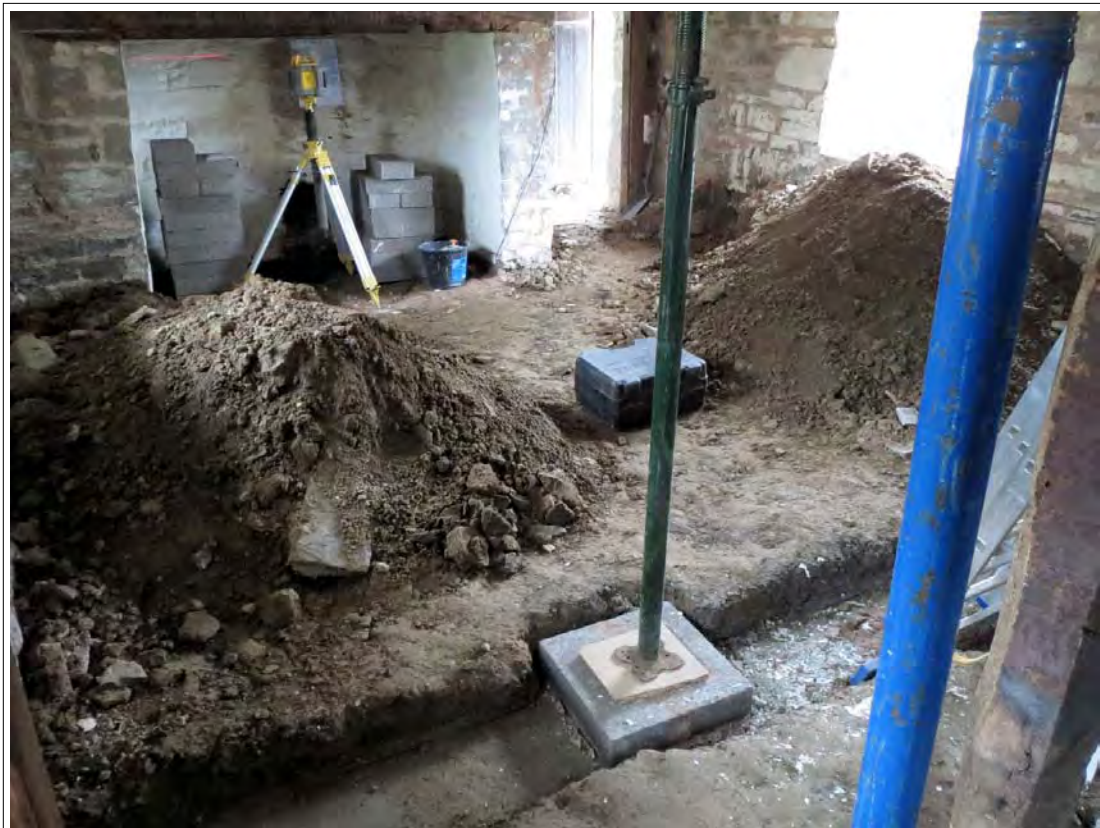
Plate 16. Foundations for the eastern timber partition supporting the staircase (as located within the 18th century farmhouse). This area was formerly located within the 15th century hall. Looking South-East.

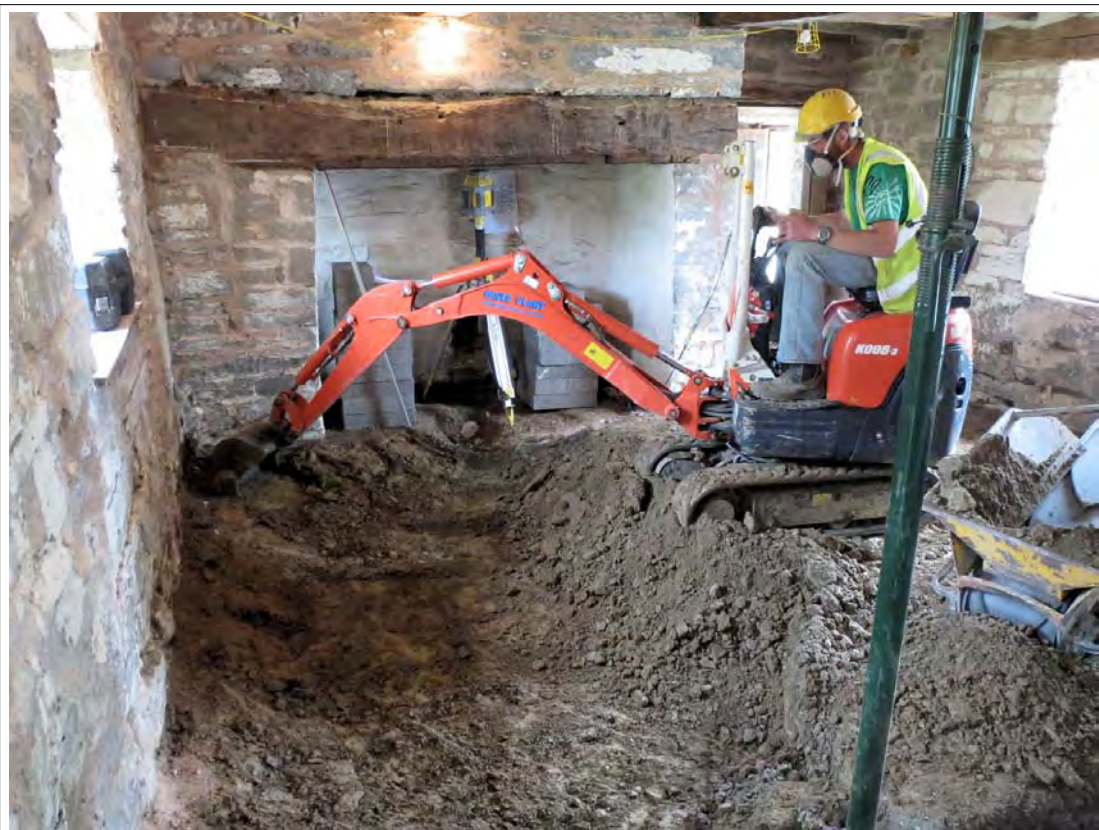
Plate 17. Excavation of internal floor levels (203) (204) within the former hall to allow for a new floor slab. Looking East.

- 4.2.8 The underlying subsoil (204), the natural, comprised a stiff mottled light-mid brown-orange and mid grey silt. The subsoil (204) was excavated some 0.25m to allow for a new floor slab (Plate 17). Foundation trenches were also excavated for renewed timber partitions supporting the staircase (Plates 15 & 16). The excavation depth for the floor slab was recorded at approximately 97.45m Site Datum.

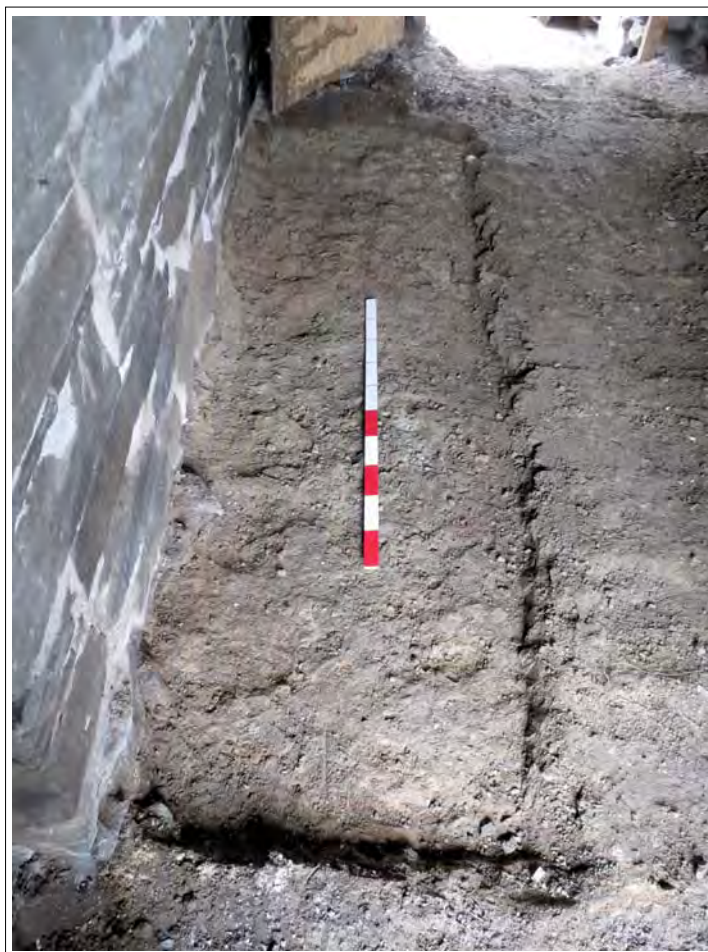
Plate 18. Working shot of excavations within the former cross passage of the hall-house. The deposits below the slab floor (200) comprised mortar bedding (201), blinding material (202) and a compacted floor surface of 'dirty' natural (207). Looking North.

- 4.2.7 Within the cross passage, hand excavation of layer 202 (Plate 18) exposed a surface of compacted subsoil (207). This comprised a mid brown-grey silt, interpreted as 'dirty' natural, that was much darker than the compacted natural (203) in the adjacent living room. The compacted subsoil was encountered at approximately 97.70m Site Datum. This layer (207) potentially represents an earthen floor that once extended along the cross-passage (Plate 20). The boundary with the underlying natural (204) was diffuse, as was the boundary with the compacted natural in the adjacent room of the farmhouse (203). This layer was sample excavated by hand, but contained no finds. The compacted surface was approximately 0.05m thick.

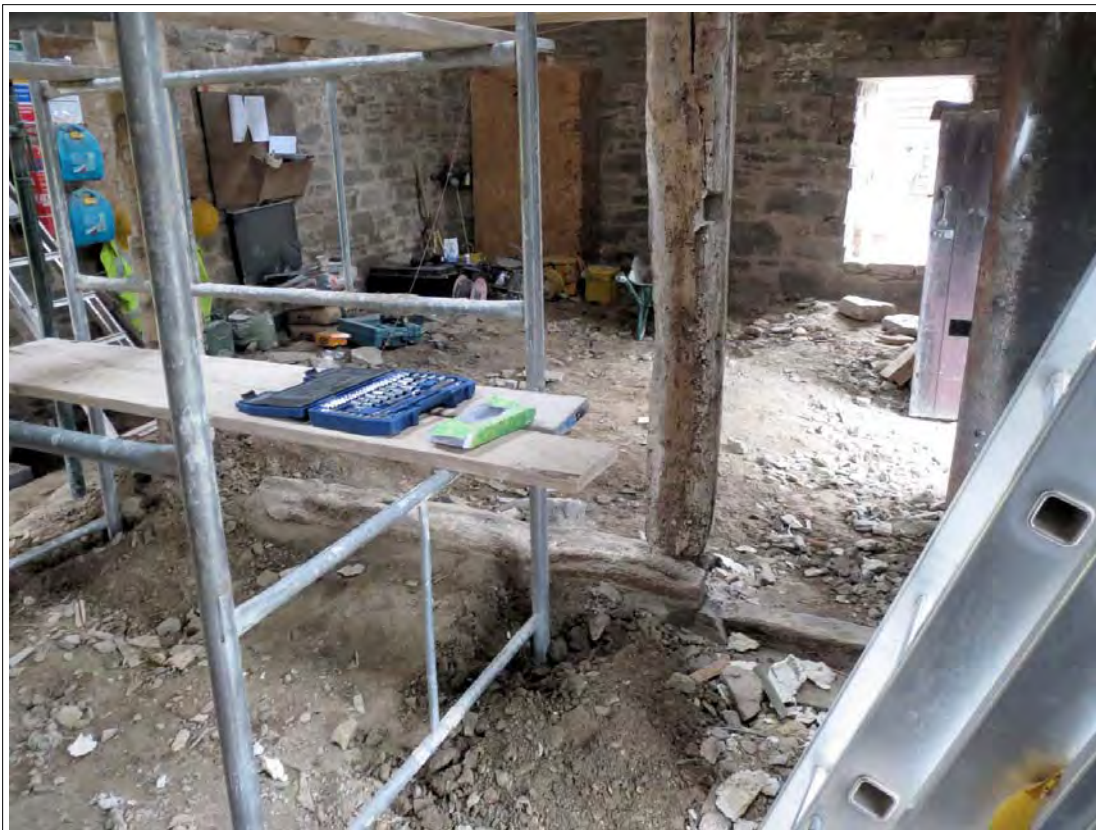
Plate 19. Pre-excavation shot of the barn interior, east of the farmhouse. The barn was formerly separated from the hall cross-passage by a timber partition. Looking North-East.

- 4.3.1 This was originally the outer-room of the fifteenth century hall-house, which was demolished when the barn was built (Plate 19). It is thought to have been used as a cow-house before being converted into stables in the late eighteenth or early nineteenth century.

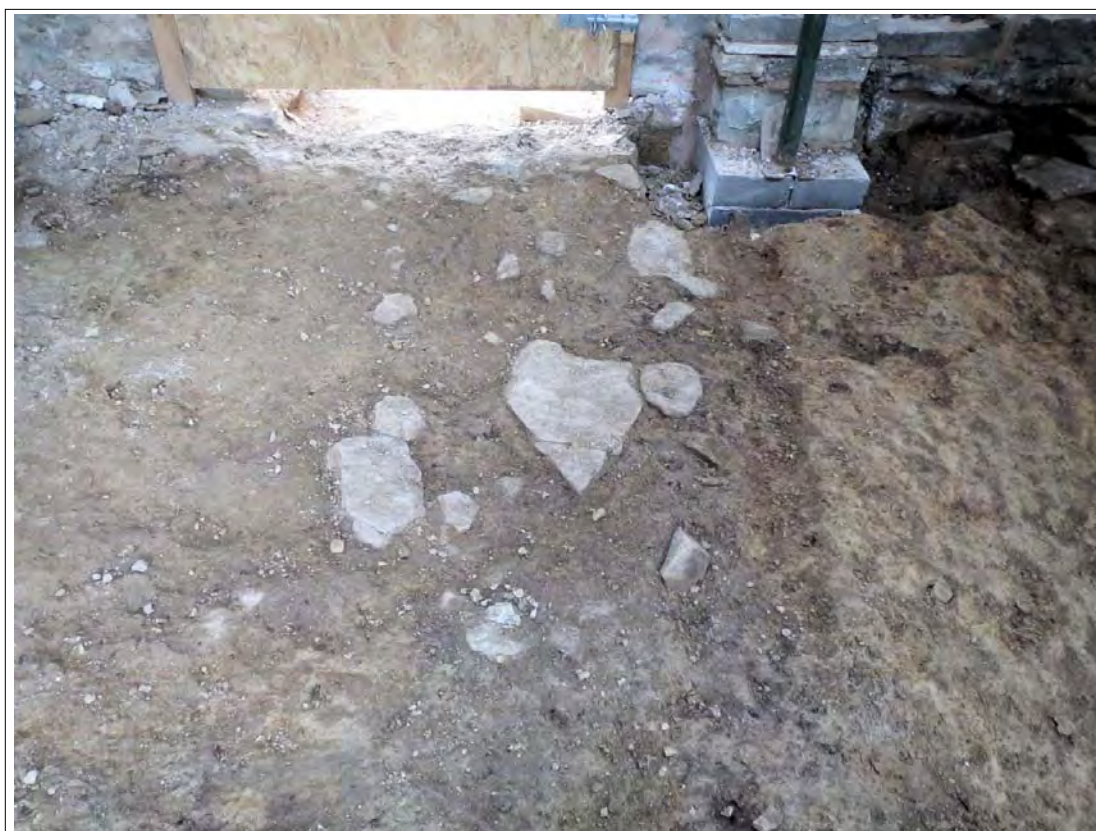
Plate 20. Compacted floor layers associated with the former cross passage (207) and barn (303), shown to the left and right of the photograph, respectively. Looking North.

- 4.3.6 It was noted that the compacted subsoil (303) within the barn was a relatively 'clean' deposit in comparison to the compacted natural (207) within the former cross-passage (Plates 20 & 21). The compacted layer in the barn (303) does not appear to represent a floor surface associated with the eighteenth century barn (or the fifteenth century hall-house).

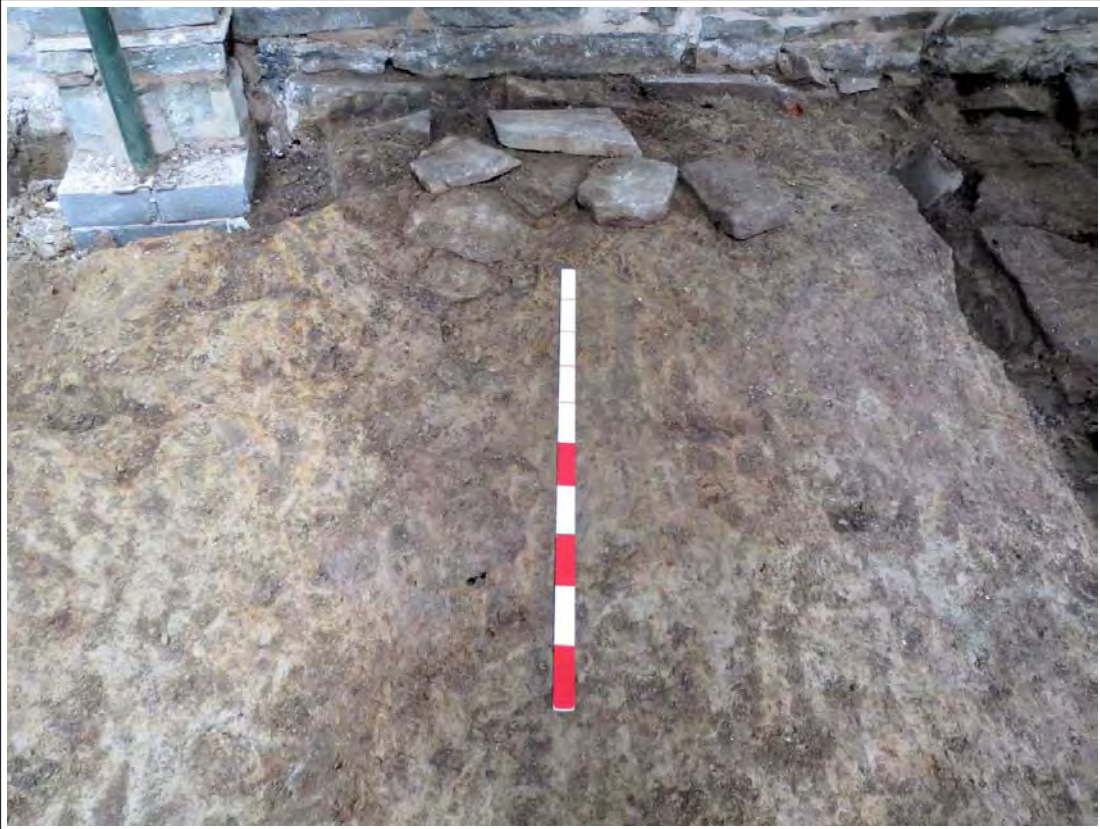
Plate 21. The northern wall of the 18th century (and later) barn, showing two potential phases of stone and earth floors (304) (305) above compacted natural (303). Looking North.

- 4.3.3 The made ground (302) was excavated by machine to expose a floor level (304) consisting of loose flags and cobbles (Plate 21) and compacted earth, a firm mottled dark grey-orange silt, derived from the subsoil. The earth floor (304) extended across the entire barn at approximately 97.80m to 97.85m Site Datum. A number of

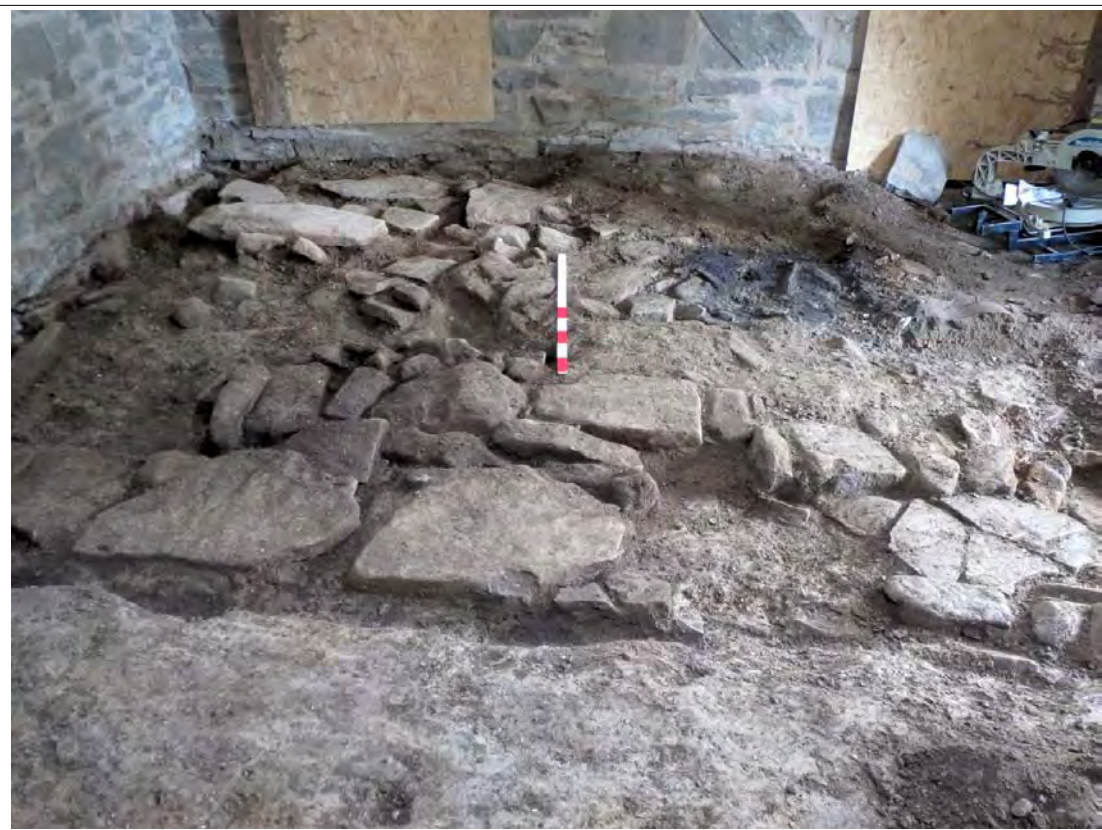
Plate 22. Overall post-excavation shot of the remains of stone and earth floors (304) (305) associated with the former barn. Looking East.

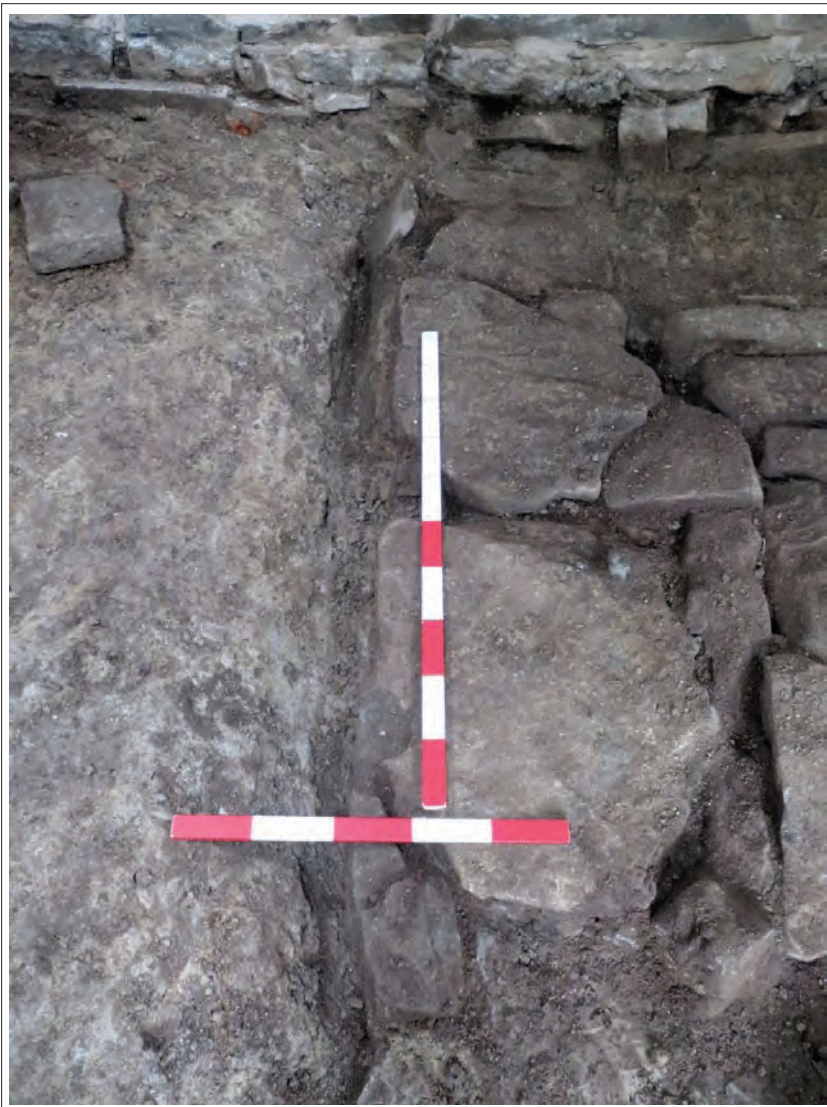
Plate 23. The western edge of the (eastern) barn floor (305). This may have been defined by a stone-lined gully, which is potentially marked by a broken line of pitched stones. Looking North.

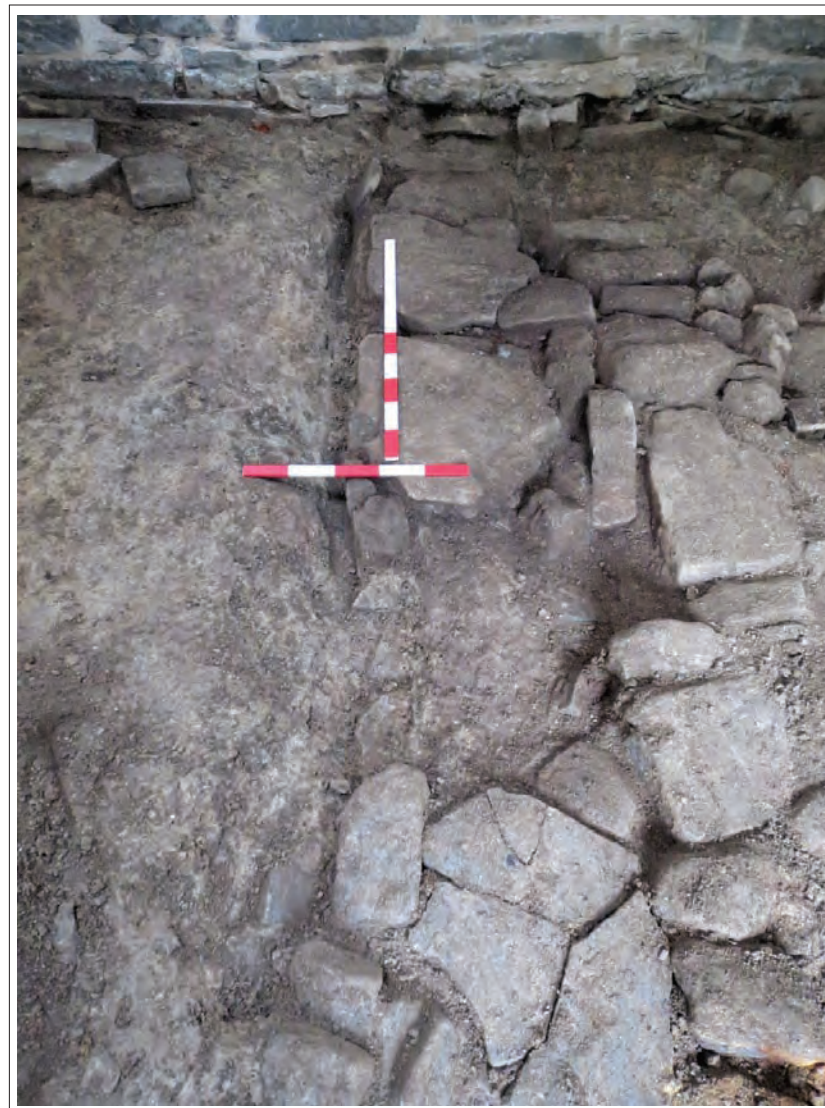
Plate 24. General view of the edge of the 'cobbled' floor (305), set within/above a layer of disturbed natural (306). Looking North.
