Little Wern-Y-Pentre, Clyro, Powys

Archaeological Watching Brief

Report No. 1441

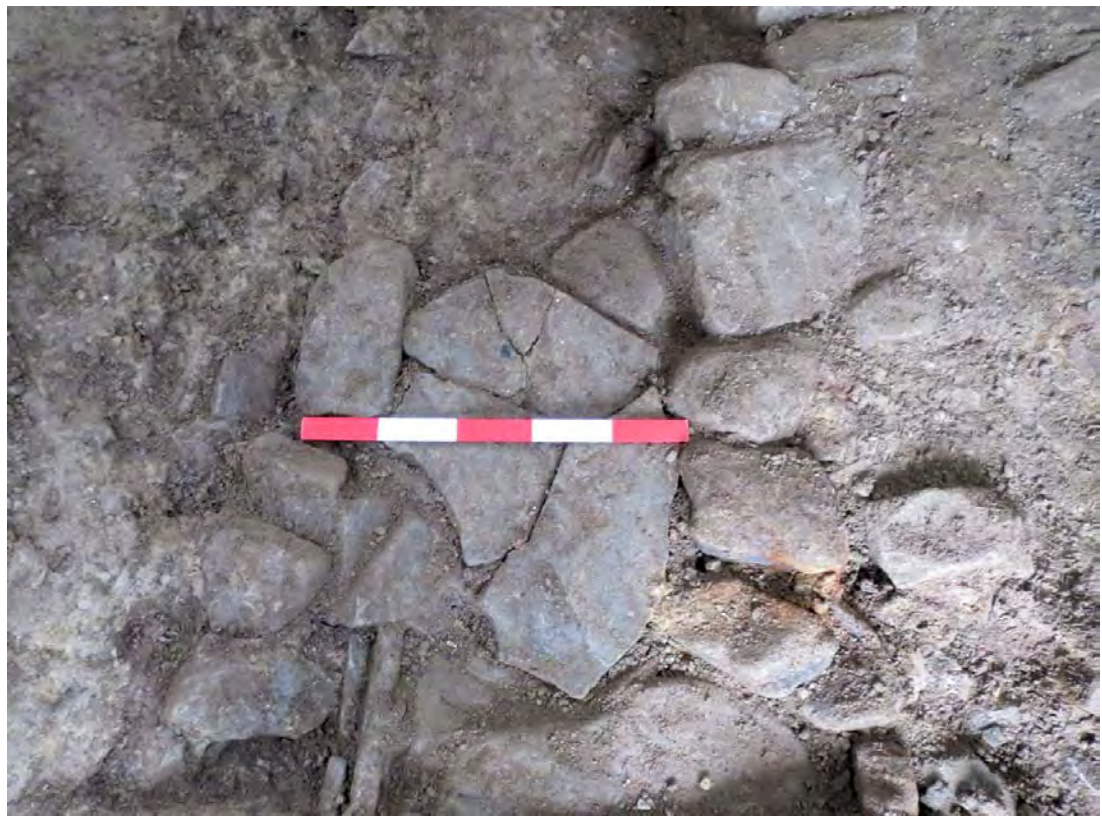
Plate 25. Detail of the 'cobbled' floor (305) towards the southern barn wall. Looking North

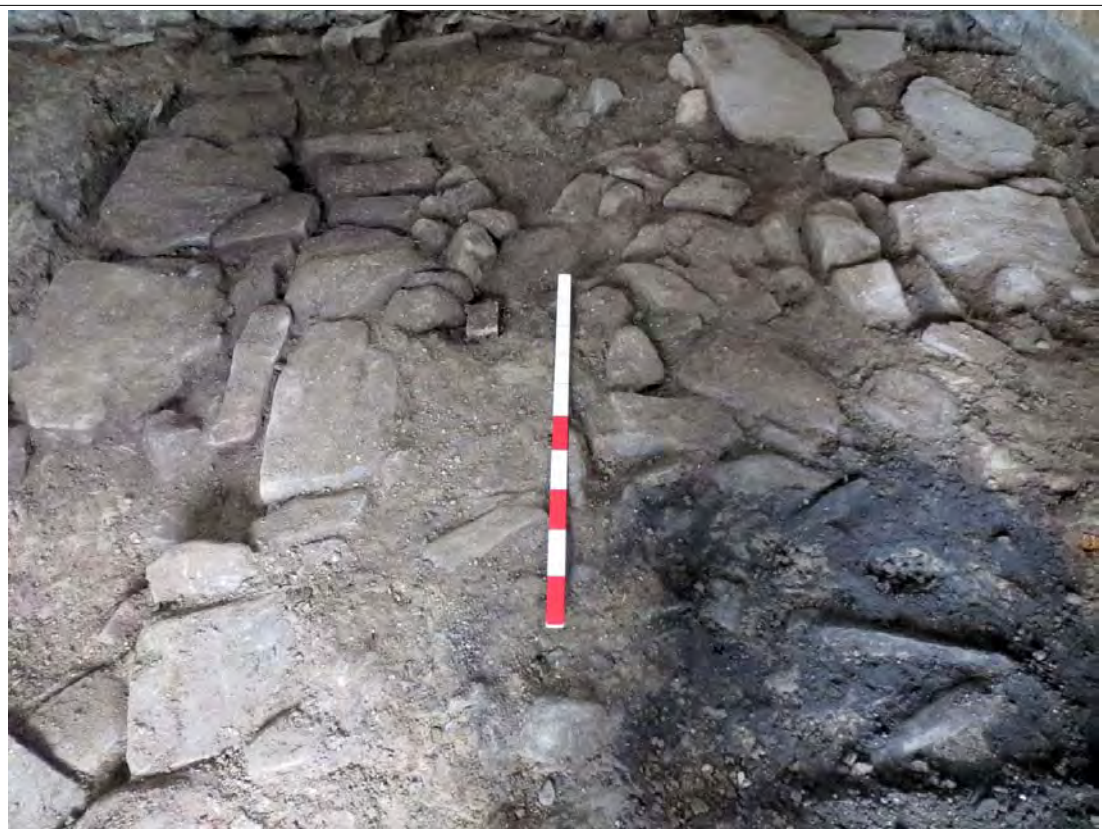
Plate 26. Post-excavation shot of the stone floors (304) (305) at the centre of the barn. Looking North.

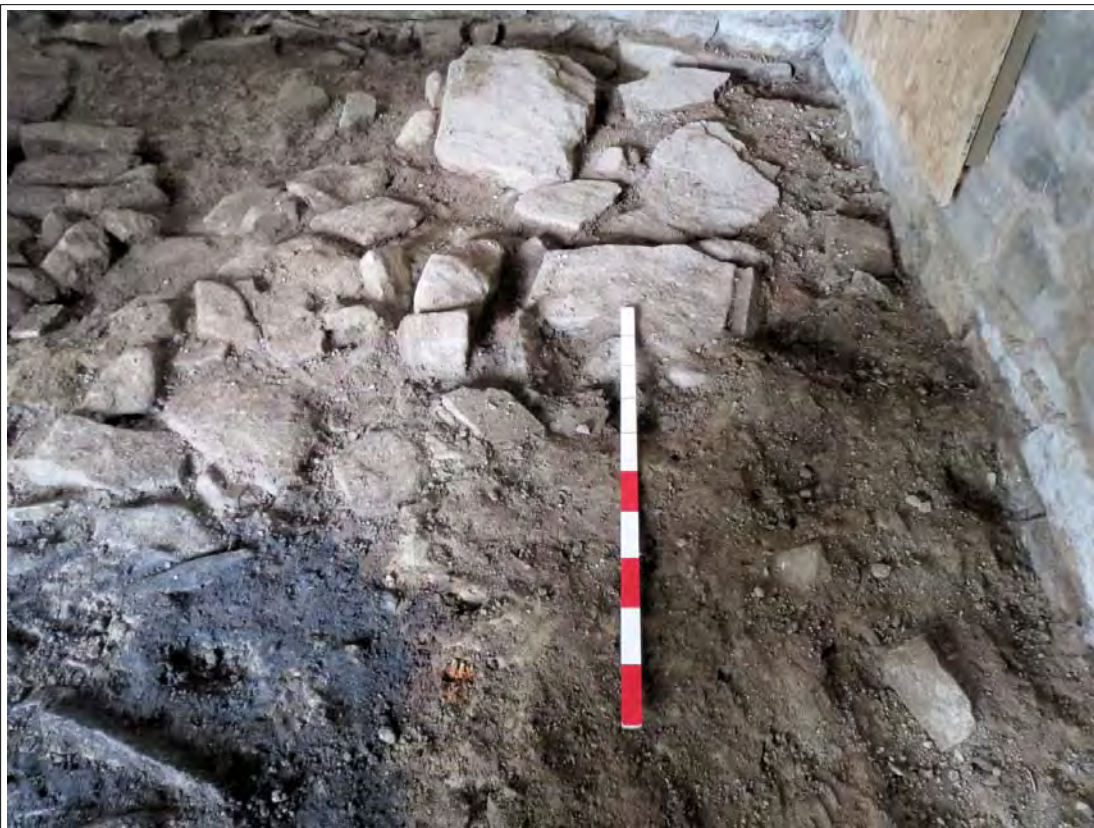
Plate 27. Post-excavation shot of the stone floors (304) (305) along the eastern edge of the barn. Looking North.

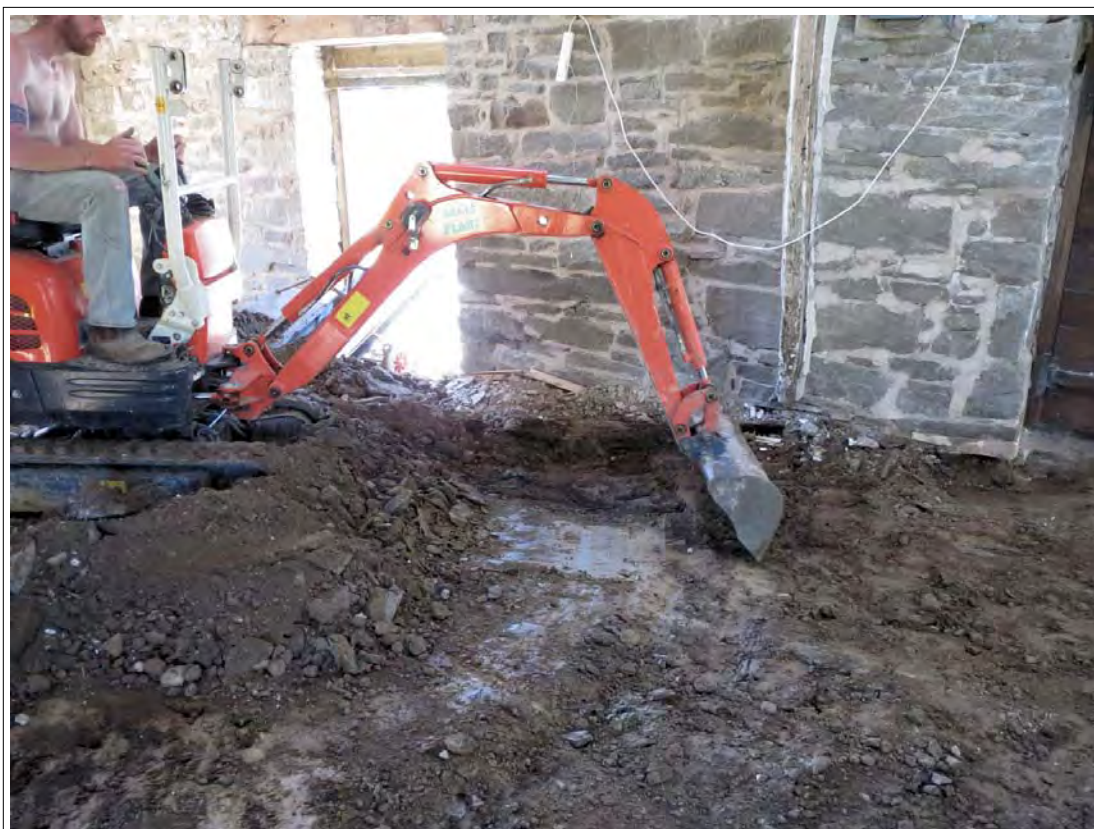
Plate 28. Excavation of internal floor levels (306) (307) within the former barn to allow for a new floor slab. Looking South-South-East.

- 4.3.8 The underlying subsoil (307) comprised a stiff mottled light-mid brown-orange and mid grey silt. The subsoil within Area C was excavated by some 0.20m to allow for a new floor slab (Plate 28). A foundation base was also excavated along the northern barn wall for a pier to support a tie-beam / ceiling beam (Plates 20 & 21). The excavation depth was recorded as approximately 97.45m Site Datum.
