Rose Cottage, Llancadle, Vale of Glamorgan Watching Brief 2016/00035/FUL

**Rose Cottage
Llancadle
Vale of Glamorgan
Watching Brief
2016/00035/FUL**

Trysor Project No. 2017/548

1.1 In April 2017, Trysor undertook a watching brief on groundworks for a single storey extension at Rose Cottage, Llancadle, planning application 2016/00035/FUL (Vale of Glamorgan).

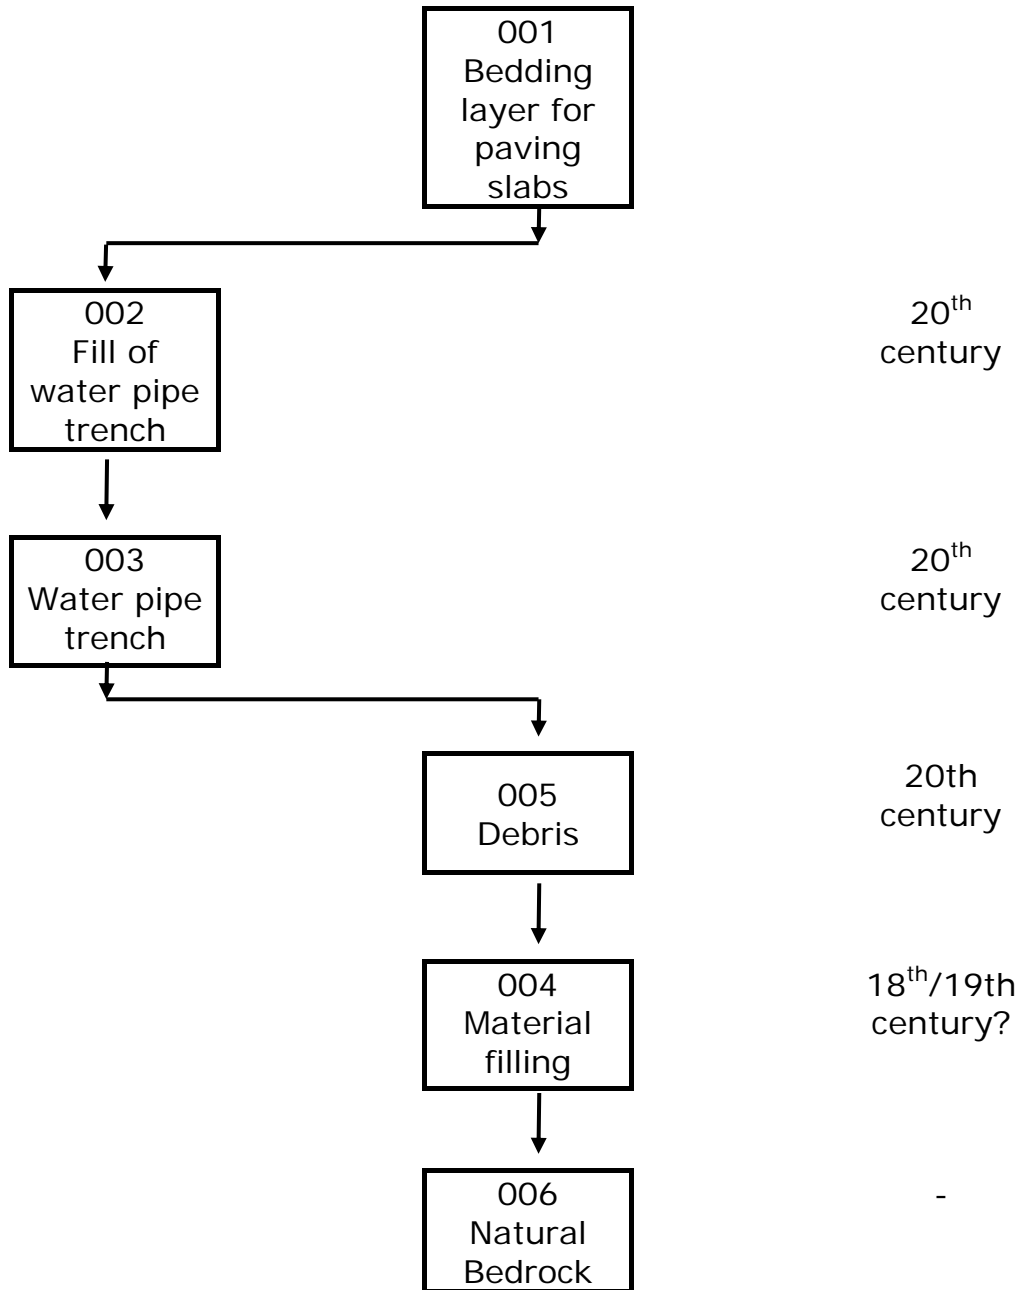
Figure 3; Site plan after removal of (001) and (005)

Context Number	Depth	Description	Interpretation
001	Less than 0.05m	Scalplings and sand	Bedding layer for paving slabs, previously removed
002	Not excavated	2.5Y 4/3 loose sand plus blue alkathene pipe	Fill of modern water pipe trench
003	Not excavated	Cut for modern water pipe trench	Modern water pipe trench
004		2.5Y 3/1 clay with gravel, small coal flecks and partial glazed pottery	Late post medieval material filling a hollow in the surface of the bedrock
005		2.5Y 3/2 mottled sandy clay with gravel, slate, clay pipe and metal	20 th century, mixed layer,
006	-		Bedrock Jurassic limestone Porthkerry Member

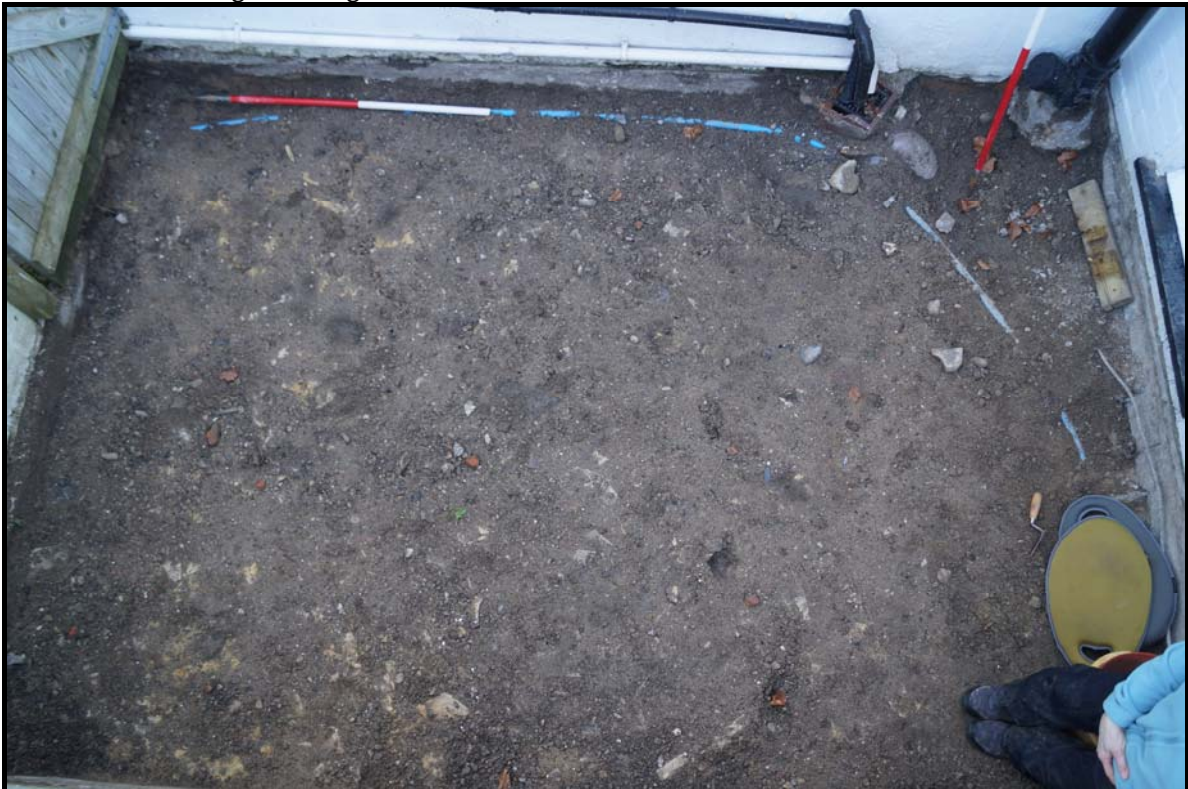
Plate 2: RCL2017_102, after the paving slabs had been lifted, showing remains of (001), the bedding for the paving slabs and (005) debris layer, probably from when extension was built, looking southeast.

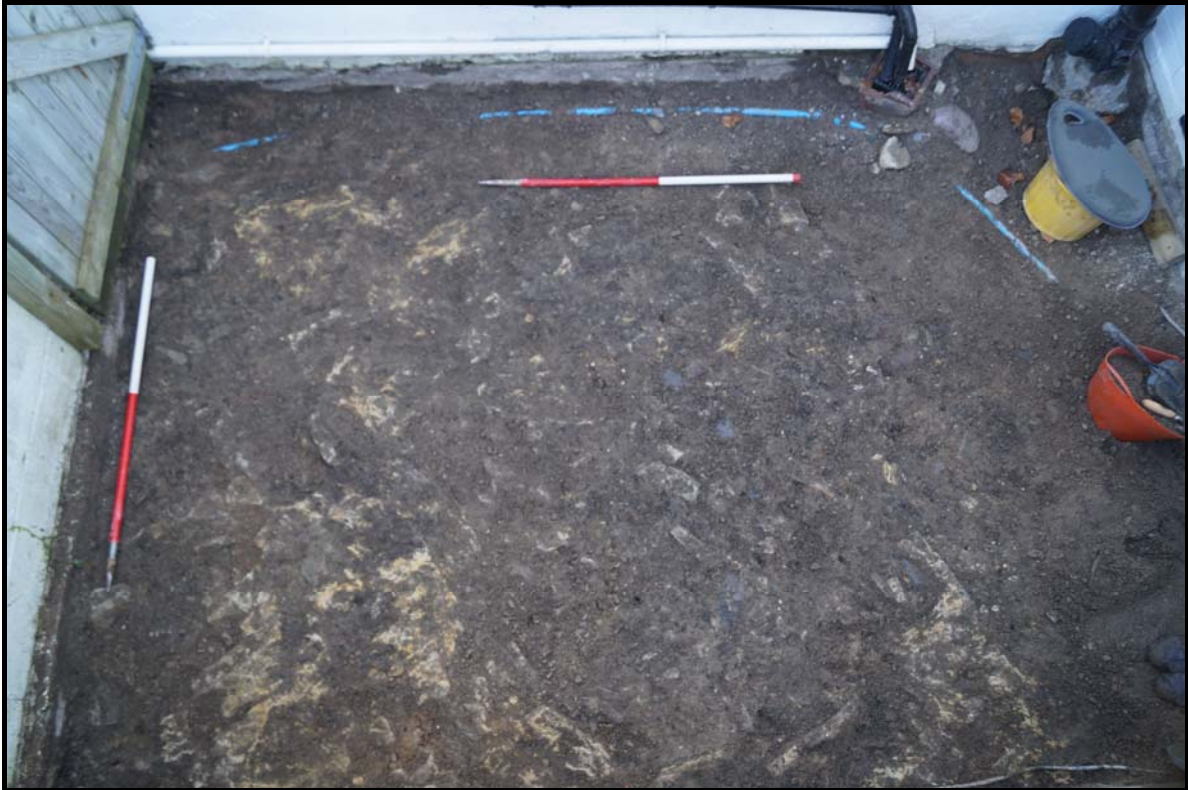
Plate 3: RCL2017_103, after removal of (001) and (005) showing (002)/[003], the modern water pipe trench, and (004) material filling a hollow in (006) natural bedrock, looking southeast..

10.2 Context (004) was left in situ but would not be impacted on by the development.

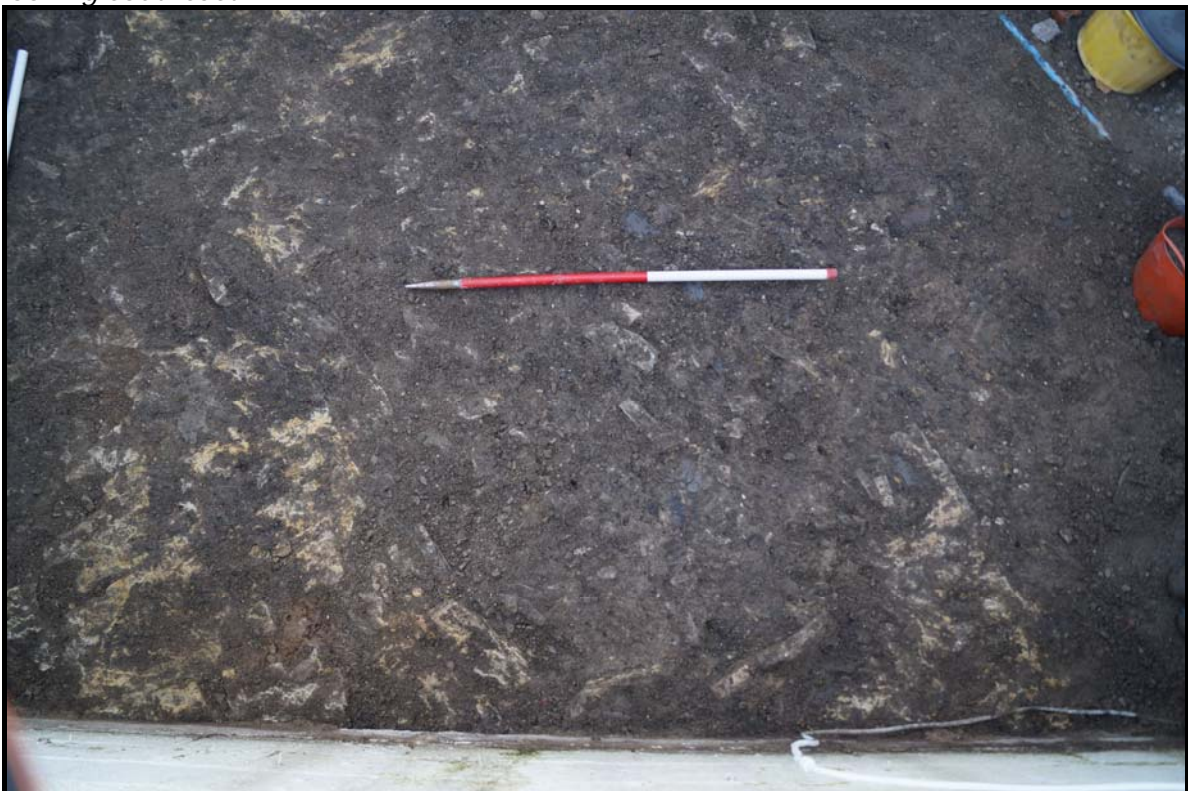
Plate 4: RCL2017_104, detail of the (004), material filling a hollow in the natural bedrock, looking southeast.

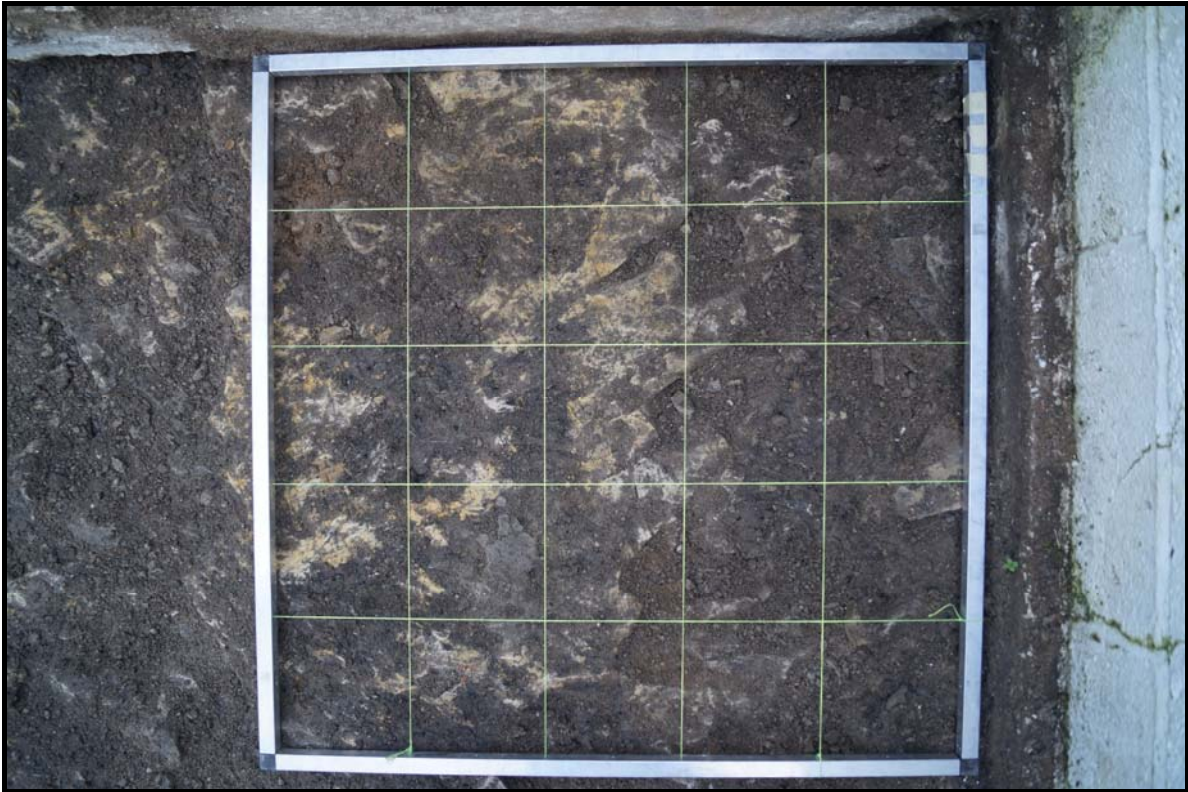
Plate 5: RCL2017_105, First in sequence of photos with planning frame running from northeast to southwest, along northwestern edge of site, showing (006), looking northwest

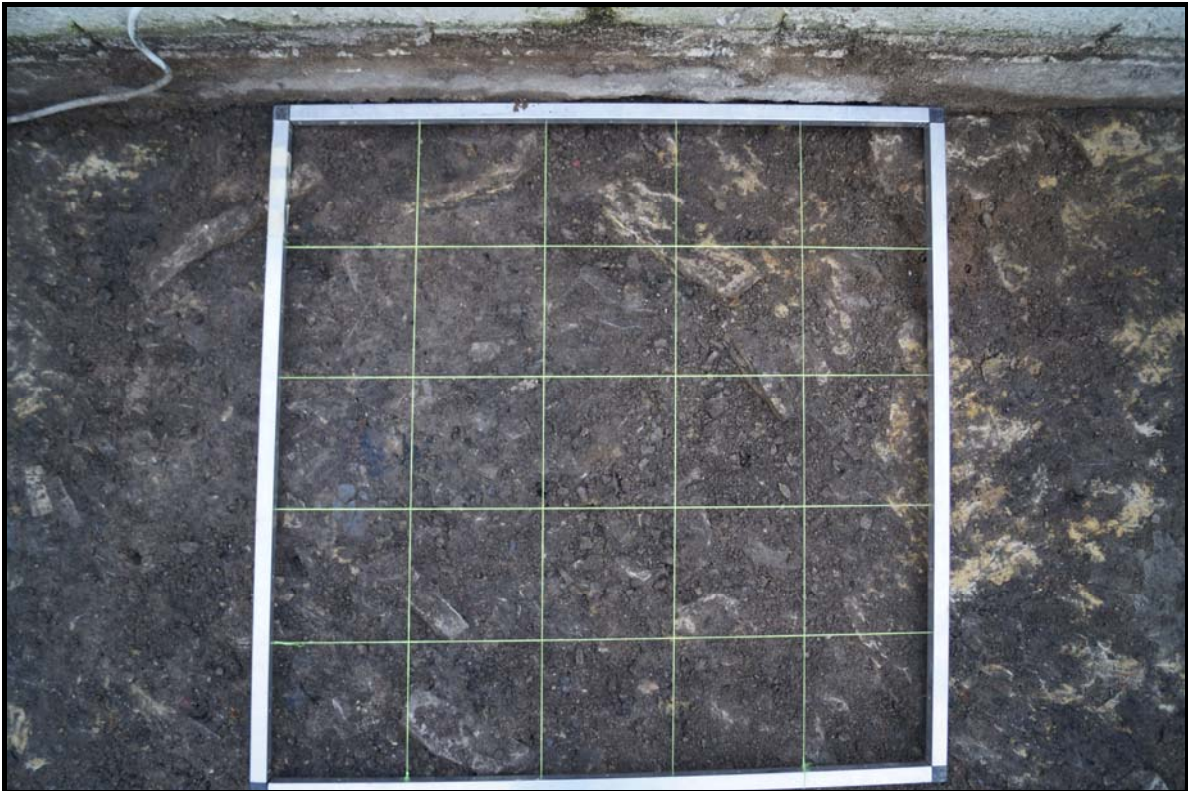
Plate 6: RCL2017_106, Second in sequence of photos with planning frame running from northeast to southwest, along northwestern edge of site, showing (006), looking northwest.

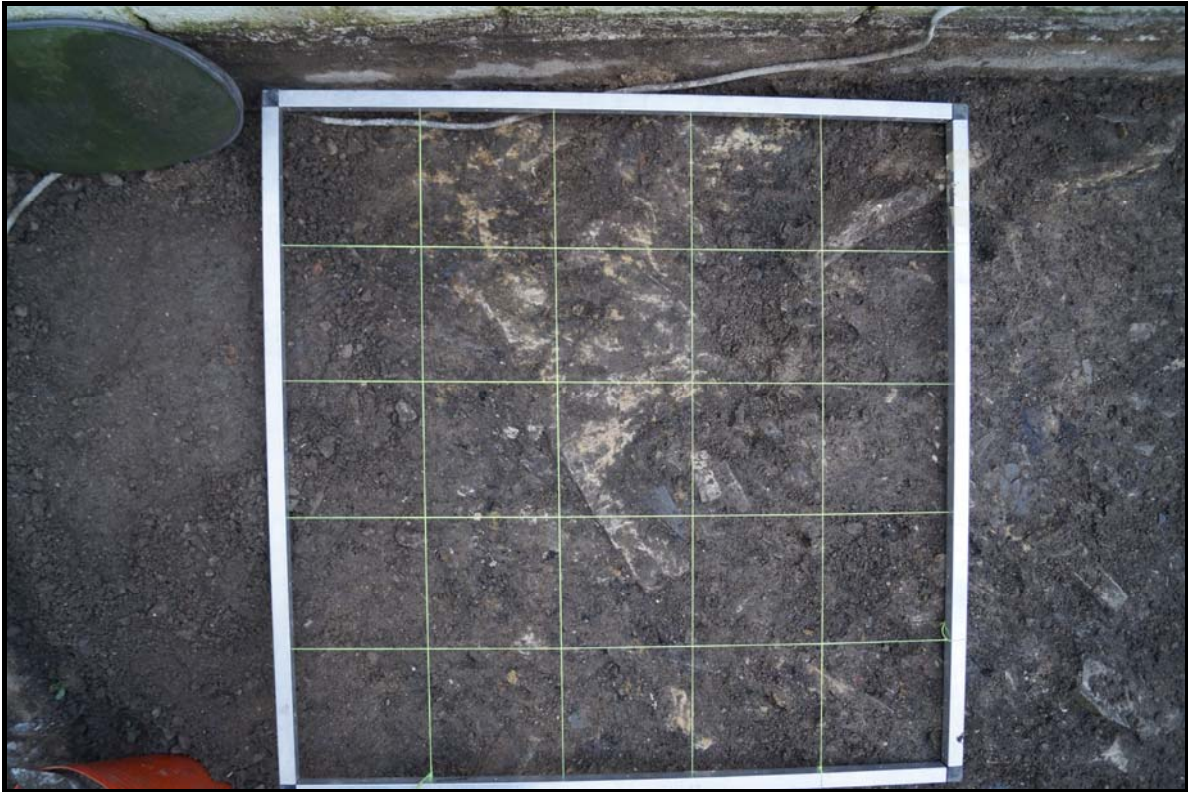
Plate 7: RCL2017_107, Third in sequence of photos with planning frame running from northeast to southwest, along northwestern edge of site.

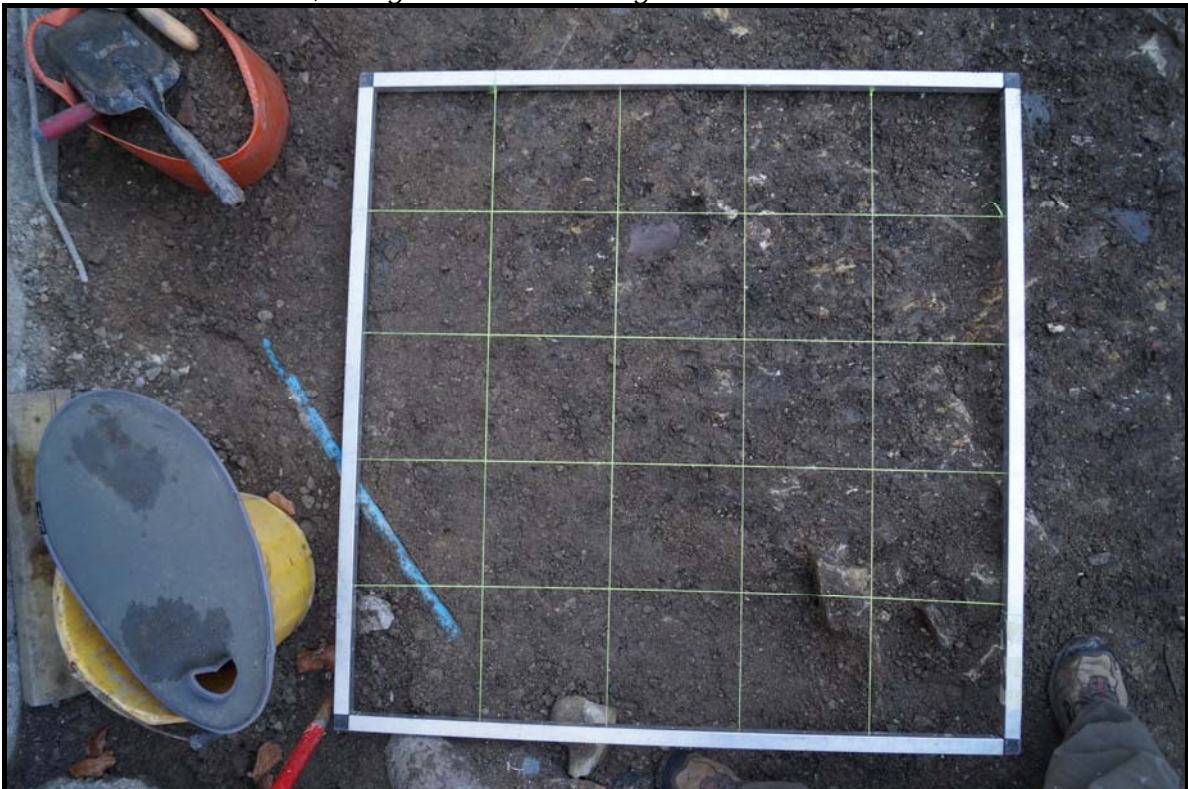
Plate 8: RCL2017_108, First in sequence of photos with planning frame running from southwest to northeast, along centre of site, looking northwest.

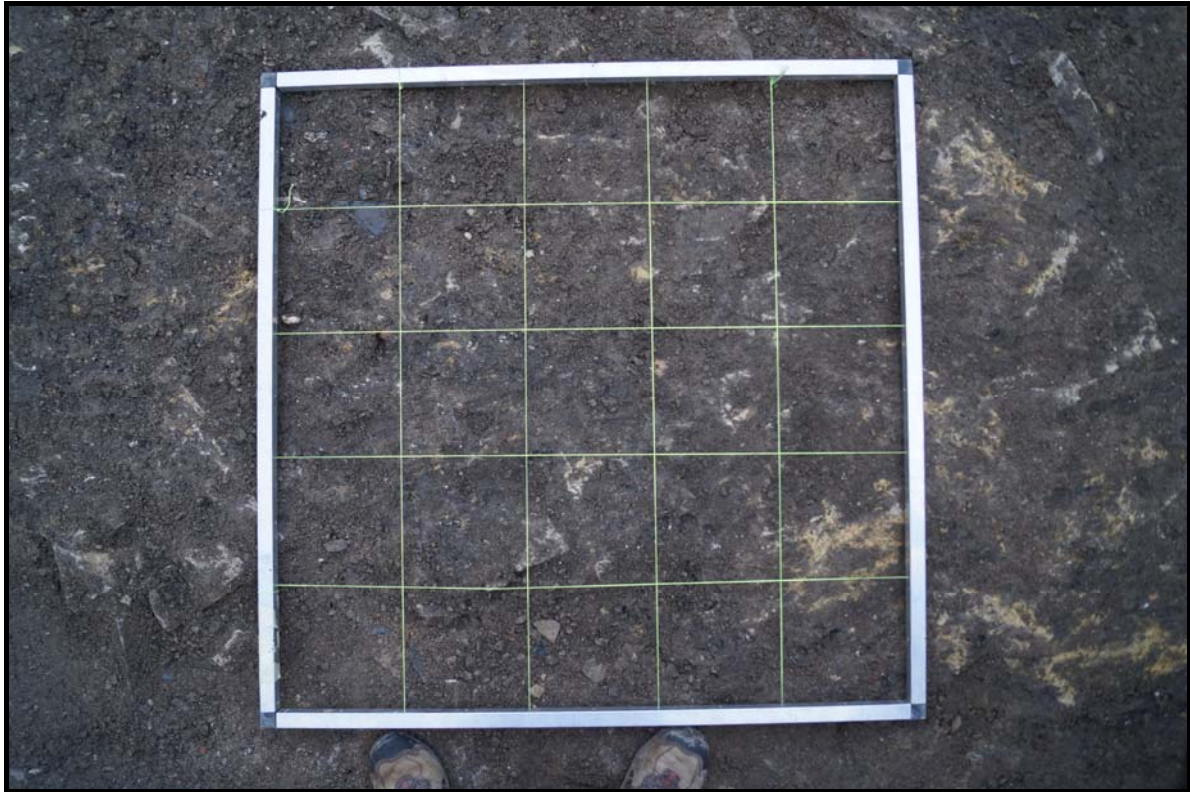
Plate 9: RCL2017_109, Second in sequence of photos with planning frame running from southwest to northeast, along centre of site, looking northwest.

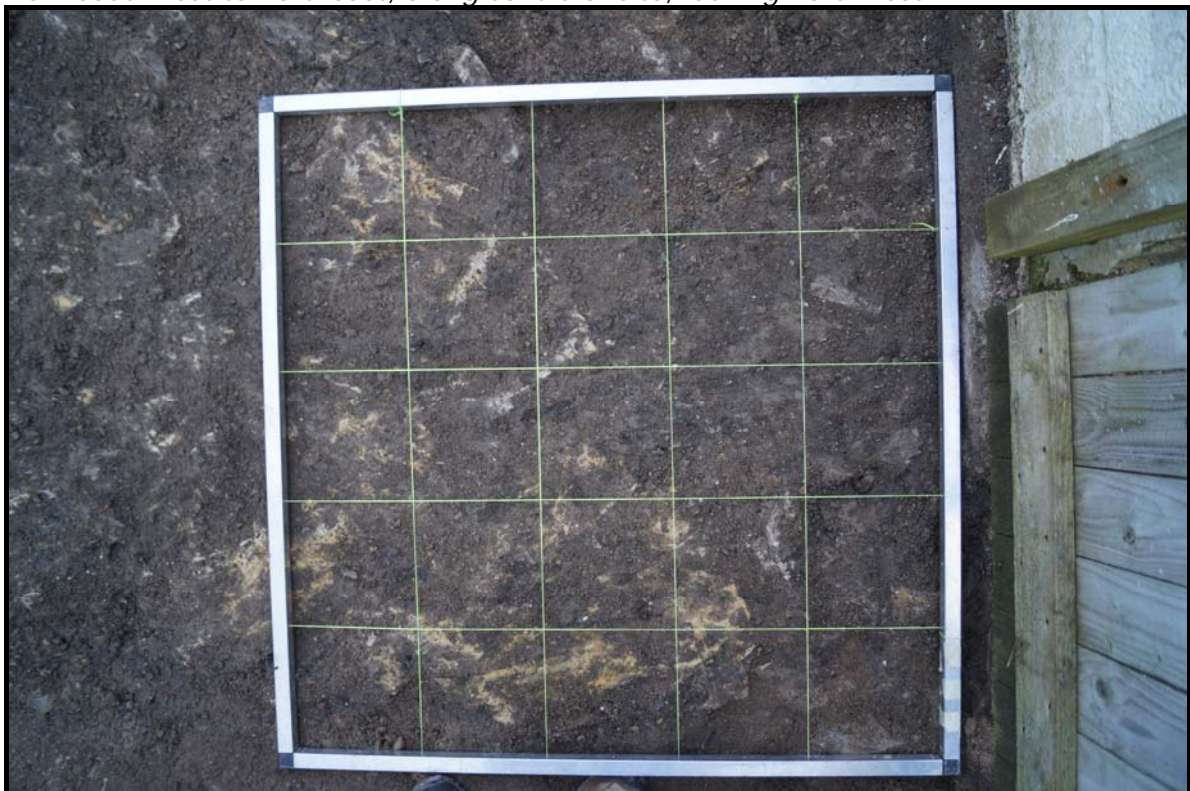
Plate 10: RCL2017_110, third in sequence of photos with planning frame running from southwest to northeast, along centre of site, looking northwest.

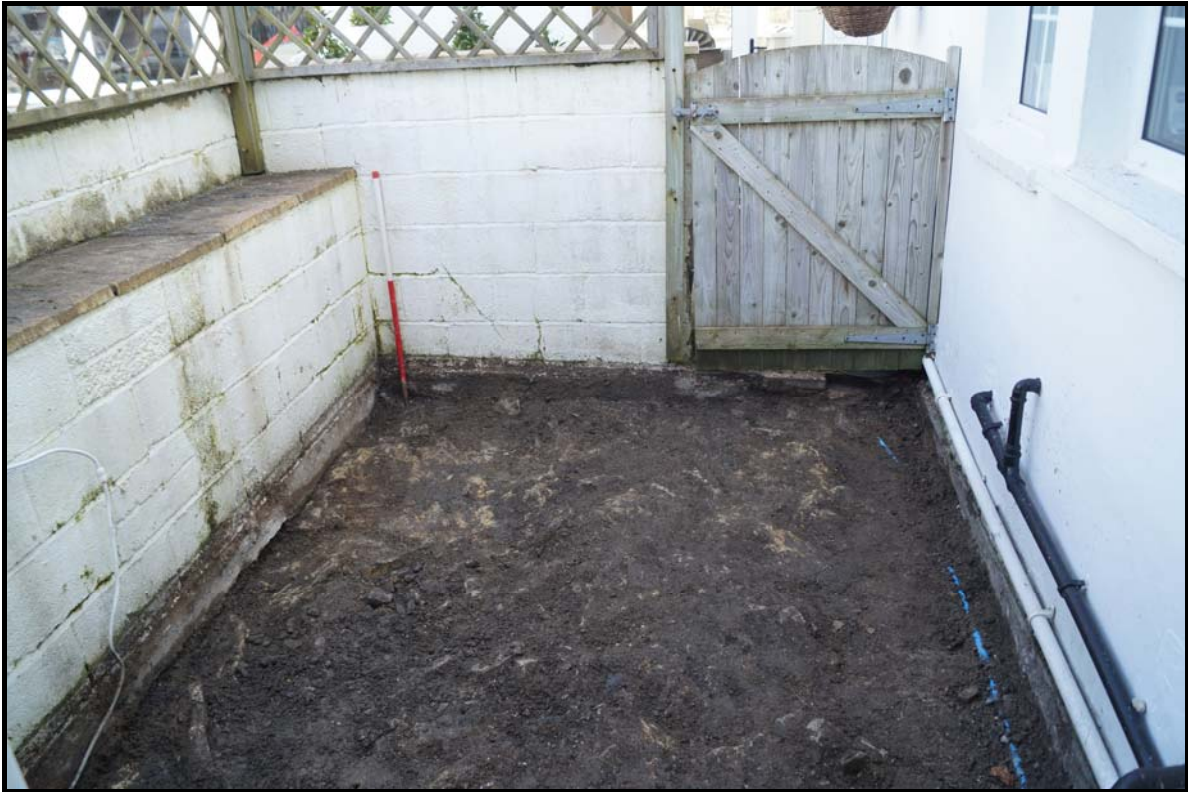
Plate 11: RCL2017_111, general view of site, looking northeast.

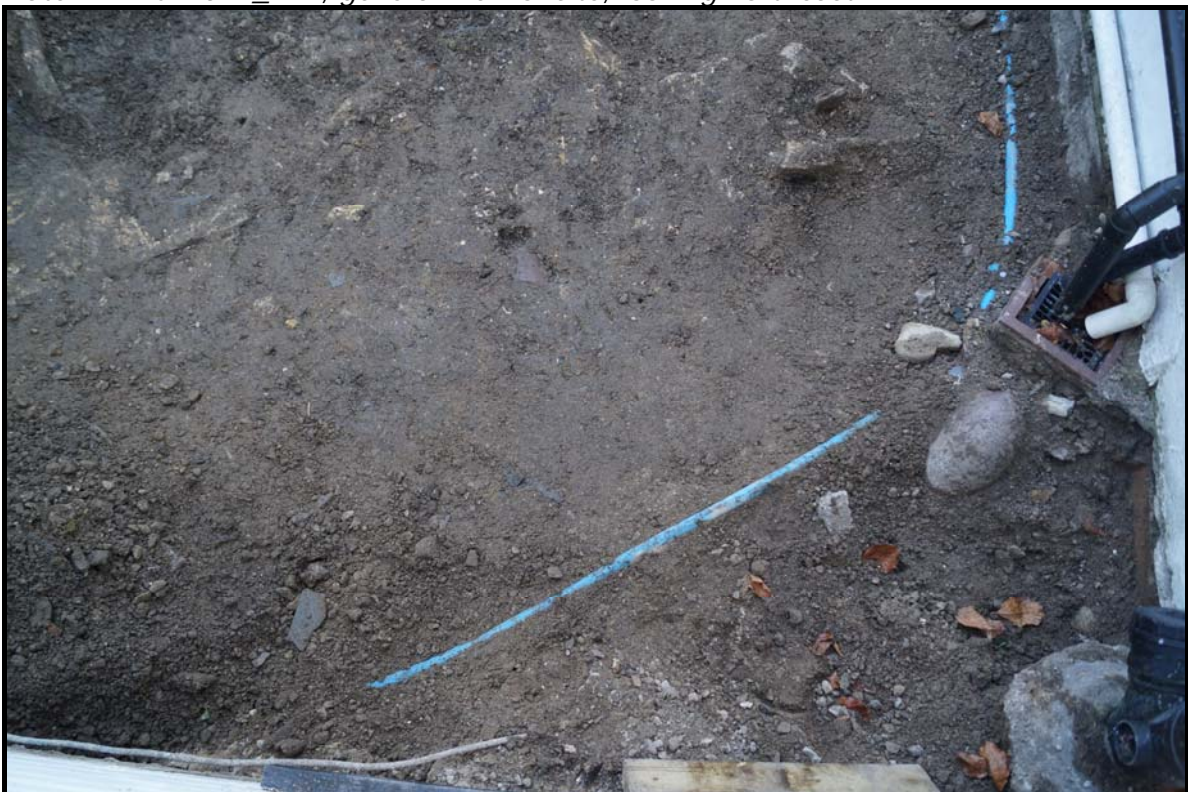
Plate 12: RCL2017_112, the modern water pipe (002) and [003] at southwestern end of site, looking northeast.

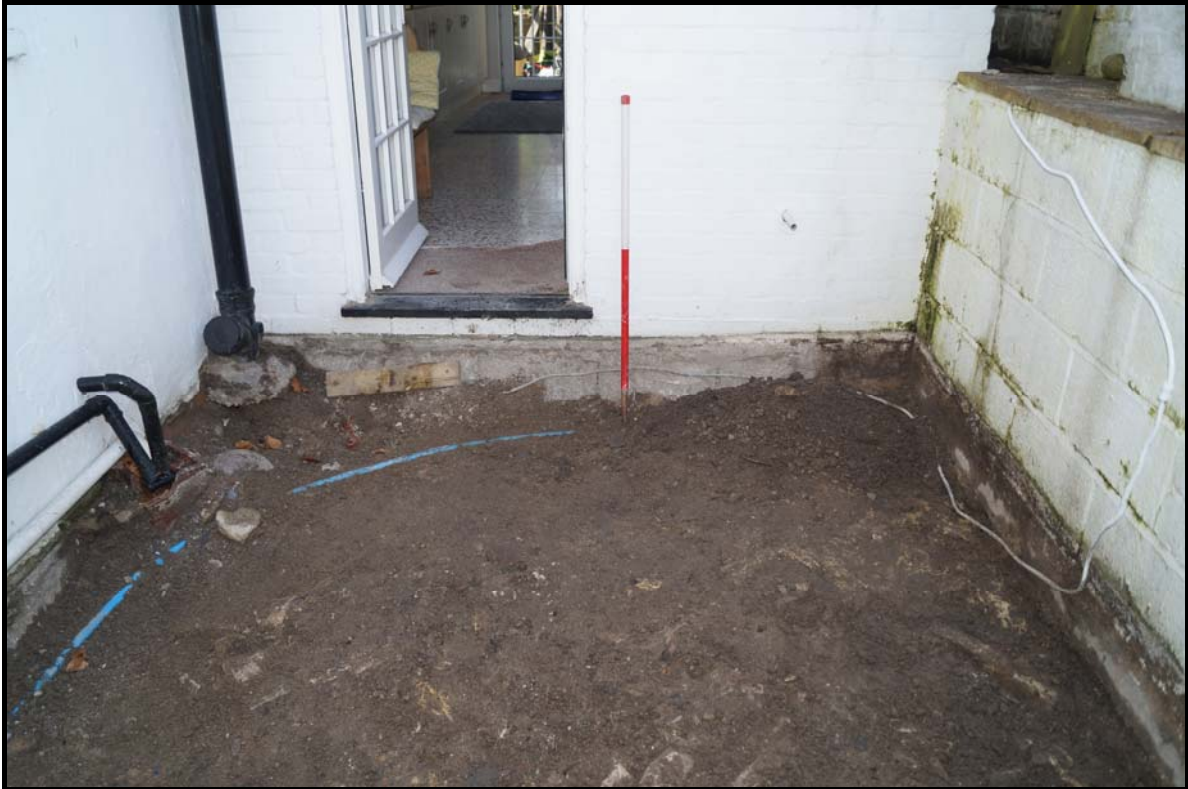
Plate 13: RCL2017_113, general view, looking southwest.
