Sketty Isaf, Derwen Fawr, Sketty, Swansea

Archaeological Watching Brief

Report No: 1400

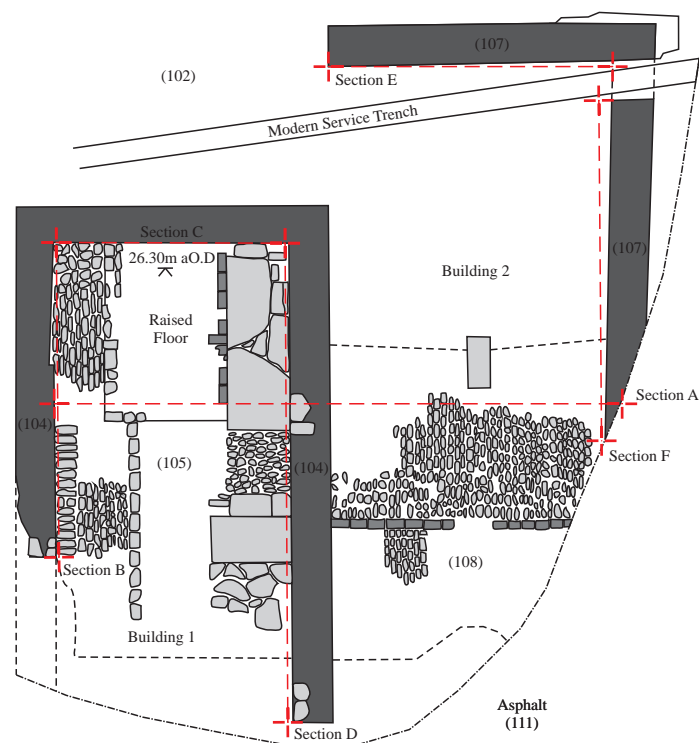
Figure 5: Plan of Buildings 1 & 2, and Well Site plan

- 6.1.4 The internal floor of Building 1 was covered in a cobble and flag stone floor (105), which was subdivided (Figure 5; Plate 4). The northern side had a small pathway, predominantly of flagstones with red brick edging. The southern side was a mirror image, but was constructed of cobbles, with larger cobbles used as edging. The central section was constructed of cobbles, and had a heavy camber; it continued from the western end of the building east for 2.2m. The paths stepped inward after the central plinth and continued the length of the building.

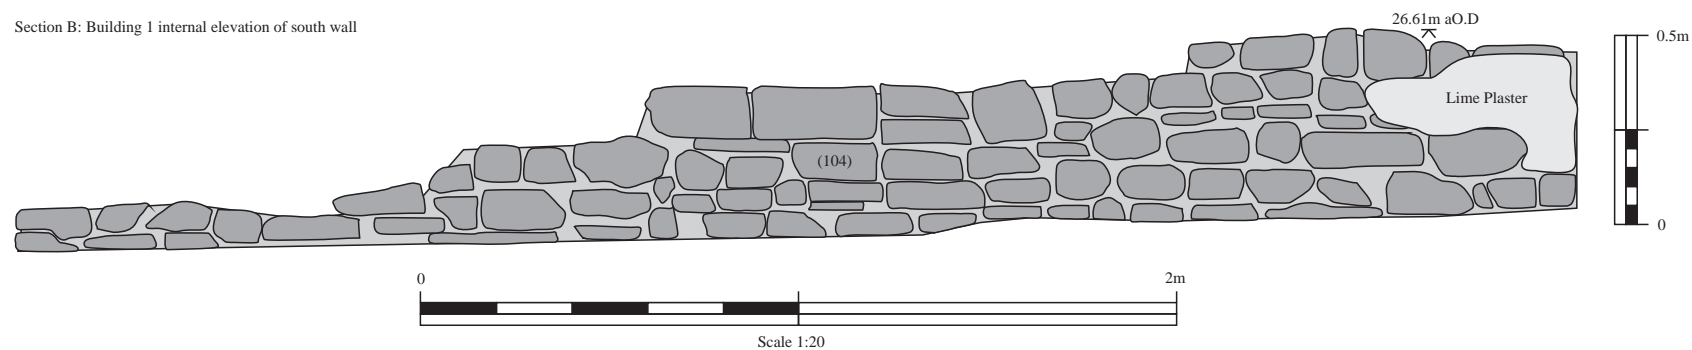
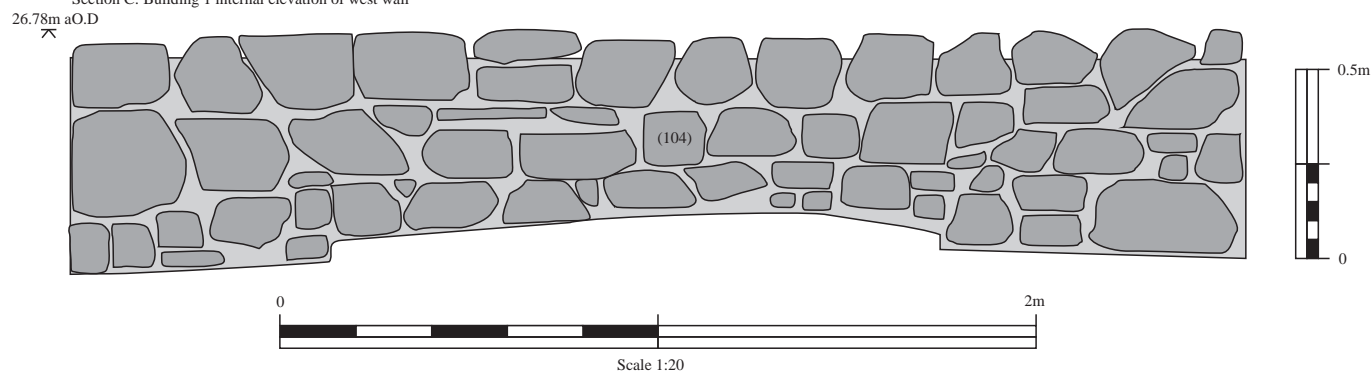
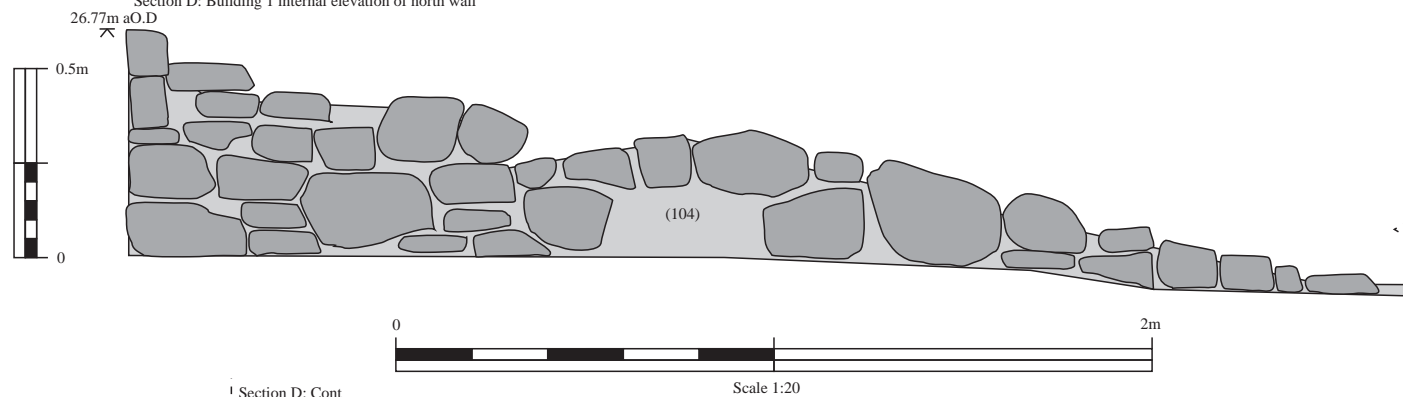
Figure 6: Building 1 Wall Sections

- 6.1.3 Building 1 was rectangular, orientated east to west, and measured 6.9m in length (although truncated at its eastern end) by 4.15m in width, with walls standing to a maximum of 0.6m in height along the western end (Figures 4, 5 & 6; Plates 1-7). The eastern end of the building was truncated by an asphalt surface [114](111) that formed the current access to the Meeting Room. The walls (104) were constructed using limestone and lime mortar bonding in random rubble coursing. The walls included a few un-frogged red bricks, which appeared contemporary to the wall construction. The walls showed signs of being lime plastered internally, with the larger surviving areas of plaster located along the south wall (Figure 6, Section B). The construction cut for these walls [103] could not be identified; it would appear likely that the walls had been built up against the edge of the foundation trench.

Section B: Building 1 internal elevation of south wall

Section C: Building 1 internal elevation of west wall

Section D: Building 1 internal elevation of north wall

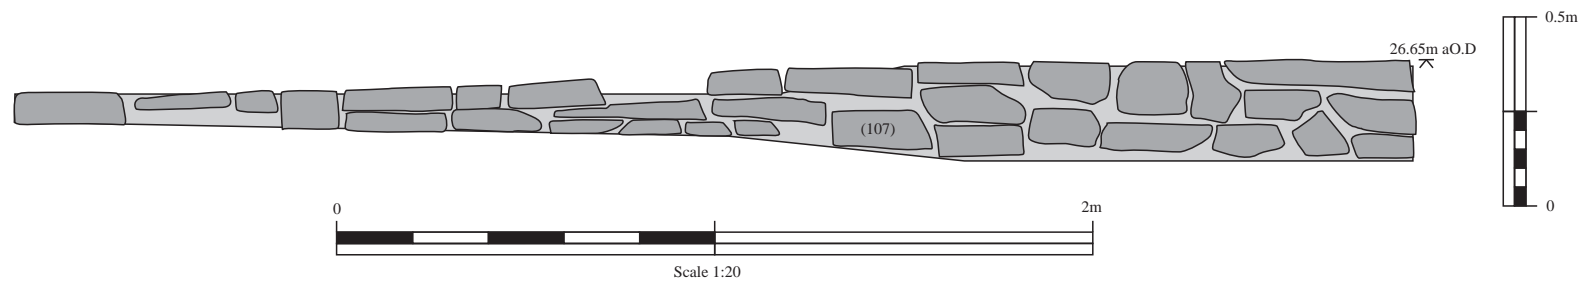
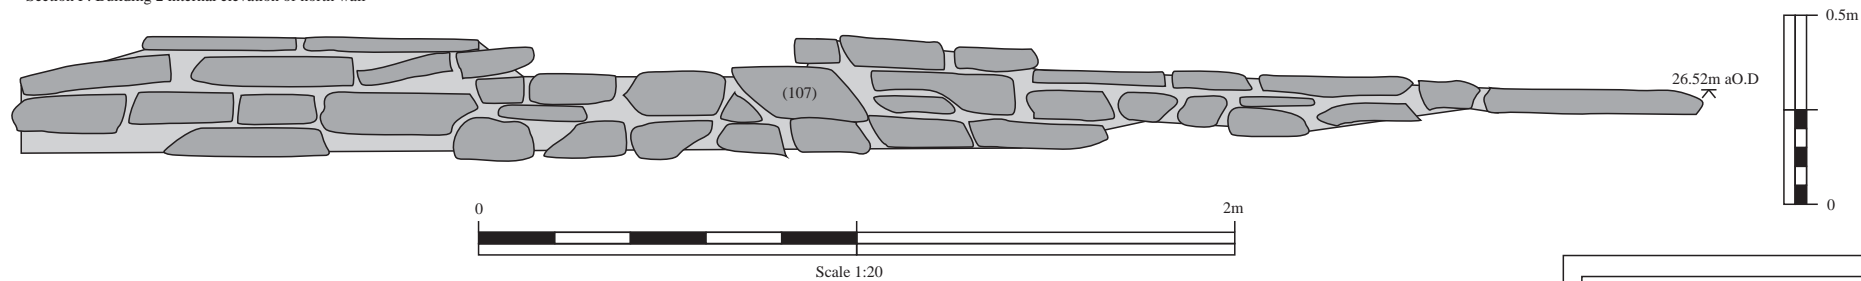
Figure 7: Building 2 Wall Sections

- 6.1.5 Building 2 lay immediately to the north of Building 1. The cut [106] for the foundations/walls (107) of Building 2 could not be identified, and was most likely constructed up against the foundation trench similar to Building 1. Building 2 was rectangular, orientated east to west and measured 6m in length in trench (truncated to the east) by 4.35m in width (Figures 4, 5 & 7; Plate 2, 8-10). It consisted of a single wall, parallel to the north wall of Building 1, which projected out slightly further west than Building 1, before returning south forming an end wall. An opening was apparent between the western wall of Building 2 and the north wall of Building 1. The walls (107) were constructed using limestone and lime mortar bonding in a random rubble coursing.

Section E: Building 2 internal elevation of west wall

Section F: Building 2 internal elevation of north wall

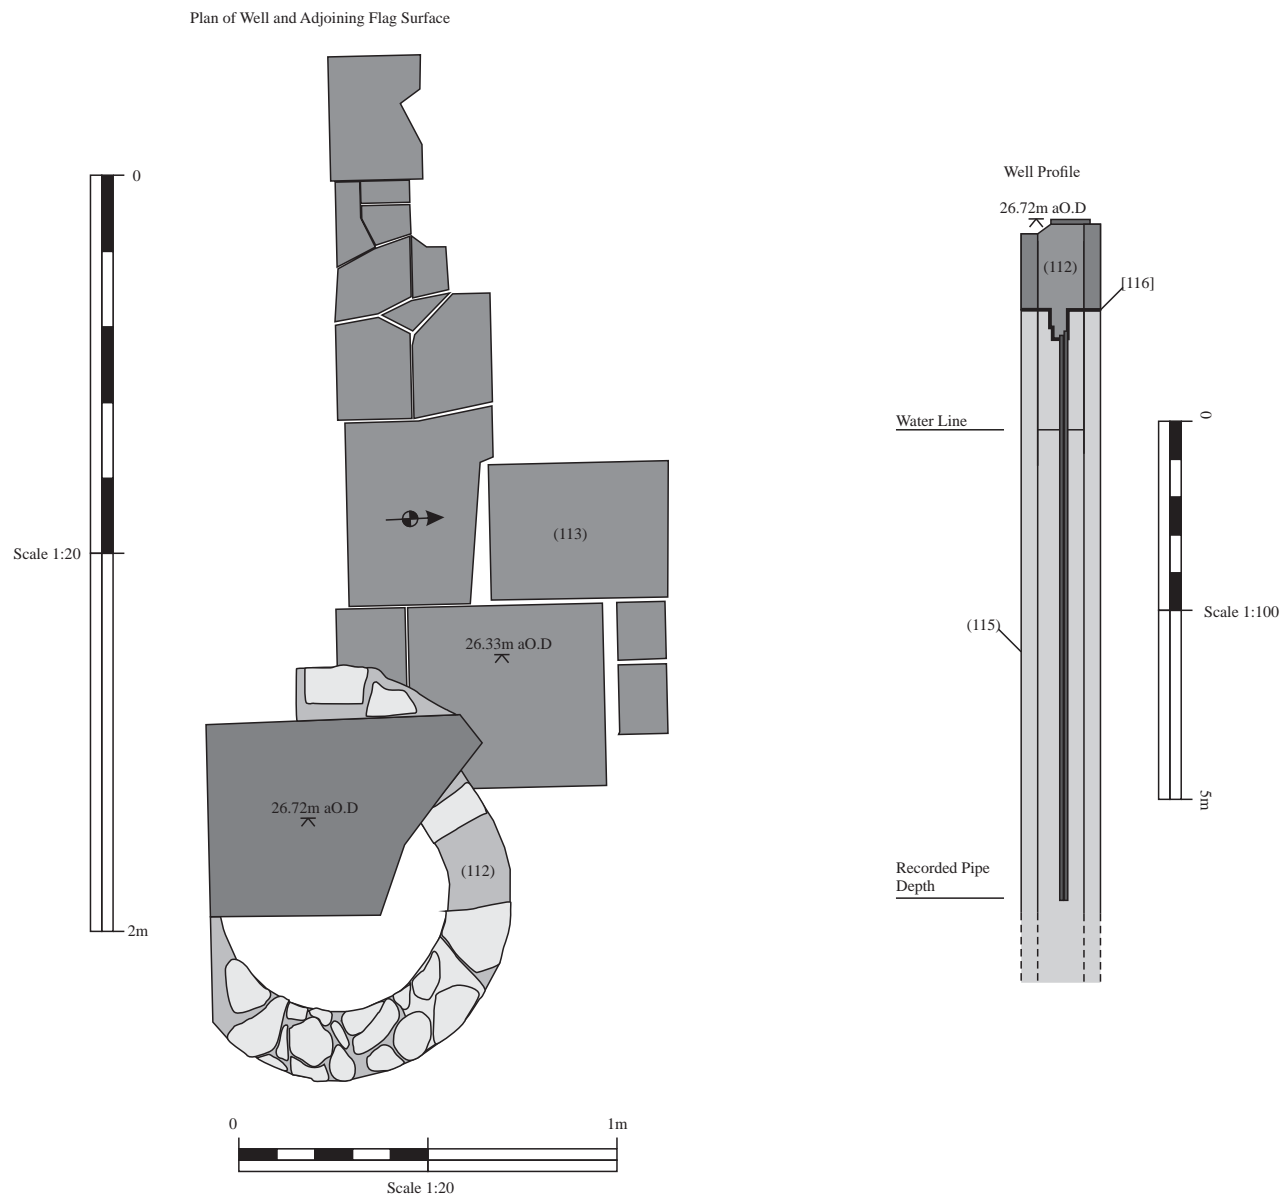
Figure 8: Well plan and profile

- 6.1.9 Approximately 3m to the west of Building 1 a stone-lined circular well (115) was identified. This had lime mortar bonding, and was approximately 0.75m in external diameter, and 0.5m internally (Figures 4, 5 & 8; Plate 11). This had been partially demolished/cut [116] and 1.1m to 1.3m of the upper courses rebuilt, with lead pipes inserted in its southern side (Plates 12 & 13). The rebuilt upper courses of the well (112) were constructed using the original stone and additional red brick, with cement mortar bonding. The well was capped with a large purple slate block. An associated small fragmentary flag surface (113) abutted the western side of the well; the floor measured approximately 7.5m in length by 3.5m in width (Plate 11).

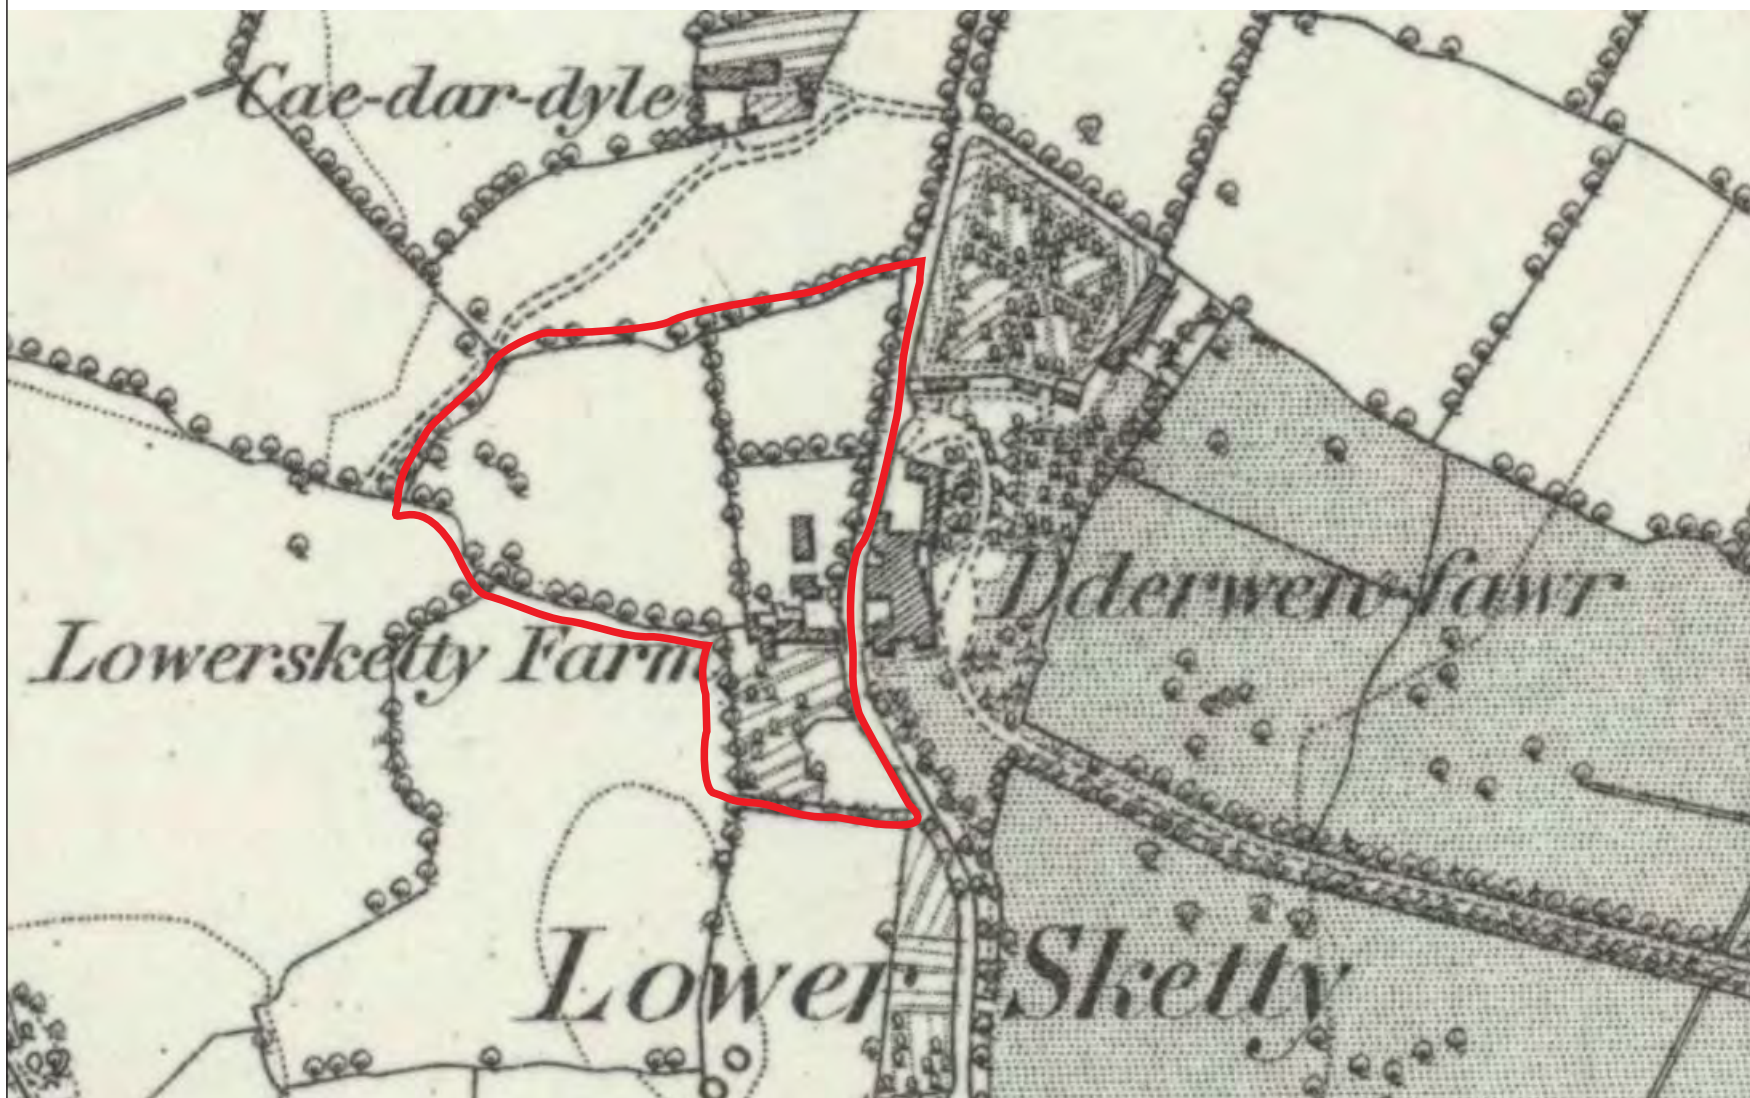
Figure 11: Extract from the 1878 Ordnance Survey 6 Inch Map

- 3.10 The buildings at Sketty Isaf are shown in greater detail on the Ordnance Survey map of 1878 (Figure 11). Sketty Isaf is labelled as Lower Sketty Farm, with the main farmhouse shown in roughly the same location as the current house, but with a ground plan that differs enough to indicate this is the site of an earlier farmhouse. To the north of the house stands an outbuilding, roughly in the location of the building marked on the tithe map. This building stands on the northern edge of an enclosed yard, bounded by the road on the east, and the eastern wing of the main house to the south. This would suggest the eastern wing consisted of a range of farm-buildings, with the farmhouse itself occupying the western end of the building. To the north lay an additional outbuilding, orientated north – south, in the location of the current Meeting Room. The building that was shown to the south is no longer marked. The internal field boundaries in the land to the north of the farm have been rearranged, to divide the area into three fields. The line of the east – west field boundary has been preserved by a line of mature trees within the development area.

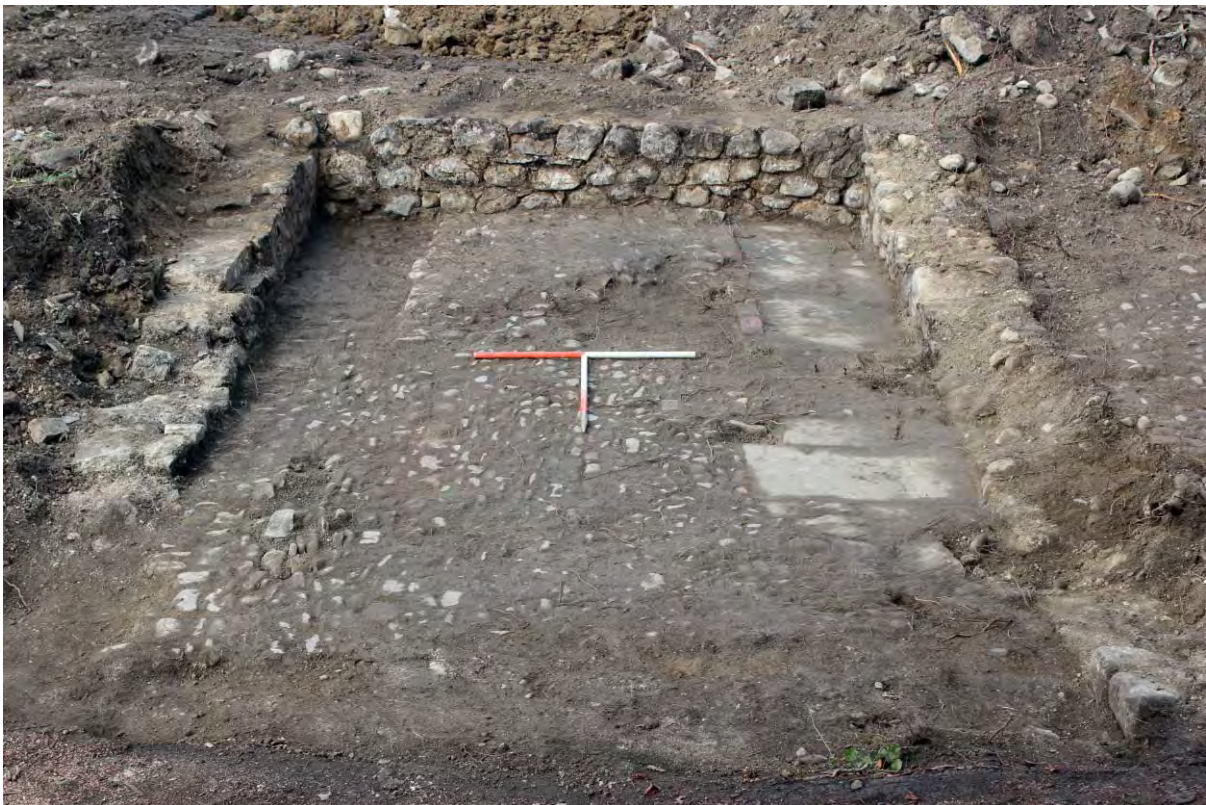
Plate 4: Building 1, showing internal cobble surface (105). 1m scales. Looking west.

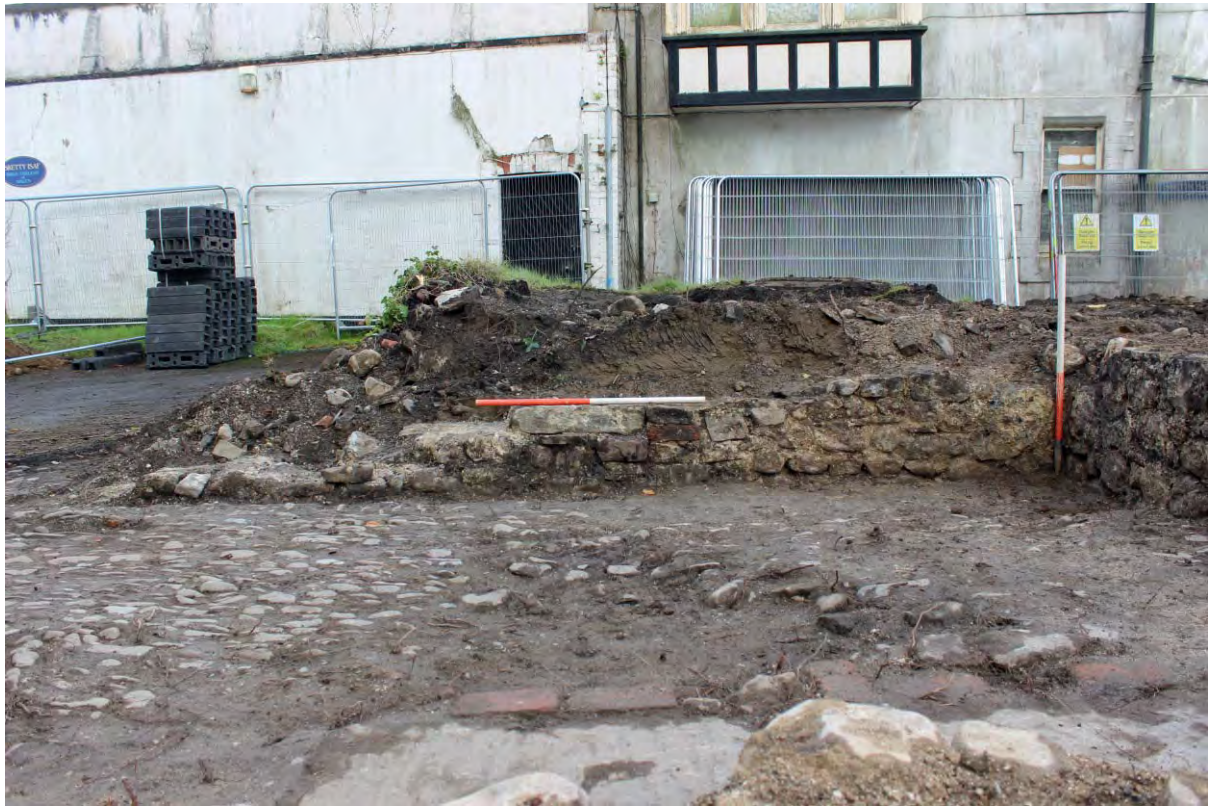
Plate 5: Building 1, showing internal face of south wall (104). 1m scales. Looking south.

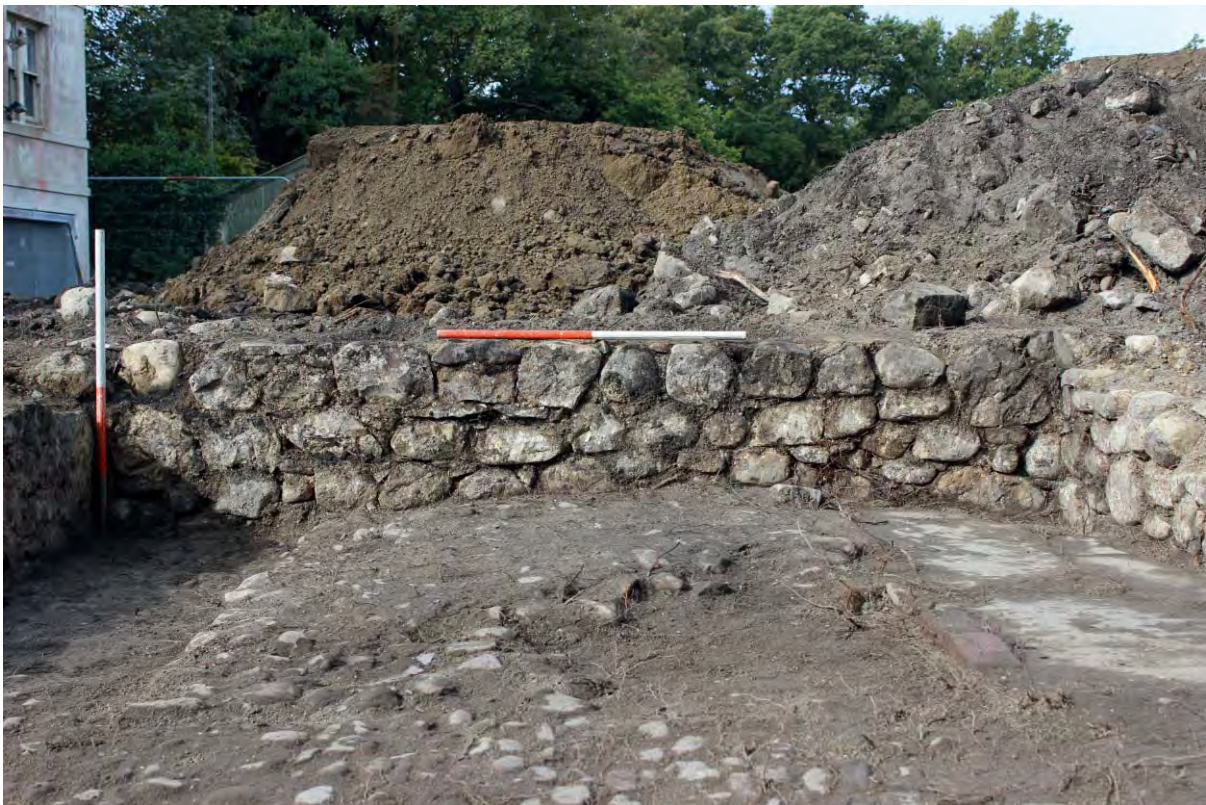
Plate 6: Building 1, showing internal face of west wall (104). 1m scales. Looking west.

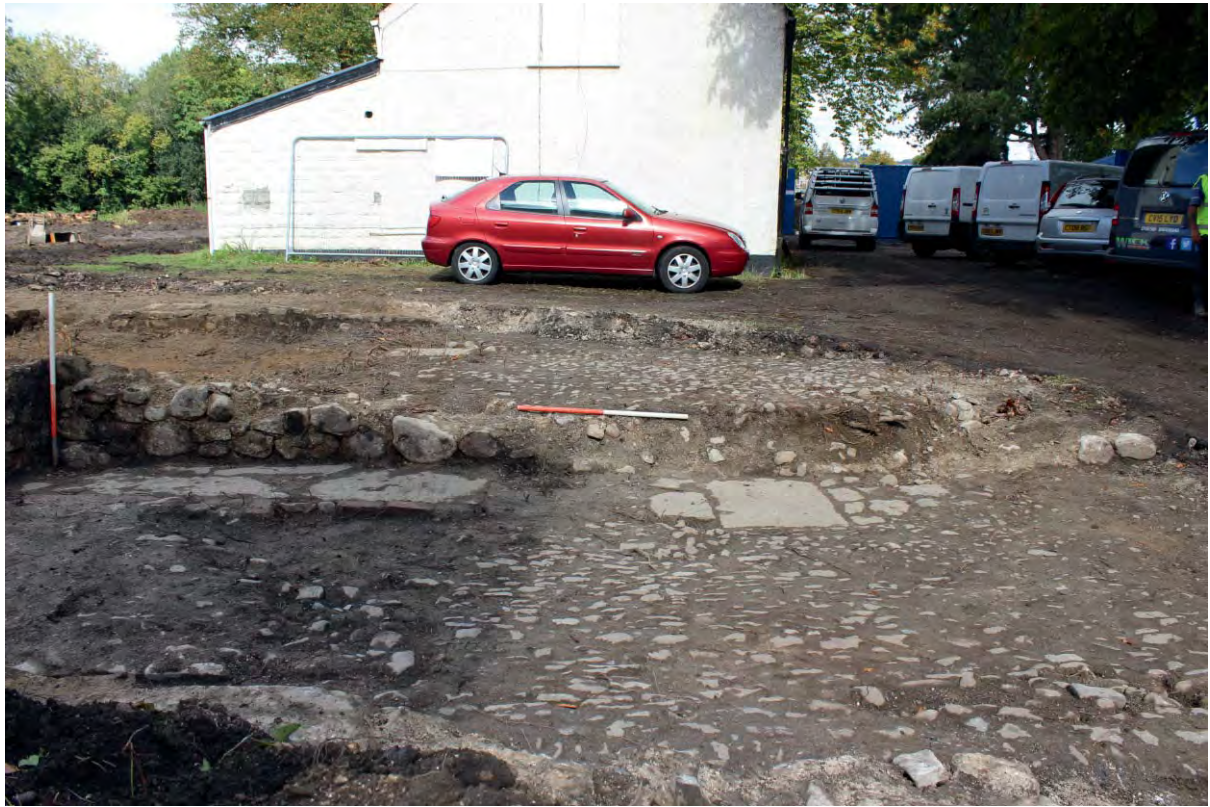
Plate 7: Building 1, showing internal face of north wall (104). 1m scales. Looking north.

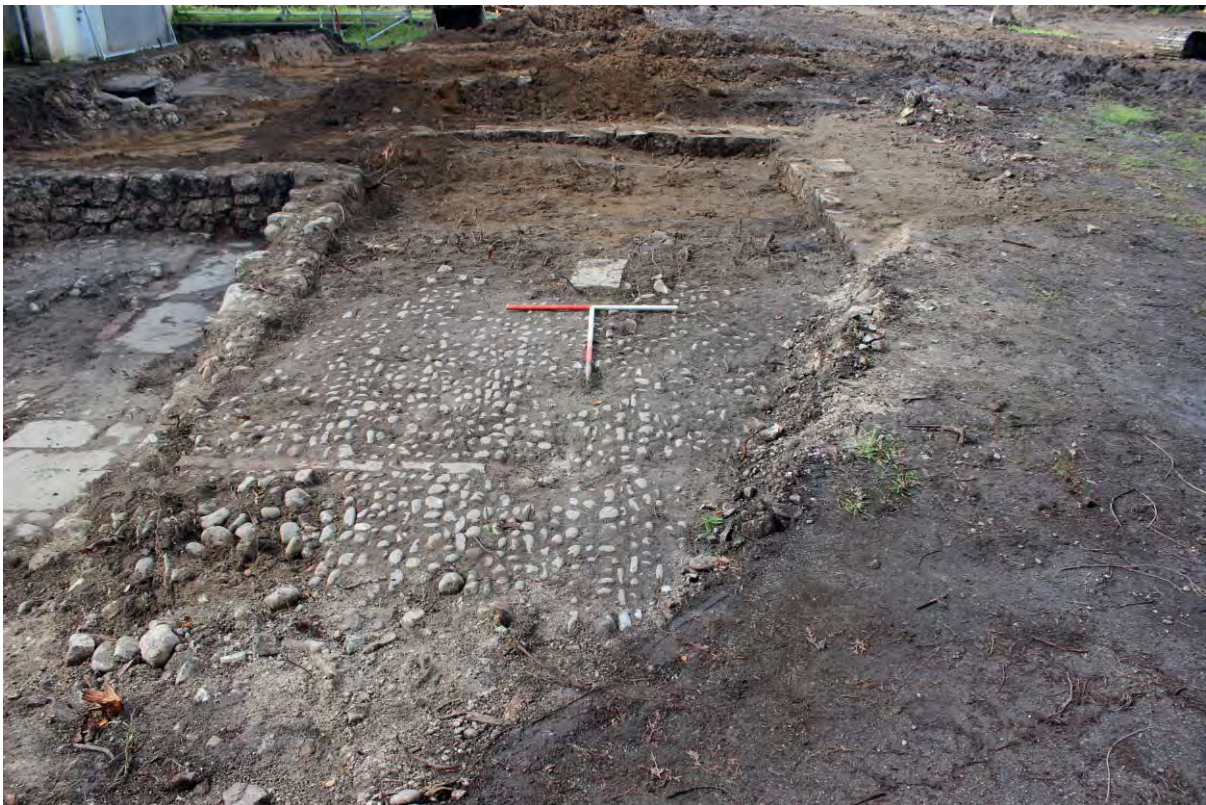
- 6.1.6 The interior of Building 2 had a cobbled surface (108) with an un-frogged red brick divide, running north to south toward the eastern end. A single flag stone also survived located centrally in the building (Plate 8). The western end was heavily truncated and showed signs of heavy bioturbation in the form of tree roots destroying any remnants of the floor in this area, although the lack of any cobbling would suggest this floor was either bare earth or this originally had flagstones.

Plate 8: Building 2, showing internal cobble surface (108). 1m scales. Looking west.

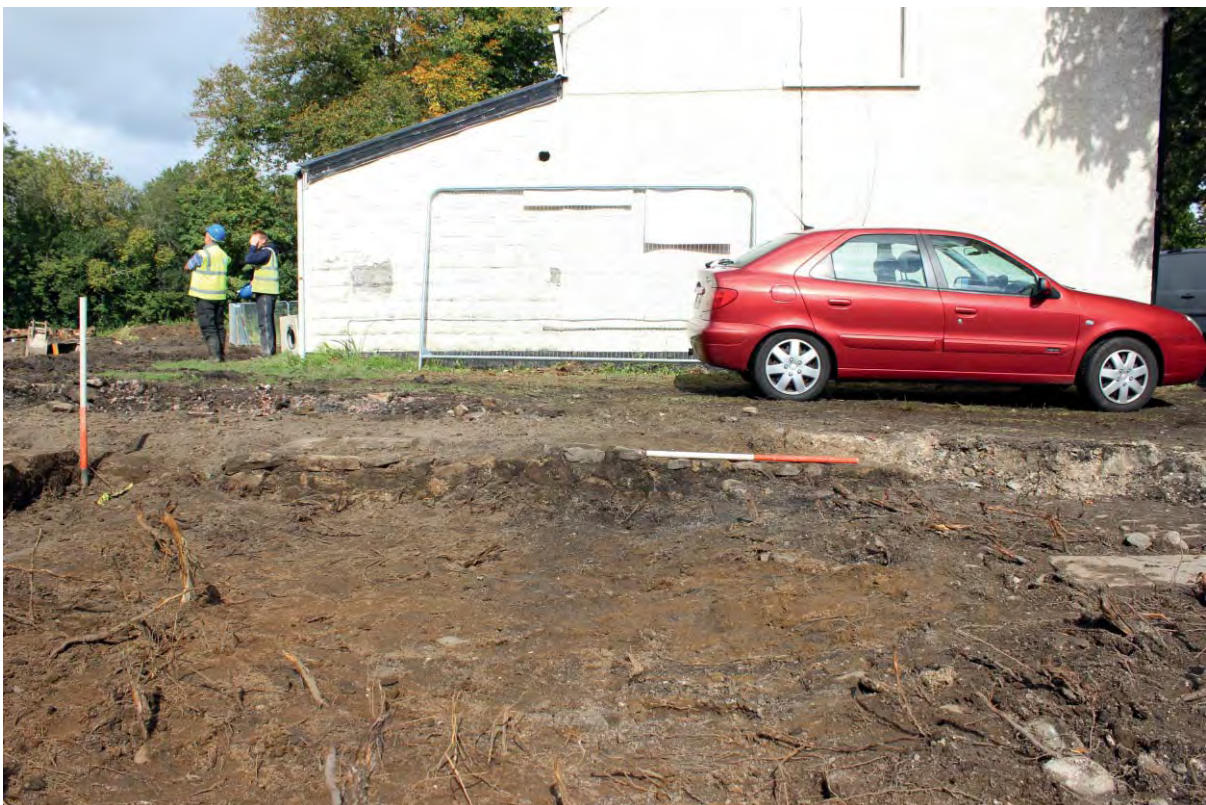
Plate 10: Building 2, showing internal face of north wall (107). 1m scales. Looking north.

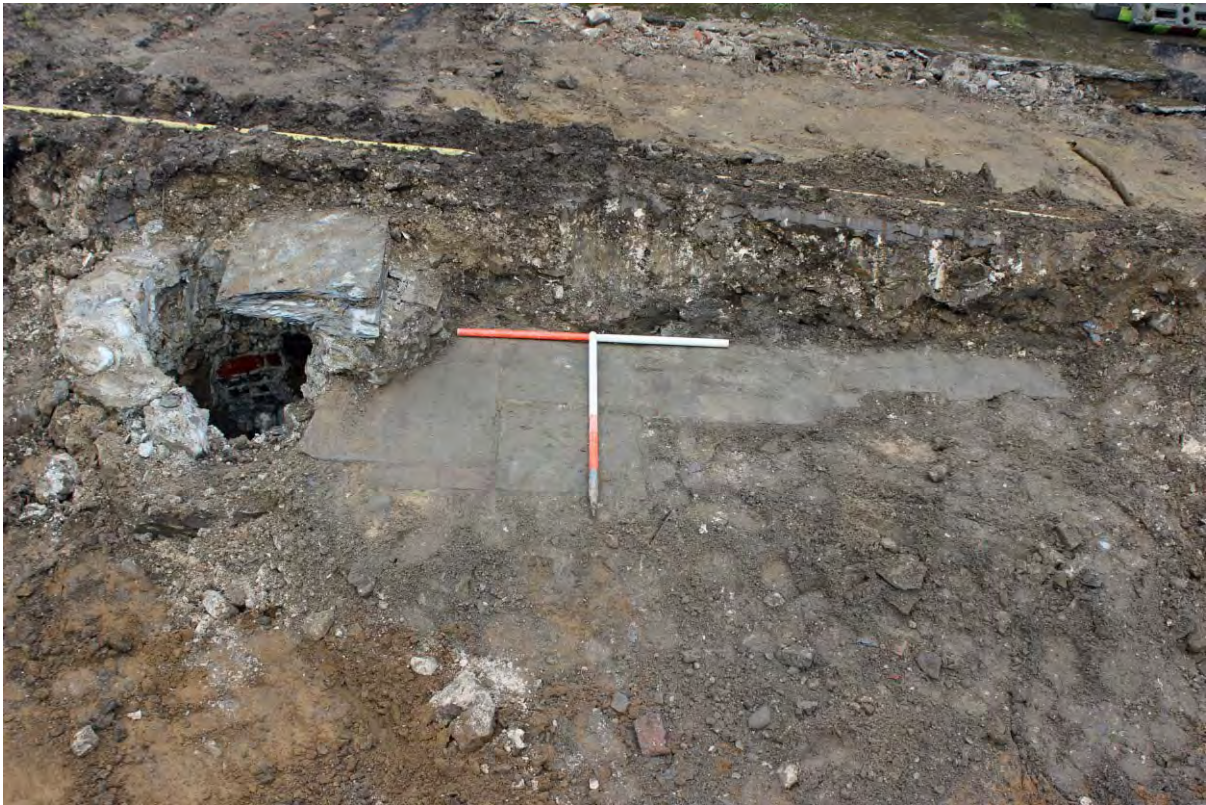
Plate 11: View of Well, upper rebuild 112, and abutting flagstones 113. 1m scales.
Looking south.

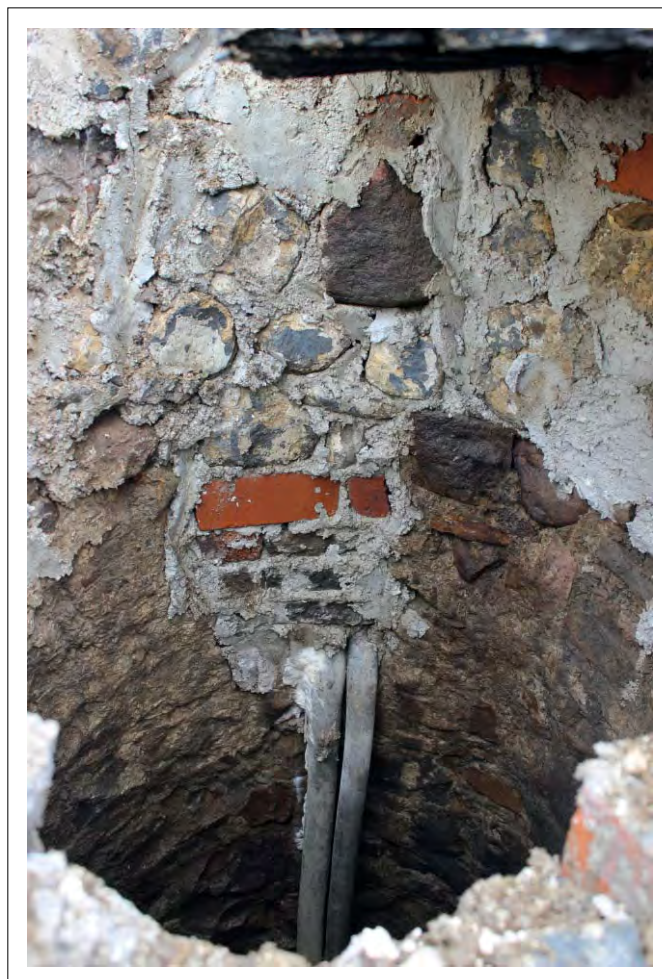
Plate 12: Internal view of upper rebuild [116] (112) of Well 115 and contemporary lead pipework.

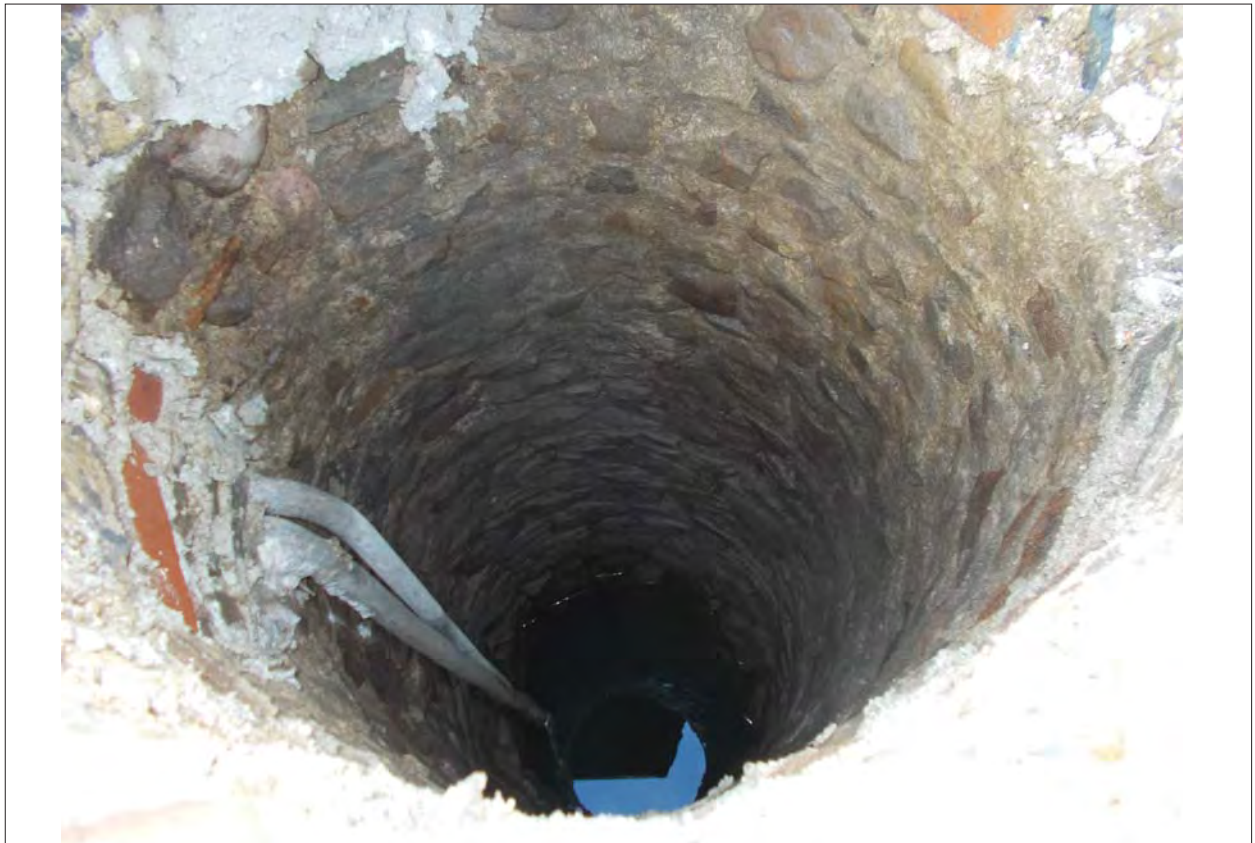
Plate 13: View down well 115, showing lead water pipes to draw water.

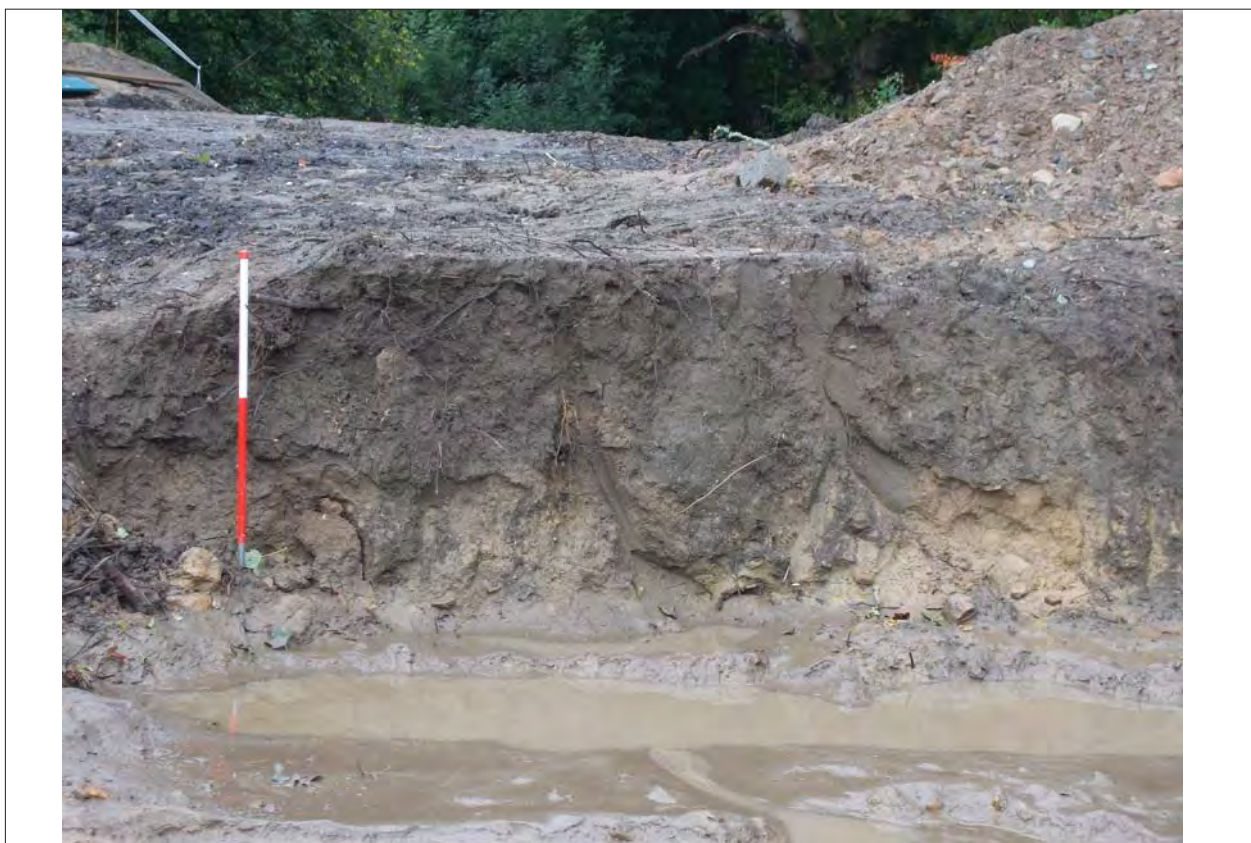
- 6.2.1 The area to the west of both the Meeting Hall and the remains of Buildings 1 and 2 consisted largely of open lawn and scrub. Across this area, topsoil deposits in this area had been churned up due to inclement weather (Plate 14). Also in this area lay a series of large pits excavated as part of the knotweed removal prior to groundworks commencing, with up-cast material mixed with topsoil deposits and spread across this area.
- 6.2.2 Stripping, levelling and trenching did revealed a natural subsoil layer of fairly compact light orangey-brown sandy-clay throughout this area, which represented a continuation of deposit 102 (Plate 15). No deposits of archaeological interest were recorded at this level (truncating deposit 102). Deeper excavations revealed a lower deposit of light grey-brown clayey-sand (117) with the occasional medium to large sub-rounded stone inclusion (Plate 16).

- 6.2.3 The upper deposit in this area consisted of up to 0.5m of mixed dark brown to mid grey-brown silty-clay (118) (Plate 16). No finds were recovered from this deposit.
- 6.2.4 Along the western edge of this area ground levels fell away by 2m to 3m towards the woodland that borders the western edge of the site. This would appear to represent the limits of any potentially cultivated ground associated with Sketty Isaf House.

Plate 16: Representative section of natural subsoil (117) and disturbed topsoil (118) in the western part of the site. 1m scale. Looking east.

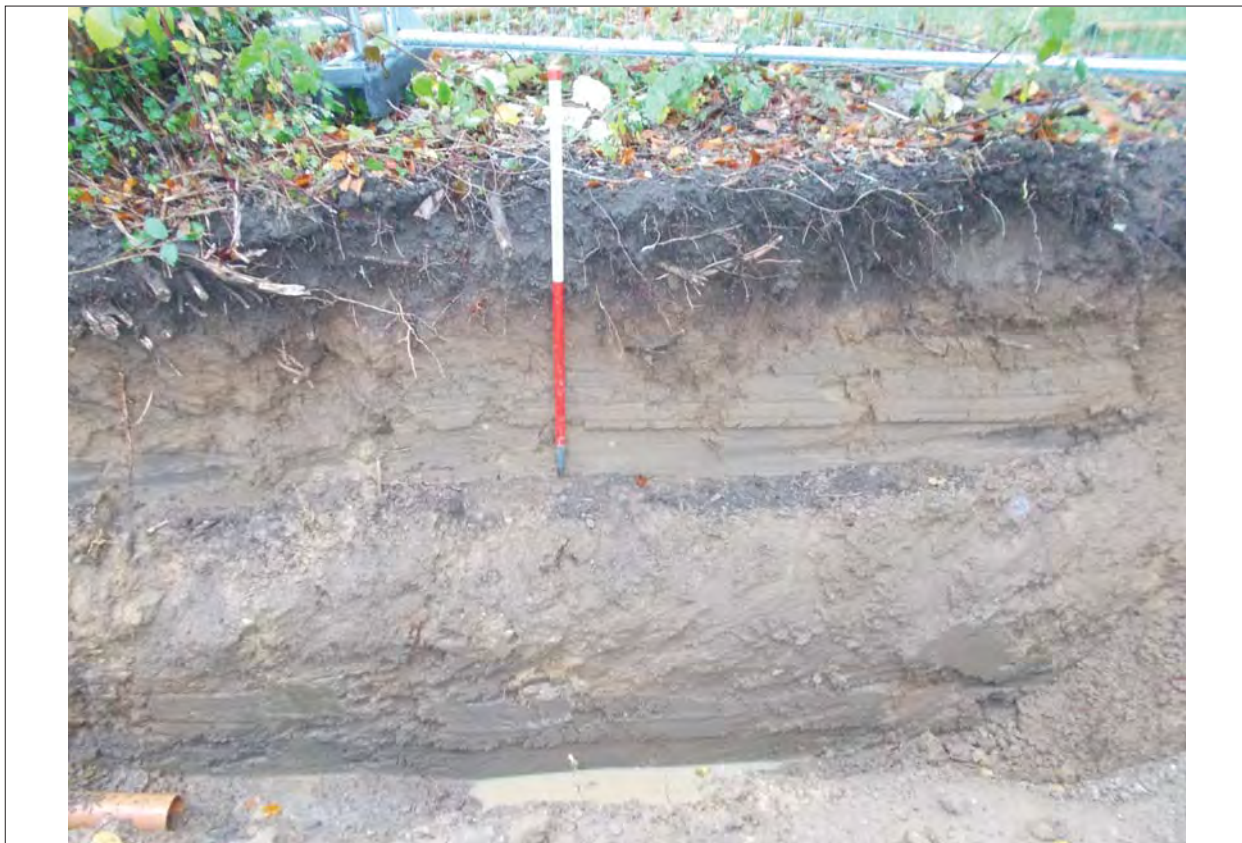
Plate 19: Representative section of natural subsoil deposits (120) (121), below topsoil (123), in the northern part of the site. 1m scale. Looking east.

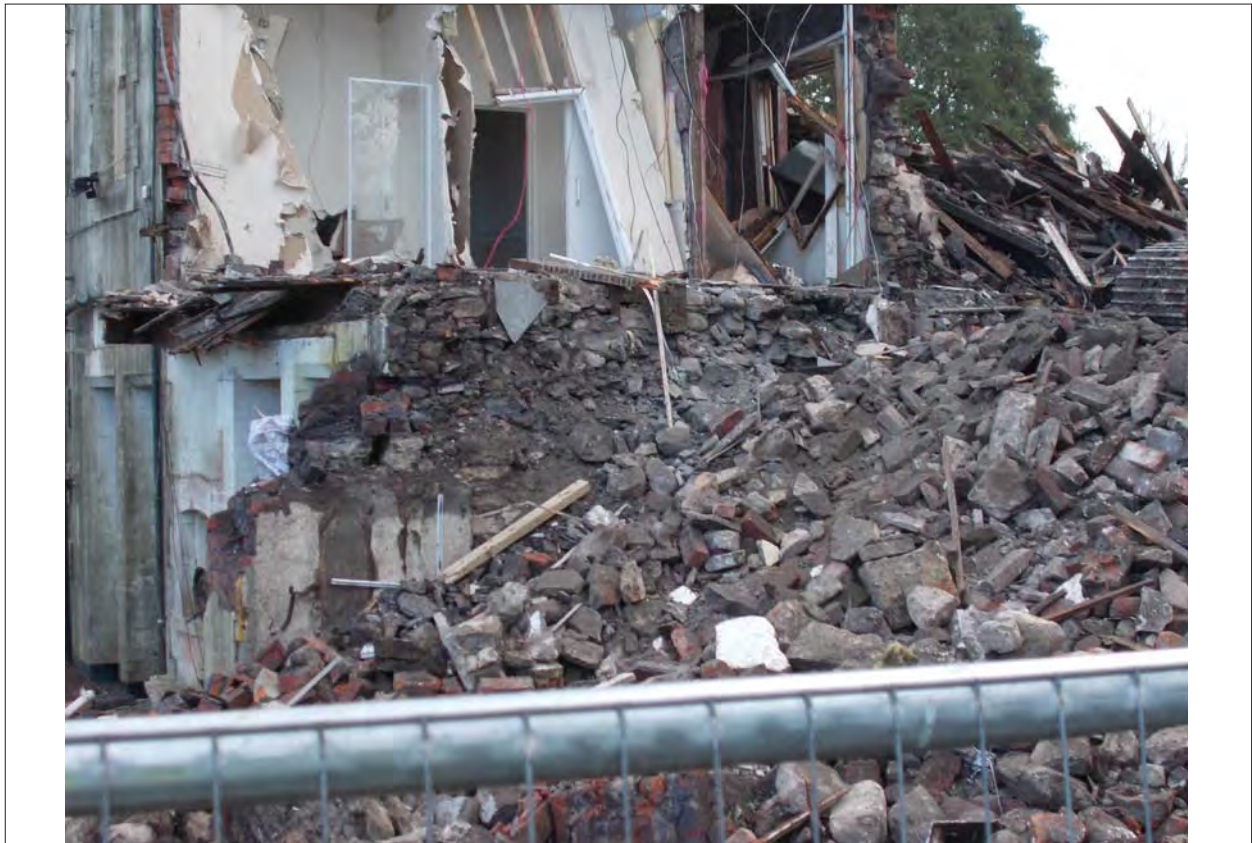
- 7.3 The demolition of Sketty Isaf House revealed it to be largely brick-built, with a mixture of brick and stone in the lower storeys. The main house appeared to be a single build of the late 19th century, with a later (early to mid-20th century) extension on its western side. There was no clear evidence of the re-use of an earlier farmhouse. The demolition process did not allow for an examination of the ground plan or foundations however.

Plate 25: The demolition of the ground floor level of Sketty Isaf House, showing a high concentration of stone in the construction.

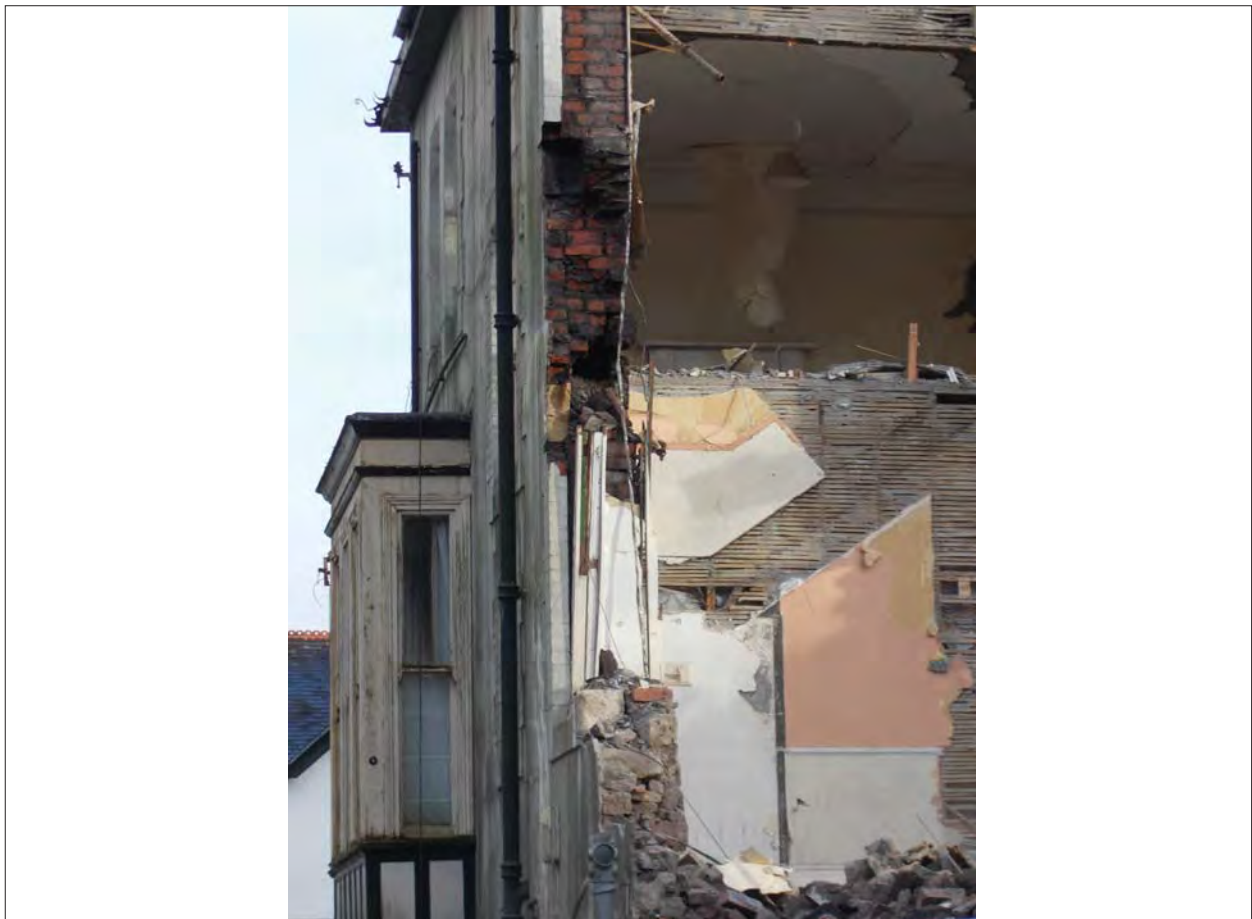
Plate 27: View of external walls during demolition works, showing upper section built in brick. Looking east.
