CPAT Report No. 1638

# The Coach House, Maenol, Llanidloes

BUILDING SURVEY

In February 2019 the Clwyd-Powys Archaeological Trust conducted a survey to record a former Coach House at Maenol, Llanidloes, in Powys, as a condition of planning consent for the conversion of the building to domestic accommodation. Maenol lies along the B4518 on the outskirts of Llanidloes. The survey provided a detailed photographic record of the surviving Coach House building which dates from 1833.

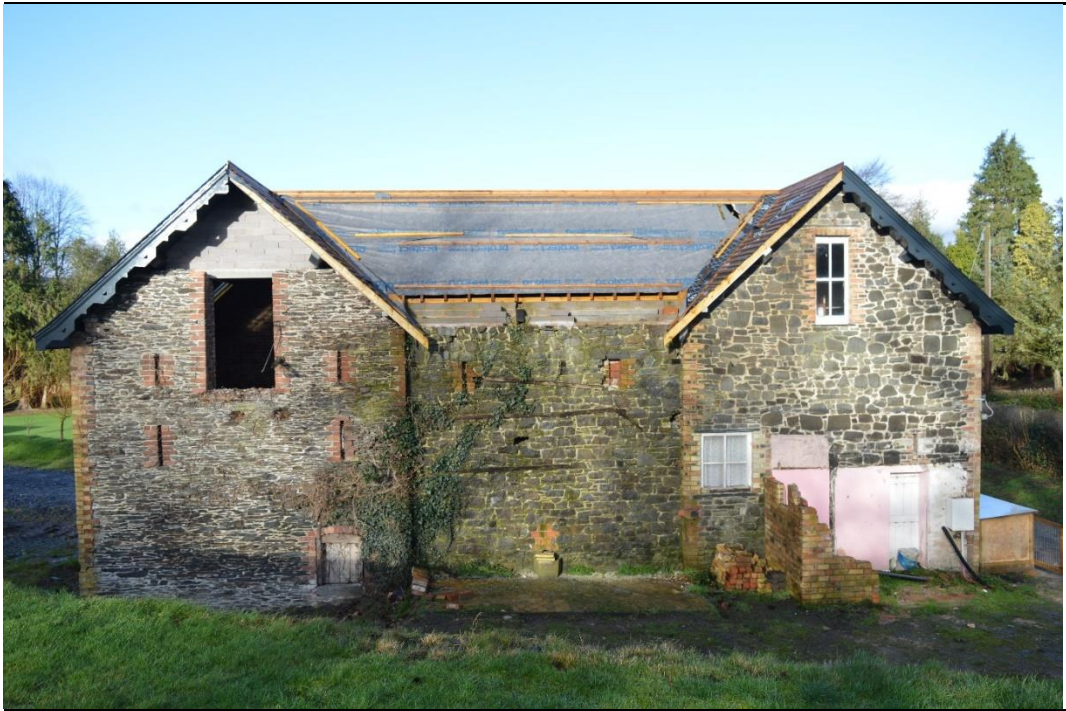
- 2.12. To the rear, the north-east and central wall are of rubble stone blocks, whereas the south-eastern gable is of finer, horizontally laid slate rubble with four ventilation slits dressed with red brick and a single doorway to the first floor, also dressed with red brick. There is a small opening to the ground floor.

- 2.13. Although undoubtedly part of the building as a whole, this side of the building is shown on the early mapping as a separate structure, which perhaps explains the difference in the building materials employed in its construction.

- 2.14. The rear wall of the coach store houses two ventilation slits within the upper walling, dressed with red brick and to the north-eastern gable the remnants of two ventilation slits to the ground floor, although these have been obscured by a later brick extension

Figure 3. The rear of the Coach House showing the difference in building stone utilised in each gable. CPAT image 4592-0015.

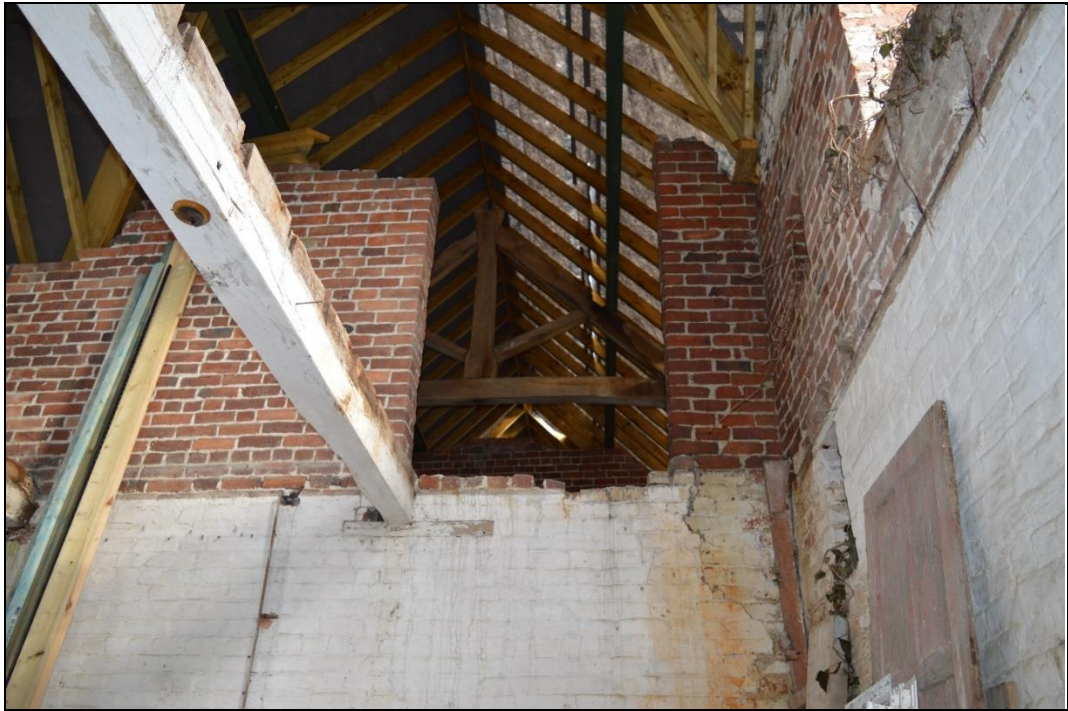
- 2.18. The room is now open to the rafters although evidence of a former floor above is visible in the elevations and the central beam to support the joists remains in situ. It is likely this side of the building was utilised as a stable with a hayloft above which was accessible via the doorway in the south-eastern gable, with further access provided into the space above the cart store within the north-eastern dividing wall.

Figure 4. Internal view of the south-western gabled wing (north-eastern dividing wall).

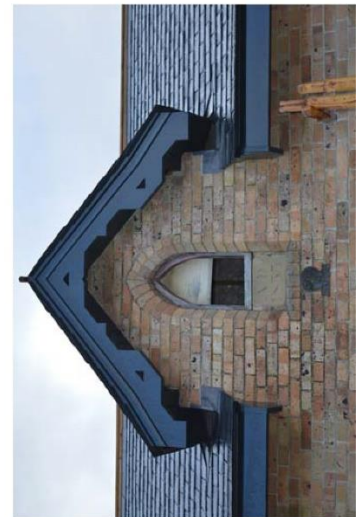
4592-0006.JPG

- 
- 2.6. The roof has recently been renewed with planning consent, but is known to have originally been slated.
- 2.7. To the exterior, above the cart doors is a small attic gable with a lancet window. The date stone of 1833 is immediately below and a Salop Fire Office insurance plaque below that (CPAT image 4592-0006). Prior to the introduction of the Penny Postal System in 1840, the naming of Streets and numbering of houses was rather haphazard. To enable insurance companies to identify properties which they insured, metal plates or firemarks were issued with insurance policies to be securely fixed onto the front of a property in a prominent position. Fires were attended by the Fire Insurance Companies and the plaques allowed them to easily identify properties within a certain fire company's care. The Salop Fire Office fire mark displays three leopard heads, which is taken from the arms of Shrewsbury.

4592-0006 – Exterior: Coach House date stone and Salop insurance plaque. View from north-west.

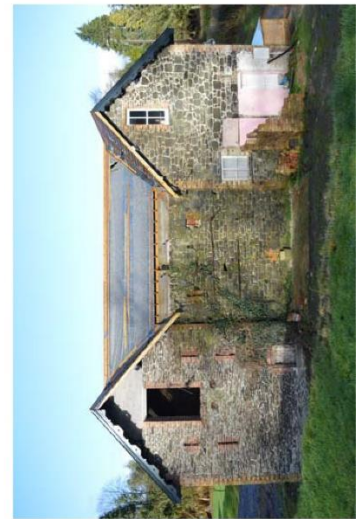
4592-0015.JPG

4592-0015 – Exterior: View from south-east.

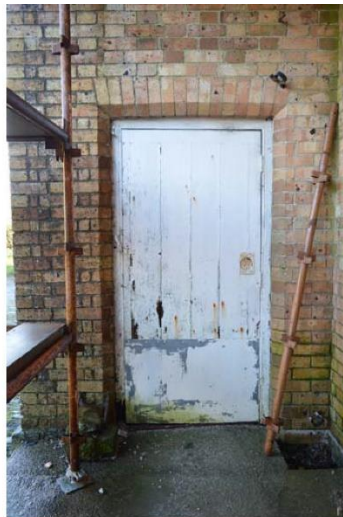
4592-0020.JPG

- 2.15. The north-eastern gabled wing has been converted sometime in the recent past for domestic use, and the original front entrance alongside the coach store entrance has been blocked from the inside (CPAT images 4592-0020/35). The ground floor room is accessed via a doorway within the north-east elevation and is open-plan providing living space/fireplace and a small kitchen. There is a paired sash window to the left of the door to the ground floor and a small casement window directly above to the first floors. A later window has been inserted at ground floor level to the right of the doorway.

- 
- 4592-0017 – Exterior: View from east.
- 4592-0018 – Exterior: View from east.
- 4592-0019 – Exterior: View from north-east.
- 4592-0020 – Exterior: Ground floor doorway. View from south-west.

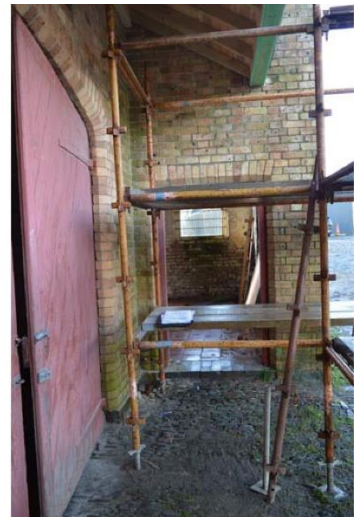
4592-0021.JPG

- 2.17. The south-western gabled wing is accessed via a large single doorway in the north-eastern elevation (CPAT image 4592-0021). The floor is tiled with red quarry tiles and the walls are covered by a red brick skin, which has been whitewashed in the ground floor room.

- 4592-0021 – Exterior: Ground floor doorway. View from north-east.
- 4592-0022 – Interior: Ground floor (southern side): View from north.
- 4592-0023 – Interior: Ground floor (southern side): View from north.

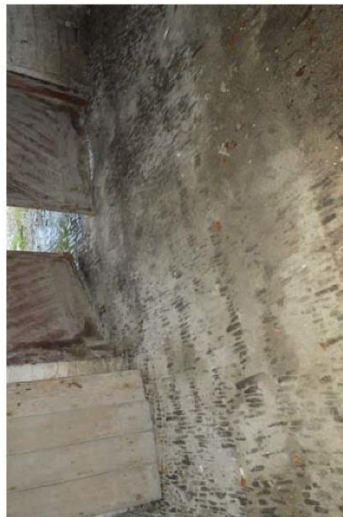
4592-0032.JPG

- 2.10. The coach store is accessed from the yard via a segmental arched coach entrance surrounded by chamfered bricks and herringbone boarded doors. The original cobbled floor surface is still visible within the coach store and extends to form a large cobbled yard out front with a pathway marked within the cobbles leading directly from the coach store towards the main house (CPAT image 4592-0045). It is intended the cobbled floor within the coach store will be lifted during refurbishment to allow for the insertion of under floor heating and then re-laid.

- 4592-0030 – Interior: Ground floor (coach room): View from south-west.
- 4592-0031 – Interior: Coach room doorway: View from south-east.
- 4592-0032 – Interior: Coach room stone cobble floor: View from south-east.

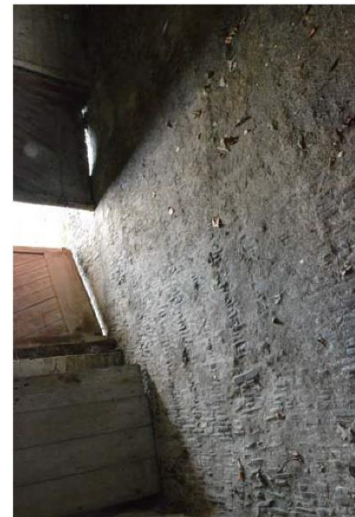
4592-0033.JPG

- 4592-0033 – Interior: Coach room stone cobble floor: View from south-east.
- 4592-0034 – Interior: Ground floor living space (northern side). View from north-west.

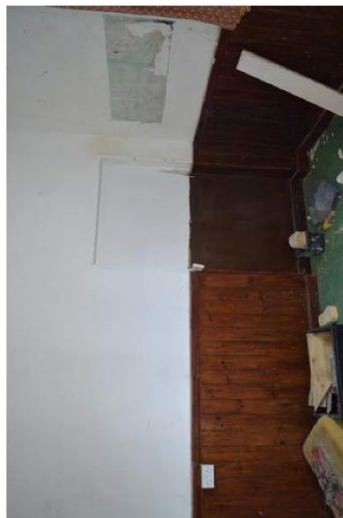
4592-0035.JPG

- 4592-0035 – Interior: Ground floor living space (northern side). Blocked doorway. View from north-east.
- 4592-0036 – Interior: First floor living space (northern side). View from north.

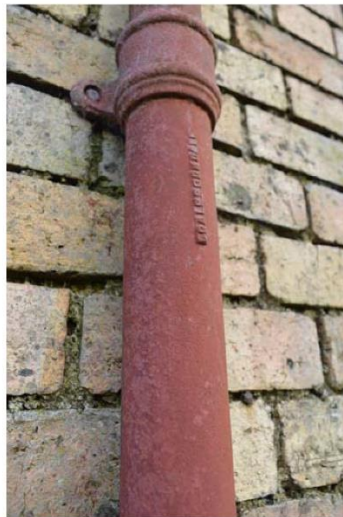
4592-0041.JPG

- 2.8. A further link to Shropshire evident in the buildings construction is the use of Coalbrookdale cast iron drain pipes at either side of the building (CPAT image 4592-0041).

- 4592-0039 – Exterior: View from south.
- 4592-0040 – Exterior: Coaalkbrookdale cast iron drain-pipe. View from south-west.
- 4592-0041 – Exterior: Coaalkbrookdale cast iron drain-pipe. View from south-west.
