**Plas yn Llan, Cilcain, Mold,
CH7 5PB.**

**February 2018
V 1.0**

Historic Building Record Level 2/3
Project Code: A0152.1
Report no. 0159

Historic Building Record Level 2/3

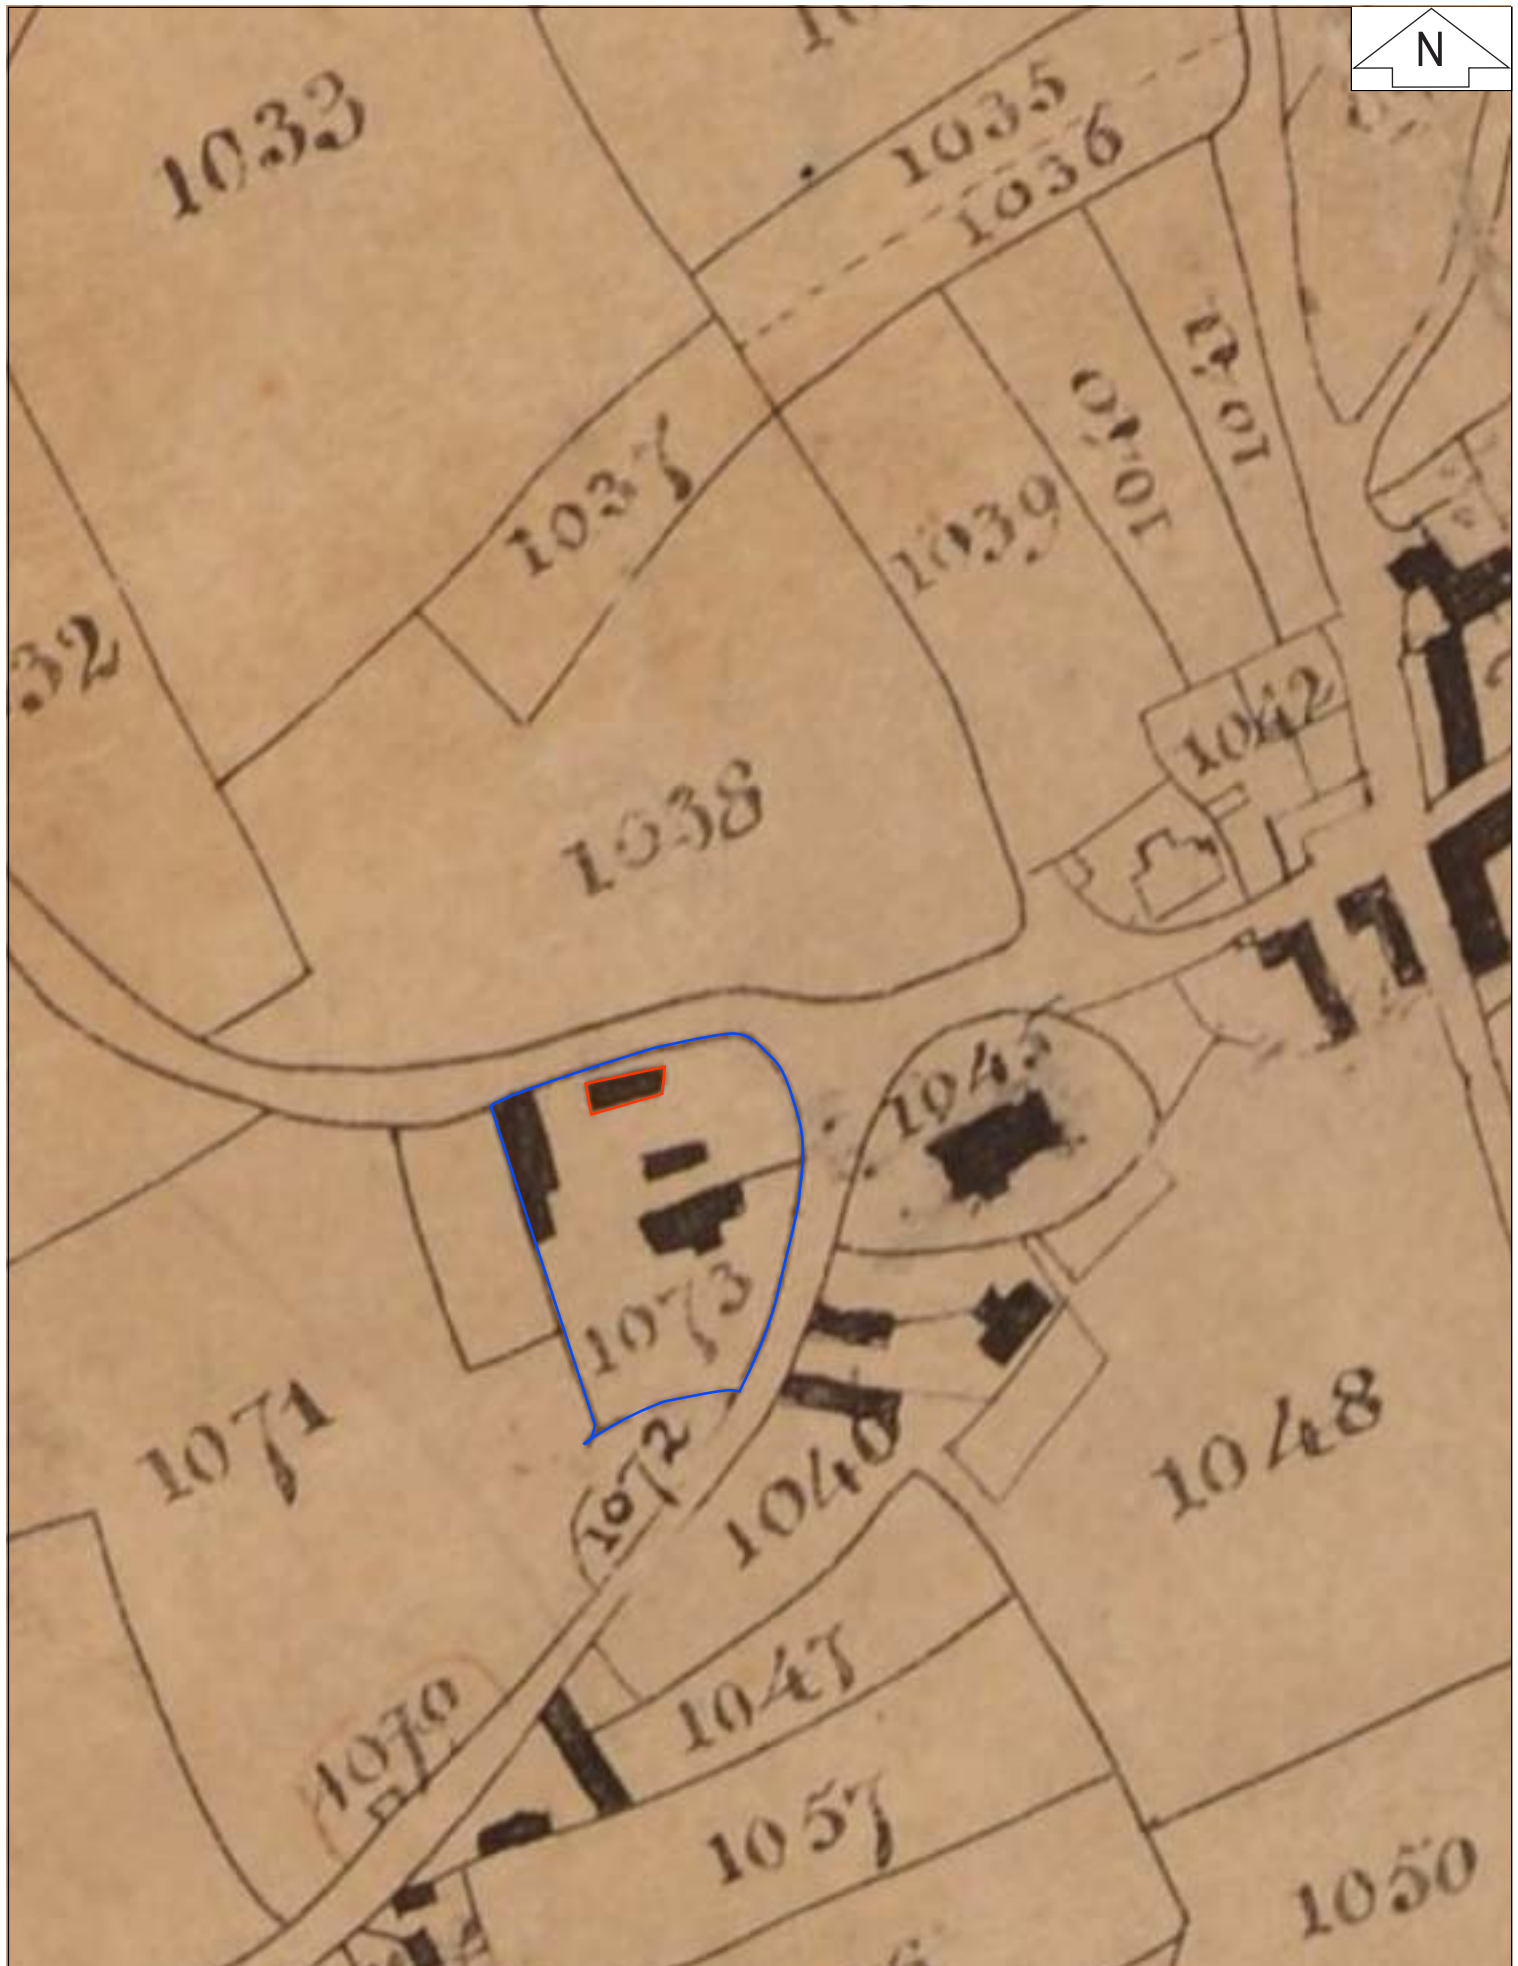
Figure 04. Tithe Map showing location of Plas Yn Llan (Tithe apportionment in blue) and location of the outbuilding recorded (Red outline).

The historic mapping for the area of Plas yn Llan shows that the building has been present in its current form since at least the late 1830's, the Cilcain tithe map is dated 1841. Plas yn Llan is shown as plot 1073 which the tithe apportionment records as having been owned by Gabriel Roberts Esq and tenanted by William Thomas. Furthermore the building remains unchanged in its form according to the OS six inch maps from 1871, 1878 and 1910.

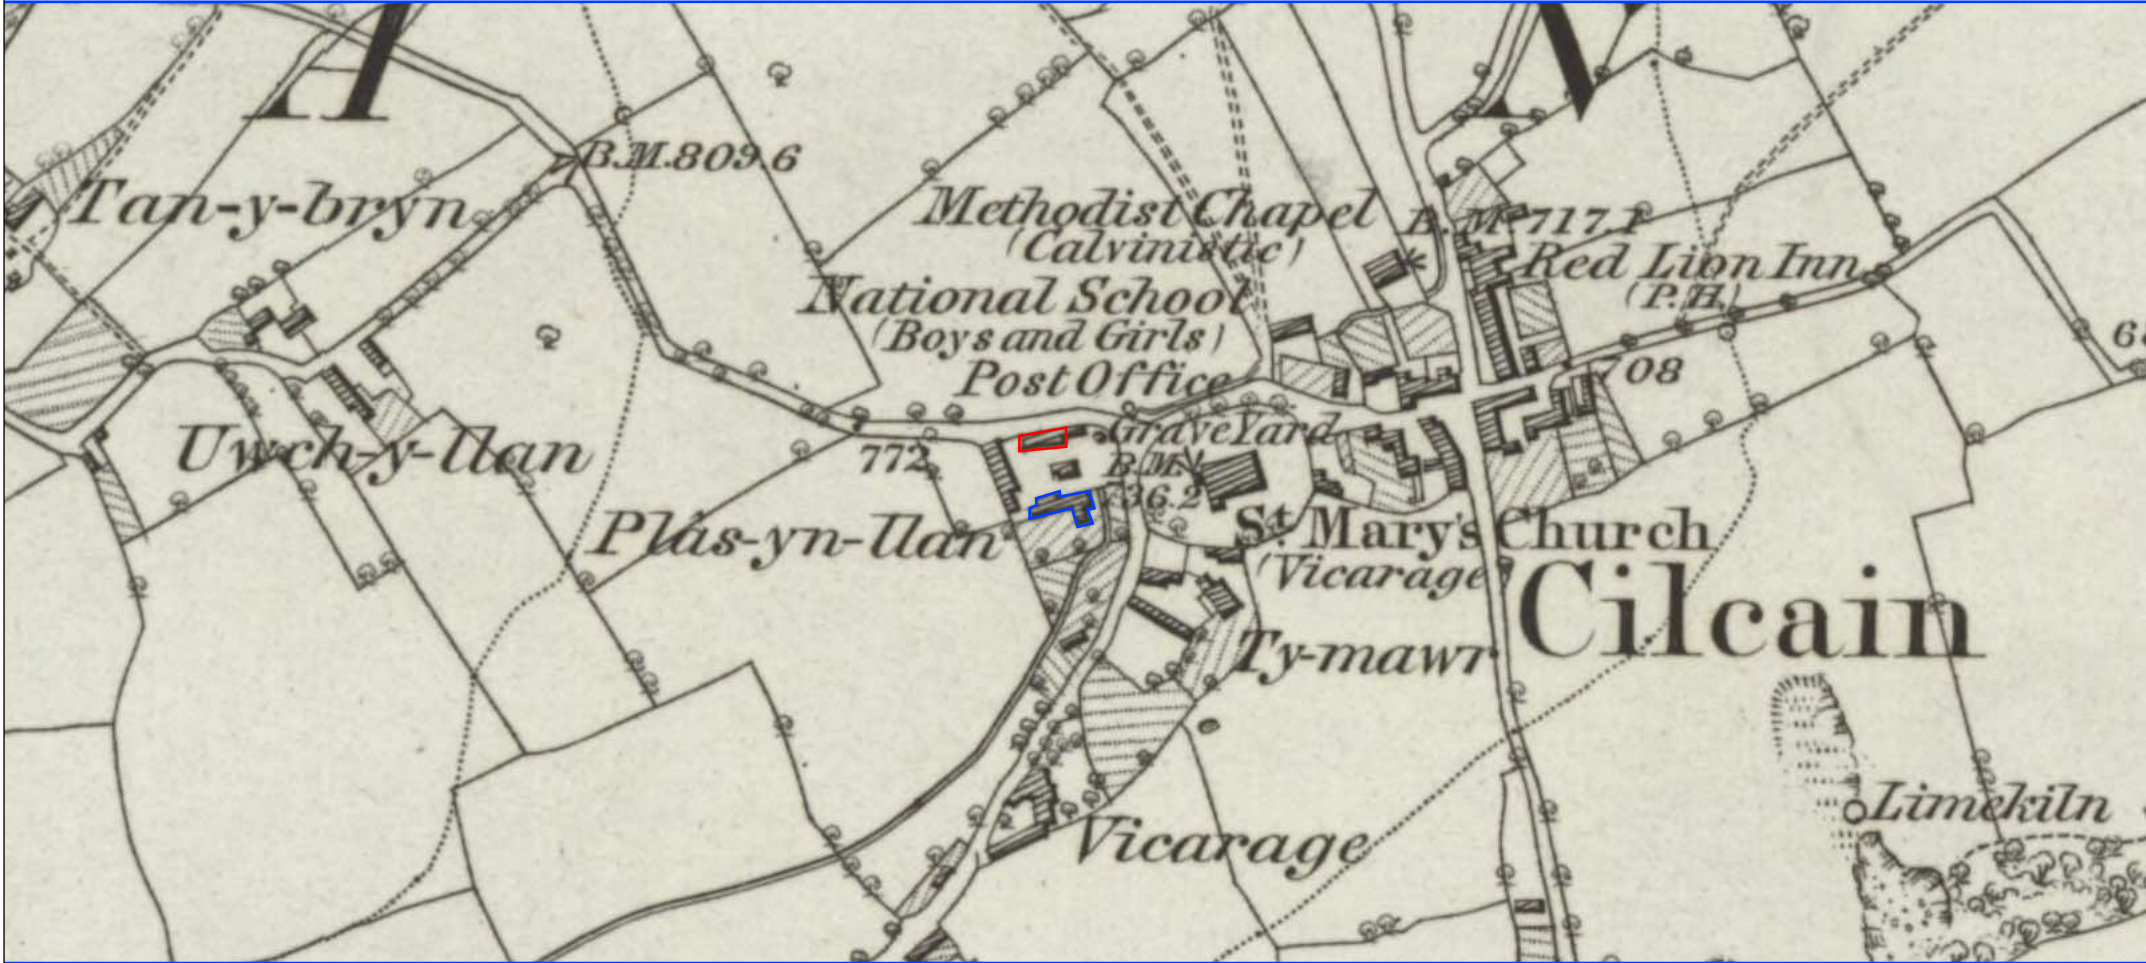
Figure 05: Location of outbuilding (red outline) to be converted at Plas yn Llan (blue outline), Cilcain, Flintshire on OS Six inch 1871.

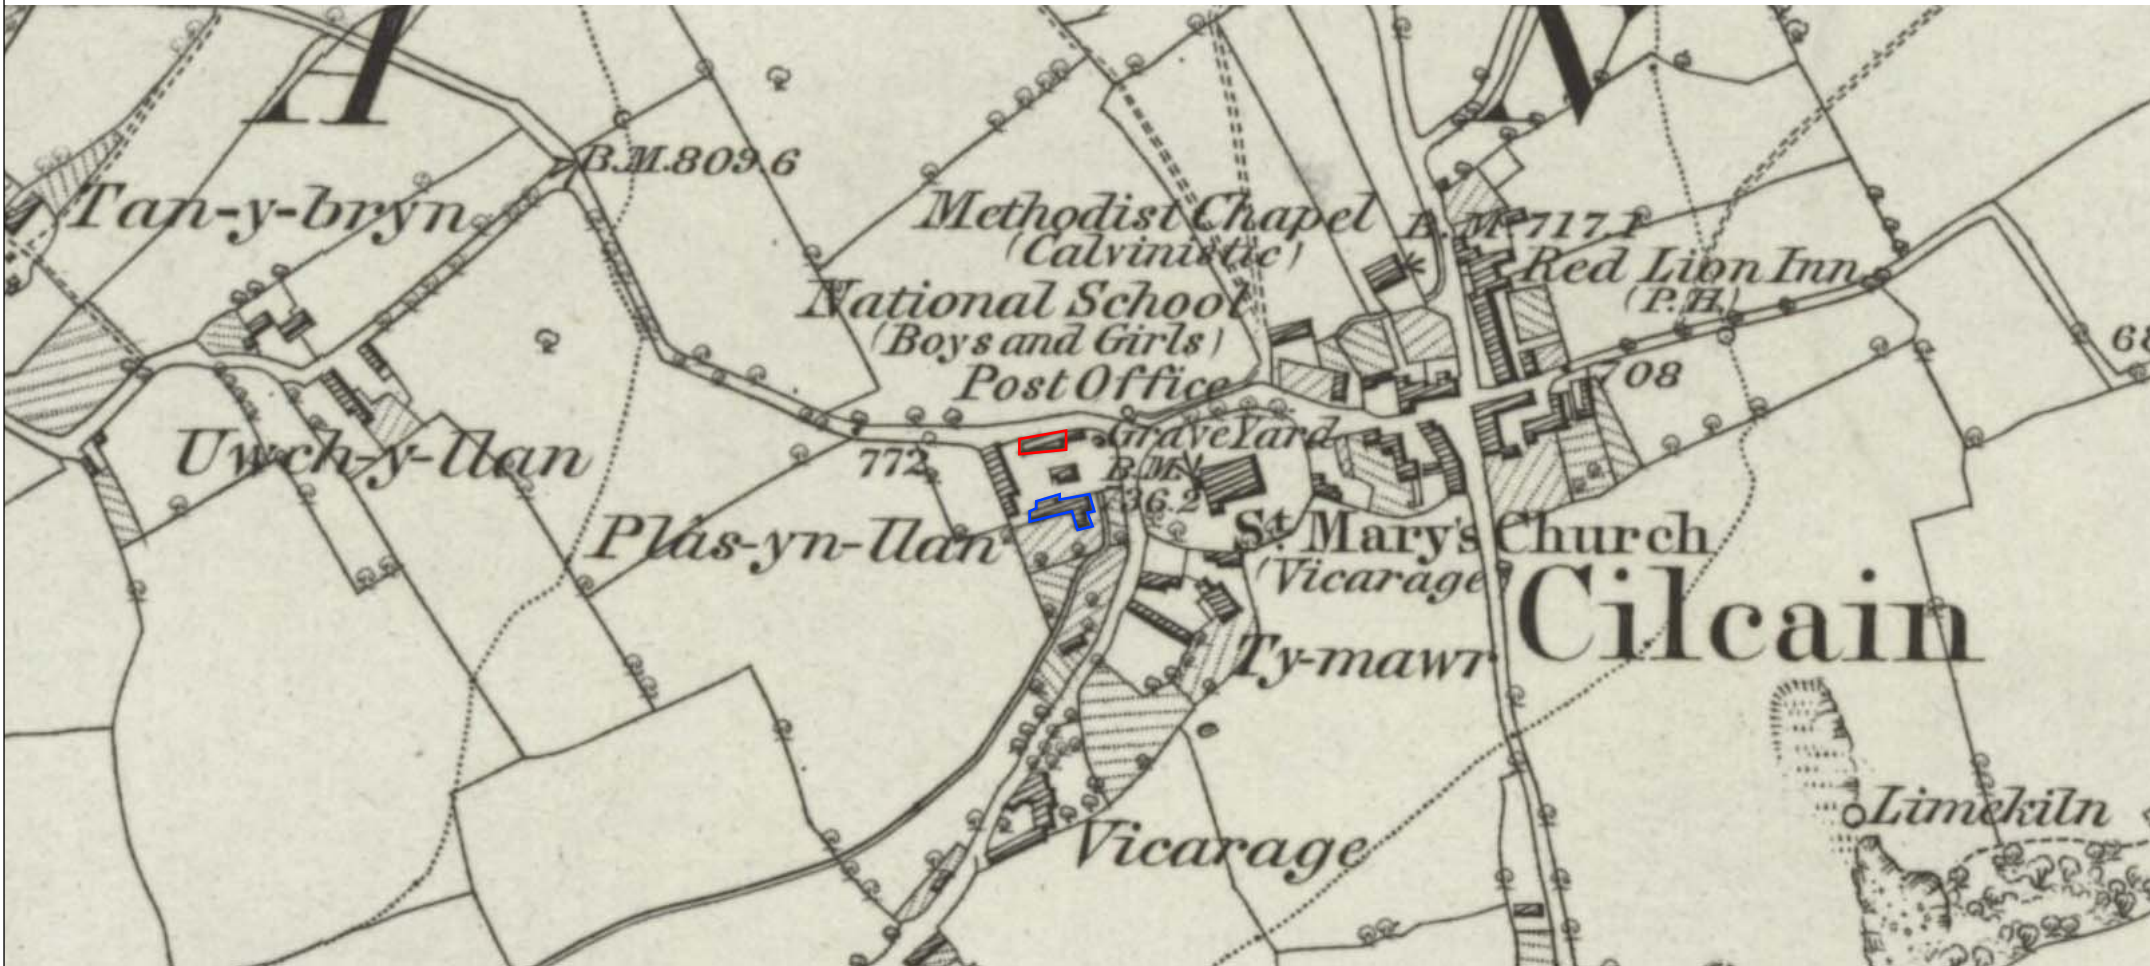
Figure 06: Location of outbuilding (red outline) to be converted at Plas yn Llan (blue outline), Cilcain, Flintshire on OS Six inch 1898.

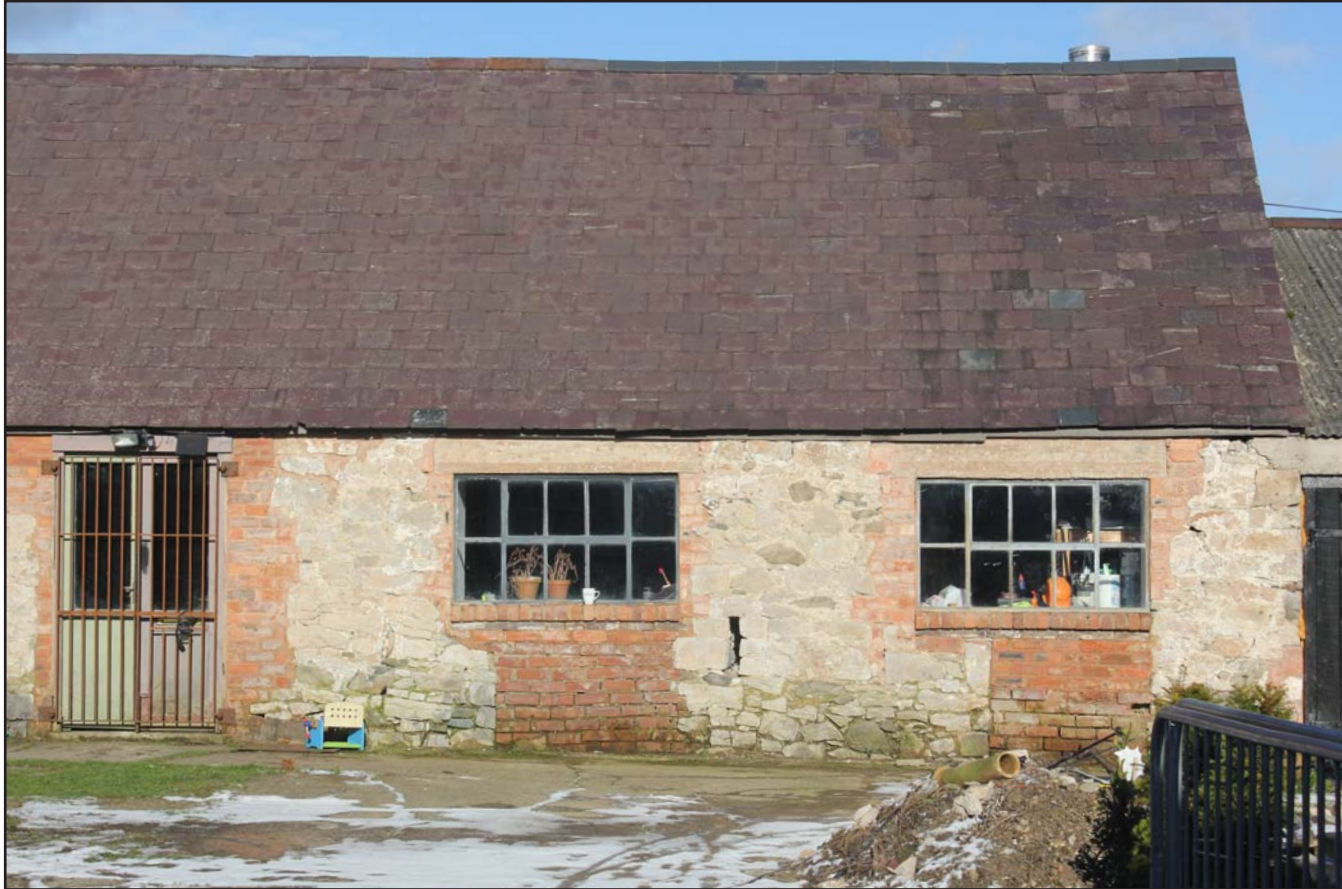
The building is rectangular in plan and orientated east to west and is single-storey. The roof of the building is comprised of modern slates and appears to have been recently re-roofed. The western elevation is comprised of angular stone rubble bonded by mortar and a single window is situated in the upper portion of the gable. This window has nine panes within a wooden frame. Located below this window are two vertical embrasures (openings in the wall). At the very base of the wall there appears to be a blocked up opening which may have once been the drain and there is evidence of a small stone archway at this point on the elevation. Projecting from this elevation is a medium height stone wall with a stone gatepost which forms part of the entrance to the Plas yn Llan property.

Plate 02: Plas Yn Llan, Cilcain, Flintshire. External shot - central portion of southern elevation - From the south - no scale

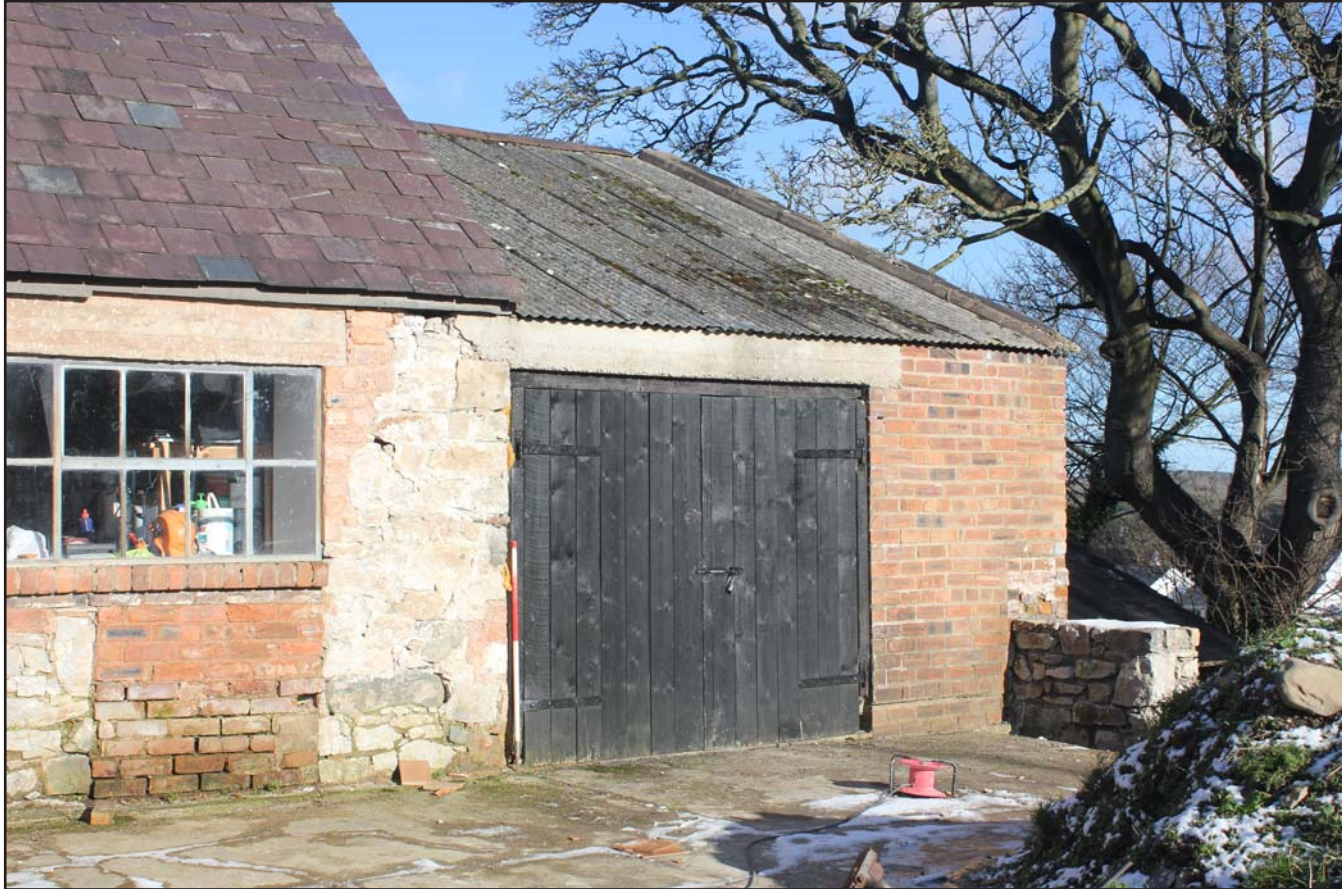
Plate 03: Plas Yn Llan, Cilcain, Flintshire. External shot - right hand end of southern elevation (Stores) - From the south - 1m scale

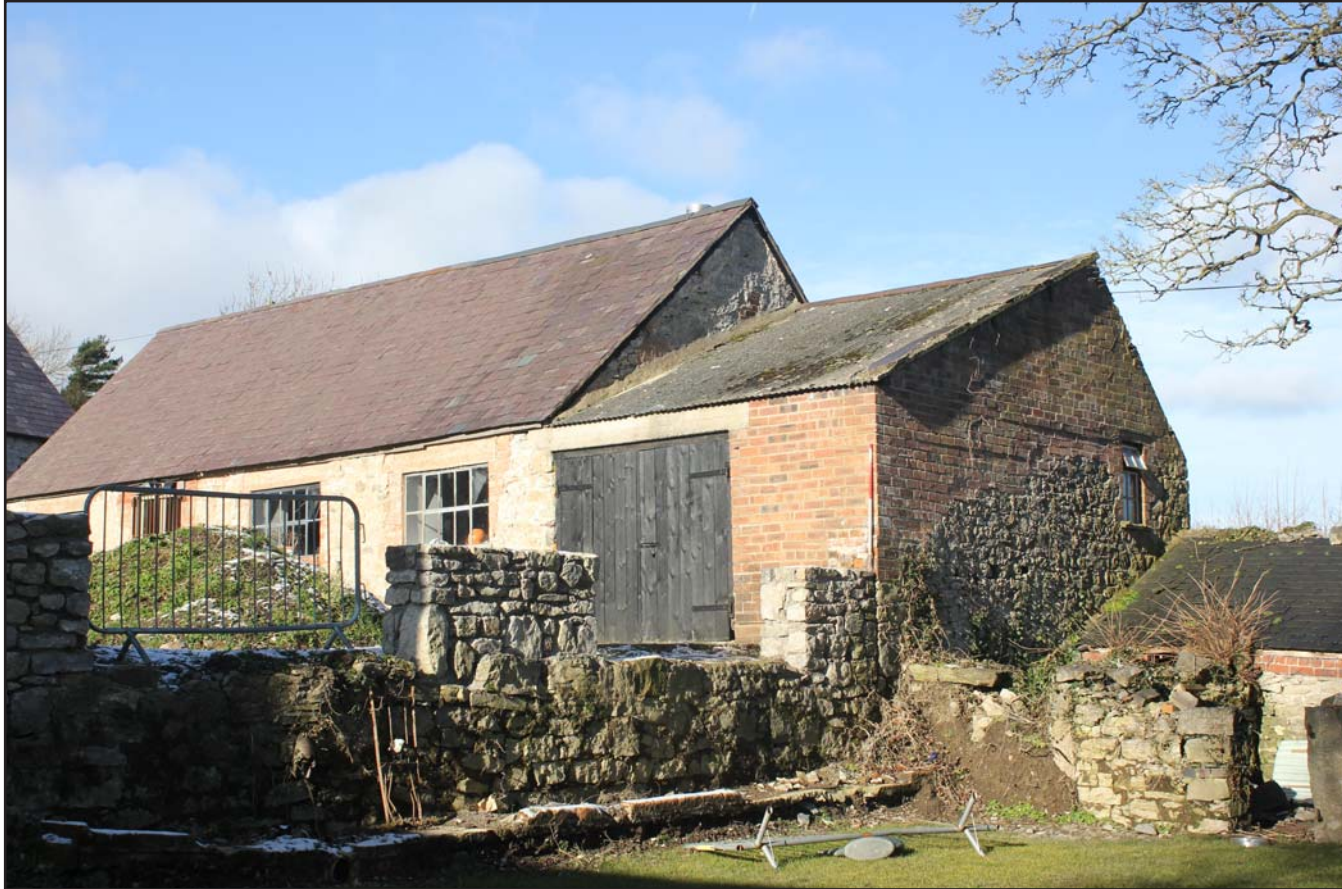
Plate 04: Plas Yn Llan, Cilcain, Flintshire. External shot - oblique shot showing southern & eastern elevations - From the southeast - 1m scale

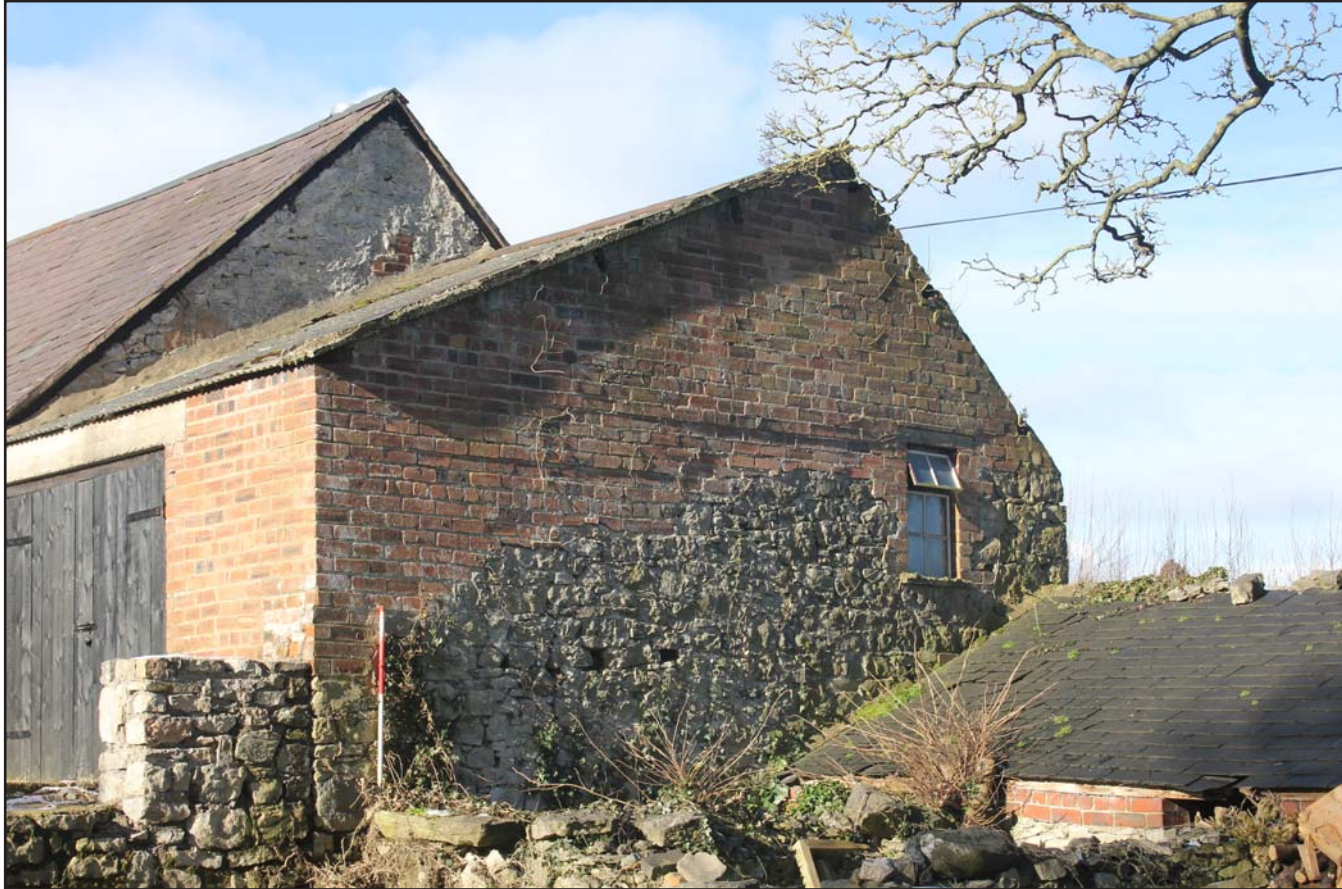
The upper portion of the eastern elevation appears to have been entirely rebuilt with redbrick bonded by mortar. The majority of the lower portion is of the same angular stone rubble bonded by mortar visible on the northern elevation. In the upper right hand corner of the elevation a small, six pane steel framed window is visible.

Plate 05: Plas Yn Llan, Cilcain, Flintshire. External shot - eastern elevation (Stores) - From the southeast - 1m scale

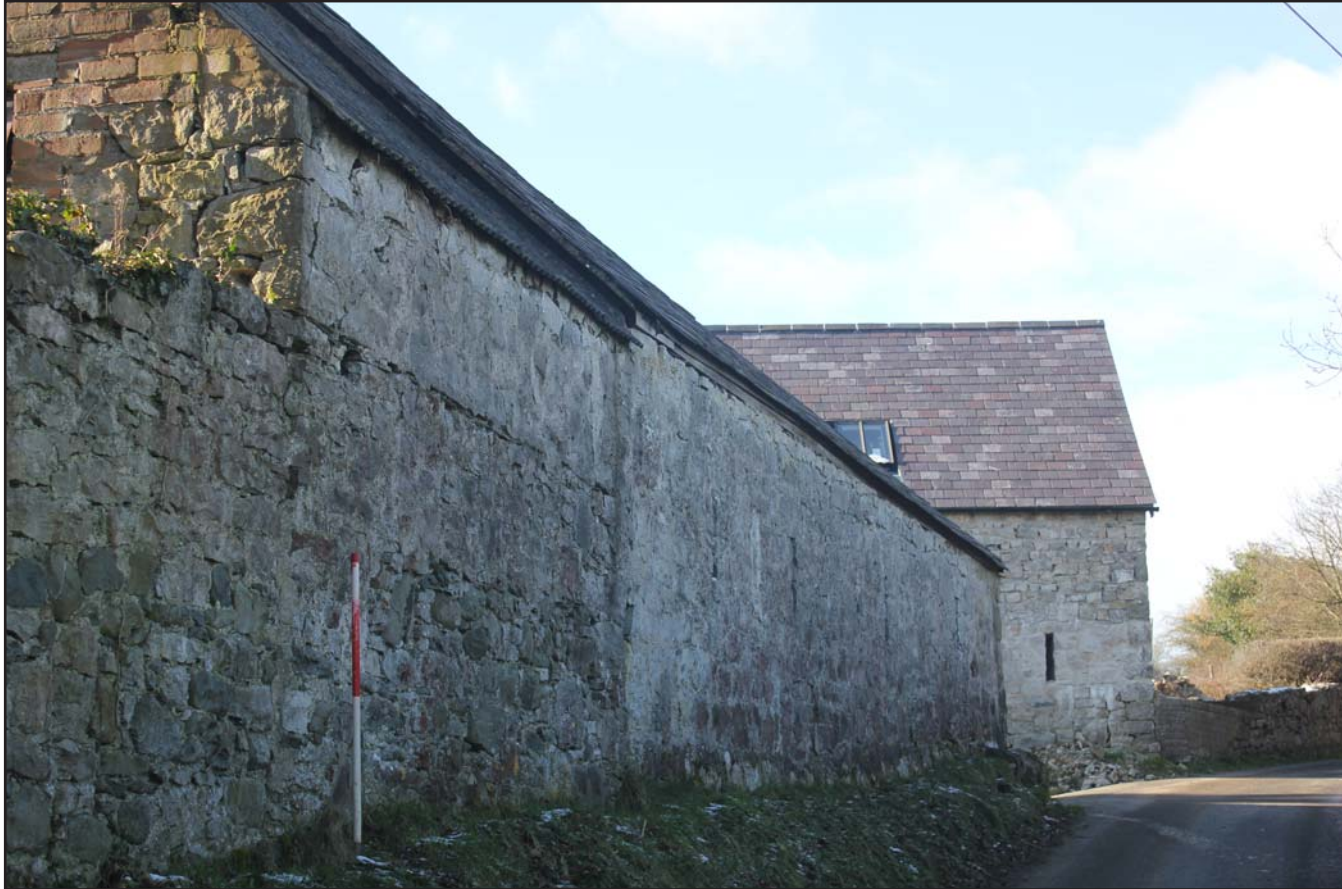
The northern elevation is once more comprised of angular stone bonded by mortar. At the far right-hand end of the northern elevation there are large stones near foundation level which may be incorporated onto a natural outcropping of bedrock beneath. Equally spaced along the northern elevation's length are four vertical embrasures that appear to have been blocked up behind with either masonry or brickwork. At the eastern end of the elevation the addition of a later extension of slightly lower storey appears evident. The lower extent of the stonework in this area differs from the main body of masonry (to the west) of the elevation and shares an appearance (smaller angular rubble blocks bonded by white grey mortar) with the pigsties further to the east making it the initial phase. The appearance of the wall suggests that initially the pigsties extended further to the west but subsequently, the northern elevation of these pigsties became incorporated into the extension of the outbuilding to the west, this would represent the second phase. Furthermore the extension appears to have had the majority of its eastern gable, southern elevation and upper portion of its northern elevation (under the eaves) rebuilt succeeding to the addition of the stone extension building making it the third and final construction phase visible on the eastern end of the building.

Plate 06: Plas Yn Llan, Cilcain, Flintshire. External shot - left hand end of northern elevation - From the northeast - 1m scale

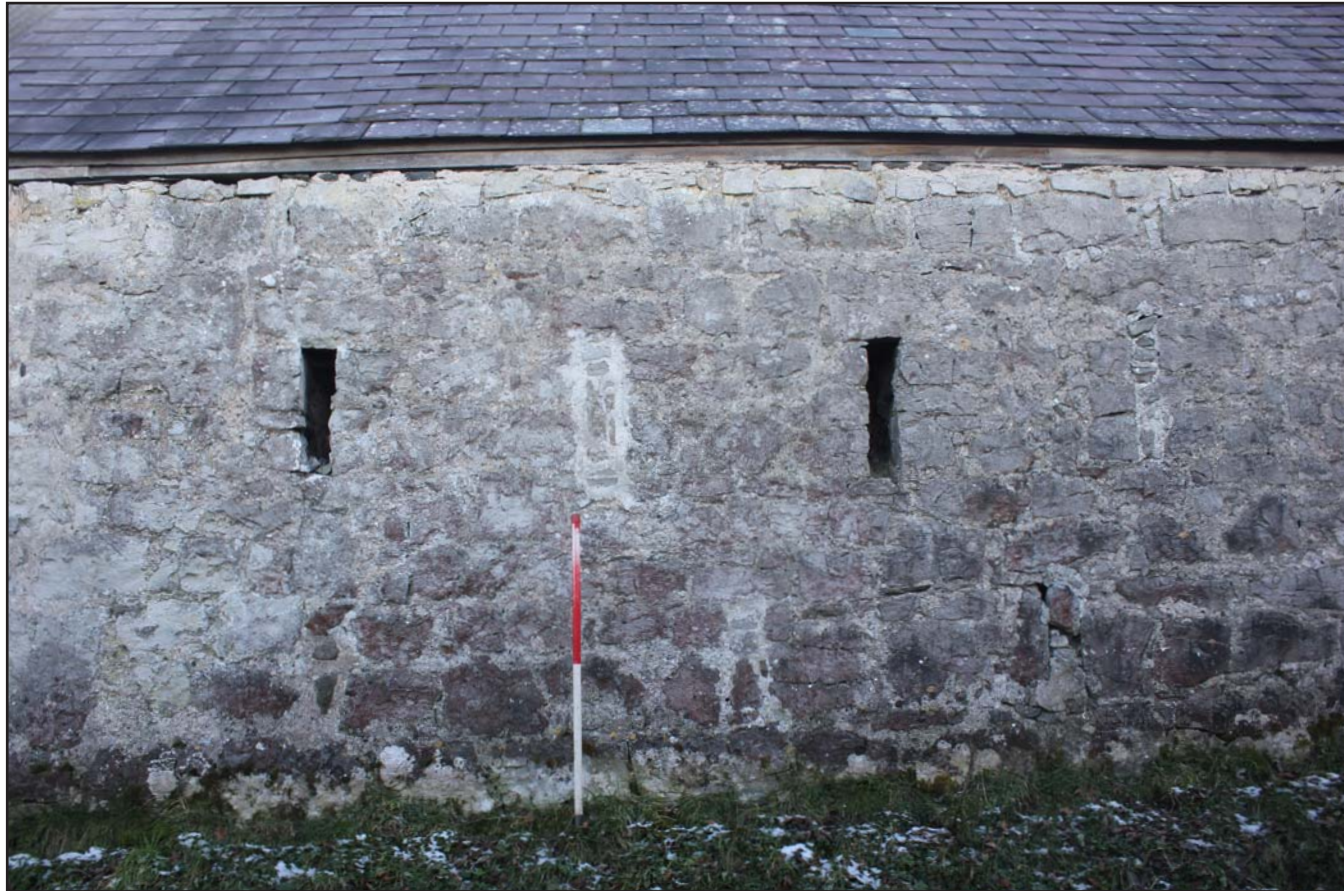
Plate 07: Plas Yn Llan, Cilcain, Flintshire. External shot - central portion of northern elevation - From the north - 1m scale

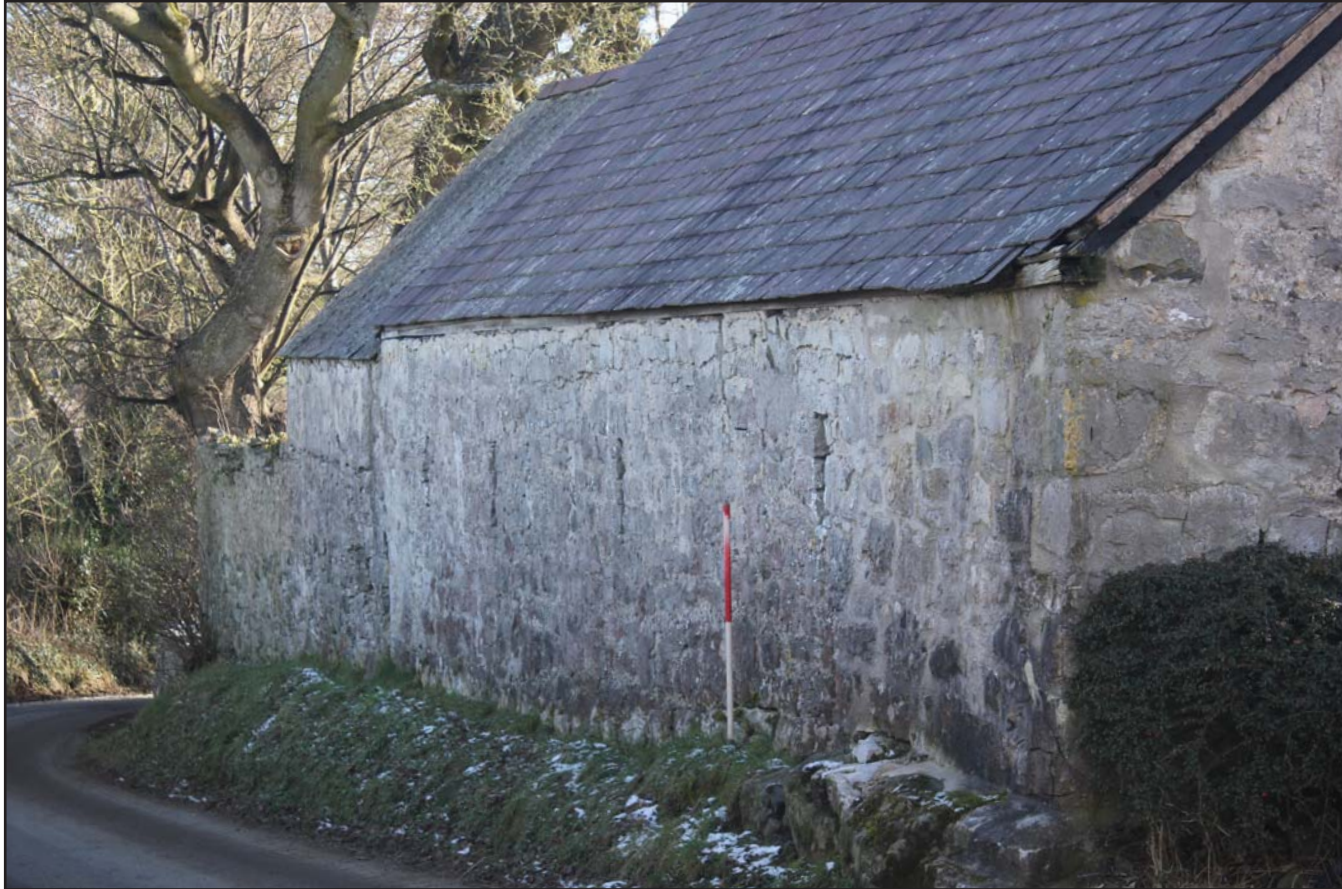
Plate 08: Plas Yn Llan, Cilcain, Flintshire. External shot - right hand end of northern elevation - From the northwest - 1m scale

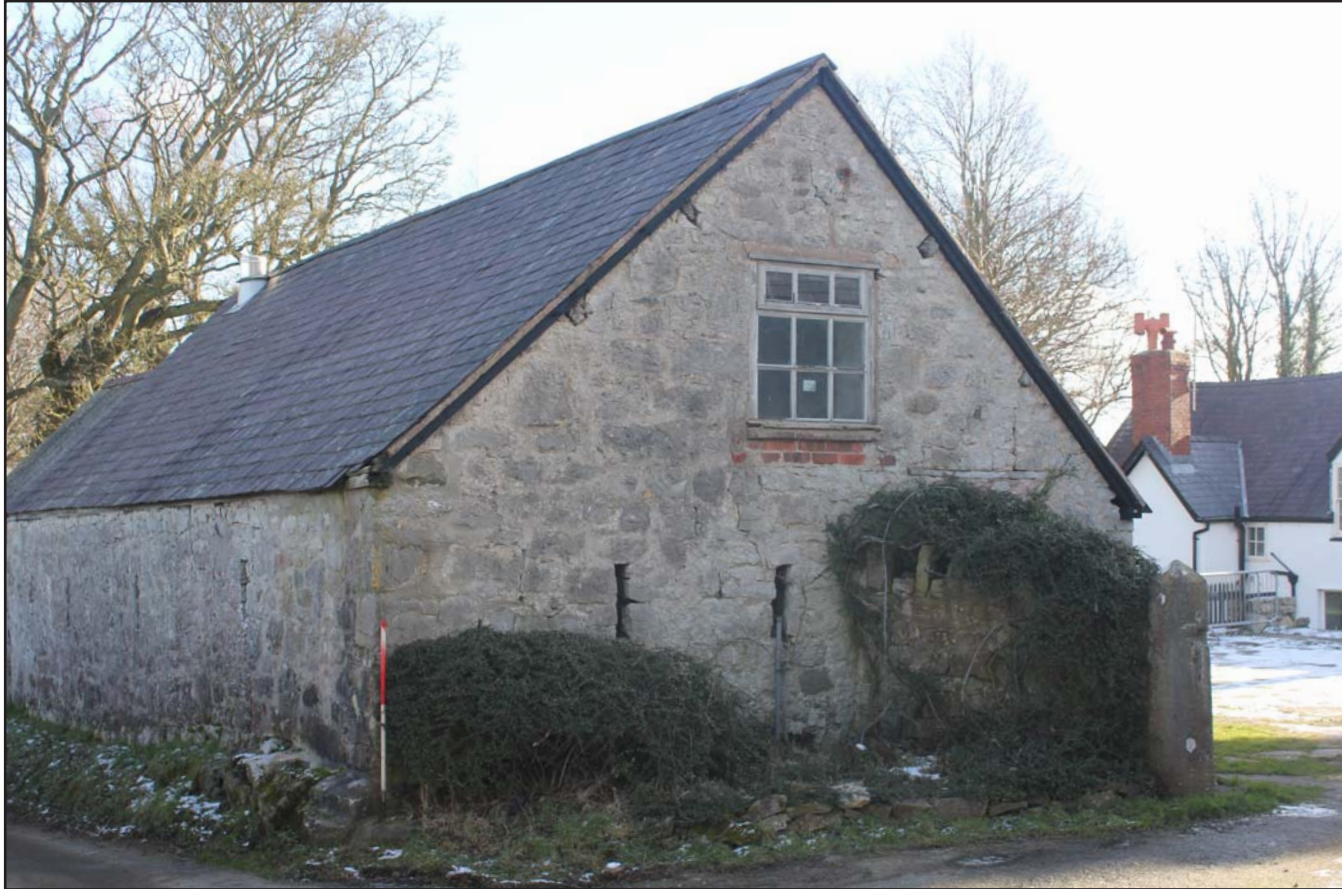
Plate 09: Plas Yn Llan, Cilcain, Flintshire. External shot - oblique shot showing northern & western elevations - From the northwest - 1m scale

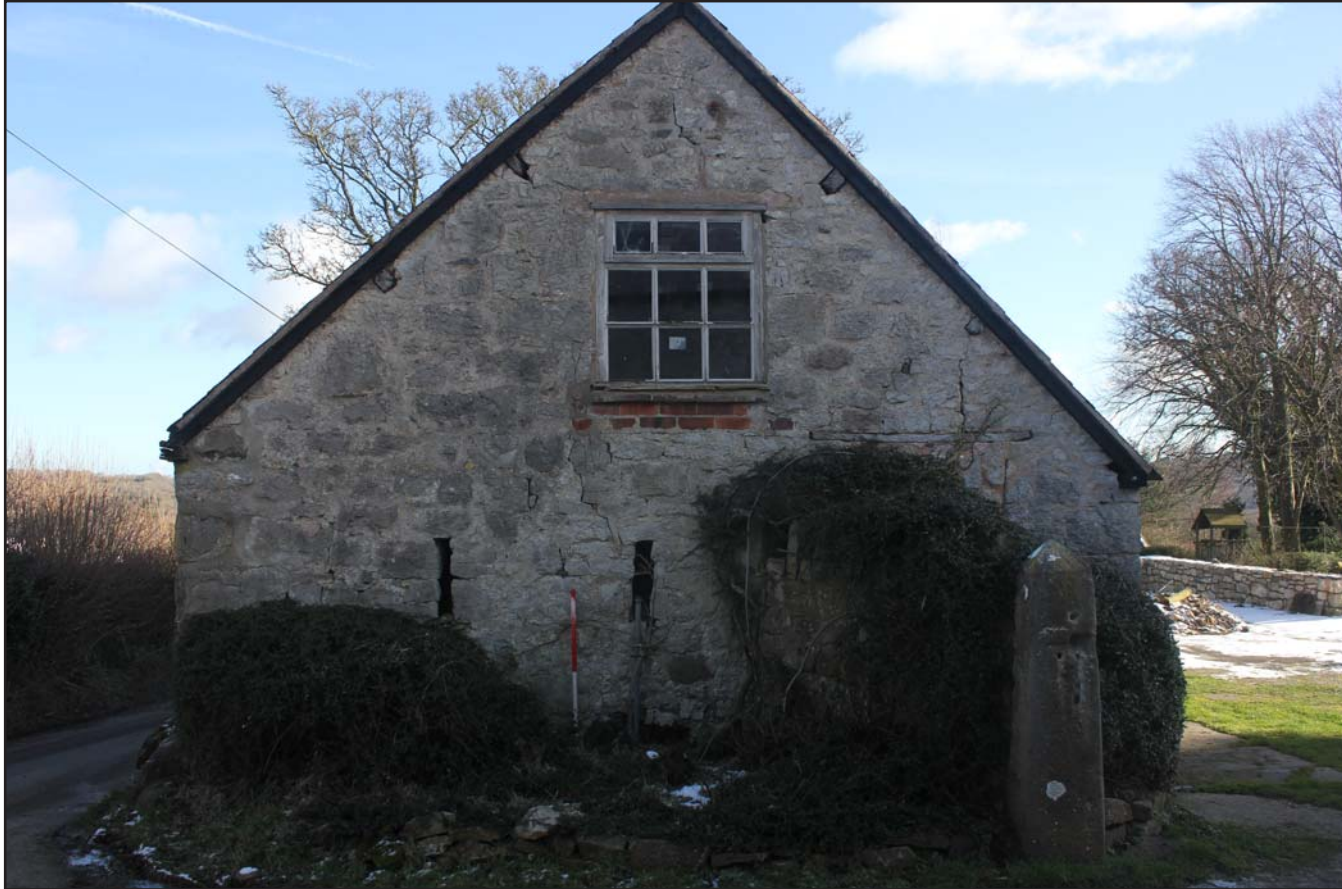
The western elevation has been subject to heavy modification and adjustment. There are three windows and a single doorway visible on the main part of the outbuilding (west to centre), and on right hand side there are pair of large wooden double doors. Remnants of the original stonework are still visible but these are interrupted by modern brick build sections around the doors and windows. The masonry is of angular stone rubble bonded by mortar.

Plate 10: Plas Yn Llan, Cilcain, Flintshire. External shot - western elevation (gable end) - From the west - 1m scale

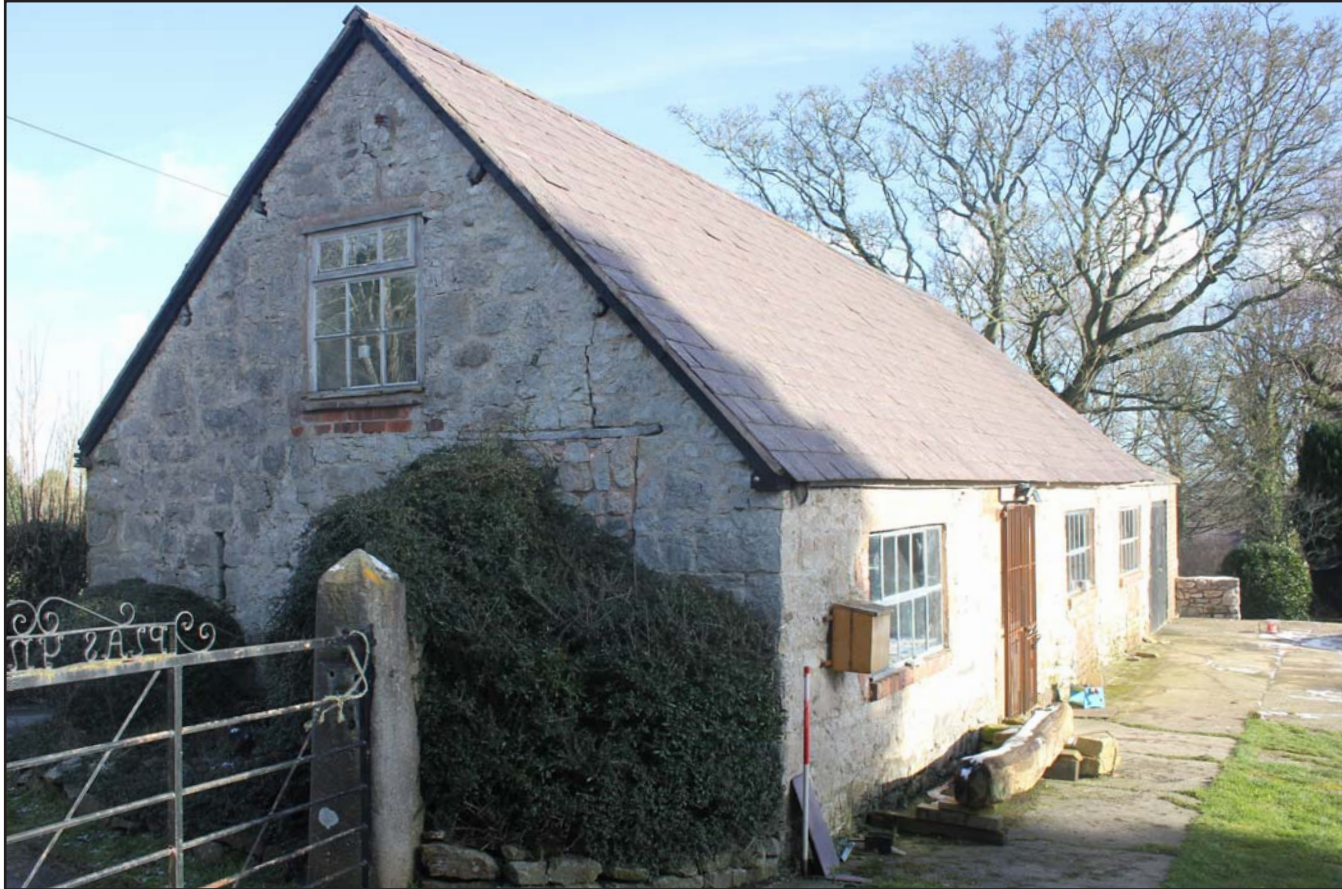
Plate 11: Plas Yn Llan, Cilcain, Flintshire. External shot - oblique shot showing western & southern elevations - From the southwest - 1m scale

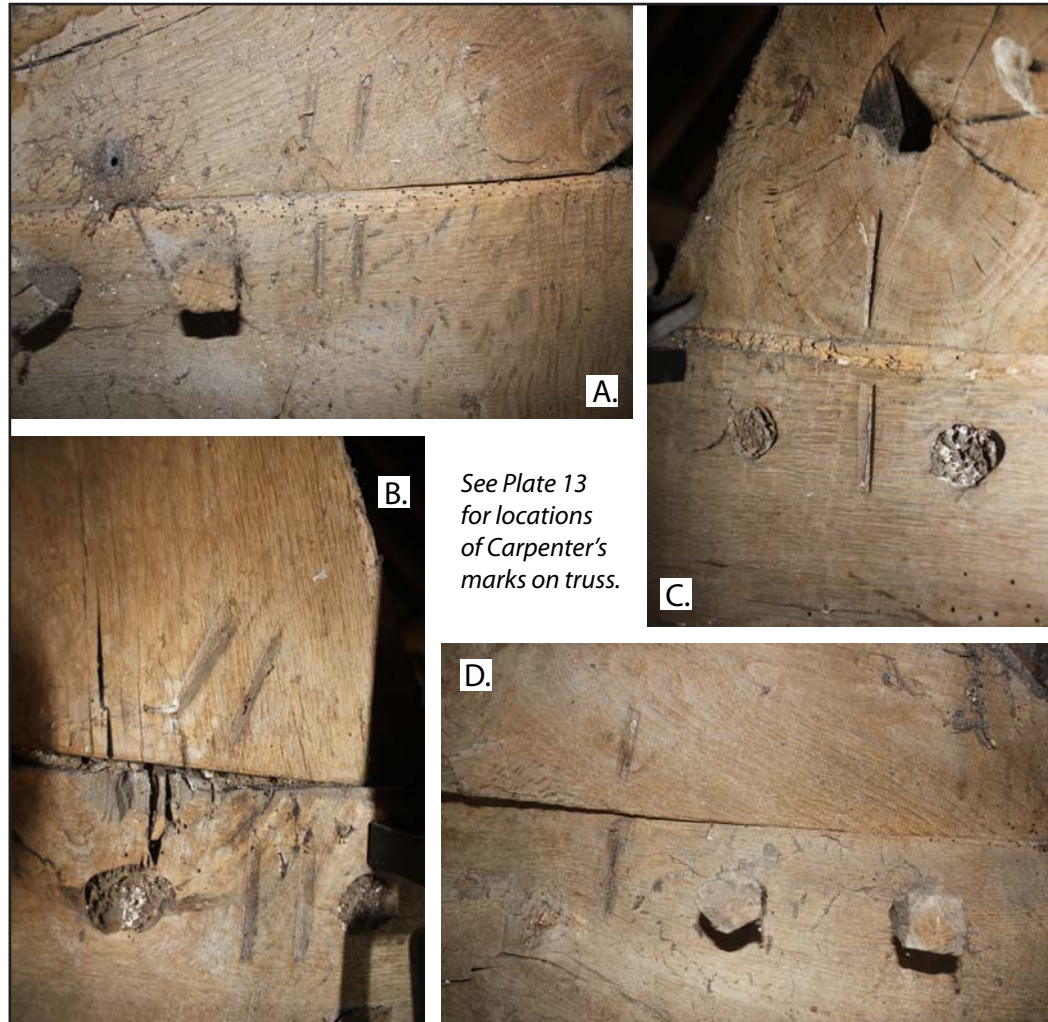
The easternmost frame has been fitted with timber upright struts and this feature is unique to that frame as the others have not been modified. The central timber frame (**Plates 1 & 2**) exhibit carpenter's marks; where the *principle rafters* fit into the *tie beam* and where the angled *queen posts* fit into the tie beam - two vertical incised marks are present on the base northern rafter and queen post and on the corresponding location where they fit into the tie beam. On the base southern rafter and queen post only a single mark has been incised with a corresponding mark located at the point where these fit into the tie beam. Furthermore the frames are of mortise and tenon joint construction with the queen posts and rafters morticed into the tie beam and the upper extent of the queen posts morticed into the the principal rafters. All of the tenon joints have been secured with substantial wooden dowels. All of the purlins are then recessed onto outer part of the principal rafters.

Plate 12: Plas Yn Llan, Cilcain, Flintshire. Carpenter's marks on the central timber truss inside the former workshop - From the west - no scale
