**Plas yn Llan, Cilcain, Mold,
CH7 5PB.**

**February 2018
V 1.0**

Historic Building Record Level 2/3
Project Code: A0152.1
Report no. 0159

Historic Building Record Level 2/3

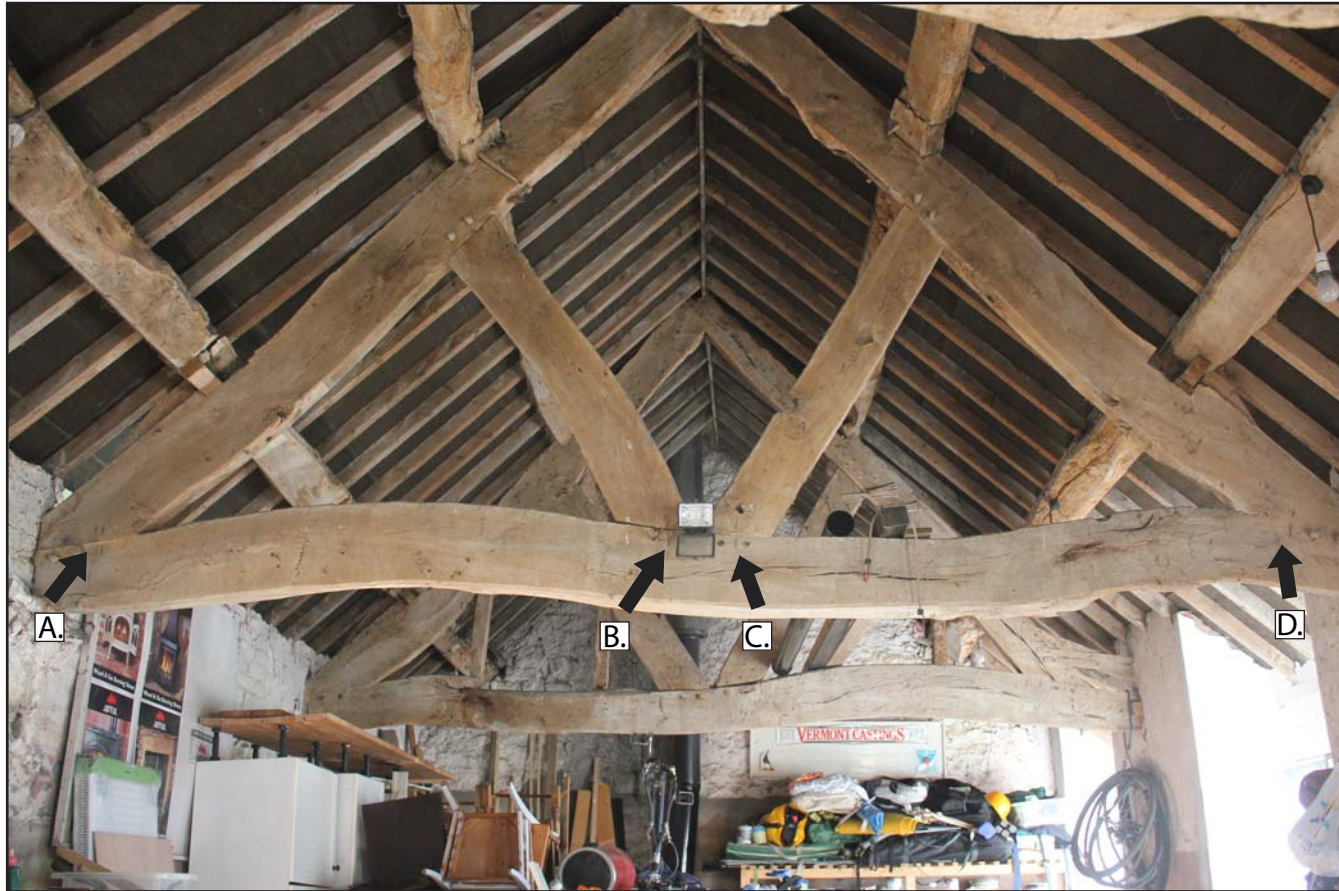
The easternmost frame has been fitted with timber upright struts and this feature is unique to that frame as the others have not been modified. The central timber frame (**Plates 1 & 2**) exhibit carpenter's marks; where the *principle rafters* fit into the *tie beam* and where the angled *queen posts* fit into the tie beam - two vertical incised marks are present on the base northern rafter and queen post and on the corresponding location where they fit into the tie beam. On the base southern rafter and queen post only a single mark has been incised with a corresponding mark located at the point where these fit into the tie beam. Furthermore the frames are of mortise and tenon joint construction with the queen posts and rafters morticed into the tie beam and the upper extent of the queen posts morticed into the the principal rafters. All of the tenon joints have been secured with substantial wooden dowels. All of the purlins are then recessed onto outer part of the principal rafters.

Plate 13: Plas Yn Llan, Cilcain, Flintshire. Internal shot - west facing side of central timber truss inside the former workshop, showing locations of the Carpenter's marks - From the west- no scale

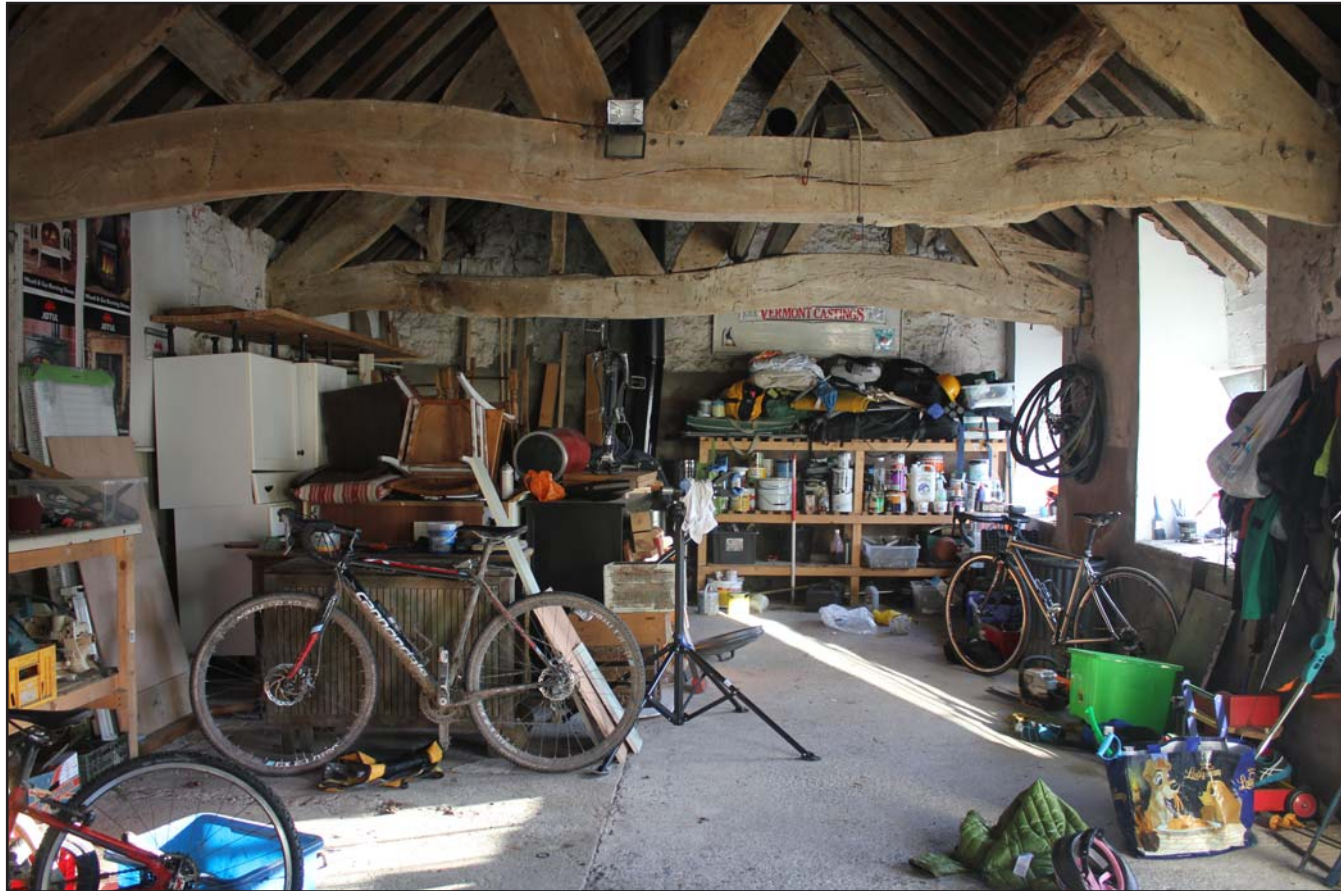
The former workshop room is rectangular in plan and orientated east to west and single storey. It is currently a workshop/storage area however it is possible that once used to be a barn. The roof is comprised of modern timber batons upon which modern roofing felt had been fixed. The roof is supported by two horizontal hand-cut timber purlins which are in turn supported by three *Queen truss* frames which have been recessed into the walls and sit upon timber pads which are in turn seated upon corbel tables which are comprised of the same angular stone bonded by mortar which form the lower thirds of the wall.

Plate 14: Plas Yn Llan, Cilcain, Flintshire. Internal shot - Former Workshop context shot - from the west - 1m scale

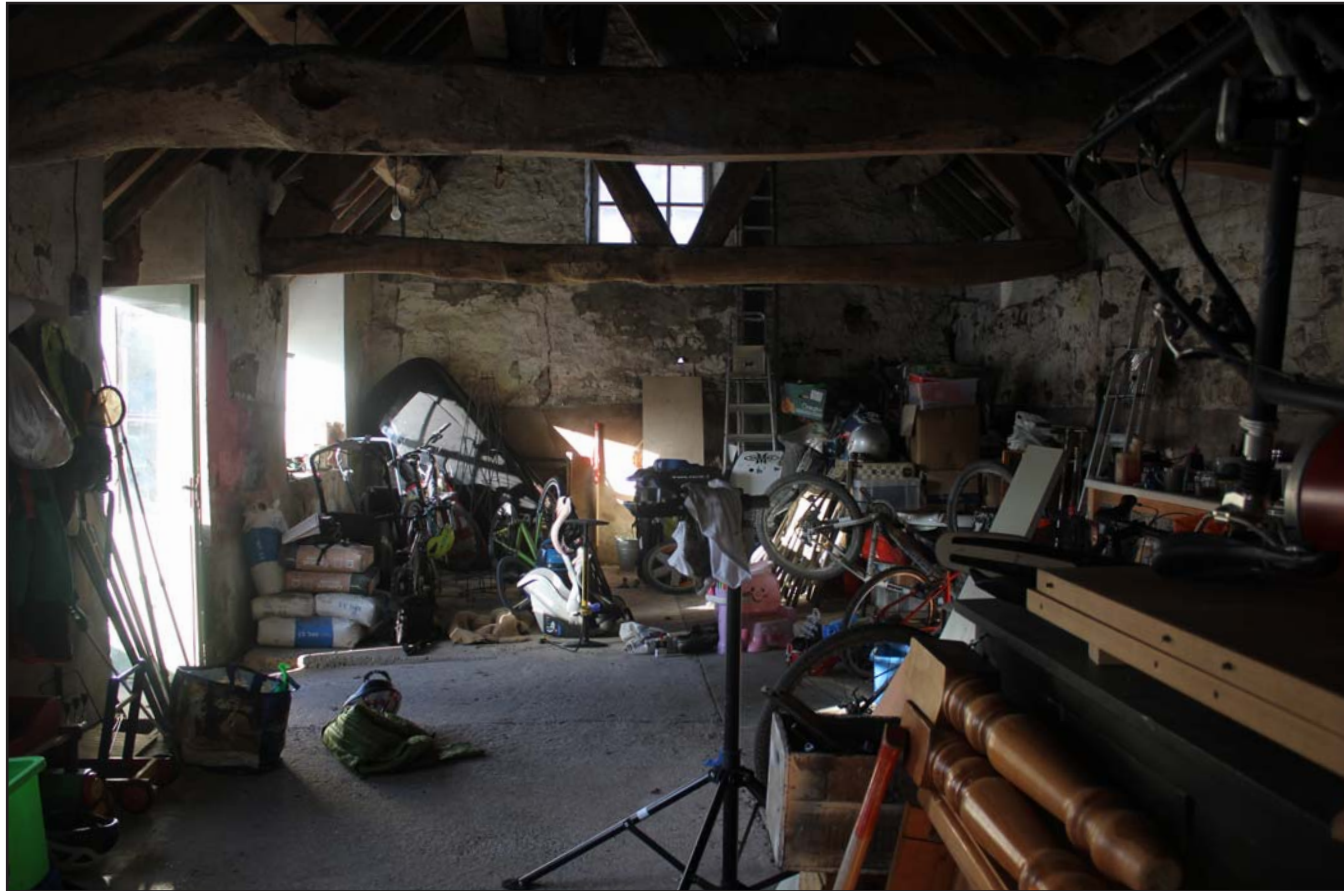
Plate 15: Plas Yn Llan, Cilcain, Flintshire. Internal shot - Former Workshop context shot - from the east - 1m scale

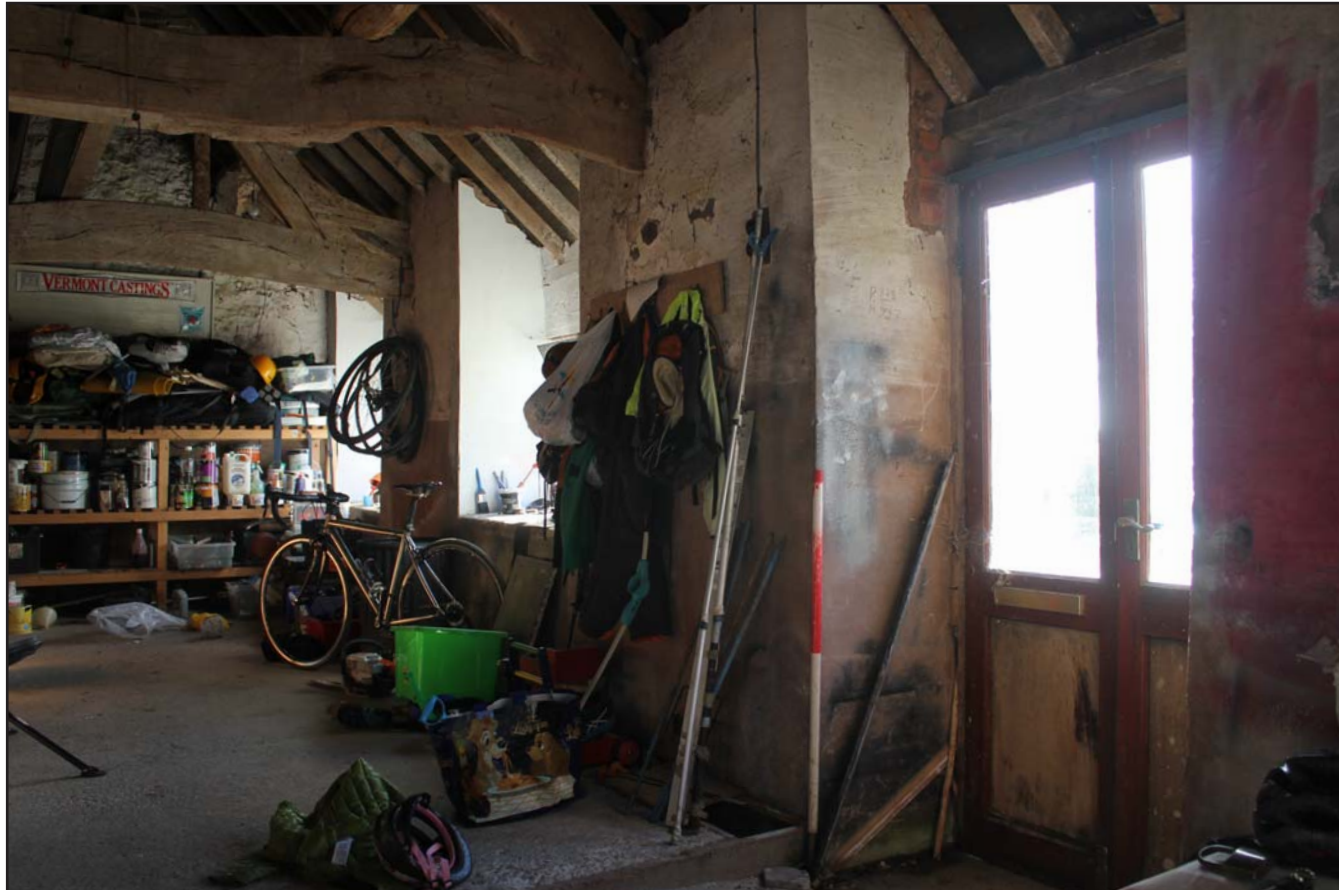
The southern elevation is probably constructed from angular stone rubble bonded by mortar, however most of this stonework is obscured by modern render which has in the main been painted white. The elevation has three separate windows and a single doorway. The windows have narrow timber lintels and what appears to be brickwork located above the openings and these have been painted white. On the left hand side (eastern) there are two metal framed windows which are recessed into the wall each with concrete sills. These windows have ten glass window panes and the central upper three of these window panes open to form chute like window lights. To the immediate right of the central part of the elevation is a timber framed double door which has been glazed in its upper portion, this door is not painted on the inside and has a wooden lintel located above. To the right of the door is another window identical to those ones previously described. The floor of this room is a cast concrete however running along the southern side of the floor there appears to be a cavity which may be for services.

Plate 16: Plas Yn Llan, Cilcain, Flintshire. Internal shot - oblique shot of southern elevation - from the northwest - 1m scale

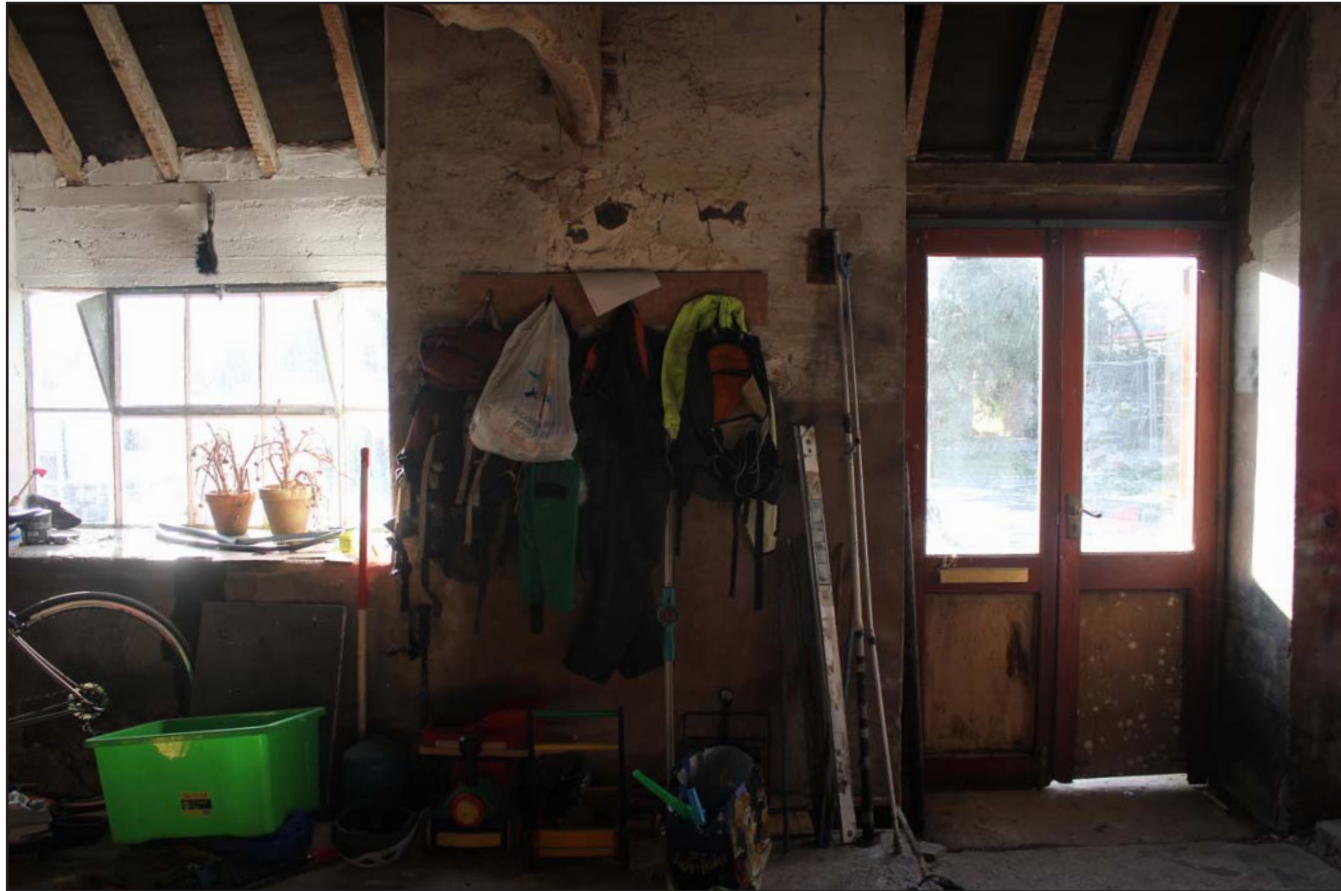
Plate 17: Plas Yn Llan, Cilcain, Flintshire. Internal shot - example section of southern elevation - from the north - 1m scale

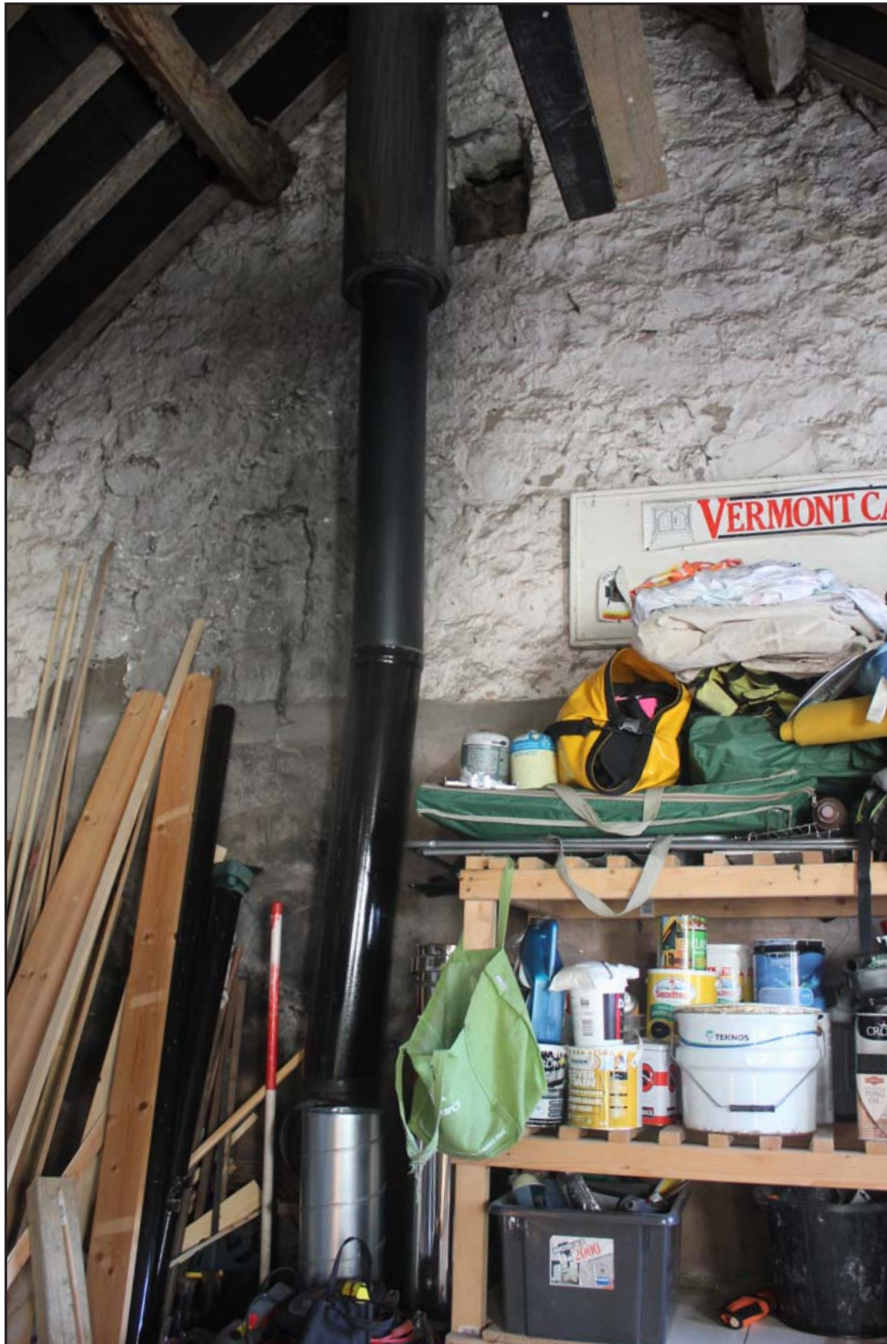
The eastern elevation it's similar to the western elevation in that it is comprised of angular stone rubble bonded by mortar which has been painted white, however the lower half of the elevation has been rendered and this render sits proud of the wall by approximately 0.25 m. Also there is a flue which runs from the floor to the roof and some staining is visible on the wall around the general alignment of this flue. The flue is not currently connected to any kind of ignition source. The majority of the elevation to right hand side (southern portion) is mainly obscured by a large shelving unit.

Plate 18: Plas Yn Llan, Cilcain, Flintshire. Internal shot - eastern elevation - from the southwest - 1m scale

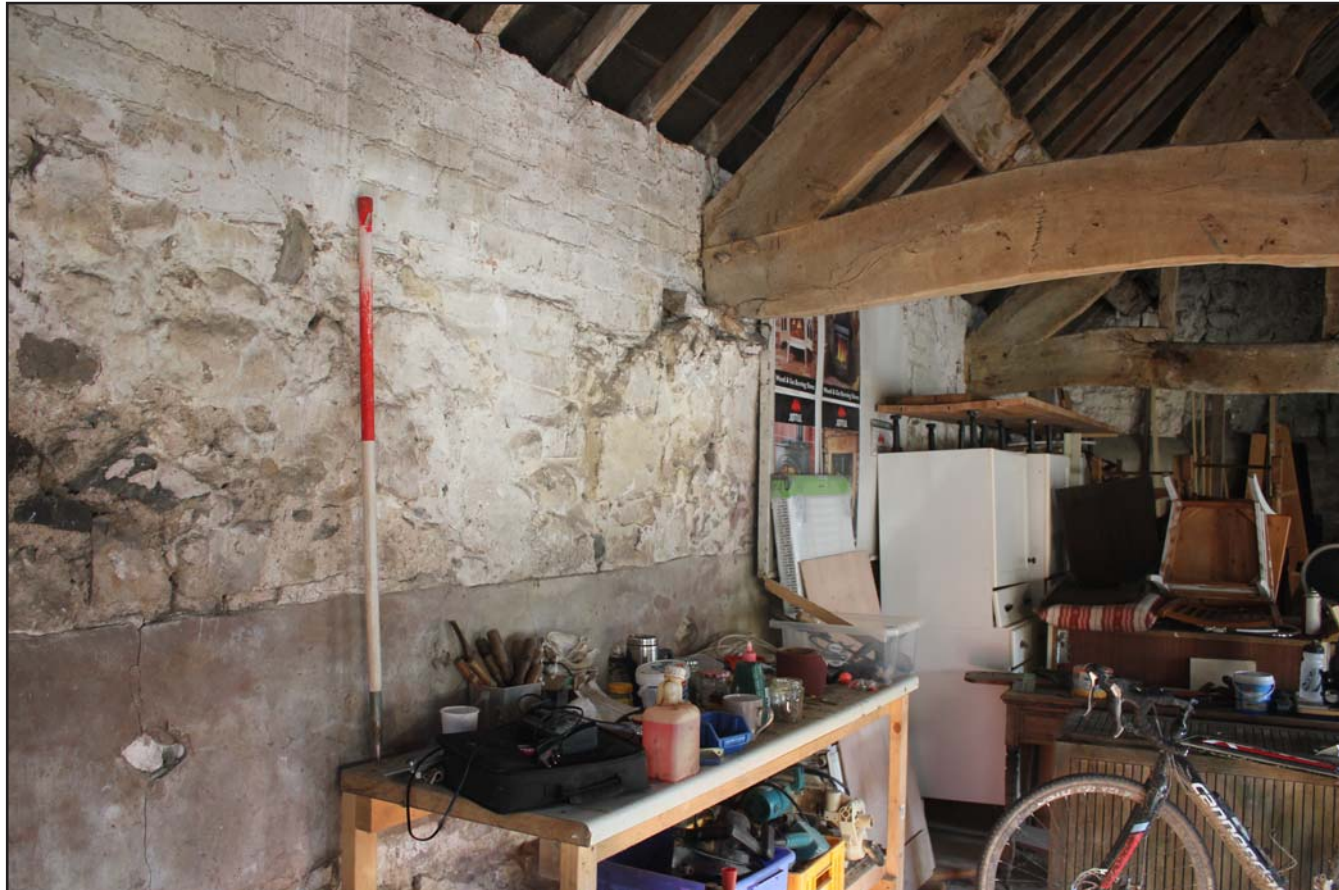
The northern wall is mainly constructed from angular stone bonded by mortar painted white, however the upper 0.50 m of the wall is constructed from brick (also painted white). This brickwork appears to be a later addition which perhaps was implemented as part of a prior re-roofing of the building. The tie beams of the timber queen post trusses are located upon indistinct corbel tables on this elevation, these rough corbel tables and the rest of the masonry

Plate 19: Plas Yn Llan, Cilcain, Flintshire. Internal shot - oblique shot of northern elevation - from the southwest - 1m scale

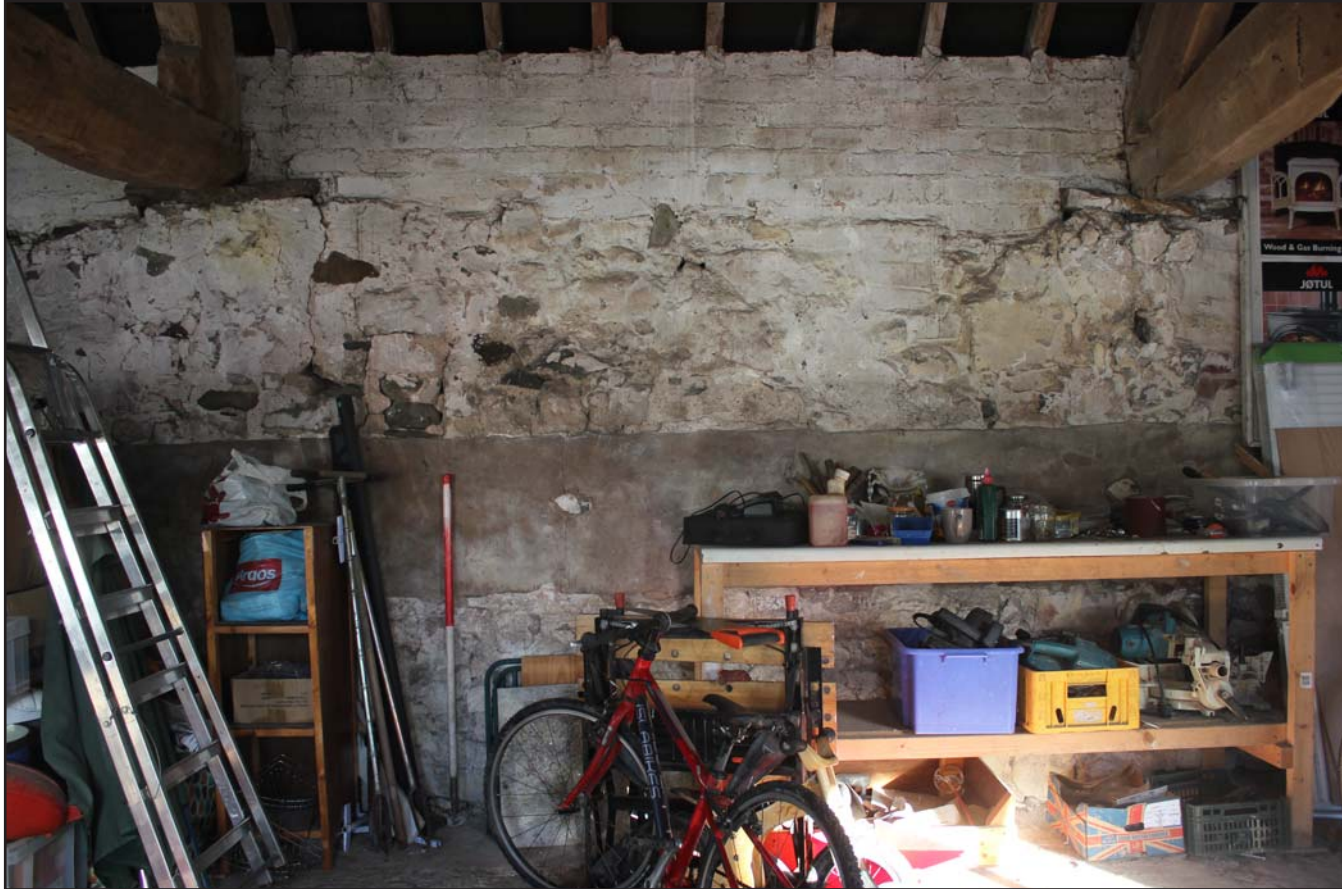
sit at the boundary between the angular masonry and the modern brickwork. A strip of rendering runs from left to right across the elevation, approximately half of the way up the wall which perhaps covers the embrasures visible on the exterior. The majority of the wall is obscured by items now in storage.

Plate 20: Plas Yn Llan, Cilcain, Flintshire. Internal shot - example section of northern elevation - from the south - 1m scale

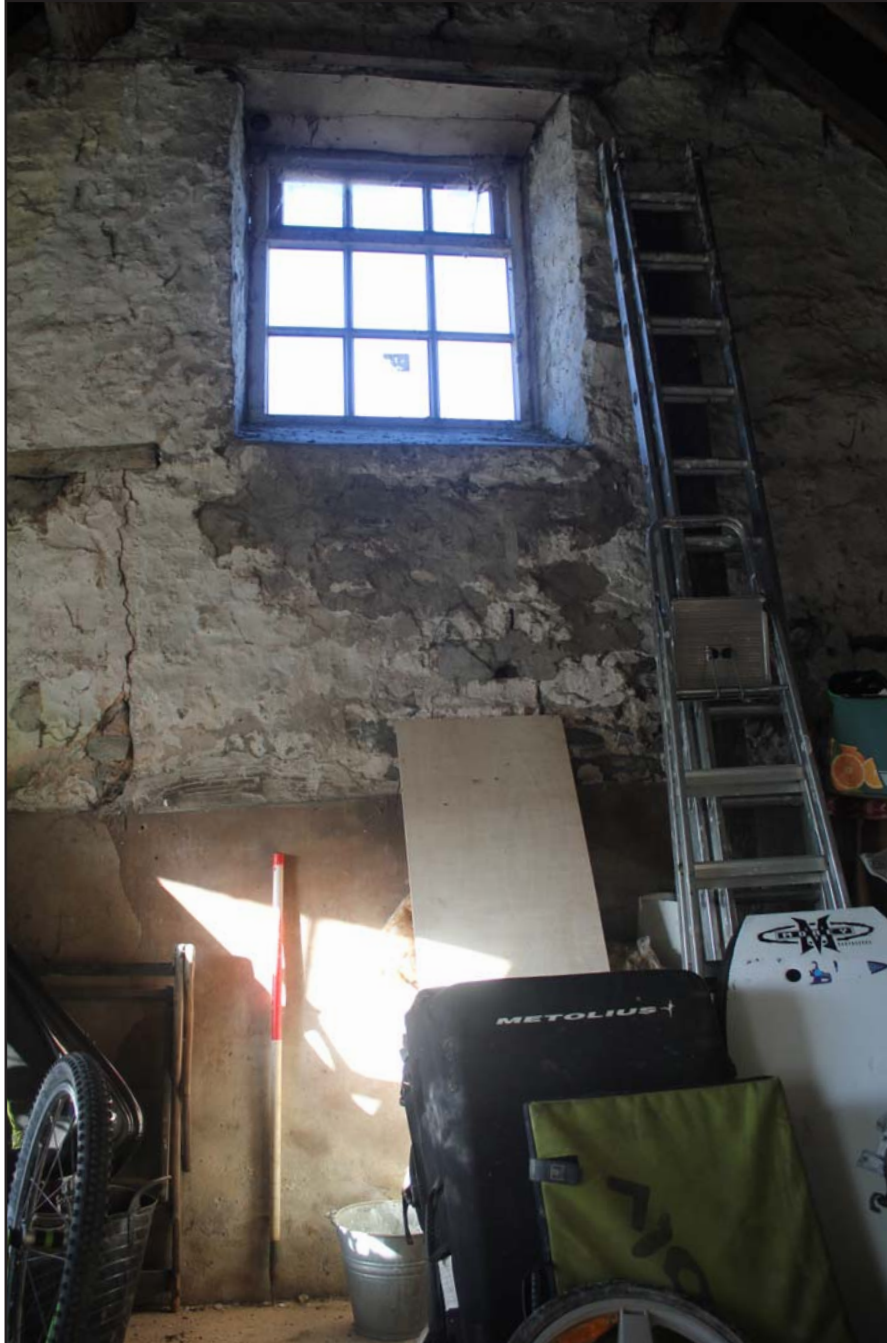
The western elevation is the gable end of the building which appears to be comprised of angular stone bonded by mortar and painted white, the four horizontal purlins are also recessed into this wall. Located in the upper portion of this wall is a single wooden framed window, which is recessed into the elevation. It has nine glass window panes; the upper three of which open as a light. The lower third of the wall appears to have been rendered heavily and projects into the room. On the left hand side, about 2/3 of the way up the wall there is a horizontal timber lintel, this has bowed and appears to quite clearly have been infilled with masonry. Furthermore there are other cavities in the wall which have also been filled up with mortar and masonry; in particular the central area on the elevation, below the window there is a small opening with a cavity visible behind it which is perhaps the embrasure visible on the exterior. Apart from these elements the wall is featureless.

Plate 21: Plas Yn Llan, Cilcain, Flintshire. Internal shot - western elevation - from the southeast - 1m scale

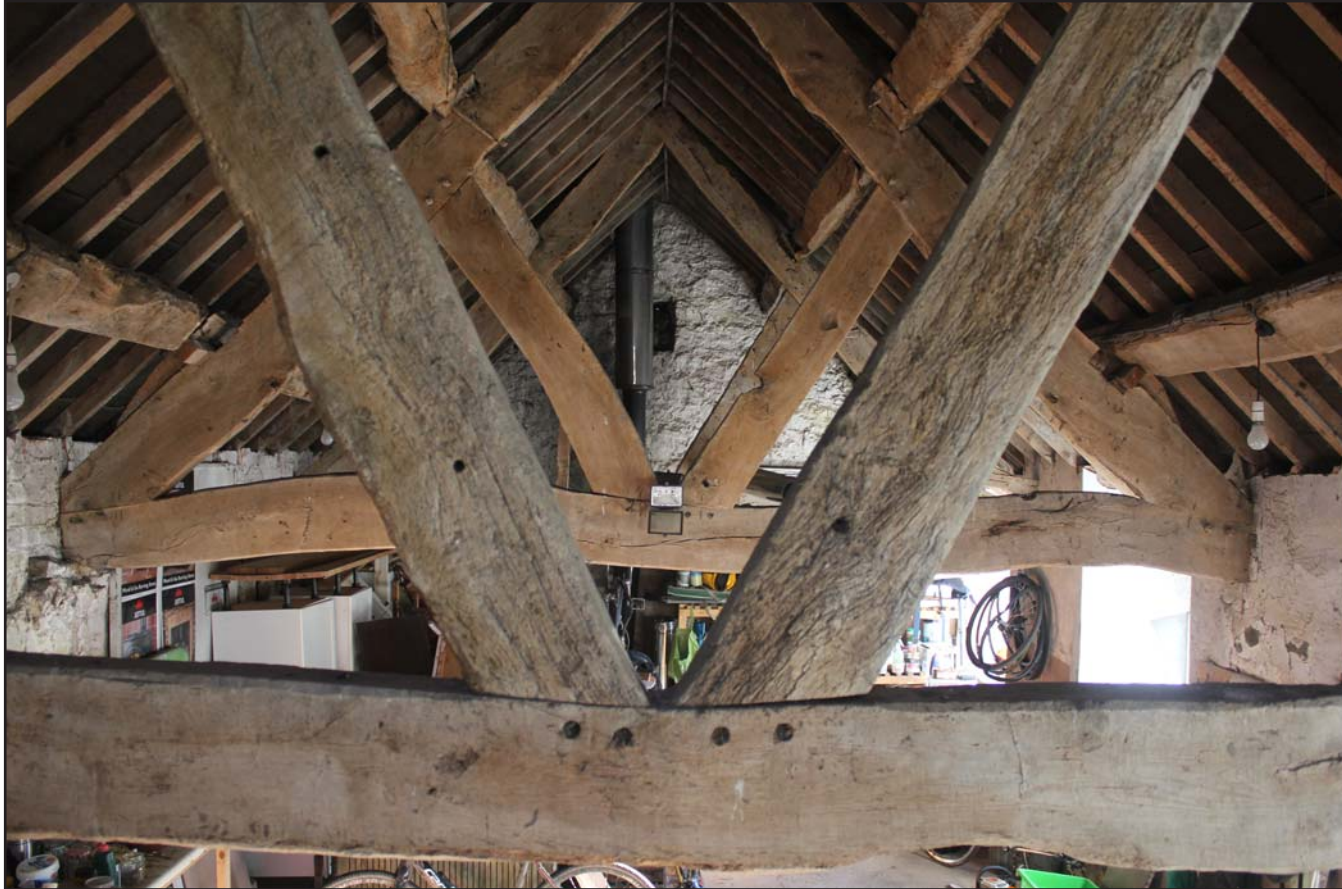
Plate 22: Plas Yn Llan, Cilcain, Flintshire. Internal shot - Queen truss timber frame context shot from above (central) - from the west - no scale

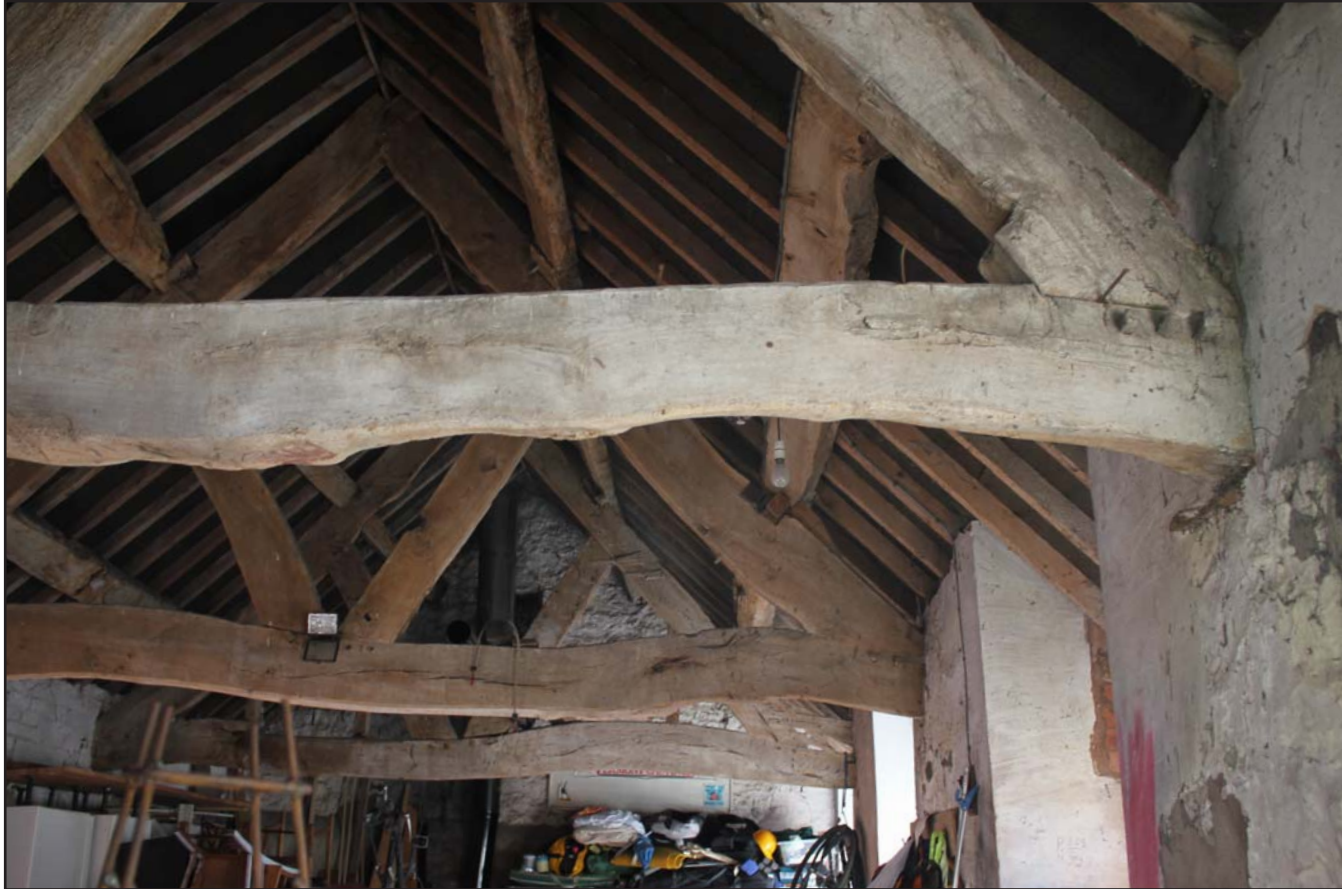
Plate 23: Plas Yn Llan, Cilcain, Flintshire. Internal shot - Queen truss timber frame context shot from below (southern) - from the west - no scale

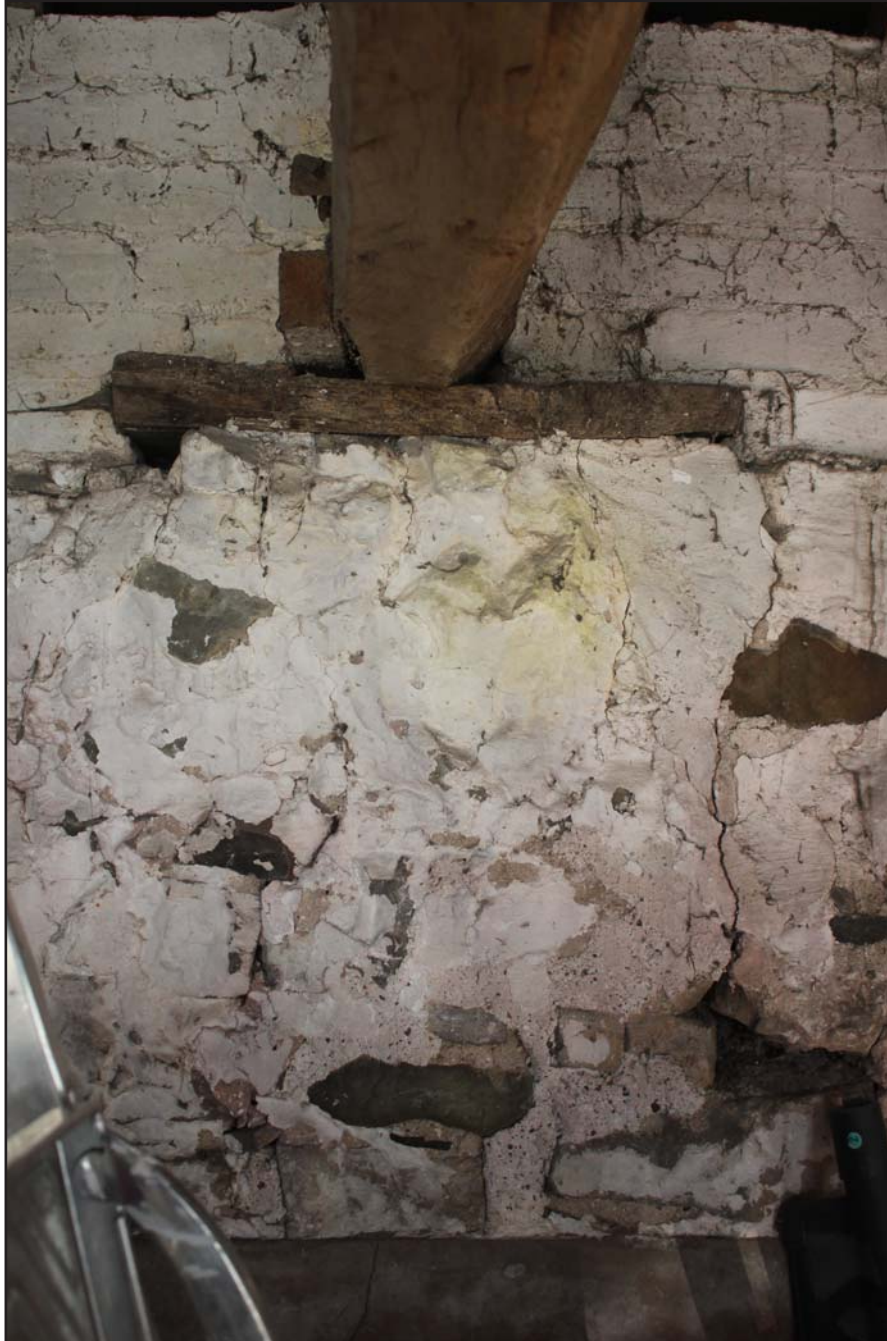
Plate 24: Plas Yn Llan, Cilcain, Flintshire. Internal shot - example of corble table on northern elevation - from the south - no scale

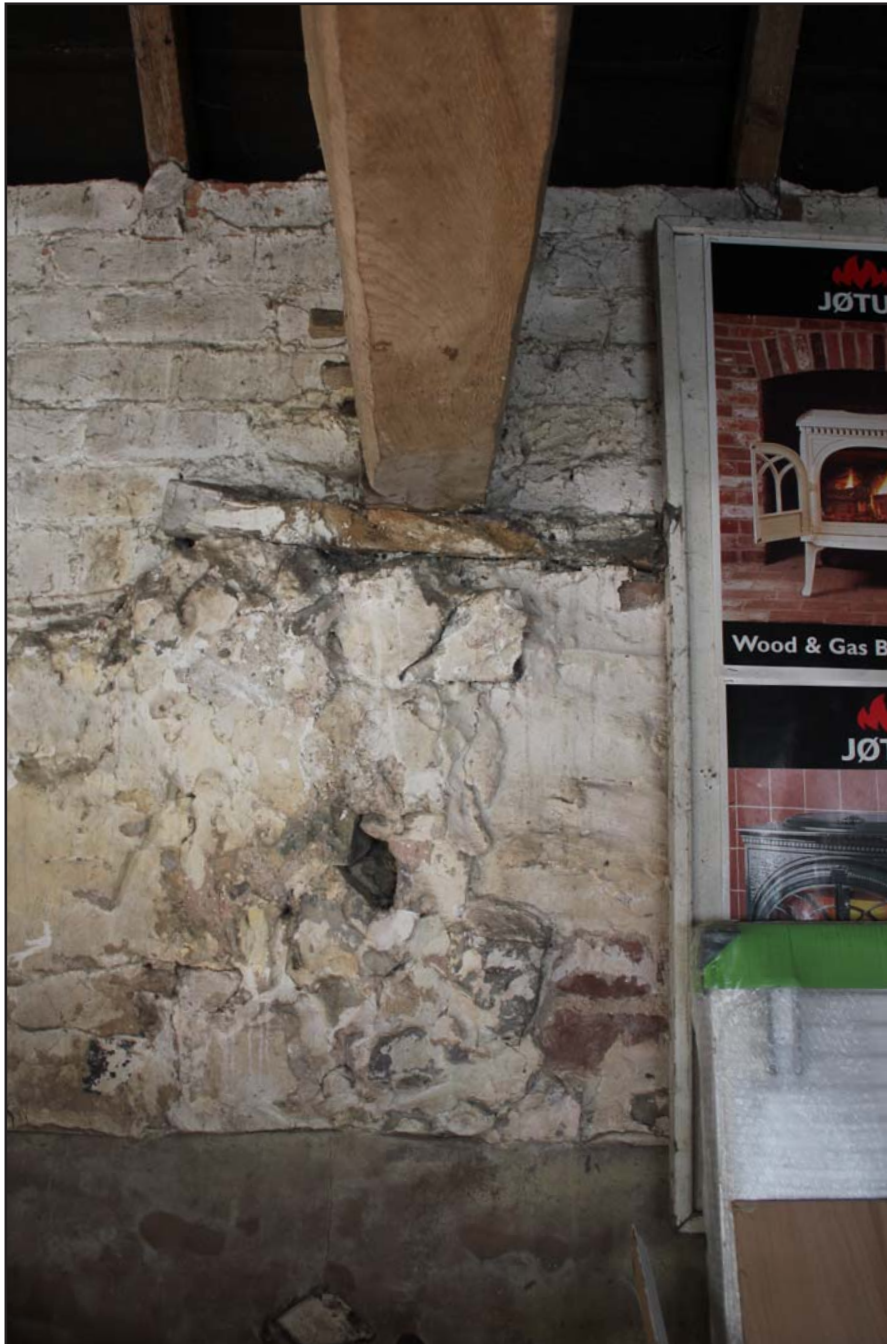
Plate 25: Plas Yn Llan, Cilcain, Flintshire. Internal shot - another example of corble table on northern elevation - from the south - no scale

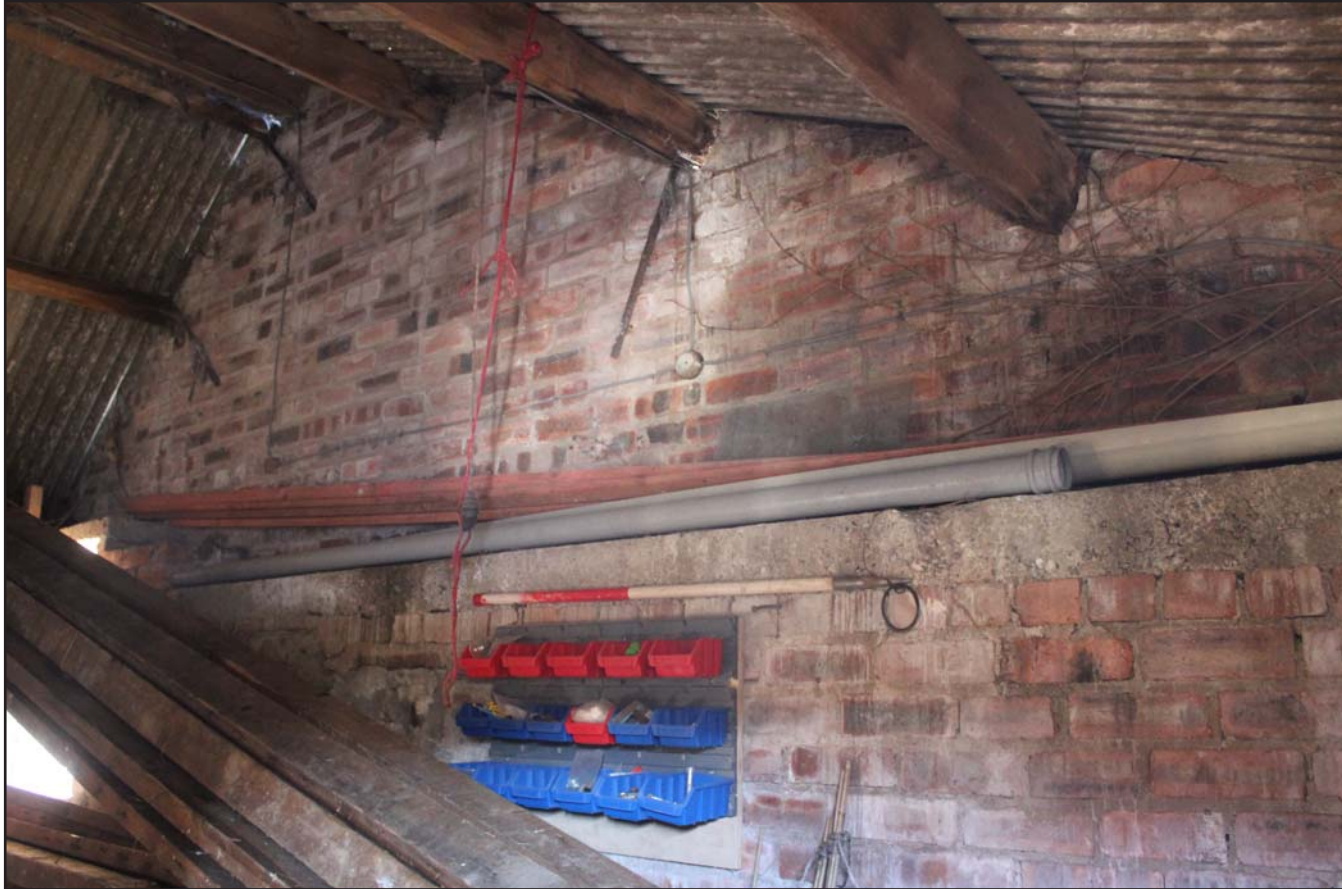
This room is rectangular in plan and orientated north to south. The room is currently a workshop/storage area. This room is also single-storey although lower than the room to the west by approximately 1m at the roof pitch. The ceiling is comprised of six horizontal purlins and central ridge beam, upon these timbers asbestos roof sheets have been fixed. The western elevation is comprised of angular stone rubble bonded by mortar and this appears to have been at least partially rendered in the past although now most of the render is no longer present. The northern elevation is comprised of stone rubble bonded by mortar however a dual course of bricks is present at the joint between ceiling and wall in the eaves. This wall was mostly obscured by a large wooden shelving unit and as such a visible description could not be made. The eastern elevation is almost entirely built from red bricks bonded by mortar, this brickwork steps out into the room at about 1/3 height down from the ceiling by 0.25 m which forms a shelf of sorts which has been capped with concrete. At the far left hand side (northern) of the elevation there is a small window recessed into the brickwork, this window has a metal frame with six glass panes the upper two of which open as a light. Around the window the brickwork is present however visible in this area are the only remnants angular rubble masonry bonded by mortar visible on this elevation; this tapers down rapidly towards the southern elevation. This elevation appears to have been subject to heavy re-modelling in the past.

Plate 27: Plas Yn Llan, Cilcain, Flintshire. Internal shot - eastern and northern elevations of Stores - from the southwest - 1m scale
