CPAT Report No. 1696

4 High Street, Overton

BUILDING SURVEY

Client name: Leslie Cairns
 CPAT Project No: 2420
 Project Name: 4 High Street, Overton
 Grid Reference: SJ 37294192
 County/LPA: Wrexham Borough Council
 Planning Application: OVE P/2019/0532
 CPAT Report No: 1696
 HER Enquiry No: N/A
 Event PRN: 140316
 Report status: Final
 Confidential until: N/A

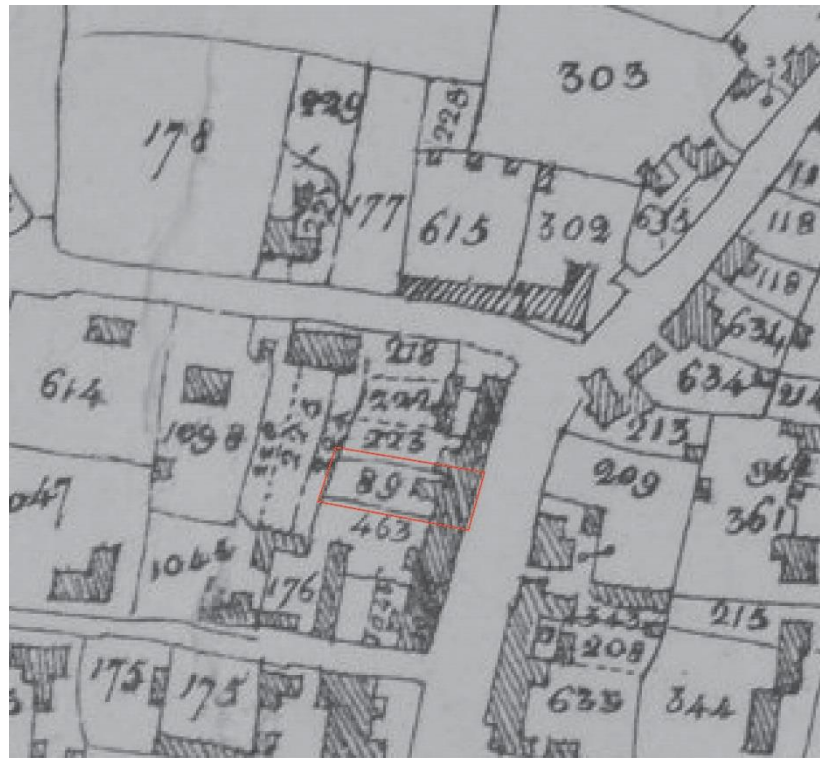
Fig. 2 Extract from the 1838 Tithe map of Overton showing the original plot outlined in red

- 2.11. The 1838 tithe map (figure 2) for the Parish of Overton recorded a similar arrangement to that which can be seen today, with a long terrace of buildings located along the western side of High Street. The building in question occupied a long plot of around 40m in length which is likely to be remnants of the old burgage plots which once ran along High Street. The building was shown with a long range projecting from the rear. The tithe apportionment records the plot (89) as 'two dwelling and gardens'. It was owned by Chapel Trustees of Mary ? Coomer? and was occupied by 'herself and Susannah Hunt'.

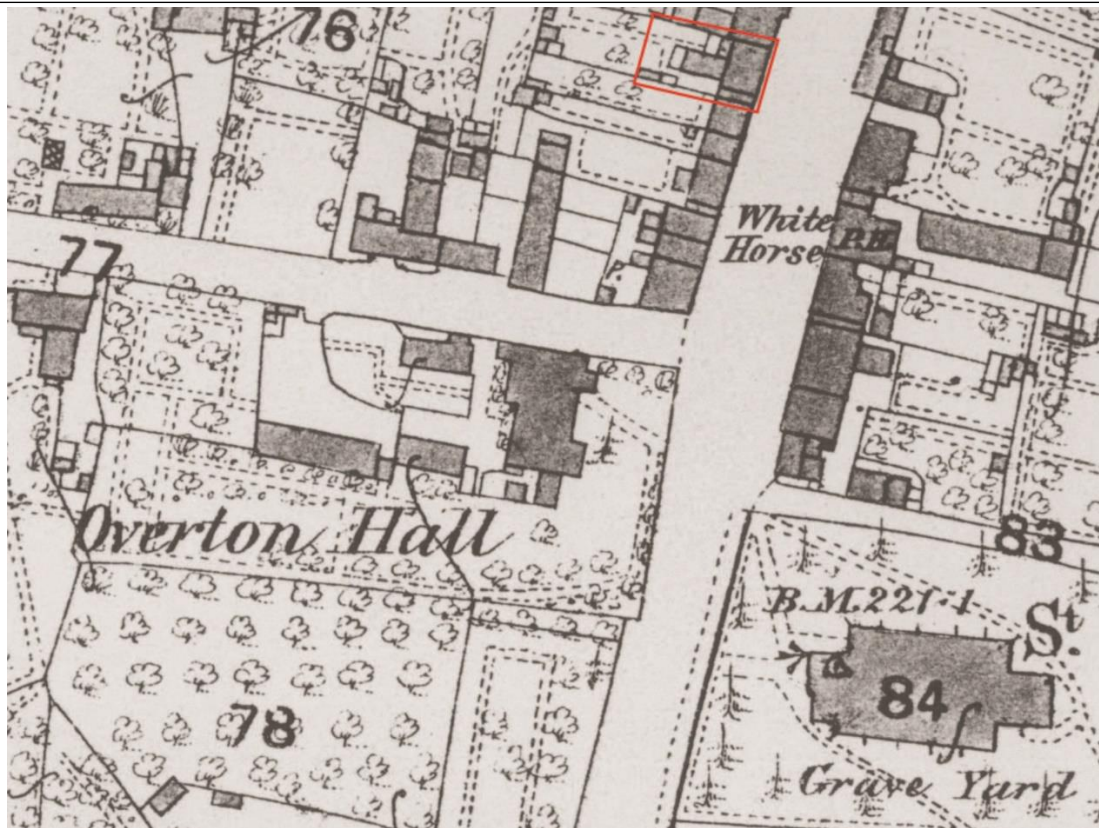
- 2.12. The first edition Ordnance Survey 25" map of 1872 (figure 3) showed the buildings in slightly more detail, defining the two gardens for each and also showing a smaller building projecting from the rear, to the north of the longer range defined on the tithe map. An assortment of smaller buildings (probably privies and stores) were shown at the bottom of the gardens.

Fig. 3 Extract from the 1872 Ordnance Survey map of Overton showing the Development plot outlined in red

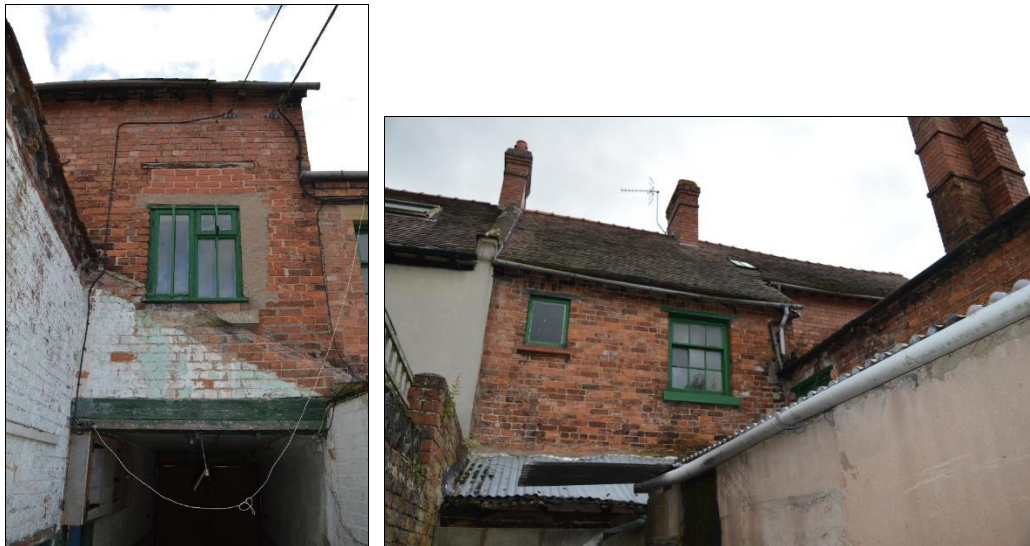
Fig. 4 View of the rear elevations showing the step in the walling and infill window (left). CPAT images 4701-0007 and 4701-0015

- 3.8. A step in the rear elevation is thought to define the extent of the two original houses although much of the rear elevation was obscured by the later rear brick range (figure 4).
- 3.9. Of the original rear elevation, a wooden framed casement window could be seen to the first floor above the passageway (figure 4 left). The window partially infilled an earlier opening, with a red brick infill above and the remnants of a wooden lintel. A sandstone sill could also be seen directly below the existing window as well as the shadow of a former lean-to roof (presumably to cover the passageway).
- 3.10. Above the window, the entire rear wall of the southern side of the building had been heightened.
- 3.11. To the northern side of the rear elevation there were two small casement windows to the first floor with on edge heads and sloping red ceramic tiled sills (figure 4 right).

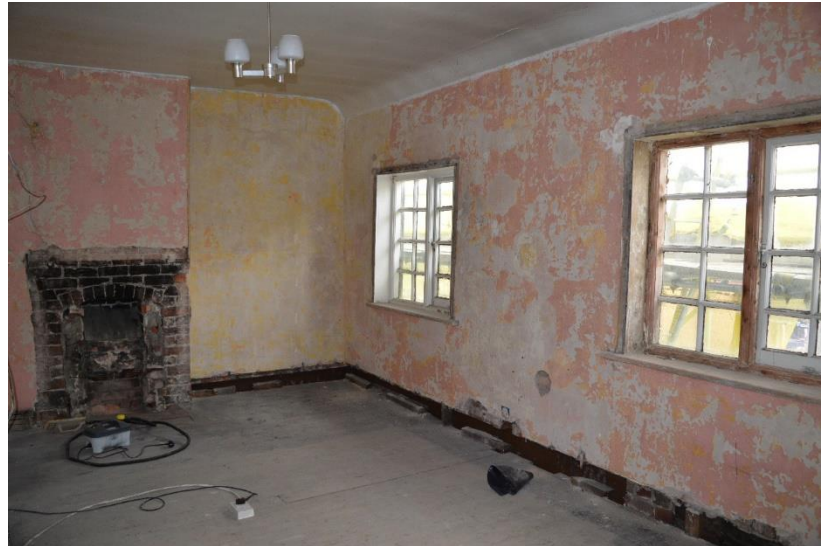
- 3.14. The first floor was divided into five rooms, all with wooden floor boards. The partitions were primarily modern lath and plaster, although one original brick dividing wall survived, which was aligned east-west and contained two open fire places. This wall is likely to mark the original first floor division between the two houses.

*Fig. 5 First floor, northern room located at the front of the building and containing a brick fireplace.
CPAT image 4701-0029*

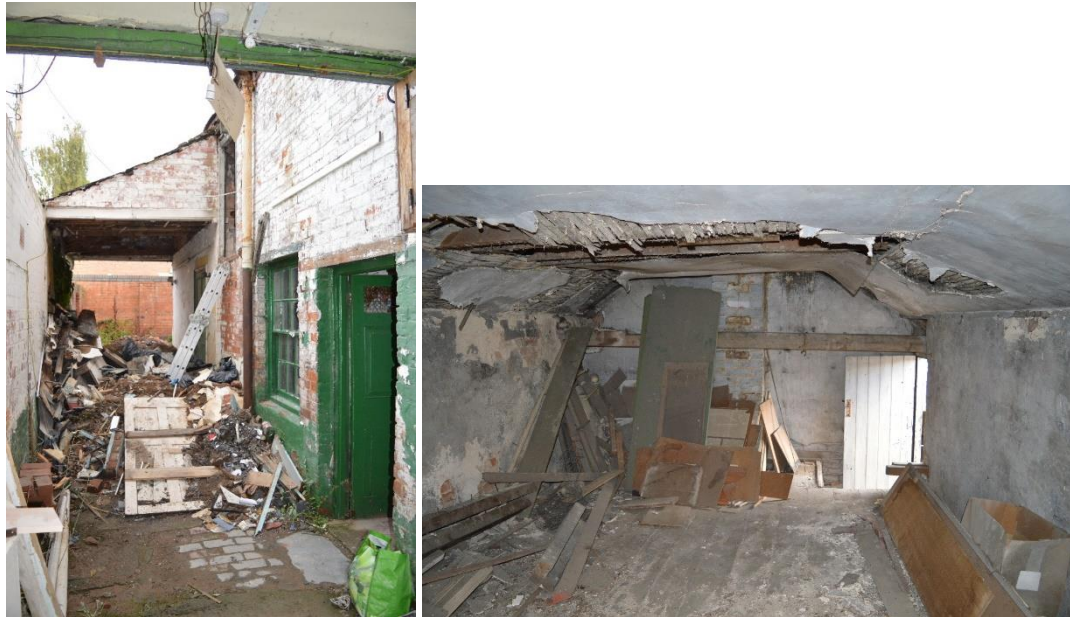
- 3.17. Architects plans show that a doorway through the first floor of the southern house provided access into the eastern side of the extension's loft via a set of two steps which led up into a small kitchen and toilet. This part of the building was not accessed at the time of survey owing to a new breeze block partition having been erected.

- 3.18. The remaining loft space of the additional brick range was accessed via a suspended doorway within the southern elevation, with a strengthening arch below. This was accessed via a ladder (see figure 6). Internally, the floor was boarded and all elevations had been plastered and painted. The remains of the brick chimney breast could be seen at its eastern end (figure 6 right). Externally the chimney stack had seen several additions to its height.

Fig. 6 Western extension showing ladder access (left) into the loft space (right). CPAT images 4701-0009 and 4701-0034

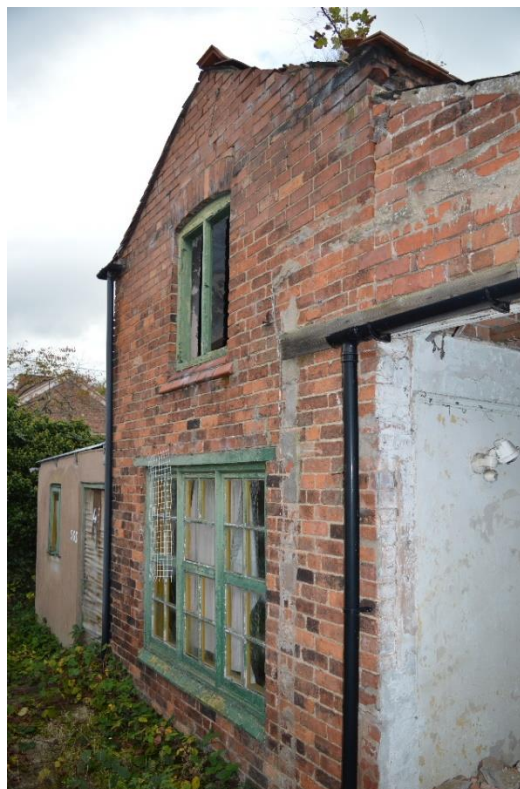
- 3.19. This brick range was then further extended to the west at a later time, the western gable having been constructed from (possibly re-used) handmade red bricks measuring (see figure 7). The gable of this building contained a large wooden framed window to the ground floor with an on edge brick head above and a smaller wooden framed window to the loft with a segmental arch above. The window sills were of angled terracotta tiles.

Fig. 7 Western gable of brick extension. CPAT image 4701-0011

- 3.20. At a later date, the upper part of the gable was rebuilt or repaired in machine-made red brick.
- 3.21. The early Ordnance Survey maps show that a smaller range also projected from the rear of the northern house and remnants of brick walling could be seen internally, although the majority of this structure had been rebuilt in breeze blocks.
- 3.22. At some time, probably in the 20th century, the original shallow pitched roof (certainly to the southern side of the building) was raised by around one meter to align with the roof height of the terraced cottages to the north. At this time, the western elevation of the southern house was also extended upwards in a red brick, as well as the southern gable end (see figure 8).

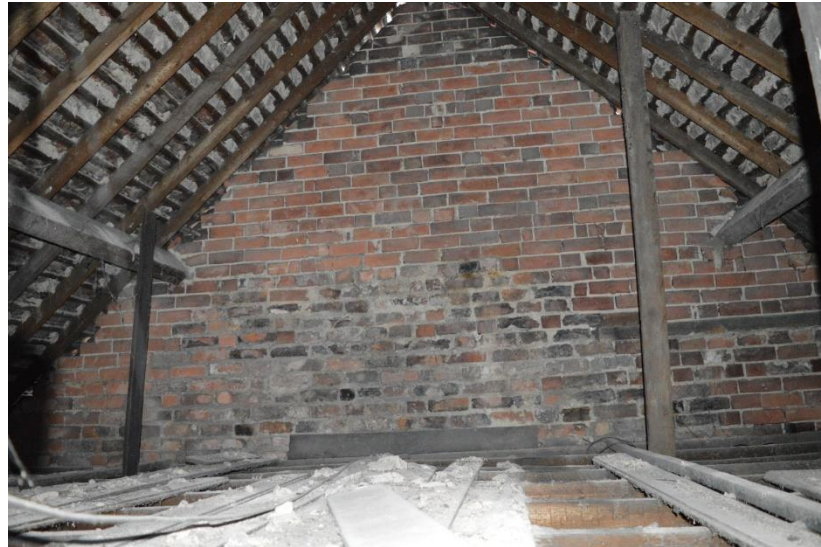
Fig. 8 Internal view of southern gable, showing the original roof line. CPAT image 4701-0042

- 3.23. This raising of the roof probably took place at the same time as the reconfiguration of the front of the building in mock timber framing and during which time it seems likely the building was converted to accommodate the Post Office.
- 3.24. Finally, a series of 20th-century single-storey breeze block structures with a mixture of quarry tiled and concrete floors were erected to the rear of the building alongside the earlier brick extension. These were accessed through the rear elevation of the Post Office. Three additional structures were erected in total, all of which were inter-connected and an additional doorway was inserted within the northern elevation of the brick extension, allowing access between it and the breeze block structures.

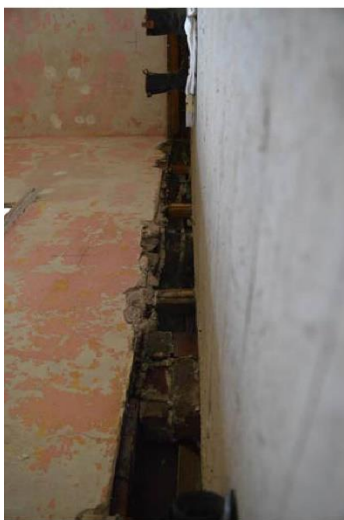
4701-0031.JPG

4701-0031	N	Internal - first floor	08/10/2019
4701-0032	N	Internal - first floor	08/10/2019
4701-0033	E	Internal - view from Post Office floor into rear brick extension	08/10/2019
4701-0034	W	Internal - view of loft in rear brick extension	08/10/2019
4701-0035	E	Internal - view of loft in rear brick extension	08/10/2019
4701-0036	NE	External - rear elevation/brick extension	08/10/2019
4701-0037	NE	External - rear elevation/brick extension	08/10/2019
4701-0038	NE	External - rear elevation	08/10/2019
4701-0039	NE	External - general view of 4 High Street, Overton	08/10/2019
4701-0040	NE	Internal - view of Post Office	08/10/2019
4701-0041	N	Internal - view of roof extension (southern gable)	08/10/2019
4701-0042	N	Internal - view of roof extension (southern gable)	08/10/2019
4701-0043	S	Internal - view of roof extension (dividing wall)	08/10/2019
4701-0044	S	Internal - view of roof extension (dividing wall)	08/10/2019
