# Manorbier Castle, Manorbier, Pembrokeshire Watching Brief

November 2015

# Manorbier Castle Manorbier, Pembrokeshire Watching Brief

Trysor Project No. 2015/446

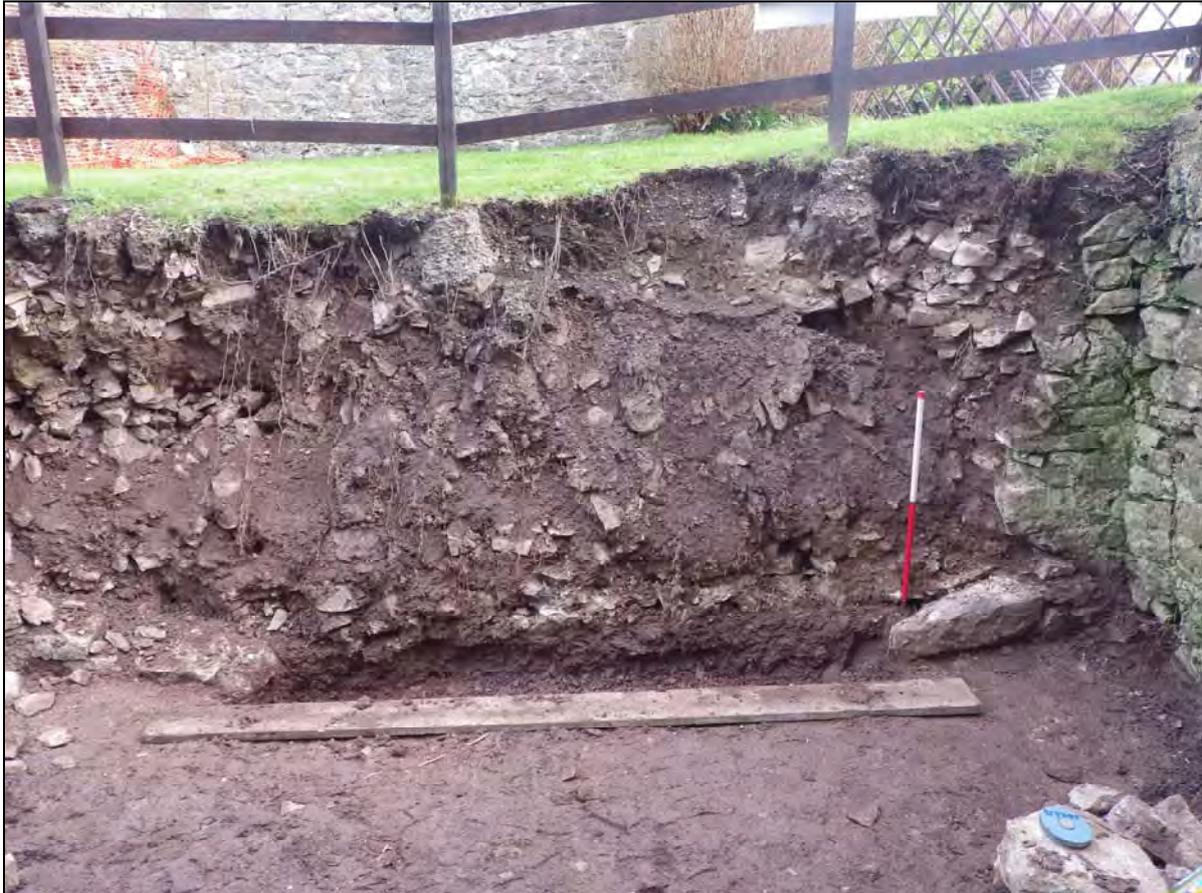
*Cover photograph: Collapsed revetment removed and foundation trench hand dug, looking northeast.*

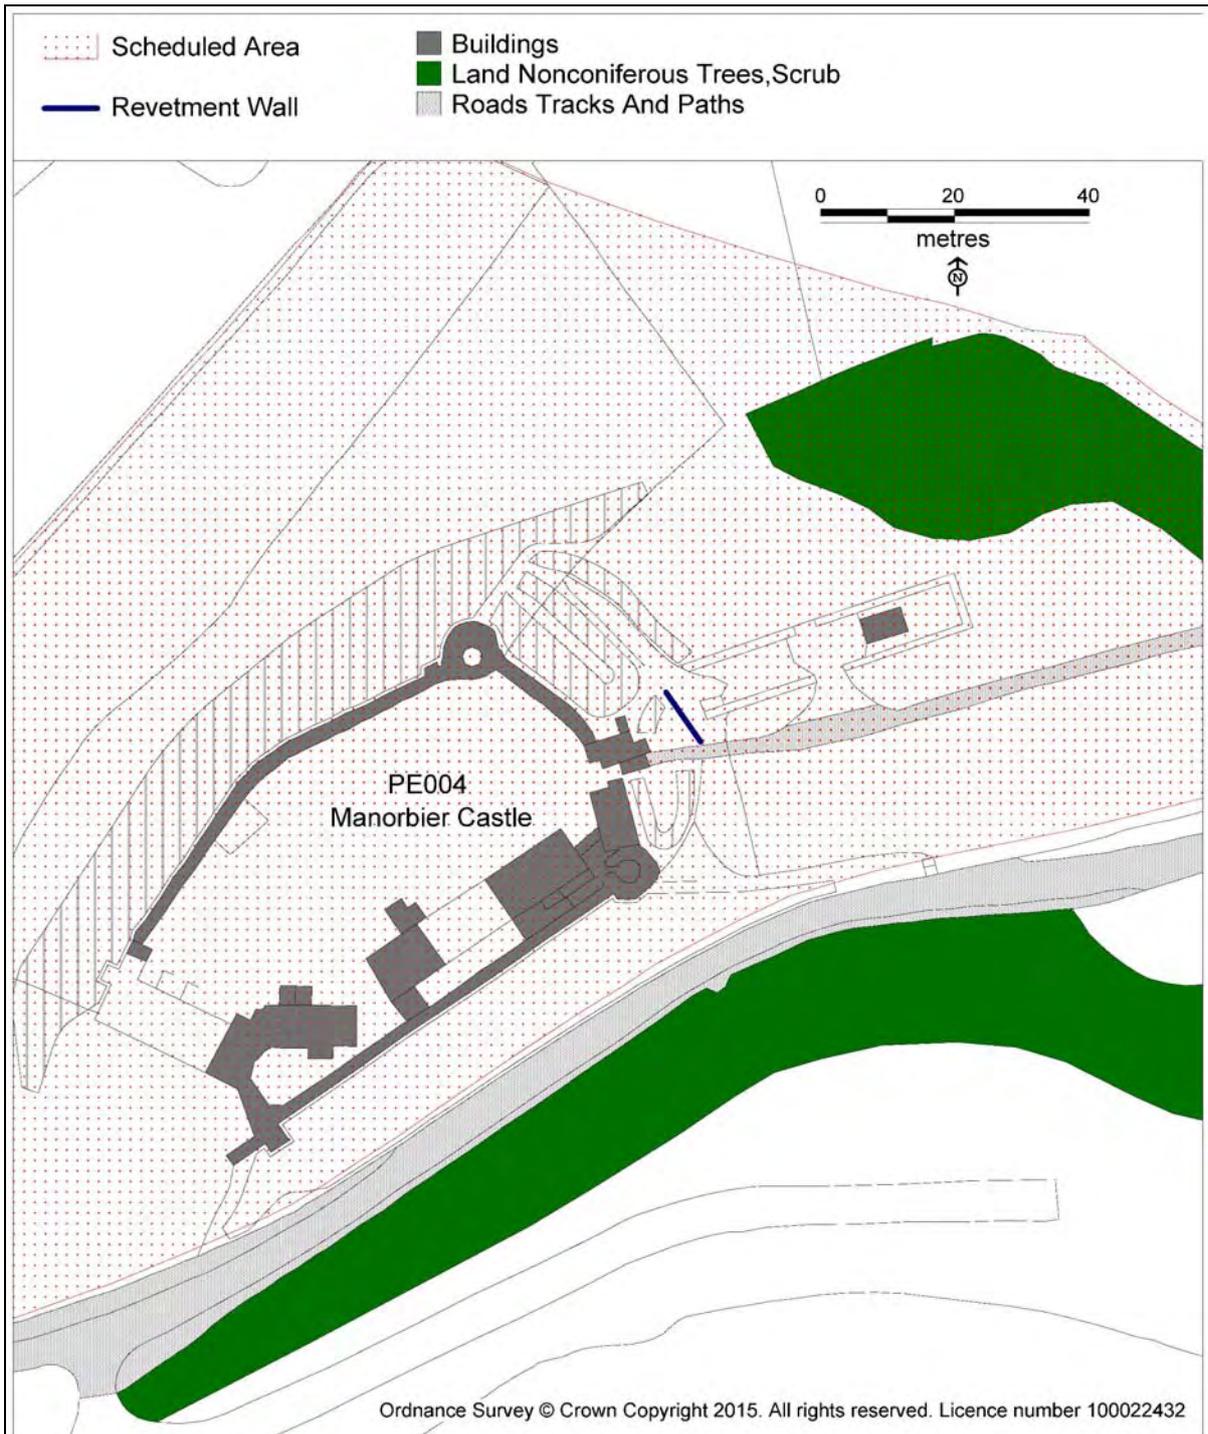
Figure 2: The location of the collapsed revetment wall

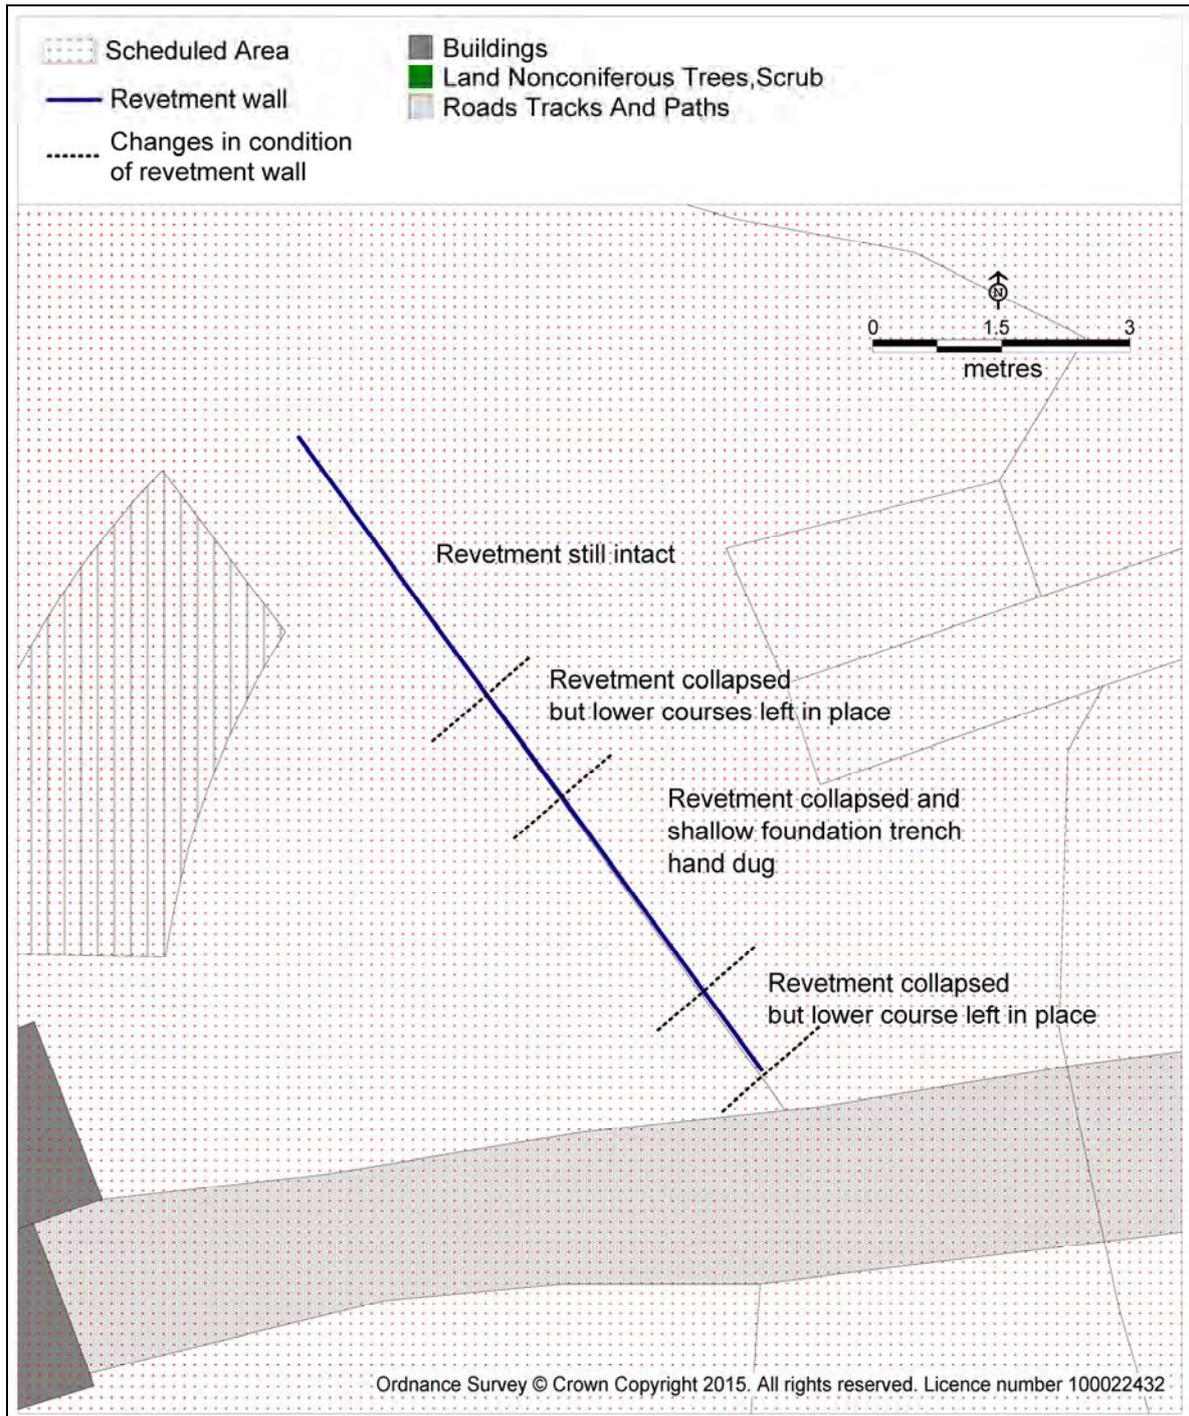
Figure 3: The detail of the collapsed revetment wall

6.2 The foundation trench was 2.75 metres long and 0.30 metres deep. At either end of the trench the lowest course(s) of the revetment wall was still sound and left in place, although the collapse above was removed and to be replaced. This additional area of collapse extended 1.40 metres to the north and 1.1 metres to the south of the foundation trench.

| Context Number | Depth | Description | Interpretation |
|---|---|--|---|
| 002 | Variable | Remains of stone revetment facing, at ground level in section where wall had collapsed. The revetment was on the eastern side of the ditch outside the eastern end of the castle. The revetment stands up to 1.8 metres high and is at least 0.70 metres deep, but the full width was not exposed. It has unmortared, roughly coursed stone facing with stone rubble fill behind it. | Revetment of ditch |

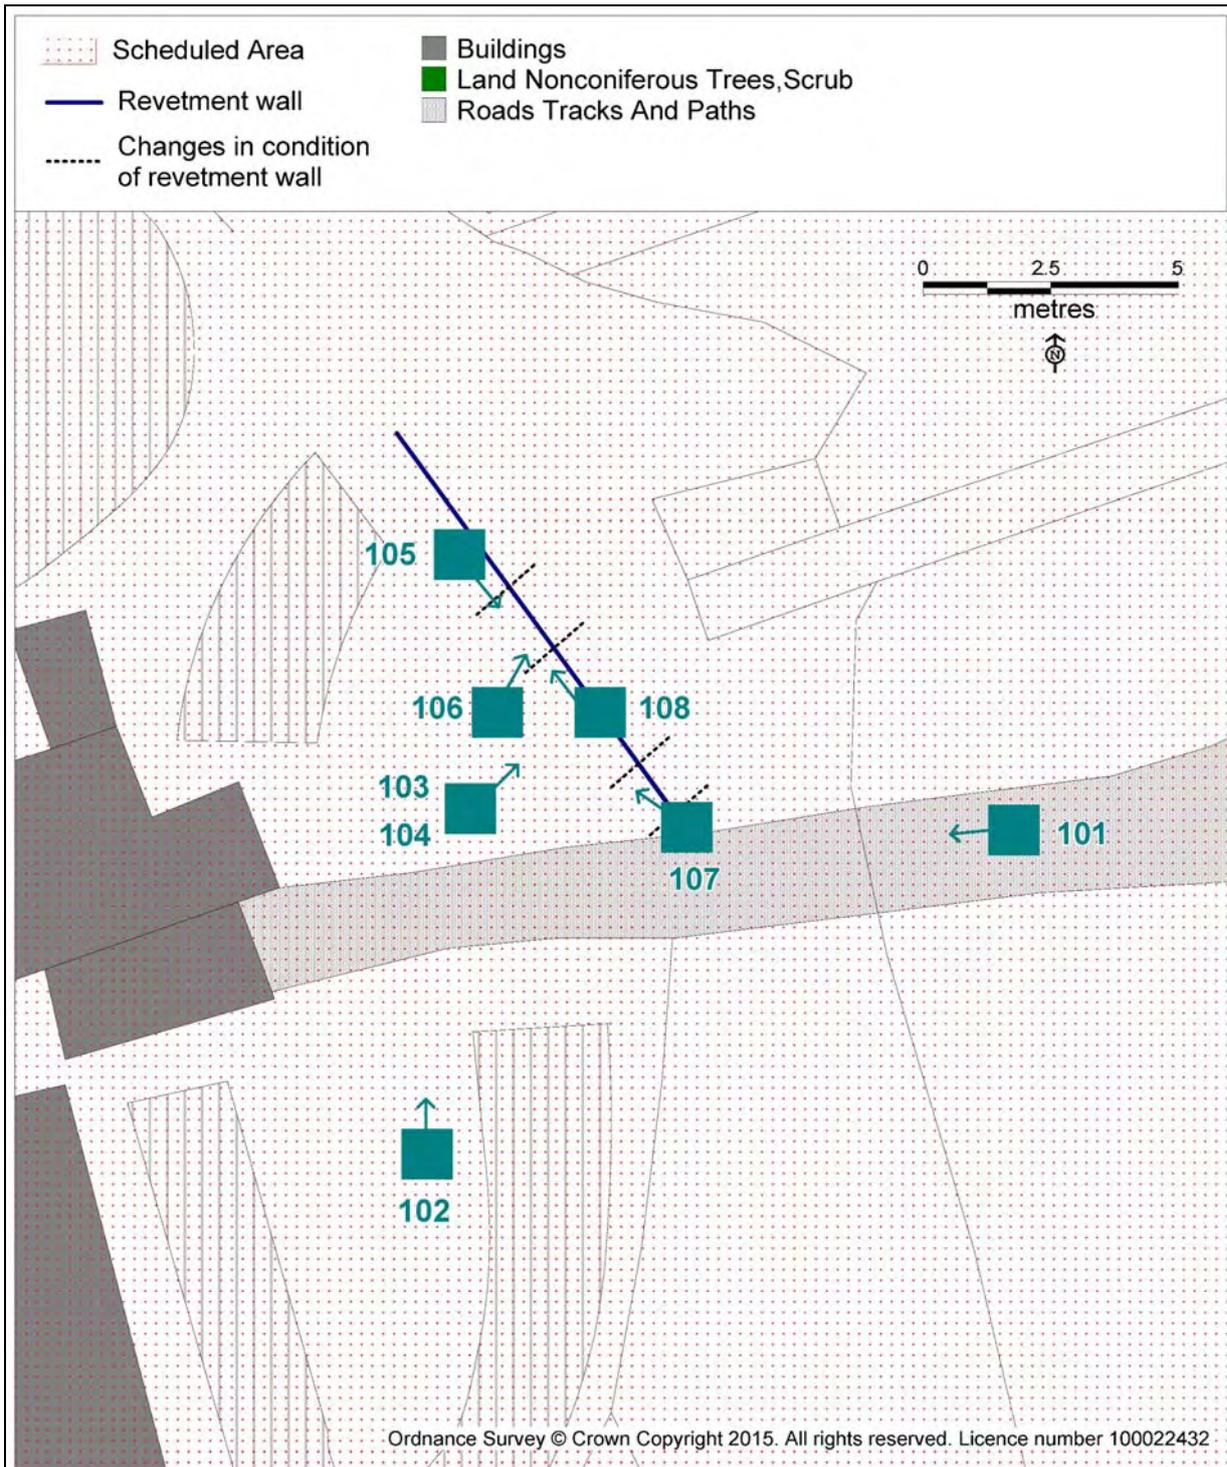
Figure 4: Location of photographs

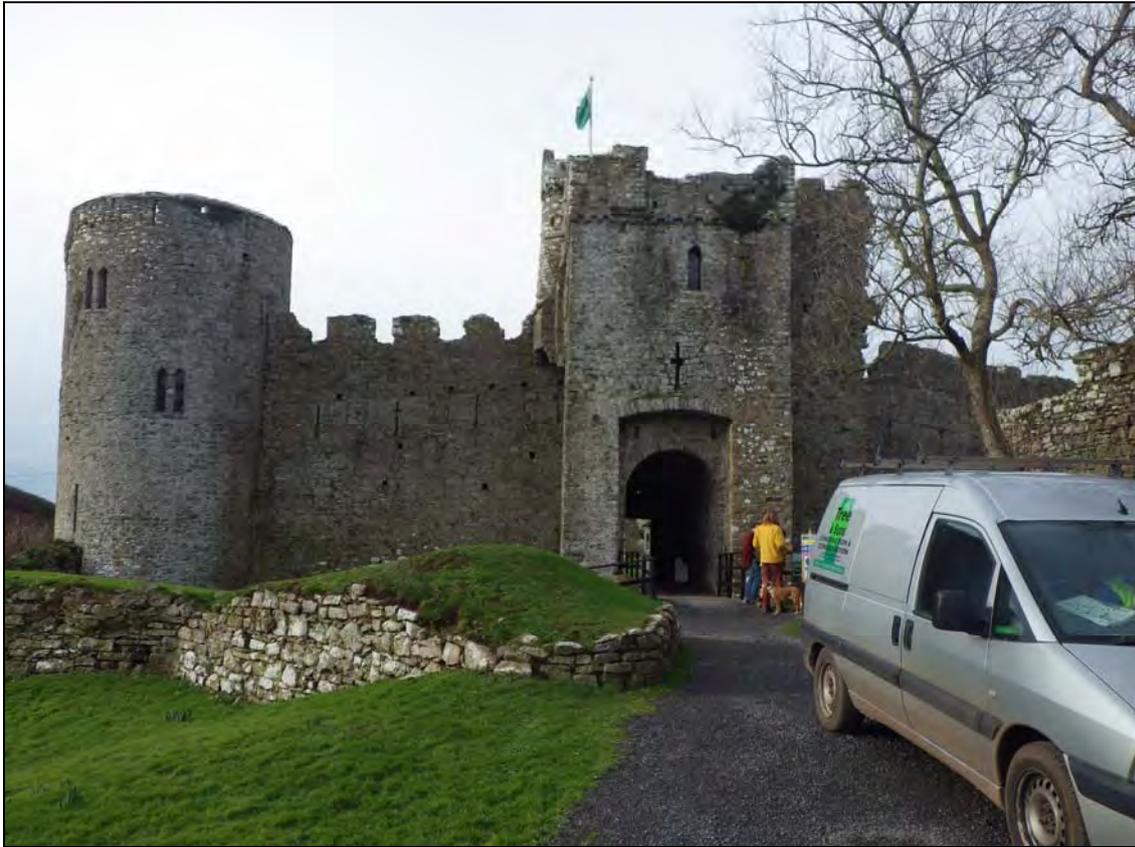
*Plate 1: MBC2015\_101, Looking west towards the gatehouse. The revetment wall lay in the ditch to the north side of the footbridge that crossed the ditch into the castle.*

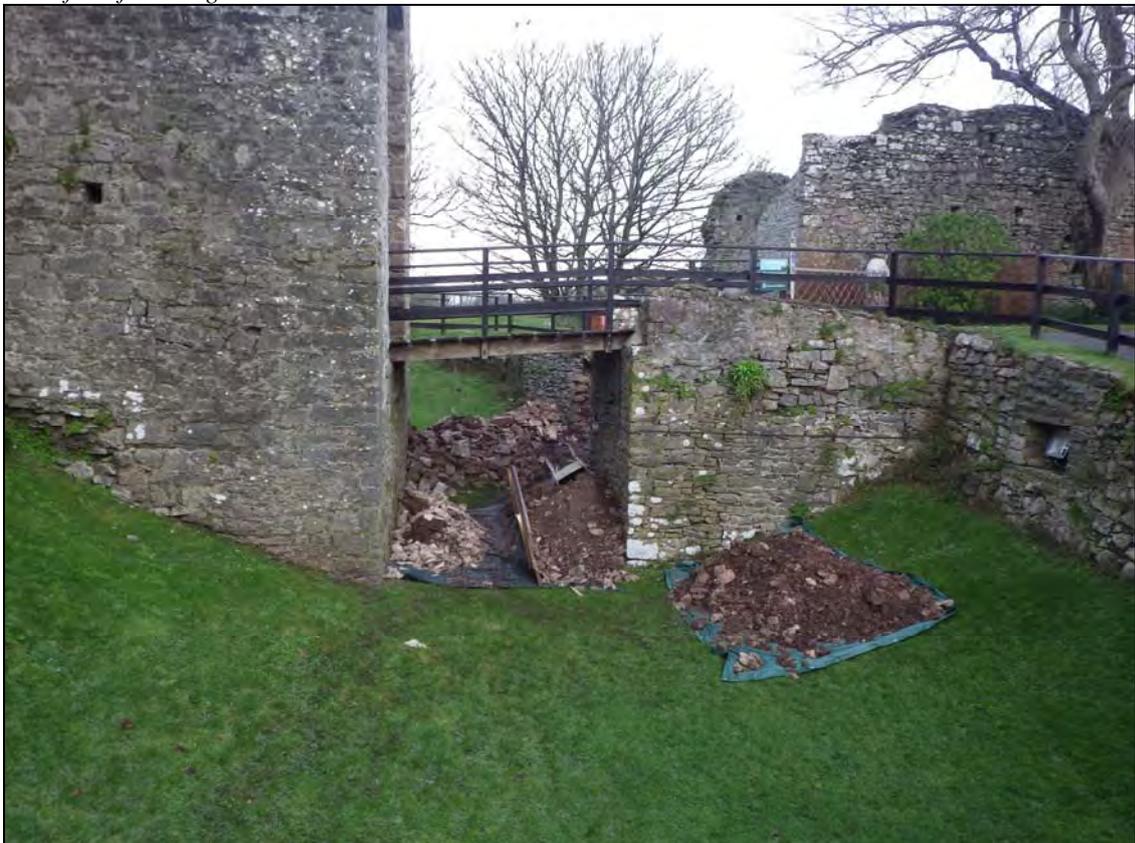
*Plate 2: MBC2015\_102, looking north in the ditch to the east of the castle, south of the footbridge crossing into the gatehouse. Collapsed revetment wall to the north of the footbridge.*

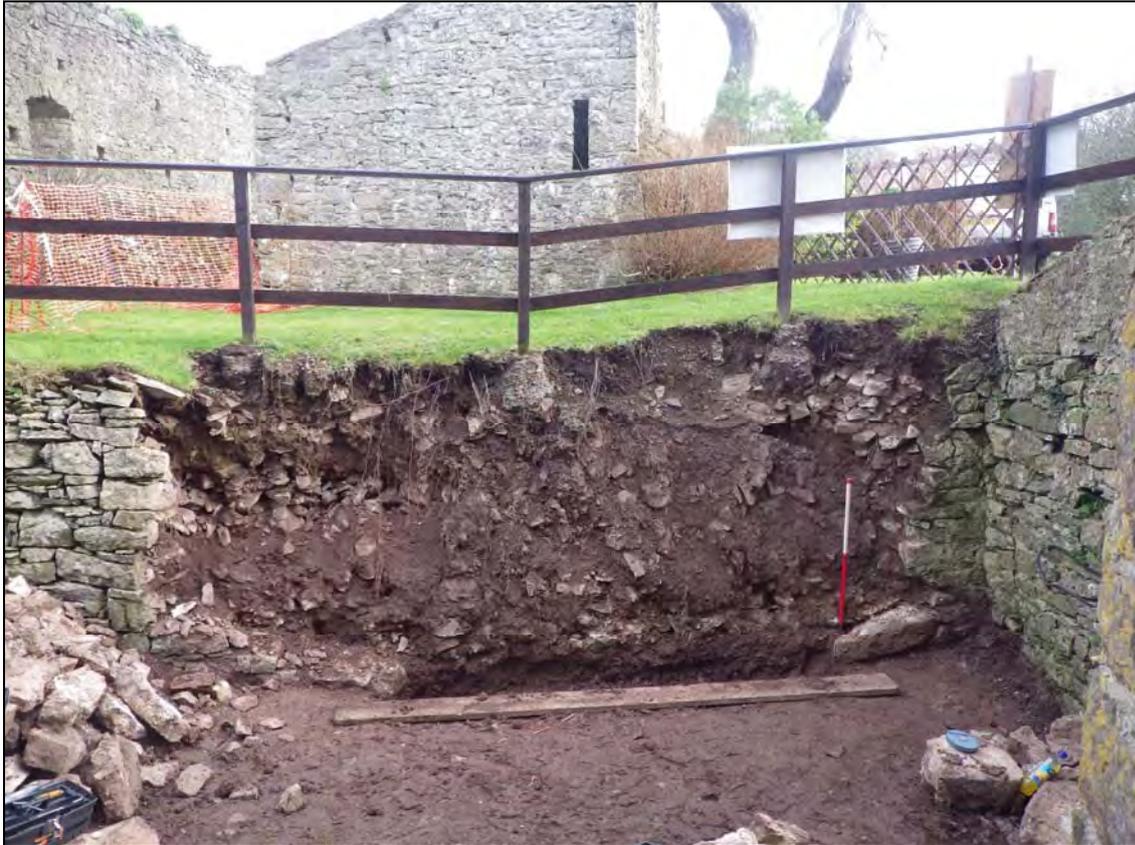
*Plate 3: MBC2015\_103, the area of collapsed revetment after cleaning and foundation trench excavated, looking northeast.*

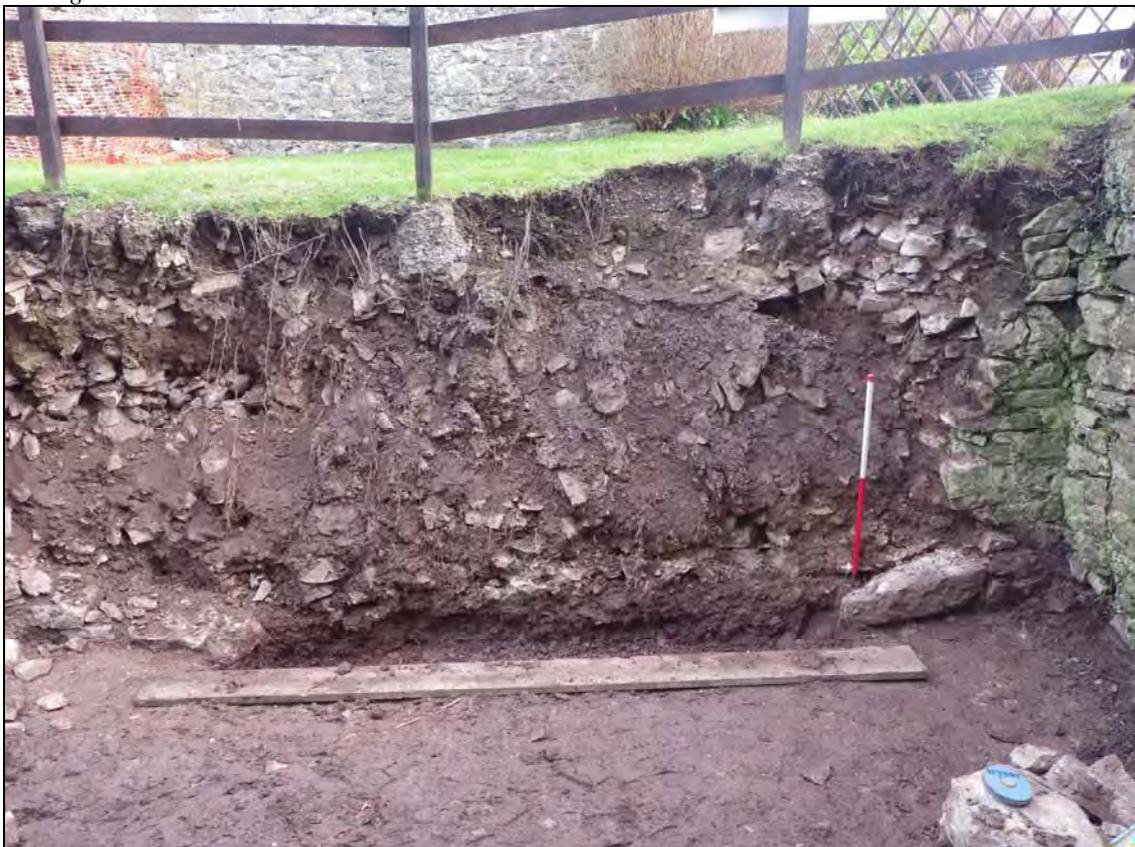
*Plate 4: MBC2015\_104, the section of collapsed revetment after cleaning and foundation trench excavated, looking northeast.*

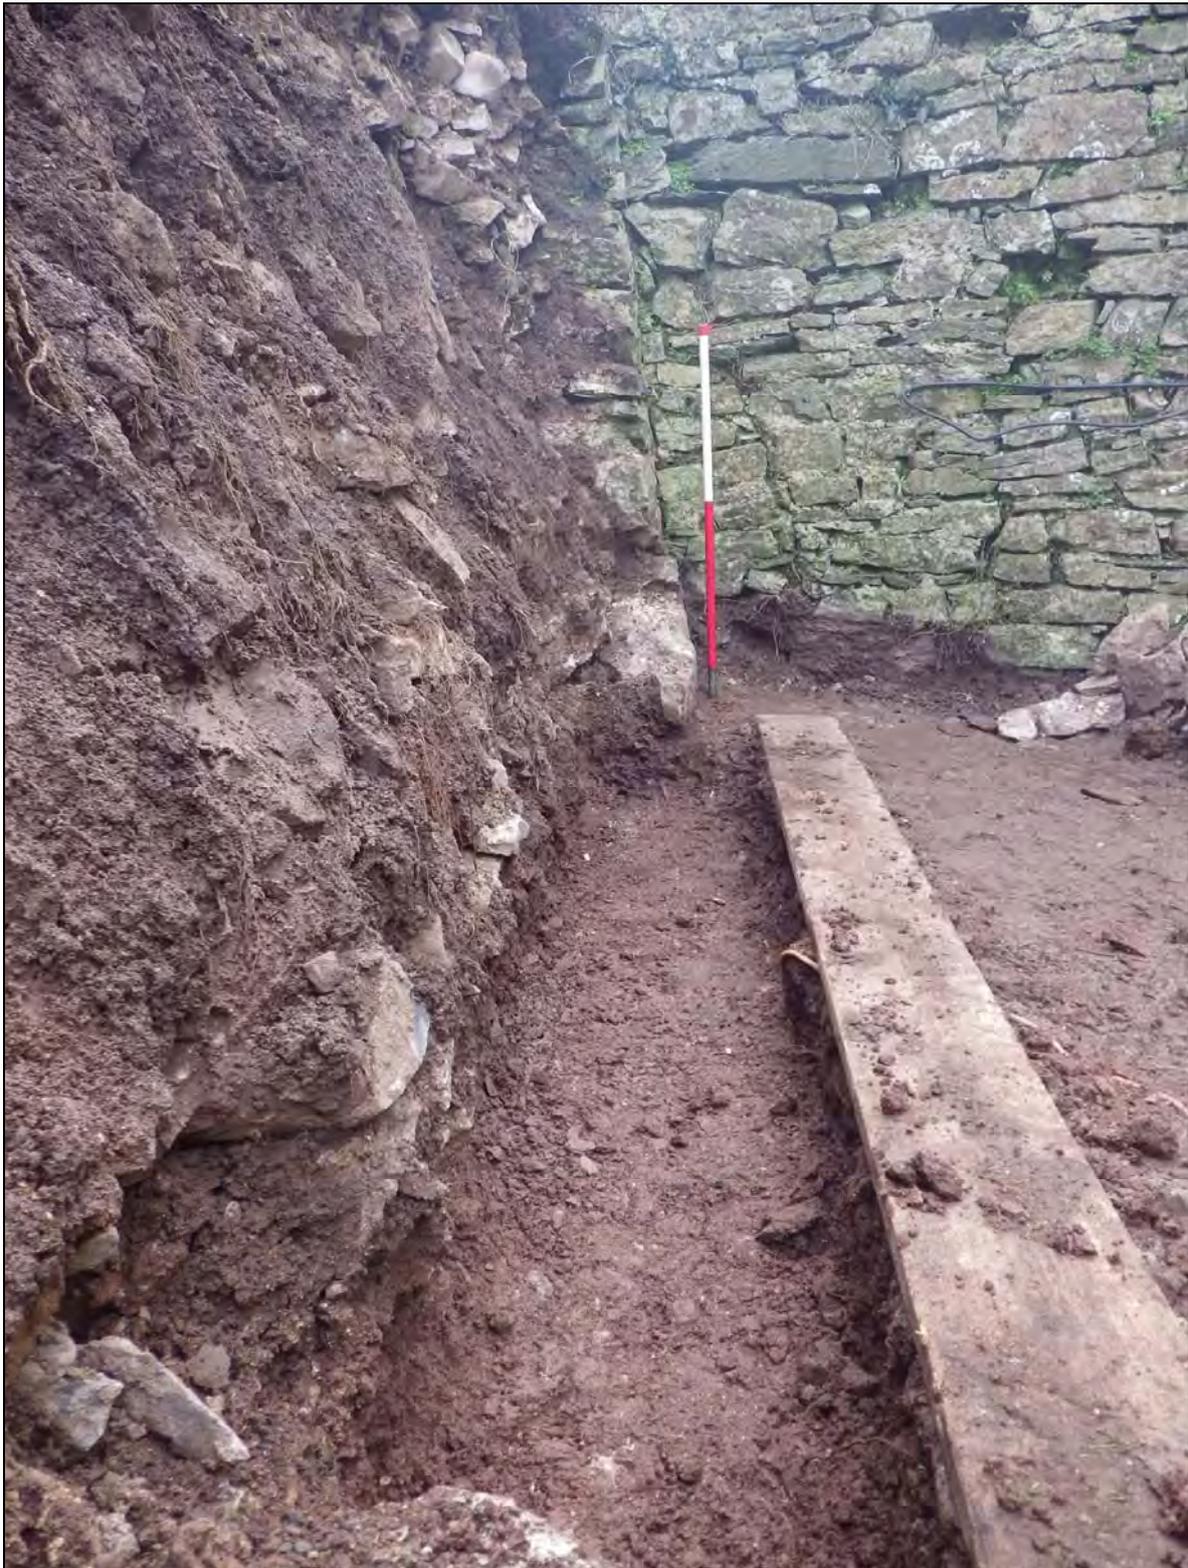
*Plate 5: MBC2015\_105, the collapsed revetment after cleaning and foundation trench excavated, looking southeast.*

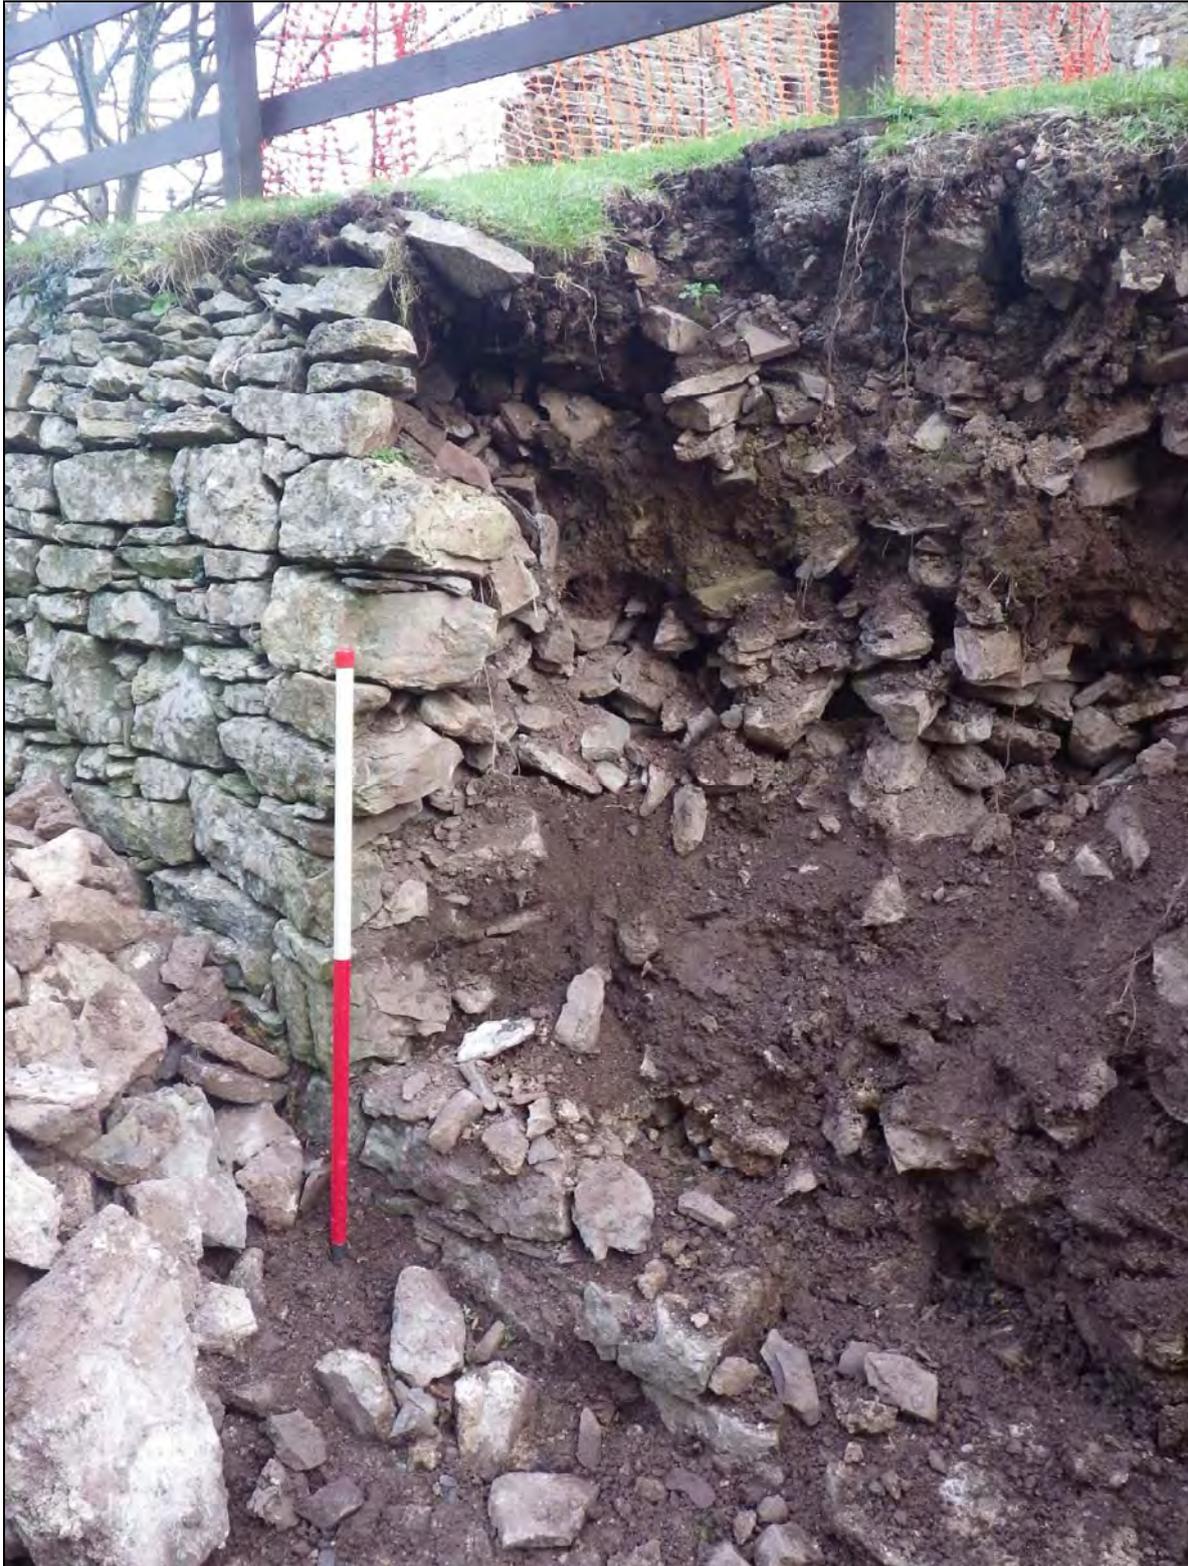
*Plate 6: MBC2015\_106, the northwestern end of the collapsed section of revetment wall, looking north northeast.*

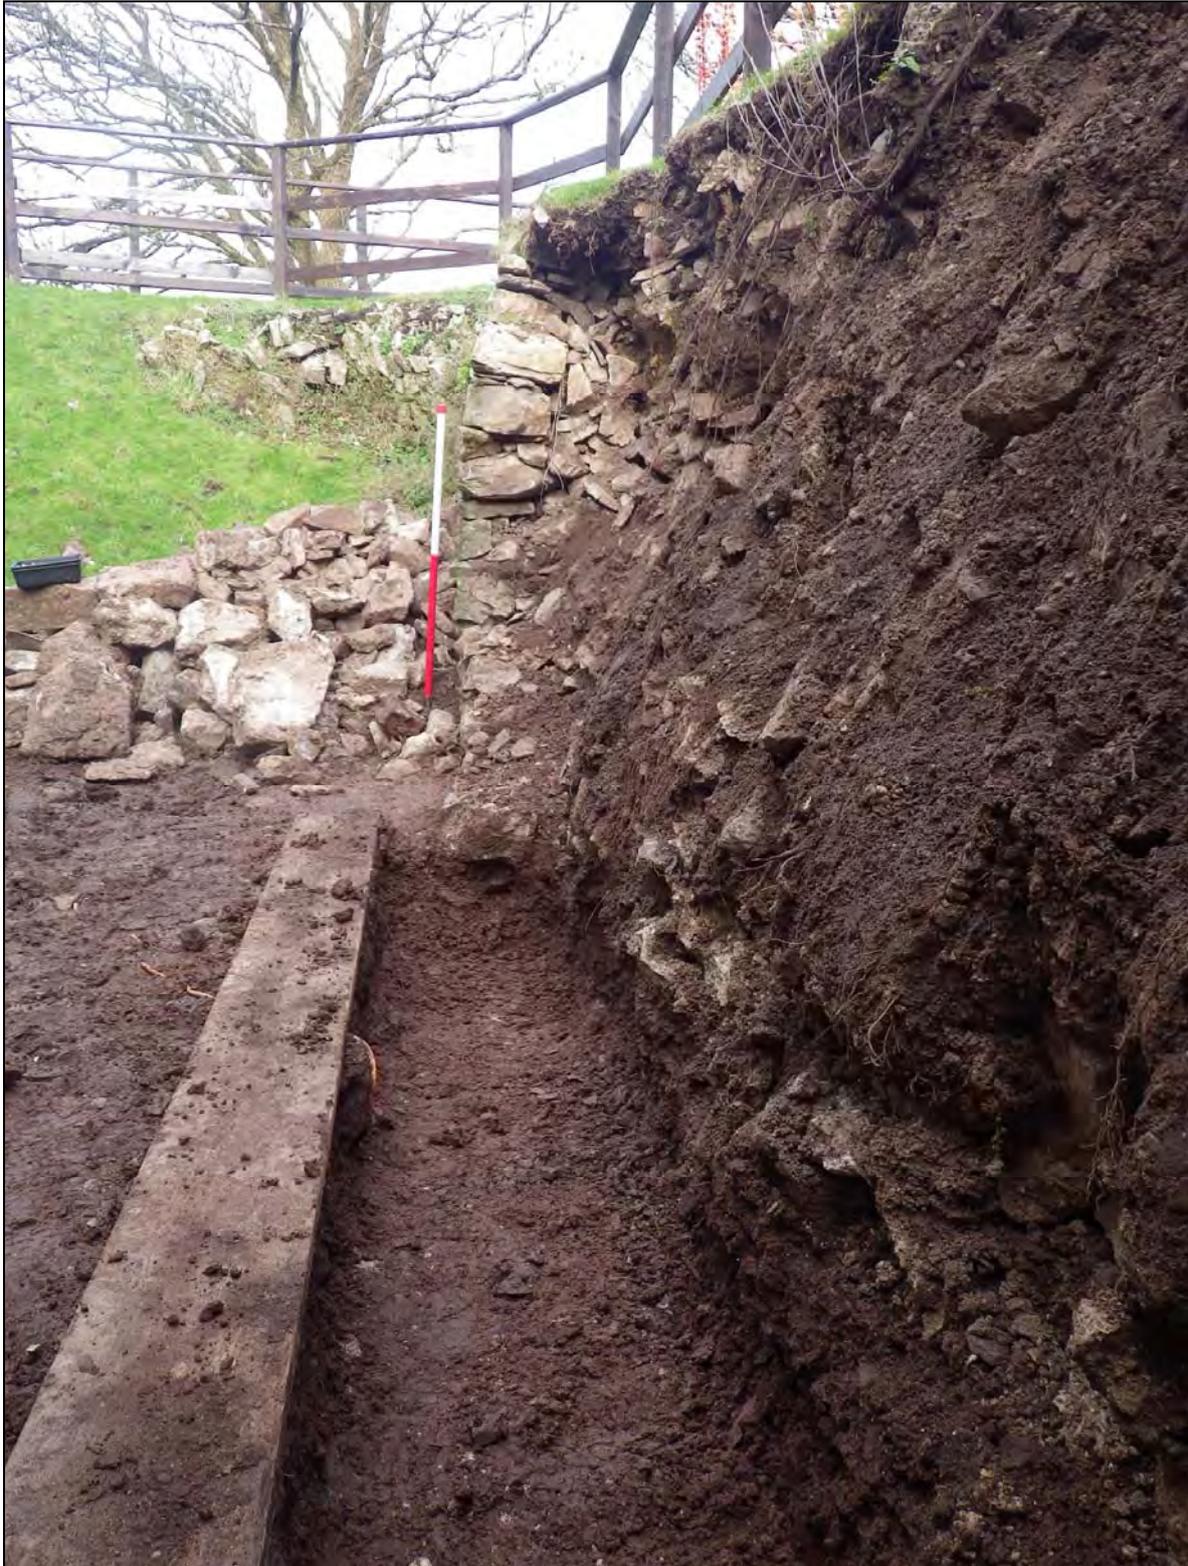
*Plate 7: MBC2015\_107, the collapsed revetment after cleaning and foundation trench excavated, looking northwest.*

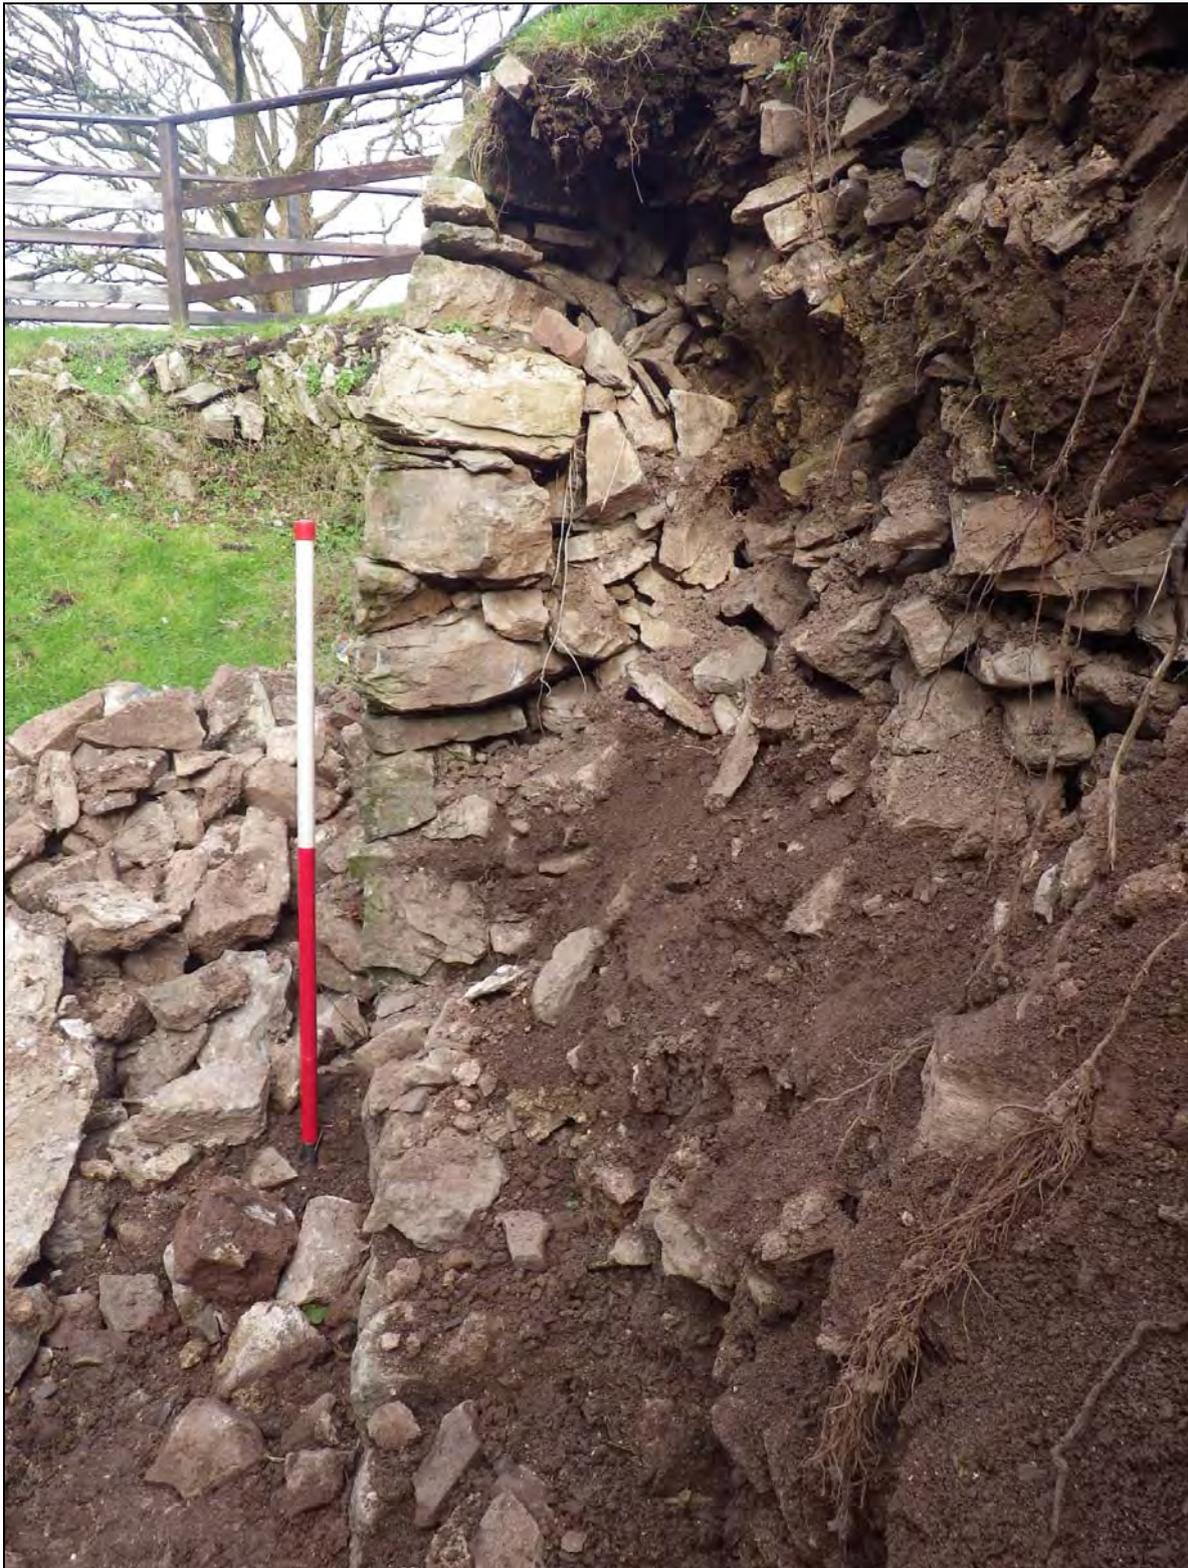
*Plate 8: MBC2015\_108, the northwestern part of the collapsed section of revetment after cleaning. This section did not need a new foundation trench as the lower part of the revetment was still in situ, looking northwest.*
