CPAT Report No. 1671

# Downton Cottage, New Radnor, Powys

Photographic Survey

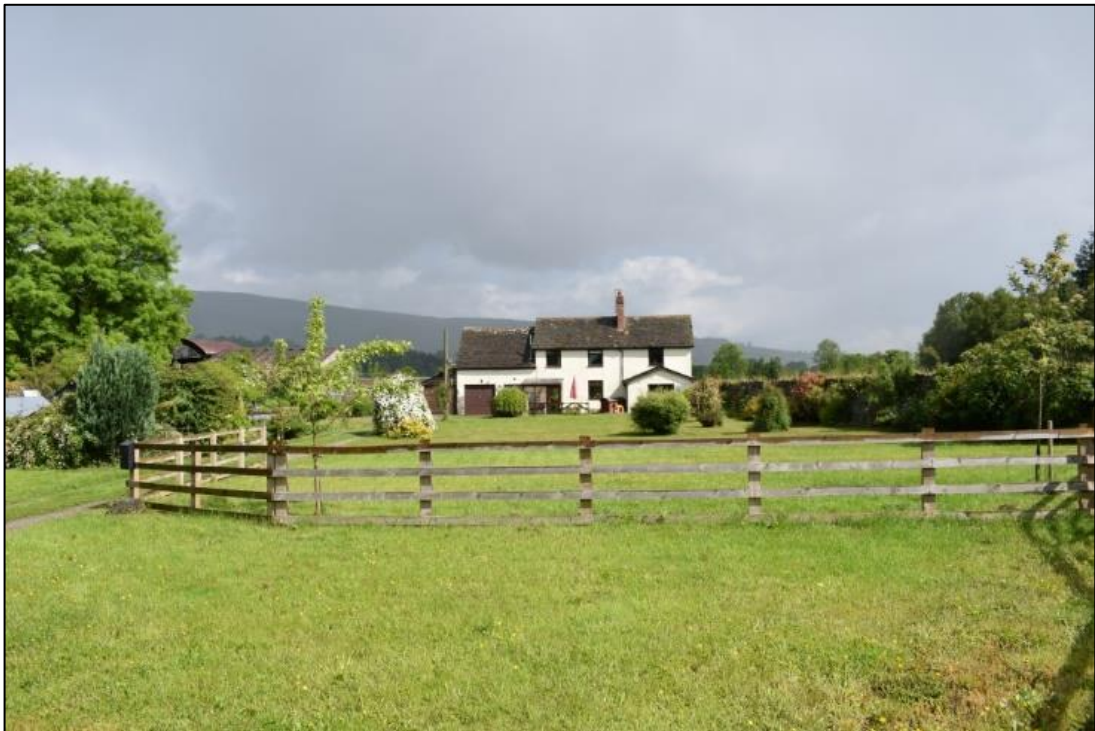
*Fig. 2: Downton Cottage and garden, from the south. Photo CPAT 4653-0011*

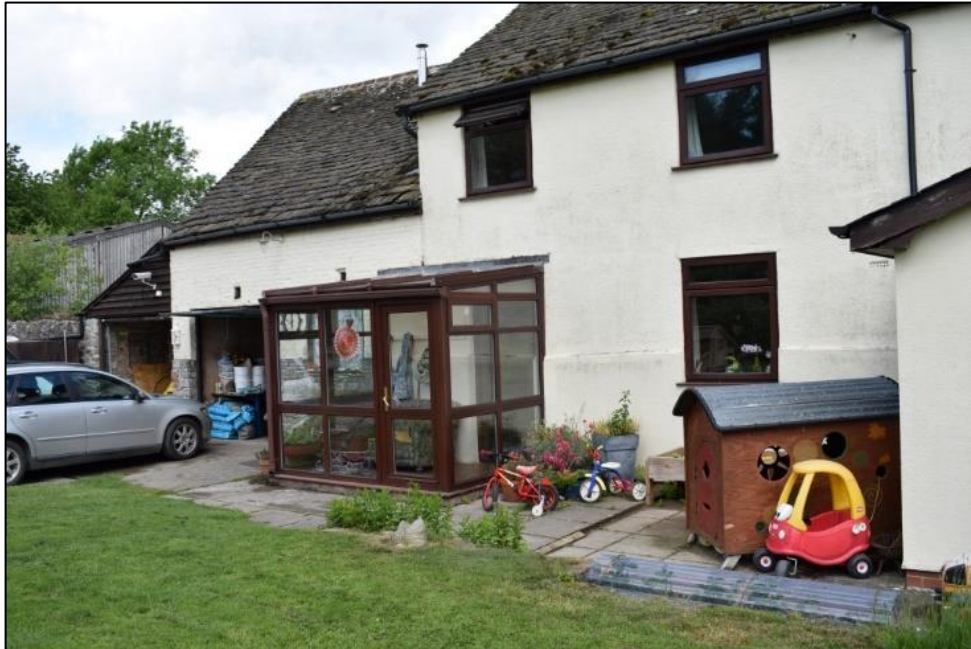
*Fig. 5: The stone wall of the kitchen garden predating the cottage, seen as a step in the wall halfway up the conservatory and between the two garages to its left. Photo CPAT 4653-0042*

- 2.4. Although much modernised, particularly in the interior where there are no surviving early features or fittings, the main structure is relatively intact. It comprises a brick-built house which seems to have been appended to the boundary of the stone walled garden to the west of Downton, known to have been in place in the first half of the 19<sup>th</sup> century. Some structures are visible on the 1846 map, but none of these have survived and both the cottage and the current outbuilding to the rear (north) are not evident.

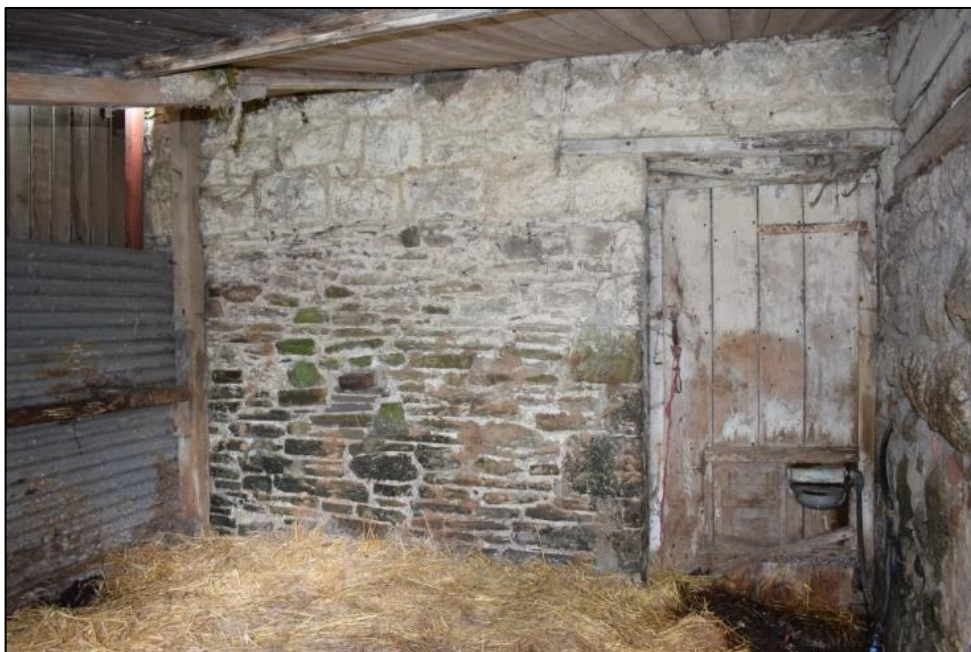
*Fig. 6: The former garden wall within the outbuilding, showing the added courses. CPAT 4653-0005*

- 2.5. Sections of the walled garden survive, particularly those defining its west and east sides, and there is a section of wall within the outbuilding which is almost certainly the wall forming the north end of the garden on the 1846 map, though additional courses were added to give its current appearance.

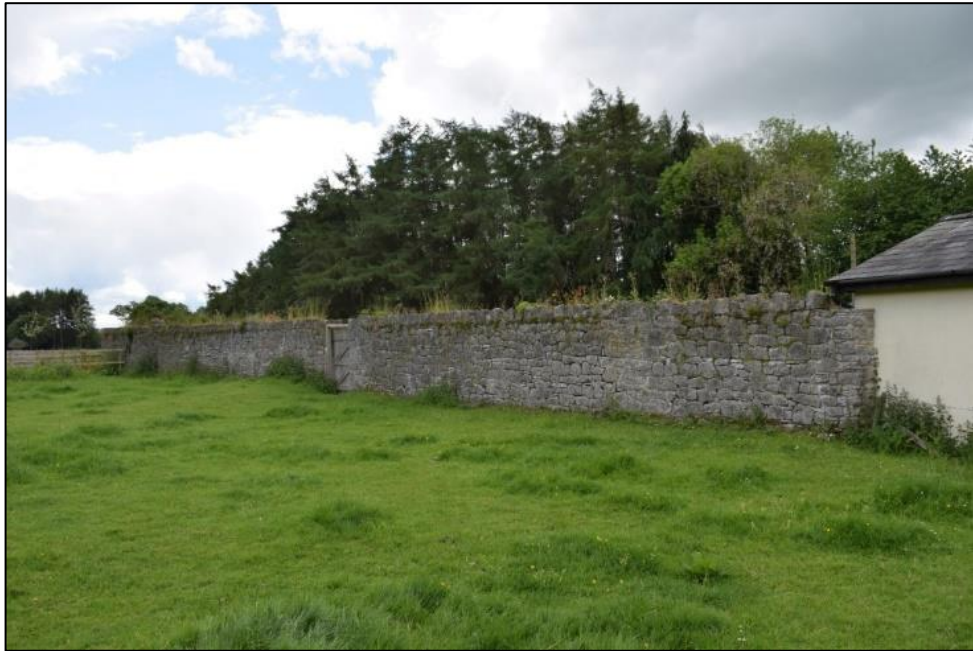
*Fig. 7: The eastern side of the former walled garden. Photo CPAT 4653-0057*

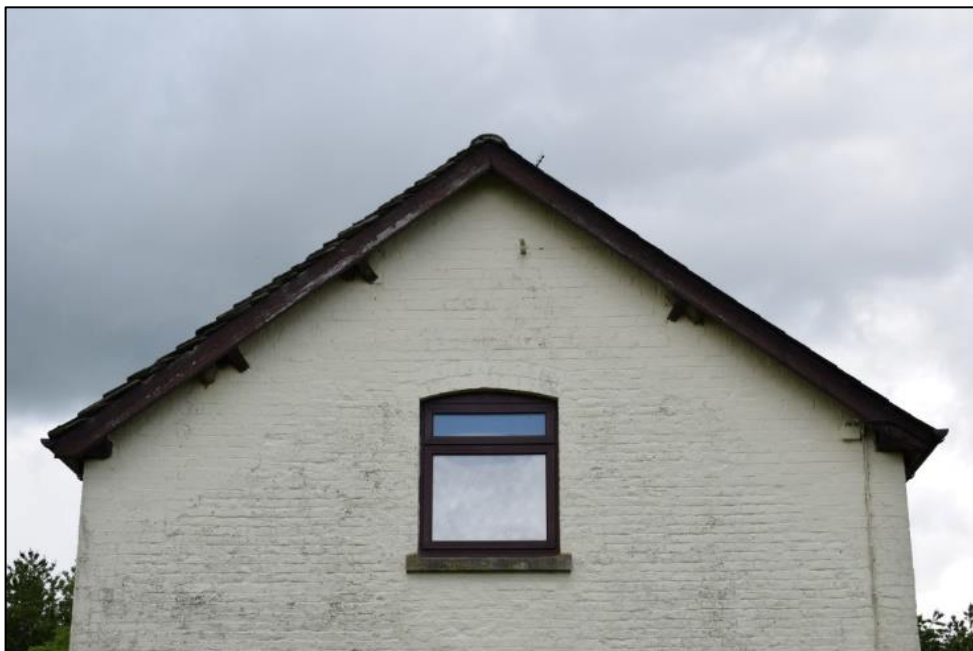
*Fig. 8: The eastern gable of the cottage showing the former roof level. Photo CPAT 4653-0056*

- 2.6. On the east and north sides of the cottage there is clear evidence that the roof height was raised at some point, in the form of a change of brick type from local irregular bricks to later industrially-produced bricks. The original structure no doubt was of the same height and appearance as the lower section to the west (see Fig. 9 and the right hand side of Fig. 11) and it seems probable that, although the north wall of the lower section has been replaced, the rest is a survivor of an earlier version of the building. The early brick structure is interesting in that it seems to have been built in a random manner without a deliberate bond. Although this might suggest an early origin, the cartographic sources do not support that possibility and it is therefore most likely to indicate the unfamiliarity of the builder with brick as a building material. Curiously, the south side of the roof is clad in stone tiles while the north is slated.

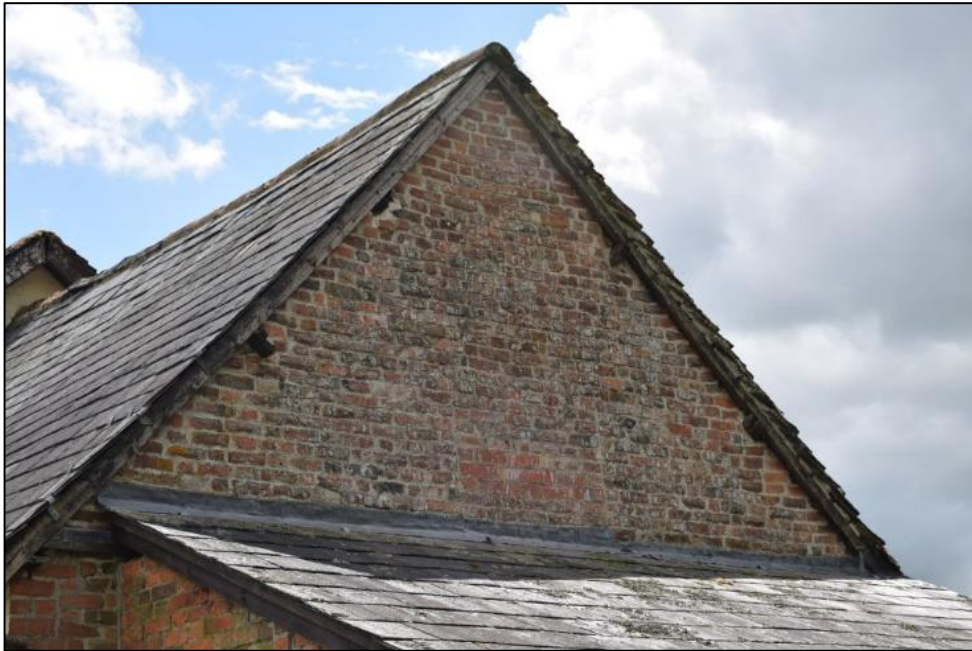
*Fig. 9: The western gable of the cottage, probably a surviving portion of an earlier version of the building, showing its appearance and roof line. The north side, to the right, has stone roof tiles while the south side is slated; the same is true of the rest of the cottage. Photo CPAT 4653-0054*

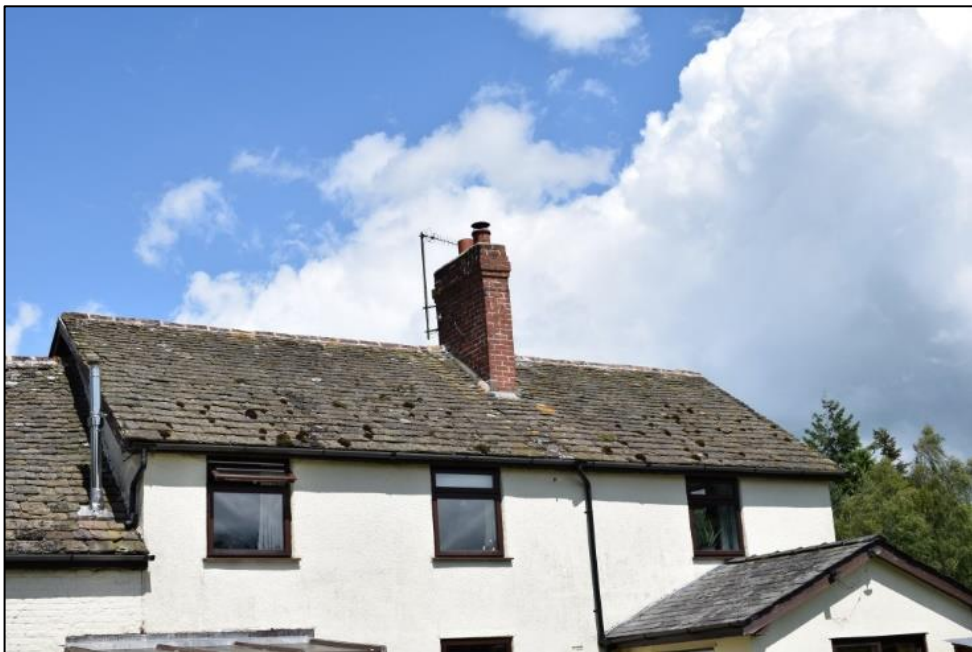
*Fig. 10: The stone roof tiles on the south side of the cottage. These were no doubt reused after the roof height of this part was raised. Photo CPAT 4653-0059*

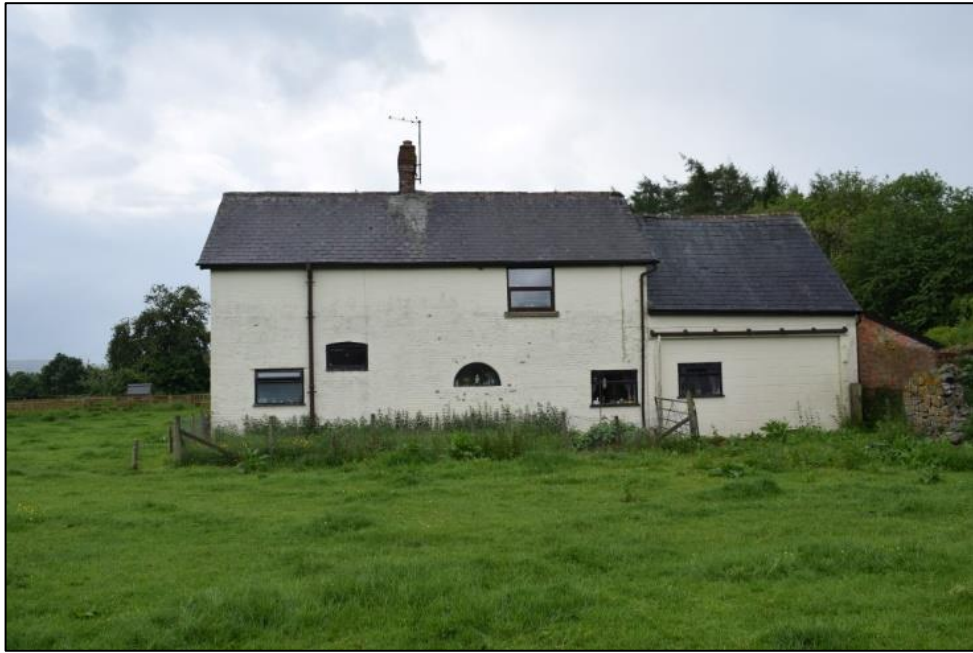
- 2.7. The north wall of the cottage (Fig. 11) contains some fairly random features, particularly the two arched window openings towards its western end (Fig. 12), one of which is now partially blocked. There is no evidence of these having been doorways as might be expected, so they were presumably intended as two of perhaps three or four similar ornamental windows on this side. There seems to have been a rebuild and window insertions at the eastern end of the wall which would have removed any others that may once have occupied this area.

*Fig. 11: The north side of the cottage, with slate roof and random windows. Note the lower section to the right which probably indicates the original roof line and pitch. Photo CPAT 4653-0002*

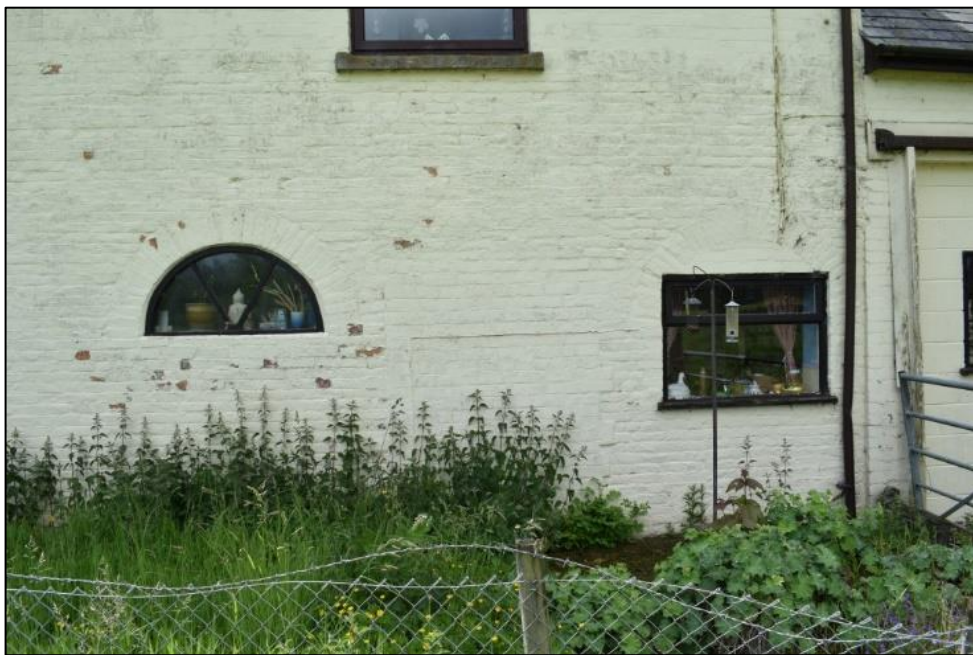
*Fig. 12: The arched openings in the north wall of the cottage, the one to the right partially blocked. Photo CPAT 4653-0046*

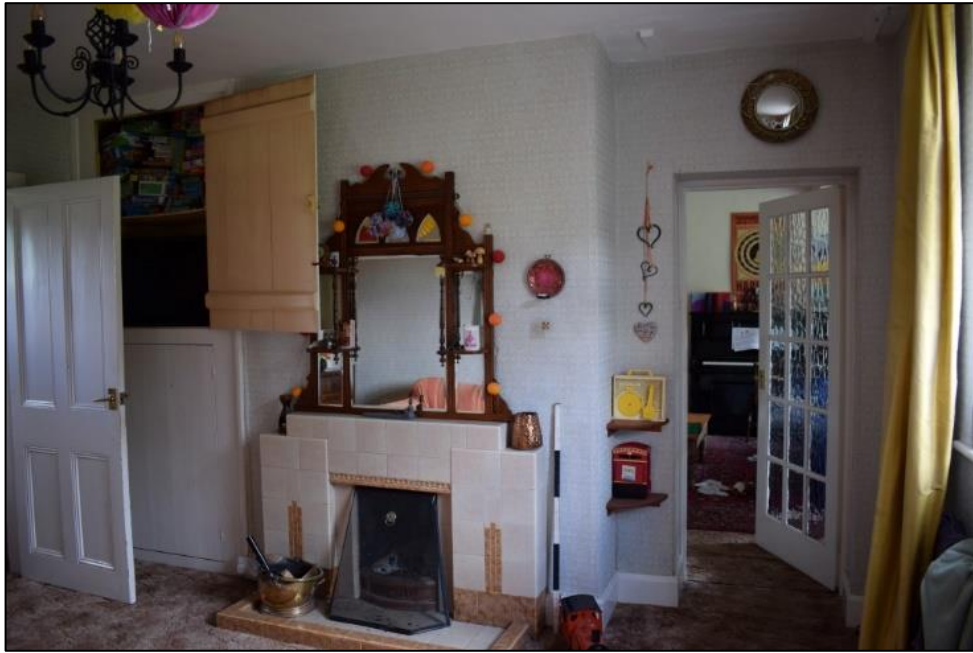
- 2.8. Internally, there is no evidence for original features, the fireplace on the ground floor (Fig. 13) is of 20<sup>th</sup>-century date and where the chimney is visible in the attic space it is evident that the structure is built of industrial standard bricks, not the irregular ones that identify the early structure. It might well have been a later insertion but this could not be determined owing to the change in the roof height. The roof timbers look to have been replaced in the main part of the cottage but the lower section to the west could have retained its original timbers; this part was not accessible from the interior so this must remain as speculation, based on the irregular appearance of the ridge line.

*Fig. 13: The fireplace in the ground floor sitting room. Photo CPAT 4653-0032*

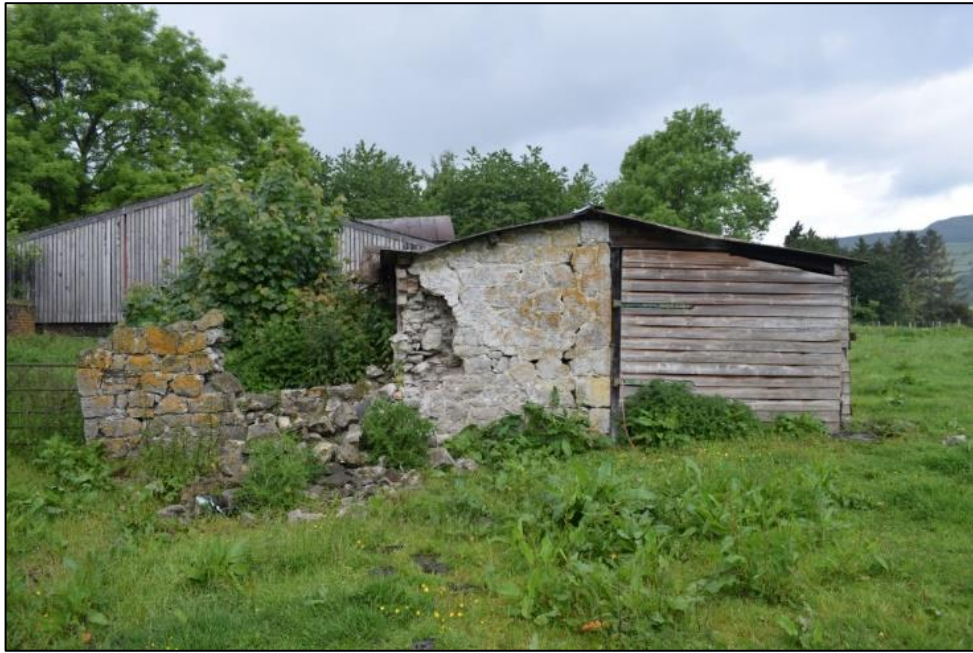
- 2.9. The outbuilding to the rear of the cottage (Figs 15 and 16) is predominantly stone walled in construction, though with a wooden framed and clad section forming its northern part, outside the garden wall that has already been mentioned. It seems to have appeared in the later part of the 19<sup>th</sup> century and more recently was used as individual loose boxes for stock, with the northern part forming a storage area.

*Fig. 15: View of the outbuilding to the north of the cottage, from the east. Photo CPAT 4653-0006*

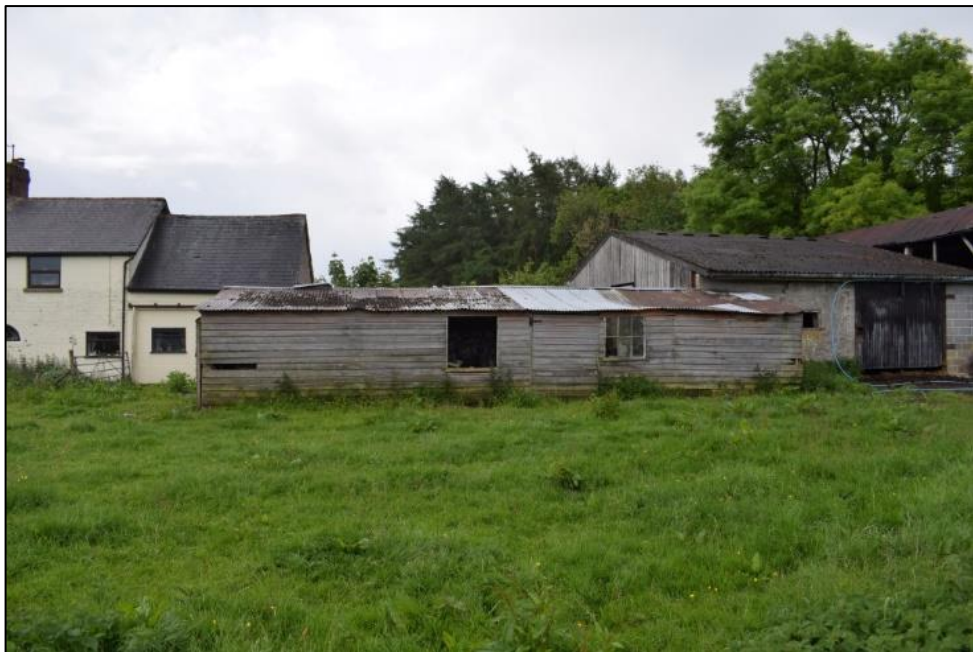
*Fig. 16: The northern view of the outbuilding. The buildings to the right are not part of the planning application. Photo CPAT 4653-0003*
