ARCHAEOLOGICAL
Topographical and Geophysical

Survey
SC/JBT/09

Furnace Cottage, Tintern.

Dr N. Phillips
31/12/2009

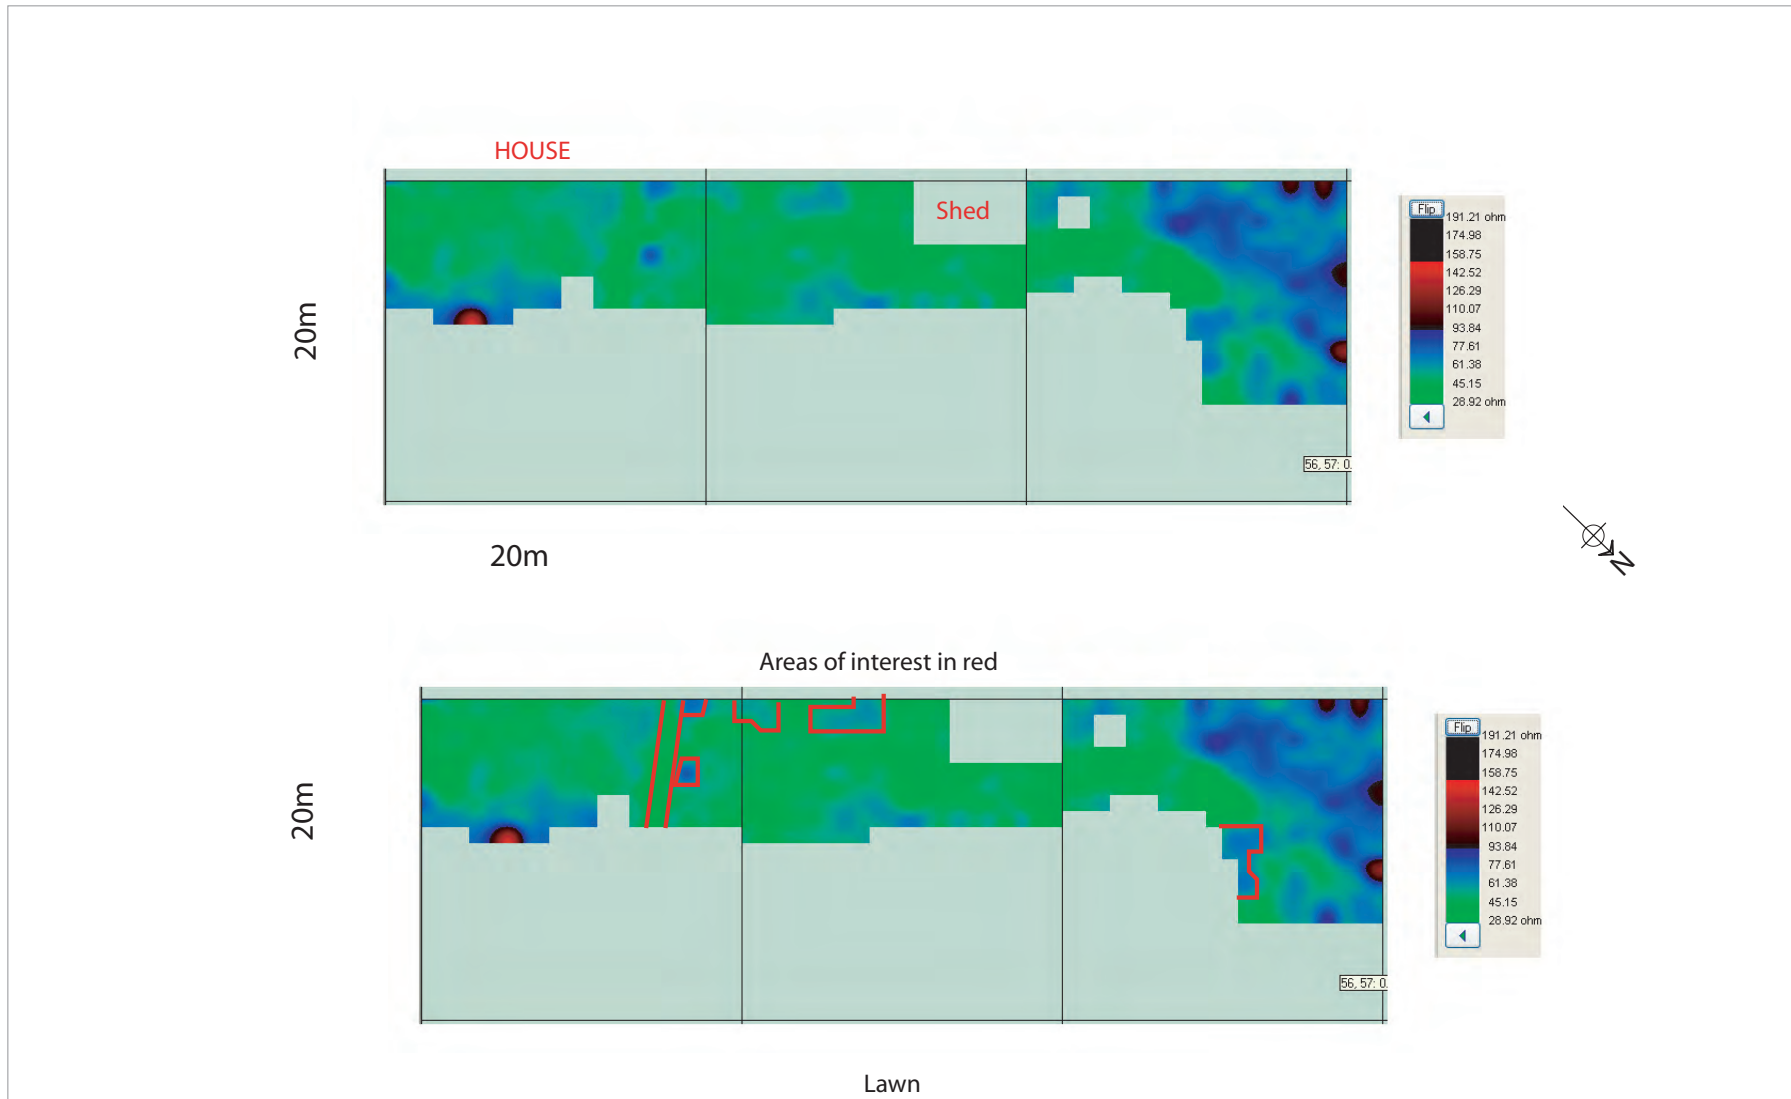
Fig 08: Resistivity plot, front lawn

The second resistivity survey was located across the front lawn of the house. The area was quite narrow which tends to diminish the usefulness of the data but some features were noticeable, if somewhat faintly. The area, which is now a lawn, has probably been subject to a lot of remodelling. Two walls at least used to run across it (Saunders *pers com.*), separating the then three cottages from one another. It is possible one of those walls has shown up as low resistance in the south east segment.

The very high resistance red semicircle to the west is unusually contrasting; however, it is at the edge a retaining wall and so is unlikely to be a structure of any significance.

The area to the north west is highly visible as a high resistance anomaly. However, the topography in this area would appear to be a bank of sandstone and it has a lot of trees on it. Possibly more interesting is the low resistance feature that cuts its eastern edge.
