CPAT Report No. 1639

Erddig Hall Visitor Car Park, Wrexham

Archaeological Watching Brief

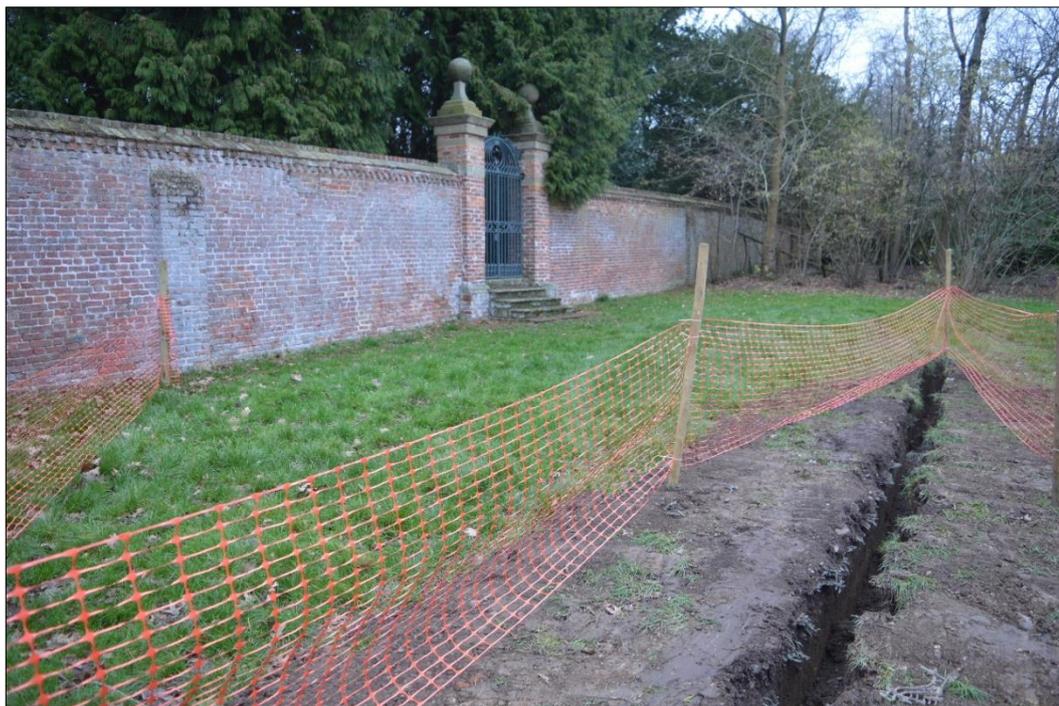
Fig. 2 Drainage trench in the north-east part of the car park. Photo CPAT 4596-0003

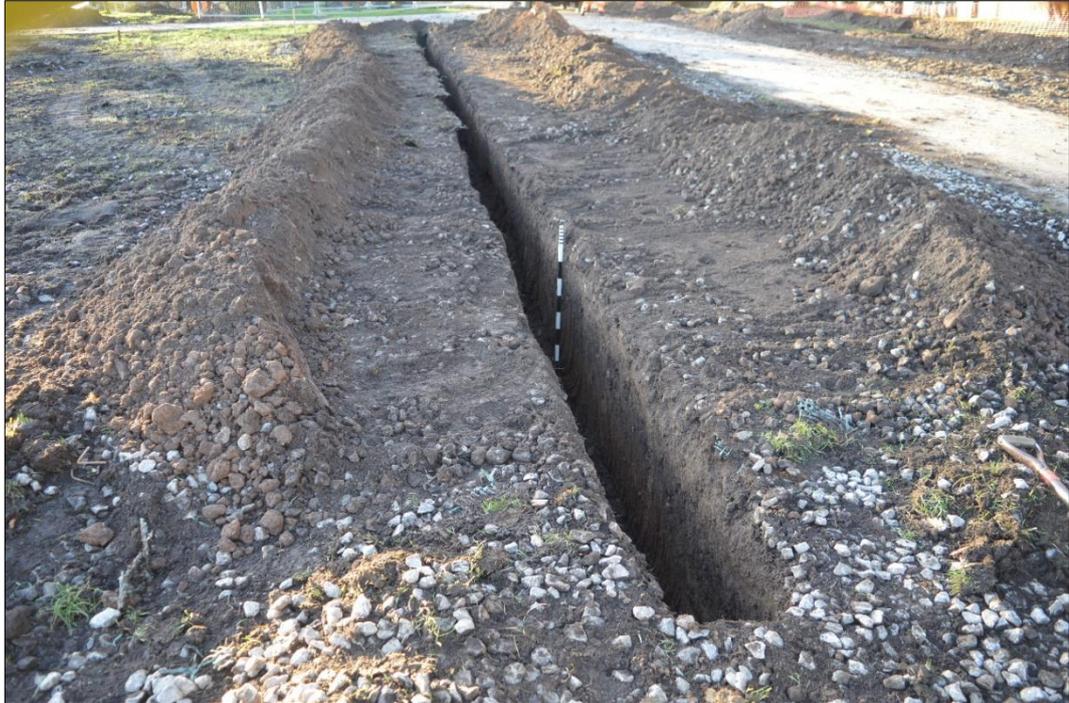
- 3.3. In the centre of the car park (Fig. 8, B) the topsoil sealed a layer of dark grey brown clay, 0.10m to 0.30m thick, which contained fragments of ceramic building material, but no datable artefacts, overlying the natural subsoil. In the south-eastern corner of the car park the stratigraphy was slightly different, comprising the same upper two layers as noted above, sealing a 0.30m-thick layer of light brown silty clay, similar to that in the north-eastern part of the site. In addition, a deposit of gleyed light grey silt, 0.15m thick, was observed in the base of the excavation. Of particular note was a concentration of broken, hand-made bricks/tiles which may be part of a drain or culvert (Fig. 4; see below).

Fig. 3 Drainage trench in the central part of the car park Photo CPAT 4596-0011

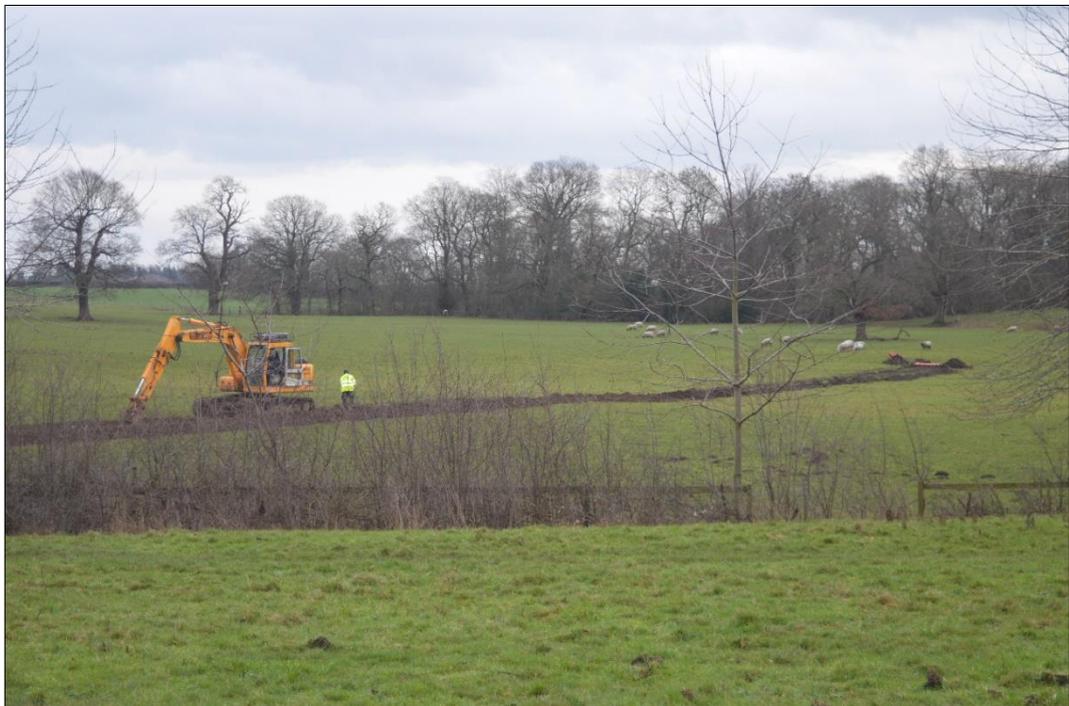
- 3.5. From the south-eastern corner of the car park a new drain was cut across the park land to link into an existing man hole (Fig. 9). This was cut using a 0.50m-wide toothed bucket, excavating a trench up to 0.70m deep, work progressing in sections owing to the 'cut and fill' approach.

Fig. 6 The excavation of the new drainage connection across the park land. Photo CPAT 4596-0009

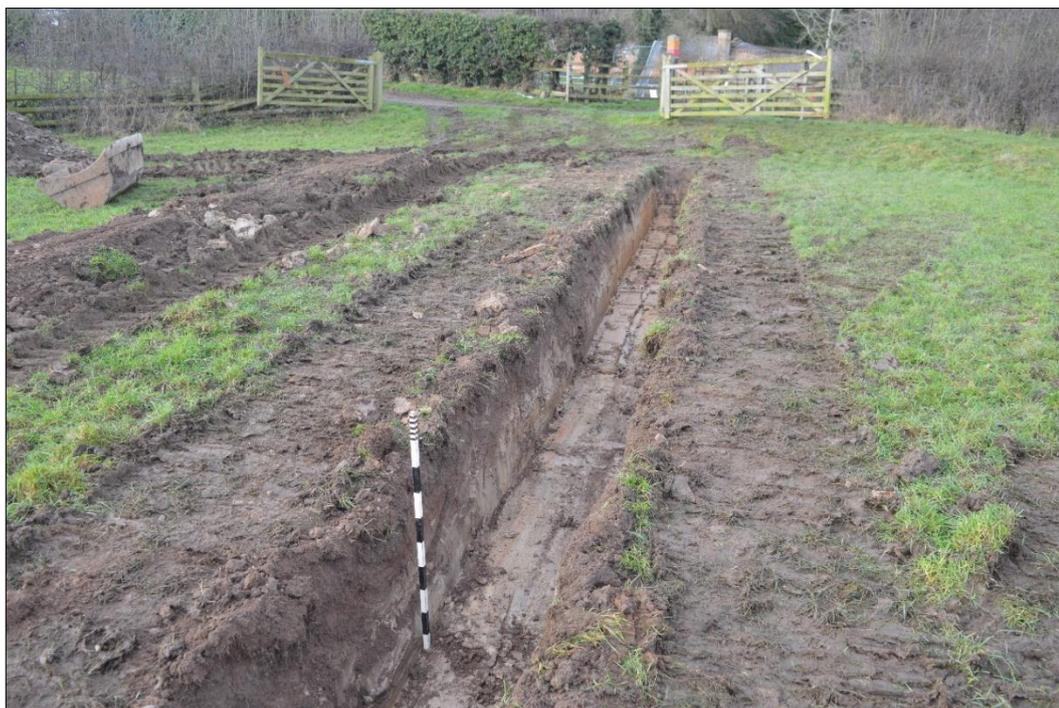
- 3.6. In the north-western half of the trench the stratigraphy comprised around 0.20m of topsoil, overlying a former ploughsoil, typically up to 0.1m thick, lying directly on the natural subsoil, an orange silty clay. The topography was such that the south-eastern section also contained a layer of very dark, peaty silt, 0.10m to 0.15m thick, below the former ploughsoil, the subsoil here consisting of gleyed grey silty clay at a depth of around 0.45m. The upper layers contained 19th-century building materials, most notably around the break of slope, which may be derived from a former building in the area.

Fig. 7 The north-western section of the new drainage trench in park land. Photo CPAT 4596-0007

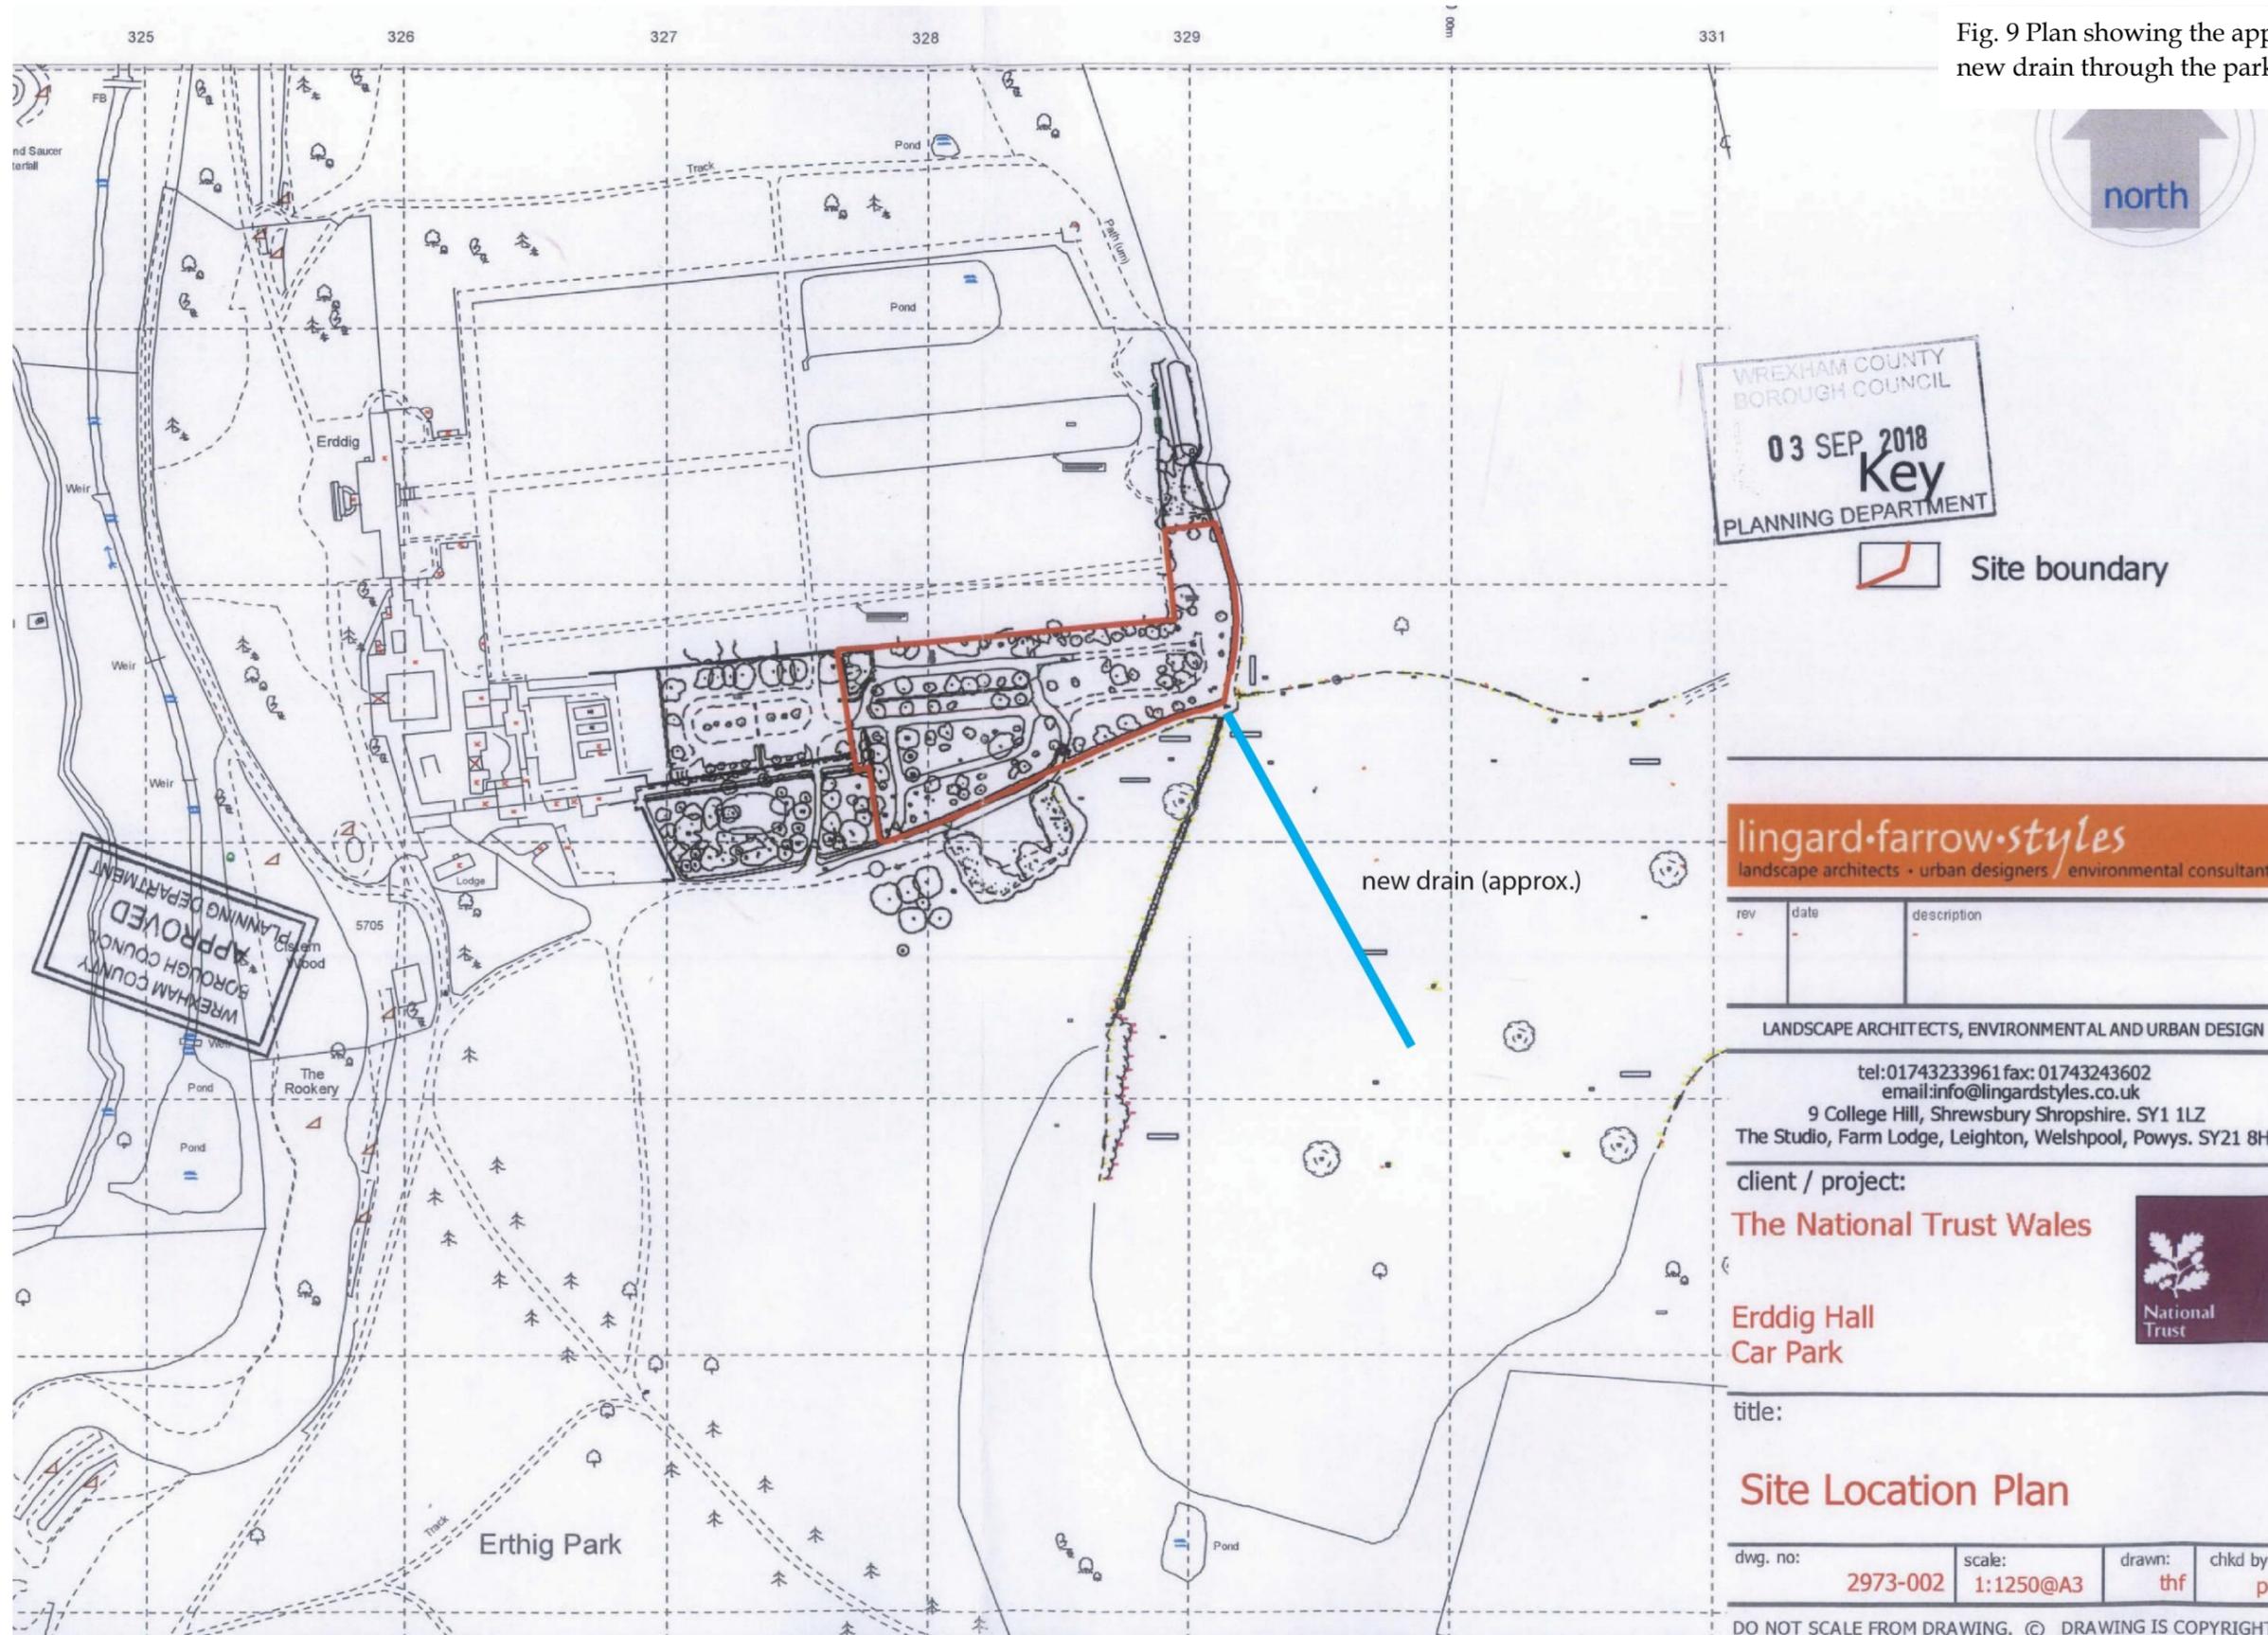
Fig. 9 Plan showing the approx. line of the new drain through the park
