CPAT Report No. 1625

St George Church, Abergele, Conwy

Archaeological Watching Brief

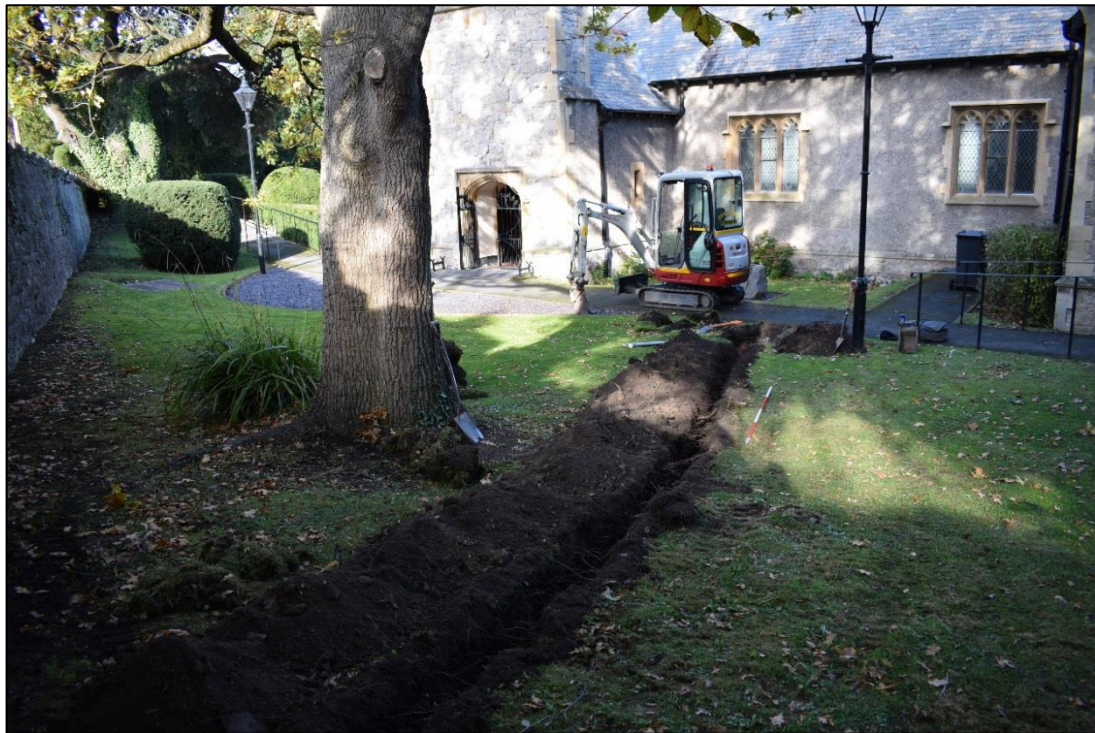
Fig. 3: The southern section of the pipe trench. Photo CPAT 4560-0005

- 3.2. The oil tank location and the southern section of the trench fell within a grassed area bounded by the main church access path; the trench here was 0.25m wide and excavated to a maximum depth of 0.4m, though a wider area, to 0.7m wide by 1.2m long and an approximate depth of 0.5m, was dug adjacent to the path to allow for the section beneath the path to be mole bored. The northern section extended beyond the path and linked with an existing buried pipe that allowed access to the interior of the church at the junction between the south transept and the main body of the church; this section was also 0.25m wide and up to 0.4m deep.
- 3.3. The southern part of the trench and oil tank location revealed dark grey silt to a depth of 0.3m, below which there was a layer of mid-grey sandy silt containing a small

amount of 19th and 20th-century pottery. On the north side of the path, the trench was entirely in made up ground composed of rubble hardcore associated with the church path which ran parallel to the trench.
