**Capel Annibynnol Brynteg
Brynteg Independent Chapel,
Gorseinon, Swansea
Photographic Survey
P/2015/0026 (Swansea)**

Trysor Project No. 2017/560

1.1 In October and November 2016, Trysor undertook a photographic survey at Brynteg Independent Chapel, Gorseinon prior to the conversion of the now redundant chapel into 12 residential flats.

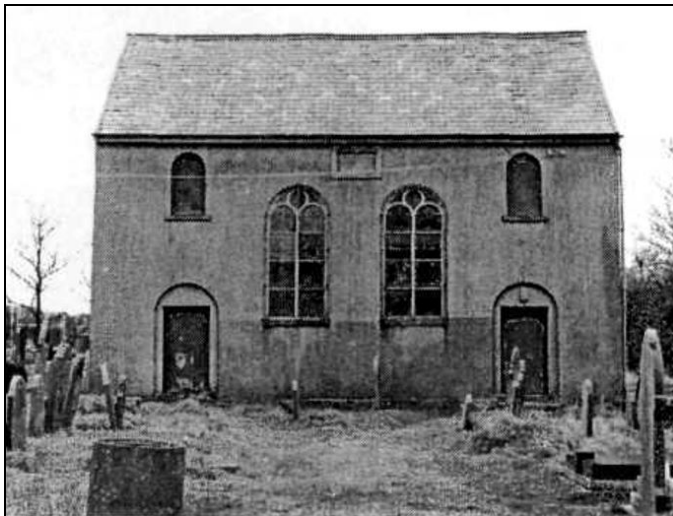
*Figure 2: The 1847
Brynteg Chapel.*

7.4 By 1847, with the local industries causing a rapid growth in the population of the district, this chapel was also too small for its growing congregation, and a second Brynteg Chapel was built nearby to replace it. This chapel could seat 400 hundred people. It was a long-wall entry type chapel, built in the Simple round-headed style.

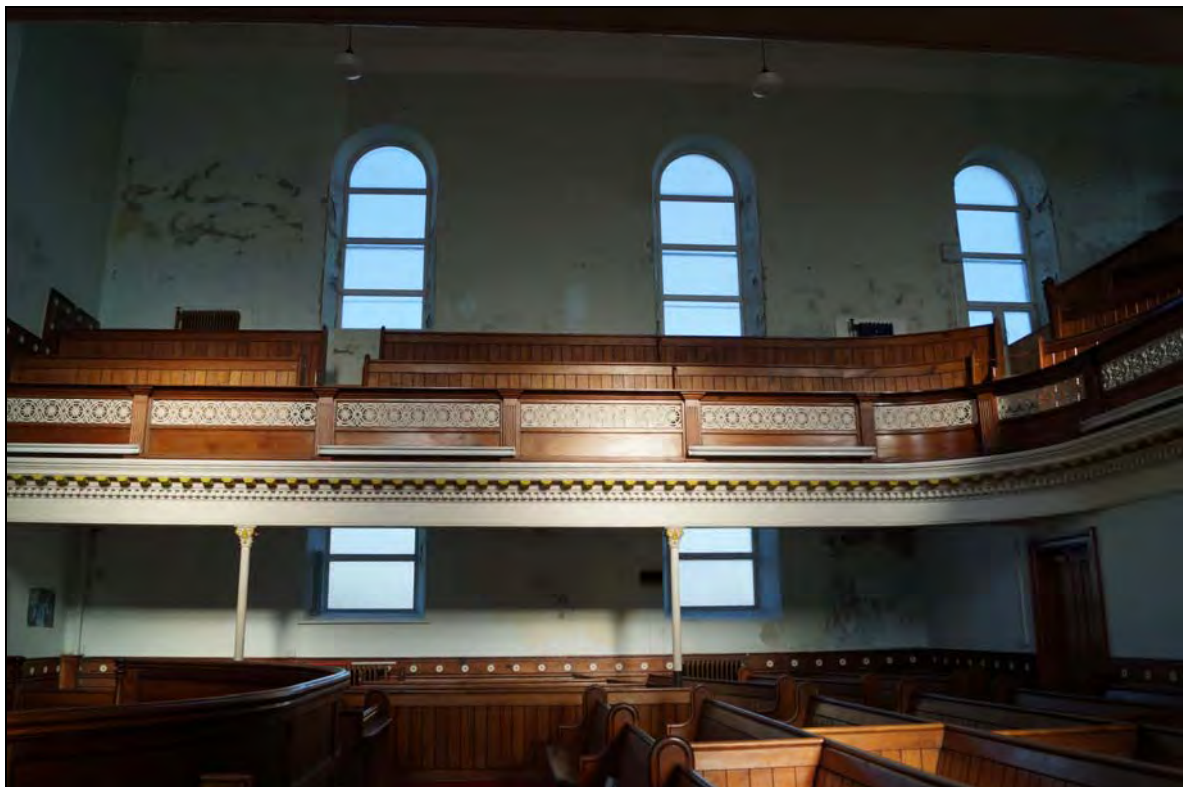
Plate 42: BTC2017_042, internal view of the chapel looking east-southeast across the ground floor with the ornate gallery above, supported on cast iron pillars.

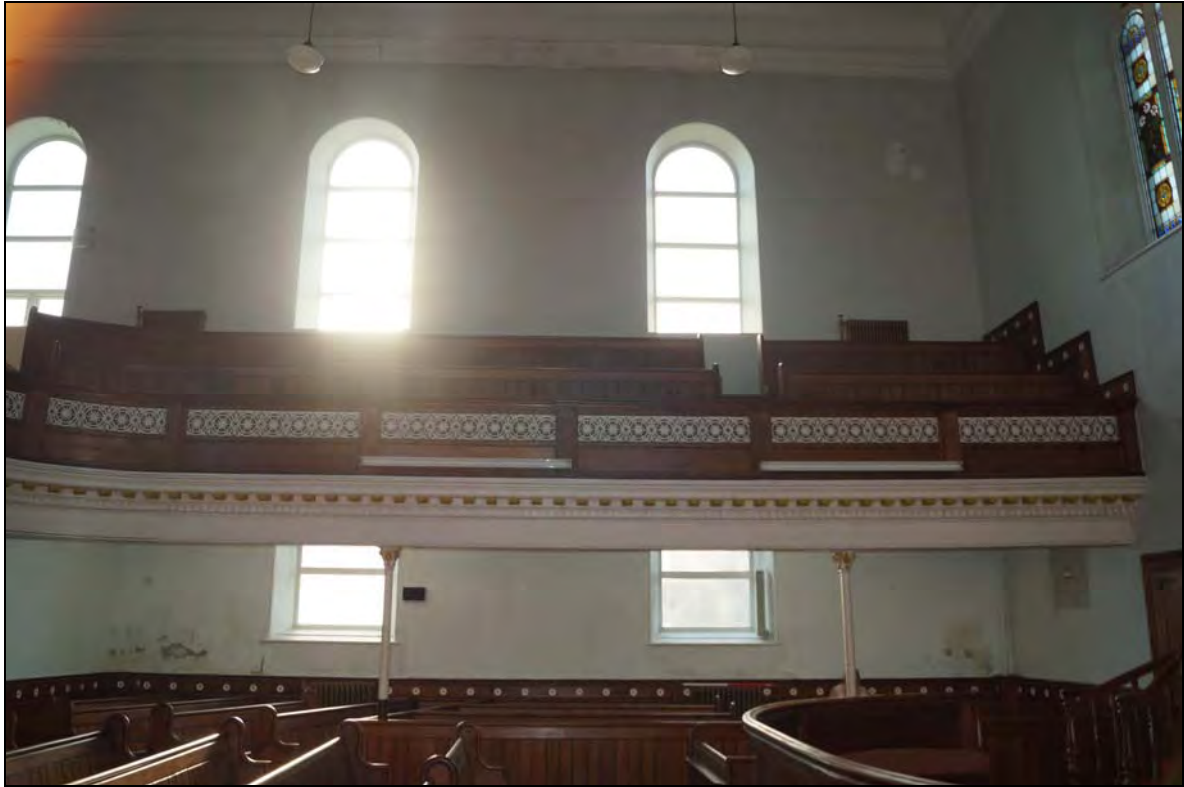
Plate 43: BTC2017_043, internal view of the chapel looking west-northwest across the ground floor with the ornate gallery above, supported on cast iron pillars.

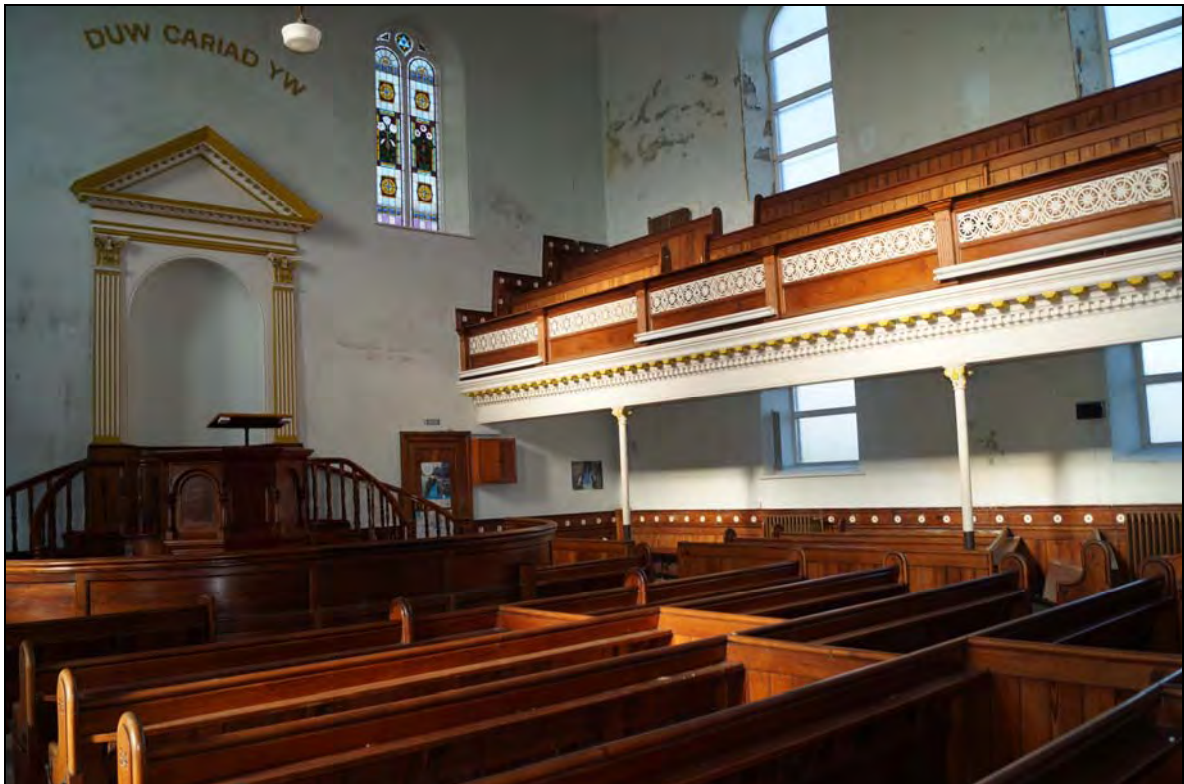
Plate 44: BTC2017_044, internal view of the chapel looking northeast across the ground floor with the ornate gallery above, supported on cast iron pillars.

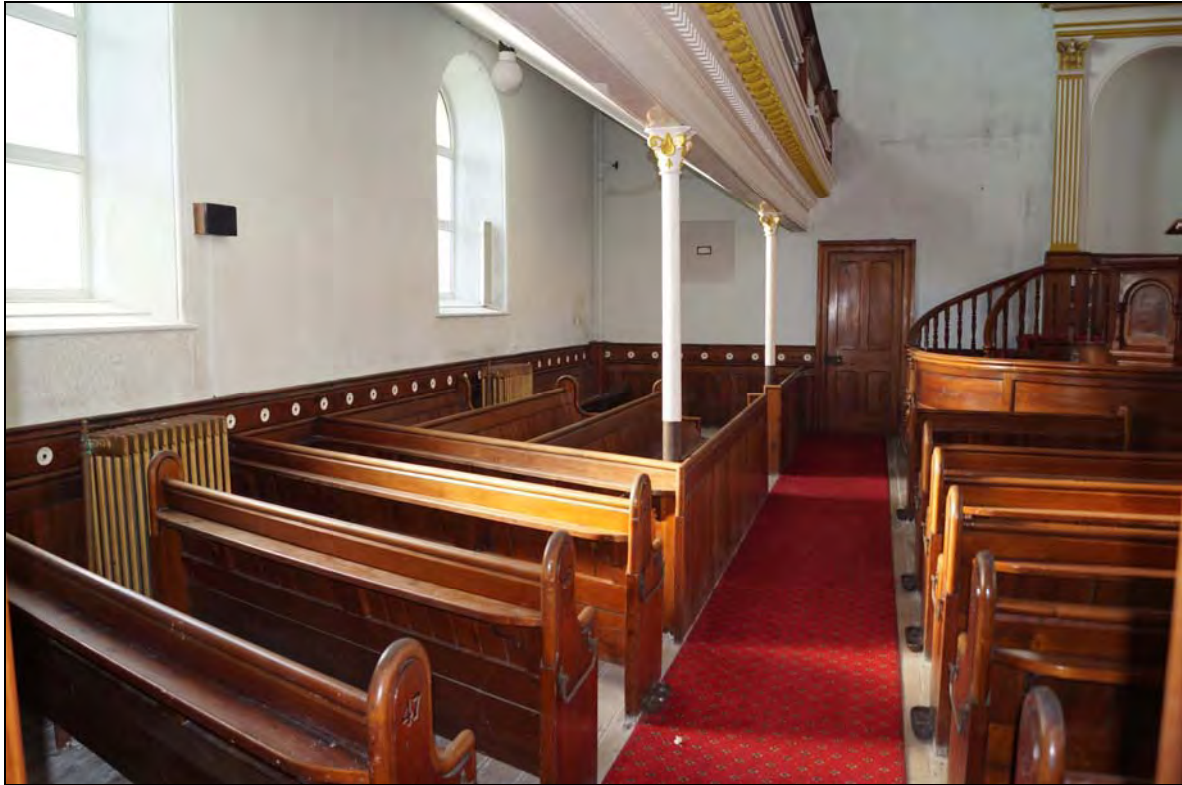
Plate 45: BTC2017_045, internal view of the chapel along the western aisle with the pews along the western wall to the left, below the gallery, supported on cast iron pillars, looking north-northeast.

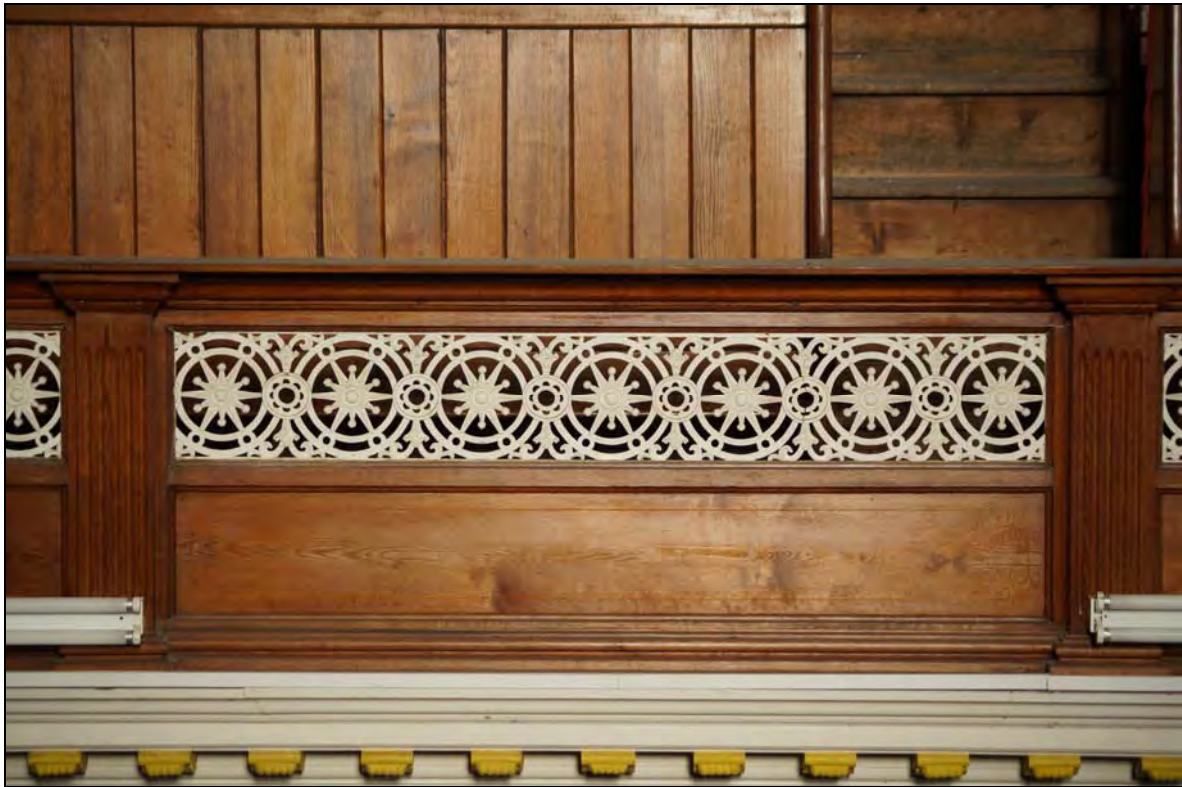
Plate 56: BTC2017_056, a closer view of the decorative cast-iron tracery fronting the eastern side of the gallery, looking east-southeast.

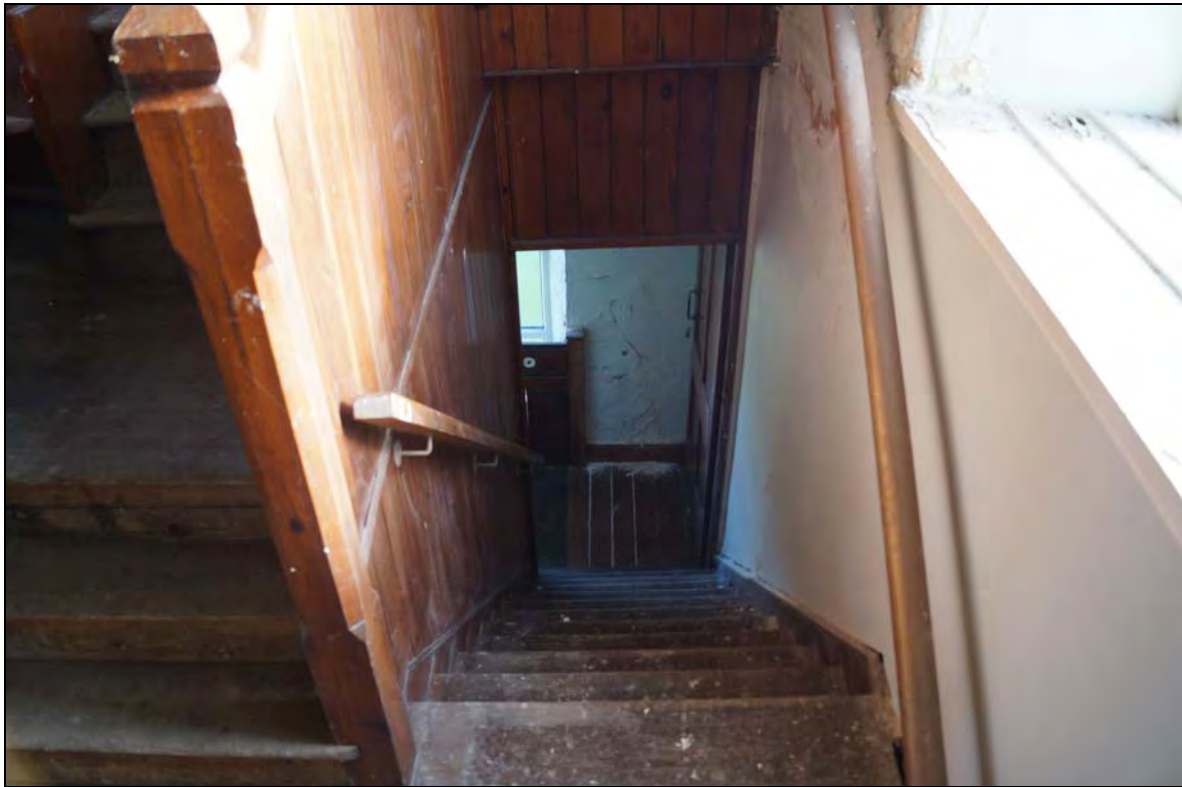
Plate 60: BTC2017_060, a view down the upper flight of stairs from the western gallery to the landing, from where a lower flight of steps leads to the entrance lobby, looking south-southwest.

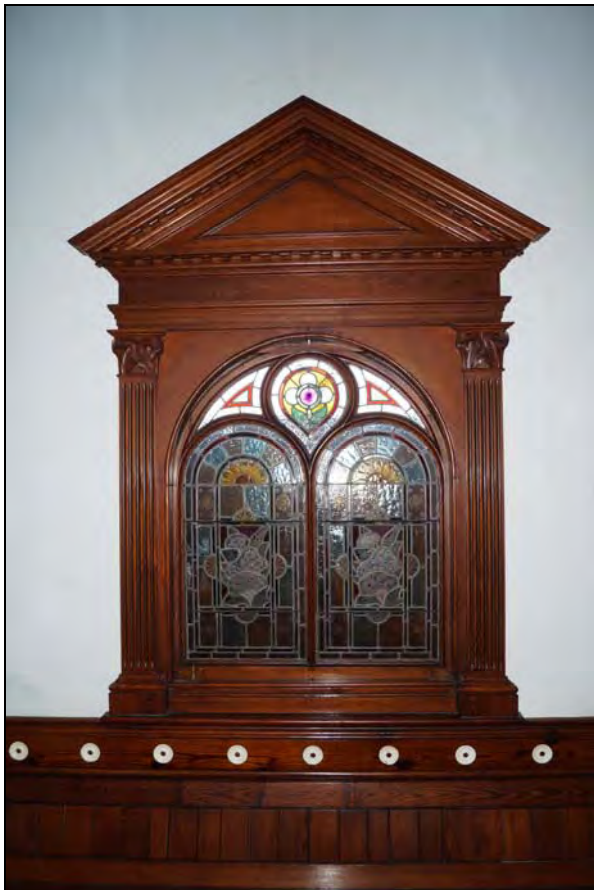
Plate 63: BTC2017_063, the highly decorative, stained-glass window in the wall which originally separated the entrance lobby from the main body of the chapel, looking south-southwest.

BTC2017_063	The highly decorative, stained-glass window in the wall which originally separated the entrance lobby from the main body of the chapel.	South-southwest	7 July 2017	RPS

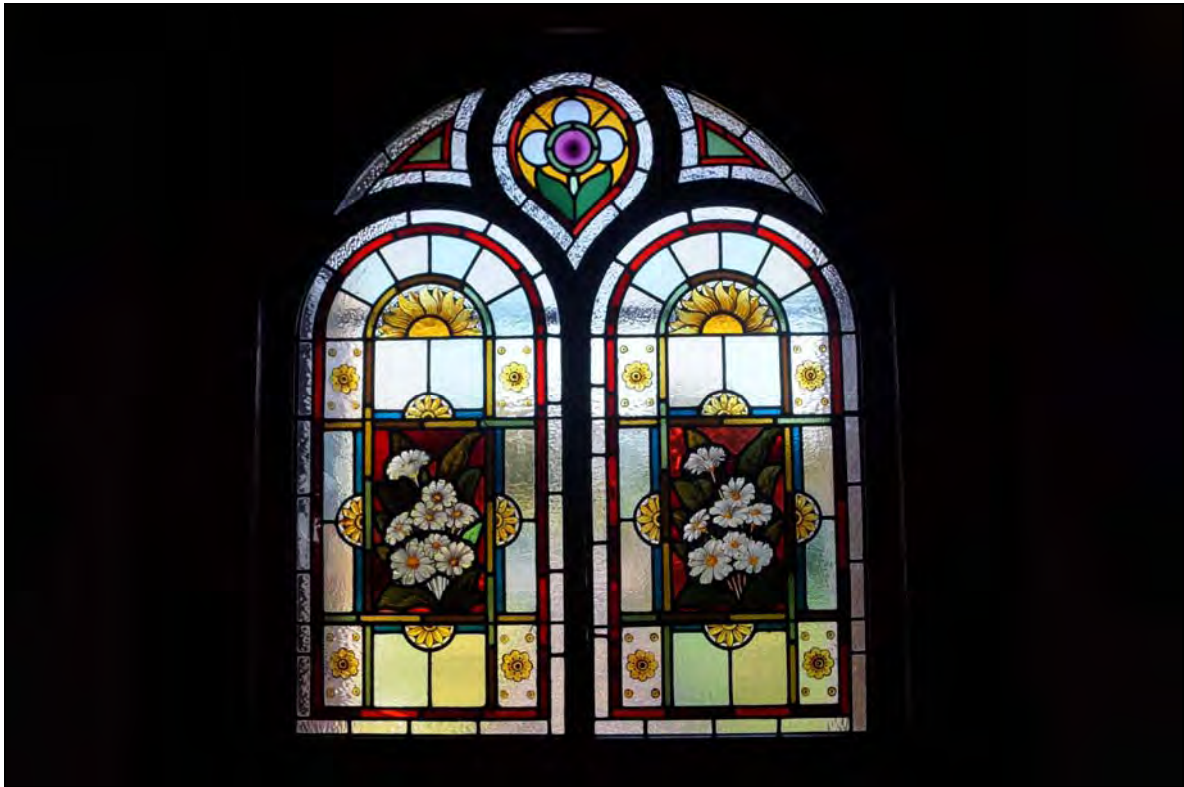
Plate 64: BTC2017_064, the highly decorative, stained-glass window in the wall of the entrance lobby, looking south-southwest.

Site Code:	Site Name:		NGR:	
BTC2017	Brynteg Chapel, Gorseinon			
Photo Number	Contexts/ Description	Direction Looking	Date	Taken by
BTC2017_064	The highly decorative, stained-glass window in the wall of the entrance lobby.	South-southwest	7 July 2017	RPS
BTC2017_065	The eastern pane of the highly decorative, stained-glass window in the wall of the entrance lobby.	South-southwest	7 July 2017	RPS
BTC2017_066	The western pane of the highly decorative, stained-glass window in the wall of the entrance lobby.	South-southwest	7 July 2017	RPS
BTC2017_067	The inner lobby of the chapel, created in modern times by removing the rear pews and building a partition wall and new ceiling beneath the gallery. A kitchen was installed and is visible through the facing door. The main body of the chapel is entered via the door on the left here.	East-southeast	7 July 2017	RPS
BTC2017_068	The inner lobby with the stained-glass window of the entrance lobby to the right.	East-southeast	7 July 2017	RPS

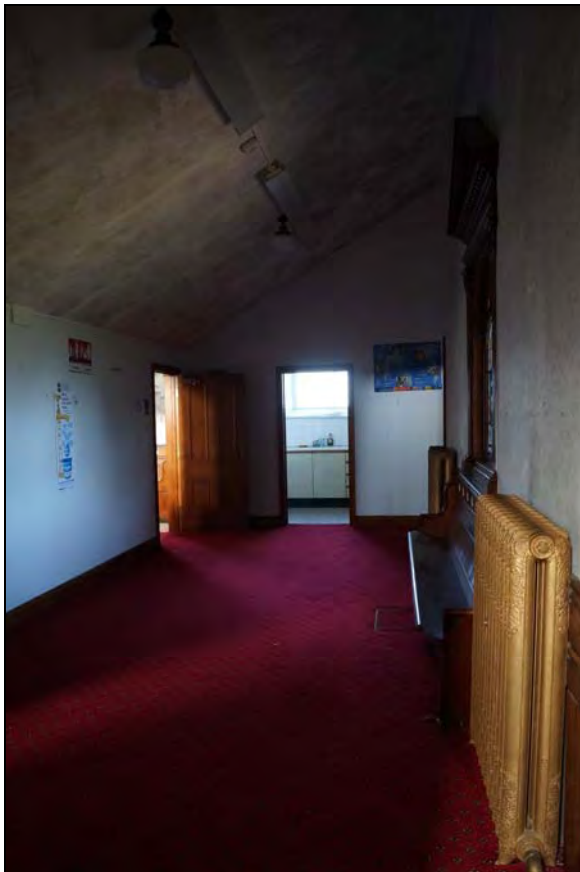
Plate 67: BTC2017_067, the inner lobby of the chapel, created in modern times by removing the rear pews and building a partition wall and new ceiling beneath the gallery. A kitchen was installed and is visible through the facing door. The main body of the chapel is entered via the door on the left here.

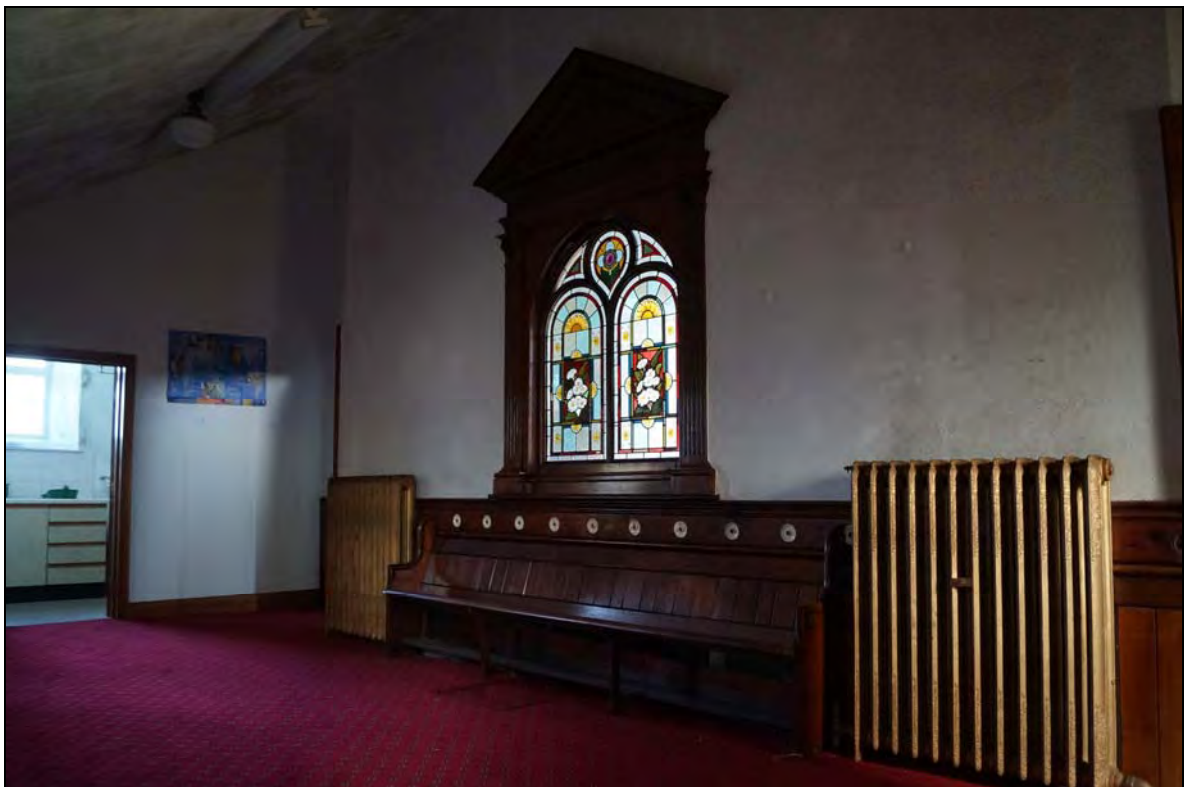
Plate 69: BTC2017_069, the inner lobby and the stained-glass window of the entrance lobby. A pew removed from the chapel when it was truncated to create the inner lobby is placed below the window, with decorative radiators either side. Looking southeast.

BTC2017_069	The inner lobby and the stained-glass window of the entrance lobby. A pew removed from the chapel when it	Southeast	7 July 2017	RPS

Site Code:	Site Name:	NGR:		
BTC2017	Brynteg Chapel, Gorseinon			
Photo Number	Contexts/ Description	Direction Looking	Date	Taken by
	was truncated to create the inner lobby is placed below the window, with decorative radiators either side.			
BTC2017_070	The inner lobby with the stained-glass window of the entrance lobby to the right. The facing doors lead to separate, modern WCs.	Southwest	7 July 2017	RPS
BTC2017_071	A view from the front door of the chapel, looking towards the gateway.	South-southwest	7 July 2017	RPS
BTC2017_072	The inner lobby showing the stained-glass window of the entrance lobby, the pew below and the decorative radiators.	Southeast	7 July 2017	RPS
BTC2017_073	A close up of the western decorative radiator in the inner lobby.	South-southwest	7 July 2017	RPS
BTC2017_074	A close up of the western decorative radiator in the inner lobby.	Southeast	7 July 2017	RPS
BTC2017_075	A close up of the western decorative radiator in the inner lobby.	East-southeast	7 July 2017	RPS

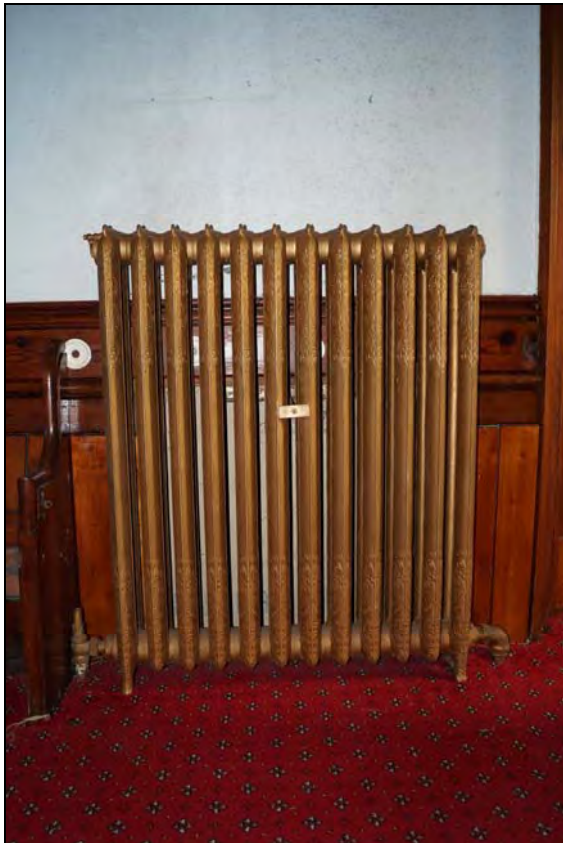
Plate 73: BTC2017_073, a close up of the western decorative radiator in the inner lobby, looking south-southwest.

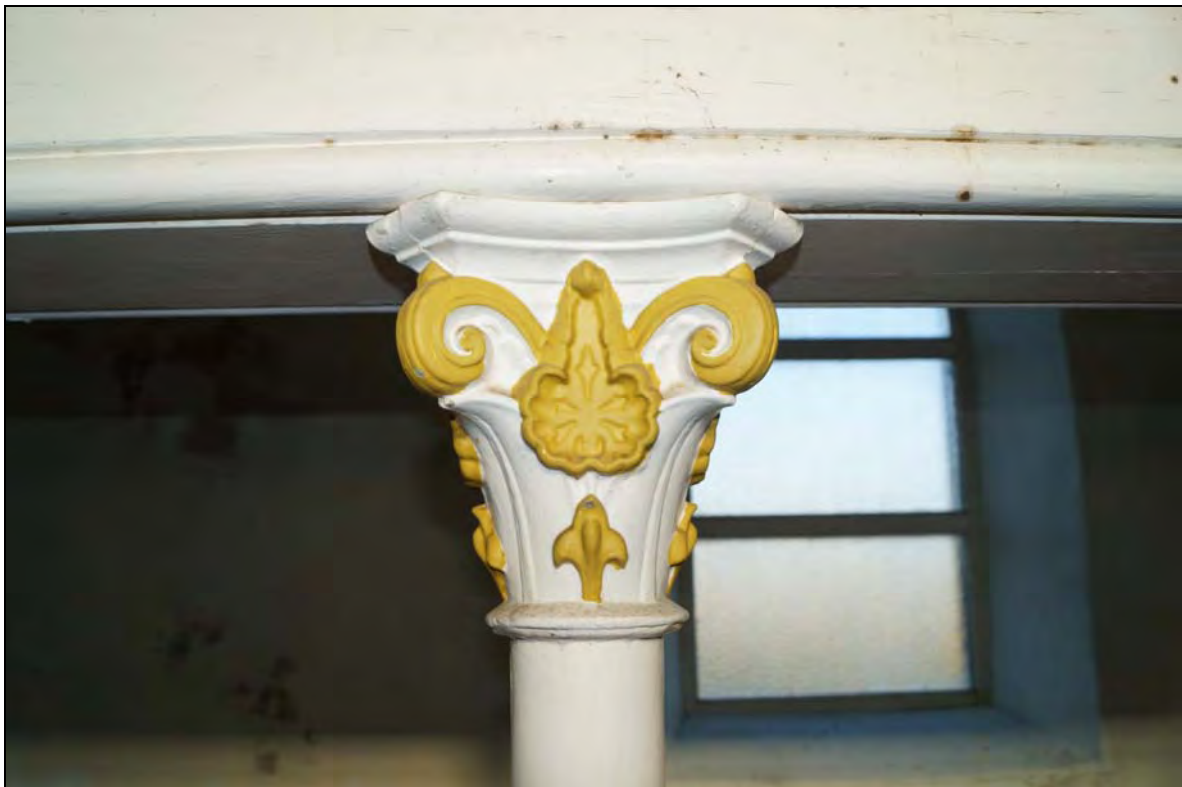
Plate 81: BTC2017_081, a close up of the decorative capital of one of the cast-iron columns supporting the gallery, looking east-southeast.

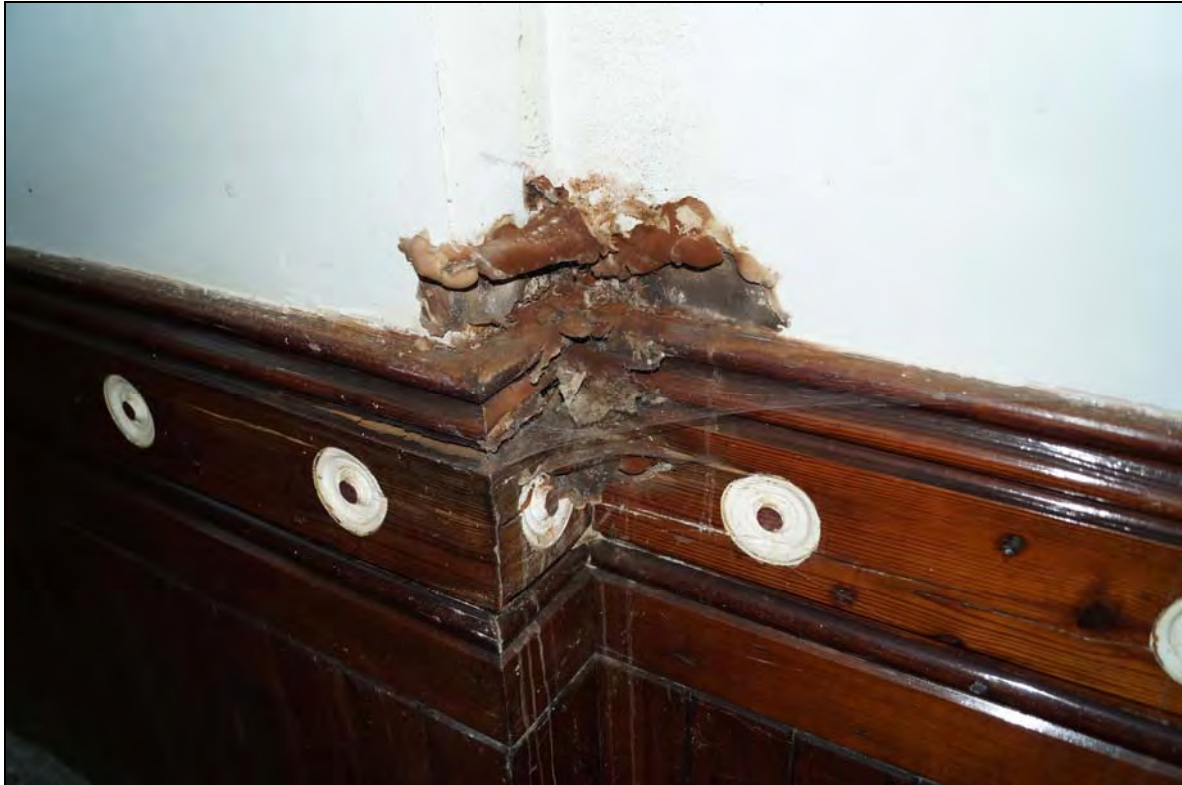
Plate 118: BTC2017_118, wet rot in the outer lobby panelling, looking southeast. Note the decorative, white-painted roundels, which feature throughout the chapel.

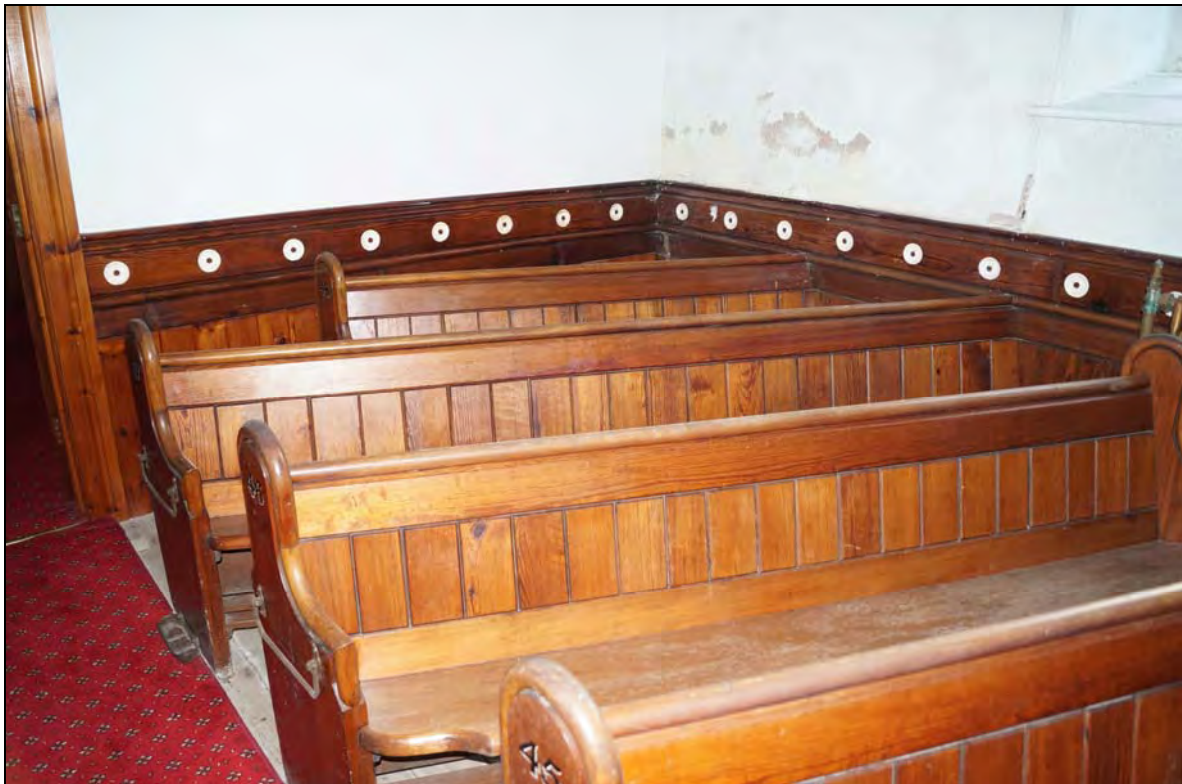
Plate 119: BTC2017_119, the pews in the southwest corner of the chapel. The furthest pew has been truncated to fit into the new layout created when the inner lobby was added. Looking southwest.
