# Land adjacent to Hen Ysgol, Llanarthne, Carmarthenshire Evaluation Report

Trysor Project No. 2016/508

RHIF YR ADRODDIAD - REPORT NUMBER: Trysor 2016/508

1.1 In April 2016, Trysor undertook an evaluation in advance of groundworks for a single dwelling at SN5338620221 on land adjacent to the old school in Llanarthne, Carmarthenshire, W/32733.

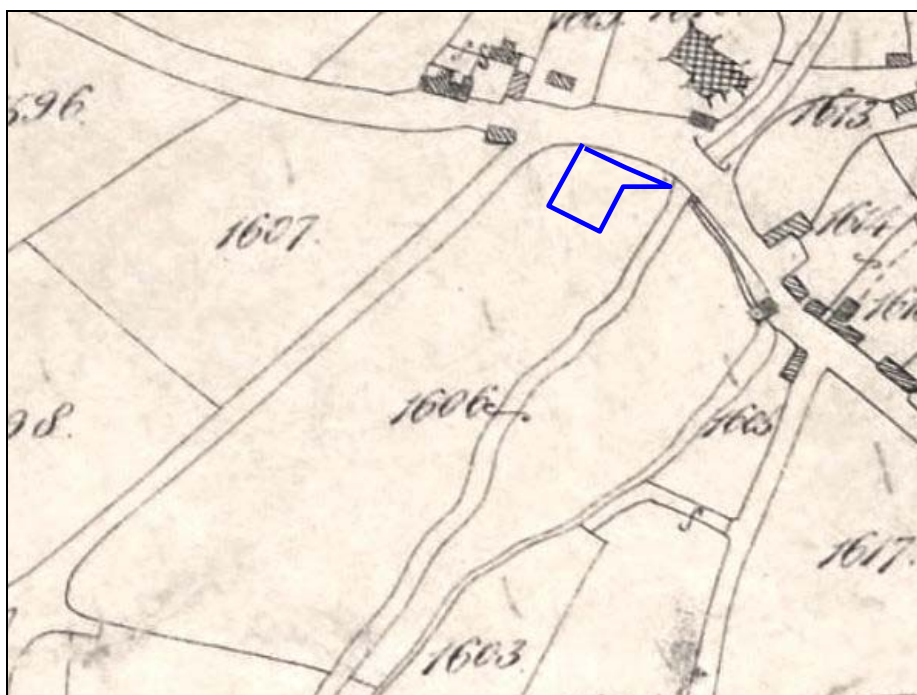
Figure 2: Parish tithe map, showing approximate location of development plot.

8.2 On the Llanarthne parish tithe map of 1848, the development plot lies in a large field, parcel number 1606, *Gwaun y Felyn*, through which the Afon Gwynon ran. There are no features shown on the west side of the stream where the development plot lies. On the east side of stream, a watercourse is shown running adjacent and parallel to the road from a building down to the stream. The building is presumably the mill in the field name *Gwaun y Felyn*.

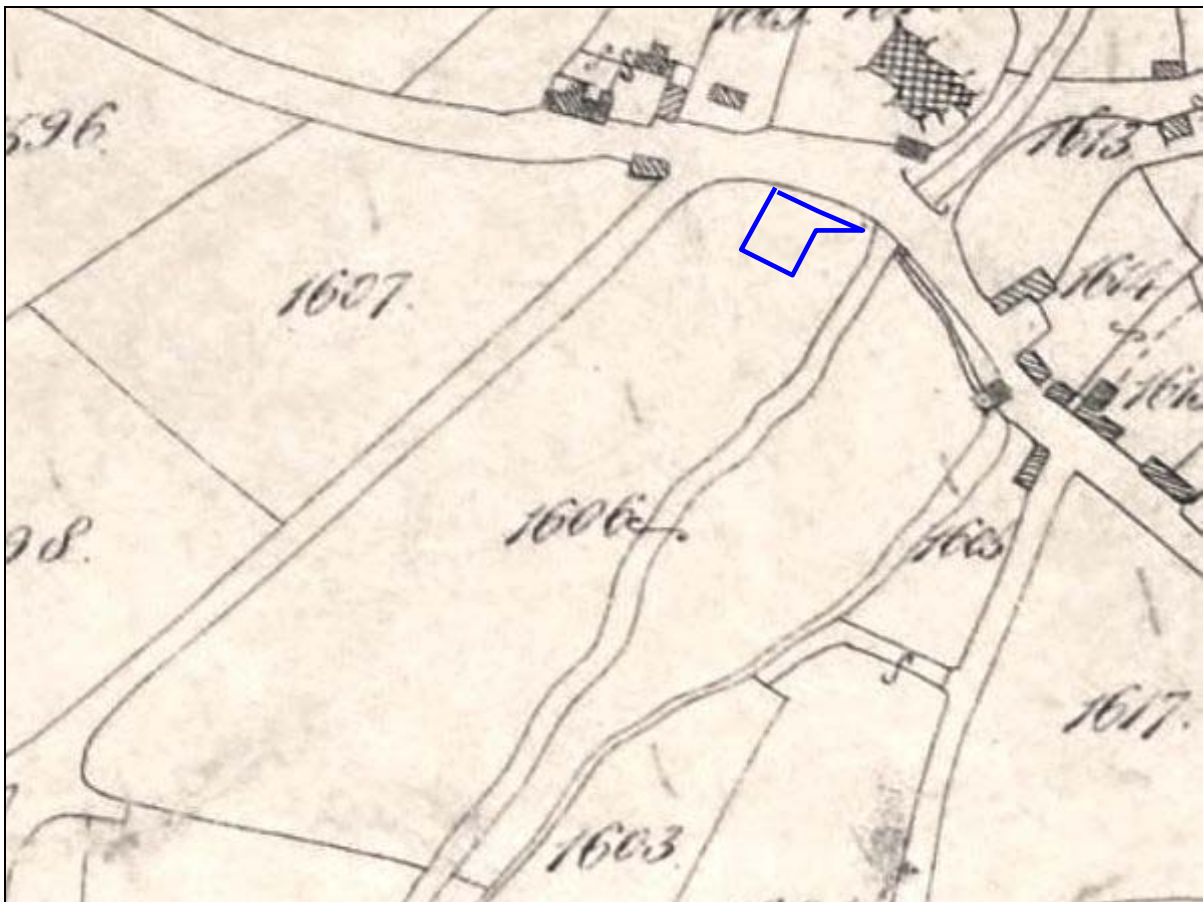
*Figure 2: Parish tithe map, showing approximate location of development plot.*

6.4 On the Llanarthne parish tithe map of 1848, the development plot lies is a large field, 1606, *Gwaun y Felyn*, through which the Afon Gwynon ran. There are no features shown on the west side of the stream. On the east side of stream a watercourse is shown running adjacent and parallel to the road from a building to the stream, presumably the mill in the field name *Gwaun y Felyn*.

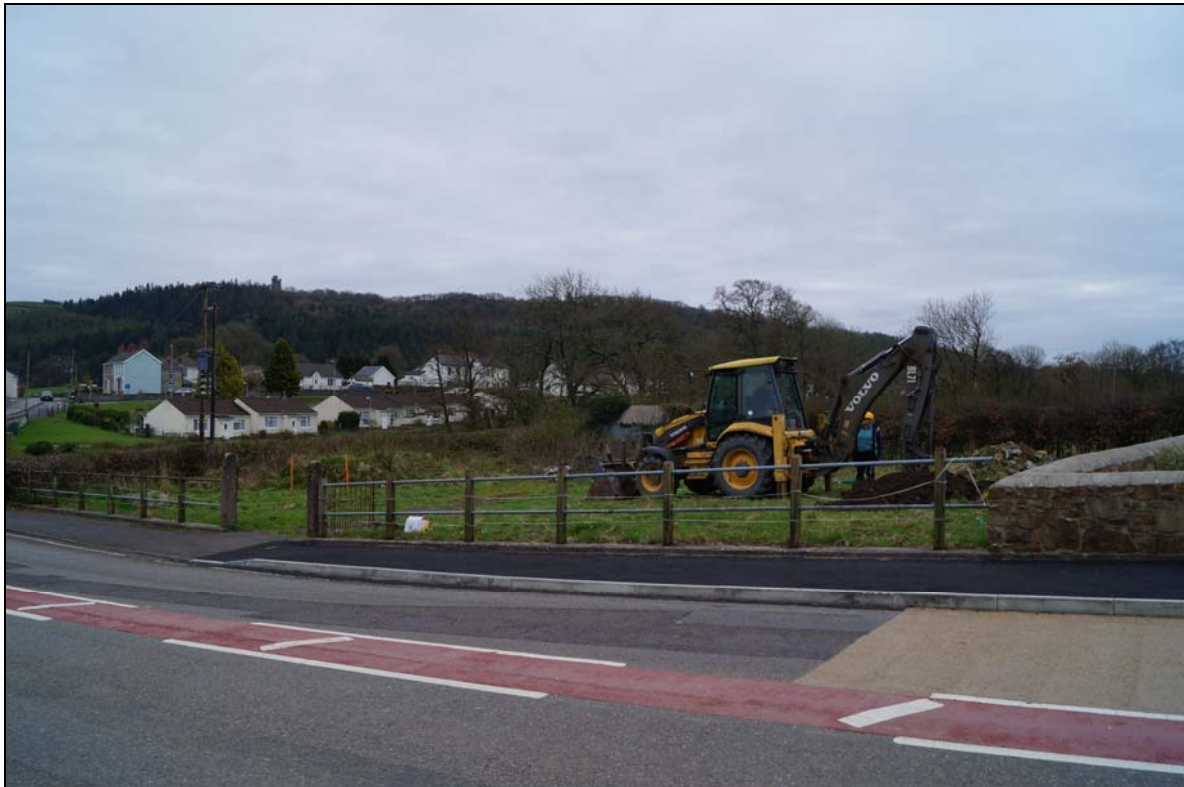
*Plate 1: LNE2016\_101. A general view of the development plot, looking southeast.  
The machine is opening Trench 1*

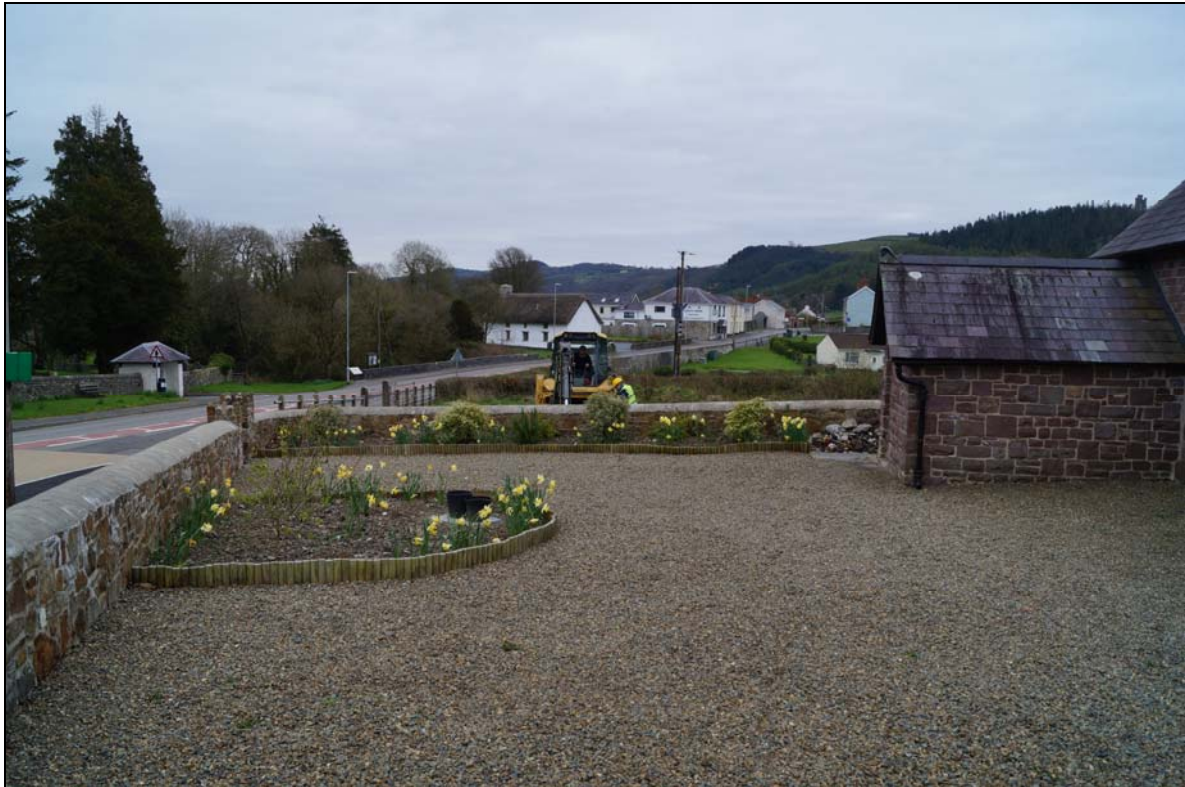
*Plate 2: LNE2016\_102. Looking east towards the development area from the western edge of the original playground of the school.*

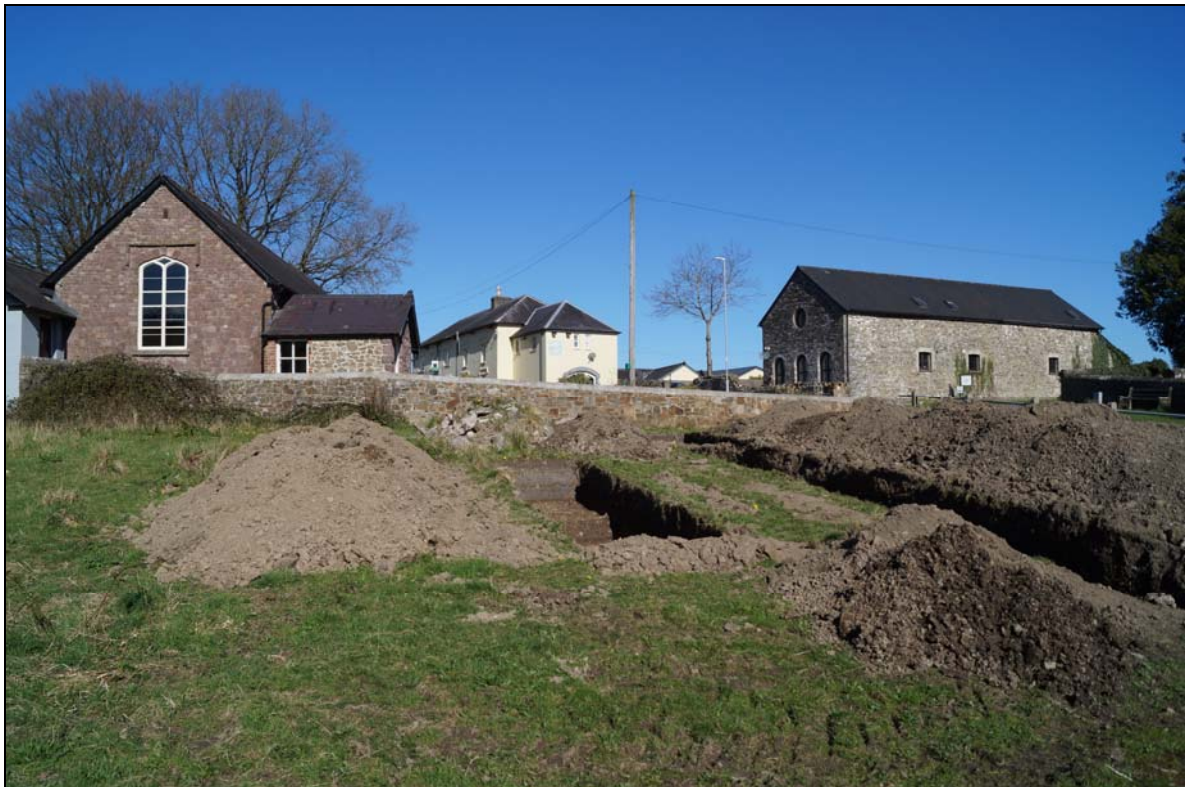
*Plate 3: LNE2016\_103. General view of part of the development area, looking northwest, towards the former school and the Golden Grove Arms*

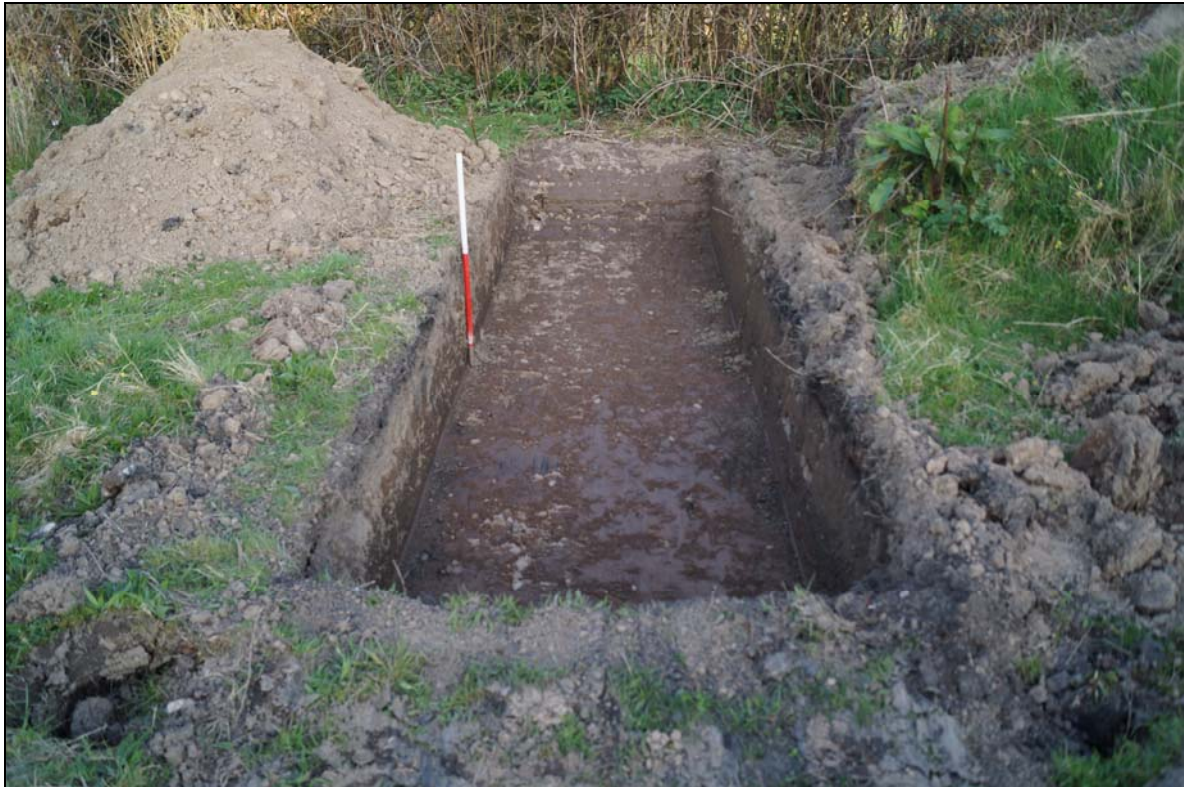
*Plate 4: LNE2016\_104. Trench 2, looking southeast. No features were seen in this trench*

13.3 No archaeological features were noted in Trench 2.

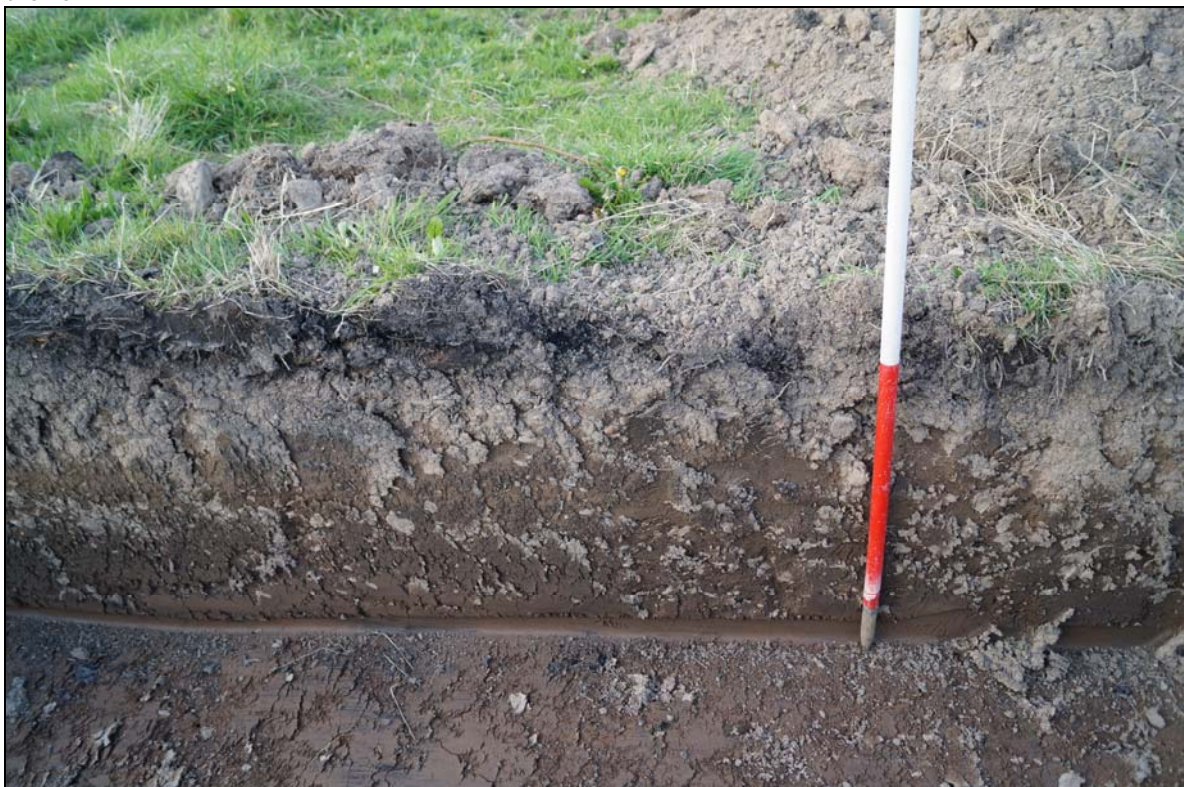
*Plate 5: LNE2016\_105. Section of Trench 2, looking northeast, showing contexts 001,003 and 014.*

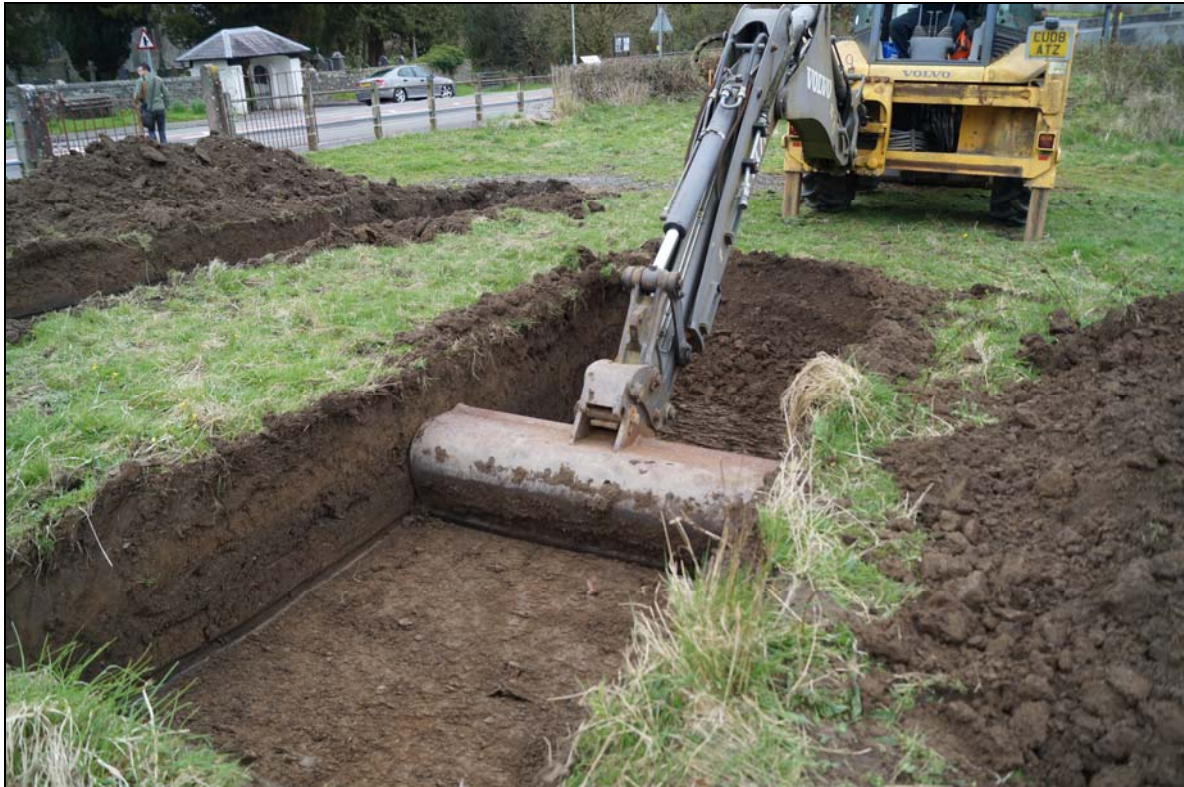
*Plate 6: LNE2016\_106. Trench 3, looking east northeast, showing contexts 001, 003, 005 and 014 in section*

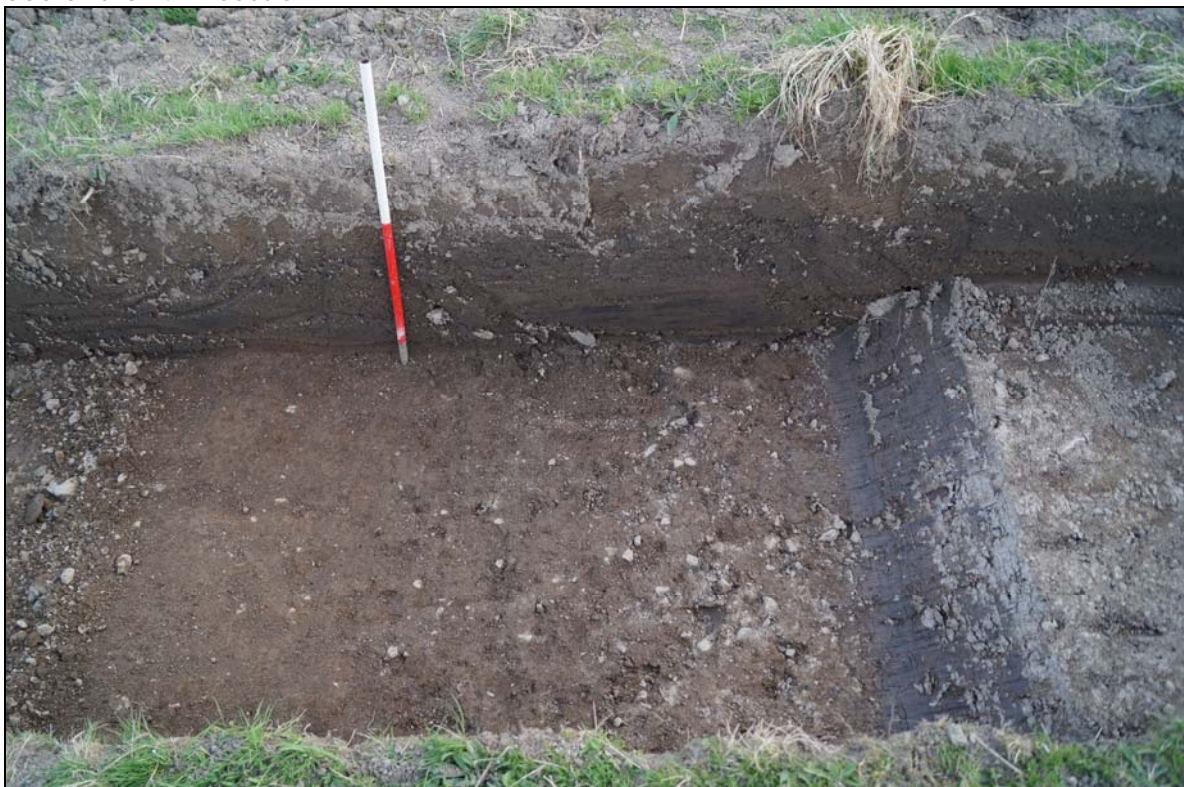
*Plate 7: LNE2016\_107. Trench 3, looking southwest, showing fill 010, the fill of a ditch 011, that was excavated in Trench 1.*

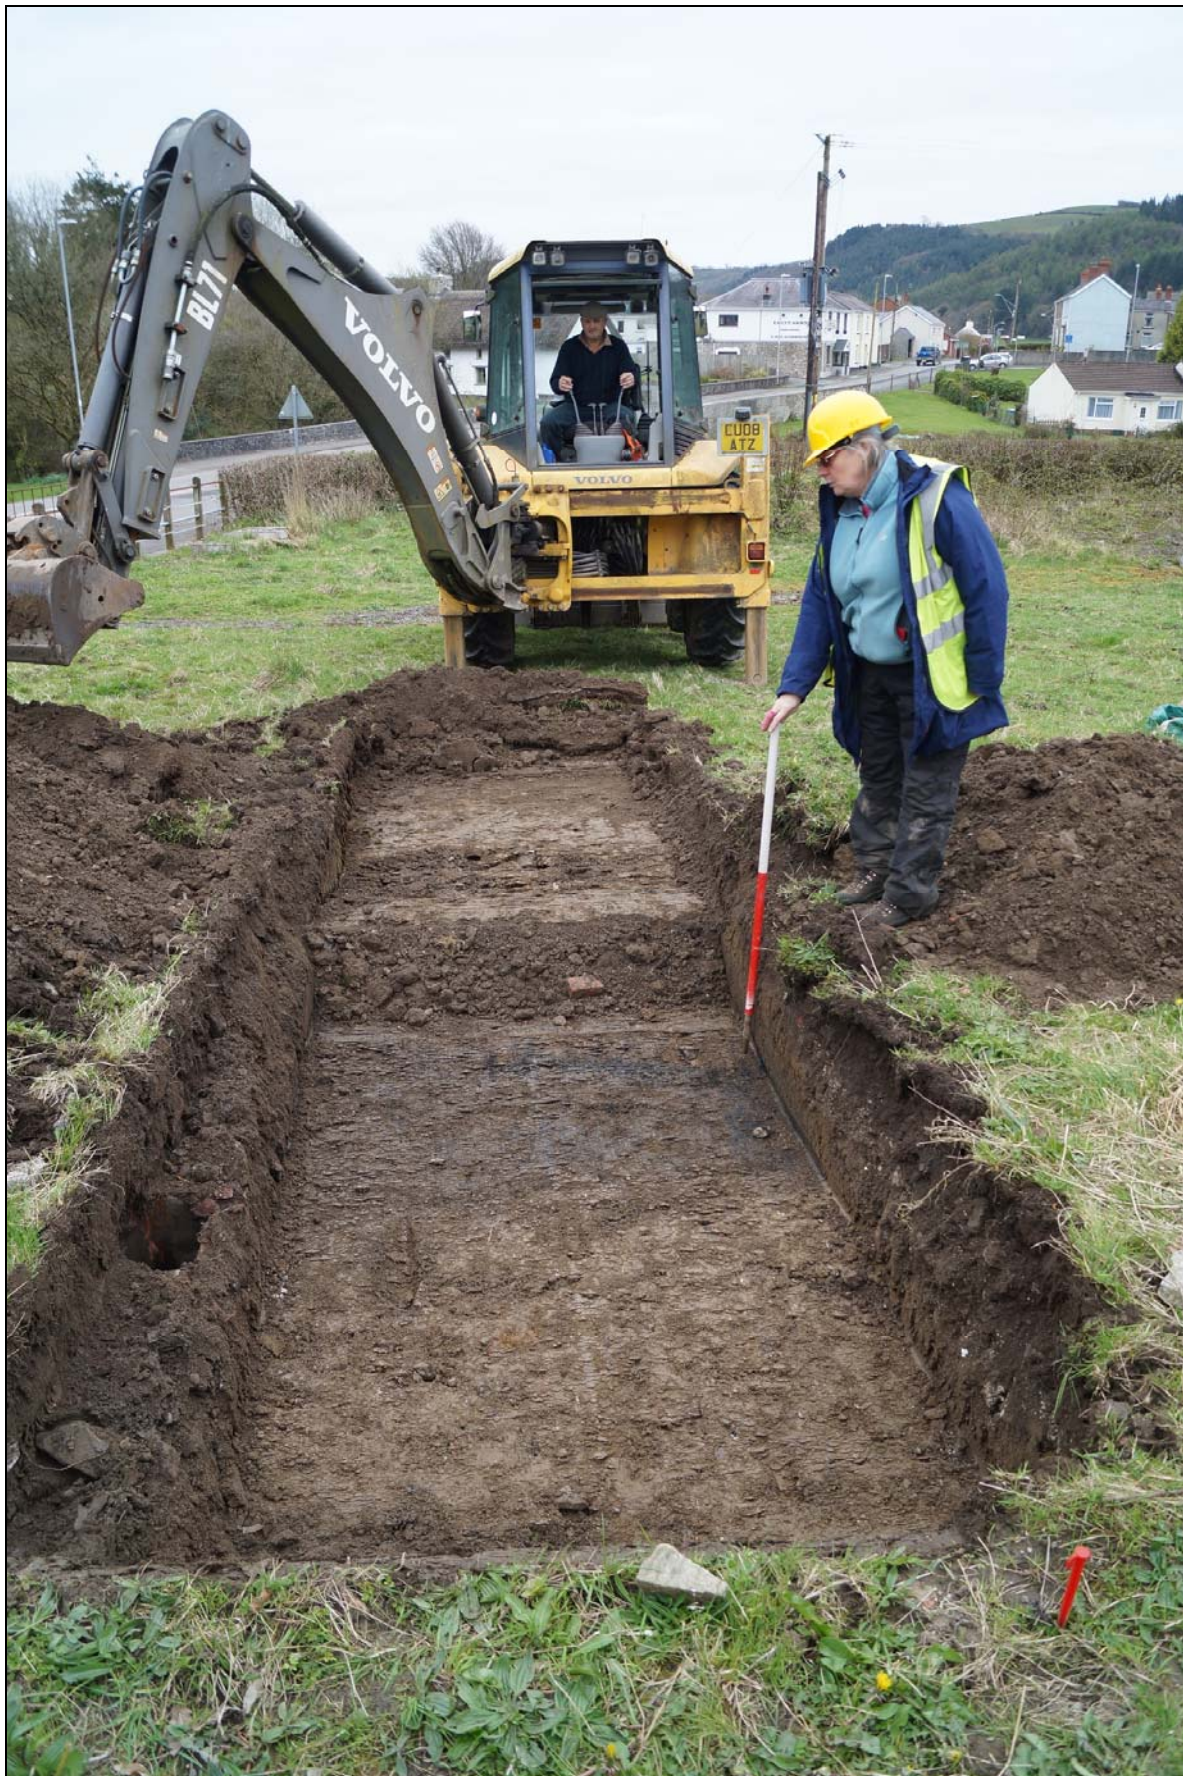
Plate 8: LNE2016\_108. Starting excavating Trench 1 with 004 visible in the foreground and 005, the darker layer starting to be revealed beyond, looking southeast

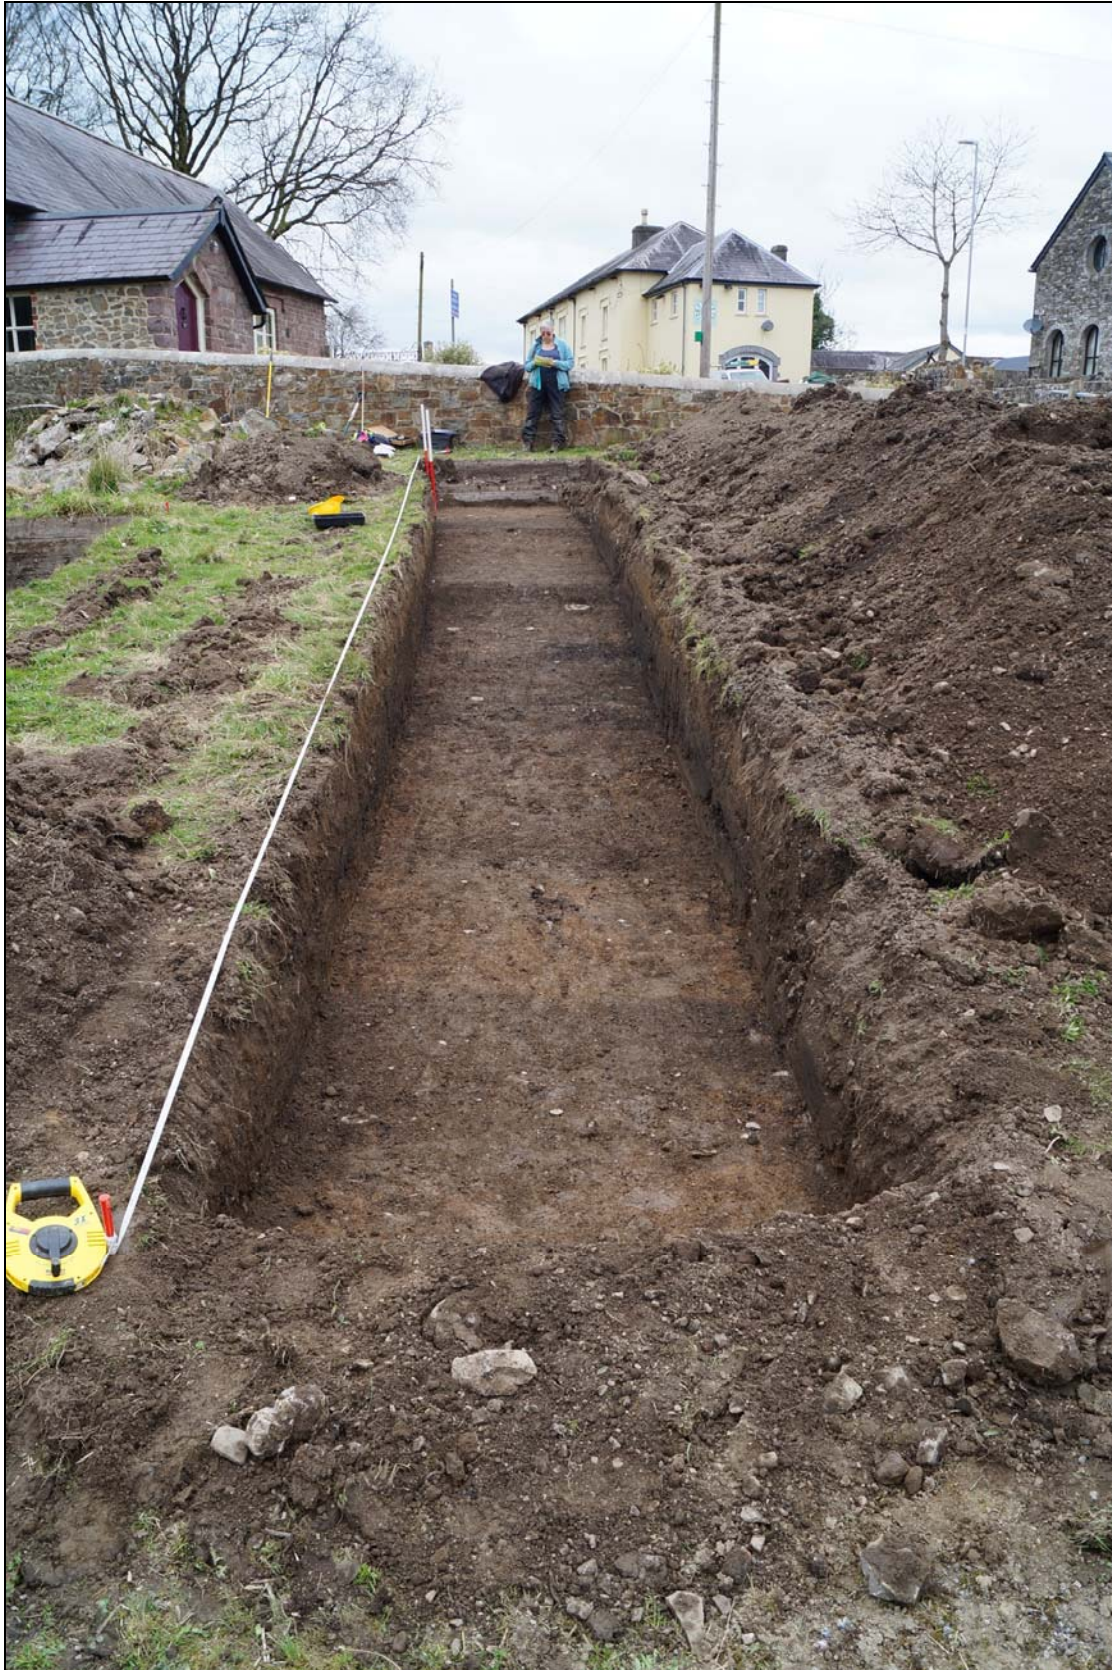
*Plate 9: LNE2016\_109. Trench 1, looking northwest, showing context 006 clearly in the foreground with 008 and 010 beyond but not so defined.*

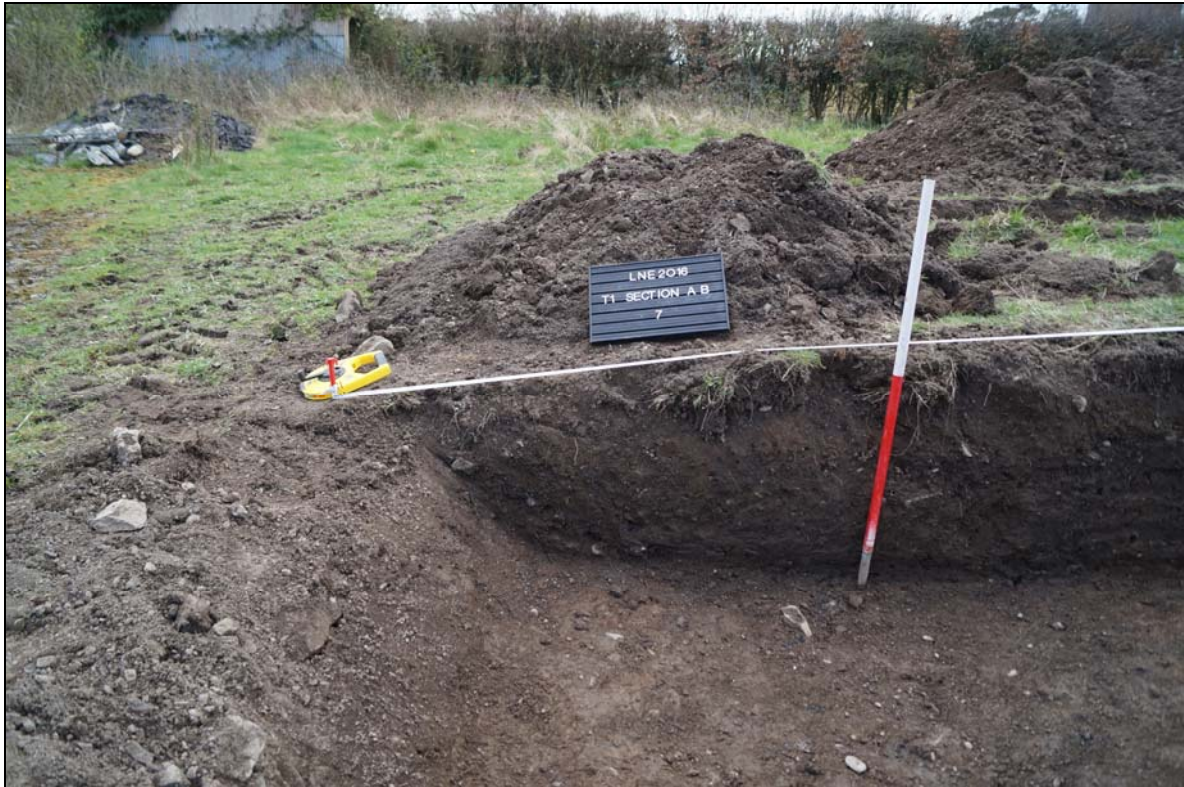
Plate 10: LNE2016\_110. Trench 1, section A to B, part 7, at southeastern end, looking southwest

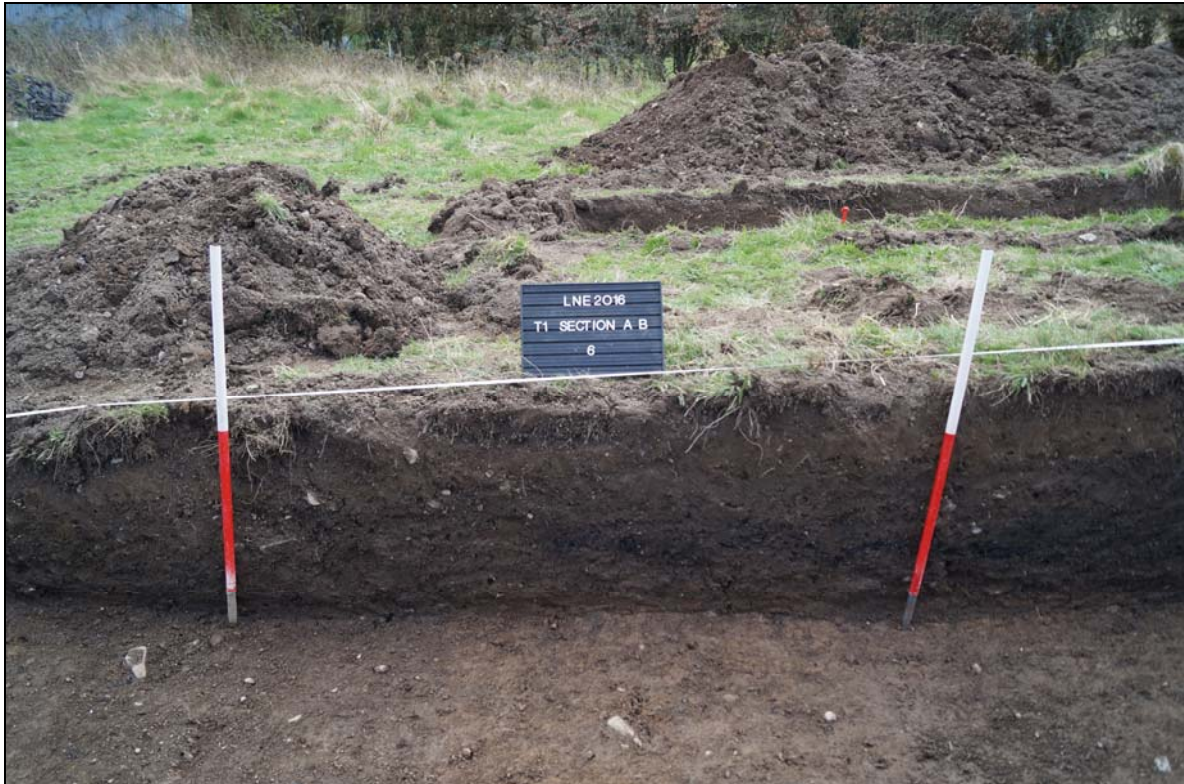
Plate 11: LNE2016\_111. Trench 1, section A to B, part 6, looking southwest, ranging poles 2 metres apart. Contexts 001, 003, 005 and 014 are visible in section. Fills 006 (to the left) and 008 (to the right)

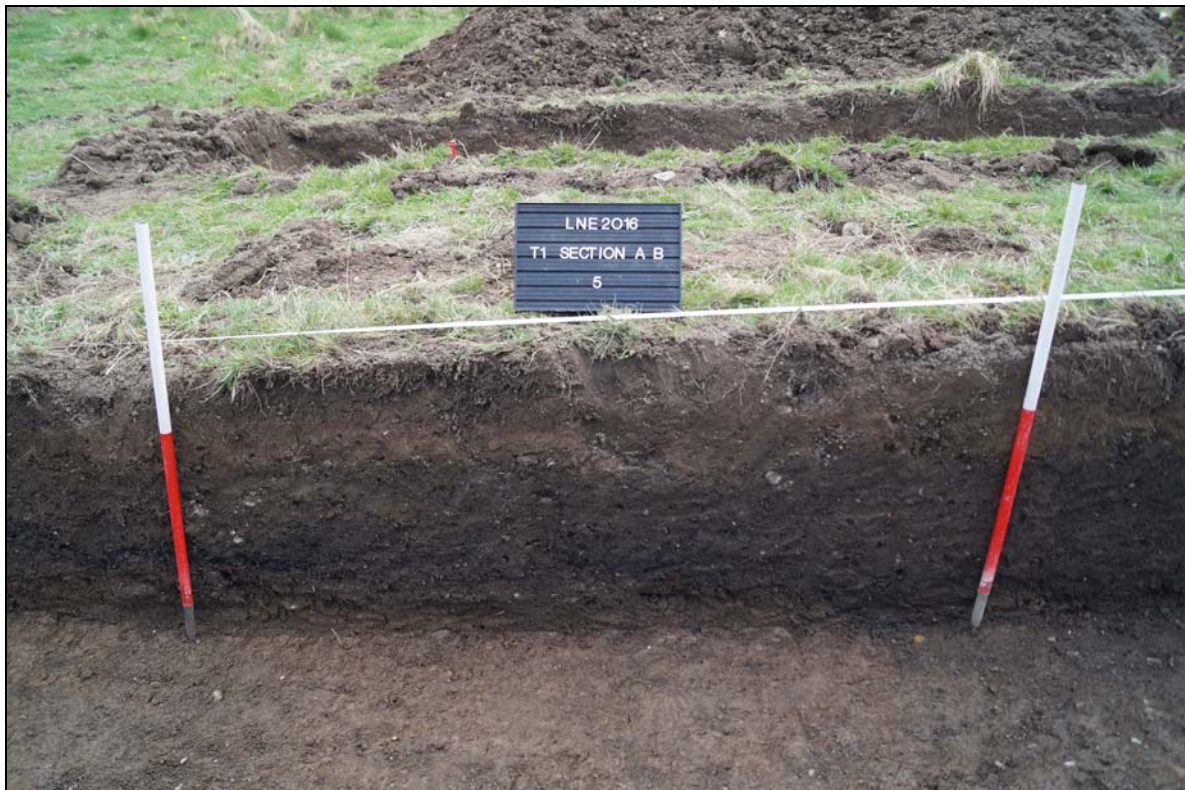
Plate 12: LNE2016\_112. Trench 1, section A to B, part 5, looking southwest, ranging poles 2 metres apart. Contexts 001, 003, 005 and 014 are visible in section. Fill 010 visible on the right of photo in the base of the trench.

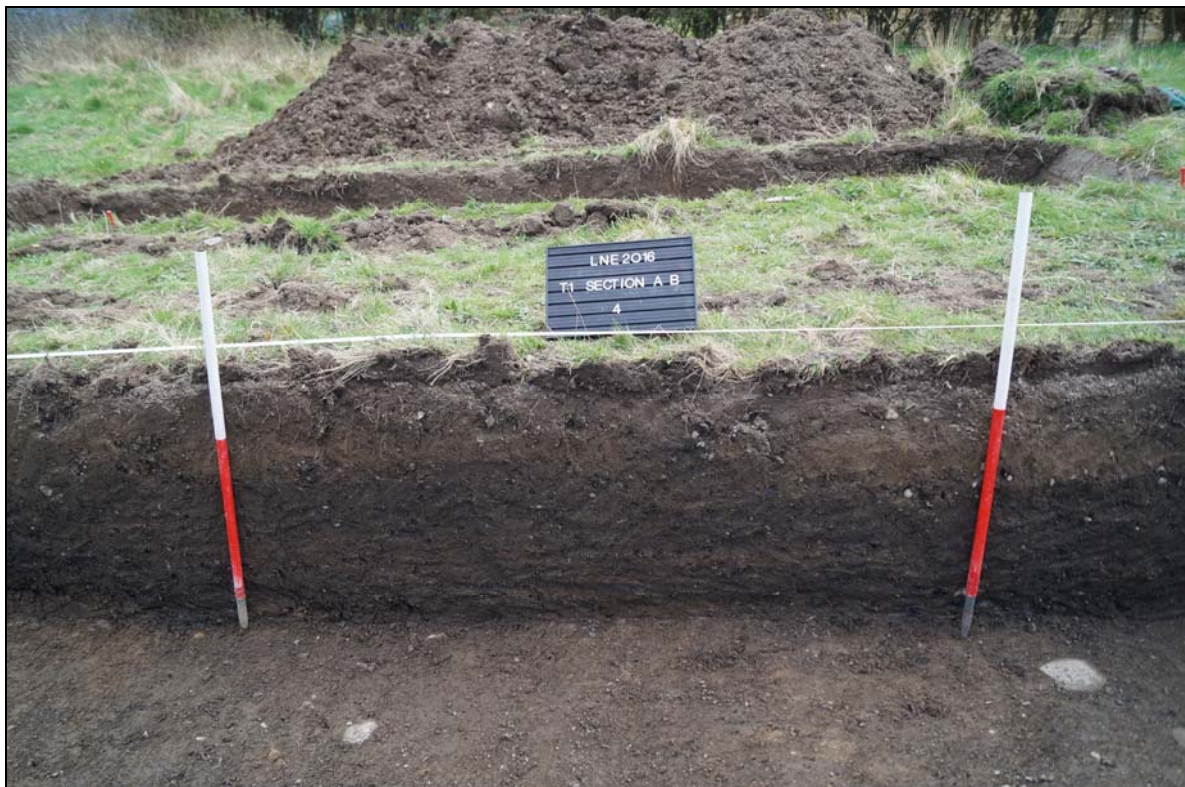
Plate 13: LNE2016\_113. Trench 1, section A to B, part 4, looking southwest, ranging poles 2 metres apart. Contexts 001, 003 and 005 are visible in section. Fill 010 visible in the base of the trench.

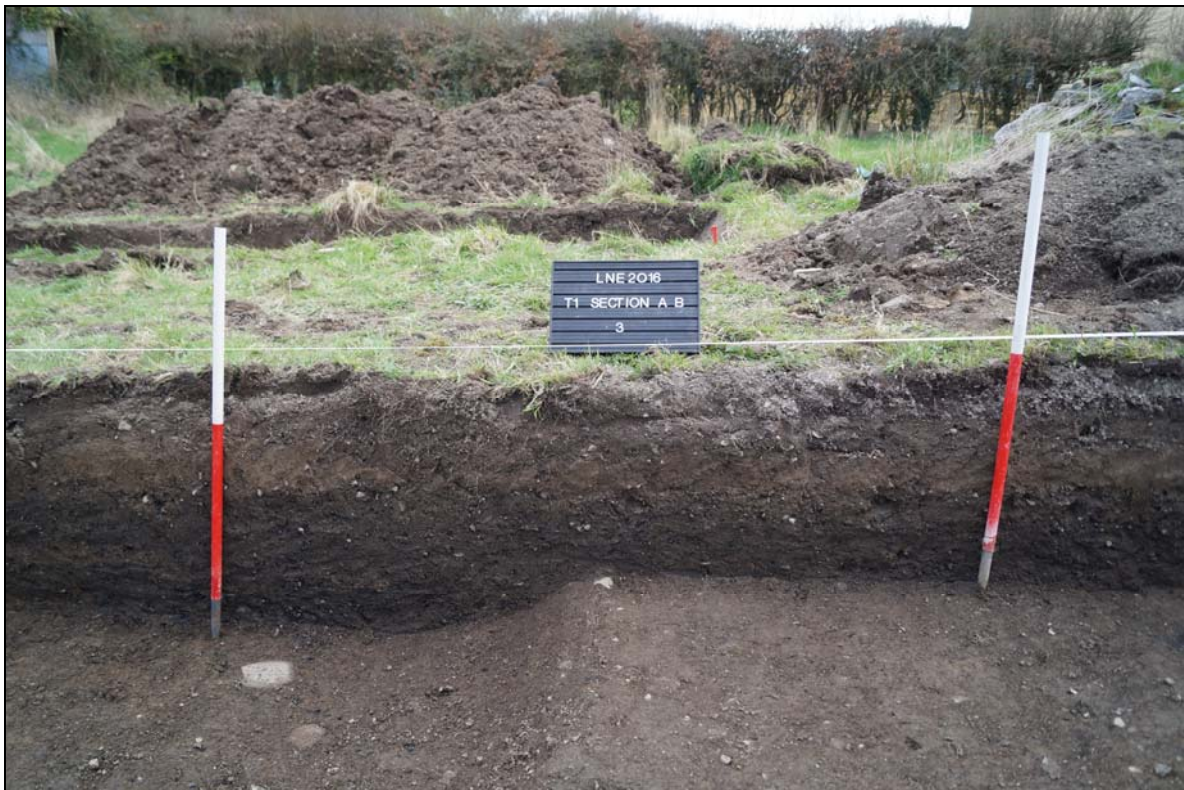
Plate 14: LNE2016\_114. Trench 1, section A to B, part 3, looking southwest, ranging poles 2 metres apart. Contexts 001, 003 and 005 are visible in section. Fill 010 visible in the base of the trench on the left

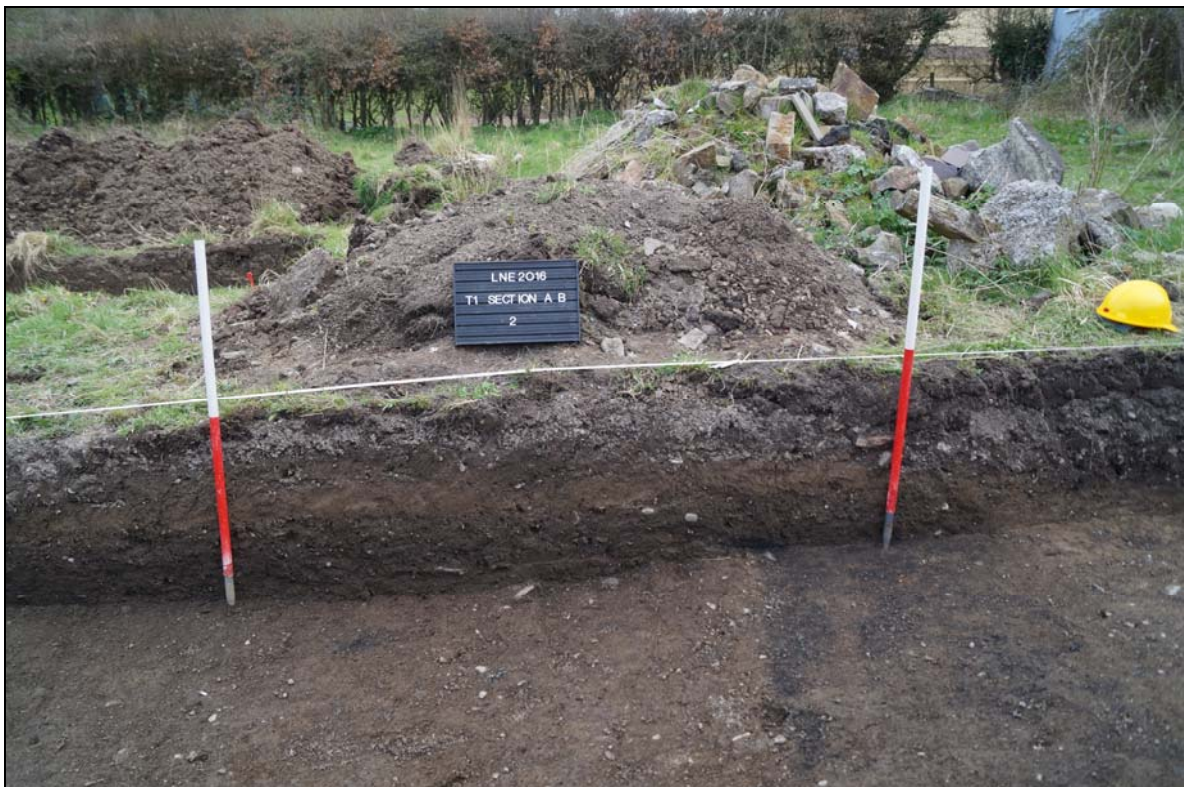
Plate 15: LNE2016\_115. Trench 1, section A to B, part 2, looking southwest, ranging poles 2 metres apart. Contexts 001, 003, 005 and 013 are visible in section.

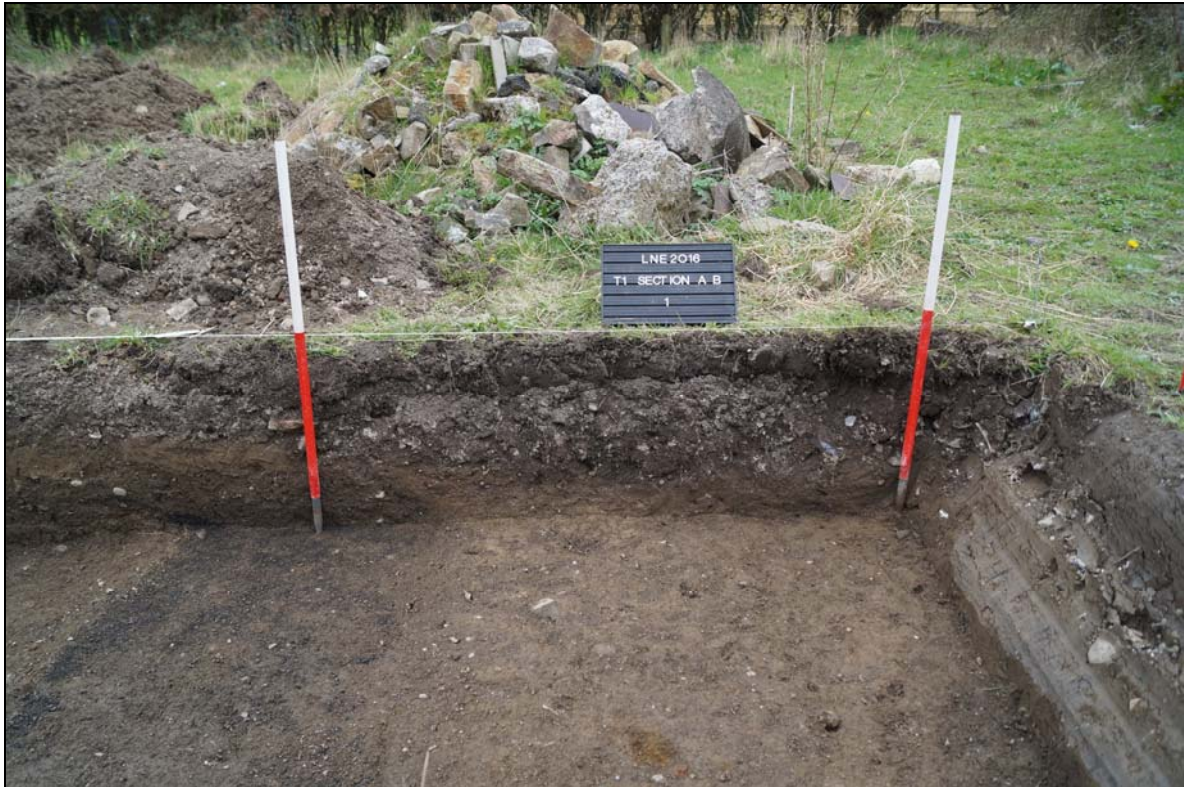
Plate 16: LNE2016\_116. Trench 1, section A to B, part 2, looking southwest, ranging poles 2 metres apart. Contexts 001,002, 003/004 and 005 are visible in section. 004 and 005 visible in the base of the trench

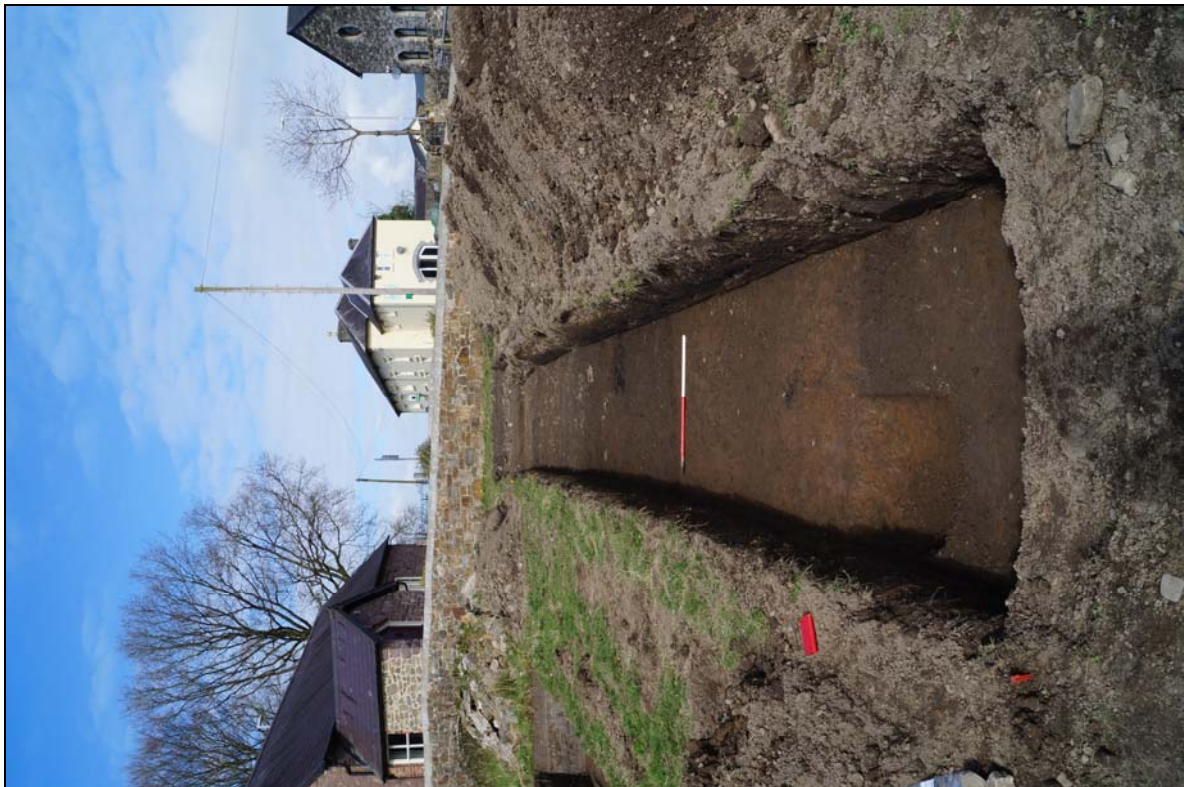
Plate 17: LNE2016\_117. Trench 1, looking northwest, showing excavated section of gully 007 in the foreground

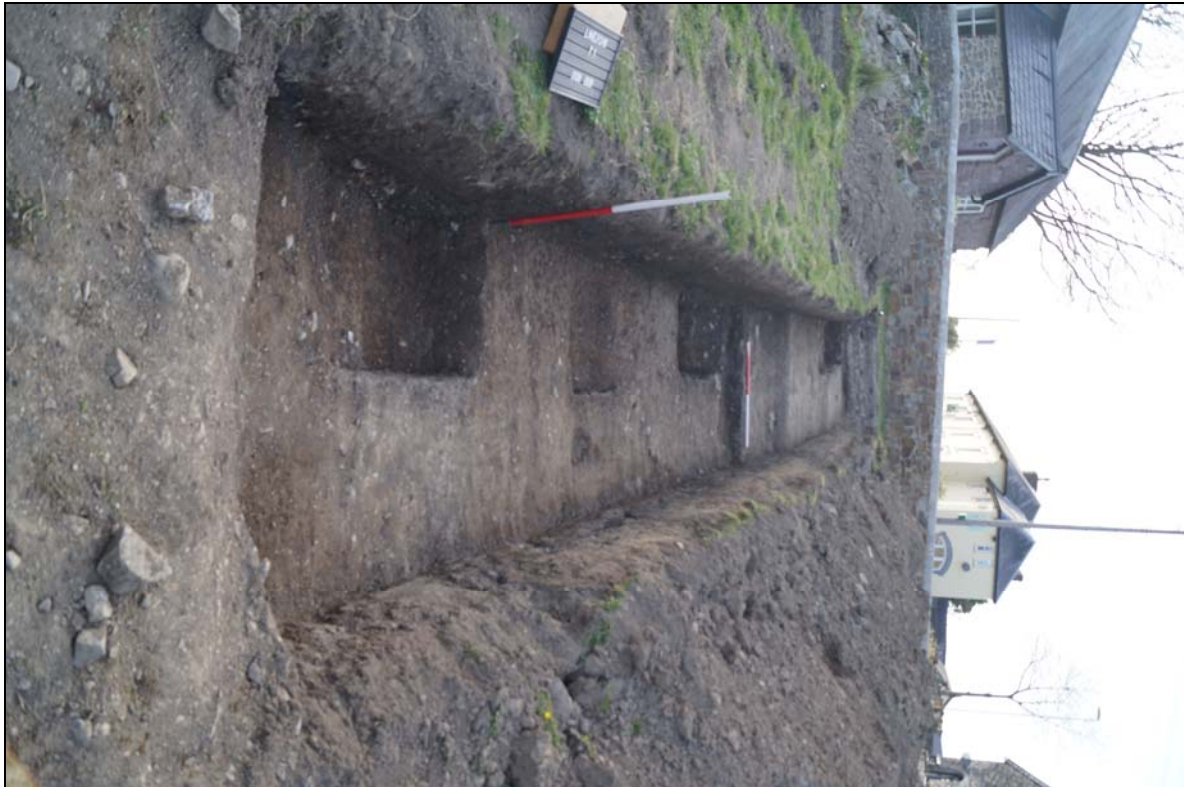
Plate 18: LNE2016\_118. Trench 1 showing excavated sections of gullies 007, 009 and ditch 011, looking northwest.

13.2.3 The purpose of Ditch 011 and the Gullies 007 and 009 is not apparent. It can only be surmised that they were still open cuts when the process of dumping coal waste or ash began on the surface of the field and that they became quickly infilled, and that this occurred at some point between the 17<sup>th</sup> and 19<sup>th</sup> centuries, based on the evidence of the pottery sherds found in the fills of each feature.

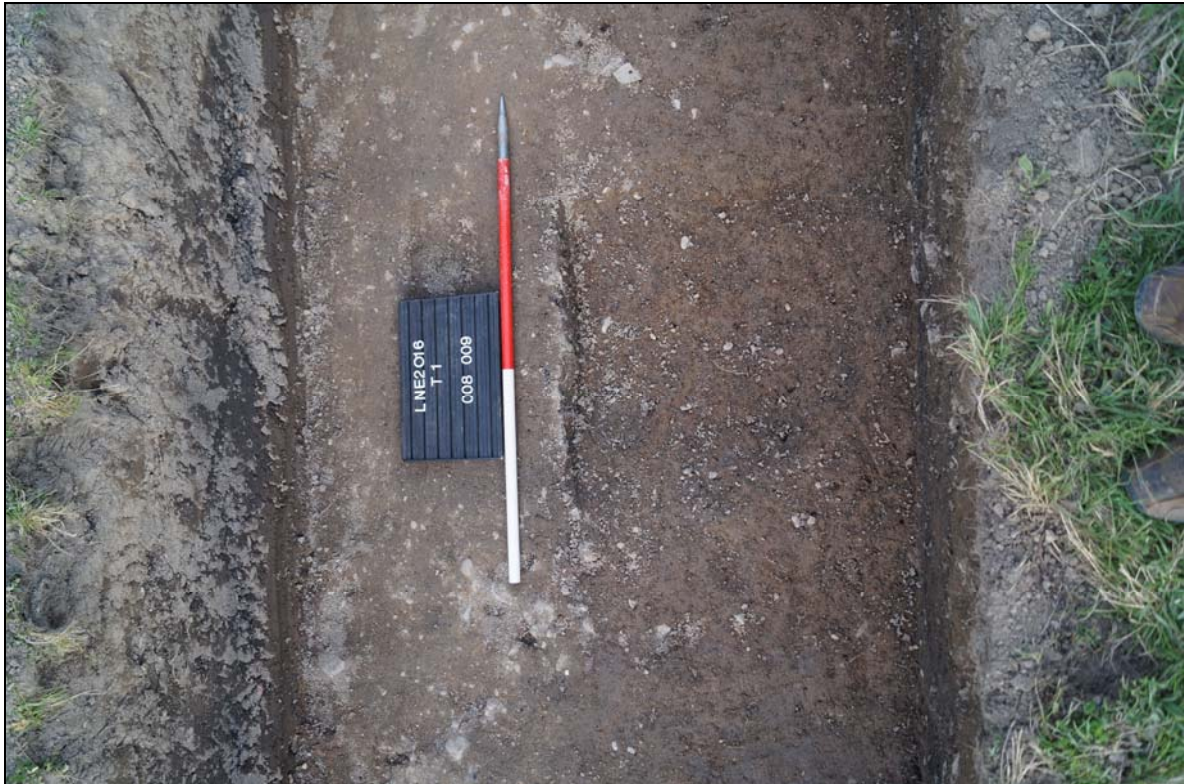
Plate 19: LNE2016\_119. Trench 1, the excavated end of gully 009, looking northeast
