# Land adjacent to Hen Ysgol, Llanarthne, Carmarthenshire Evaluation Report

Trysor Project No. 2016/508

RHIF YR ADRODDIAD - REPORT NUMBER: Trysor 2016/508

1.1 In April 2016, Trysor undertook an evaluation in advance of groundworks for a single dwelling at SN5338620221 on land adjacent to the old school in Llanarthne, Carmarthenshire, W/32733.

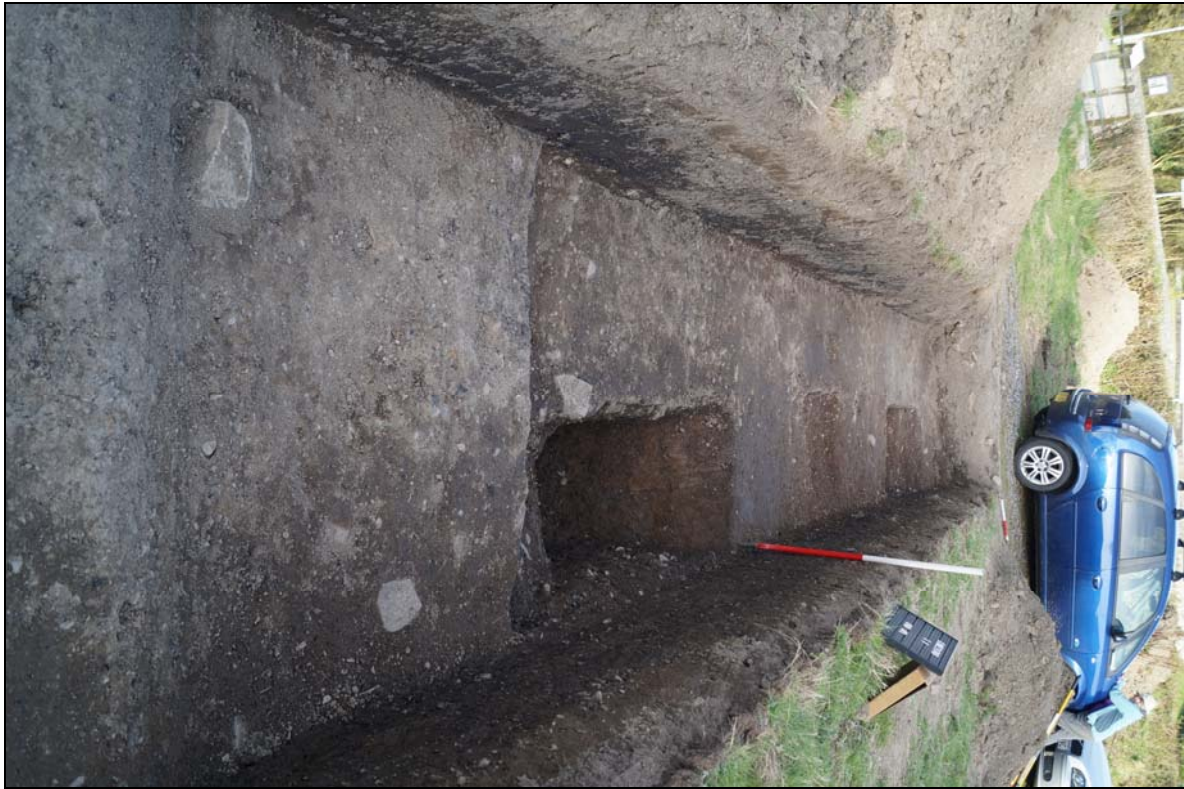
*Plate 20: LNE2016\_120. Trench 1, looking southeast, showing excavated section of ditch 011 and gullies 009 and 007.*

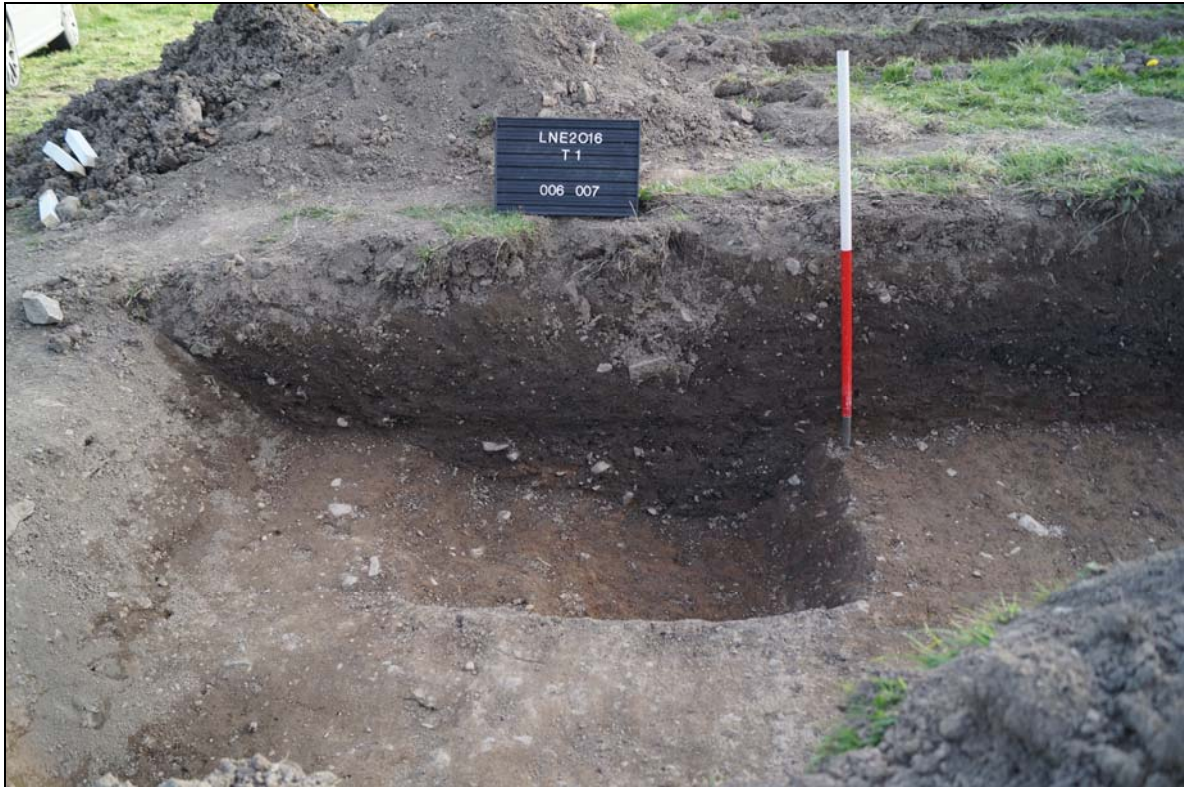
*Plate 21: LNE2016\_121. Trench 1, excavated section of gully 007, looking southwest.*

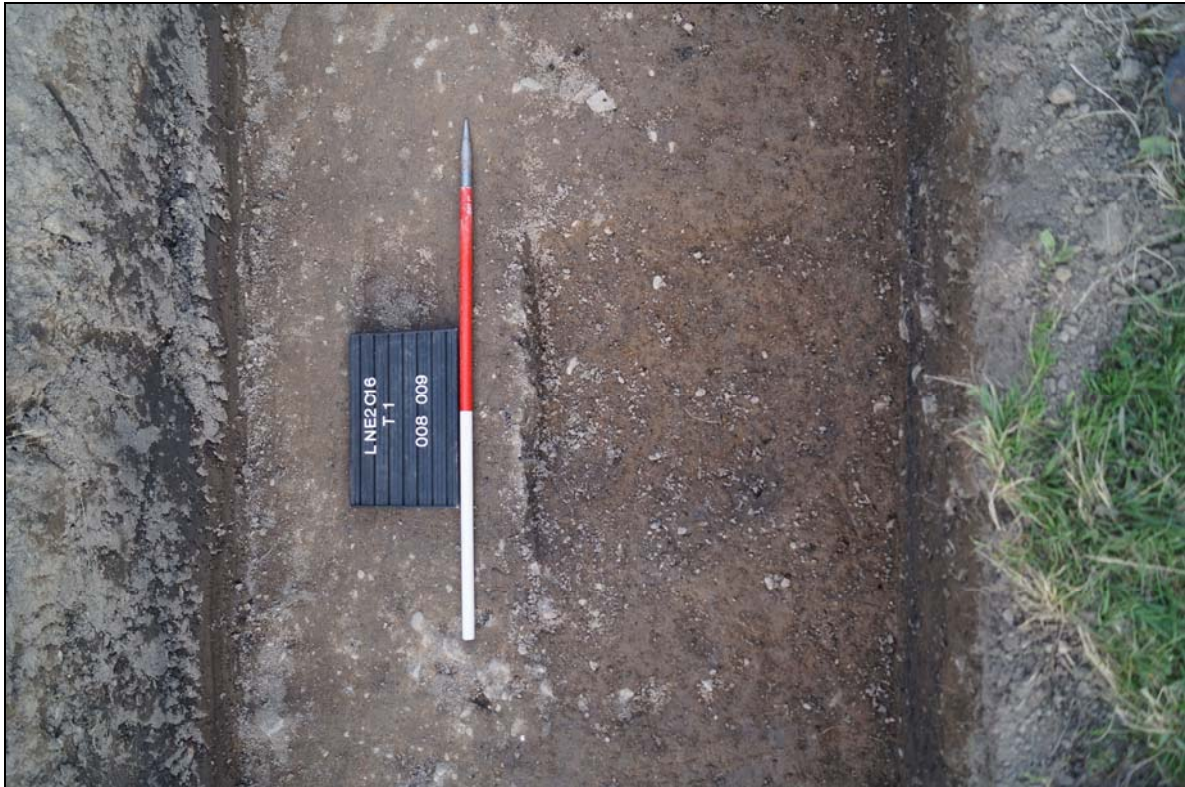
Plate 22: LNE2016\_122. Trench 1, looking northeast, showing excavated section of the end of gully 009

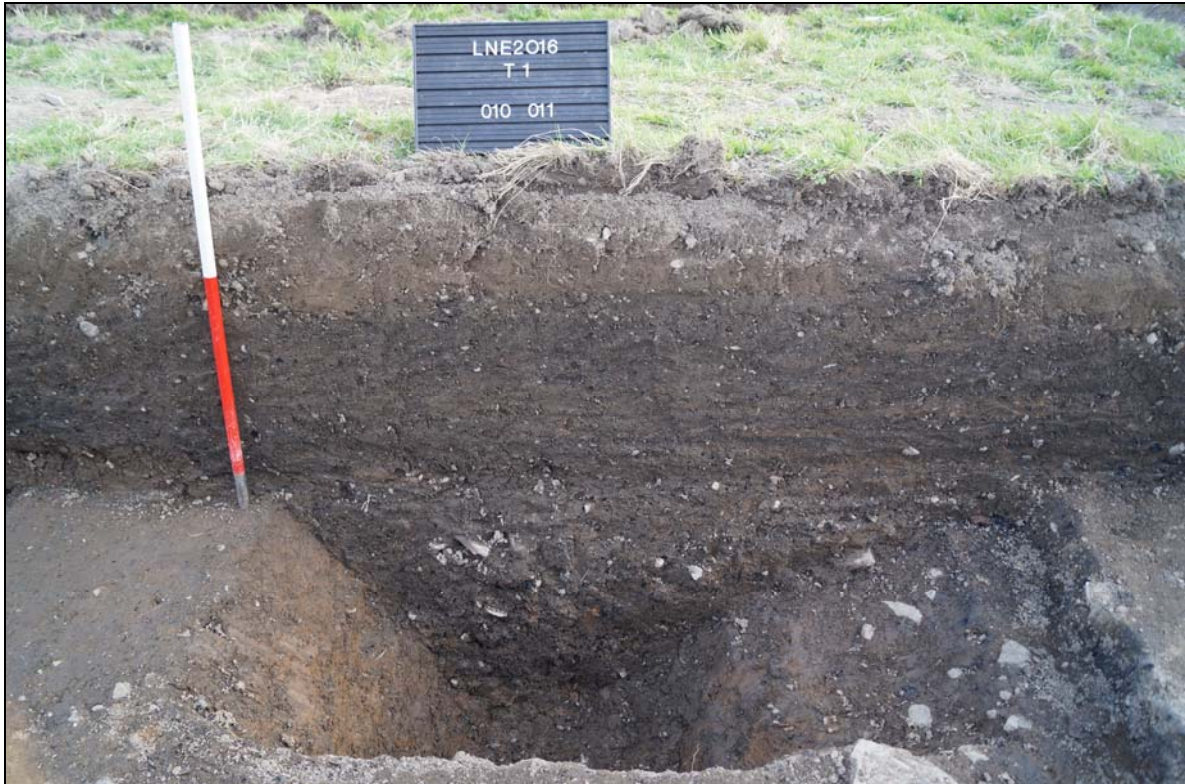
Plate 23: LNE2016\_123 Trench 1, looking southwest, showing excavated section of ditch 011, and contexts 005 and 010 in section

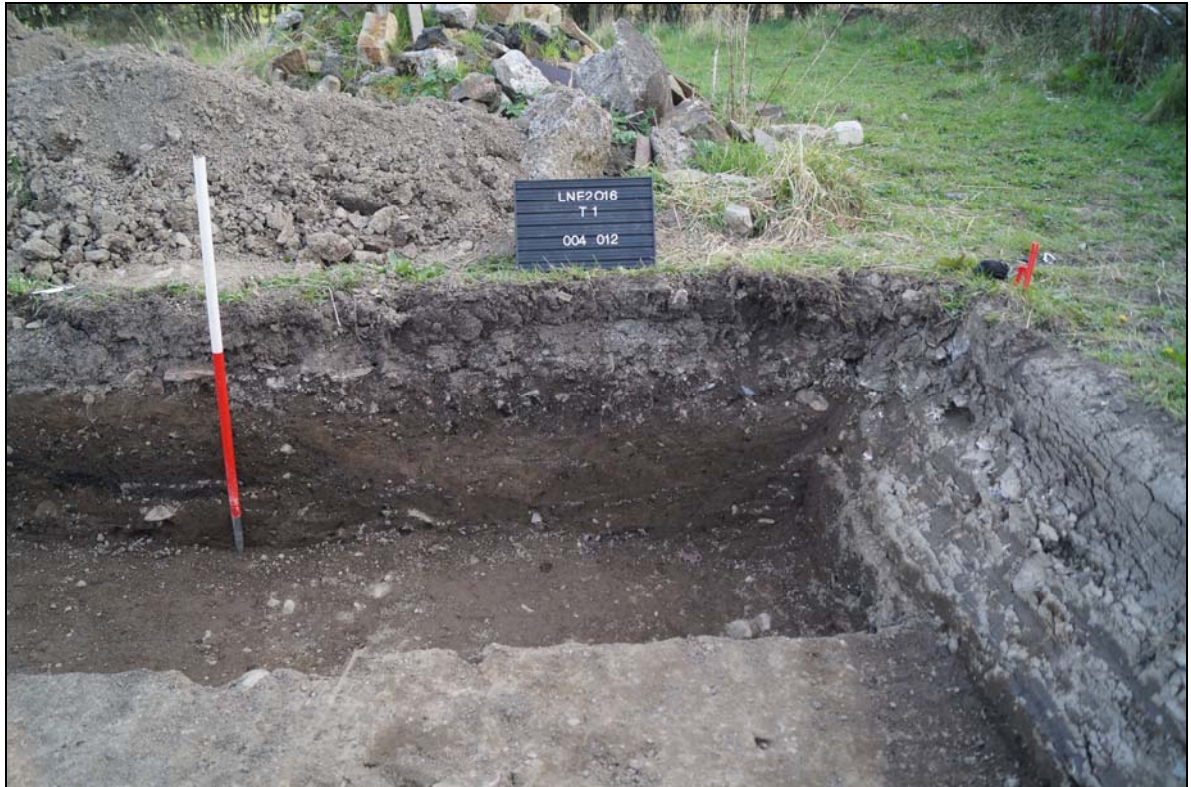
*Plate 24: LNE2016\_124. Trench 1, looking southwest, partially excavated feature 012, filled by 004 and 002, with 001 above.*

13.2.4 The fourth feature in Trench 1, context 012, was cut through context 005 and its own fill, context 004 included pottery and other artefacts of 19<sup>th</sup> century date. These included broken writing slates and inkpots which evidently originated from the adjacent village school, which first opened in 1856. Context 012

appears to be a rubbish pit, as its fill (context 004) included clay pipe fragments, window glass and coal.
