RATCOED RESERVOIR, GWYNEDD

Archaeological Mitigation

Prosiect Rhif / Project No. G2609

Adroddiad Rhif / Report No. 1483

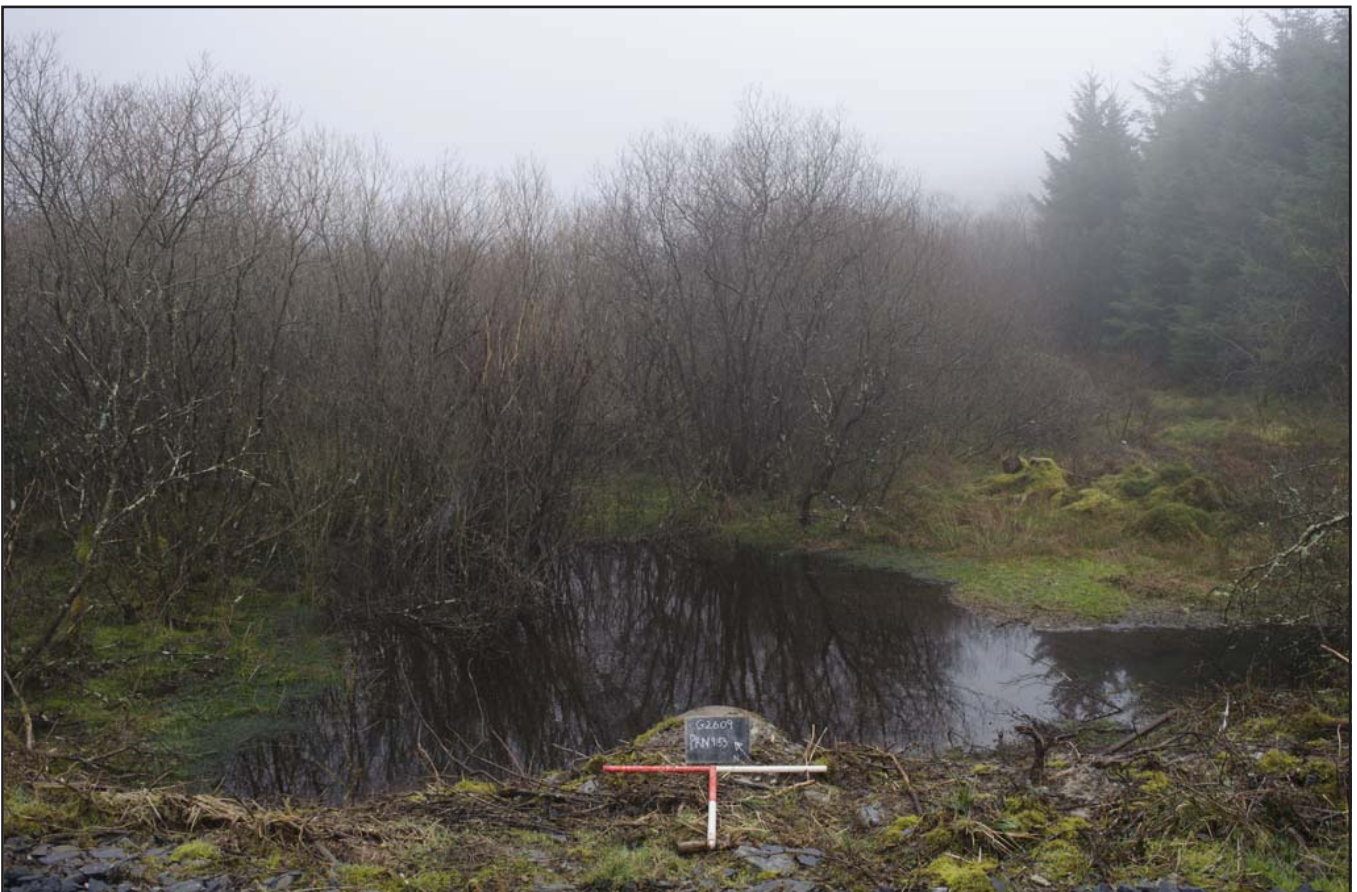
Plate 2: View of reservoir PRN 9153 from the access road showing extent of silting and tree growth; scale: 2x1m (archive reference: G2609_002).

Feature Number	02 – Plates (2 to 6,24)
Site name	Ratcoed Reservoir
PRN number	9153
Grid reference	Centred on NGR SH786123
Period	19 th century
Site type	Reservoir
Assessment category	C
Description	<p>Reservoir PRN 9153 is the smallest of the three reservoirs. It has a length of c.36m down its longest axis (NE-SW) and 26 meters in width. The reservoir has silted up with dense tree growth within the interior; trees are of a young elder brush variety (Plate 2 and 4). In addition, evidence of forestry management with cut trees, tree stumps and logs are present within the reservoir. Very wet within the interior with only a pool of water still standing next to/abutting the forestry track (Plate 2 and 24). This is the result of the breached water course running through and discharging through a modern sluice which runs under the trackway and discharging to the south-west.</p> <p>No earthworks relating to the initial cutting of the reservoir were observed. However, the cut was fairly prominent on the north-western side with a fairly vertical drop down to the bed (Plate 4 and 5). From the roadside to the south-west the gradient could be seen, however, the forestry track would have truncated it slightly at this point and modified its appearance (Plate 24). On the south-eastern side the gradient was less sharp but still present. The overflow of the main dam would have drained into this reservoir; signs of the overflow are seen on the south-eastern edge of the dam.</p>

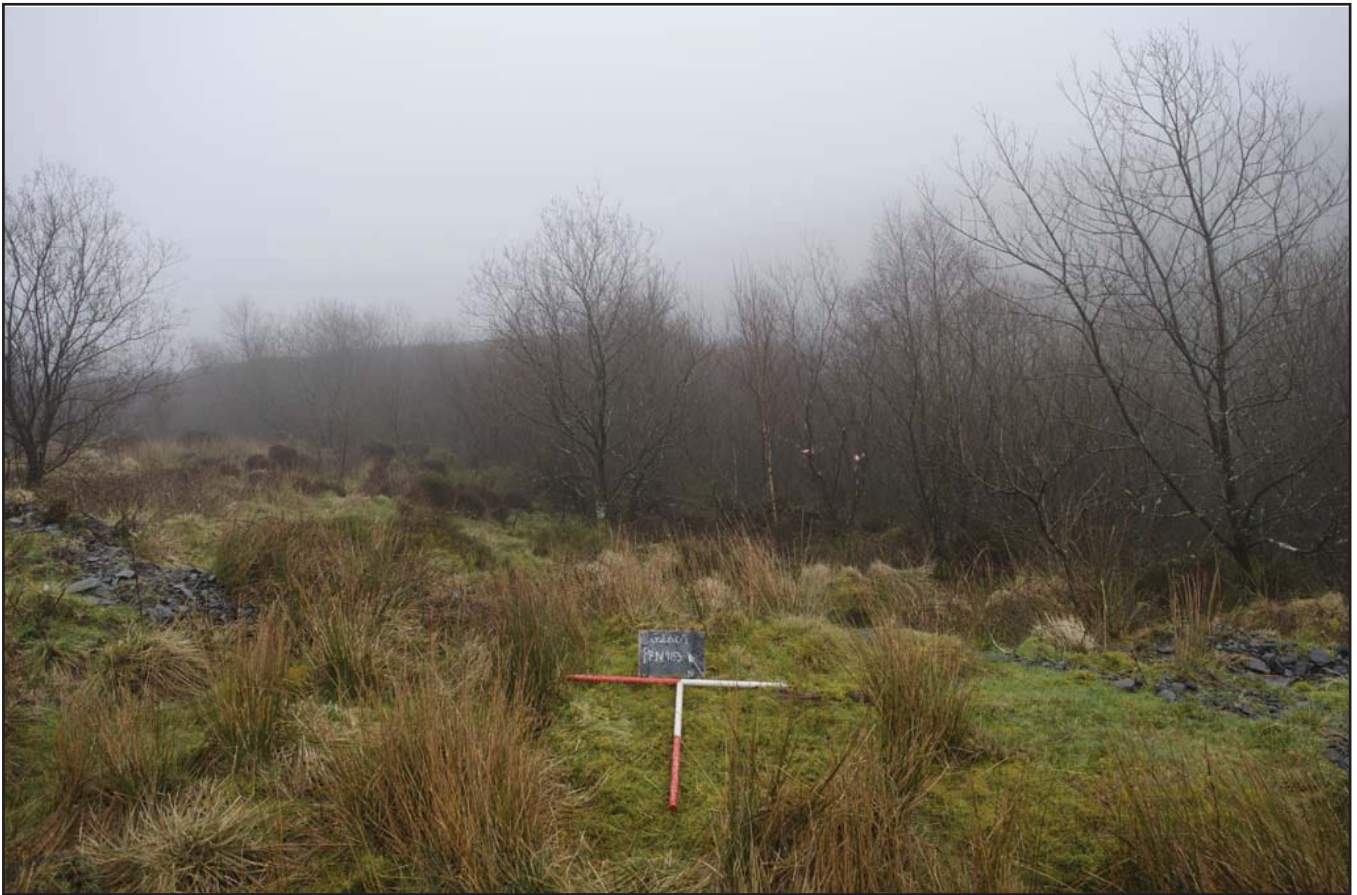
Plate 3: View of gradient on north-western side running down to reservoir PRN 9153 also showing extent of tree growth; scale: 2x1m (archive reference: G2609_003).

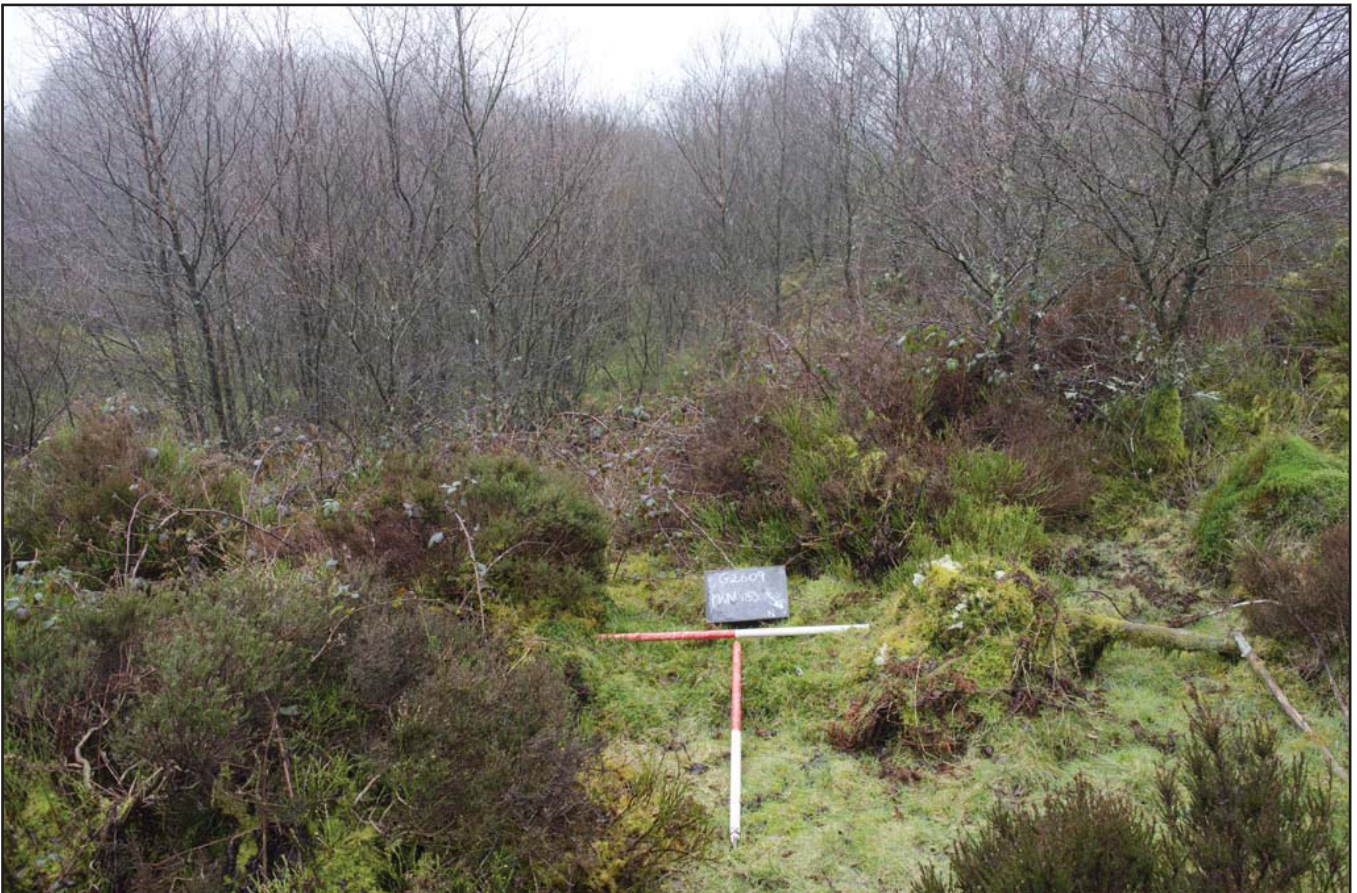
Plate 4: View of PRN 9153 showing cut of reservoir on north-western side ; scale: 2x1m (archive reference: G2609_004).

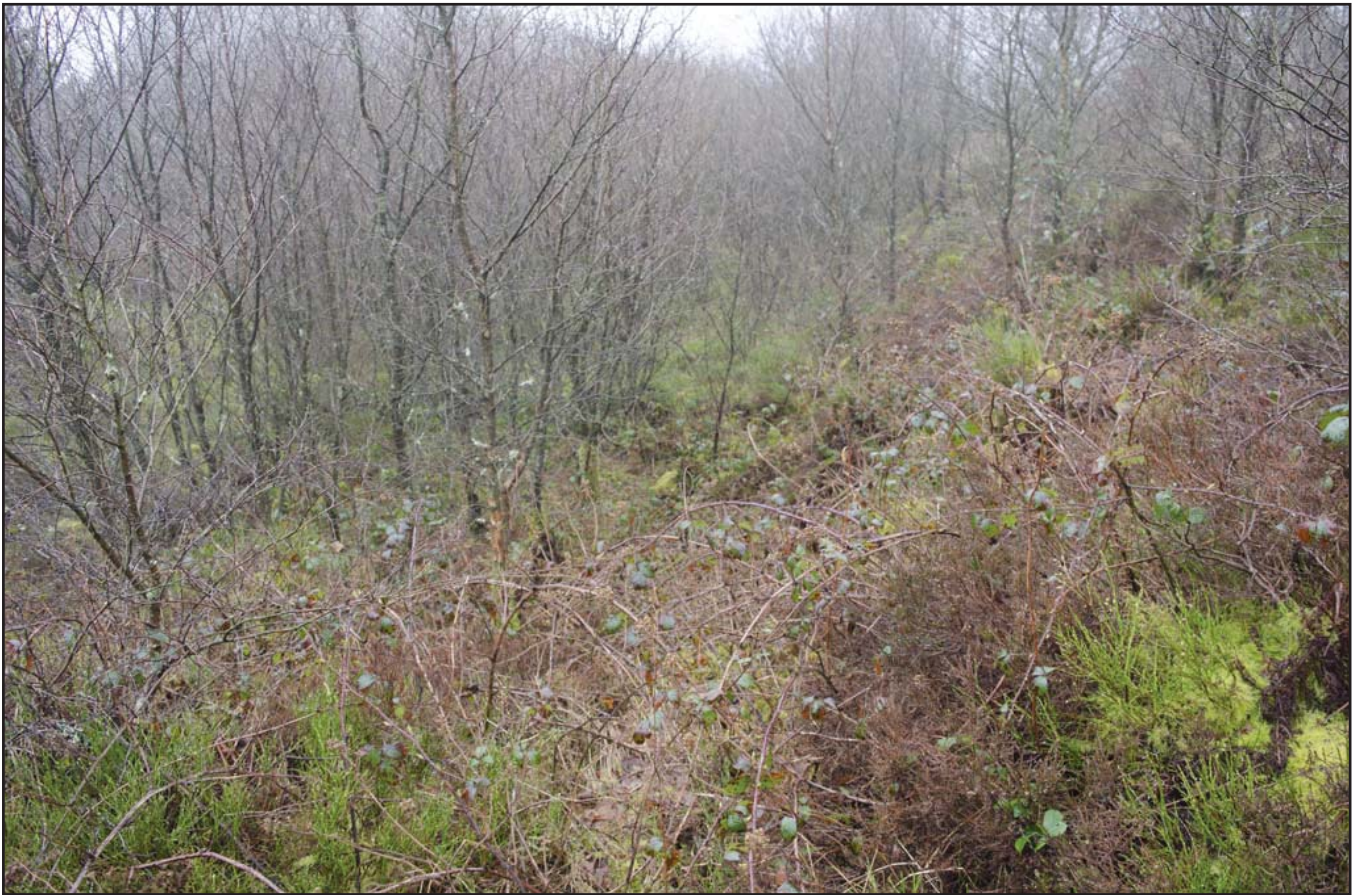
Plate 5: View of PRN 9153 showing cut of reservoir on north-western side (archive reference: G2609_005).

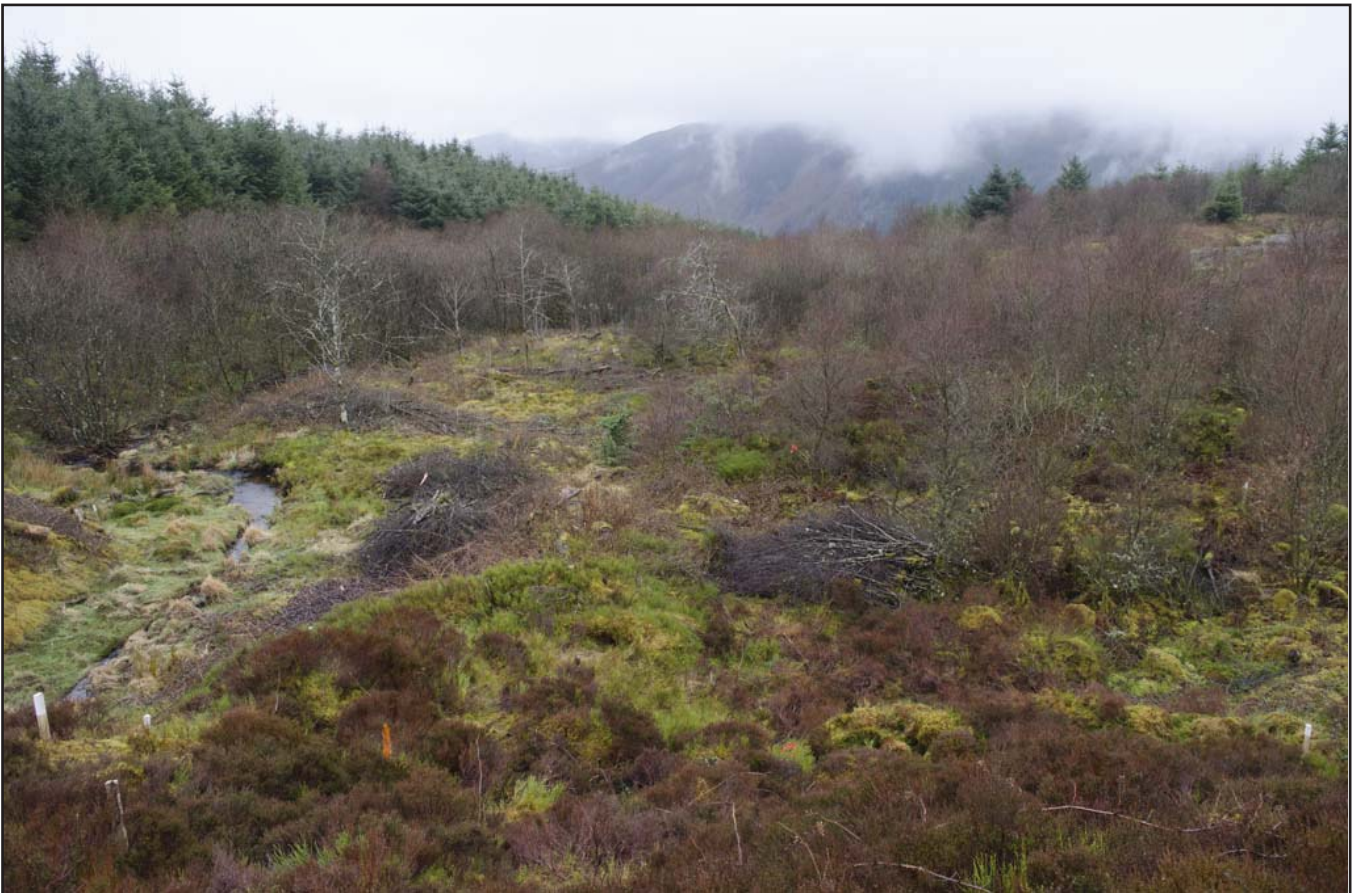
Plate 6: General view of reservoir PRN 9153 from top of dam (archive reference: G2609_006).

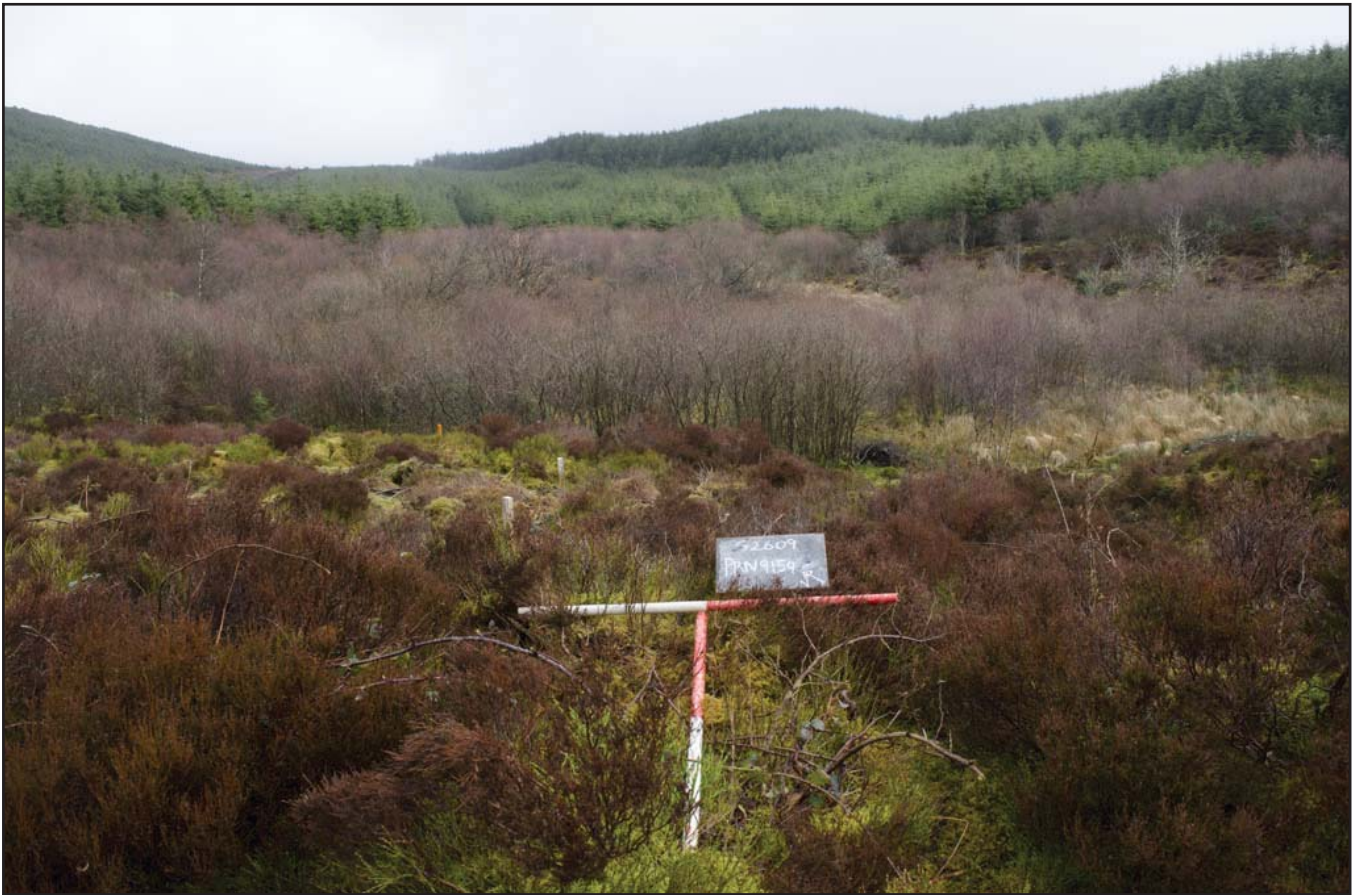
Plate 7: View of reservoir PRN 9154 from top of dam looking north-east; scale: 2x1m (archive reference: G2609_007).

Feature Number	01 - Plate (7-12, 17-18)
Site name	Ratcoed Reservoir
PRN number	9154
Grid reference	Centred on NGR SH786123
Period	19 th Century
Site type	Reservoir
Assessment category	C
Description	<p>Reservoir PRN 9154 is the larger of the infrastructure in conjunction with Ratcoed quarry. The reservoir is silted up and has a dense coverage of young elder brush trees growing within (Plate 7 and 11). Similar to PRN 9153, the conditions are very wet and deep in parts, meaning that access into the reservoir was not possible and could only be seen properly from atop of the dam. Visually the contours of the old reservoir could be made out with the cut being a steeper gradient on the south-eastern side although mostly blocked on the northern side by tree cover (Plate 11). The current watercourse could also be seen running through the middle of the old reservoir and exiting through the breach within the old dam (Plate 19). In addition, the feeder leat PRN 9158 could be seen running into the reservoir from north-east to south-west (Plate 17 and 18), but could not be accessed due to the wet conditions along with the foliage impeding the way. The dam crest and embankment on the western side of the reservoir was recorded as Feature 03 and assigned PRN number 77200.</p>

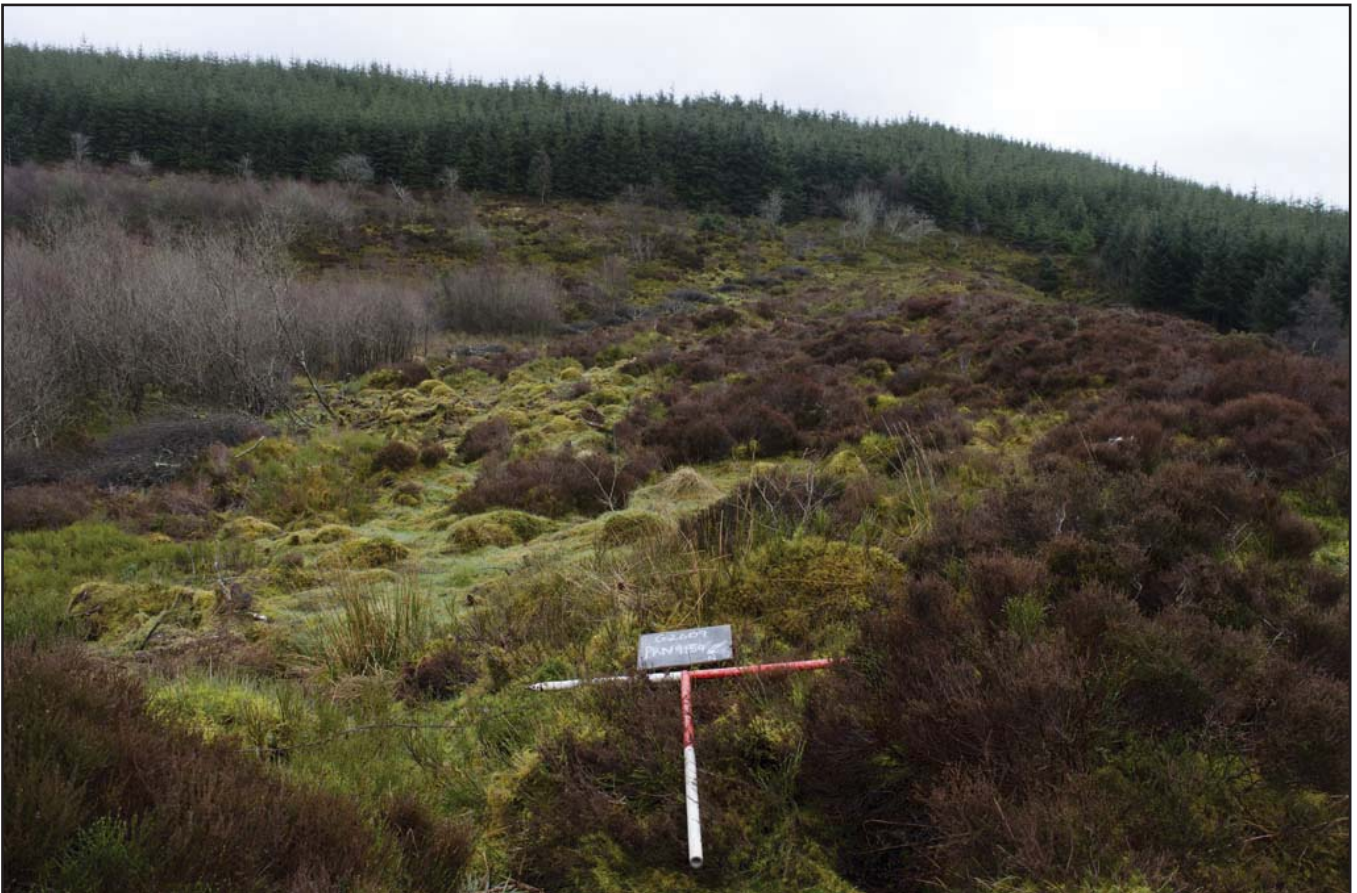
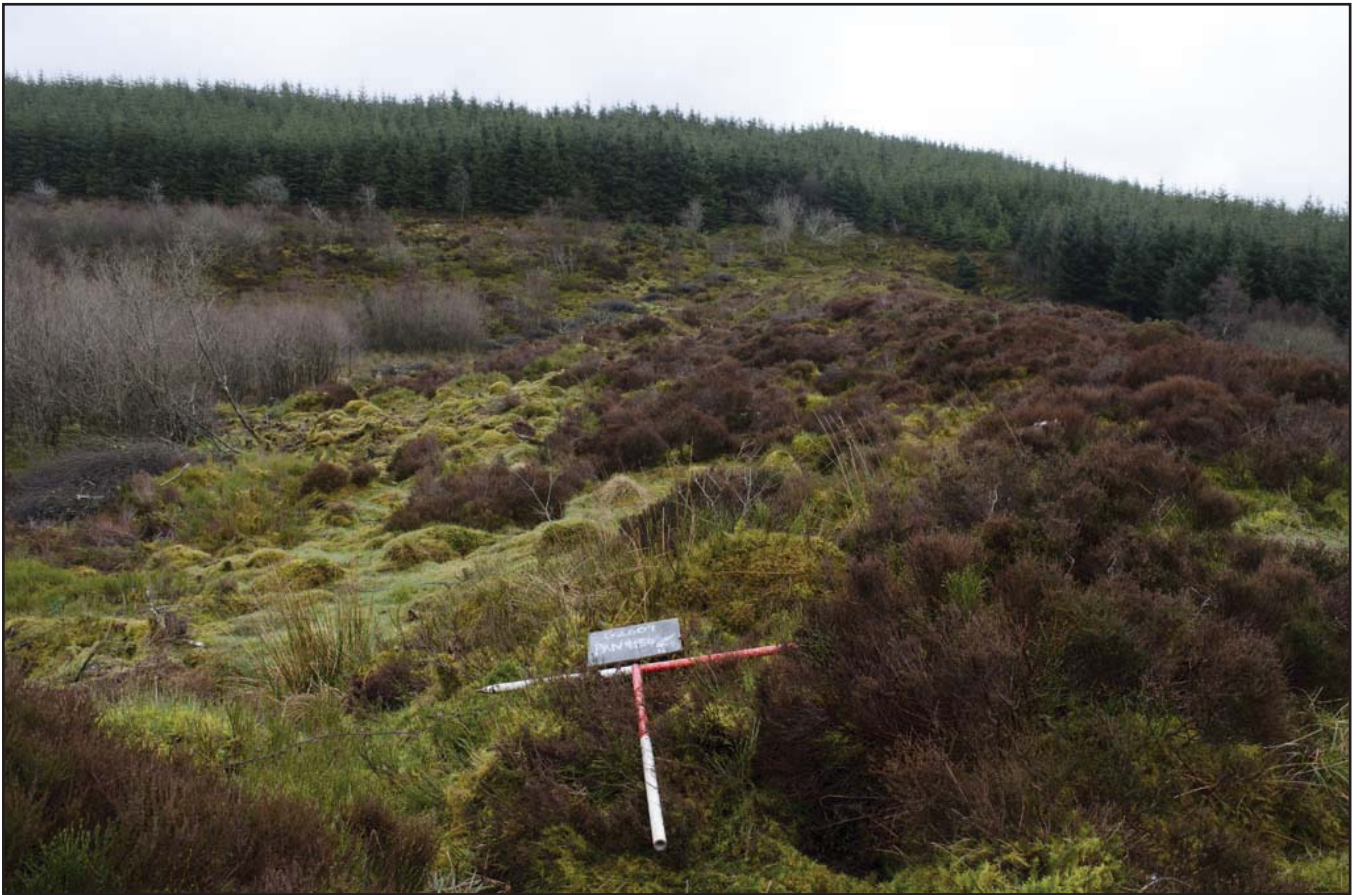
Plate 8: View of north-eastern gradient of dam down to reservoir PRN 9154; scale: 2x1m (archive reference: G2609_008).

Plate 9: View of north-eastern gradient of dam down to reservoir PRN 9154; scale: 2x1m (archive reference: G2609_009).

Feature Number	03 - Plates (8-9, 15-16, 19-20)												
Site name	Ratcoed Reservoir												
PRN number	77200												
Grid reference	Centered on NGR SH786123												
Period	19 th Century												
Site type	Dam												
Assessment category	C												
Description	<p>Large earthwork dam which runs north-west south-east forming the reservoir PRN 9154 (Plate 20). Although vegetated over, the makeup of the dam is made up of earth and stone with a height of around 22m, a total length of 96m and a depth of 39m from bottom of crests. It has been breached in the centre with the current water course running through (Plate 19). The breach opening measures 14.5 meters width on the south-western side and 5.4 meters on the north-eastern side. On the south-eastern side of the dam there is evidence of the dam failing and being repaired while also the emergency overflow just about evident and seen on the south-eastern crest edge running downwards towards PRN 9153 (Plate 15 and 16). Dimensions:-</p>

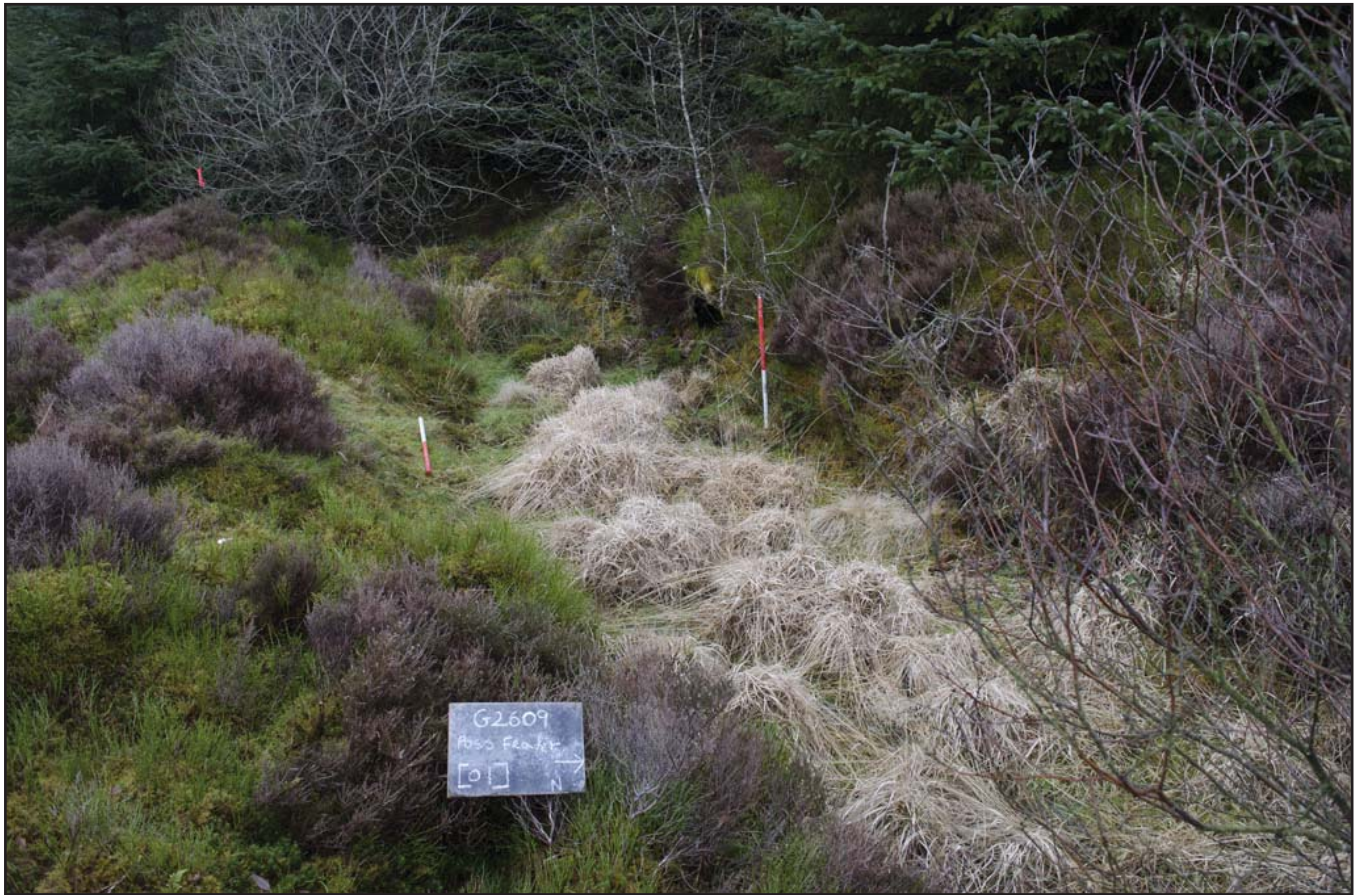
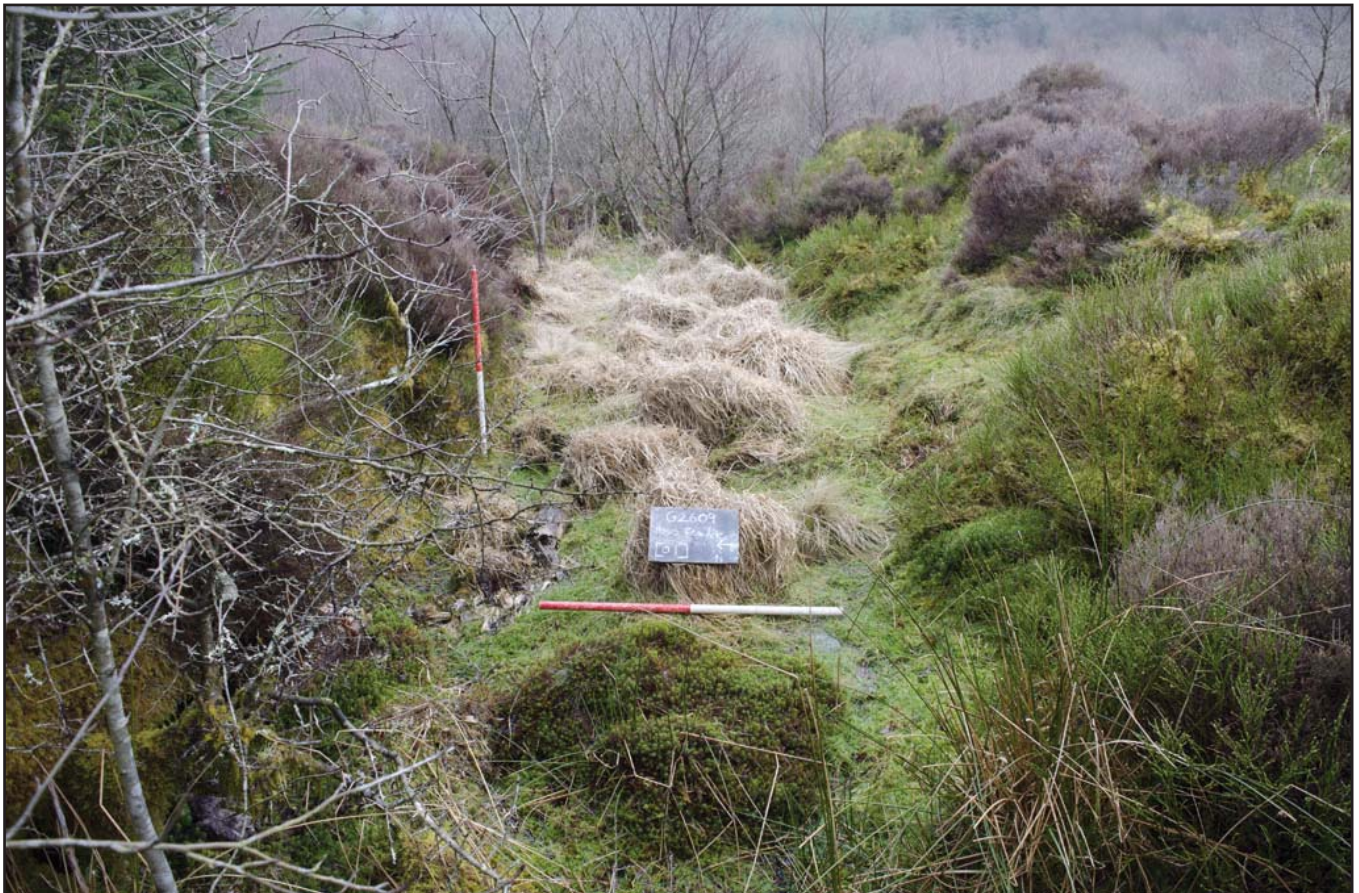
A possible additional leat was identified to the north-west of reservoir 9154, near the dam edge (PRN 77201; Figure 07: Plates 13 to 14) comprising a trench leading to reservoir 9154 from higher ground. The trench was snake like in shape with vertical sides, with a length of 14m, width of 2.5m and a depth of 0.90m. Due to its elevation leading down to the reservoir it can most likely be interpreted as part of the existing feeder system. As it was not visible on the Ordnance Survey historic mapping, it was possibly associated with later quarry workings.

Plate 13: View along possible feeder leat [01] on the north-west edge of dam; scale: 2x1m (archive reference: G2609_013).

Plate 14: View along possible feeder leat [01] on the north-west edge of dam; scale: 2x1m (archive reference: G2609_014).

Feature Number	05 – Plates (13-14)
Site name	Ratcoed Reservoir
PRN number	77201
Grid reference	Centred on NGR SH786123
Period	19-20 th Century
Site type	Possible small feeder leat
Assessment category	C
Description	A smaller possible feeder leat was observed on the north-western edge of the dam running from west to east and feeding into the reservoir PRN 9154 from higher ground. The vertical sided trench was not linear in shape but rather snake like and fed down into the reservoir to the west with water still present and running through slightly. Some stones were visible on the northern section so could once be stone lined (Plate 13-14). Length of 14m, width of 2.5m and a depth of 0.90m. Not present on any historic 19 th century OS maps. Possibly a 20 th century feature when the quarry re-opened in the 1940s.
Impact	None
Recommendation for further assessment/evaluation	None
Recommendation for mitigatory measures	None

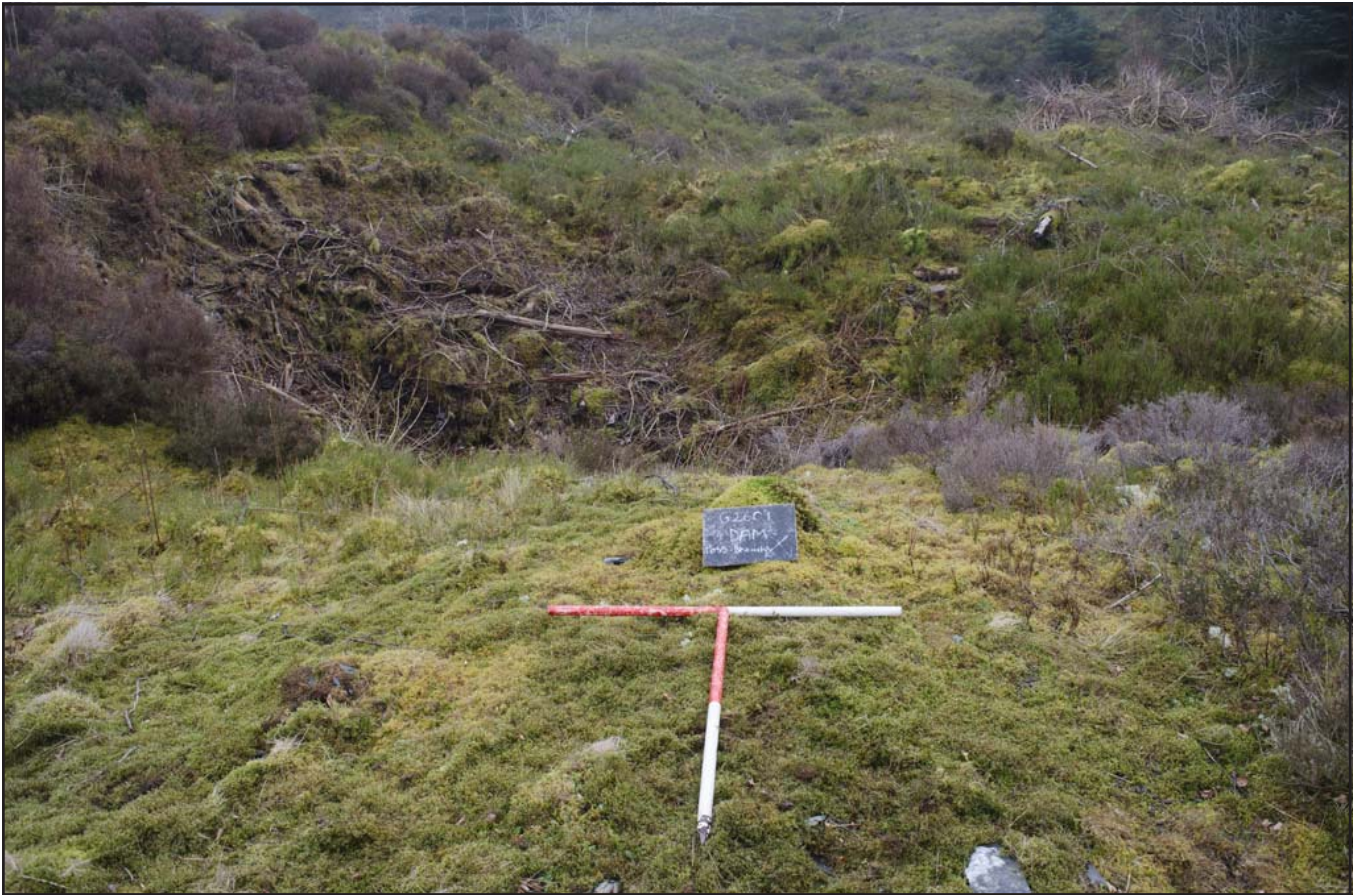
Plate 15: View of possible old breach in dam along with overflow; scale: 2x1m (archive reference: G2609_015).

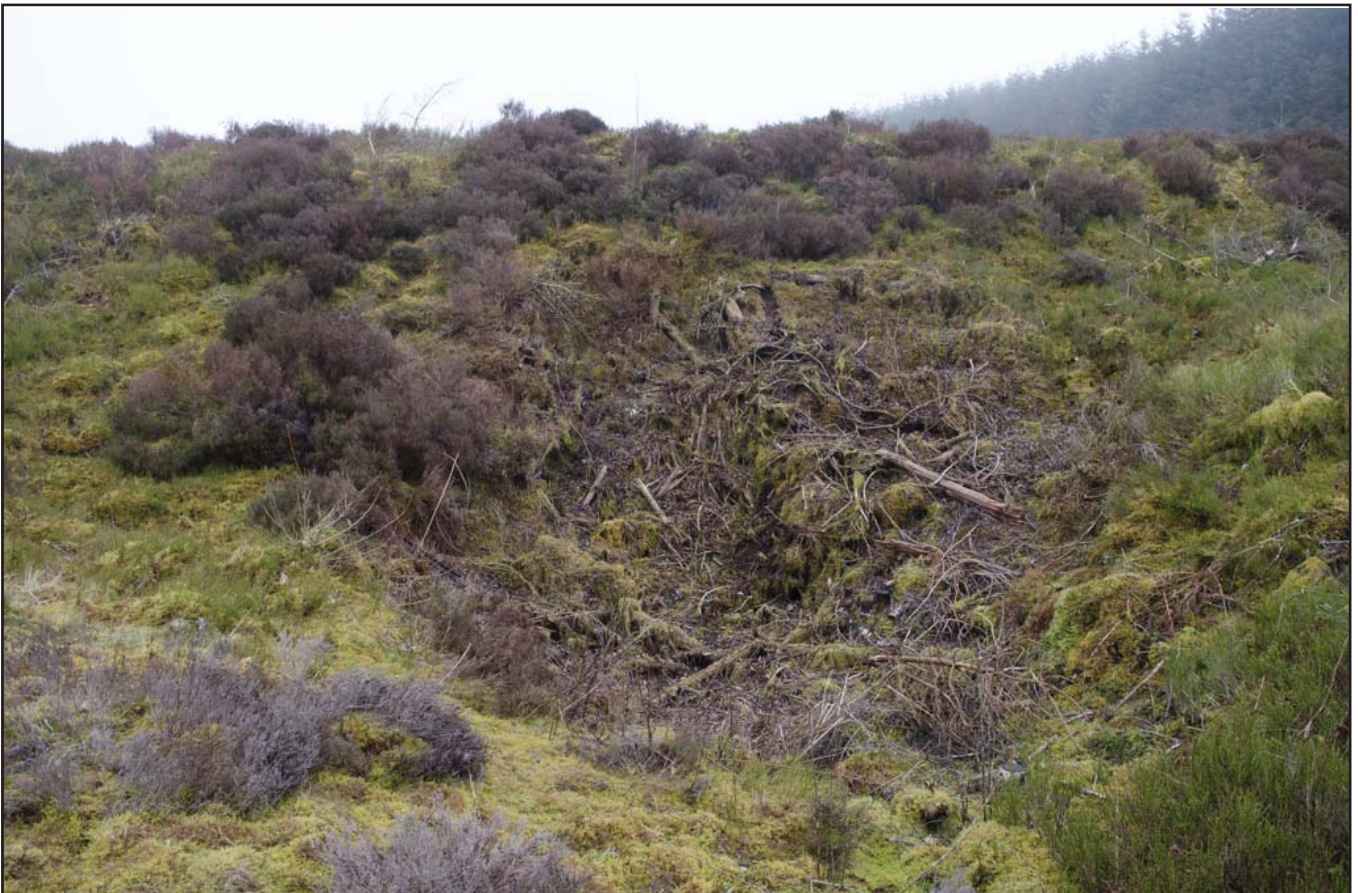
Plate 16: View of possible old breach in dam wall (archive reference: G2609_016).

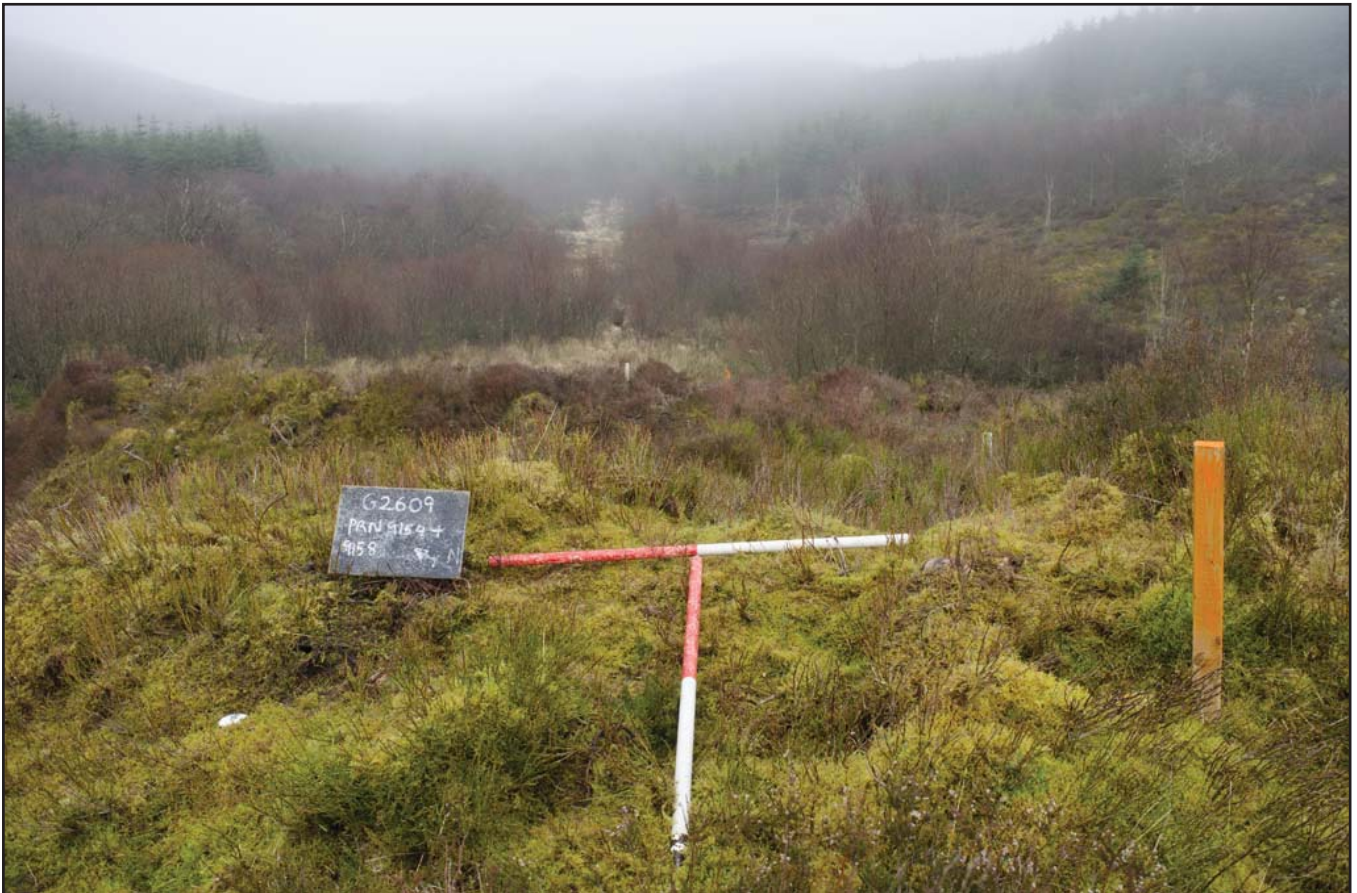
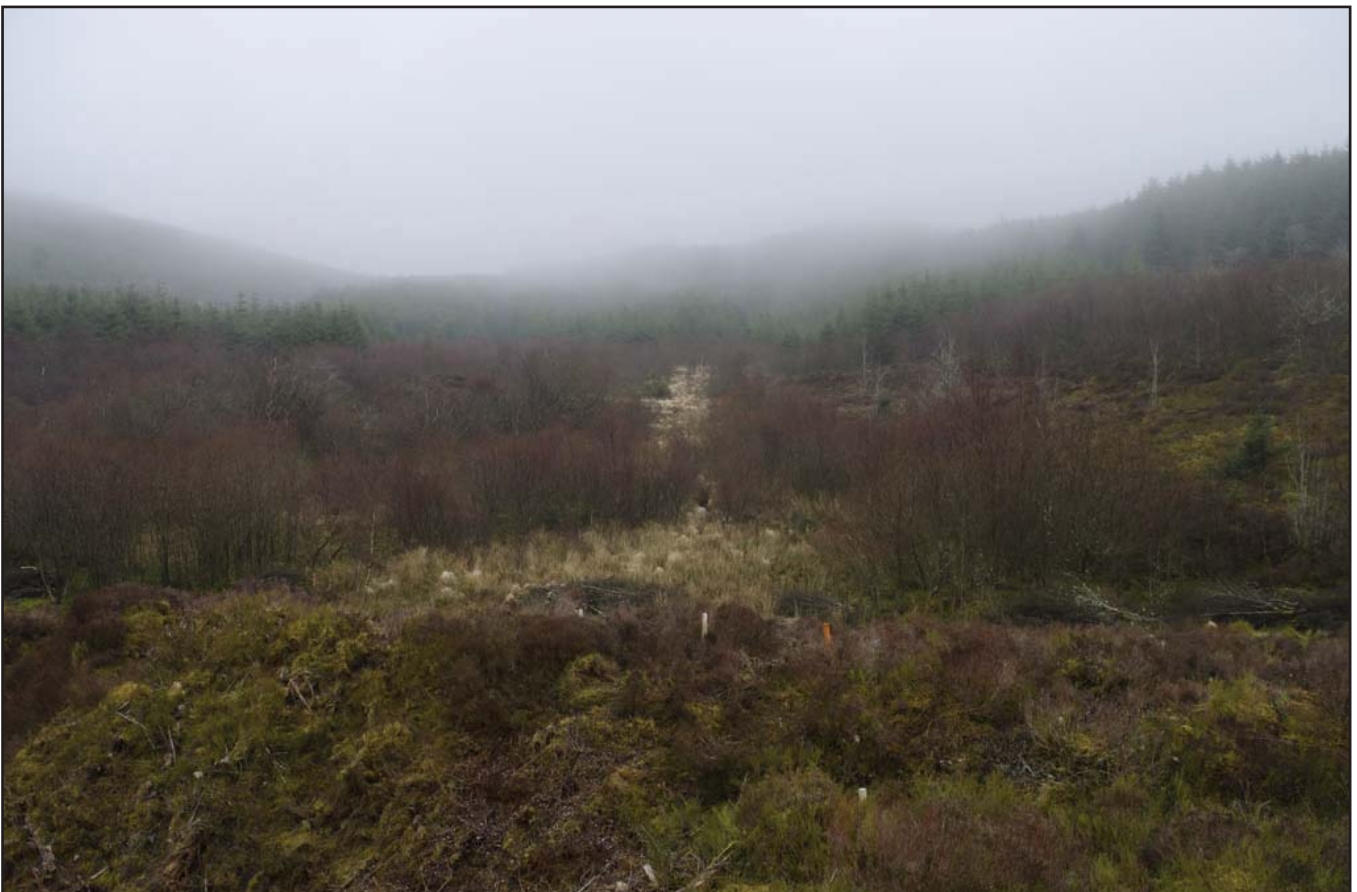
Plate 17: View across reservoir PRN 9154 and showing feader leat PRN 9158; scale: 2x1m
(archive reference: G2609_017).

Plate 18: General view across reservoir PRN 9154 and showing feader leat PRN 9158
(archive reference: G2609_018).

Feature Number	04 – Plates (17-18, 23)
Site name	Ratcoed Reservoir
PRN number	9158
Grid reference	Centred on NGR SH787124
Period	19 th Century
Site type	Feeder leat
Assessment category	C
Description	Feeder leat PRN 9158, could be made out from the top of the dam running north-east south-west (Plate 17 and 18). The leat is silted up with wetland weeds growing throughout and most likely does hold some water. The leat was linear in plan and no earthworks were evident within the immediate vicinity. The feeder leat could only be documented from afar as the conditions did not make it viable to have closer observations.
Impact	None
Recommendation for further assessment/evaluation	None
Recommendation for mitigatory measures	None

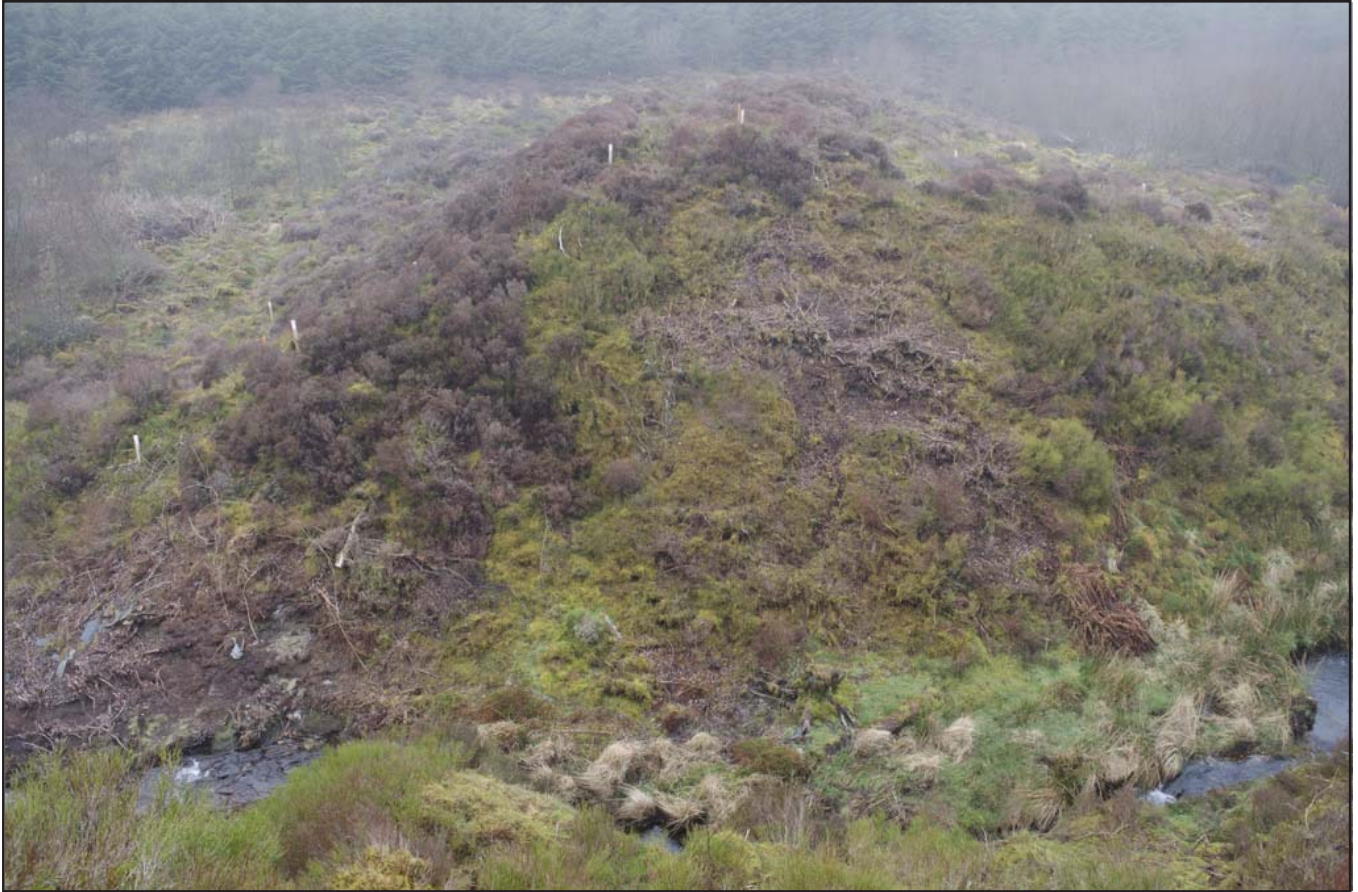
Plate 19: View of north-eastern side of dam showing breach (archive reference: G2609_019).

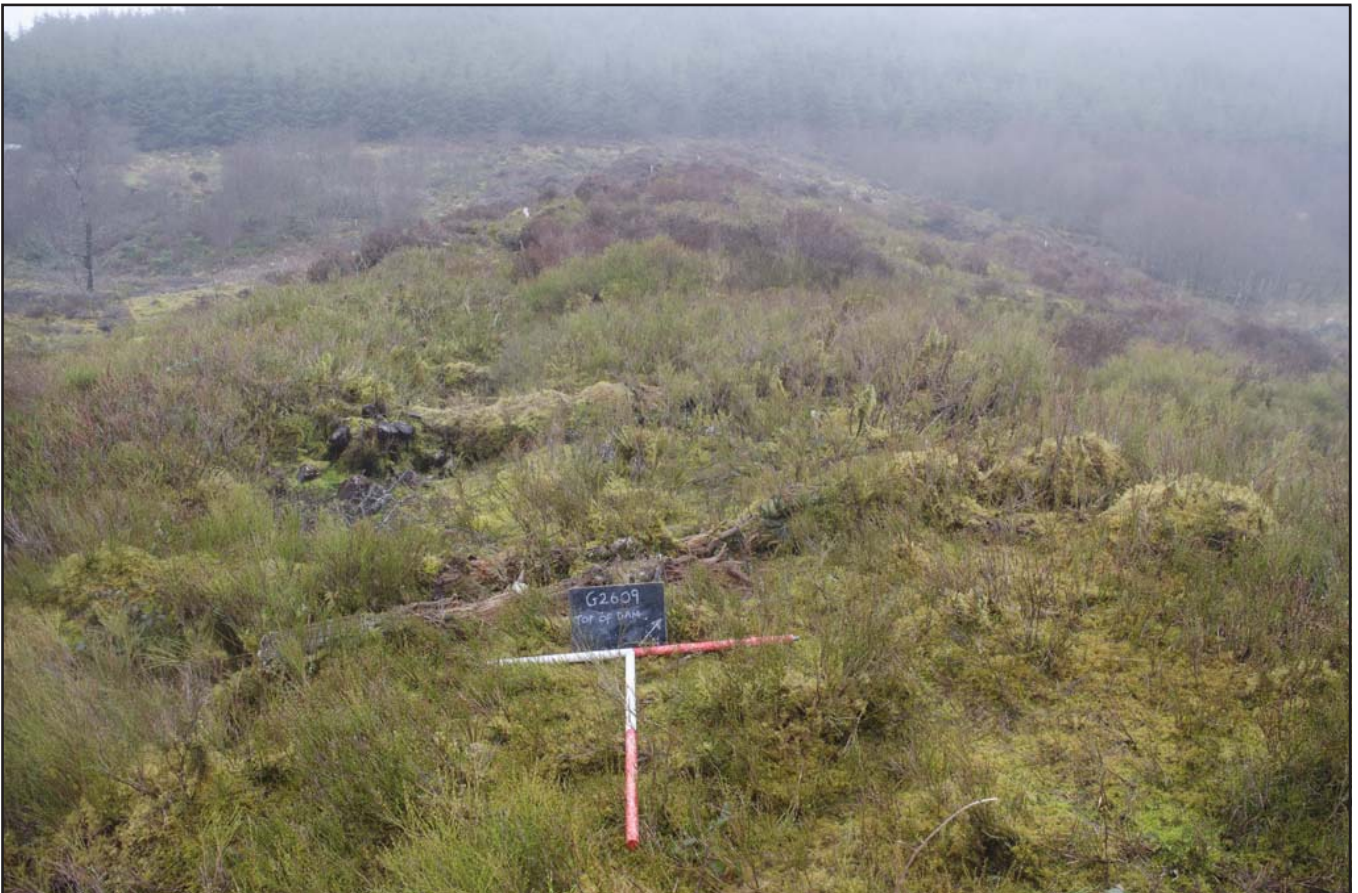
Plate 20: View along length of dam; scale: 2x1 m (archive reference: G2609_020).

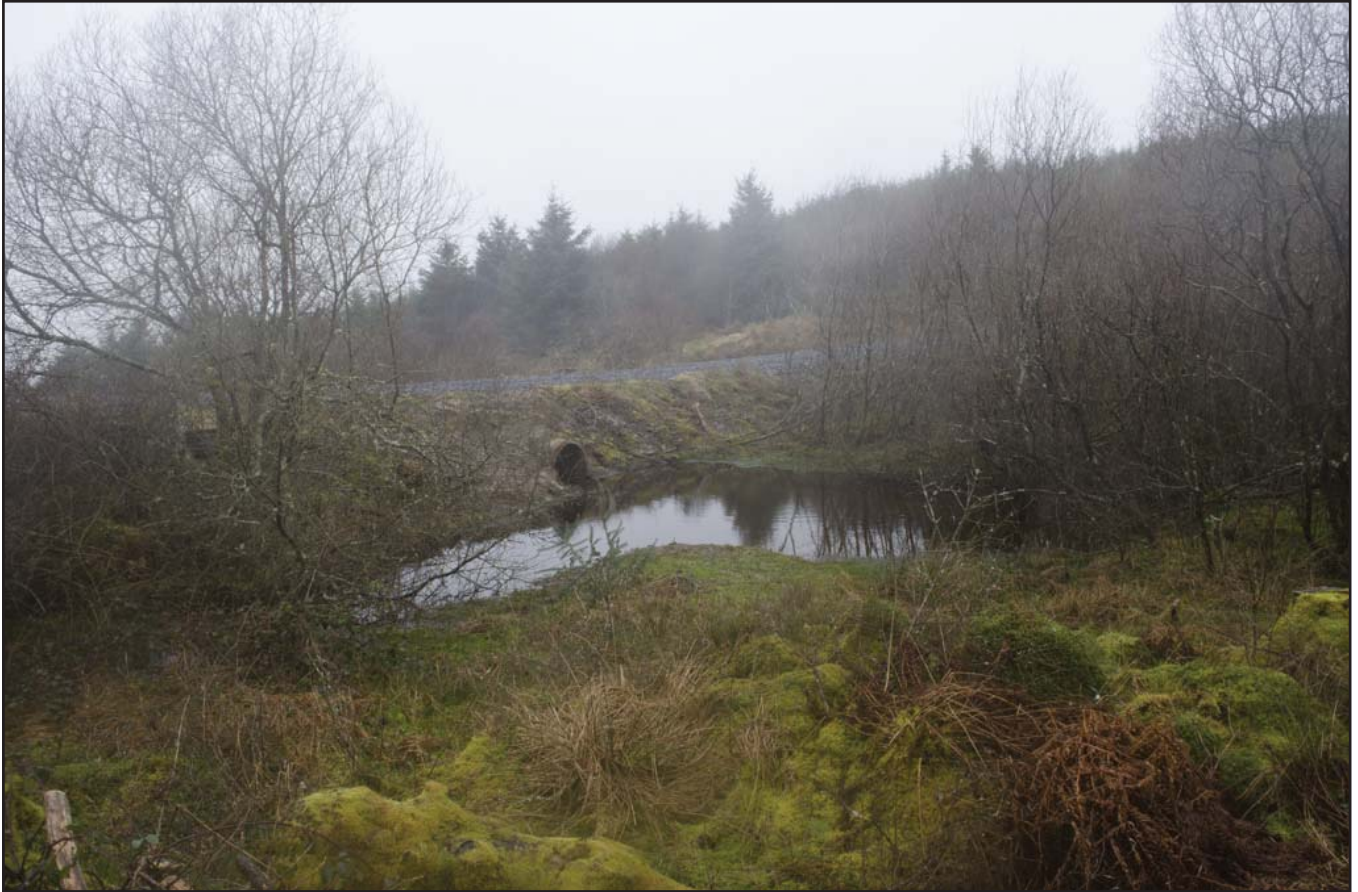
Plate 23: View of pool and modern outflow pipe/sluice within PRN 9153 next to track (archive reference: G2609_024).
