Bryn Ysguboriau, Llanelidan, Denbighshire

Level 2: Archaeological Building Recording

Report No. 1653

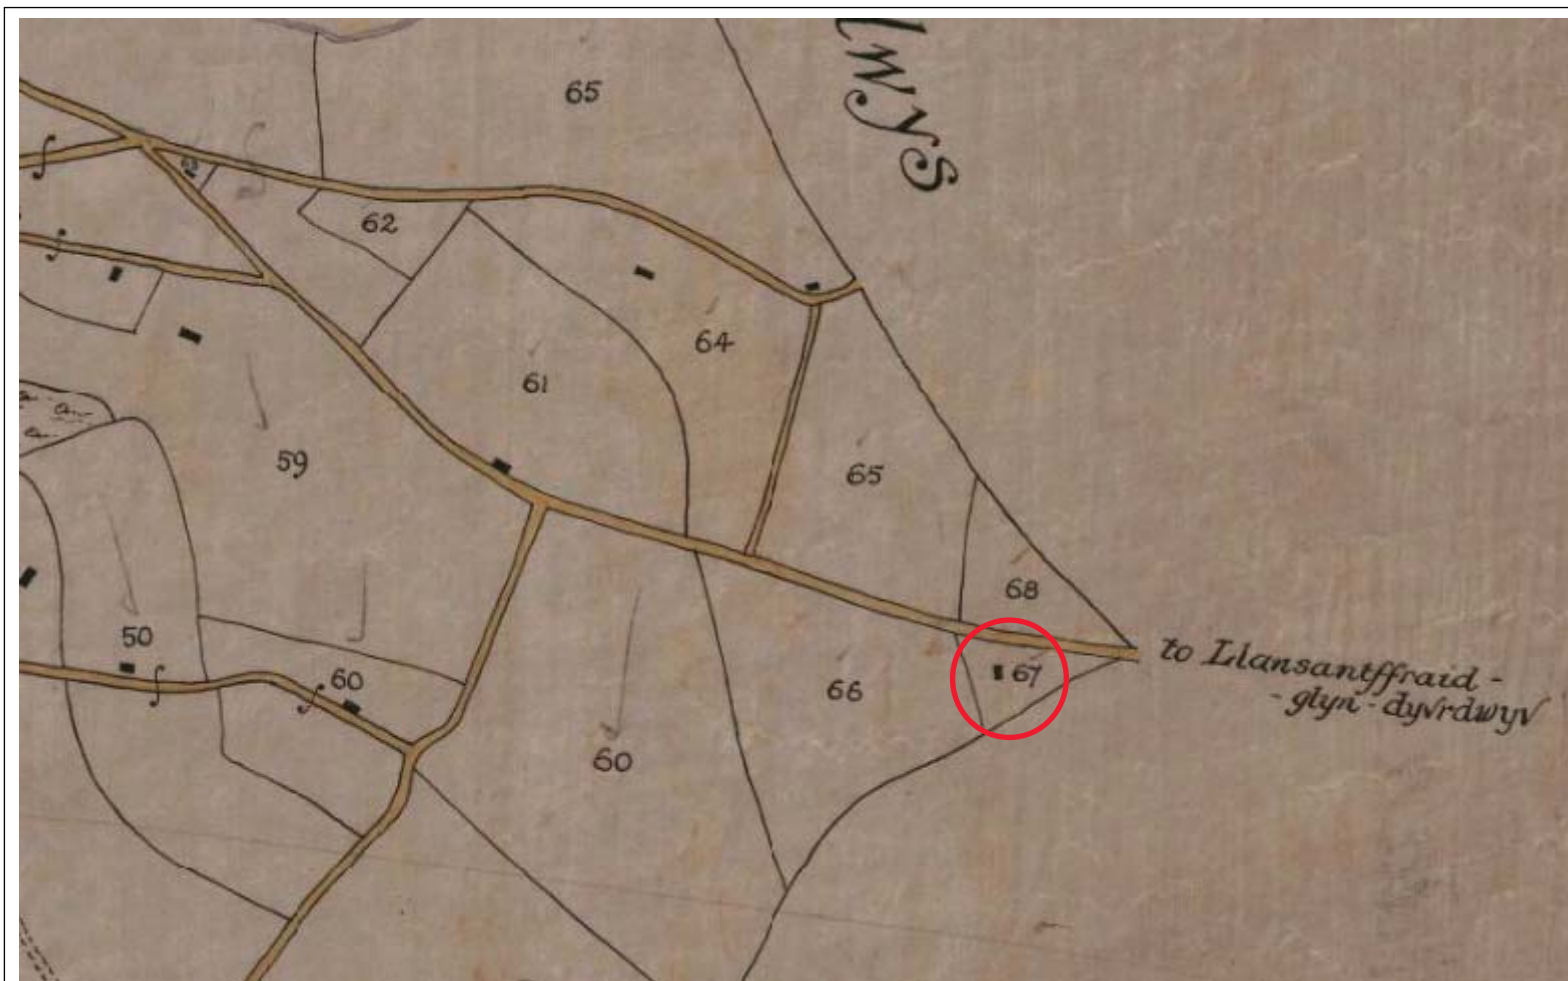
Figure 3
Tithe map of Lanelidan
of 1846

A building is represented on the 1846 Tithe Map of Llanelidan (Figure 3), where the fields are documented as field number 67, named Bryn Sgyuborian, occupied by Evan Jones and owned by John Roberts. The building is on a north-east to south-west alignment and is therefore likely to be the barn at Bryn Sgyuborian. The first cartographic records of the house and barn buildings appear on the Ordnance Survey (OS) County Series First edition of 1874 (Figure 4), which show the house, yard and access track in the same location as today and the barn adjacent to the house to the immediate north-east. The barn had a small additional building attached to its north-east gable end. A small path is evident from the yard that leads to the small outside toilet building. To the north of the complex a quarry is marked.

The cartographic evidence dates the barn to before 1846 and the house to after 1846: the Tithe map shows the site with only one building in the location of the barn. The Ordnance Survey map of 1874 shows a house and barn at the site, with the same layout as the surviving original buildings, dating the house construction to between 1846 and 1874.

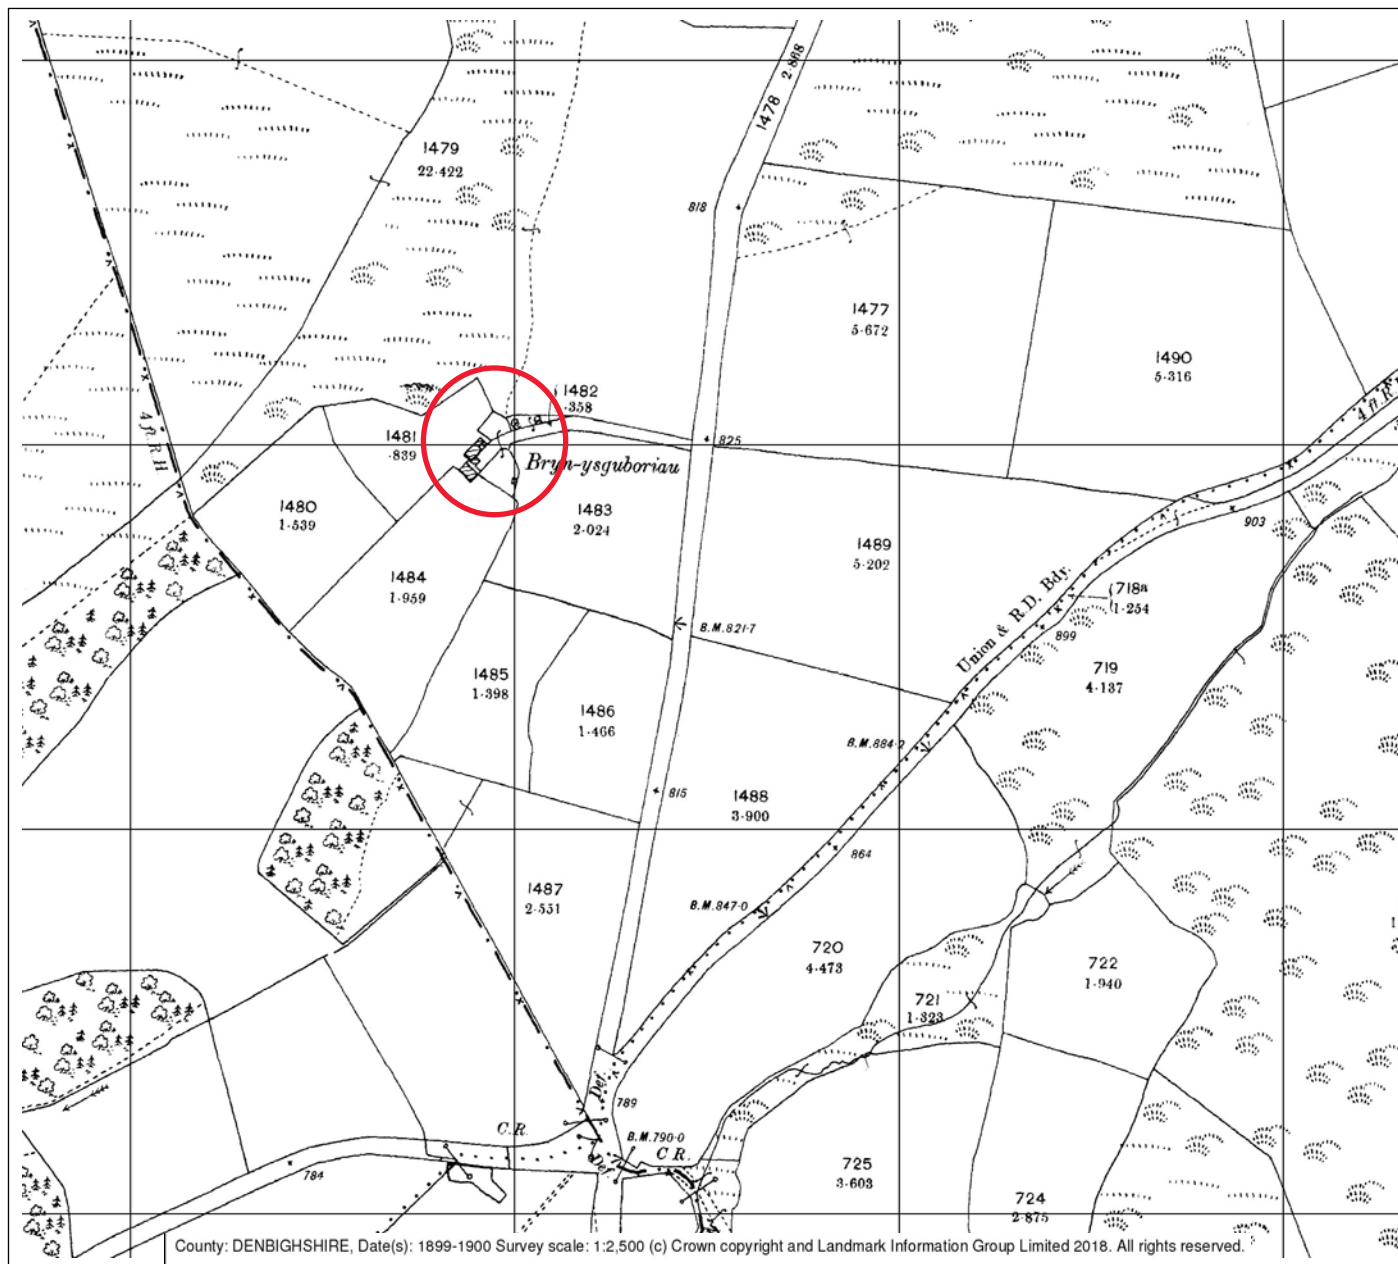
Figure 5
Extract of the Ordnance
Survey map of
Denbighshire of
1899-1900

The Ordnance Survey (OS) Map of 1899-1900 (Figure 5) shows buildings with the same layout. Two small extensions are added to the north-east side of the barn. The Ordnance Survey (OS) Map of 1912 (Figure 6) shows buildings with the same layout and an additional small building in the field to the north of the barn, a likely agricultural shelter.

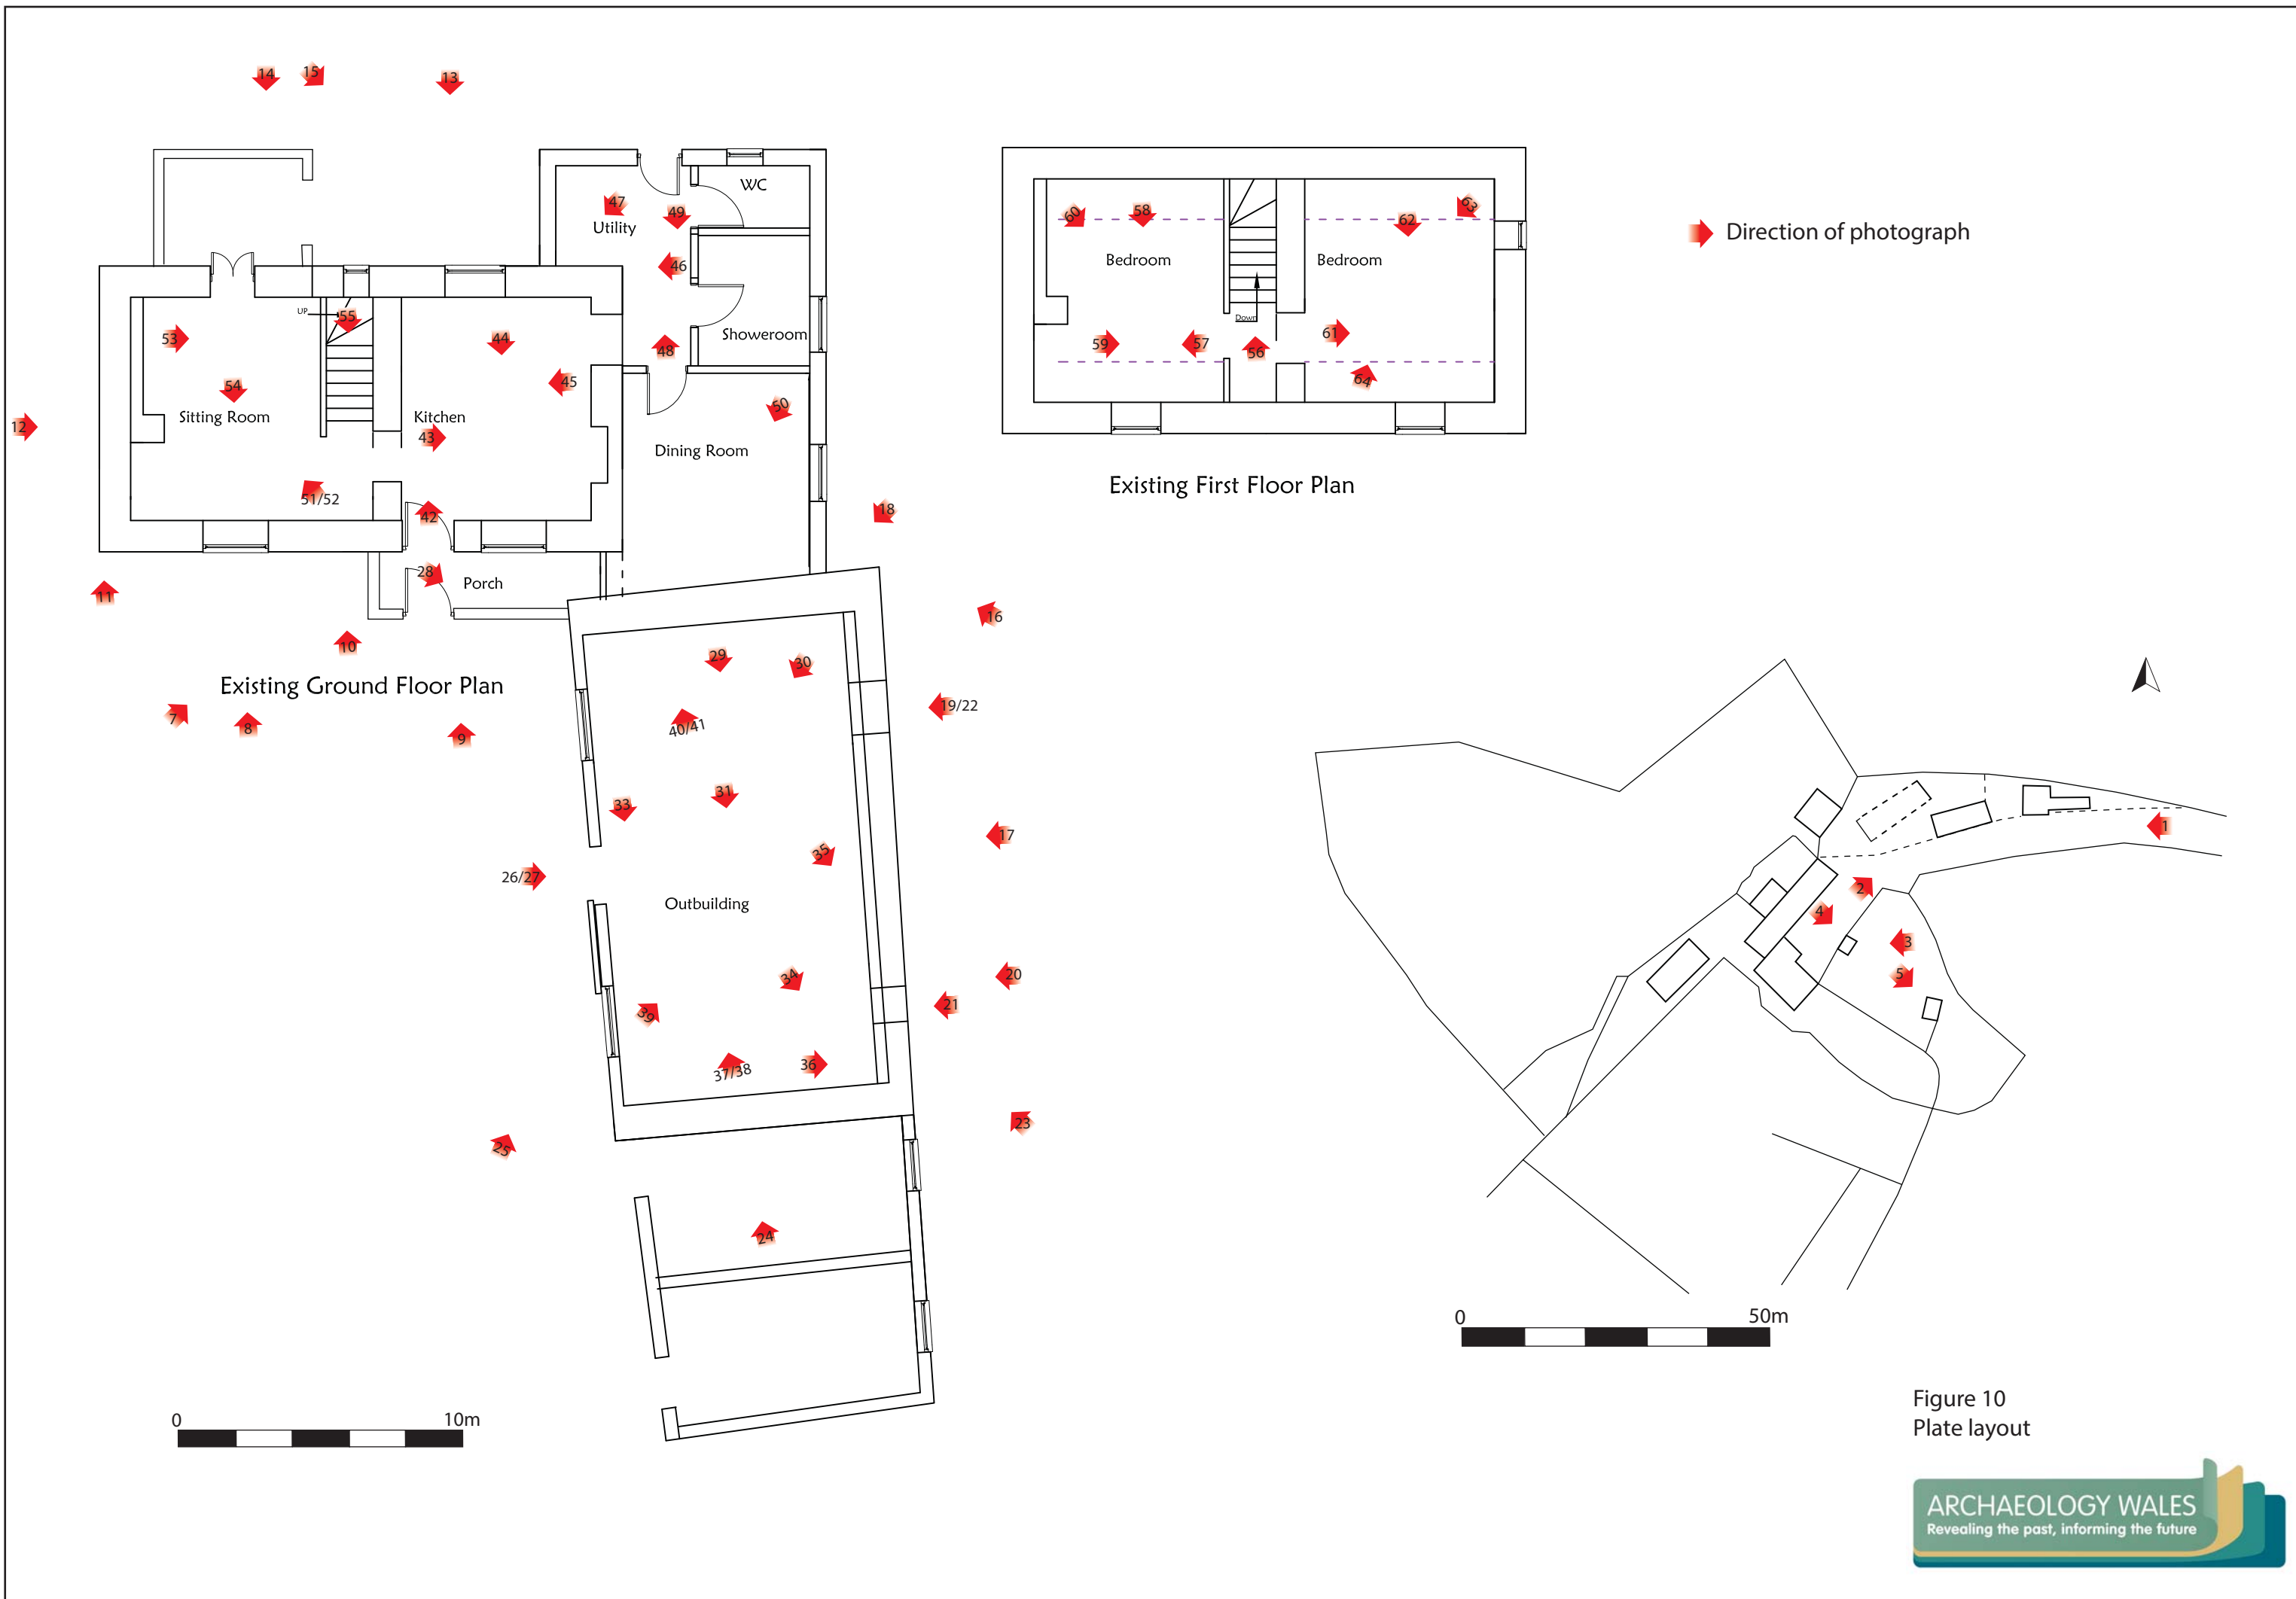
Figure 10
Plate layout

Figures 1-2 show the existing location and plans of the buildings. Figure 10 shows the location and direction from which the photographic plates were taken. The number after each arrow corresponds to the plate on which the photograph appears. Not all photographs taken on site are presented in this report, but will form part of the archive.

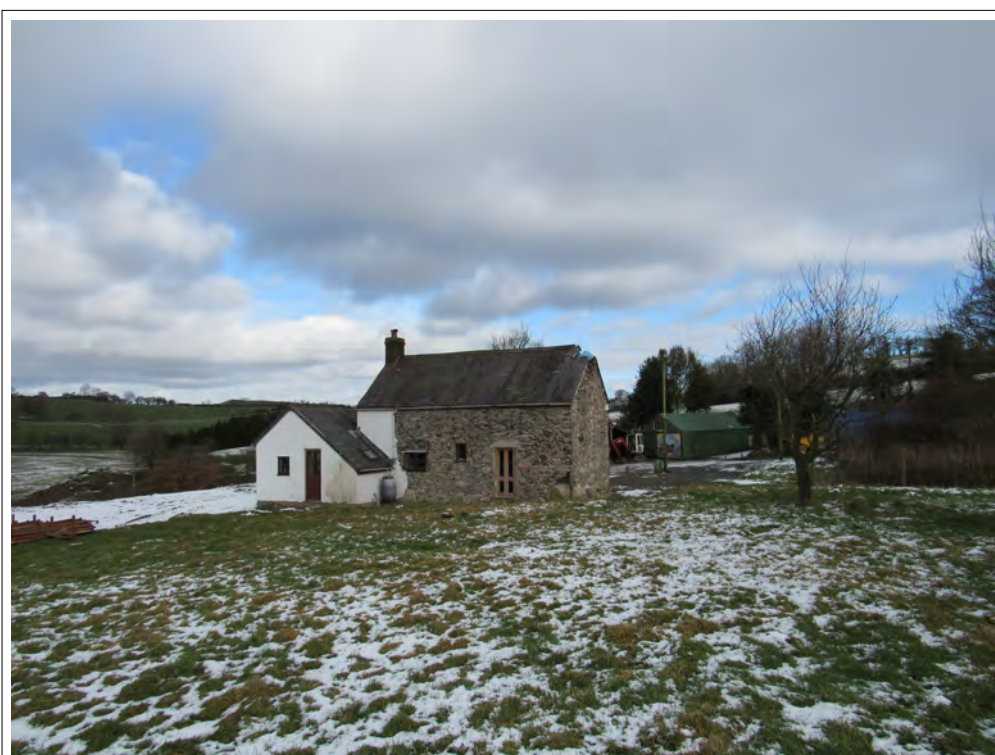
Plate 6. The rear of the house with modern extension, view north-east.

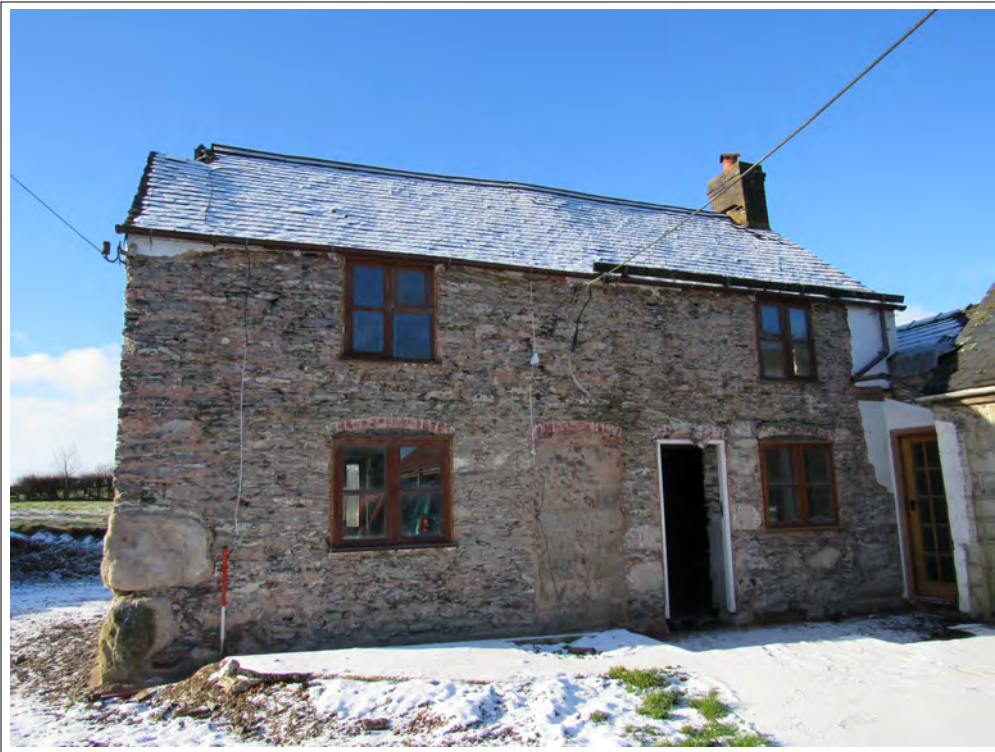
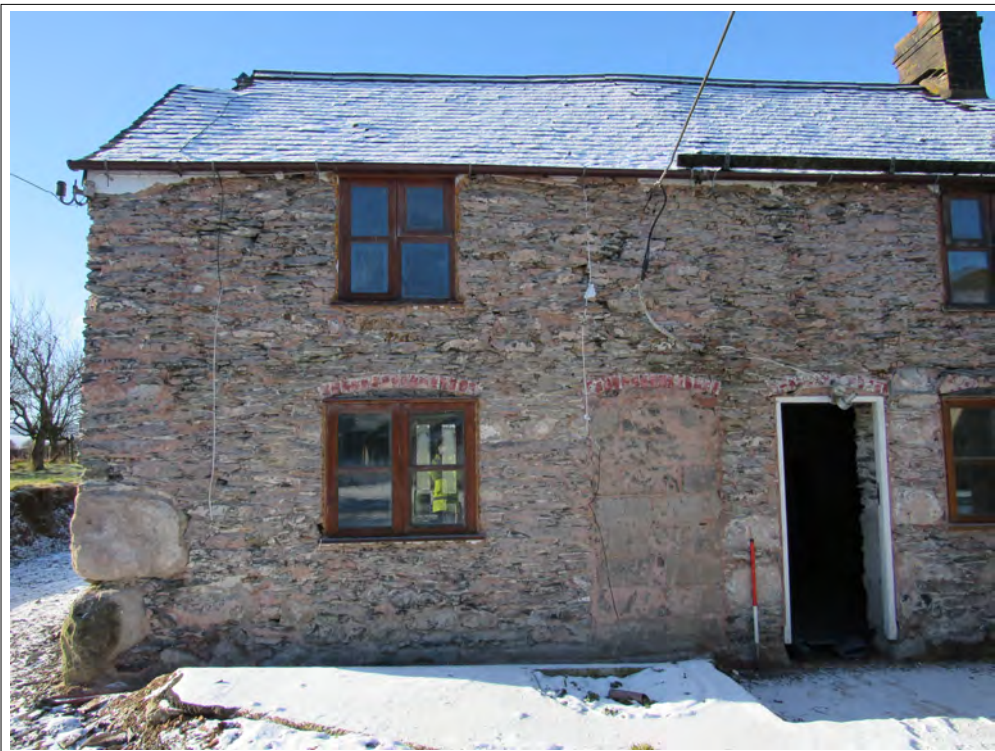
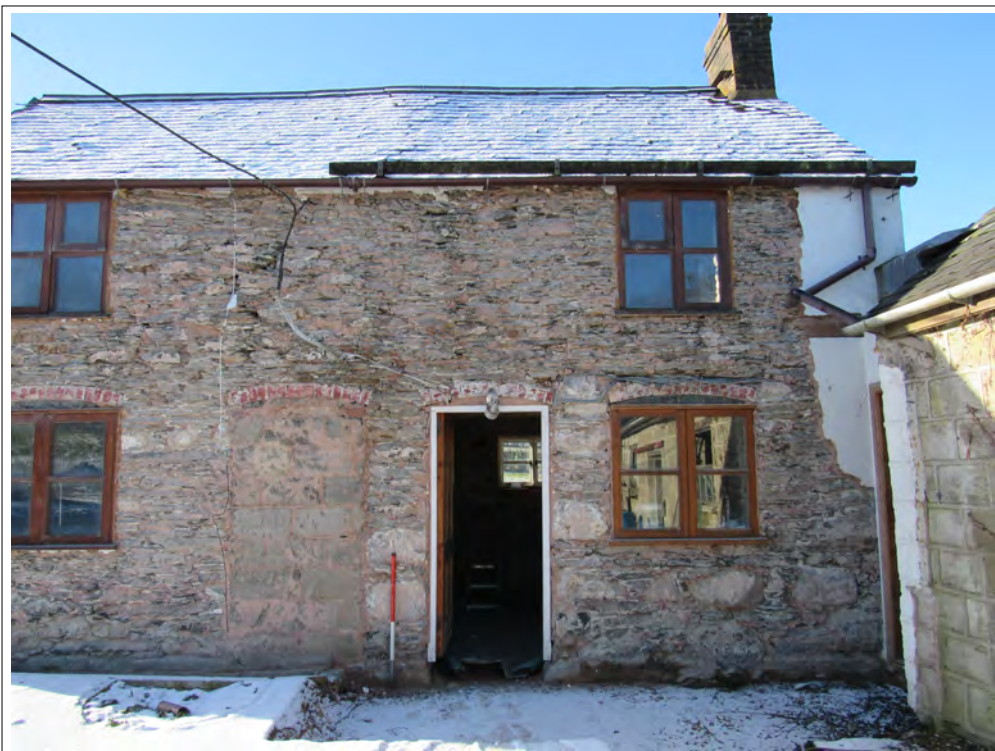
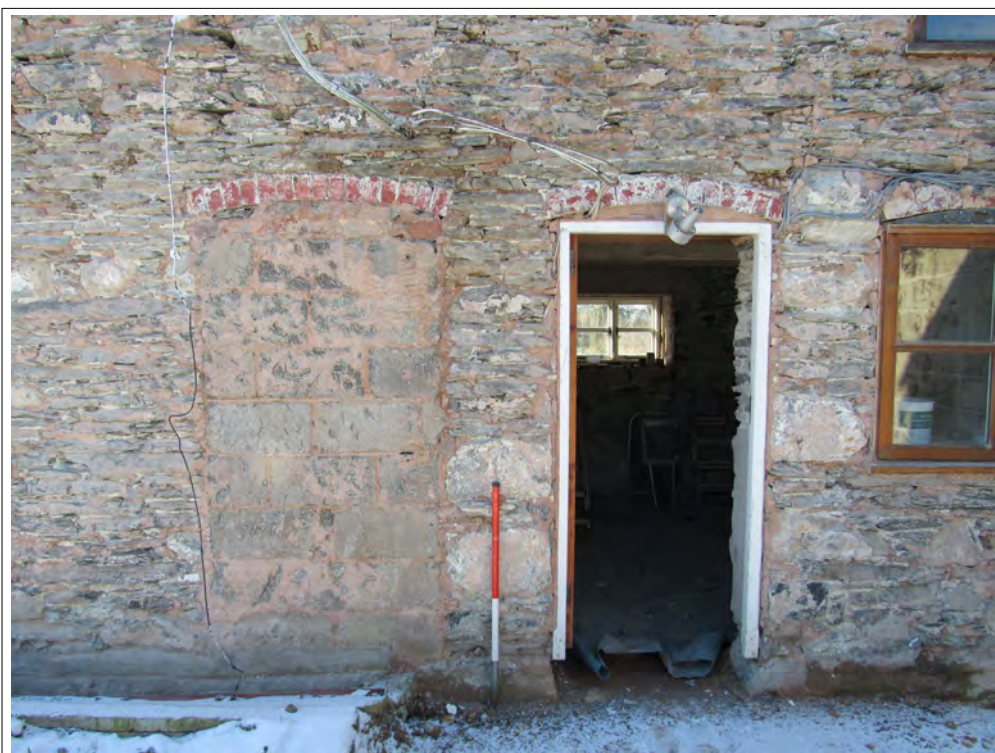
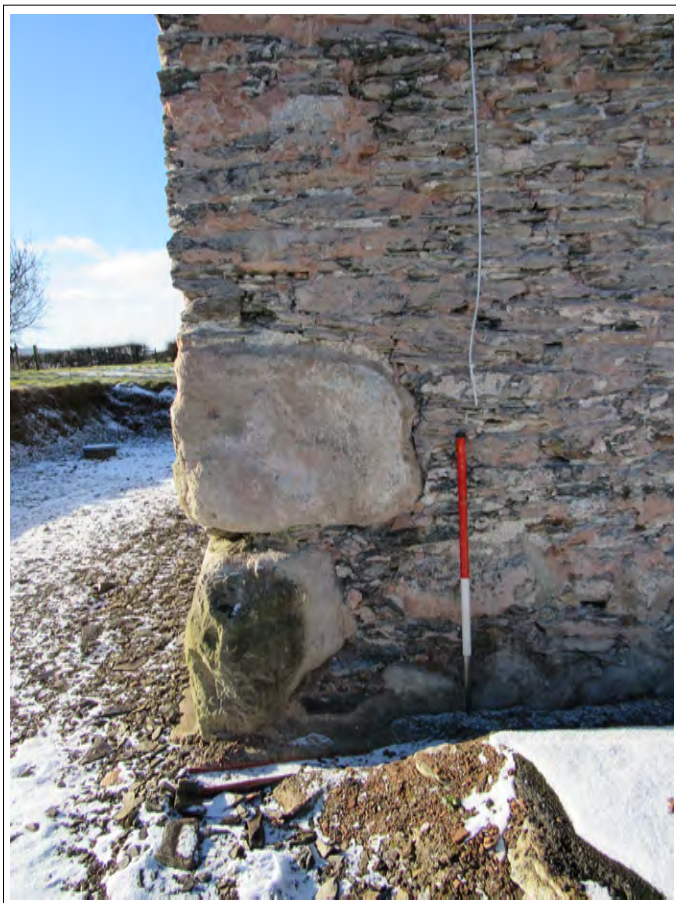
This elevation shows that the original house was of shale stone construction with large foundation corner-stones and a slate roof. The house had two chimneys, one on each gable end, one being of later brick construction, the other recently removed. The original arched doorway opening of red-brick headers-on-edge had been blocked with breeze blocks and a modern doorway inserted into a window opening, also brick-arched. Four other replacement windows were present on this elevation, the ground floor windows using the previous openings with brick arches of red-brick headers-on-edge.

Plate 7. The house north-east elevation, view south-west. 1m scale

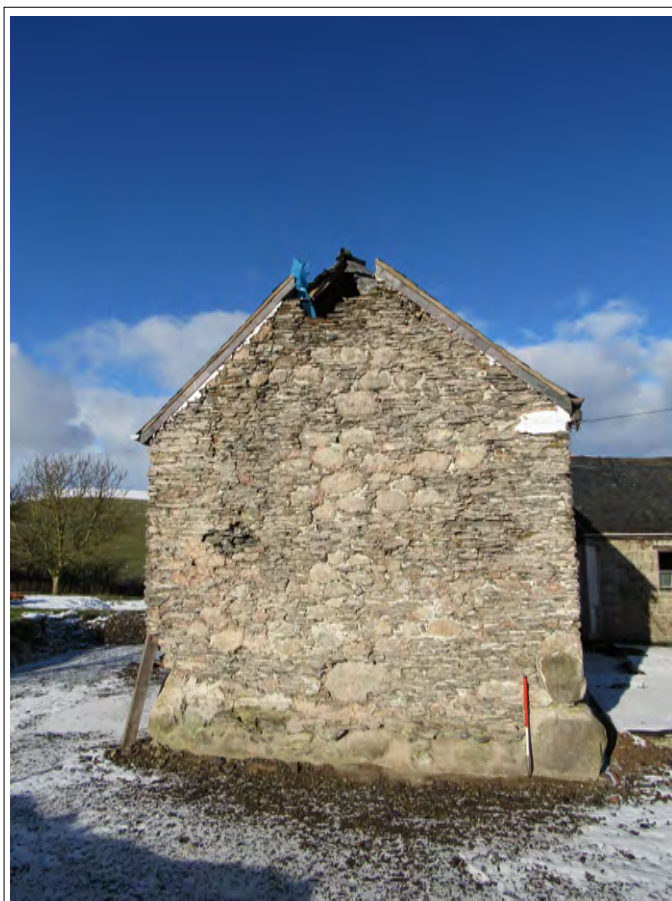
The original gable end of the house was seen to have large stone foundation boulders and other boulders randomly incorporated, with the majority of the build being of shale. The chimney stack had been removed, leaving an open void.

Plate 12. The house south-east elevation gable end, view north-west. 1m scale

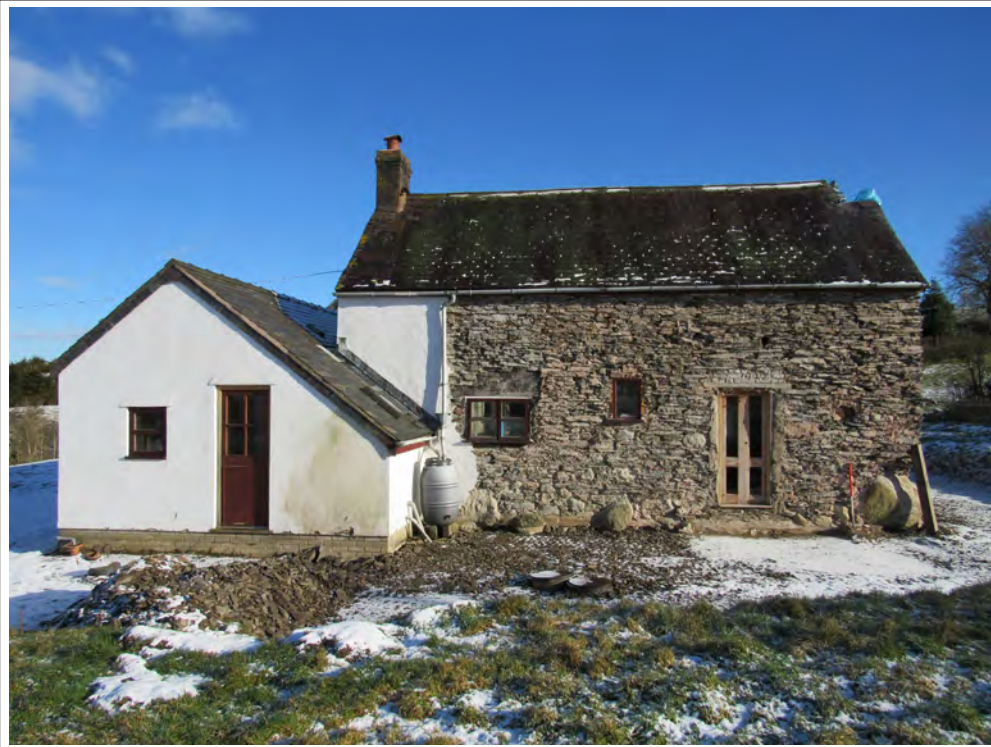
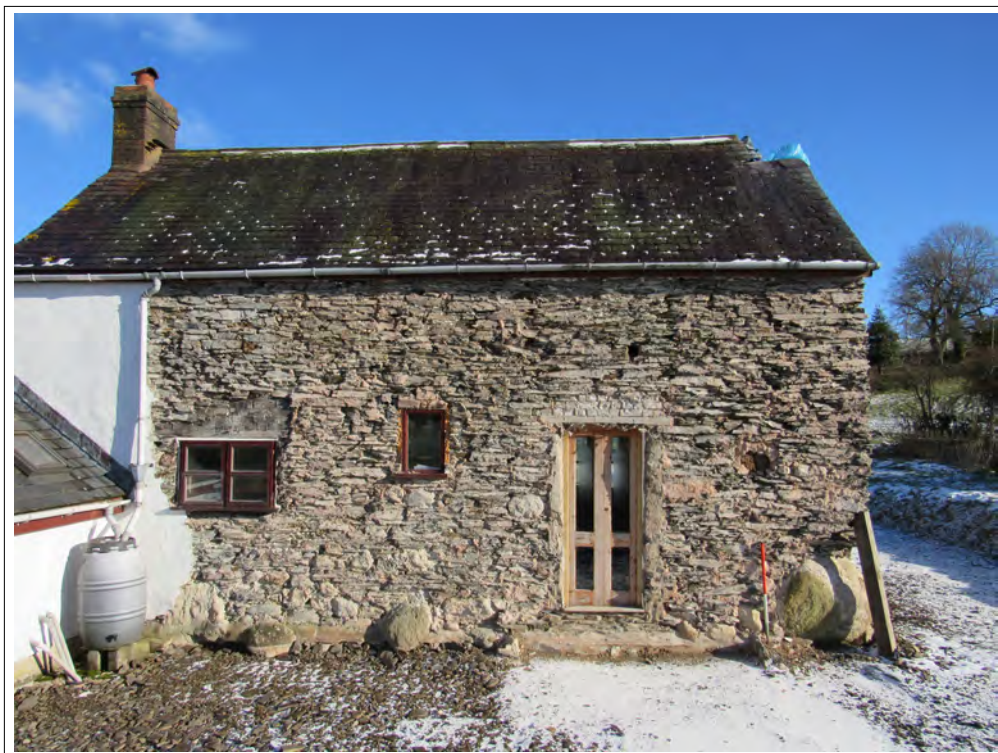
The rear of the original house was of irregular coarsed shale construction with large stone foundation boulders. A modern door and two windows had been inserted into the wall. To the north-west, the stone had been rendered and a modern extension added. The grounds have been recently levelled and landscaped on this side.

Plate 13. The house south-west elevation, view north-east. 1m scale

Plate 14. The house south-west elevation, view north-east. 1m scale

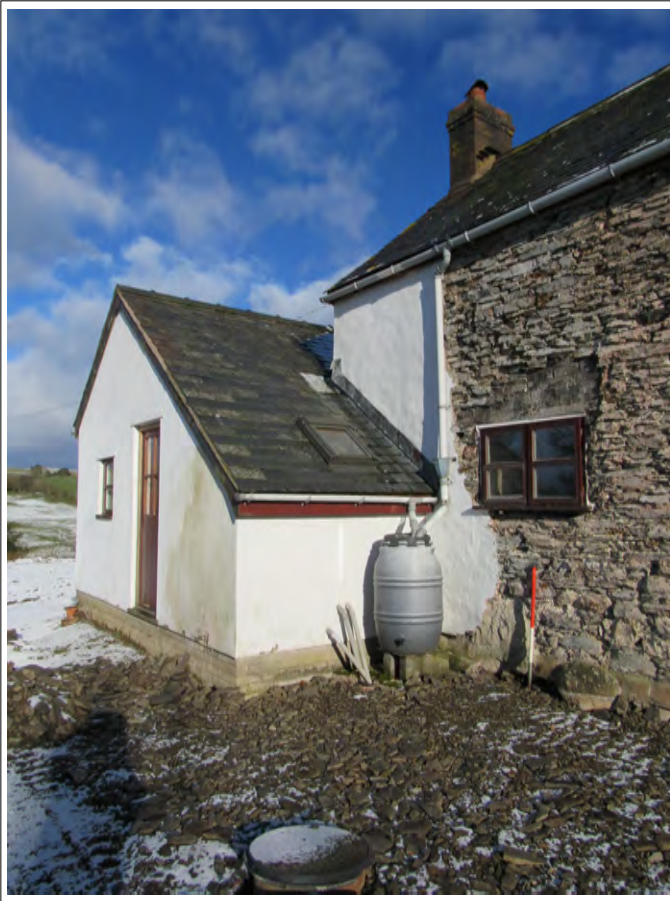
Plate 15. The house south-west elevation with modern extension, view north. 1m scale

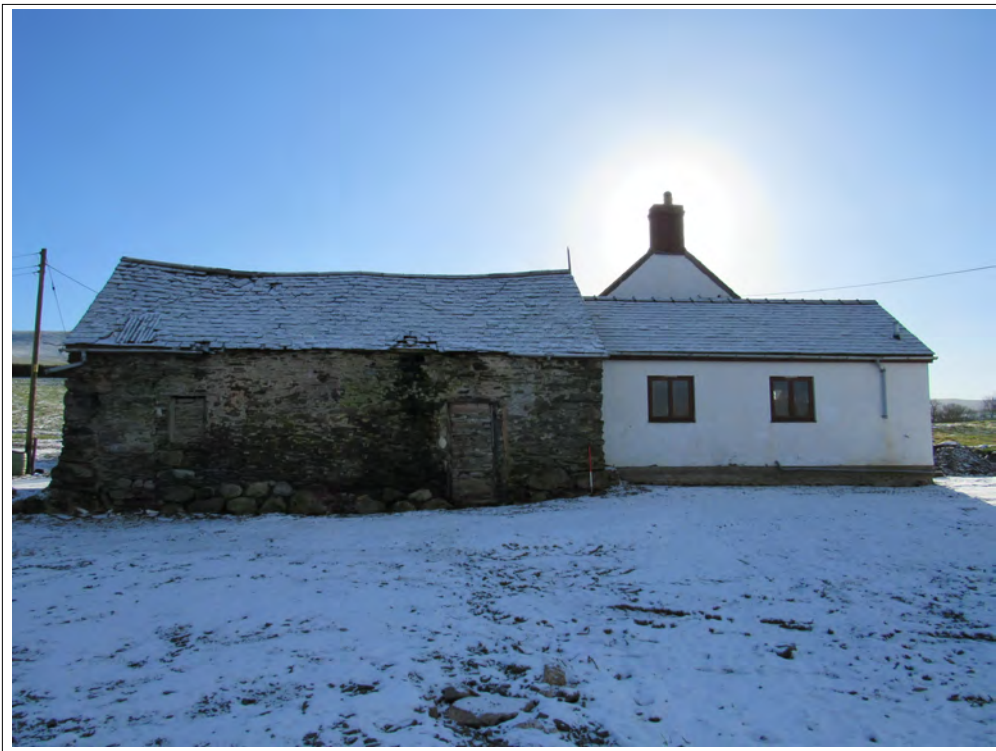
The rendered modern extension was evident, which adjoined the original house to the stone barn.

Plate 16. The barn and modern extension north-west elevation, view south-east. 1m scale

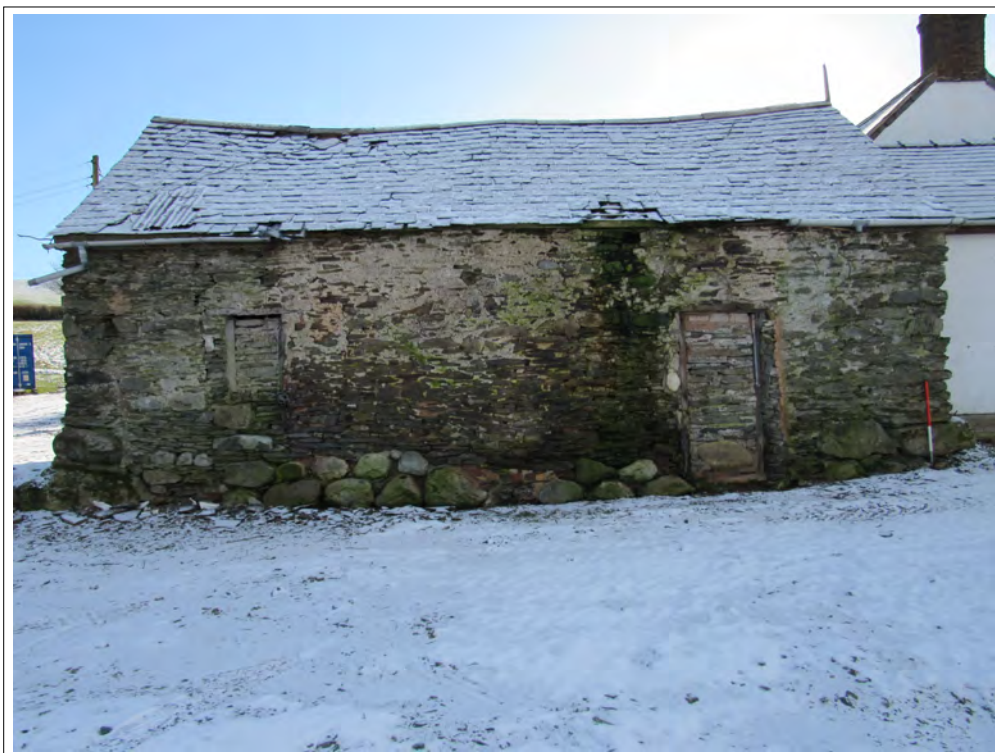
The stone barn was constructed of shale with large foundation corner-stones and a slate roof. On the north-west elevation a blocked doorway and a window were evident. The blocked window to the north-eastern end of the barn appears as an original feature, with the blocked doorway to the south western end appearing as a later inserted entrance with roughly fitted wooden frame, which is subsequently blocked. Adjacent to the blocked window is a possible blocked doorway or wall scar. The lower half of the north-eastern gable end of the barn is seen to be white-washed, indicating that at some point there was an extension and it was the interior, which compliments the historic OS cartographic sources. The frontage of the barn is constructed in modern breeze-block and cement with two modern windows and an entrance doorway, with a date-mark of 1961 above.

Plate 17. The barn north-west elevation, view south-east. 1m scale

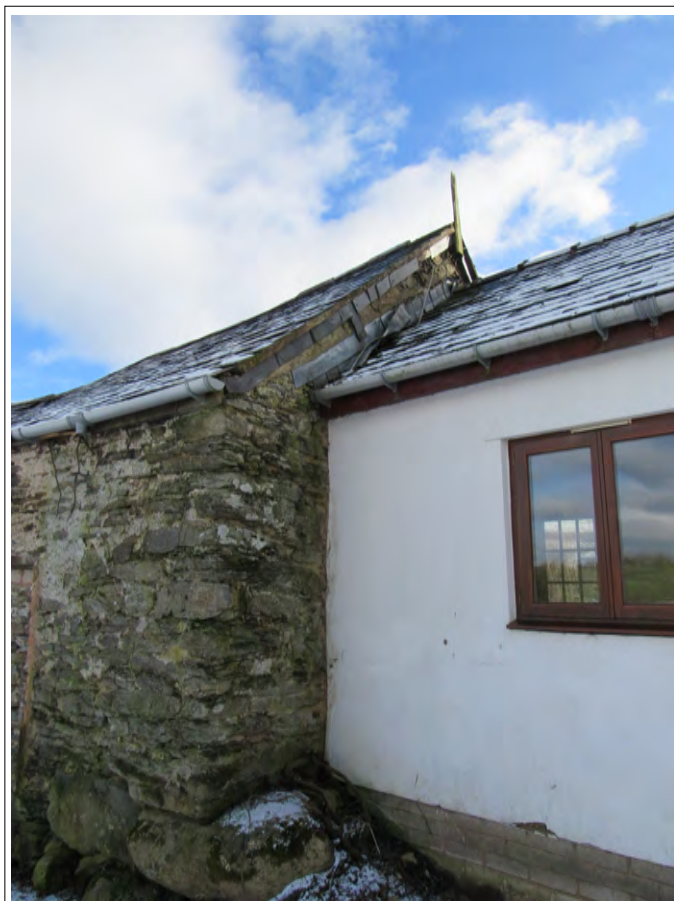
Plate 18. The barn south-west elevation, gable end with modern extension, view north-east. 1m scale

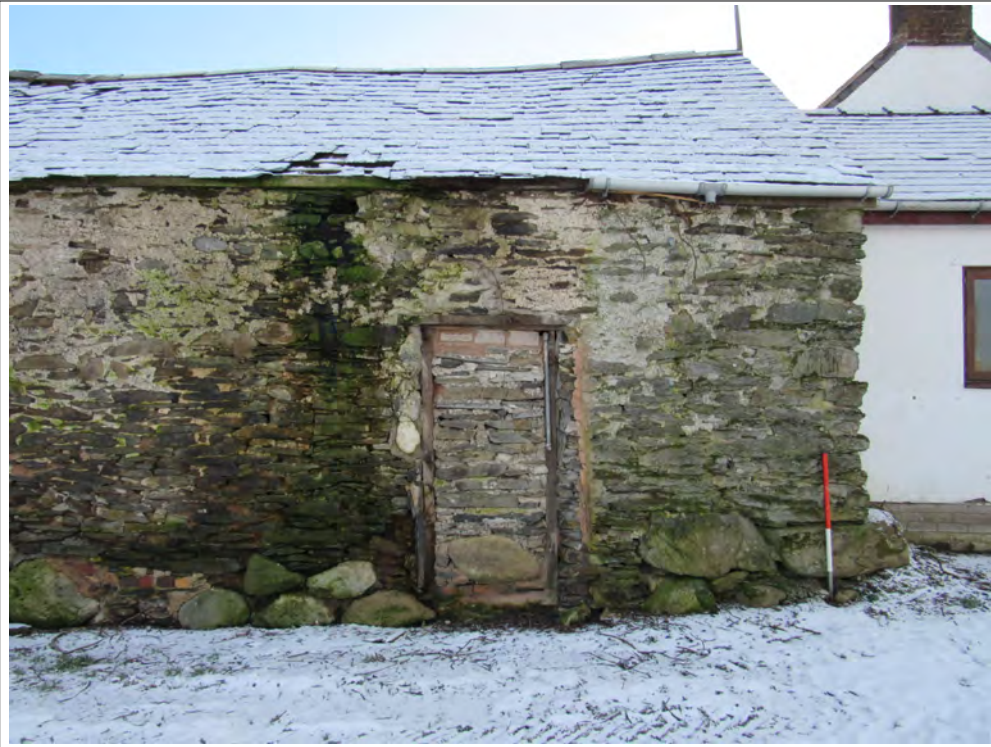
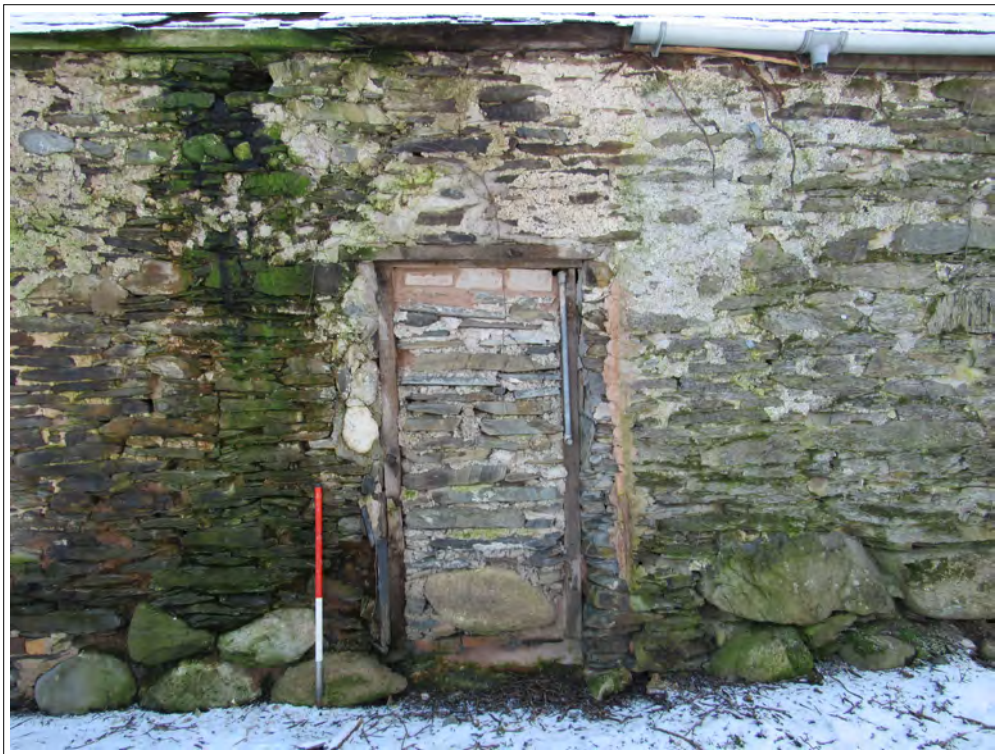
Plate 19. The barn north-west elevation blocked doorway, view south-east.
1m scale

Plate 22. The barn north-west elevation blocked doorway, view south-east. 1m scale

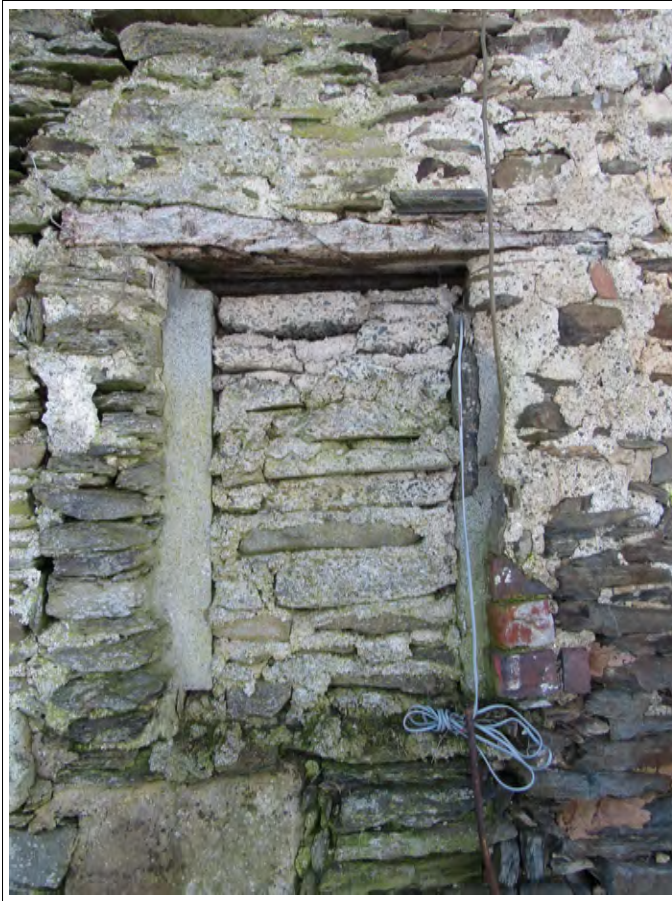
Plate 21. The barn north-west elevation blocked window, view south-east. 1m scale

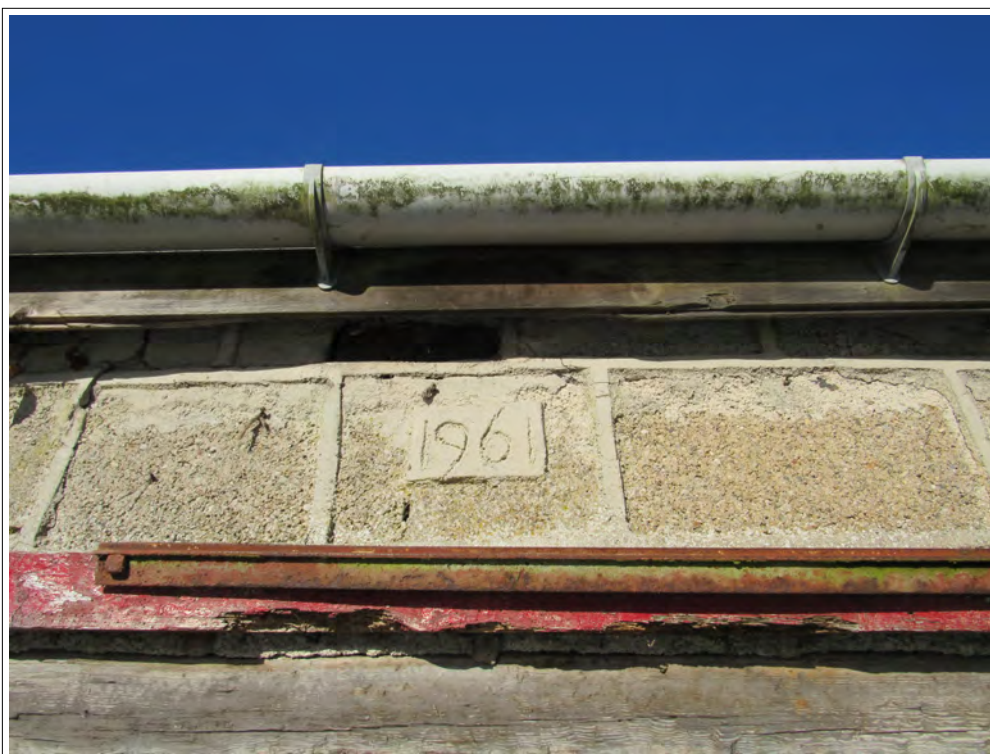
Plate 27. The barn south-east elevation date mark, view north-west. 1m scale

The frontage of the barn building (to the south-east) may have been opened up to serve the farm yard of the house in the mid-19th century, and was later blocked up in 1961, at the same time as the roof truss was supported on a beam that may have replaced a pillar. During the 20th century the original barn has undergone a series of small extensions, and by 1972 a number of outbuildings had also been constructed of which the majority have since been cleared.

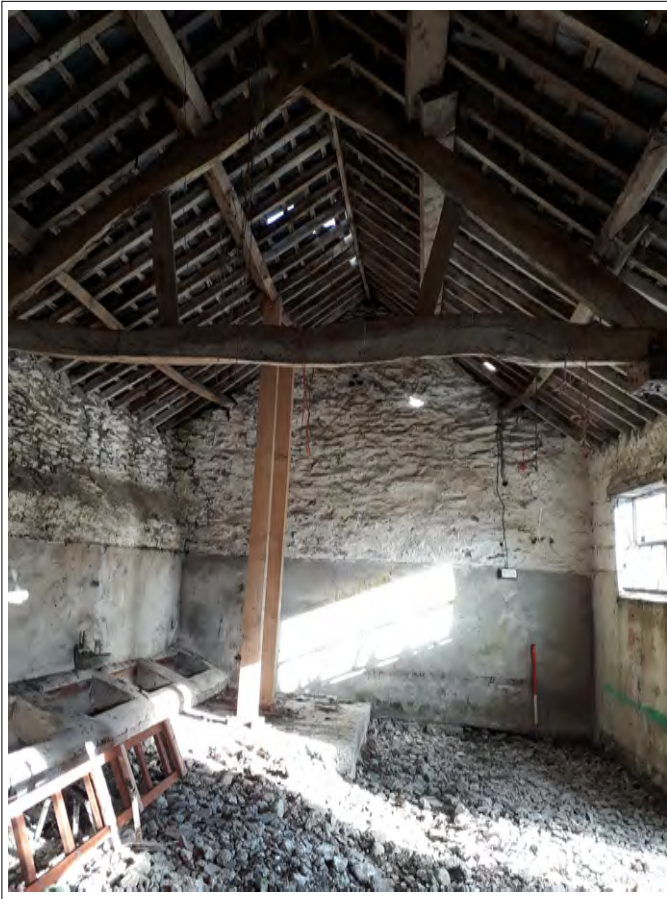
The barn interior had white-washed stone walls with a traditional timber roof truss of pegged and jointed construction, used to support machine-cut purlins and rafters. The truss itself was supported on a short section of beam protruding from the breeze-block frontage, secured by metal bolts. The slate roof was dilapidated in parts, causing rot to the purlins that was rectified by modern wooden supports. The lower sections of the stone walls were skimmed with concrete with a line of modern animal feeding troughs and a watering system of mid-20th century date.

Plate 29. Barn interior with roof truss, view north-east. 1m scale

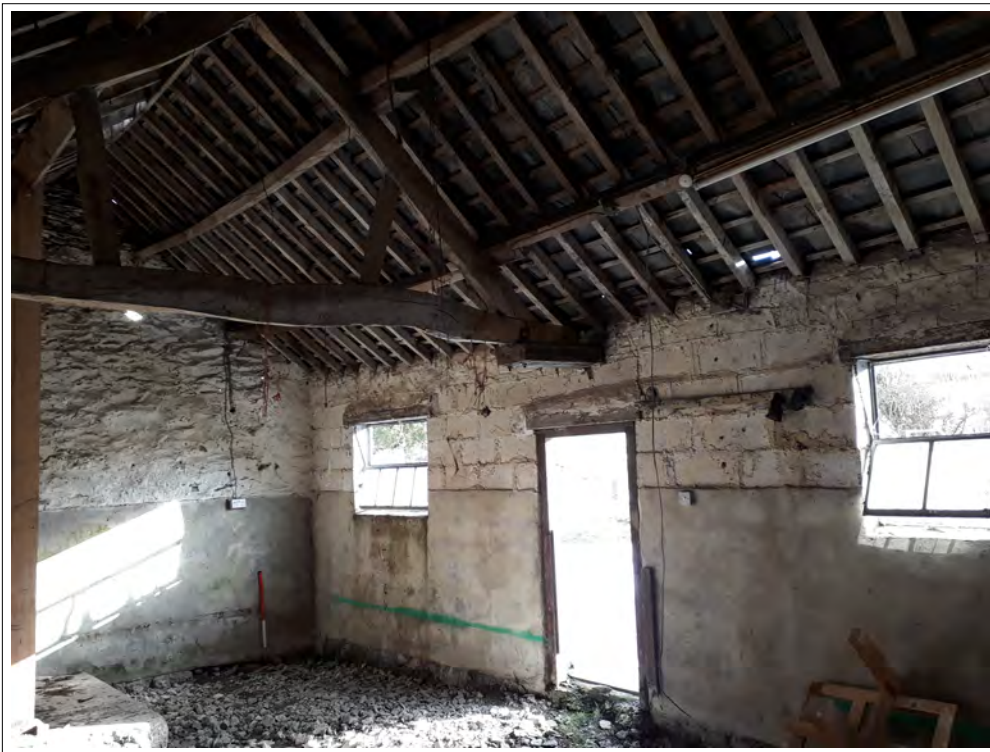
Plate 30. Barn interior with breeze block frontage, view north-east. 1m scale
