Bryn Ysguboriau, Llanelidan, Denbighshire

Level 2: Archaeological Building Recording

Report No. 1653

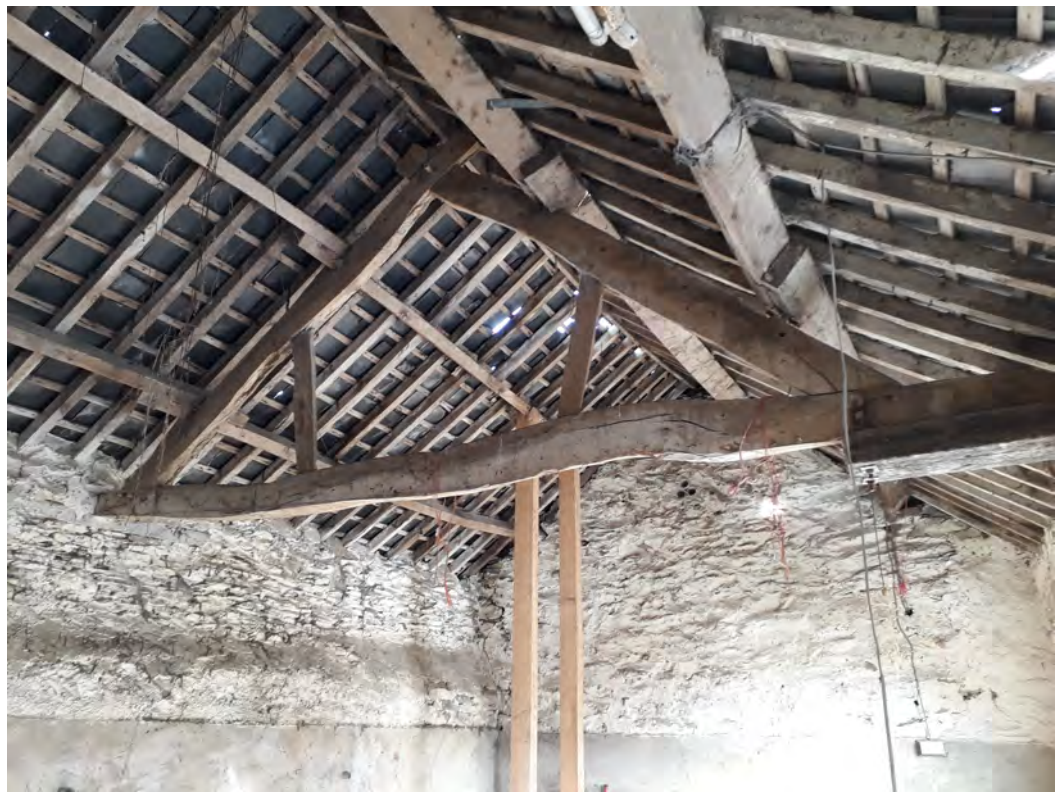
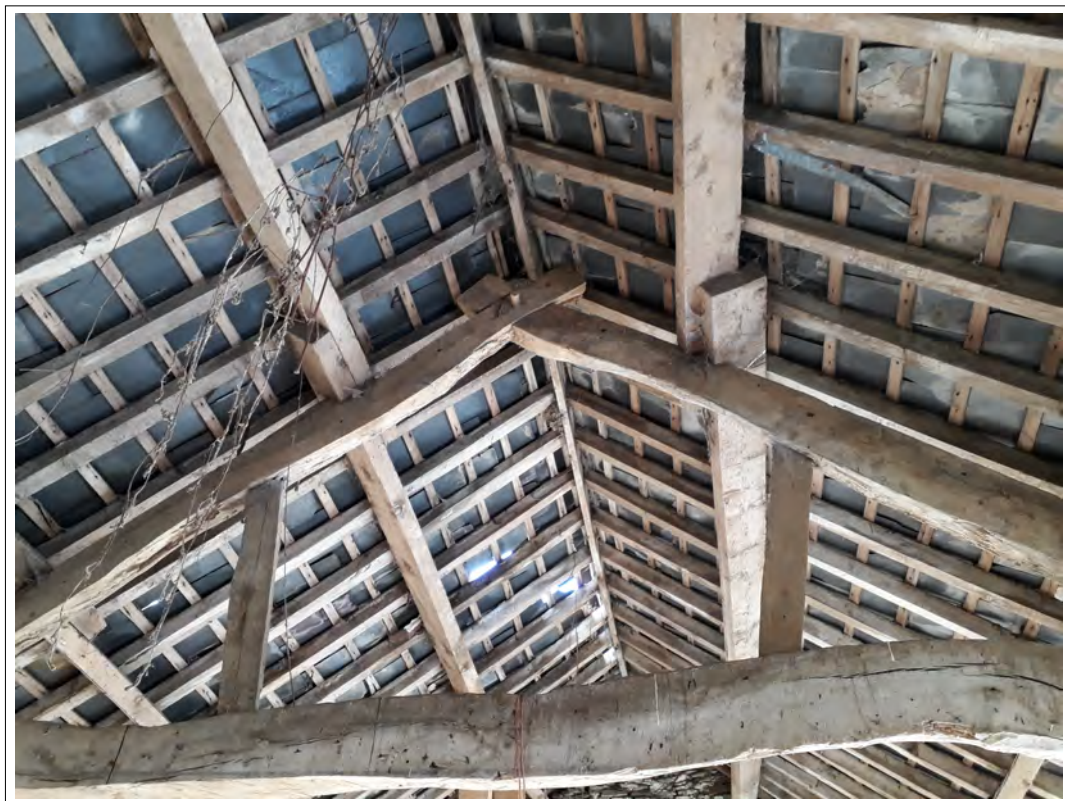
The barn interior had white-washed stone walls with a traditional timber roof truss of pegged and jointed construction, used to support machine-cut purlins and rafters. The truss itself was supported on a short section of beam protruding from the breeze-block frontage, secured by metal bolts. The slate roof was dilapidated in parts, causing rot to the purlins that was rectified by modern wooden supports. The lower sections of the stone walls were skimmed with concrete with a line of modern animal feeding troughs and a watering system of mid-20th century date.

Plate 31. Barn interior with mortise and tenon jointed and pegged roof truss, view north-east.

Plate 32. Barn interior roof truss detail, view north-east.

A traditionally constructed pegged roof truss is incorporated into the roof build of the barn, which is older in character than the machine-cut timbers of the rest of the roof and is therefore likely re-used from an earlier building when the roof was re-built. This may have been in the mid-19th century when the house was built, to make the barn serviceable if it was in disrepair.

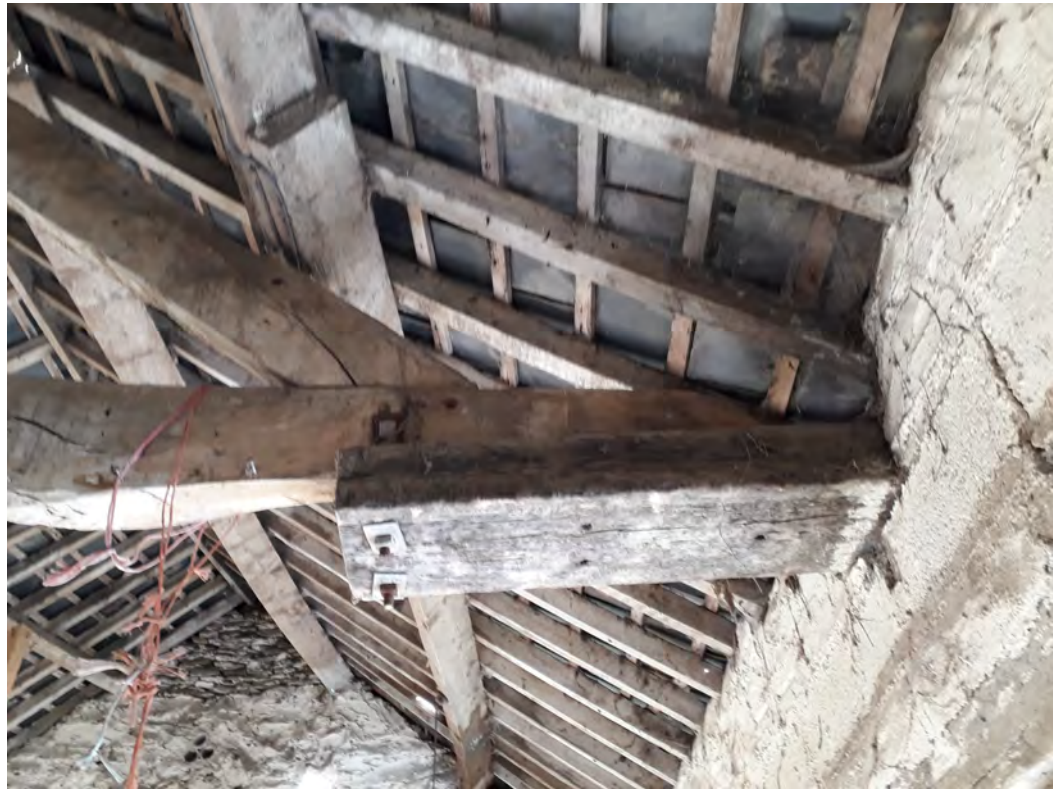
Plate 33. Barn interior roof truss support, view north-east.

The frontage of the barn building (to the south-east) may have been opened up to serve the farm yard of the house in the mid-19th century, and was later blocked up in 1961, at the same time as the roof truss was supported on a beam that may have replaced a pillar. During the 20th century the original barn has undergone a series of small extensions, and by 1972 a number of outbuildings had also been constructed of which the majority have since been cleared.

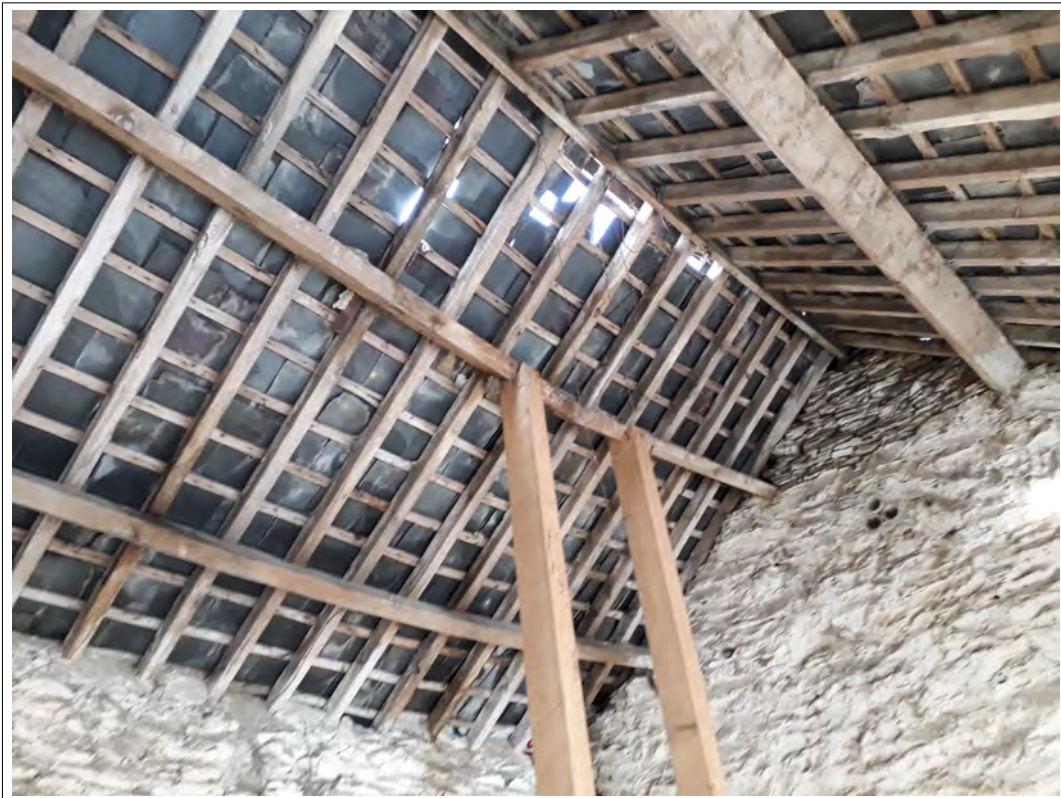
Plate 34. Barn interior purlin damage with modern supports, view north-east.

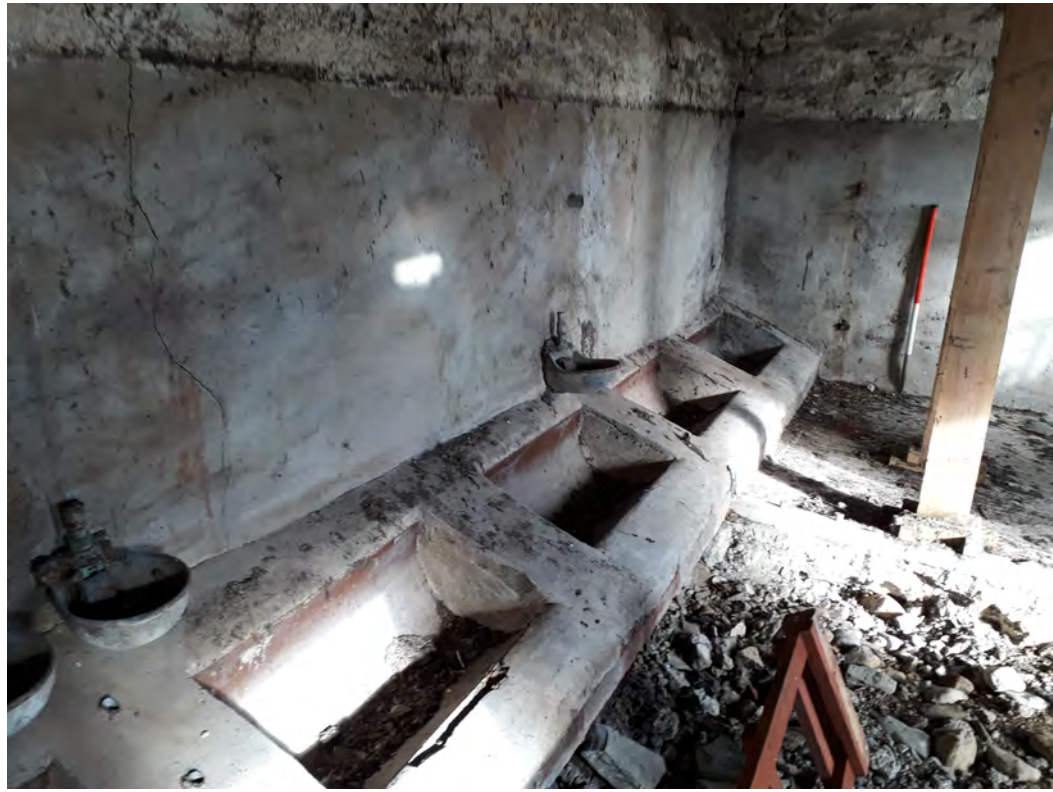
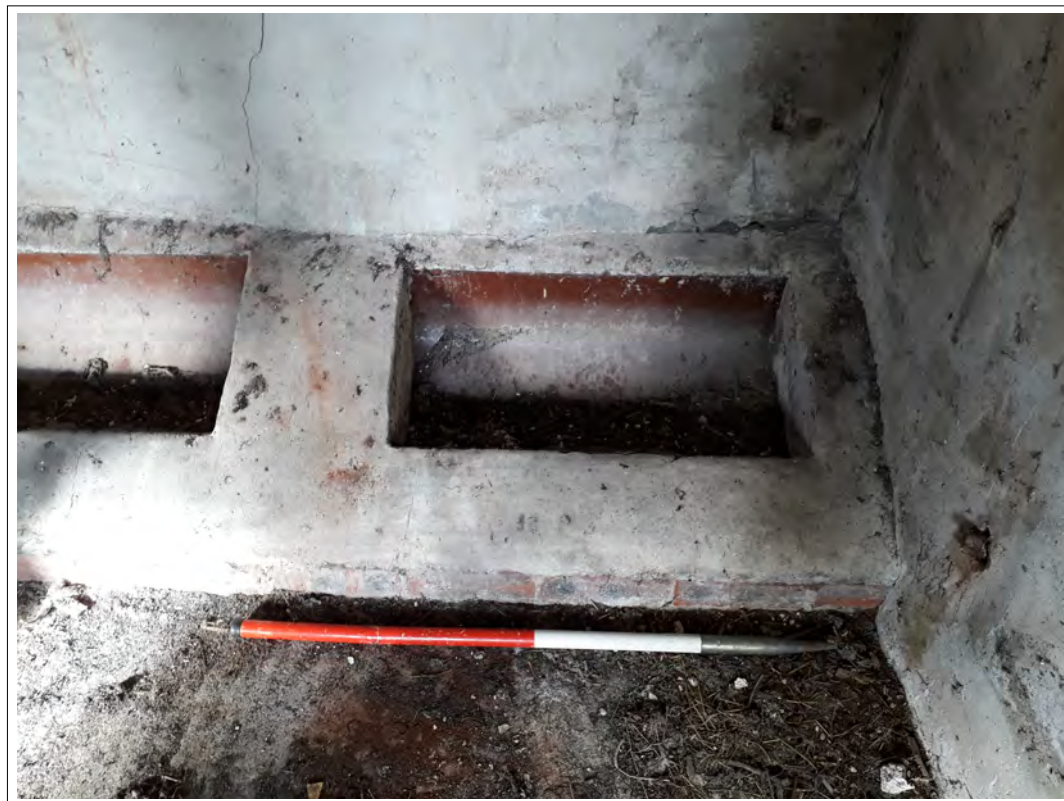
Plate 35. Barn interior view north-east, modern animal troughs. 1m scale

Plate 36. Barn interior animal trough detail, view north-west. 1m scale

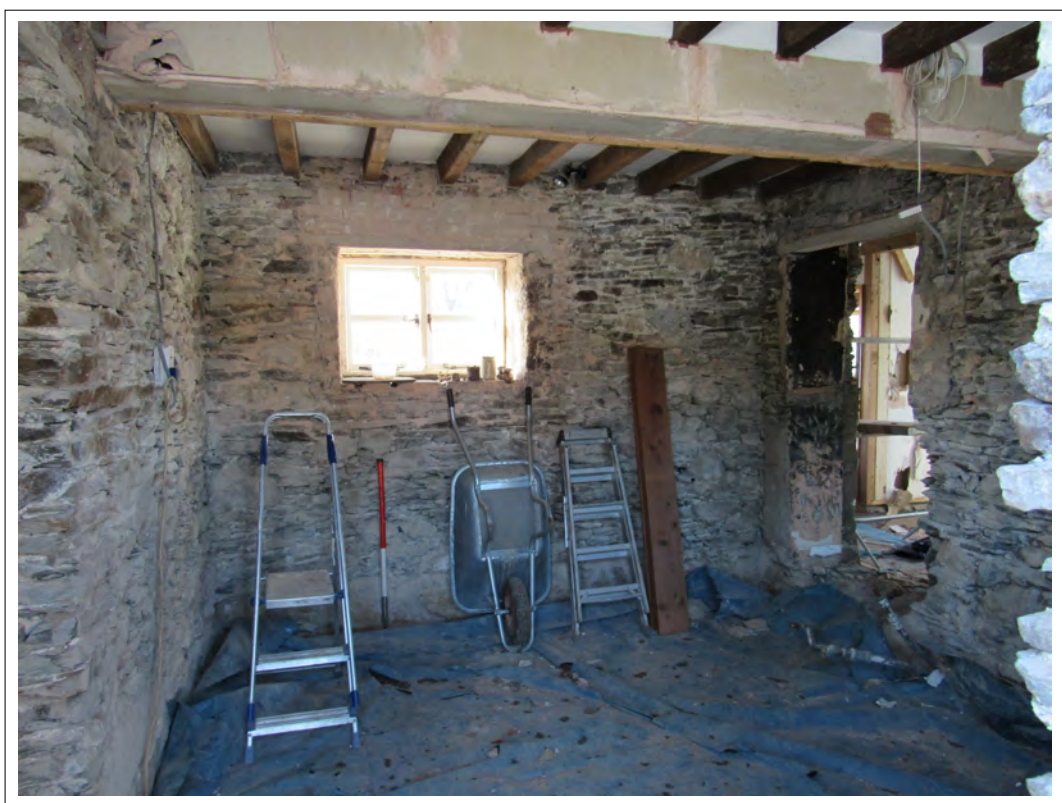
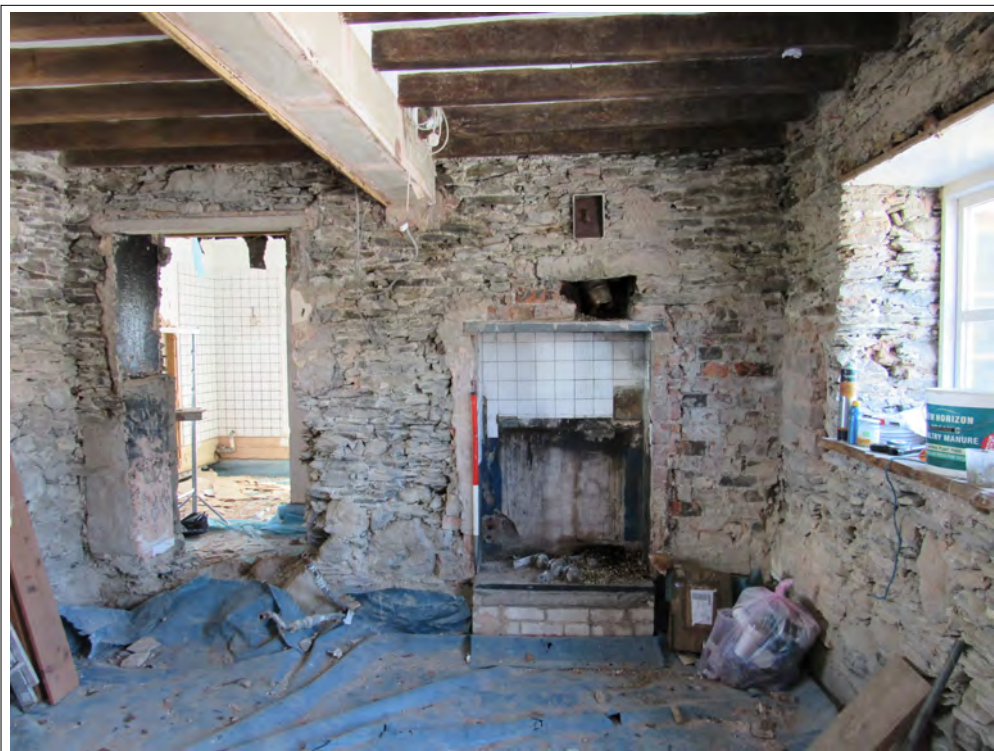
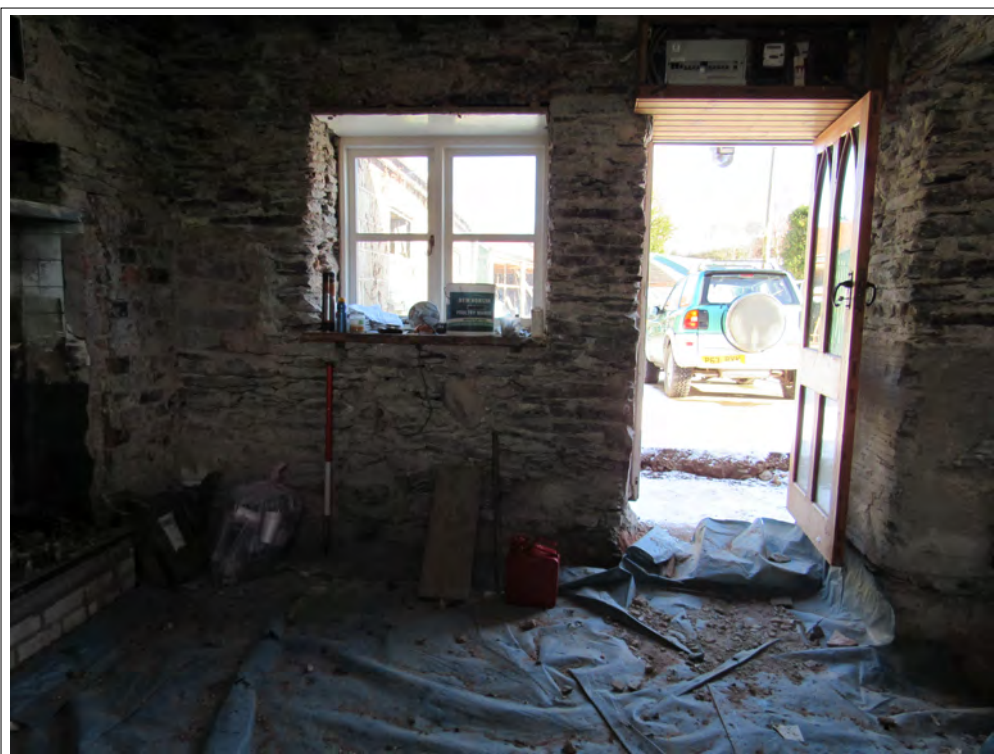
The kitchen was in the original house, with stone walls, beamed ceiling, remains of a 20th century stove, replaced windows and an inserted entrance door. Additionally, a doorway had been knocked through into the modern extension in the western corner of the house.

Plate 42. Kitchen in original house with inserted doorway to modern extension, view south-west. 1m scale.

Plate 43. Kitchen in original house with inserted doorway to modern extension, view north-west. 1m scale

Plate 44. Kitchen in original house with modern inserted entrance doorway, view north-east. 1m scale

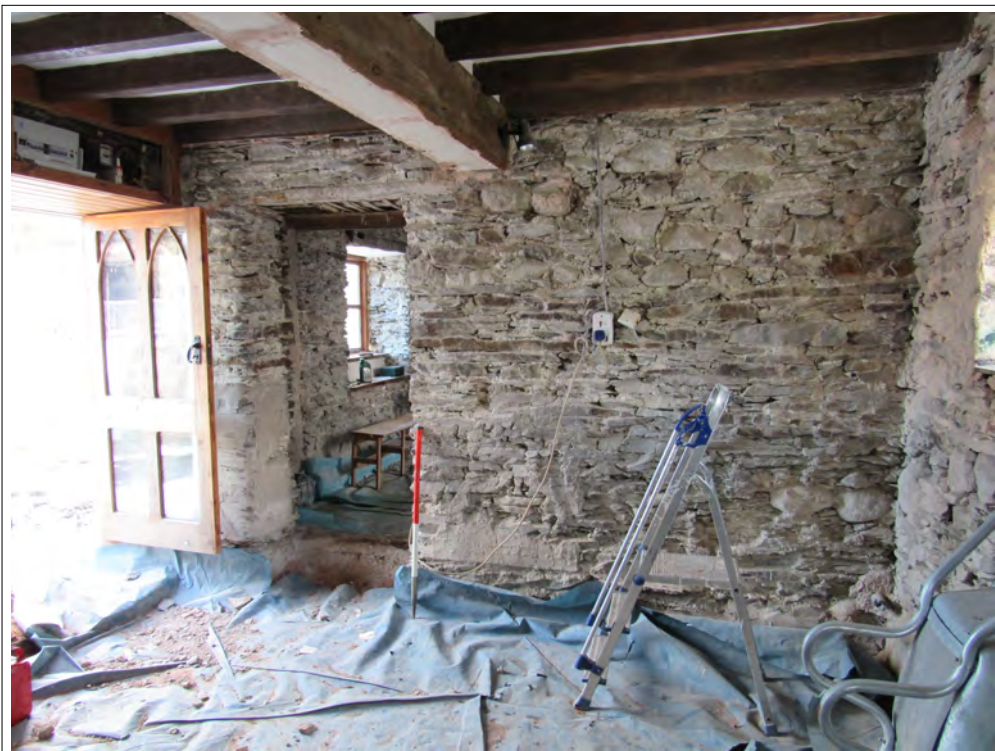
Plate 45. Kitchen in original house with doorway to lounge, view south-east.
1m scale

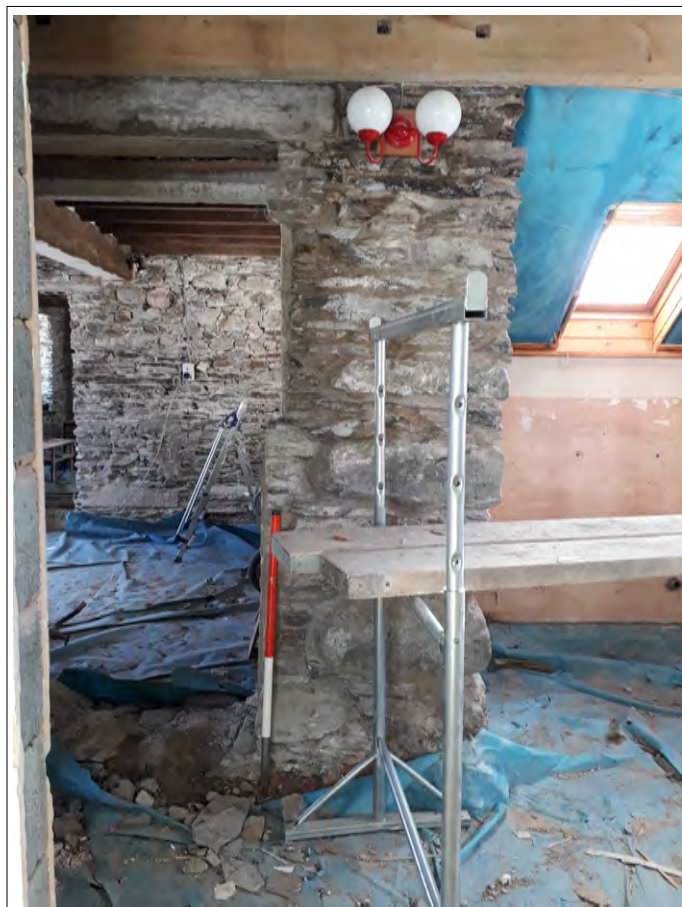
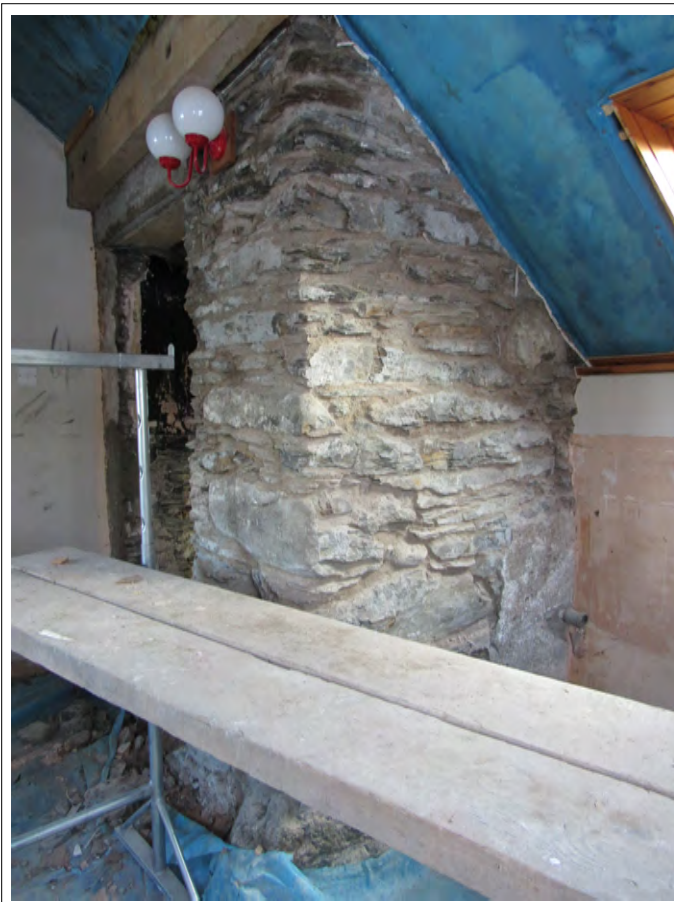
The modern extension comprised a toilet, utility and dining room. The dining room incorporated the south-western gable end of the barn, with the painted stone-work showing in the north-eastern wall. This extension post-dates the OS Map of 1972.

Plate 46. Original western corner of the house, now incorporated into the modern extension, view south-east. 1m scale

Plate 47. Original western corner of the house, now incorporated into the modern extension, view east. 1m scale

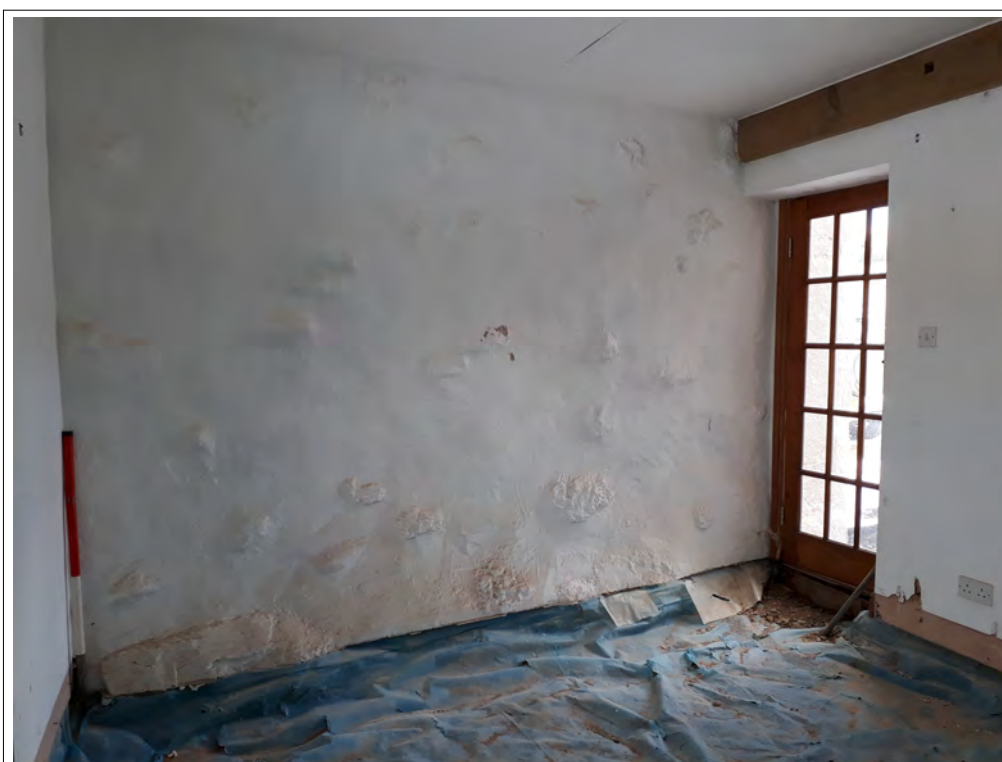
Plate 50. The modern extension incorporating the south-west end of the barn, view north-east. 1m scale

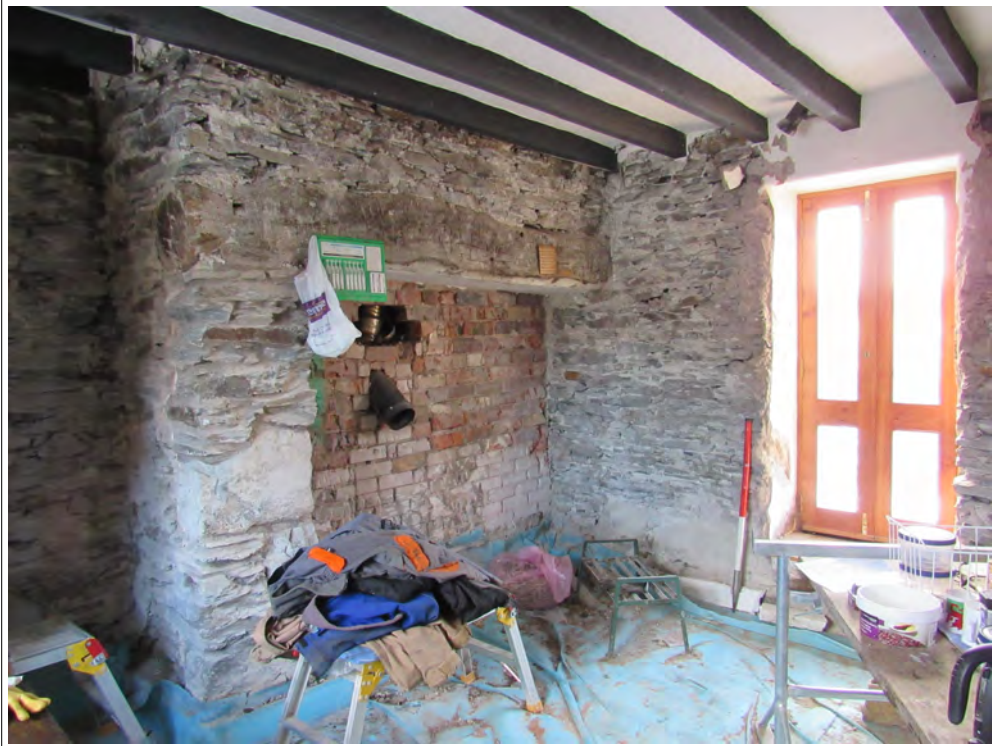
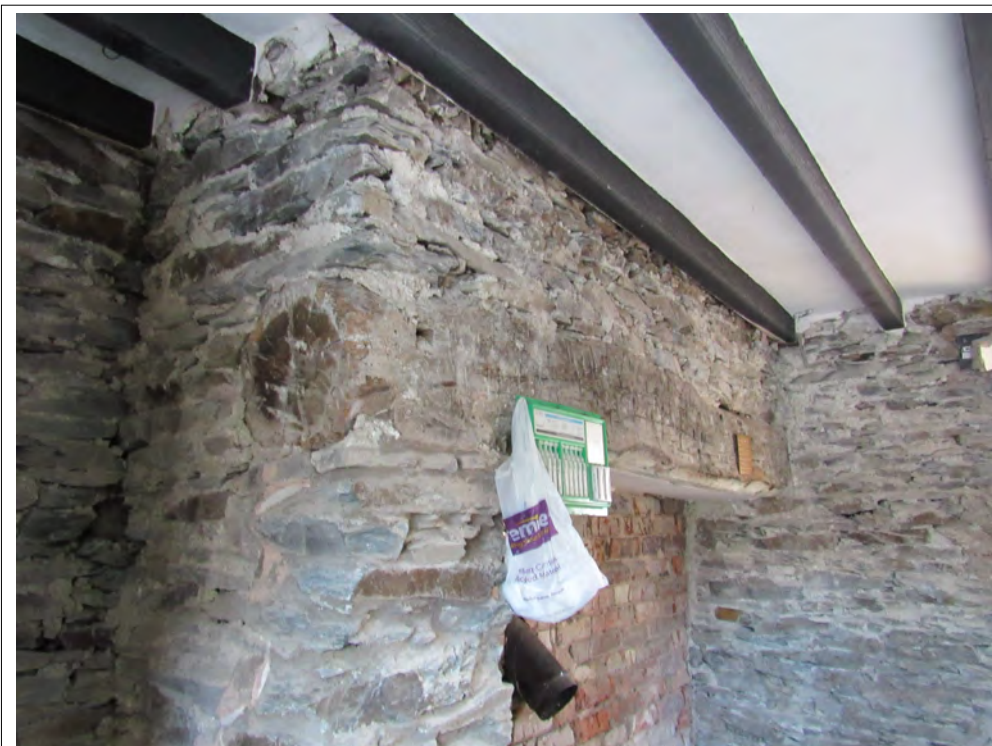
The lounge had the original fireplace extant, with a wooden mantle. The original entrance doorway to the front of the house could be seen, now blocked. A modern doorway had been inserted into the south-western wall of the lounge, which served the modern conservatory no longer extant. The wooden staircase went up from the lounge to Bedroom 1.

Plate 51. The lounge with fireplace and inserted door, view south. 1m scale

Plate 52. The fireplace mantle in the lounge. View south

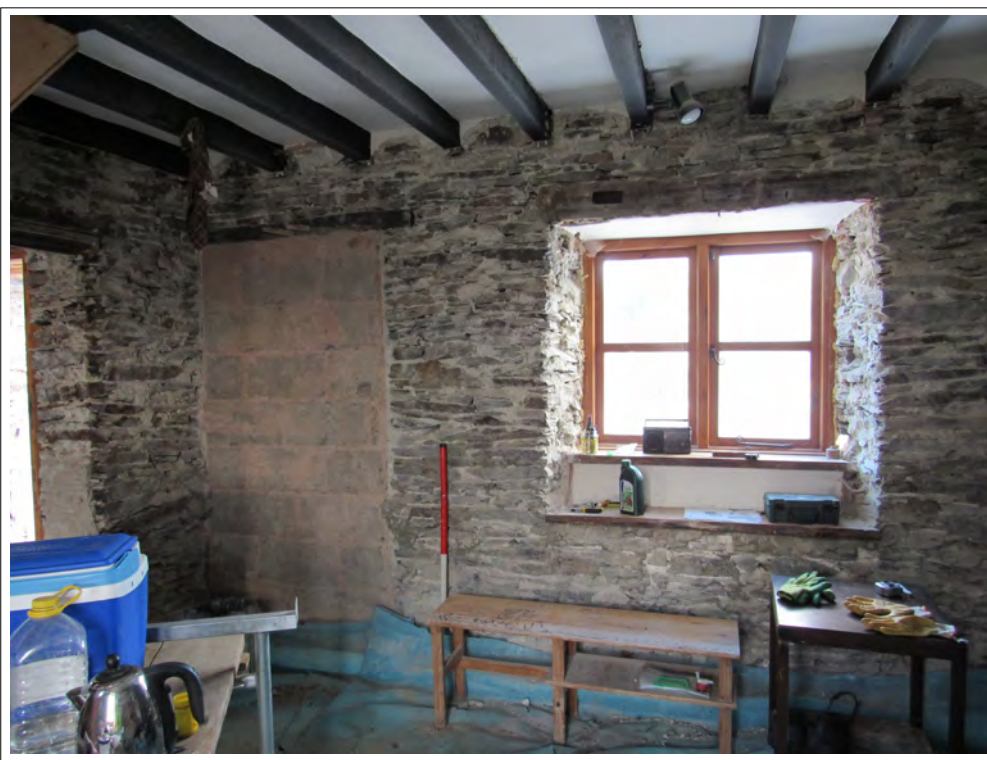
Plate 54 The original blocked entrance doorway in the lounge.
View north-east. 1m scale

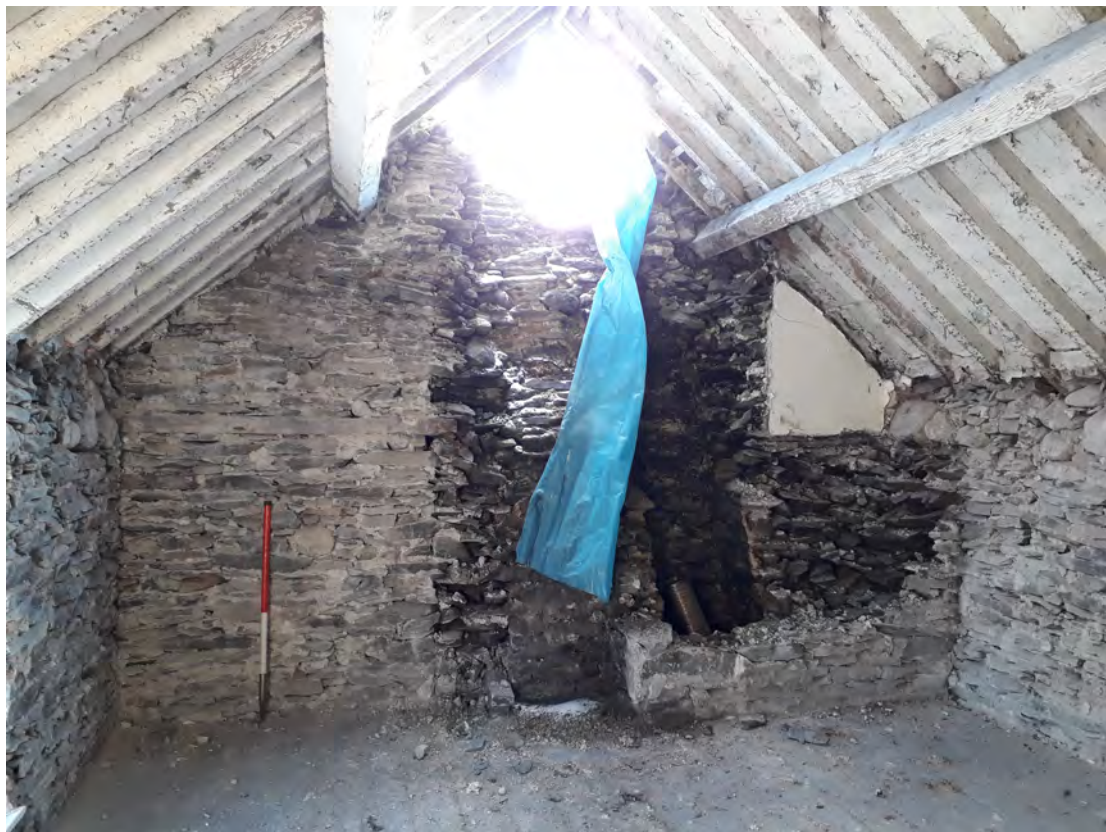
Bedroom 1 was the original upstairs of the house, with stone walls and the machine-cut timber roof construction surviving. The chimney breast and stack had been removed and window replaced in modern times. A doorway with original lintel and a modern inserted door frame led to the adjacent Bedroom 2.

Plate 57. Bedroom 1 with demolished chimney breast. View south-east. 1m scale

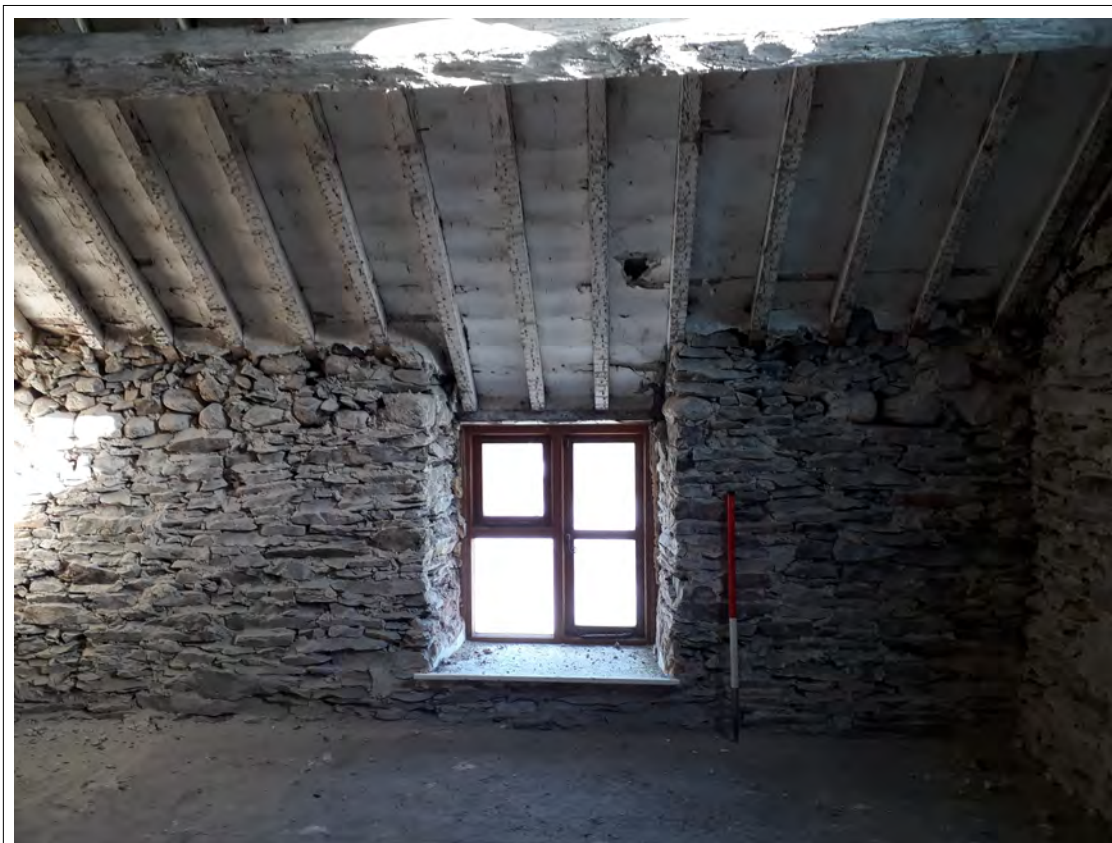
Plate 58. Bedroom 1. View north-east. 1m scale

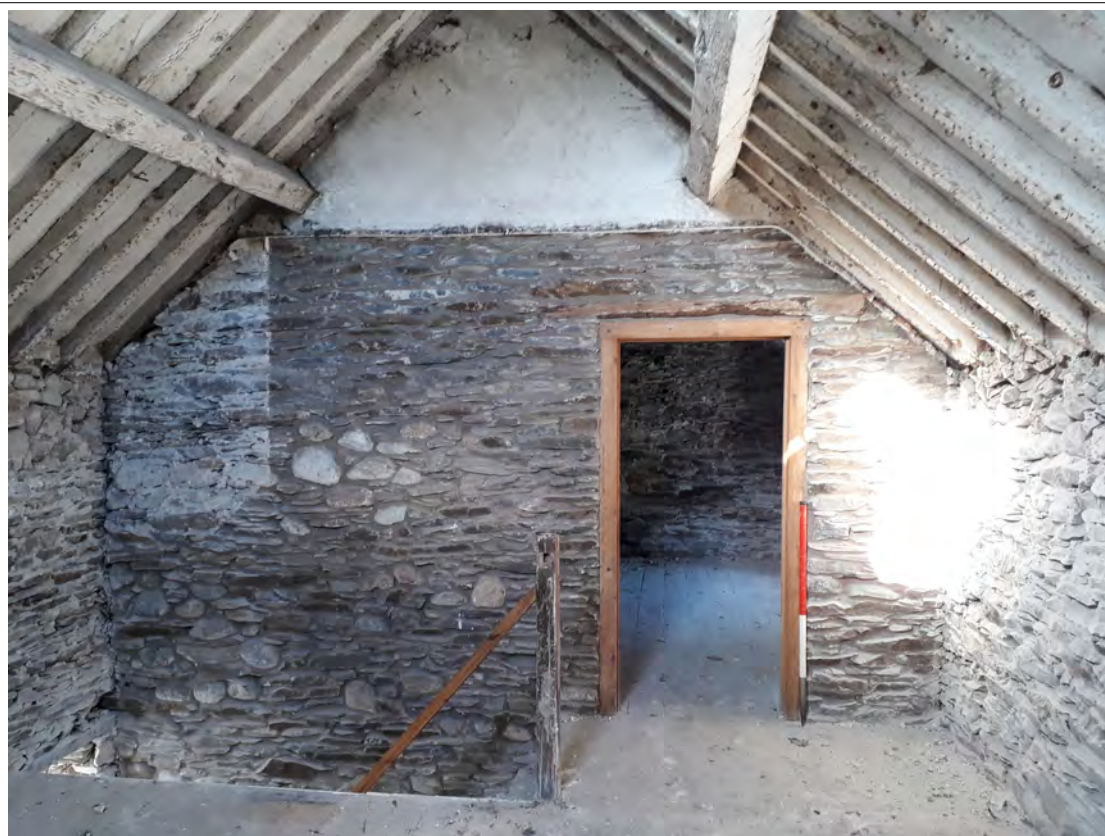
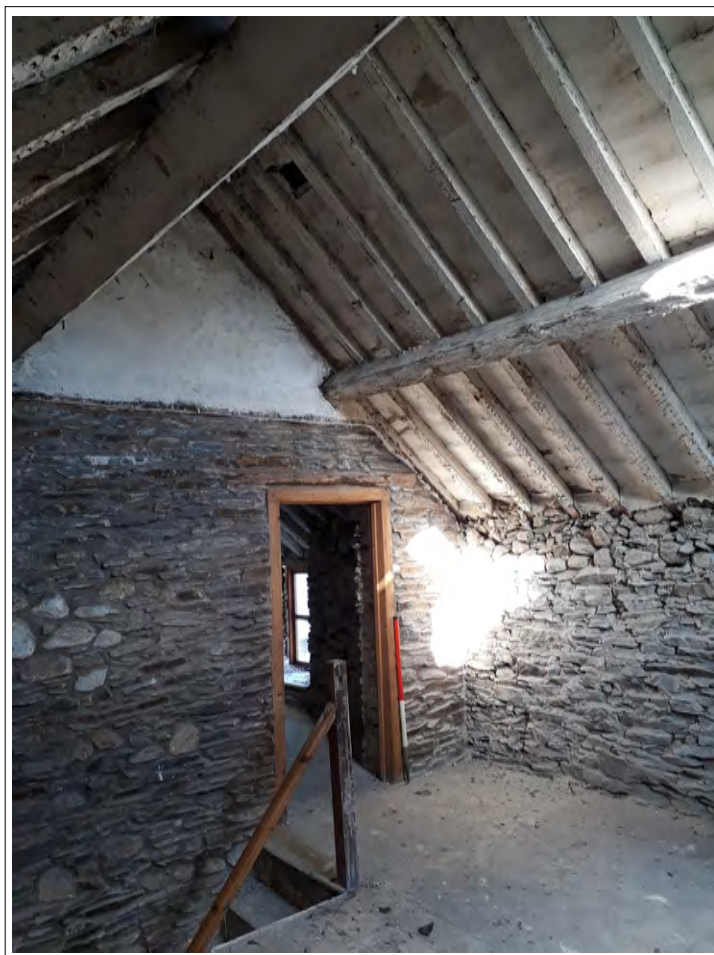
Plate 59. Bedroom 1, doorway to Bedroom 2. View north-west. 1m scale

Plate 60. Bedroom 1, doorway to Bedroom 2. View north. 1m scale

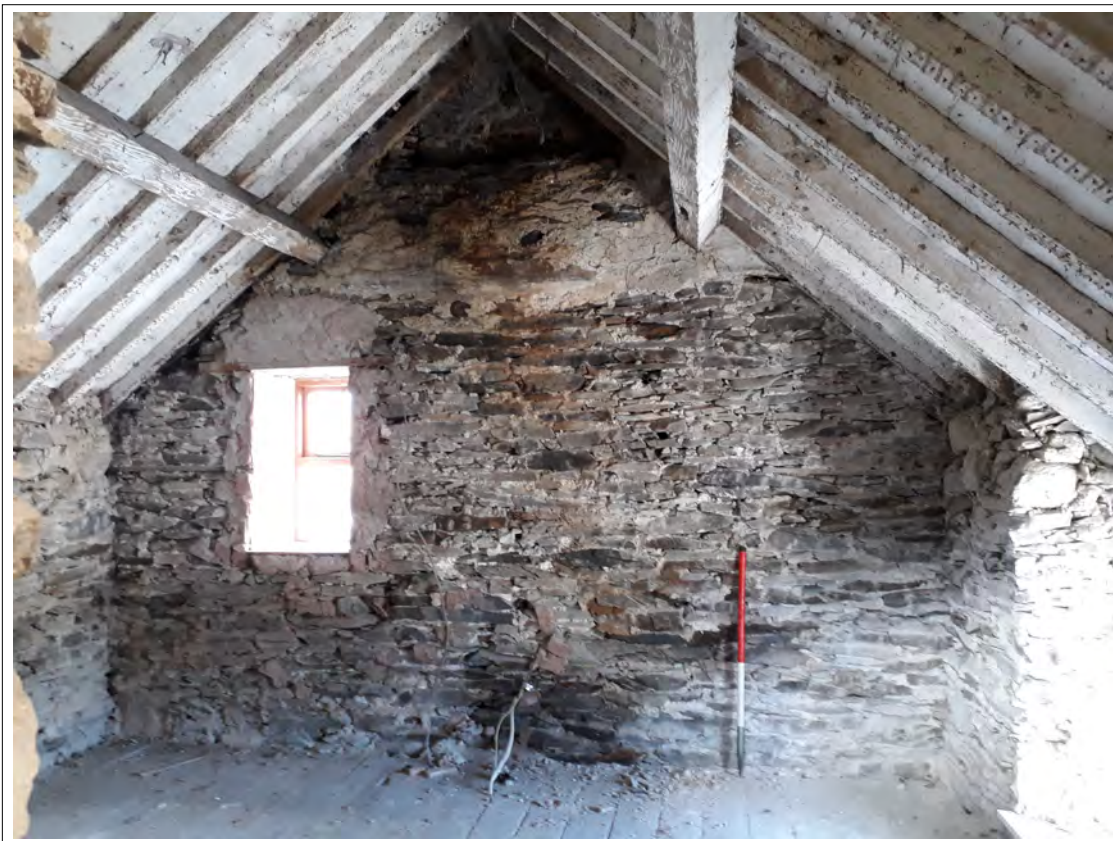
Bedroom 2 was the original upstairs of the house, with stone walls and the machine-cut timber roof construction surviving. The window to the north-east had been replaced in modern times, with a small window having been inserted into the north-western gable-end.

Plate 61. Bedroom 2. View north-west. 1m scale

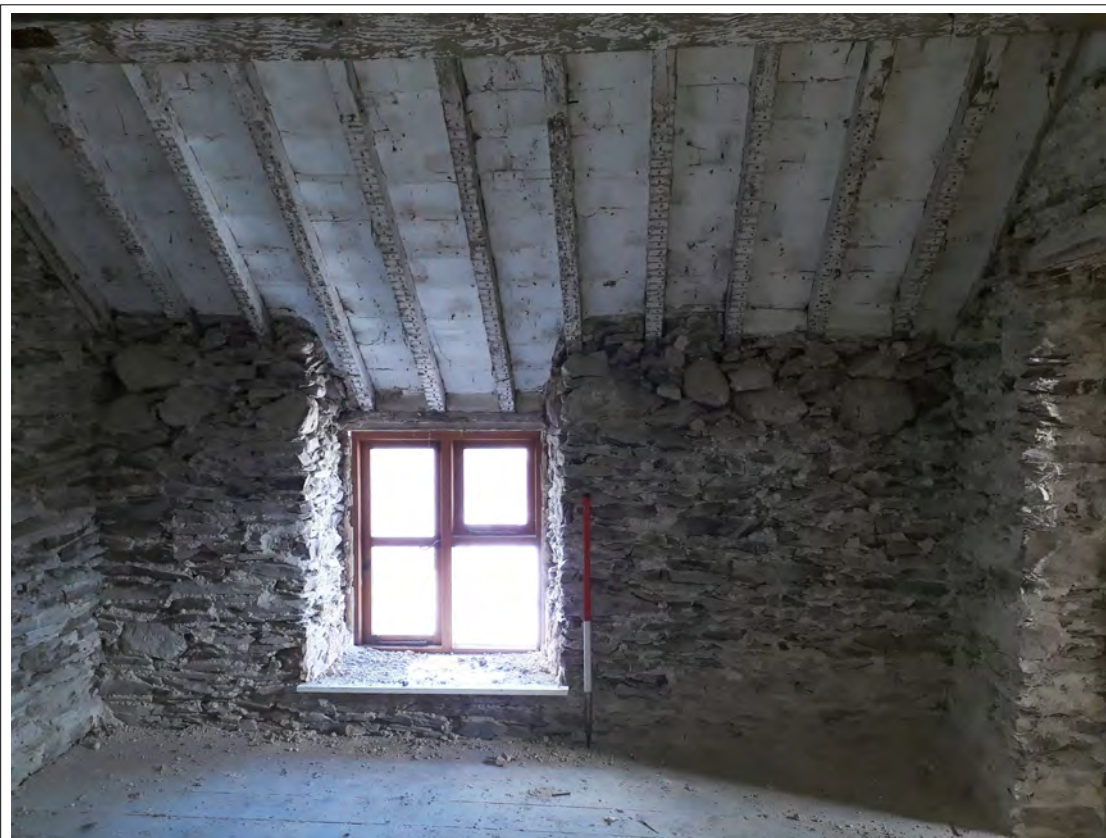
Plate 62. Bedroom 2. View north-east. 1m scale

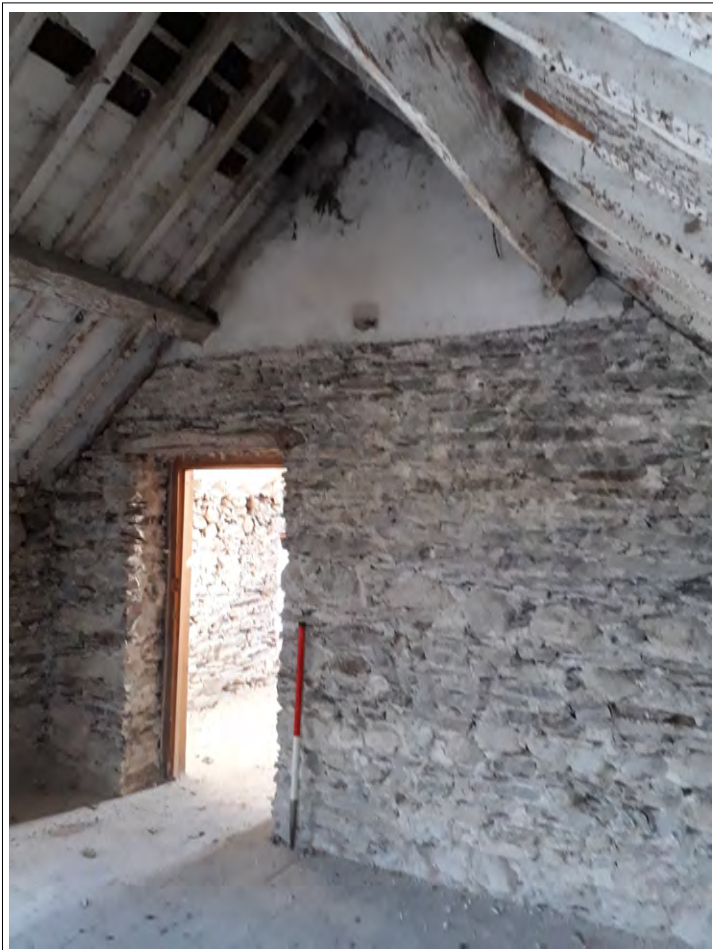
Plate 63. Bedroom 2. View south-east.
1m scale

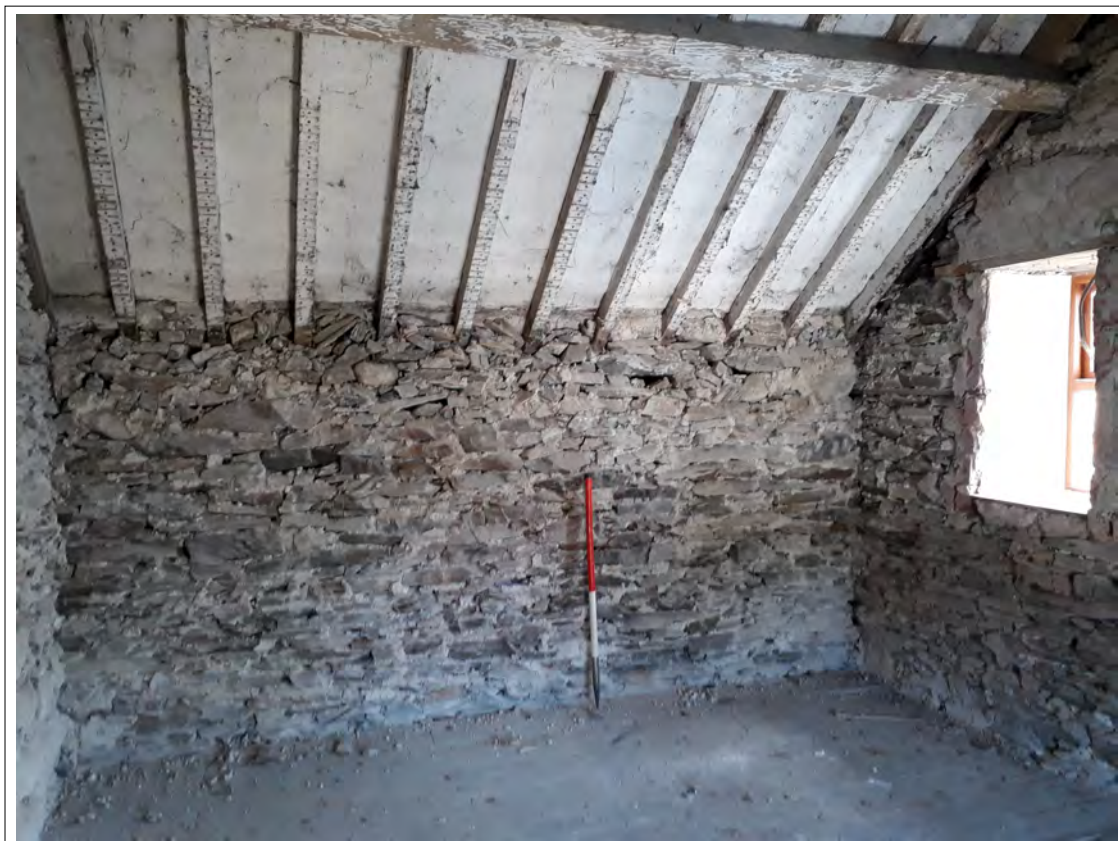
Plate 64. Bedroom 2. View south-west. 1m scale
