CPAT Report No. 1454-2

Plas Uchaf, Whitford, Flintshire

Building Survey and Watching Brief

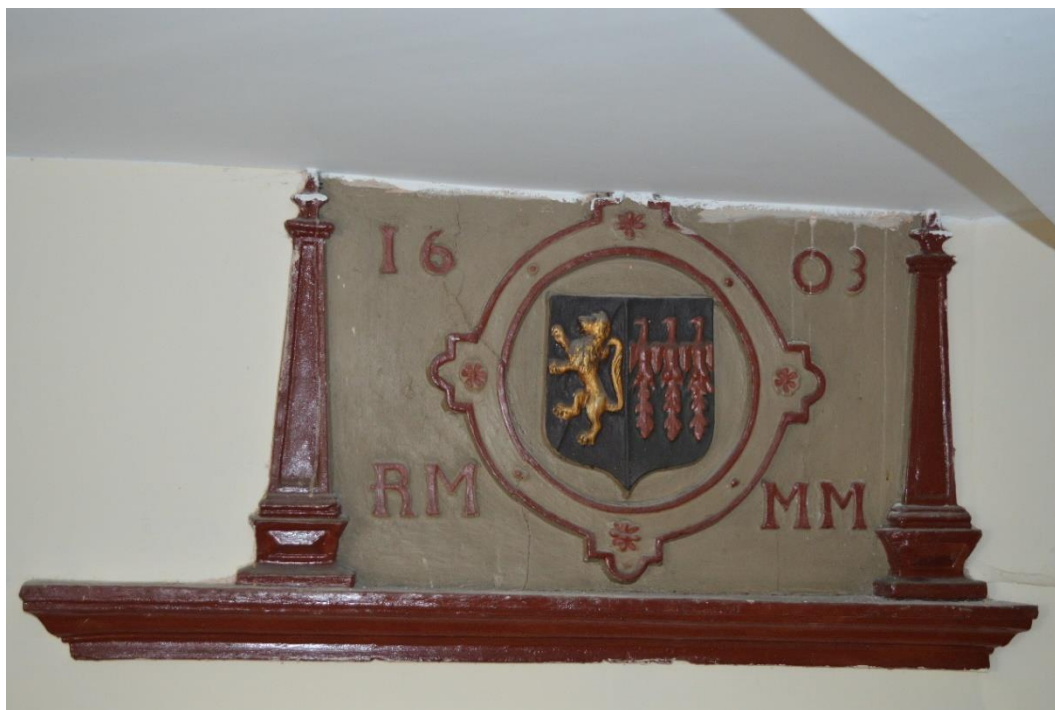
Sir Roger Mostyn and his wife Mary who were responsible for undertaking considerable alterations to the structure in c.1603 and it is their initials ('RM' and 'MM') and conjoined coats-of-arms which can be seen above the first floor fireplace.

Fig. 2 The coat of arms above the first-floor fireplace. Photo CPAT 4232-0054

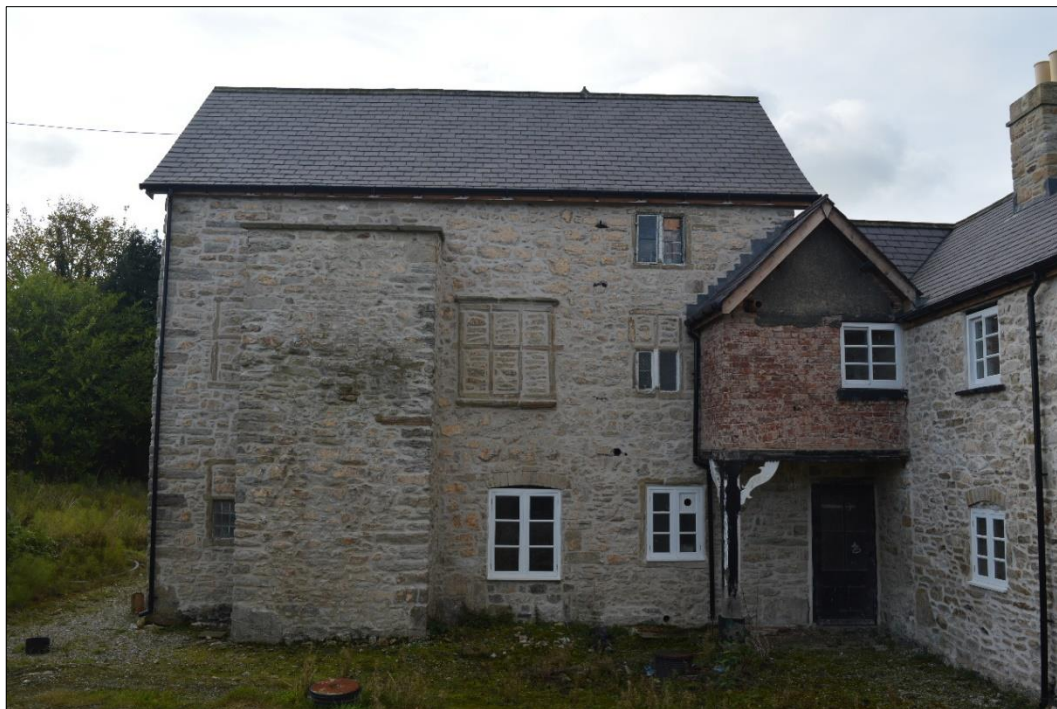
Fig. 3 The south-west elevation of the 16th-century range. Photo CPAT 4246-0001

- 4.2. 16th century. The core of the house is a storeyed hall with lateral chimney, cross-passage and outer room. This house-type is well represented in north-east Wales. The original doorway, on the north-west side of the chimney, is recorded as having a round arch but has since been infilled and replaced by a window (WG04). On the opposite side of the hall a second round arched doorway, which leads to the Phase 2 extension, has been suggested as providing evidence for a former cross passage, although the two doorways are not exactly opposite each other.

- 4.6. Externally, the lateral chimney has been reduced in height and capped, while the north-east elevation contains several of the original stone-mullioned windows, most of which are now blocked. The south-east gable wall has wide window openings (WG06, WF05 and WF02) under segmental heads on all three floors, which replaced the four-light mullioned windows depicted by Ingleby. The tall chimney stack in the southern corner, also depicted by Ingleby, is no longer present.

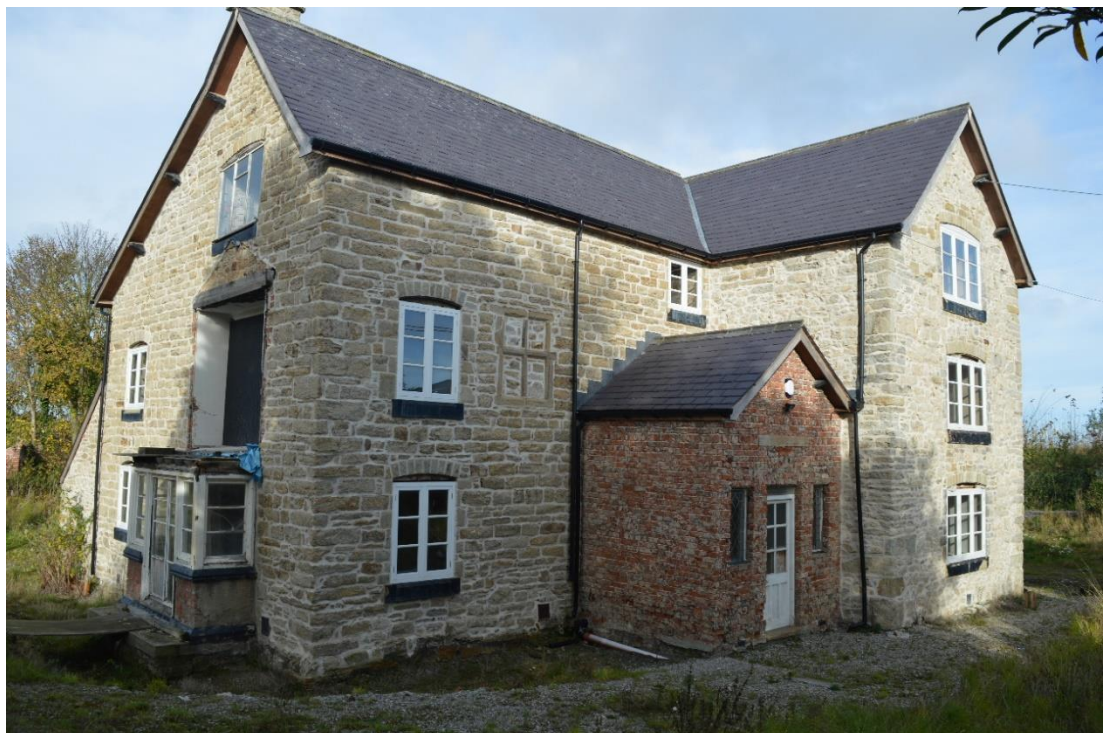
Fig. 5 Plas Uchaf today, viewed from a similar angle. Photo CPAT 4246-0011

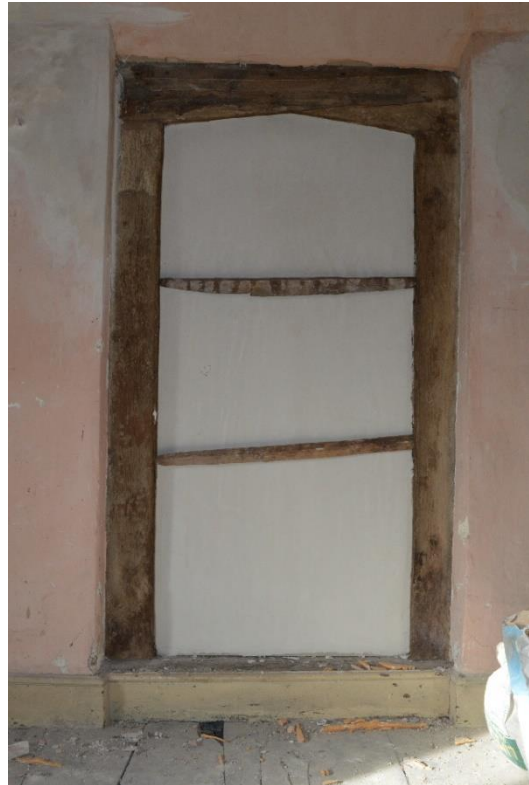
- 4.10. The second floor has the same layout as those below, with a main chamber containing a fireplace in the corner. The connecting door into what is an adjoining attic room is blocked, but retains the original doorframe.

Fig. 6 The blocked dorrway on the second floor of the 17th-century range. Photo CPAT 4246-0073

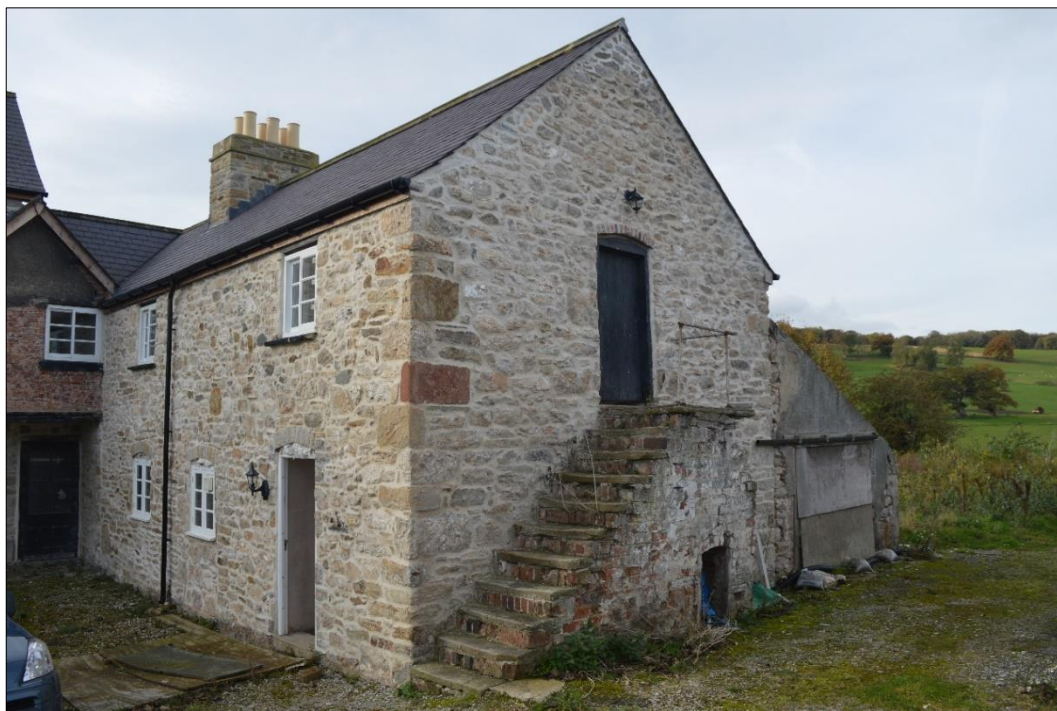
- 4.14. 19th century. A range was added to the side of the kitchen, encompassing the lateral chimney and comprising a service room with fireplace on the ground floor and a granary on the first floor, accessed via an external stair. Later additions include a lean-to against the north-west wall of the granary range, further outbuildings, now demolished, and a more polite entrance which was contrived on the east side between hall and parlour.

Fig. 8 The 19th-century granary range. Photo CPAT 4246-0020

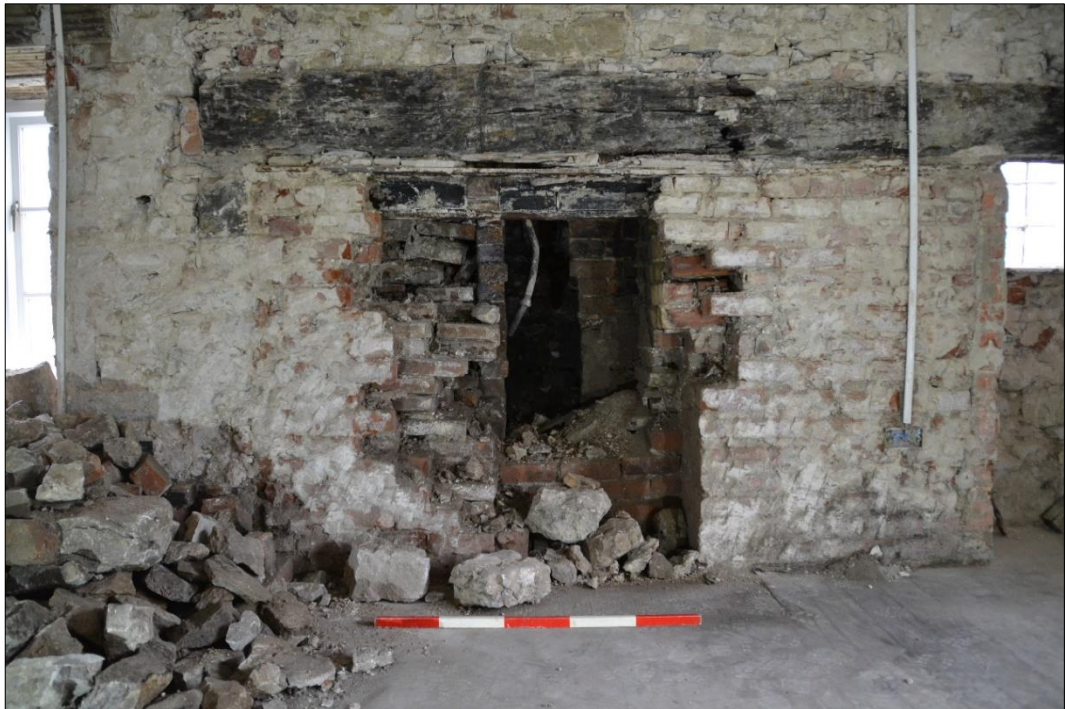
- 5.2. On the ground floor the works revealed the original fireplace, which was partly reopened, together with a substantial beam above this, which also formed a lintel above an adjacent window (see Fig. 9).

Fig 9 The original fireplace opening in Room G14. Photo CPAT 4404-0002

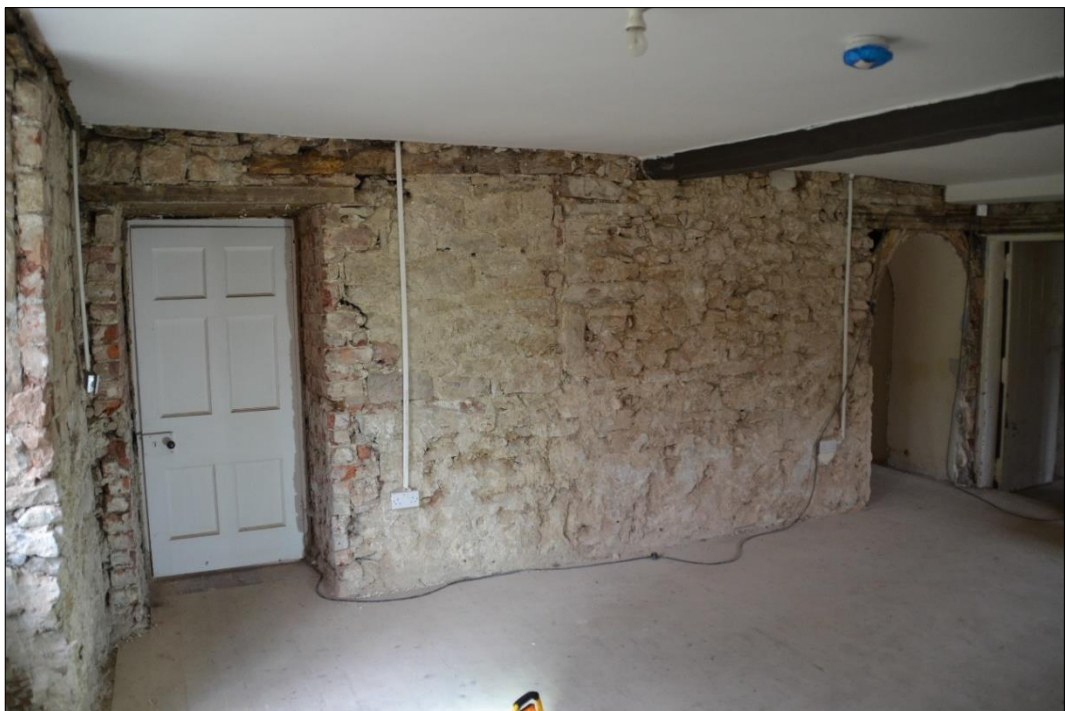
Fig. 10 Exposed south-west wall in Room G14. Photo CPAT 4404-0006

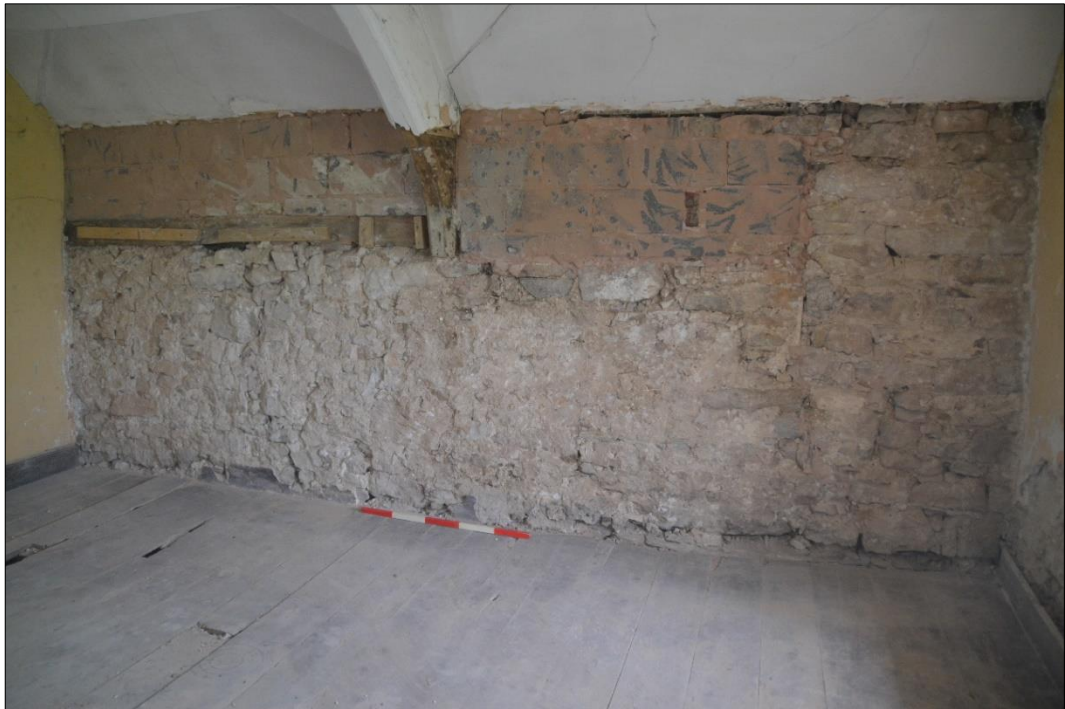
- 5.3. On the second floor the removal of plaster revealed a blocked window in room S06 and also demonstrated that the upper part of this wall, at least internally, had been rebuilt using concrete blocks (Fig. 11).

Fig. 11 Exposed walling in Room S06. Photo CPAT 4404-0011

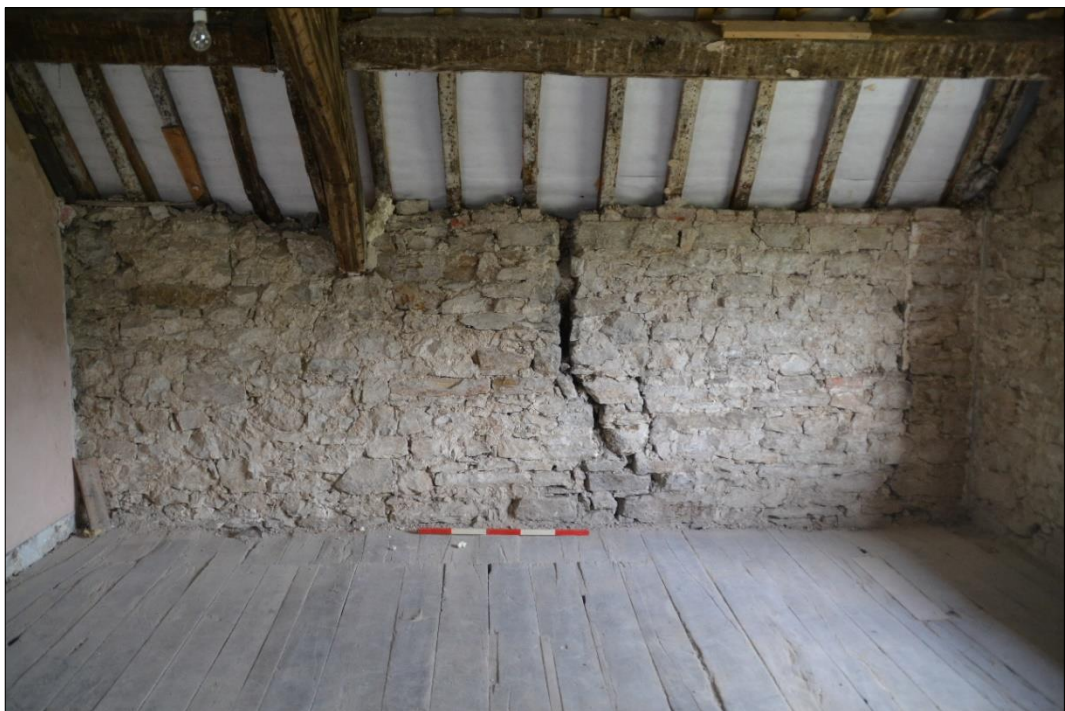
- 5.4. In Room S03 the removal of plaster on the south-eastern wall revealed substantial displacement of the masonry, as well as a blocked window (Fig. 12). The position of a former coat of arms was also exposed above the door (Fig. 13), while the removal of the ceiling allowed recording to be undertaken on the original roof truss (Figs 14-15). The opportunity was also taken to record the roof truss in Room S06 (Fig. 15).

Fig. 12 Exposed walling in Room S03 showing substantial displacement of masonry, with a blocked window to the right of the crack. Photo CPAT 4404-0024

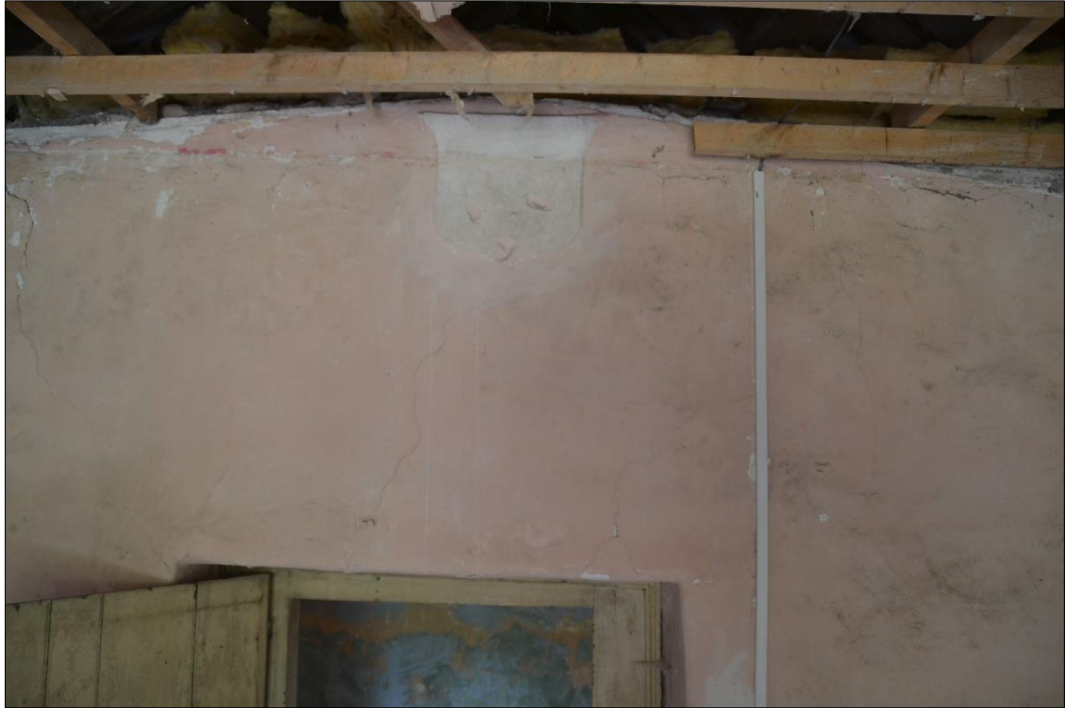
Fig. 13 Position of coat of arms above the door in Room S03. Photo CPAT 4404-0045

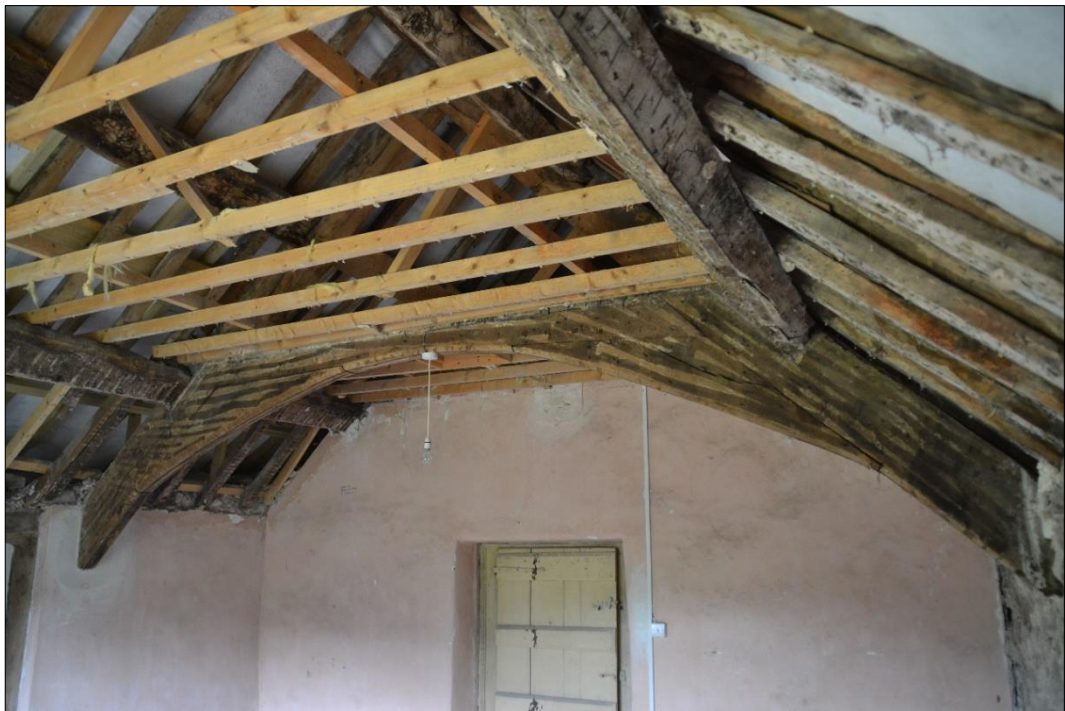
Fig. 14 Original roof truss in Room S03. Photo CPAT 4404-0034

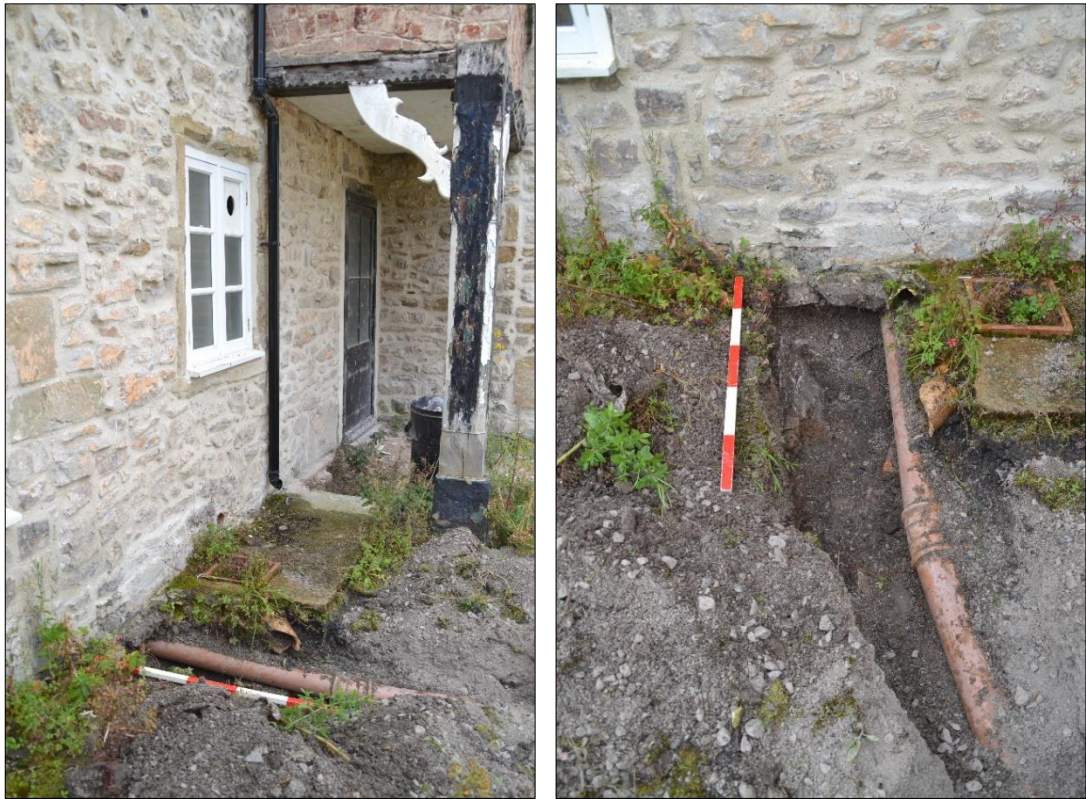
- 5.5. Groundworks associated with a new external drain between windows WG03 and WG04 were monitored, although this revealed nothing of archaeological significance (Figs 16-17; see Fig. 19 for location).

Figs 16-17 Grounds for a new drain. Photo CPAT 4404-0023 and 0022

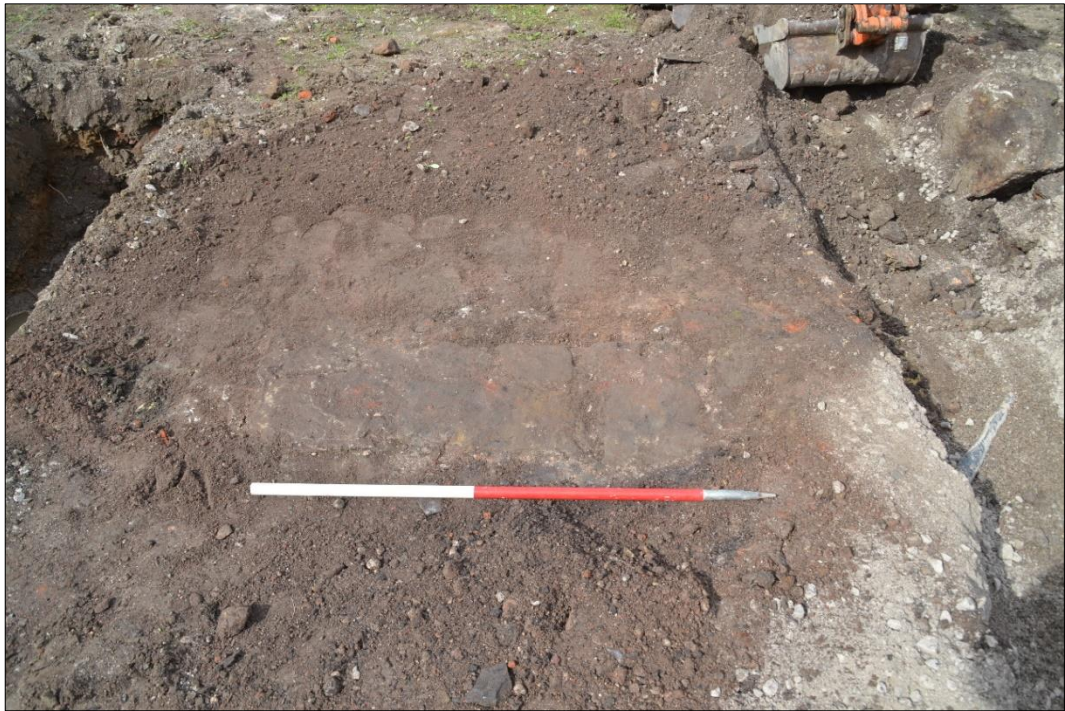
Fig. 19 The internal dividing wall within the outbuilding. Photo CPAT 4563-0013

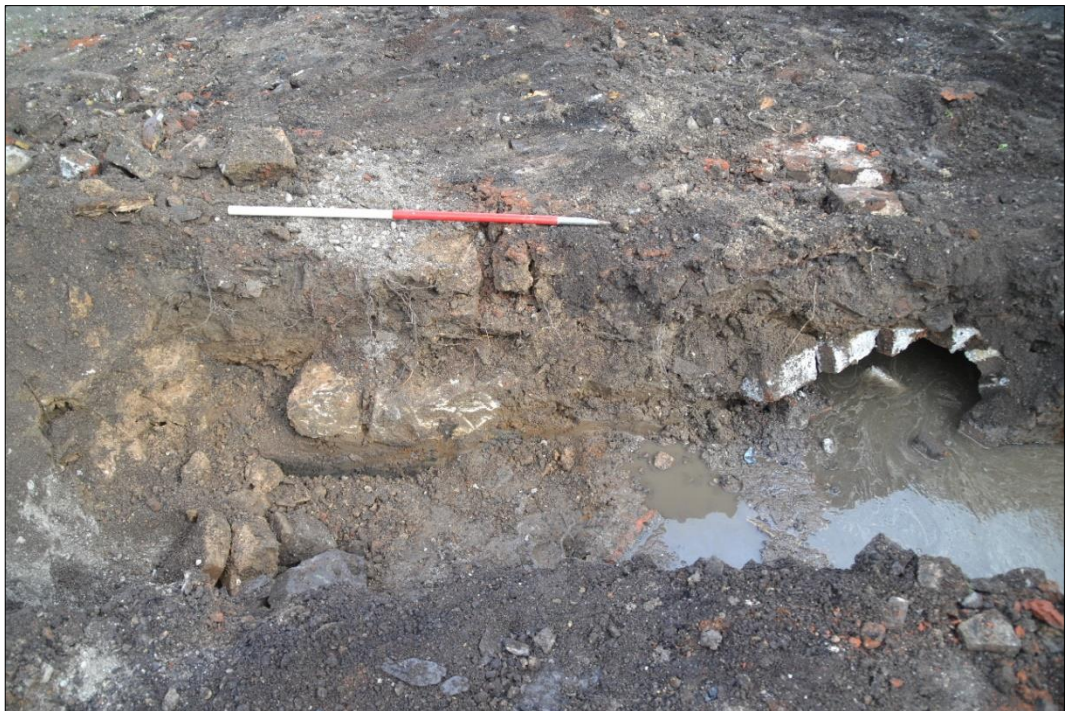
Fig. 20 The brick-arched culvert with the basal remains of the outbuilding wall to the left. Photo CPAT 4563-0009

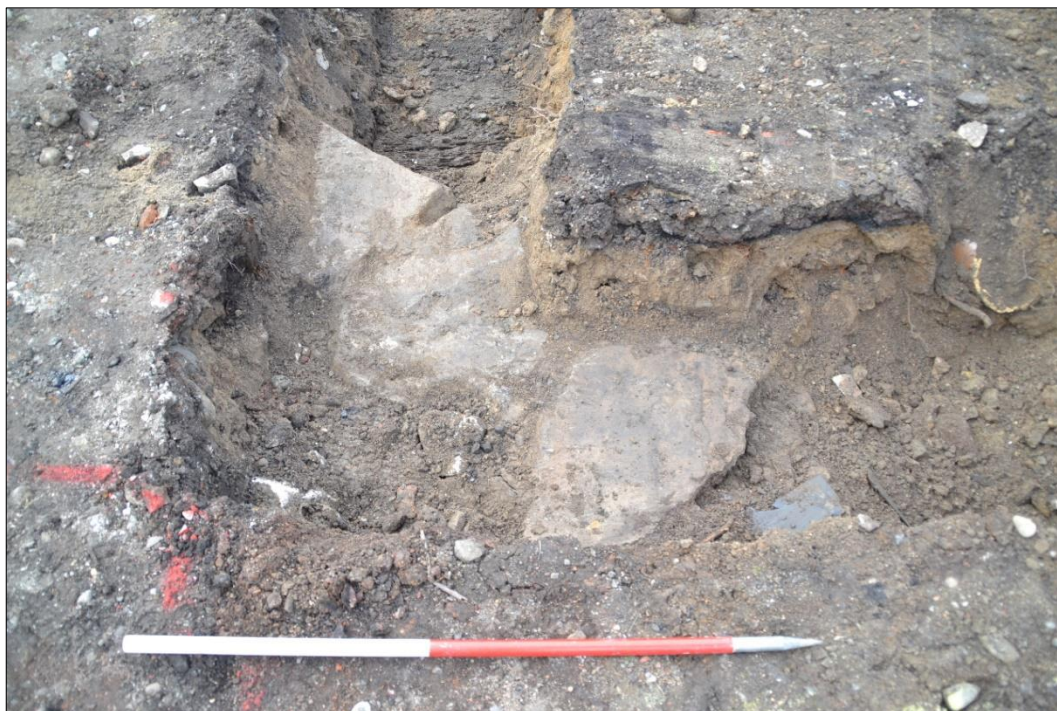
Fig. 21 The stone-slabbed top of the second culvert. Photo CPAT 4563-0021

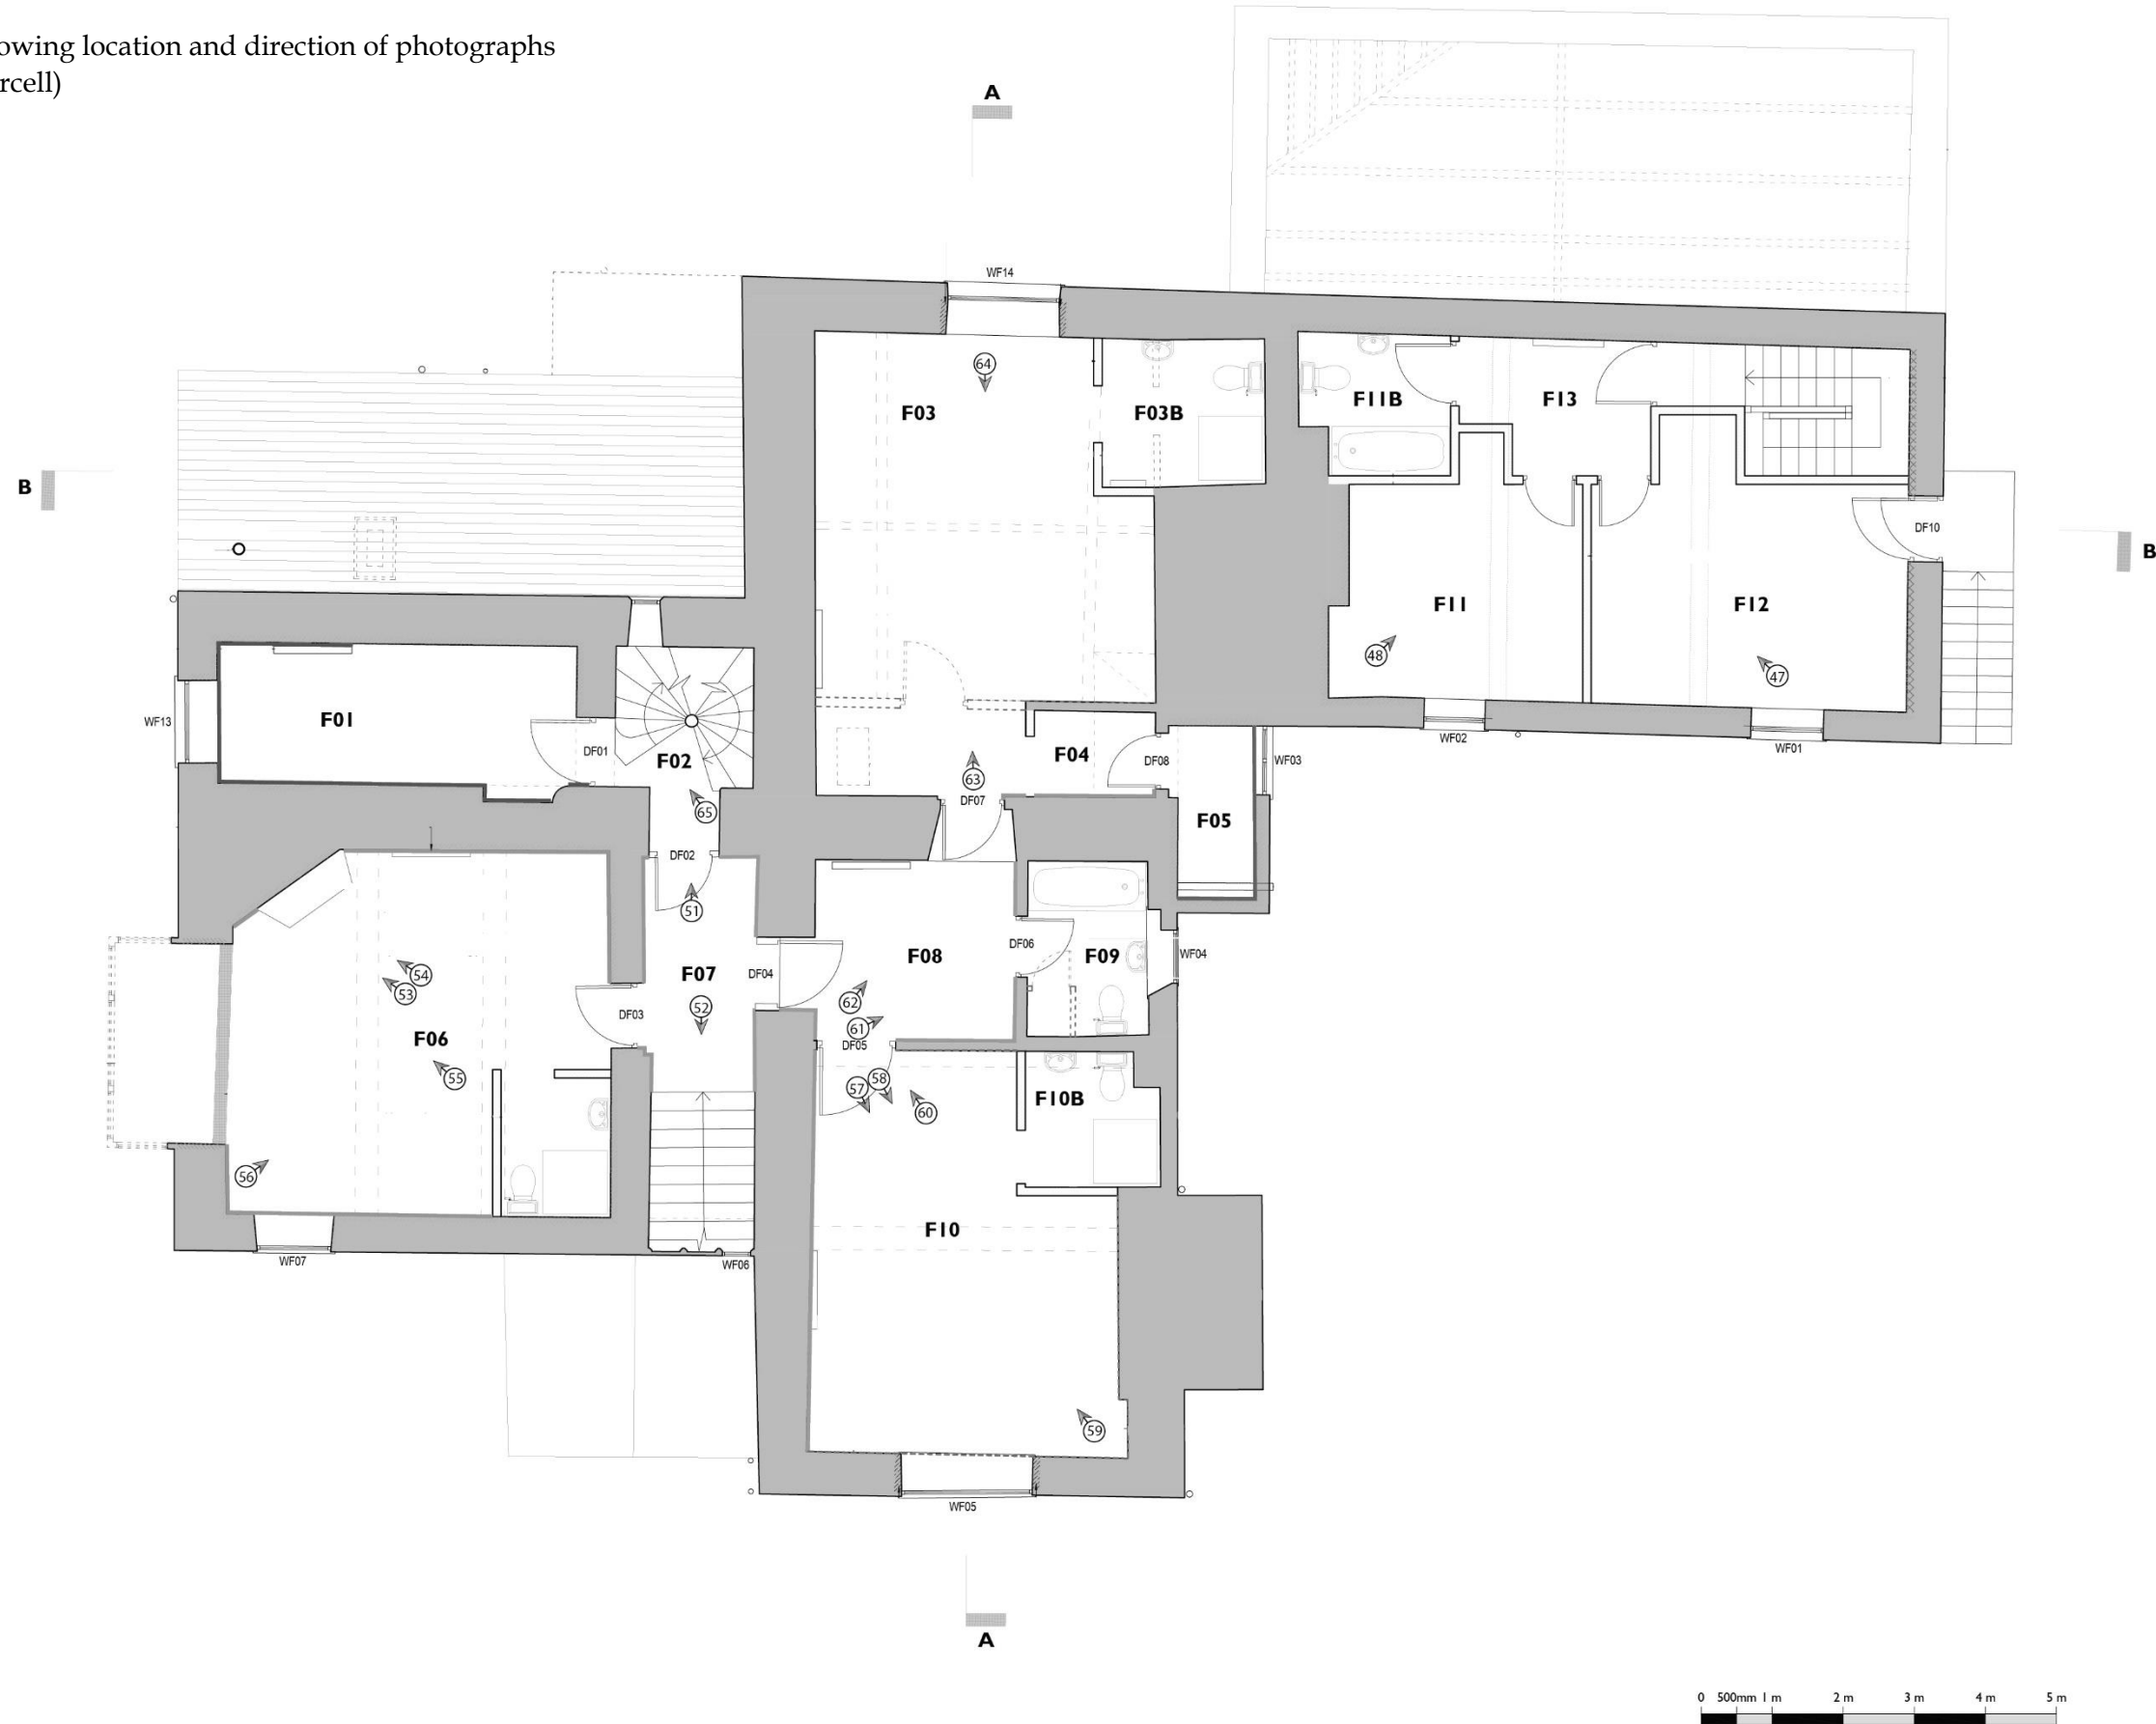
Fig. 25 Second floor plan showing location and direction of photographs - watching brief Sept 2017 in blue.
(based on a survey by Purcell)
