**Building Survey and Photographic Record  
(Level 1):**

**Written Account (Volume 1)**

Former Custom House, Custom House Street,  
Cardiff

July 2018

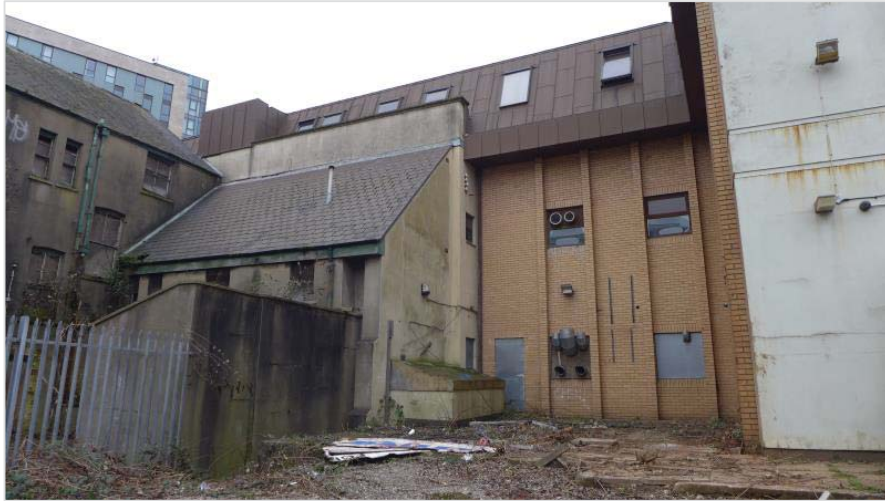
2.13 The late 20<sup>th</sup> century saw significant, authorised changes to the Site, which had major and irreversible impacts on the particular significance of the listed building. Most significantly, the former Custom House was gutted, altered and extended by Lock-Newcrews, Hill & Partners c.1983-5. The works were so extensive; they effectively amounted to façade retention, with a new structure inserted behind the retained northern and western facades and incorporated a metal clad mansard roof. This has been confirmed by an inspection of the listed building in 2017, as outlined later in this Section (Figure 2.8).

Figure 2.8: Rear façade of the Former Custom House showing late 20<sup>th</sup> century structure

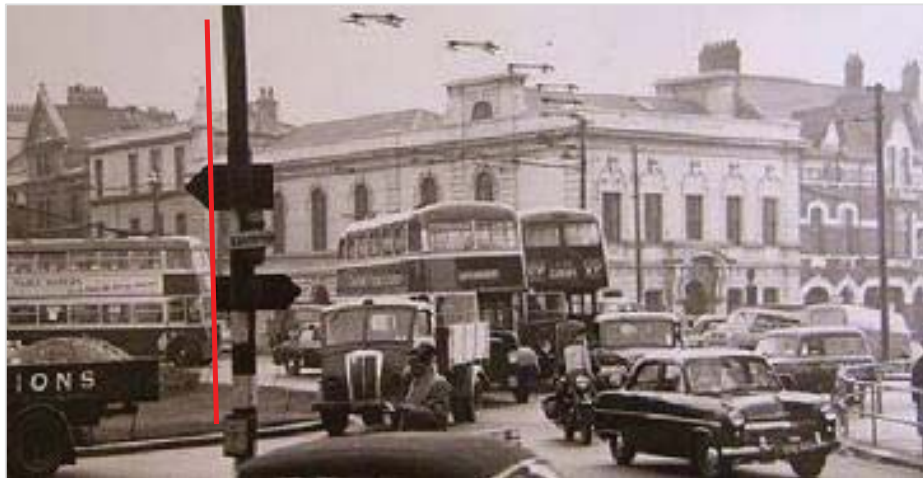
2.14 The extensive late 20<sup>th</sup> century works to the former Custom House had a significant impact and resulted in the rebuilding of the eastern bay of the existing building, identified as the 1865 extension in the List Entry. In its current form, it bears little resemblance to its original character (Figures 2.9 and 2.10).

Figure 2.9: c.1950s Photograph of the Site (original building to the right and 1865 extension to the left)

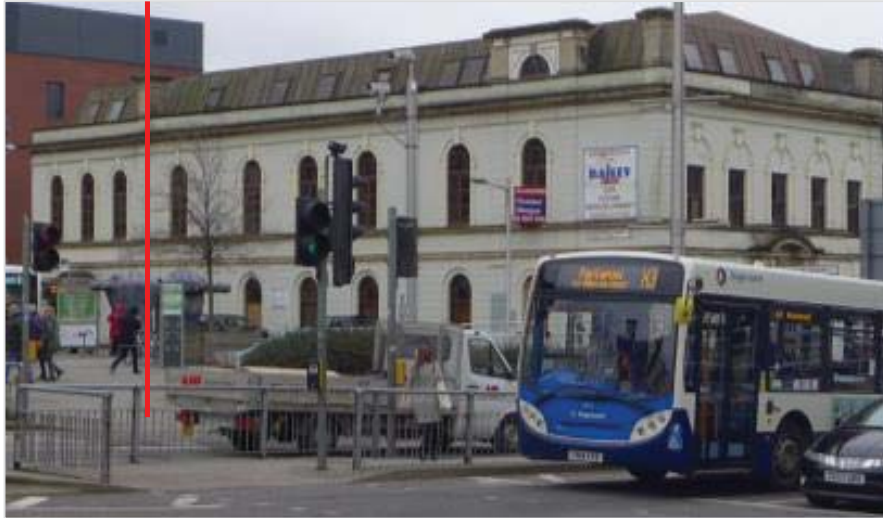
*Figure 2.10: Northern Elevation of the Former Custom House (original building to the right and rebuilt extension to the left)*

- 2.19 The northern elevation is irregular and asymmetrical (Figure 2.10), reflecting its iterative process of adaptation and extension and has the character of a secondary elevation, given the building's original focus on the interaction with the former canal and locks. The later 19<sup>th</sup> century additions, to the east are of a complementary character and illustrate the rapid growth of Cardiff and its expanding commercial activity. In those terms, the later 19<sup>th</sup> century extension contributes to the special interest of the listed building.

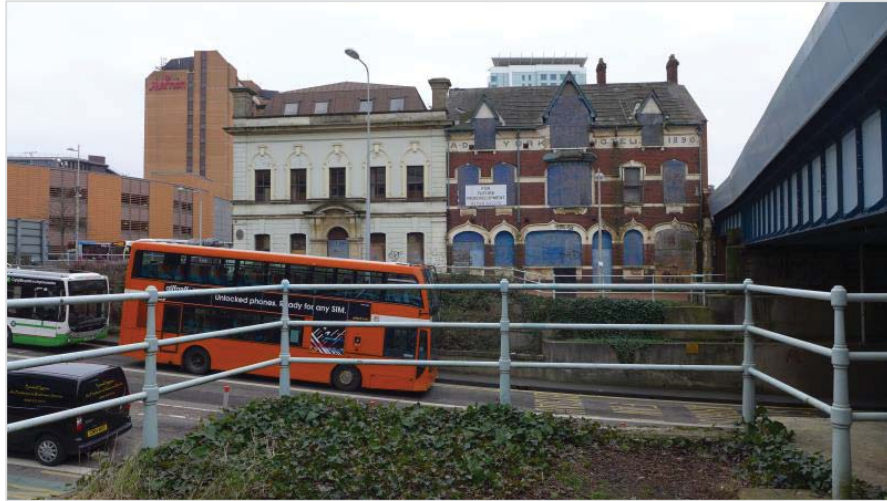
- 2.17 The architectural interest of the former Custom House is derived from the civic/institutional character and quality of the two remaining historic elevations (north (Figure 2.10) and west (Figure 2.11)). The remaining elevations of the listed building are late 20<sup>th</sup> century in date and of a plain, utilitarian character that do not form part of the building’s special interest (Figures 2.8 and 2.12).

*Figure 2.11: Western Elevation of the Listed Building*

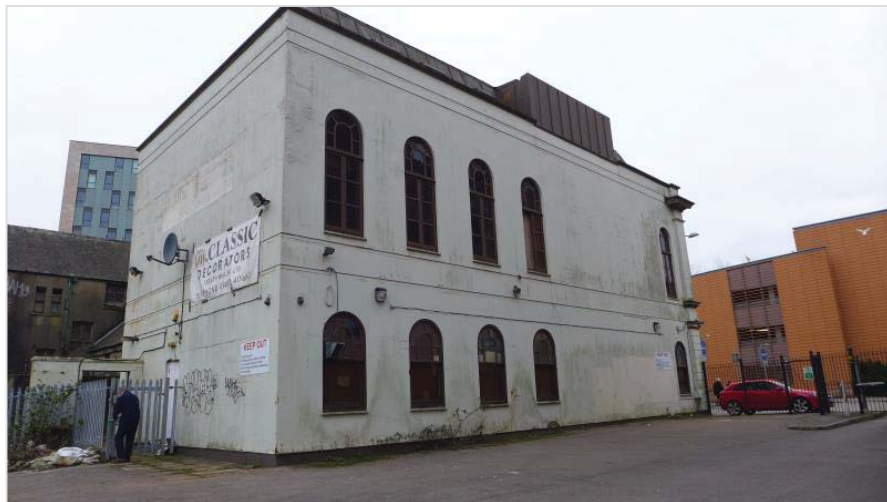
*Figure 2.12: Eastern Elevation of the Listed Building*

- 2.20 To the rear of the Site, the extensive late 20<sup>th</sup> century interventions are readily apparent in the utilitarian and unattractive elevations addressing an open area of hardstanding. These elevations are of no architectural value and do not relate to any significant phases of the building's development. Accordingly, they do not contribute positively to the special interest of the listed building. Moreover, the current vacant condition of the rear yard is, historically, atypical and inconsistent with the dense pattern of development that previously characterised this part of the Site.

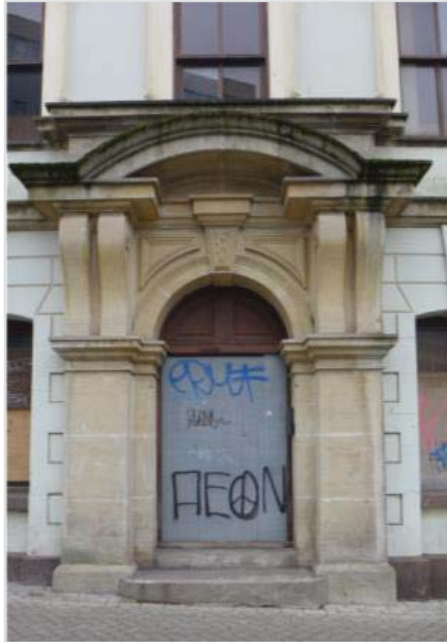
- 2.18 The remaining original elements of the listed building are designed in a heavy classical style, reminiscent of an Italian palazzo (consistent with its original function); with a channelled rusticated ground floor and a smooth painted render finish above. The ground and first floor storeys are linked by quoins. The building is arranged over two storeys (with the later mansard roof extension above the heavy cornice and strong parapet, which undermines the legibility of the classical impression of a flat-roofed building) and is faced with painted stucco render with Bath stone dressings. The western elevation is symmetrical and arranged in five bays with an imposing ‘Mannerist’ door surround (Figure 2.13), perhaps reflecting its status as the principal elevation addressing the now infilled canal.

*Figure 2.13: Front entrance to the Former Custom House, facing onto St. Mary Street.*

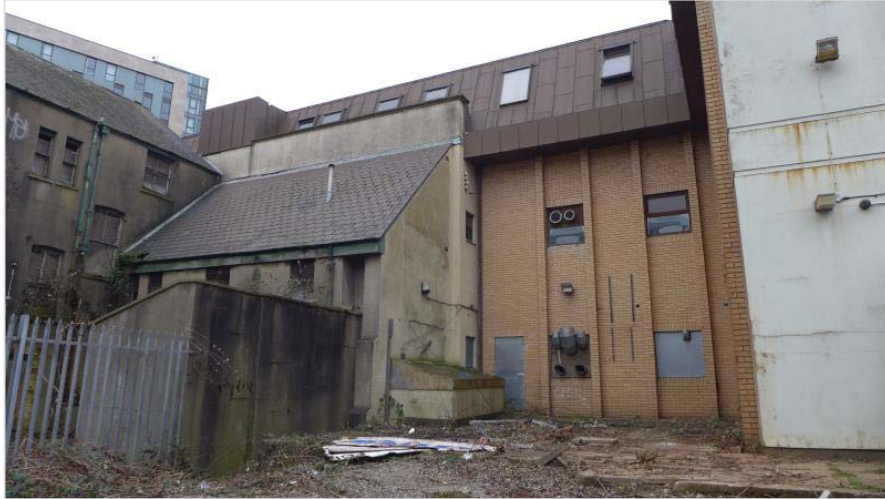
northern and western facades and incorporated a metal clad mansard roof. This has been confirmed by an inspection of the listed building in 2017, as outlined later in this Section (Figure 2.8).

Figure 2.8: Rear façade of the Former Custom House showing late 20<sup>th</sup> century structure

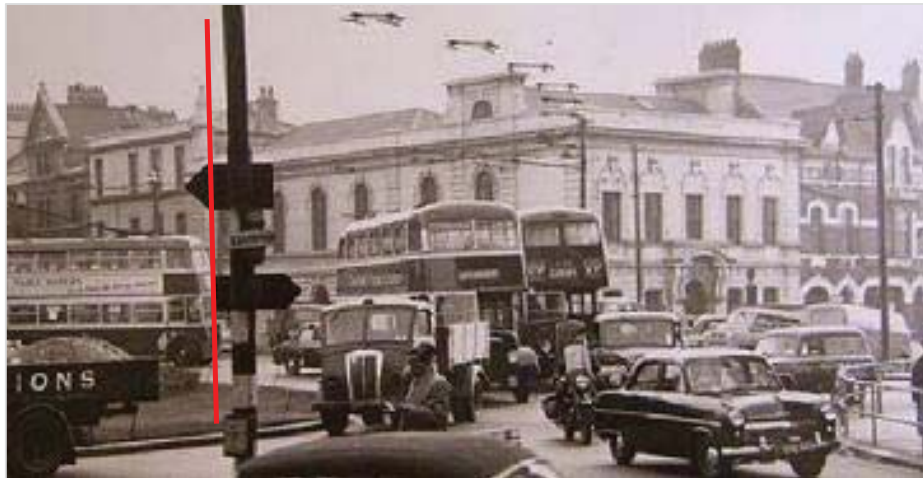
- 2.12 The extensive late 20<sup>th</sup> century works to the former Custom House had a significant impact and resulted in the rebuilding of the eastern bay of the existing building, identified as the 1865 extension in the List Entry. In its current form, it bears little resemblance to its original character (Figures 2.9 and 2.10).

Figure 2.9: c.1950s Photograph of the Site (original building to the right and 1865 extension to the left)

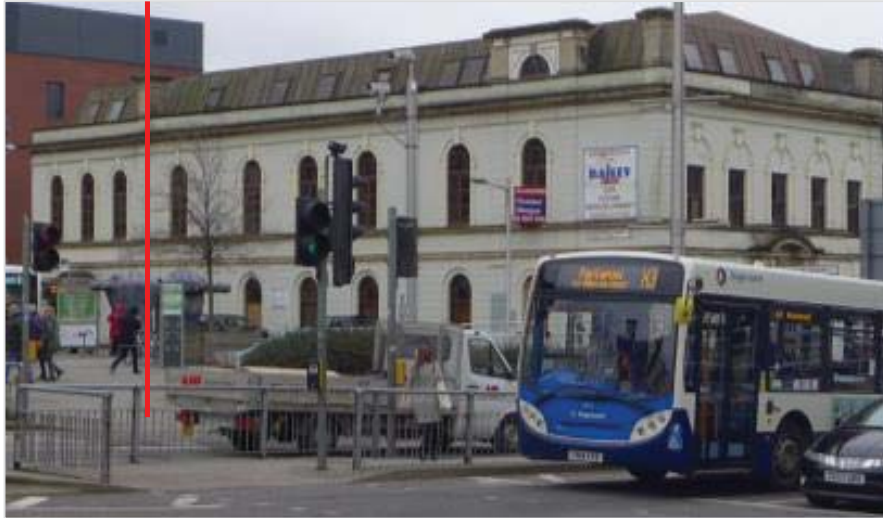
Figure 2.10: Northern Elevation of the Former Custom House (original building to the right and rebuilt extension to the left)

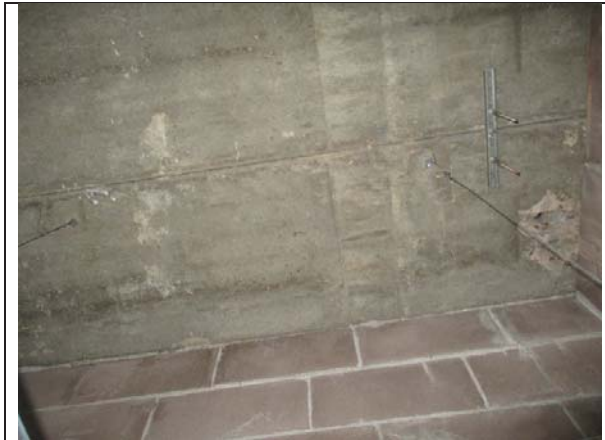
**PHOTOGRAPH 01**

2.2.1 Within the eastern aspect of the building, the floor construction is formed of precast concrete planks, though not able to validate if hollow or solid. (Please refer to [Photograph 01](#)).

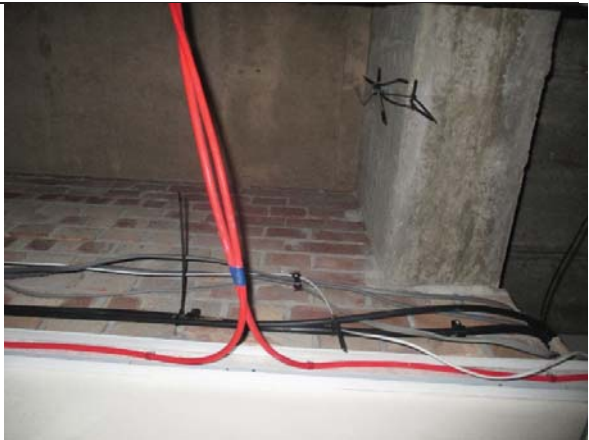
**PHOTOGRAPH 02**

2.2.2 Beams supporting the planks are either reinforced concrete beams, or more likely to be structural steelwork encased in concrete, when consideration is given to the slender form of the beam. (Please refer to [Photograph 02](#))

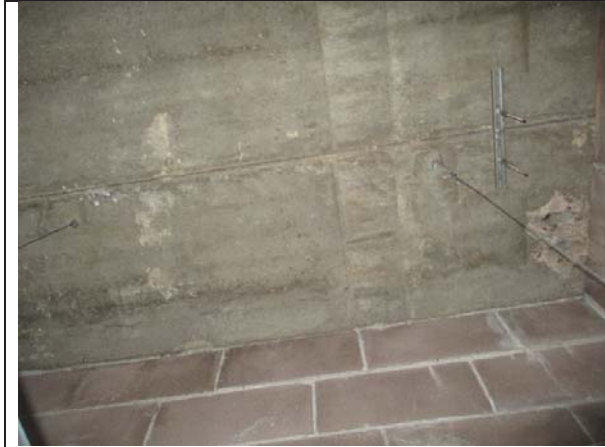
**PHOTOGRAPH 03**

2.2.3 Masonry (Blockwork and Brickwork) walls within this phase form non-load bearing elements. (Please refer to [Photographs 03](#) and [04](#))

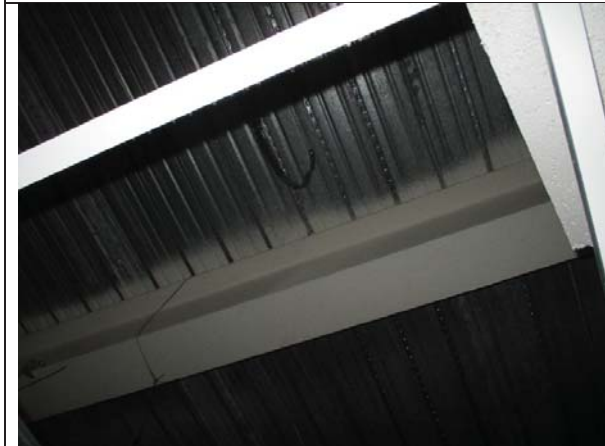
**PHOTOGRAPH 05**

2.3. Within the remaining areas of the building the floor construction is formed of composite metal decking. (Please refer to [Photograph 05](#)).

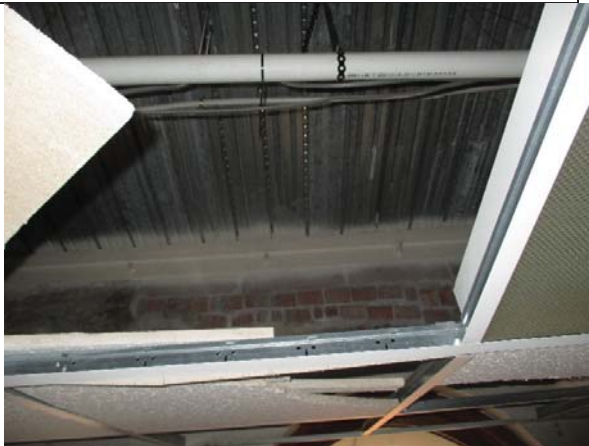
**PHOTOGRAPH 06**

- 2.4 The decking is supported off existing masonry walls and new steel beams. (Please refer to [Photographs 06](#) and [07](#)).
- 2.5 Where decking is supported off existing masonry walls, an angle is provide to support the decking, which is fixed to the masonry wall. (Please refer to [Photograph 08](#)).

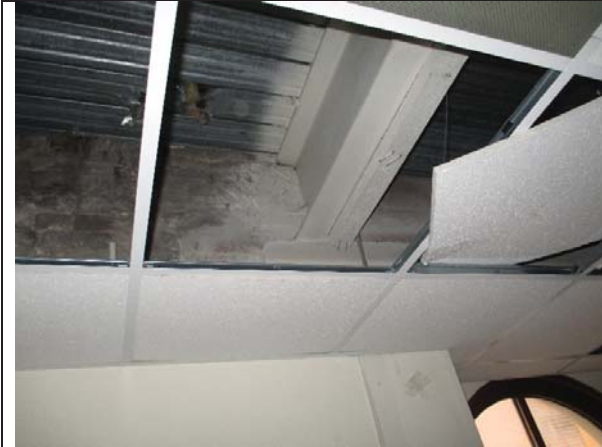
**PHOTOGRAPH 09**

- 2.6 The steel beams are supported off both load bearing walls, via insitu concrete padstones and steelwork columns. (Please refer to [Photographs 09](#) and [10](#)).

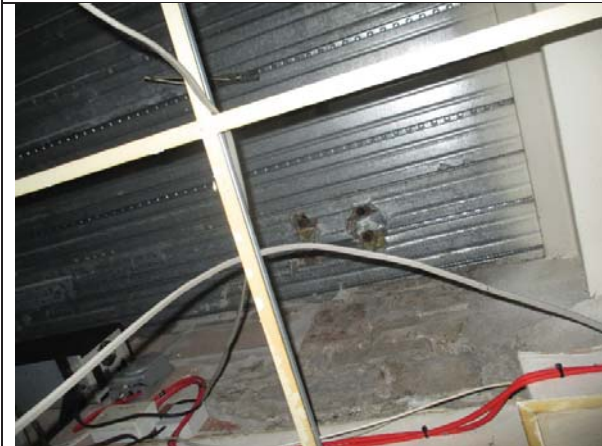
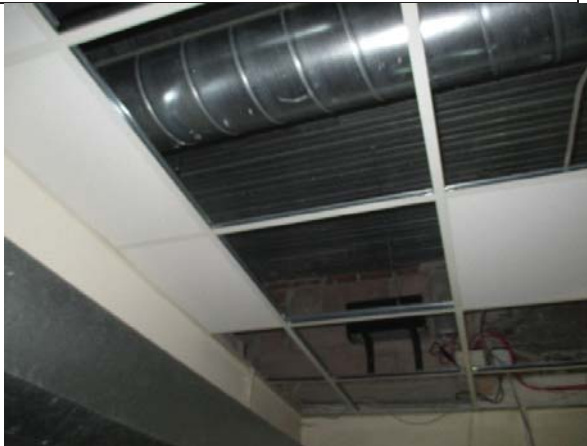
- 2.7 Internal/Buttressing walls are formed of existing stonework/brickwork and patch repaired with new brickwork and blockwork. (Please refer to [Photographs 11](#) and [12](#)).

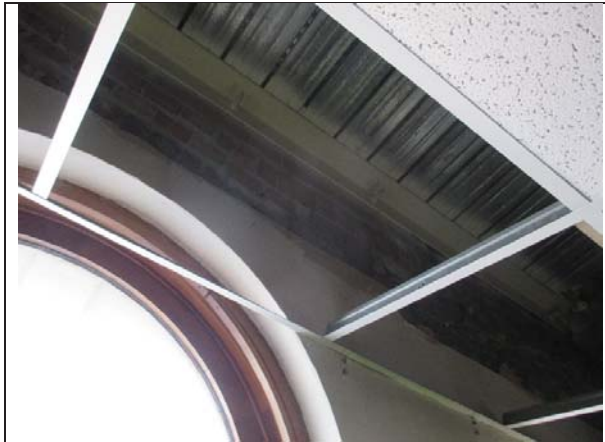
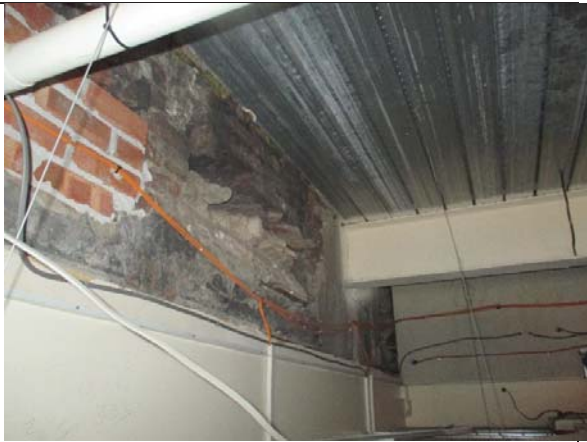
- 2.8 The front façade is formed of existing stonework/brickwork and as internal walls is patch repaired with new brickwork and blockwork. (Please refer to [Photographs 13](#) and [14](#)). The patch repairs are more prevalent above and around the window openings. (Please refer to [Photograph 15](#)).

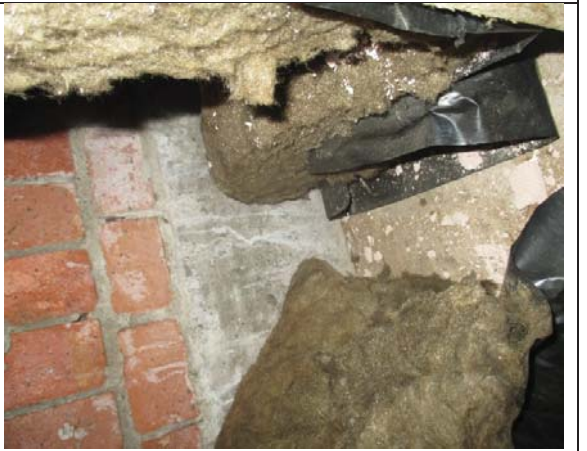
PHOTOGRAPH 16

- 2.11 Due to the provision of the concrete ring beam, the parapet has been built of the ring beam. (Please refer to [Photograph 16](#)).

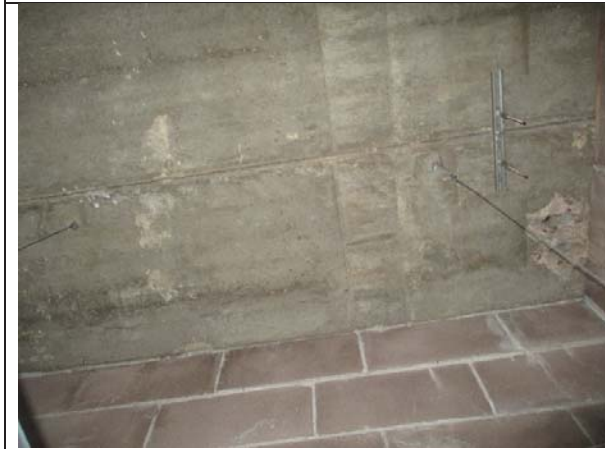
**PHOTOGRAPH 03**

2.2.3 Masonry (Blockwork and Brickwork) walls within this phase form non-load bearing elements. (Please refer to [Photographs 03](#) and [04](#))

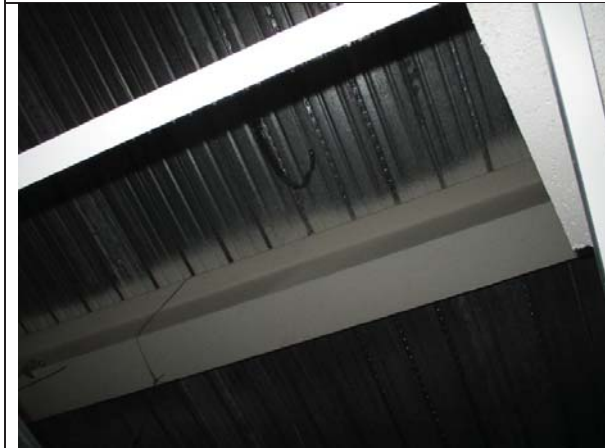
**PHOTOGRAPH 05**

2.3. Within the remaining areas of the building the floor construction is formed of composite metal decking. (Please refer to [Photograph 05](#)).

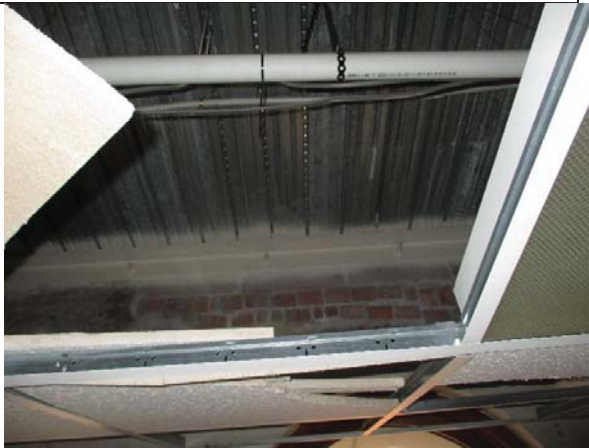
**PHOTOGRAPH 06**

- 2.4 The decking is supported off existing masonry walls and new steel beams. (Please refer to [Photographs 06](#) and [07](#)).
- 2.5 Where decking is supported off existing masonry walls, an angle is provide to support the decking, which is fixed to the masonry wall. (Please refer to [Photograph 08](#)).

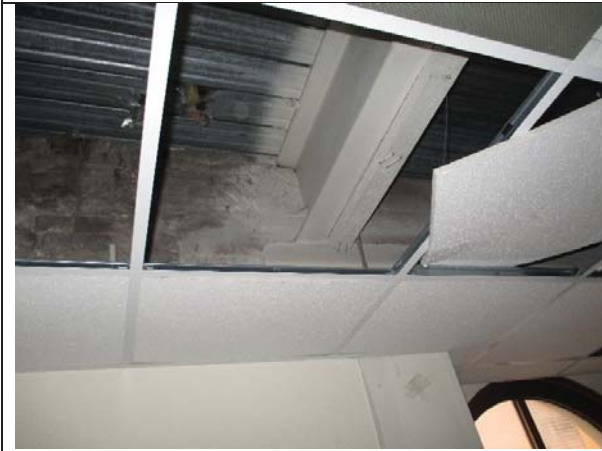
**PHOTOGRAPH 09**

- 2.6 The steel beams are supported off both load bearing walls, via insitu concrete padstones and steelwork columns. (Please refer to [Photographs 09](#) and [10](#)).

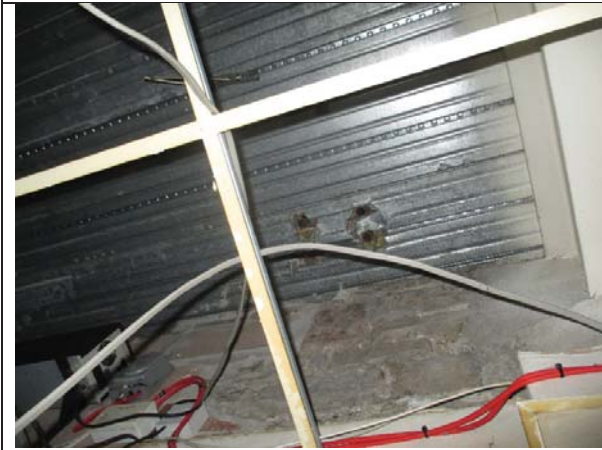
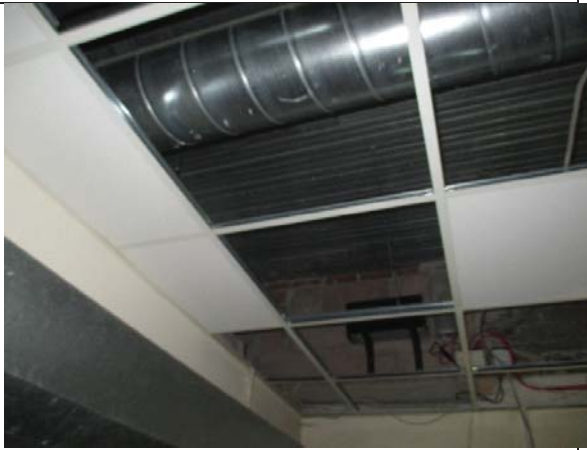
- 2.7 Internal/Buttressing walls are formed of existing stonework/brickwork and patch repaired with new brickwork and blockwork. (Please refer to [Photographs 11](#) and [12](#)).

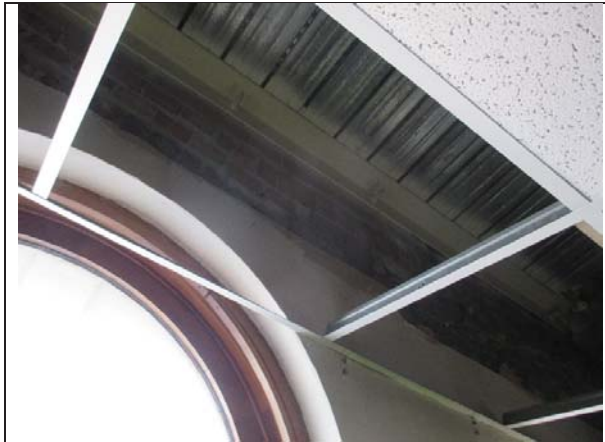
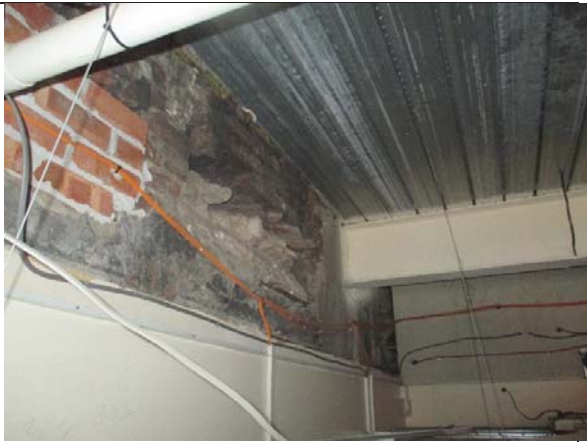
- 2.8 The front façade is formed of existing stonework/brickwork and as internal walls is patch repaired with new brickwork and blockwork. (Please refer to [Photographs 13](#) and [14](#)). The patch repairs are more prevalent above and around the window openings. (Please refer to [Photograph 15](#)).
