CPAT Report No. 1333

# **Glyn Neath Gunpowder Works**

## **CULTURAL HERITAGE IMPACT ASSESSMENT**

Client name: Brecon Beacons National Park Authority  
CPAT Project No: 2008  
Project Name: Glyn Neath Gunpowder Works  
Grid Reference:  
County/LPA:  
CPAT Report No: 1333  
Issue No: 1  
Report status: Draft  
Confidential: No

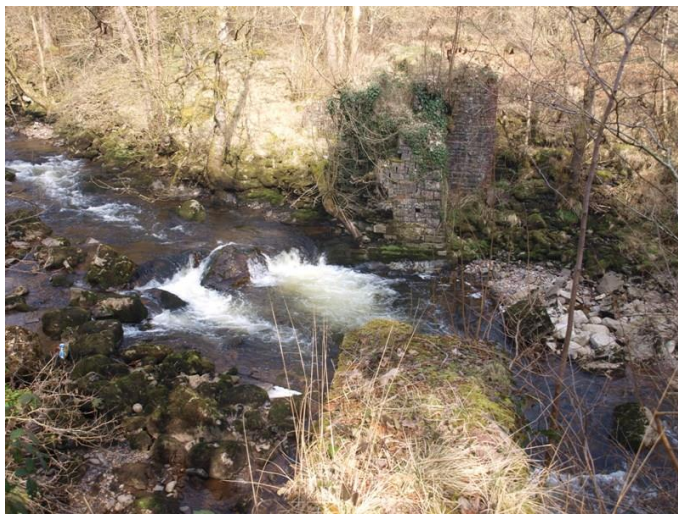
- 5.06 **Upper Aqueduct (W<sub>2</sub>).** This is located at SN 92046 08708, and carried water across the Afon Mellte, running from the leat on the east side of the river which took water from the Upper Weir (W<sub>1</sub>). According to the Nobel plan it (or an adjacent structure) also carried the tramway to the eastern side of the river. Stone abutments on each bank, and a central stone pier, supported a cast-iron channel. At least some part of upper aqueduct was evidently still in situ in 1974, but damaged, as it was noted that water ‘now spills down into the river below’ (Stevens 1974, 2). A photograph published in 1985, but evidently taken much earlier, shows the wrought-iron structure in place but apparently disused (Pritchard *et al.* 1985, 31). The central pier is no longer extant, but parts of the wrought iron structure survive in the steam bed (Fig. 6).

*Fig. 6. Upper Aqueduct (W2). Top: historic photograph (from Pritchard et al. 1985) showing the aqueduct in situ. Bottom left: looking north across the Afon Mellte, showing the abutment on the other side of the river. Bottom right: looking north-west up the Afon Mellte, showing a fragment of the aqueduct in the river bed and the surviving abutments in the background.*

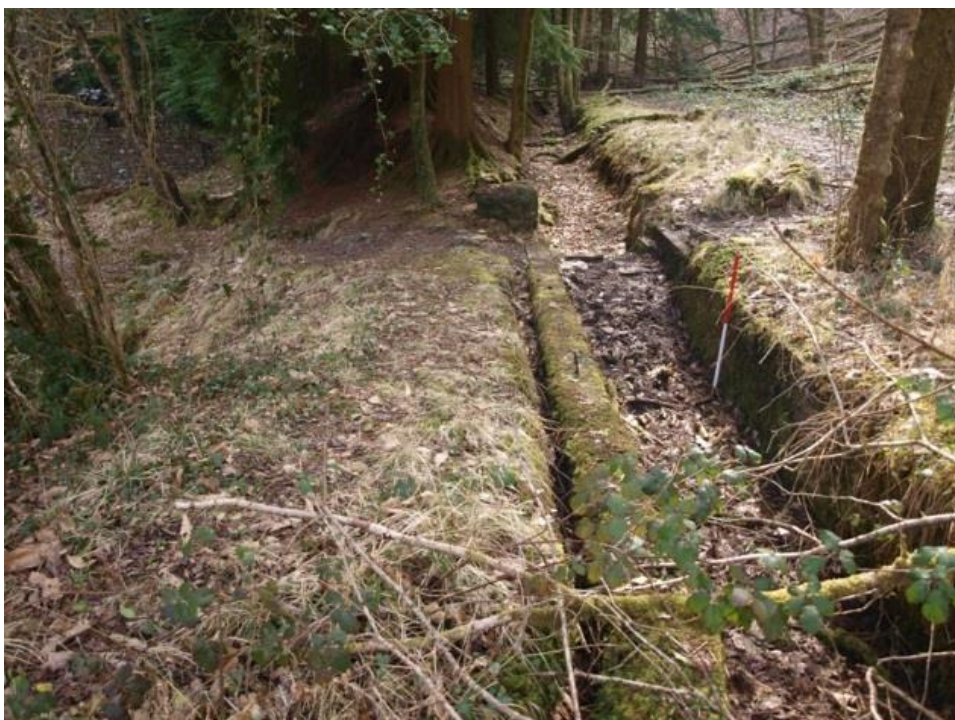
*Fig. 7. Upper Leat (W3), north end. Looking south from the interface with the former aqueduct, showing showing the brick and concrete former sluice emplacement (foreground) and the stone-lined main channel running towards the Boiler House (B7).*

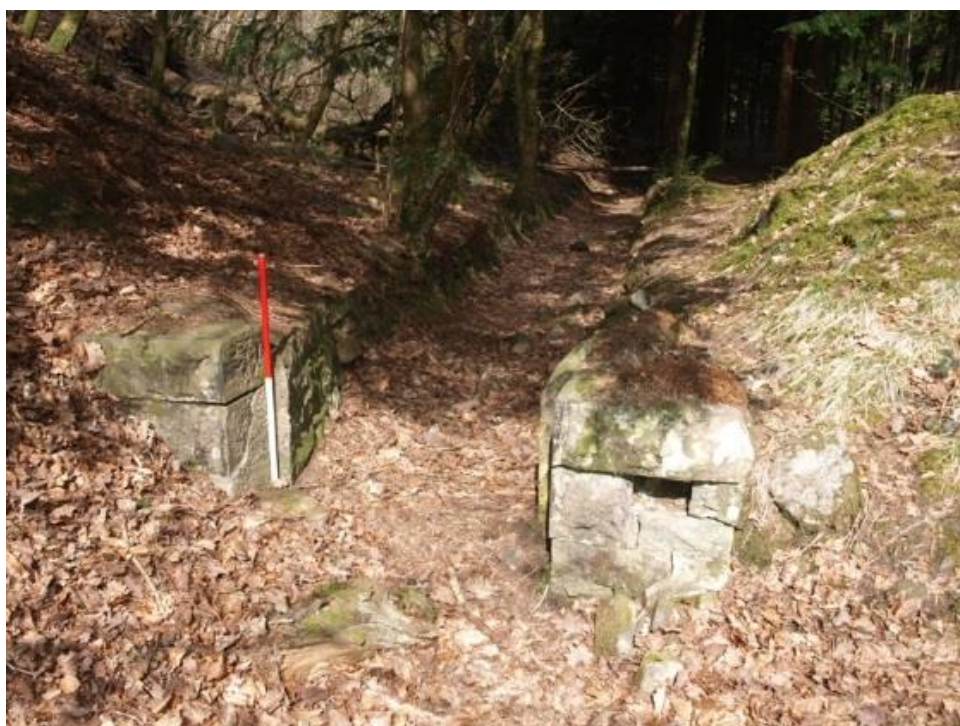
*Fig. 8. The Upper Leat (W3), south end. Looking north from the Boiler House (B7).*

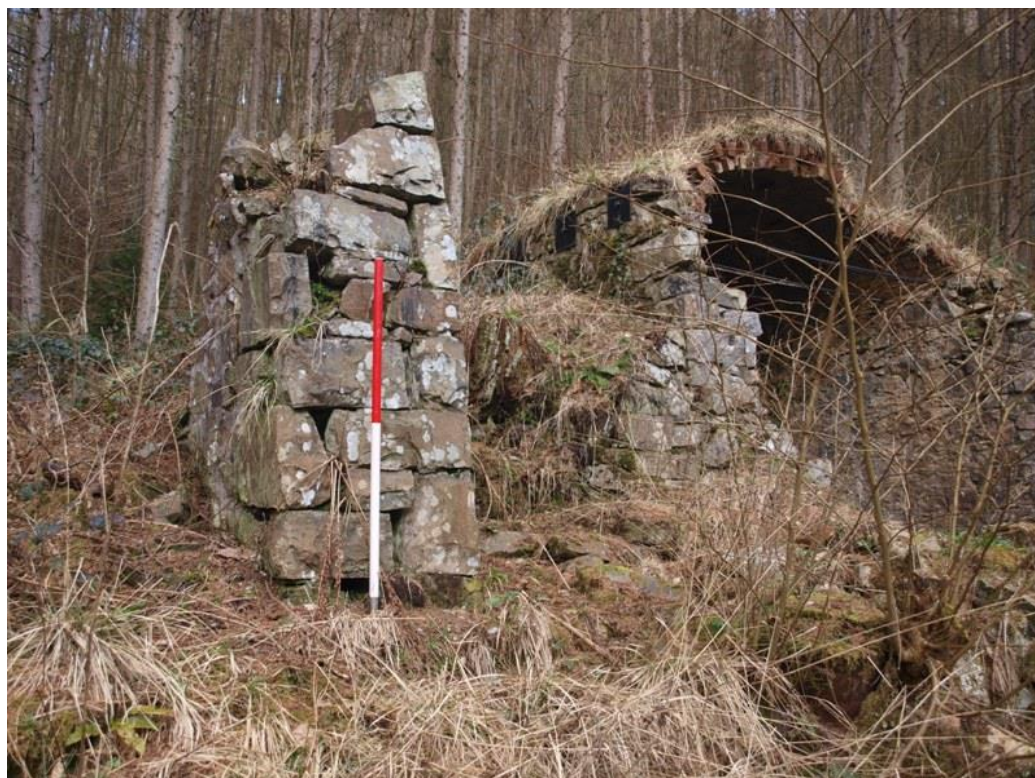
*Fig. 10. Elevated Leat (W<sub>4</sub>). Detail of one of the stone supporting pillars, adjacent to the Expense Magazine (B12)..*

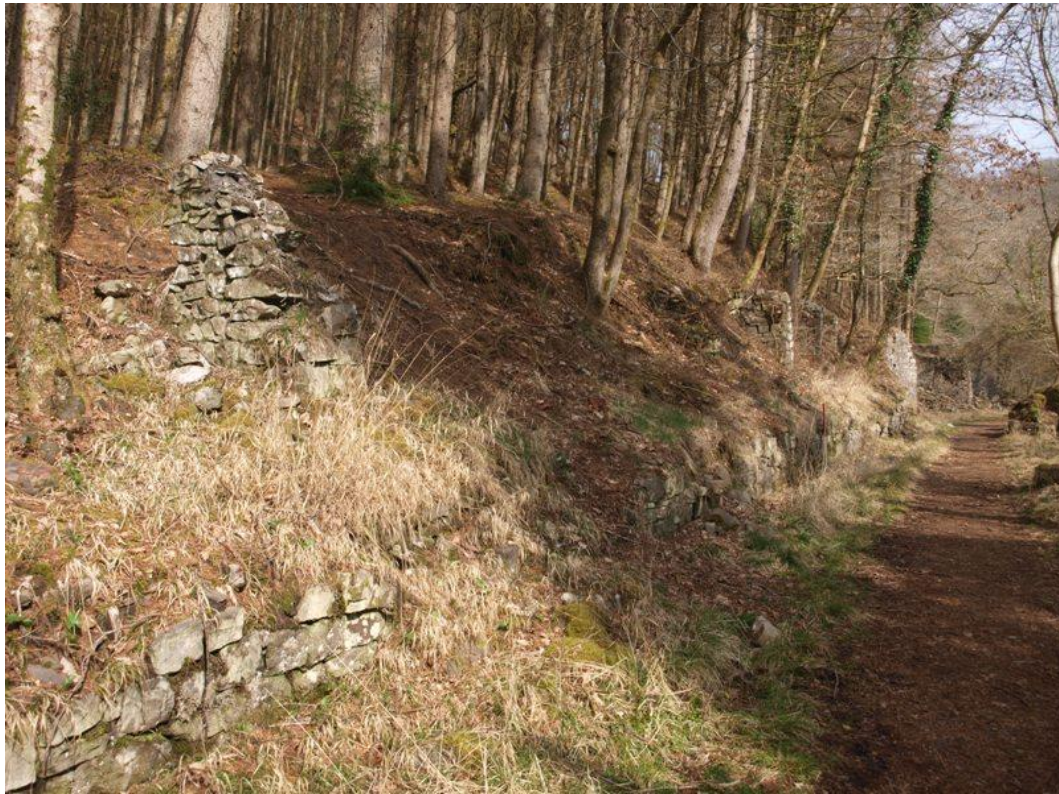
*Fig. 11. Stone pillars of the Elevated Leat (W4) alongside the Main Tramway (T1).*

- 5.08 **Elevated Leat (W4).** This was a continuation of the leat to the south of the Boiler House, running ultimately to the 12-15hp Turbine House at SN 91560 08194. It consisted of a launder (water channel) supported on a series of stone pillars. The launder itself could have been made of timber or iron, but given the date and the presumably similar construction of the Upper Aqueduct (W2), iron seems more likely. The Elevated Leat is shown on an undated (but presumably pre-1931) historic photograph (Fig. 9, on previous page). Ten of the free-standing pillars which formerly supported the leat survive in various stages of preservation (Figs. 10 and 11). The north wall of the Stable (T5) also incorporated a support for the Elevated Leat (see below).

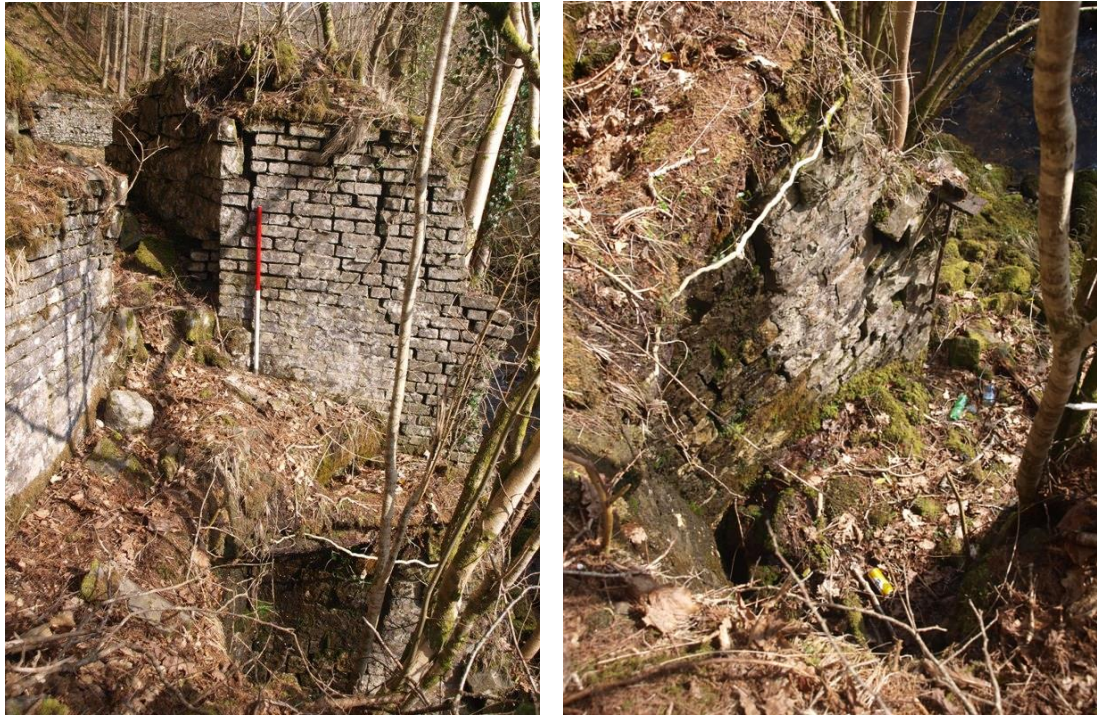
- 5.10 **12-15hp Turbine House (W6).** This is located to the south of the Glazing House (B12), between the tramway and the Afon Mellte, at SN 91990 08505. The turbine would have provided power to the Glazing House (see below). The structure is built of brick and stone, and comprises a turbine housing that runs from the tramway level down to river level, and the remains of part of the superstructure (Fig. 12). It was extant before 1877.

*Fig. 12. The 12-15hp Turbine House (W6). Left: View of the superstructure at the level of the Main Tramway, looking north. Right: view down into the turbine housing.*

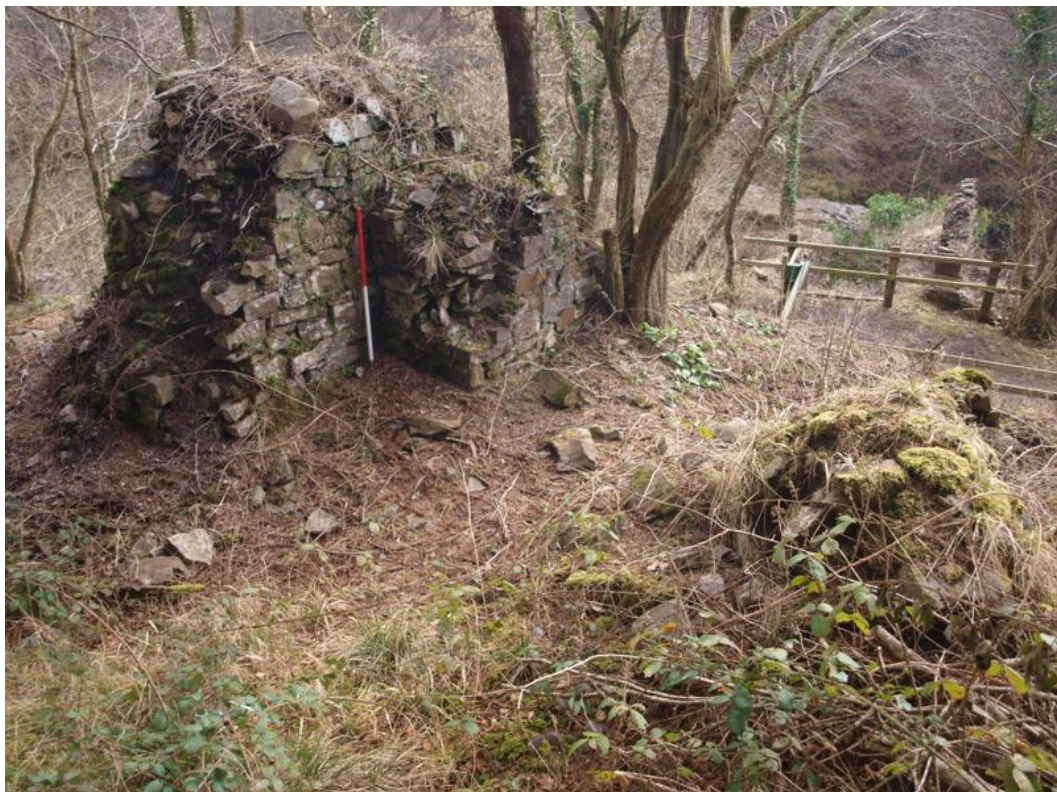
*Fig. 13. Structure at the junction of the Elevated Leat (W<sub>4</sub>), the Lower Leat (W<sub>12</sub>) and the 'Clean Gangway' (W<sub>7</sub>). View looking south, with the Waterwheel (W<sub>8</sub>) in the background, beyond the line of the Main Tramway (T<sub>1</sub>).*

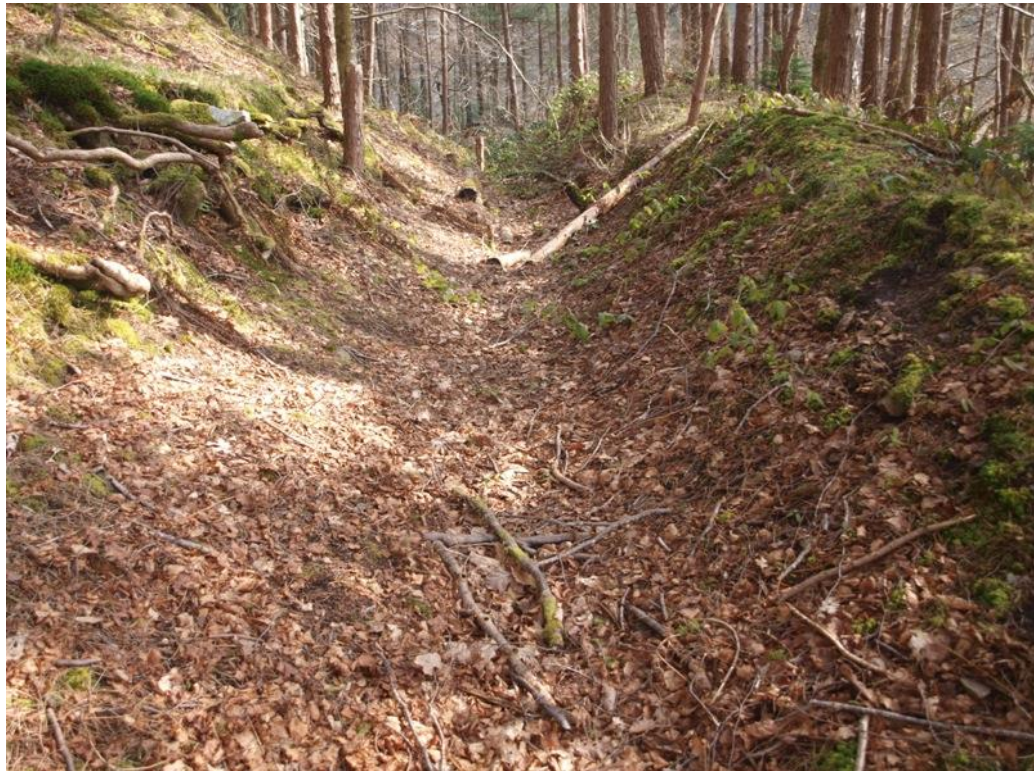
*Fig. 14. The 'Clean Gangway' (W7) surviving as an earthwork between the two corning houses. View looking east from above the (old) Corning House (B14) towards the New Corning House (B15).*

- 5.11 **Clean Gangway (W7).** According to the Nobel plan, there was a junction in the leat at approximately SN 92030 08820. The main part of the leat went on to the Waterwheel and 18hp Turbine and Pump House (W8 and W9), and the remainder ran westwards (downstream) for another 100m or so to another Waterwheel (W10) located in the river bed. This westward extension was called the 'Clean Gangway' on the Nobel plan. It appears to have passed over the top of both the corning houses (B14 and B15). The watercourse junction is probably marked by the stone structure opposite the Waterwheel (W8) on the north side of the tramway (Fig. 13, on previous page). The first part of the 'Clean Gangway' was probably elevated as far as the New Corning House (B14); an earthwork (Fig. 14) survives to the west of the New Corning House which must have been the western continuation of the 'Clean Gangway'. This has been wrongly described by RCAHMS as 'Upper Leat'. It was not possible to trace the course of this feature west of the (old) Corning House (B15).

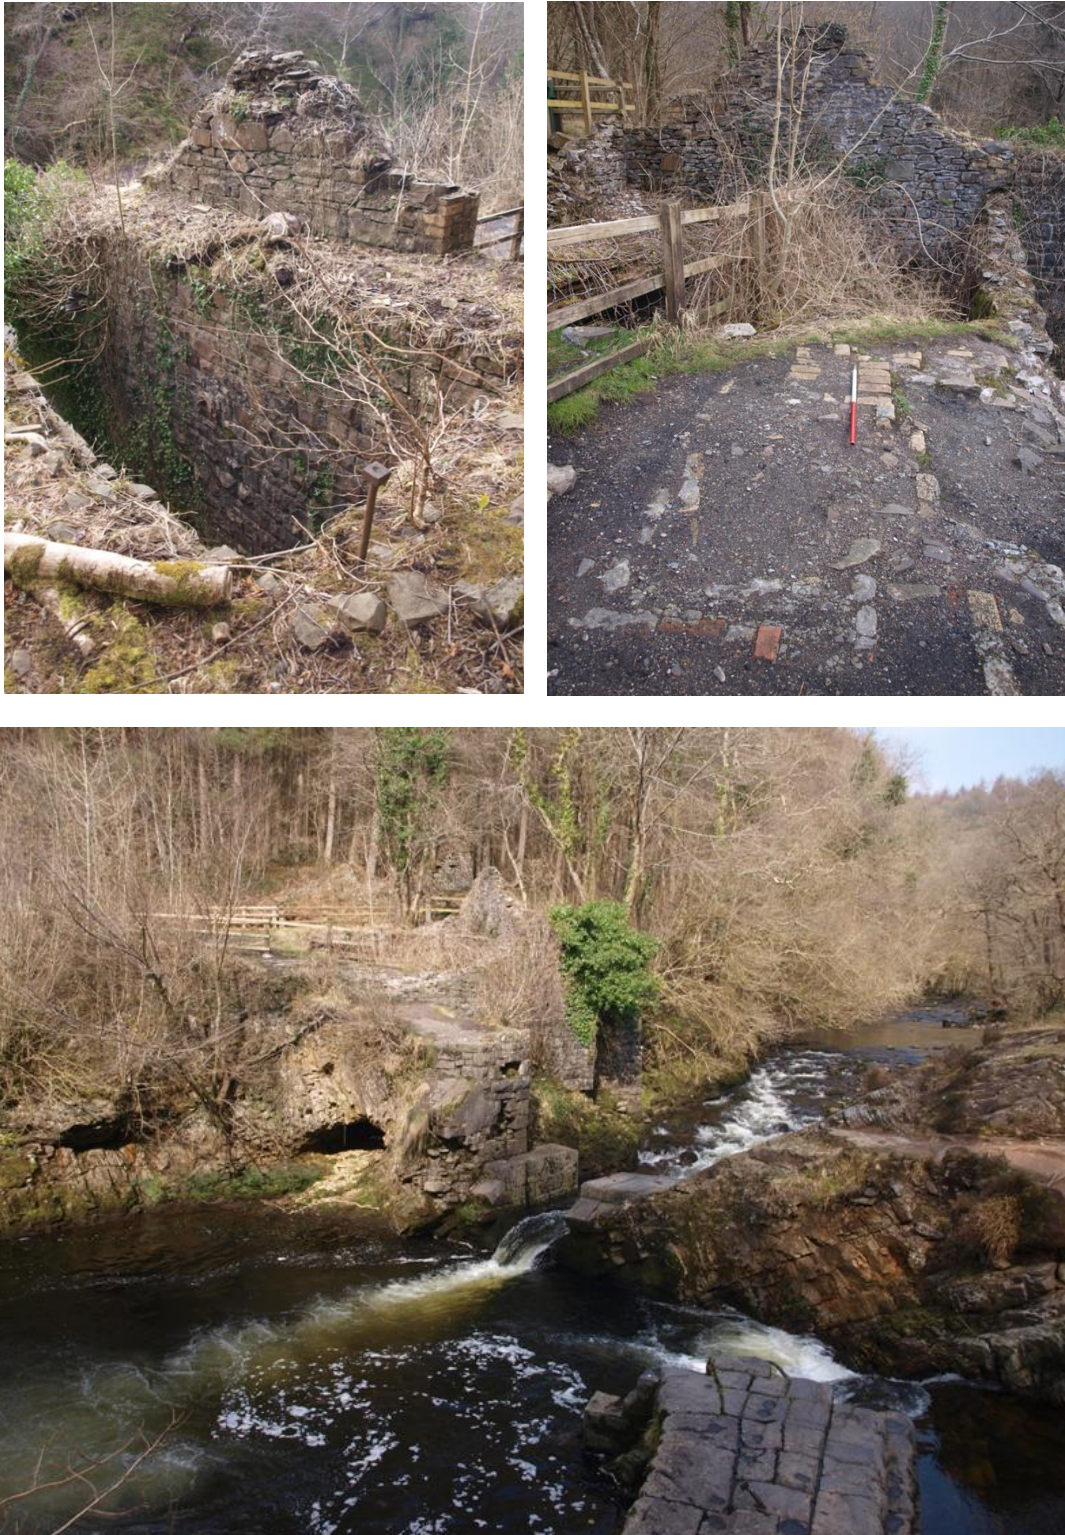
- 5.13 **18hp Turbine and Pump House (W9).** A bearing box in the south wall of the wheelpit leads to the adjacent 18hp turbine house, also built between 1877 and 1904. As noted above the Pump House was built after the wheelpit and is keyed into it, this, together with differences in the style of construction and materials used, suggest that the turbine

was a later addition to augment the power supplied by the water wheel. Only the eastern gable wall, which is built on top of the earlier wheelpit structure, survives to its original extent; the remaining walls have been demolished or removed. Parts of the floor survive.

*Fig. 15. Waterwheel (W8) and 18hp Turbine and Pump House (W9). Top left: the top of the Wheelpit with the gable wall of the Pump House. Top right: the interior of the Pump House. Bottom: Both structures viewed from the east side of the river, showing the relationship between them and the Main Weir (W11).*

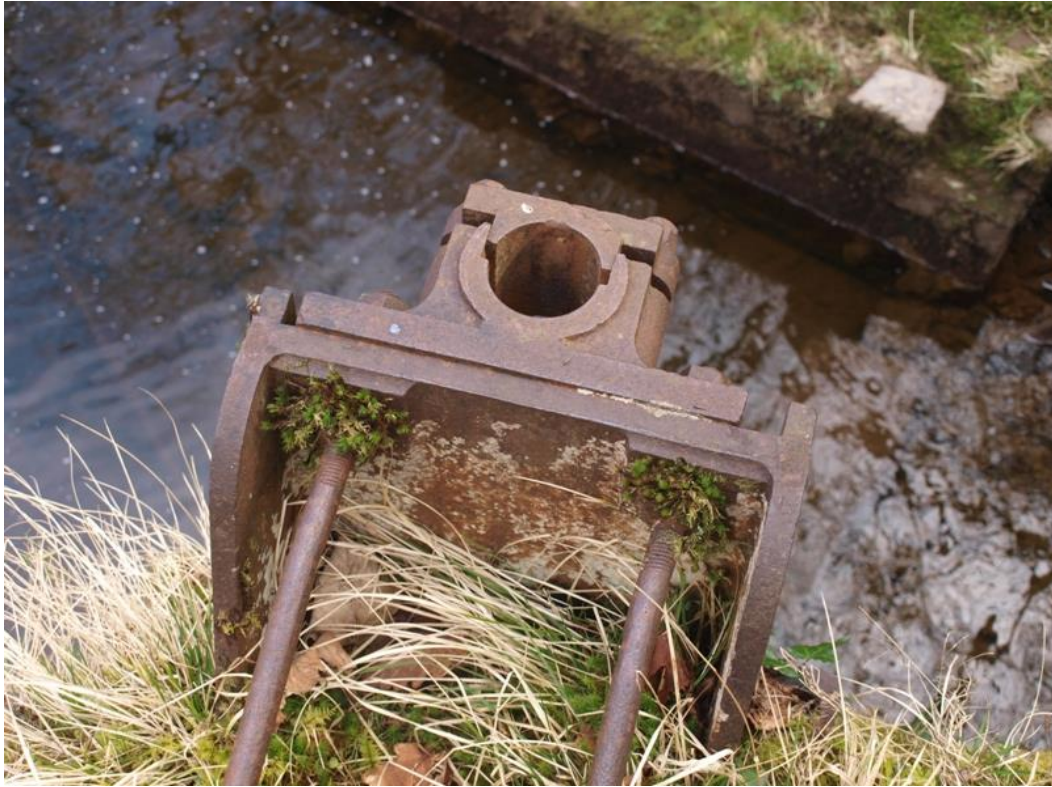
Fig. 18. Detail of iron fixtures on the Main Weir (W11).

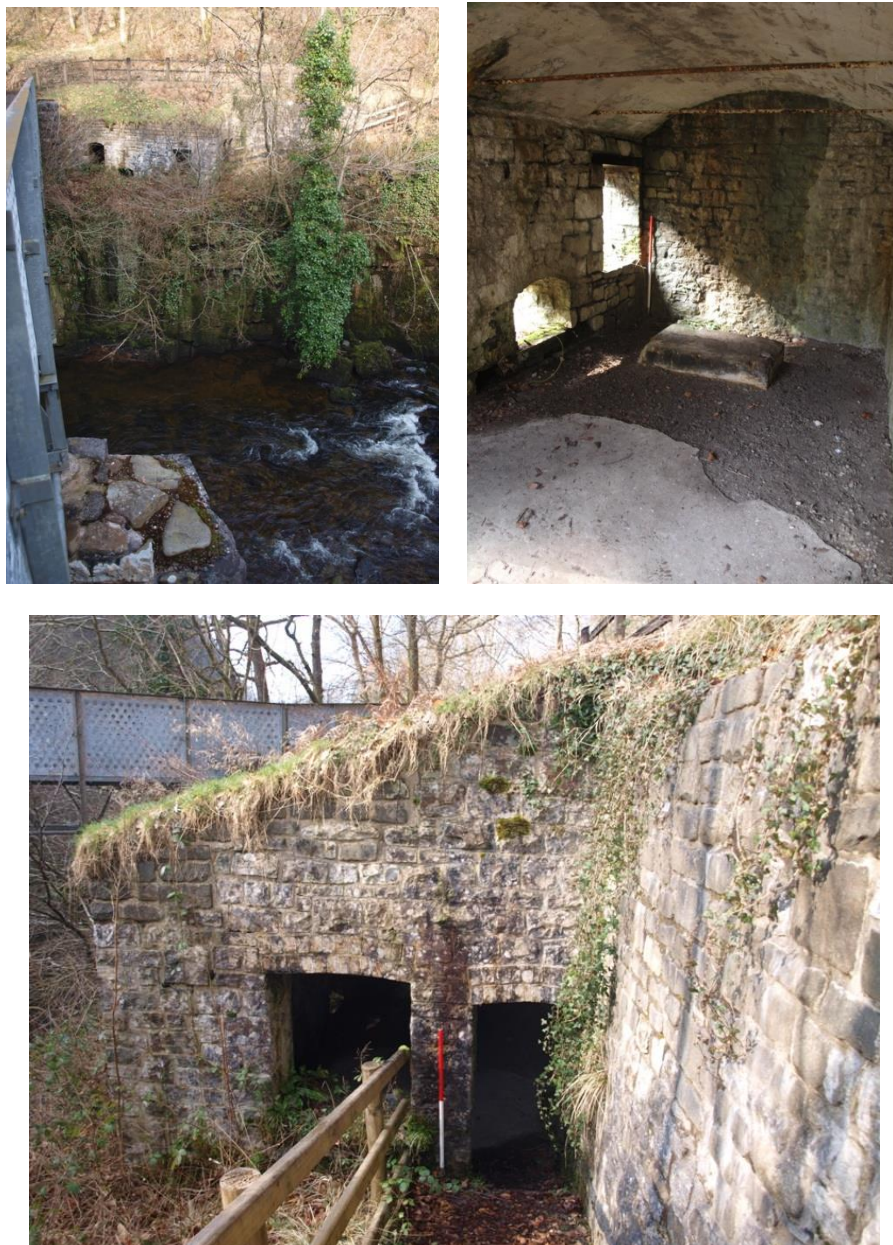
*Fig. 19. 6hp Turbine and Pump House (W14). Top left: view from across the river, looking along the modern footbridge built on the abutments of the Lower Aqueduct (W13). Top right: interior view, showing the arched roof, concrete floor, machine base and aperture for a bearing block. Bottom: exterior view looking south-west, with the footbridge behind.*

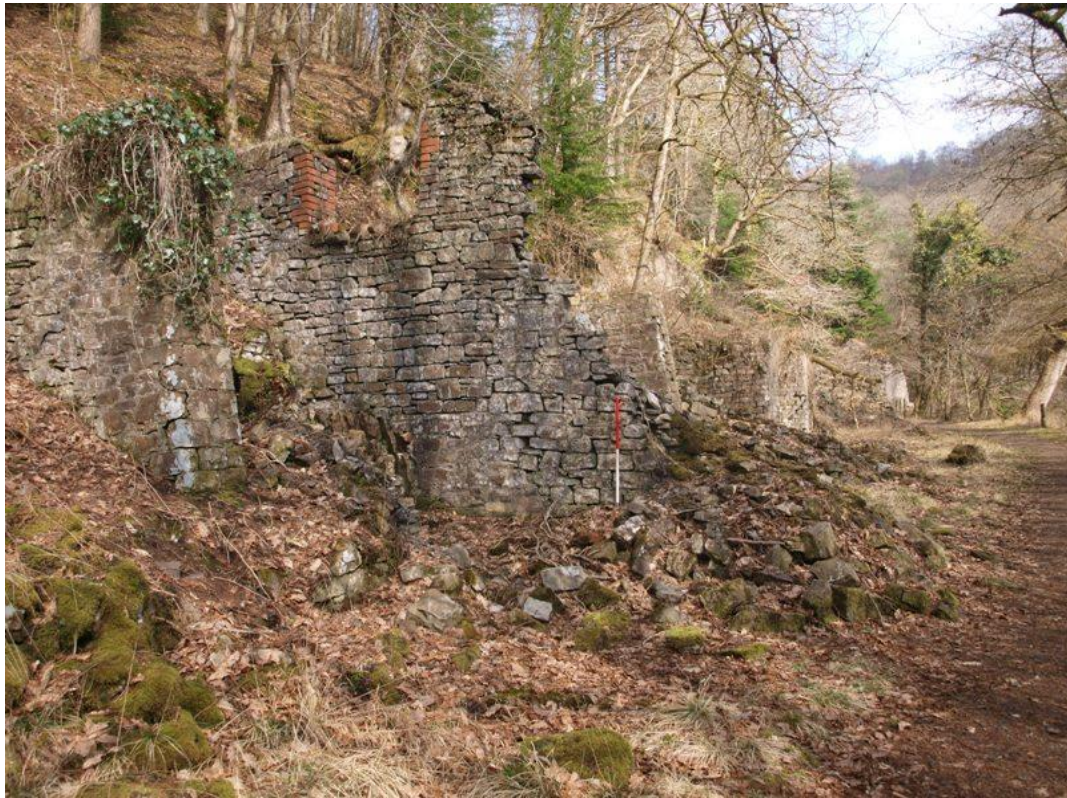
window (there would be no need for a first floor in a stable, and, as the CAP points out, the location of this wall is consistent with the location of other piers for the Elevated Leat. Further investigation of both this structure and the Glazing House would be useful in confirming its function as a stable.

*Fig. 20. The Stable (T5). View looking north along the Main Tramway (T1), showing the northern wall of the stable with brick surround to the support for the Elevated Leat (W4).*

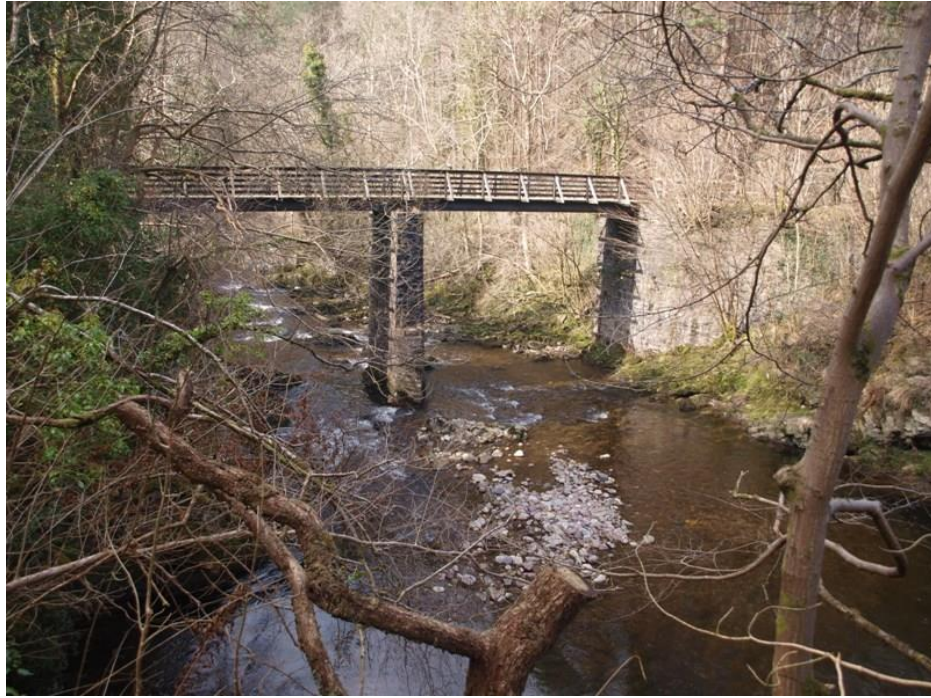
- 5.25 **Lower Tramway Bridge (T6).** This is located downstream of the Main Weir (W11), at SN 9190 0838. It carried a branch of the tramway to a magazine and pellet press house on the south side of the Afon Mellte (outside the study area). The original superstructure has been replaced by a modern timber footbridge. However original masonry survives in the form of an abutment on either side of the river and a central pier; the masonry of the upstream edge of the lower part of the pier is angled to form a cutwater (Fig. 21).

*Fig. 21. Lower Tramway Bridge (T6). View from the east showing the upstream side of the bridge.*

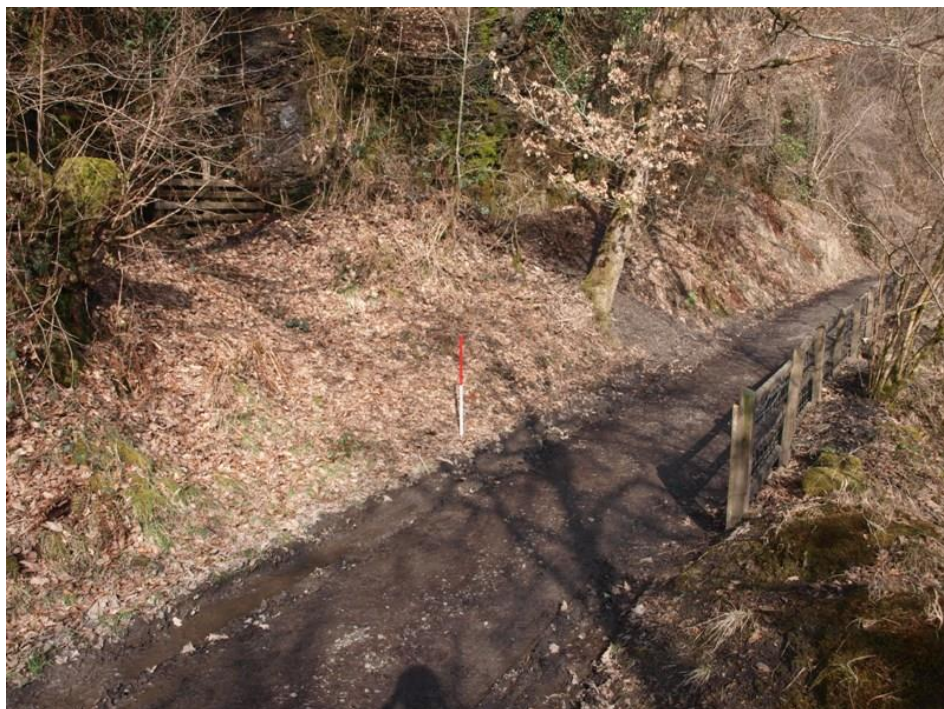
*Fig. 22. Tramway Tunnel (T8). View from the line of the Main Tramway (T1), looking west showing the relationship of the tunnel entrance to the main line. The tunnel entrance is fenced off; there is a Holloway evident between the tunnel and the main line.*

- 5.27 **Tramway Tunnel (T8).** This curious feature is located at SN 9172 0838. It is noted on the Nobel Plan, and is described by in the Scheduling description as having 'bi-passed [sic] a formerly difficult section of the river bank before the construction of the existing tramroad beneath the cliff'. It was not possible to inspect the interior, although again the Scheduling notes state that there is 'some masonry walling inside'. The southern entrance to the tunnel is visible (Fig. 22) but the northern entrance appears to have been blocked by partial collapse of the cliff. Further investigation here could determine the nature of the tunnel's construction, and whether the route of the tunnel is indeed the very pronounced loop shown on the Nobel Plan. There is also a possibility that tramway sleepers and rails may survive.

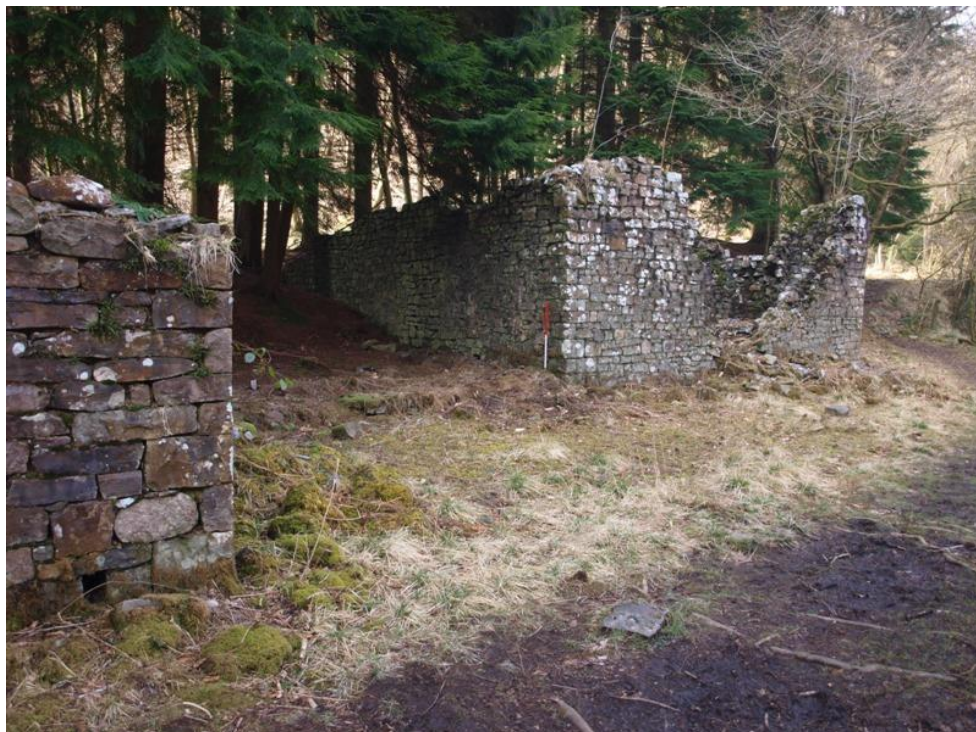
*Fig. 23. The group of buildings at the northern end of the Upper Tramway Branch. View looking north from the tramway, showing the north-east corner of Magazine (B3) on the left, with Magazine (B1) on the right. The rubble foundations of Pellet House (B2) can be discerned between the two. The Truck Shop (T4) was located in front of Magazine (B1).*

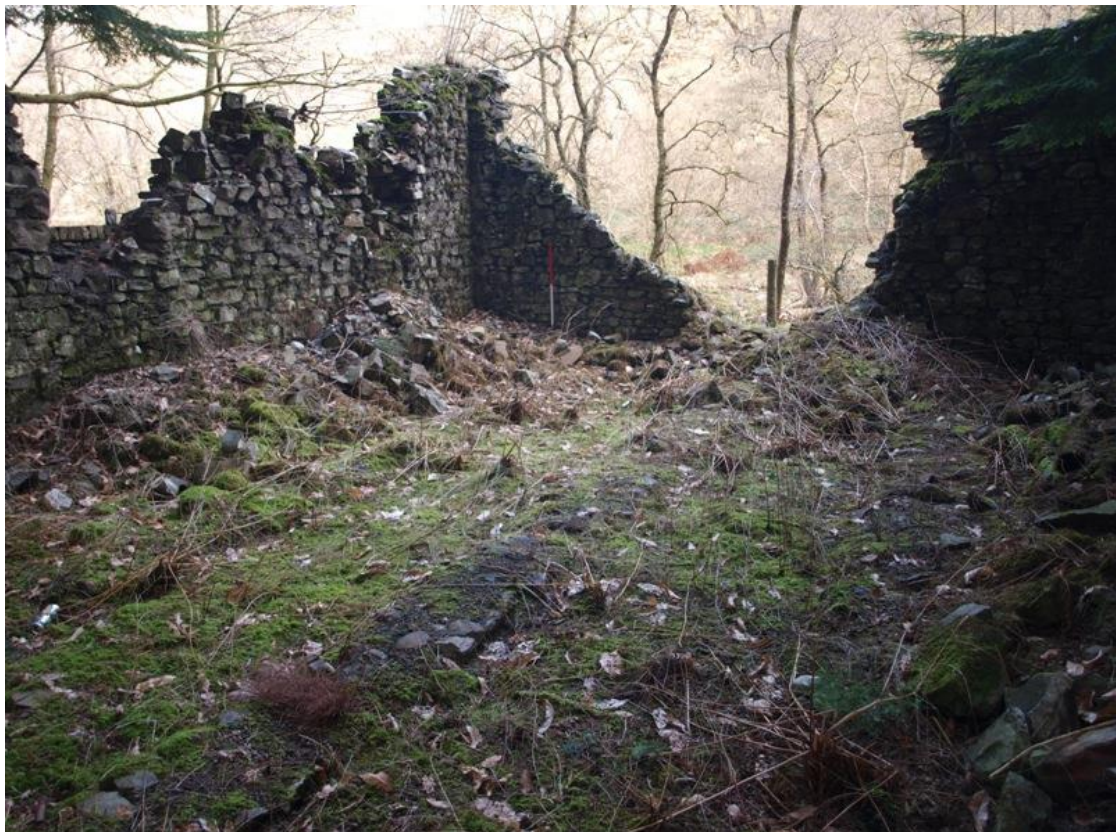
- 5.29 **Magazine (B1).** This is part of the northern cluster of buildings, located at SN 9206 0867. It is a stone-built structure, square in plan; the south, west and north walls survive to a height of between 2 and 2.5 metres. The west wall partly acts as a revetment for the Upper Leat (W3). The eastern wall has a large collapsed section in the centre, rubble from which overlies the site of the former Truck Shop (T4) as noted above. Internally there are sleeper walls which would have supported the former floor (Fig. 24).

*Fig. 24. Magazine (B1). Interior view looking north-east, showing the internal sleeper walls and collapse of the eastern wall.*

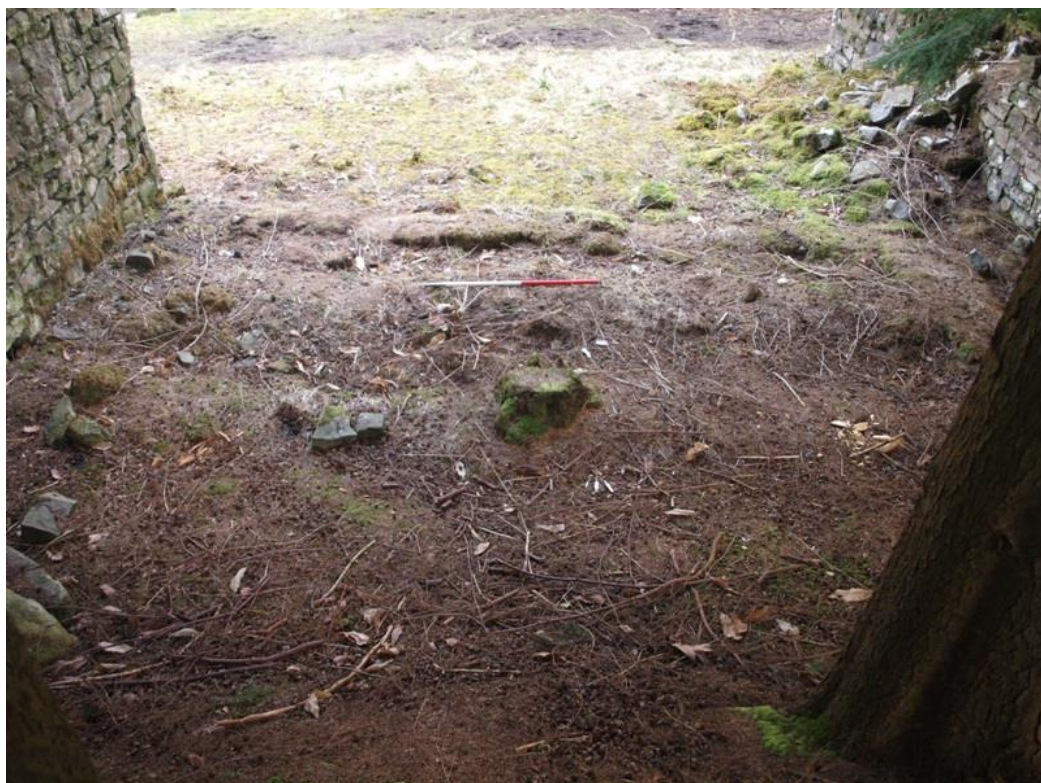
- 5.29 **Pellet House (B2).** This is part of the northern cluster of buildings, located at SN 9206 0867; the Pellet House was situated between the two Magazines (B1 and B3), although it appears to have been built originally as a free-standing structure as it did not abut the Magazine (B1) to the north. The superstructure has been completely removed, although foundations and internal sleeper walls survive; rubble from the collapse has filled in the gaps between the sleeper walls (Fig. 25).

*Fig. 25. Pellet House (B3). View from the embankment to the west, showing the sleeper walls and foundations. Magazine (B1) is to the left, Magazine (B3) is to the right.*

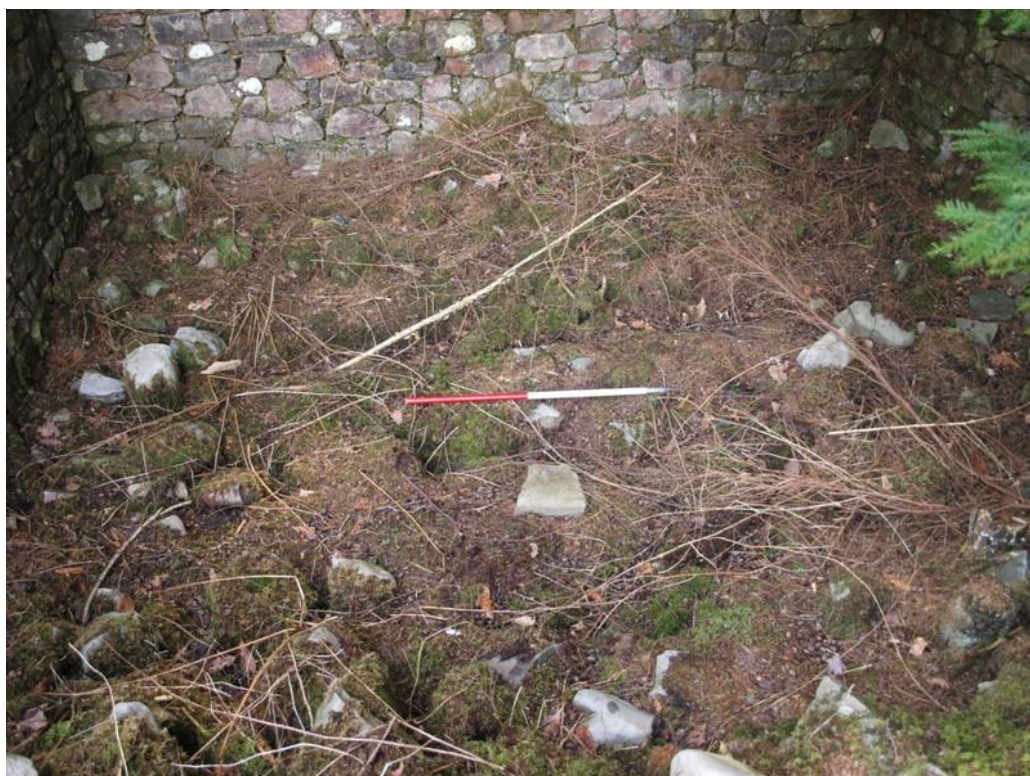
- 5.30 **Magazine (B3).** This is part of the northern cluster of buildings, located at SN 9206 0867. This stone-built structure is square in plan, and all walls survive to a height of between 1.5 and 2.5 metres; however the north wall is partly collapsed both into and outside the building. Again, despite being shown on the Nobel Plan as being connected to the adjacent Pellet House (B2) this was in fact constructed as a free-standing structure. As with the other buildings in this complex, sleeper walls survive internally below ground level (Fig. 26).

*Fig. 26. Magazine (M3). Interior view showing sleeper walls and rubble.*

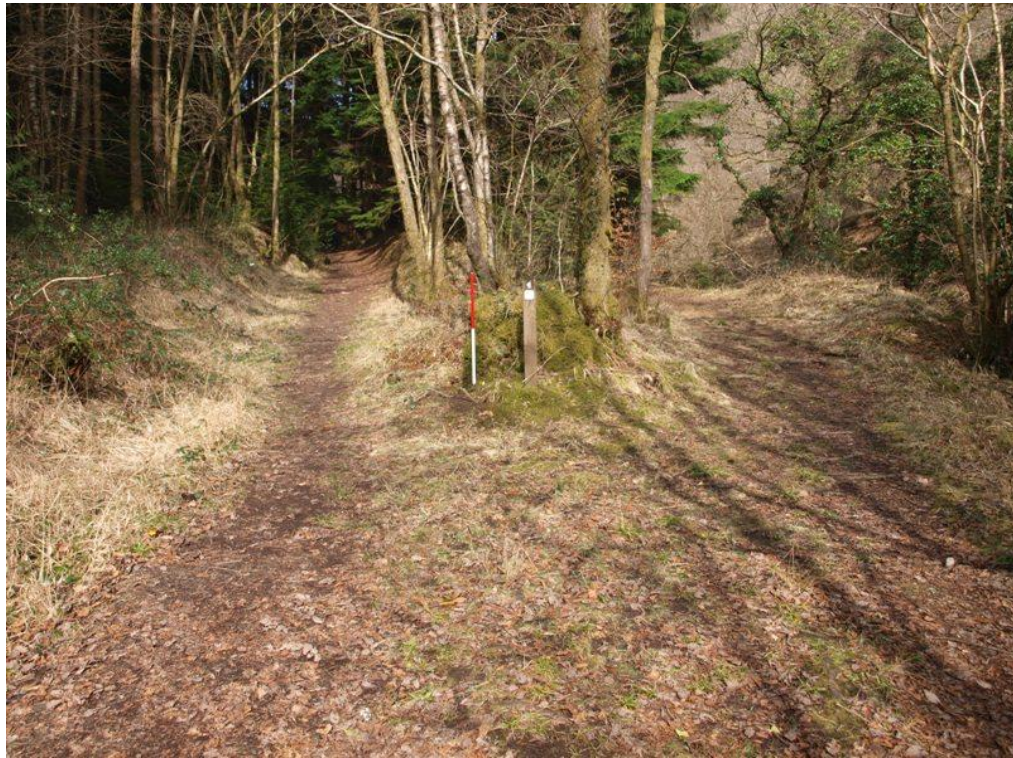
- 5.31 **Barrel House (B<sub>4</sub>).** According to the Nobel Plan this isolated building, located between the Magazine/Pellet House complex noted above, and the Boiler House/Stove House complex described below, was situated in the apex of the junction between the Main Tramway (T<sub>1</sub>) and the Upper Tramway Branch (T<sub>3</sub>) (Fig. 27). No above-ground evidence was extant at the time of survey, and it is not noted by the RCAHMW or the Cadw Schedule. Further investigation here may enable better understanding of its form and role within the gunpowder works.

*Fig. 27. The junction between the Main Tramway (T<sub>1</sub>), running to the left, and the Upper Tramway Branch (T<sub>3</sub>), to the right. The Barrel House (B<sub>4</sub>) was located in the apex of this junction.*

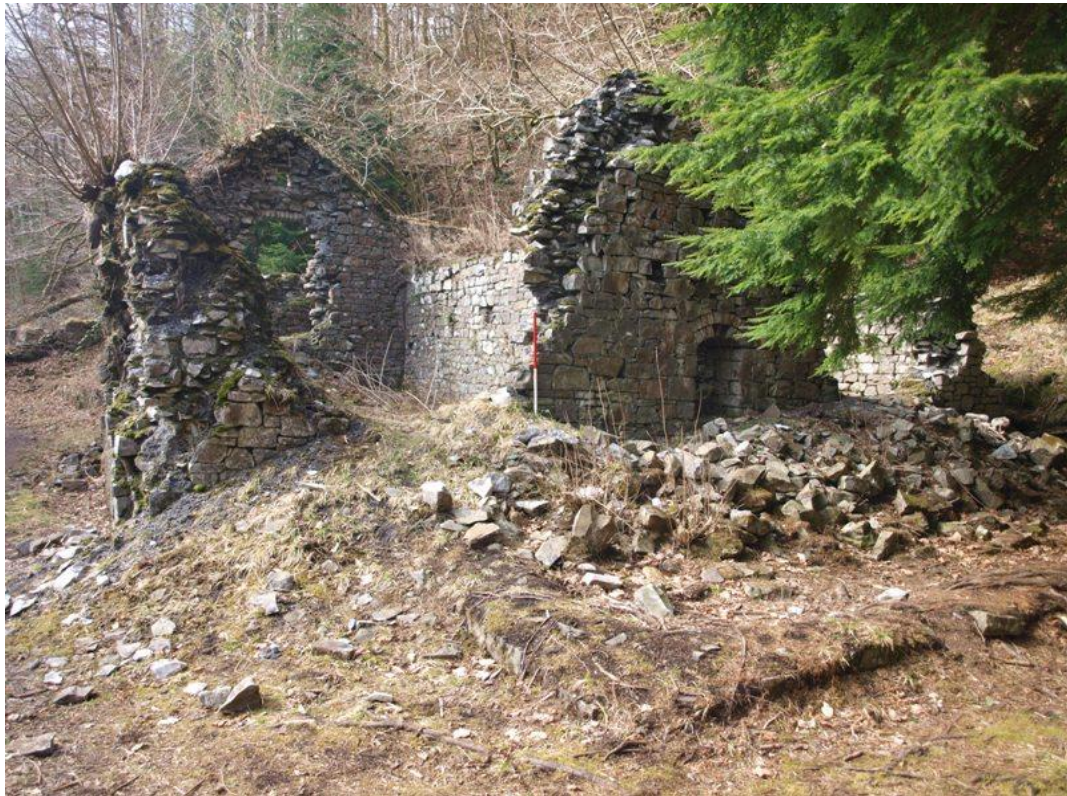
- 5.32 **Stove House (B<sub>5</sub>).** The Stove House is located at SN 9206 0855, and marks the northern end of the large cluster of buildings in the centre of the study area. It was in existence before 1877. It is a stone- and brick-built two cell building, formerly with a pitched roof, and is located adjacent to the Boiler House (B<sub>5</sub>) and was constructed at the same time. This is a relatively elaborate building, with brick detailing at eaves height on the gables, and brick surrounds to window and door openings. The south gable is largely intact, and the remaining walls are extant to eaves height, although the north wall has been partly demolished (presumably in order to extract machinery). An area to the north of this building – although not noted in previous surveys – appears to have been the site of an additional structure: there is a platform approximately 3.5m square which stands slightly above the surrounding ground surface (Fig. 28). Some investigation of this platform, and its relationship with the Stove House, would better inform understanding of the use and development of the site.

*Fig. 28. Stove House (B5). View looking south, with the tramway and river to the left of the photograph. The building platform to the north – not marked on the Nobel Plan – is evident in the foreground.*

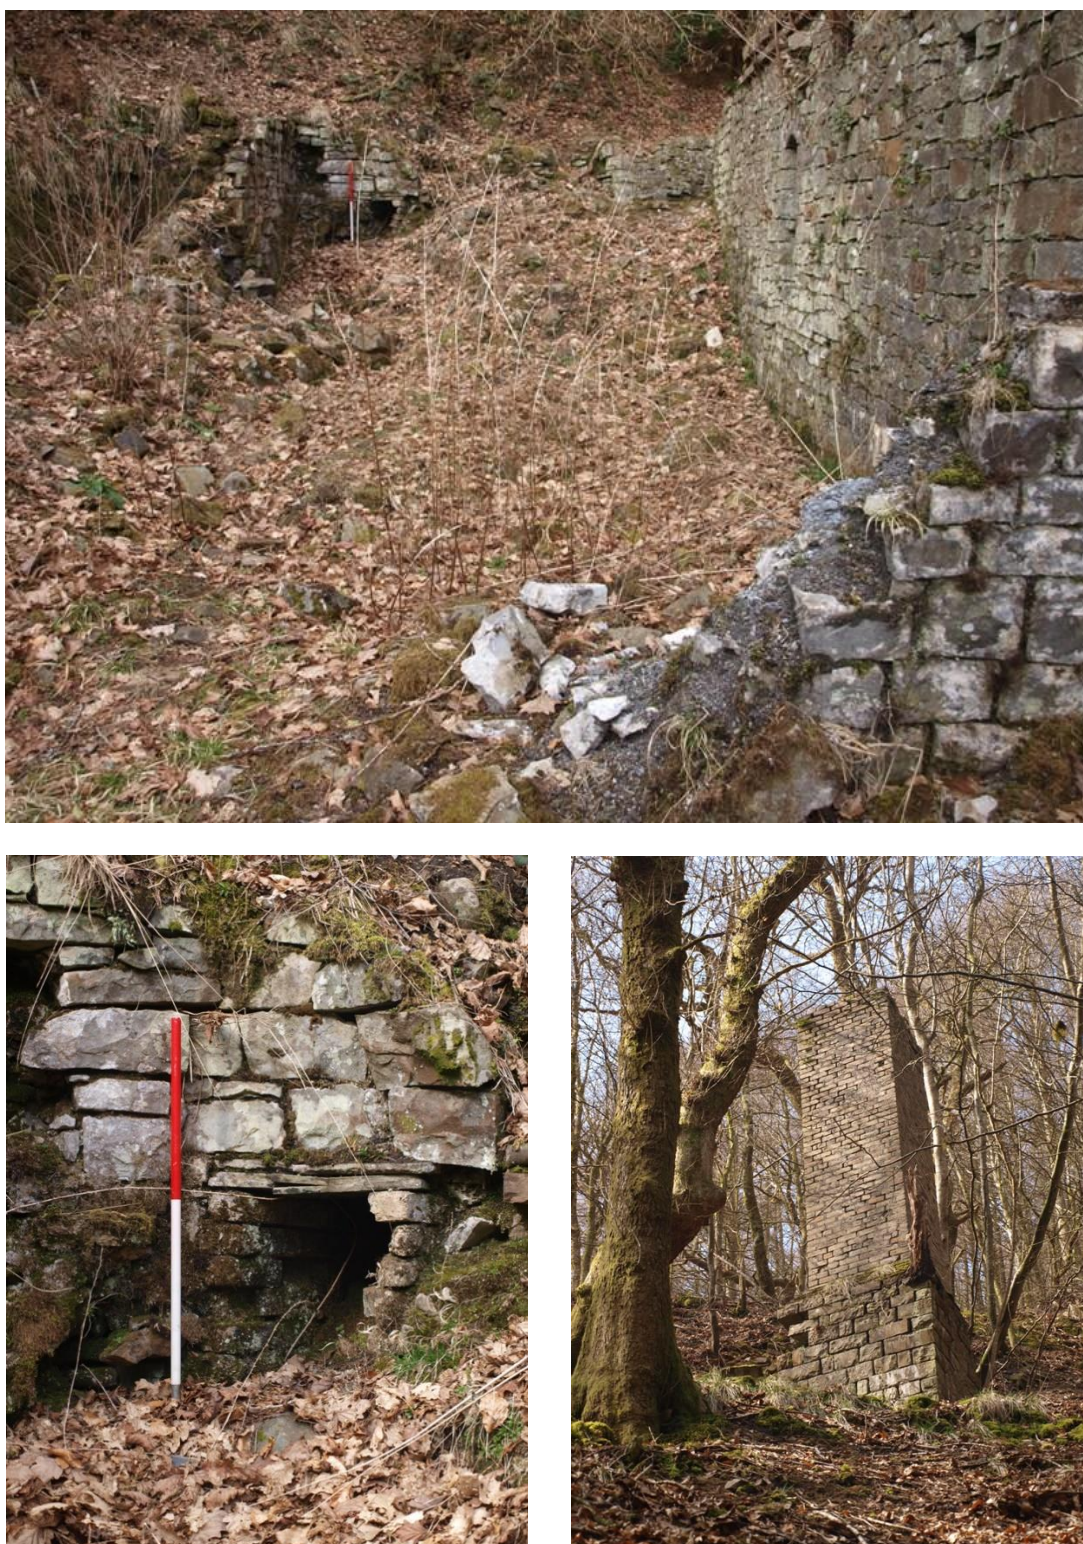
- 5.35 **Chimney (B8).** This is located to the north-west of the Boiler House/Stove House, at SN 9206 0855. It is square in plan, built of firebrick on a stone base (Fig. 29). It has been significantly truncated since the closure of the works, including serious loss of fabric in the last twenty years. A photograph taken in October 1996 shows that it was then almost twice as high as it is now, with an extra tier rising above the present top of the chimney.

*Fig. 29. Boiler House (B6), Flue (B7) and Chimney (B8). Top: the interior of the Boiler House looking west. Bottom left: detail of the entrance to the flue in the western wall of the Boiler House. Bottom right: the Chimney.*

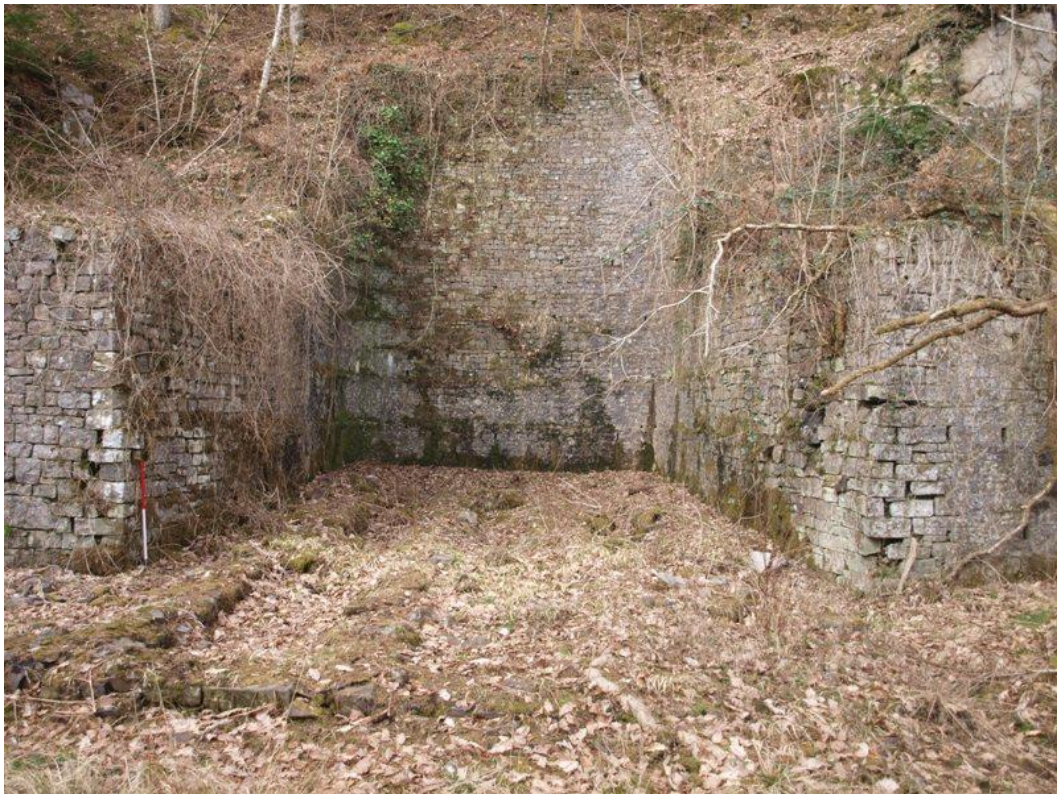
- 5.36 **Dusting House (B9).** This substantial masonry structure is located at SN 9203 0852, and its rear (western) wall forms a retaining wall built into the bank to the north-west, standing approximately 9.5m high (Fig. 30). This was in existence before 1877, and is adjacent to the 3½hp Turbine House (W5) and the Heading Packing House (B10). The side walls survive to a height of approximately 3.5m and are over 2m thick; the returns with the rear walls are curved slightly. There is no evidence for a front wall, which was presumably a relatively flimsy structure that would have enabled any blast to escape in the event of an accident. Internal sleeper walls (of brick) survive, together with a variety of holding-down bolts. The Elevated Leat (W4) crossed the front of this building.

*Fig. 30. Dusting House (B9). View looking west from the line of the Main Tramway.*
