CPAT Report No. 1333

# **Glyn Neath Gunpowder Works**

## **CULTURAL HERITAGE IMPACT ASSESSMENT**

Client name: Brecon Beacons National Park Authority  
CPAT Project No: 2008  
Project Name: Glyn Neath Gunpowder Works  
Grid Reference:  
County/LPA:  
CPAT Report No: 1333  
Issue No: 1  
Report status: Draft  
Confidential: No

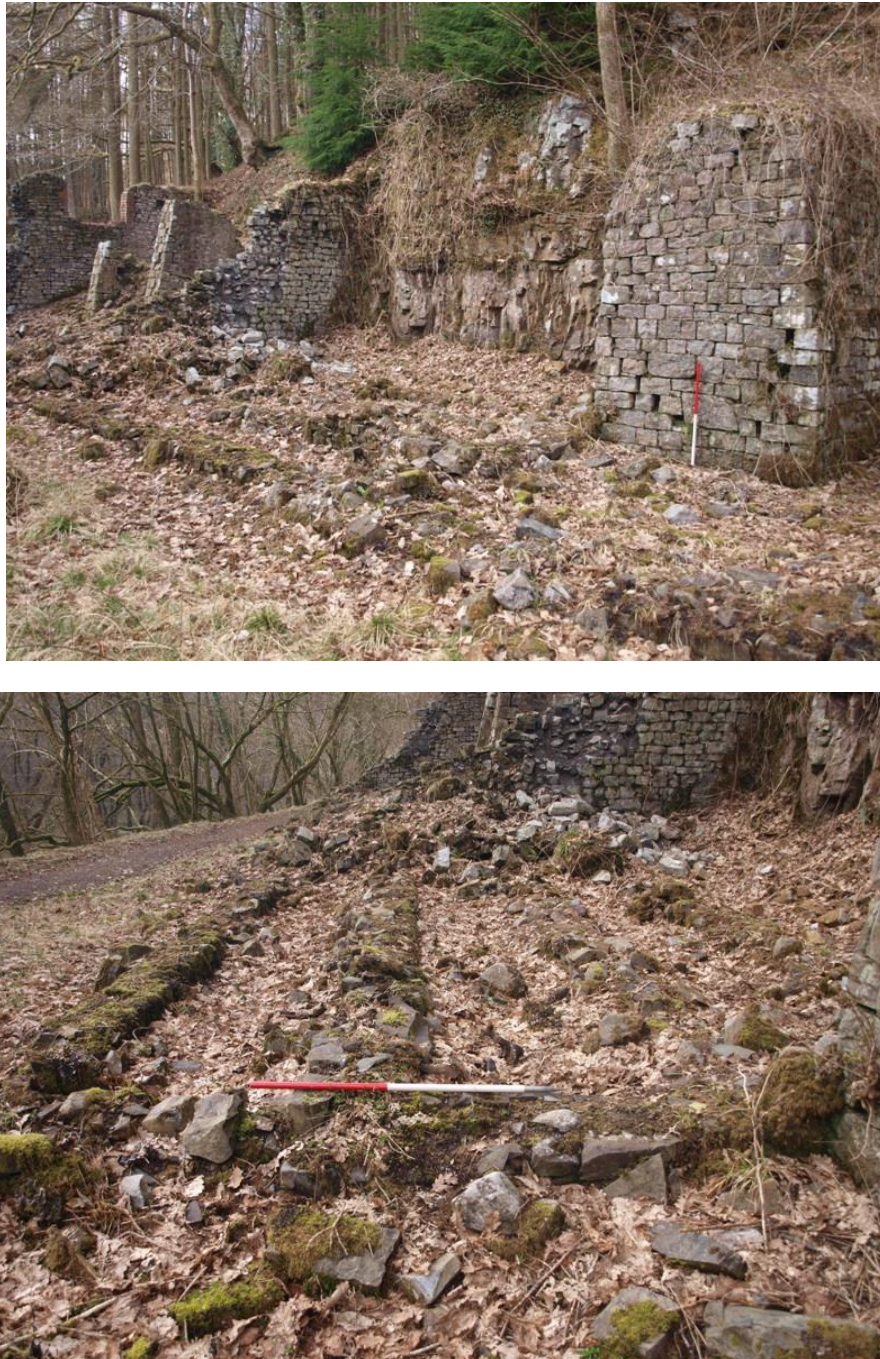
(W6), to the south. It was in existence before 1877. As with the nearby buildings there are internal sleeper walls of brick, containing iron bolts and other fixtures for machinery; there no evidence of a substantial front wall so again this was probably a 'blast wall'. The side walls survive to a height of up to 3m, but the rear wall has collapsed and the resulting rubble has partly infilled the gaps between the sleeper walls.

*Fig. 31. Heading Packing House (B10). Top: view looking south-west from the line of the tramway. The wall in the foreground is also the south wall of the Dusting House (B9). Piers for the Elevated Leat (W4), and the north wall of the Stable (T5) are visible in the background. Bottom: detail of internal sleeper walls, looking south from the north end of the building.*

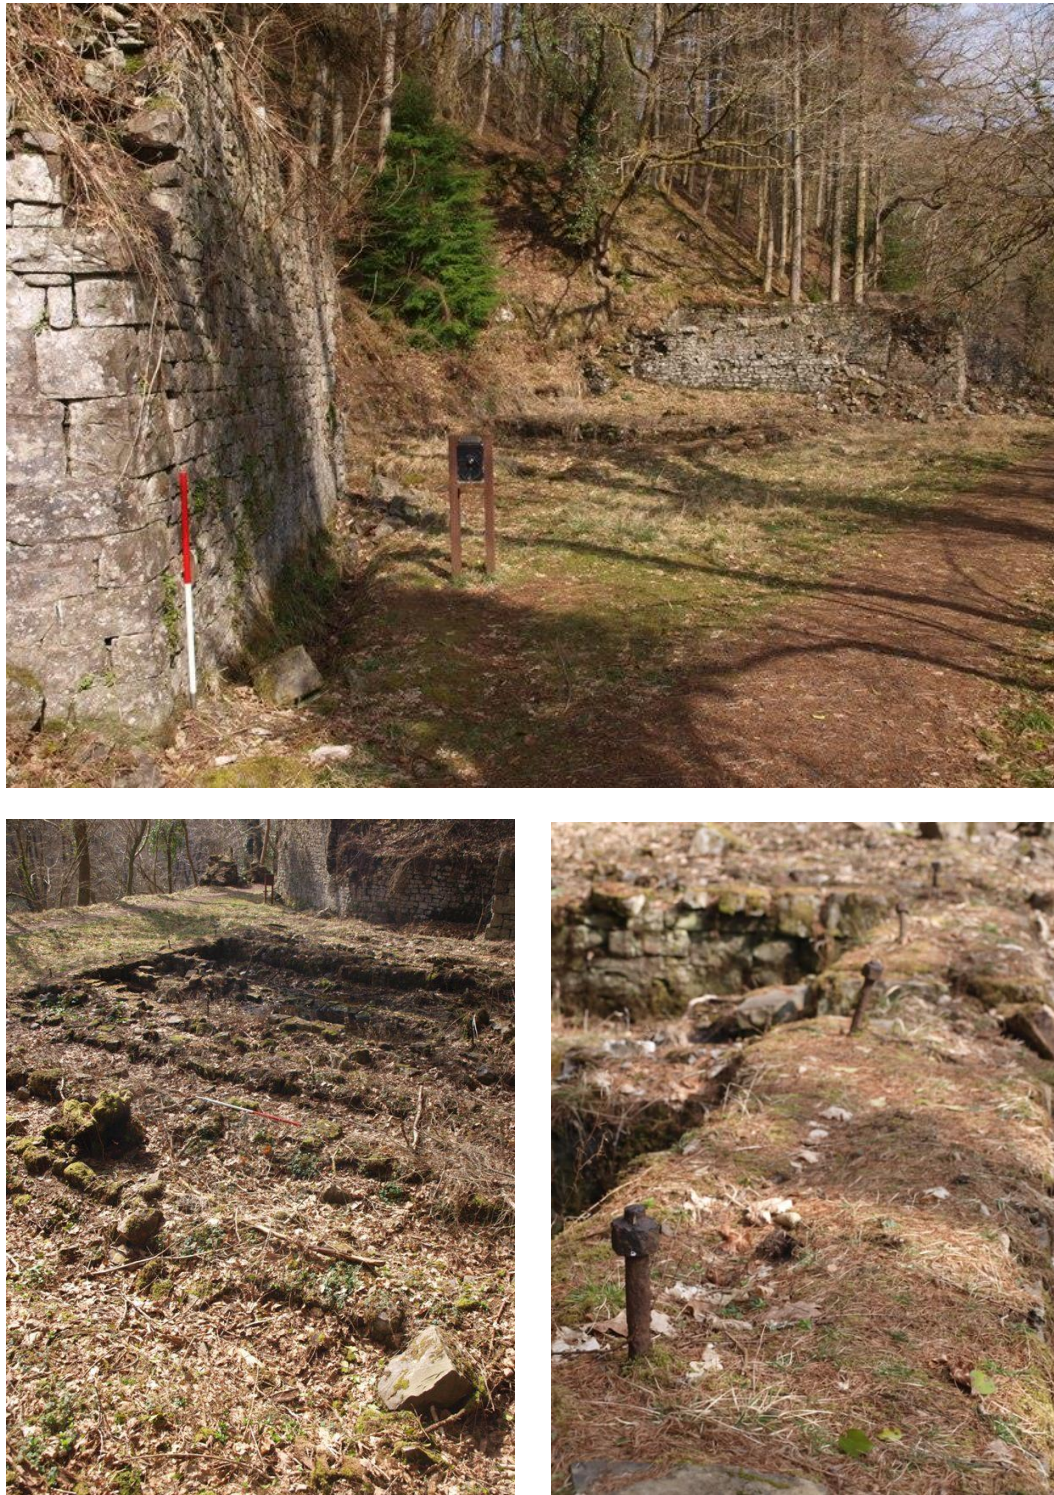
*Fig. 32. Glazing House (B11). Top: general view, looking north from the tramway; the wall in the foreground is the continuation of the revetment wall, with the building itself located beyond the interpretation feature. Bottom left: view across the Glazing House looking south with the revetment wall and the 12-15hp Turbine House (W6) in the background. Bottom right: detail of bolts in the sleeper wall.*

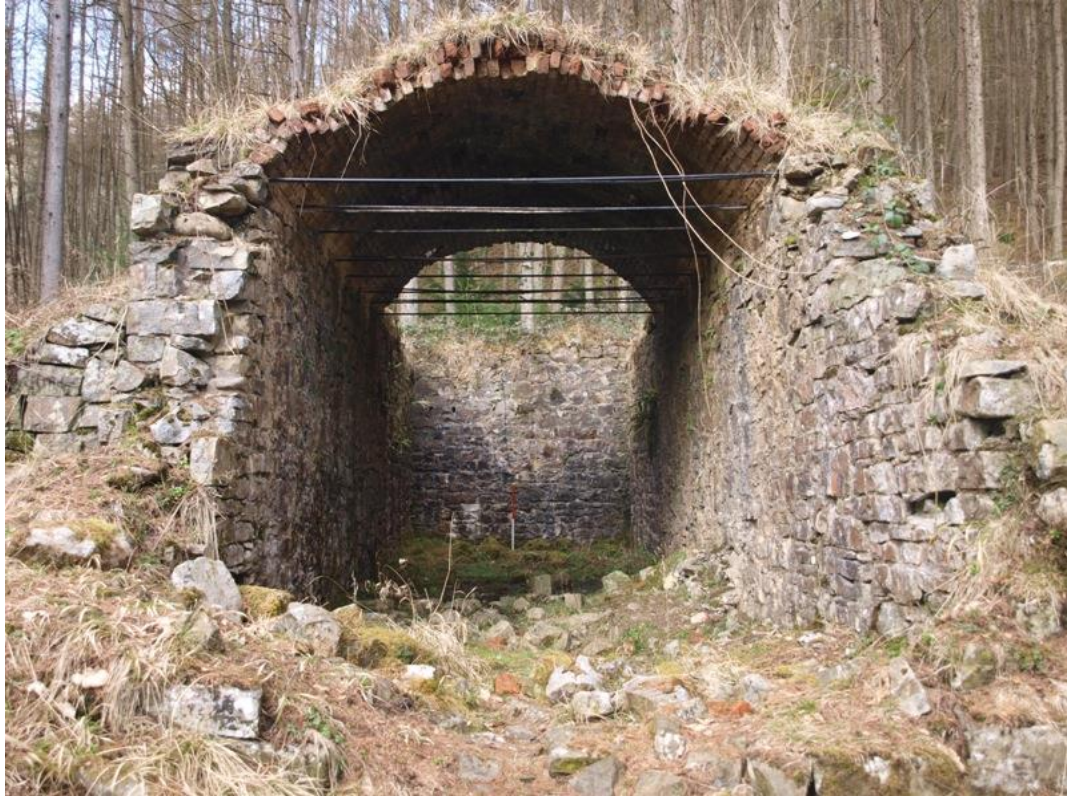
*Fig. 33. Expense Magazine (B1).*

- 5.39 **Expense Magazine (B12).** This isolated structure is located at SN 9195 0846. It is a substantial stone-built structure with a brick-arched roof incorporating wrought iron tension rods (Fig. 33). Recent restoration has supplemented these with additional mild steel rods. There are supporting buttresses at the front, flanking to the north-east and south-west sides; the Elevated Leat (W4) passed across the front of this building (Fig. 10, above).

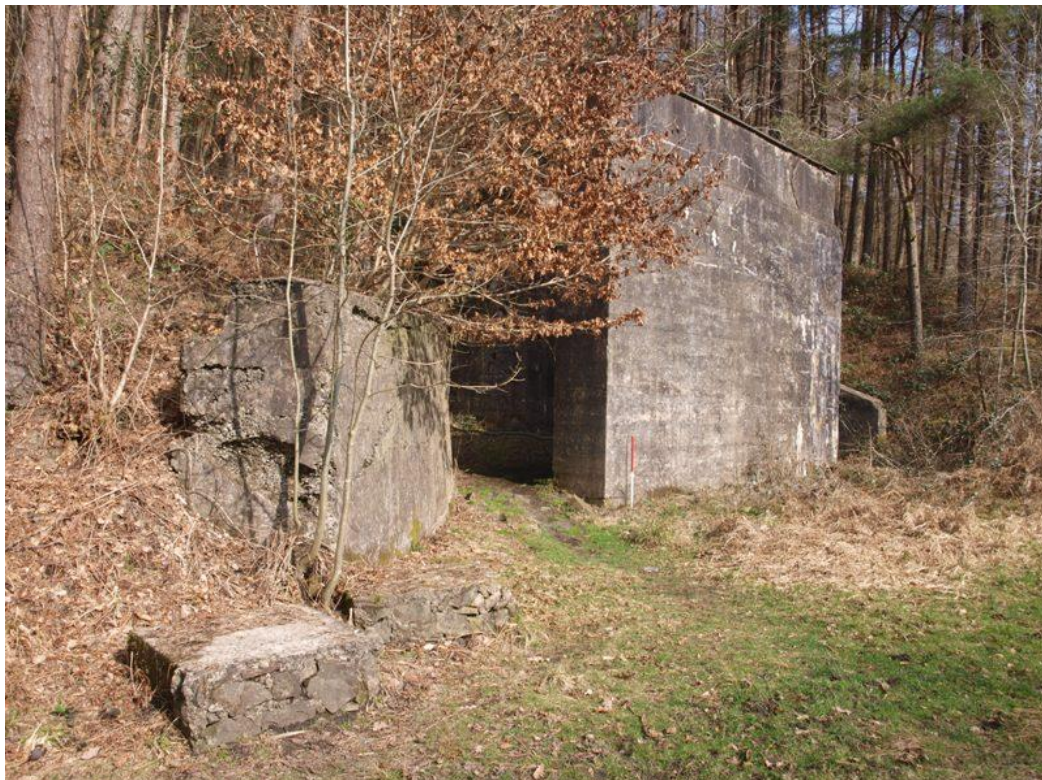
Fig. 34. New Corning House (B14). View looking north from the former junction of the Main Tramway (T1) with the Lower Tramway Branch (T7).

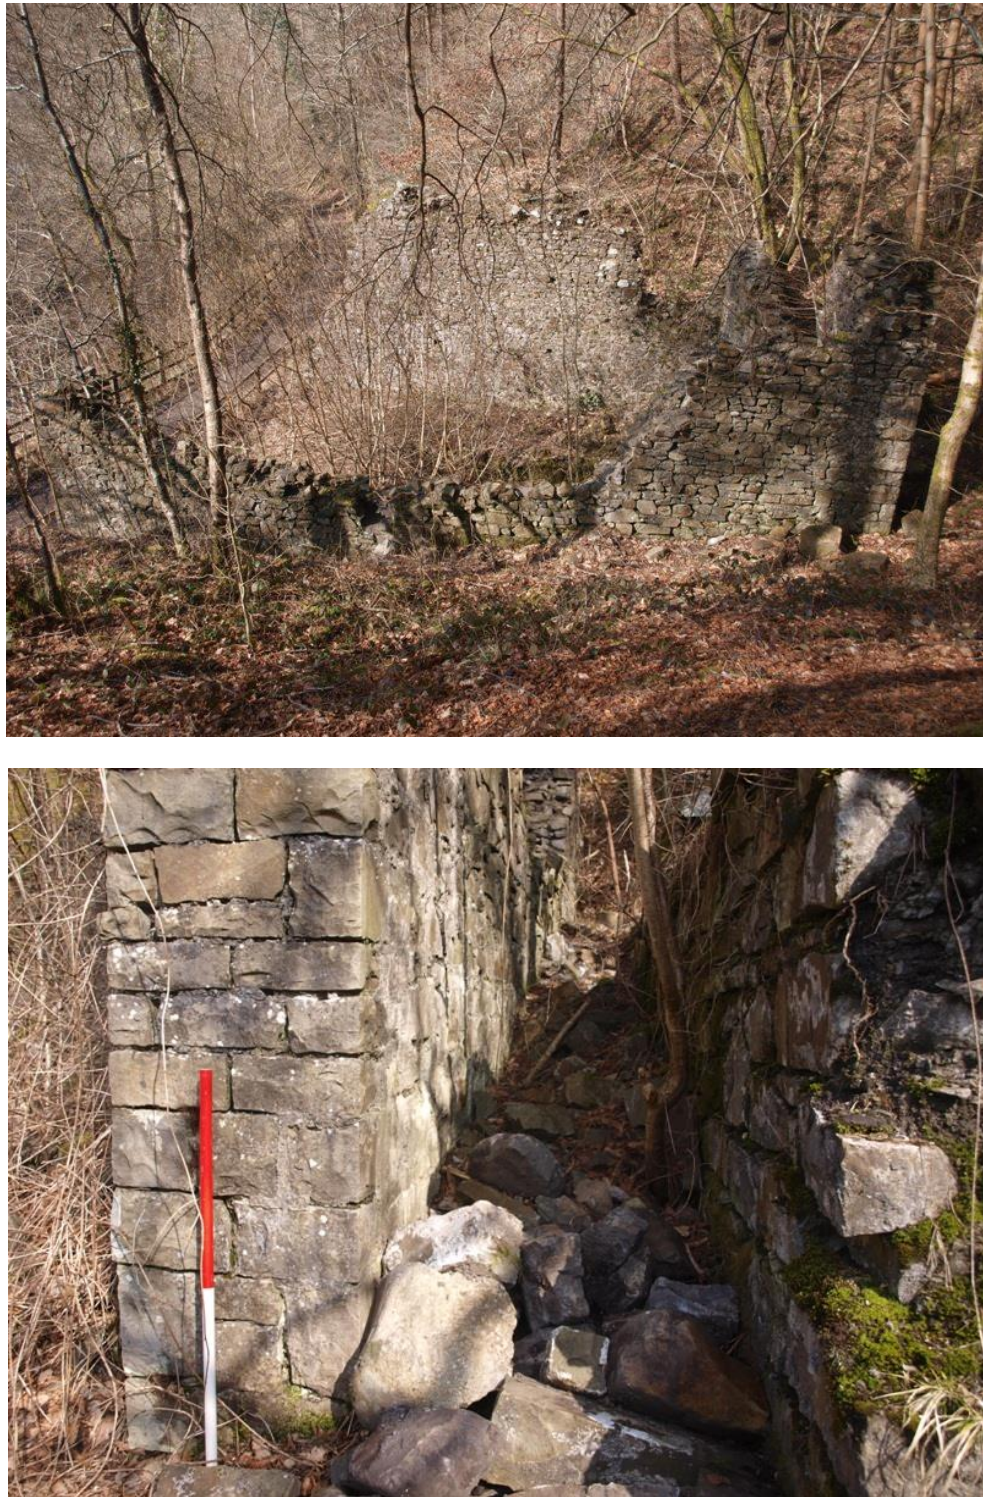
- 5.42 **Corning House (B15).** This isolated building is located at SN 9183 0843, to the south-west of the New Corning House (B14) and adjacent to the Main Tramway (T1). It was powered by the Waterwheel (W10) on the opposite site of the river, and was in existence before 1877. The building is located in a hollow, which has a retaining wall to the east side but not to the rear (north) or west; the front (south) side of the building fronts on to the tramway (Fig 35). The building is constructed of roughly-coursed stone, with well-finished detailing to the south ends of the walls; the south wall was probably a ‘blast wall’. The walls stand to a maximum height of c.4m, although partly collapsed in places. There are a number of beam-slots and other apertures built into the internal faces of the walls, suggesting at least two and possibly three levels of sieving and crushing machinery. In the centre of the building is a pit containing a number of iron bolts; this was probably the location of machinery transferring power from the waterwheel to the building (Fig. 36). The interior of the building, and the gap between it and the retaining wall on the east side, is partly filled with rubble from its collapse, but there is considerable archaeological potential here.

*Fig. 35. Corning House (B15). Top: general view looking east from the line of the 'Clean Gangway' (W7), with the tramway and river to the left. Bottom: detail of the south-eastern corner of the building, showing the well-finished end to the east wall on the left, and the retaining wall on the right.*

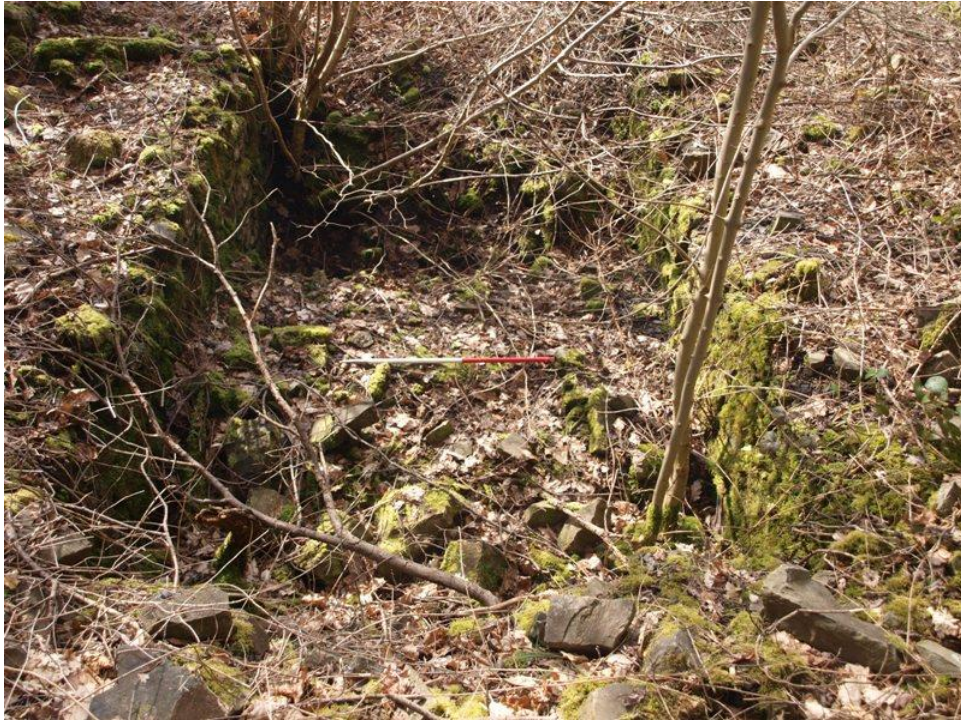
*Fig. 36. Corning House (B15). The possible power transmission pit in the centre of the building; view looking south from the northern end of the building.*

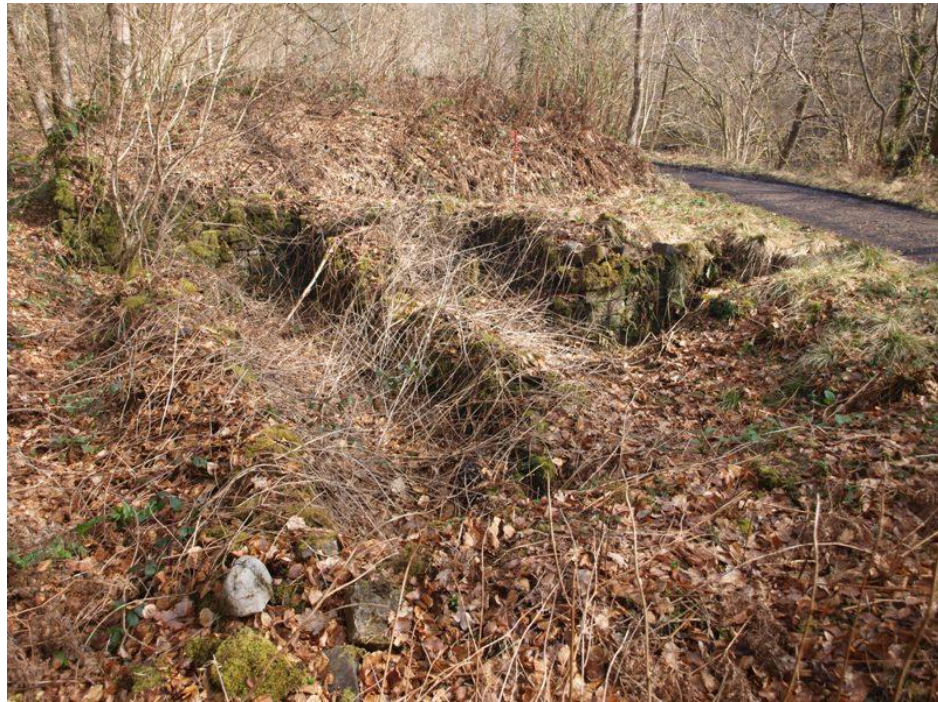
- 5.44 **Cake Press House (B17).** This isolated structure is located at SN 9168 0827, and according to the Nobel Plan was served by a loop in the tramway that ran behind the building. A building was in existence here by 1877. Although only a single building is shown on the Nobel Plan, the field evidence suggests that there were two or possibly three separate structures (Fig. 38). The central part of the area is occupied by a rubble mound which appears to represent a collapsed structure; to the west, separated by a narrow pit, are the foundations and sleeper walls of another structure. There may be an additional structure to the east. Further investigation would be helpful here in elucidating the layout of buildings and the sequence of construction, as well as the relationship to the main line of the tramway and the tramway loop.

*Fig. 38. Cake Press House (B17). View looking east from the western end of the complex, with the Main Tramway (T1) to the right. The footings of the western structure are evident in the foreground, with the rubble mound (another building) behind.*

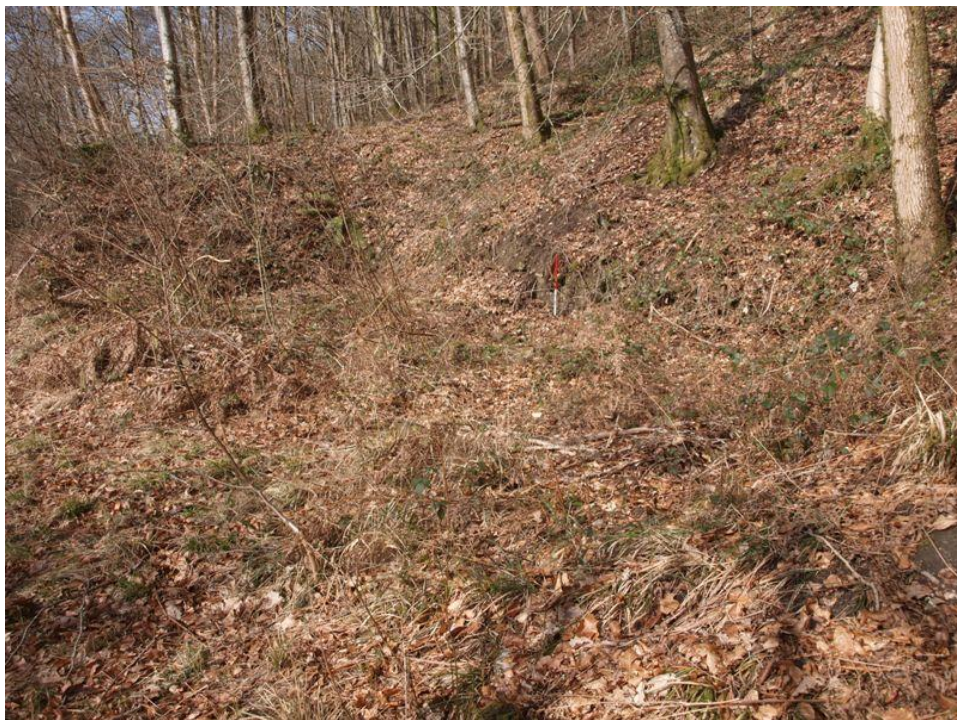
- 5.45 **Cake Press House (B18).** This is located at SN 9155 0822, to the north of the 6hp Turbine and Pump House (W14) which presumably provided a source of power. The rear wall of the building formed the retaining wall for the bank behind. Foundation walls and sleeper walls survive, but the side walls and front wall (presumably a 'blast wall') are not evident above ground; it is also possible that part of the building lies under the present footpath (Fig. 39). Further investigation would enable the original form of the building to be determined.

*Fig. 39. Cake Press House (B18). View looking west from the line of the tramway. The scale rod marks the rear (revetment wall).*
