SEION WASTE WATER TREATMENT WORKS, SEION, GWYNEDD

Archaeological Evaluation

Project No. G2563

Report No. 1435

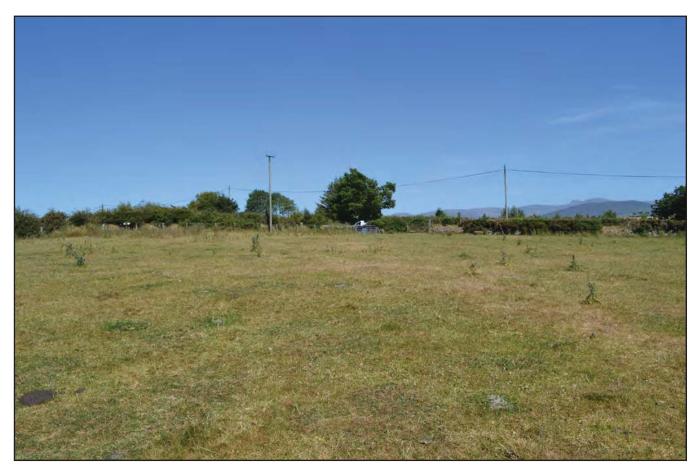
Plate 1 - View of field entrance and gateway to adjoining field to the north (archive reference: G2563_010).

The proposed works are located on the north and eastern side of a sub rectangular shaped field of improved pasture grassland (Plates 1 & 2). The field is 0.83 ha in area and bounded by minor roads to the east and south, and further agricultural fields to the north and west. It is enclosed by grown out post-medieval stone faced hedge banks, cloddiau, on all sides, with modern wooden post and wire fences set on, or inside of the cloddiau (Plates 3 & 4). Some semi mature trees have colonised the northwest-southeast aligned clawdd that forms the southern boundary (Plate 5). A wooden gate in the eastern corner of the field provides access from the road side (Plate 6), whilst access to the field to the north is via an adjacent gateway with a galvanised steel gate set at the eastern end of the northwest-southeast aligned northern boundary. A set of overhead power lines extends northeast-southwest above the eastern boundary, while a second extends approximately parallel to the first within the field, approximately 20m from the eastern boundary.

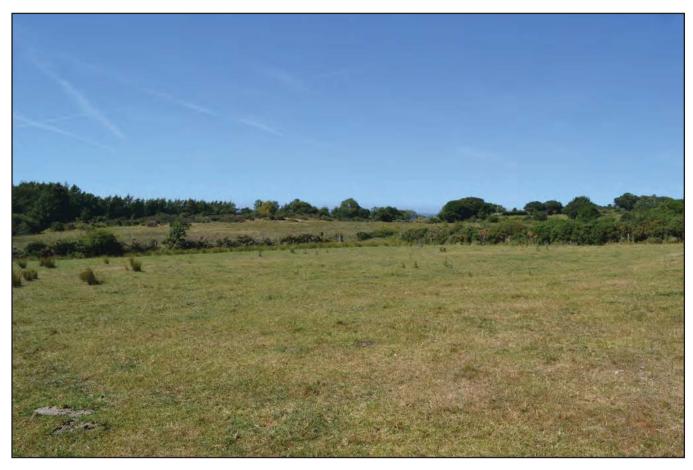
Plate 2 - Proposed WWTW location in northern corner of field (archive reference: G2563_011).

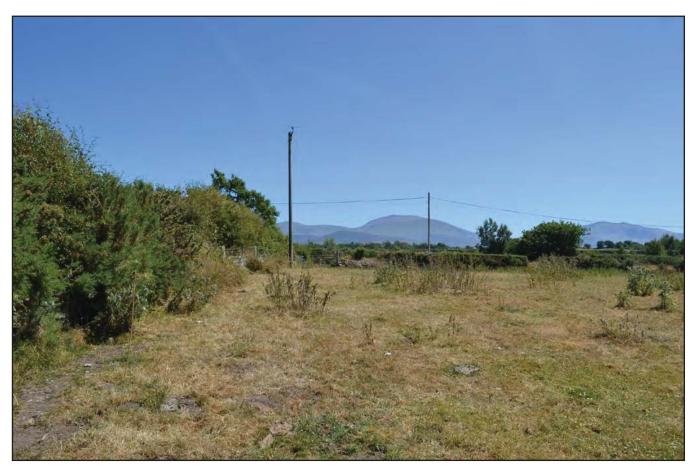
Plate 3 - View along northern field boundary towards entrance along proposed access road route (archive reference: G2563_005).

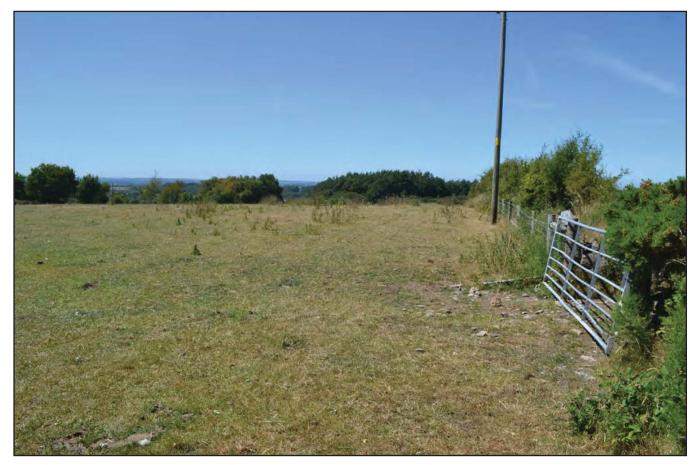
Plate 4 - View along northern field boundary from entrance along route of proposed access road towards treatment plant location (archive reference: G2563_001).

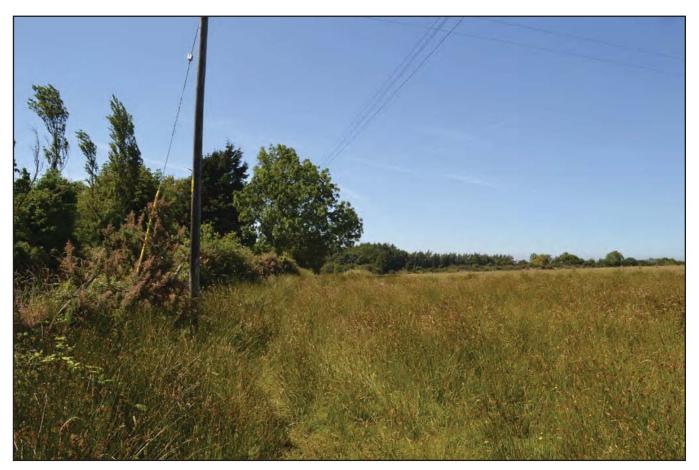
Plate 5 - View along southern field boundary towards lower western corner of field (archive reference: G2563_012).

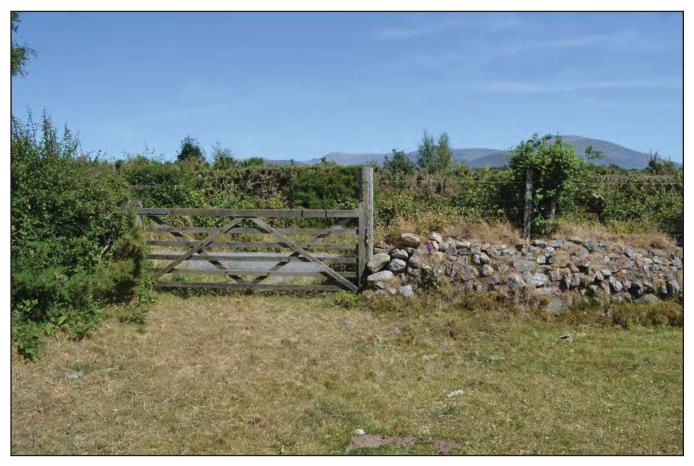
Plate 6 - Close up view of field entrance and clawdd wall field boundary on eastern side of field (archive reference: G2563_014).

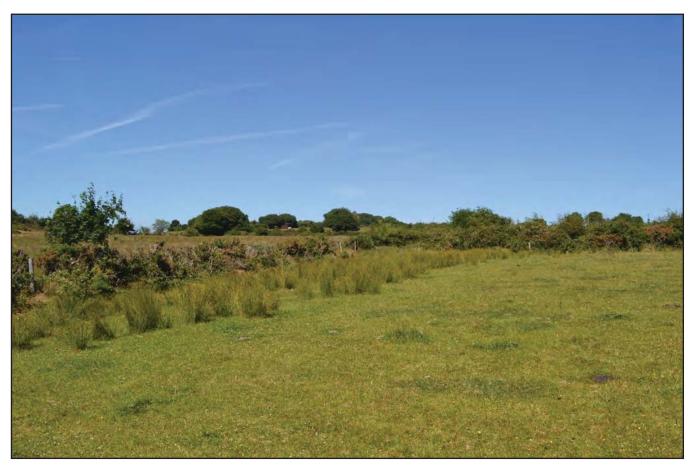
Plate 7 - Wetter ground in northern corner of field (archive reference: G2563_009).

The presence of patches of rushes (juncus) (Plate 7) in both the lower northern and southern corners suggests that under typical rainfall conditions, both of these areas are normally wetter than the rest of the field. This may be particularly significant in the northern corner as this lies within the footprint of the proposed waste water treatment works and it may be that the potential for survival of peat deposits or organic material in any as yet unknown archaeological features here is increased.

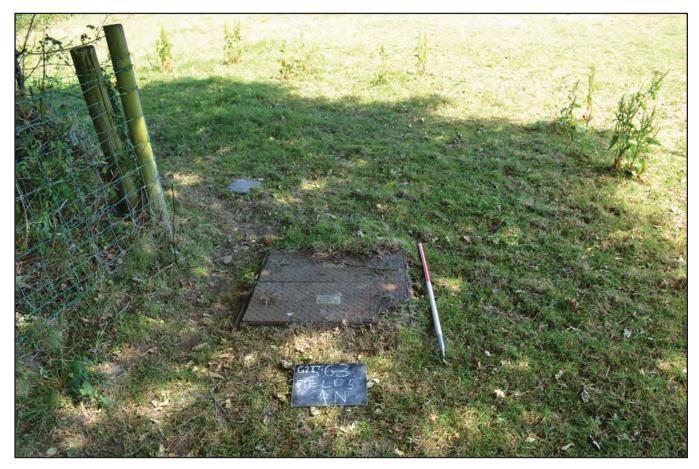
Plate 10 - Manhole cover adjacent to Feature 4, Field 5; scale: 1x1m (archive reference: G2563_035).

The area through which the pipe routes pass is undulating, with the local high point concentrated around the farm Ty'r-yr-allt and the house Bryn Clychau'r Gog and the ground slopes quite dramatically to the north of these properties. While the majority of the routes pass through fields of pasture, sections of *Route Three* extend along lanes that are public rights of way and the garden of Tan-yr-wylfa (Figure 09). It was noted during the walkover survey parallel with the southern field boundaries of Fields 1, 2 and 5 that there were several manhole covers (Plate 10). This would indicate the presence of an existing pipe.

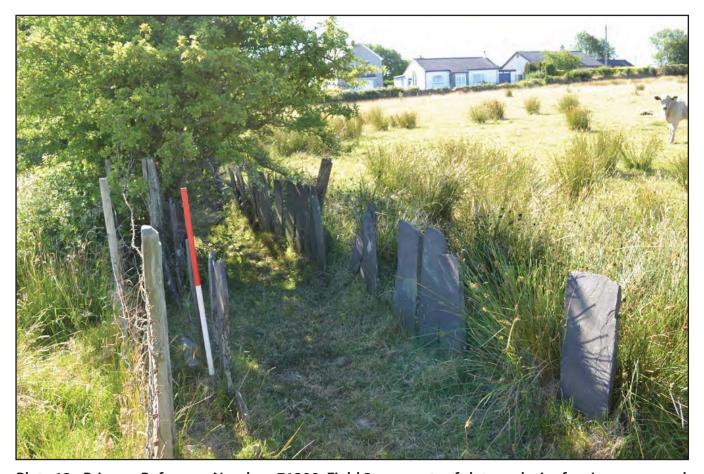
Plate 12 - Primary Reference Number: 71209. Field 3 remnants of slate and wire fencing, proposed pipe routes 1 & 2; scale: 1x1m (archive reference: G2563_022).

Description: This is the remnants of wire and slate fencing that appears to define a path aligned east-west. It extends along the northern boundary of Field 3. The slates are machine cut, set vertically into the ground and held in place by thick, rusted iron wire. The path enclosed by the fencing is 1.20m wide, with an average height of 0.70m for the slates. It has an approximate length of 55m, before disappearing into thick undergrowth at the east corner of Field 3 and has been truncated by a more recent wire and post fence in the southwest corner of Field 1. *Routes One* and *Two* will most likely have a negative impact on sections of this feature. Feature 01 is probably depicted on the Vaynol estate map of 1867.

Recommendations for mitigatory measures: Avoidance or have an archaeologist present to record the breach.

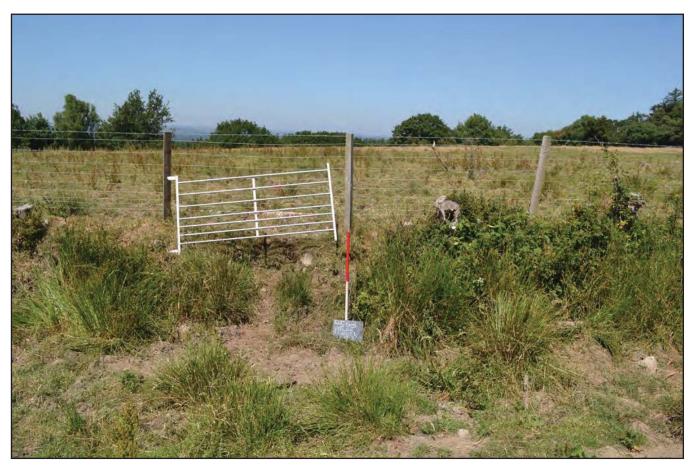
Plate 19 - Primary Reference Number: 71213. Exit point for proposed pipe route 1 through Feature 6; scale: 1x1m (archive reference: G2563_054).

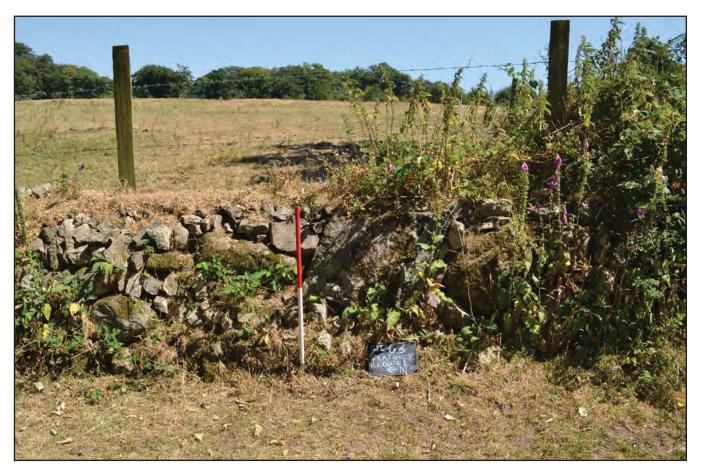
Plate 21 - Primary Reference Number: 71214. Feature 7, eastern clawdd; scale: 1x1m (archive reference: G2563_060).

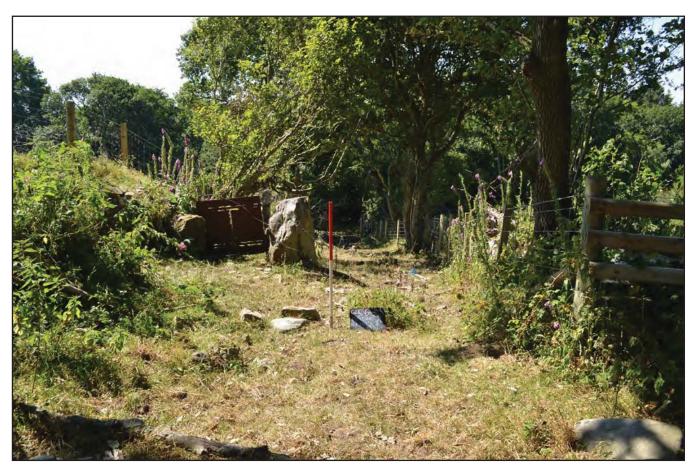
Plate 23 - Primary Reference Number: 71216. Proposed pipe route 3 access to Feature 9; scale: 1x1m (archive reference: G2563_068).

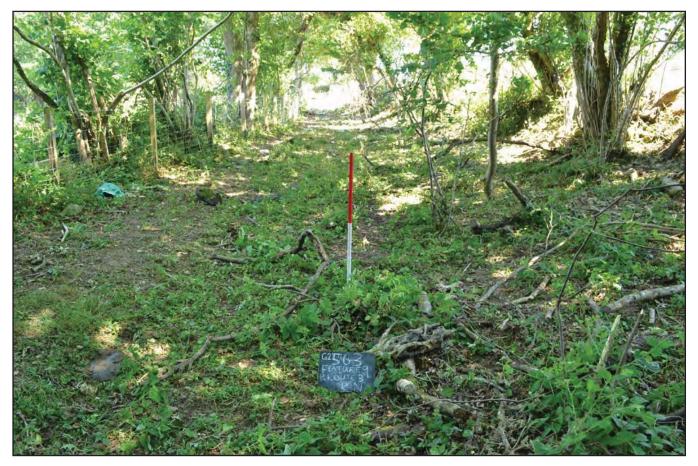
Plate 24 - Primary Reference Number: 71216. Proposed pipe route 3 through Feature 9; scale: 1x1m (archive reference: G2563_069).

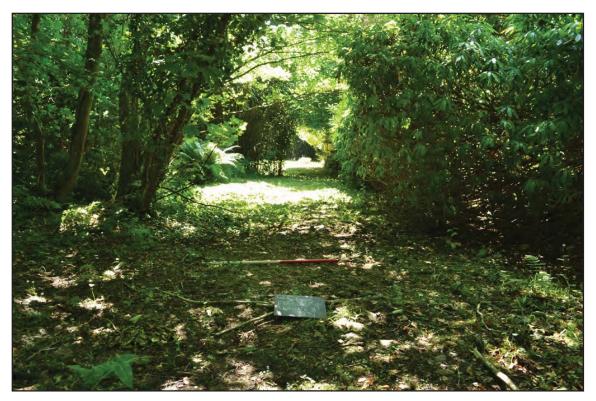
Plate 25 - Primary Reference Number: 71216. Proposed pipe route 3 through Feature 9; scale: 1x1m (archive reference: G2563_072).

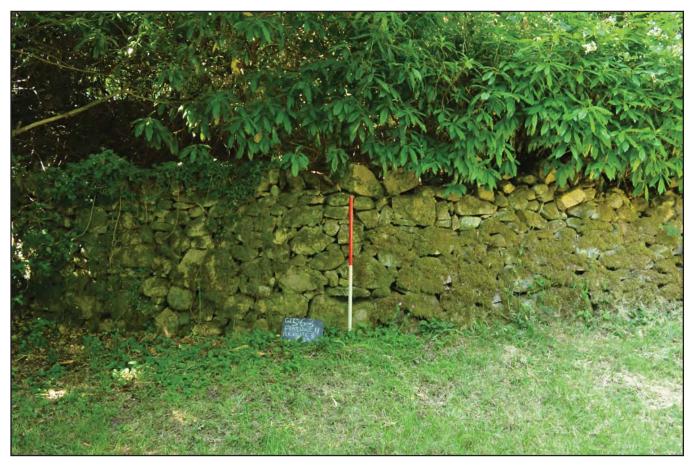
Plate 28 - Primary Reference Number: 71218. Southwest face of Feature 11, proposed pipe route 3; scale: 1x1m (archive reference: G2563_073).

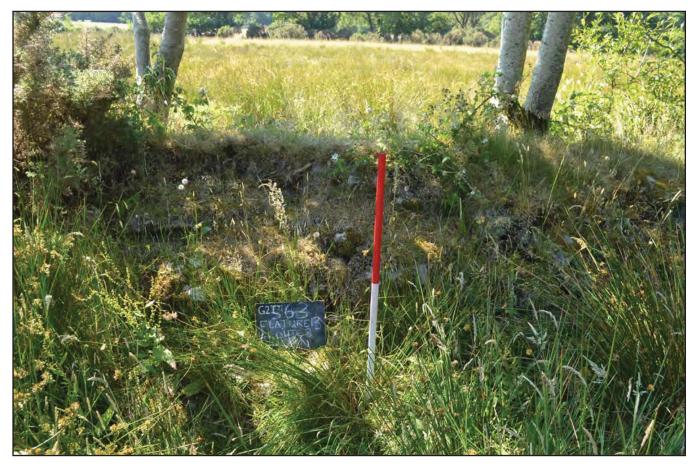
Plate 32 - Primary Reference Number: 71219. Exit point from Field 12 (Feature 13), proposed pipe route 3; scale: 1x1m (archive reference: G2563_084).

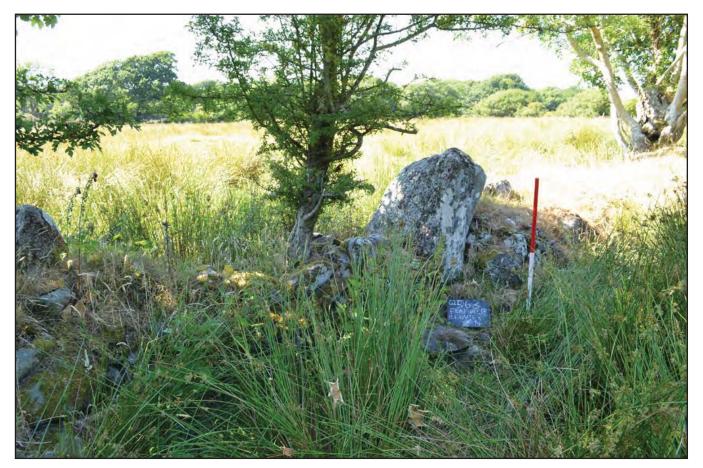
Plate 33 - Primary Reference Number: 71219. Feature 13 in Field 12; scale: 1x1m (archive reference: $G2563_085$).
