# Glan Yr Afon, Llangernyw

ARCHAEOLOGICAL MITIGATION:

LEVEL 3 BUILDING RECORD &  
ARCHAEOLOGICAL WATCHING BRIEF

Project No. G2479

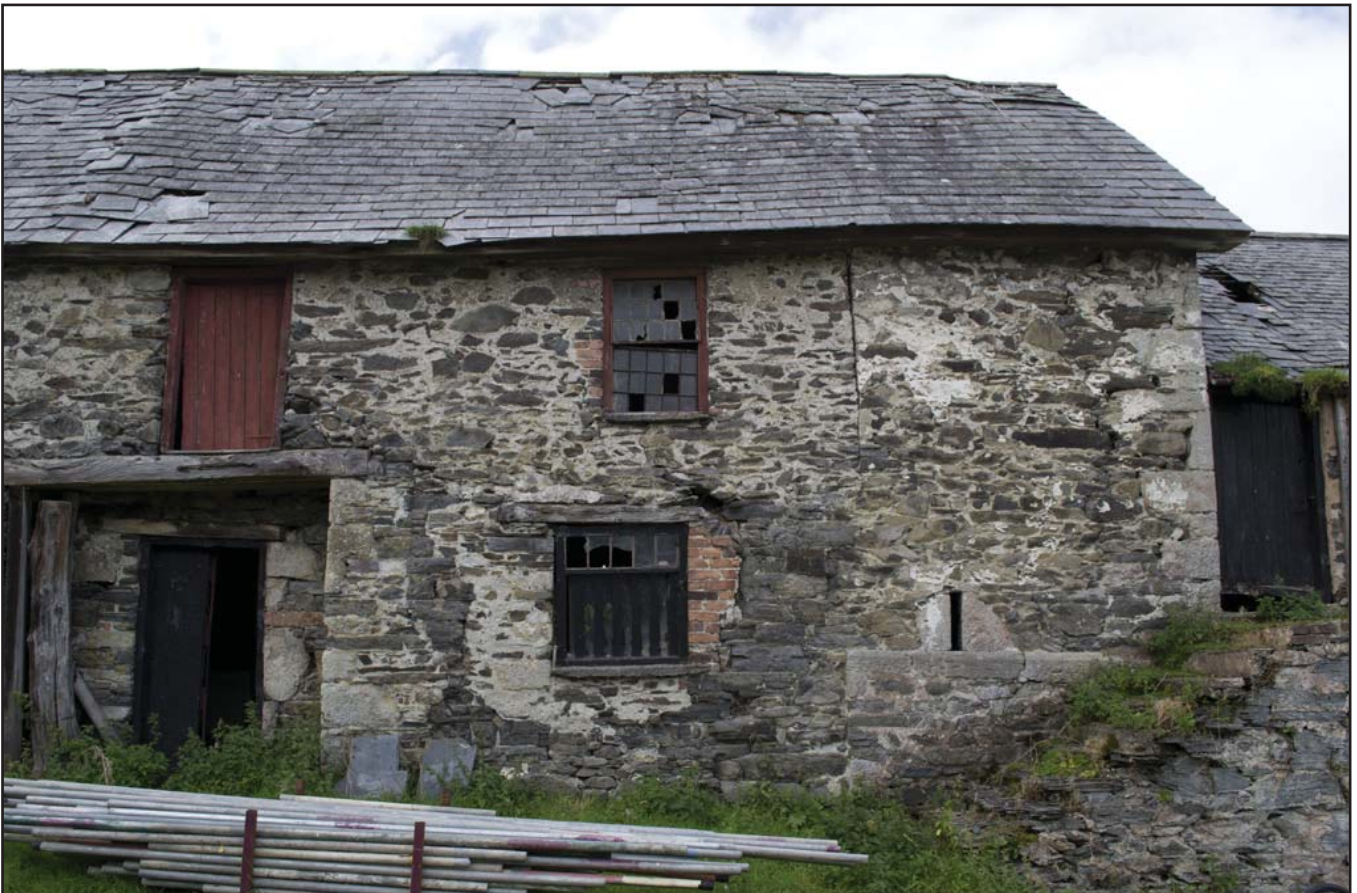
Plate 6: NE end of G01/F01 showing structural failings around ground floor window (archive reference: G2479\_031).

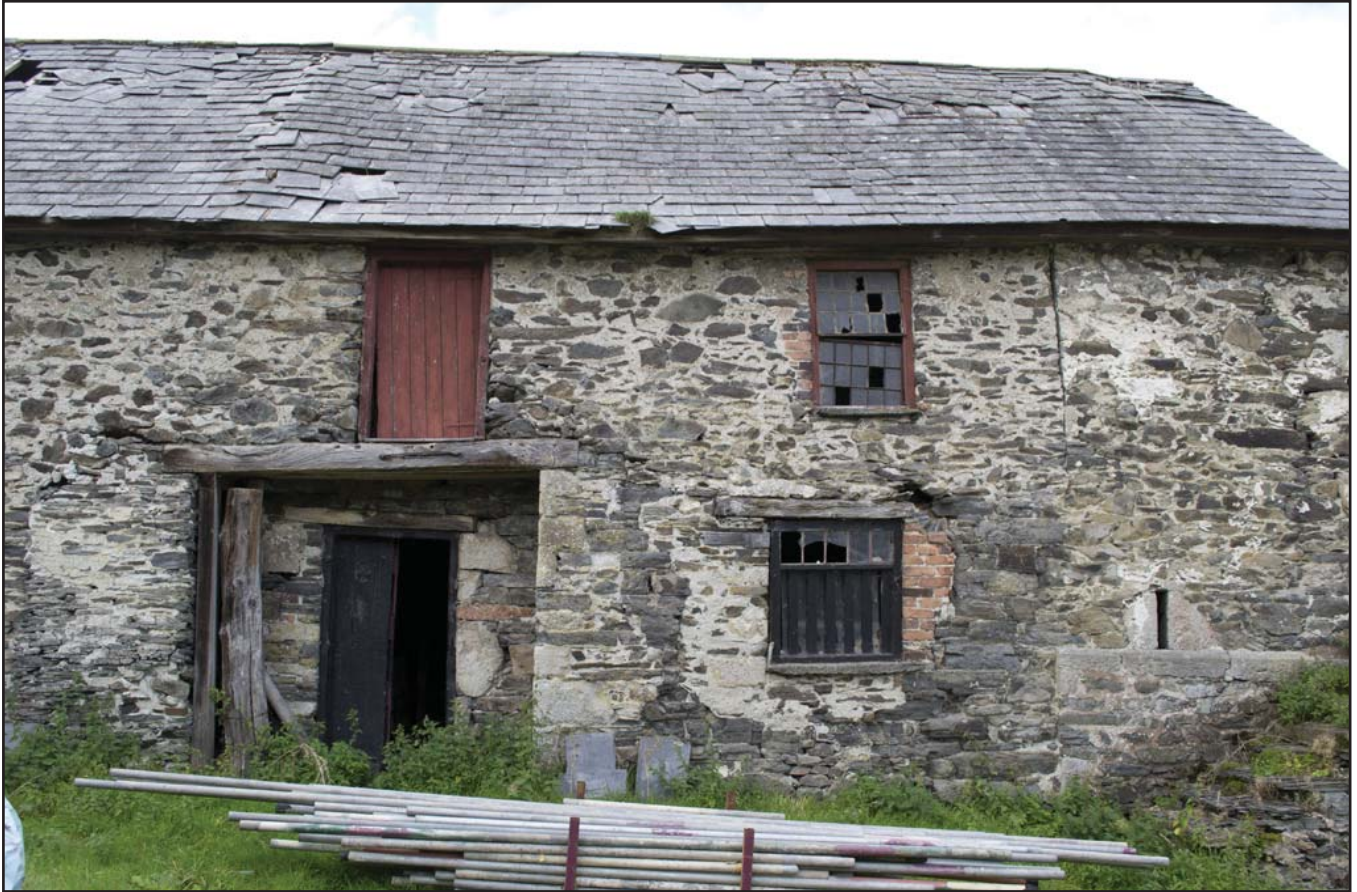
Plate 7: Central portion of G01/F01 showing entrance doorway; (archive reference: G2479\_032).

The probable second phase of the original three-unit (Parlour and Kitchen with central Pantry opposite the front door) sub-medieval house of Glan Yr Afon is now represented by the upper storey walls and the horizontally rectangular windows, probably with stone mullions and transoms within them which have been subsequently blocked when the vertically rectangular windows were inserted (Plate 6). The lower storey walls consist almost entirely of repairs of several different

phases which have all failed to one degree or another, leading to the eventual abandonment of the house and its conversion to a stables, hayloft and stores (Plate 7).

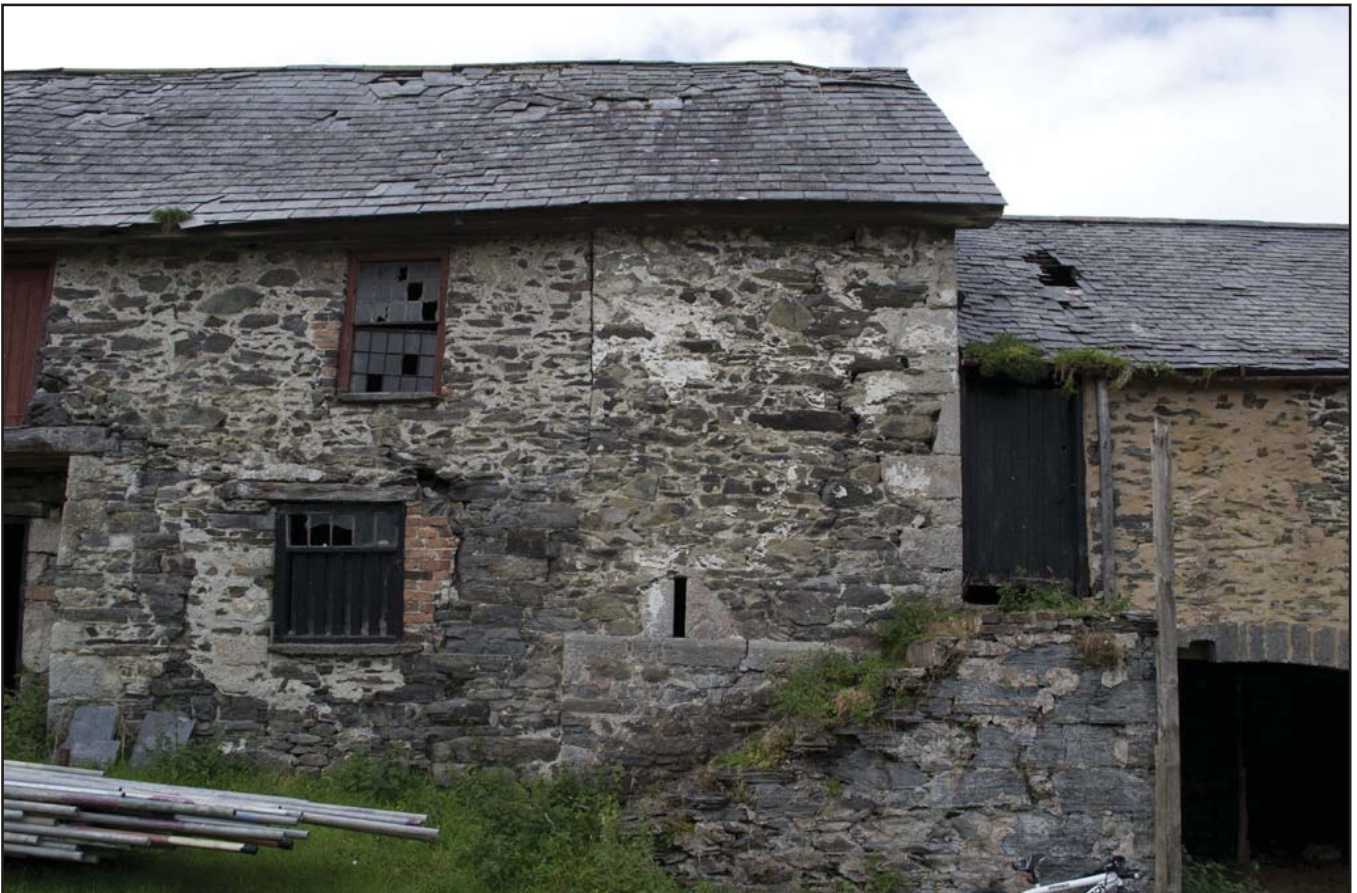
Plate 8: NE end of G01/F01 showing vertical crack and slit window (archive reference: G2479\_030).

There is a single window (**WF04**) in this elevation with a timber lintel and stone sill. This window has subsequently been narrowed to a slit by constructing a thin wall containing bricks in its construction. A vertical crack running from the bottom left hand corner of the window is recorded on the drawing prepared by Donald Insall Associates (**GYAS.01 104 North Elevation**). The wall has suffered some movement, particularly in relation to the interface between the long and short rubble quoins linking the gable to both the east and west elevations. A pink mortar, also visible on the east elevation and within the cart shed (**G04**) suggests movement of the wall above this point had become an issue which required a fairly recent repair to maintain the structural integrity of the building. These repairs predated the visit by Morriss for his report (2004:20).

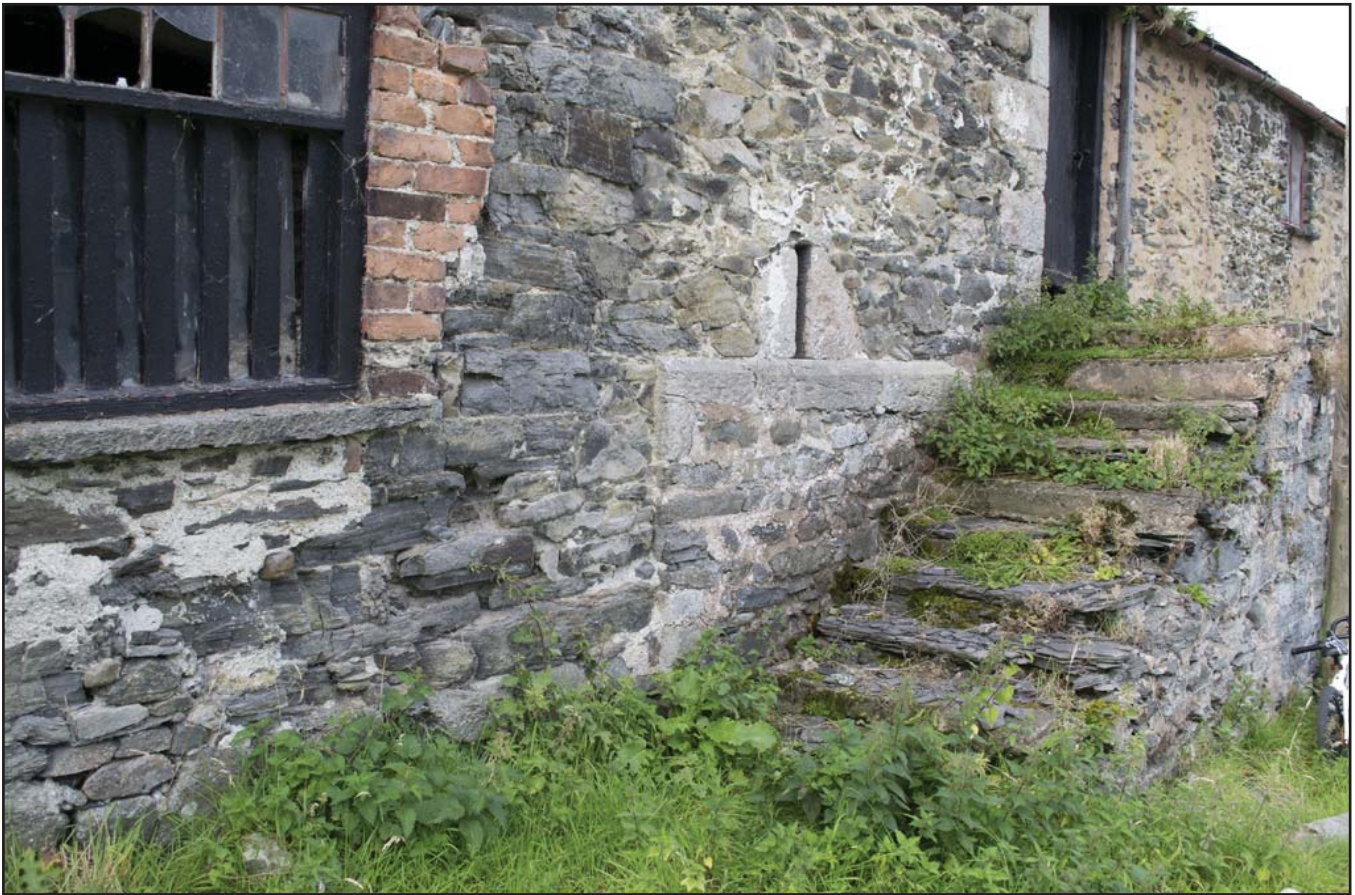
Plate 9: Relationship of external stairs, string course and structural failure (G01)  
(archive reference: G2479\_033).

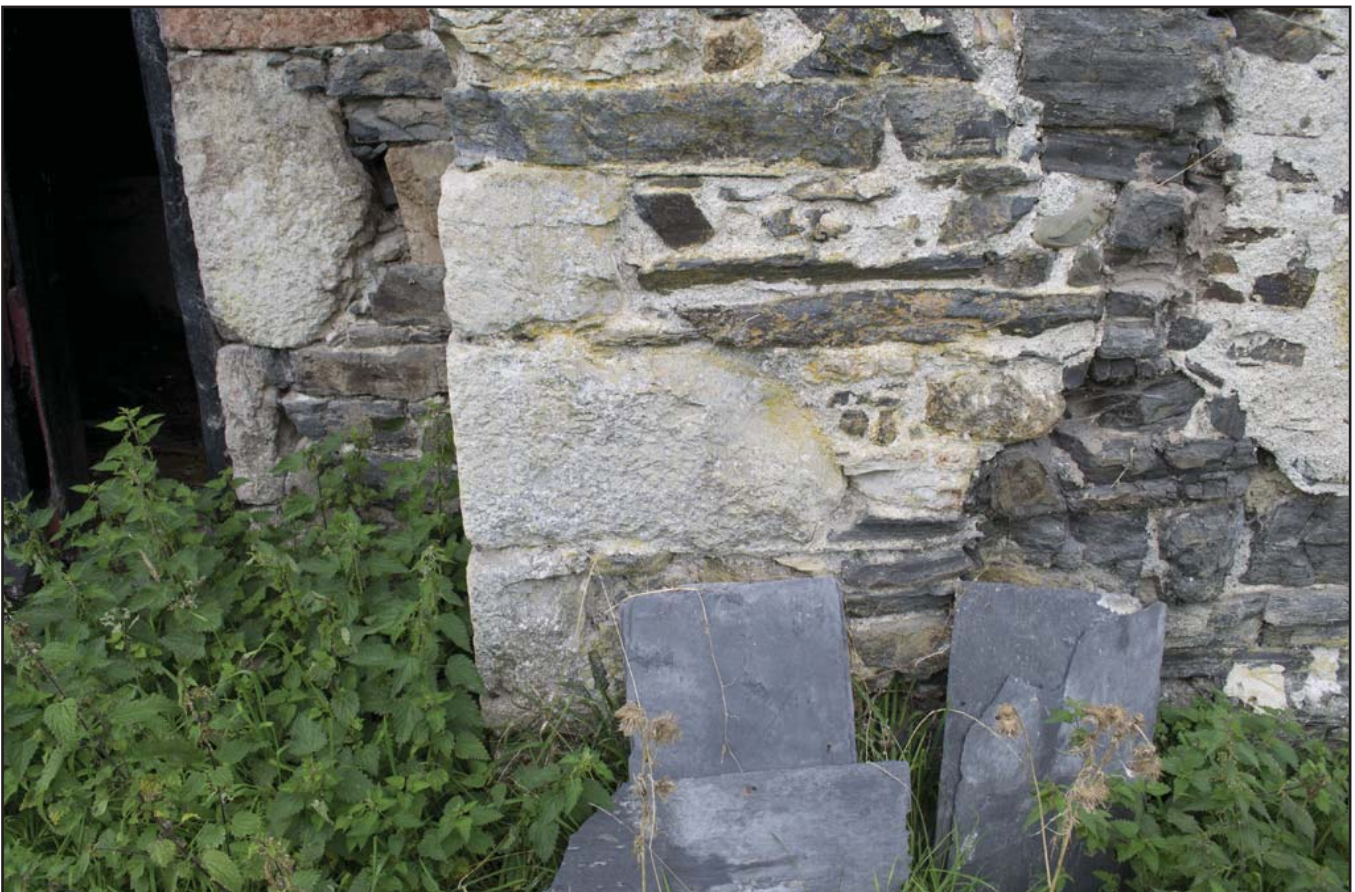
Plate 10: Limestone quoins visible in both inner and outer faces (G01) (archive reference: G2479\_034).

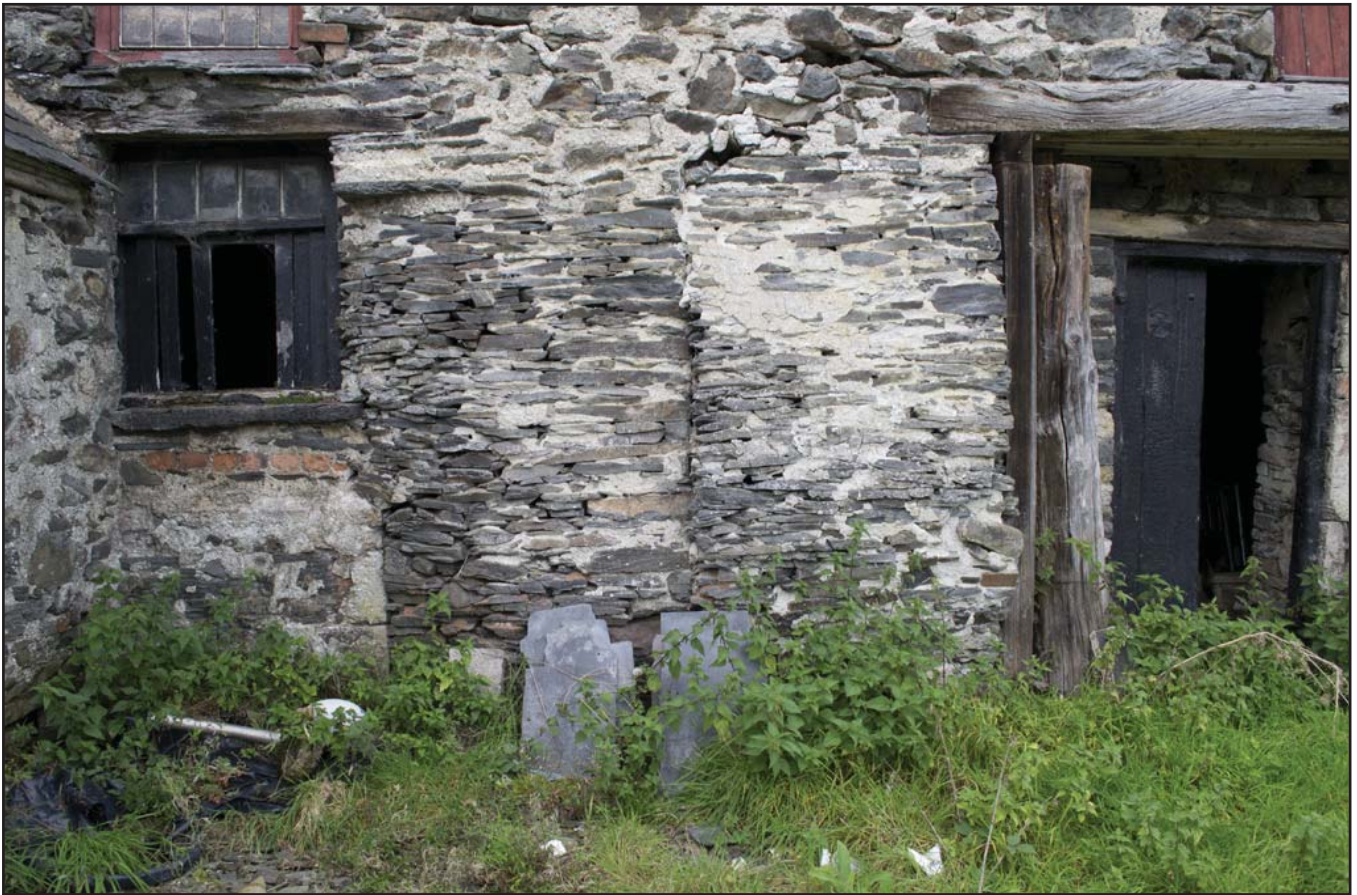
Plate 11: Collapsing repair between central door of G01 and Outbuilding G02 (archive reference: G2479\_036).

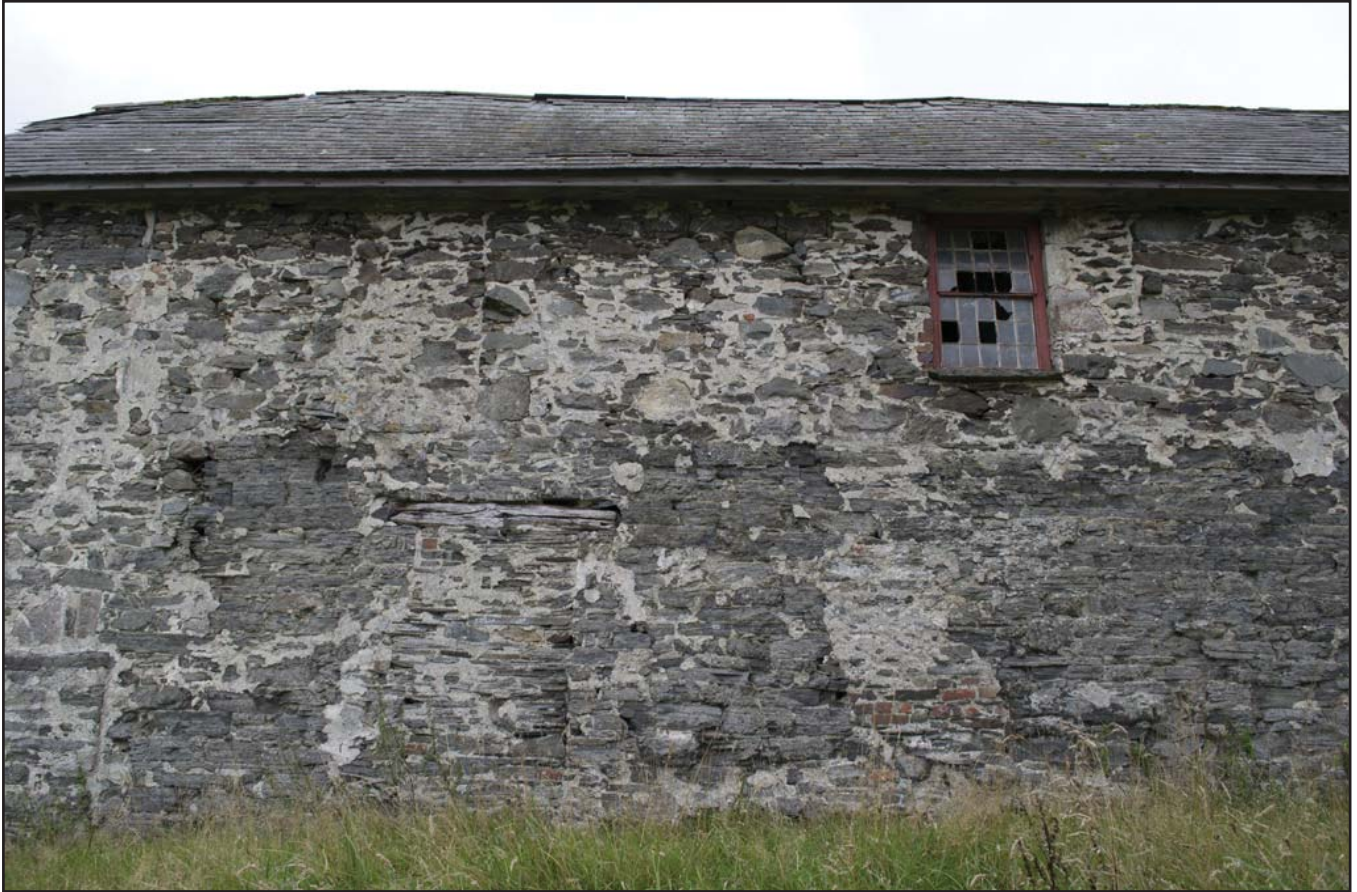
Plate 15: NW wall of G01/F01 showing complex phasing (archive reference: G2479\_041).

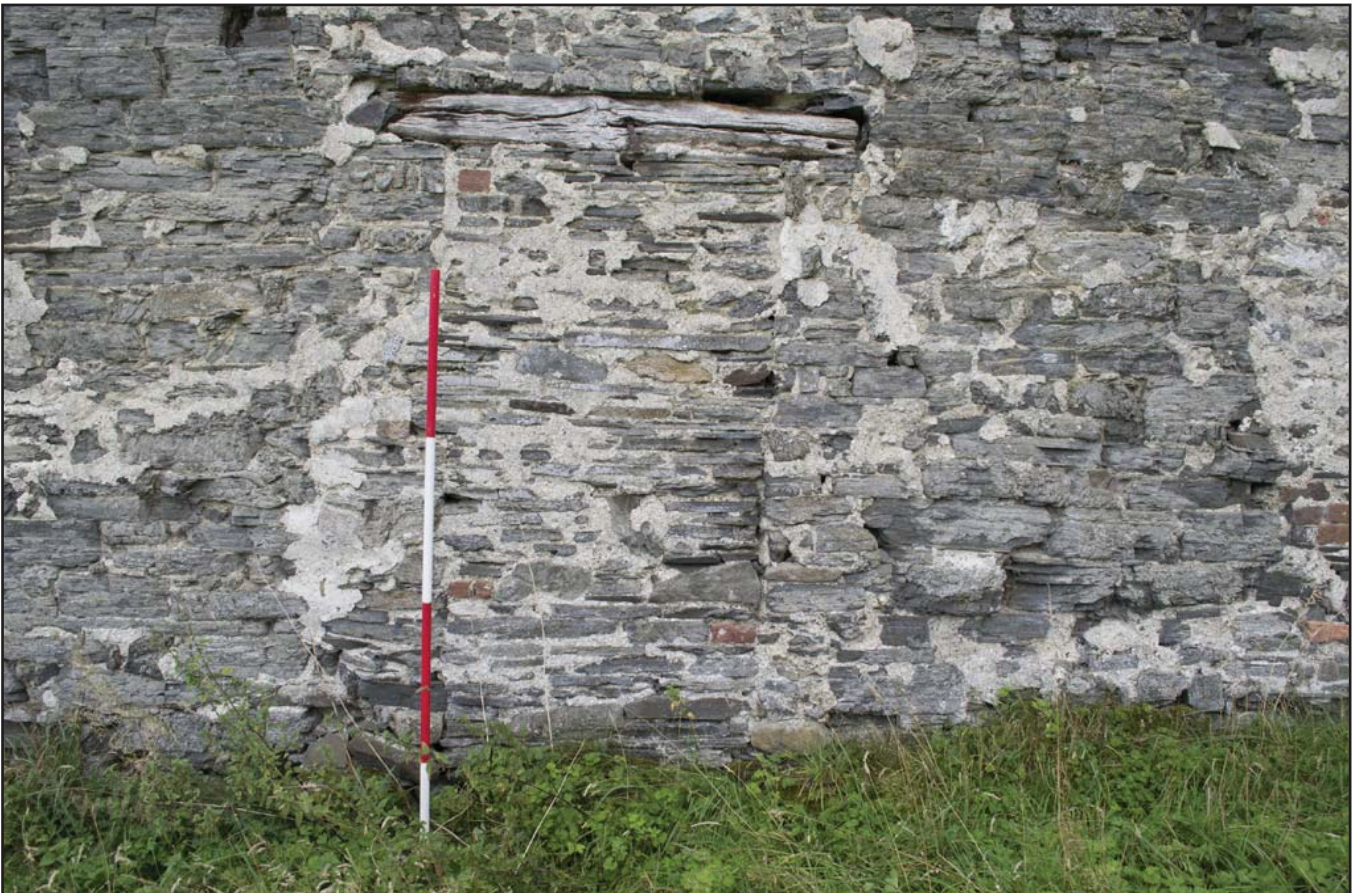
Plate 16: Blocked doorway in NW elevation of G01/F01 with butt joint either side; scale: 1x2m (archive reference: G2479\_048).

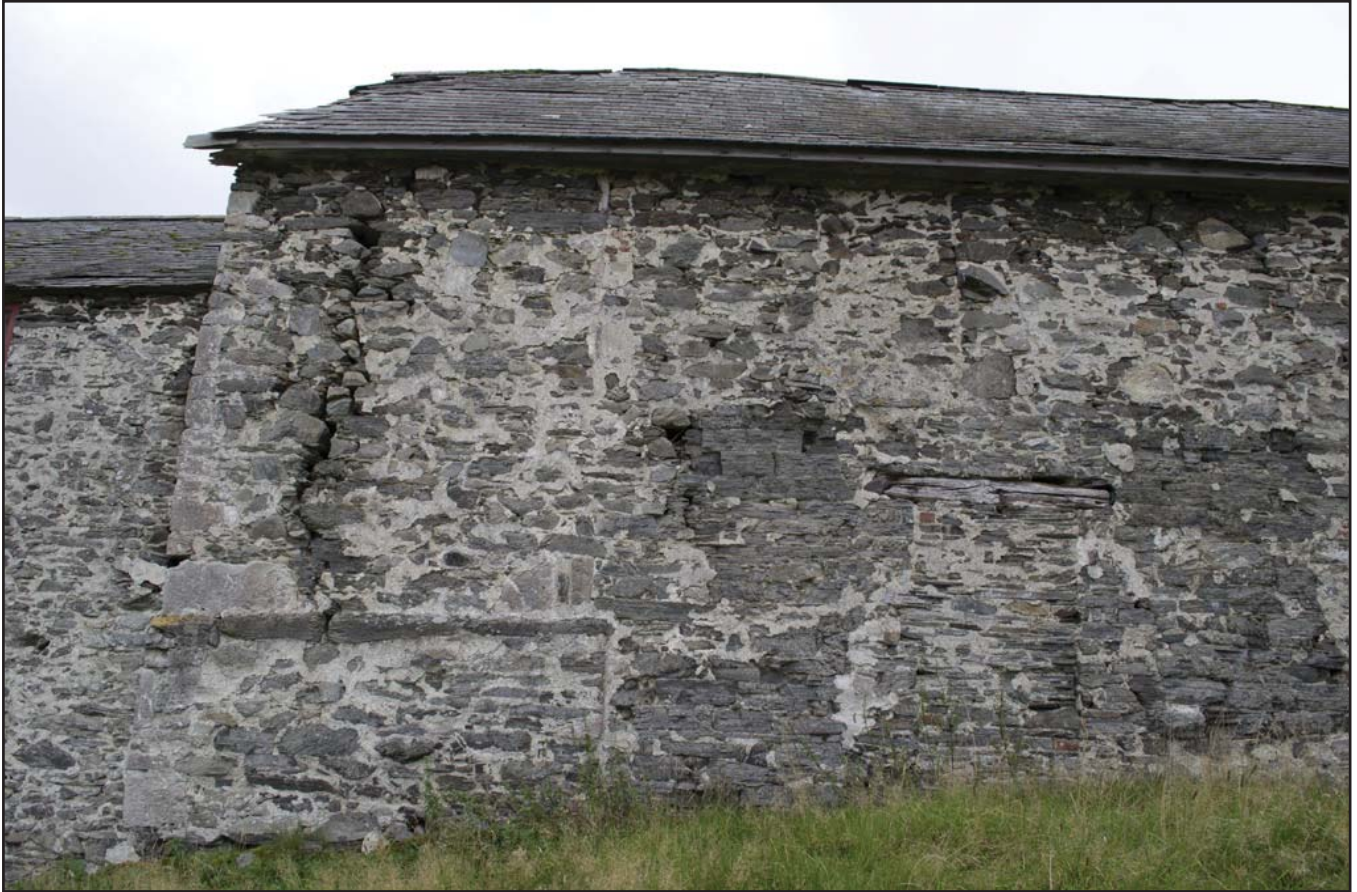
Plate 17: NW wall of G01/F01 showing complex phasing (archive reference: G2479\_040).

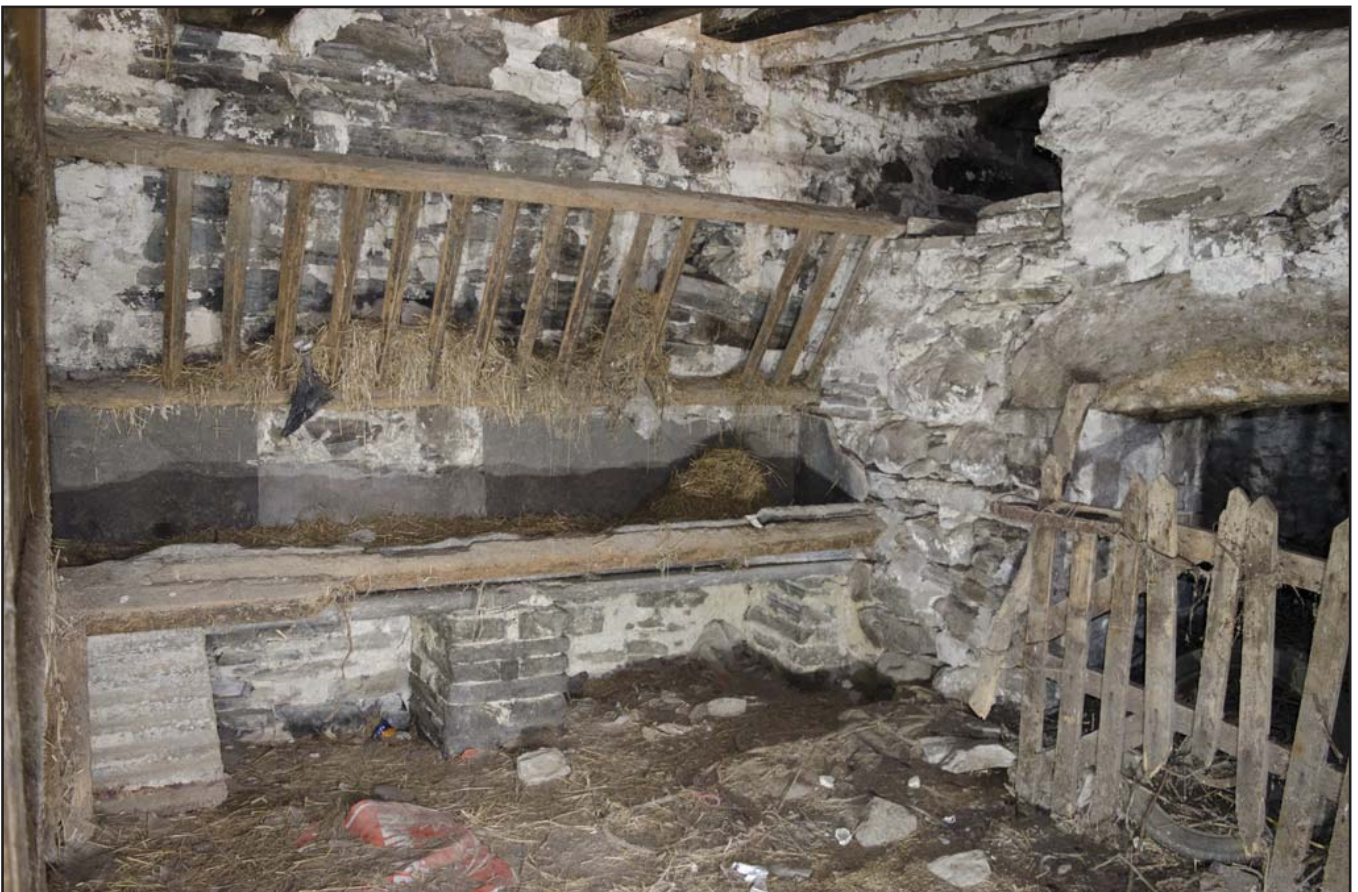
Plate 20: Loose box in G01 Stables (archive reference: G2479\_127).

A six stall stable with the horses facing across the building (Type 2 in William 1982:164-166) (Plate 73) and a separate loose box at the north end, which has a wooden manger and slate feeding trough attached to the east wall (Plate 20). The stall dimensions conform to the measurements of provided in William (1982:169) and all have both wooden mangers and slate feeding troughs attached to the east wall and (Plate 21) as a representative example.

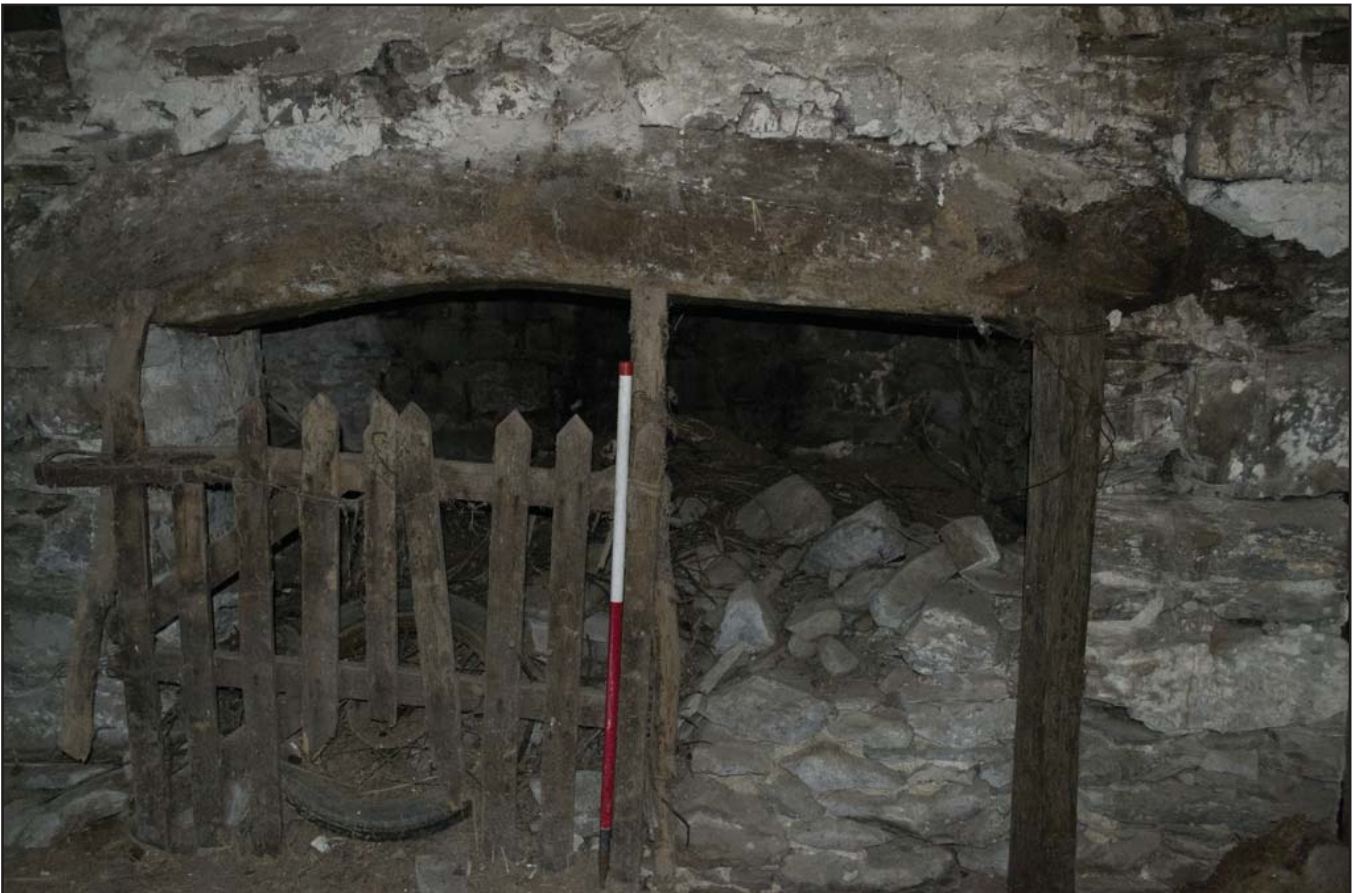
Plate 28: Chimney breast in end of building showing timber lintel above, reduction in width and built in oven on left of photo (G01); scale: 1x1m (archive reference: G2479\_066).

The fireplaces at the southern (Plate 72) and the northern (Plate 28) end of the building survive, but show signs of phased blocking, where the grate space has been made smaller and smaller over time. There are traces of a cobbled stone floor in the loose box (Plate 29), and other evidence may be identified during the archaeological watching brief to the undertaken. The original location of the stairs was not identified by Morriss (2004:15), and could not be identified during this building recording survey. Evidence for their position, orientation and construction may come to light during the archaeological watching brief to the undertaken.

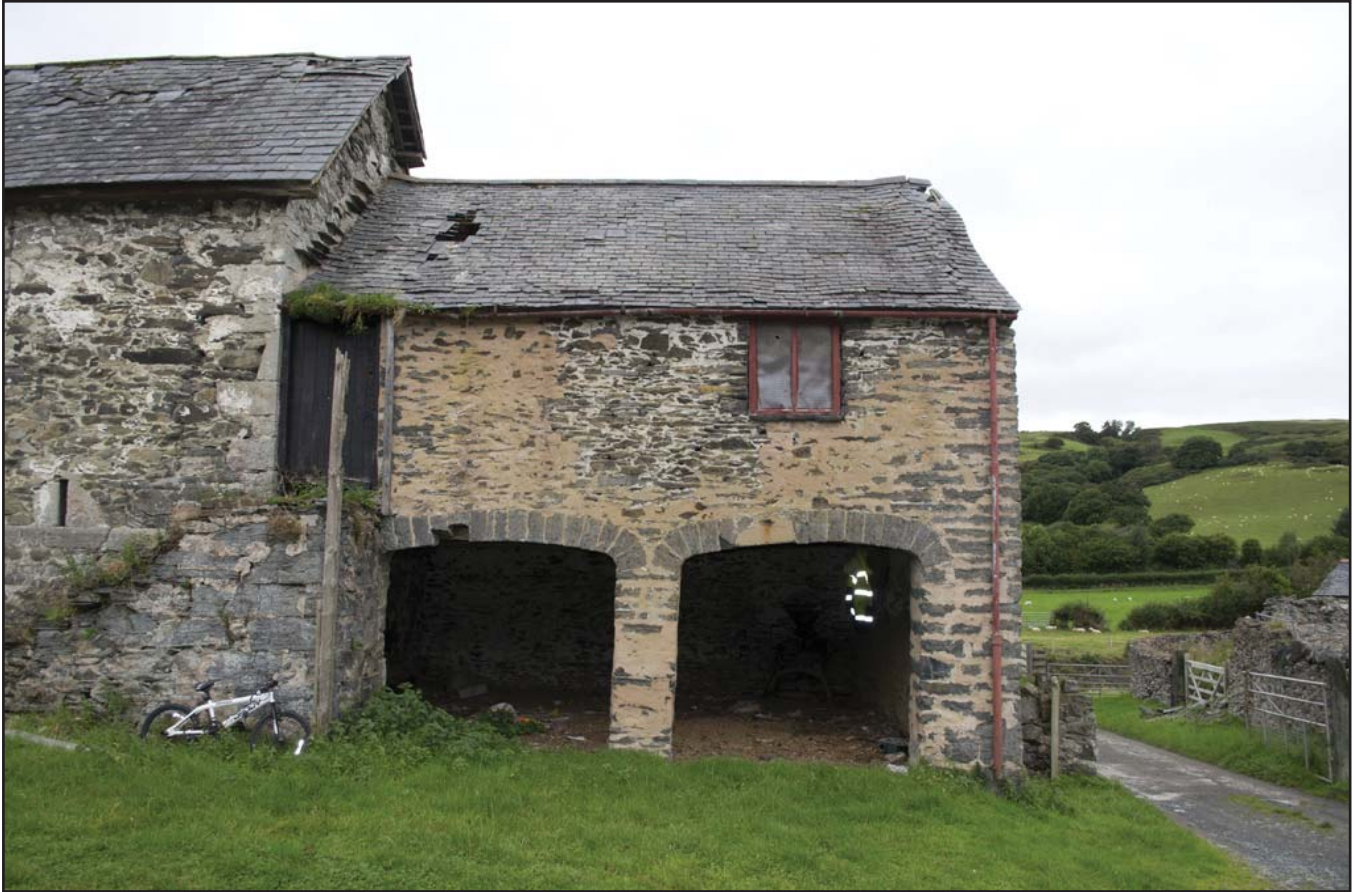
Plate 33: SE elevation of Cart Shed G04 (external) (archive reference: G2479\_002).

A custom built cart shed (**G04**) below the grain store (**F04**) with both stories constructed at the same time (Plate 33). The situation of a cart shed below a grain store was found in 258 of the 279 granaries surveyed by William (1982: 240). The cart shed is of two bays (**SOG01** and **SOG02**), and these are articulated on the east elevation by fairly flat three-centred arches with worked stone voussoirs (Morriss 2004: 19). Behind the arches is a large full width chamfered timber beam which supports the roof of the cart shed (Plate 34) and shows signs of reuse, having mortice holes cut into it at various points along its length. Beams also support the floor at the southern end of the building and through the centre, where a single rectangular post on a pad post, has later been supplemented by a round, partly debarked tree branch inserted immediately east of it (Plate 35). The floor joists rest on the beams, and run directly into the north gable wall as there is no beam on this side of the roof / floor structure (Plate 36). The recess in the north gable wall identified by Morriss for the storage of grease or oils to service the machinery stored in the cart shed (2004: 19) is still open, with a stone sill and timber lintel (Plate 37)

A custom built grain store / granary above the cart shed (**G04**) (Plate 33), comparing very closely to the description and location of an idealised granary as described by William (1982: 239-244). The situation of a grain store above a cart shed was found in 258 of the 279 granaries surveyed by William. Prior to this in north-east Wales, grain was usually stored within the farm house (1982: 240).

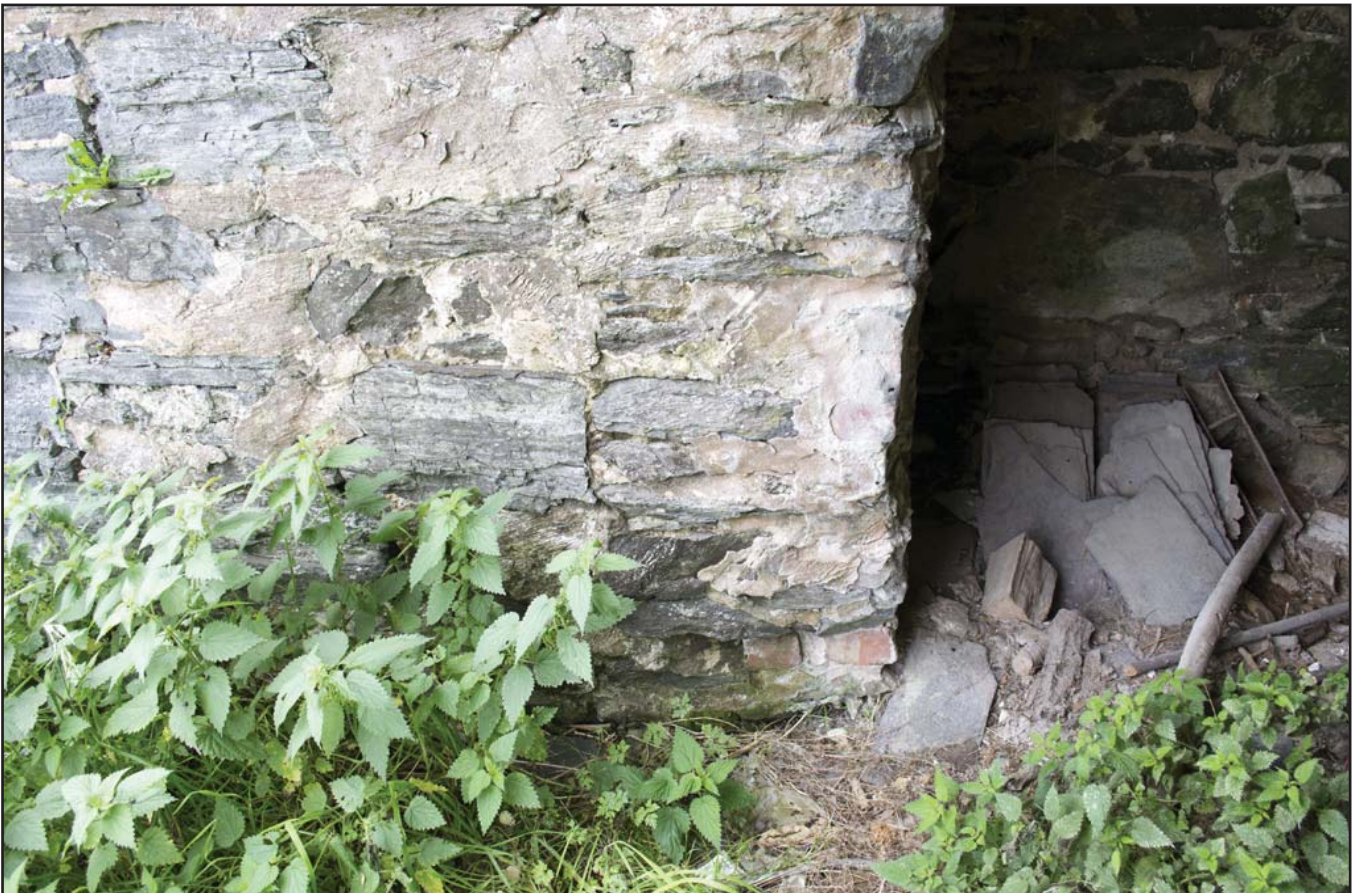
Plate 38: Butt joint between Cart Shed G04 and external access stairs, bricks visible at base of wall (archive reference: G2479\_011).

The walls show signs of repair and consolidation, particularly visible on the lower part of the north gable wall where a pink mortar has been used along the full length of the wall and wrapping around the pier on the north cart shed opening. The pink mortar has also been applied in limited quantities to the lower part of the central pillar. These repairs predated the visit by Morriss for his report (2004:20). There are

signs of building movement on the southern side of cart shed opening **SOG01**, where repairs have been undertaken using brick inserted into the lower courses of the wall (Plate 38). The floor has a cobbled stone surface (Plate 39).

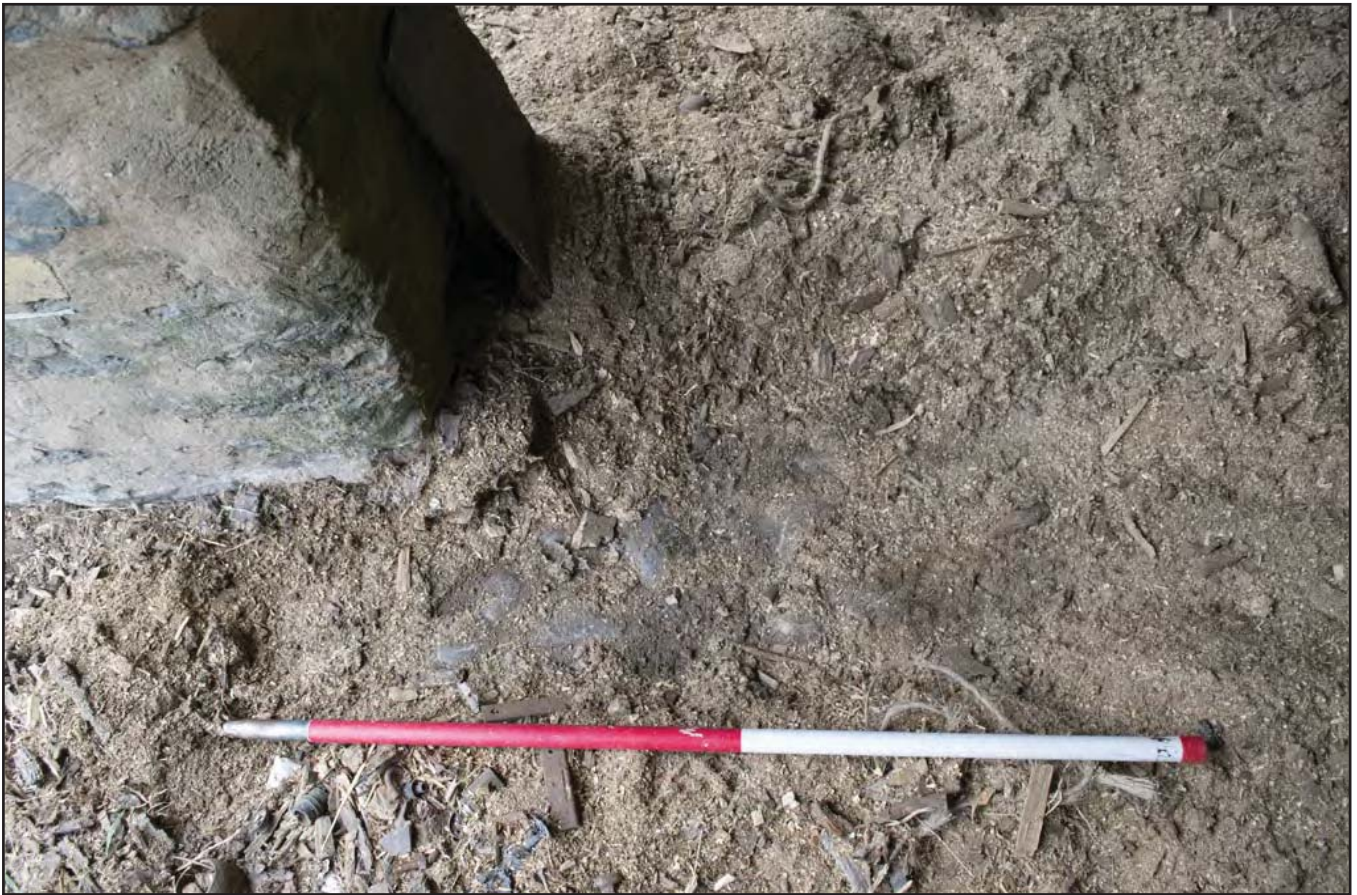
**Plate 39: Cobbled surface partly revealed under sawdust covering floor of Cart Shed G04 (archive reference: G2479\_012).**

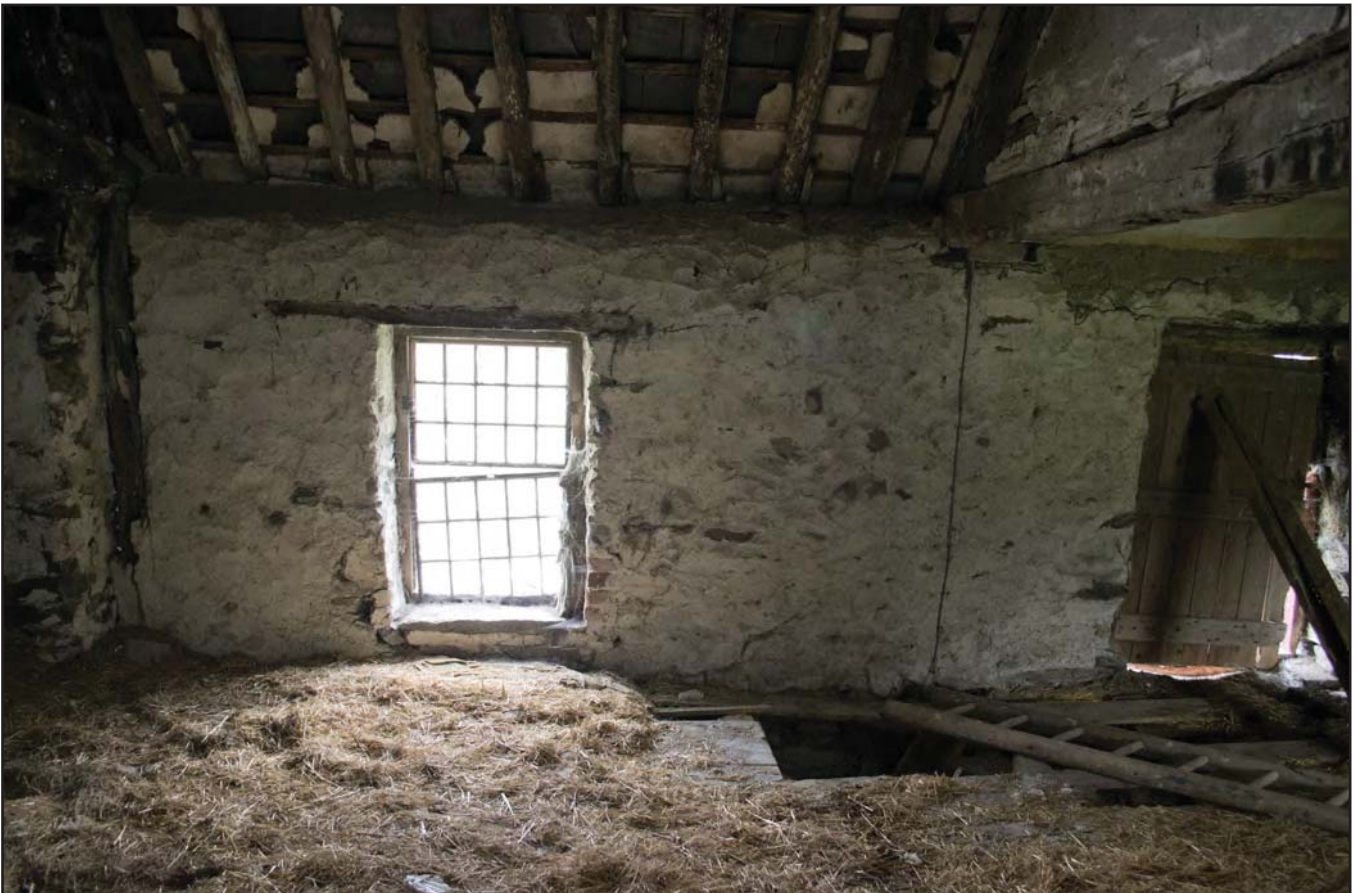
**Plate 40: Central portion of SE internal elevation. Access point in floor F01 Hayloft (archive reference: G2479\_077).**

A room which extends over more than half of the upper floor area of the building. The existing access from the floor below (**G01**) consists of a hole in the floor with a narrow set of stairs (Plate 40). Rooms **F02** and **F03** are accessed by doors in the original partition wall at the southern end of the room (Plate 41). There is visible evidence for the original window arrangements, particularly in the western wall to the south of **WF01** (Plate 42). Morriss (2004: 16) suggests that the two western bays made up the 'great chamber', not including the later bay added on the northern end of the building. The chimney breast for the Parlour fireplace at the northern end of the building projects out into the space (Plate 43).

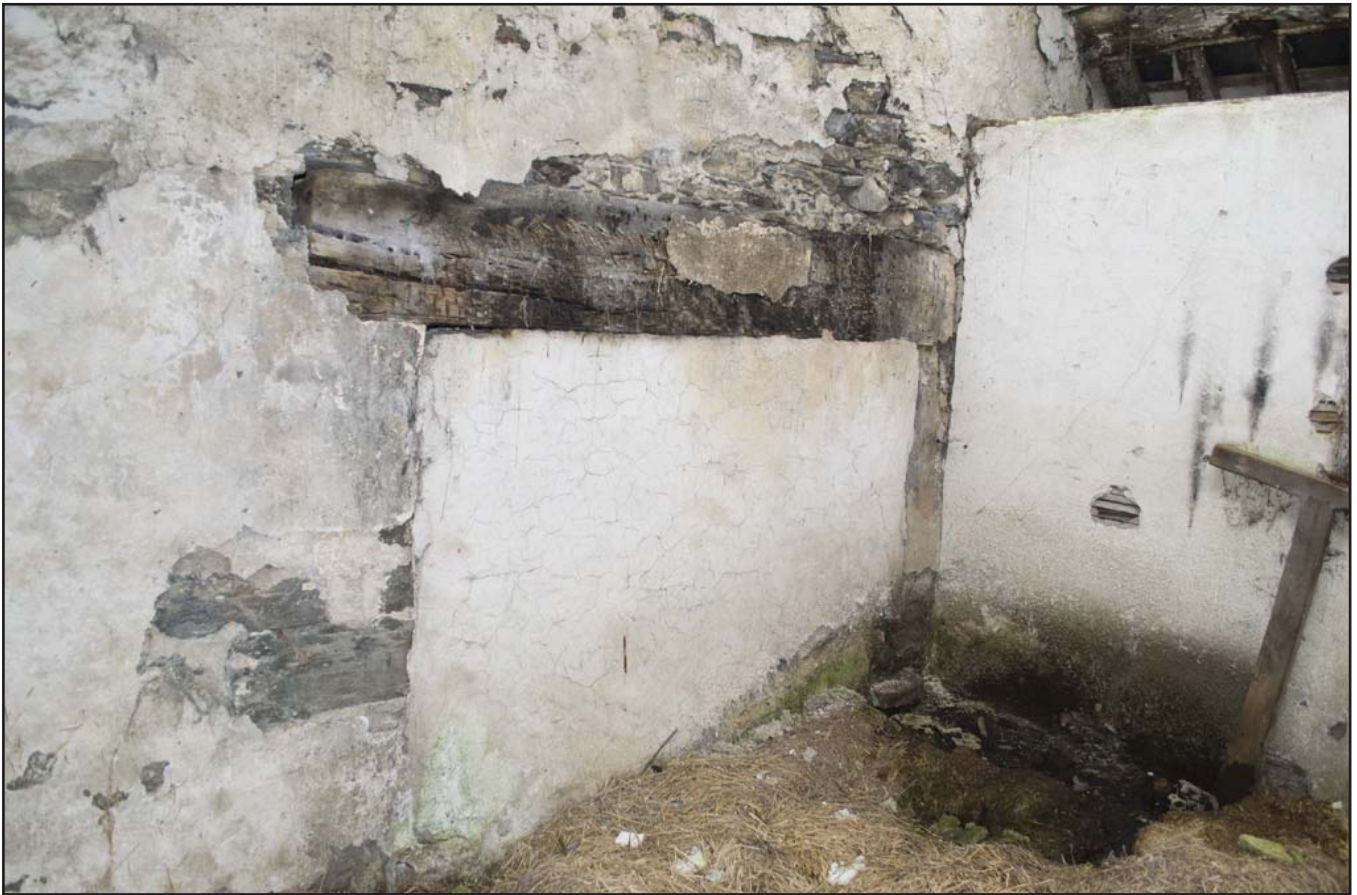
**Plate 51: Blocked fireplace with internal still in place, low quality plaster. F02 Store**  
(archive reference: G2479\_093).

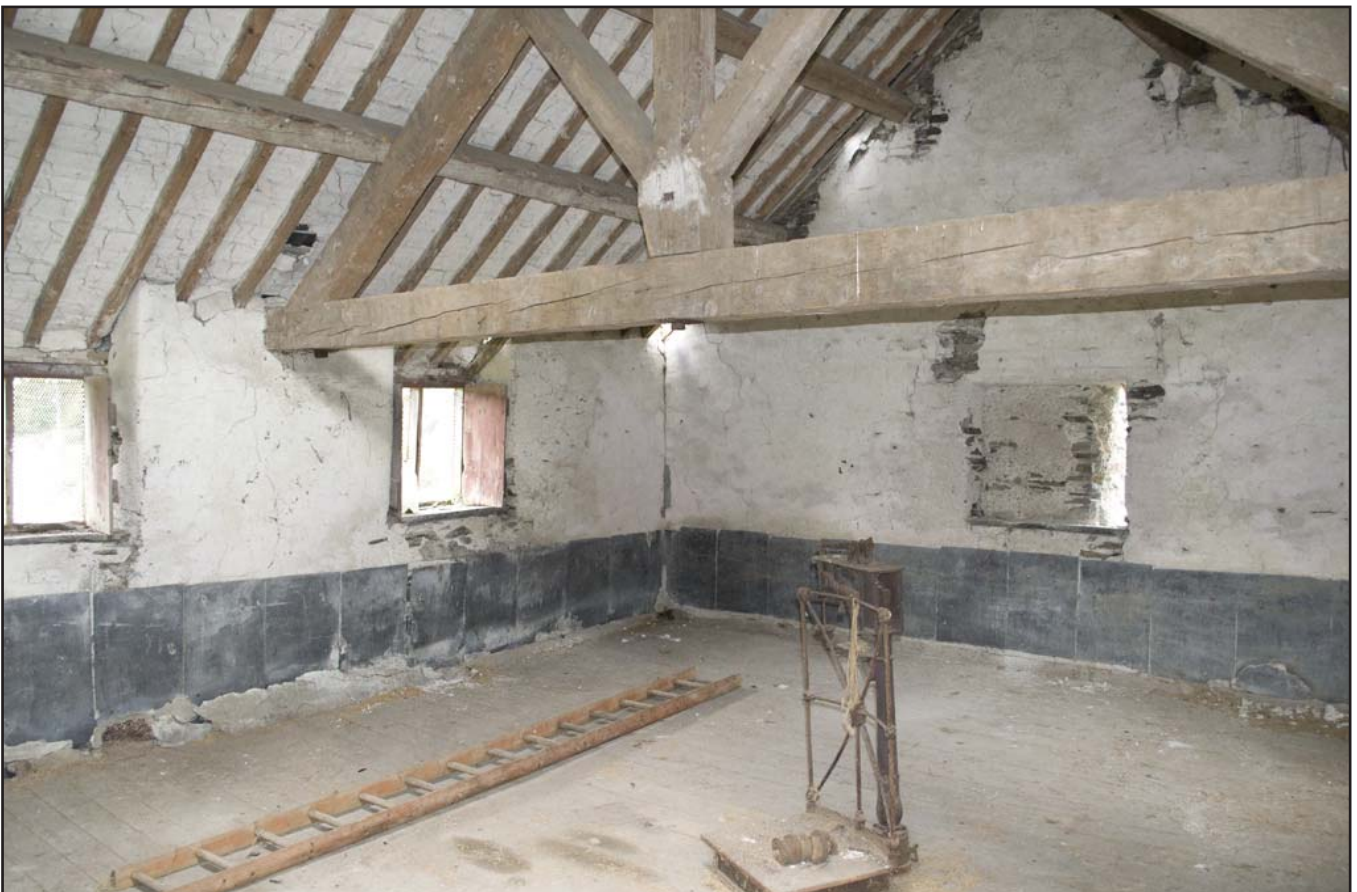
Plate 62: NE/NW elevation of Grain Store F04 - upper floor - (internal) (archive reference: G2479\_021).

The roof is supported by a single king-post truss with raking purlins, which is bolted together and has the appearance of having been made elsewhere and subsequently brought to site and assembled (Plate 62). The truss has historic graffiti on it, an example of which is provided here (Plate 56). The description of the roof structure by Morriss 2004: 19) is still applicable, with a single tier of chocked purlins and a ridgeboard. The roof slates are identical to those on the main building (**G01 / F01**) and the outbuildings (**G02** and **G03**, suggesting the whole structure was re-roofed in a single event.
