# Glan Yr Afon, Llangernyw

ARCHAEOLOGICAL MITIGATION:

LEVEL 3 BUILDING RECORD &  
ARCHAEOLOGICAL WATCHING BRIEF

Project No. G2479

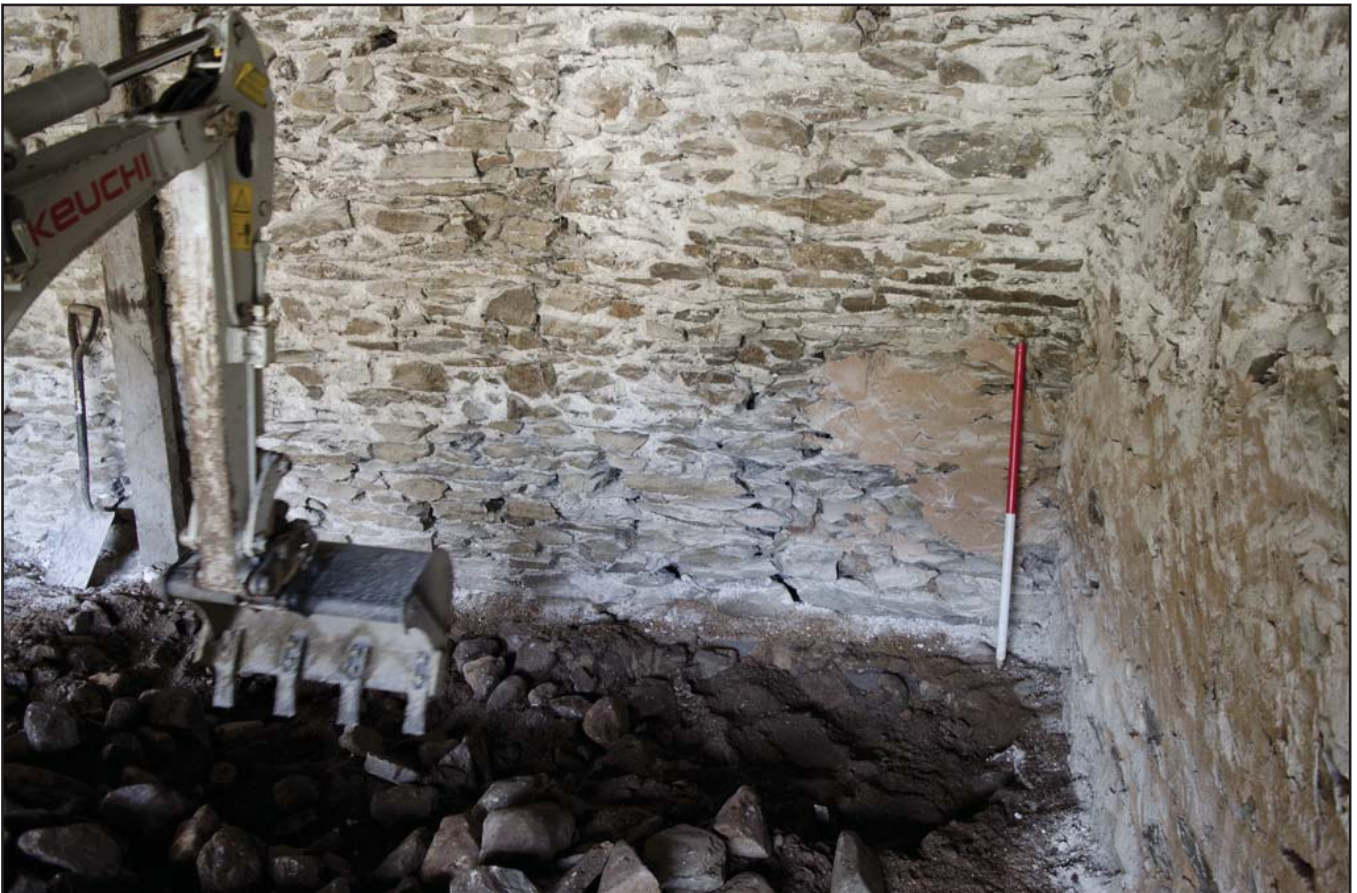
Plate 66: Lifting of Cobbles in NW corner of G04 Cart Shed; scale: 1x1m (archive reference: G2479\_196).

- A cobbled surface within **G04** was lifted by a mechanical excavator and was supervised by an archaeologist at all times who observed and cleaned areas as the machine cleaned back in order to identify archaeological features and finds.
- The results were recorded on GAT pro-formas and with digital SLR cameras set to maximum resolution in RAW format.

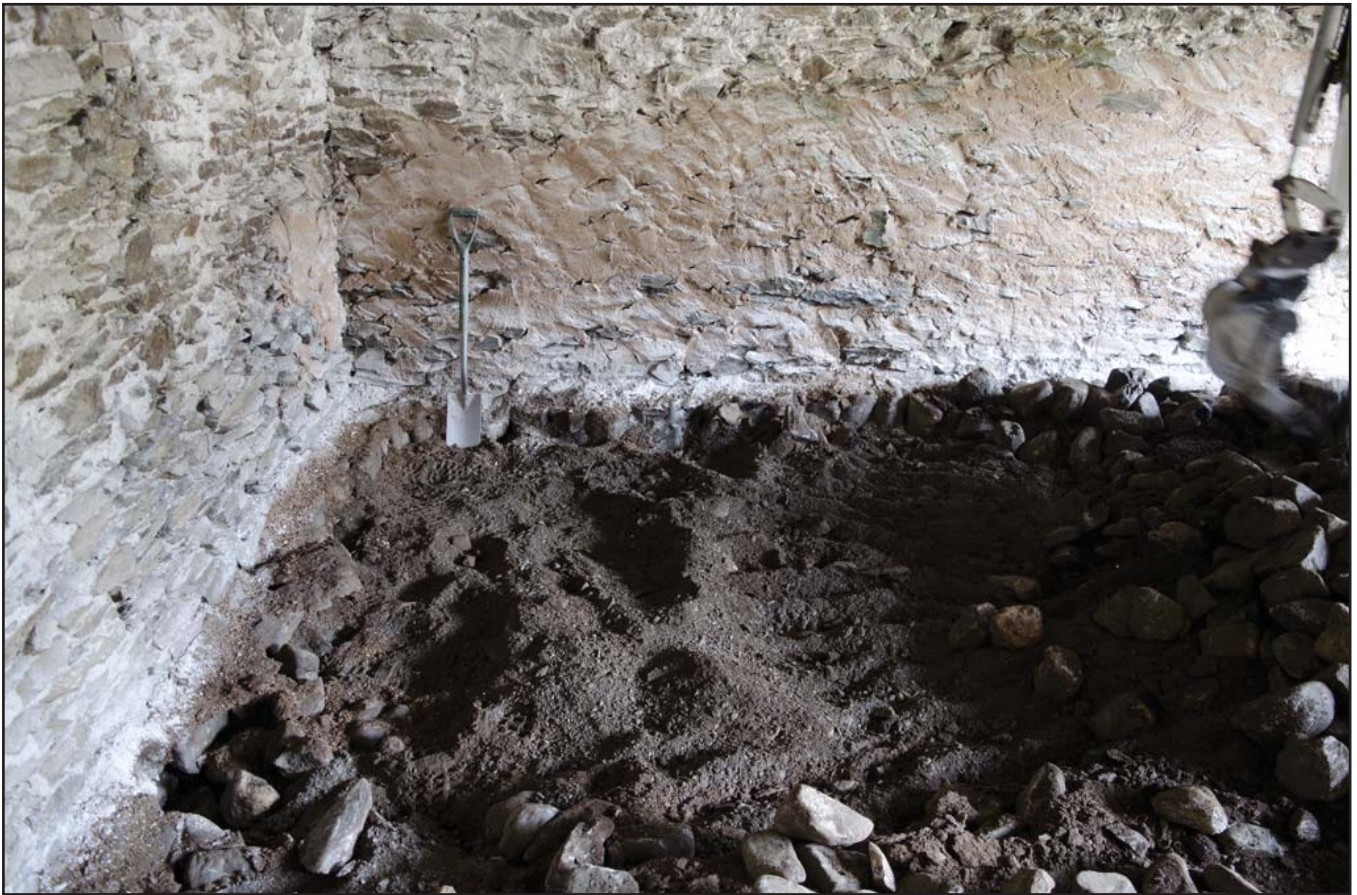
Plate 67: Cobbles lifted on N side of G04 Cart Shed showing depth of bedding gravel (archive reference: G2479\_198).

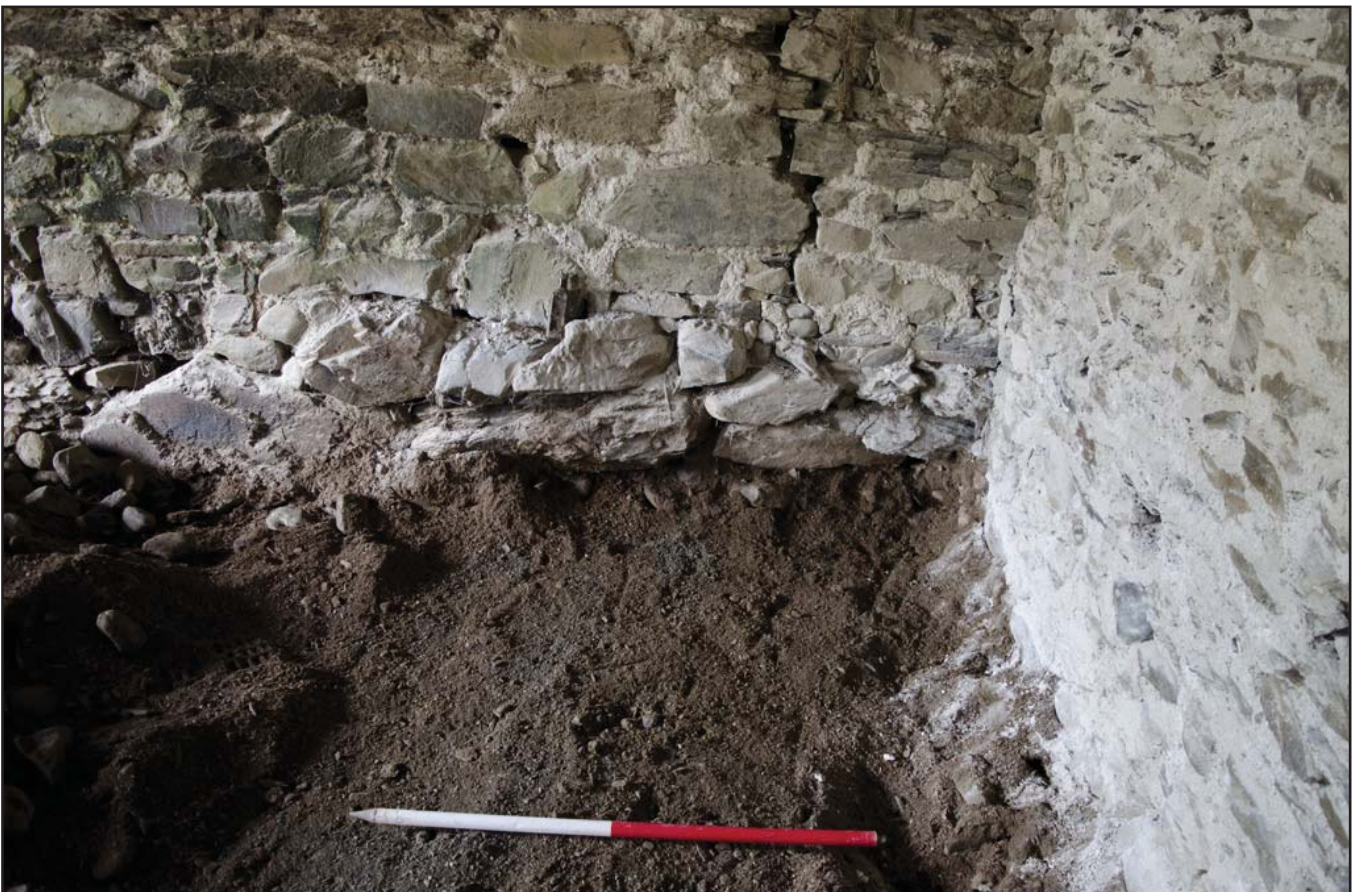
Plate 68: Cobbles lifted on S side of G04 Cart Shed showing depth of bedding gravel; scale: 1x1m (archive reference: G2479\_201).

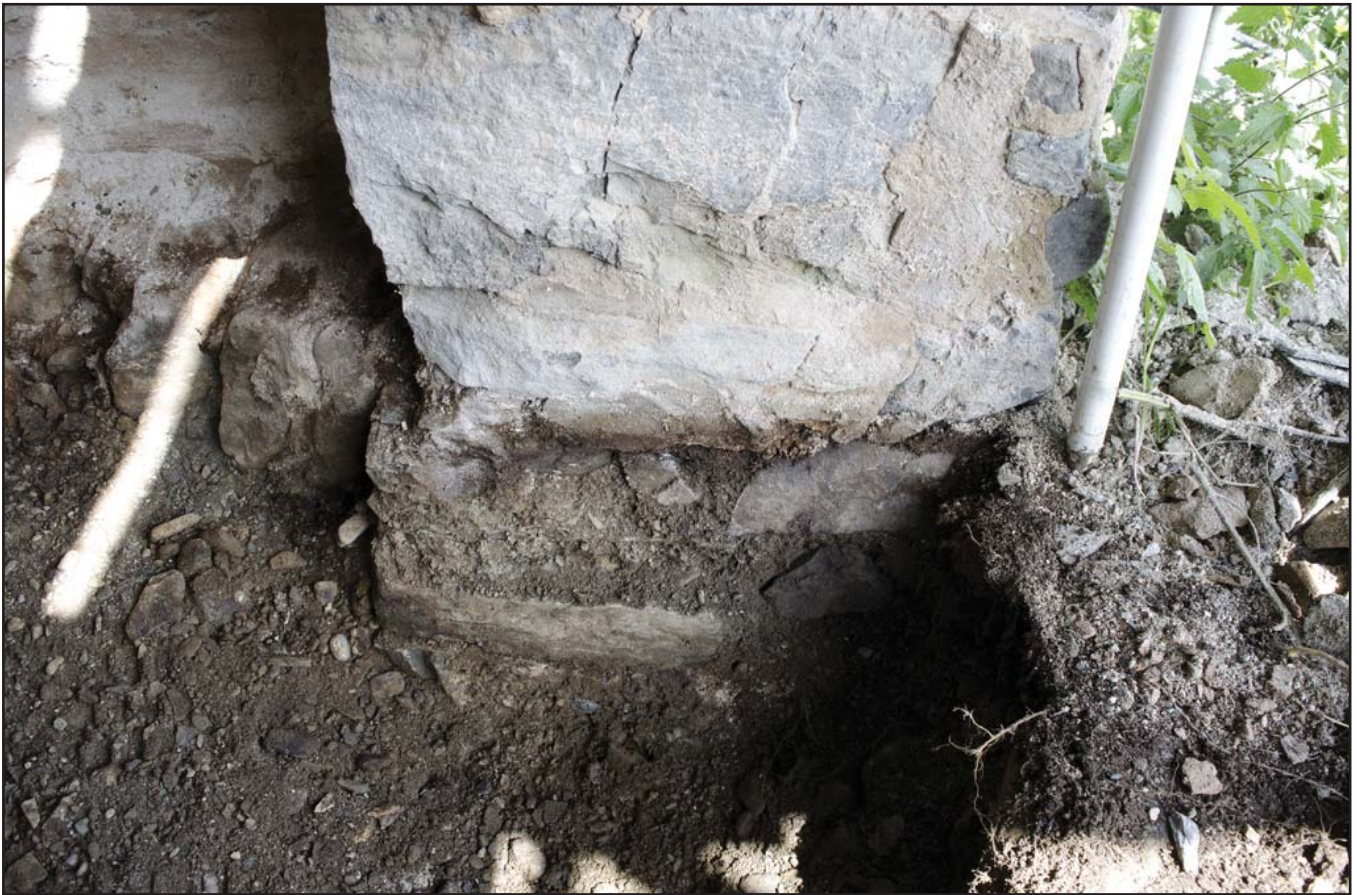
Plate 69: Cobbles lifted on N side of G04 Cart Shed showing base of wall of G04 Cart Shed; scale: 1x1m (archive reference: G2479\_209).

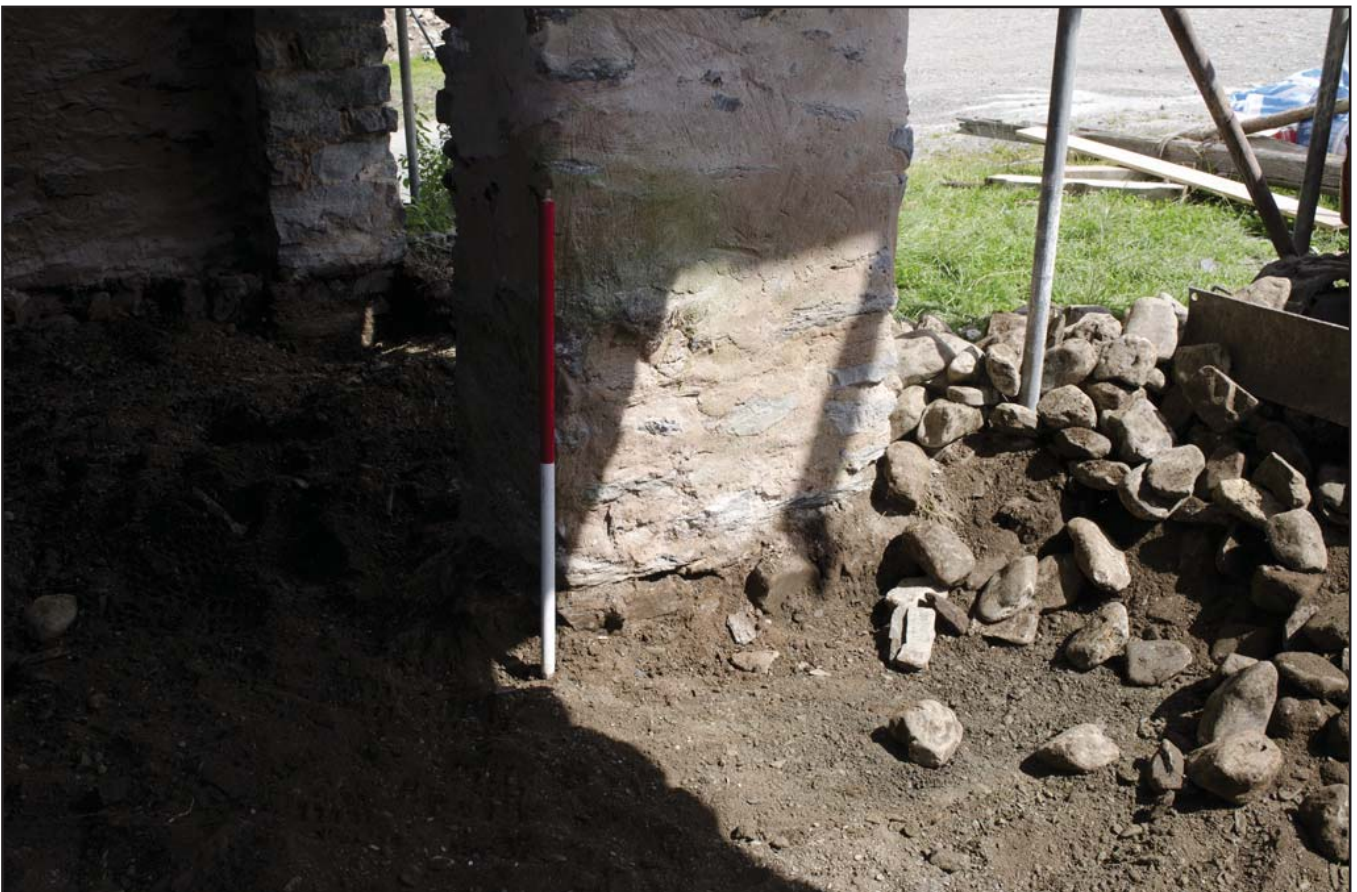
Plate 70: Cobbles lifted in G04 Cart Shed showing base of pillar of G04 Cart Shed; scale: 1x1m (archive reference: G2479\_218).
