## **The Old Sawmill, Llanidloes, Powys**

Level 2: Archaeological Building Survey

Report No. 1645

*This report results from a Level 2 Building Survey by Archaeology Wales Ltd (AW) on The Old Sawmill, Llanidloes (SN 95281 84534) produced at the request of Charles Cowan, on behalf of Mr and Mrs G Hamer.*

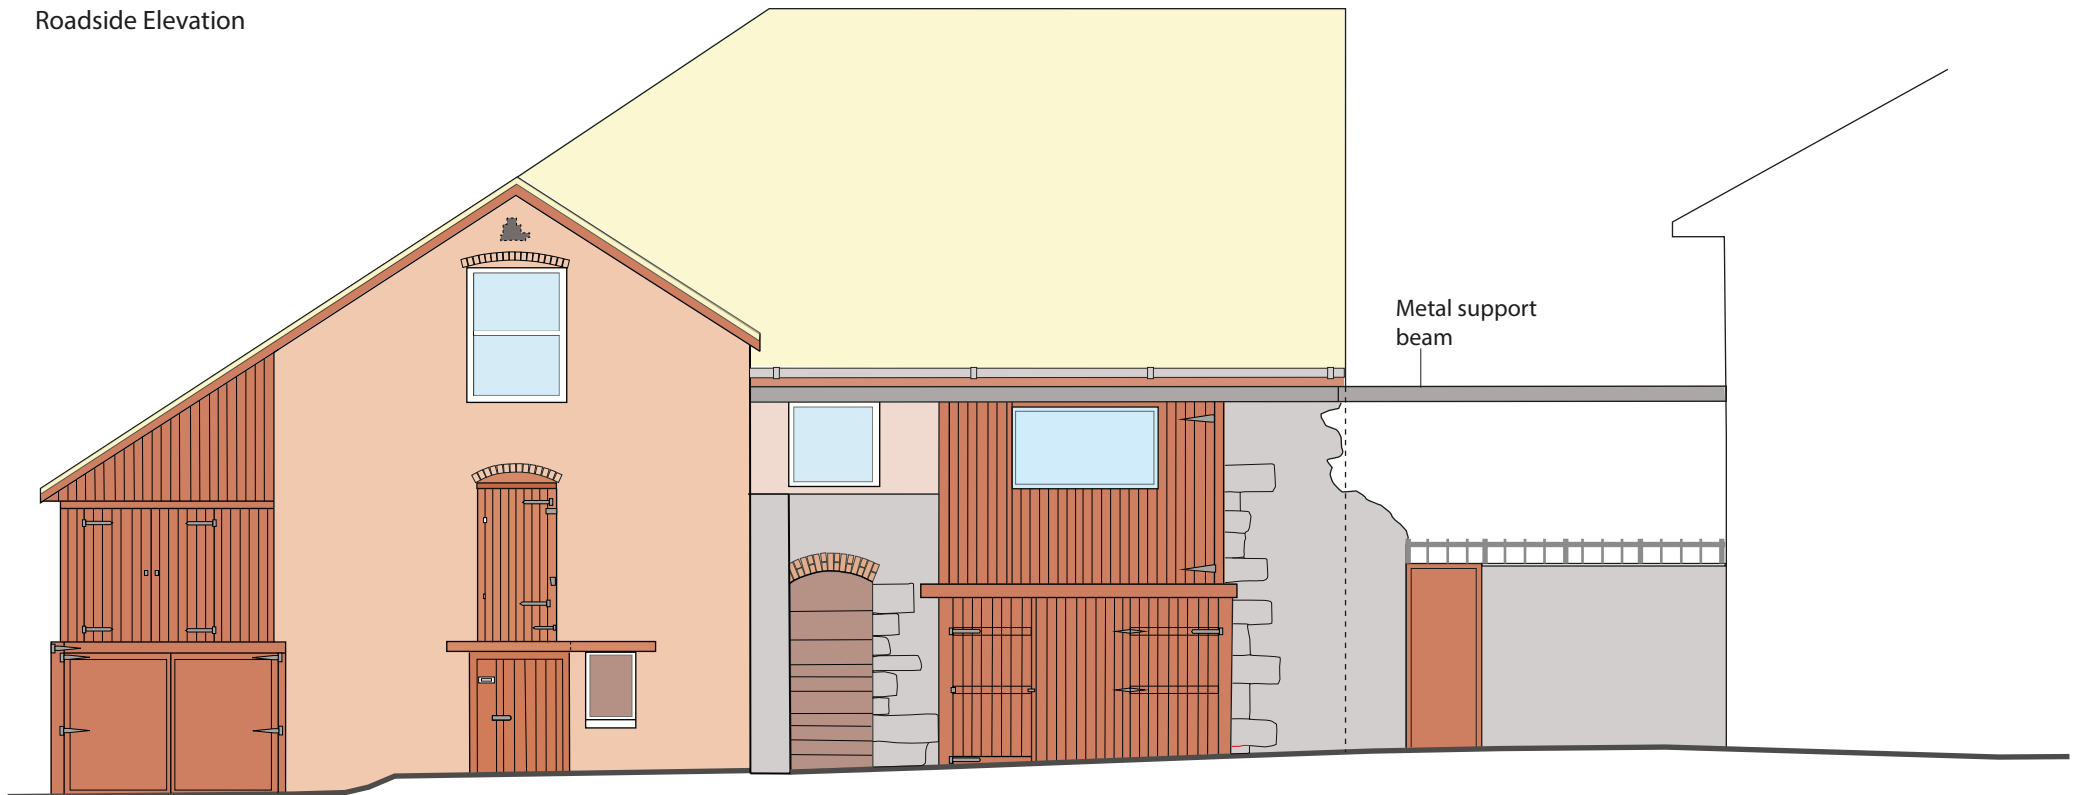
Figure 9 . Roadside elevation.

- Stone
- Timber/wood
- Brick (red/grey)
- Tin sheets
- Asbestos
- Perspex sheets

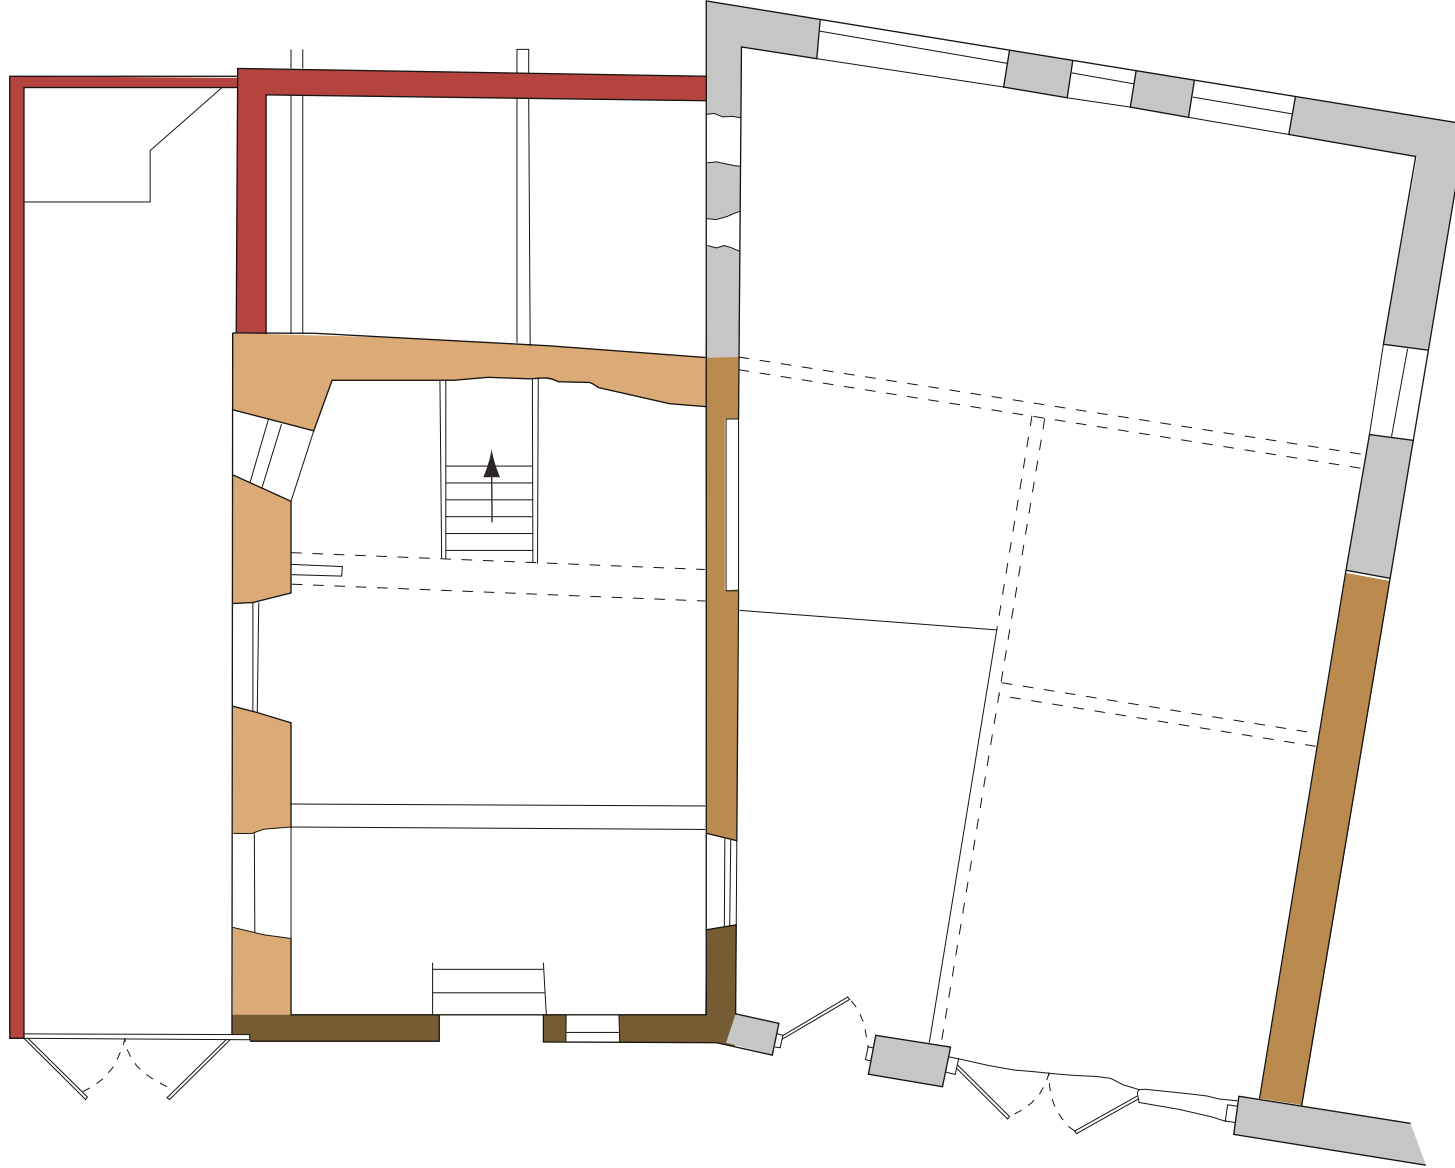
Figure 13.  
Ground floor plan  
with phasing.

- Phase 1
- Phase 2
- Phase 3
- Phase 4
- Phase 5

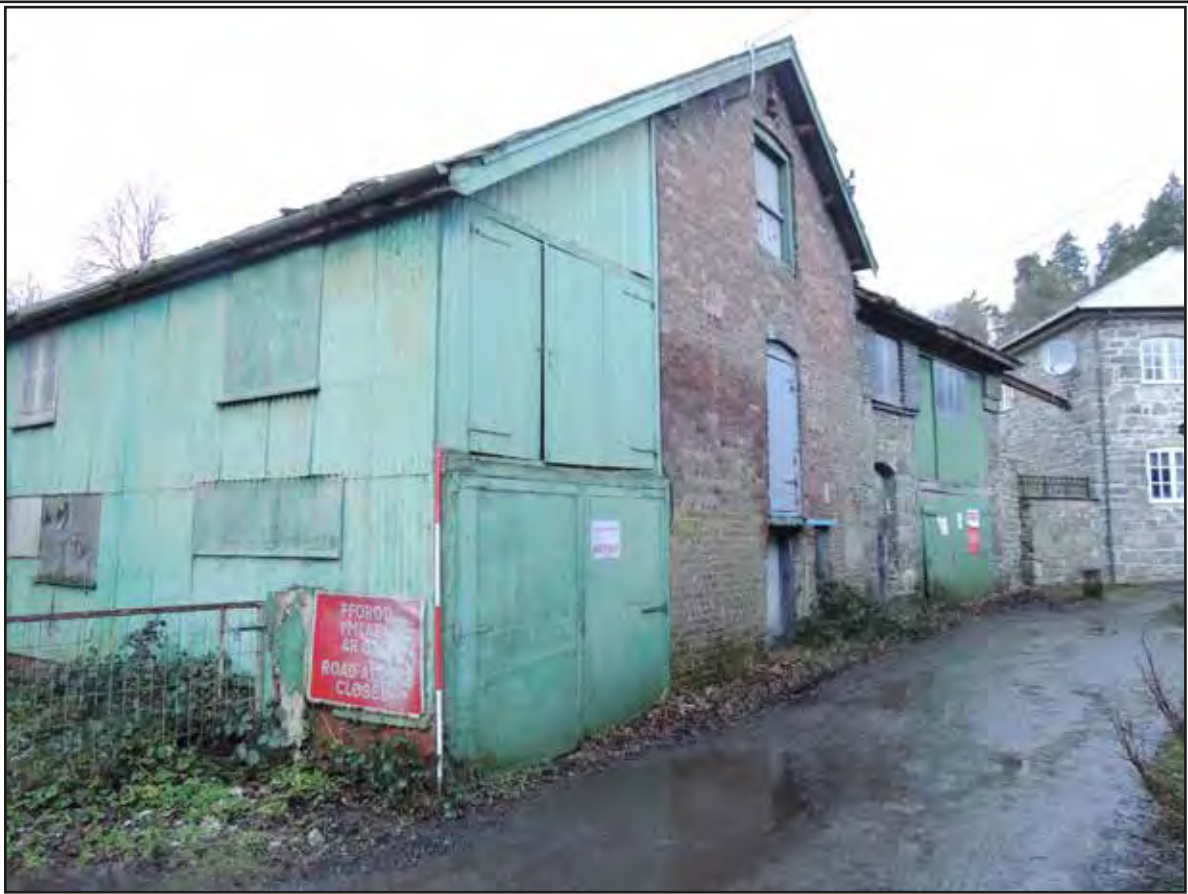
Plate 1 (above): Roadside elevation. Oblique view, looking NW.

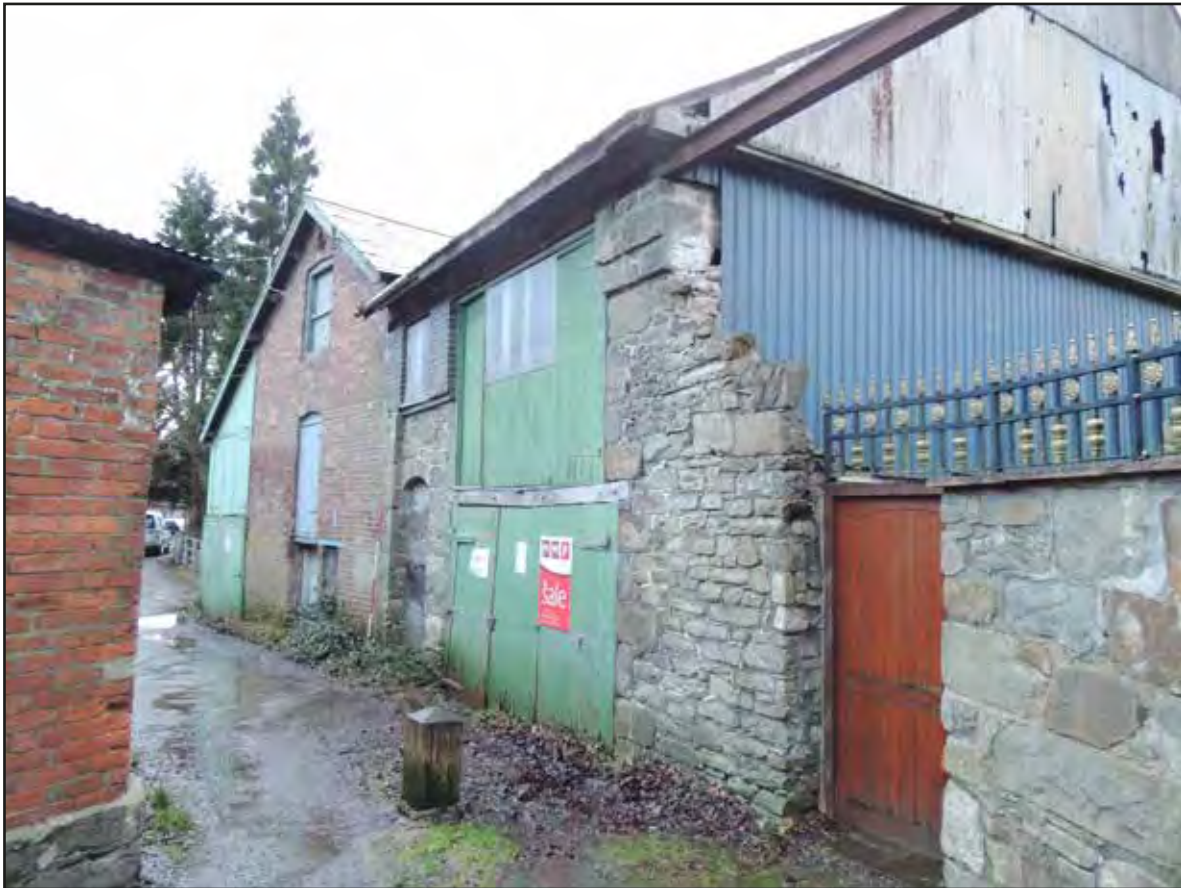
Plate 5 (above): Detail roadside elevation - Phase 2 openings. Looking N.

The door located in close proximity with Phase 2 building is 2.2m high and is ornamented by a brick segmental arch. No further detail could be gathered during the survey as the door is currently blocked by wooden boards. A square window is located immediately above the door. This window is currently blocked by corrugated panels. The space in which this window is located has been repaired as it appears evident by the use of grey brick.

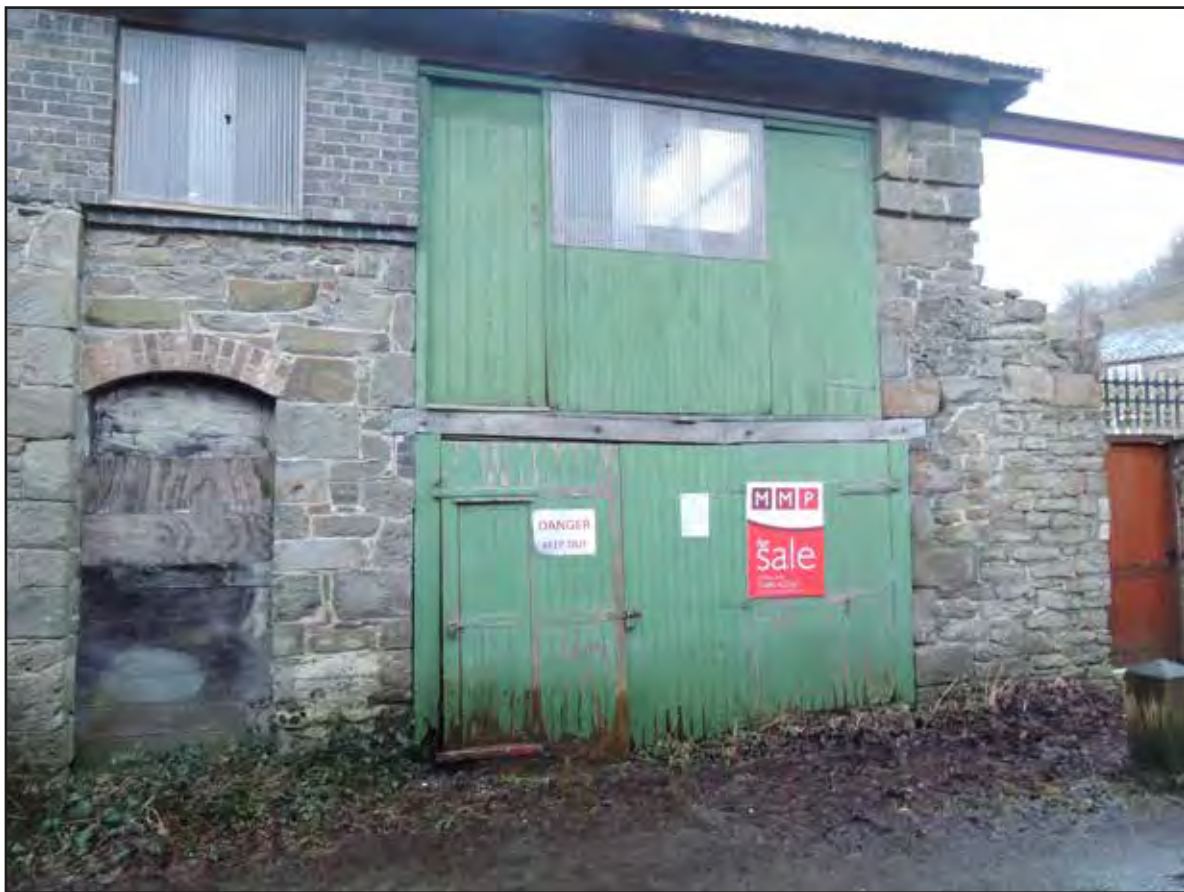
Plate 7 (above): Roadside elevation. Detail of NW addition. Looking SW.

In section 4, it was noted that the NW addition was the result of annexing the corn mill and the Bridgend Mill during the time of the construction of the latter or soon after. This is documented in cartographic maps and evident by the fabric selected for the construction of this addition as well as its roof. However, during the examination of the building interior it was noticeable that some of the space occupied by this extension was already in used by the old mill (for details see building interior).

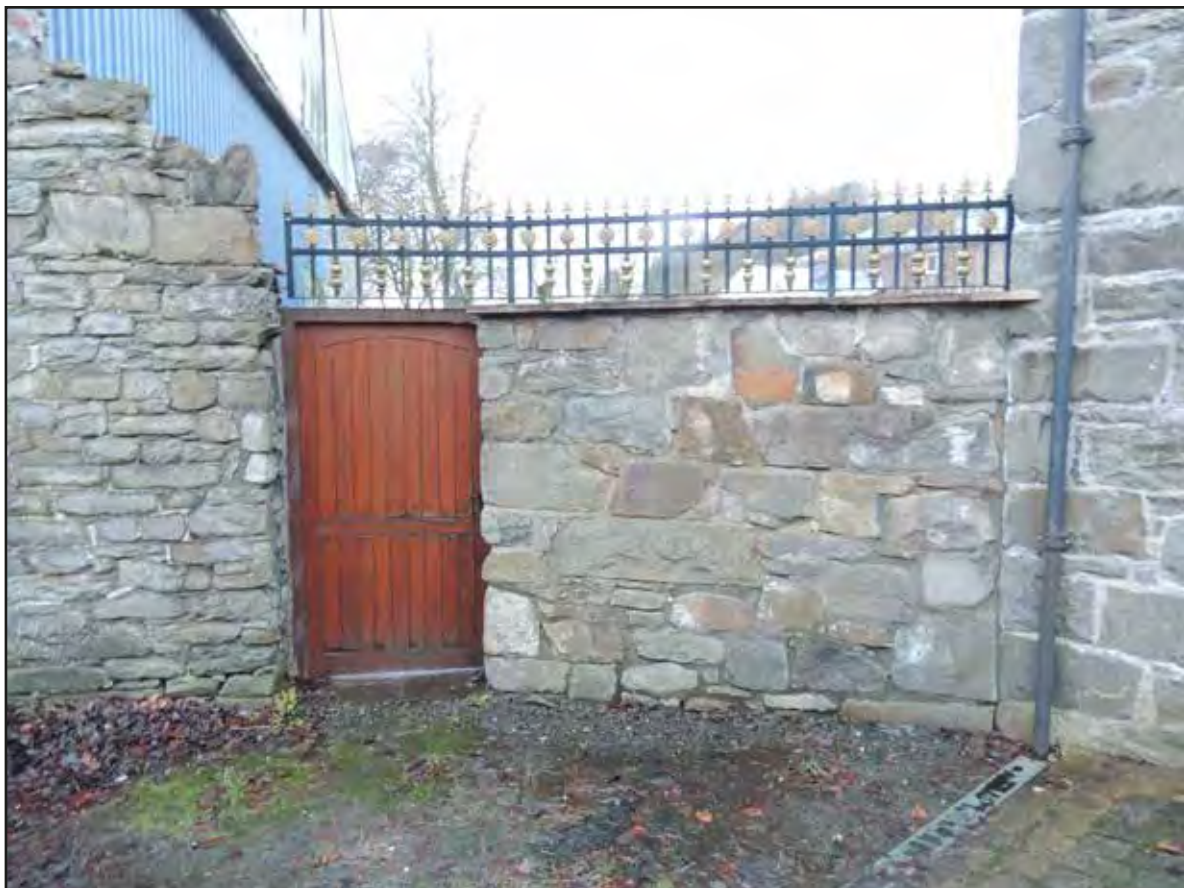
Plate 8 (below): Detail of Bridgend Garden entrance. Looking SW.

A door that gives access to Bridgend Mill Garden is located on this elevation too. At this point, it becomes evident that the wall of this elevation once adjoined the two mills but was demolished sometime before 1943, creating a separation between the two buildings. This is also observed when observing the roof. The addition would have formed a slate gable roof with Bridgend Mill. The main beam that would have sustained the roof still is noticeable.

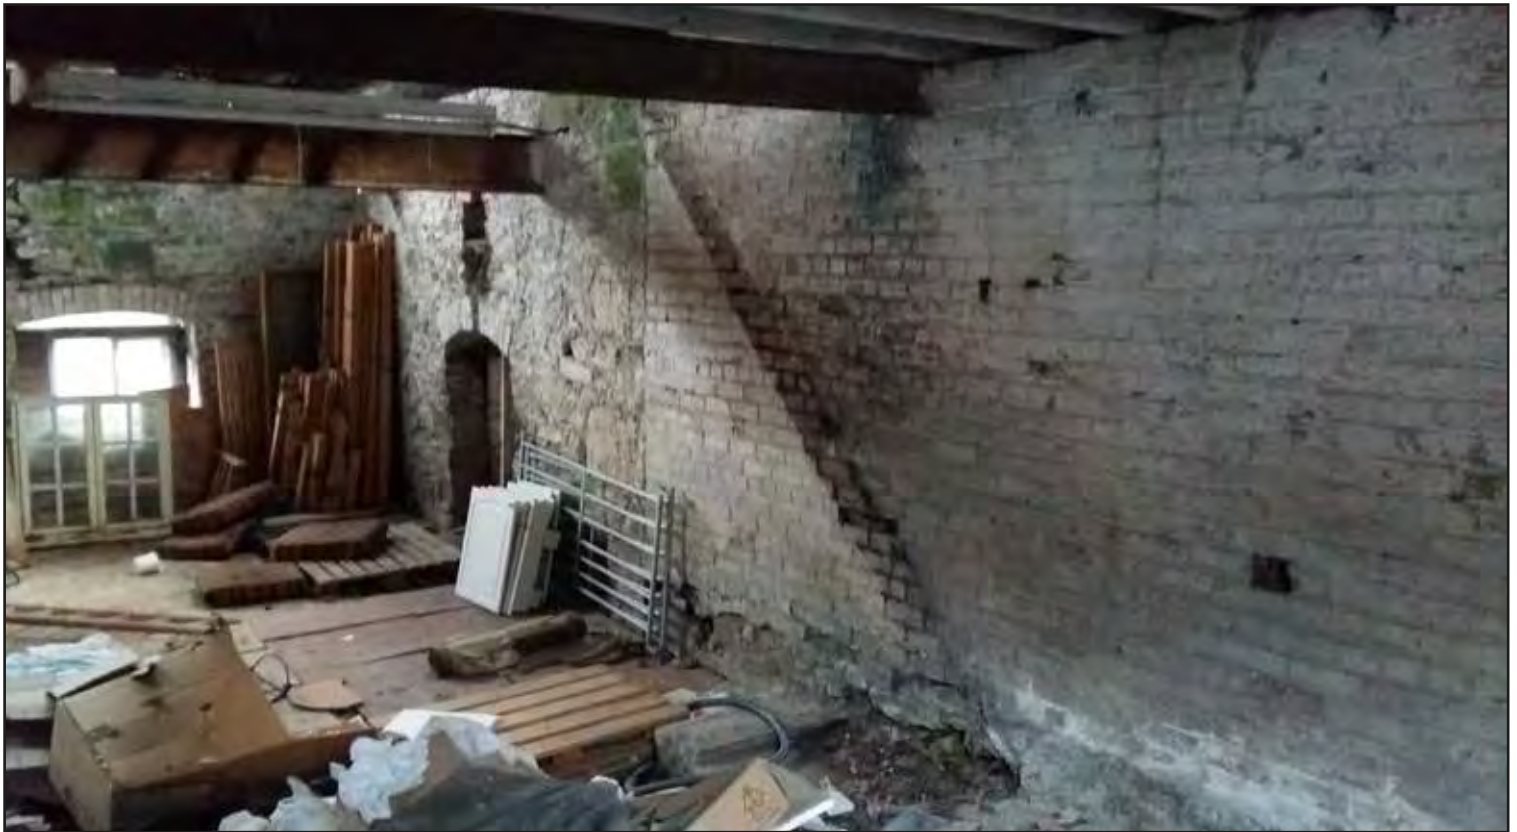
Plate 20 (below): View of NE elevation with brick wall and rubble masonry wall.

NE elevation: As noted, this elevation is defined by a brick wall and a rubble masonry wall. Both elevations are currently covered with white render. An opening is located on the rubble masonry wall. This opening is currently blocked by wooden boards and it is therefore difficult to provide much detail about it. A segmental brick arch is located above this opening. The brick wall contains no openings and it is currently covered by timber boards from outside. A number of main beams are attached to these walls, forming the base for the first floor.

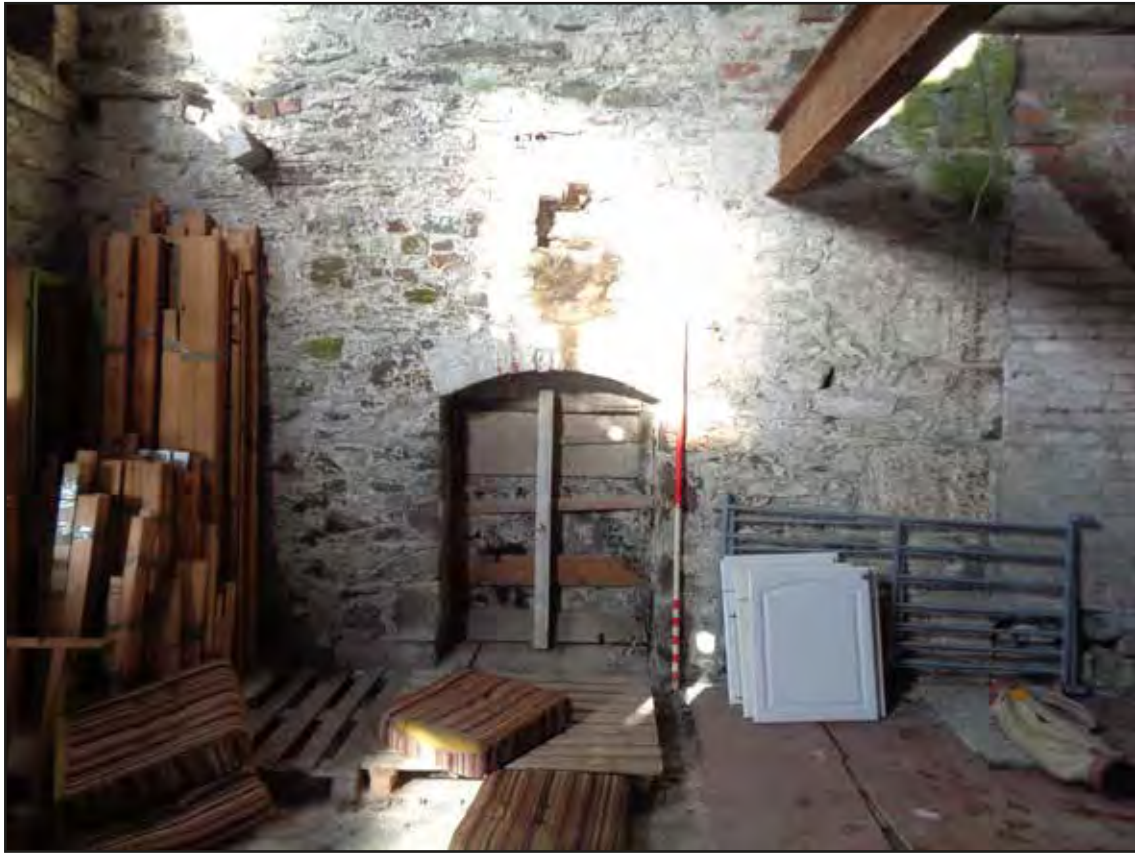
Plate 21 (above): Opening through rubble masonry wall. NE elevation.

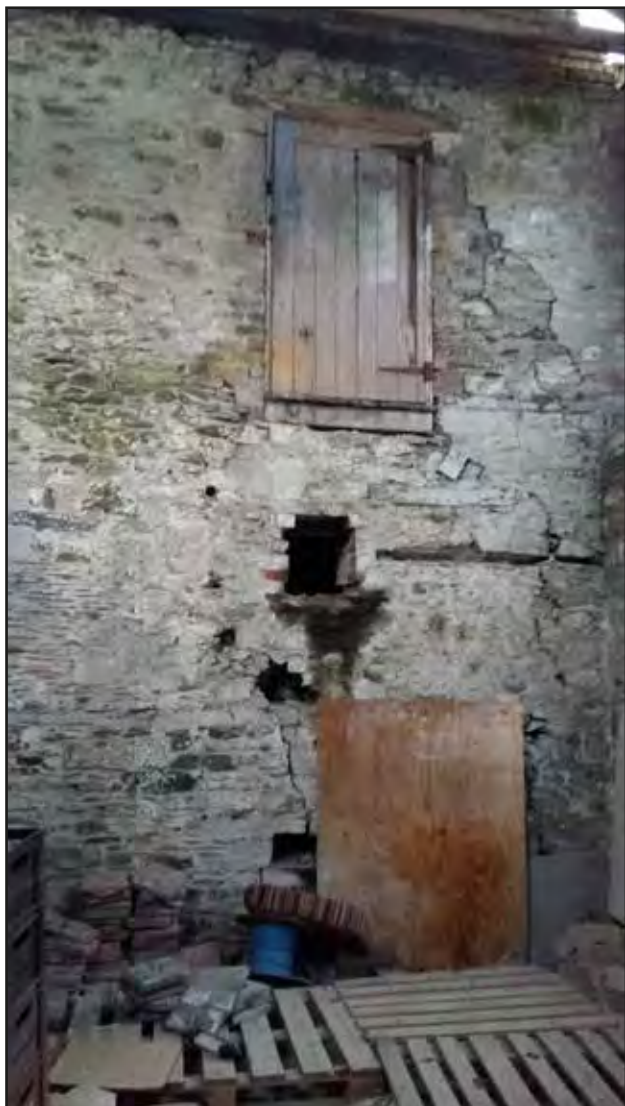
Plate 23 (above): Warehouse interior. Riverside elevation.

Riverside elevation: This elevation is defined by a rubble masonry wall with three window openings. Two windows are characterised by elongated openings within which wooden side hung casement windows are inserted, with unglazed two panelled glass. These windows are topped by segmental brick arches. The third window was rectangular and showed evidence of repair using red brick. All these openings are facing the river.

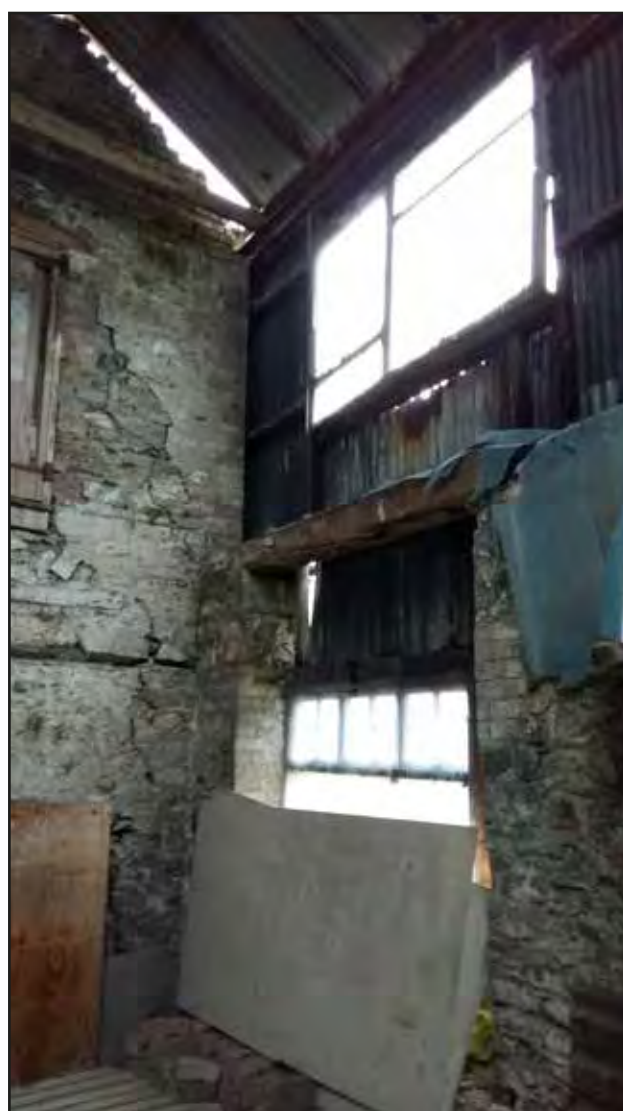
Plate 24 (below): Brick and rubble masonry wall. SW elevation.

The brick walls may correspond to the expansion of the old mill (Phase 3) toward the NW, predating the construction of Bridgend Mill. The SW and NE elevations would have been replaced by the attachment of this building to Bridgend Mill, expanding the interior space toward the river bank.

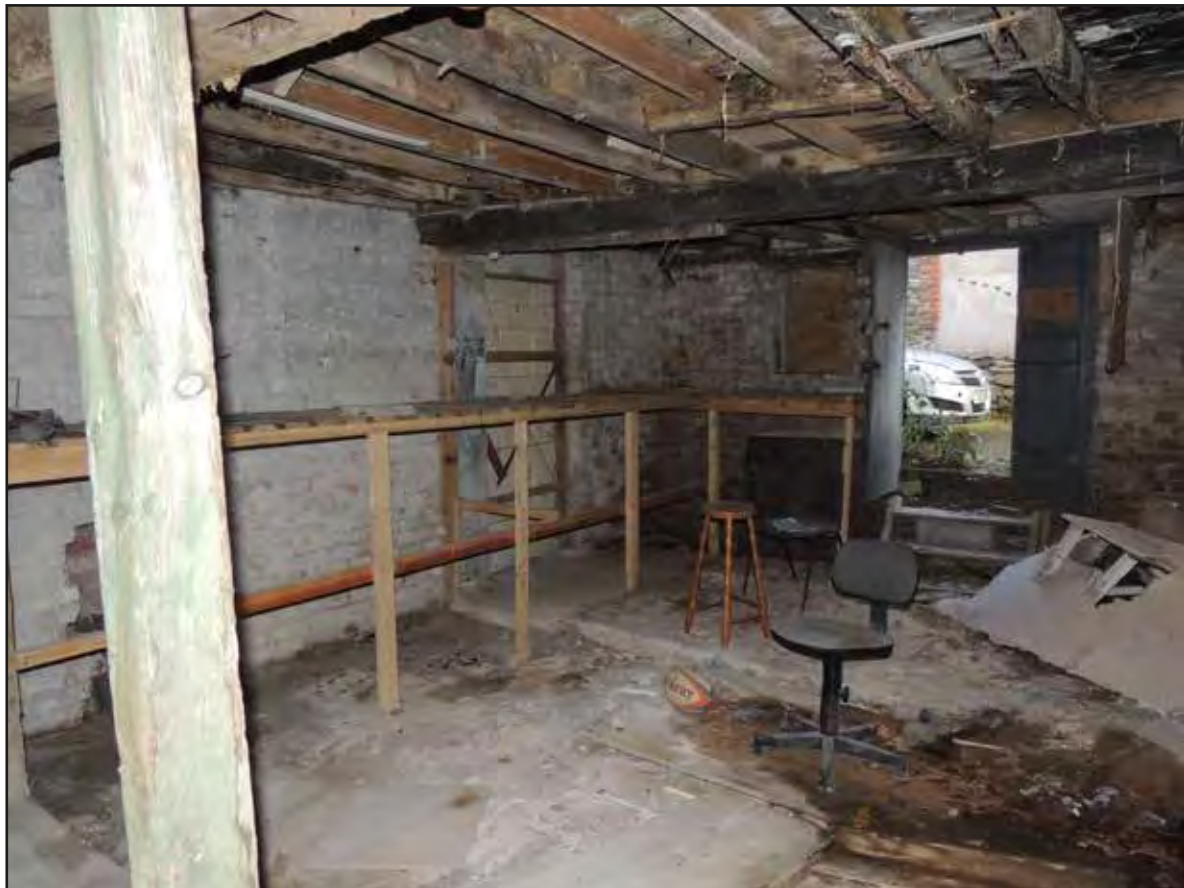
Plate 36 (below): View of old mill ground floor area, looking NNW.

Plate 36: This image shows the NW elevation. As noted, this is made of brick using English Garden Wall bond. A door is located on this wall, however it was not possible to obtain any details from it as it is currently blocked.

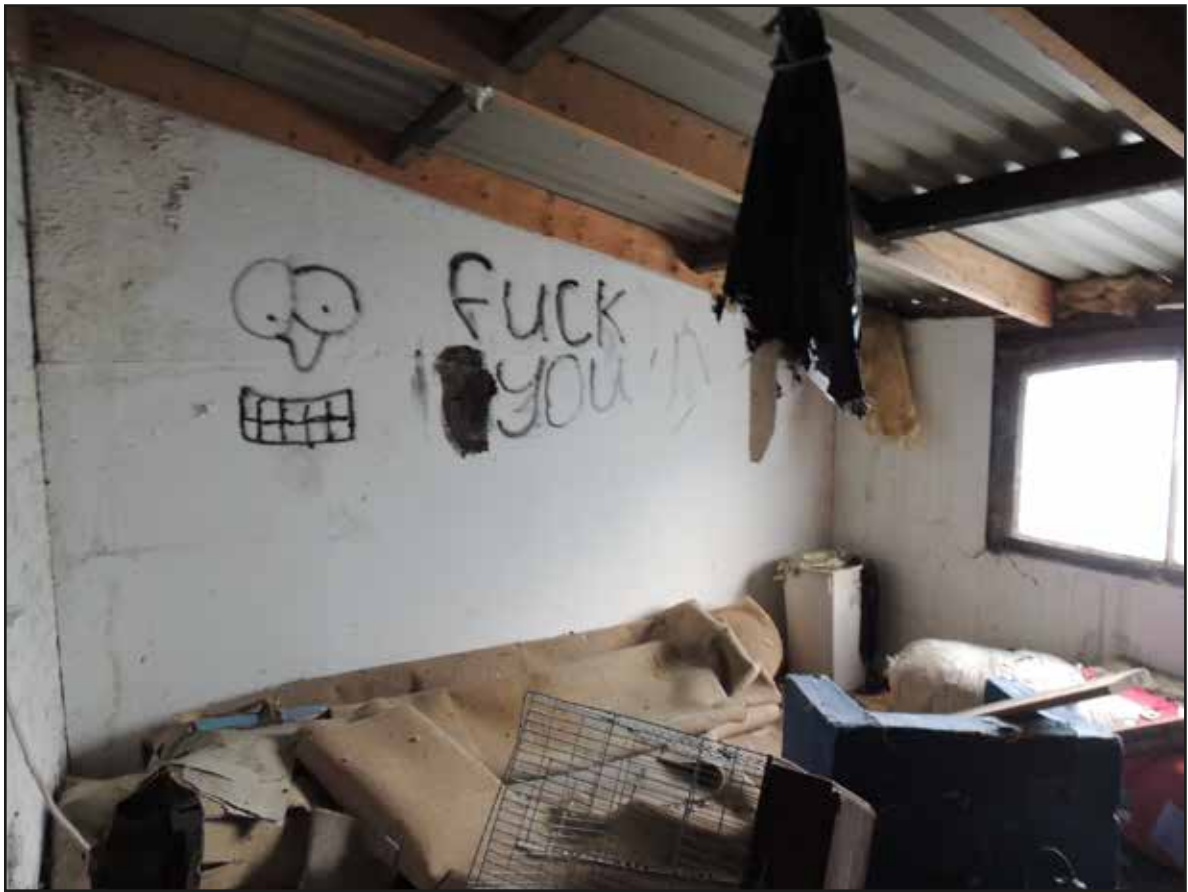
Plate 39 (above): SW lean-to, looking SE.

Phase 2: The only visible remains of this phase are located at the SW lean-to which enclosed the area of the wheel and mill race. This area was, in later years repaired using breeze blocks.

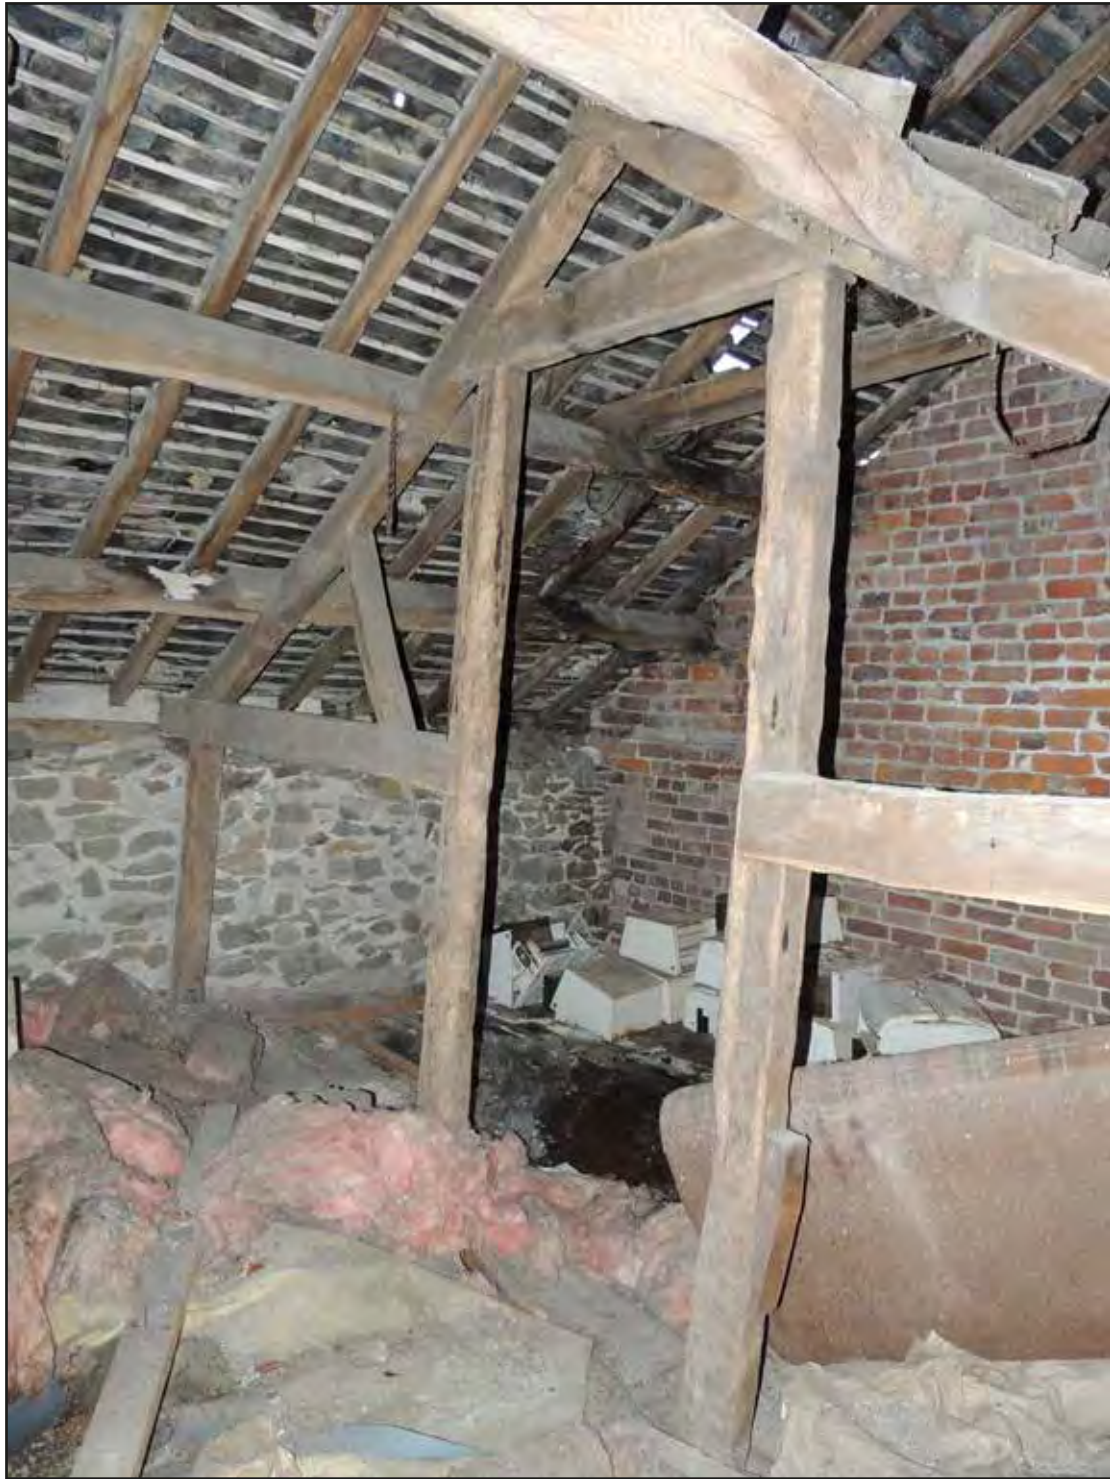
Plate 43: Old mill area, second floor. Truss detail.
